**PERFORMANCE EVALUATION OF THE
FREE-STANDING TEMPORARY BARRIER –
UPDATE TO NCHRP 350 TEST NO. 3-11
(2214TB-1)**

MwRSF Research Report No. TRP-03-173-06

October 11, 2006

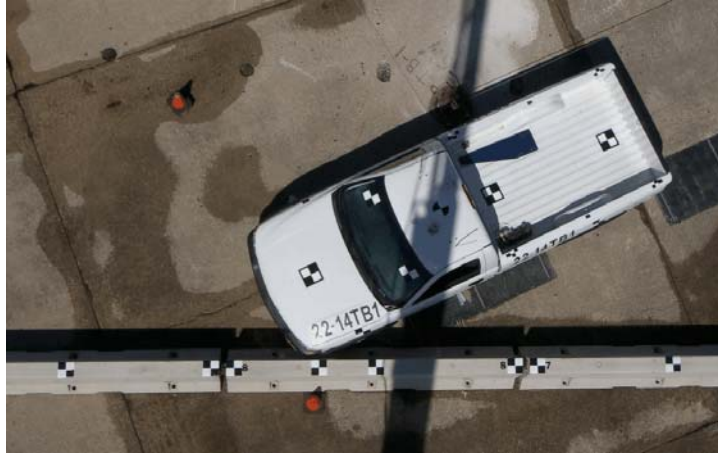
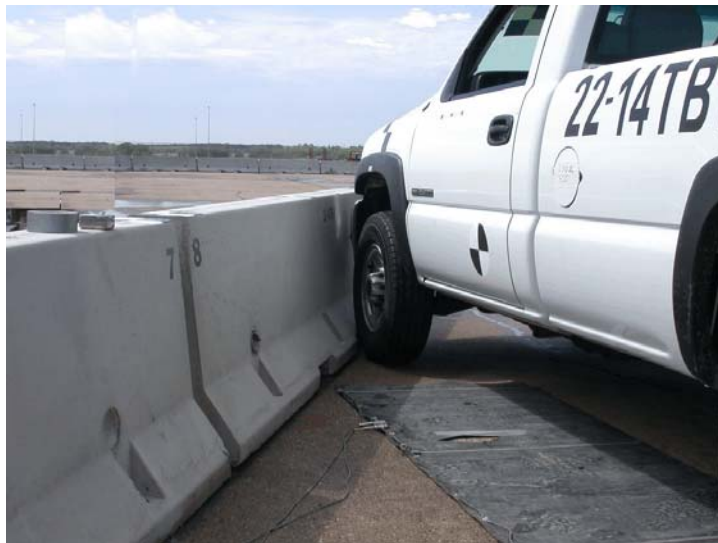
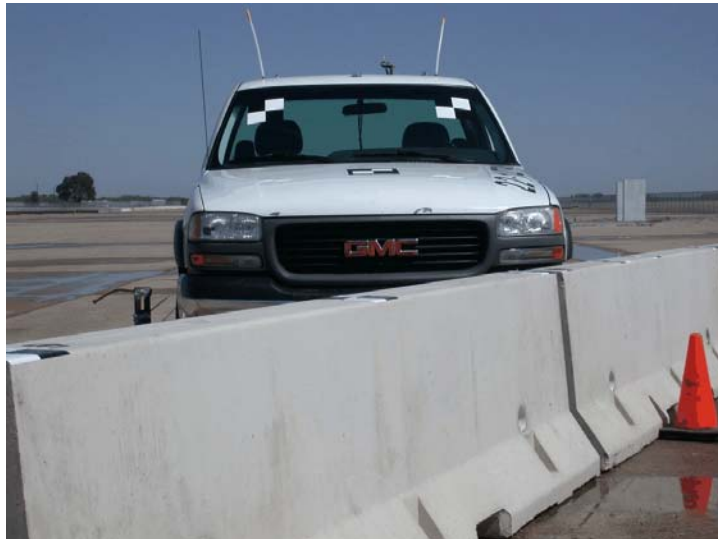
Figure 20. Impact Location, Test 2214TB-1

Initial vehicle impact was to occur 1,219 mm (48 in.) upstream from the center of the gap between barrier nos. 8 and 9, as shown in Figure 20. Actual vehicle impact occurred 1,645 mm (64.75 in.) upstream from the center of the gap between barrier nos. 8 and 9. At 0.010 sec after initial impact, the left-front corner crushed inward as the left-front corner of the hood protruded over the top of barrier no. 8. At 0.028 sec, concrete dust appeared as barrier no. 8 encountered damage from impact with the left-front tire. At this same time, the left-front quarter panel crushed. At 0.040 sec, barrier no. 8 deflected backward as the hood continued to protrude over the top of the barrier. At 0.060 sec, the left-front corner of the hood was located at the joint between barrier nos. 8 and 9. At this same time, barrier no. 9 began deflecting backward and a gap formed between the top of the left-side door and the rest of the vehicle's cab. At 0.084 sec, the hood deformed up and away from the rest of the vehicle. At this same time, vertical cracks appeared on the back side of barrier no. 9. At 0.120 sec, the left-front corner of the hood was located at the middle of barrier no. 9 as barrier nos. 8 and 9 continued to deflect backwards. At 0.150 sec, the left-front side of vehicle was

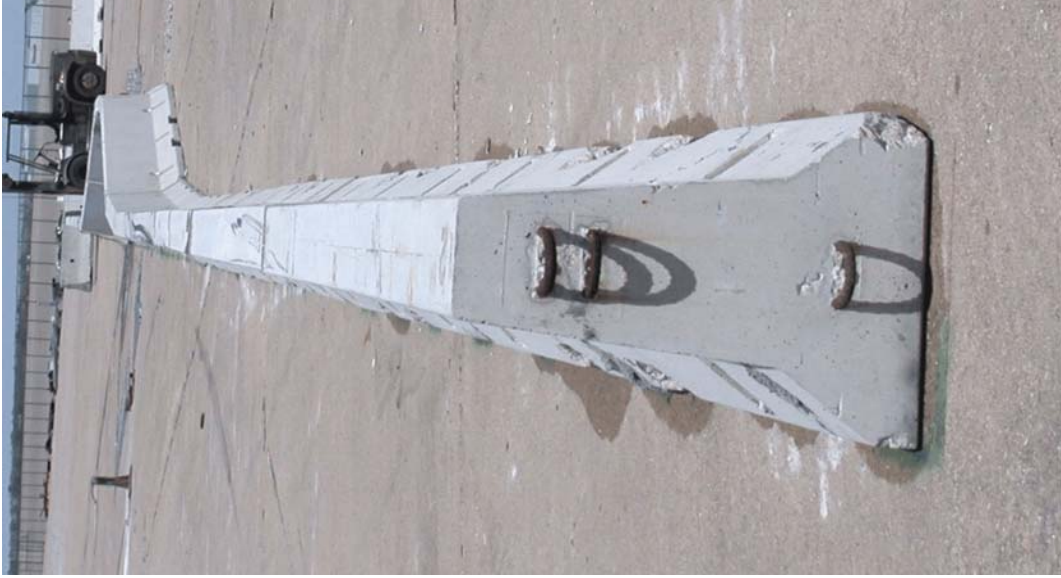
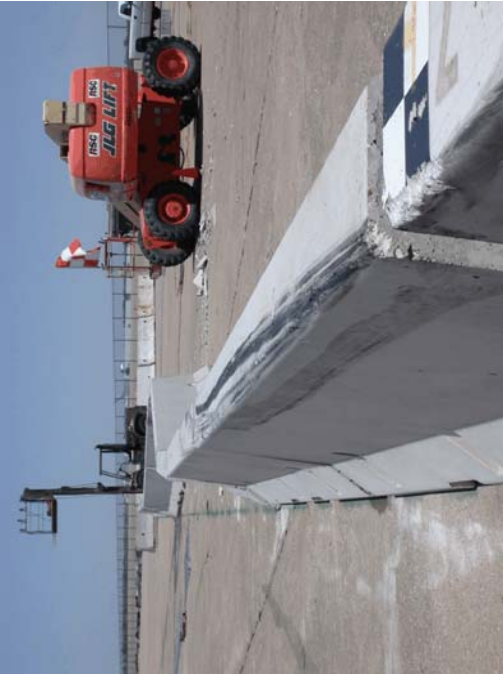
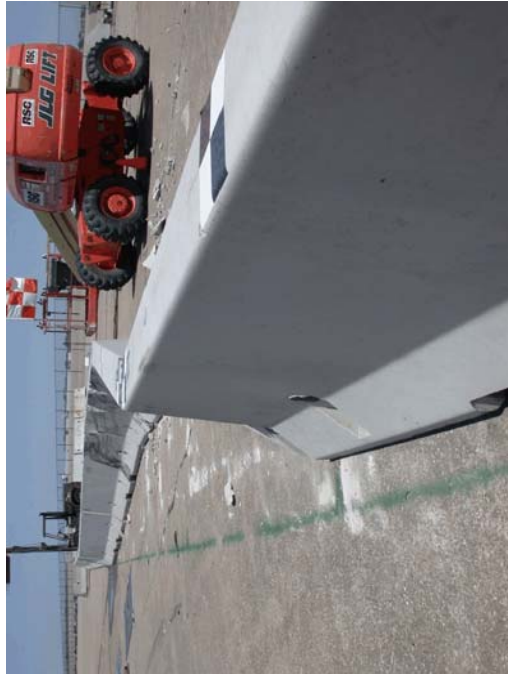
Figure 22. Temporary Barrier Damage, Test 2214TB-1

Damage to the barrier was moderate, as shown in Figures 22 through 26. Barrier damage consisted of contact and gouge marks, concrete barrier cracking, and spalling of the concrete. The length of vehicle contact along the temporary concrete barrier system was approximately 30 m (98 ft), which spanned from 1,600 mm (63 in.) upstream from the downstream end of barrier no. 8 through 864 mm (34 in.) downstream from the upstream end of barrier no. 16.

Concrete spalling occurred at impact on barrier no. 8. The lower-front corner at the downstream end of barrier no. 8 was fractured and separated. The front upstream edge of barrier no. 9 encountered concrete spalling 305 mm (12 in.) from the top of the barrier and was approximately 76 mm (3 in.) long. Concrete spalling found on the backside of the upstream end of barrier no. 9 was 102 mm (4 in.) wide and 483 mm (19 in.) long starting at the top of the barrier. Concrete spalling was found on the bottom-front face 965 mm (38 in.) downstream from the upstream end of barrier no. 9 and was 330 mm (13 in.) wide by 203 mm (8 in.) tall. A 305-mm (12-in.) wide piece of concrete was separated from the top of barrier no. 9 and exposed the top rebar beginning 1,321 mm (52 in.) downstream from the upstream end of the barrier. Concrete spalling with an average width of 102 mm (4 in.) was located 2,540 mm (100 in.) downstream from the upstream end of barrier no. 9 and exposed the longitudinal rebar. Concrete spalling occurred from 1,803 mm (71 in.) to 2,540 mm (100 in.) downstream from the upstream end of barrier no. 9. A 191-mm (7.5-in.) long piece of concrete, with an average width of 279 mm (11 in.), was separated from barrier no. 9 beginning 2,540 mm (100 in.) downstream from the upstream end of the barrier and exposing the stirrup. The concrete on the backside of barrier no. 9 was completely fractured 1,422 mm (56 in.) downstream from the upstream end of the barrier. The backside of barrier no. 10 encountered significant spalling measuring 76 mm (3 in.) wide by 343 mm (13.5 in.) long starting at the top of the barrier. Minor concrete spalling was found 660 mm (26 in.) downstream from the upstream end of the barrier no. 10. An 89-mm (3.5-in.) wide by 203-mm (8-in.) long area of concrete spalling was found on barrier no. 10 beginning 1,829 mm (72 in.) downstream from the barrier's upstream end. Minor concrete spalling measuring 89 mm (3.5 in.) wide by 51 mm (2 in.) tall was found 114 mm (4.5 in.) upstream

from the downstream end of barrier no. 10. Minor spalling was also found on barrier no. 14.

Cracking was found on barrier no. 8 and began 1,372 mm (54 in.) upstream from the downstream end of the barrier and extended upward and slightly downstream along the front face of the barrier. This crack was also visible on the backside of barrier no. 8. Cracking occurred on both the front and back sides of barrier no. 9 beginning 686 mm (27 in.) downstream from the upstream end of the barrier. Two cracks were found 1,270 mm (50 in.) downstream from the upstream end of the barrier and began at the upper-left corner of the upstream lifting slot propagating up and around to the back side of the barrier. Another crack on barrier no. 9 occurred 1,562 mm (61.5 in.) downstream from the upstream end of the barrier at the upper-right corner of the upstream lifting slot. Minor cracking in barrier no. 9 occurred on the top and back side at 2,032 mm (80 in.) downstream from the upstream end of the barrier. Cracking was found on barrier no. 10 beginning at the upper-left corners of both lifting slots and propagating upward to the top of the barrier. Barrier no. 11 encountered a small crack which began at the upper-left corner of the downstream lifting slot and propagated to the midpoint of the top face of the barrier.

The connection pin between barrier nos. 8 and 9 was bent 102 mm (4 in.) from the top of the pin. The connection pin between barrier nos. 9 and 10 was bent approximately 127 mm (5 in.) from the bottom of the pin. The connection pins between barrier nos. 10 and 16 remained undamaged, but were lodged in the joints. No noticeable deformations were found on the barrier joint loops.

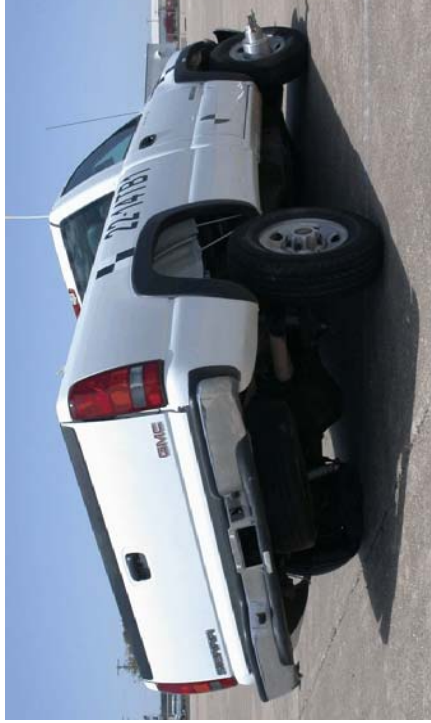
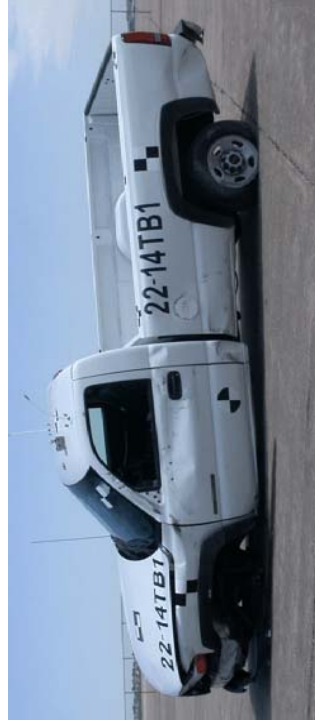
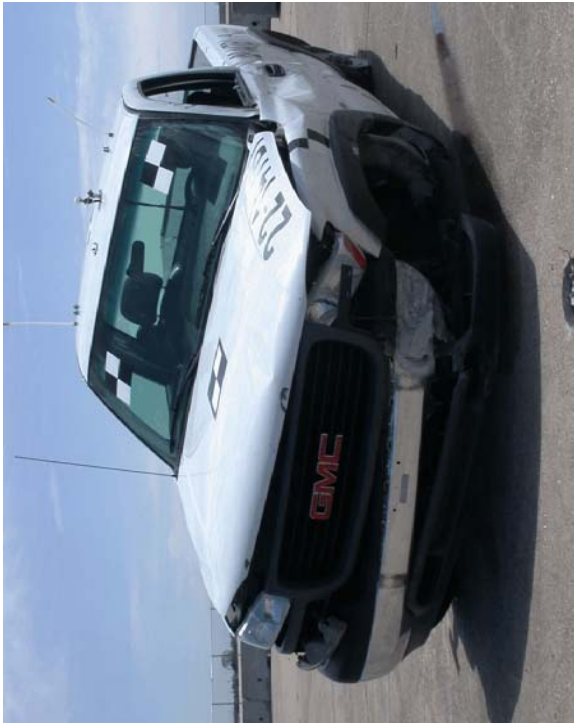
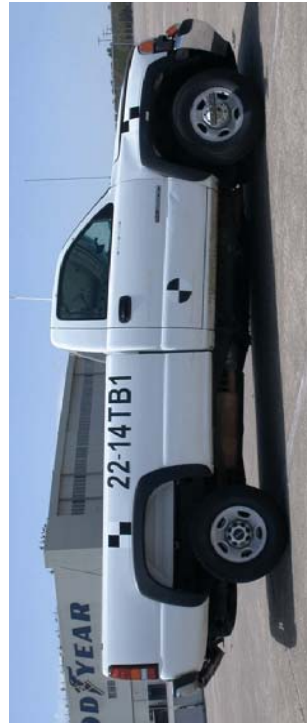
Figure 27. Vehicle Damage, Test 2214TB-1

Exterior vehicle damage was moderate, as shown in Figures 27 through 29. Occupant compartment deformations to the left side and center of the floorboard were judged insufficient to cause serious injury to the vehicle occupants. Maximum longitudinal deflections of 146 mm (5.75 in.) were located near the front center of the left-side floor pan. Maximum lateral deflections of 32 mm (1.25 in.) were located near the left-front corner of the left-side floor pan. Maximum vertical deflections of 64 mm (2.5 in.) were located near the left-front corner of the left-side floor pan. Complete occupant compartment deformations and the corresponding locations are provided in Appendix C.

Damage was concentrated on the left-front corner of the vehicle. The left-front quarter panel was deformed inward and downward toward the engine compartment. The left side of the front bumper was flattened and bent back toward the engine compartment nearly contacting the lower frame rail. The left-side door encountered a large dent below the window. The top of the left door was ajar. The cab encountered two dents right behind the left-side door. The box encountered numerous dents along the entire right side. The left-front wheel assembly deformed and crushed inward toward the engine compartment. The left-side lower ball joint, top ball joint, and steering linkage were fractured. The left-side sway bar and lower control arm connection was bent. The left-front tire disengaged from the rest of the wheel assembly. The left-front and left-rear steel rims were deformed and dented. The left-front and left-rear tires' side walls were torn, and the tires deflated. The left-side park light disengaged from the vehicle. The left-side door's window glass was

fractured and missing. The lower-right side of the windshield encountered minor cracking. All other window glass remained undamaged. The right side and rear of the vehicle remained undamaged.
