GUARDRAIL AND GUARDRAIL TERMINALS INSTALLED OVER CURBS - PHASE II

MIDWEST ROADSIDE SAFETY FACILITY

MwRSF Research Report No. TRP-03-105-00

November 5, 2001

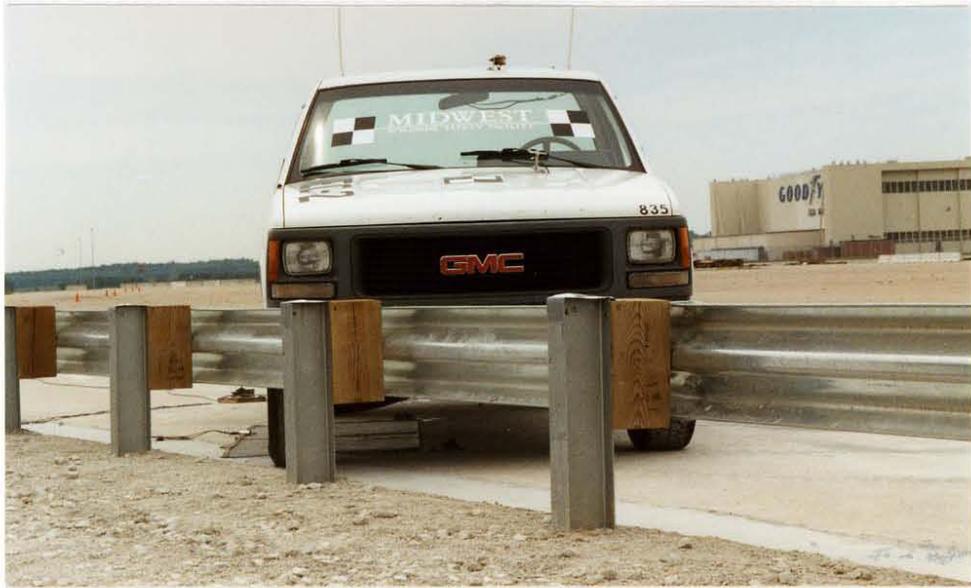
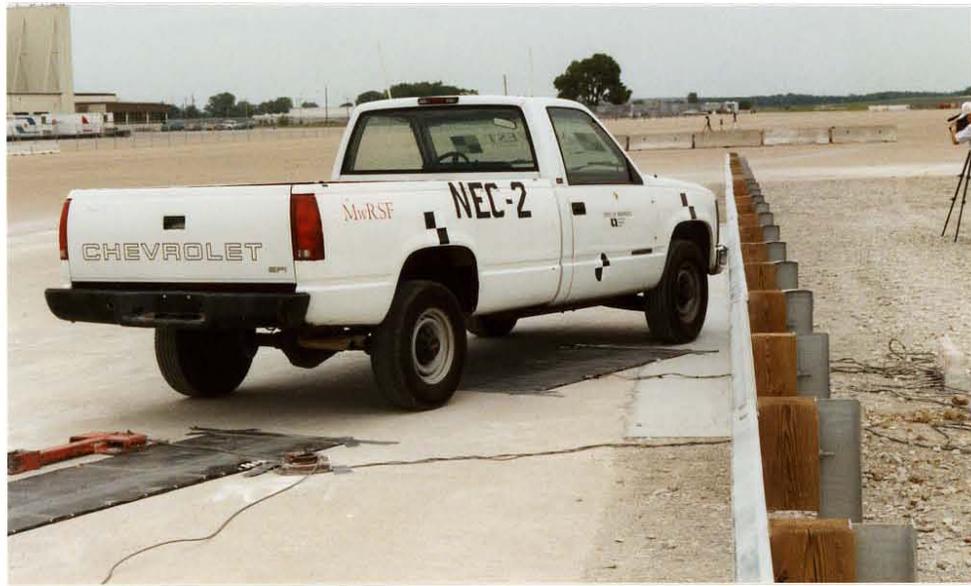
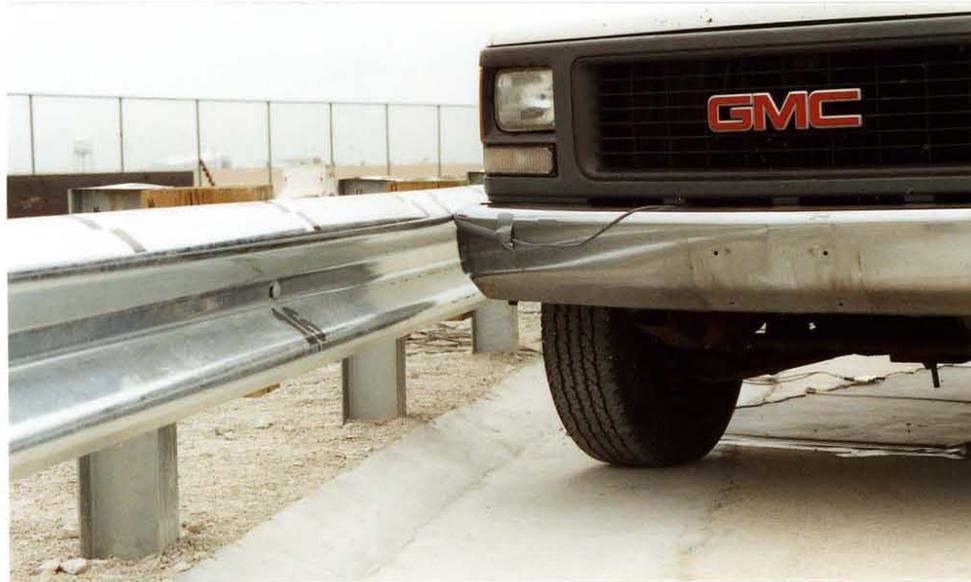
Figure 14. Impact Location, Test NEC-2

Damage to the barrier was moderate, as shown in Figures 15 through 25. Actual vehicle impact occurred 356-mm downstream from the center of post no. 17. Barrier damage consisted mostly of deformed guardrail posts, contact marks on a guardrail section, and deformed W-beam rail.

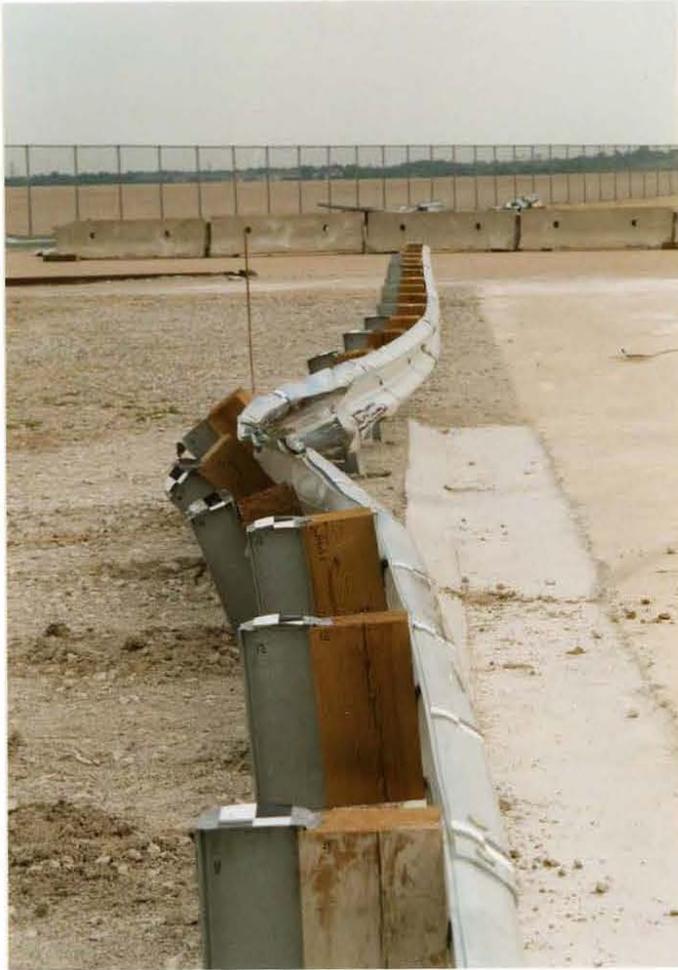
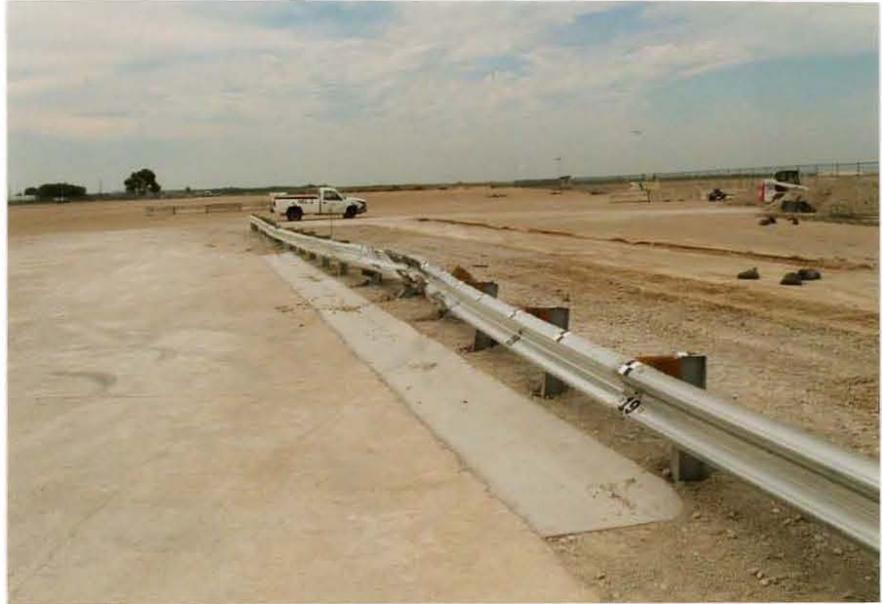
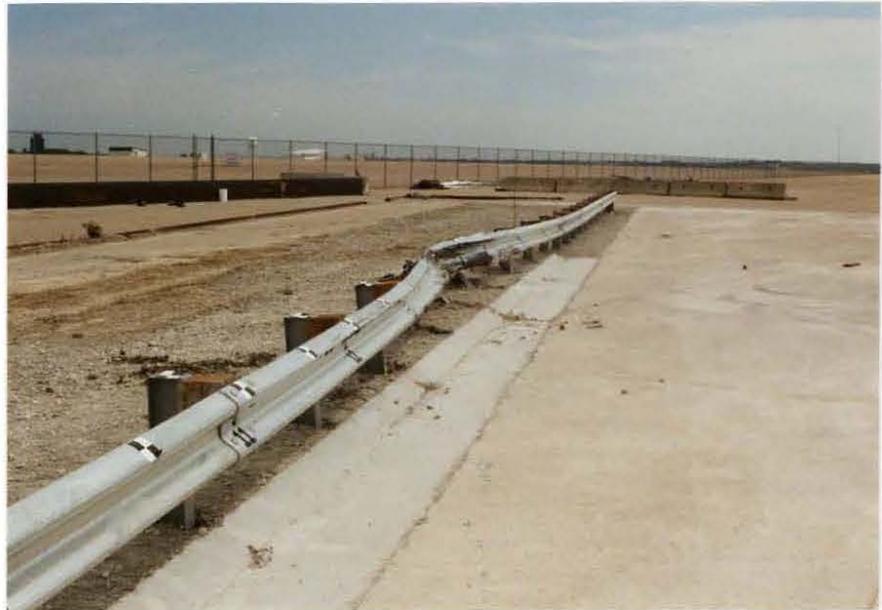
Figure 15. Guardrail Over Curb System Damage, Test NEC-2

The guardrail damage consisted of moderate deformation and flattening of the W-beam rail between post nos. 13 and 17. Contact marks were found on the guardrail between post nos. 3 through 4 and 6 through 17. The top of the guardrail was buckled at post nos. 13 and 14. The lower edge of the guardrail at post no. 14 was also buckled. The W-beam was pulled off of post nos. 7, 8, 14, 16, and 22. No significant guardrail damage occurred upstream of post no. 18 nor downstream of post no. 5.

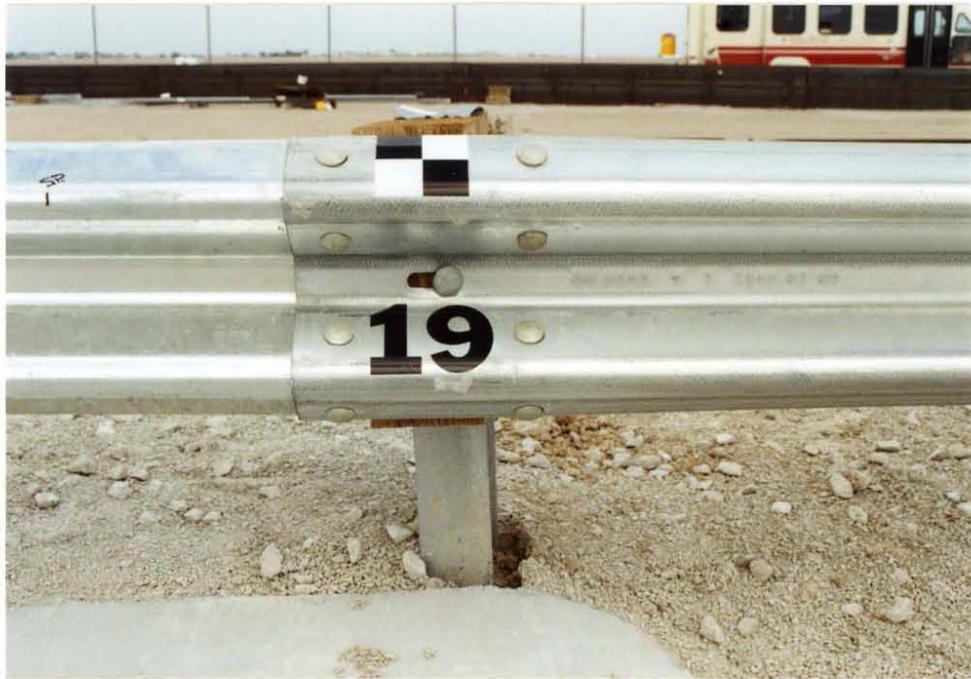
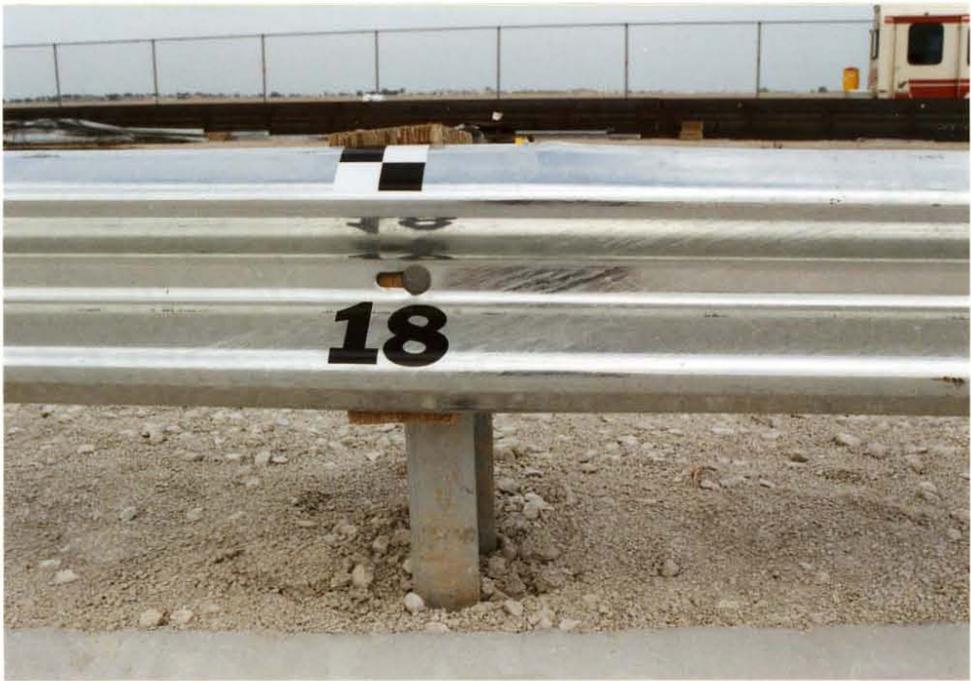
Figure 17. Guardrail Over Curb System Rail and Post Damage, Test NEC-2

Steel posts, post nos. 14 through 19, were twisted and bent toward the ground. Five steel posts, post nos. 7 through 9, 12, and 13, were bent toward the ground without rotating. Seven other steel posts, post nos. 20, 21, and 23 through 27, were slightly rotated and moved in the soil. The wooden blockouts at post nos. 8 and 17 encountered heavy contact and were damaged. The downstream and upstream BCT posts, post nos. 1, 2, 28, and 29, remained undamaged except for movement in the soil. No significant post damage occurred to post nos. 10, 11, 22, nor downstream

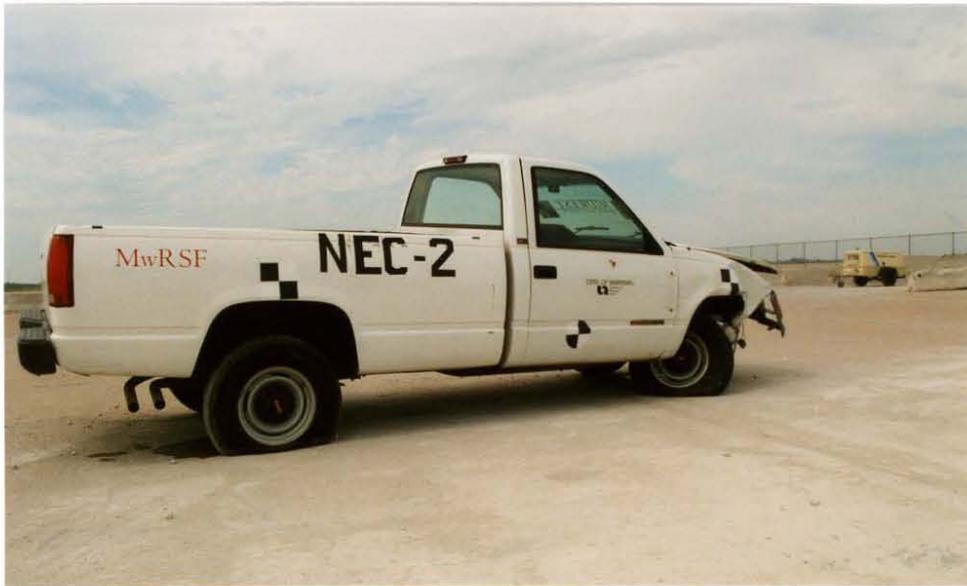
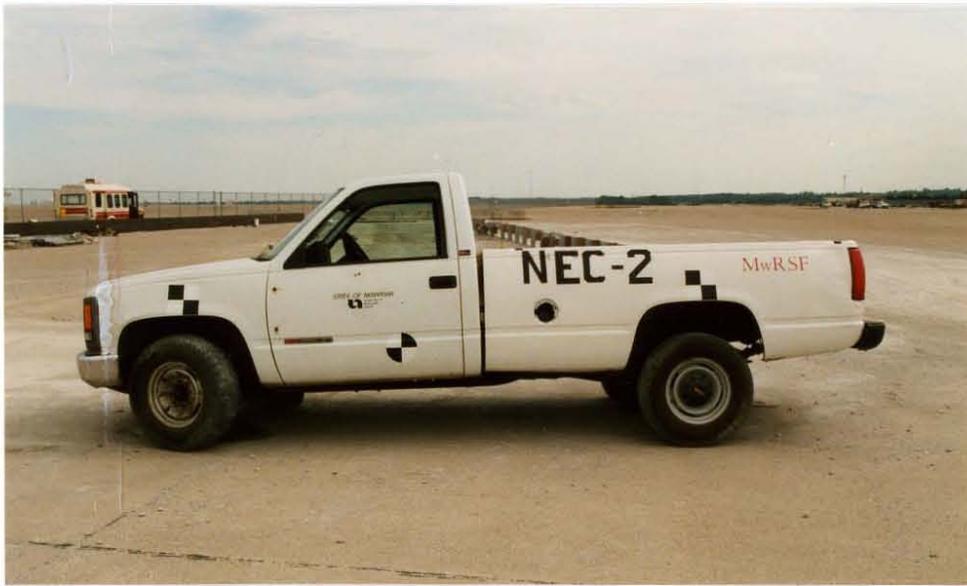
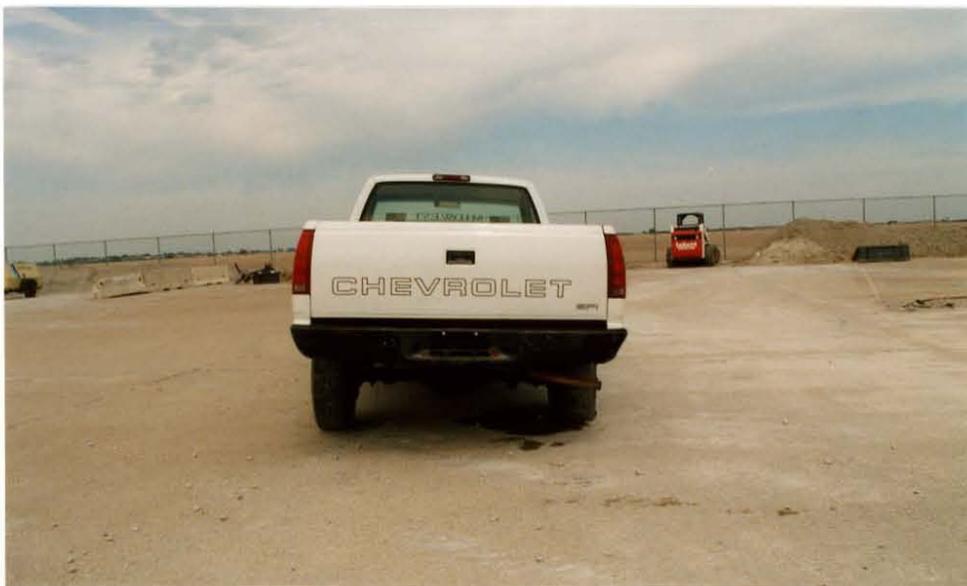
Figure 26. Vehicle Damage, Test NEC-2

Exterior vehicle damage was moderate, as shown in Figures 26 and 27. Occupant compartment damage was negligible. The vehicle experienced moderate frontal crush, as shown in Figure 27. The front bumper buckled at the centerline of the bumper and the right side was pushed back into the engine compartment. The right-front fender was dented and deformed. The right-front wheel assembly was deformed to approximately a 90-degree bend. The right-front and right-rear tires were deflated. Minor damage was found on the right-front steel rim. In addition, the right-front tie-rod disengaged, the right-rear shock mounts tore, and the drive shaft shifted to the left. The right side of the grill disengaged from the front of the vehicle. The right-side headlight was disengaged. The lower-front portion of the left-side fender was slightly damaged. The box was shifted slightly to the left. Deformation occurred to the left-front, right-front, and right-rear quarter panels. The roof, the hood, the right-side and left-side doors, and all the window glass remained undamaged.
