DEVELOPMENT OF THE GC-8000 BRIDGE RAILING AND TRANSITION

MwRSF Research Report No. TRP-03-161-06

May 2, 2006

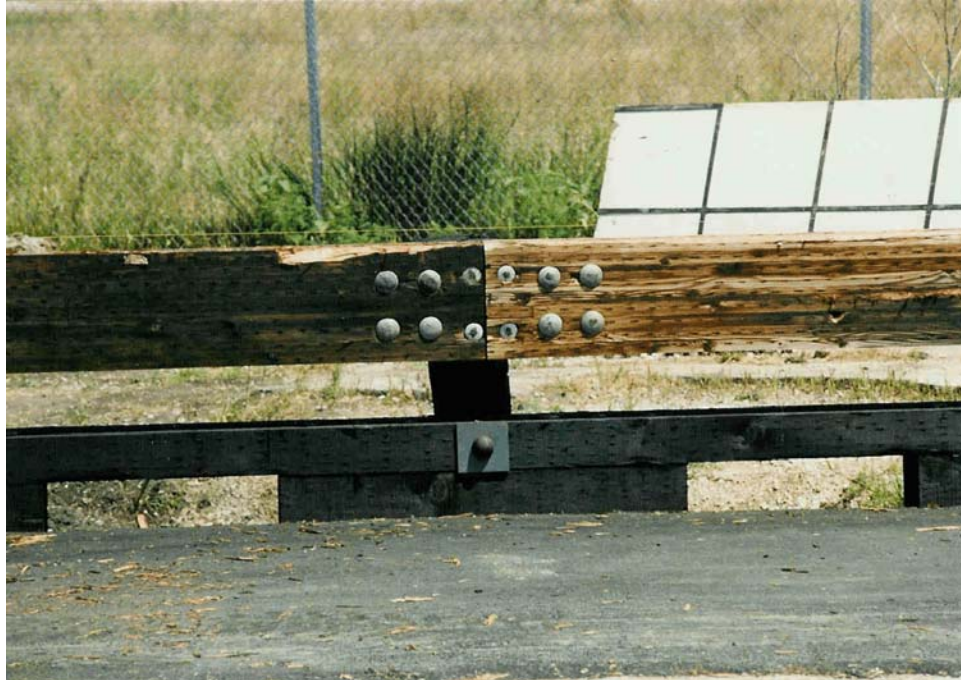
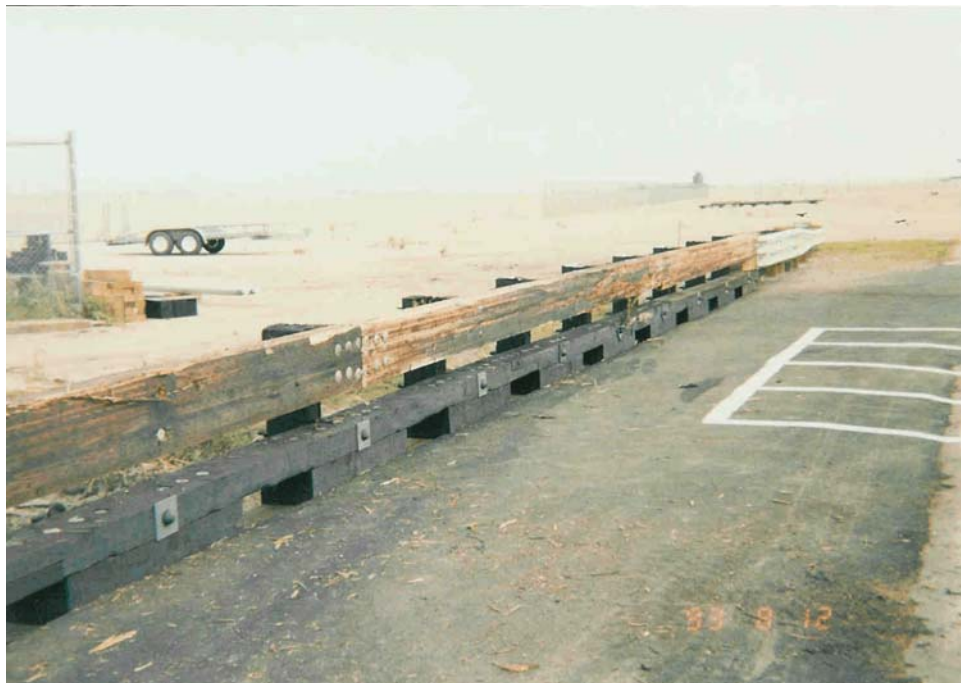
Post nos. 7 and 8 were damaged near the top of each post due to contact between the truck box and timber posts. Vehicle contact on post no. 8 was measured approximately 229 mm (9 in.)

Figure 52. Rail Damage at Post No. 8, Test FSCR-1

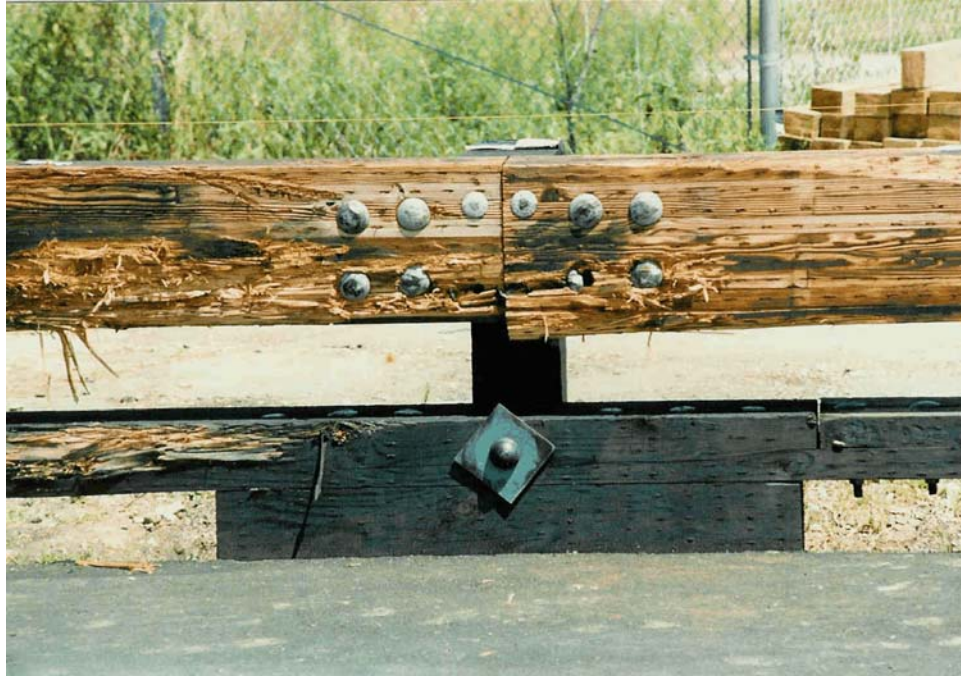
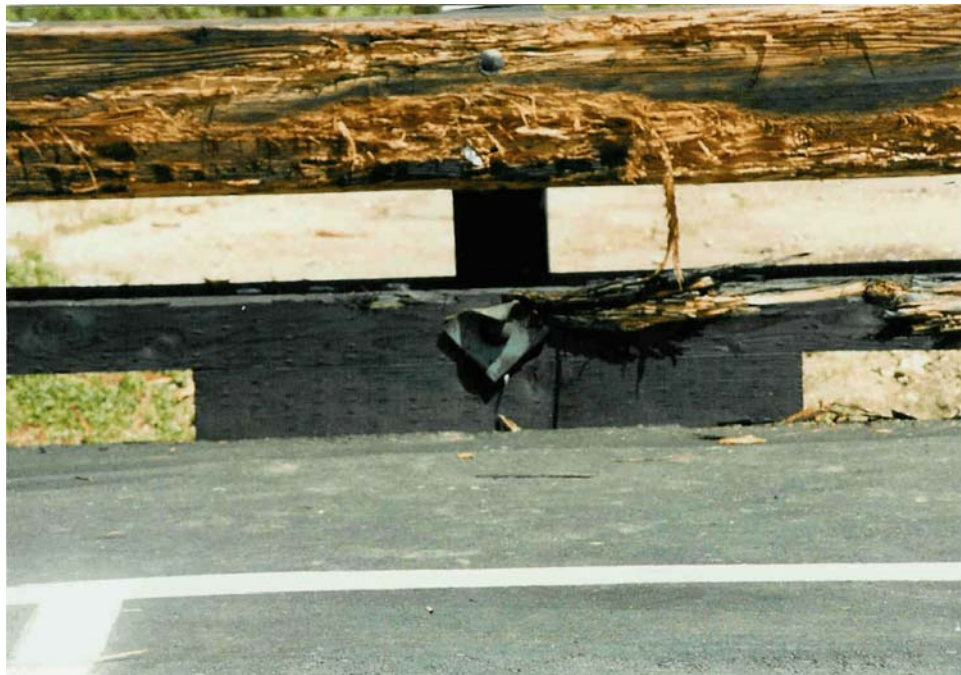
The moderate bridge railing damage is shown in Figures 51 through 59. Significant gouging and scrapes occurred to the glulam rail from the midspan between post nos. 3 and 4 to post no. 5. The curb rail received major gouges between post nos. 4 and 5. Minor scrapes were found on the glulam rail between post nos. 5 and 7. Major gouging and scrapes occurred to the top of the glulam rail from post nos. 7 through 12. Significant gouging and scrapes occurred to the glulam rail from the midspan between post nos. 12 and 13 to the midspan between post nos. 13 and 14, as shown in Figure 51. Minor scrapes were evident on the curb rail near post no. 13, as shown in Figure 51. The lower portion of the downstream end of glulam rail no. 1, located at post no. 4, was fractured on the lower part of the rail. Timber material was removed from the lower portion of the upstream end of glulam rail no. 2, also located at post no. 4. Three steel plate washers, located on the face of the curb rail at post nos. 4 through 6, were deformed due to wheel hub contact. At post nos. 4 and 5, the dome heads of several bolts on the rail face were deformed and/or severed due to vehicle gouging on the glulam rail, as shown in Figure 54.

Figure 54. Rail Damage at Post Nos. 4 and 5, Test FSCR-1

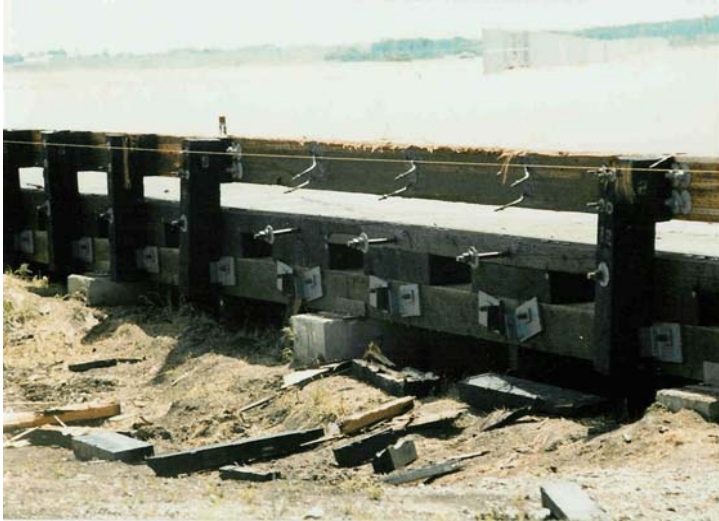
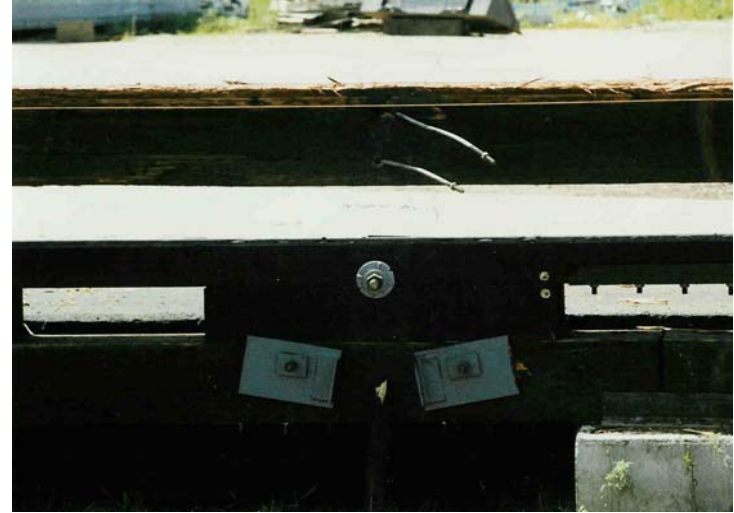
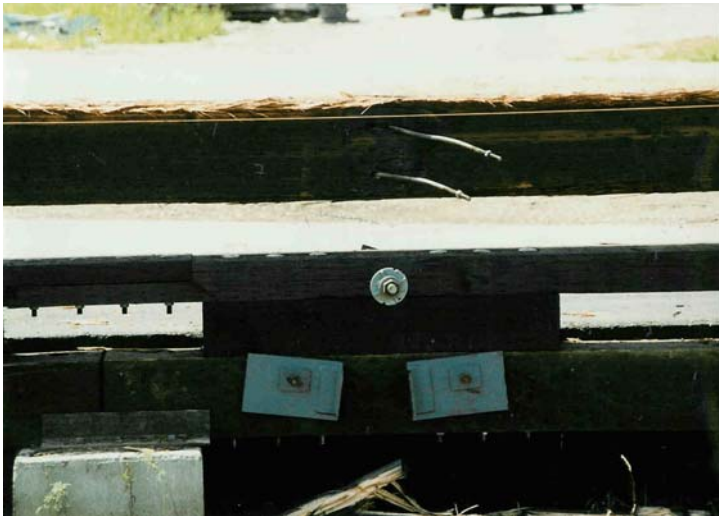
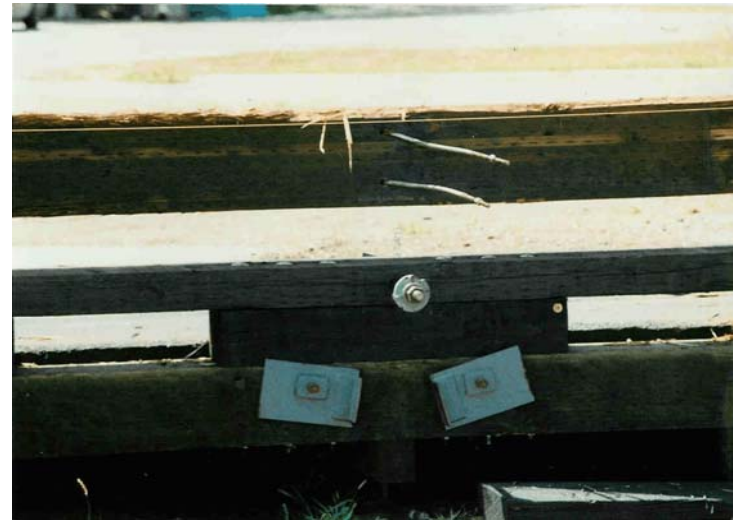
below the top of the post. Post nos. 9 through 11 were fractured away from the bridge rail due to the truck box extending over the rail and impacting the posts. Damage to the top of post no. 12 was the result of vehicle contact. Post no. 13 was fractured on the downstream side. Minor gouging and scrapes were evident on post no. 14. The top of post no. 15 was gouged from the truck box. The spacer blocks at post nos. 7 and 8 were scraped and fractured, respectively. The spacers at post nos. 9 through 11 were fractured and removed. The spacers at post nos. 12, 14, and 15 were also fractured.

Figure 56. Damage to Post Nos. 9 through 11, Test FSCR-1

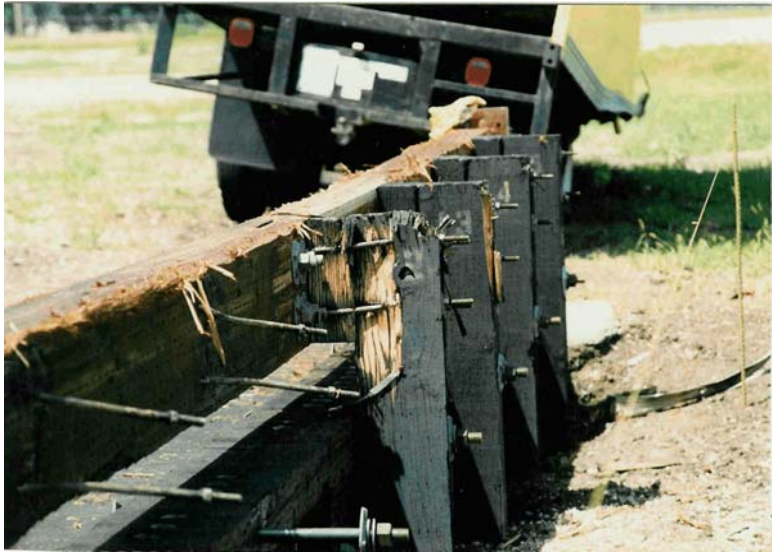
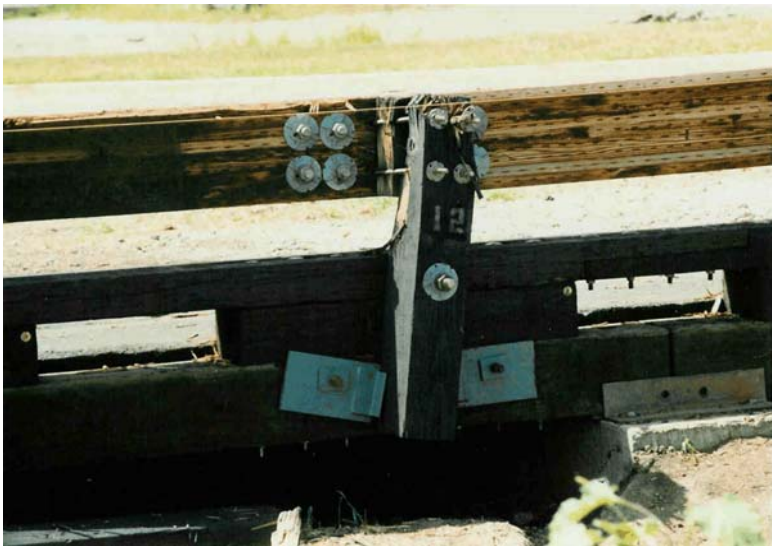
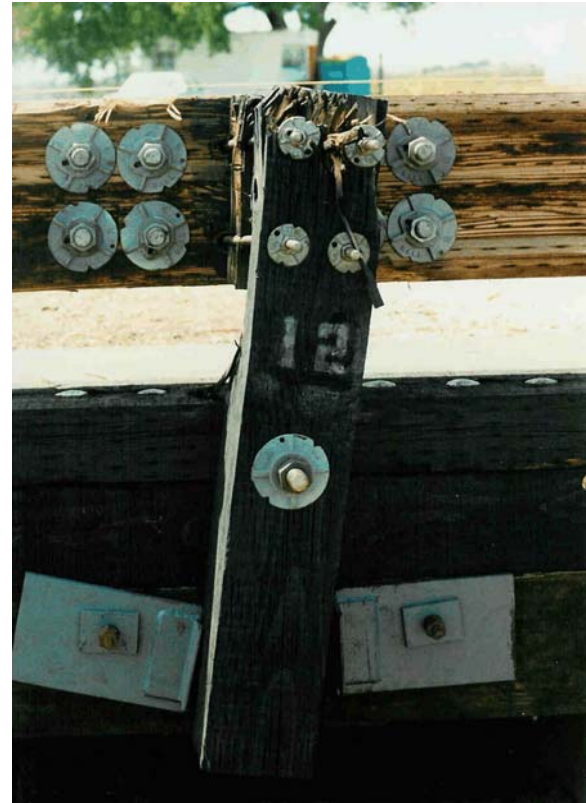
Figure 57. Post No. 12 Damage, Test FSCR-1

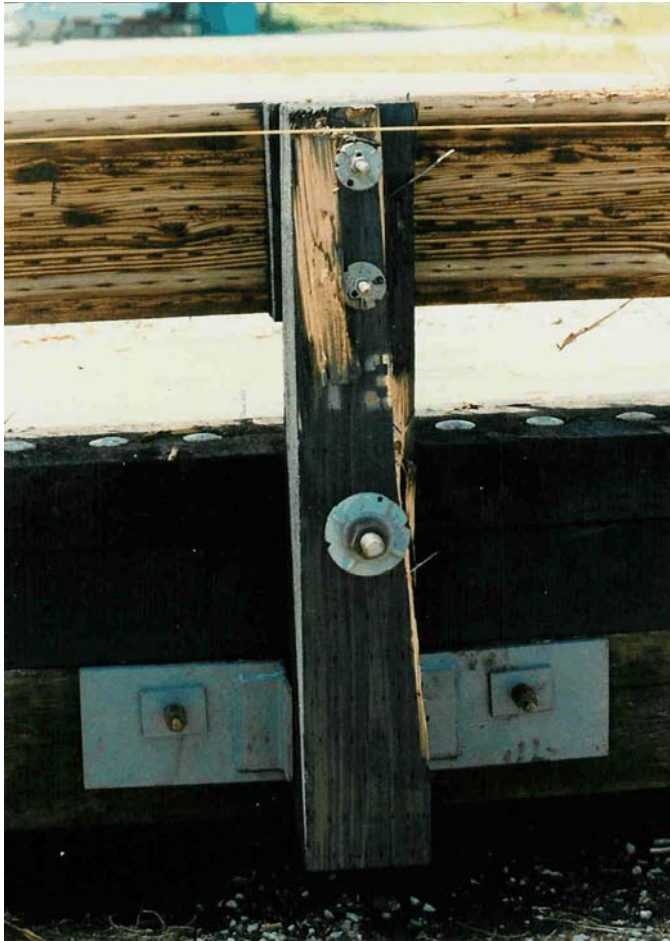
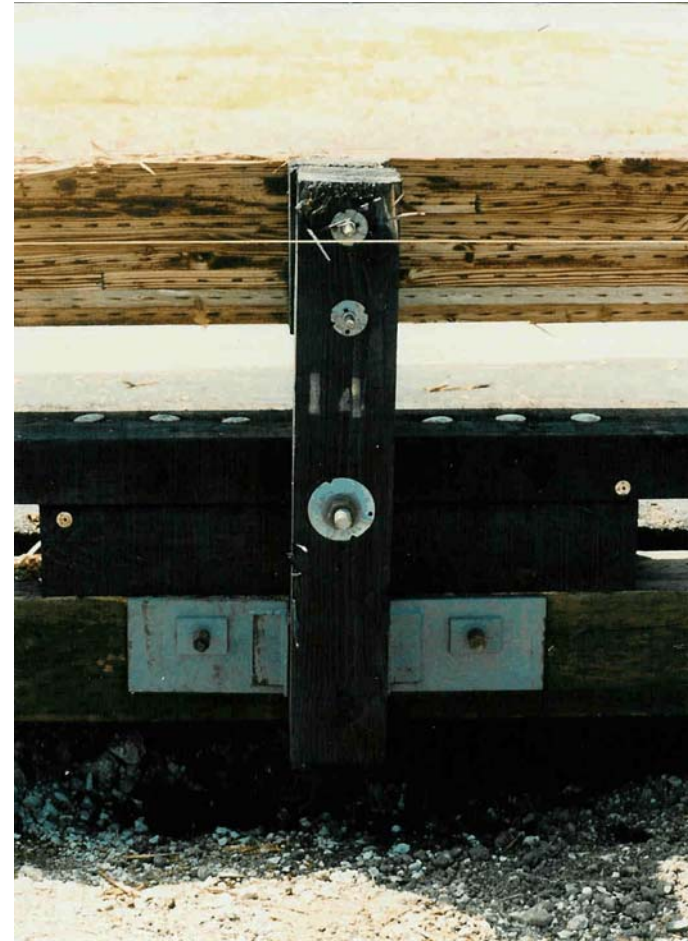
Figure 58. Damage to Post Nos. 13 and 14, Test FSCR-1

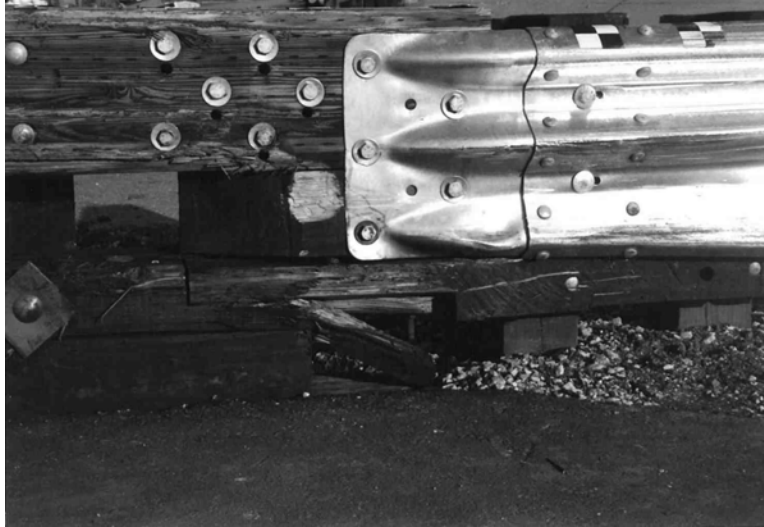
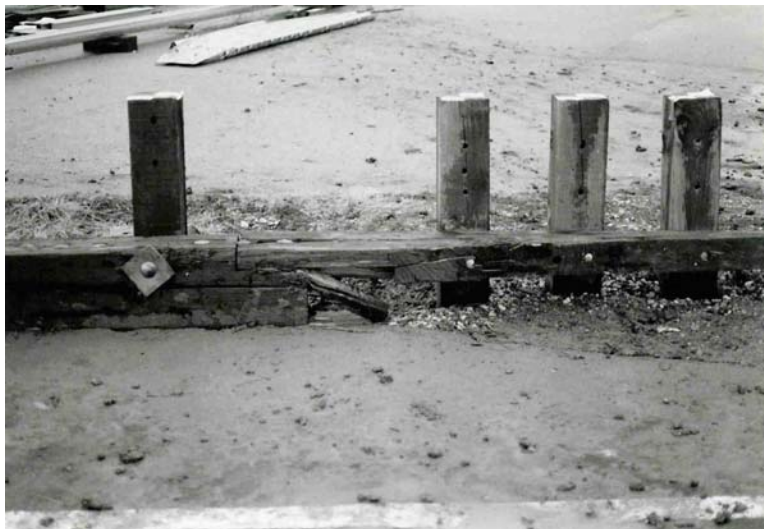
The moderate bridge railing damage is shown in Figures 75 through 79. Marks and scrapes were found on the thrie beam rail from post no. 1A to the end of the thrie terminal connector. Approximately one 1,905-mm (6-ft 3-in.) section of thrie beam was damaged. Most of the thrie deformation occurred on the lower corrugation, as shown in Figure 75. Vehicle contact with the curb rail was first evident at the location where the curb rail was blocked out 292 mm (11 ½ in.) away from the front face of the guardrail posts. The curb rail was fractured from post no. 1A to the downstream end of the splice connecting the transition curb rail to the bridge curb rail. The upstream end of the bridge curb rail was also fractured at the splice between the bridge and transition curb rails. Scrapes and gouging from vehicle contact were found on the upstream end of the glulam and curb bridge rails. Gouges were also found on the timber transition block located between the glulam and curb rails. No damage occurred to the guardrail posts or spacer blocks. However, the posts were rotated in the compacted aggregate soil mix. No damage occurred to the bridge posts or spacer blocks. Minor permanent set deflection was observed at bridge post no. 1. The steel plate washer, located on the front face of the curb rail at post no. 1, was deformed due to contact with the vehicle sheet metal on the right-side lower doors. A longitudinal centerline crack was found in the timber scupper block located at bridge post no. 1.

Figure 76. Curb Rail Damage, Test FSCR-2

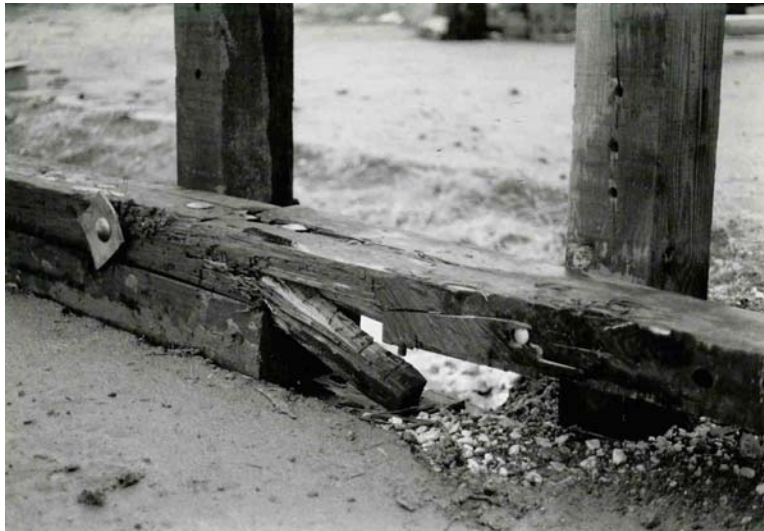
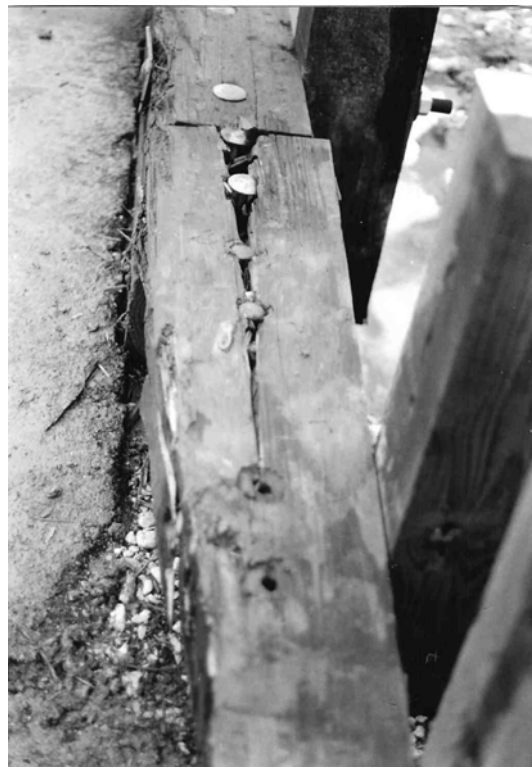
Figure 77. Curb Rail Damage, Test FSCR-2

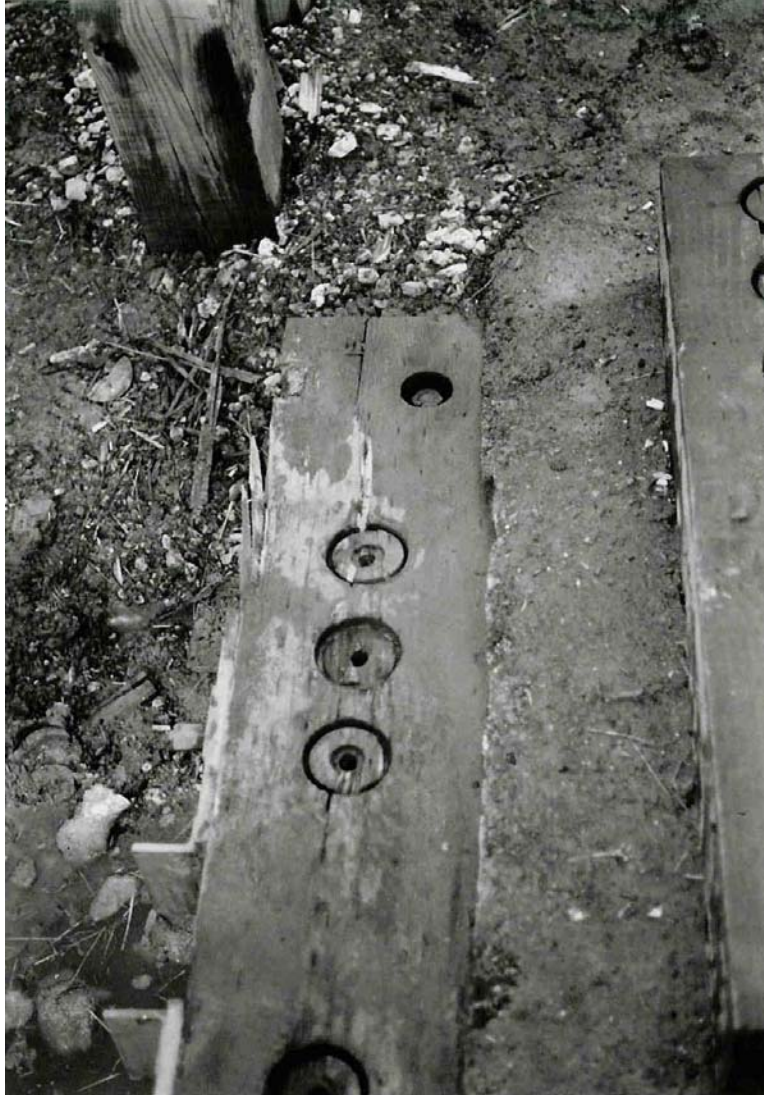
The glulam timber bridge deck received some surface cracking upstream from post no. 1. The crack width ranged between 1.59 and 3.18 mm ($\frac{1}{16}$ and $\frac{1}{8}$ in.). The maximum lateral permanent set deflections for midspan rail and post locations of the transition were approximately 74 mm (2.9 in.) and 81 mm (3.2 in.), respectively, as measured in the field. The maximum dynamic lateral deflections for midspan rail and post locations of the transition were 241 mm (9.5 in.) and 246 mm

Figure 78. Deck Cracking, Test FSCR-2

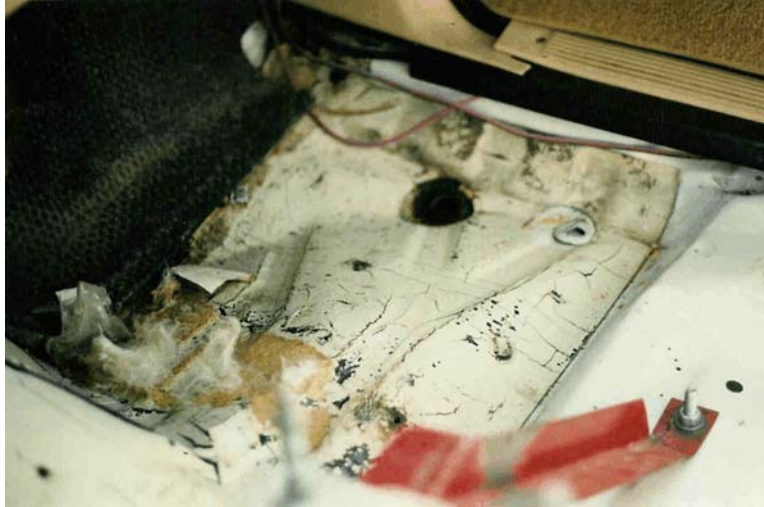
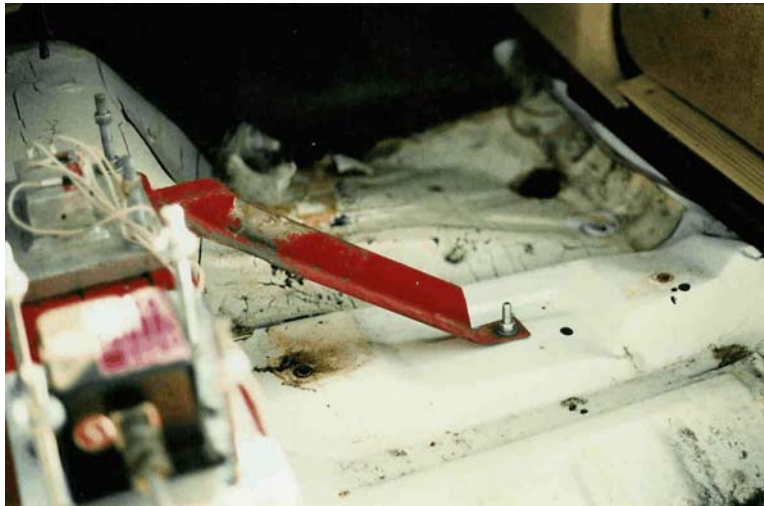
Exterior vehicle damage was moderate, as shown in Figures 80 through 82. Occupant compartment deformations to the right-front floorboard, as shown in Figure 83, were judged insufficient to cause serious injury to the vehicle occupants.

Figure 83. Occupant Compartment Deformation, Test FSCR-2

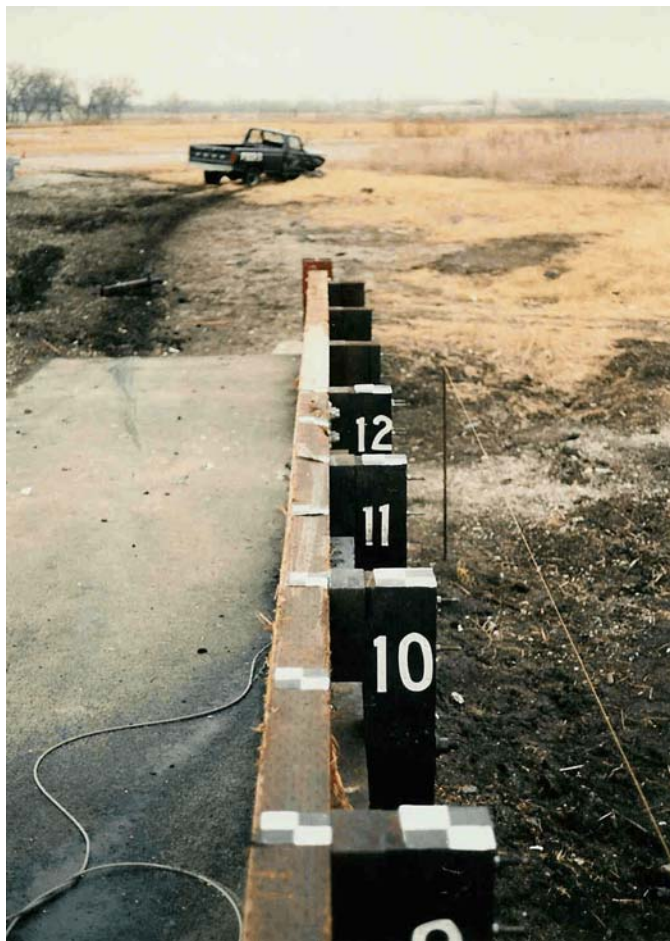
Figure 92. Bridge Rail Damage, Test FSCR-3

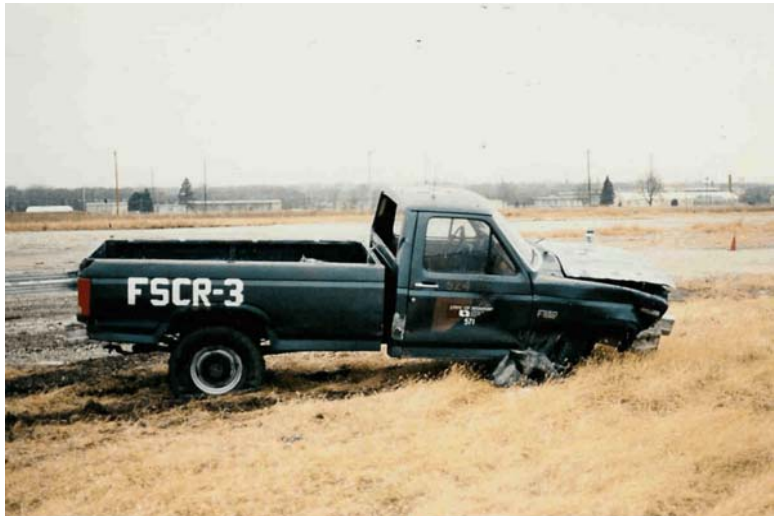
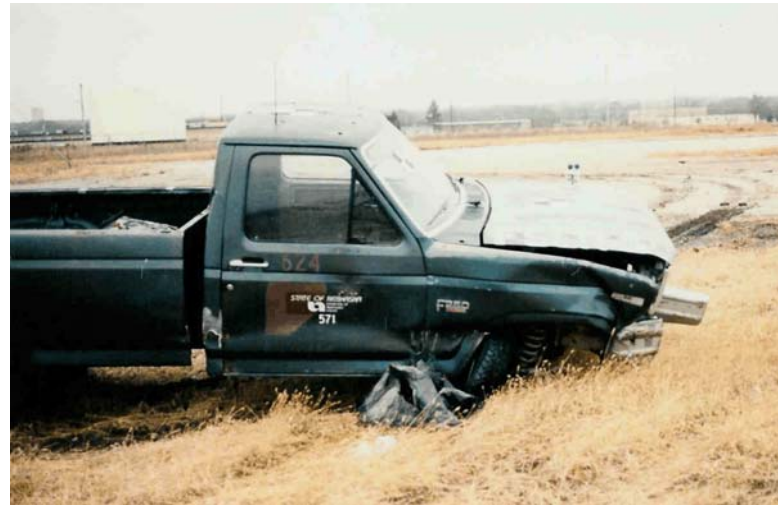
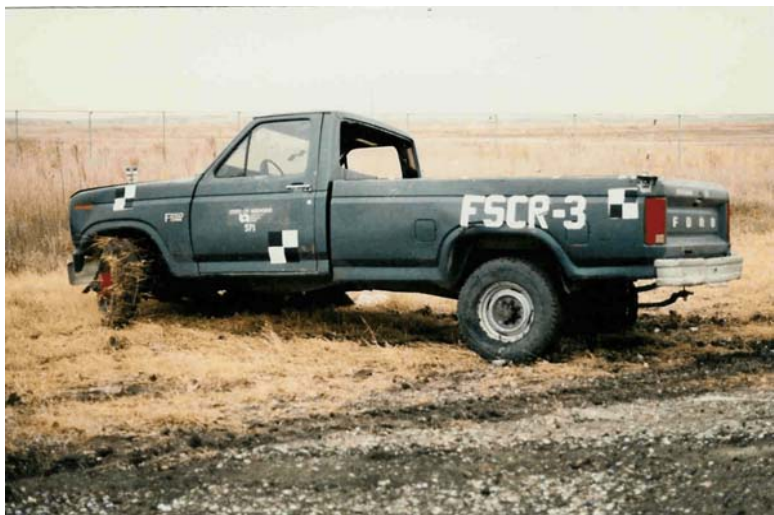
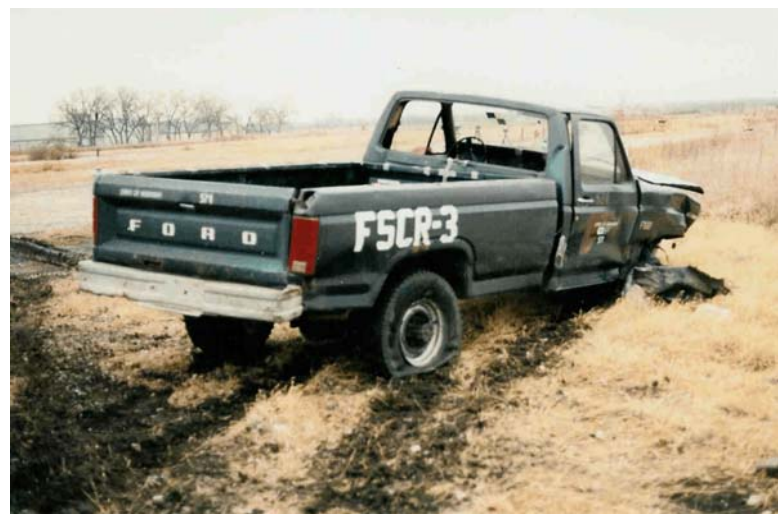
Figure 93. Vehicle Damage, Test FSCR-3

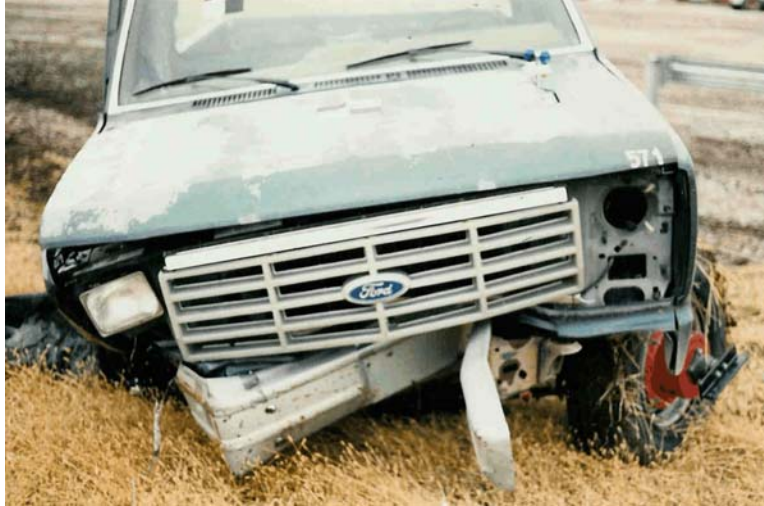
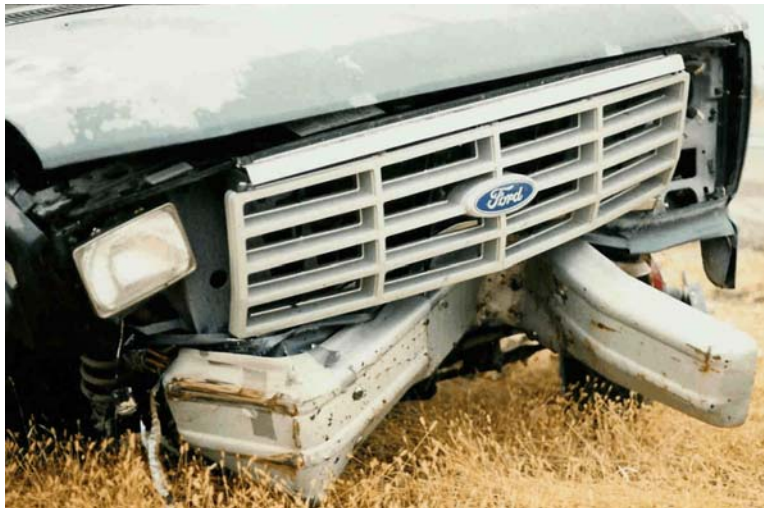
Figure 94. Front-End Vehicle Damage Due to Shear Post Impact, Test FSCR-3

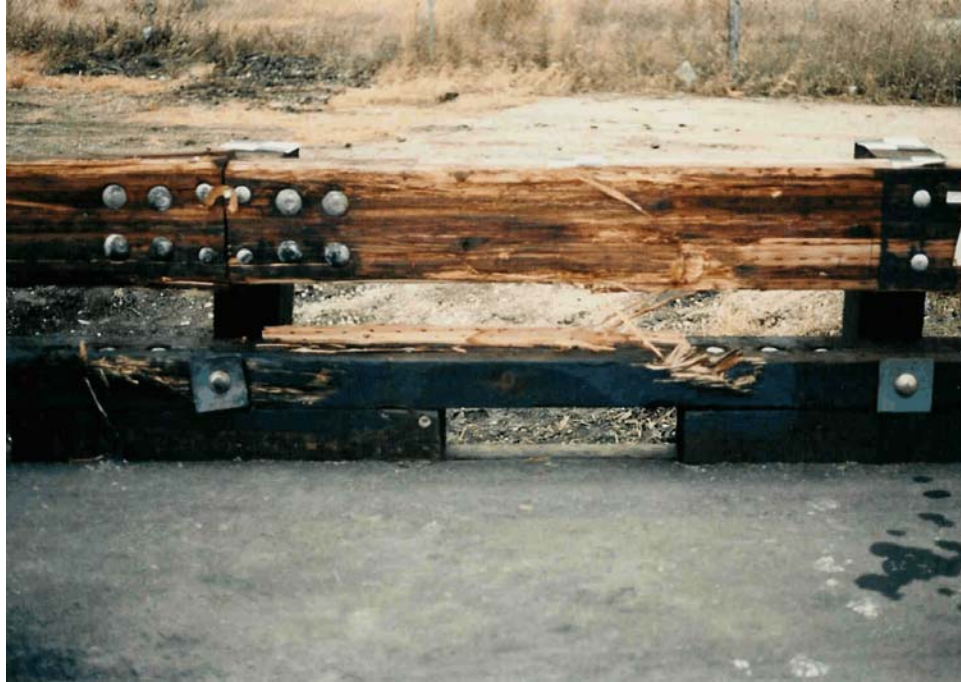
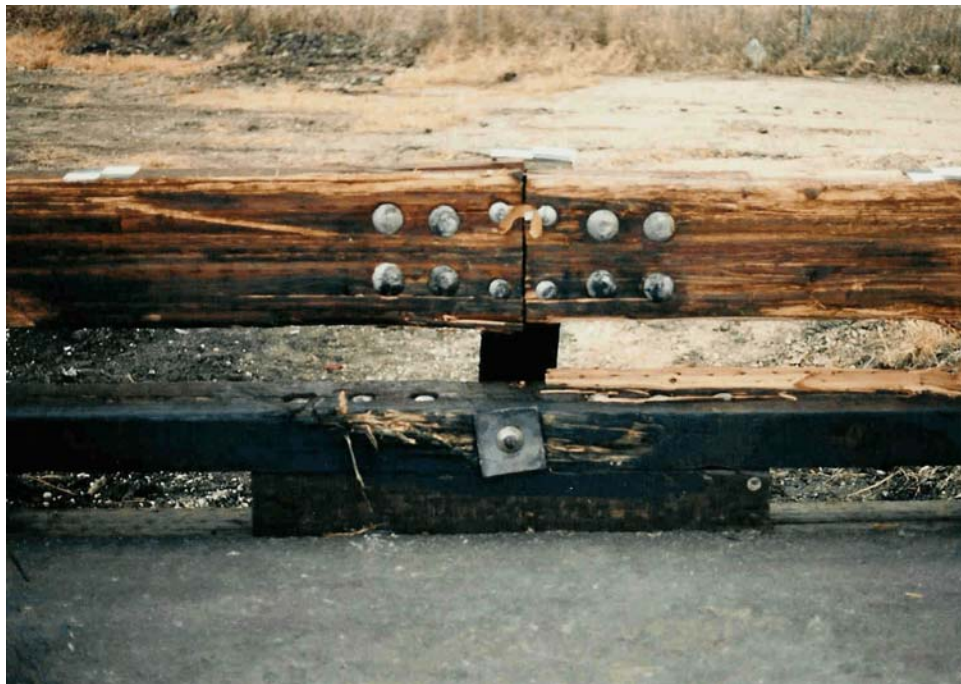
Figure 100. Bridge Rail Damage, Test FSCR-4

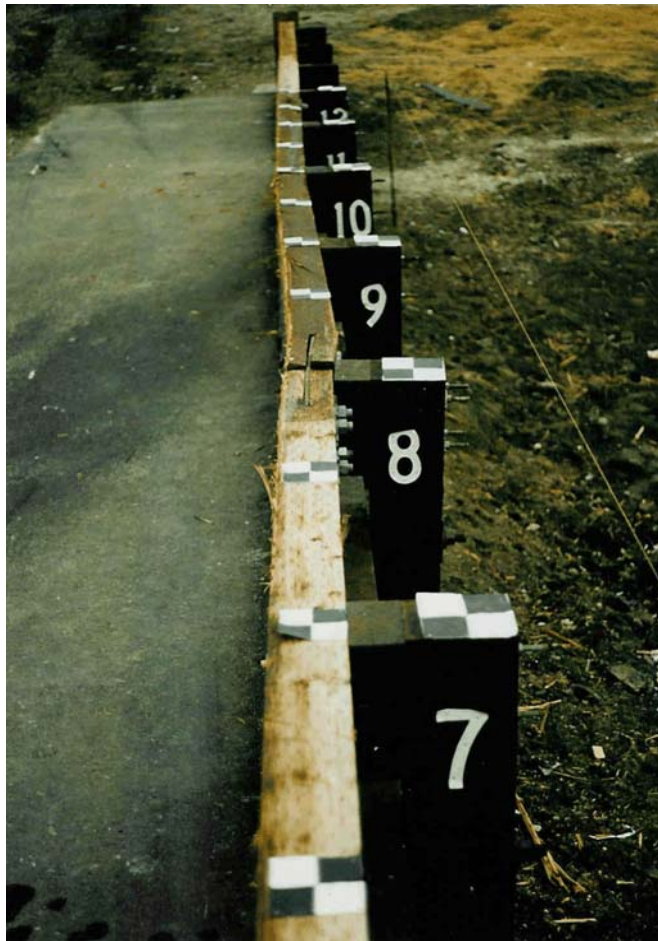
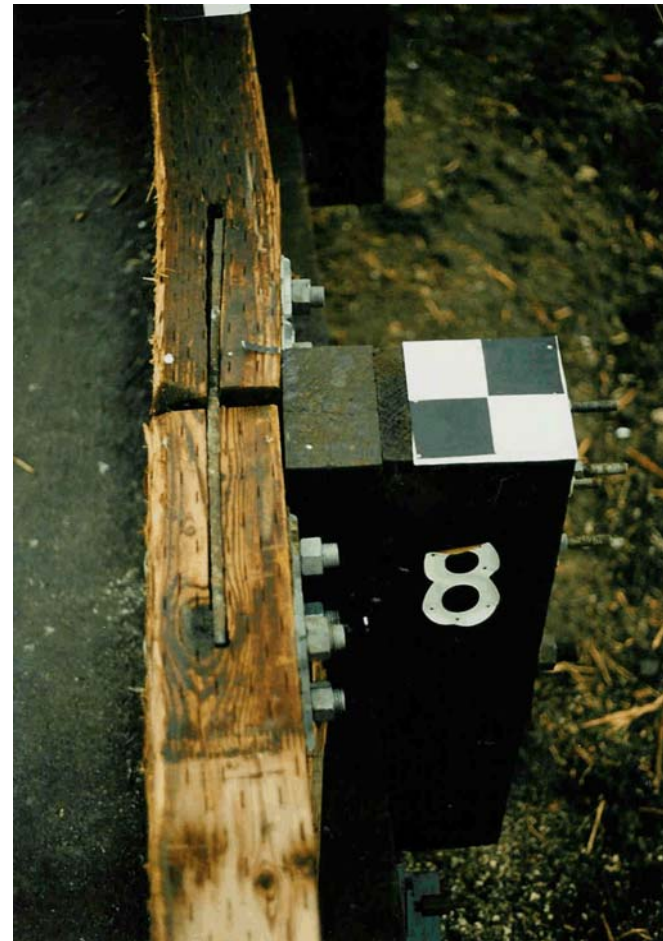
Figure 101. Glulam Rail Deformation at Post No. 8, Test FSCR-4

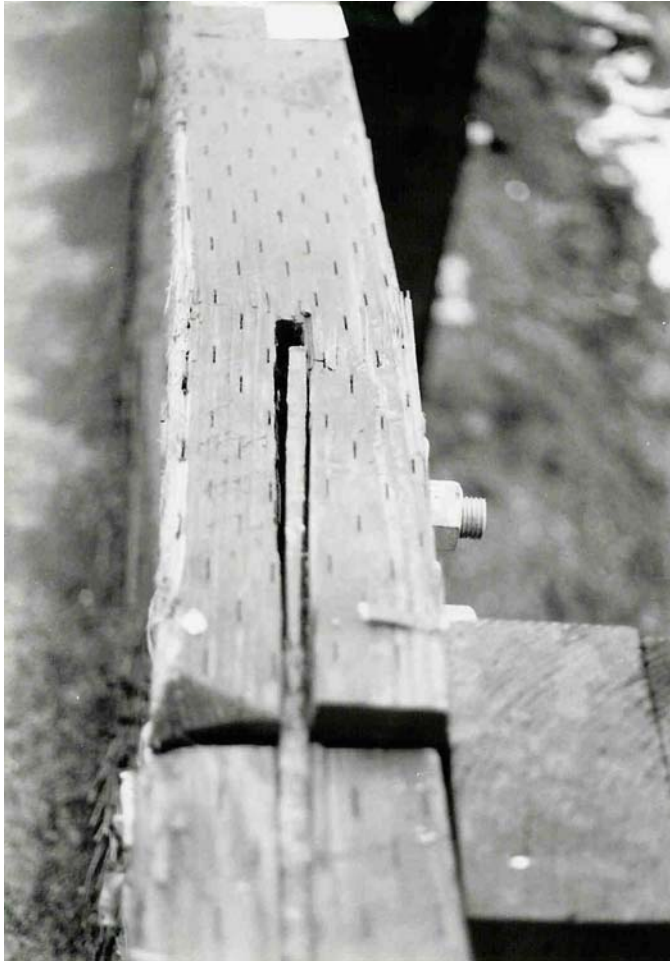
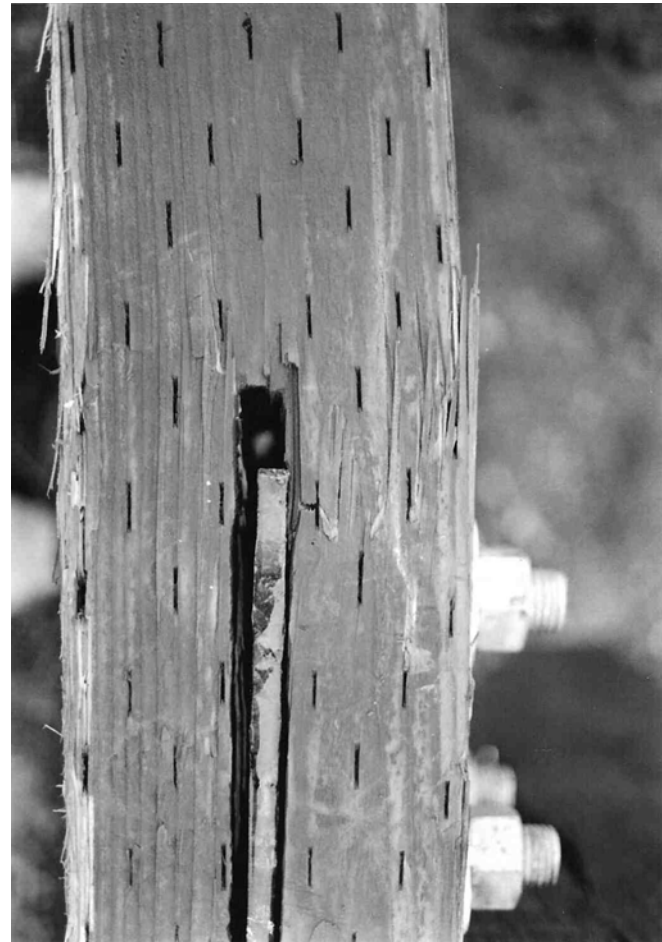
Figure 102. Glulam Rail Fracture at Post No. 8, Test FSCR-4

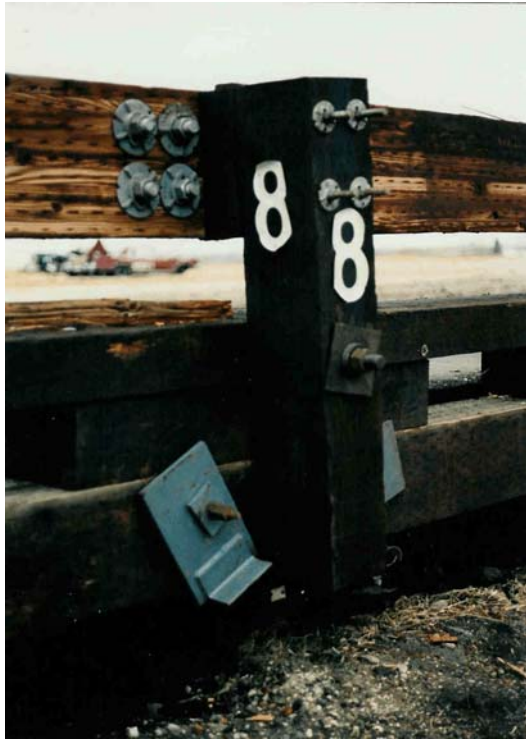
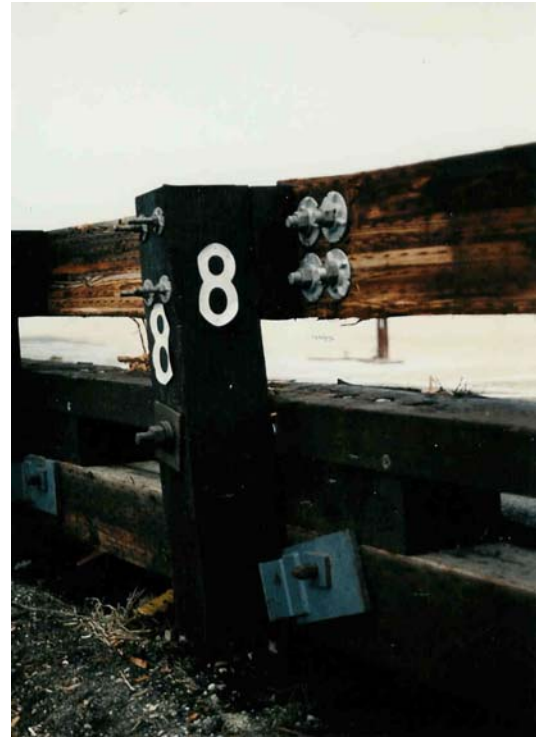
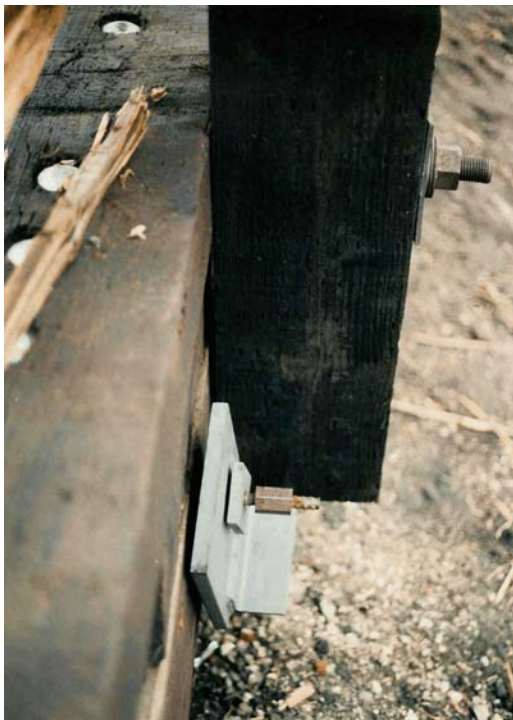
Figure 103. Damage at Post No. 8, Test FSCR-4

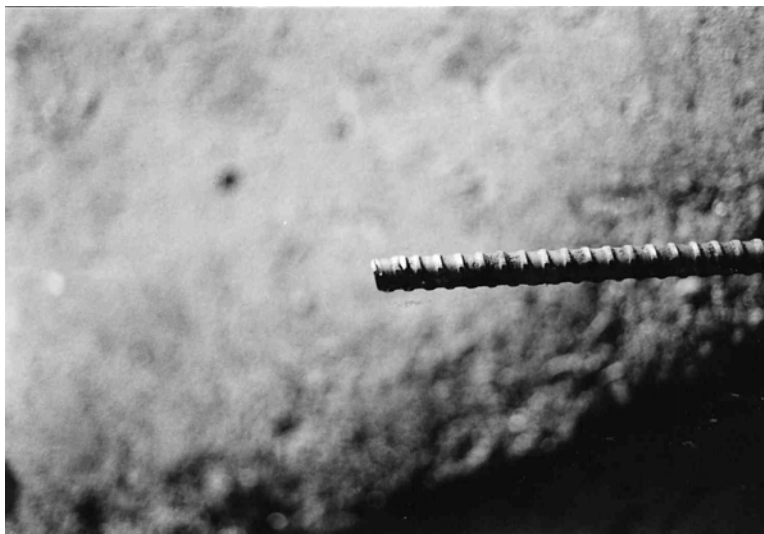
Figure 104. Internal Deck-Side end of High-Strength Bar Located at Post No. 8 (Note residual nut threads left on the end of the bar), Test FSCR-4

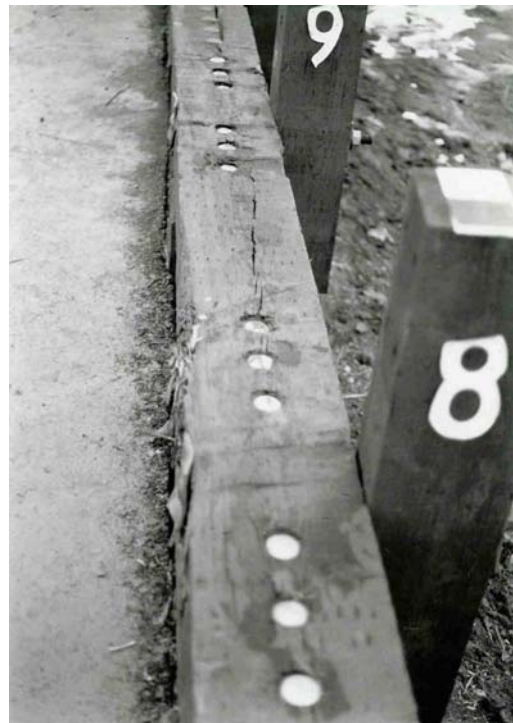
Figure 106. Curb Rail Damage Between Post Nos. 8 through 10, Test FSCR-4

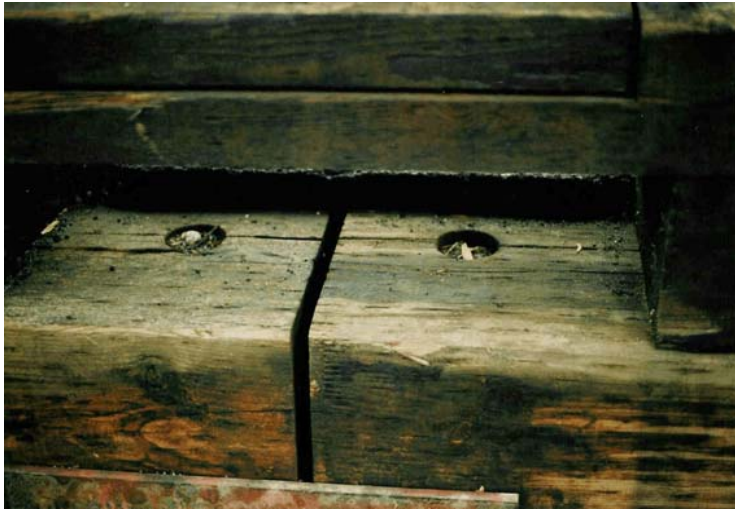
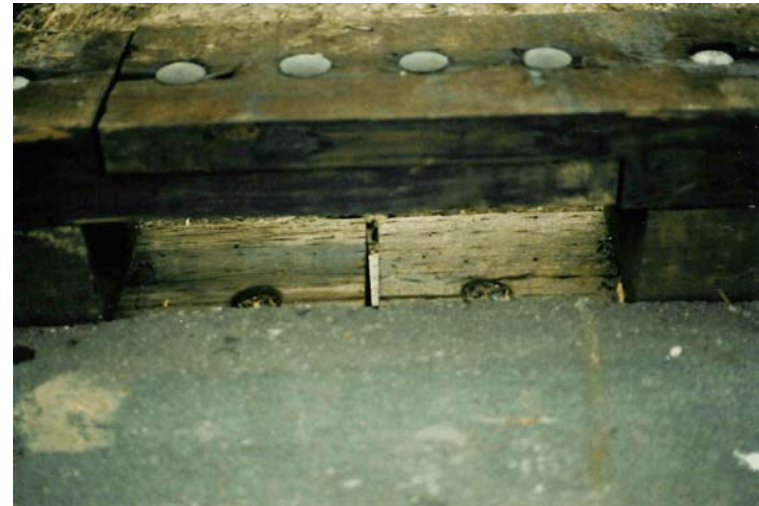
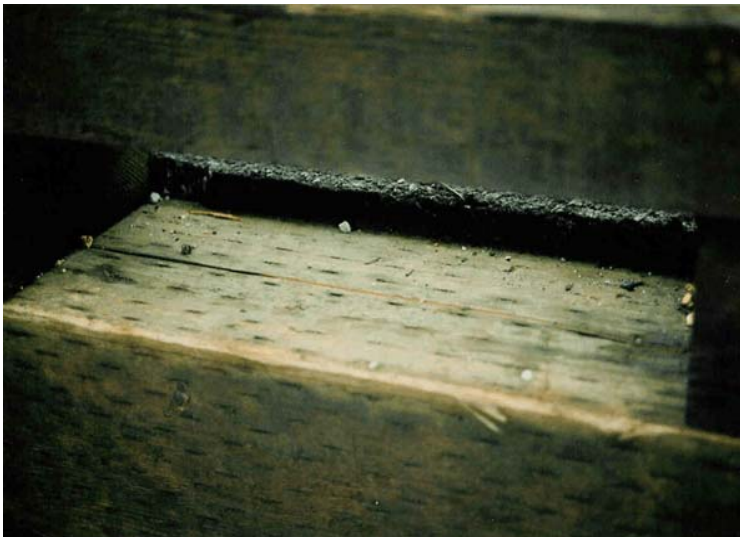
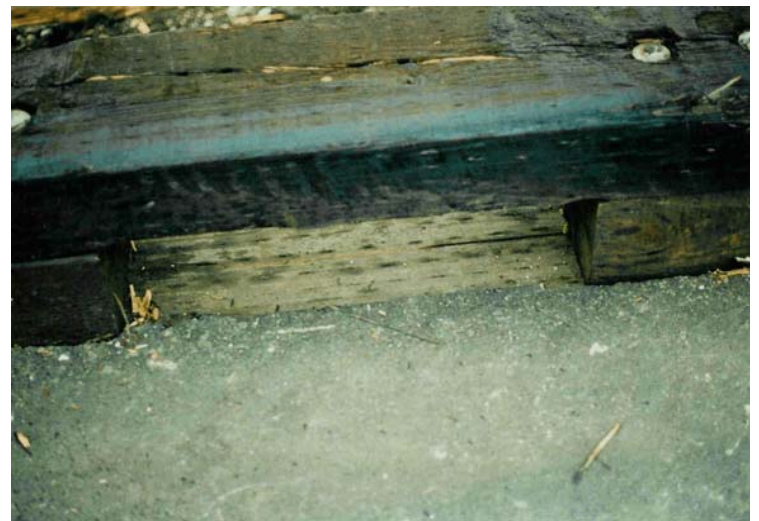
Figure 107. Deck Cracking Between Post Nos. 6 and 7, 8 and 9, Test FSCR-4

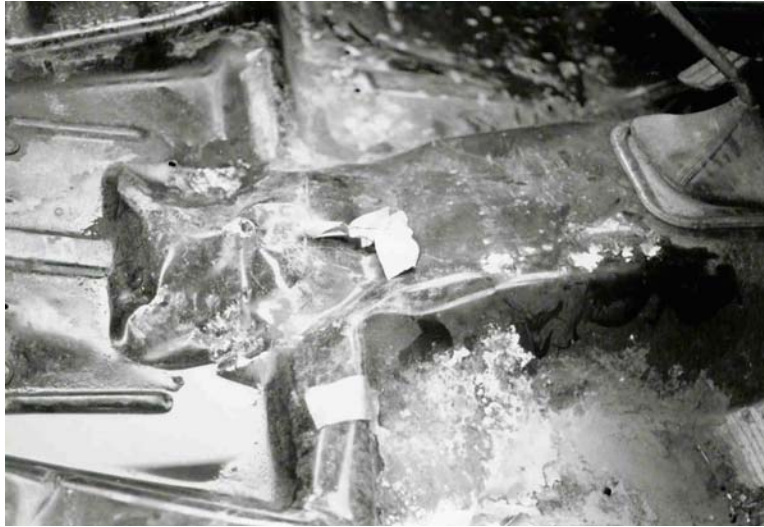
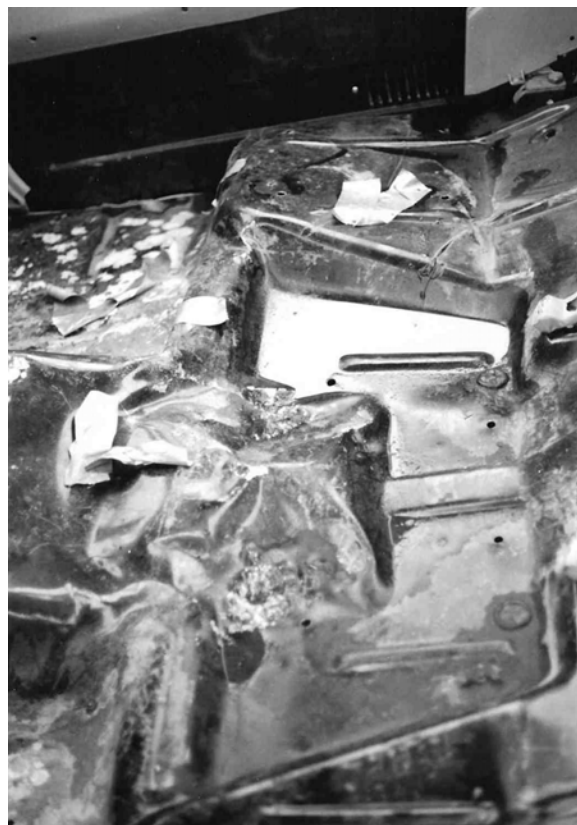
Figure 112. Occupant Compartment Deformation, Test FSCR-4
