FULL-SCALE VEHICULAR CRASH TESTING
of
EXPERIMENTAL SIGNS
on
BARRICADE STRUCTURES

TRANSPORTATION RESEARCH REPORT TRP-03-017-88

Civil Engineering Department
W348 Nebraska Hall
University of Nebraska-Lincoln
Lincoln, Nebraska 68588-0531
(402) 472-2371

June 1989

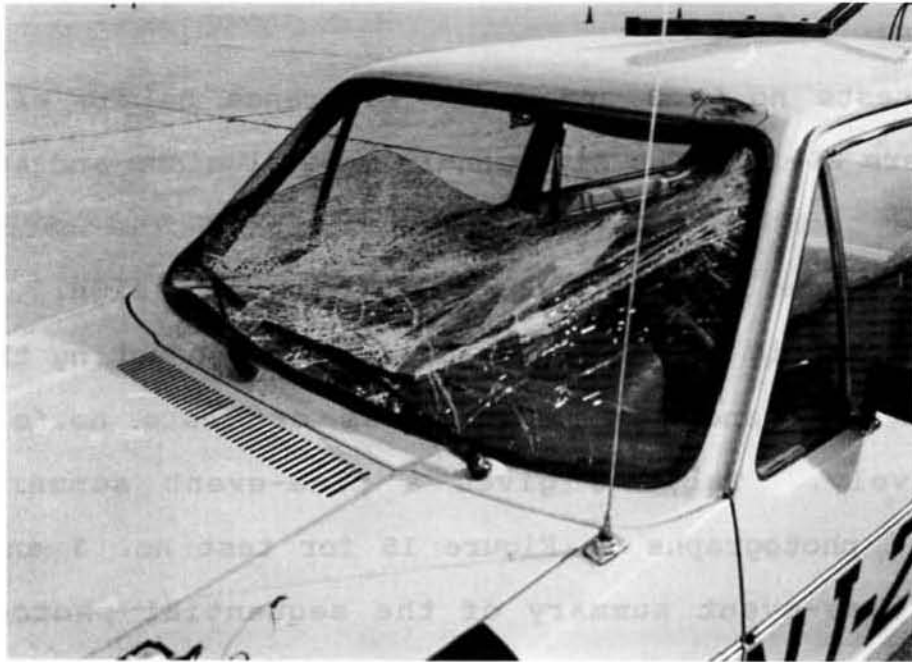
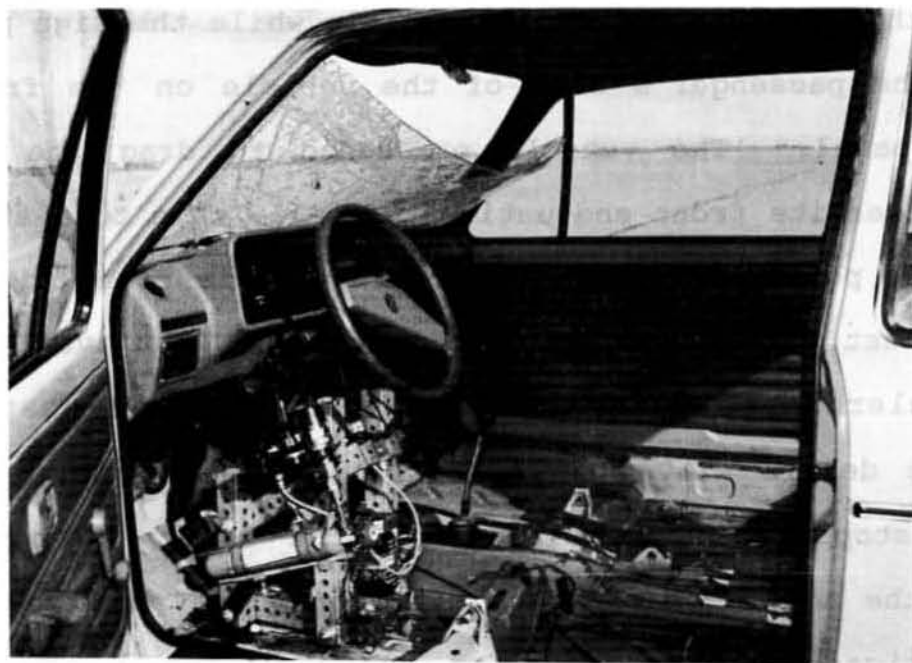
FIGURE 13. Photographs of Vehicle Damage in Test No. 2

In test no. 2, the test vehicle received a significant amount of damage. As in test no. 1, the PVC shattered upon impact; however, instead of the sign staying in front of the vehicle, as in test no. 1, it was projected into the windshield. The windshield shattered and was dished-in by a PVC elbow behind the aluminum sign panel. No debris from the test article penetrated the vehicle but, the integrity of the occupant compartment was not maintained due to the intrusion of the front

TAD	FD-1
VDI	12FDHN6
Passenger Compartment	
Intrusion By Test Article	No
Was Windsheild Broken ?	Yes (severe)

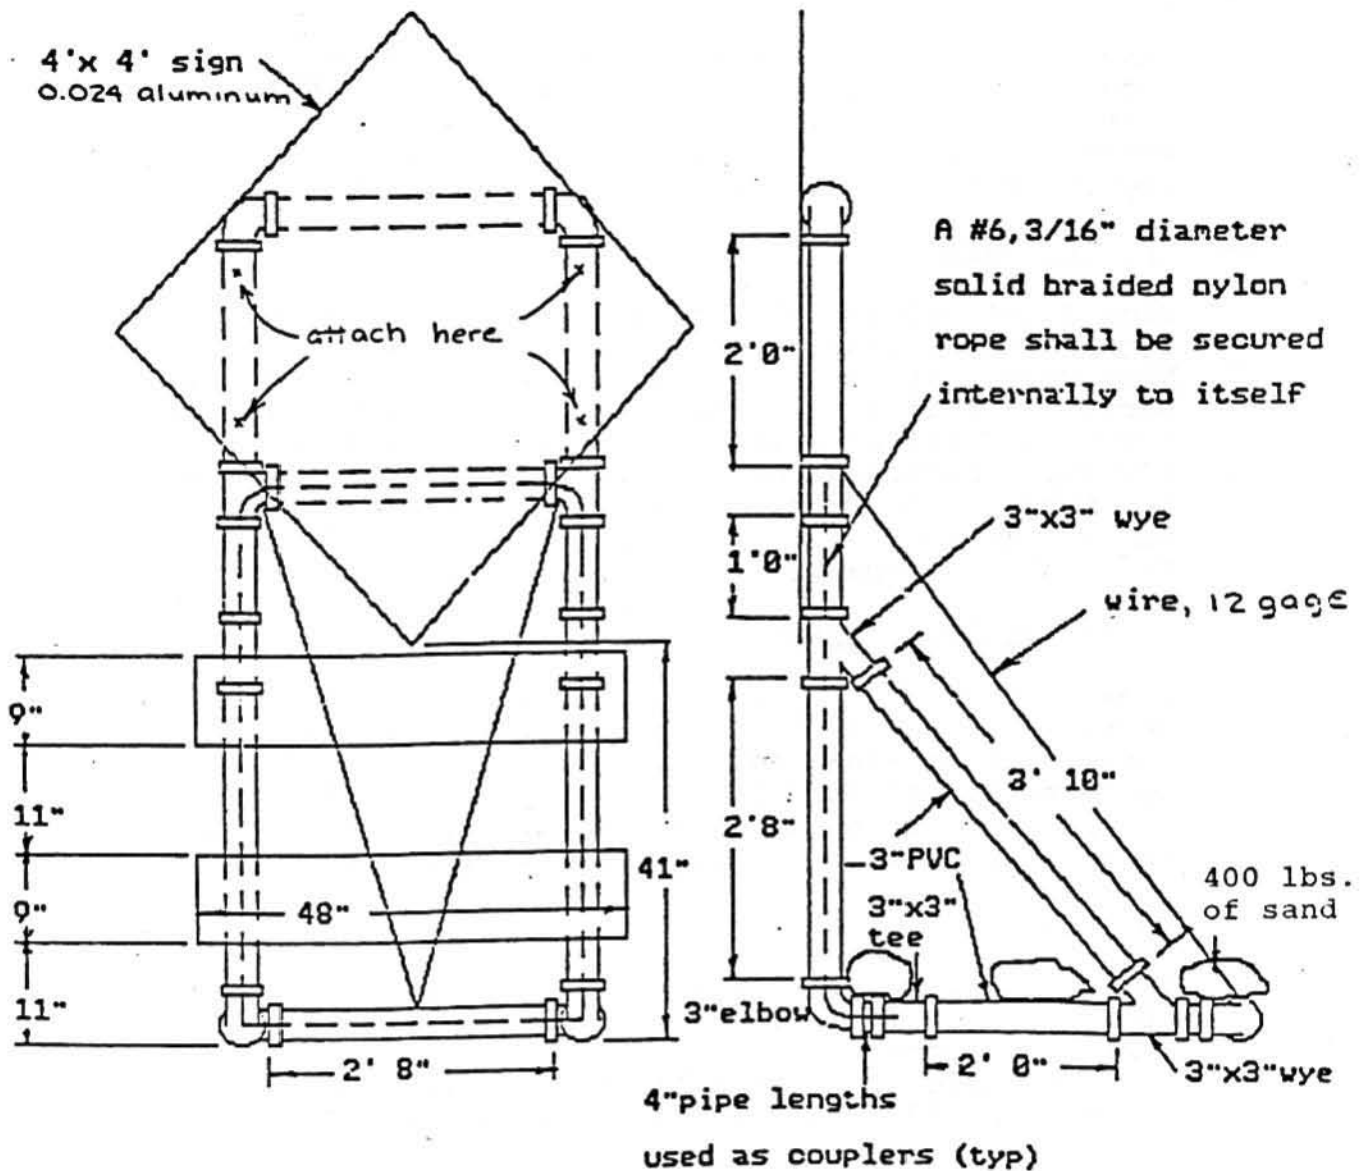
FIGURE 23. Breakaway Barricade For Test No. 5 and Test No. 6

In test no. 5, which was conducted at a target impact speed of 20 mph, the barricade again collapsed and the barricade debris piled-up underneath the front end of the vehicle as in tests no. 1 and test no. 3. The barricade continued to push the debris until the vehicle came to a stop 33-ft beyond the point of impact. The pile-up of barricade debris caused a higher 'g' force than one might expect, as shown in Table 11. The sign panel detached from the barricade and was projected over the vehicle coming to a resting point which was 11-ft beyond the point of impact. The vehicle received no damage. Photographs of the test vehicle and barricade, before and after impact, are shown in Figures 25, 26, and 27.

the barricade and was projected over the the vehicle landing 10-ft. beyond its initial position before impact. The vehicle traveled 285-ft. beyond the point of impact and received a small amount of damage to the two front corners of its hood as a result of the impact. The accelerometer data cable broke in this test so the high-speed film was used for analyzing purposes. It should be noted here that not enough data could be obtained from the high-speed film to get the time at which the occupant 24-in. flail space would have occurred; therefore, the occupant impact velocity and the occupant ridedown acceleration are not available for this test. However, looking at the vehicle's change-in-velocity plot in Appendix C, one can see that the curve starts to level out near the end of the plot; thus, one may assume that at the time the occupant reaches the 24-in. flail space, the change-in-velocity would be around the 15 fps range. Also, looking at the deceleration curve, one may assume that the maximum deceleration experienced by the occupant would not be much more than 2.5 g's. Figures 29, 30, and 31 show photographs of the barricade and test vehicle before and after impact.

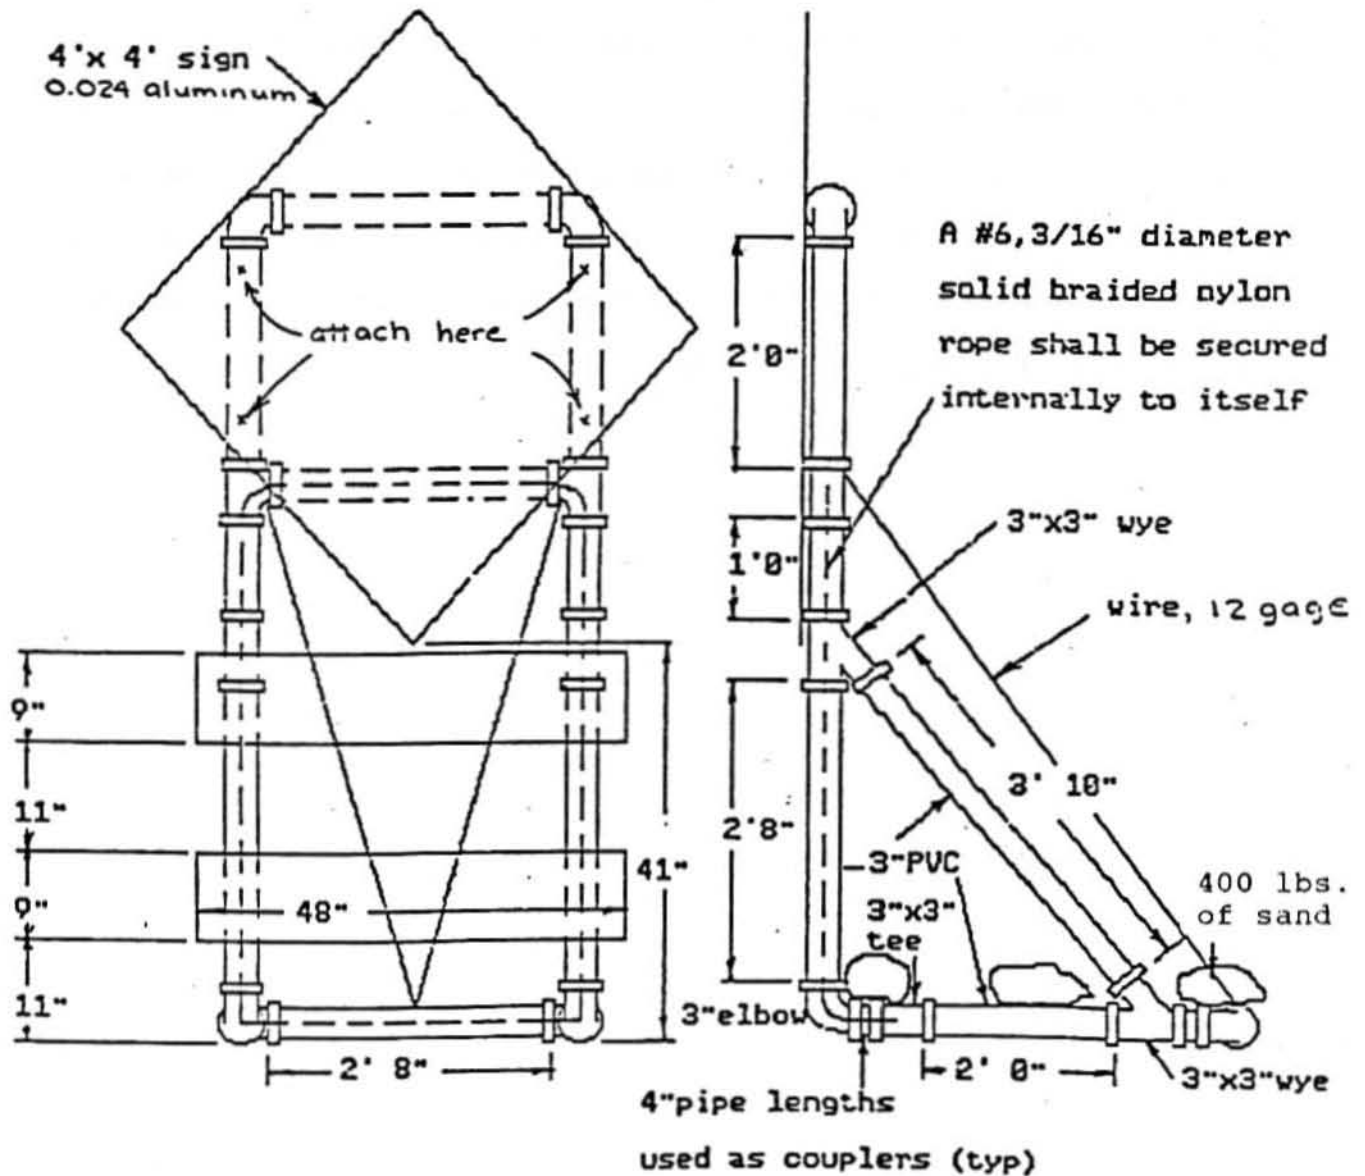
FIGURE 32. Breakaway Barricade For Test No. 7 and Test No. 8

Test no. 7 was conducted at a target impact speed of 20 mph. The upright post of the barricade on the driver's side was the only post impacted during this test. At impact, the barricade collapsed and the sign panel detached from the barricade. The sign then proceeded over the vehicle where it hit the coaxial cable support bar used to support the accelerometer data cable. After the sign hit the support bar, it was deflected left and landed 21-ft. beyond the point of impact. The vehicle traveled 45-ft. past the point of impact and veered 8-ft. to the right of its initial path. No damage was done to the vehicle. Figures 34, 35, and 36 show photographs of the barricade and the test

In test no. 8, which was conducted at a target impact speed of 60 mph, again only the left upright post of the barricade was impacted. The barricade collapsed at impact and some pieces of PVC were projected. The sign panel did not detach , but just fell to the side after the post on the driver's side was impacted. The vehicle came to rest 405-ft. beyond the point of impact and did receive some minor damage. The damage was a broken windshield and a dent on the front center of the hood. Before and after photographs of the test vehicle and barricade are shown in Figures 38, 39, and 40 .

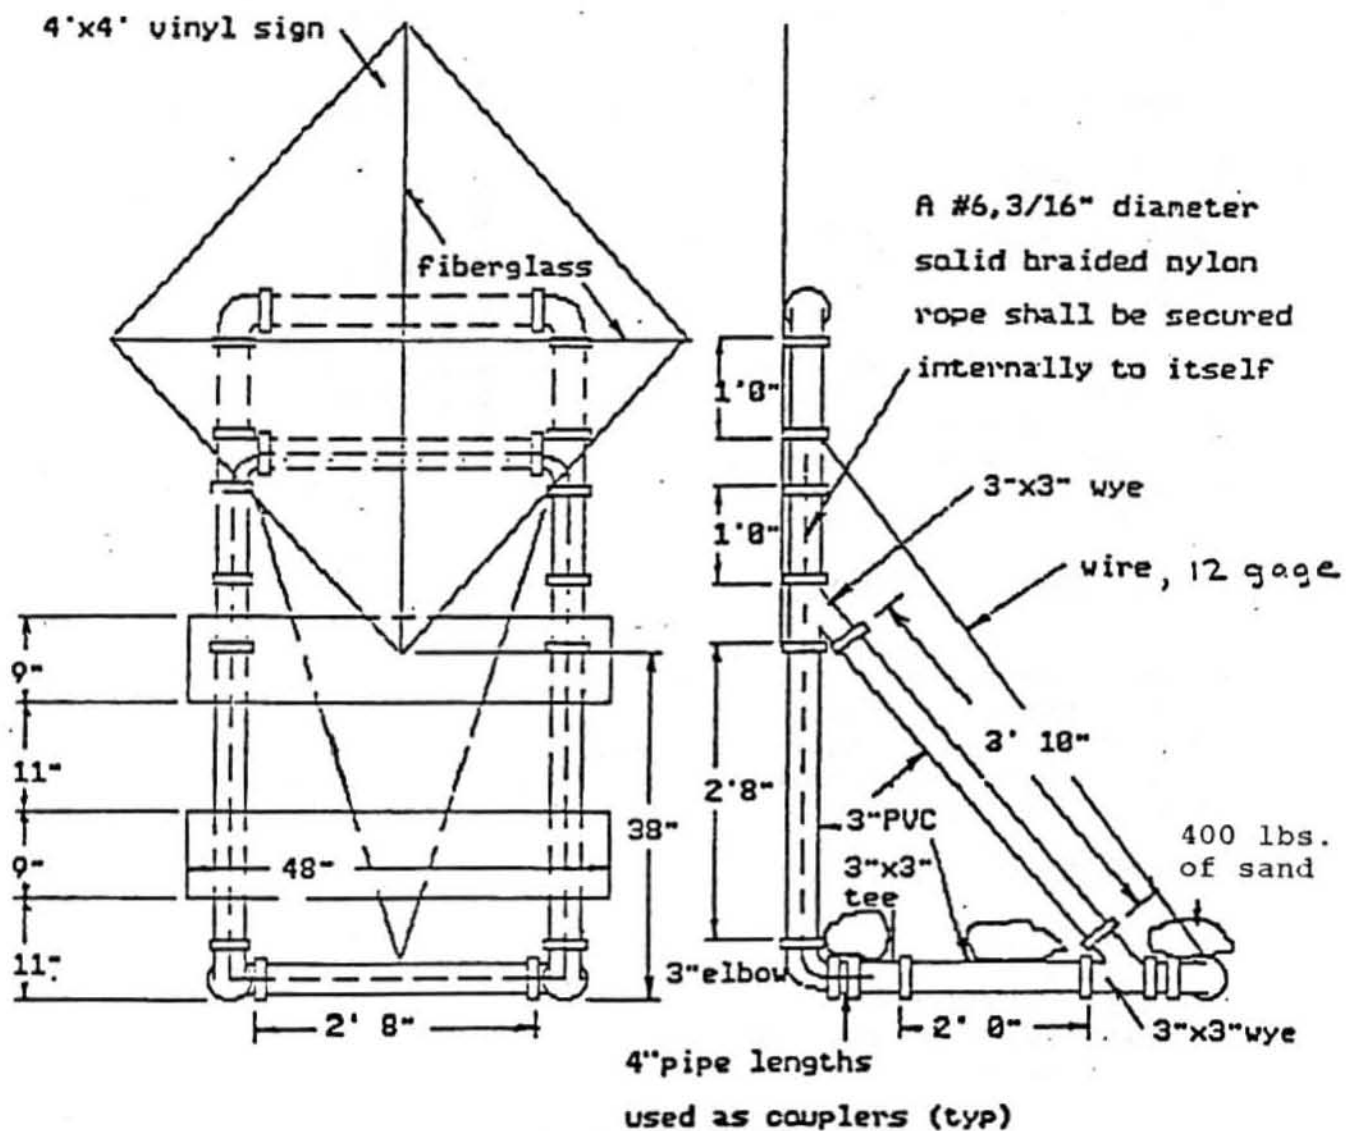
FIGURE 41. Breakaway Barricade For Test No. 9 and Test No. 10

In test no. 10 the barricade was shattered upon impact and pieces of PVC pipe were projected from the barricade. The sign detached and was projected over the vehicle and landed 13-ft. in front of the initial position of the barricade. Figures 47 and 48 show photographs of the barricade before and after the test. In this test, the accelerometer data cable broke; therefore, all the analyses of this test were from the high-speed film. Accessing the damage to the test vehicle was impossible due to the test vehicle going through the fence which borders the test facility. The damage to the vehicle after going through the fence was far more extensive than what would be expected from the impact with the barricade; thus, the damage resulting from the impact could not be determined.

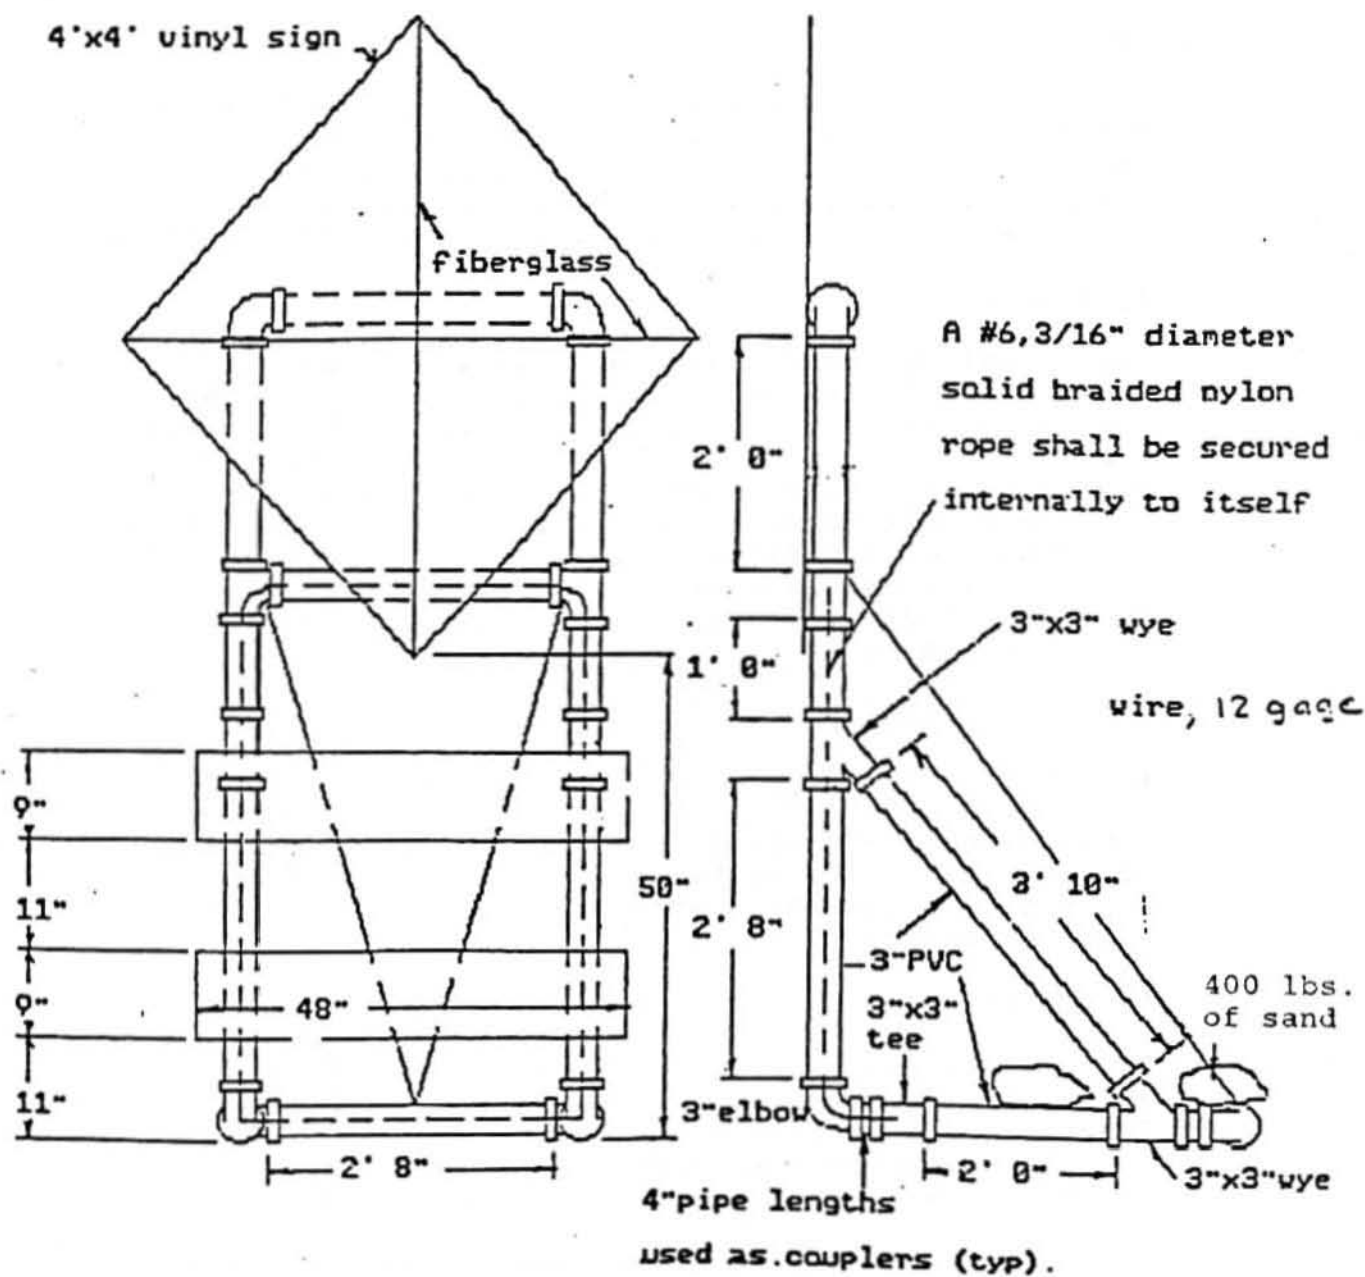
FIGURE 49. Breakaway Barricade For Test No. 11 and Test No. 12

Test no. 11 was conducted at a target impact speed of 20 mph. At impact, the barricade collapsed with some of the debris from the barricade getting piled-up under the front end of the vehicle. The vehicle then proceeded to drag the debris until it came to a stop 66-ft. beyond the point of impact. The sign panel was projected over the vehicle and landed 5-ft. behind the initial position of the barricade. The vehicle did not receive any damage during the test. Figures 51, 52, and 53 show photographs of the test vehicle before and after impact.

In test no. 12, which was conducted at a target impact speed of 60 mph, the barricade shattered upon impact and pieces of PVC pipe were projected from the barricade. Again the sign panel detached from the barricade and was projected over the vehicle landing right on the spot where the barricade was positioned before impact. The vehicle traveled 236-ft. beyond the point of impact and received only minor damage which consisted of two small dents on the front of the vehicle's hood. Figures 55, 56,

and 57 show photographs of the test vehicle and barricade before and after the test. It should be noted that this test was conducted with the vehicle impacting the center of the barricade with the center of the vehicle's bumper. Actually, the vehicle should have impacted the barricade at the center with the point of contact on the vehicle's bumper being the quarter point as required in NCHRP 230 (3). However, seeing that the outcome of this test was satisfactory, and realizing that AASHTO considers the impact at the quarter point of the bumper too stringent for 60 mph tests (4), the test was considered valid.
