CRASH TESTING OF SOUTH DAKOTA'S CABLE GUARDRAIL TO W-BEAM TRANSITION

MIDWEST ROADSIDE SAFETY FACILITY

SOUTH DAKOTA DEPARTMENT OF TRANSPORTATION

MwRSF Research Report No. TRP-03-80-98
December 4, 1998

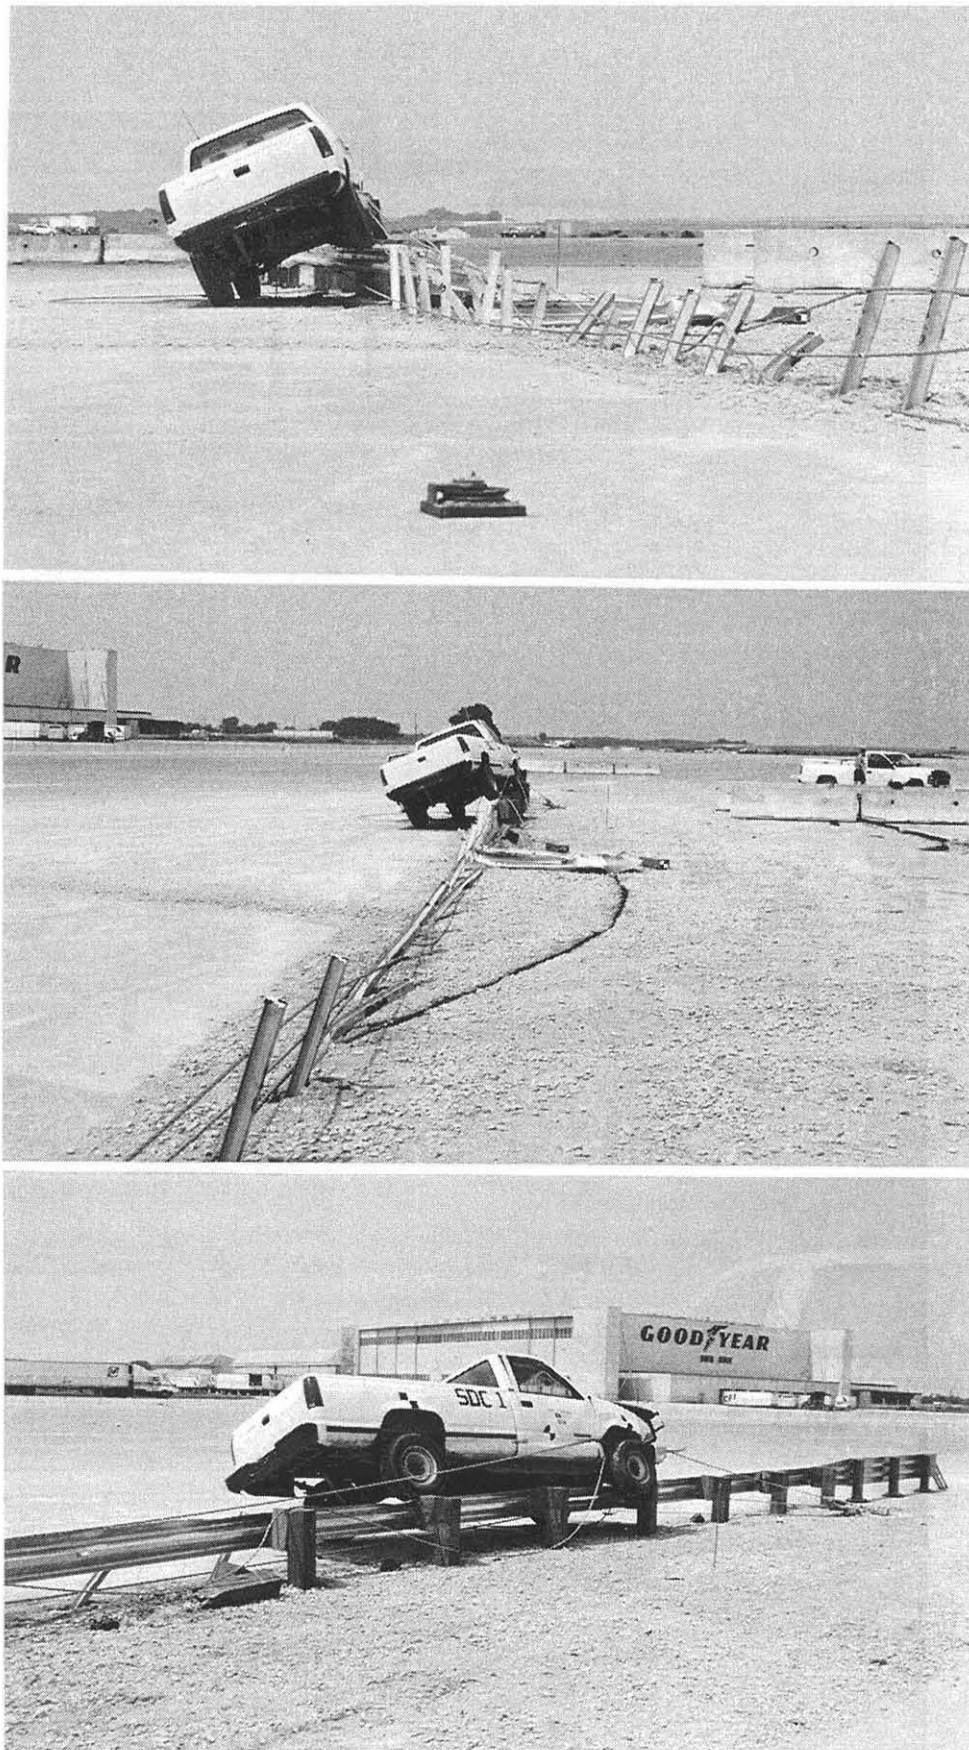
Figure 25. Cable Guardrail to W-Beam Transition Damage, Test SDC-1

Damage to the barrier was extensive, as shown in Figures 25 through 28. Barrier damage consisted mostly of deformed steel posts and W-beam, fractured wood posts, ruptured or stretched cables, and deformations to the steel anchorage hardware. Steel post nos. 1C through 14C were deformed above the ground line, while post nos. 15C through 17C were rotated in the soil. Wood post nos. 1W through 4W were fractured, while post nos. 5W through 11W were all displaced, as determined either visually or by measurements taken at the ground line. The BCT head was collapsed at the nose section, and the W-beam buckled and deformed at post nos. 2W and 3W, respectively. The upper and lower cables remained intact while the middle cable was no longer anchored at the upstream end due to the failure of the threads on the connecting rod. The steel transition brackets located at post nos. 7W and 9W were deformed and only contained the lower cable following the crash test. The maximum lateral dynamic cable deflection was 2.4 m (7.9 ft), as determined from the high-speed film analysis.

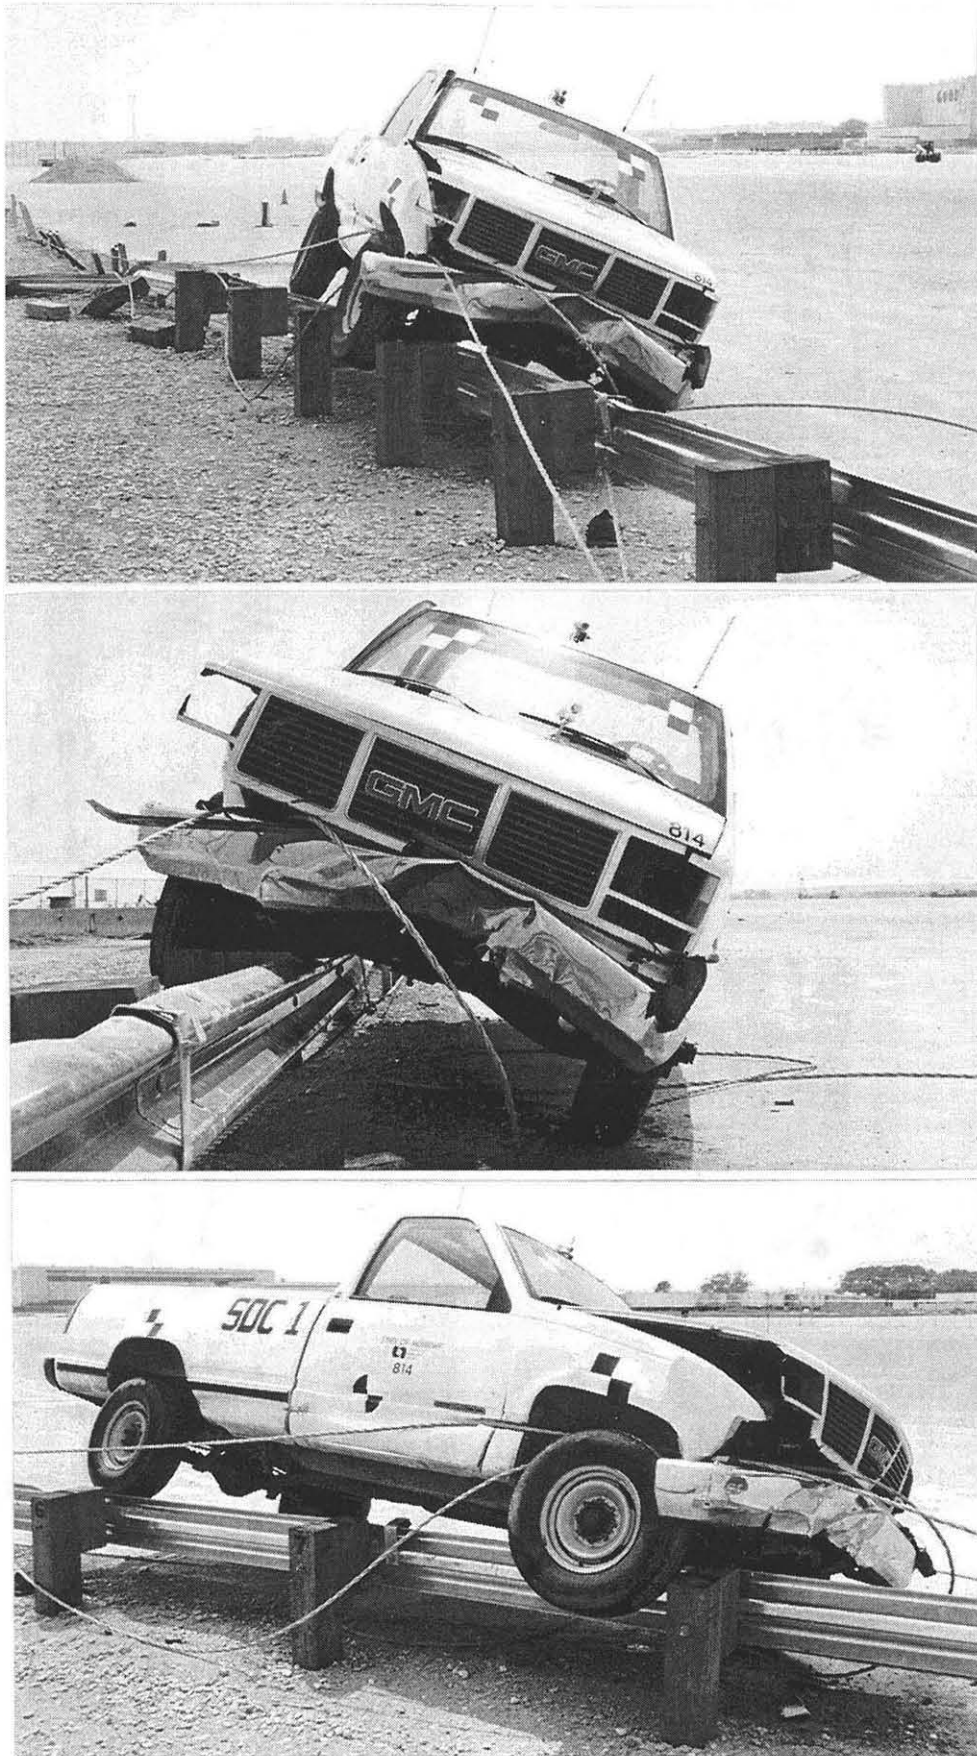
Figure 29. Vehicle Damage, Test SDC-1

Exterior vehicle damage was moderate and occurred at several body locations, as shown in Figure 29. The vehicle's front end was crushed inward due to contact with the BCT terminal and W-beam guardrail, the right-front quarter panel was crushed, and the right-side front bumper was bent back toward the engine compartment. The engine compartment was also moved backward, and the undercarriage near the front end was deformed. Very minor deformations were found on the floorboard of the occupant compartment. Evidence of vehicle-rail interlock was also found from the

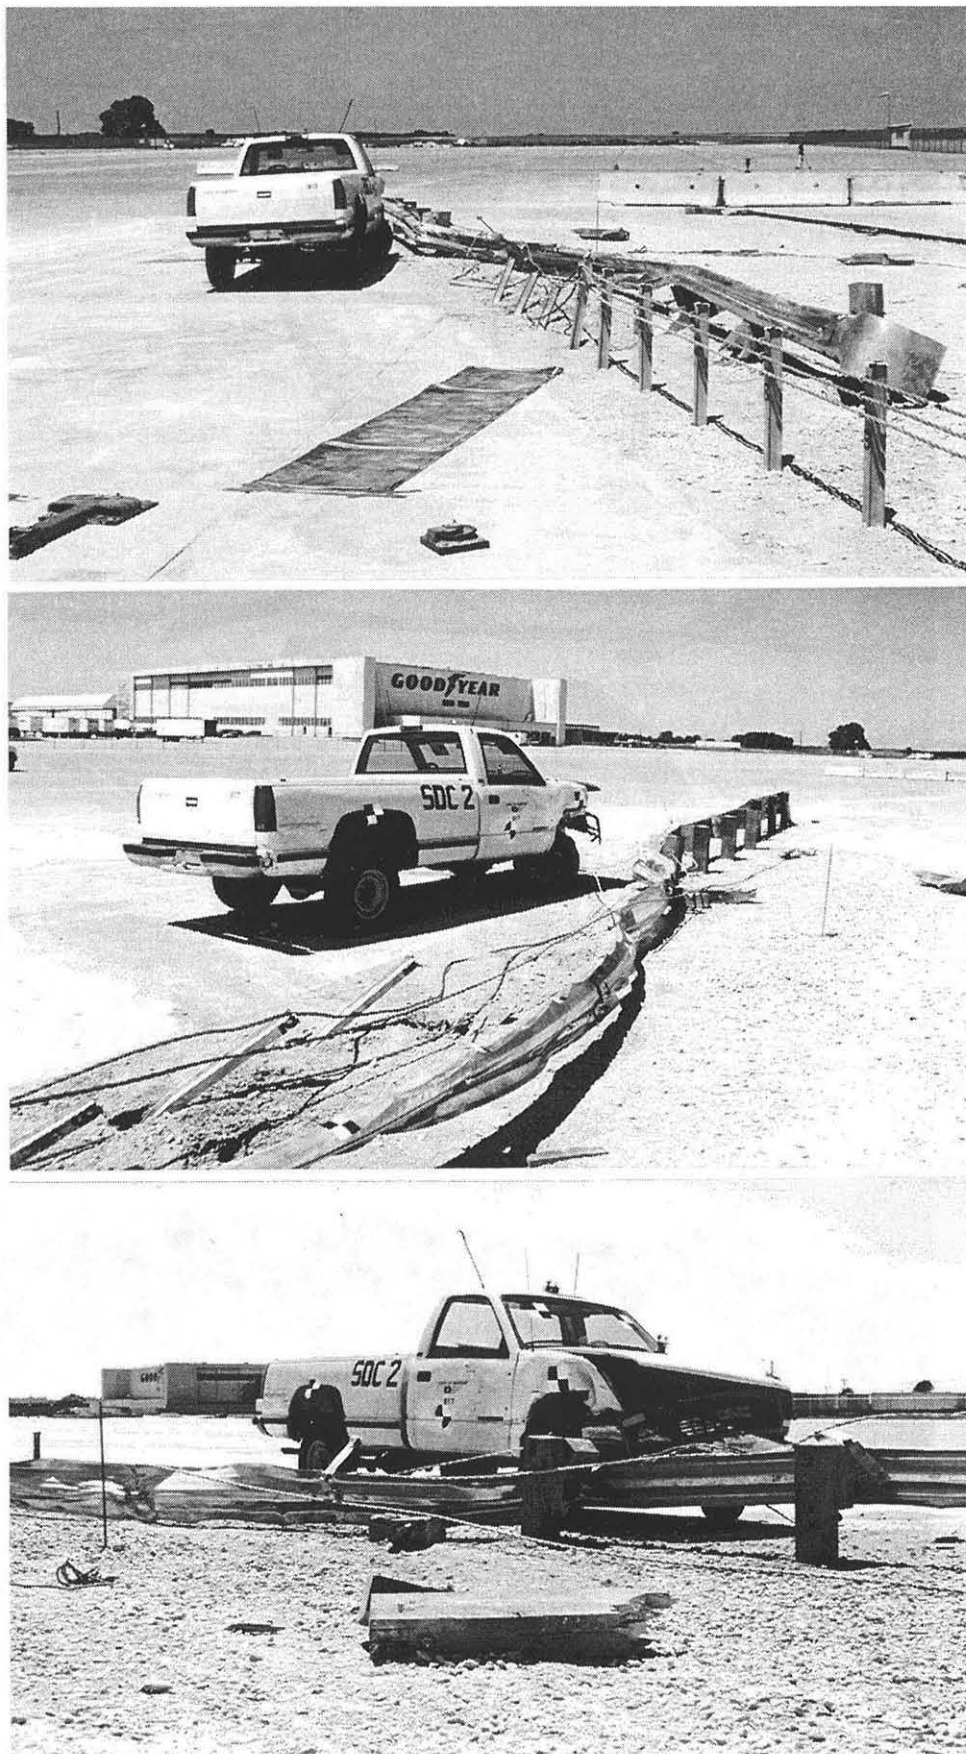
Figure 36. Cable Guardrail to W-Beam Transition Damage, Test SDC-2

Damage to the barrier was extensive, as shown in Figures 36 through 39. Barrier damage consisted mostly of deformed steel posts and W-beam, fractured wood posts, ruptured or stretched cables, and deformations to the steel anchorage hardware. Steel post nos. 1C through 3C were deformed above the ground line, while post nos. 4C through 5C were rotated in the soil. Wood post

nos. 1W through 7W were fractured, while post no. 8W was displaced, as determined either visually or by measurements taken at the ground line. The initial vehicle contact marks were found on the W-beam rail at a location 330-mm (13-in.) upstream from the midspan between post no. 3W and 4W. In addition, significant flattening of the W-beam rail occurred between post nos. 5W and 7W. The upper cable remained intact while the lower and middle cables were no longer anchored at the downstream end. The steel transition brackets located at post nos. 7W and 9W were deformed.

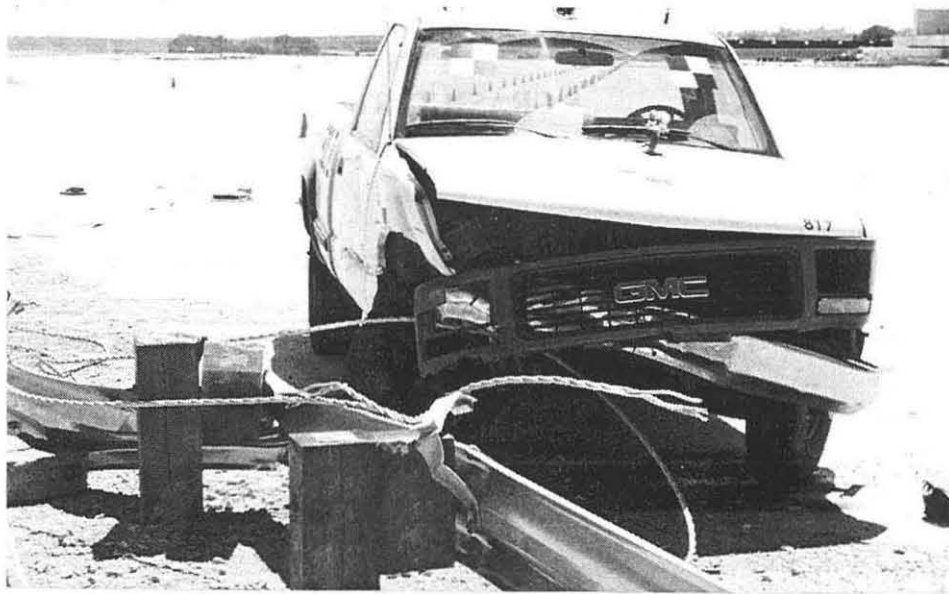
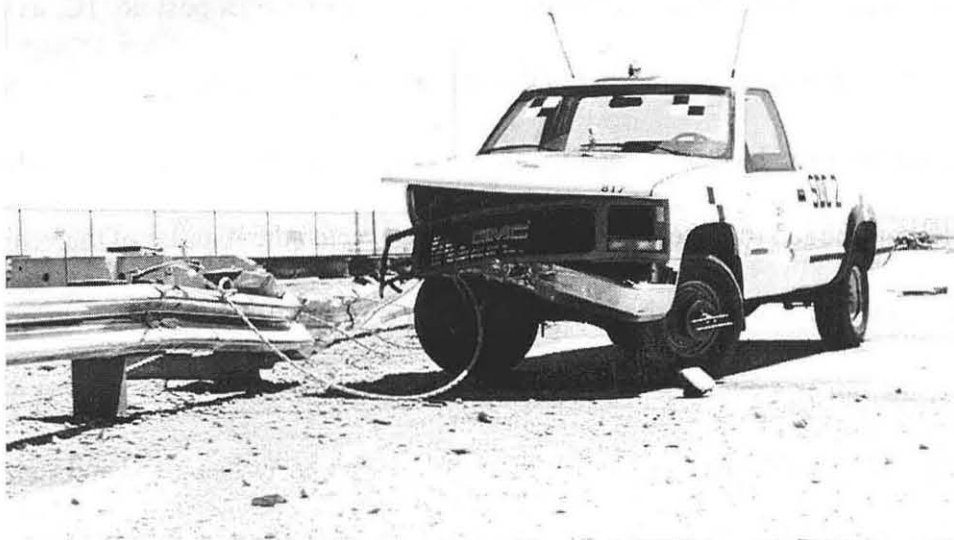
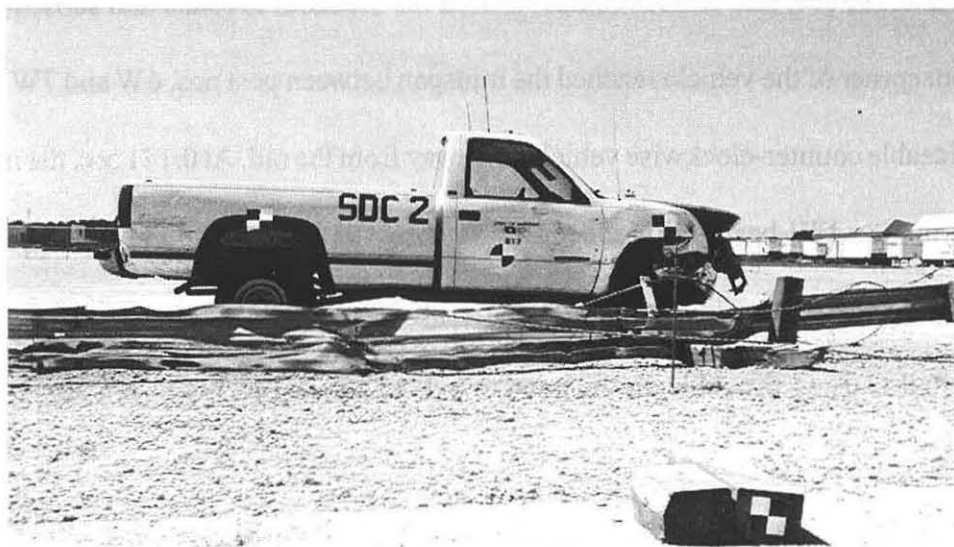
Figure 40. Vehicle Damage, Test SDC-2

Exterior vehicle damage was moderate and occurred at several body locations, as shown in Figure 40. The vehicle's front end, right-front bumper, and right-front quarter panel were crushed inward toward the engine compartment due to contact with the barrier. Components within the engine compartment and front undercarriage were either deformed or moved backward and upward. Very minor deformations were found on the right-side firewall of the occupant compartment.

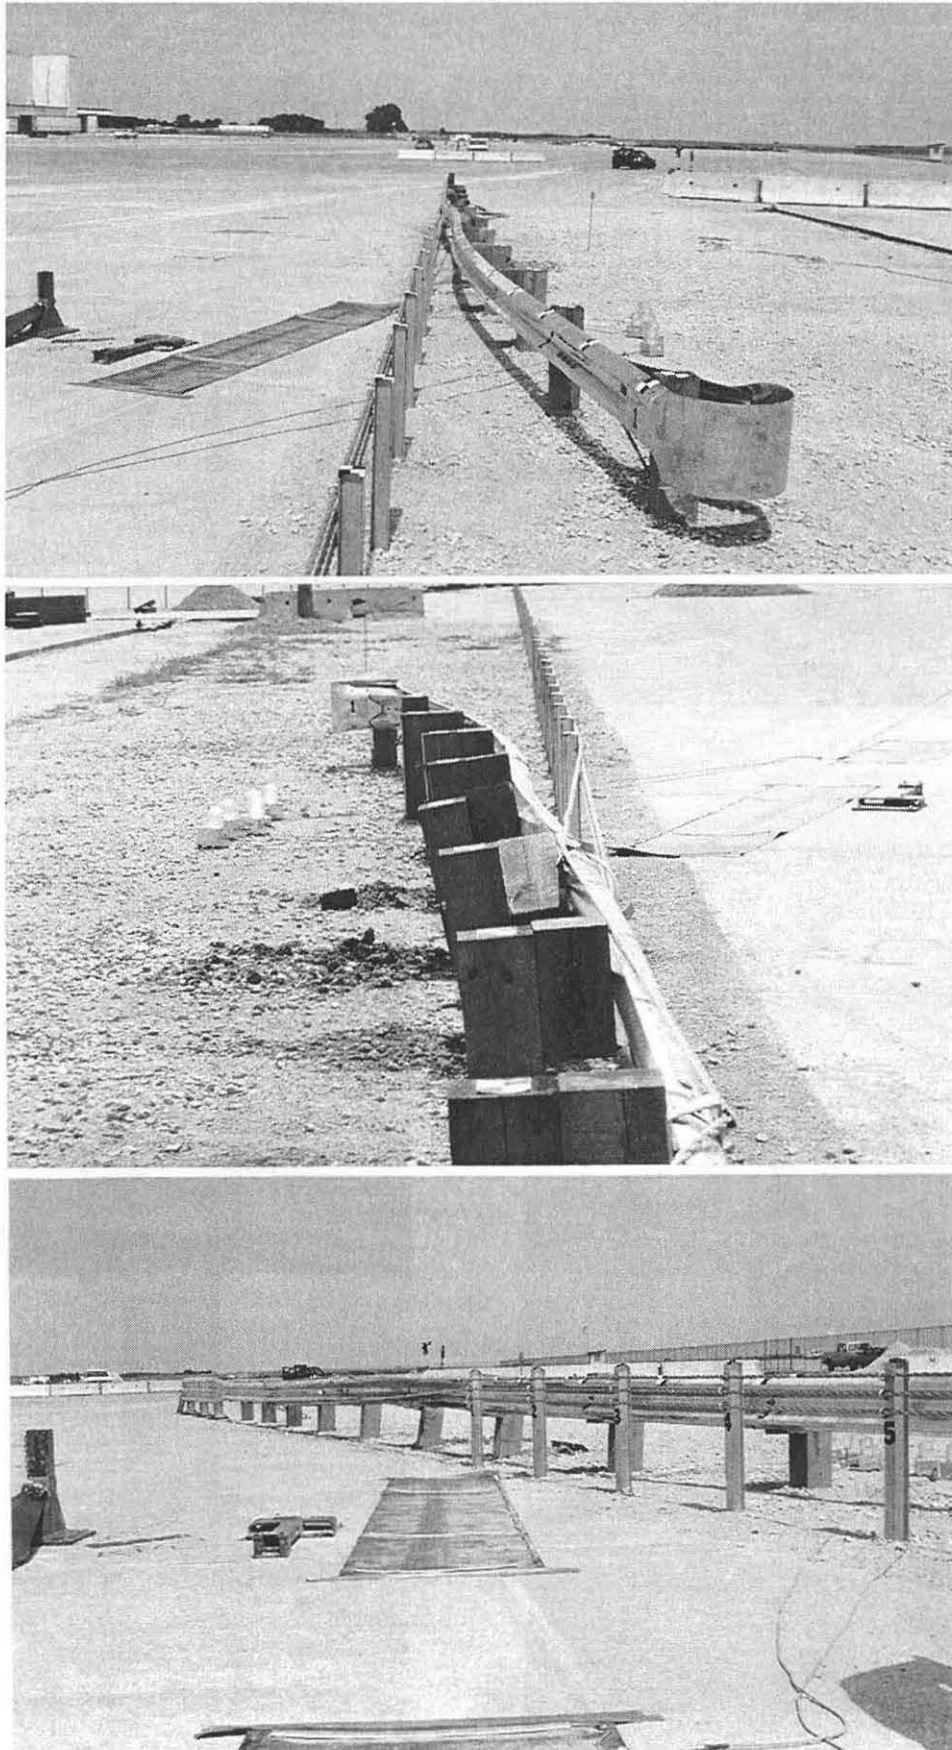
Figure 46. Cable Guardrail to W-Beam Transition Damage, Test SDC-3

Damage to the barrier was moderate, as shown in Figures 46 through 47. Barrier damage consisted mostly of deformed W-beam, displaced steel and wood posts, and stretched cables. Steel post no. 1C and wood post nos. 3W through 9W were rotated in the soil, as determined either visually or by measurements taken at the ground line. Tire contact marks were found on the front face of post no. 6W and the front and upstream side faces of post no. 7W. Vehicle contact marks were found on the W-beam rail between the post no. 5W through 152-mm (6-in.) downstream from post no. 7W. All three cables remained intact and no damage was found at either cable anchorage device. The steel transition bracket located at post no. 7W was deformed with all three cables pulled out. The maximum lateral dynamic post and W-beam rail deflection was 0.50 m (1.64 ft), as determined from the high-speed film analysis.

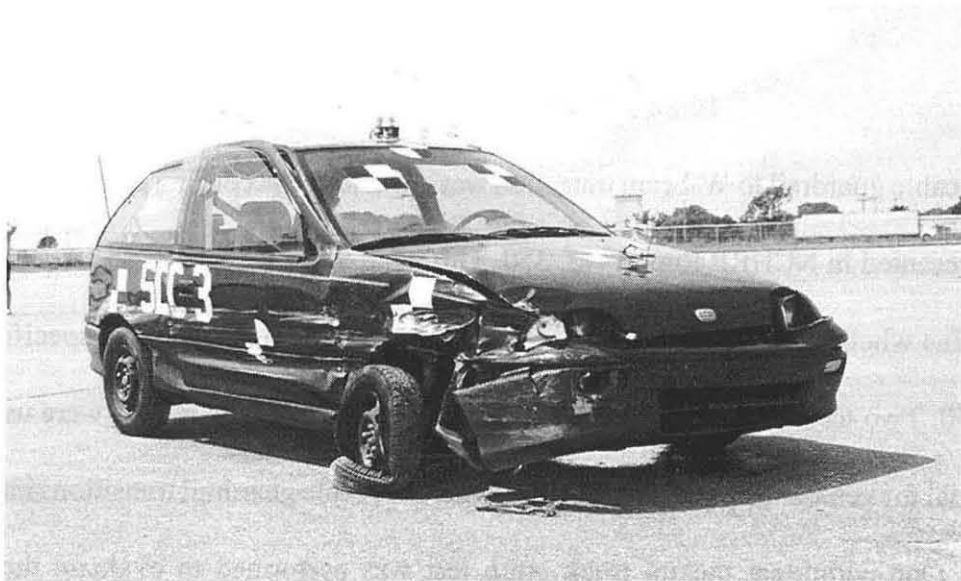
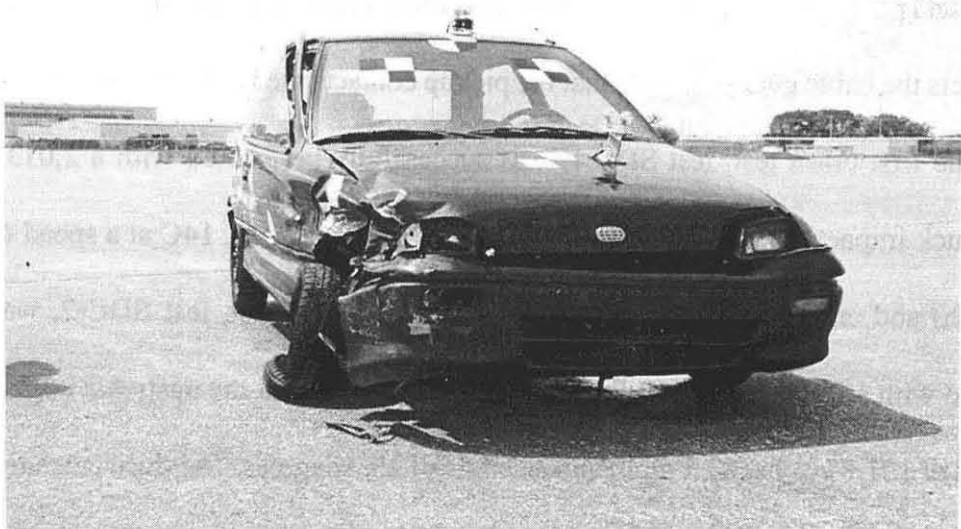
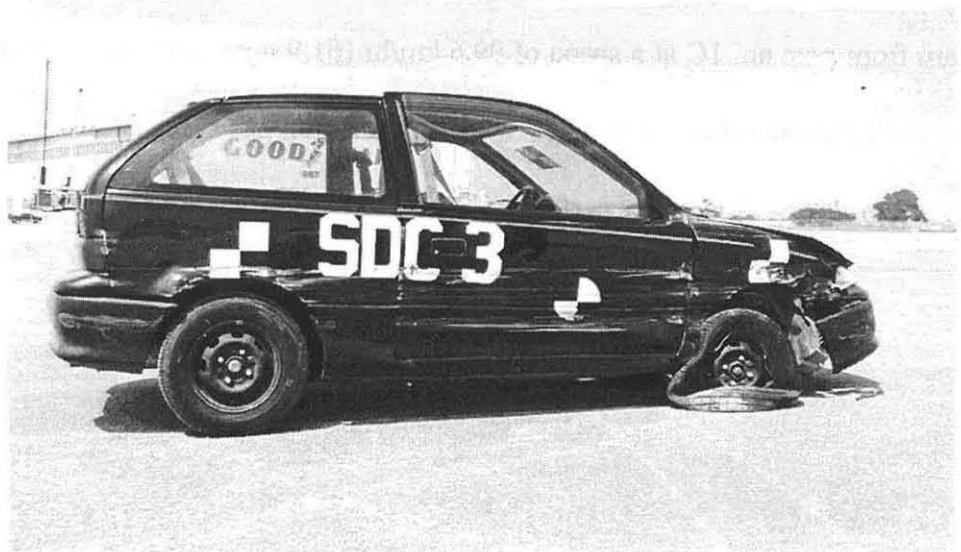
Figure 48. Vehicle Damage, Test SDC-3

Exterior vehicle damage was moderate and occurred at several body locations, as shown in Figure 48. The vehicle's front end and hood, right-front bumper, and right-front quarter panel were crushed inward toward the engine compartment due to contact with the barrier. The right-front tire was deflated while the steel rim was deformed. Evidence of vehicle-rail interlock was also found from the front end to the midpoint of the rear quarter panel. Minor deformations were found on the right-side floorboard and firewall of the occupant compartment.
