# **Safety Performance Evaluation of the Steel Backed Wood Rail to Bridge Rail Transition**

Transportation Research Report TRP-03-49-95

**FHWA Contract No. DTFH71-90-C-00035**

September 1995

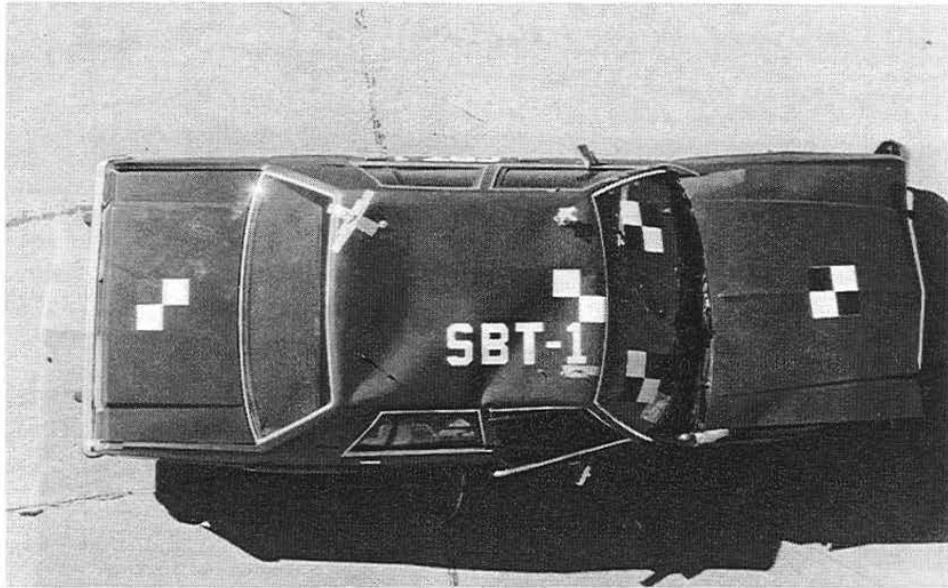
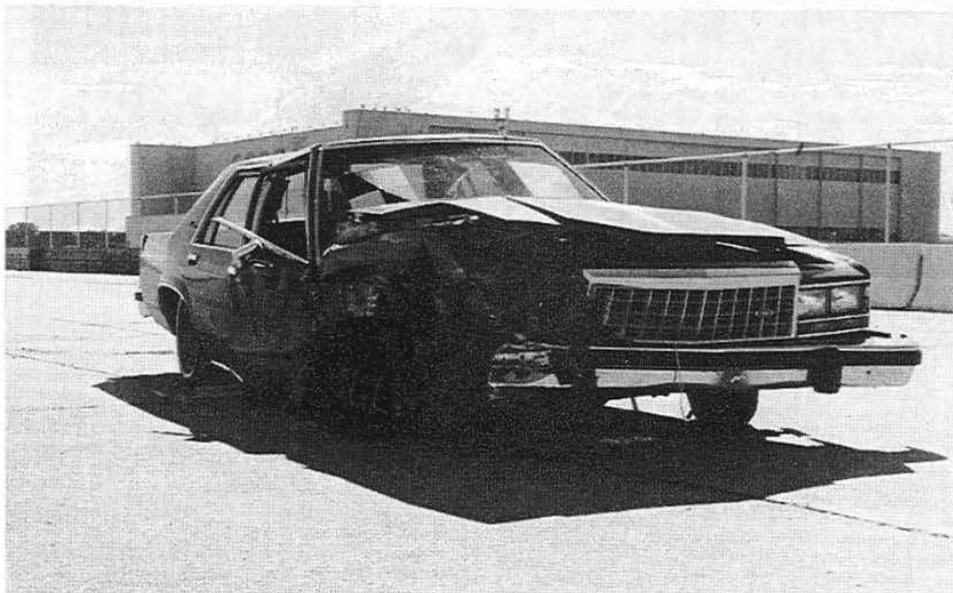
**Figure 7.** Vehicle Damage, Test SBT-1.

Damage to the vehicle, which can be seen in Figures 7 and 8, included major crushing and deformation of the right front corner of the vehicle, as well as buckling of the vehicle roof. The entire front half of the vehicle was bent slightly toward the drivers side. Interior compartment damage included buckling of the floorboard on the passenger side, as well as buckling of the dash. The maximum crush deformation of 17 in. (492 mm) is shown in Figure 9.

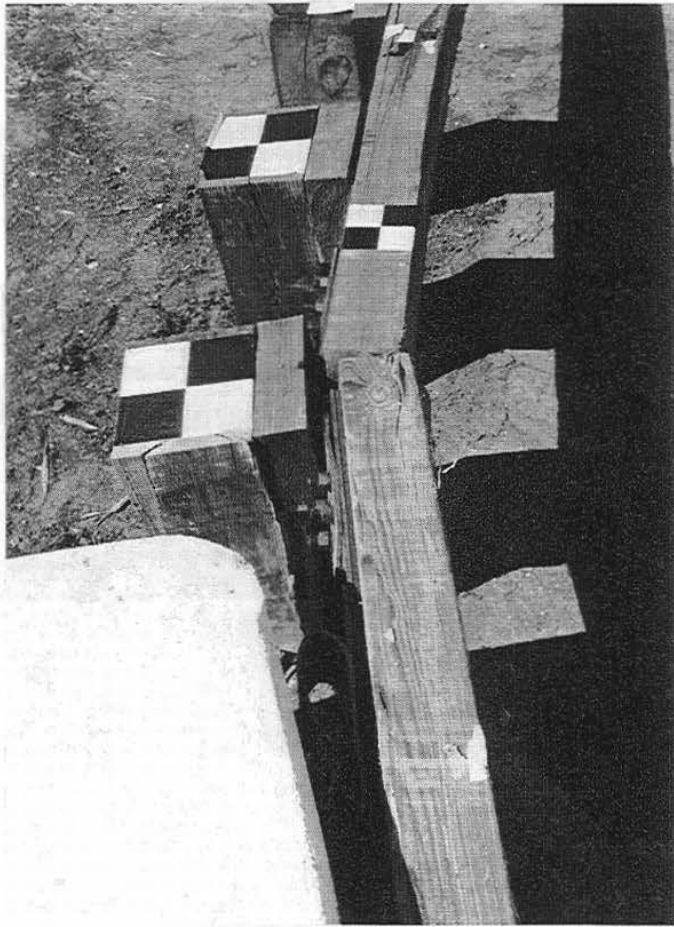
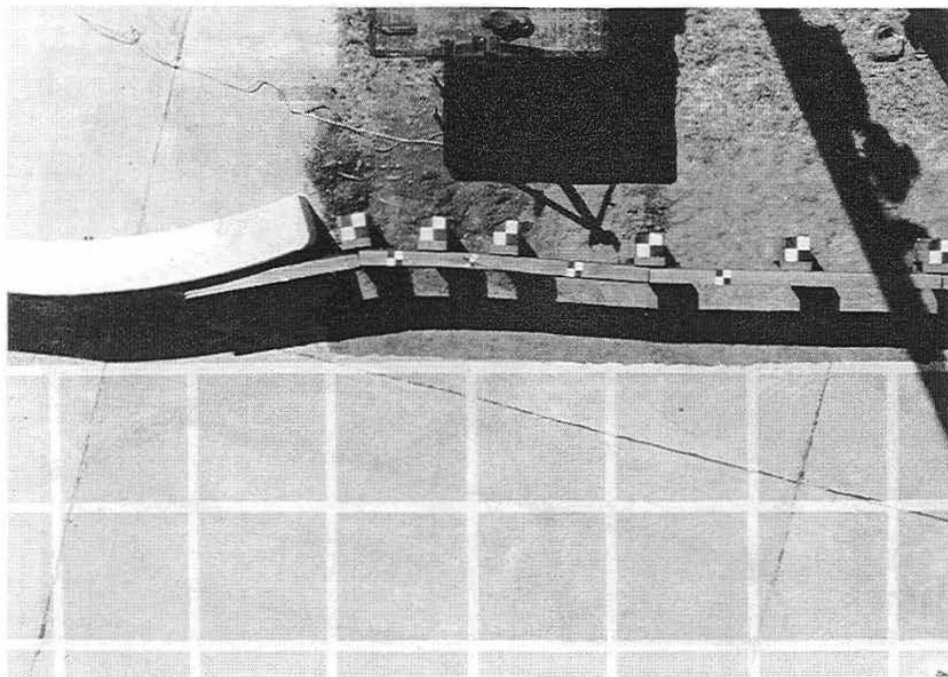
**Figure 10.** System Damage, Test SBT-1.

The damage to the system, shown in Figures 10 through 12, consisted of a maximum permanent set deformation of 11.25 in. (286 mm) at post No. 1. A bending failure occurred in the first rail, approximately 4.5 ft (1.37 m) from the downstream end of the rail. The 8 in. (203 mm) I.D. pipe located between the first rail and the concrete abutment was completely flattened. There was evidence of vehicle snagging at the splice between rail Nos. 1 and 2, as sheet metal from the vehicle was embedded in the end of rail No. 1. There were continuous scrape marks along the face of the rail from the point of impact to exit, as well as impact markings on the concrete abutment.

The impact with the end of the concrete abutment caused excessive occupant compartment deformation, which resulted in the failure of this test. It was determined that the stiffness of the steel backed wood rail was inadequate, as it deflected considerably, allowing the vehicle to impact the end of the concrete abutment. The system was redesigned for the next test by increasing the length of posts 1, 2, and 3 from 7 ft (2.13 m) to 8 ft (2.44 m). The 8 in. (203 mm) I.D. pipe spacer between the rail and concrete abutment was replaced with an angled block of wood in order to restrict the deflection of the first rail. The splice between the first and second rails was stiffened by adding a second 3/8 in. (10 mm) backup plate. The bolts at this splice were moved closer to the post and increased in number from 8 to 12. The details of these design changes are presented in the plan drawings in Appendix A.

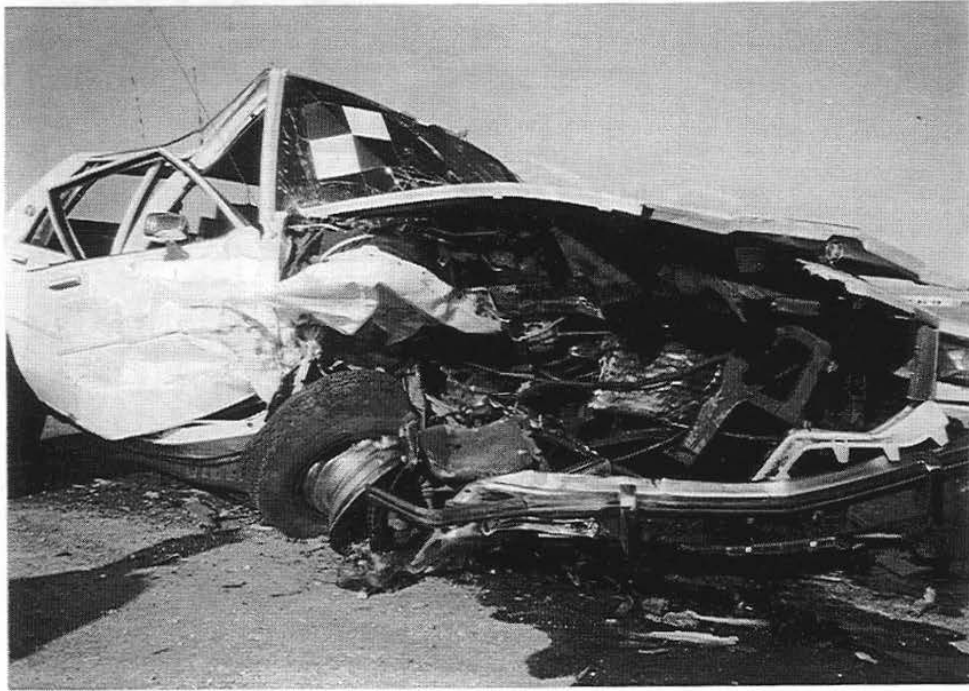
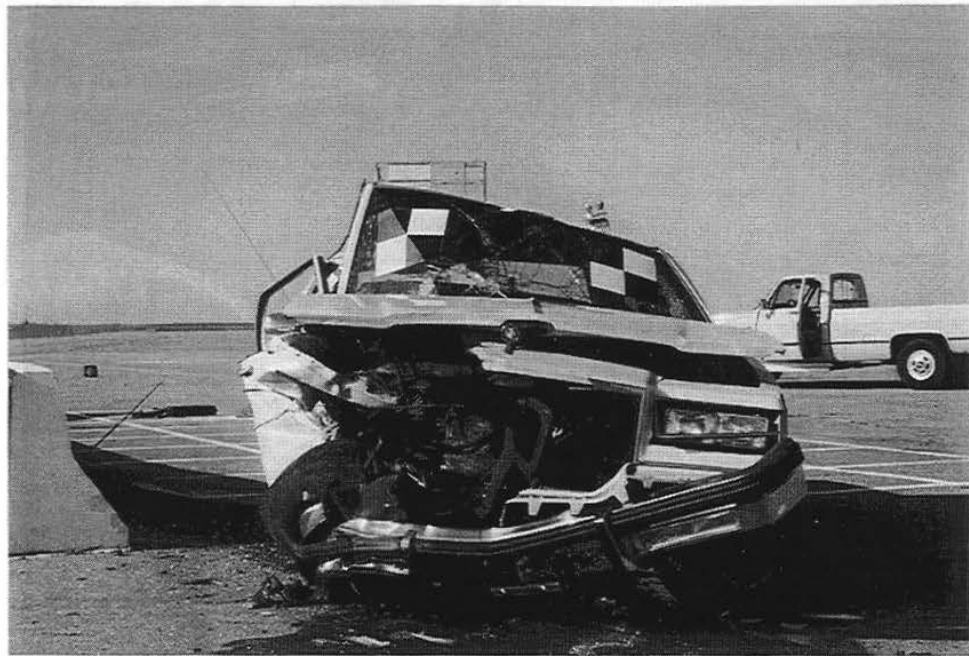
**Figure 18.** Vehicle Damage, Test SBT-2.

The damage to the vehicle was substantial, as can be seen in Figures 18 and 19. The entire front right portion of the vehicle was crushed and pushed back toward the occupant compartment considerably. The firewall and floorboard were pushed up and in on the passenger side, and a section of the wood rail penetrated the firewall on the extreme right hand side. The windshield was broken and the roof of the vehicle was buckled considerably. The maximum vehicle crush of 31.5 (800 mm) inches is shown schematically in Figure 20.

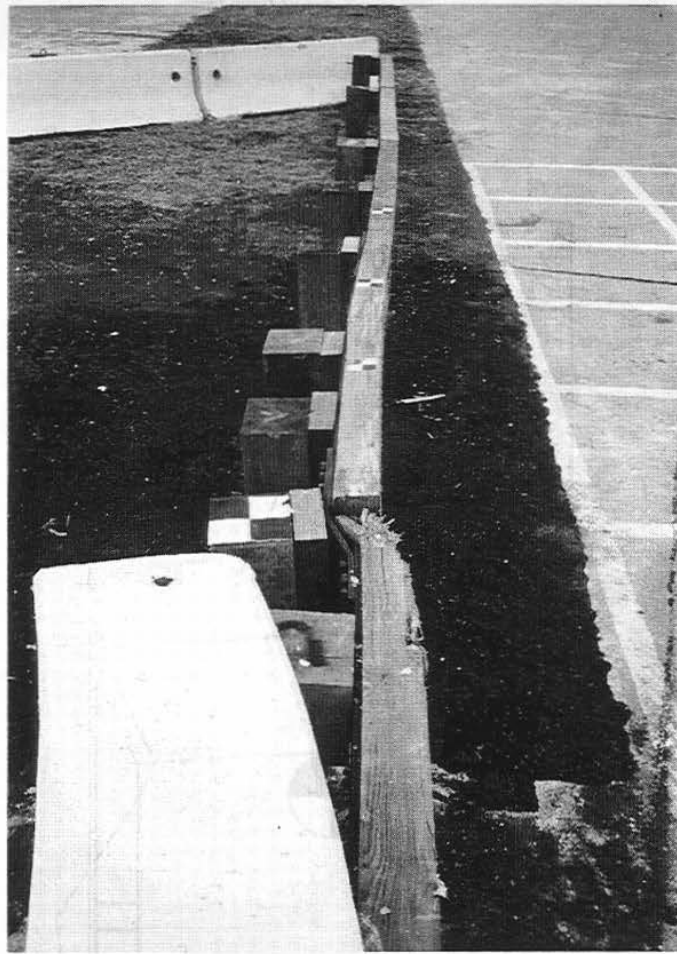
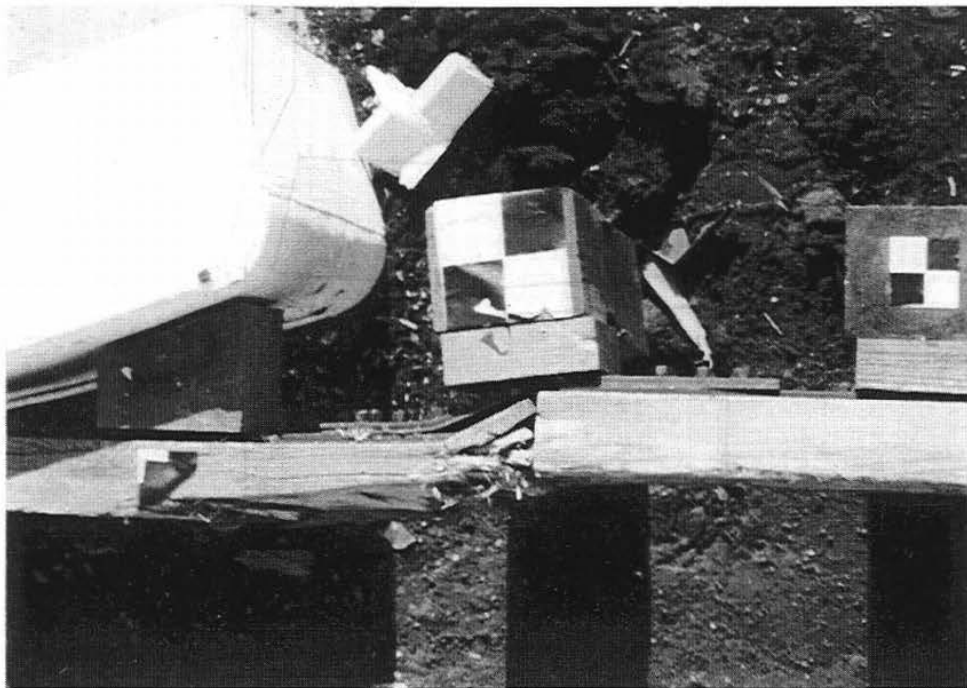
**Figure 21.** System Damage, Test SBT-2.

Damage to the steel backed wood rail was considerable, as can be seen in Figures 21 and 22. The upstream end of rail No. 1 was damaged as the vehicle snagged on it, and the splice plates between rails No. 1 and No. 2 were bent significantly. There were marks along the face of the rail and concrete abutment throughout the length of contact.

Two of the systems design flaws became apparent as a result of this test. The first was that the wood blockout between the wood rail and concrete abutment made the first rail section much too stiff, which resulted in the snagging problem at splice No. 1. The second observation was that the steel splice plates did not provide adequate strength for the splice between the first and second rail. Thus, two design changes were incorporated into the next design in an effort to alleviate these problems.

First, the angled wood blockout between the steel backed rail and the concrete abutment was replaced with a 6 in. diameter pipe. Secondly, the two 3/8 in. (10 mm) splice plates at post No. 1 were replaced with a 3 ft (0.91 m) length of 6 in. x 4 in. x 1/2 in. (152 mm x 102 mm x 13 mm) structural steel tube. The details of these design changes can be found in Appendix A.

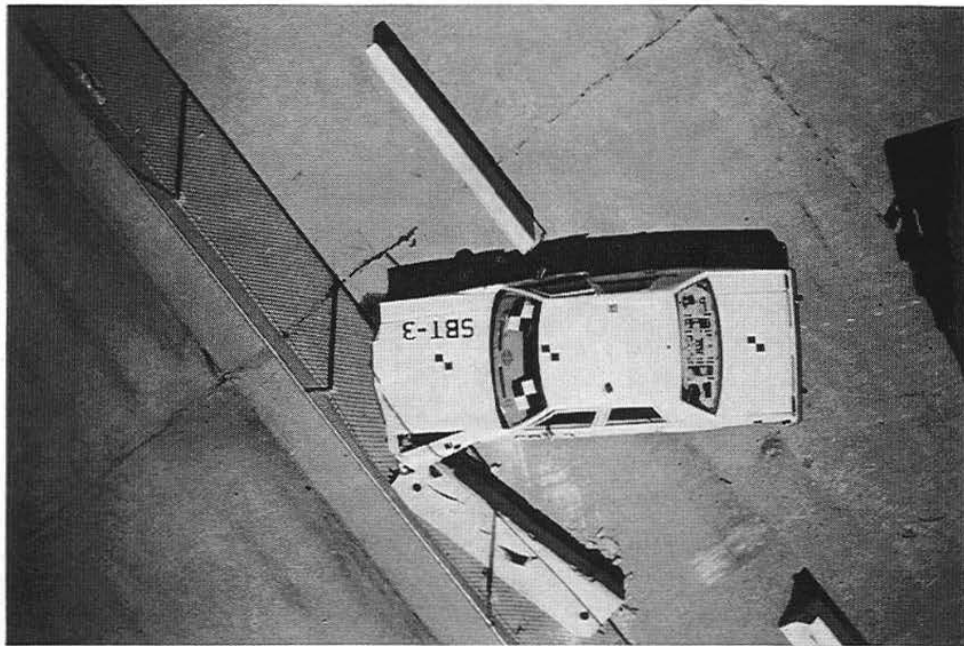
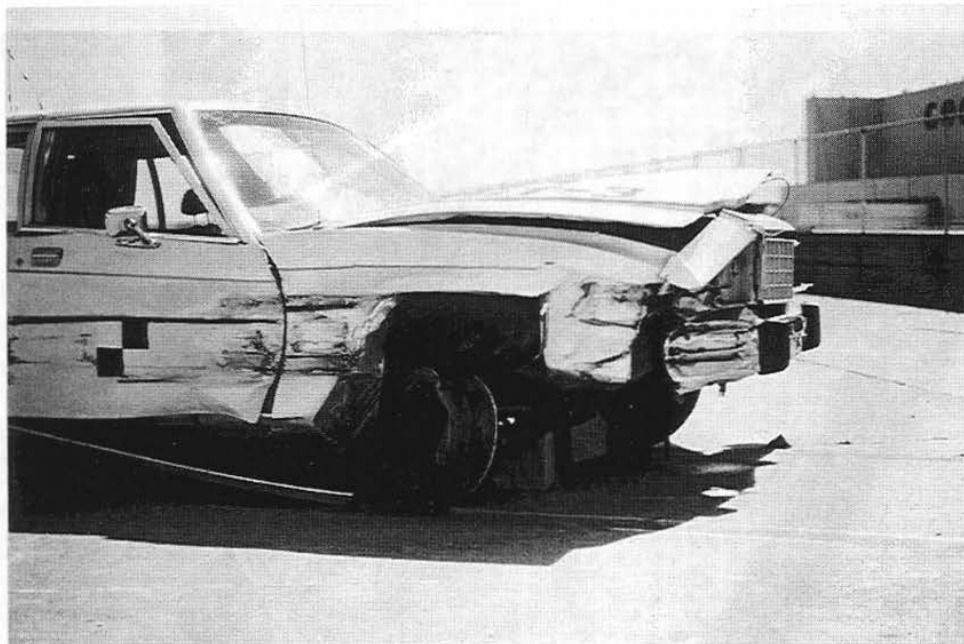
**Figure 28.** Vehicle Damage, Test SBT-3.

The vehicle damage, shown in Figures 28 and 29, consisted of the crushing of the front right corner of the vehicle, as well as scrapes and dents continuing down the side to the rear wheel well. The tire was torn off the front right wheel, and the rim was bent. Occupant compartment damage included buckling of the floor on the passenger side of the vehicle, as well as buckling of the dashboard. The maximum crush deformation of 13.75 in. (349 mm) is shown schematically in Figure 30.

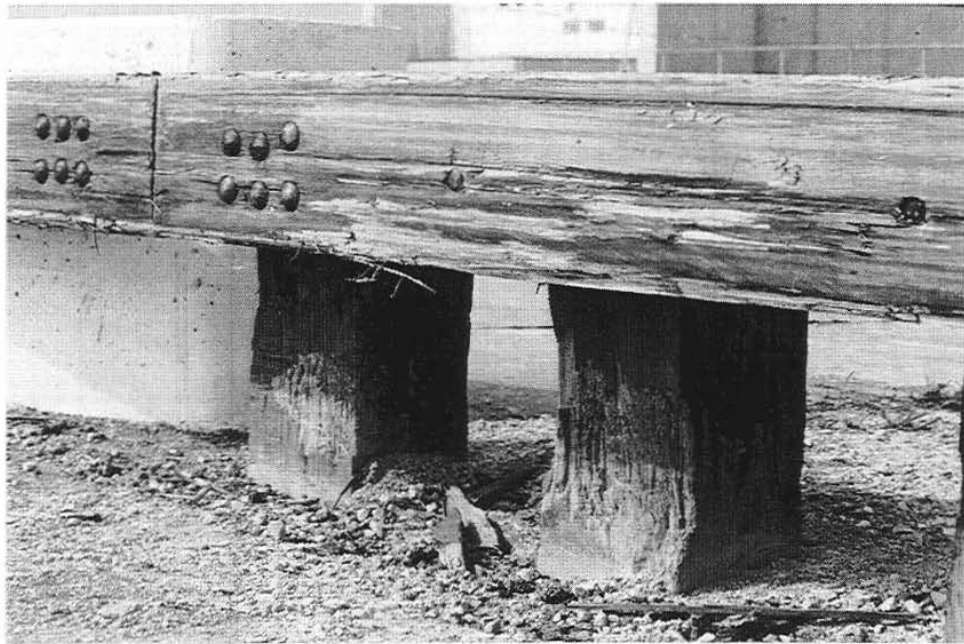
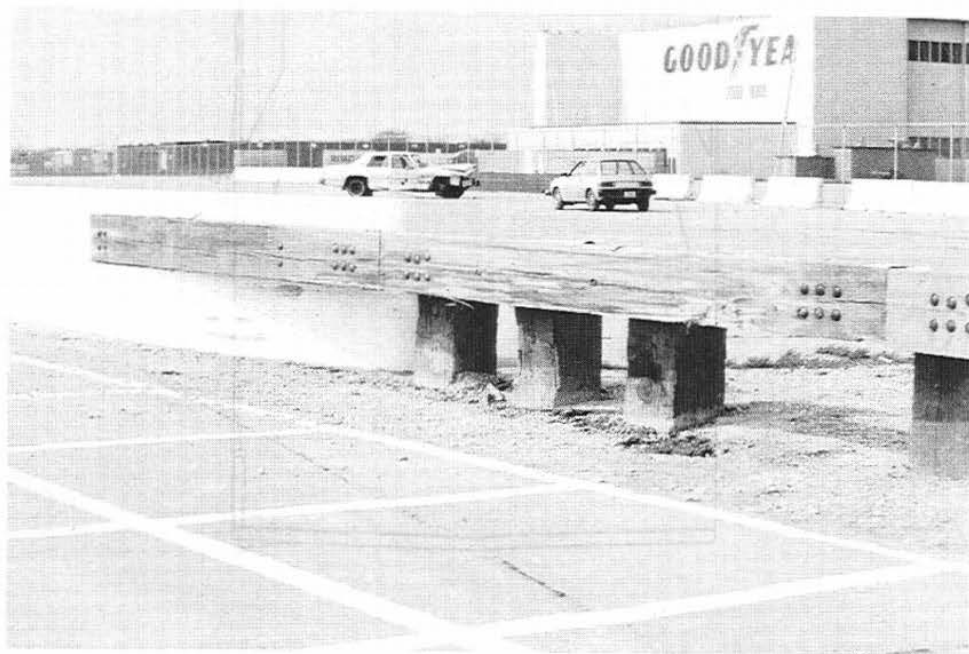
**Figure 31.** System Damage, Test SBT-3.

Damage to the system, shown in Figure 31 and 32, consisted of minor scrapes along the face of the

rail, and significant gouges in post Nos. 1 and 2. There were only minor tire marks evident on the concrete abutment. The maximum permanent set deflection of the rail was 2.5 in. (64 mm), which occurred at post No. 2.

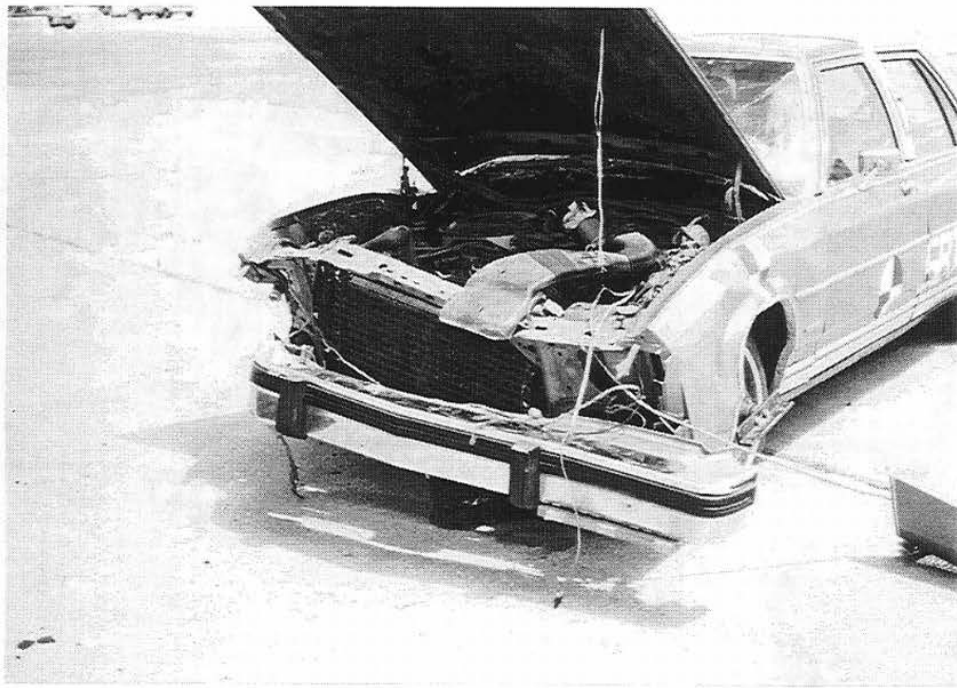
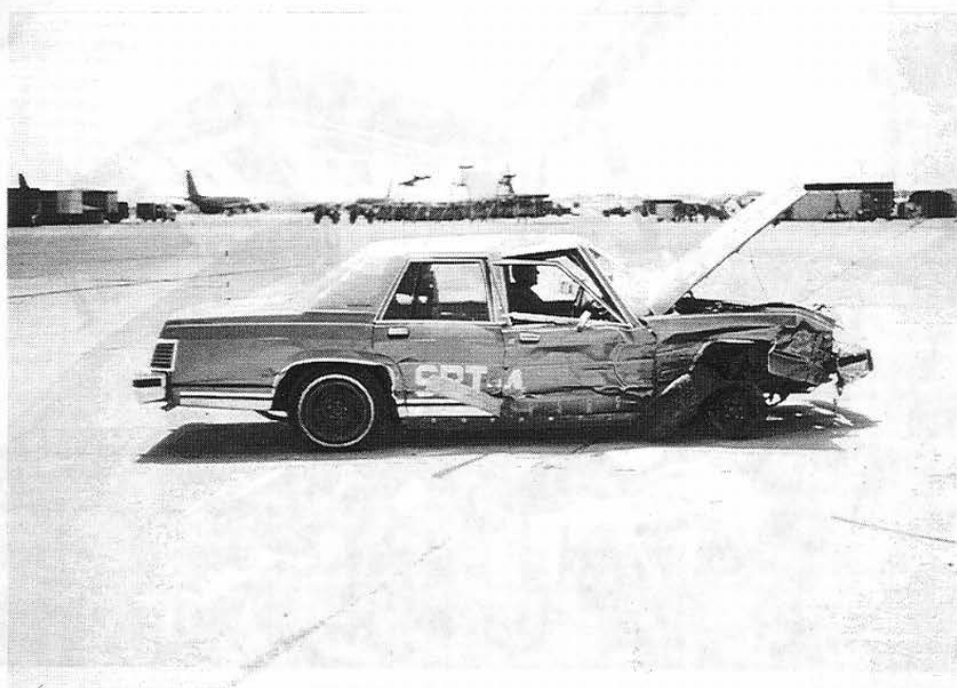
**Figure 38.** Vehicle Damage, Test SBT-4.

The damage to the vehicle, shown in Figures 38 and 39, consisted of deformation of the front right corner of the vehicle, which continued down the passenger side of the vehicle as scrapes and dents. The front left tire was removed from the rim, and the front bumper was pushed toward the drivers side considerably. The entire front end of the vehicle was pushed toward the passenger side and the roof was buckled. Interior compartment damage consisted of buckling of the floorboard on the passenger side and of the dash. The maximum crush deformation of 13.75 in. (349 mm) is shown schematically in Figure 40.

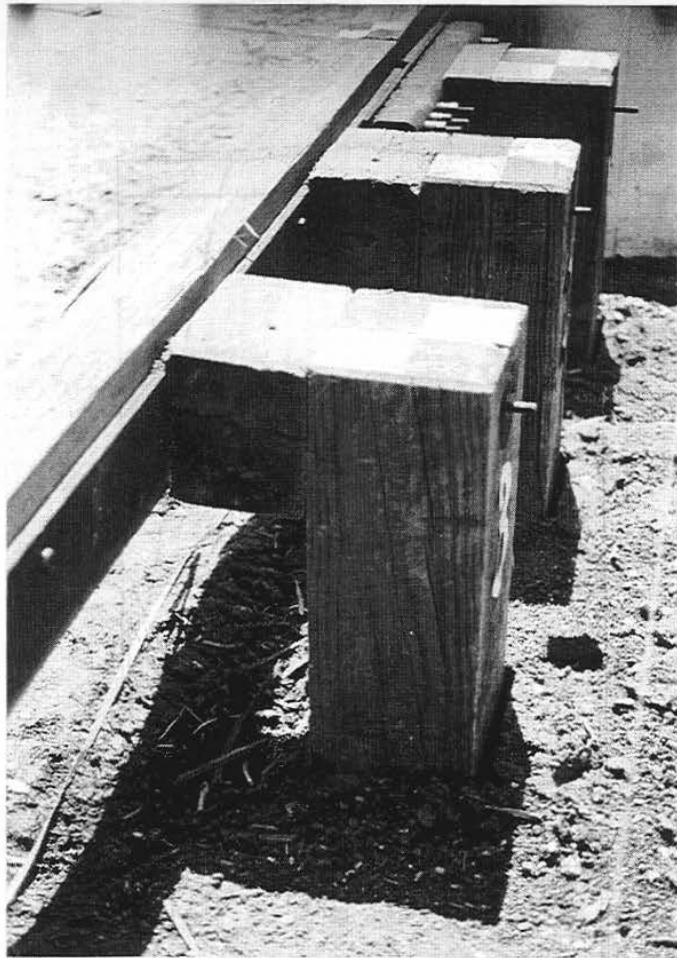
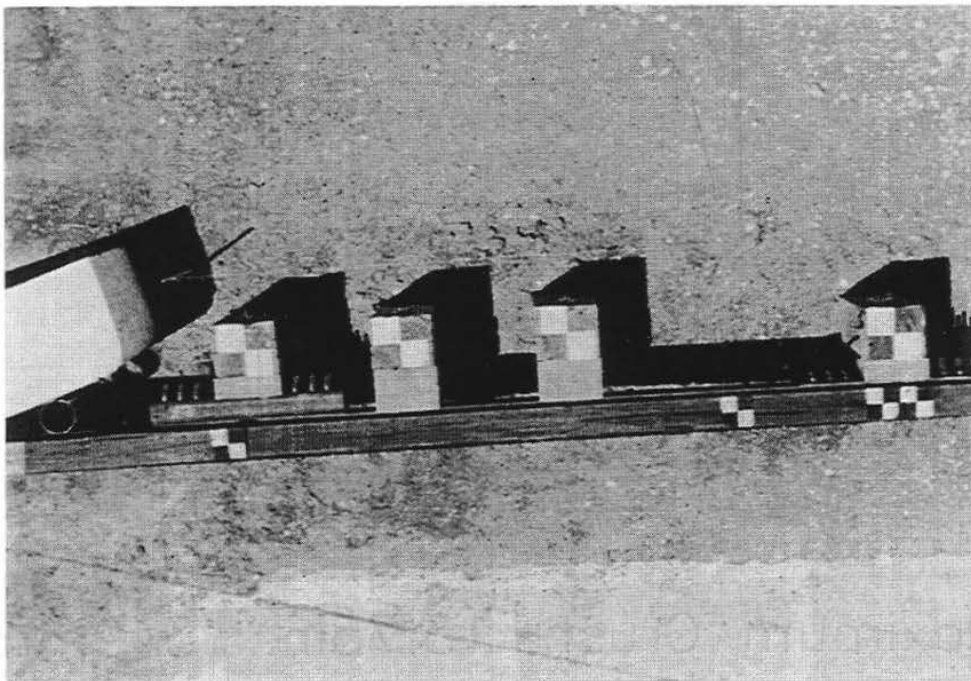
**Figure 41.** System Damage, Test SBT-4.

Damage to the system, shown in Figure 41 and 42, consisted of scrapes and gouges along the face

It was obvious from the results of this test that the additional 4 inches of blackout was not sufficient to eliminate the snagging or reduce it to a tolerable amount. It was deemed impractical to extend the blackout beyond 8 in. (203 mm), so it was decided to add a rub rail to the system to reduce the snag potential. A 4 in. x 6 in. x 11ft - 6in. (102 mm x 152 mm x 3.55 m) wood rub rail was therefore attached to post Nos. 1,2, and 3 for the next test. The details of this design change can be found in Appendix A.

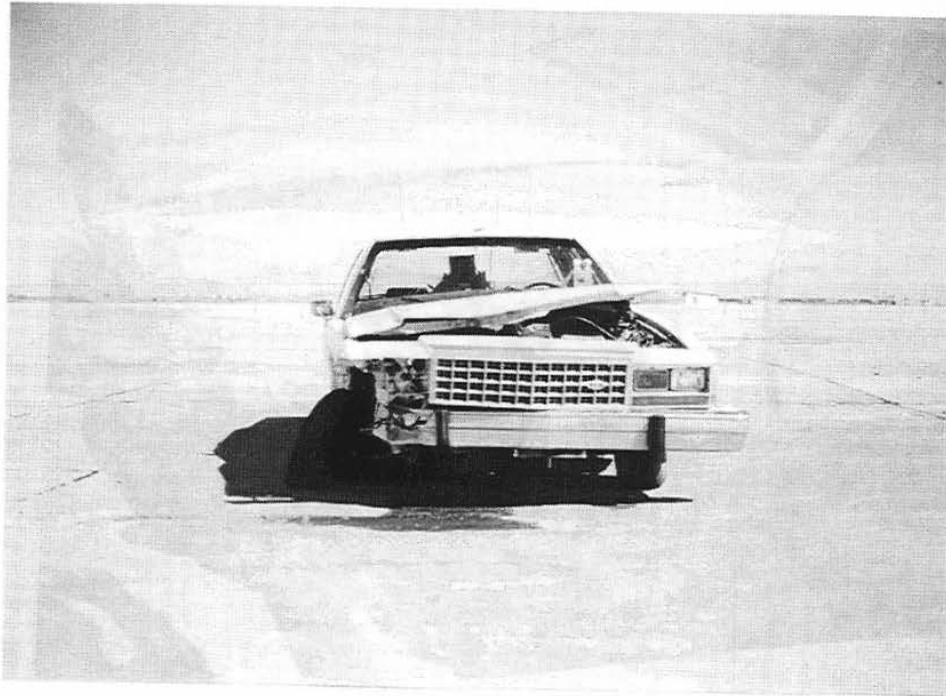
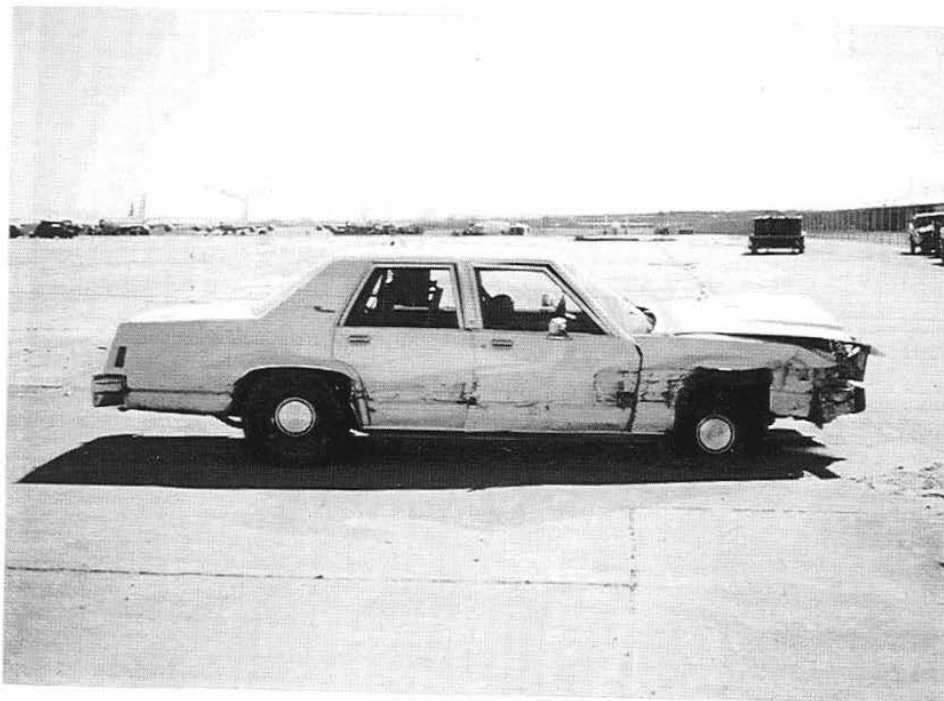
**Figure 48.** Vehicle Damage, Test SBT-5.

Damage to the vehicle, shown in Figures 48 and 49, included deformation of the front right corner, continuing along the length of the vehicle to the rear wheel well. There was no evidence of snagging, and the occupant compartment remained intact with the exception of minor deformation of the floorboard on the passenger side. The maximum crush deformation of 19.4 in. (492 mm) is shown schematically in Figure 50.
