**Safety Performance Evaluation of  
a Modified Perforated Tension Fuse Plate  
for Dual Support Breakaway Signs**

Project RES 2 (0099) P464  
TRANSPORTATION RESEARCH REPORT TRP-03-33-92

March 1993

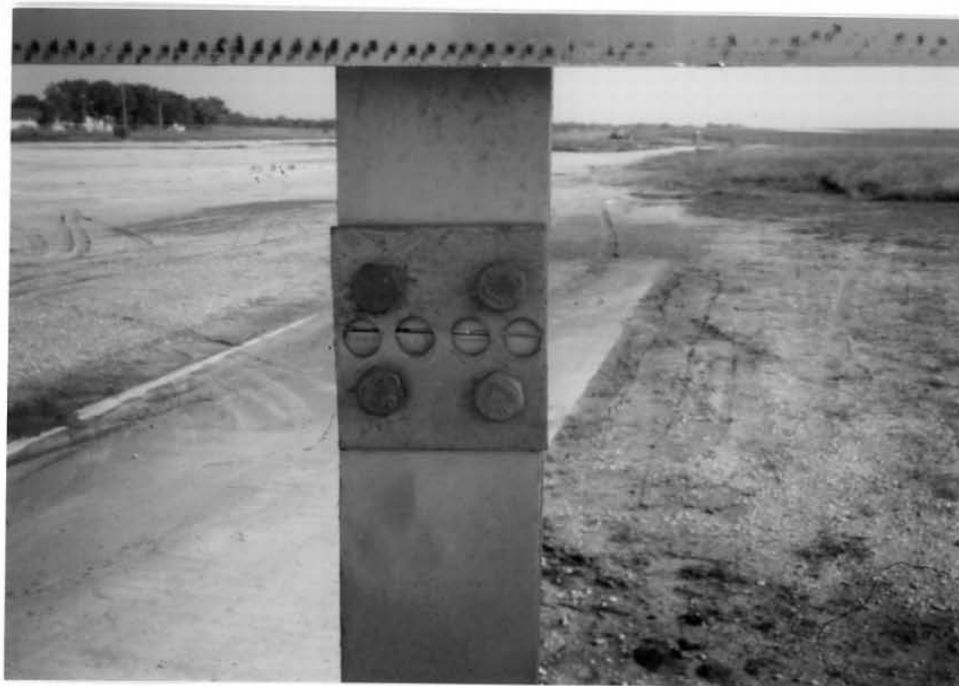
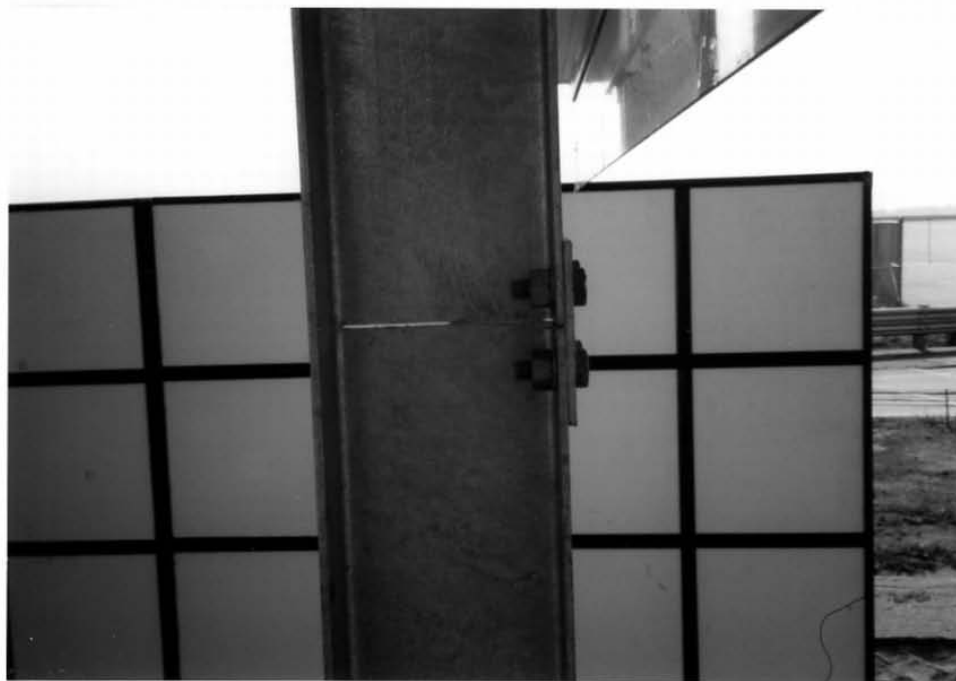
FIGURE 4. Photographs of the modified perforated tension fuse plate

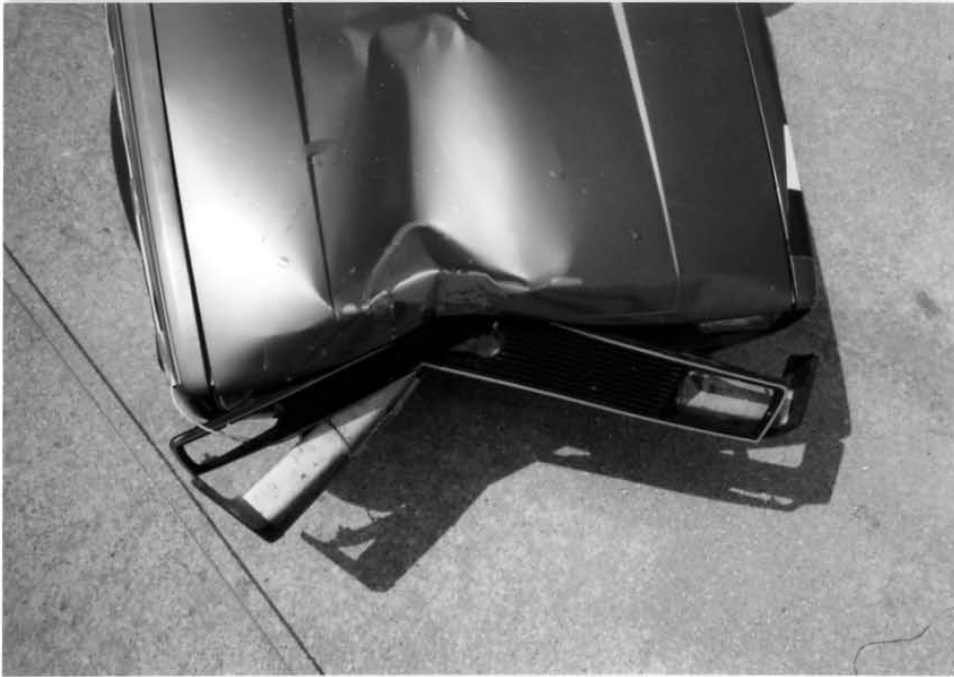
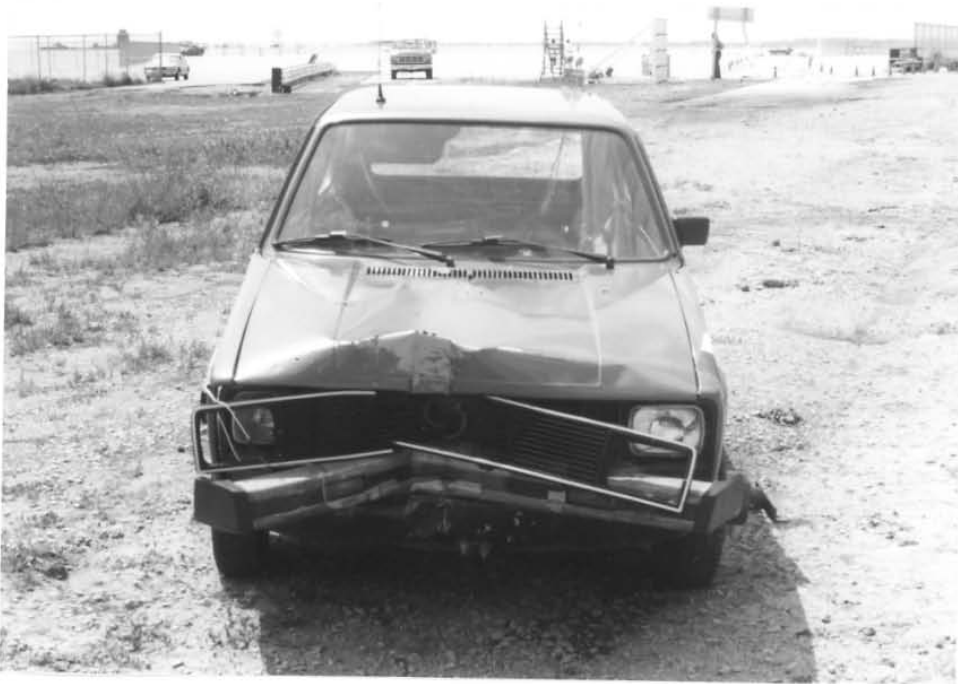
FIGURE 9. Vehicle damage, Test MOBS-1

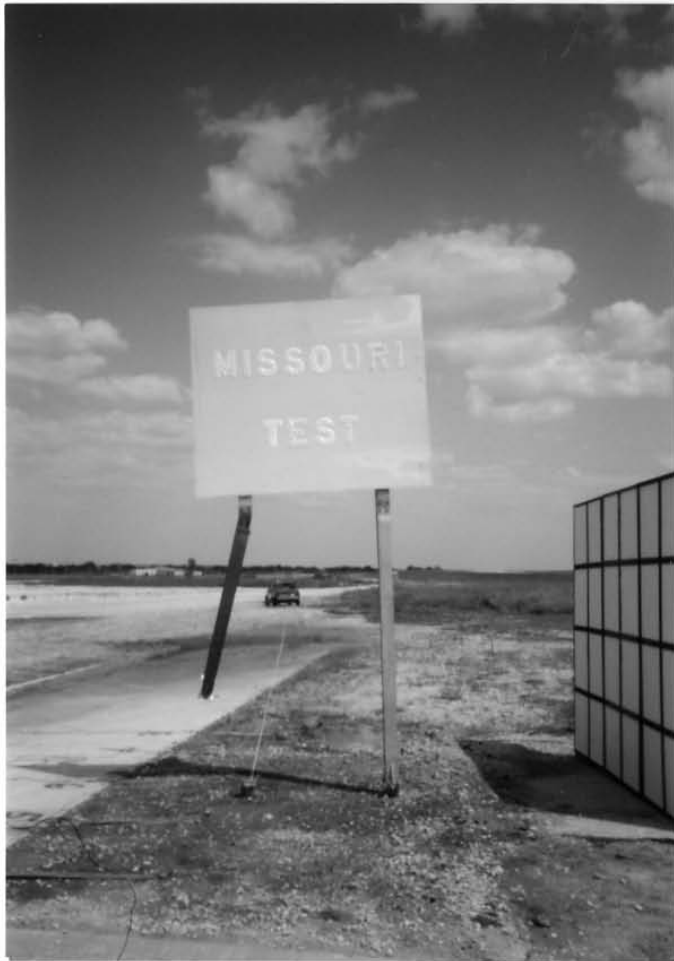
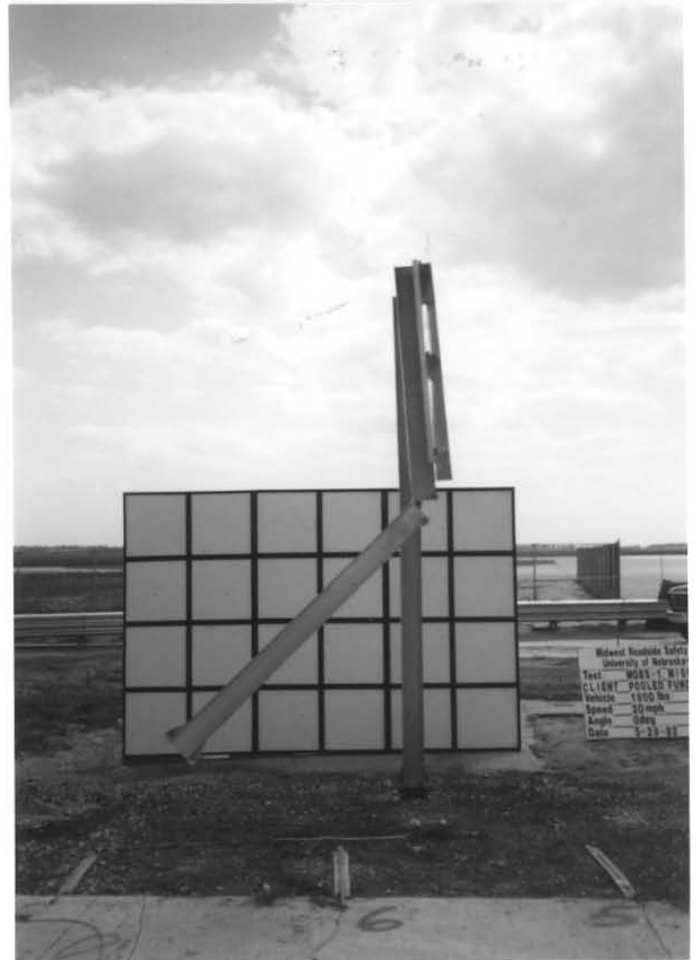
In Test MOBS-1, the 1979 Volkswagen Rabbit impacted the sign structure head on at a speed of 20.6 mph. A summary of the test results is shown in Figure 8. The target impact point was the center of the front bumper, but the actual impact was offset 5.5 in. toward the passenger side of the vehicle. A maximum crush depth of 9.75 in. was measured on the front bumper of the test vehicle. The damage to the test vehicle is shown in Figure 9. Damage to the sign support consisted only of destruction of the perforated tension fuse plate and the impacted support. Damage to the installation is shown in Figure 10.

FIGURE 10. Sign support damage, Test MOBS-1

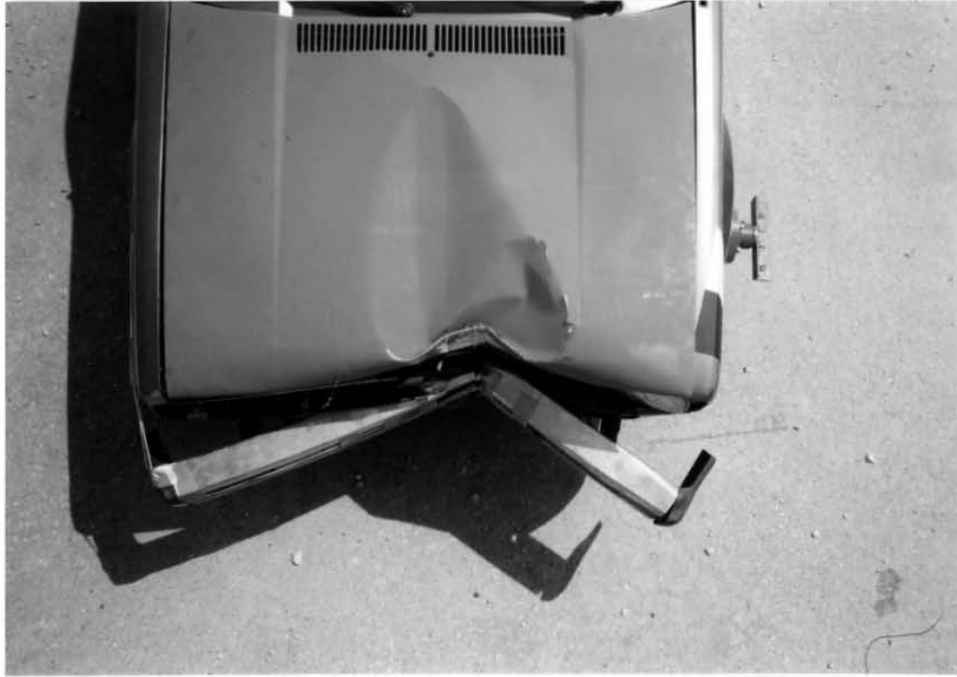
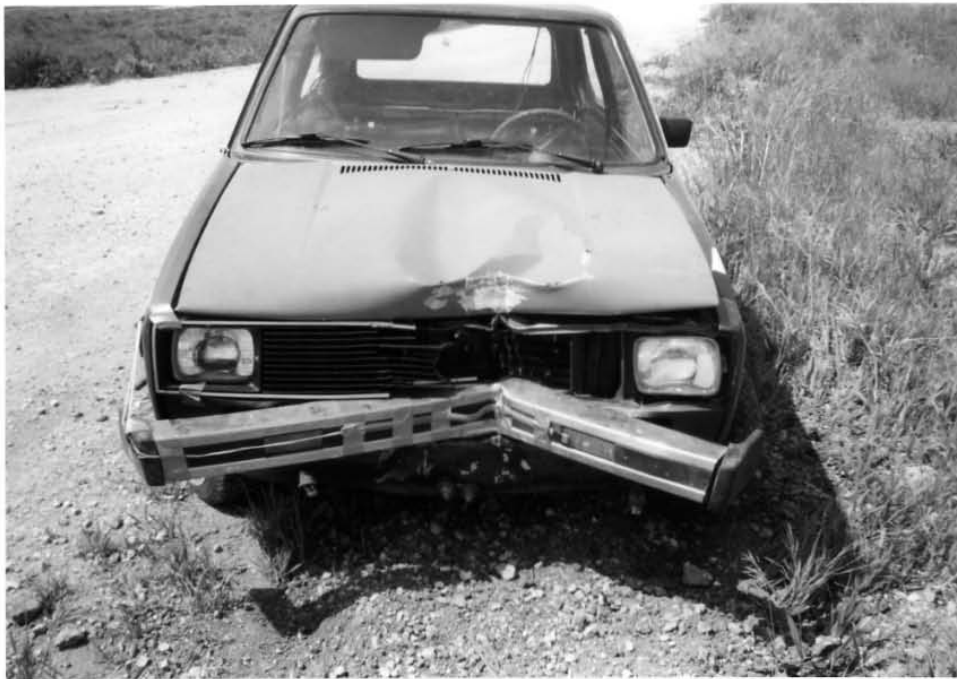
In Test MOBS-2, the 1979 Volkswagen Rabbit impacted the sign structure head on at a speed of 59.3 mph. A summary of the test results is shown in Figure 11. The target impact point was the center of the front bumper, but the actual impact occurred 6.25 in. from the center point toward the driver side of the vehicle. The damage to the test vehicle is shown in Figure 12, and damage to the test installation is shown in Figure 13. The impacted support and corresponding fuse plate were destroyed shortly after impact when the hinge mechanism activated. The other support was deformed as the sign system rotated around clockwise. One of the flanges from the stub of the non-impacted support was torn off as the support was rotated around. Damage to the sign was minimal, but one of the support beams was partially separated from the back of the sign.

FIGURE 12. Vehicle damage, Test MOBS-2

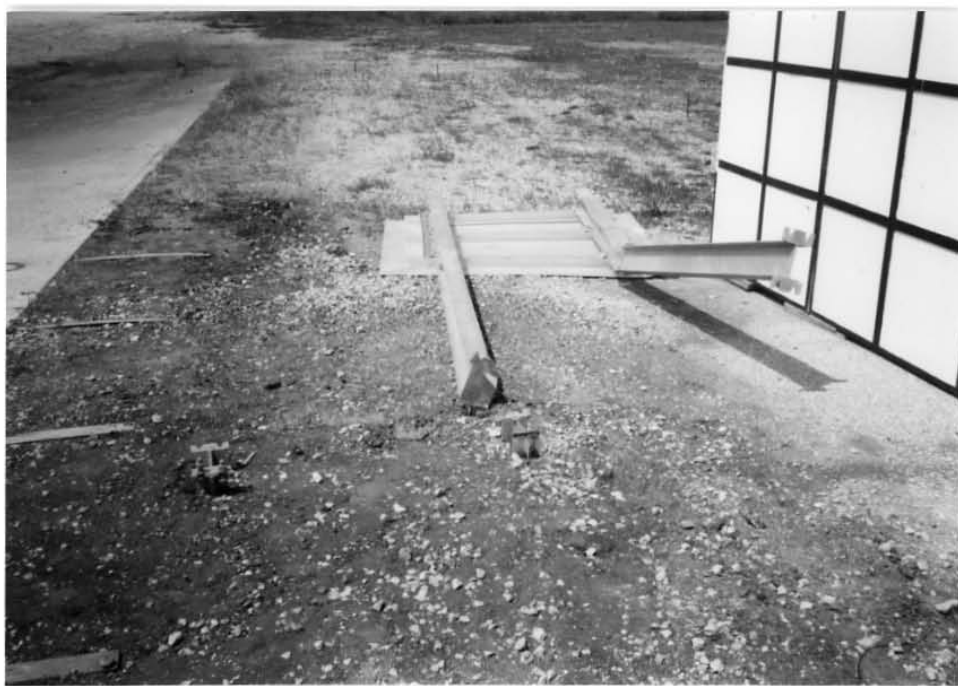
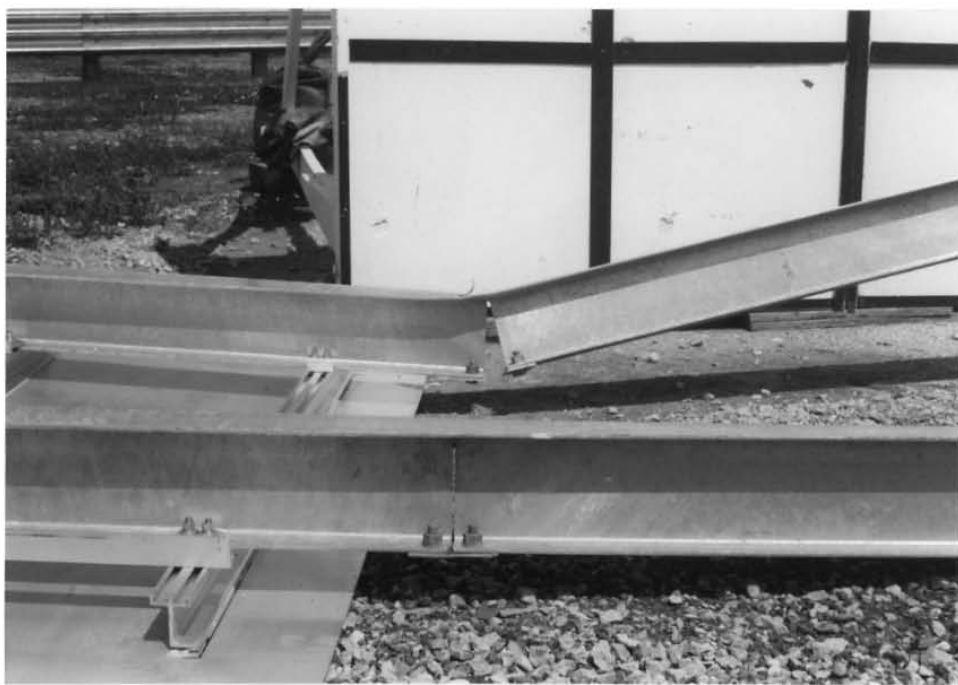
FIGURE 13. Sign support damage, Test MOBS-2

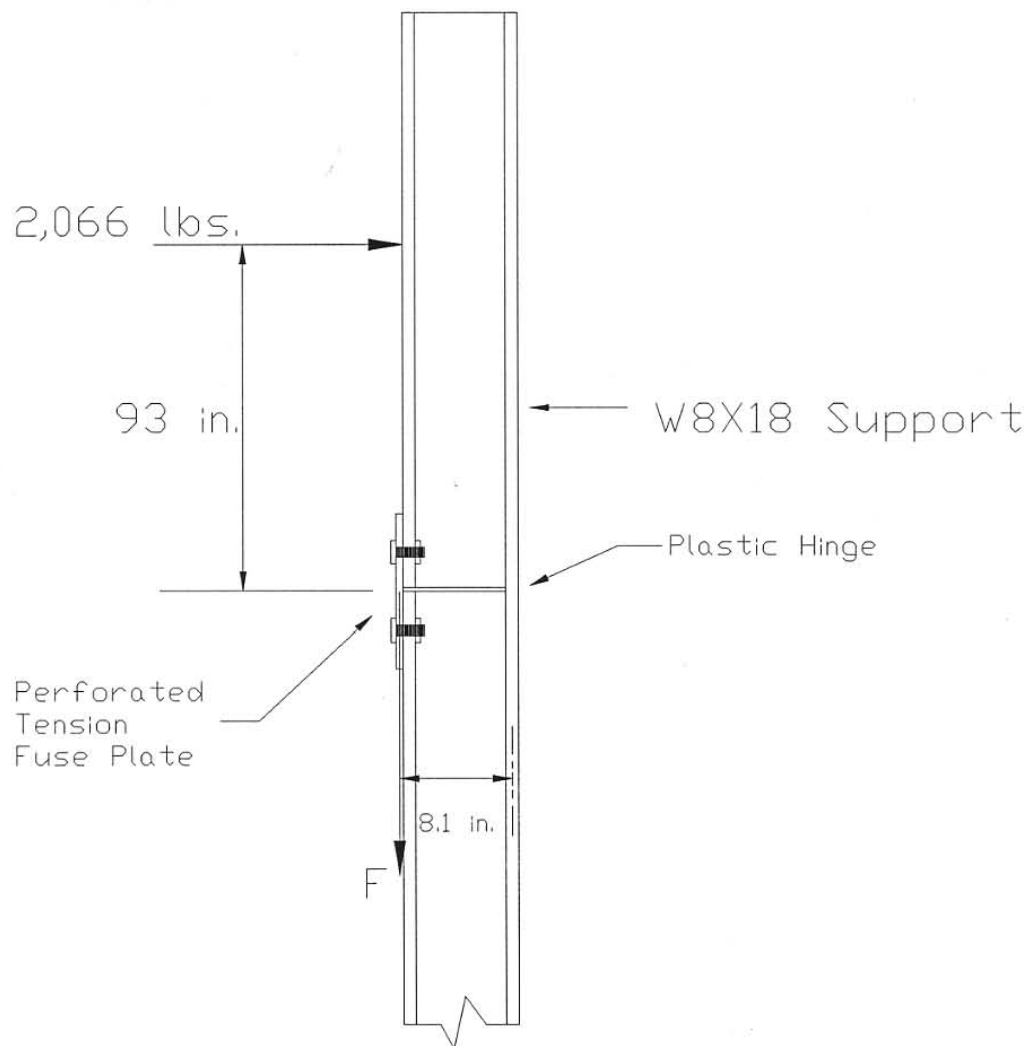
FIGURE B-1. Forces applied to sign as a result of wind loads.

The pressure applied to the sign by a 70 mph wind was calculated to be 23.74 lb/ft<sup>2</sup>. For a sign with a 174 ft<sup>2</sup> surface area, the total wind force was 4,132 lbs, or 2,066 lbs per support.

As can be seen, when the moments were summed about the hinge, it was found that the stress in the perforated tension fuse plate was approximately 94.9 ksi. The material used for the fuse plate had a minimum yield strength of 36 ksi, so it is evident that this fuse plate would fail under high wind loads.

A number of static bend tests were performed on the existing design as shown in Appendix C. It was determined that a potential solution to this problem involves specifying a free machining steel to be used for the fuse plate. This type of steel contains inclusions which cause the dynamic strength of the plate to be reduced by approximately 50% in the direction perpendicular to rolling. When the perforation holes are drilled in a line parallel to the roll direction, the static strength of the plate remains the same, but the plate will fail in a dynamic loading situation such as a collision. A suggested material for this plate is AISI 8620 (Yield Strength = 65 ksi, Ultimate Tensile Strength = 89 ksi, % elongation at failure = 25%). The cost of this material is about 70% higher than that of the A36 material which is currently being used, but because of the relatively small size of the fuse plate, this would represent an increase of only approximately \$25 per system. If this material was to be used, the geometry of the fuse plate could remain the same except for those changes indicated in Table 3.
