**Safety Performance Evaluation of a
Nested W-Beam with Half-Post Spacing
Over a Low-Fill Culvert**

Transportation Research Report No. TRP-03-36-92

March 1993

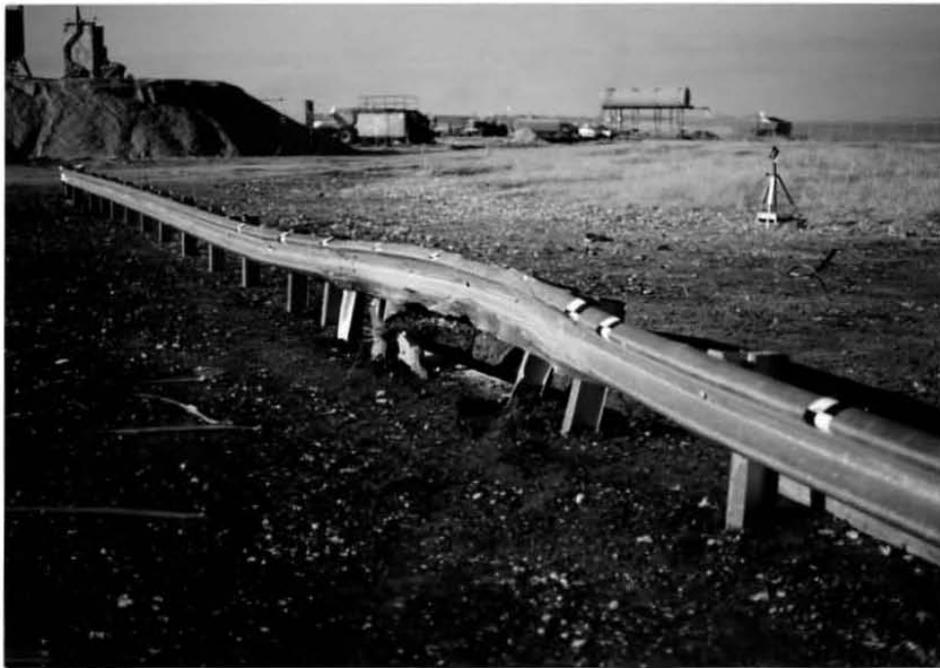
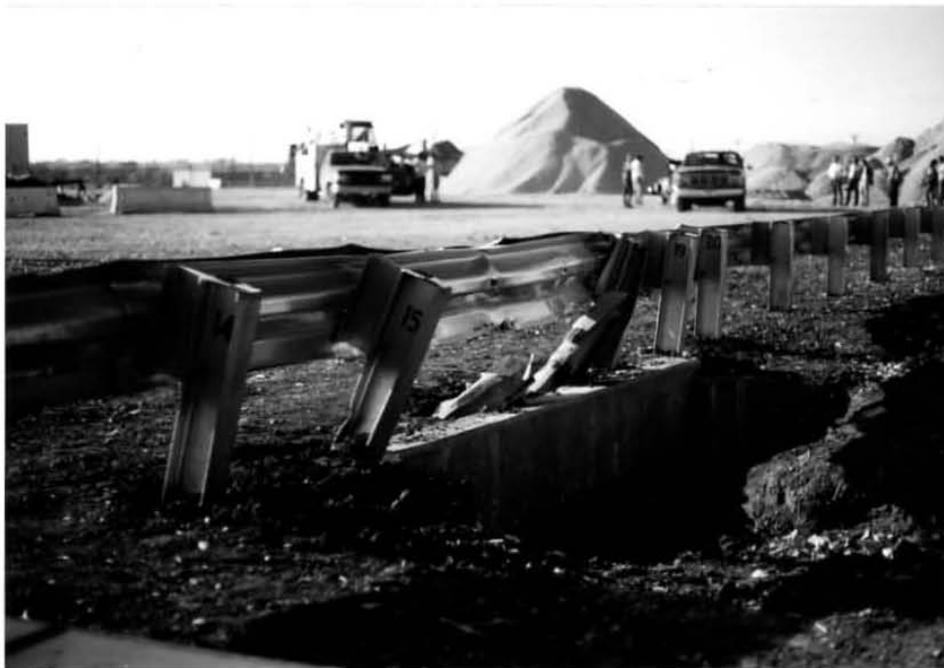
FIGURE 10. Guardrail Damage

Damage to the W-beam system is shown in Figure 11. A maximum permanent set deflection of 18⅝ in. was measured at Post No. 16. Additional measurements of permanent set deflections of the guardrail are presented in Figure 12. The concrete box culvert was not damaged.

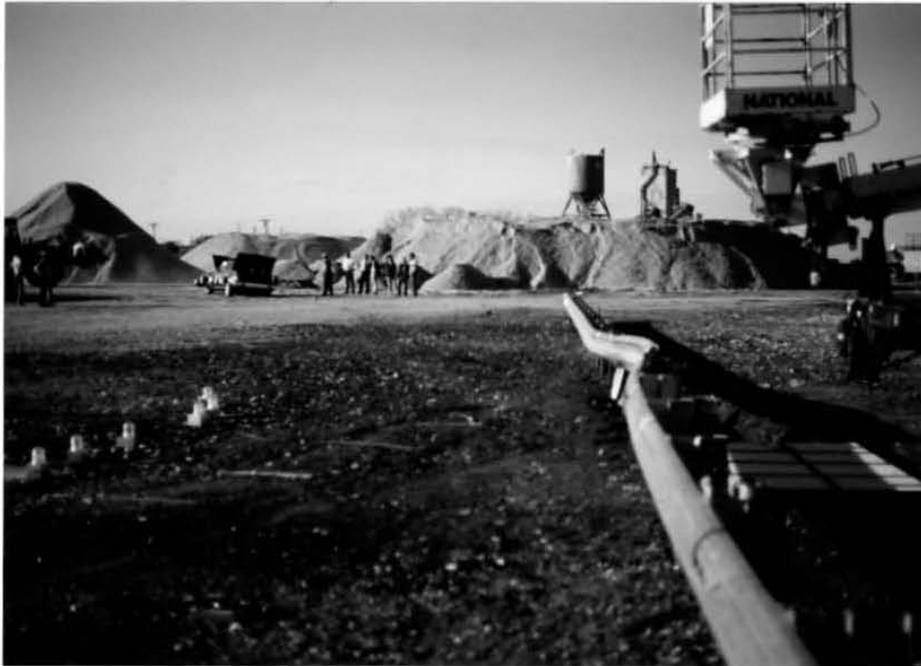
FIGURE 11. Vehicle Trajectory

The vehicle exited the rail at an angle and speed of 7.7 degrees and 30.6 mph, respectively, 350 ms after impact. After exiting the rail the vehicle continued to travel downstream and to the left, coming to rest 160 ft downstream from impact and 39 ft to the left of a line parallel to the railing face. This vehicle trajectory is shown in Figures 7 and 10.

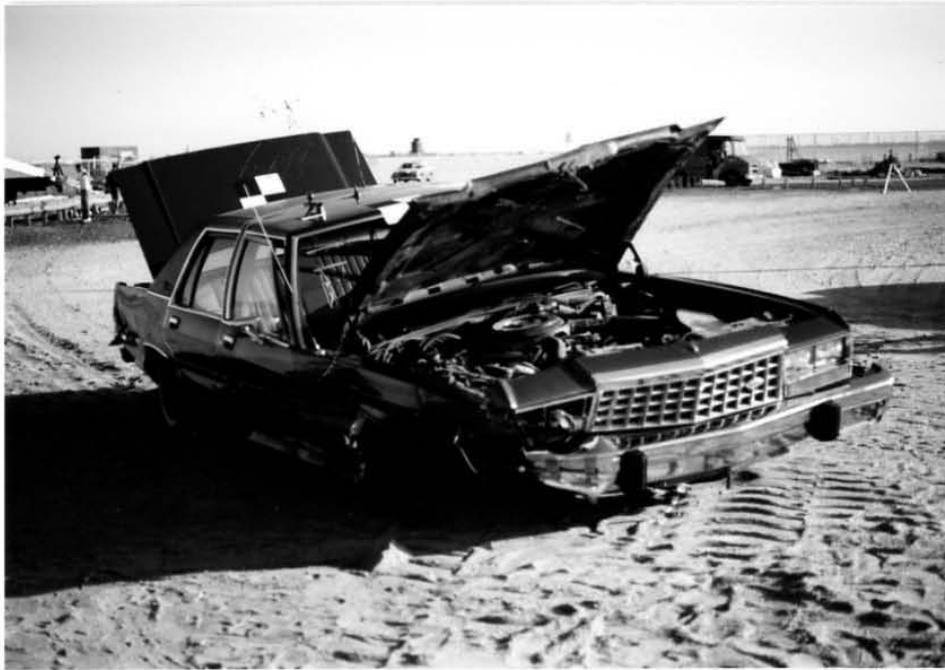
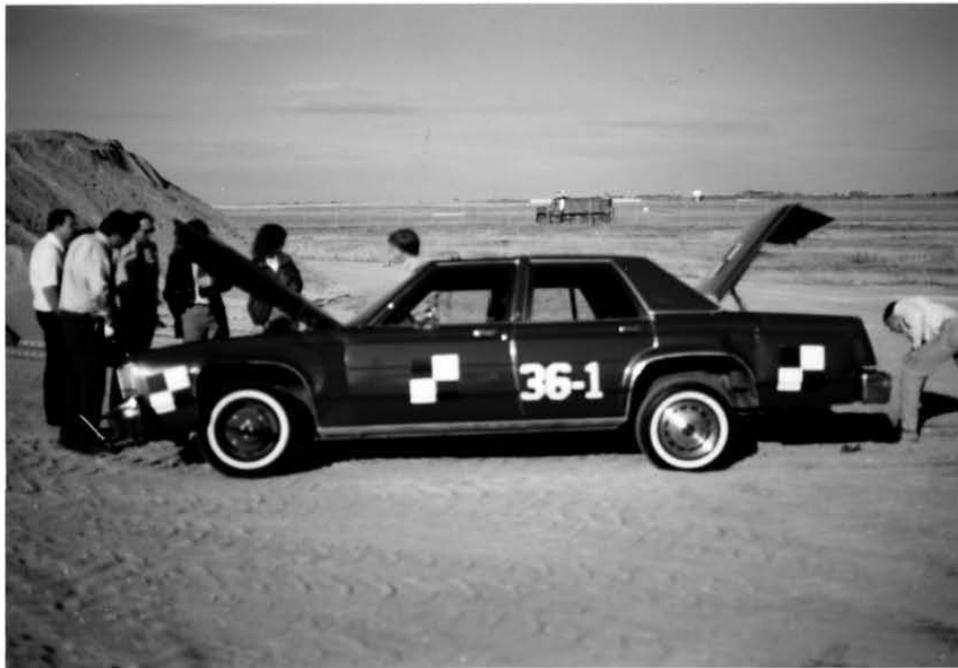
FIGURE 13. Vehicle Damage

The test vehicle damage, shown in Figure 13, was extensive along the entire passenger side. The normalized longitudinal and lateral occupant impact velocities as determined from accelerometer data were 27.9 fps and 13.5 fps, respectively. The highest 10-ms average occupant ridedown decelerations were 11.3 g's (longitudinal) and 18.7 g's (lateral). The vehicle change in speed of 30.4 mph was greater than the value of 15 mph required by NCHRP 230 (2). However, many systems which have been approved for use by FHWA have been unable to pass this criteria (5,6), and the update to NCHRP Report 230 (4) does not contain this requirement. Accelerometer traces from this test are shown in Appendix A.
