DYNAMIC EVALUATION OF MISSOURI'S MODIFIED BRIDGE ANCHOR SECTION

MIDWEST ROADSIDE SAFETY FACILITY

MwRSF Research Report No. TRP-03-38-93

February 1994

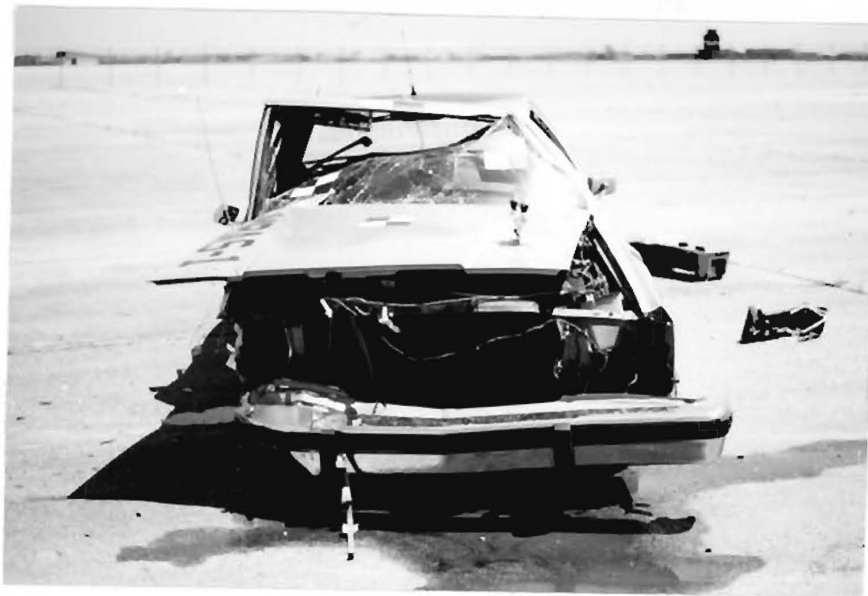
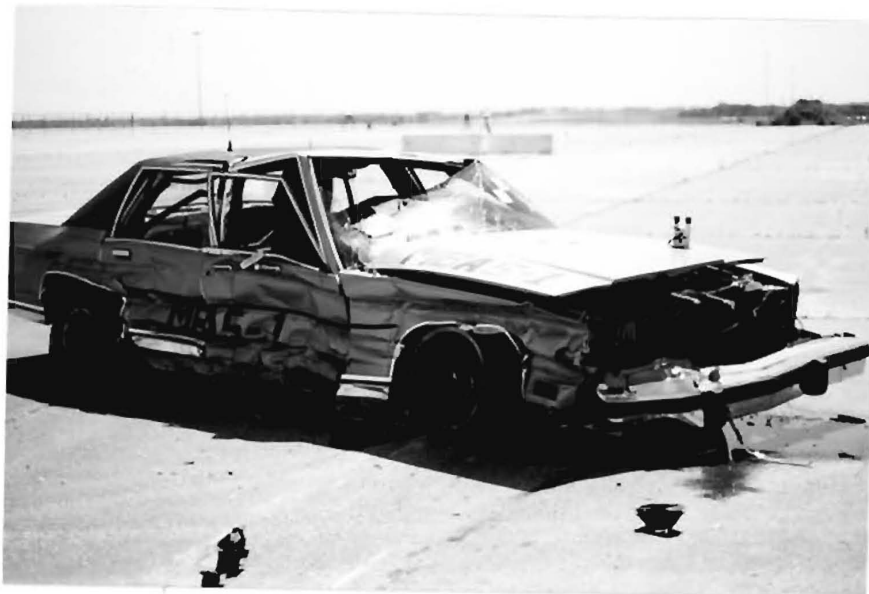
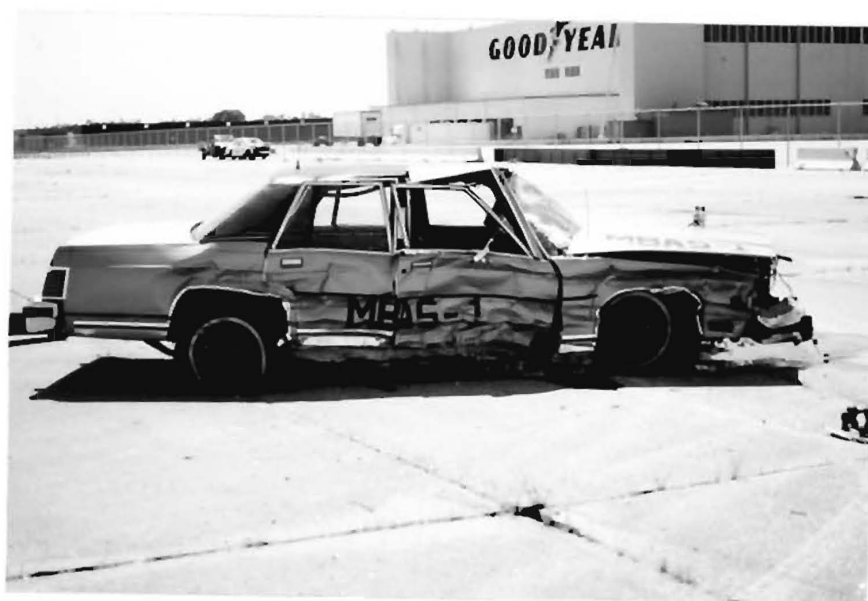
Figure 18. Vehicle Damage, Test MBAS-1

Exterior vehicle damage was extensive (Figures 18 through 20), and interior vehicle

damage was also significant (Figures 20 and 21). Vehicle damage occurred to several body locations, such as door and quarter panels, front bumper and grill, right-side wheels and rims, engine housing and hood, roof, windshield and windows, and occupant compartment floorboard and dashboard. Both right-side tires were deflated in conjunction with deformed steel rims (Figures 18 and 19). The right-side body panels were deformed due to vehicle-railing interlock and contact with concrete barrier curb (Figure 18). The right-side frame and undercarriage rested on the concrete surface. The right-front bumper and quarter panel were crushed inward (Figures 18 and 19). The engine housing was bent toward the left, away from the longitudinal centerline of the vehicle (Figure 18). In addition, the engine housing, radiator, and grill were displaced approximately 1 ft behind the rear-side of the front bumper (Figures 18 and 19). The rear-side of the engine hood was also deformed. Buckling occurred to the occupant compartment roof, steel supports, and window frames (Figures 18 and 20). The front windshield was fractured (Figures 18 through 20). The front and rear floorboards on the vehicle's right-side received extensive deformation. Deformation to the right-front floorboard, shown in Figure 21, was judged to be sufficient to cause injury to vehicle occupants. The front dashboard, shown in Figure 20, was also severely deformed and buckled transversely.

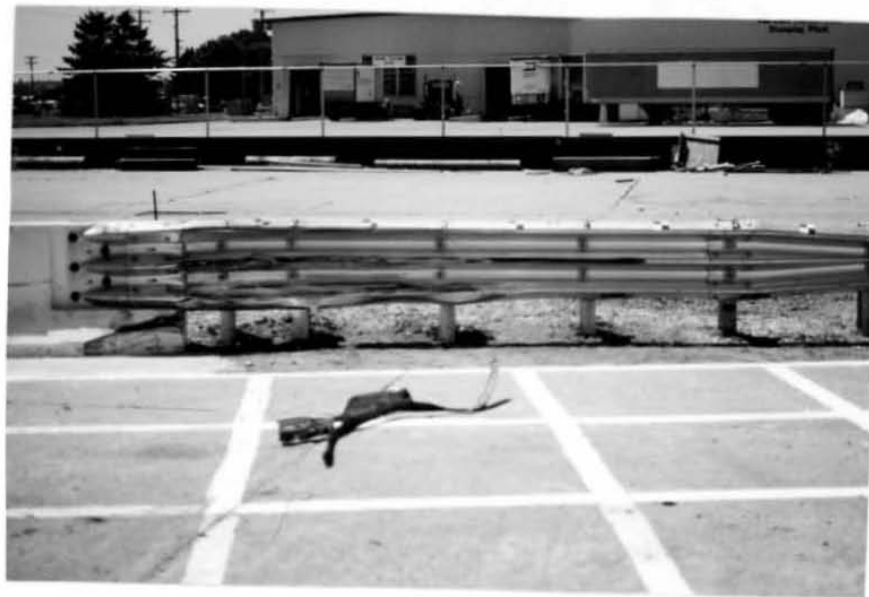
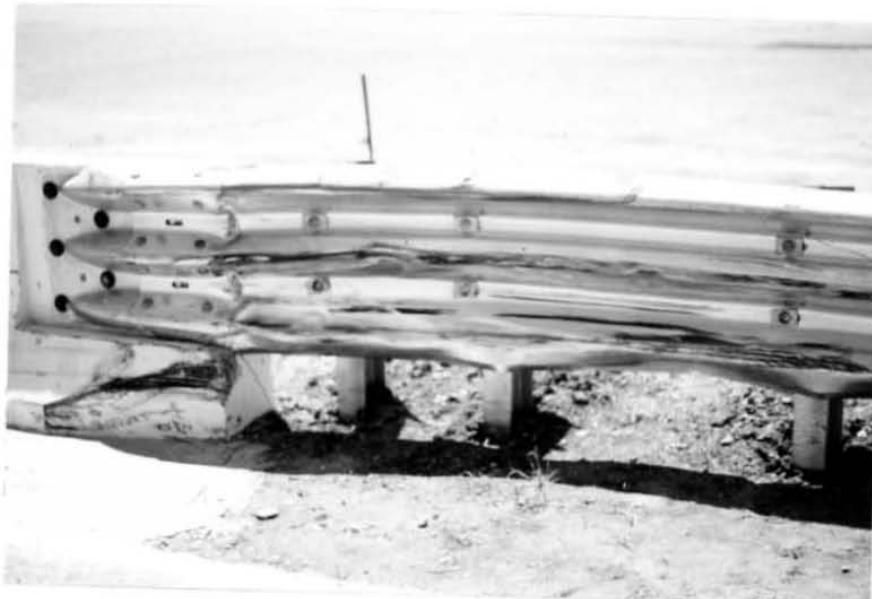
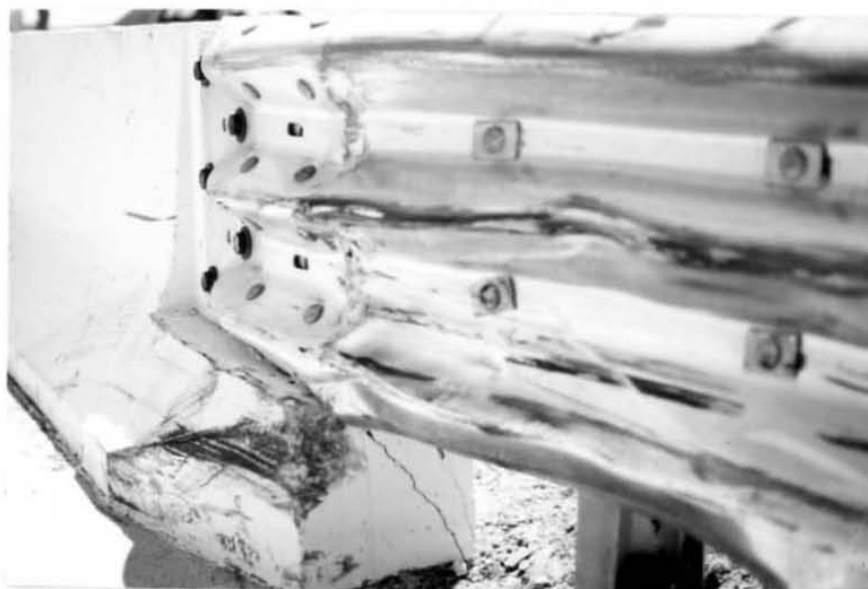
Figure 22. Bridge Anchor Section Damage, Test MBAS-1

Barrier damage was moderate as shown in Figures 22 through 24. The thrie beam and terminal connector were deformed (Figures 22 and 23). In addition, the thrie beam and terminal connector received 11 ft of black marks and scrapes beginning at 2 ft upstream from impact. Post Nos. 1 and 2 were found to be pushed back and twisted. In addition, at Post Nos. 1 and 2, the steel backup plates were flattened and the steel spacer blocks were deformed. The rectangular washers at Post Nos. 1 and 2 were scuffed and bent; however, the washers showed

no evidence of pulling through the three beam rail (Figure 22). The concrete barrier curb section received black marks, scrapes, spalling, and cracks (Figures 22 through 24). The upstream end of the concrete barrier curb showed evidence of concrete cracking along an approximate 45 degree plane with a vertical line (Figures 22 and 24). Concrete spalling occurred at the top and the lower front-face on the upstream end of the concrete barrier curb (Figures 22 through 24). The maximum lateral permanent set deflections for midspan rail and post locations, as determined from high-speed film analysis, were approximately 12.0 in. (11.8 in. field-measured) and 11.2 in. (10.5 in. field-measured), respectively. The maximum dynamic lateral deflections for midspan rail and post locations, as determined from high-speed film analysis, were 13.5 in. and 13.0 in., respectively. Midspan rail and post deflections are shown graphically in Figure 25.

First, it is recommended that the lower blunt-end face at the upstream end of the concrete barrier curb be modified to prevent wheel-hub snagging. This modification may consist of reducing the width of the blunt-end face located below the thrie beam rail by approximately $3\frac{1}{2}$ in. The blunt-end face of the current design extends $\frac{1}{4}$ in. and $3\frac{1}{2}$ in., as measured toward the roadway, away from the front and rear faces of the undeformed thrie beam rail, respectively. Figure 26 shows a barrier curb configuration that may allow the modified bridge anchor section to meet NCHRP Report 230 safety standards. Further, increased reinforcement and/or increased concrete wall thickness may be necessary to prevent cracking in the concrete barrier curb section.
