Safety Performance Evaluation of the George Washington Memorial Parkway Bridge Rail

Transportation Research Report TRP-03-45-94

June, 1995

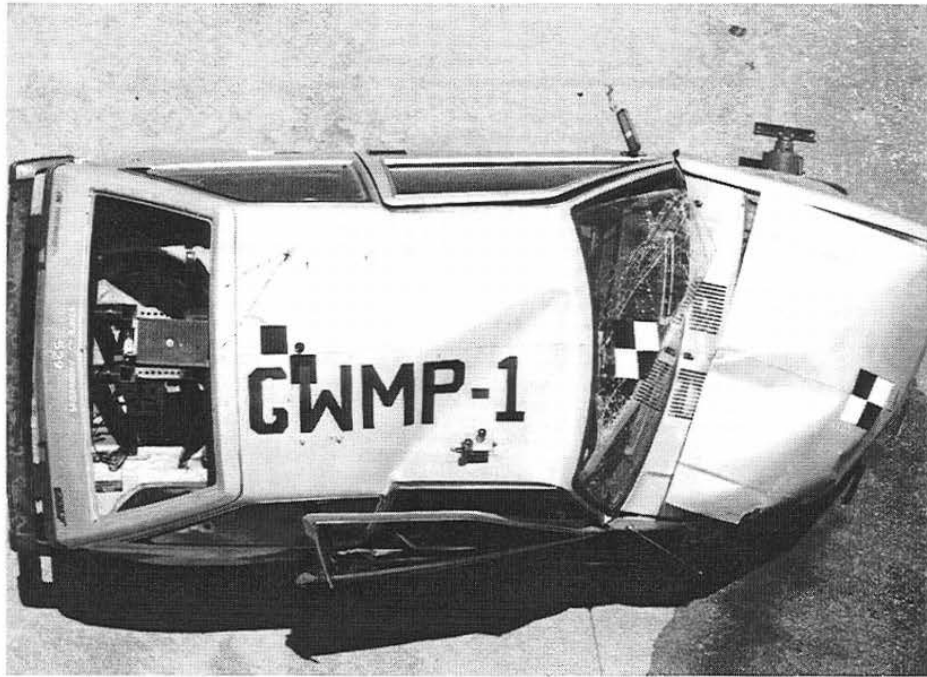
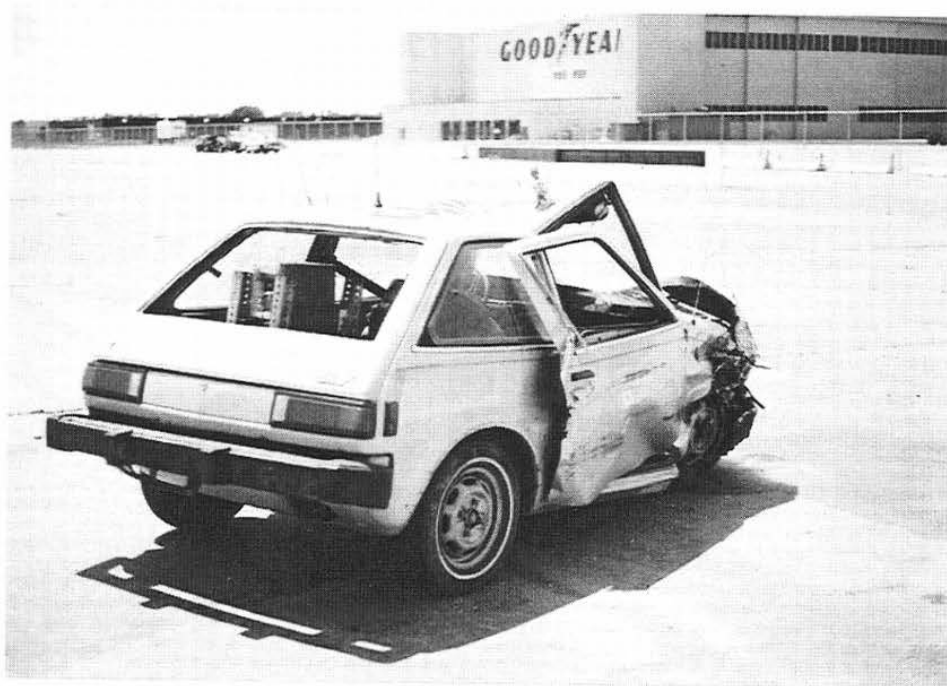
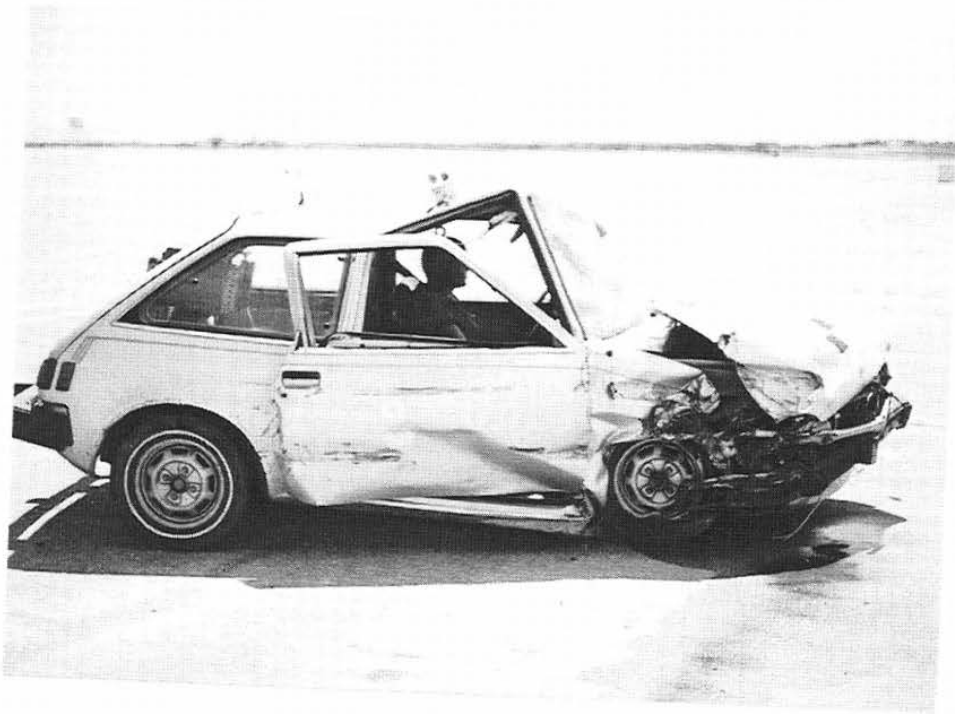
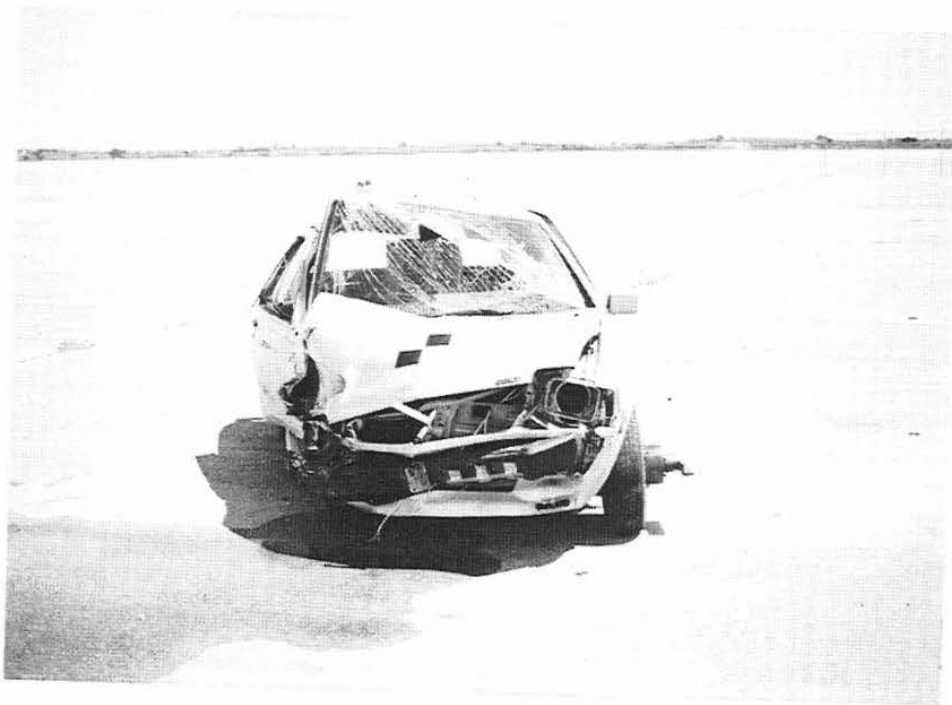
Figure 17. Vehicle Damage, Test GWMP-1.

The vehicle damage, shown in Figures 17 and 18, included the crushing of the right front corner of the vehicle, twisting of the car to the right of its longitudinal centerline, buckling of the hood, roof, windshield frame, firewall, passenger compartment floor and the passenger side door. The front right tire was deflated and the rim was deformed. The maximum crush deformation of 21

As is evident in the vehicle damage shown in Figures 17 and 18, there was significant occupant compartment damage in the test vehicle. This damage was caused by the snagging of the vehicle on the system posts and, along with the excessive lateral ridedown decelerations, caused the system to fail this compliance test. In order to alleviate this snagging problem, the rail size was increased from 4.5 in. O.D. to 5.0 in. O.D. (114 mm to 127 mm), and it was moved further out from the post. The details of this change can be seen in Figures 3 and 4.

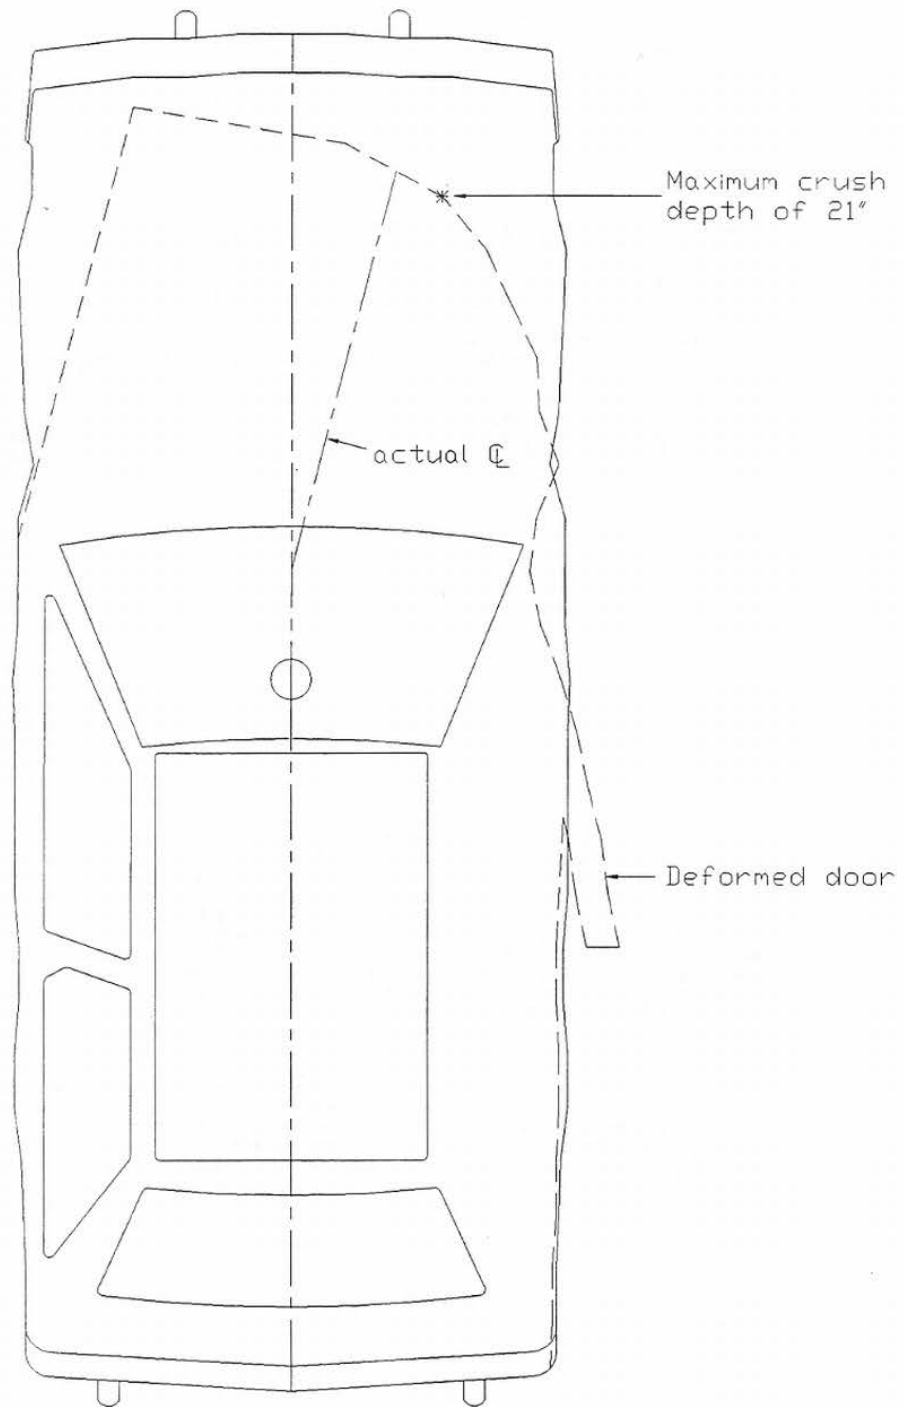
Figure 19. Vehicle Crush Measurements, Test GWMP-1.

in. (53.3 cm) is shown in Figure 19.

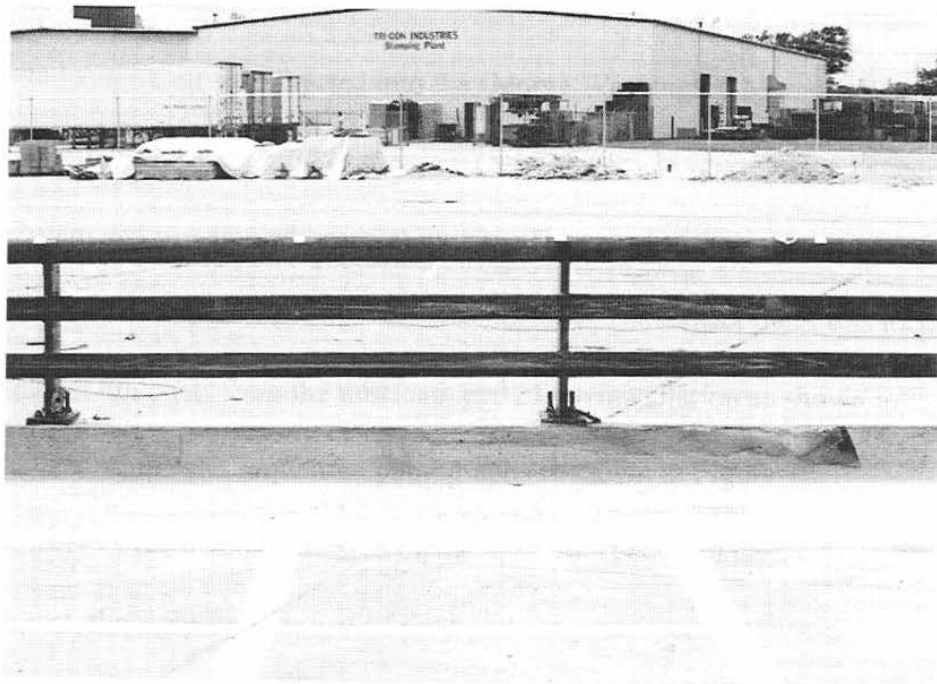
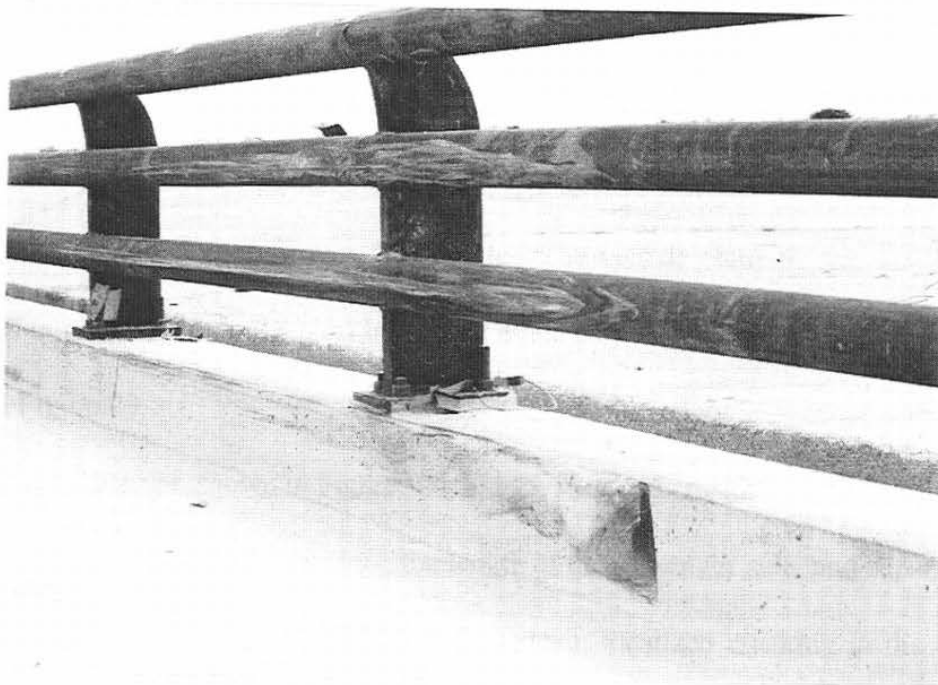
Figure 20. Bridge Rail Damage, Test GWMP-1.

The damage to the bridge rail was minor, with superficial scrapes on the curb, rail and posts as shown in Figure 20. There was no permanent set deflection in the bridge rail. The contact marks on the curb started at impact, 4 ft. - 5 in. (1.35 m) before post 4, and continued for 11 ft. - 8 in. (3.56 m). Contact with the lower rail began 4 ft. - 0 in. (1.2 m) before post 4 and continued for 19 ft. - 6 in. (5.94 m), and contact with the middle rail began 3 ft. - 8 in. (1.12 m) before post 4 and continued for 17 ft. - 0 in. (5.18 m).

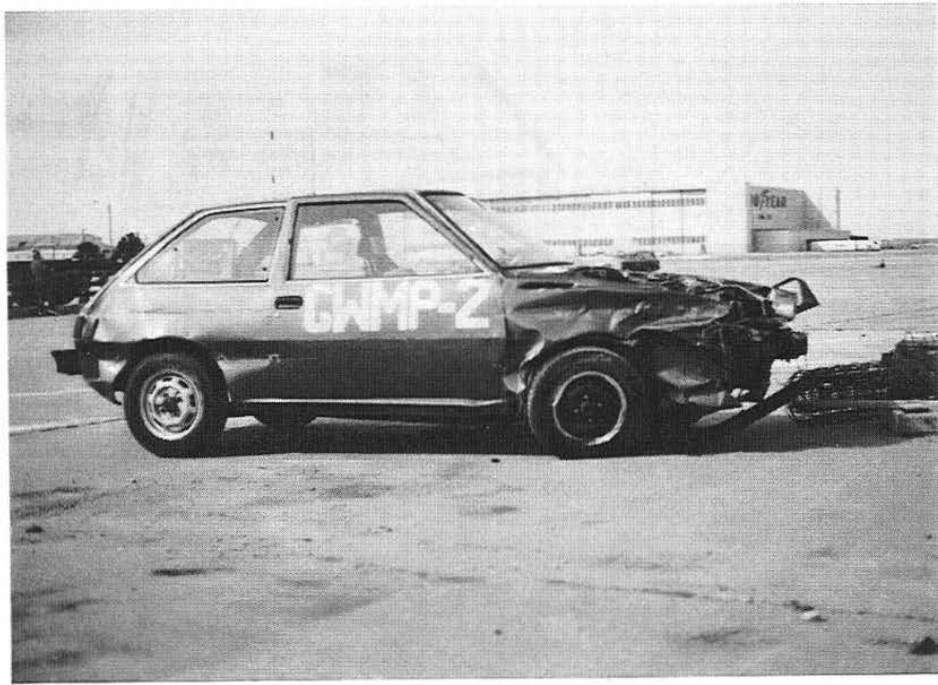
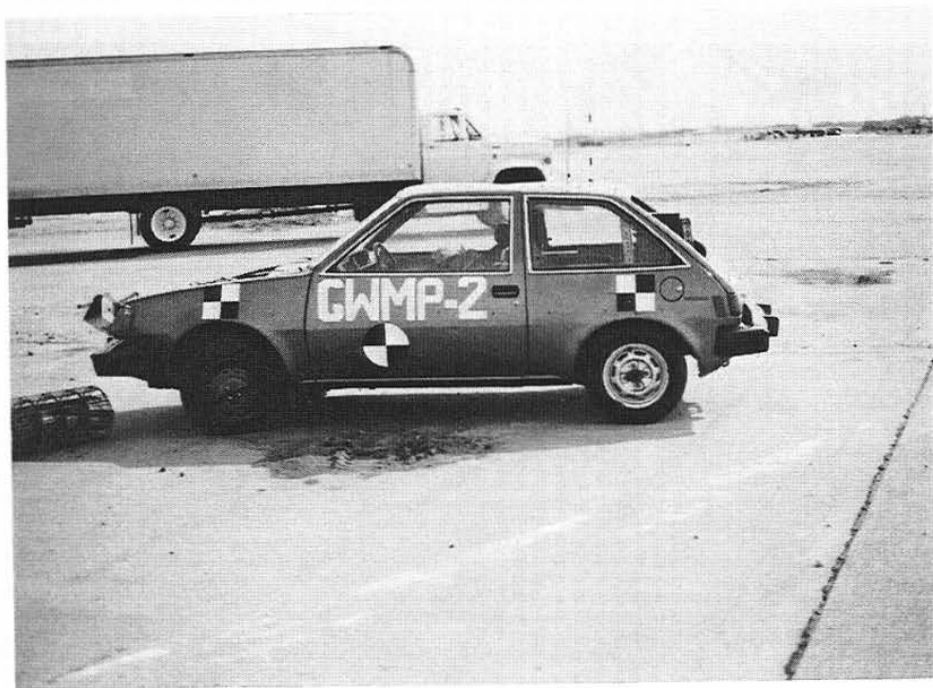
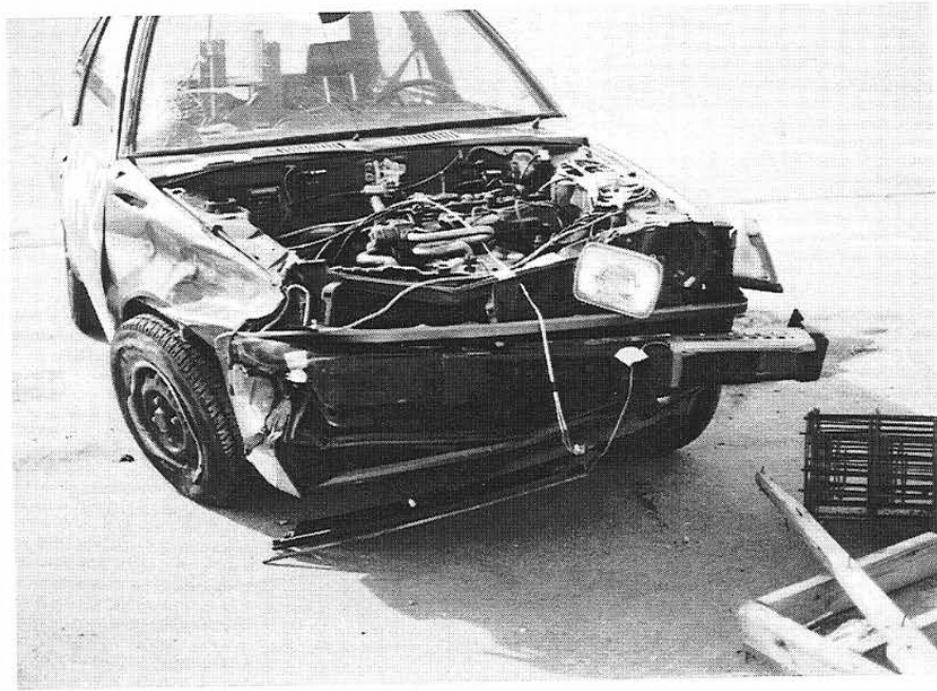
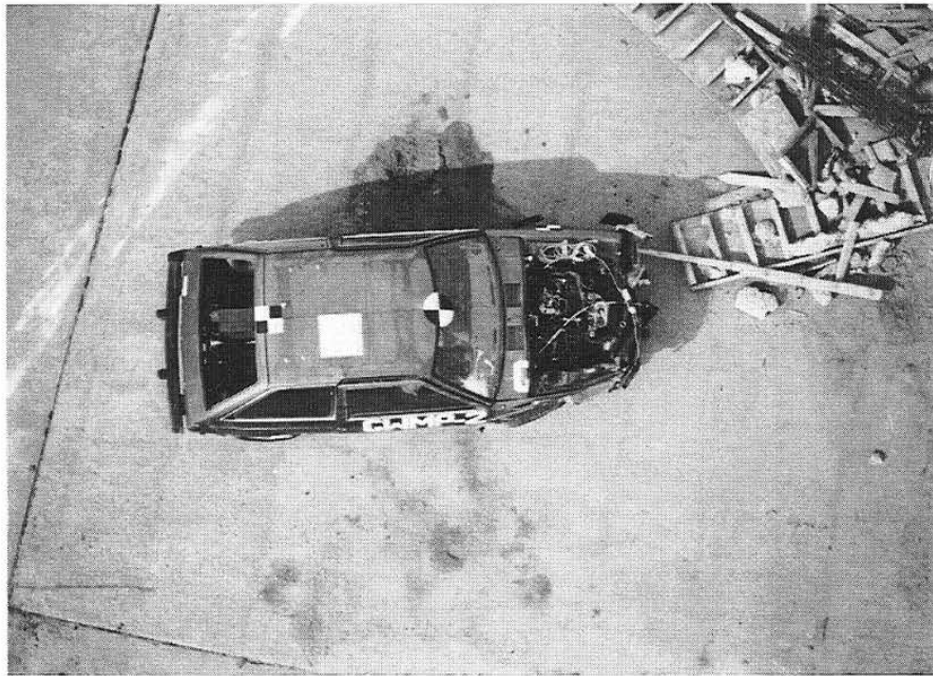
Figure 24. Vehicle Damage, Test GWMP-2.

The vehicle damage, shown in Figures 24 and 25, included crushing of the front right corner of the vehicle, minor scrapes and dents along the length of the passenger side, and separation of the hood. The windshield was not penetrated but did sustain localized cracking in the lower right corner. The front right tire was blown out and the rim was bent outward at the top. The occupant compartment floor sustained minor buckling in the front passenger side floor area. The maximum

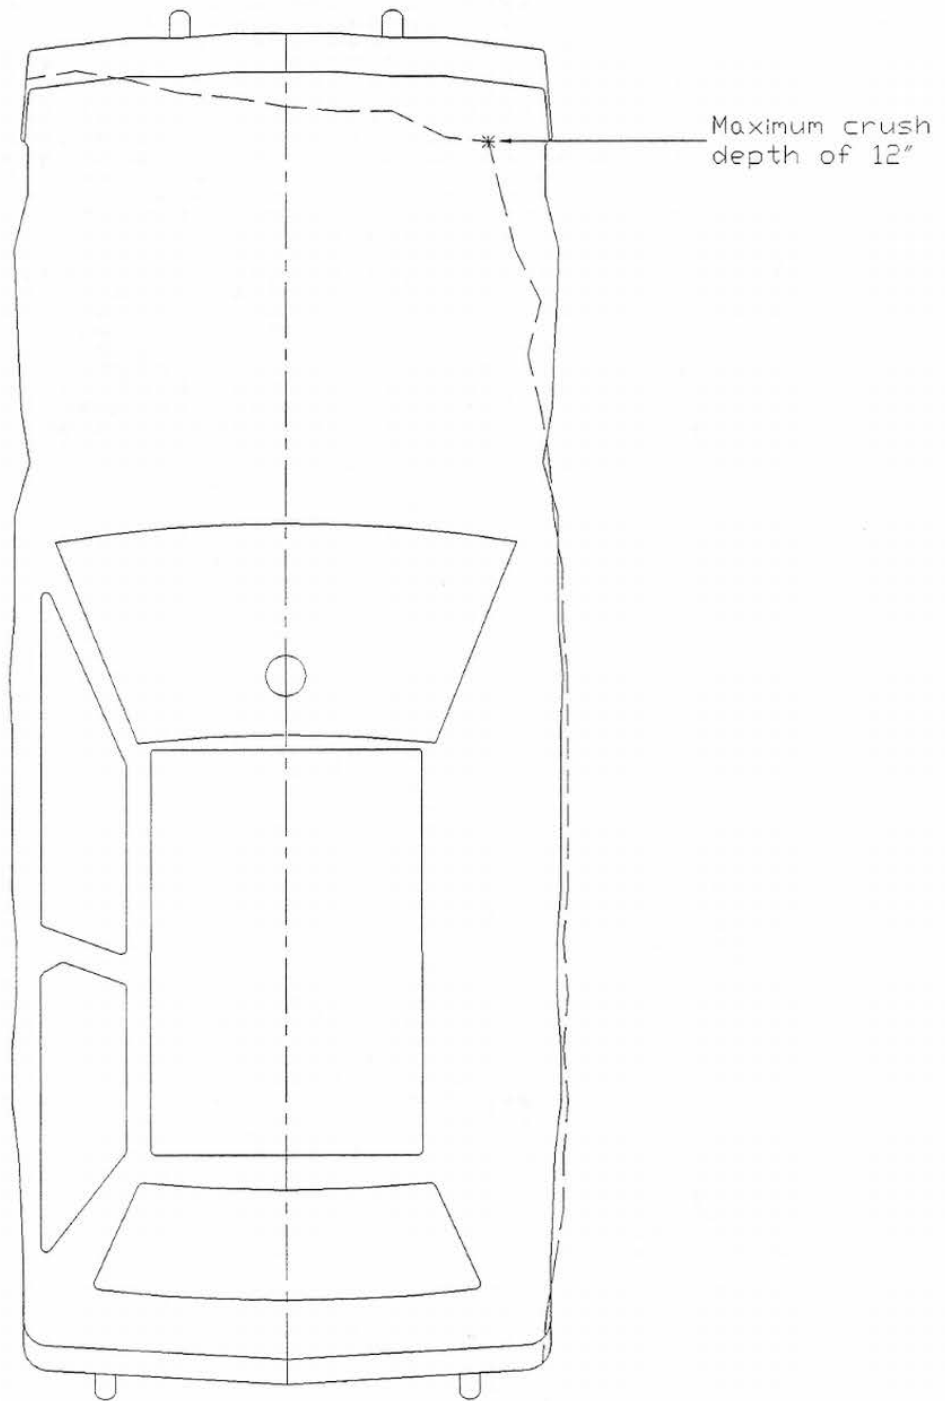
Figure 26. Vehicle Crush Measurements, Test GWMP-2.

crush deformation of 12 in. (30.5 cm) is shown in Figure 26.

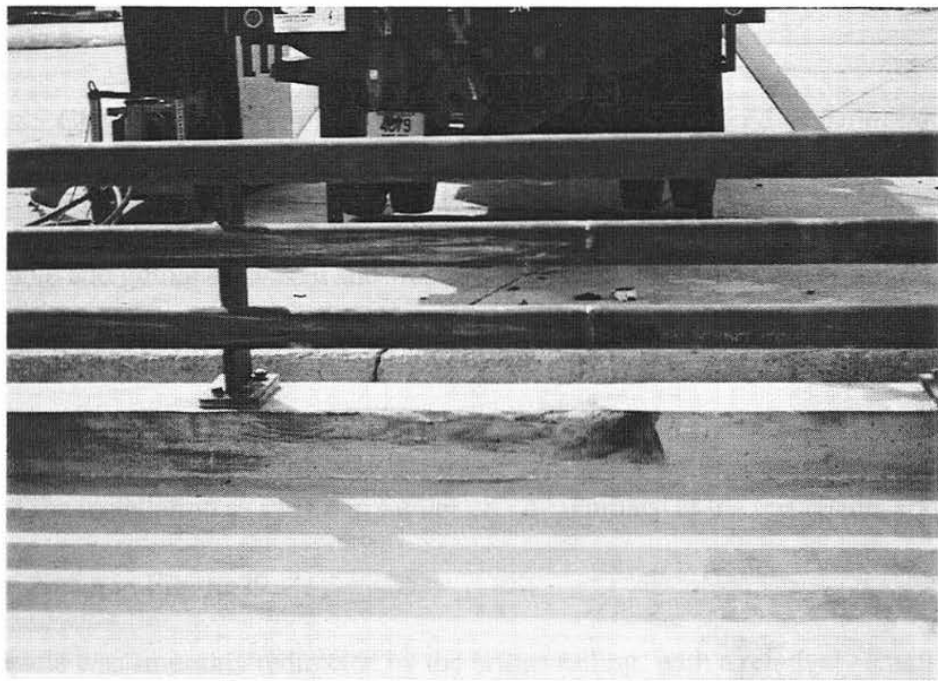
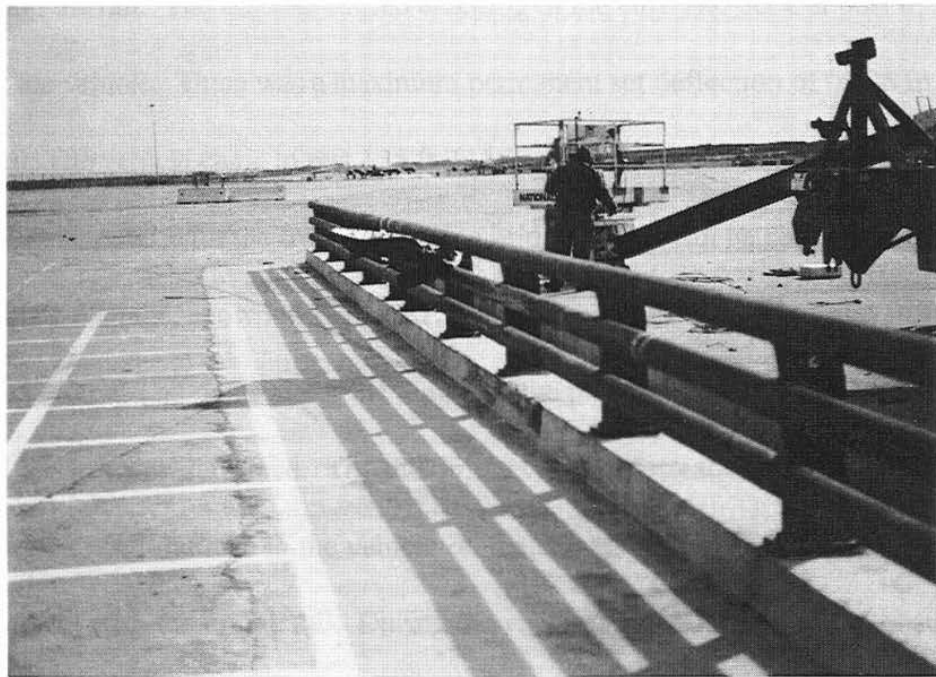
Figure 27. Bridge Rail Damage, Test GWMP-2.

As shown in Figure 27, the bridge rail and curb sustained minor scrapes in the area which the impact occurred. Contact with the middle and lower rail began at the midspan between posts 4 and 5, and continued to the midspan between posts 3 and 4.

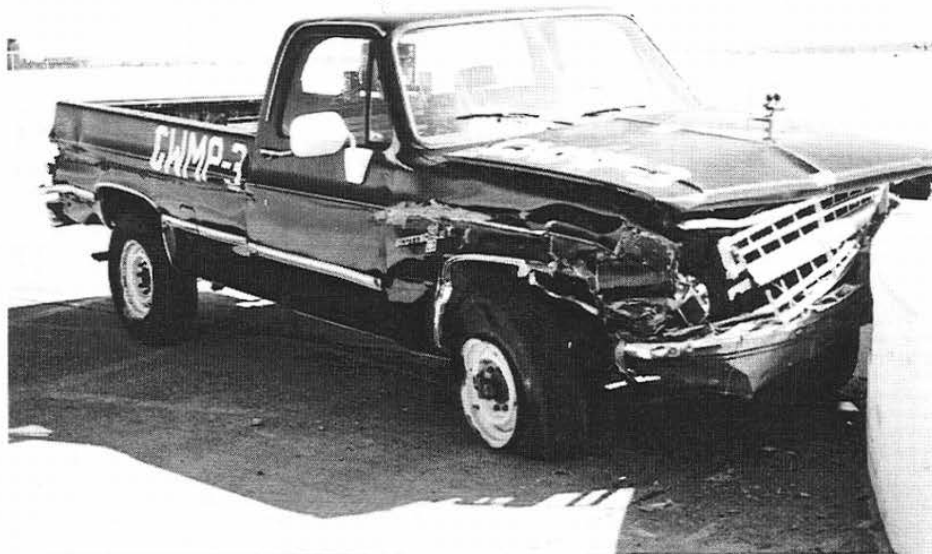
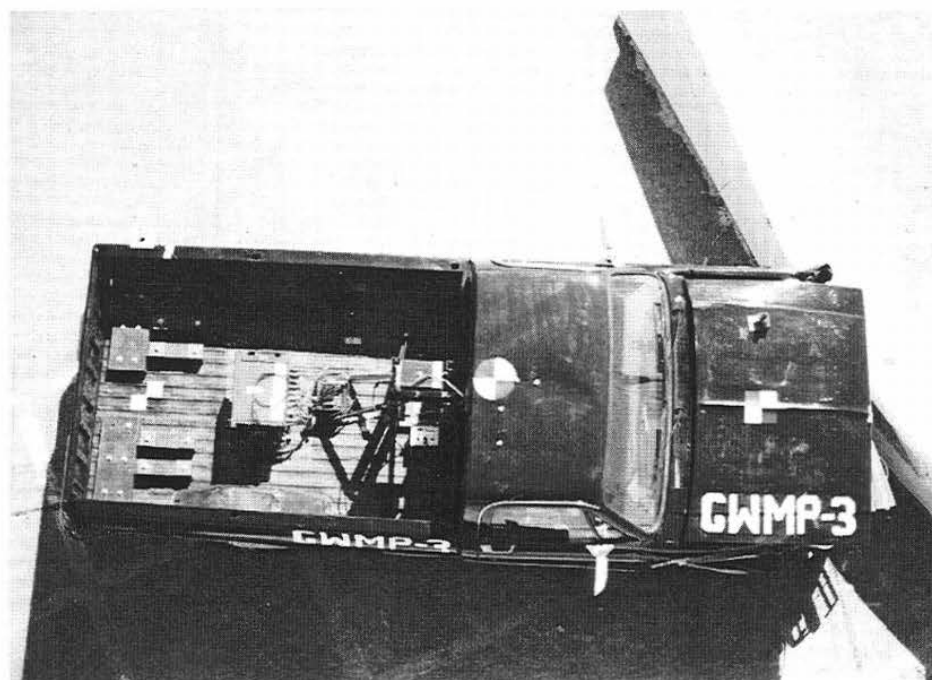
Figure 31. Vehicle Damage, Test GWMP-3..

The vehicle damage, shown in Figure 31, included the crushing of the right front corner of the vehicle, and scrapes and dents along the length of the passenger side. The right front tire was blown out and the rim was deformed. The maximum crush deformation of 9.75 in. (24.8 cm) is shown in Figure 32. All damage to the vehicle on the drivers side of the longitudinal centerline occurred after impact with the bridge rail. During the vehicle's run out, it struck an obstacle on the testing grounds, which resulted in damage to the left front corner of the vehicle..

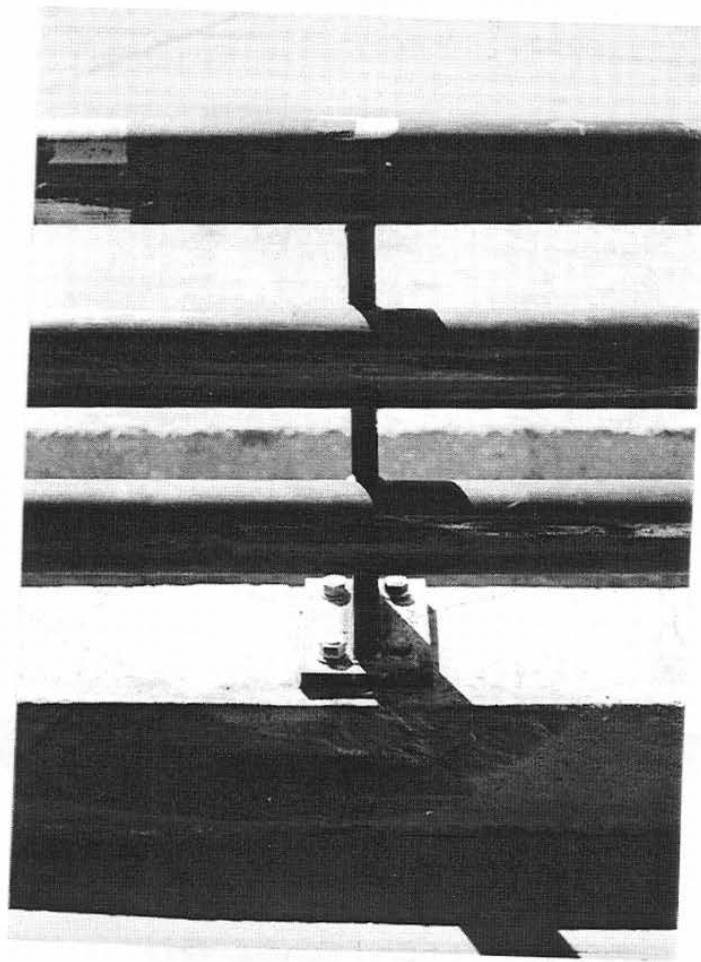
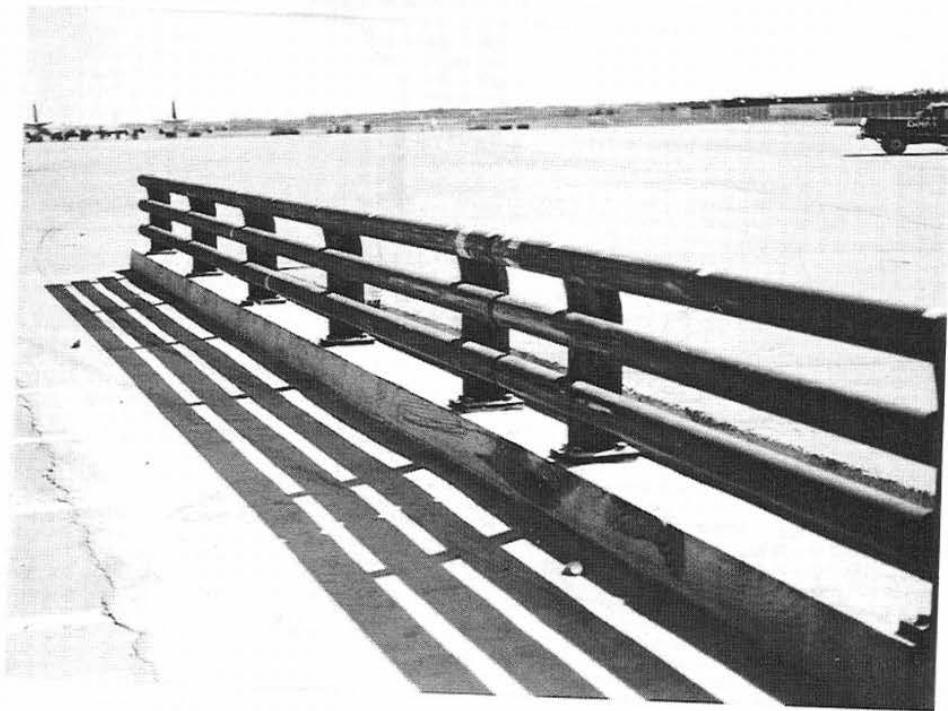
Figure 33. Bridge Rail Damage, Test GWMP-3.

The bridge rail sustained only minor cosmetic damage on each of the three rails as shown in Figure 33. Contact with each of the rails began 3 ft. - 5 in. (1.04 m) upstream of the expansion joint.

The vehicle remained in contact with the rail for 8 ft. - 0 in. (2.44 m) on the bottom rail, 8 ft. - 6 in. (2.59 m) on the middle rail, and 8 ft. - 2 in. (2.49 m) on the top rail.

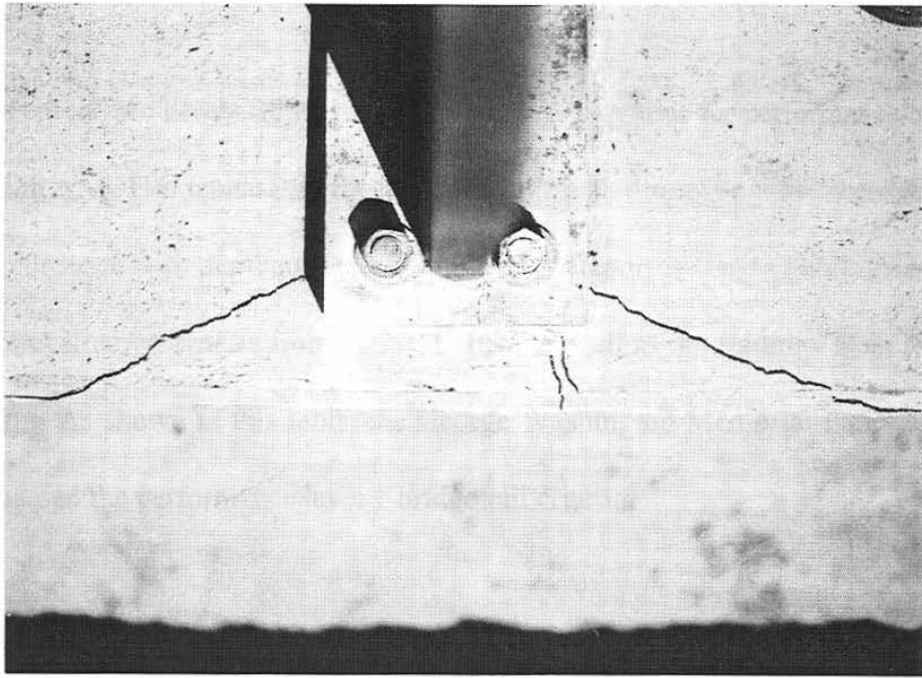
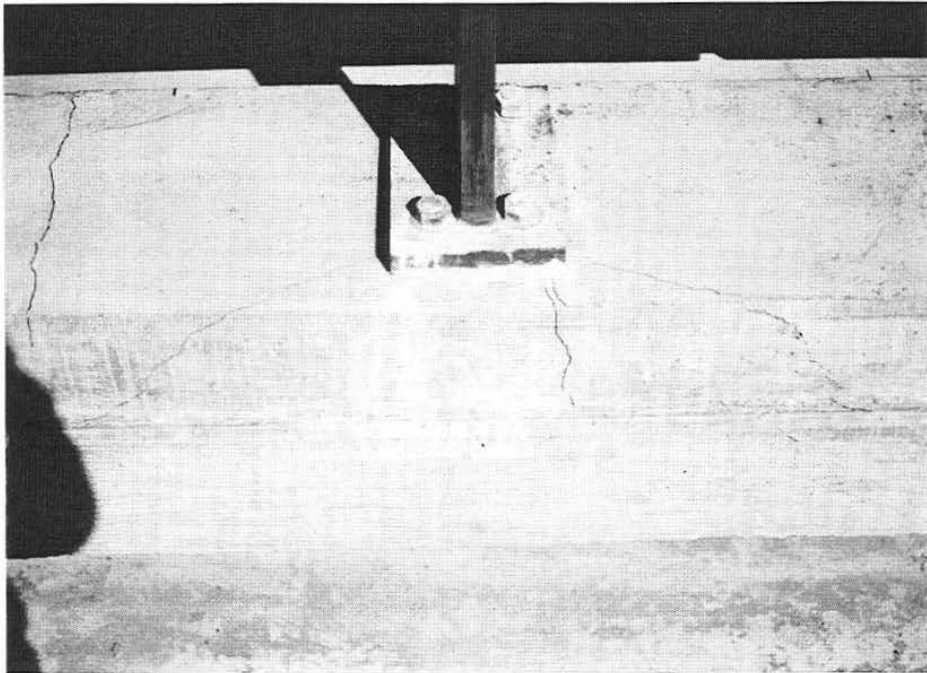
Figure 34. Curb Damage, Test GWMP-3.

Cracking occurred in the curb and bridge deck at post number 6. On top of the curb, two cracks propagated outward from each of the rear post bolts, as shown in Figure 34. The length of cracks upstream and downstream of post 6 were 10 in. (25.4 cm) and 11 in. (27.9 cm) respectively.
