# **CRASH TESTING OF MICHIGAN'S TYPE B (W-BEAM) GUARDRAIL SYSTEM**

### **Michigan Department of Transportation**

MwRSF Research Report No. TRP-03-90-99

November 10, 1999

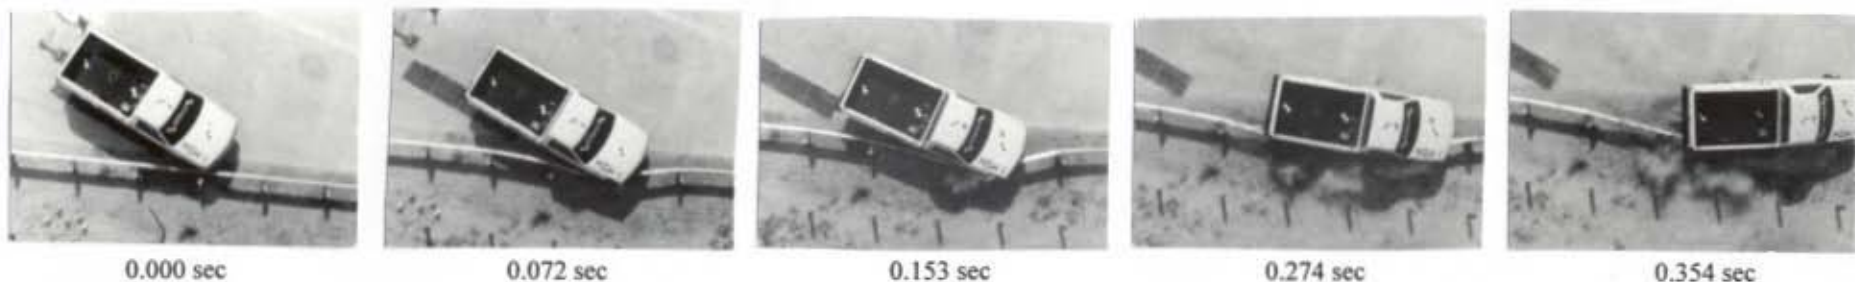
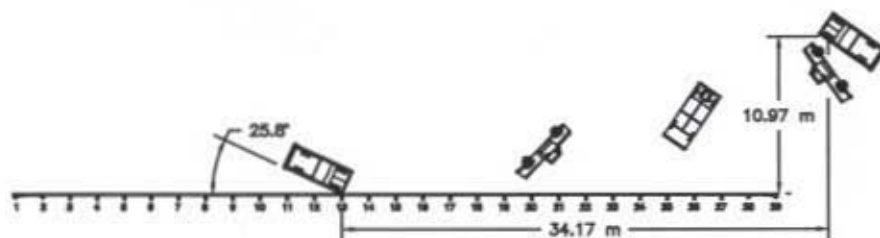
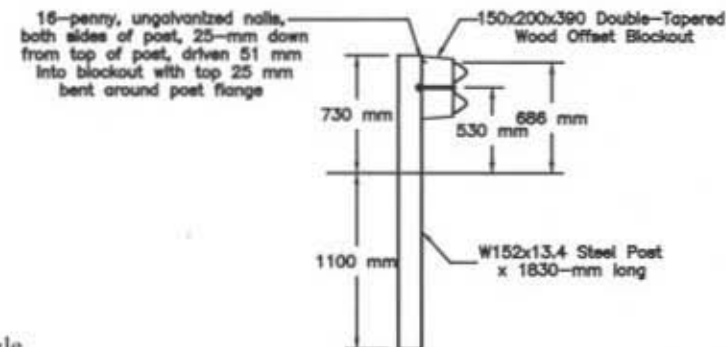
The analysis of the test results for test MIW-1 showed that the W-beam guardrail contained the vehicle but inadequately redirected the vehicle, since the vehicle did not remain upright after collision with the guardrail. Detached elements and debris from the test article did not penetrate or show potential for penetrating the occupant compartment. Deformations of, or intrusion into, the occupant compartment that could have caused serious injury did not occur. After collision, the vehicle's trajectory intruded slightly into adjacent traffic lanes but was determined to be acceptable. In addition, the vehicle's exit angle was less than 60 percent of the impact angle. Therefore, test MIW-1 conducted on MDOT's Type B (W-Beam) Guardrail System was determined to be unacceptable according to the NCHRP Report No. 350 criteria.

- Test Number ..... MIW-1
- Date ..... 8/25/99
- Appurtenance ..... Michigan's Type B (W-beam) guardrail system
- Total Length ..... 53.34 m
- Steel W-Beam (Nested)
  - Thickness ..... 2.66 mm
  - Top Mounting Height ..... 686 mm
- Steel Posts
  - Post Nos. 3 - 27 ..... W152x13.4 by 1,830-mm long
- Wood Spacer Blocks
  - Post Nos. 3 - 27 ..... 150 mm x 200 mm by 360-mm long
- Soil Type ..... Grading B - AASHTO M 147-65 (1990)
- Vehicle Model ..... 1994 GMC 2500 2WD
  - Curb ..... 2,021 kg
  - Test Inertial ..... 2,007 kg
  - Gross Static ..... 2,007 kg
- Vehicle Speed
  - Impact ..... 99.8 km/hr
  - Exit ..... NA

- Vehicle Angle
  - Impact ..... 25.8 degrees
  - Exit ..... NA
- Vehicle Snagging ..... Minor wheel snagging on post no. 14
- Vehicle Pocketing ..... Minor
- Vehicle Stability ..... Vehicle rollover
- Occupant Ridedown Deceleration (10 msec avg.)
  - Longitudinal ..... 7.43 < 20 G's
  - Lateral (not required) ..... 12.98
- Occupant Impact Velocity (Normalized)
  - Longitudinal ..... 6.35 < 12 m/s
  - Lateral (not required) ..... 4.33
- Vehicle Damage ..... Extensive
  - TAD<sup>10</sup> ..... NA
  - SAE<sup>11</sup> ..... NA
- Vehicle Stopping Distance ..... 34.17 m downstream  
10.97 m traffic-side face
- Barrier Damage ..... Moderate
- Maximum Deflections
  - Permanent Set ..... 625 mm
  - Dynamic ..... 1,002 mm

Therefore, it is recommended that this system be retested without any changes.

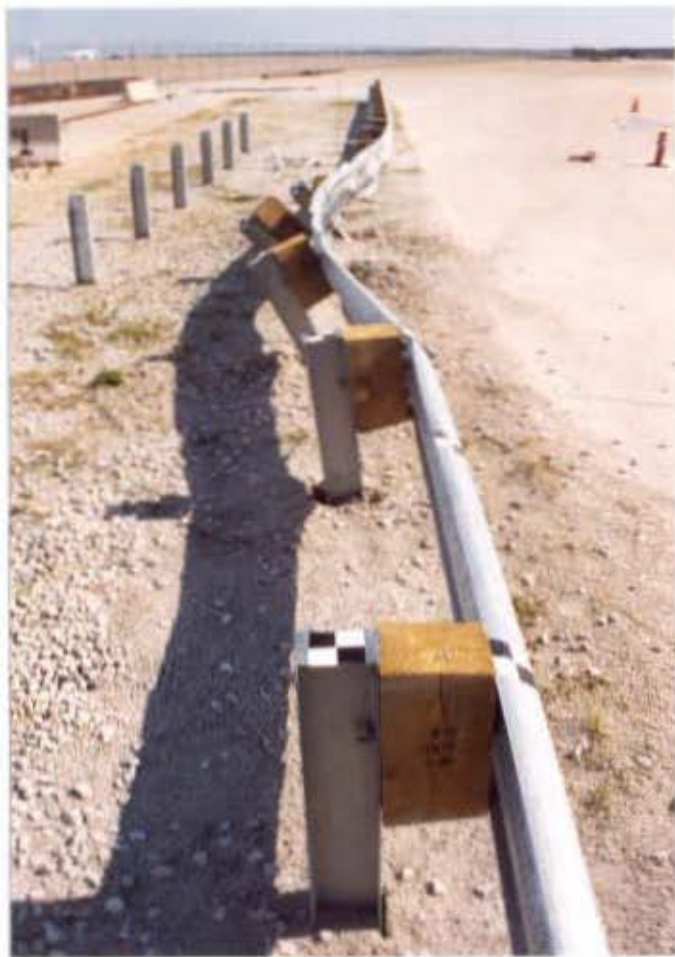
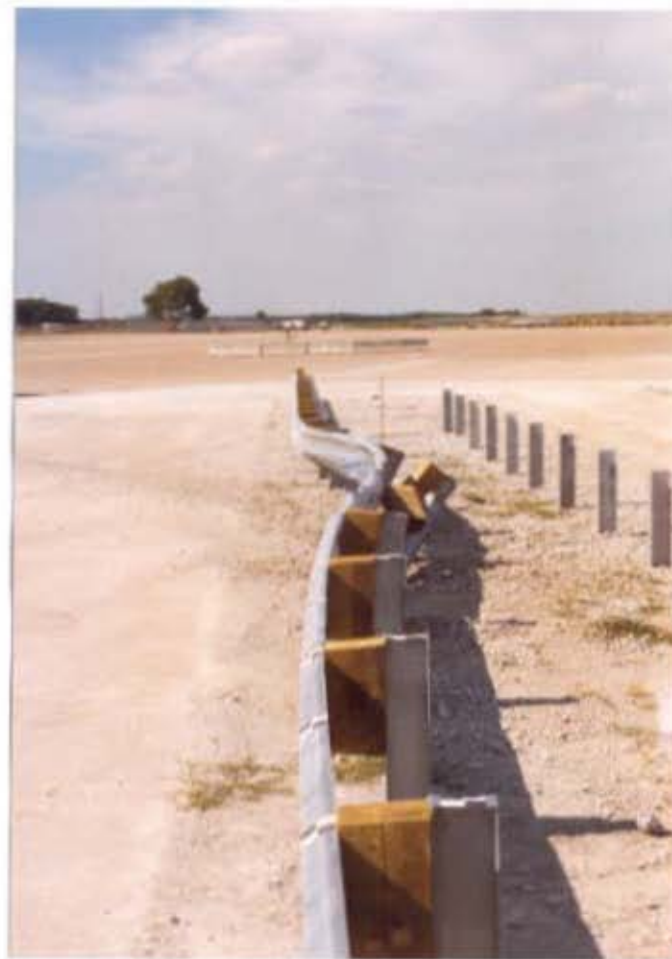
Figure 17. Type B Longitudinal Barrier Damage, Test MIW-1

Damage to the barrier was moderate, as shown in Figures 17 through 24. Barrier damage consisted mostly of deformed W-beam, contact marks on a guardrail section, and deformed guardrail posts. The W-beam damage consisted of moderate deformation and flattening of the lower portion of the impacted section between post nos. 13 and 14. Contact marks were found on the guardrail between post nos. 13 and 17. The W-beam rail at post nos. 13 through 15 was creased where the spacer block bears against the rail. The W-beam rail, 152-mm upstream of post no. 13, had a minor crease on the upper portion, while the W-beam rail's upper portion was creased 152-mm downstream of post no. 17. The W-beam rail was pulled off of post nos. 14 and 15.

Steel post nos. 3 through 10 and 19 through 27 moved backward slightly. Steel post nos. 11, 12, 17, and 18 were twisted and slightly rotated backward. Four steel posts, post nos. 13 through 16, were twisted and bent toward the ground. A 356-mm long tire contact mark was found along the upstream side of the front face of post no. 14. The lower-front face of post no. 15 was also slightly damaged. Both the upstream and downstream anchorage systems move slightly, but the posts were not damaged.

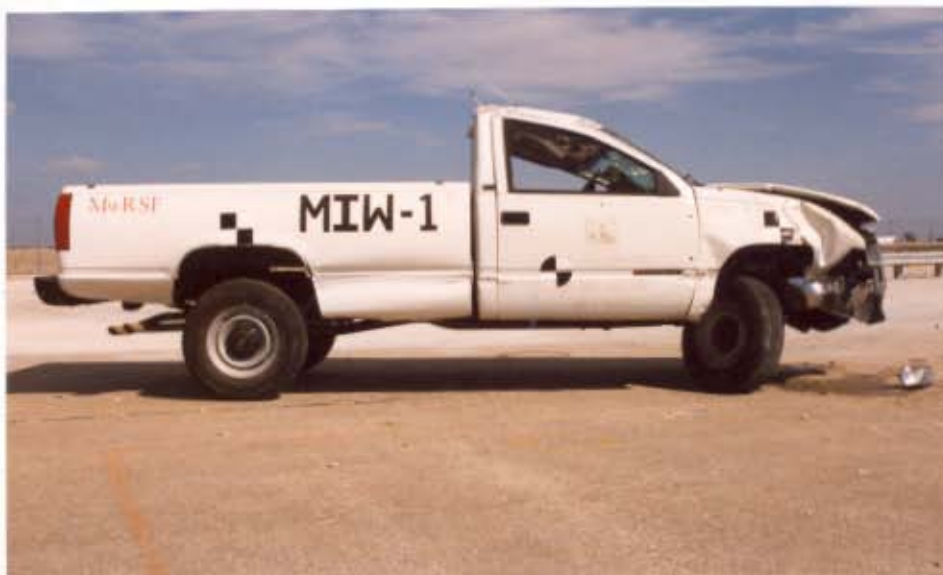
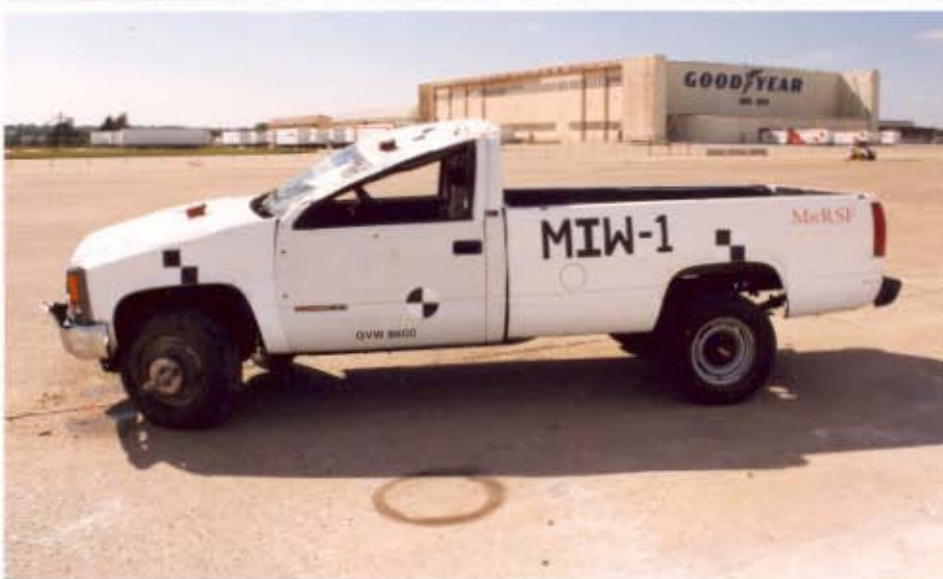
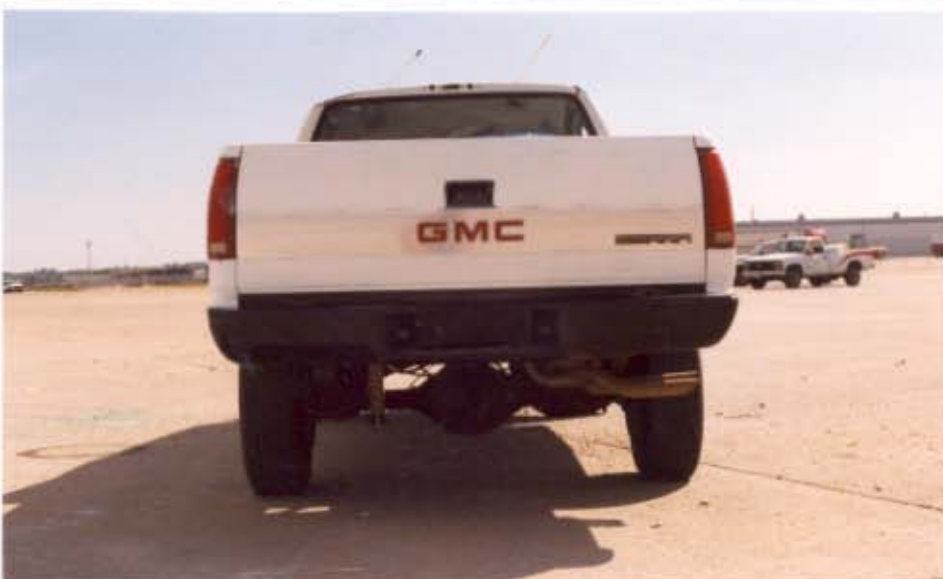
Figure 25. Vehicle Damage, Test MIW-1

Exterior vehicle damage was extensive, as shown in Figures 25 and 26. Interior occupant compartment deformations were determined to be negligible. The front bumper buckled at the centerline of the bumper and ripped at the right-front bumper attachment. The right-front quarter panel was crushed downward, and the right side of the front bumper was also bent back toward the engine compartment. The right-front wheel assembly was deformed to approximately a 90 degree bend and pushed into the frame. In addition, contact marks were observed on the rim as well as tie-rod disengagement. Small contact marks were found on the lower right side of the rear fender, the right-rear bumper, the outside surface of the right-rear tire, the lower right side of the truck box, and the right-side door. The roof, the A and B-pillars, and the left-front fender were crushed and deformed due to vehicle rollover. The windshield was cracked and deformed on the left side. Both the left- and right-side door windows were shattered. The rear window remained undamaged.
