**FULL-SCALE 18,000 LB. VEHICLE CRASH TEST
ON THE
IOWA RETROFIT CONCRETE
BARRIER RAIL**

TRANSPORTATION RESEARCH REPORT TRP-03-19-90

January, 1990

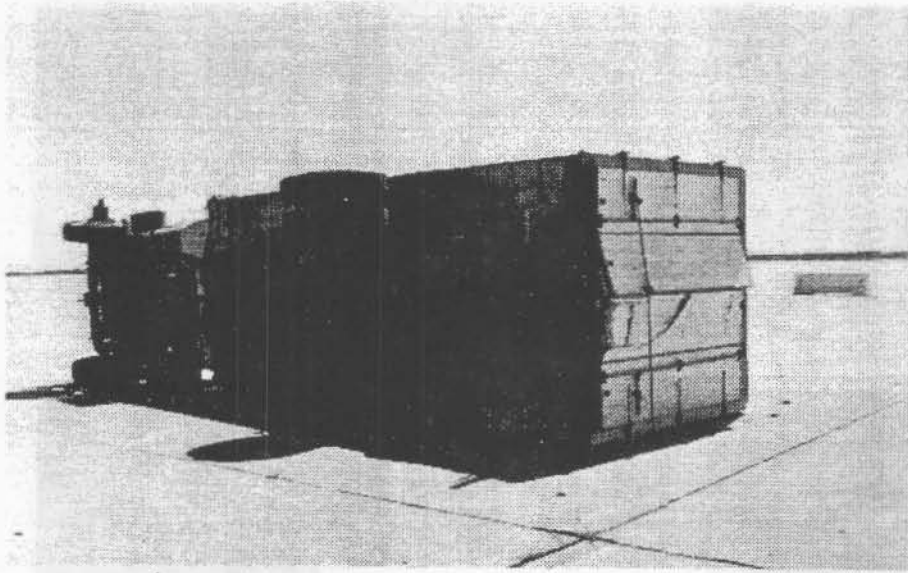
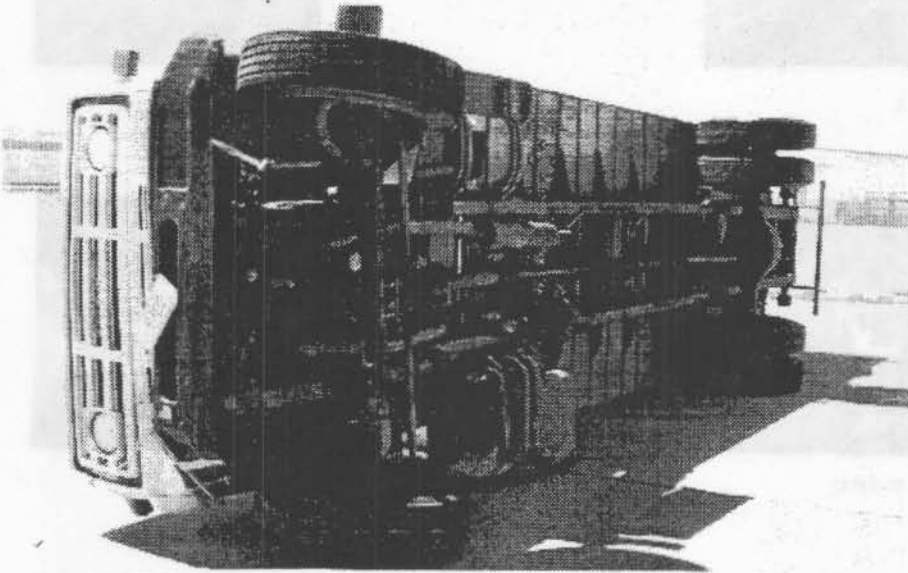
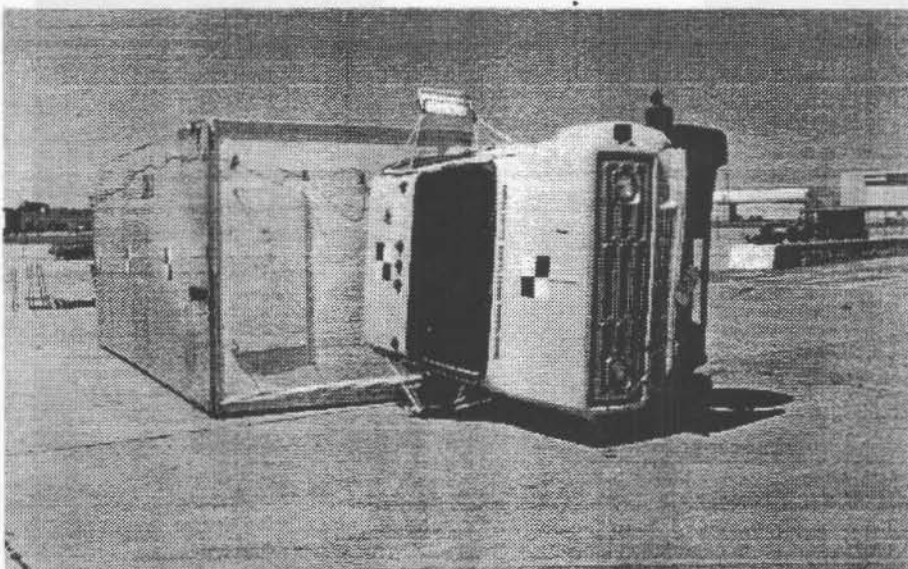
Figure 21. Photographs of vehicle damage, Test I4-1.

Upon impact with the retrofit concrete barrier rail, the right front corner of the vehicle was crushed and the wheel was bent inward. After the initial impact, the vehicle rode up on the barrier and slid along the remaining length. There was significant clockwise rolling motion as the vehicle slid along the barrier with a maximum roll angle of 31.4 degrees. After the vehicle exited from the barrier, it rolled in the counterclockwise direction for a short period of time. Hence, the momentum of the vehicle caused it to roll in the clockwise direction and tip over onto the passenger side of the vehicle. The vehicle came to rest on the passenger side of the vehicle approximately 160 ft. downstream from the point of impact.

Photographs of the vehicle damage are shown in Figure 21. The TAD (7) and VDI (8) damage classifications are shown in Figure 19. Photographs of the minimal damage to the retrofit concrete barrier rail are shown in Figure 22. Some concrete spalling occurred due to the initial impact of the vehicle.

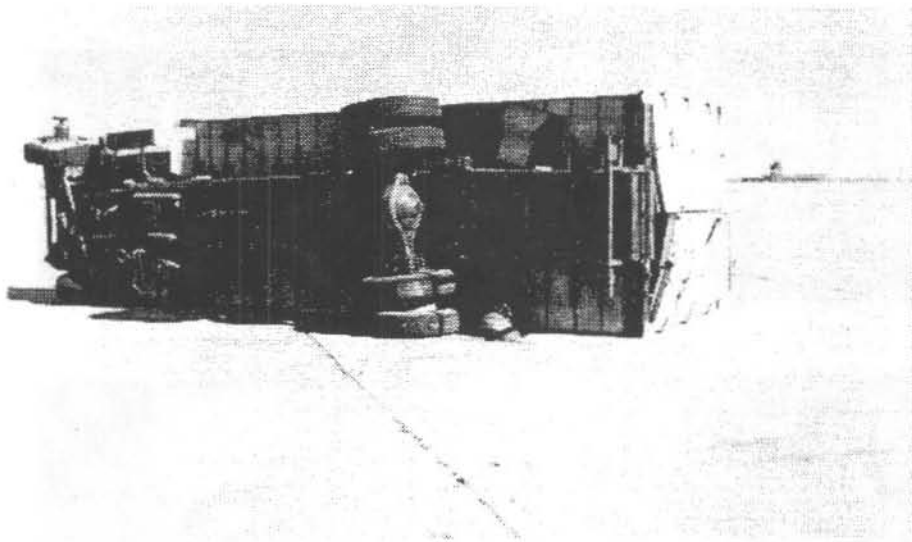
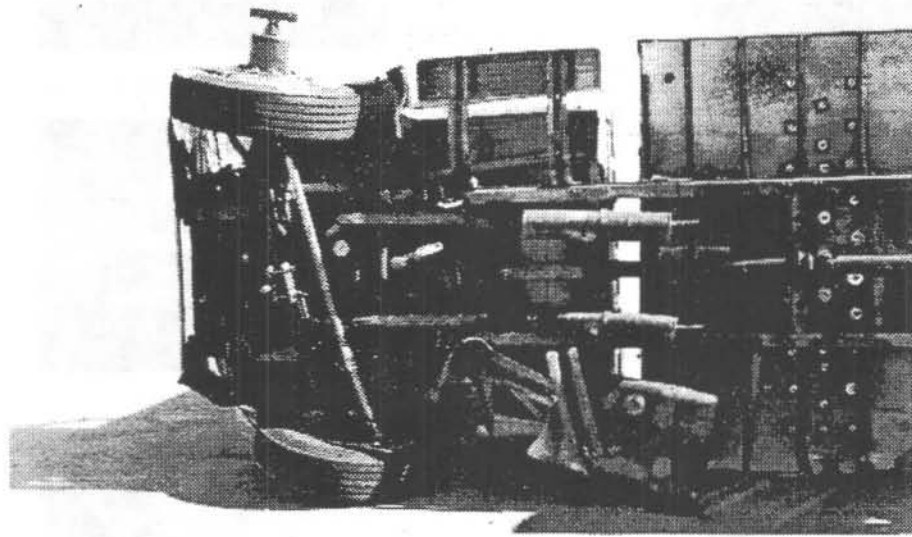
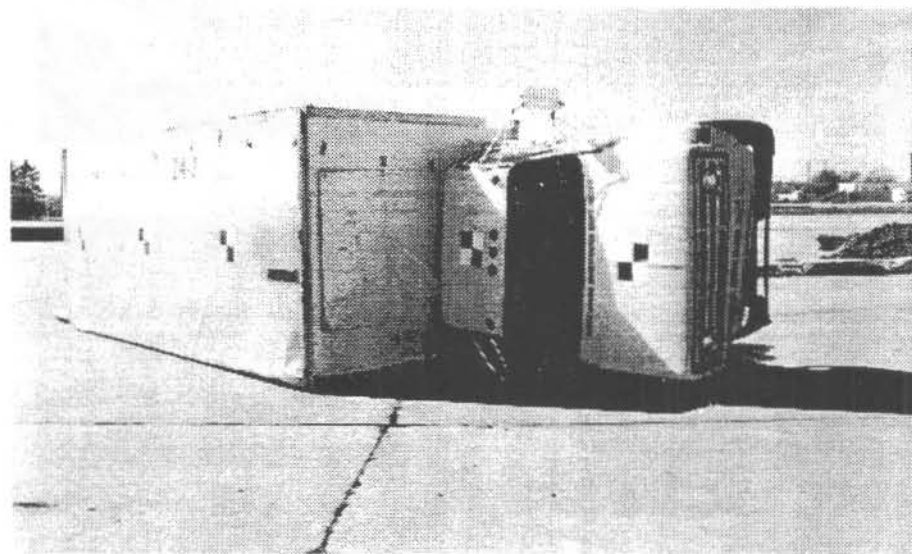
Figure 25. Photographs of vehicle damage, Test I4-2.

Upon impact with the retrofit concrete barrier rail, the right front corner of the vehicle was crushed and the wheel was bent inward. After the initial impact, the vehicle rode up on the barrier and slid along the remaining length. There was significant clockwise rolling motion as the vehicle slid along the barrier with a maximum roll angle of 28.7 degrees. After the vehicle exited from the barrier, it rolled in the counterclockwise direction for a short period of time. Hence, the momentum of the vehicle caused it to roll in the clockwise direction and tip over onto the passenger side of the vehicle. The vehicle came to rest on the passenger side of the vehicle approximately 160 ft. downstream from the point of impact.

Photographs of the vehicle damage are shown in Figure 25. The TAD (7) and VDI (8) damage classifications are shown in Figure 23. Photographs of the minimal damage to the retrofit concrete barrier rail are shown in Figure 26. Some concrete spalling occurred due to the initial impact of the vehicle.
