FULL-SCALE VEHICLE CRASH TESTS ON THE IOWA BOX-ALUMINUM BRIDGE RAIL

TRANSPORTATION RESEARCH REPORT TRP-03-013-88

Two full-scale vehicle crash tests were conducted on the Iowa Box-Aluminum Bridge Rail. Test I1-1 was conducted with an 1800 lb. vehicle at 15 deg. and 60 mph. Test I1-2 was conducted with a 4310 lb. vehicle at 25 deg. and 60 mph. The Iowa Box-Aluminum Bridge Rail contained two rail splices. Each splice was 26 ft.-6 in. from the rail post on each end. The point of impact for Test I1-1 was directly at a splice. The point of impact for Test I1-2 was directly at the midpoint of the span that contained the second splice. The tests were evaluated according to the safety criteria in NCHRP 230. The safety performance of the Iowa Box-Aluminum Bridge Rail was determined to be unsatisfactory.

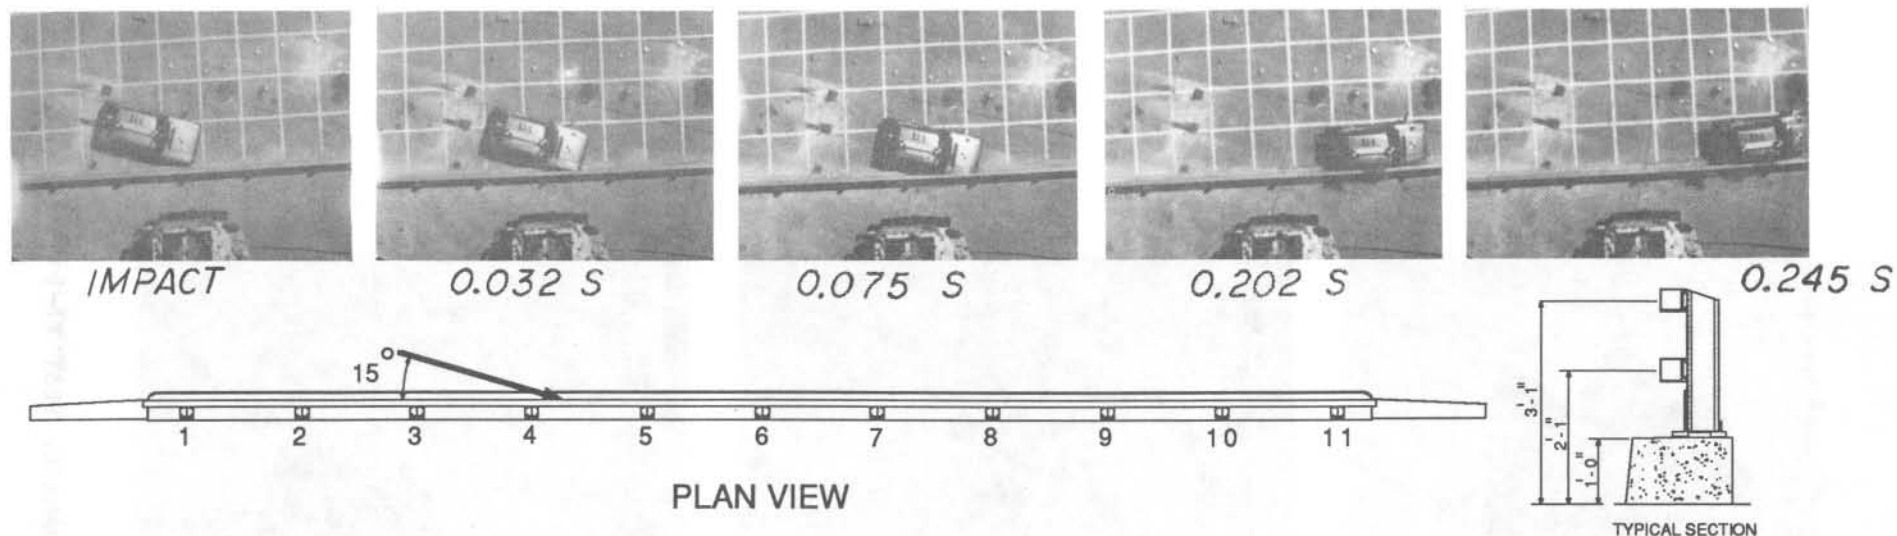
FIGURE 14. TEST I1-1 SUMMARY AND SEQUENTIAL PHOTOS

Vehicle Speed
 Impact (mph) 56.8
 Exit (mph) 47.9
 Vehicle Angle
 Impact (deg) 15
 Exit (deg) 4.2
 Vehicle Snagging None
 Vehicle Stability Rollover
 Occupant Impact Velocity (before rollover)
 Longitudinal (fps) NA
 Lateral (fps) 8.9
 Occupant Ridedown Accelerations
 Longitudinal (g's) NA
 Lateral (g's) 3.9
 Vehicle Damage Extensive
 TAD 1-RFQ-5, 1-LFQ-3, 1-R&T-3
 VDI 01FYA03
 Vehicle Rebound Distance (ft) 25
 Bridge Rail Damage Minimal

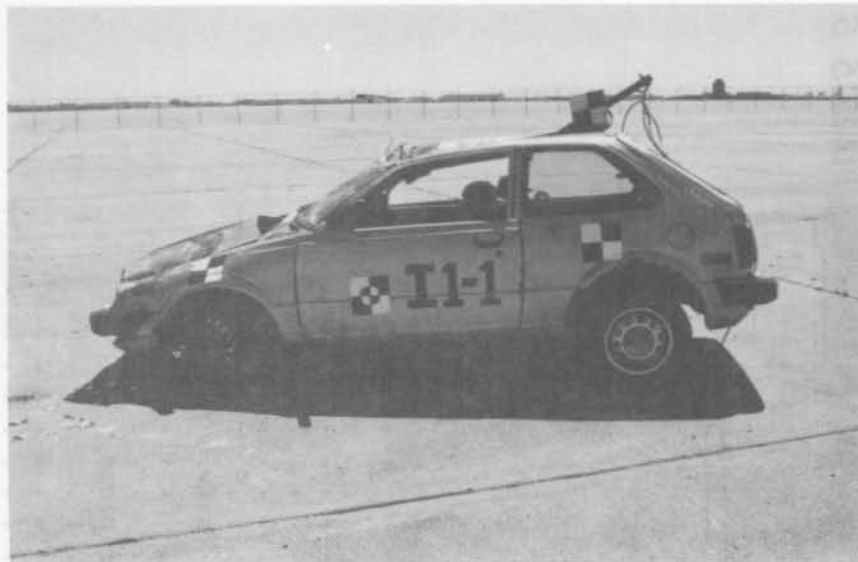
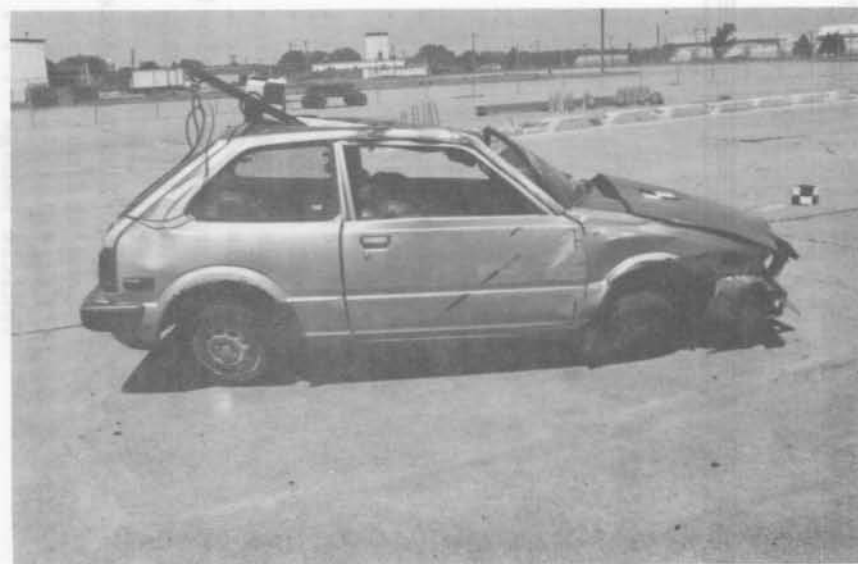
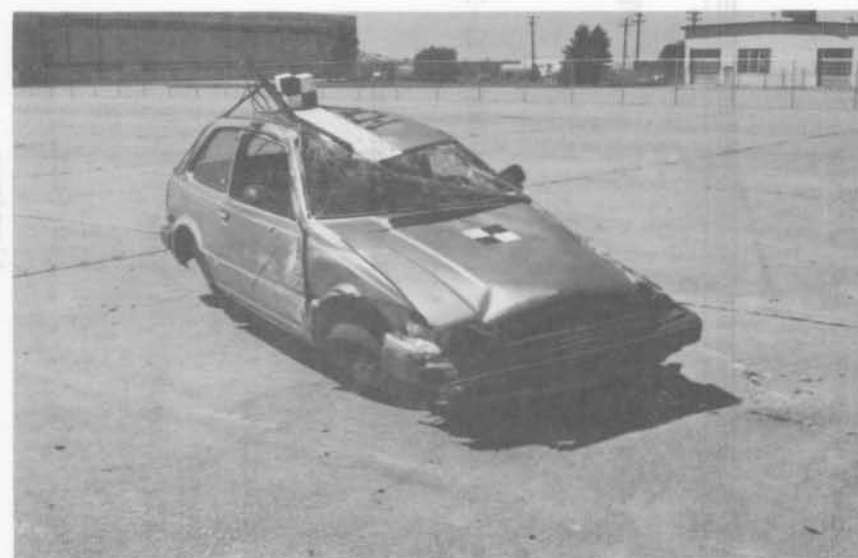
FIGURE 15. PHOTOGRAPHS OF VEHICLE DAMAGE, TEST I1-1

Upon impact with the bridge rail, the right front wheel of the vehicle collapsed inward allowing the vehicle to begin a clockwise rolling motion toward the bridge rail. The vehicle remained in contact with the bridge rail for approximately 13 ft. after initial impact. The car began to skid on its right side while traveling in a direction essentially parallel to the bridge rail. After the vehicle had traveled past the end of the bridge rail, it began a counterclockwise yaw motion. This yaw motion combined with the rolling motion allowed the vehicle to skid on its right side on the concrete airport apron and begin to roll. The vehicle came to rest 172 ft. from initial point of impact after making two complete rollovers.

Photographs of the vehicle damage are shown in Figure 15. As evident, the vehicle damage was extensive. The TAD and VDI damage classifications are shown in Figure 14. Photographs of the minimal damage to the bridge rail are shown in Figure 16. From the overhead high-speed camera, the dynamic deflection of the upper rail member was determined to be approximately 2 1/4-in. No permanent set had occurred in the lower and upper rail members.

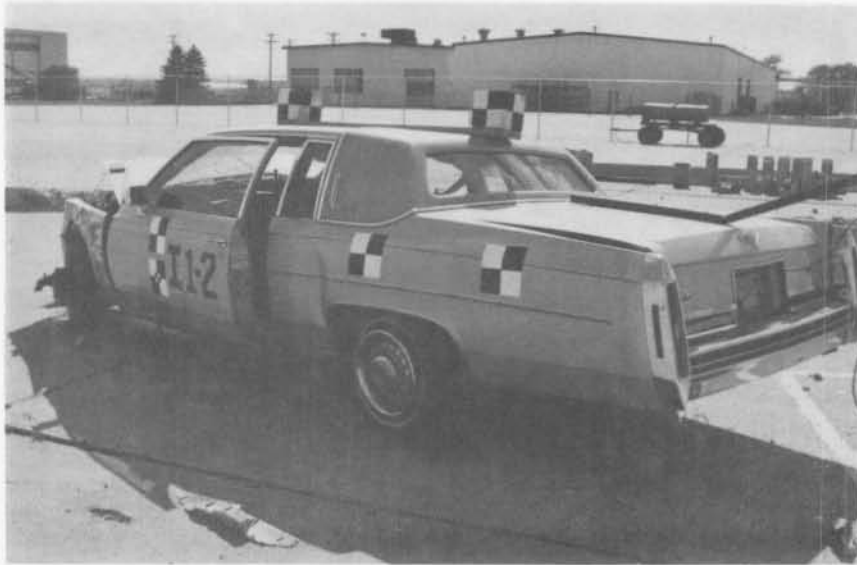
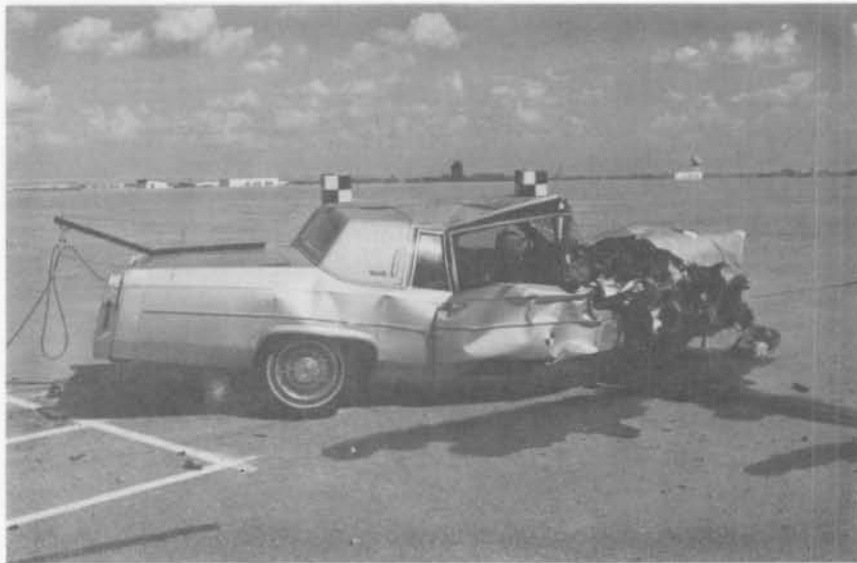
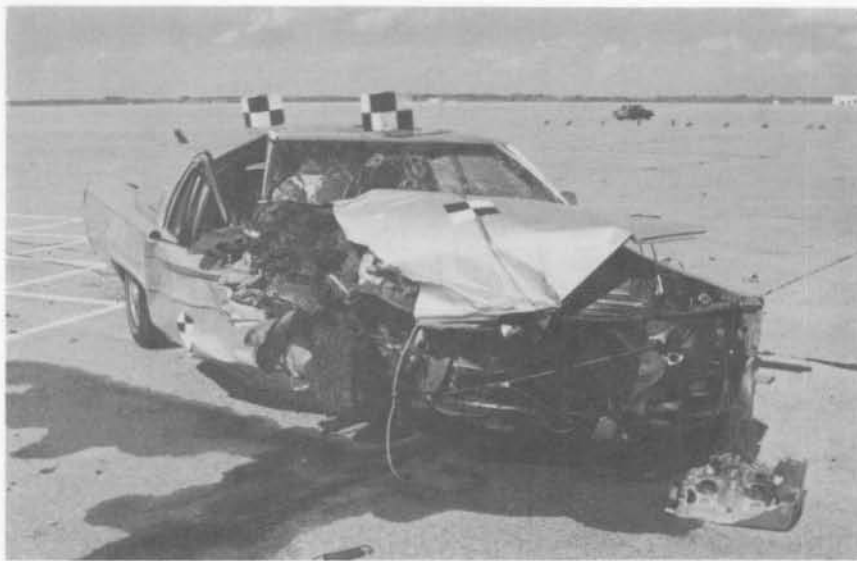
FIGURE 18. PHOTOGRAPHS OF VEHICLE DAMAGE, TEST 11-2

Upon impact with the bridge rail, the right-front corner of the vehicle became wedged between the concrete curb and the lower aluminum bridge rail. The vehicle continued to travel forward until the right front corner and bumper of the vehicle snagged on post No. 8. That, plus the force from the horizontal rail, caused the post with the attached base post assembly to break away from the concrete curb. When the vehicle began to travel past post No. 8, the front section of the vehicle (including the engine portion) buckled to the right. At that stage, the majority of the right-front side had been crunched inward due to the severe snagging. The vehicle continued to travel down the bridge rail to the next rail post (No. 9). At post No. 9, the front bumper finally detached from the car due to snagging. The vehicle then was redirected off the bridge rail after being in contact for approximately 14 ft.

A review of the damage to the car indicates that there was considerable contact of the vehicle's undercarriage against the 12" high concrete curb and considerable damage resulted from this contact.

Photographs of the vehicle damage are shown in Figure 18. As evident, the vehicle damage due to snagging was extensive while considerable undercarriage damage occurred due to contact

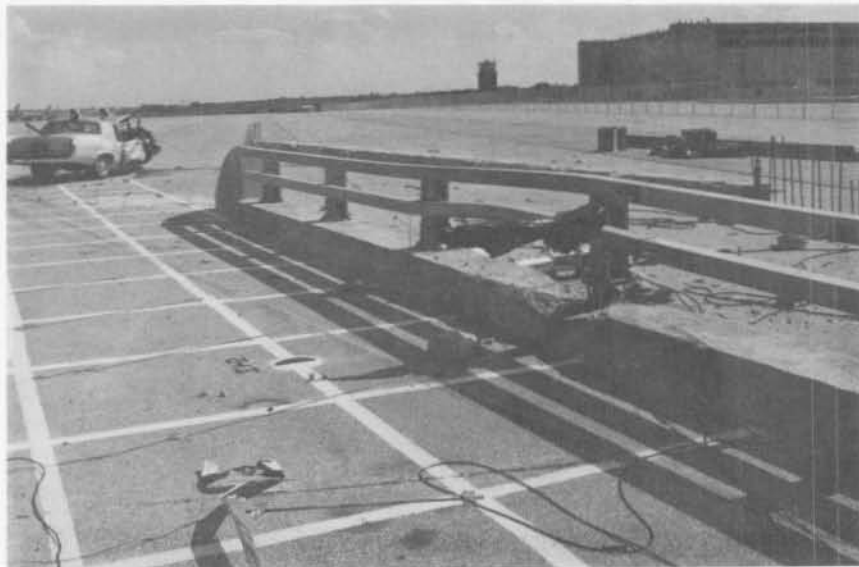
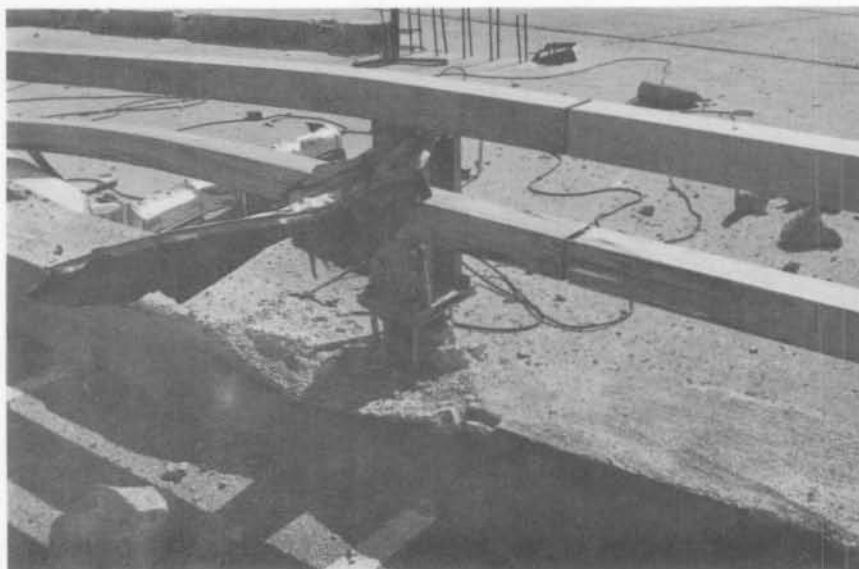
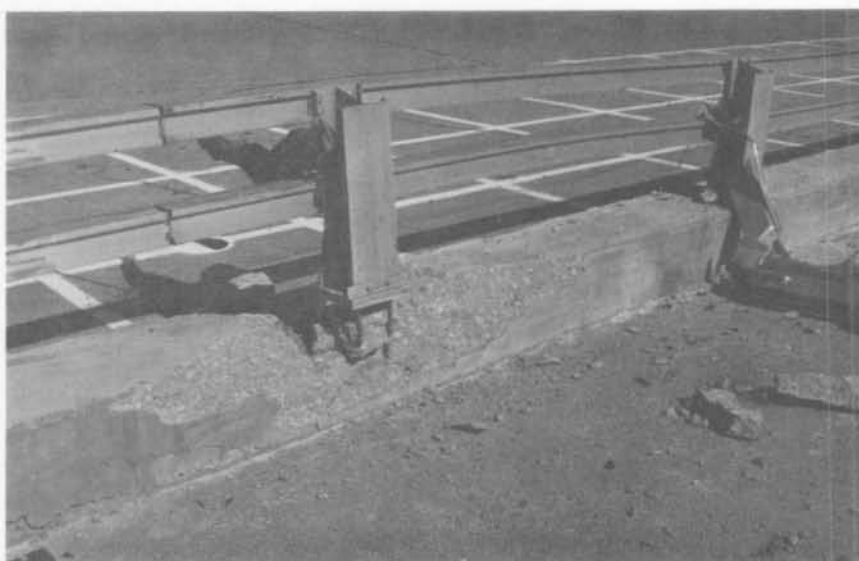
FIGURE 19. PHOTOGRAPHS OF BOX-ALUMINUM BRIDGE RAIL DAMAGE, TEST I1-2

with the concrete curb. The TAD and VDI damage classifications are shown in Figure 17. Photographs of the extensive damage to the bridge rail are shown in Figure 19.

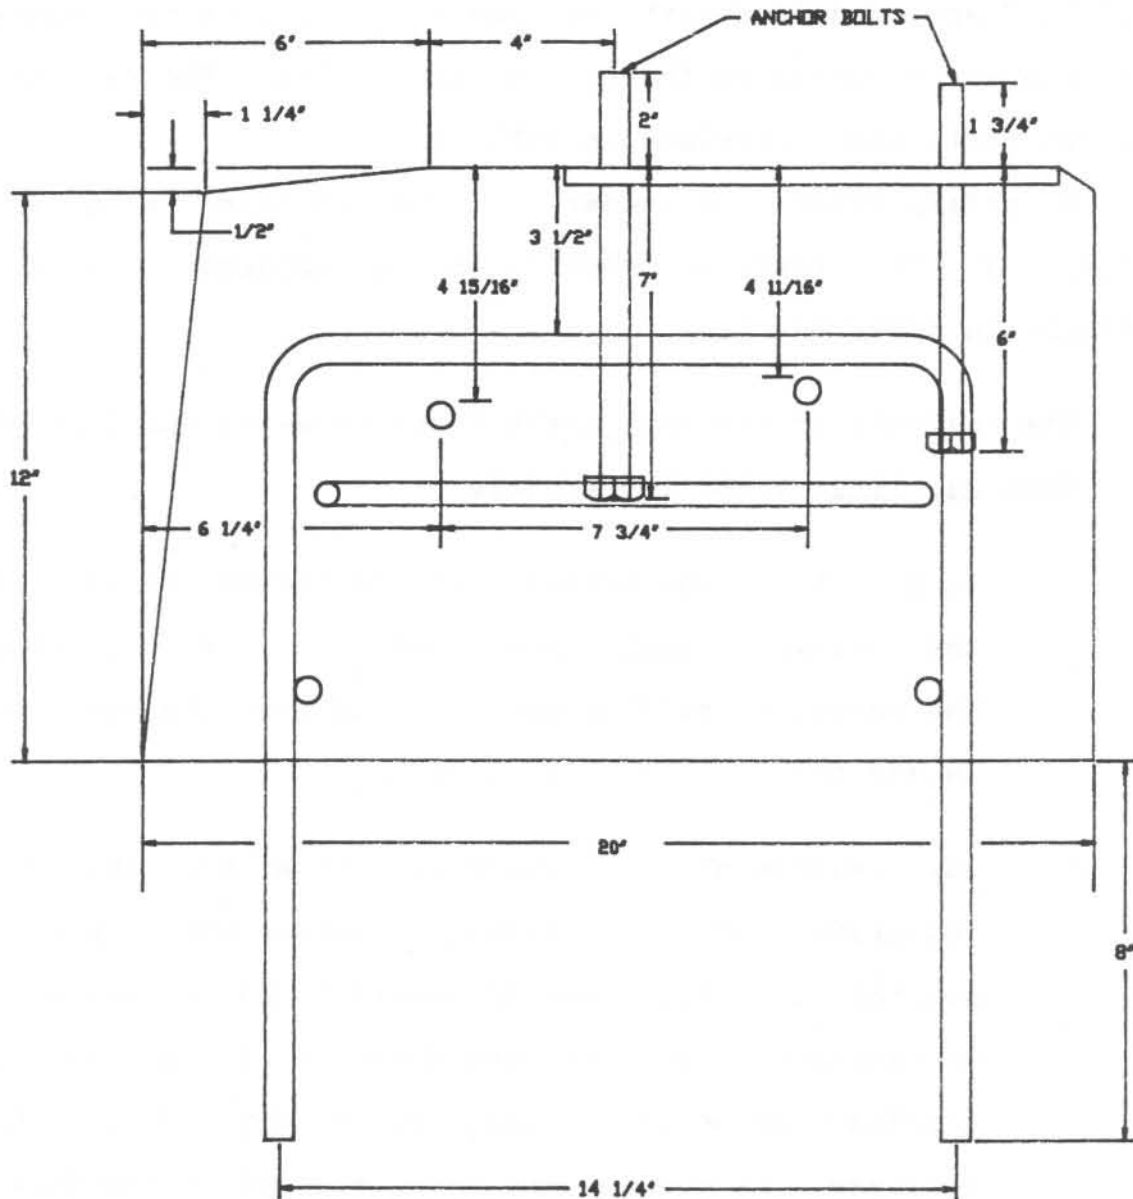
FIGURE 21.
Sketch Of Reinforcement
Steel For Task 1

After Test I1-2, it was observed that the placement of the reinforcement steel was improperly placed. The bars misplaced were the top two longitudinal bars, the horizontal bent No. 6 bar, and the vertical dowels which were bent off too short. Thus, it created 3 1/2-in. of concrete cover. A sketch of the misplaced curb reinforcement steel is shown in Figure 21.

The Civil Engineering Department at the University of Nebraska and the IDOT felt that this apparent misplacement of the steel did not effect the testing, see Appendix D.

Note: This is the actual location of the rebar which differs from the original construction plans.

Inspection of the damage to the rail and curb section due to Task I testing indicated that all of the reinforcing bars for the curb were not placed in accordance with the plan. Although this apparent misplacement probably did not affect that testing it is imperative that the rebars be placed correctly for Task II testing. I would request that this requirement be brought to the attention of the Contractor and Inspector.
