PHASE II DEVELOPMENT OF A NON- PROPRIETARY, FOUR-CABLE, HIGH TENSION MEDIAN BARRIER

MIDWEST ROADSIDE SAFETY FACILITY

MwRSF Research Report No. TRP-03-253-12

March 21, 2012

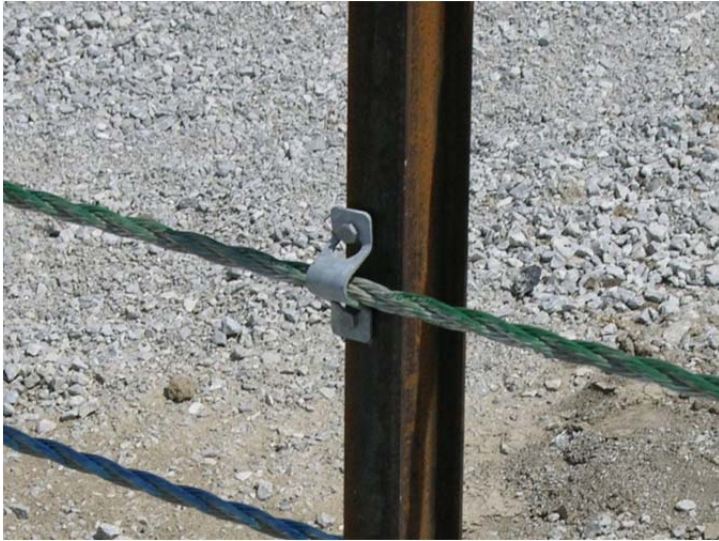
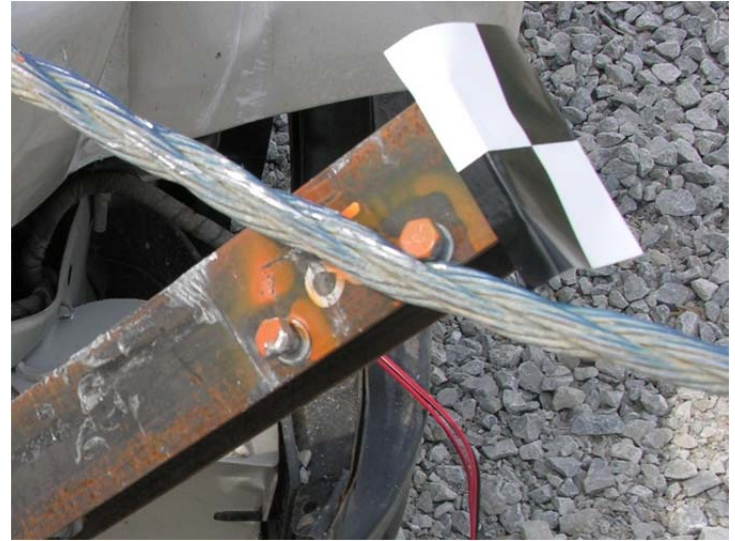
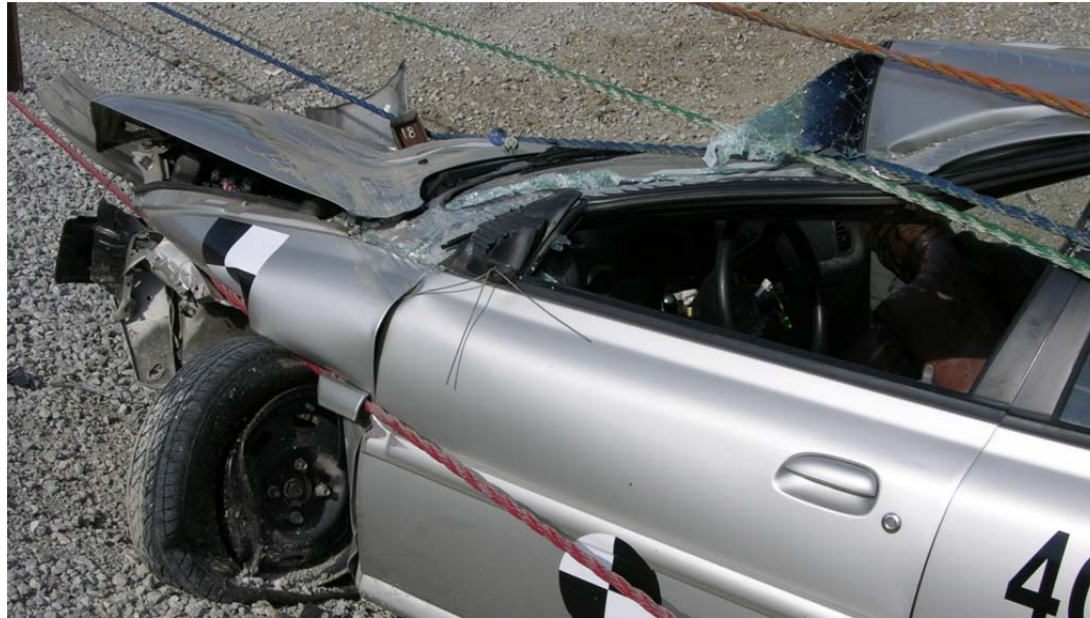
Figure 1. Test No. 4CMB-3: Slotted Bracket, Cable Snag, and A-Pillar Damage

The keyway bracket cable clips used for test no. 4CMB-3 released at the desired load, but the remaining attachment caused a snag point for the cables, which produced unacceptable results, as shown in Figure 1. In order to improve the cable release, while maintaining the attachments ability to dissipate energy through post deflection, an angled keyway bolt was developed for use with a keyway slot in the post. The shape of the bolt was optimized so that the cables would not snag on the bolt once they were released. In addition, the angled keyway bolt design utilized fewer parts, was easier to install, and less costly. Development and testing of the angled keyway bolt designed is detailed in a separate report [10]. No other design modifications were made to the system aside from the change in the cable attachment.

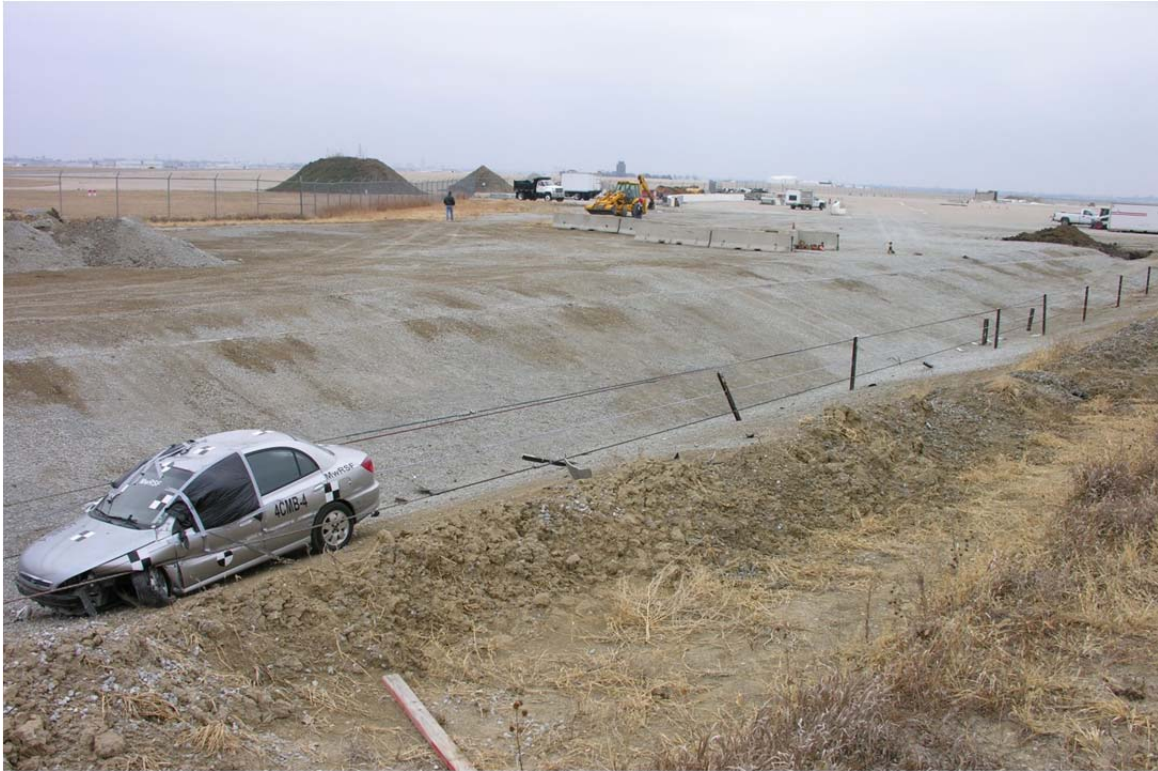
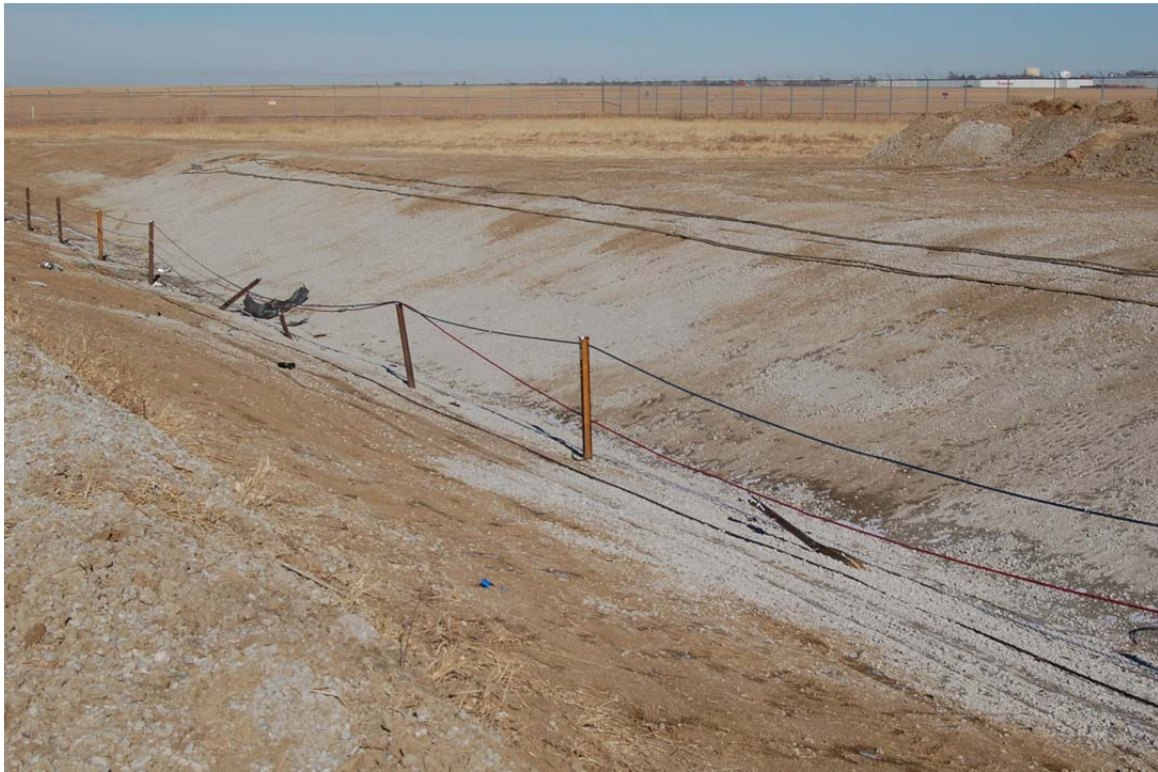
Figure 42. System Damage, Test No. 4CMB-4

Damage to the barrier was moderate, as shown in Figures 42 through 44. Barrier damage consisted of deflected posts and disengaged cables and keyway bolts. At its final resting position, the vehicle was still in contact with the cables; having cable no. 4 on the impact side and the remaining three cables on the non-impact side.

Cable no. 1 disengaged from post nos. 17, 19 through 21, and 33 when the keyway bolts bent and/or fractured. Cable no. 2 disengaged from post nos. 16 through 21. Cable no. 3 disengaged from post nos. 16 through 21. Cable no. 4 disengaged from post nos. 12 through 23.

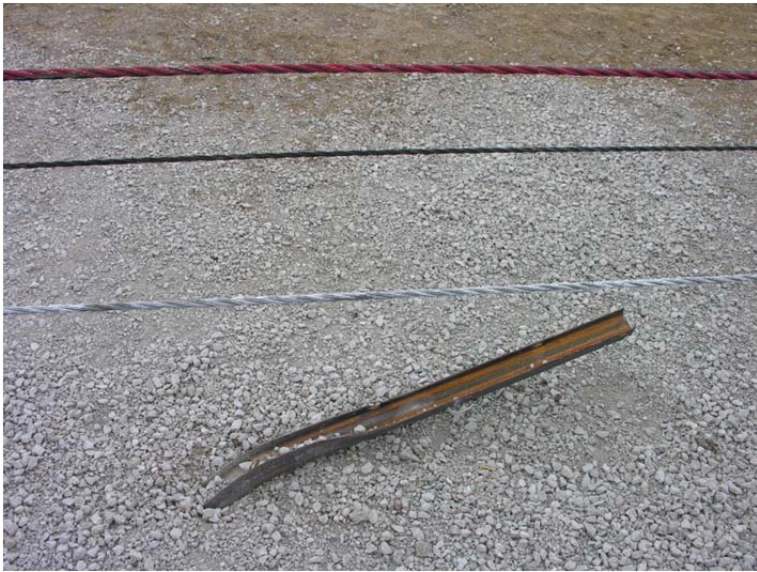
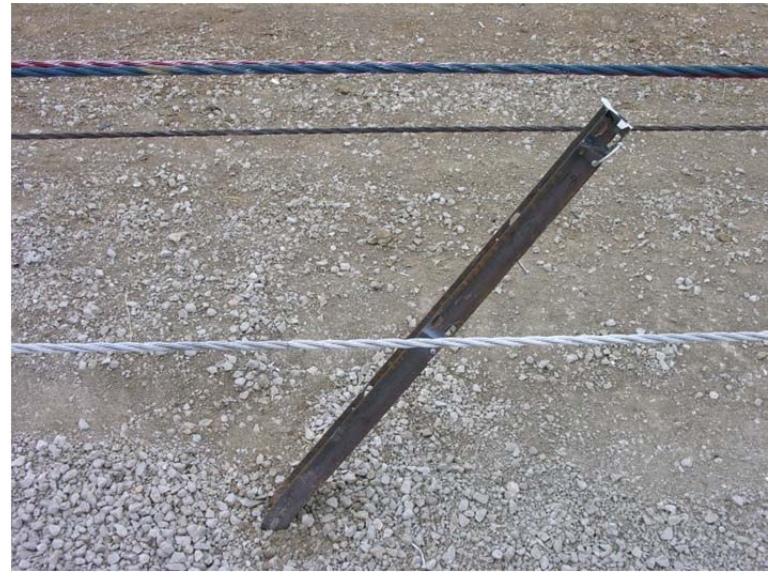
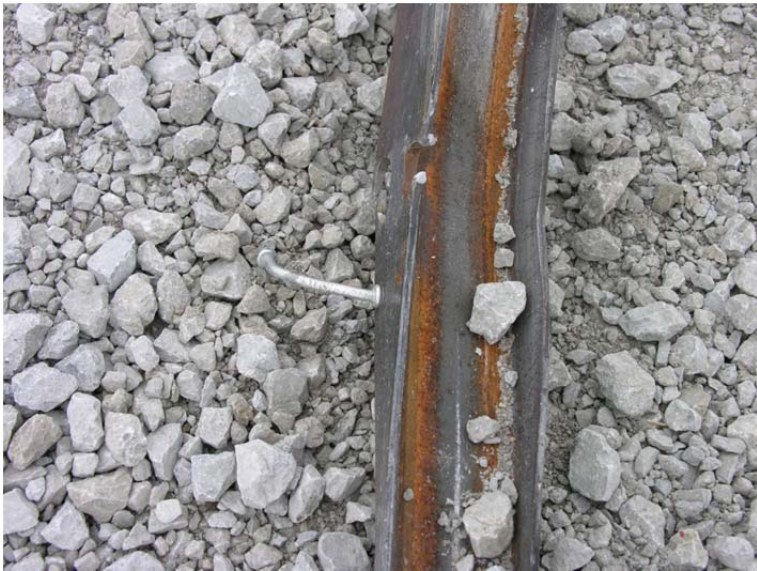
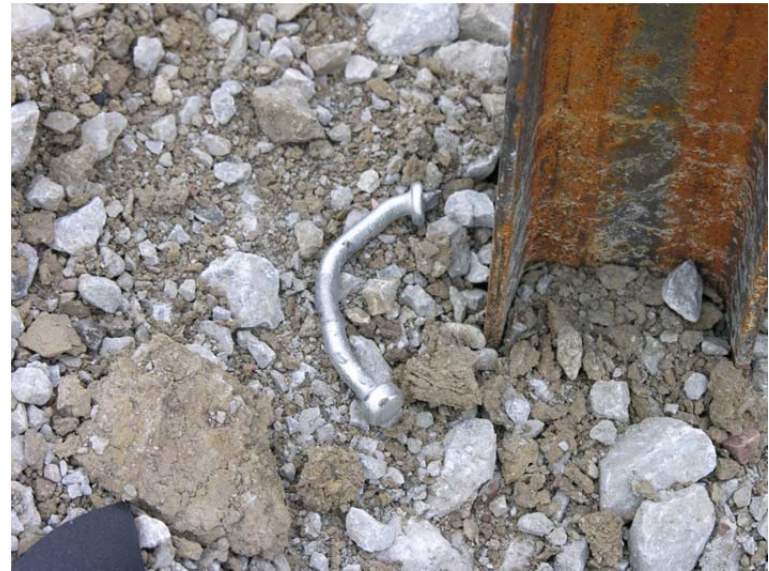
Figure 43. Post and Keyway Bolt Damage, Test No. 4CMB-4

upstream side of the flanges. Post no. 18 was bent backward slightly, and contact marks and gouging were found near the top of the post on the front side. Post no. 19 was bent downstream, and both flanges were dented at the location of cable no. 4. Post no. 20 was bent downstream and twisted to face downstream. The cable no. 4 keyway slot at post no. 20 was torn, and contact marks were found on the upstream side of the back flange near the top of the post. Post no. 21 was bent downstream with the right-rear wheel of the vehicle was resting on the post. Contact marks were found on the upstream side of both flanges extending the entire height of the post, and cable nos. 3 and 4 keyway slots were deformed. Post no. 22 was bent forward, and a $\frac{3}{4}$ in. (19 mm) soil gape was found on the back side of the post. Post no. 24 was deflected backward, and a $\frac{7}{8}$ in. (22 mm) soil gap was found on the front side of the post.

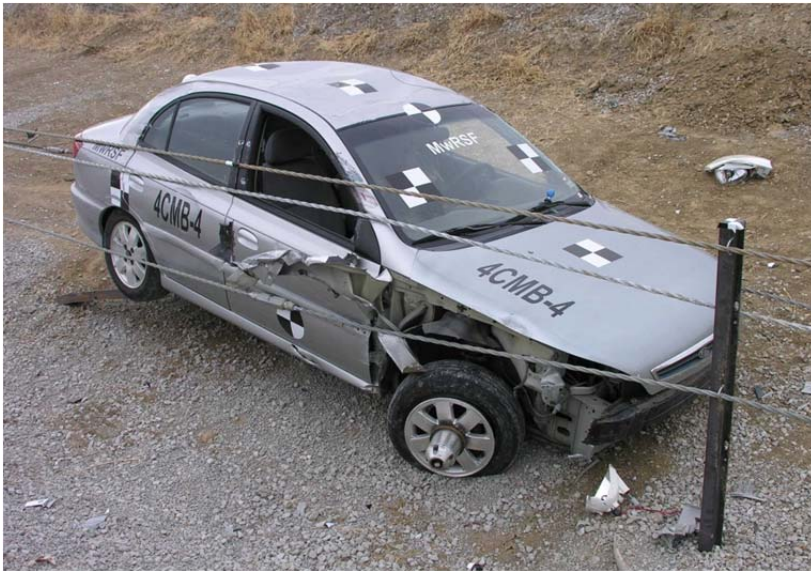
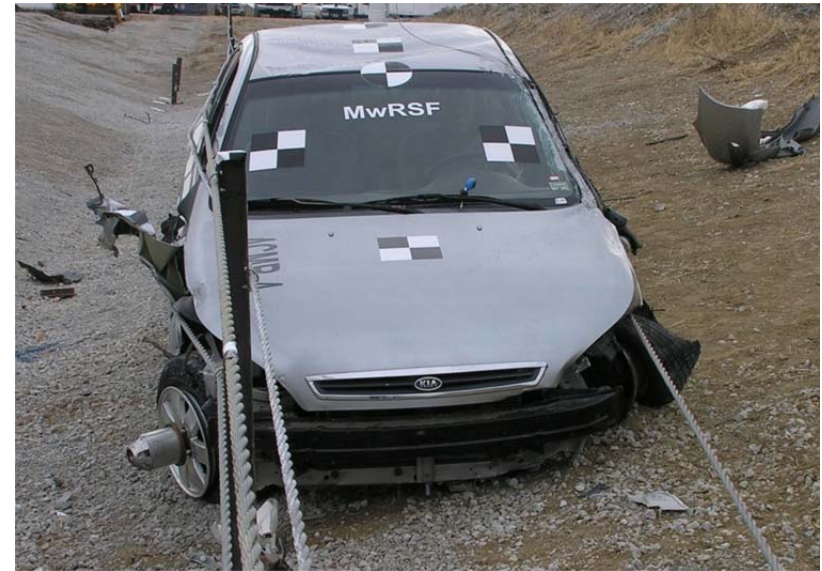
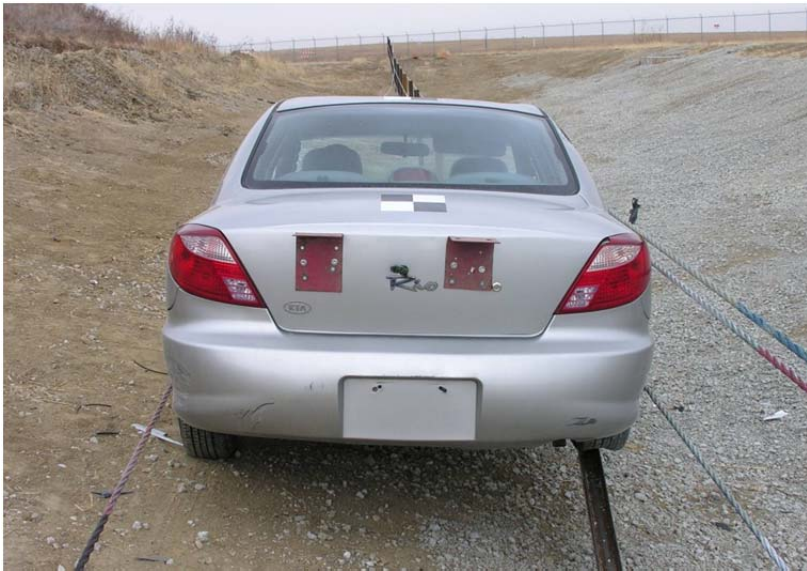
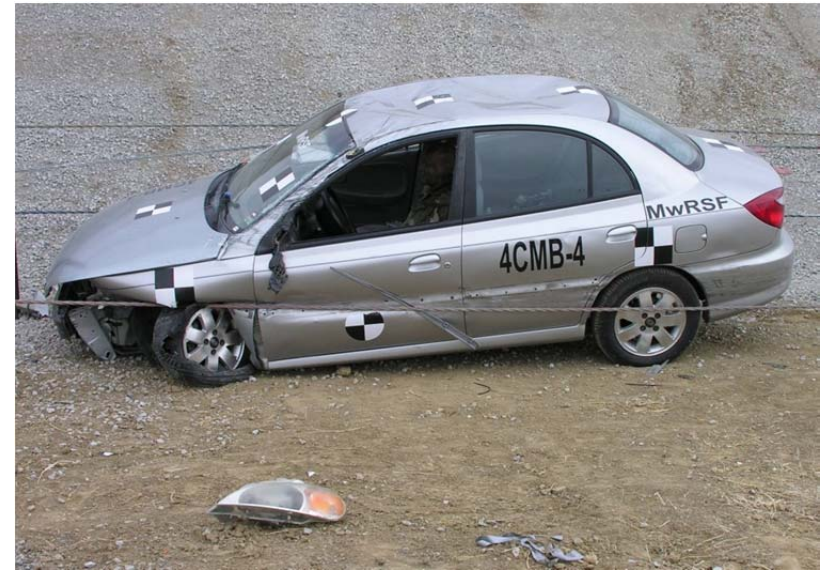
Figure 45. Vehicle Damage, Test No. 4CMB-4

The damage to the vehicle was moderate, as shown in Figures 45 through 48. The maximum occupant compartment deformations are listed in Table 6 along with the deformation limits established in MASH for various areas of the occupant compartment. Note that none of the MASH established deformation limits were violated. Complete occupant compartment and vehicle deformations and the corresponding locations are provided in Appendix D.

Damage occurred to all sides of the vehicle. The vehicle came to rest in the middle of the system with cable 4 against the left side of the vehicle and cables 1, 2, and 3 against the right side of the vehicle. The right-rear tire came to rest on top of post no. 21. The front bumper cover disengaged on the backslope. Both headlights disengaged near the bottom of the ditch. The left-front fender was dented inward approximately 7 in. (178 mm). The left-front tire was torn on the inner and outer sidewalls. A 5-in. (127-mm) long gouge was found in the left-front rim. The left tie-rod was bent. Cable contact marks extended the length of the vehicle on both the left and right sides. Both side mirrors were disengaged. Denting from the cables occurred on the left side of the hood and left A-pillar. The left 4 in. (102 mm) of the windshield had moderate spiderweb cracking. Gouges were found on the left-rear rim. Folding and denting occurred in the right C-pillar. Both front side windows were shattered. Cable contact marks were found on the right-rear side window. A 7-in. (178-mm) gouge was located below the right-front door 17 in. (432-mm) behind the right-front wheel well. Denting occurred at the center of the front and center of the back of the roof. Denting occurred in the gear box of the transmission and fluid was leaking from it. The vertical bumper horn was torn. A hole was also found in the spare tire storage floorboard.

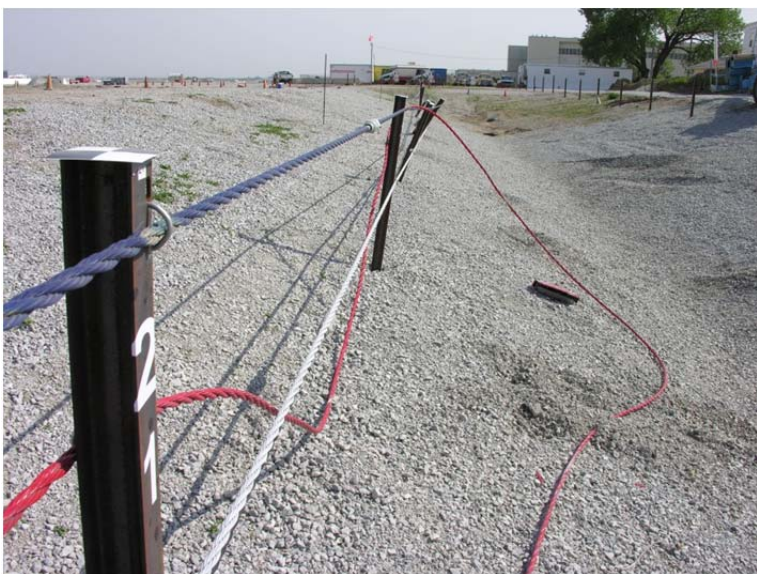
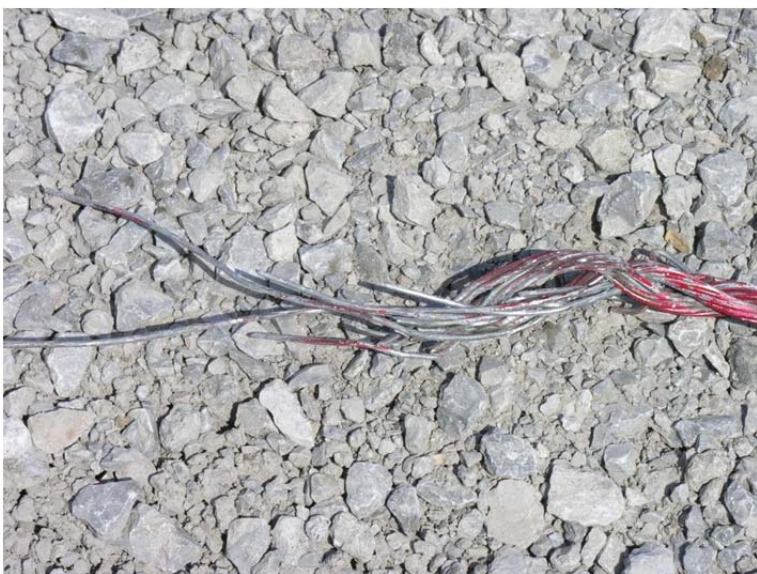
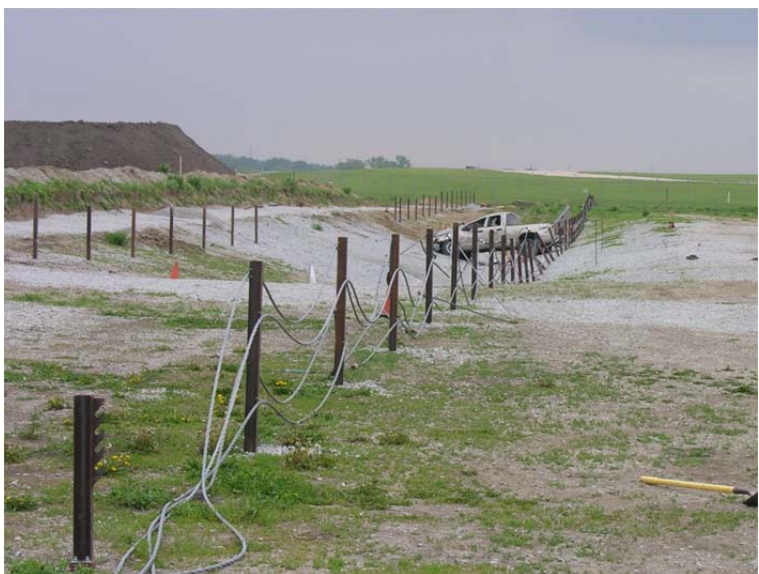
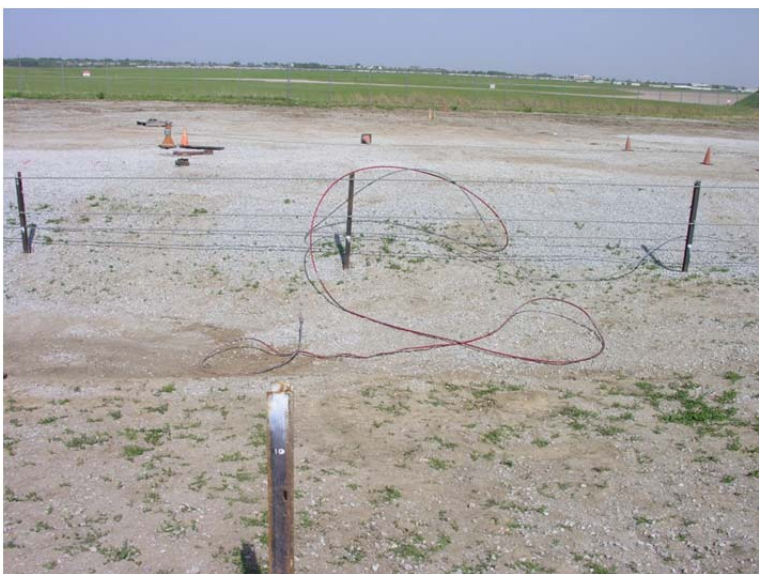
Figure 80. System Damage, Test No. 4CMB-5

Damage to the barrier was moderate, as shown in Figures 80 through 82. Tension was released in the cables prior to taking all post-test documentation photos. Barrier damage consisted of deflected posts and disengaged cables and keyway bolts.

Cable no. 1 disengaged from post nos. 15 through 17 when the keyway bolts bent and/or fractured. Cable no. 2 disengaged from post nos. 13 through 19. Cable no. 2 also fractured approximately between post nos. 17 and 18 after it snagged on the rear end of the pickup truck. Cable no. 3 disengaged from post nos. 14 through 17. Cable no. 4 disengaged from post nos. 16 and 17.

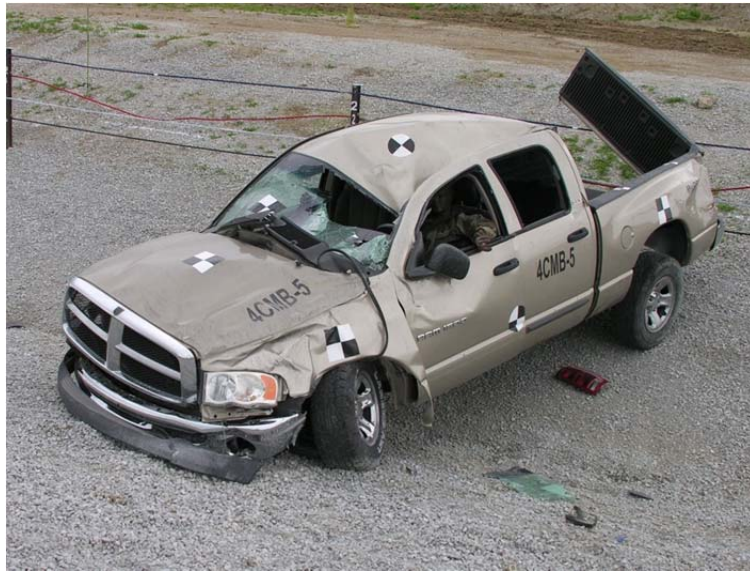
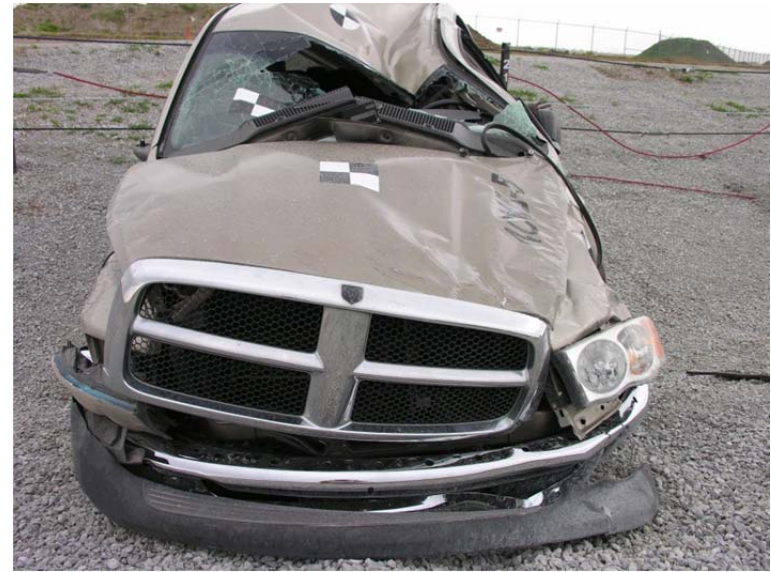
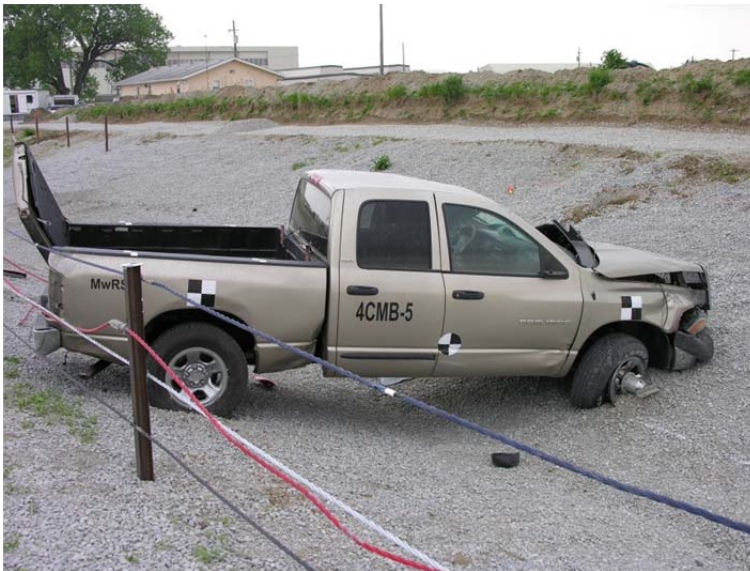
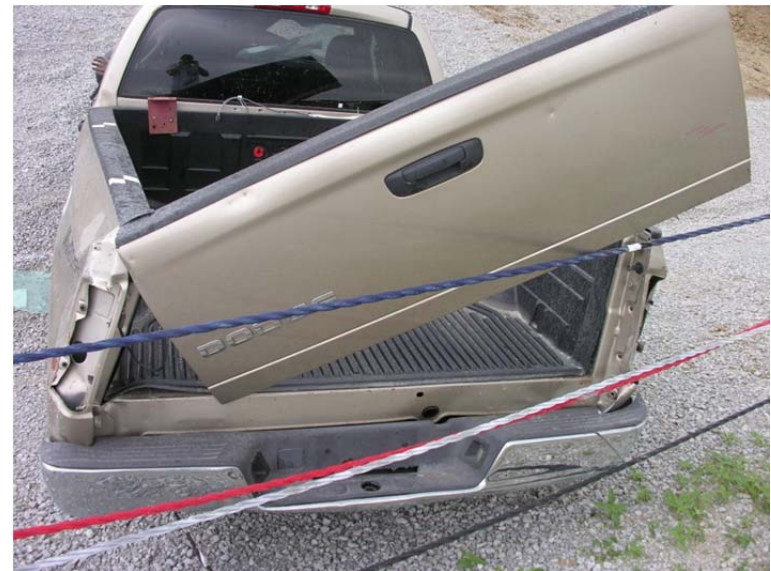
Figure 83. Vehicle Damage, Test No. 4CMB-5

The damage to the vehicle was severe, as shown in Figures 83 through 86. The maximum occupant compartment deformations are listed in Table 12 along with the deformation limits established in MASH for various areas of the occupant compartment. The roof deformation of $15\frac{1}{2}$ in. (394 mm) exceeded the MASH limit of 4 in. (102 mm). Complete occupant compartment and vehicle deformations and the corresponding locations are provided in Appendix D.

Damage occurred to all sides of the vehicle due to the rollover. The plastic bumper cover was disengaged and torn on the right side, and the bumper was dented near the center and the left side. The front frame member was bent and torn. The hood was crushed and ajar. The left side of the grill was fractured. The dash was fractured and deformed upward. The left side of the roof was severely crushed. The windshield was shattered and torn on the left side. The left headlight was disengaged and fractured. The left-front upper control arm, tie rod, and brakes were disengaged. The left-front lower control arm was fractured. The left fender was crushed inward at the front and deformed outward by the left-front door. The front and top of the left-front door and mirror were crushed inward. Both left windows were shattered and disengaged. The left-rear door was crushed at the top. The left-rear quarter panel was crushed inward behind the wheel. Both taillights disengaged. The tailgate disengaged on the right side. The right-rear quarter panel was scratched and dented behind the wheel well. The front of the right side of the box was crushed inward. The right-rear shock mount and shock fractured and disengaged. The right-front door was slightly ajar. Denting occurred at the lower-front of the right-front door. The right

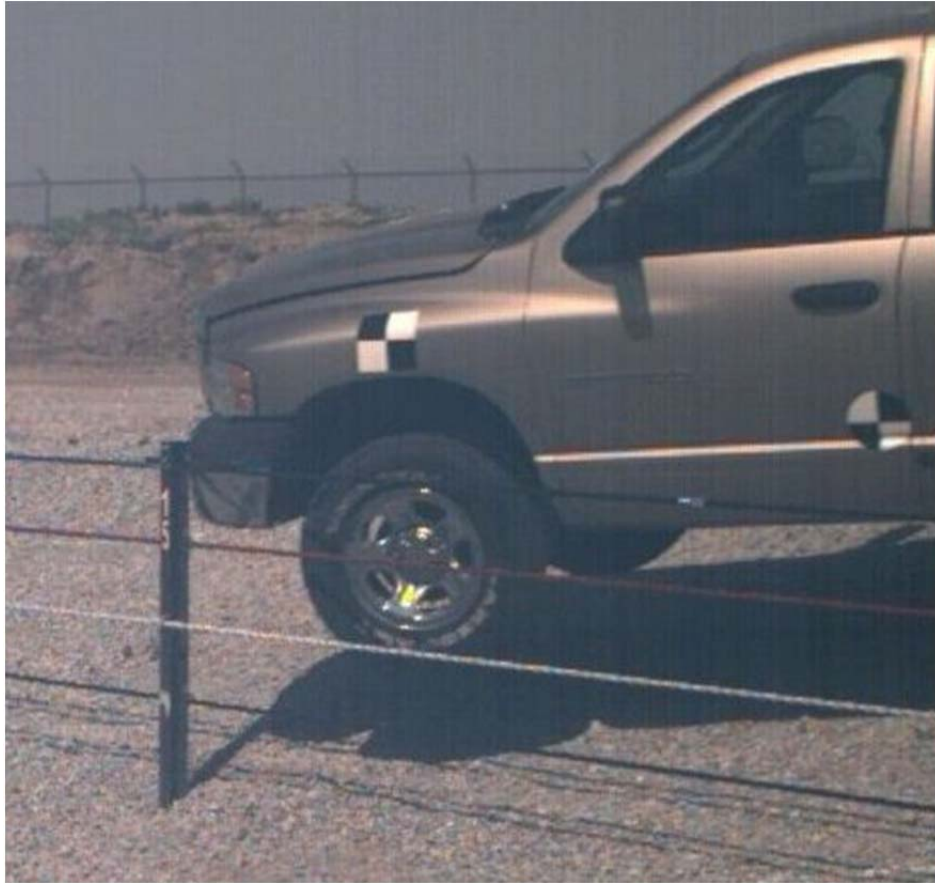
Figure 87. Bumper-to-Cable Relation at Impact, Test No. 4CMB-5

Following the analysis of test no. 4CMB-5, the researchers concluded that the failure of the test was directly attributed to failure to capture the impacting vehicle and the subsequent override of the system. The failure of the system to capture the vehicle was caused by the vehicle impacting post no. 15 prior to engaging the top cable. Post no. 15 deflected laterally back as well as longitudinally downstream. Impacting the post was shown to be critical, as the motion of the post caused the cables to be pulled down and prevent them from capturing the vehicle bumper.

Based on the results of this test, there may be a need to utilize different, or modified, cable attachments at the various cable heights in the system. It may be necessary to modify the vertical release properties of the upper cable attachments such that they release under very low forces and deflections in order to prevent the cables from being pulled downward, as observed in test no. 4CMB-5. It was noted in this test that the location of the vehicle bumper in relation to the top cable was marginal with respect to the potential for vehicle capture, even prior to the pulldown of the cables by the post, as shown in Figure 87. These modifications, along with others will be considered as the research effort moves forward.
