**SAFETY PERFORMANCE
EVALUATION OF MINNESOTA'S
ALUMINUM WORK ZONE SIGNS**

MwRSF Research Report No. TRP-03-107-01

January 29, 2002

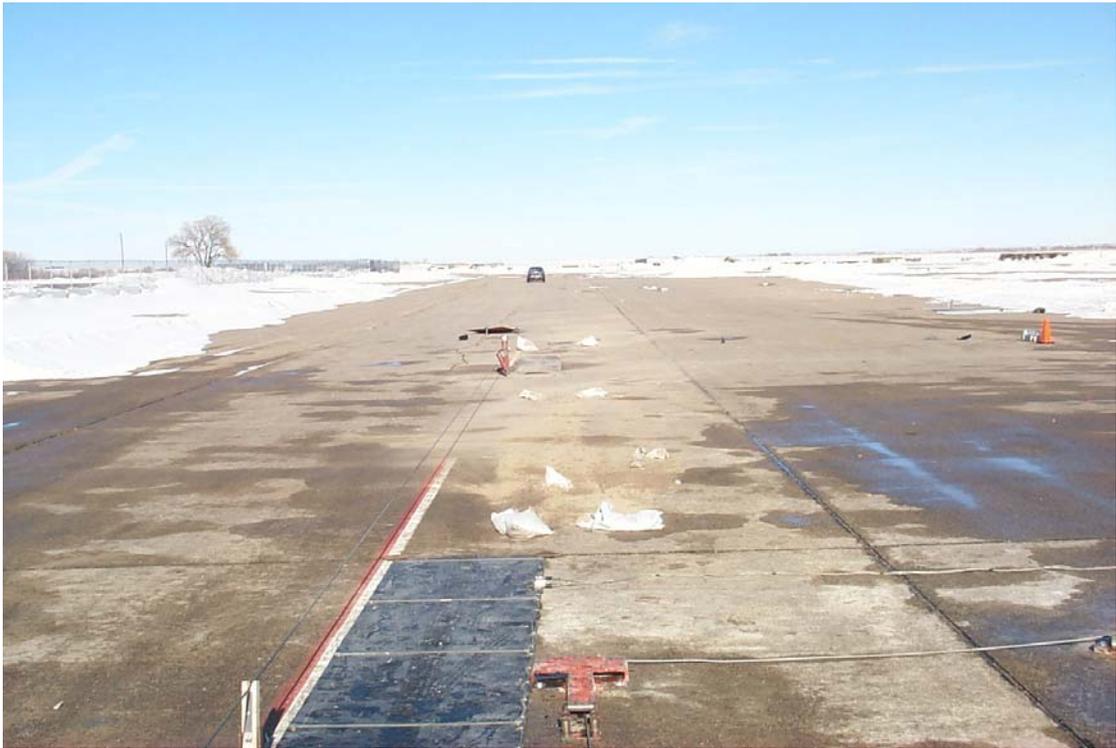
Figure 29. Overall Damage and Final Positions, Test MNS-1

Damage to System Nos. 1 and 2 is shown in Figures 29 through 32. System No. 1 encountered moderate damage. The vertical upright tube on both legs was bent, and the weld fractured on three sides. Both legs were also disengaged from the masts. Both masts were deformed at bumper height. The mast on the left side was cracked. The light portion of the warning light broke off while the bottom box portion was still attached to the sign panel. The sign panel encountered slight deformations as well as scuff and scrape marks. The sandbags were torn open with the sand scattered along the path of the vehicle, starting at the initial position of the first sign support.

System No. 2 encountered moderate damage. Both legs disengaged from the masts but remained undamaged. Three out of the four sides of both masts were fractured at the bottom sign panel bolts. The impacted mast was also deformed at bumper height. The non-impacted mast also released from the bottom sign panel bolt. The sign panel encountered a 76-mm long tear due to the impacted-side bottom sign panel bolt slicing through the sign panel. The sign panel also encountered scuff and scrape marks as well as deformation to the top corner. The warning light remained intact and attached to the sign panel. Three of the sandbags were torn open with the sand scattered along the path of the vehicle, starting at the initial position of the second sign support. The other sandbag remained undamaged.

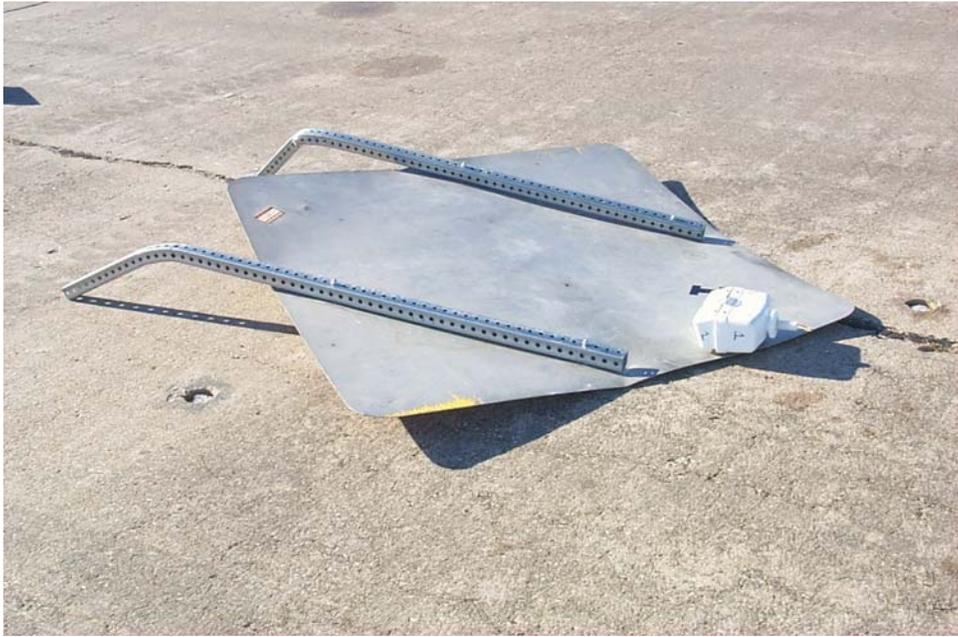
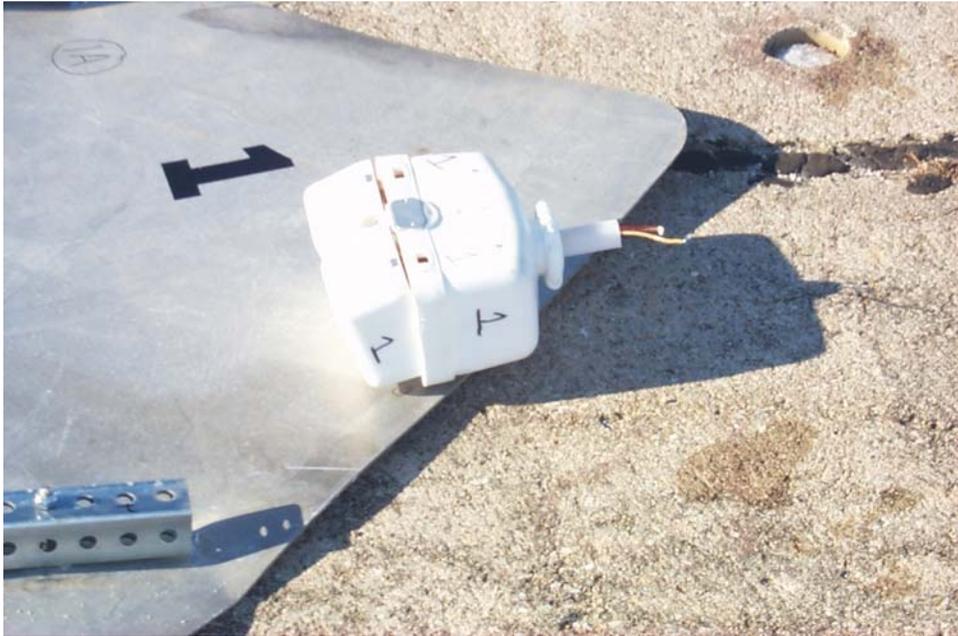
Figure 30. System No. 1 Damage, Test MNS-1

Following test MNS-1, a safety performance evaluation was conducted, and the work zone traffic control device, System No. 1 was determined to be unacceptable according to the NCHRP Report No. 350 criteria. It was deemed unacceptable due to the “spider web” cracking, indentation, and hole in the windshield, resulting in obstructed driver visibility and loss of structure of both glass layers. Deformations of, or intrusion into, the occupant compartment did occur as detached elements and debris from System No. 1 penetrated the left-central region of the windshield.

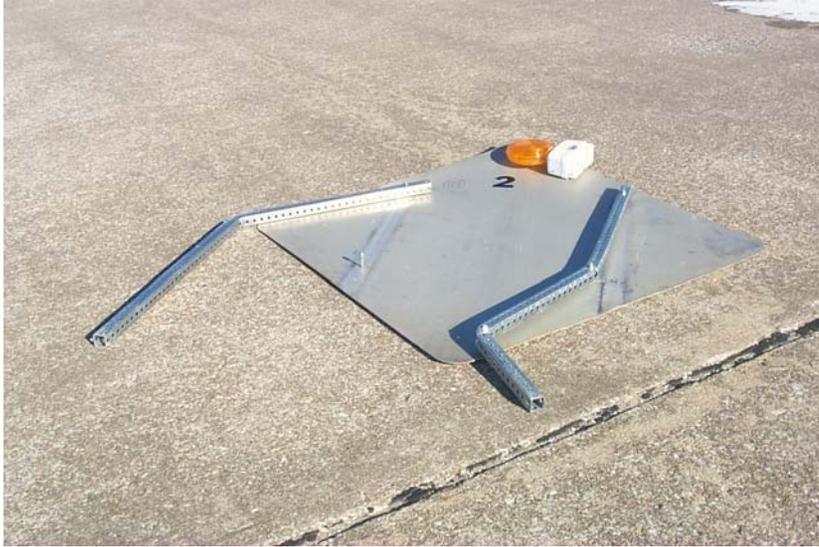
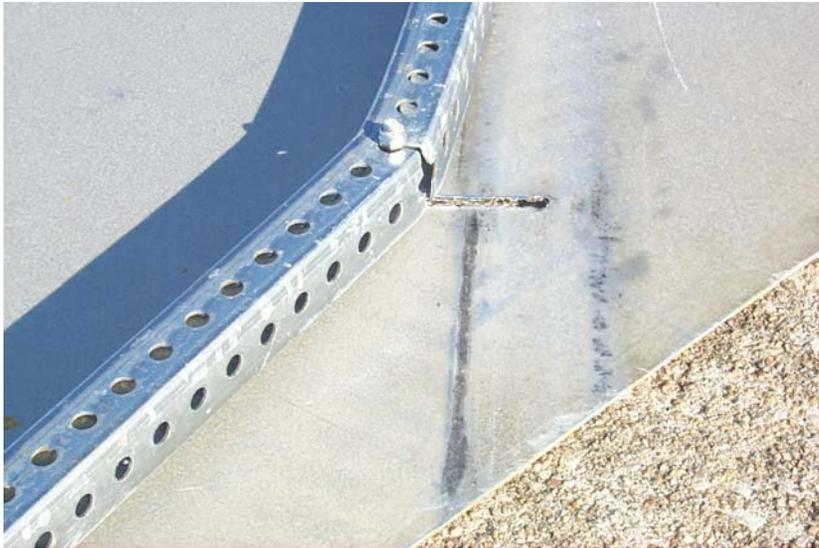
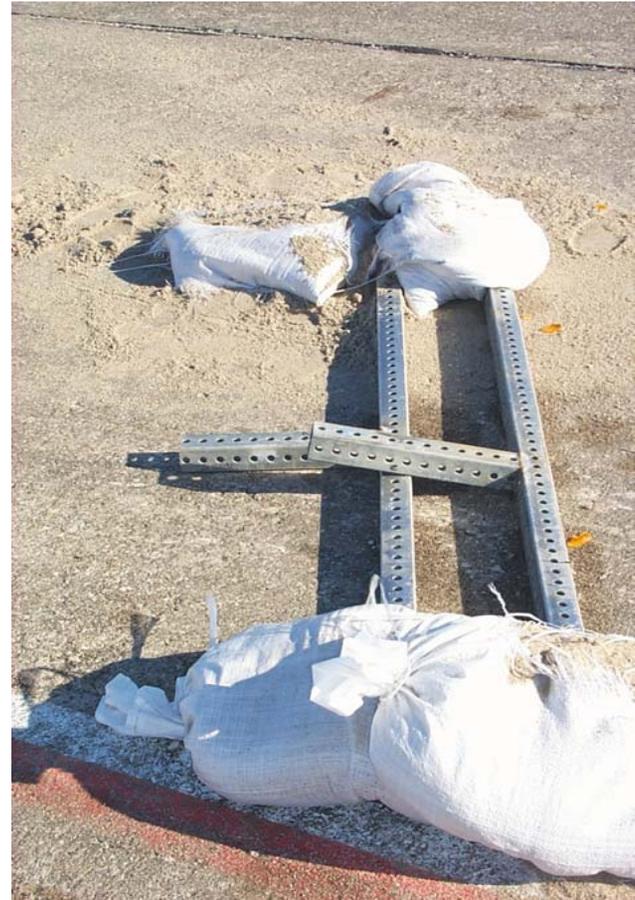
Figure 32. System No. 2 Damage, Test MNS-1

System No. 2 was determined to be acceptable according to the NCHRP Report No. 350 criteria. Detached elements and debris from System No. 2 did not penetrate nor show potential for

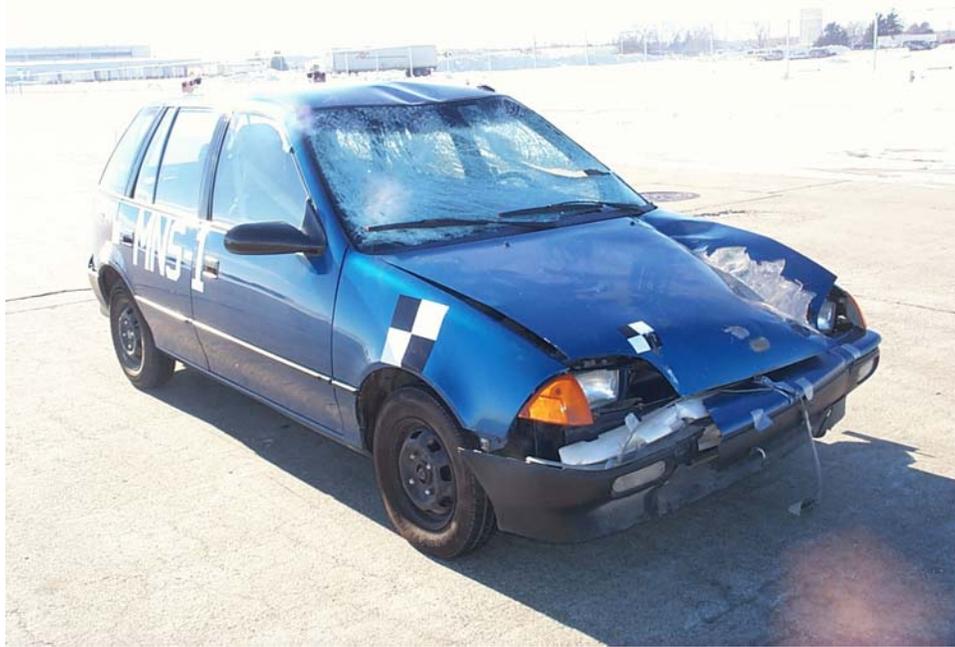
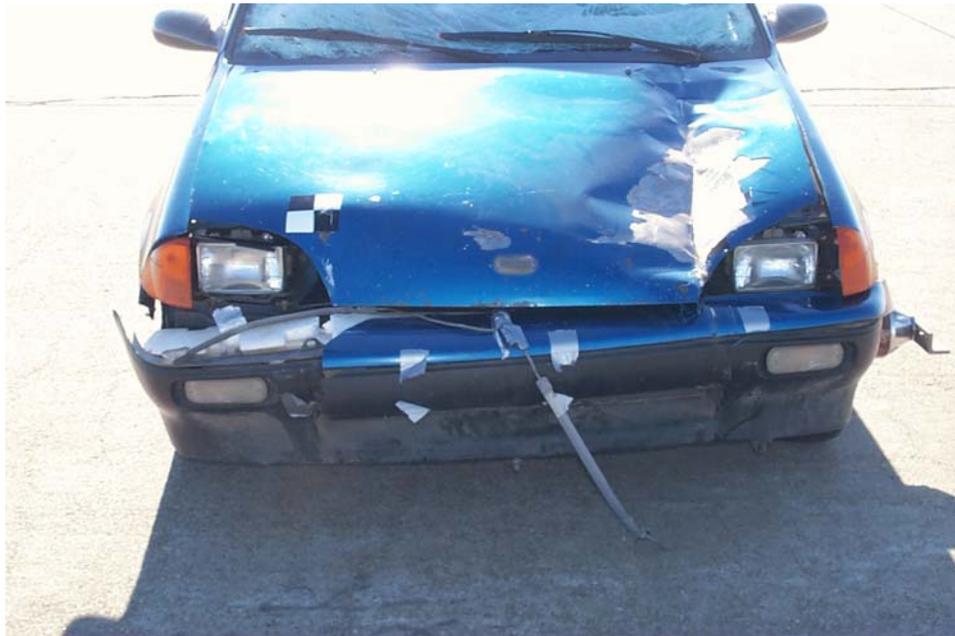
Figure 33. Vehicle Damage, Test MNS-1

Exterior vehicle damage is shown in Figures 33 and 34. The front bumper and lower plastic shield encountered dents, tears, and contact marks. The right side of the bumper disengaged from the bumper clips. A small dent was located along the right-side quarter point of the hood. The hood encountered a major indentation along the left-side quarter point. The roof also encountered a dent starting at the front-center and extending 305 mm toward the rear. A 152-mm long scrape was located along the left-side door near the left-front fender. Both headlights were pushed inward toward the engine compartment but remained undamaged. The windshield sustained major “spider web” cracking throughout, with both layers of the windshield being cracked. Most of the structural integrity of the windshield was lost and the windshield indented inward toward the occupant compartment. A 305-mm long hole through the windshield was located near the center region of the left side. No damage was found to have occurred to the rear-end, fog lights, nor parking lights.

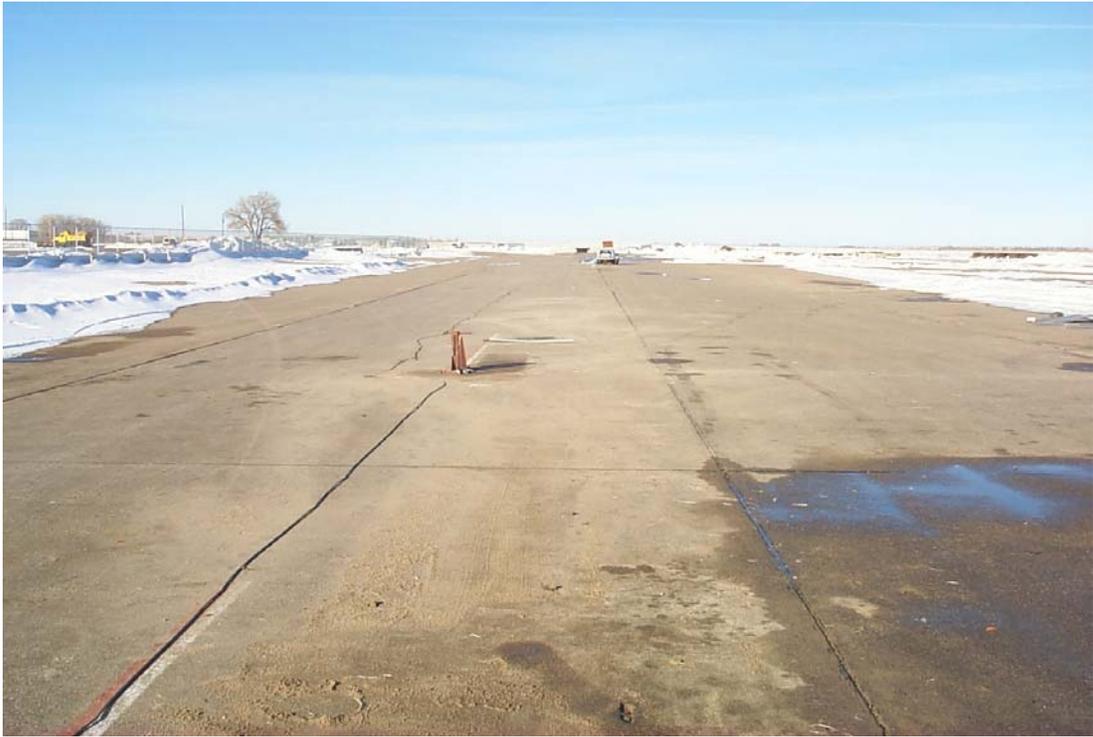
Figure 42. Overall Damage and Final Positions, Test MNS-2

Loose sand from the sandbags was scattered in a pattern bound by 0.0-m upstream, 1.83-m downstream, 0.91-m left, and 0.91-m right from the original position of the aluminum sign support. The vehicle subsequently came to rest 89.61-m downstream from the longitudinal midpoint of the two impact points and 2.04-m right from the centerline of the vehicle's original path. The final positions of the vehicle and the sign supports are shown in Figures 35, 36, and 42.

Damage to System Nos. 3 and 4 is shown in Figures 42 through 44. System No. 3 remained intact with damage consisting of deformations to the masts and sign panels. Both masts were deformed at the bumper height. The bottom sign panel deformed outward toward the vehicle. The sandbags were torn open with the sand scattered along the path of the vehicle, starting at the initial position of the first sign support.

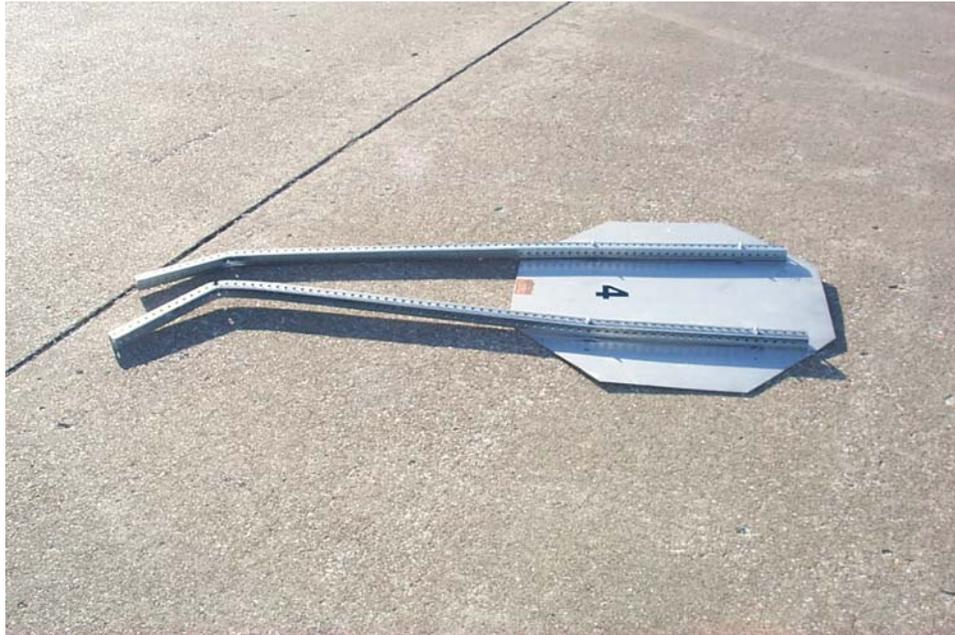
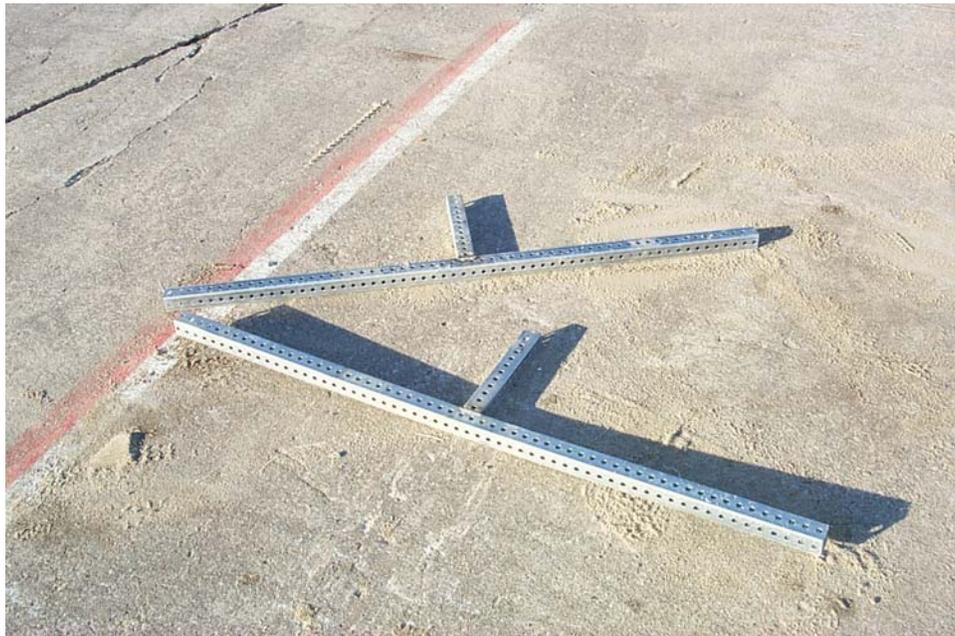
Figure 44. System No. 4 Damage, Test MNS-2

System No. 4 encountered moderate damage. Both legs disengaged from the masts but remained undamaged. Both masts were deformed and fractured approximately 457 mm from the bottom ends of the masts on three out of the four sides. The sign panel encountered scuff and scrape marks as well as deformation to the bottom corner of the impact side. Two of the sandbags were torn open with the sand scattered along the path of the vehicle, starting at the initial position of the second sign support. The other two sandbags remained undamaged.

System No. 4 was determined to be unacceptable according to the NCHRP Report No. 350 criteria. It was deemed unacceptable due to the “spider web” cracking, indentation, and hole in the windshield, resulting in obstructed drive visibility and loss of structure of both glass layers. Deformation of, or intrusion into, the occupant compartment did occur as detached elements and debris from System No. 4 penetrated the left region of the windshield. The vehicle’s trajectory did not intrude into adjacent traffic lanes.

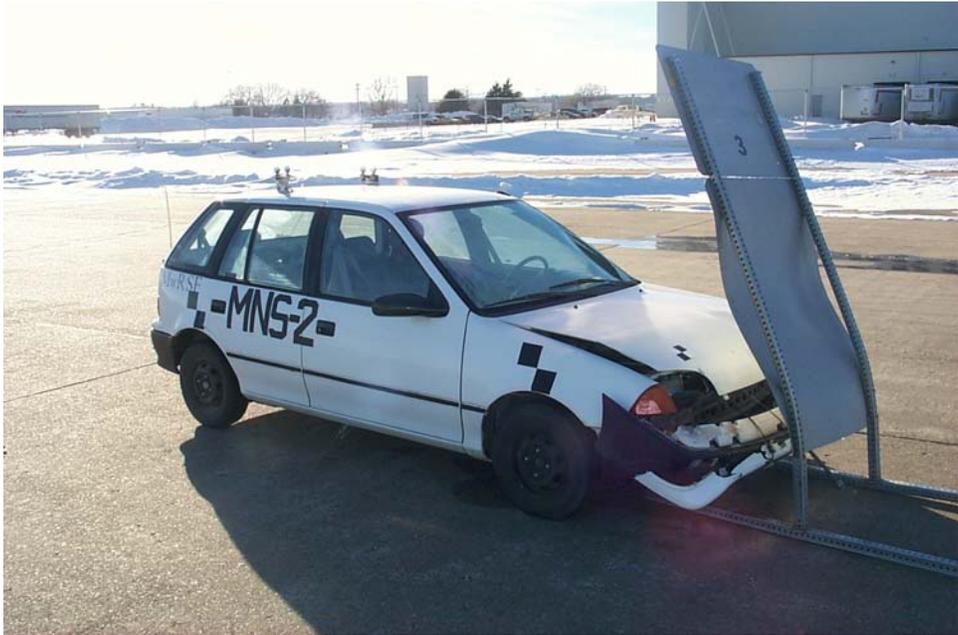
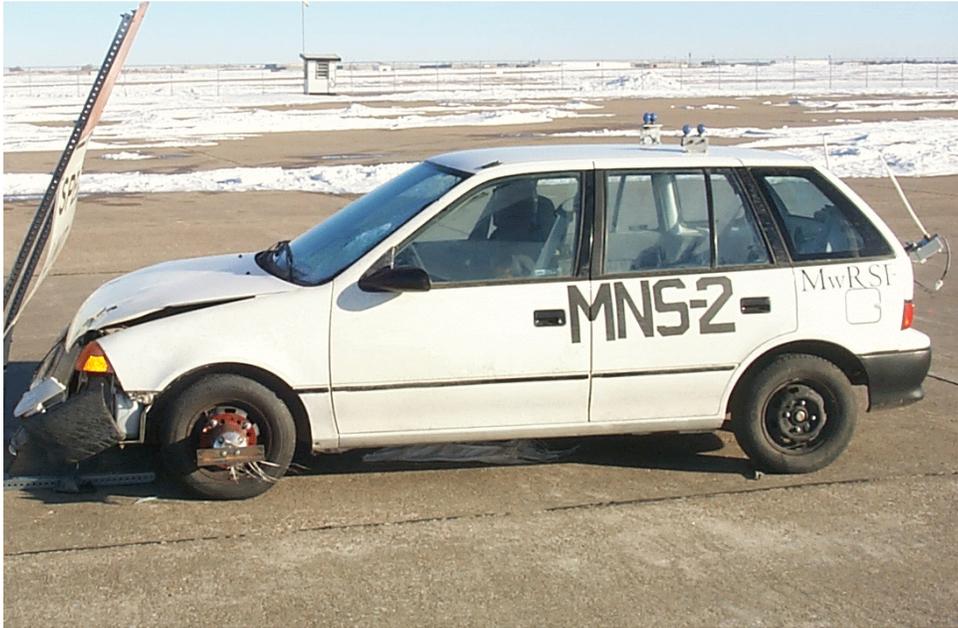
Figure 45. Vehicle Damage, Test MNS-2

Exterior vehicle damage is shown in Figures 45 and 46. The bumper disengaged from the right-side, left-side, and top-front bumper clips. The hood was buckled upward toward the windshield. A small dent was located on the front-left quarter point of the roof. Both headlights were pushed inward toward the engine compartment but remained undamaged. The windshield

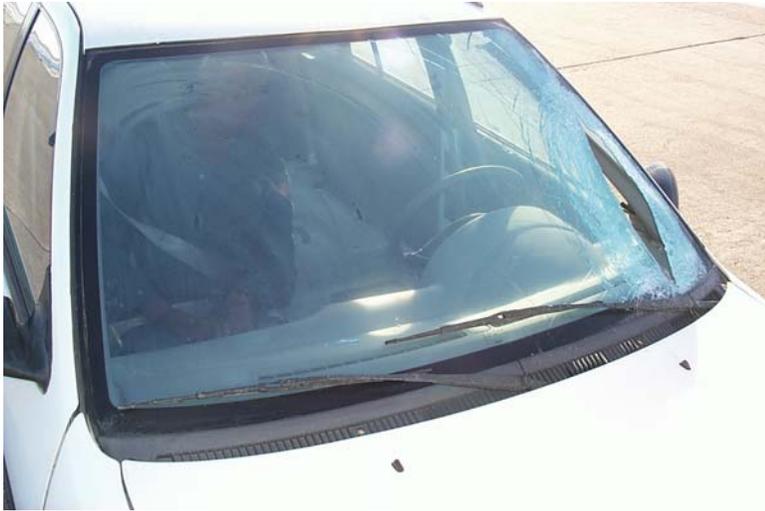
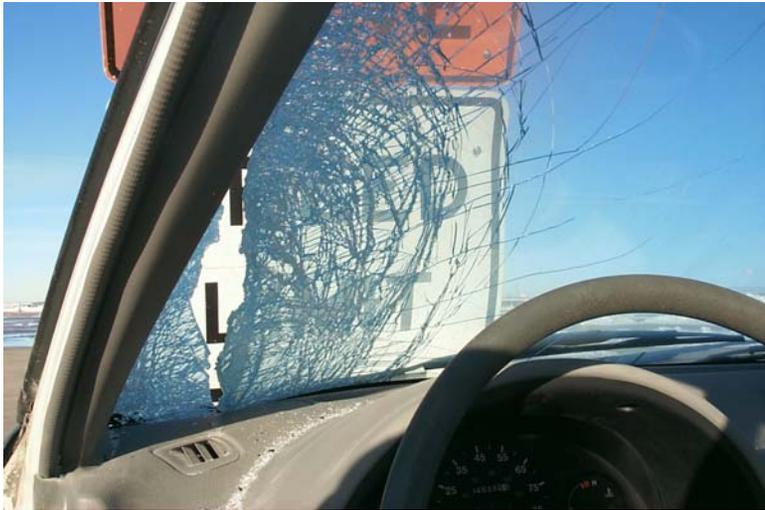
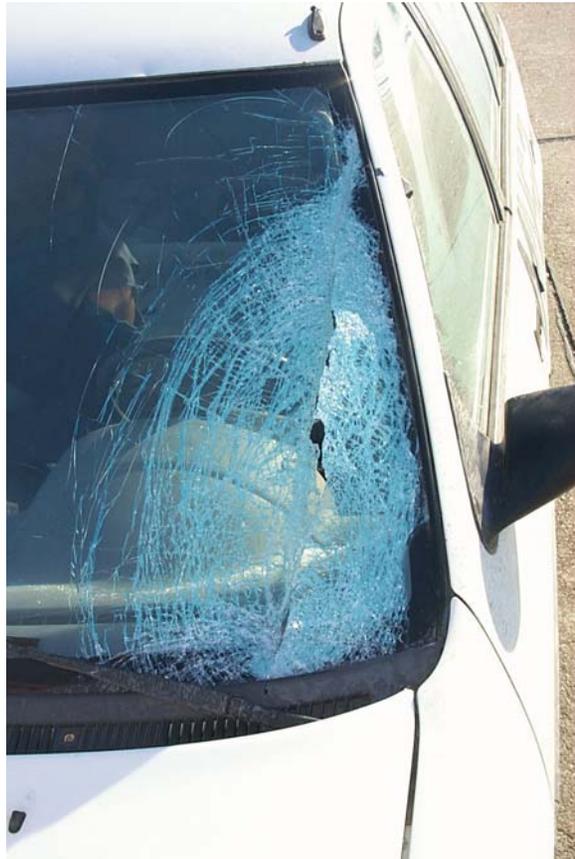
Figure 46. Windshield Damage, Test MNS-2

sustained major “spider web” cracking on the left-side, with both layers of the left-side windshield being cracked. A large hole (slice) through the windshield was located near the outer region of the left side. No damage was found to have occurred to the right-side, rear-end, headlights, fog lights, nor parking lights.

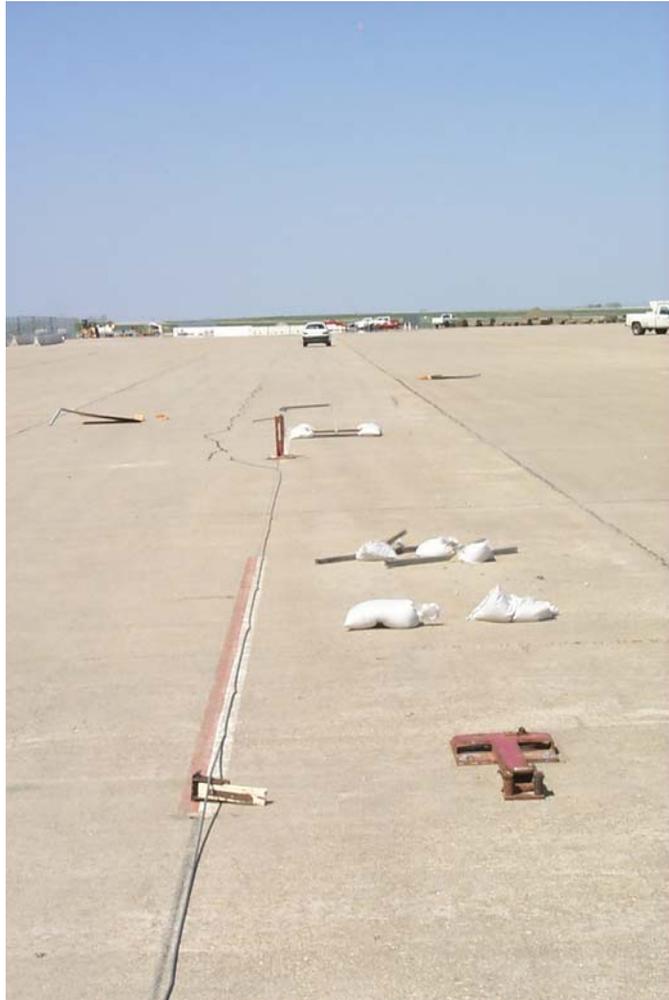
Figure 54. Overall Damage and Final Positions, Test MNS-3

Damage to System Nos. 5 and 6 is shown in Figures 54 through 56. System No. 5 encountered moderate damage. The vertical upright tube on both legs was bent and the weld fractured on three sides. Both legs were also disengaged from the masts. Both masts deformed at the bumper location. The mast on the left side disengaged from both sign panel bolts. The sign

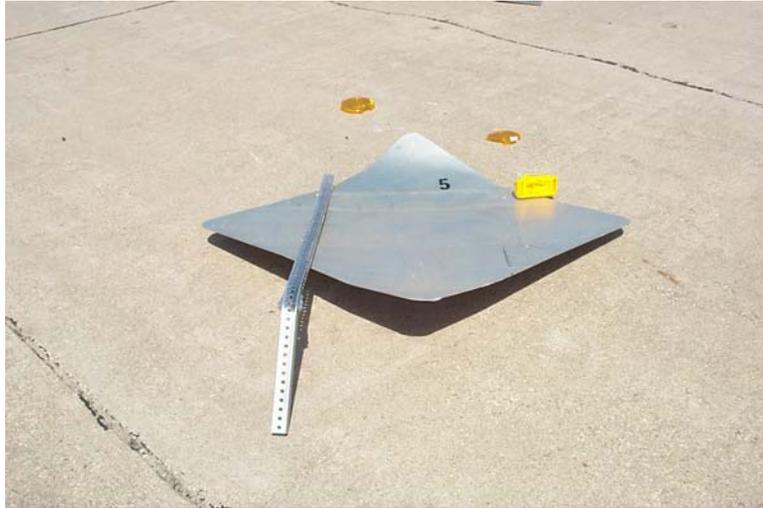
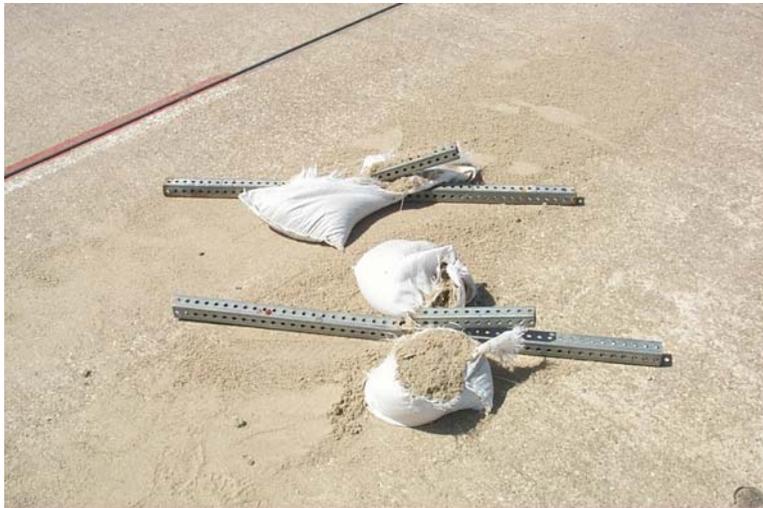
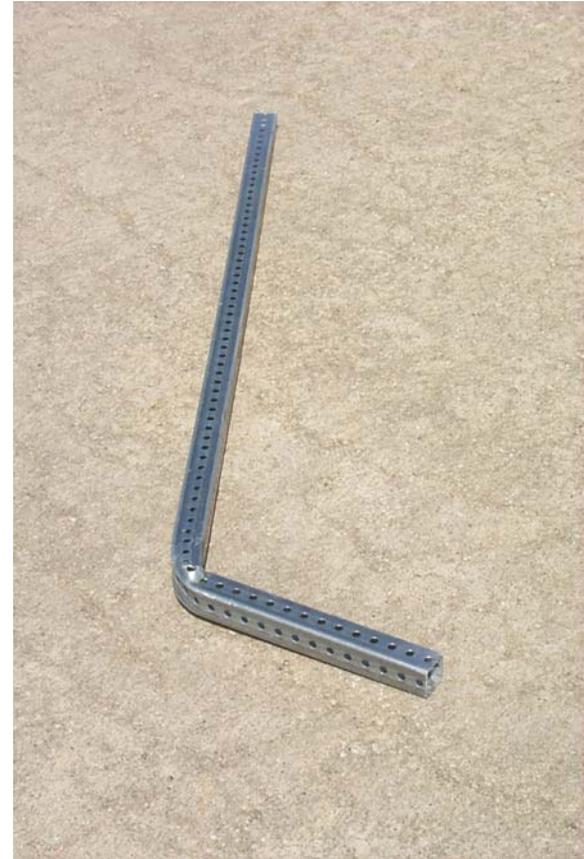
Figure 55. System No. 5 Damage, Test MNS-3

Following test MNS-3, a safety performance evaluation was conducted, and the work zone traffic control device, System No. 5, was determined to be unacceptable according to the NCHRP Report No. 350 criteria. It was deemed unacceptable due to the “spider web” cracking, indentation, and holes in the windshield, resulting in obstructed driver visibility and loss of structure of both glass layers. Deformations of, or intrusion into, the occupant compartment did occur as detached elements and debris from System No. 5 penetrated the left- and right-quarter point regions of the windshield.

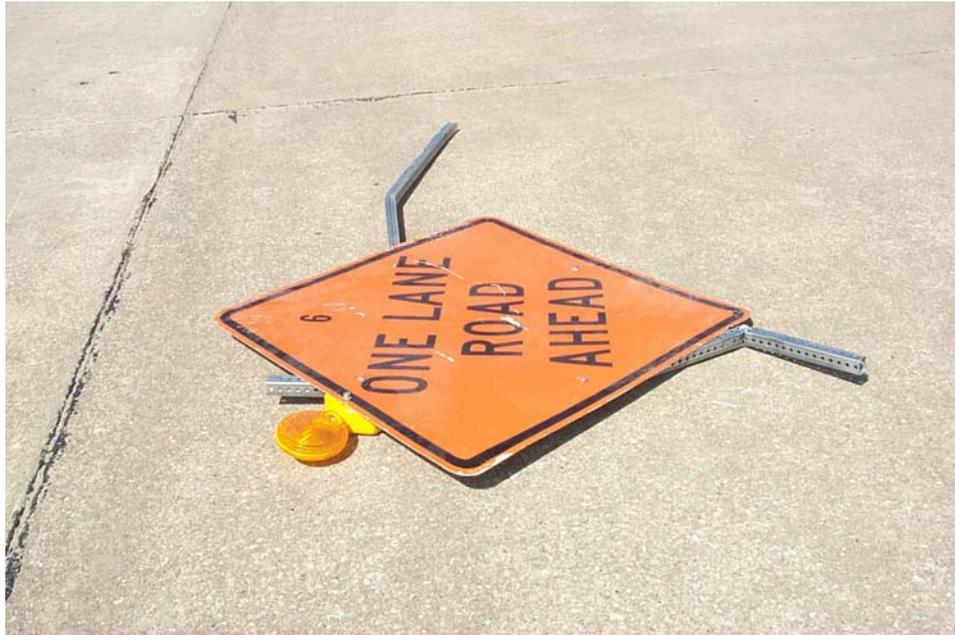
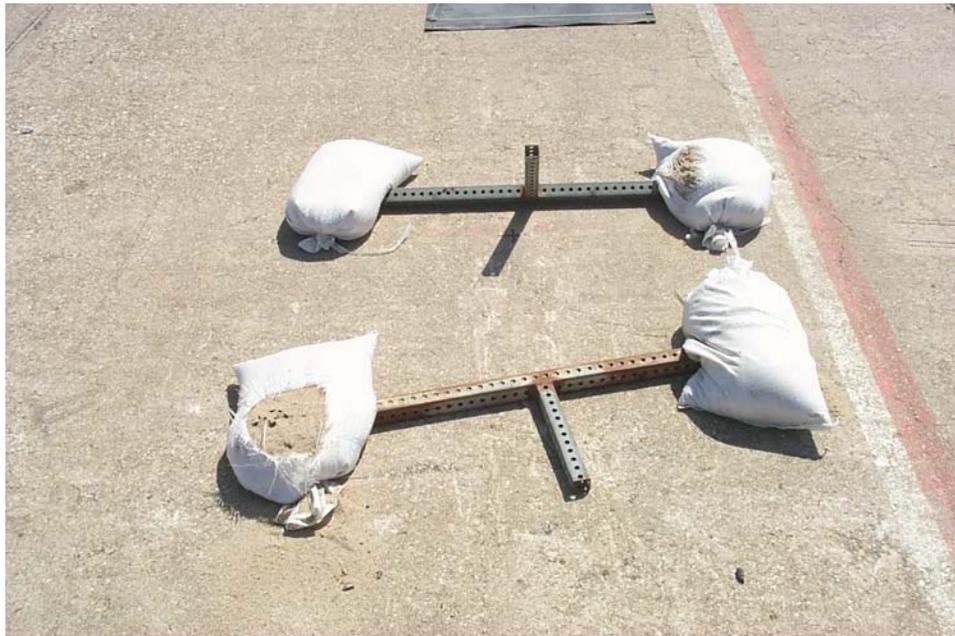
Figure 56. System No. 6 Damage, Test MNS-3

System No. 6 encountered moderate damage. Both legs disengaged from the masts but remained undamaged. The impacted mast fractured at the lower sign panel bolt but remained attached to the panel. The impacted mast also was deformed at the bumper location. The non-impacted mast fractured at and disengaged from the lower sign panel bolt. The sign panel encountered scuff and scrape marks. The warning light remained intact and attached to the sign panel. Two of the sandbags were torn open, but the sand remained in the opened bags. The other two sandbags remained undamaged.

System No. 6 was determined to be unacceptable according to the NCHRP Report No. 350 criteria. It was deemed unacceptable due to the “spider web” cracking, indentation, and hole in the windshield, resulting in obstructed driver visibility and loss of structure of both glass layers. Deformations of, or intrusion into, the occupant compartment did occur as detached elements and debris from System No. 6 penetrated the left-side windshield. The vehicle’s trajectory did not intrude into adjacent traffic lanes.

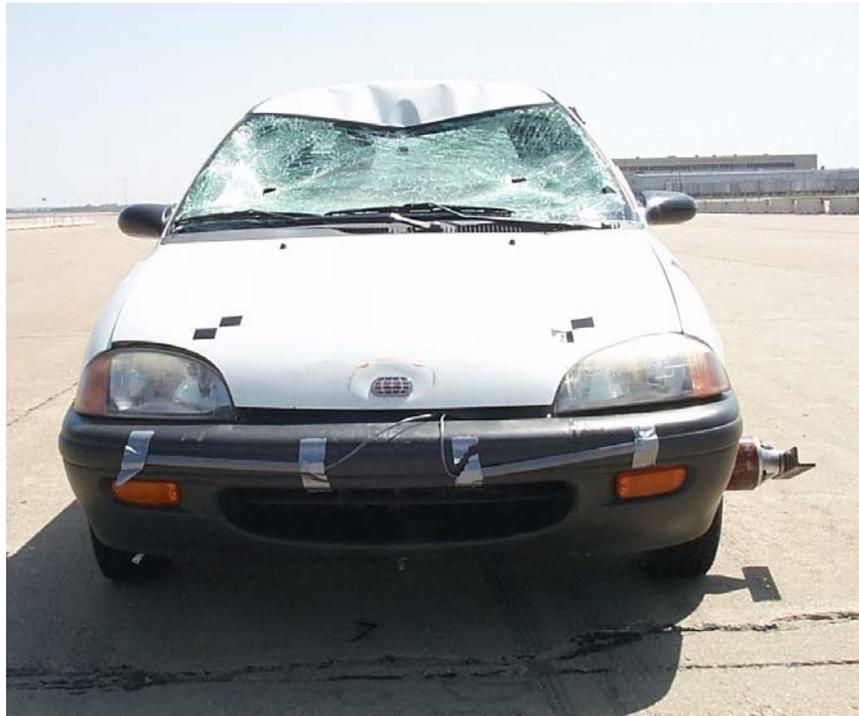
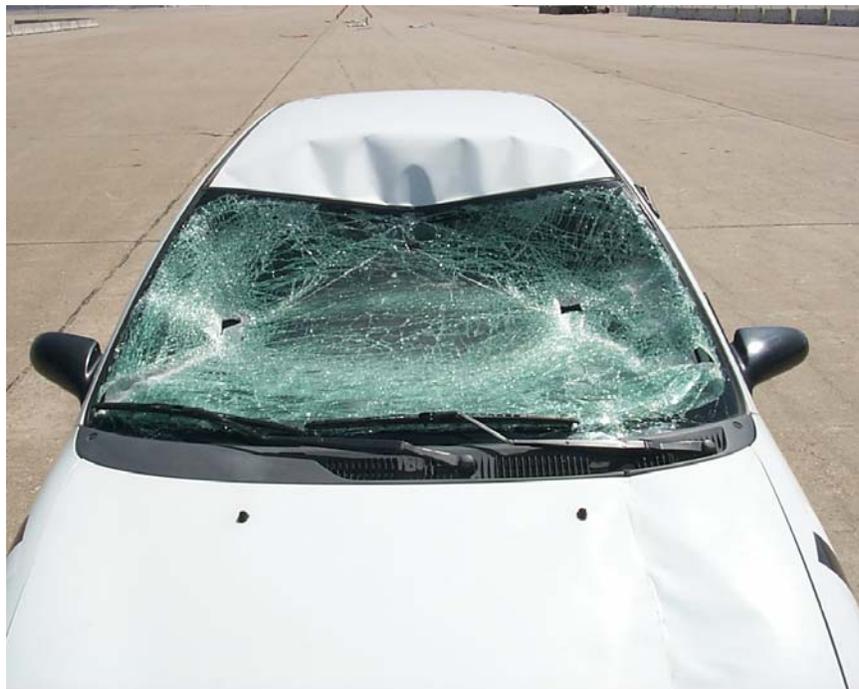
Figure 57. Vehicle Damage, Test MNS-3

Exterior vehicle damage is shown in Figures 57 and 58. The front bumper and lower plastic shield encountered contact marks. Scuff and scrape marks were also located on the front of the hood. The hood encountered a slight indentation and scrape marks along the left-side quarter point. The front of the roof was indented near the roof/windshield interface. The windshield sustained major “spider web” cracking throughout, with both layers of the windshield being cracked. Most of the structural integrity of the windshield was lost, and the windshield indented inward toward the occupant compartment. A hole through the windshield was located near the lower-left region of the windshield. Two holes through the windshield were also located at center of the windshield quarter

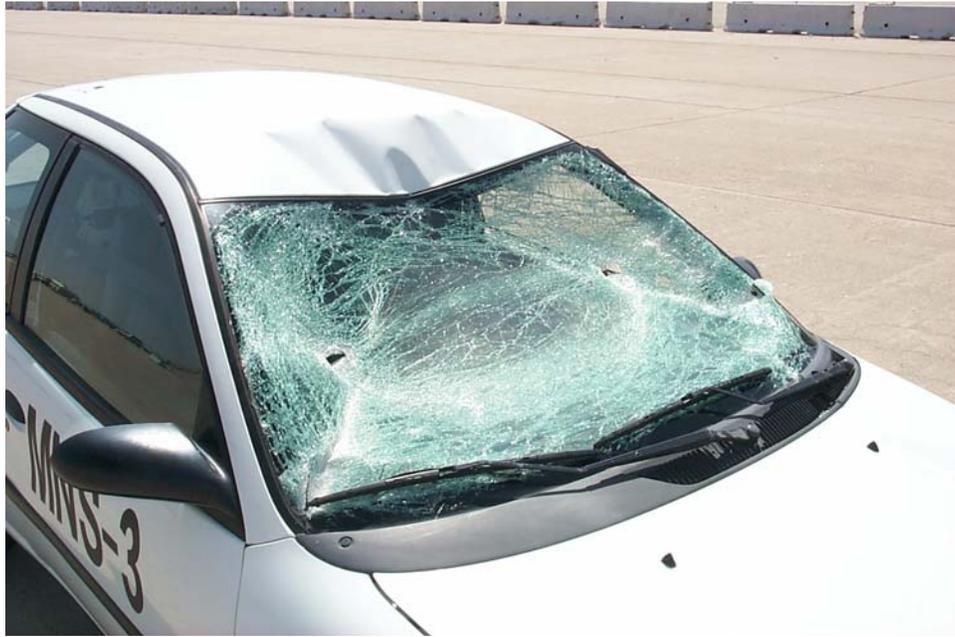
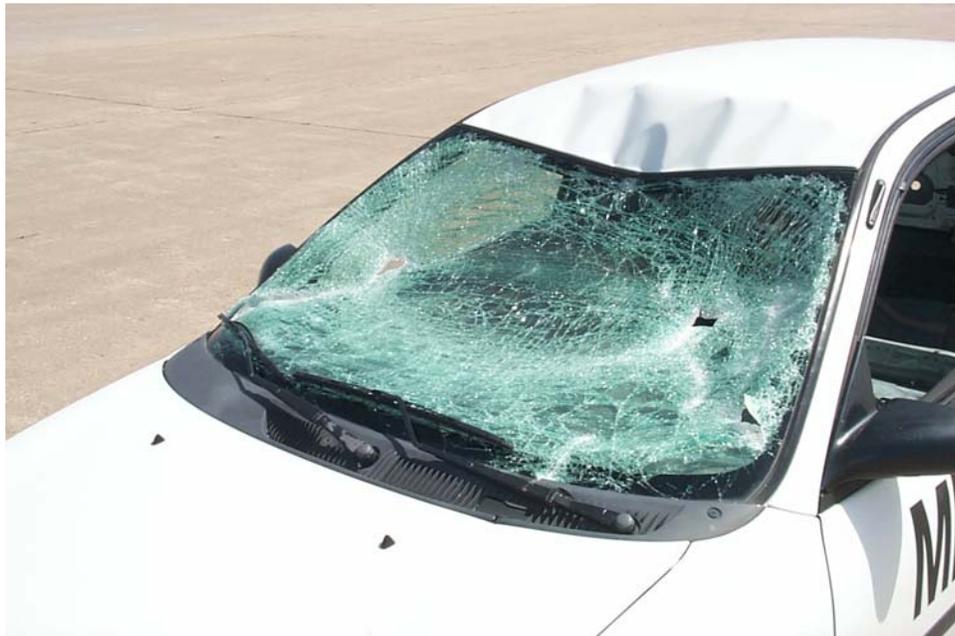
Figure 58. Windshield Damage, Test MNS-3

points. No damage was found to have occurred to the right-side, left-side, rear-end, headlights, fog lights, nor parking lights.
