**FULL-SCALE 18,000 LB. VEHICLE CRASH TEST  
ON THE  
KANSAS 32 INCH CORRAL RAIL**

Project RES1 (0099) P450  
TRANSPORTATION RESEARCH REPORT TRP-03-26-91

Midwest Roadside Safety Facility  
Civil Engineering Department  
W348 Nebraska Hall  
University of Nebraska-Lincoln  
Lincoln, Nebraska 68588-0531

July 1991

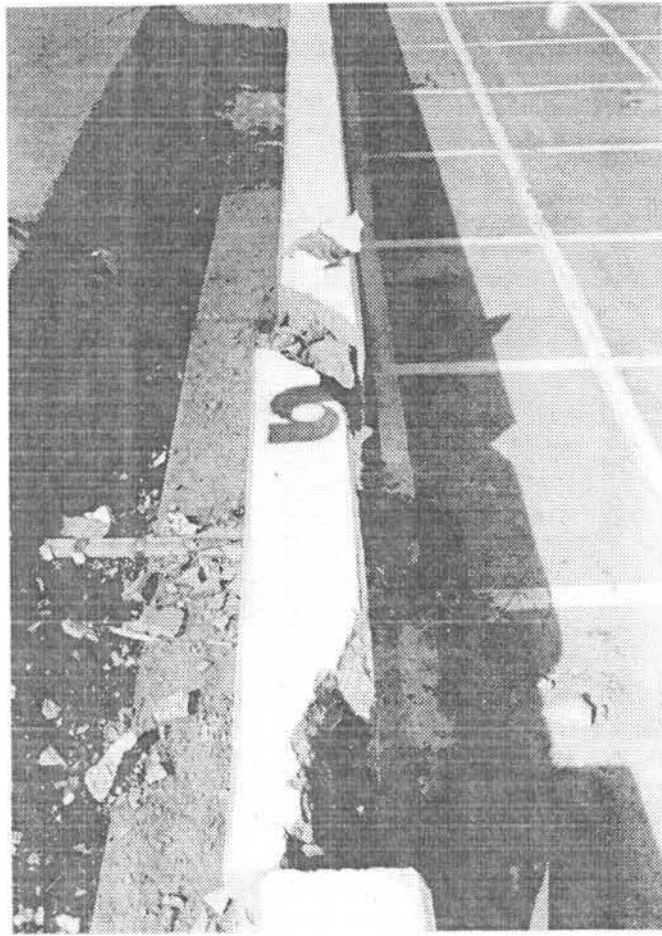
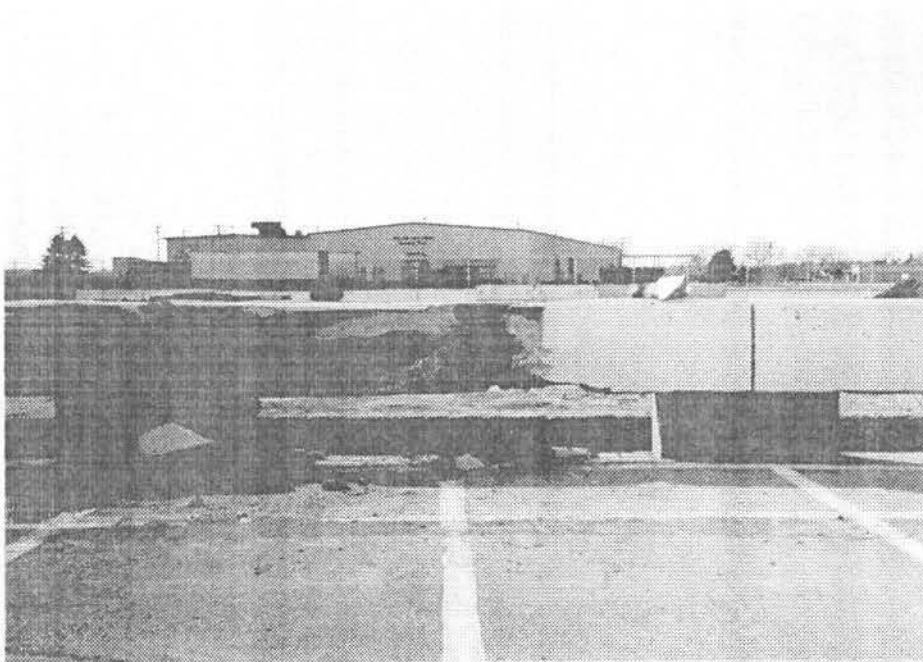
Figure 22. Rail Damage Between Posts No. 4 and No. 5

Rail damage that occurred from the full scale vehicle crash test was quite excessive. The damage that occurred at the point of impact, which was midway between posts 4 and 5, is shown in Figure 22. The total permanent set at this location was 2.5 in. A diagonal failure of the rail occurred at this point due to the impact load. The damage to the rail underneath the point of impact and on the backside of the rail is shown in Figure 23. The amount of concrete spalling underneath the rail was approximately 2 in. deep by 4 ft long.

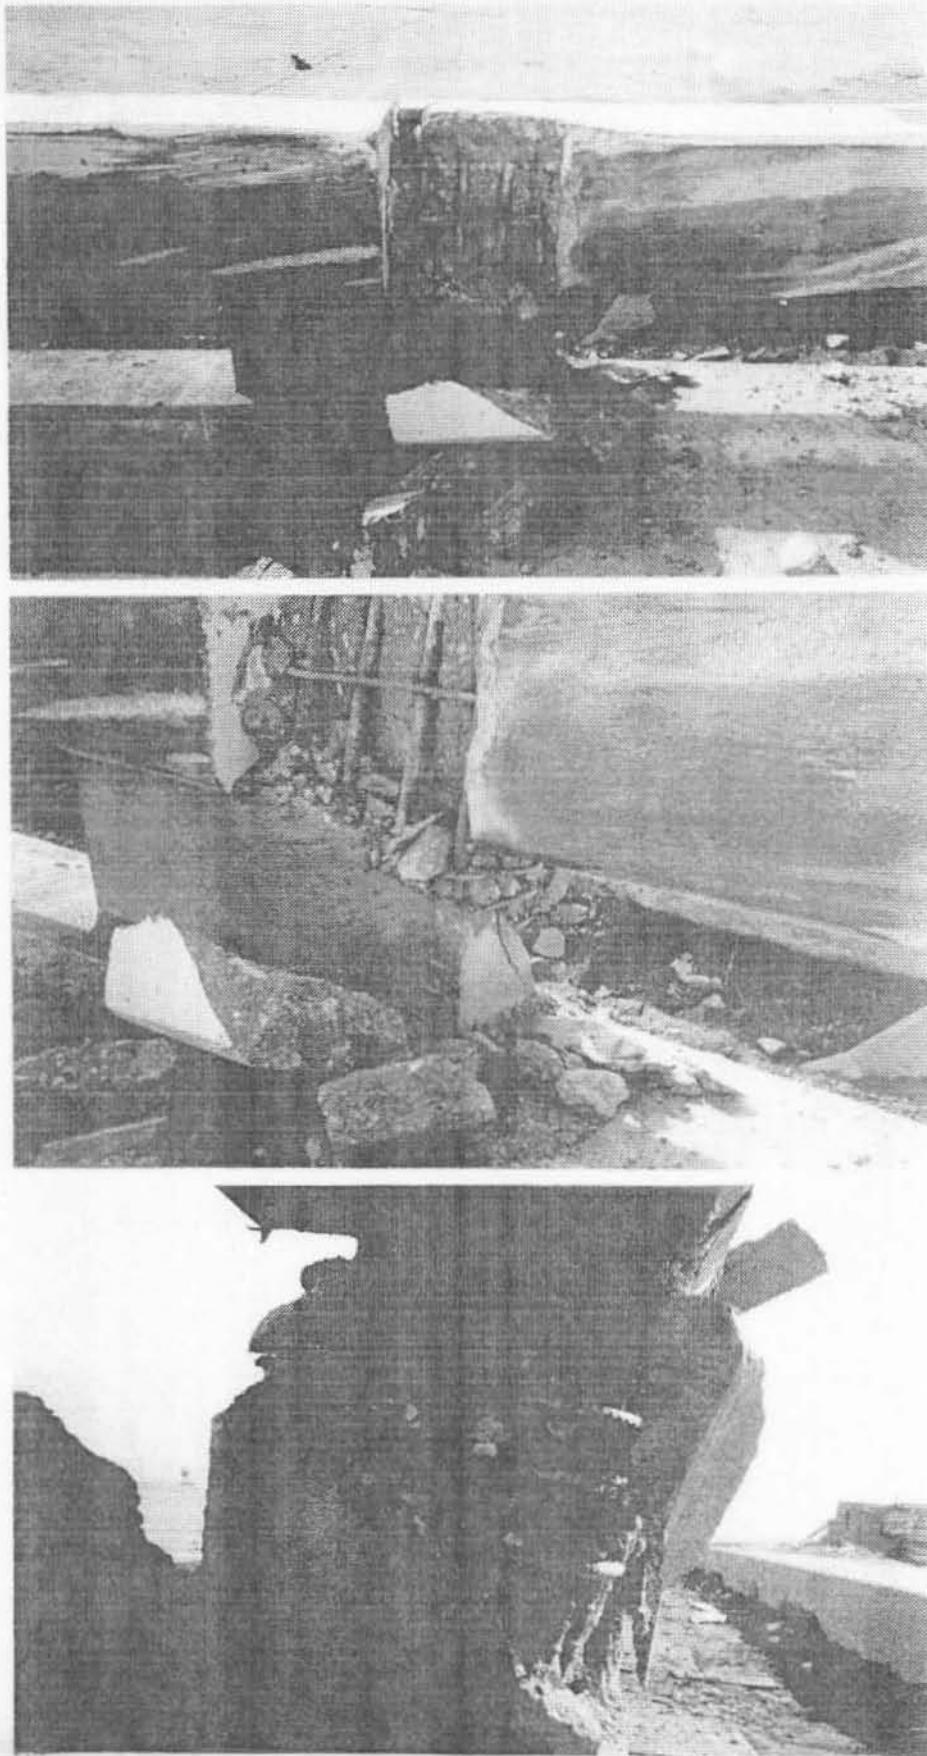
Figure 24. Rail and Post damage at Post No. 5

The other major damage occurred downstream from impact at post No. 5. Damage to the traffic face of the rail at post No. 5 is shown in Figure 24. The total amount of concrete that was removed from this failure was 18.5 in. wide, 19 in. high (entire rail height), and 5 in. deep. The same failure viewed from the backside of the rail is shown in Figure 25. This failure occurred before the gap in the rail at midpoint of Post No. 5. A vertical crack in the deck also occurred near the location of the post on the upstream end. Deck cracking also occurred at post No. 4. These deck cracks continued underneath the deck to the support.

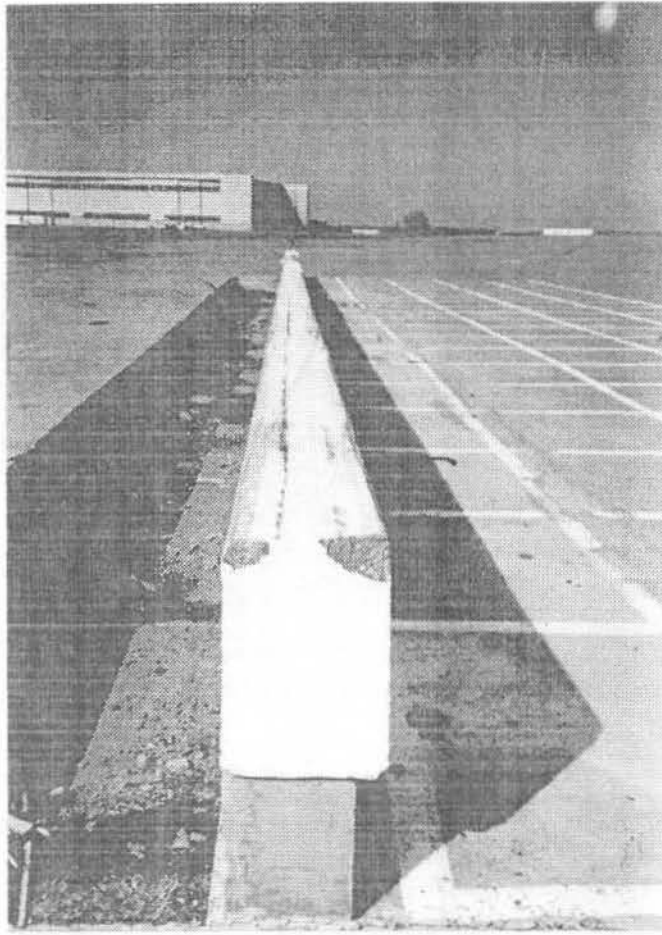
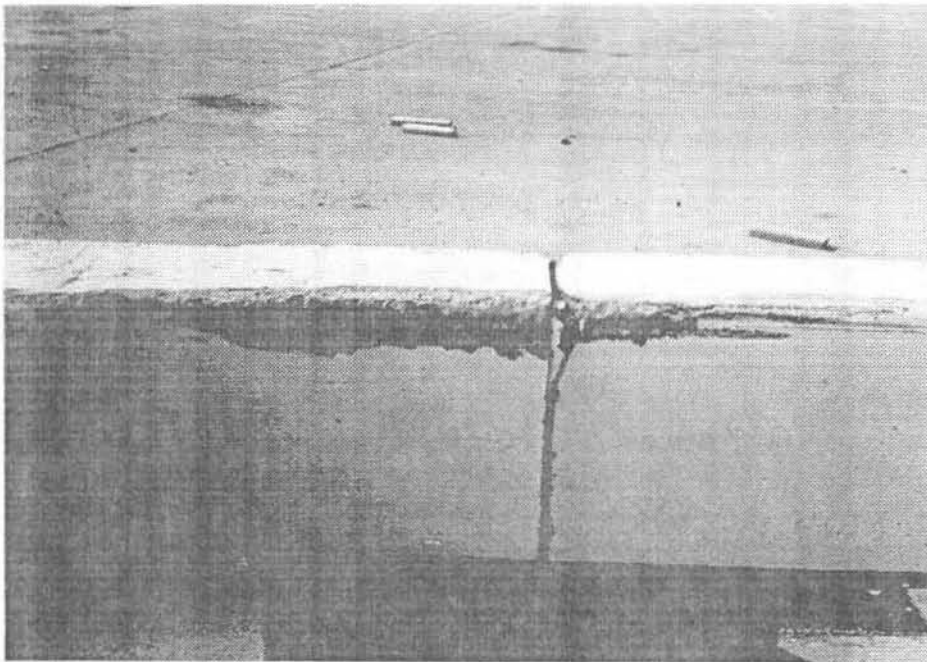
Figure 26. Damage from vehicle riding along the rail

The third major damage area resulted from the vehicle riding along the rail (Figure 26). Spalling and concrete chipping occurred continuously until the end of the rail. This damage occurred to the traffic face, the top and the back face of the rail.

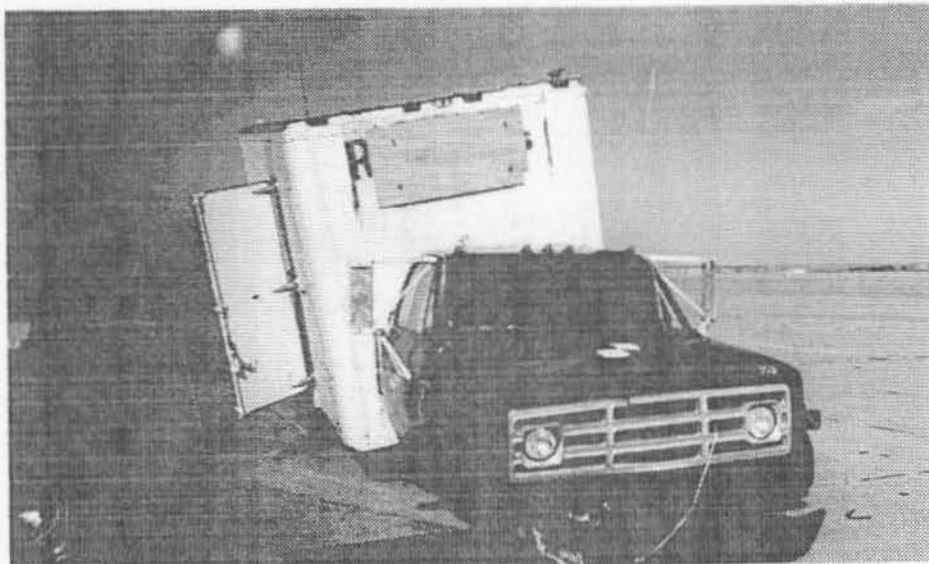
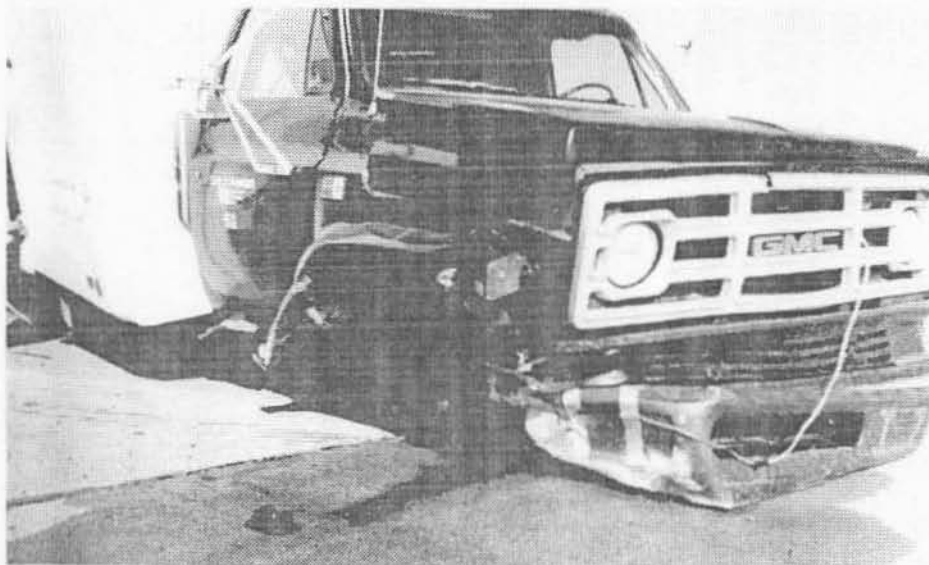
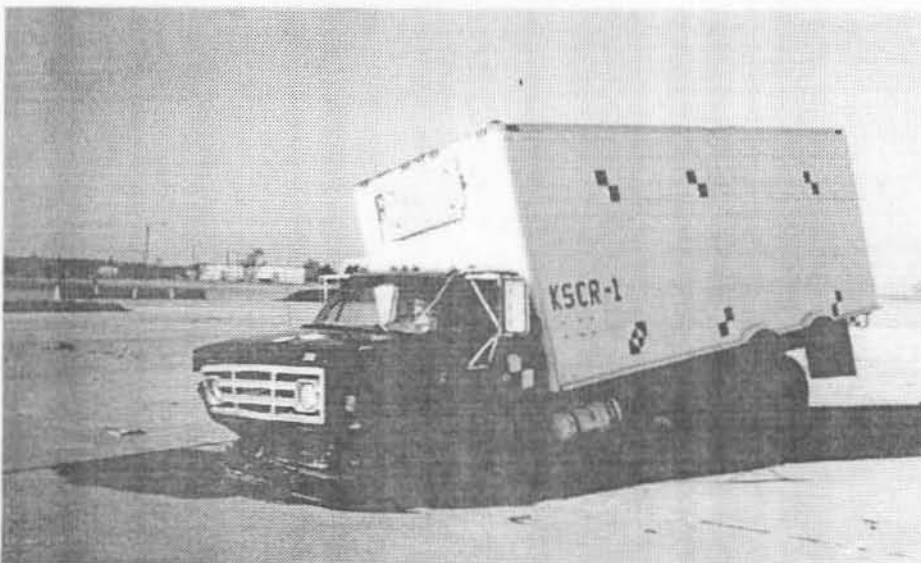
Figure 27. Vehicle Damage

The vehicle damage is shown in Figure 27. The damage included crushing of the passenger side bumper and grill. The front wheels and axle were totally removed from their original position and ended up lodged underneath the truck which may have contributed to the vehicle coming to a rest only 145 ft downstream from impact. Passenger side hood and fender damage was minimal. The TAD (5) and VDI (6) damage classifications are shown in Figure 18.
