*Midwest States Regional Pooled Fund Research Program  
Fiscal Year 2011 (Year 21)  
Research Project Number TPF-5(193) Supplemental #31  
NDOR Sponsoring Agency Code RFP-11-MGS-1*

# **MIDWEST GUARDRAIL SYSTEM (MGS) WITH SOUTHERN YELLOW PINE POSTS**

MwRSF Research Report No. TRP-03-272-13

September 4, 2013

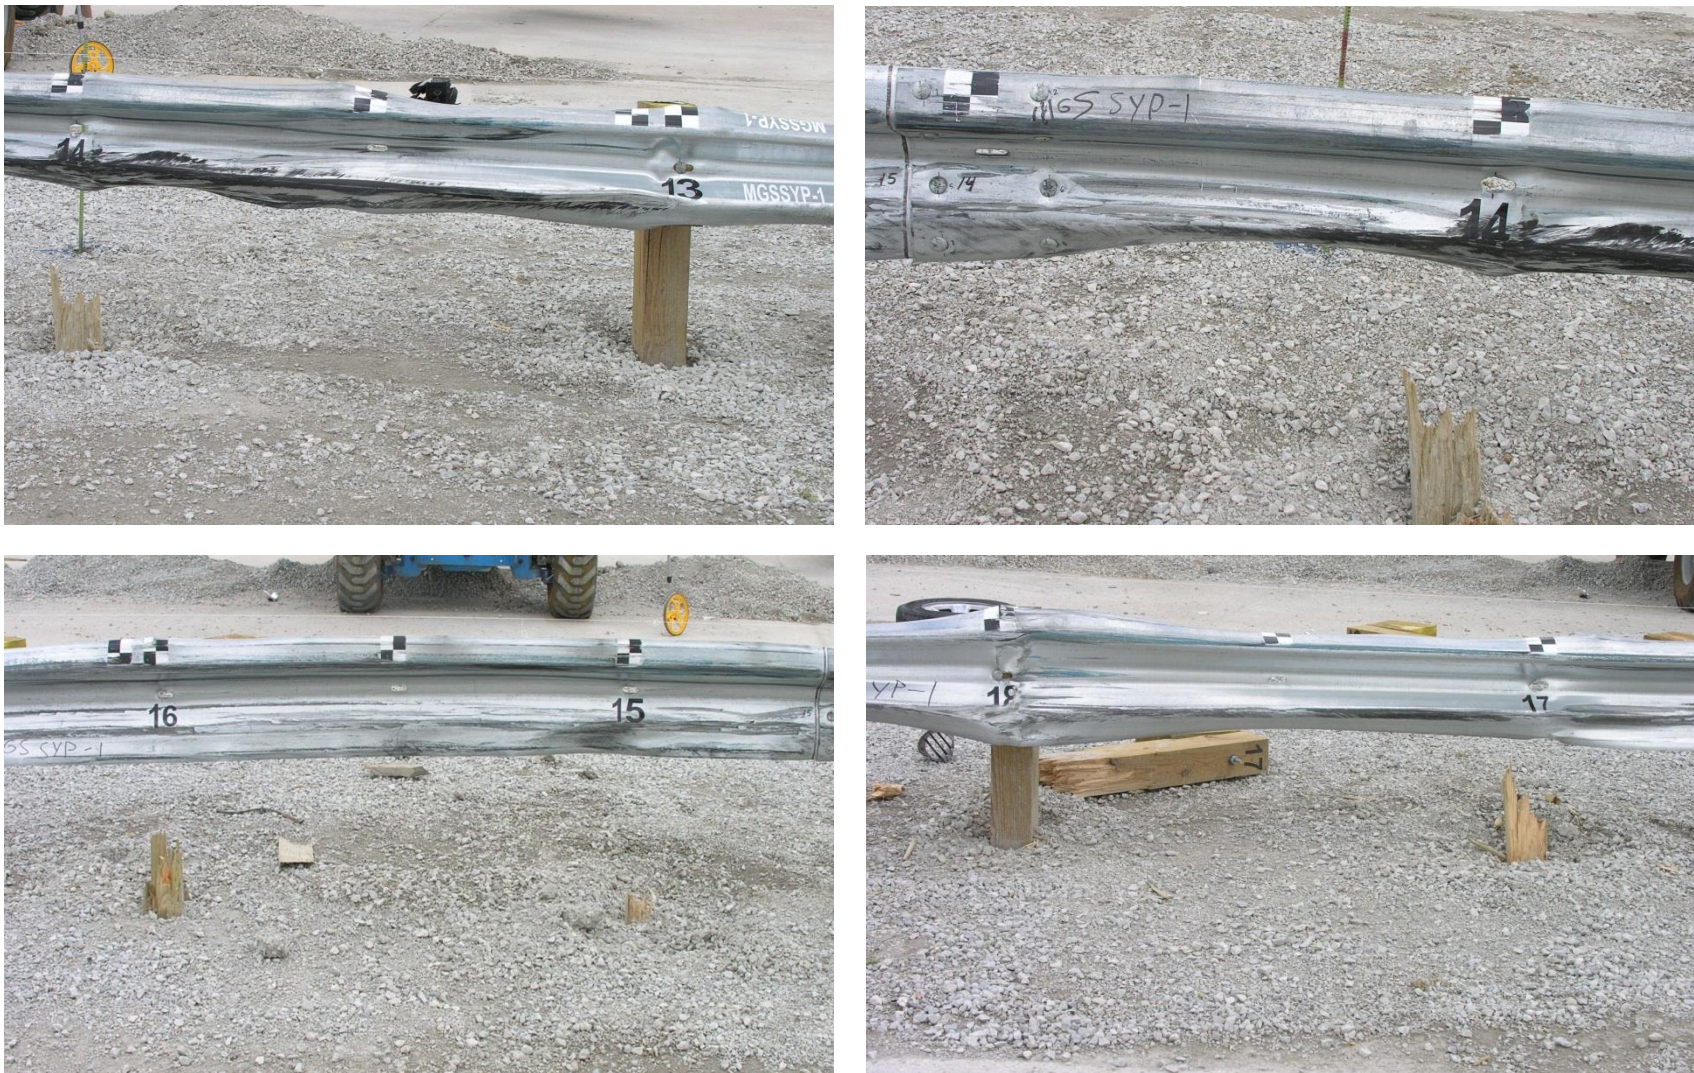
Figure 37. System Damage, Test No. MGSSYP-1

Damage to the barrier was moderate, as shown in Figures 37 through 38 . Barrier damage consisted of deformed guardrail, fractured posts, and contact marks on the front face of the W-beam guardrail. The length of vehicle contact along the barrier was approximately 34 ft – 4 in. (10.5 m) which spanned from 4 in. (102 mm) upstream of the centerline of post no. 13 and extended to 33 in. (838 mm) downstream of post no. 18.

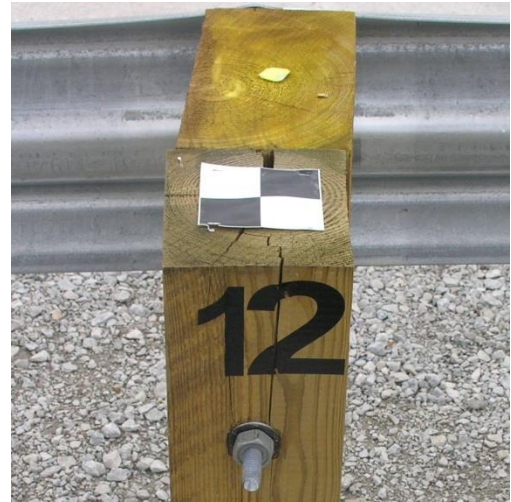
Figure 39. Post Nos. 6 and 10 Damage, Test No. MGSSYP-1

Damage to the posts began at post no. 6, which split on the front face downstream corner. Post no. 10 split at the center of the top of the post from the front to the back. This split started at the top of the post and extended 8½ in. (216 mm) down the post. Post no. 11 split at the center of the post from the front to the back. The split started at the top of the post and extended to the groundline. Post nos. 12 and 13 rotated backwards and split at the center of the post from the front of the post to the back of the post. The splits on both posts started at the top of the post and continued to the groundline. Post nos. 14 through 17 were fractured at the groundline. Post no. 14 came to rest 9 ft – 6 in. (2,896 mm) behind the barrier. Post no. 15 came to rest 9 ft – 3 in. (2,819 mm) behind the barrier. Post no. 16 came to rest 14 ft – 6 in. (4,420 mm) behind the barrier. Post no. 17 came to rest 1 ft – 1 in. (330 mm) behind the barrier. Tire contact marks were found 21 in. (533 mm) down from the top of the front face of post no. 14. Post no. 16 was split into 3 pieces due to contact with the vehicle, and contact marks were also found on the front face of the post. Soil gaps, heaves, and craters can be found in Table 5.

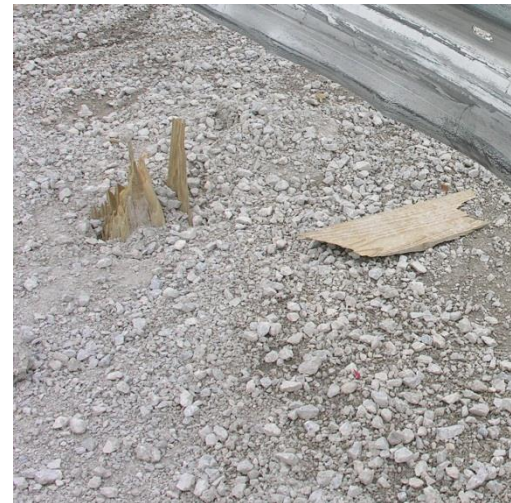
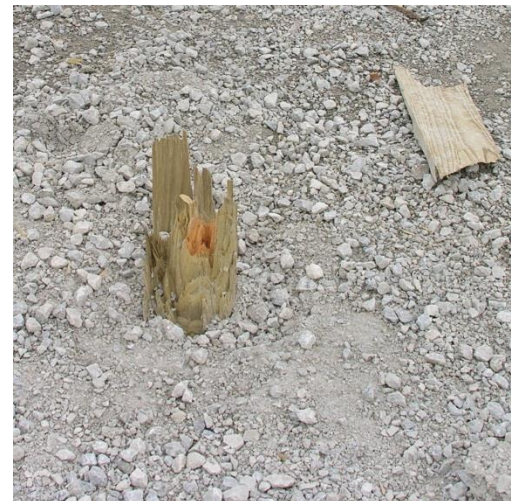
Figure 41. Post Nos. 13 and 14 Damage, Test No. MGSSYP-1

0.080	Post no. 14 began to fracture.
0.095	The posts upstream of impact rotated toward impact point, and right-front wheel snagged on post no. 14 and disengaged from vehicle.

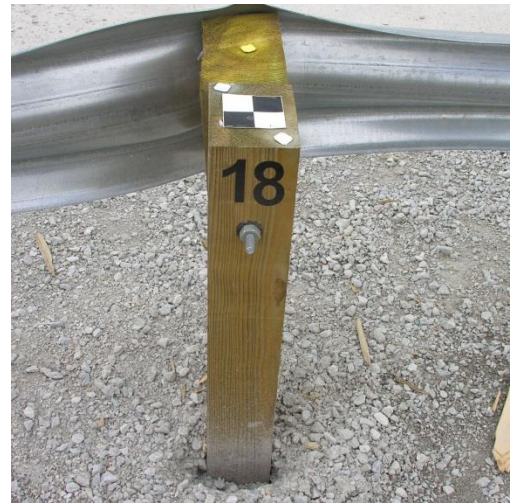
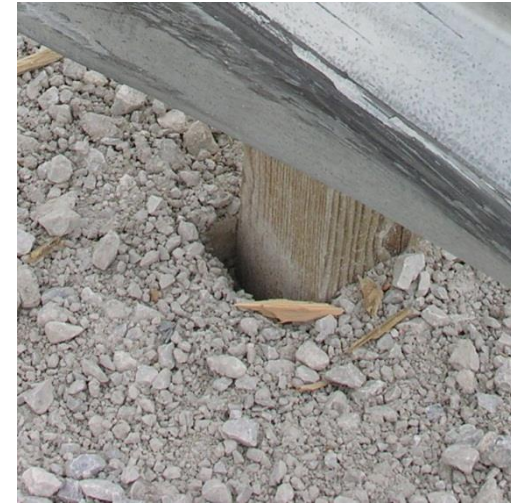
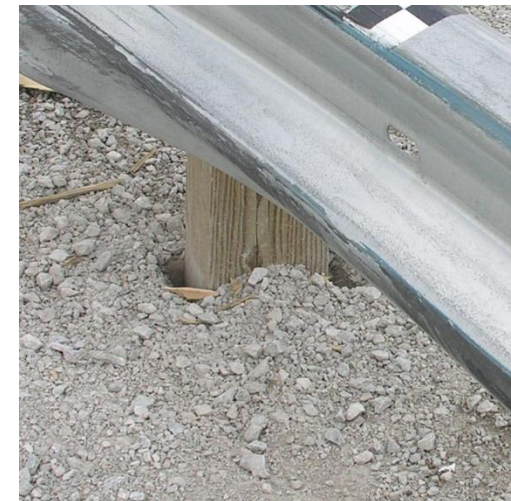
Figure 42. Post Nos. 15 and 16 Damage, Test No. MGSSYP-1

0.100	Post no. 15 fractured.
0.112	The rail released from post no. 15.
0.118	A kink formed in rail downstream of post no. 16, post no. 16 fractured approximately 1 ft (305 mm) above ground level, and right-front door of vehicle became slightly ajar.

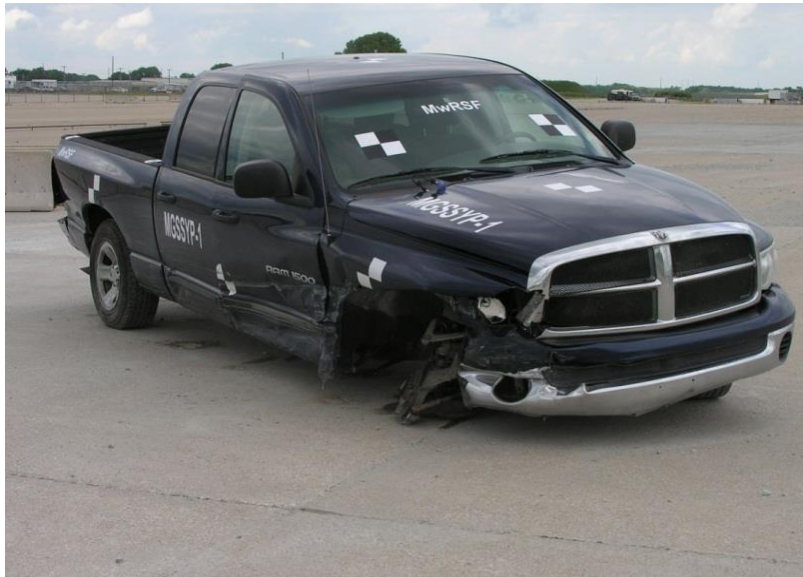
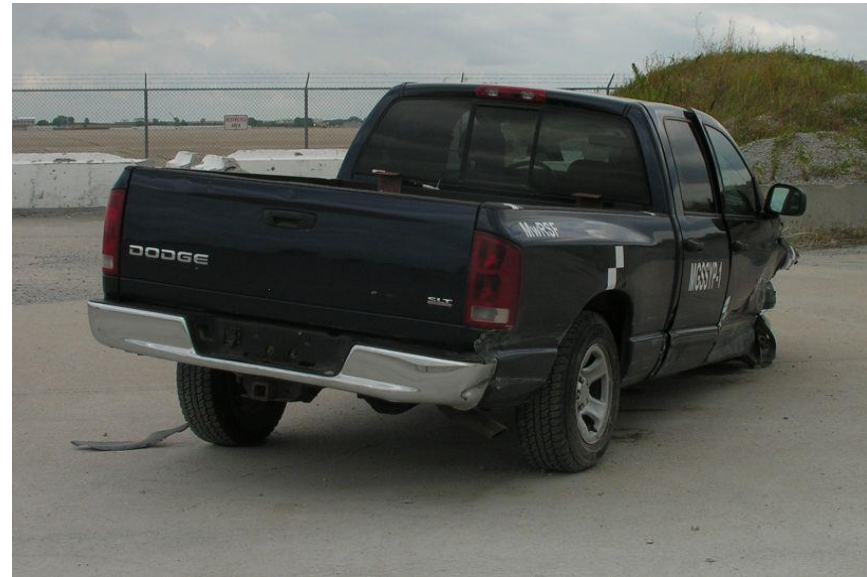
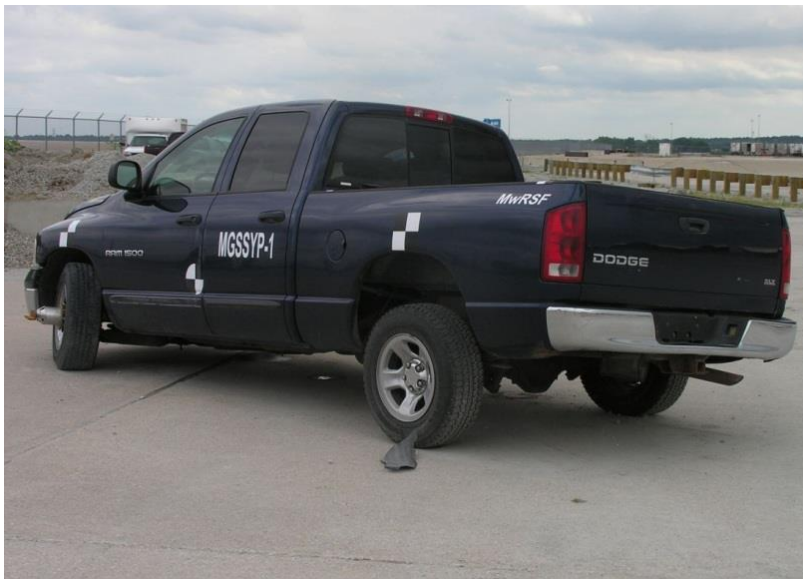
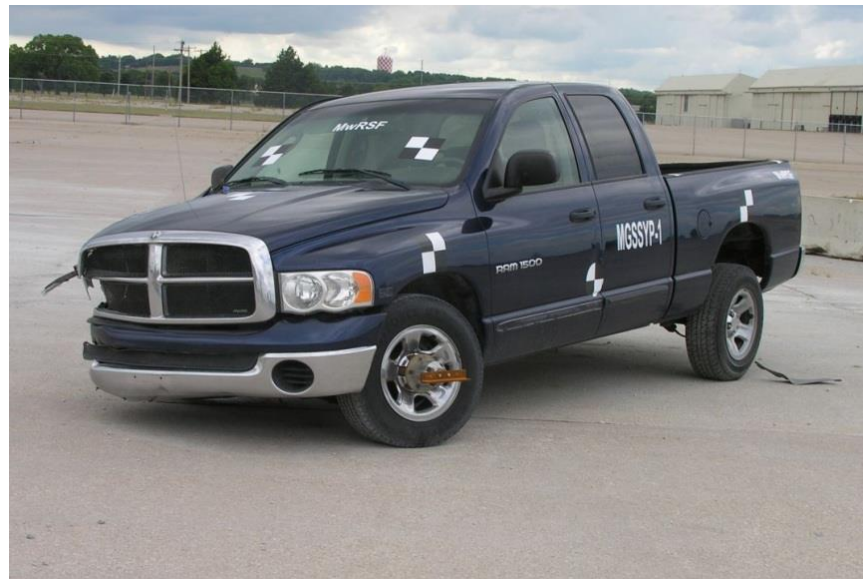
Figure 47. Vehicle Damage, Test No. MGSSYP-1

The majority of the damage was concentrated on the right-front corner and right side of the vehicle where the impact occurred. The front bumper was bent on the right lower side approximately 8 in. (203 mm) from the centerline of the vehicle. There was also a kink on the top of the front bumper approximately 19 in. (483 mm) from the centerline of the vehicle. There were contact marks on the right side of the front bumper cover. The front bumper cover also had a 5-in. (127-mm) tear along the right quarter panel. The grill of the vehicle was deformed backward 2½ in. (64 mm) on the bottom right side. The right quarter panel was folded inward 7 in. (178 mm). The right headlight fractured, and the right-front tire detached from the vehicle at the wheel bearing. The right-front upper control arm and disc brake assembly detached. Contact marks extended the entire length of the right side of the vehicle. Both of the doors on the right side were slightly ajar. The top of the right-front door separated 1 in. (25 mm) from the cab of the vehicle, while the bottom of the right rear door separated ¾ in. (19 mm) from the cab. The right-front door also had flattening that extended the entire length of the door 17 in. (432 mm) up from the bottom of the door. The right-rear door had contact marks that extended the length of the door. Flattening occurred at the bottom of the door and at the rear corner of the cab. The right

side of the rear bumper was flattened and had a kink 12 in. (305 mm) from the right fender. The right-rear taillight separated approximately 2½ in. (64) mm from the fender. A 35 in. (889 mm) long crack was found down the center of the windshield.

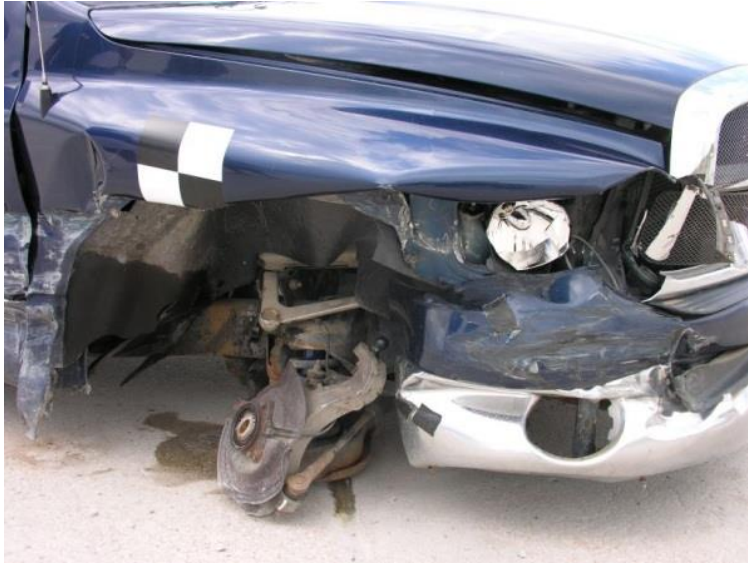
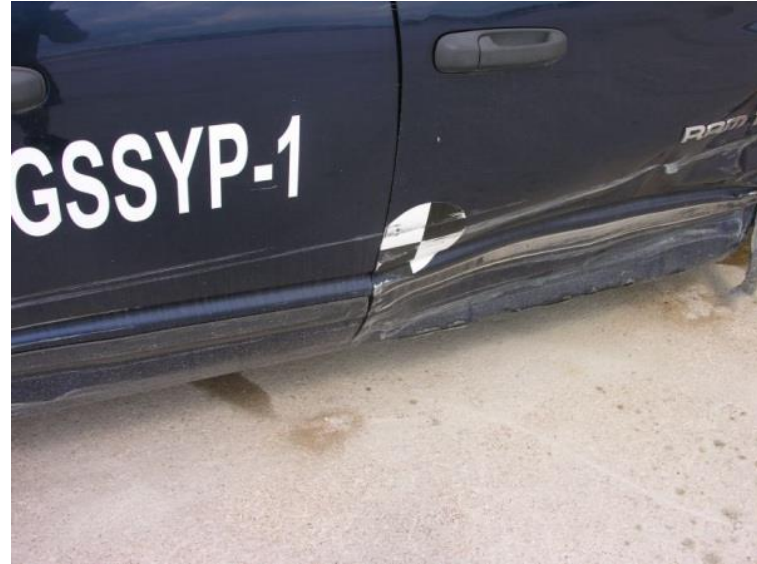
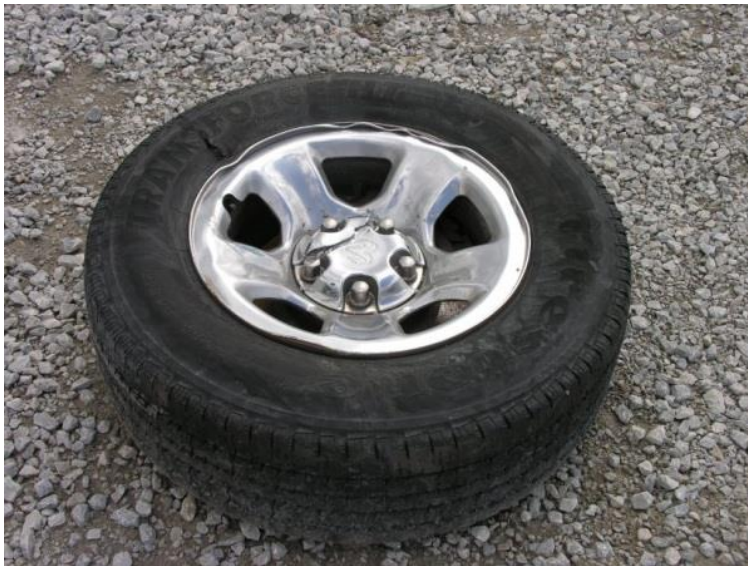
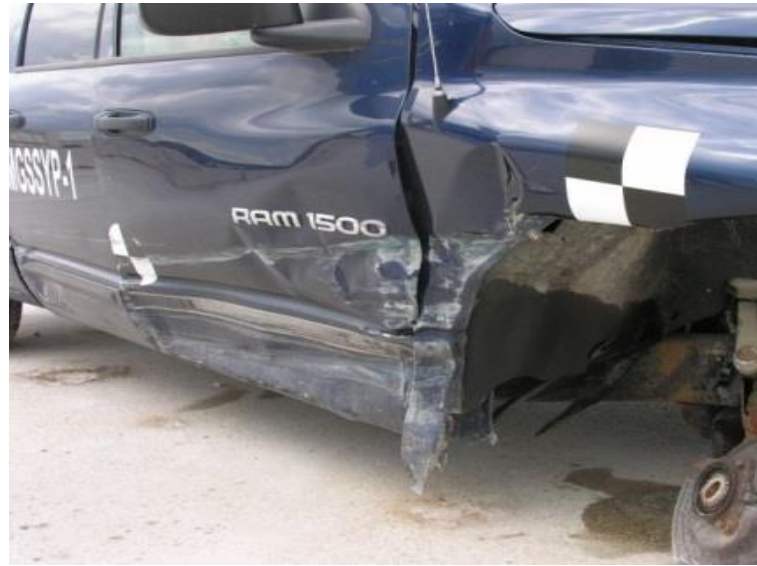
Figure 48. Vehicle Damage, Test No. MGSSYP-1

The damage to the vehicle was minimal, as shown in Figures 47 and 48. The maximum occupant compartment deformations are listed in Table 6 along with the deformation limits established in MASH for various areas of the occupant compartment. Note that none of the MASH established deformation limits were violated. Complete occupant compartment and vehicle deformations and the corresponding locations are provided in Appendix D.

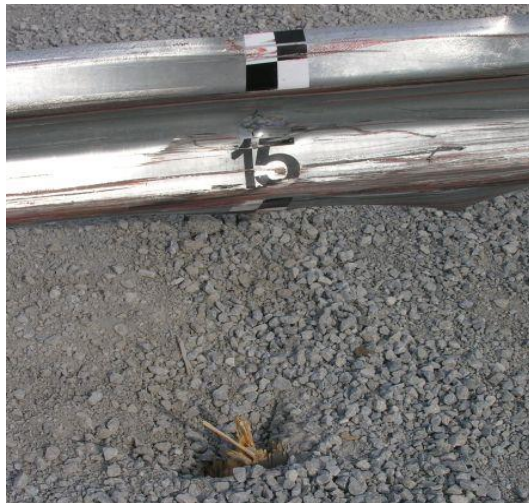
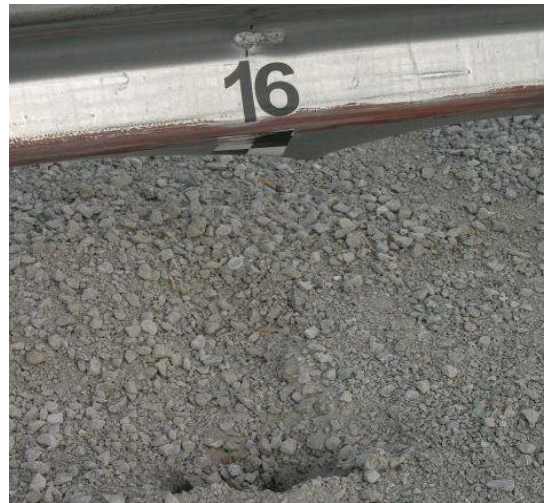
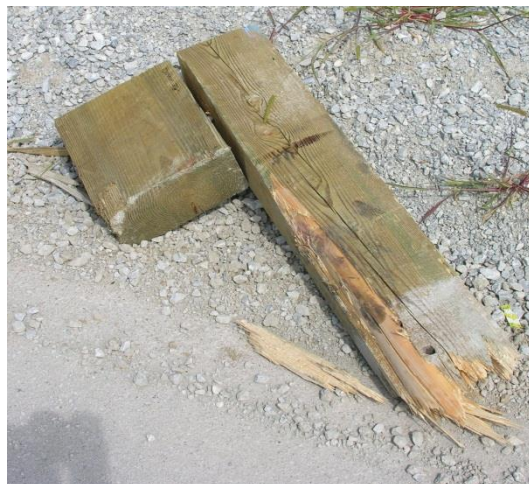
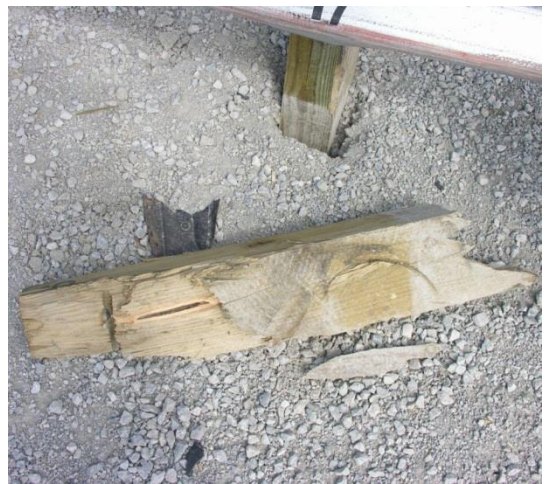
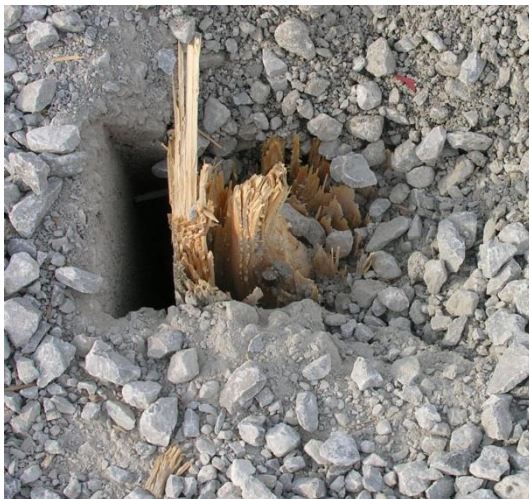
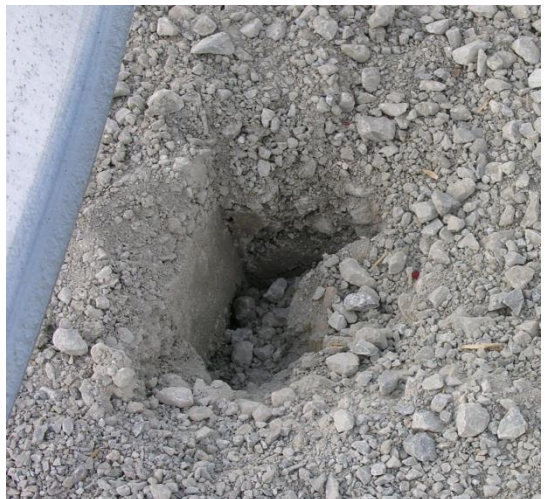
Figure 58. Post Nos. 15 and 16 Damage, Test No. MGSSYP-2

0.194	The right-front tire impacted post no. 16, causing it to split vertically and fracture near groundline.
0.222	The blockout of post no. 16 detached from post no. 16
