DYNAMIC EVALUATION OF MGS STIFFNESS TRANSITION WITH CURB

MIDWEST ROADSIDE SAFETY FACILITY

MwRSF Research Report No. TRP-03-291-14

June 30, 2014

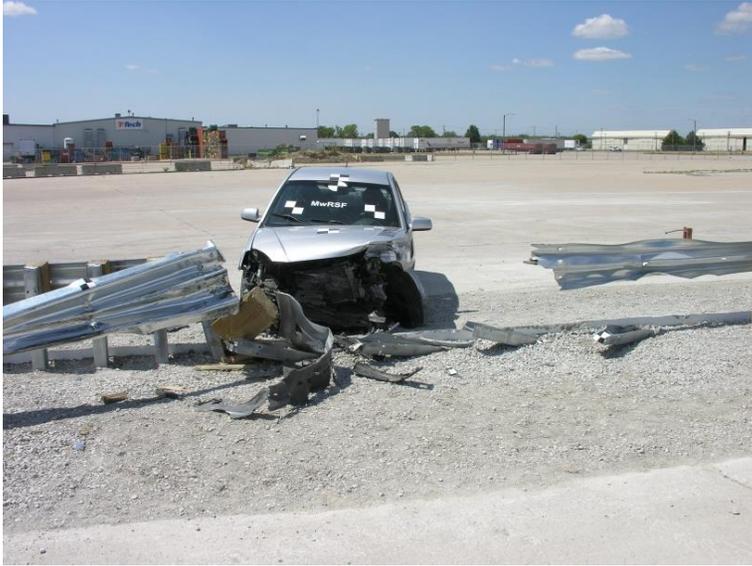
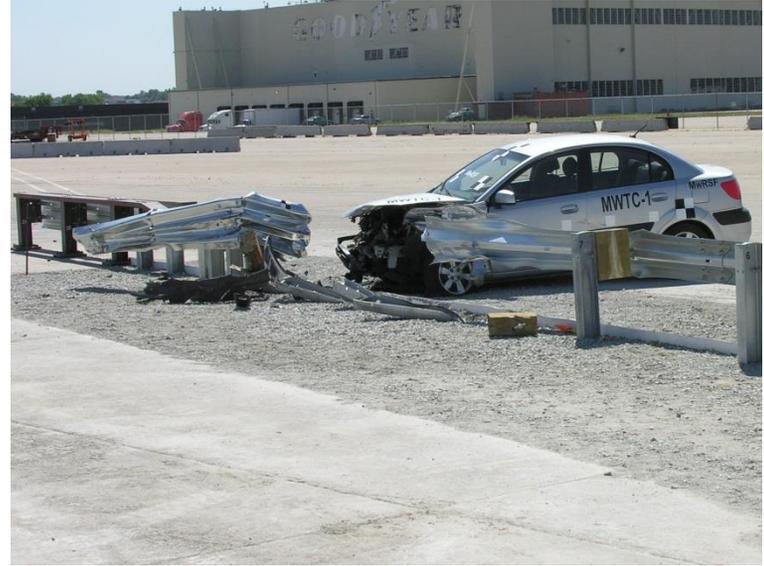
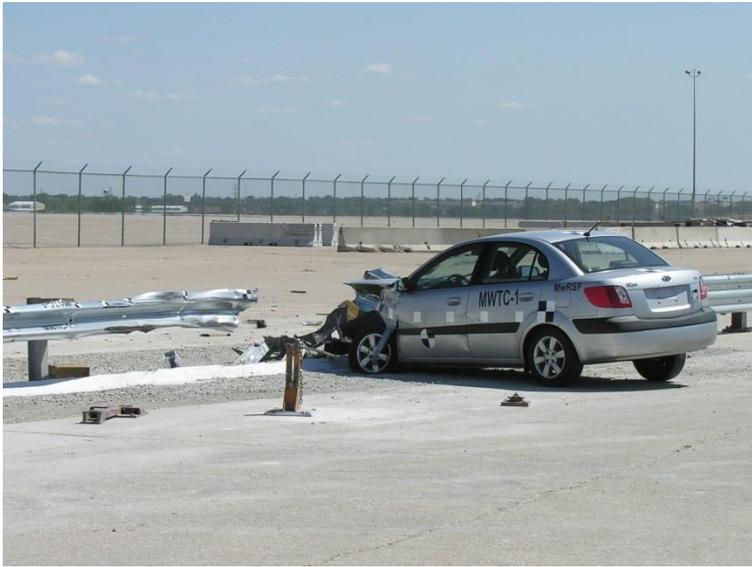
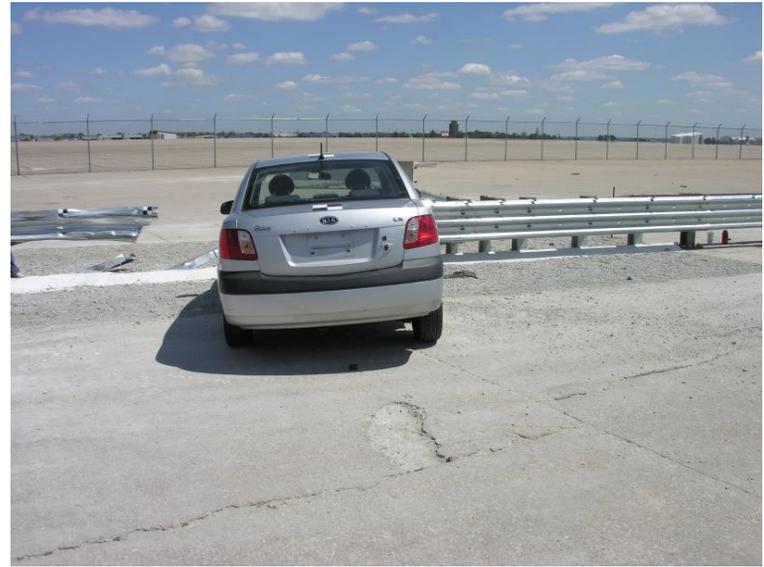
Figure 50. System Damage, Test No. MWTC-1

Damage to the barrier was severe, as shown in Figures 50 through 52. System damage consisted of deformed guardrail and posts, displaced soil, fractured wooden spacer blockouts, contact marks, and W-beam rail rupture. The length of vehicle contact along the barrier was approximately 17.5 ft (5.3 m), which spanned from 14¾ in. (375 mm) downstream of post no. 7 to post no. 12.

Rail deformation first occurred with a buckle in the guardrail 4 in. (102 mm) upstream of post no. 7. Contact marks on the rail began 4 in. (102 mm) upstream from targeted impact and extended until post no. 12. Rail flattening occurred from 18 in. (457 mm) upstream of post no. 8 and extended to downstream of post no. 9. The bottom corrugation of the W-to-thrie transition segment folded up from post no. 9 through 11 in. (279 mm) downstream of post no. 10. Two 90 degree buckles were found in the thrie beam rail adjacent to the W-to-thrie transition segment. The first was just downstream of post no. 11 and the second was at post no. 12. A 1½-in. (38-mm) vertical tear occurred at the bottom post bolt at post no. 12. There were also several kinks in the rail throughout the impact region.

A 6-in. (152-mm) long gouge was found on top of the curb beginning 27 in. (686 mm) upstream of post no. 8. Gouging also occurred at the top of the curb beginning 23 in. (584 mm) upstream of centerline of post no. 9 and extending to 2 in. (51 mm) downstream from the center line of post no. 11.

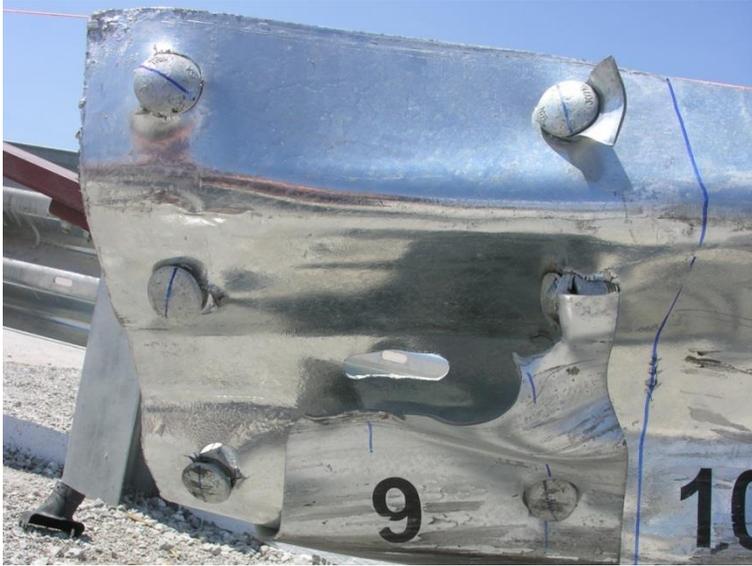
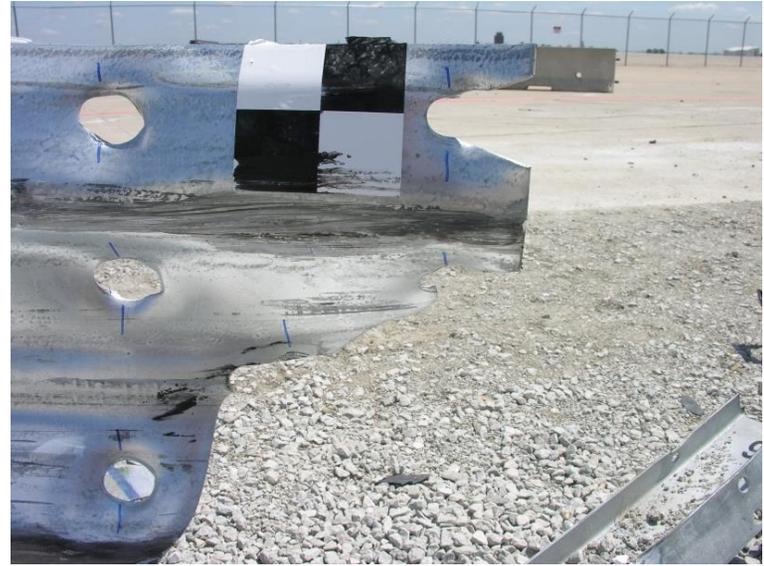
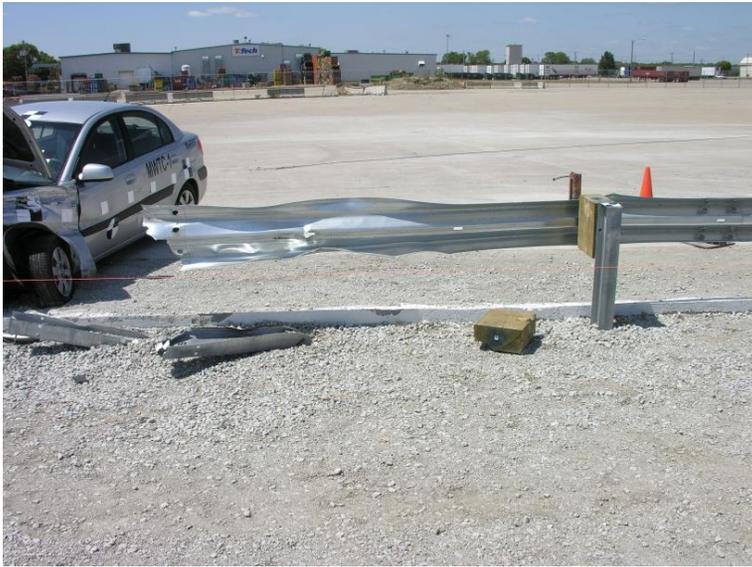
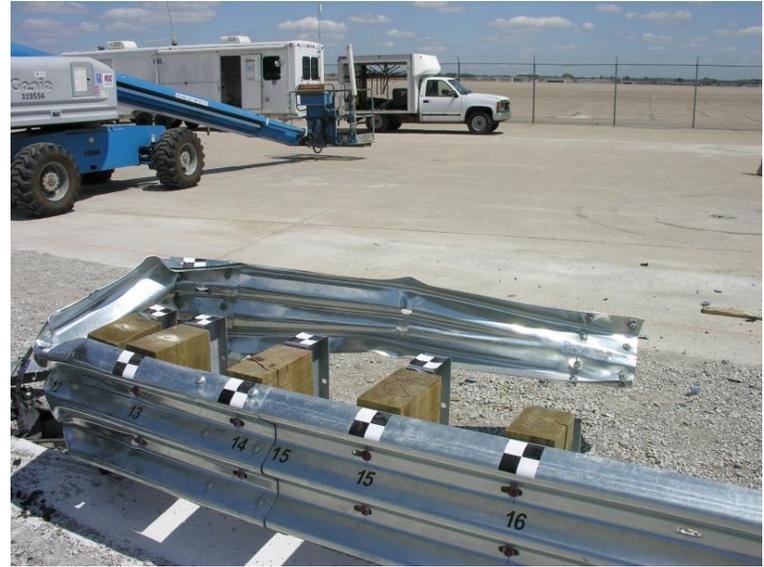
Figure 51. Rail Pocketing and Rupture, Test No. MWTC-1

0.118	W-beam guardrail ruptured at splice to W-to-thrie transition segment, at post no. 9.
0.134	The vehicle's front bumper was detached and the vehicle pitched downward.

The 12-gauge (2.66-mm thick) W-beam rail ruptured at the splice at post no. 9 with all bolts remaining on the downstream end of the ruptured rail or on the 10 gauge (3.42-mm thick) W-to-thrie transition element, as shown in Figure 51. The guardrail tore from the top, downstream corner of the splice diagonally to the bottom, upstream corner. The downstream edge of the W-beam remained attached to the W-to-thrie transition segment. The downstream end of rail folded back and behind the system at post no. 12.

Due to the rail rupture and subsequent system failure experienced during test no. MWTC-1, design modifications were required to strengthen the rail near the upstream end of the asymmetrical transition element. Thus, an additional 12-gauge (2.66-mm thick) W-beam segment was incorporated into the system such that 12.5 ft (3.8 m) of nested W-beam guardrail preceded the 10-gauge (3.42-mm thick) W-to-thrie transition segment. This minor modification was believed to be sufficient to prevent rail rupture observed during a small car impact just upstream from the asymmetrical element and in combination with a concrete curb.

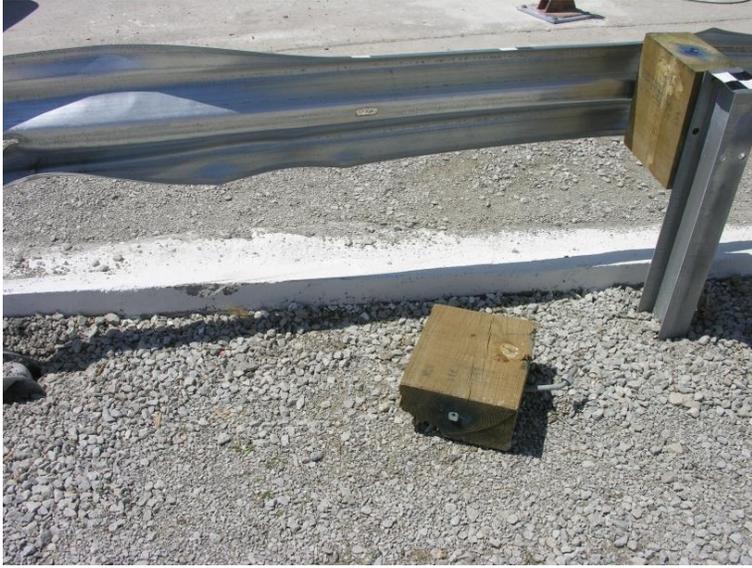
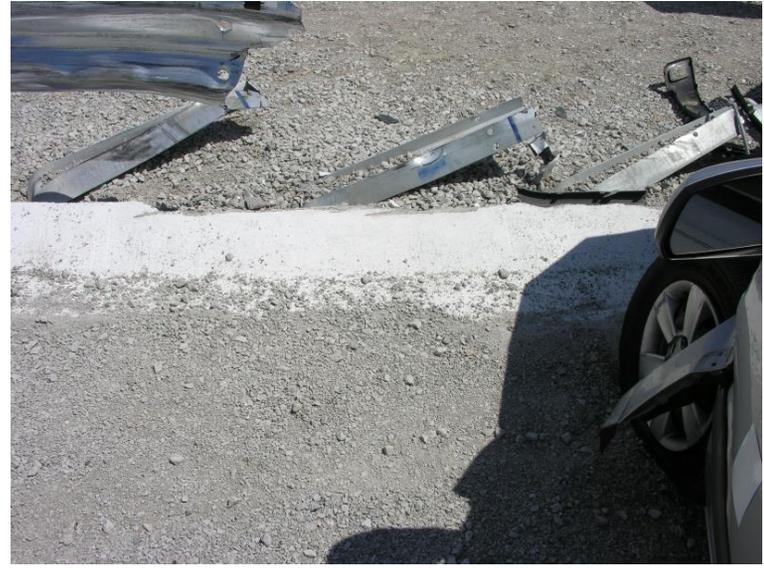
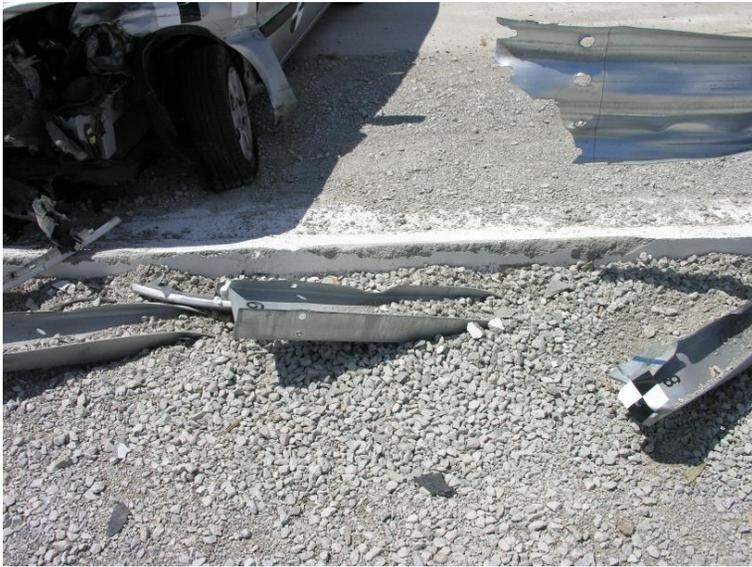
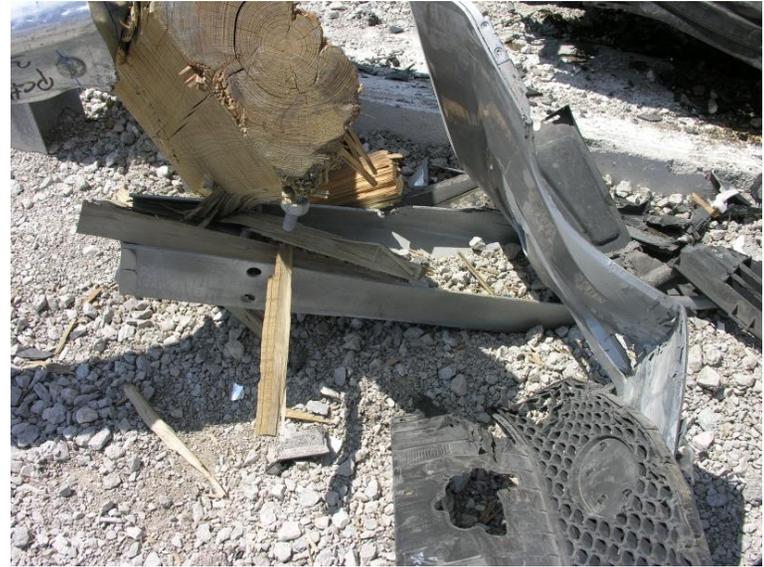
Figure 52. Post Deflection, Test No. MWTC-1

blockouts at post nos. 5, 13, 16, and 17 were split. The blockouts were disengaged from post nos. 8, 9, and 10. The blockout of post no. 11 had gouging and multiple fractures, while the upstream face of the blockout at post no. 12 fractured at the bottom bolt location.

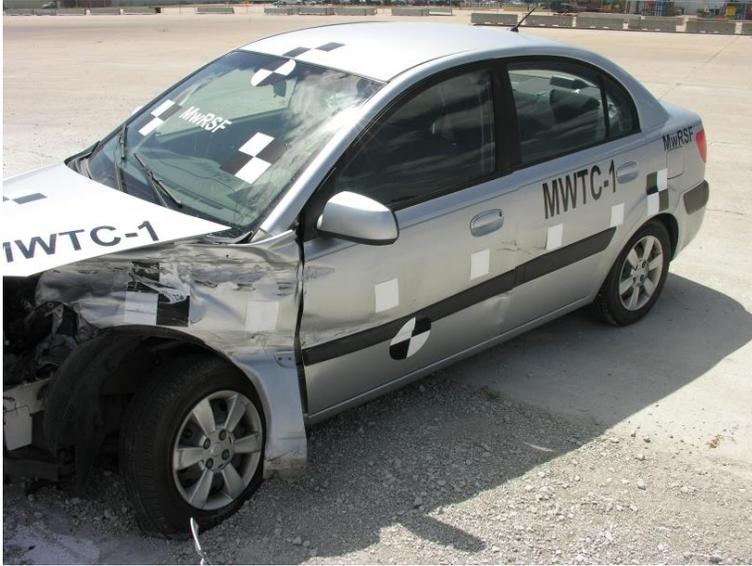
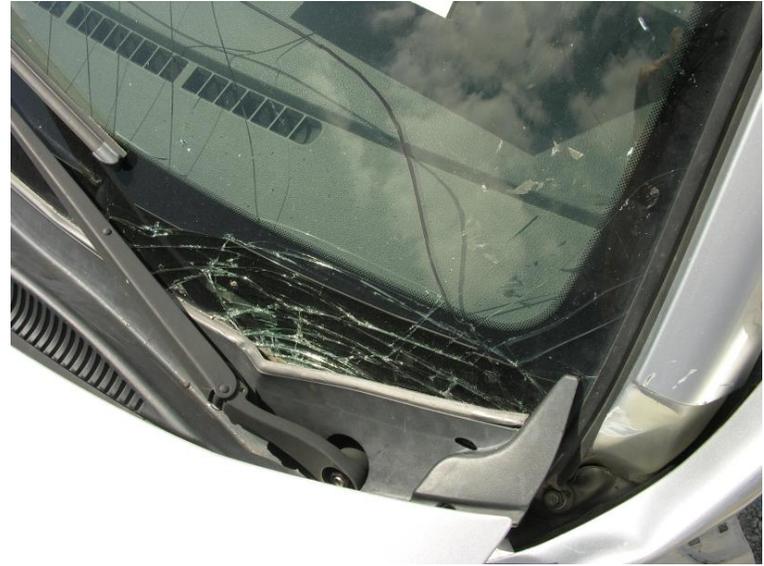
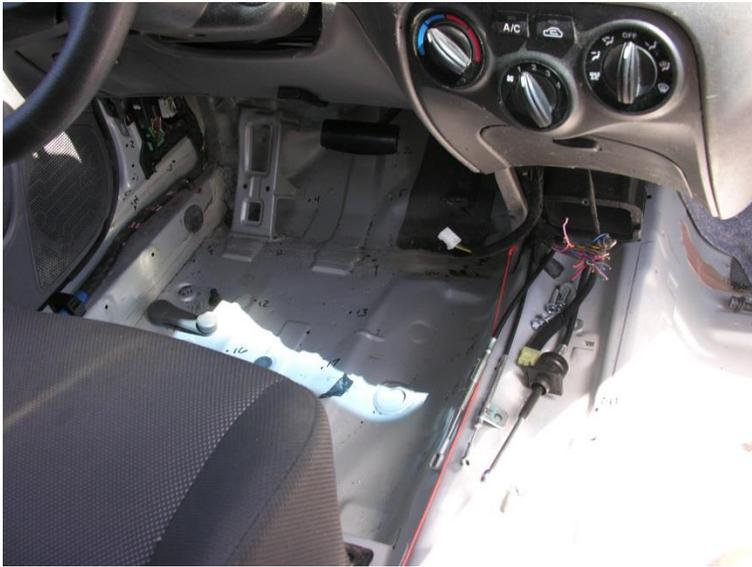
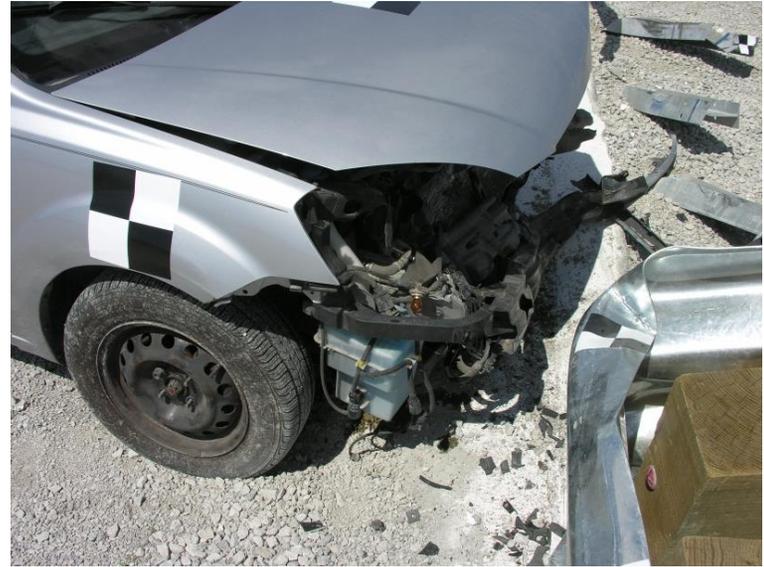
Figure 53. Vehicle Damage, Test No. MWTC-1

The damage to the vehicle was moderate with most of the damage occurring on the left side of the vehicle, as shown in Figure 53. The maximum occupant compartment deformations are listed in Table 5 along with the deformation limits established in MASH for various areas of the occupant compartment. Note that none of the MASH established deformation limits were violated. Complete occupant compartment and vehicle deformations and the corresponding locations are provided in Appendix D.

On the left side of the vehicle, a 20-in. (508-mm) long scrape was found across both doors. A 22-in. (559-mm) long dent was found on the vehicle's fender and left-front door. The fender was crushed inward and backward at the top, with the bottom of the fender pulled out and away from the door. The left-front tire was torn, and the tire was deflated. The left-front wheel well was partially disengaged. The left-front lower control arm was damaged and both the radiator and left headlight crushed inward. A 3-in. (76-mm) vertical gap was found between the fender and hood.

The front bumper and bumper cover were dented and disengaged on the left side. The left-front corner of the hood folded under and the engine cover split. Also, minor spider web cracking occurred in the lower-left corner of the windshield.

On the right side of the car, the top frame around the radiator bent inward. The right bumper frame deflected backward, and the right headlight disengaged. After the vehicle came to rest, fluid leaked under the right-front corner of the vehicle.

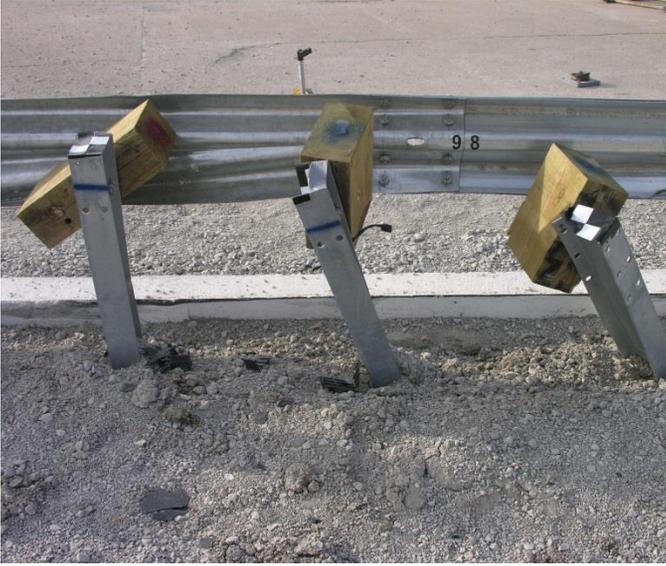
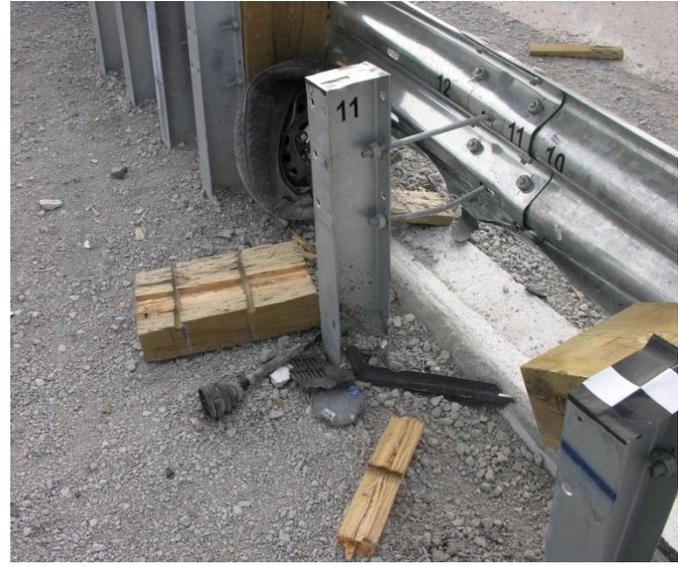
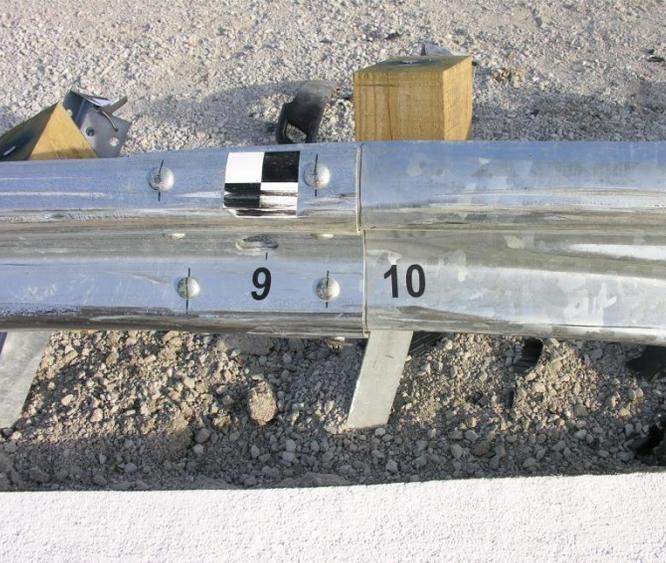
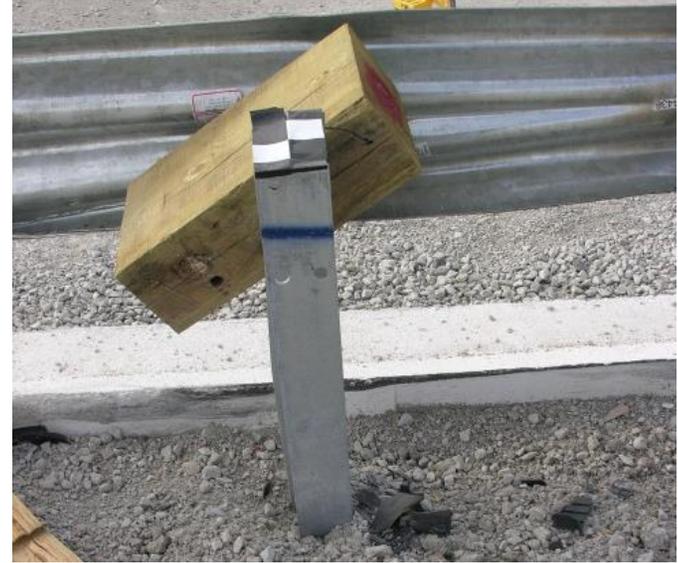
Figure 91. Post and Blockout System Damage, Test No. MWTC-2

0.230	The blockout at post no. 11 fractured.
0.240	The vehicle's right-rear tire was airborne.
0.242	Vehicle's front bumper even with post no. 13, and vehicle nearly parallel with system.
