MASH TEST NOS. 3-17 AND 3-11 ON A NON-PROPRIETARY CABLE MEDIAN BARRIER

MIDWEST ROADSIDE SAFETY FACILITY

MwRSF Research Report No. TRP-03-303-15

November 3, 2015

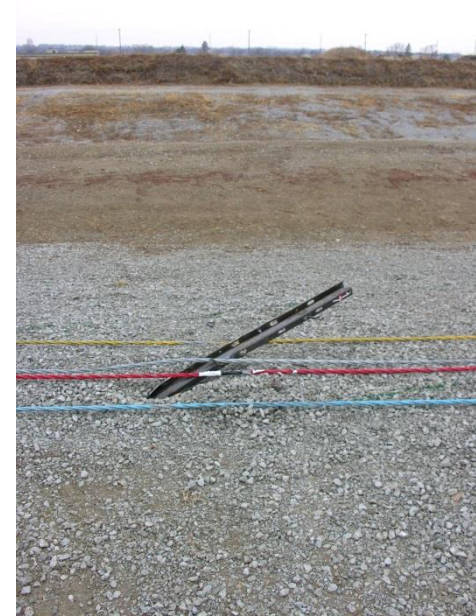
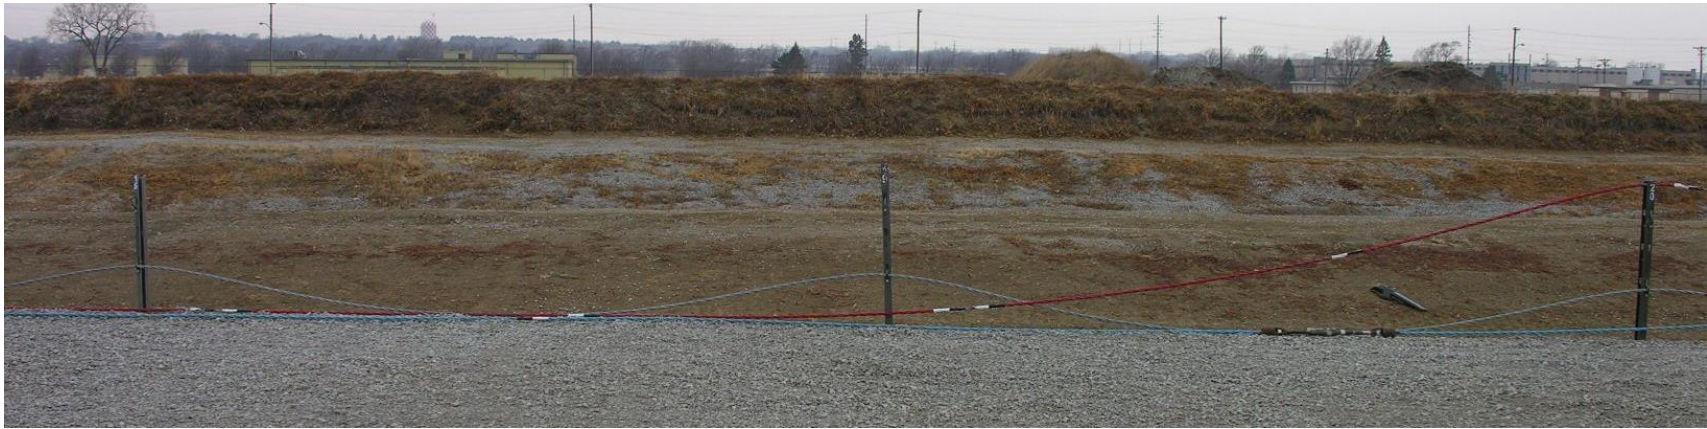
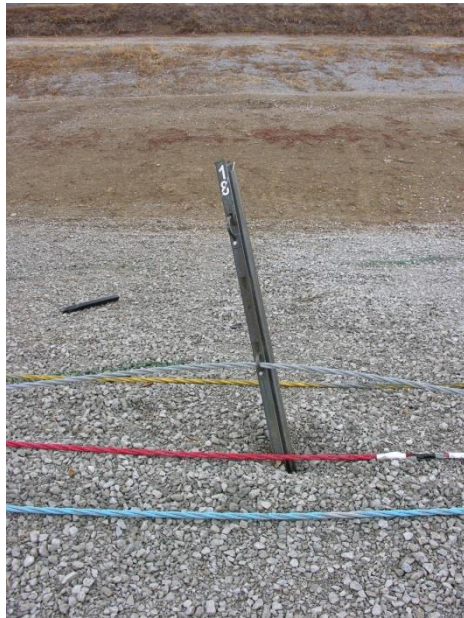
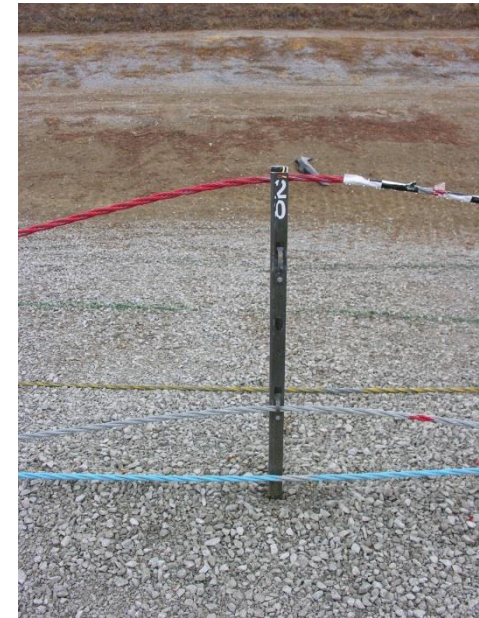
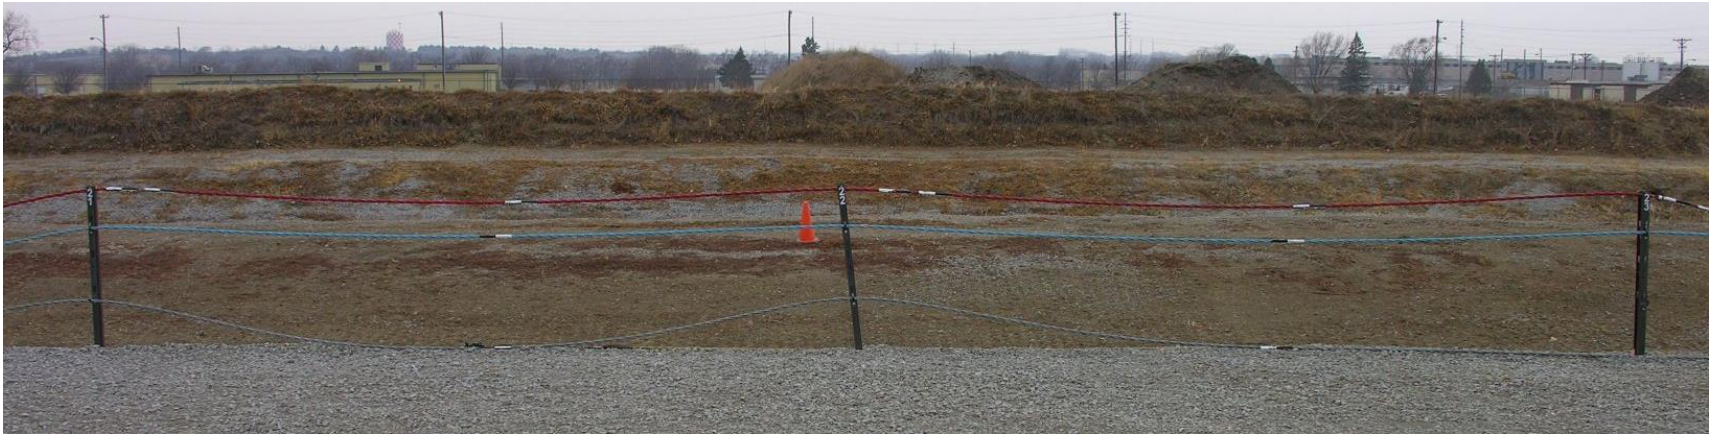
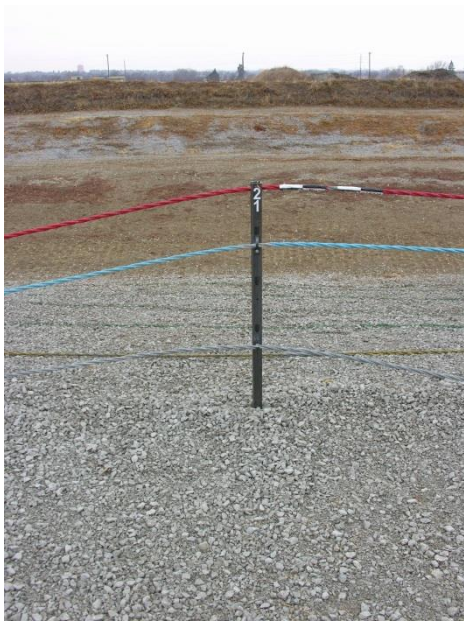
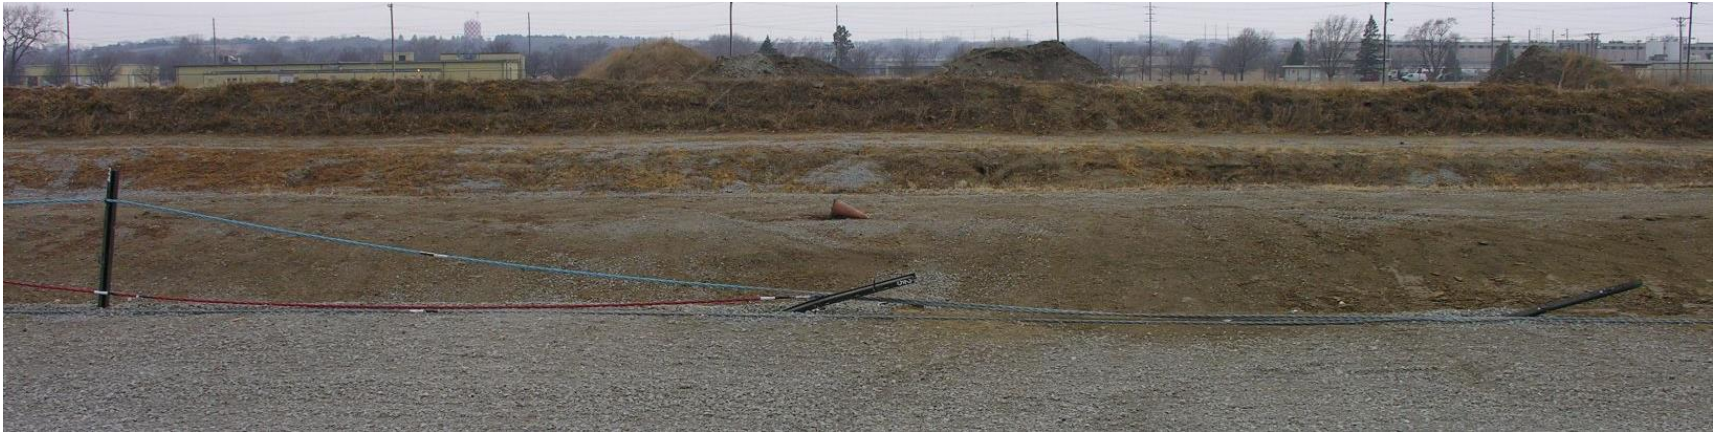
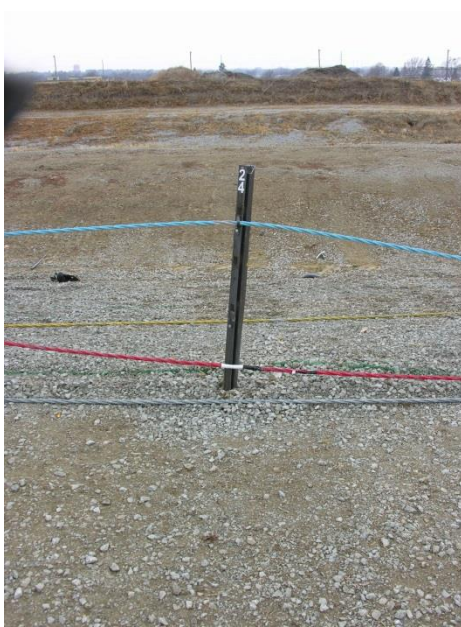
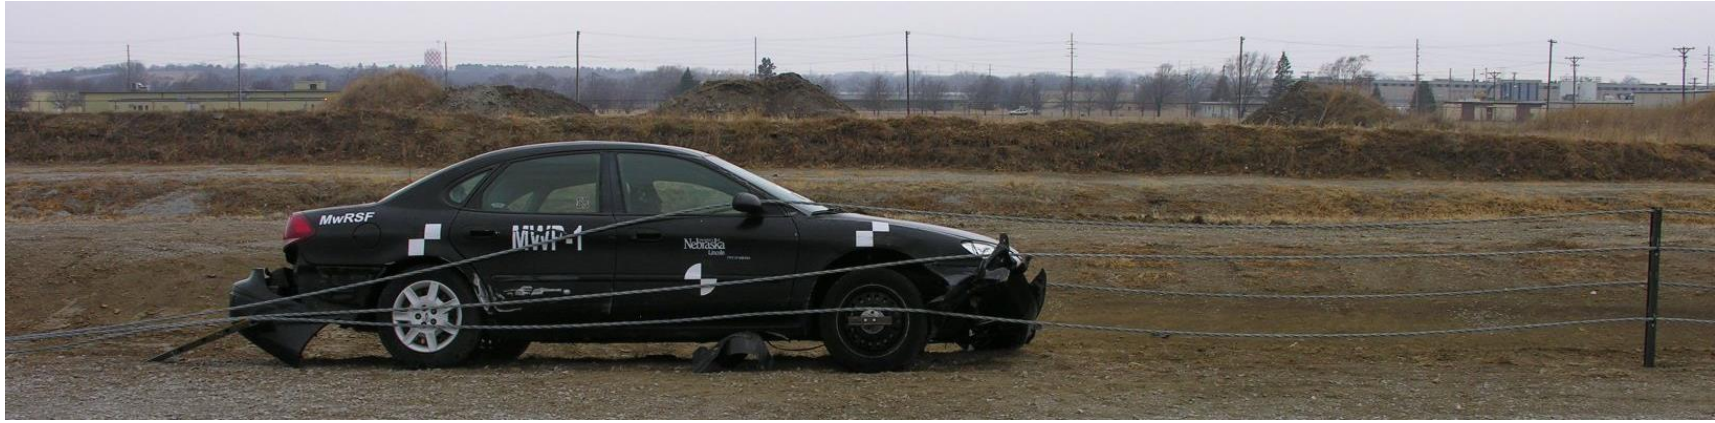
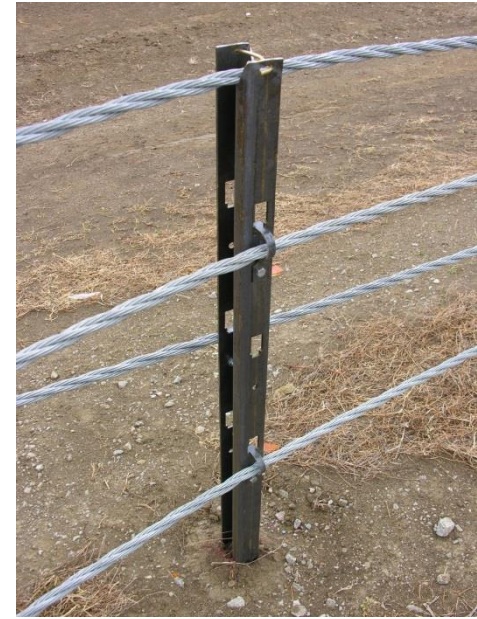
Damage to the barrier was moderate, as shown in Figures 46 through 50. Barrier damage consisted of bent posts, disengaged cables, and deformed brackets. At its final resting position, the vehicle was still in contact with the cables. Cable no. 2 was on the left side and the remaining cables were on the right side.

Cable no. 4 disengaged from post nos. 16 through 19, as well as post nos. 24 through 28, due to fracture of the brass keeper rods. Cable no. 3 disengaged from post nos. 12 through 20 and 25 through 28, cable no. 2 disengaged from post nos. 17 through 28, and cable no. 1 disengaged from post nos. 17, and 23 through 28. All of the brackets releasing cable no. 2 fractured due to high lateral cable loads pulling away from the posts. All other brackets releasing cables nos. 1 and 3 opened up with the tabs rotating through the keyway to release the cables vertically. Separation of the cable splices was documented, but the displacements were small. The maximum displacement at a splice was $\frac{1}{4}$ in. (6 mm) at the splice of cable no. 2.

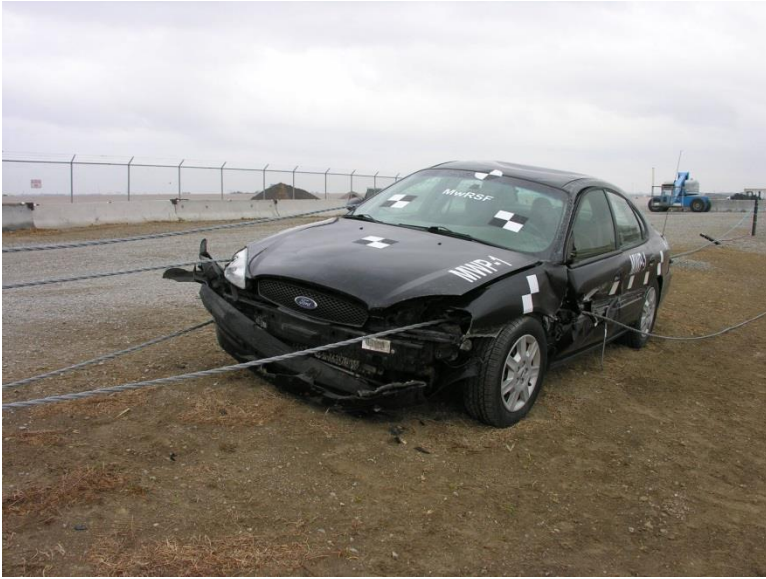
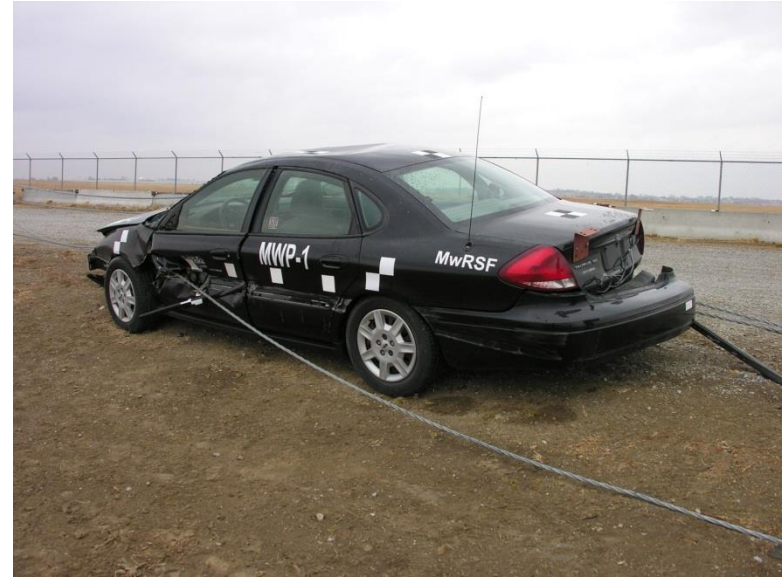
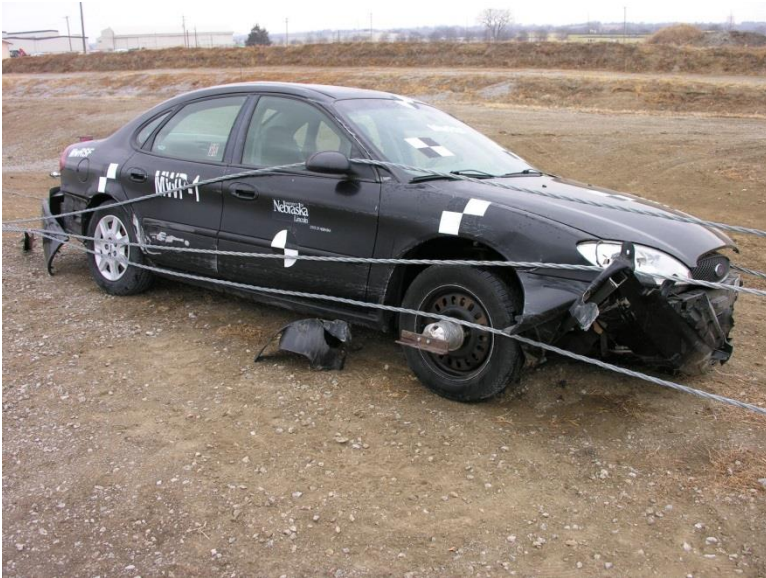
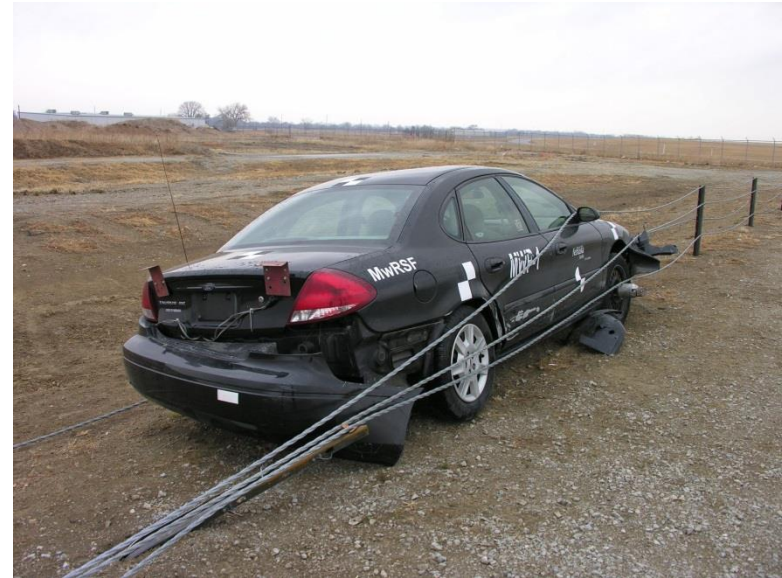
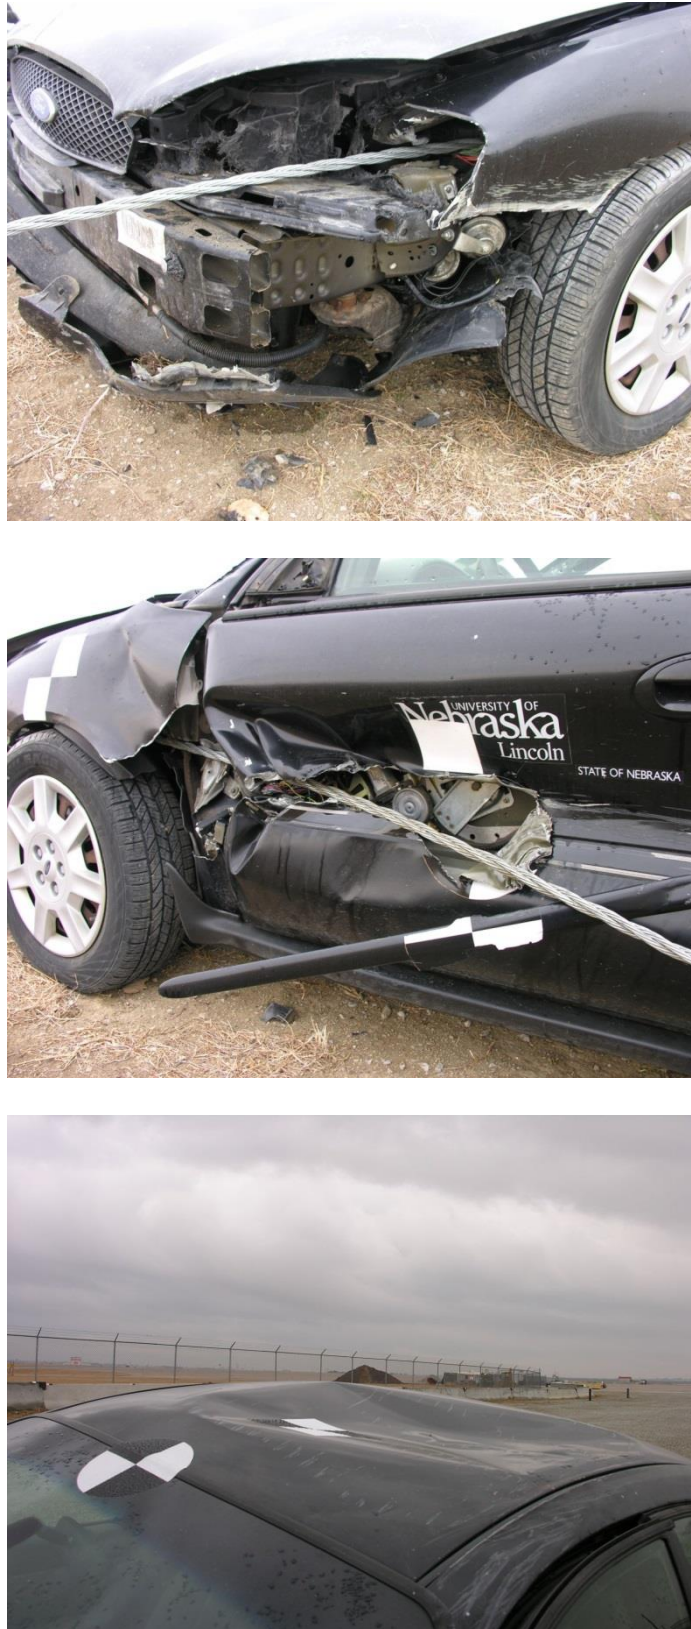
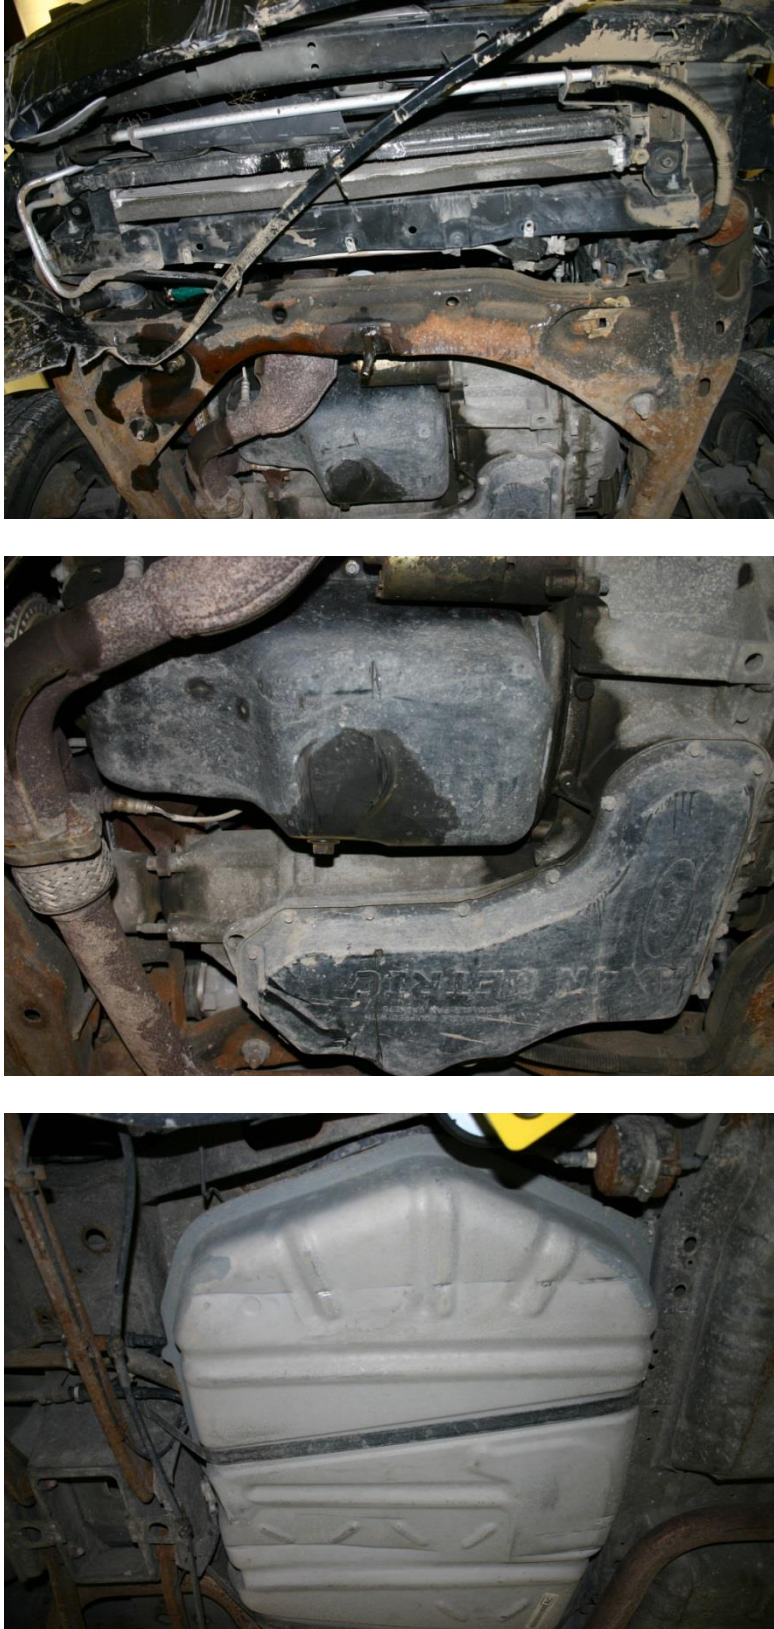
Figure 51. Vehicle Damage, Test No. MWP-1

The damage to the vehicle was moderate, as shown in Figures 51 through 53. The maximum occupant compartment deformations are listed in Table 6 along with the deformation limits established in MASH for various areas of the occupant compartment. Note that none of the MASH-established deformation limits were violated. Complete occupant compartment and vehicle deformations and the corresponding locations are provided in Appendix D.

The majority of the vehicle damage was concentrated on the left-front corner and left side of the vehicle where the impact occurred. The front bumper was under the front of the car. The left-front fender disengaged from the front bumper. There was a 2½-in. (64-mm) gap at the left headlight on the fender. The left-front tire was torn and a 10½-in. (267-mm) tear was located on the left-front fender. There were scrapes and gouges along the left side of the vehicle. Gouges were present along the A-pillar, and there were multiple cracks along the left side of the windshield. The left-side mirror was disengaged. There was a 6-in. (152-mm) wide, 32-in. (813-mm) long tear in the left-front door, starting at the back of the left-front fender and continuing along the left side of the car. The roof was scraped from the cables and was indented 2½ in. (64 mm). There was a 12-in. (305-mm) long dent on the right-rear quarter panel. The right side of the vehicle was scraped, including the right-front rim. The right-front bumper was crushed around post no. 28. The right-front headlight was broken but still attached. The remaining window glass remained undamaged. Minor scrapes were found on the undercarriage along the engine and transmission oil pans, control arms, exhaust pipe, and driver's side floor pan. A 23-in. (584-mm) long and ¼-in. (6.4-mm) deep gouge was located on the fuel tank.

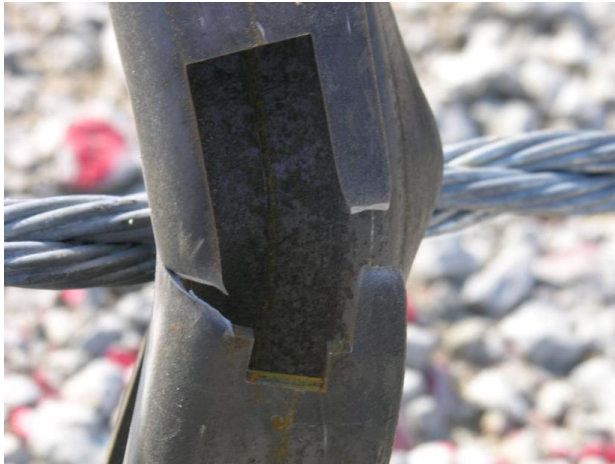
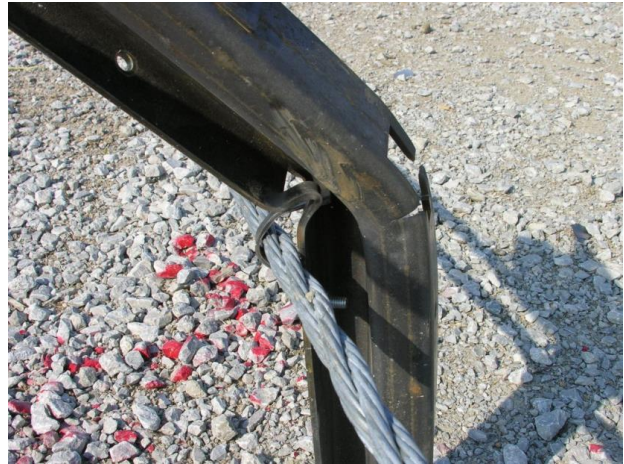
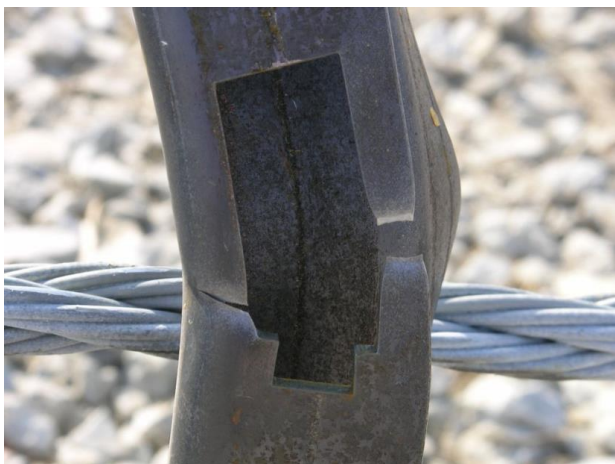
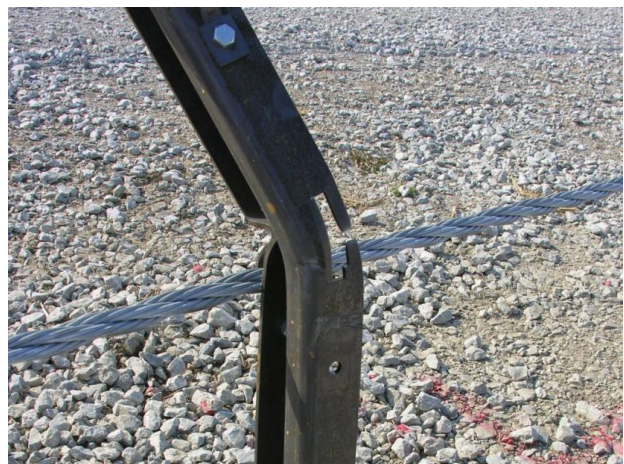
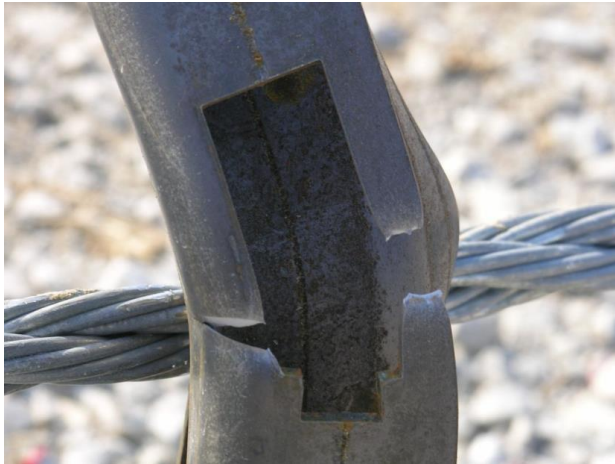
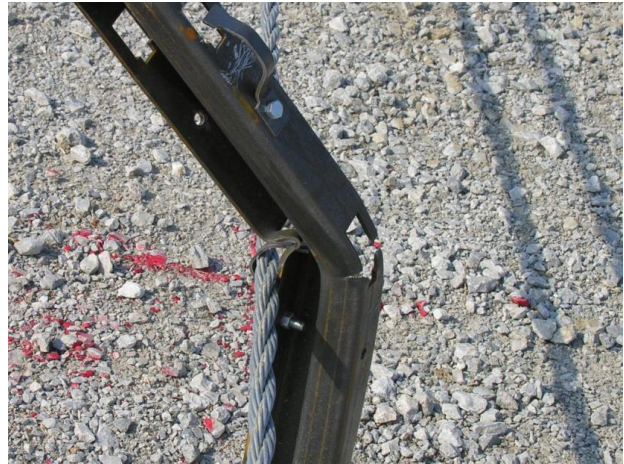
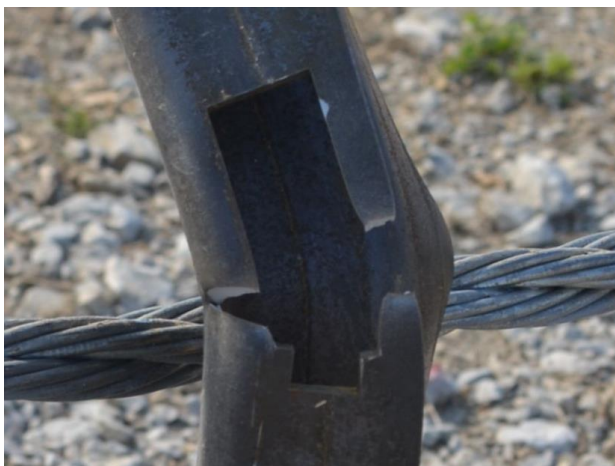
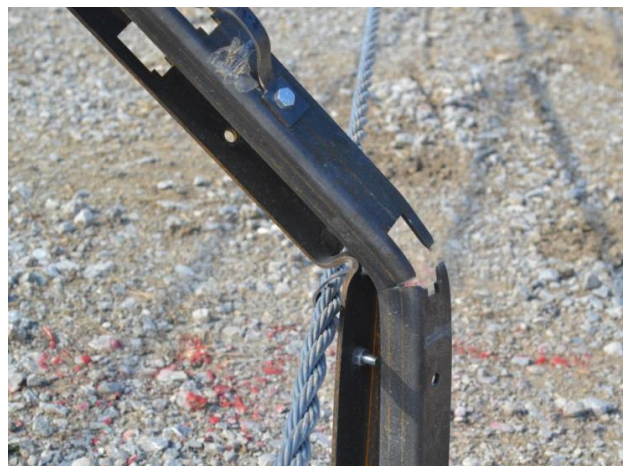
Figure 66. Damage to Lower Keyhole, Post Nos. 27 through 29, Test No. MWP-2

Modifications were made to the system posts in order to prevent the MWPs from bending and tearing at the keyways for cable no. 1 as seen in test no. MWP-2. The keyways were adjusted so that each post contained only four keyways as opposed to the six seen in the previous tests. Three keyways were placed on one side of each post at the same heights used previously. However, the opposite side had only one keyway, located at the middle cable position. This modification eliminated the symmetry of the posts, but still allowed for median and roadside versions of the system (all cables on front) with a single post. The sizes of the keyways were also modified. The height of the upper portion of each keyway was reduced by $\frac{1}{4}$ in. (6 mm) to increase the buckling strength of the steel strip located between the keyway and the free edge of the post. This change was intended to increase bending strength in the post and prevent plastic hinges from forming around the first cable keyway. Based on analysis of previous bogie testing results, this reduced keyway height was determined to not affect the bracket exiting the keyway. Finally, the tops of the posts were extended $\frac{1}{4}$ in. (6 mm) to prevent damage to the brass rod installation slot in the post flange when driving the posts into the ground. During installation of the posts for test no. MWP-2 some of the slots closed slightly from the repeated impacts of the

driver, and the brass rods were difficult to install. The added material above the slots should strengthen the post and prevent the slot from deforming. However, the bottom of the V-notch holding the top-cable was also deepened $\frac{1}{4}$ in. (6 mm) with the extension. This adjustment produced slightly steeper slopes for the V-notch. The complete drawing set can be found in Figures 69 through 92. Photographs of the test installation are shown in Figure 93. Material specifications, mill certifications, and certificates of conformity for the system materials are shown in Appendix A.
