MIDWEST GUARDRAIL SYSTEM (MGS) WITH AN OMITTED POST

MIDWEST ROADSIDE SAFETY FACILITY

MwRSF Research Report No. TRP-03-326-16

February 22, 2016

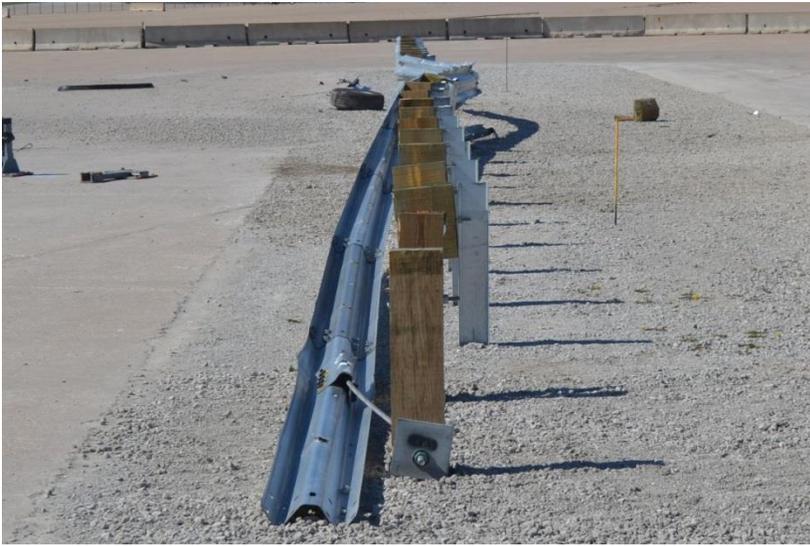
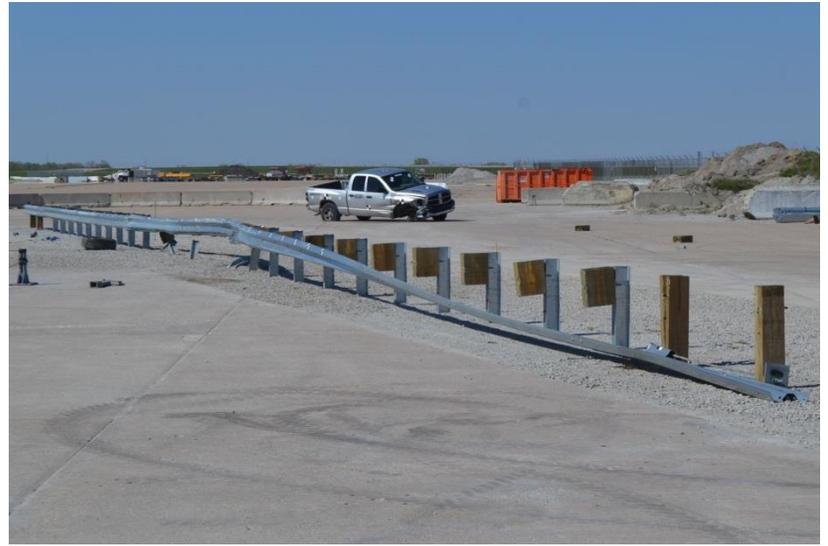
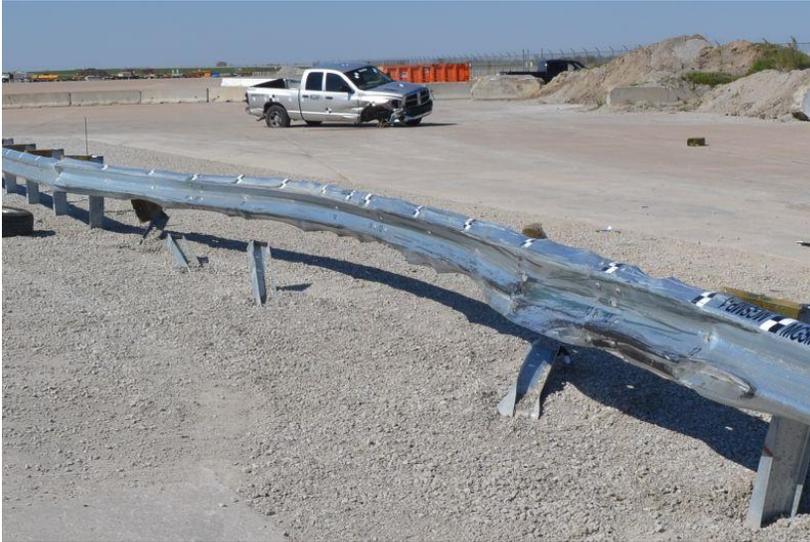
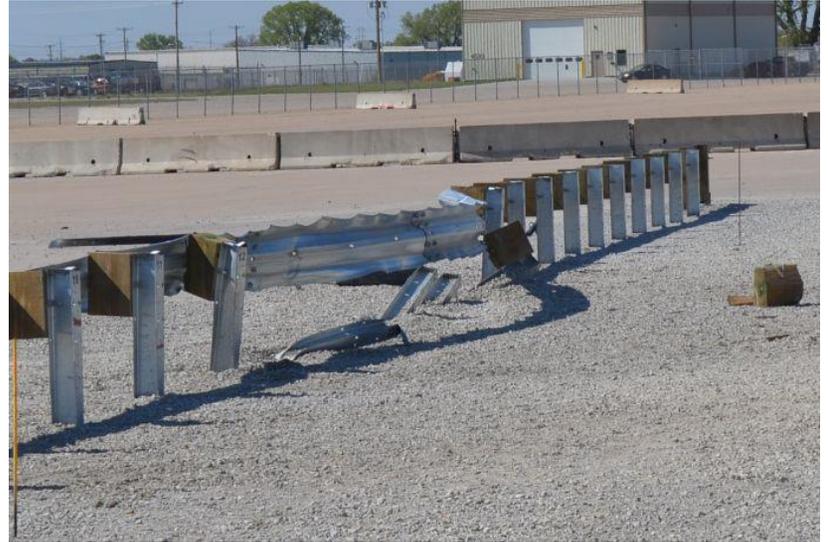
Figure 24. System Damage, Test No. MGSMP-1

Damage to the barrier was moderate, as shown in Figures 24 through 28. Barrier damage consisted of rail deformation, disengagement of the W-beam rail from the posts, bending of the steel posts, and fracture of wooded posts. The length of vehicle contact along the barrier was approximately 39 ft – 9¼ in. (12.1 m), which spanned from 18¼ in. (464 mm) upstream from the centerline of post no. 12 through 9 in. (229 mm) downstream from post no. 17.

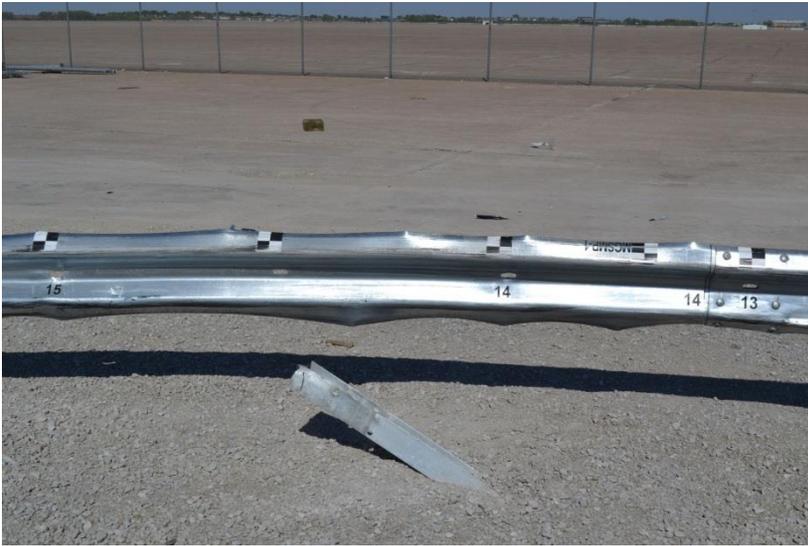
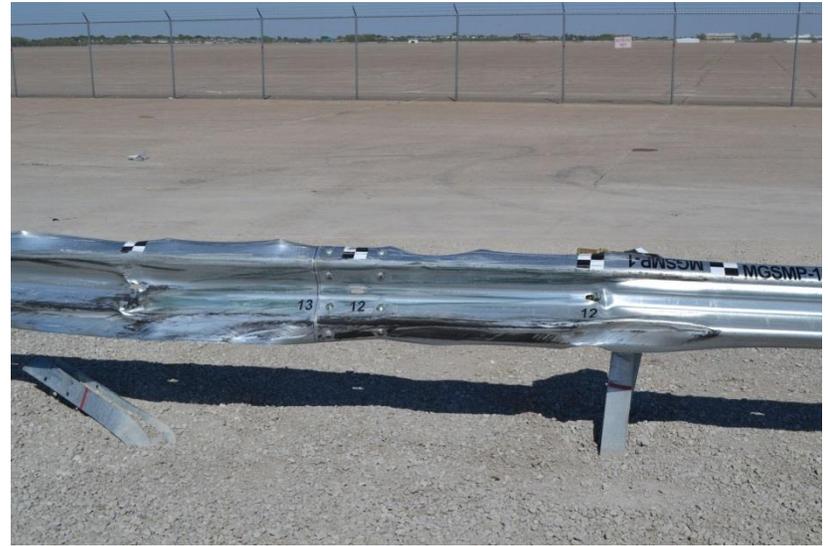
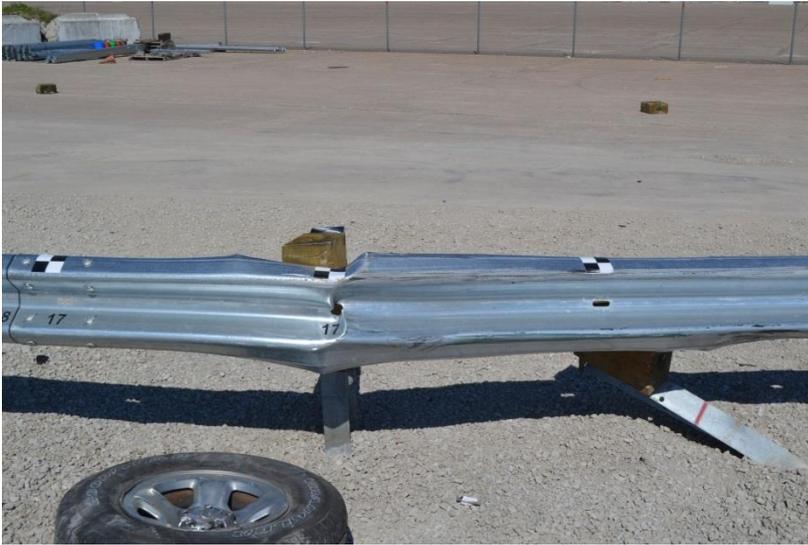
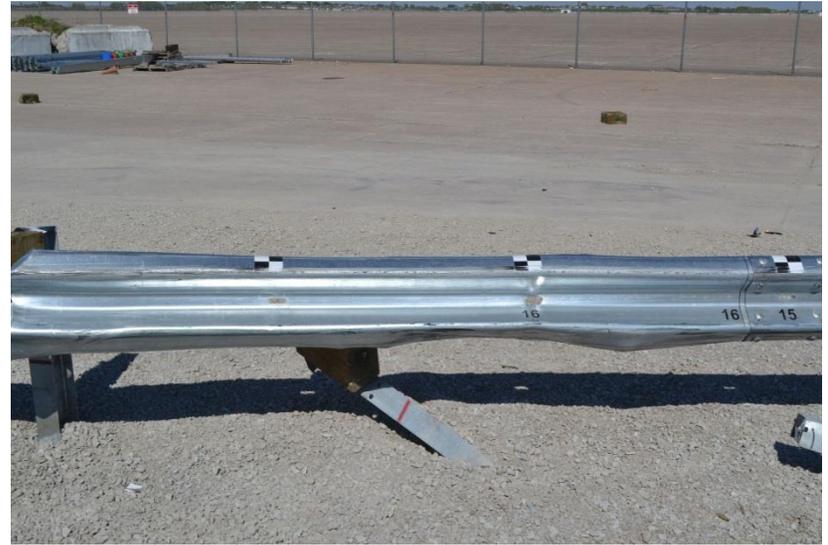
Figure 25. Rail Damage Between Post Nos. 12 and 17, Test No. MGSMP-1

Deformation of the W-beam rail occurred between post nos. 11 through 17. Flattening occurred on the bottom corrugation of the rail from the midspan between post nos. 12 and 13 to 13 in. (330 mm) upstream from the midspan between post nos. 14 and 15. A 25-in. (635-mm) long dent was found at the bottom of the rail starting 8 in. (203 mm) upstream from post no. 16. A kink was found in the rail around the blockout of post no. 17. All splice locations were measured before and after the test. A maximum splice movement of ⅝ in. (16 mm) was recorded at two adjacent splices in the contact region, which were located between post nos. 13 and 14 and between post nos. 15 and 16. The rail released from post nos. 1 through 9 and 13 through 17 where the bolt head pulled through the slots in the rail.

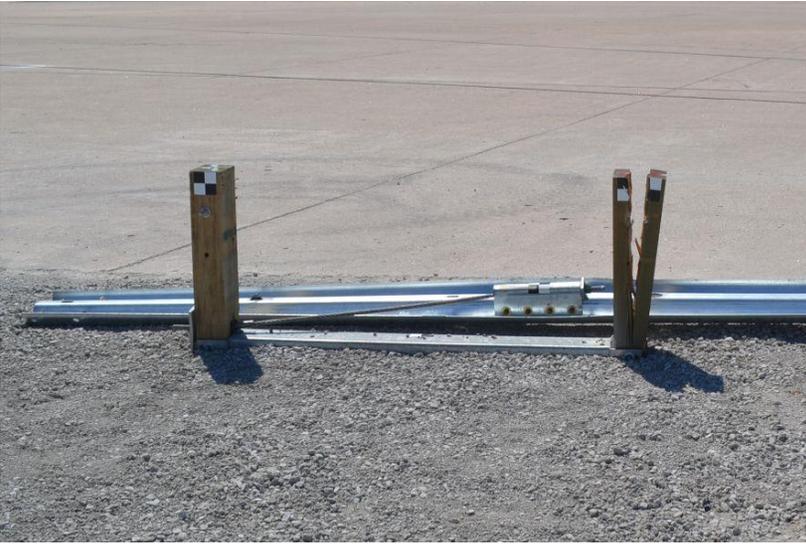
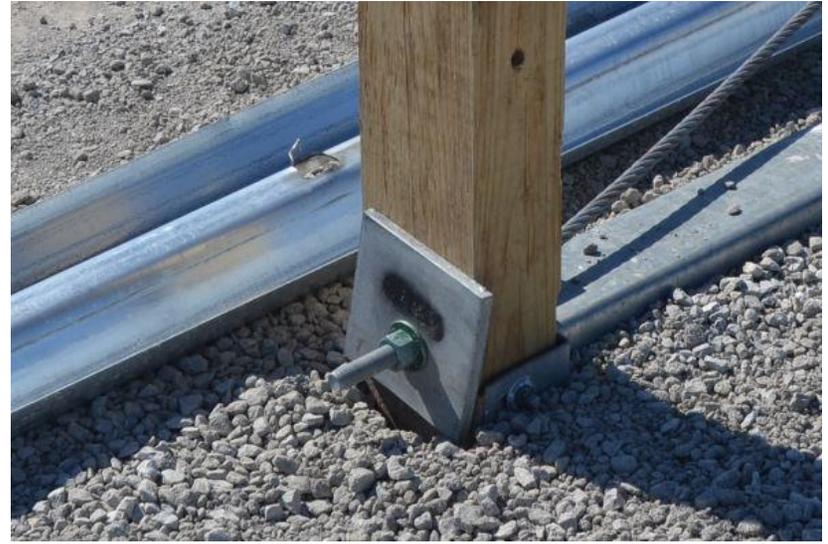
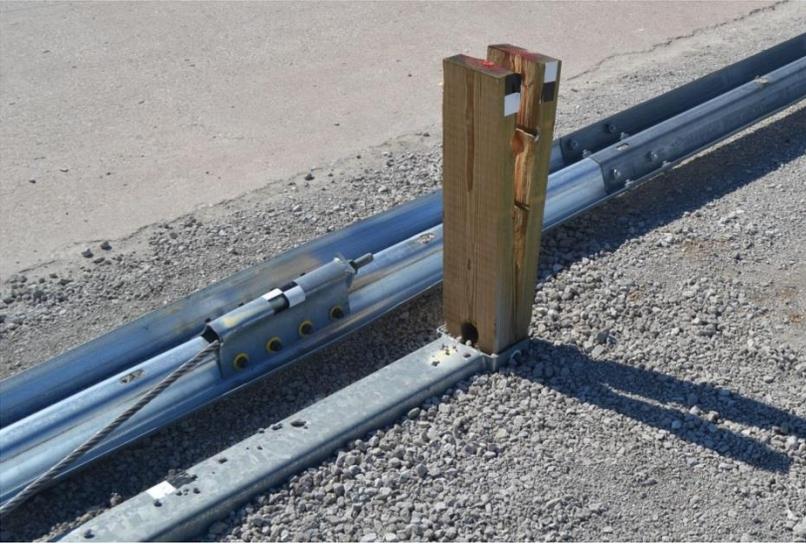
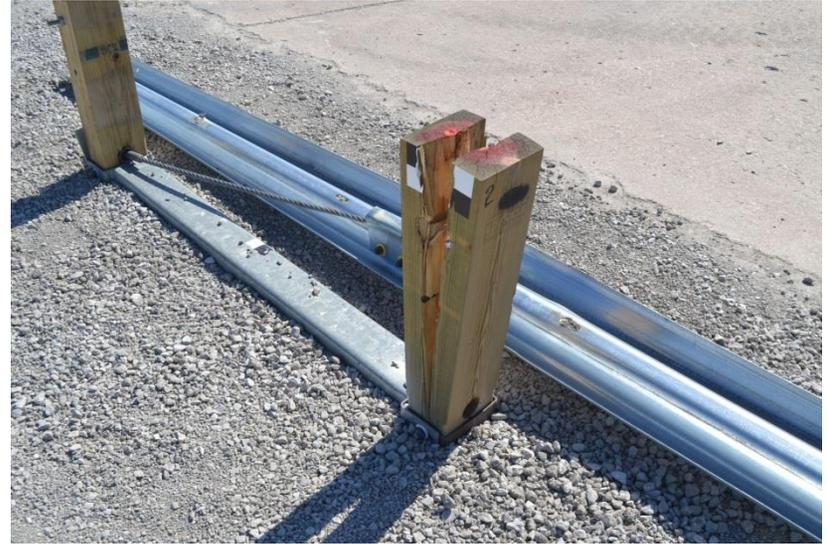
Figure 28. Upstream Anchor Damage, Test No. MGSMP-1

Although the post bolts pulled through the rail at the upstream anchor, the cable anchor remained intact between the rail and the bottom of post no. 1, as shown in Figure 28. Two tears, ¾ in. (19 mm) and ½ in. (13 mm) long, occurred in the rail at the bolt location of post no. 1. Post no. 2 was split down the center through the bolt hole. A 1-in. (25-mm) soil gap was found on the upstream side of post no. 1. The downstream anchorage was undamaged, except for a 1/16-in. (2-mm) soil gap found on the downstream side of the foundation tubes.

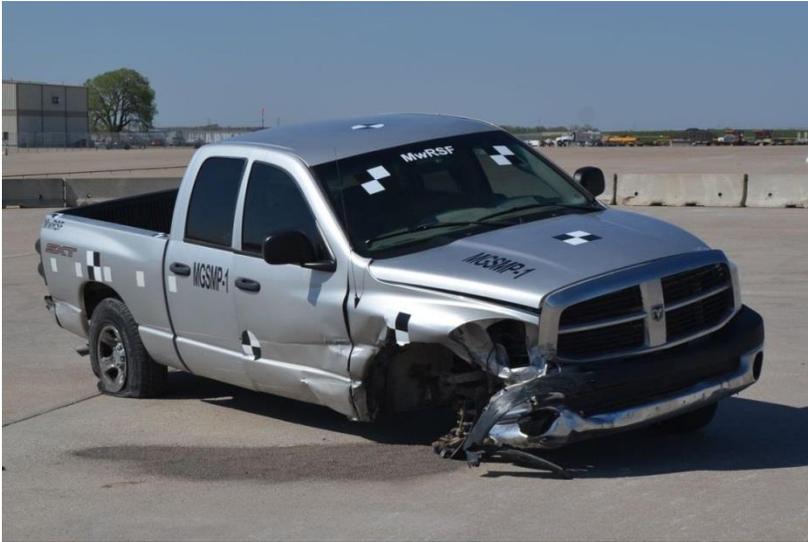
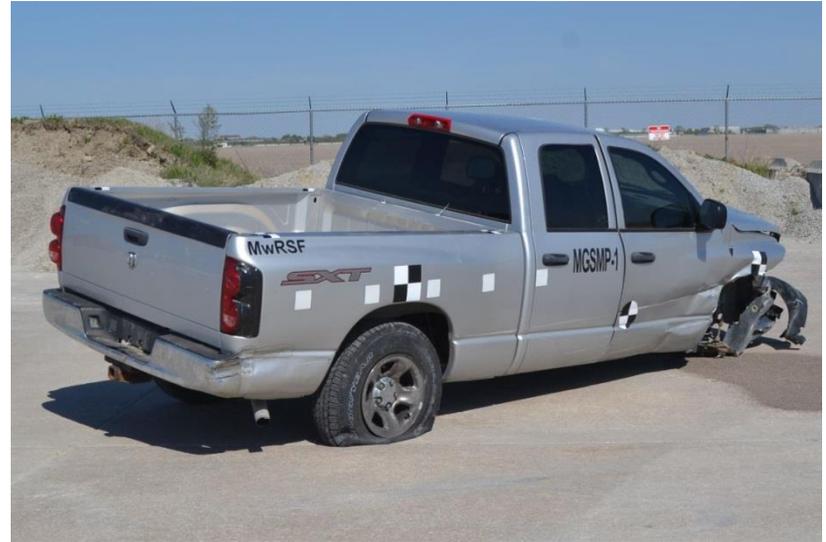
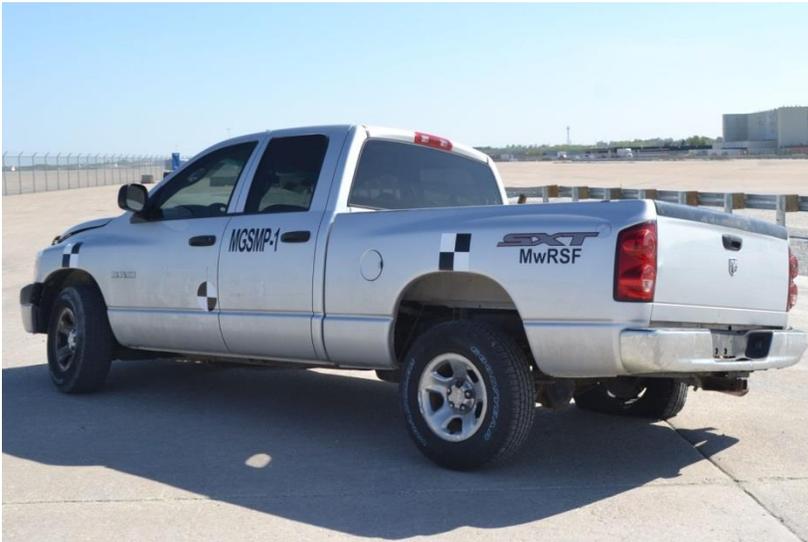
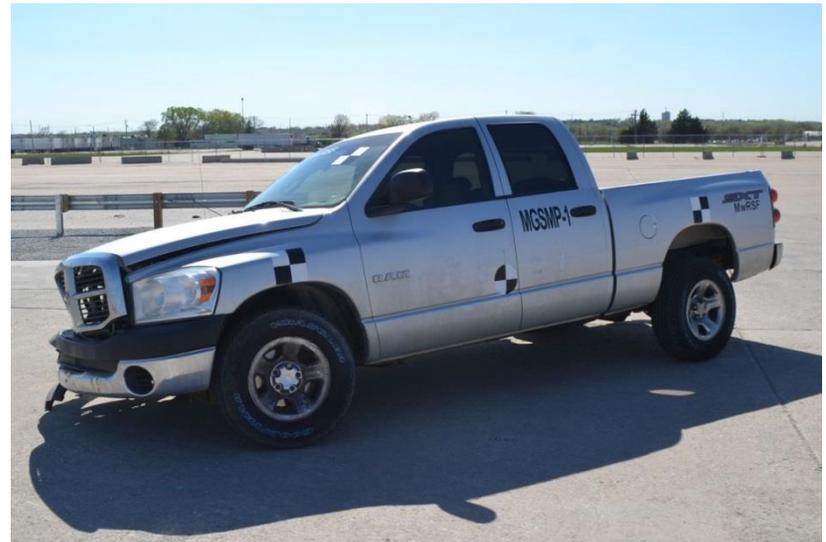
Figure 29. Vehicle Damage, Test No. MGSMP-1

The damage to the vehicle was moderate, as shown in Figures 29 and 30. The maximum occupant compartment deformations are listed in Table 6 along with the deformation limits established in MASH for various areas of the occupant compartment. Note that none of the MASH-established deformation limits were violated. Complete occupant compartment and vehicle deformations and the corresponding locations are provided in Appendix D.

The majority of the damage was concentrated on the right-front corner and right side of the vehicle where impact occurred. A 1 $\frac{3}{4}$ -in. (44-mm) separation formed between the hood and the grill. The right-front corner of the bumper was crushed inward. The right headlight disengaged. A 5-in. (127-mm) dent formed on the fender located behind the headlight location. The right-front tire was disengaged and had a $\frac{3}{4}$ -in. (19-mm) tear in its sidewall. The right-front wheel steel rim had a 1 $\frac{1}{2}$ -in. (38-mm) diameter gouge and bending around the entire edge of the rim. Additional gouges were found on the hub cap. The steering linkage broke, and the control arm was fractured. The right-front brake hose was cut. Contact marks were found on the entire length of the right side of the vehicle, starting 20 in. (508 mm) from the bottom of the right-front door and ending 9 $\frac{1}{2}$ in. (241 mm) from the bottom of the right-rear bumper. The right-front door had a 12-in. (305-mm) long tear approximately 18 in. (457 mm) below the window. Gouges and dents were found on the right-front door. A 3-in. wide x 1-in. deep x 10-in. long (76-mm x 25-mm x 254-mm) gouge was found on the rear corner of the right-rear bumper. The right-rear tire ruptured.

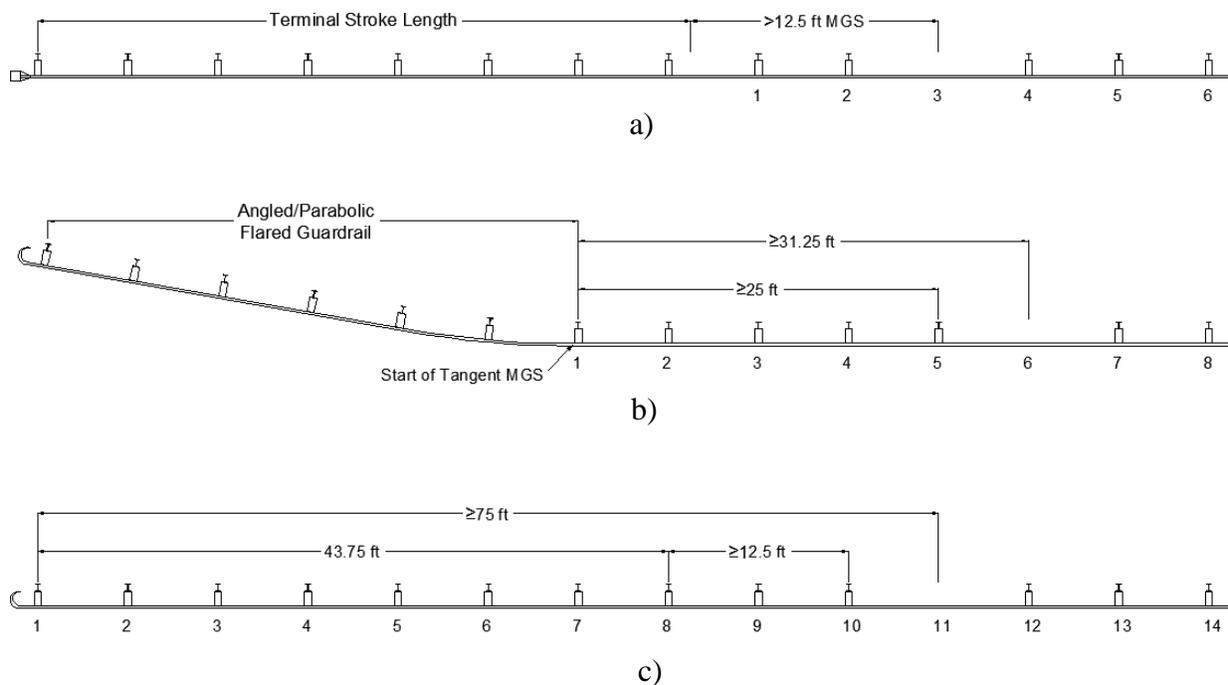
Figure 32. Recommended Distance Between Omitted Posts and a) Energy-Absorbing Terminals, b) Flared Terminals, and c) Trailing-End Guardrail Anchorages

identified by system stroke length, and the omitted post. In other words, the first post eligible for omission is the third guardrail post from the inner end of the terminal, or end of stroke length, as shown in Figure 32.

Non-energy absorbing terminals typically flare away from the roadway utilizing either an angled or parabolic geometry. Both geometric layouts result in increased effective impact angles, which result in increased system deflections for impacts on or near the flared terminal. Due to the increase in system deflections associated with guardrail flares, at least 25 ft (7.6 m) of tangent MGS should be used to separate a flared guardrail terminal and the enlarged span length, making the sixth post on the tangent length of MGS eligible for omission, as shown in Figure 32.

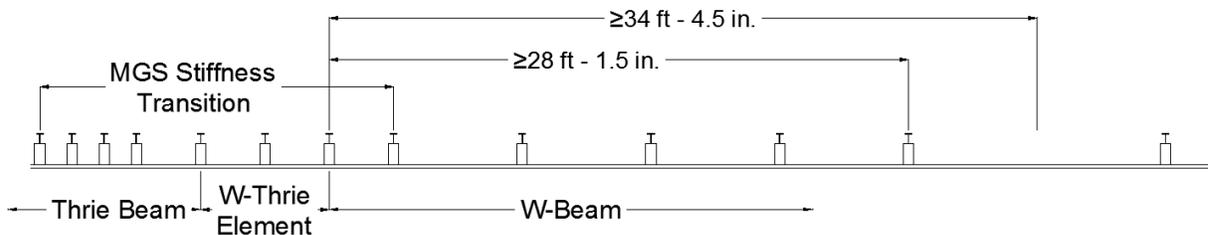
Figure 33. Recommended Distance Between Omitted Posts and MGS Stiffness Transition

The MGS stiffness transition was previously developed to connect standard MGS to various thrie beam, approach guardrail transitions. Both steel post and wood post versions of the MGS stiffness transition have been developed as well as a configuration for use adjacent to roadside curbs [30-32]. Within these previous studies, it was recommended that 25 ft (7.2 m) of guardrail be utilized between the upstream end of the asymmetrical W-to-thrie transition element and any guardrail flares. Since an omitted post results in reduced rail stiffness and increased rail deflections, it is similarly recommended that at least 25 ft (7.2 m) of guardrail separate the W-to-thrie transition element and the elongated span resulting from an omitted post. Adding in the extra 37.5 in. (953 mm) post spacing required to transition between full- and half-post spacing, the distance between the asymmetrical element and the elongated span should be at least 28 ft – 1.5 in. (8.6 m). Thus, an omitted post should be at least 34 ft – 4.5 in. (10.5 m) away from the upstream end of the W-to-thrie transition element, as shown in Figure 33.
