PHASE III DEMONSTRATION OF PONDEROSA PINE ROUND POSTS AS ALTERNATIVE TO RECTANGULAR SYP POSTS IN G4(2W) GUARDRAIL SYSTEMS

MwRSF Research Report No. TRP-03-329-15

May 17, 2016

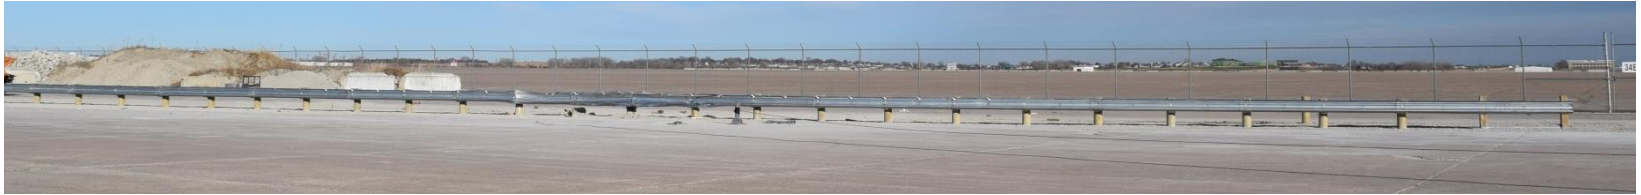
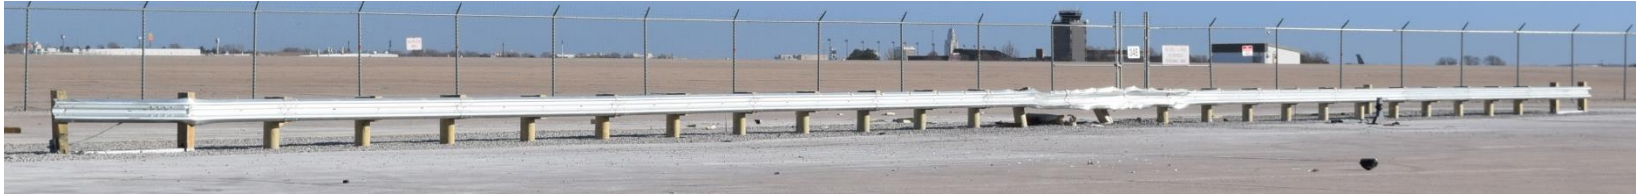
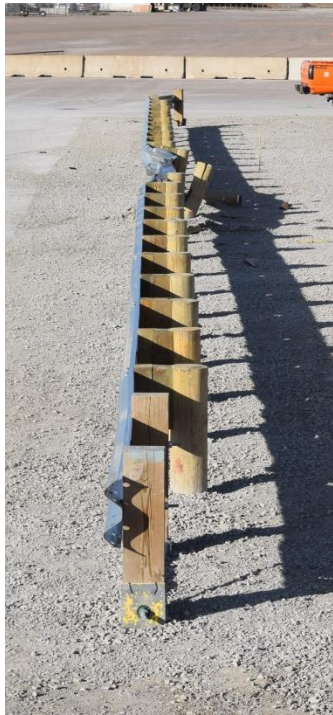
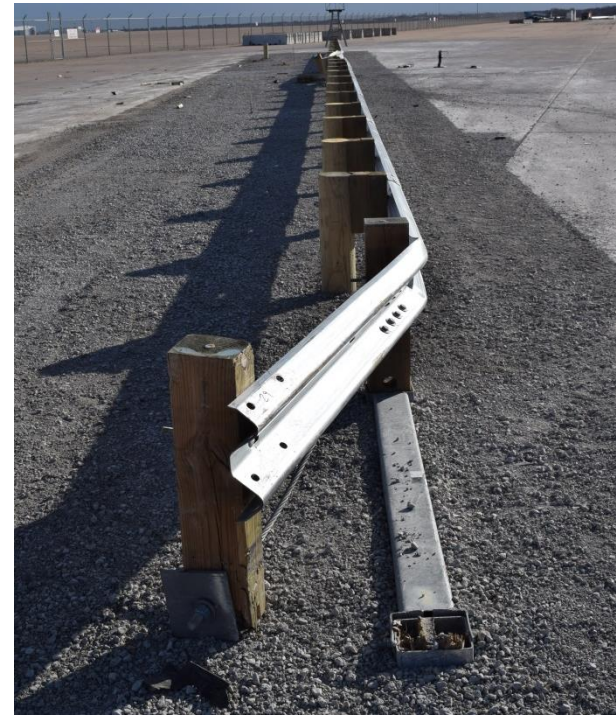
Figure 30. System Damage, Test No. AZRP-1

Damage to the barrier was moderate, as shown in Figures 30 through 39. Barrier damage consisted of rail deformation, disengagement of the W-beam rail from the posts, fractured wood posts, split wood blockouts, and displaced posts in soil. The length of vehicle contact along the barrier was approximately 27 ft – 8½ in. (8.4 m), which spanned from 32¼ in. (819 mm)

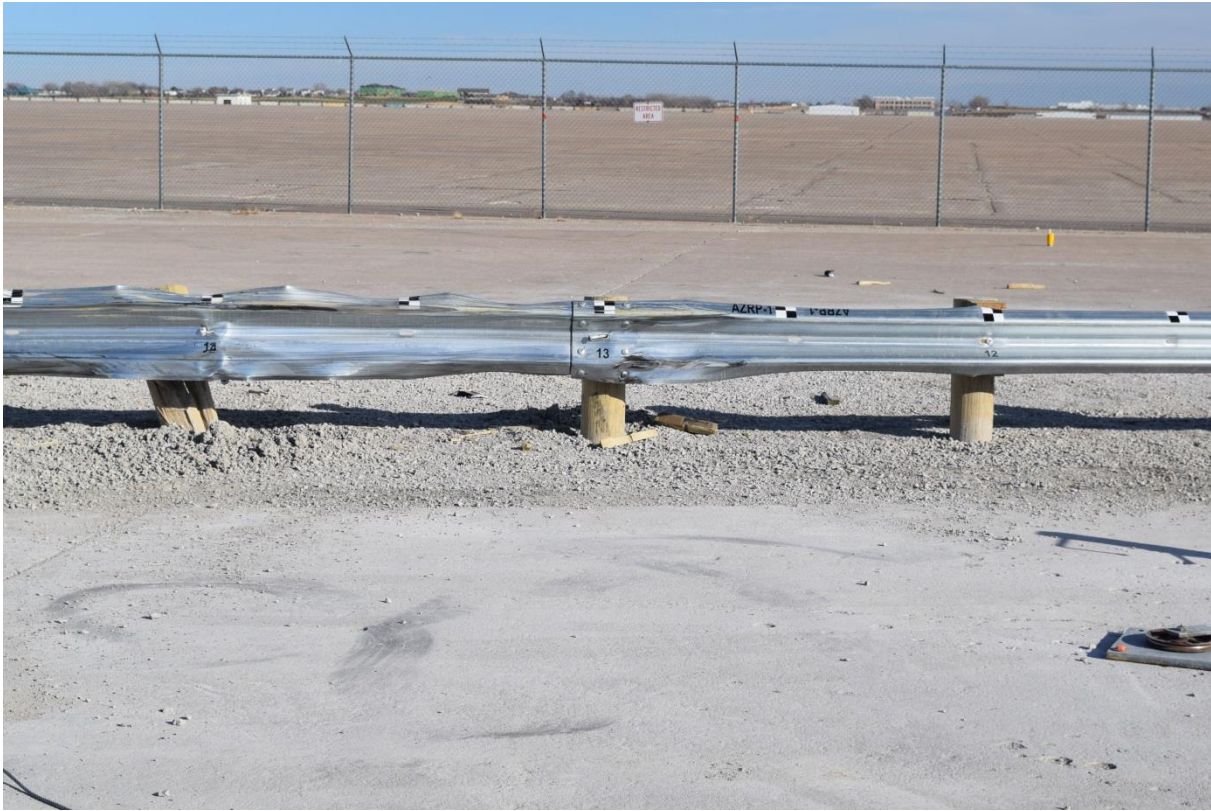
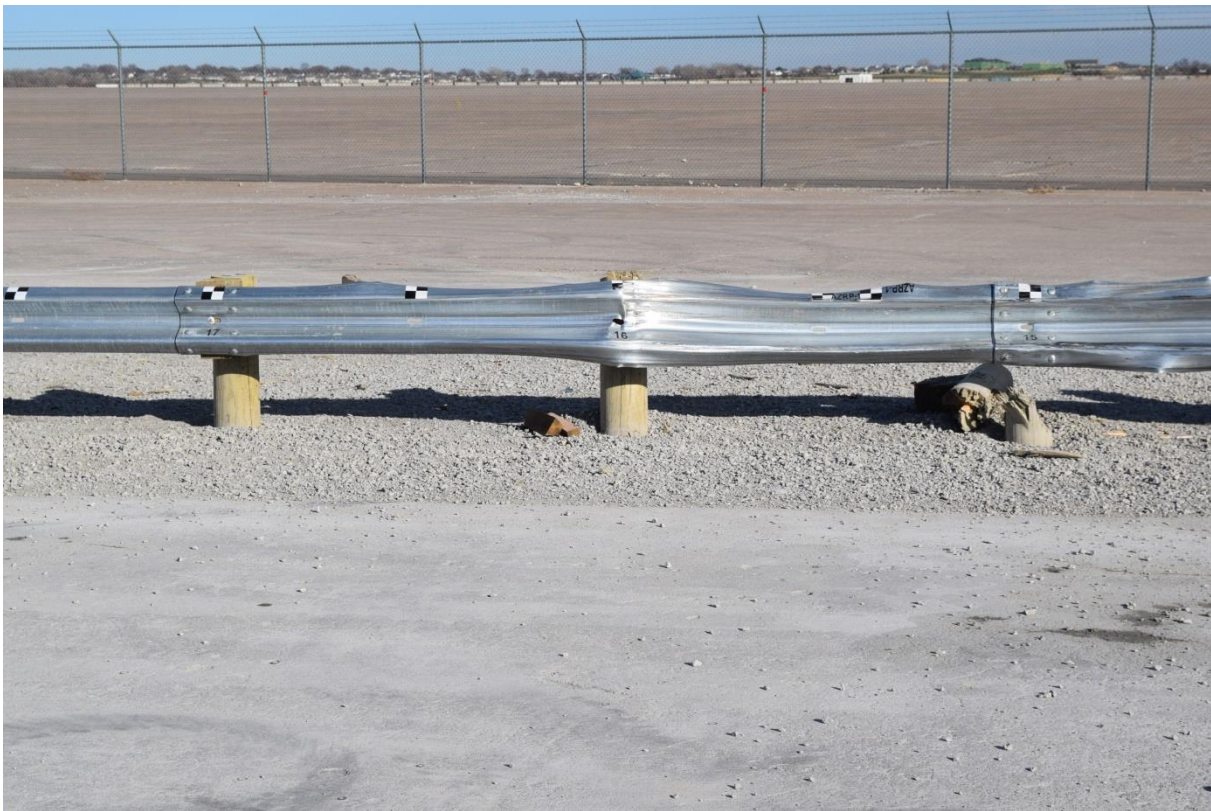
Figure 32. Rail Damage Between Post Nos. 12 and 17, Test No. AZRP-1

Deformation of the W-beam rail occurred between post nos. 12 and 17. Flattening occurred on the bottom corrugation of the rail from post no. 13 through post no. 15. Kinking of the rail was found around the blockouts of post nos. 13 through 16. A maximum splice movement of $\frac{1}{4}$ in. (6 mm) was recorded at the splices at post nos. 15. The rail released from post no. 14 when the post fractured and from post nos. 15 and 16 where the bolt head pulled through the slots in the rail. Minor rail separation from the blockout occurred at post nos. 4 through 9, 11, and 17 through 21.

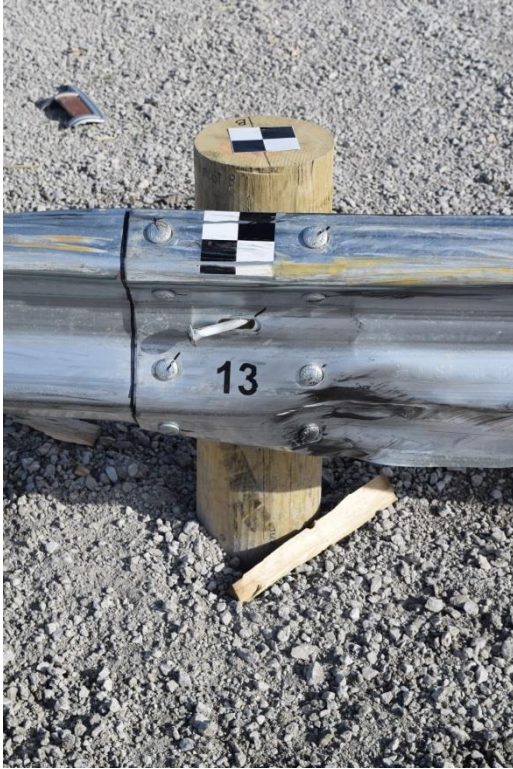
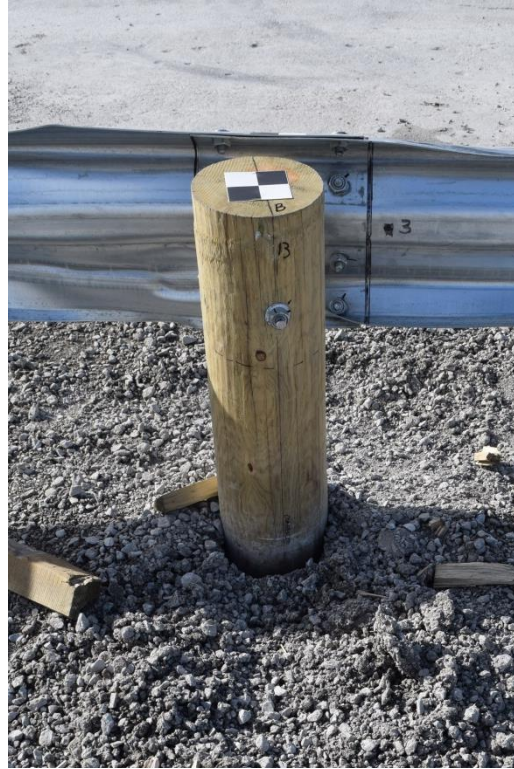
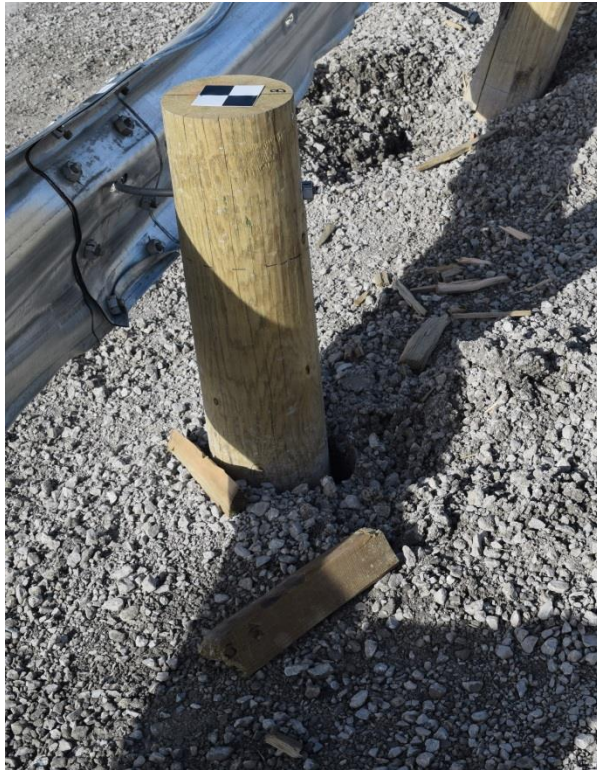
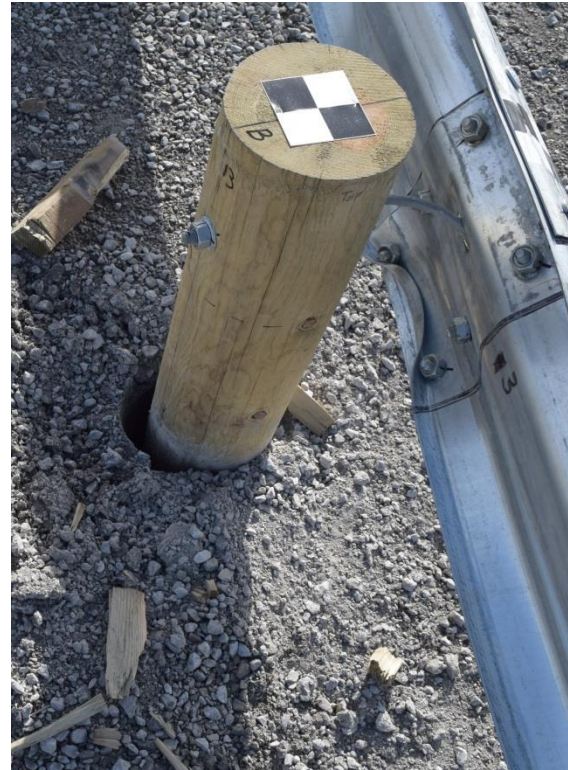
Figure 33. Post No. 13 Damage, Test No. AZRP-1

Post nos. 13 through 16 rotated backward. In addition, post nos. 14 and 15 fractured, and contact marks were found on post nos. 13 and 14 near the groundline. Blockouts at post nos. 12 and 16 encountered gouging from the rail. Blockouts fractured and were disengaged from post nos. 13 through 14. A portion of the blockout at post no. 15 fractured.

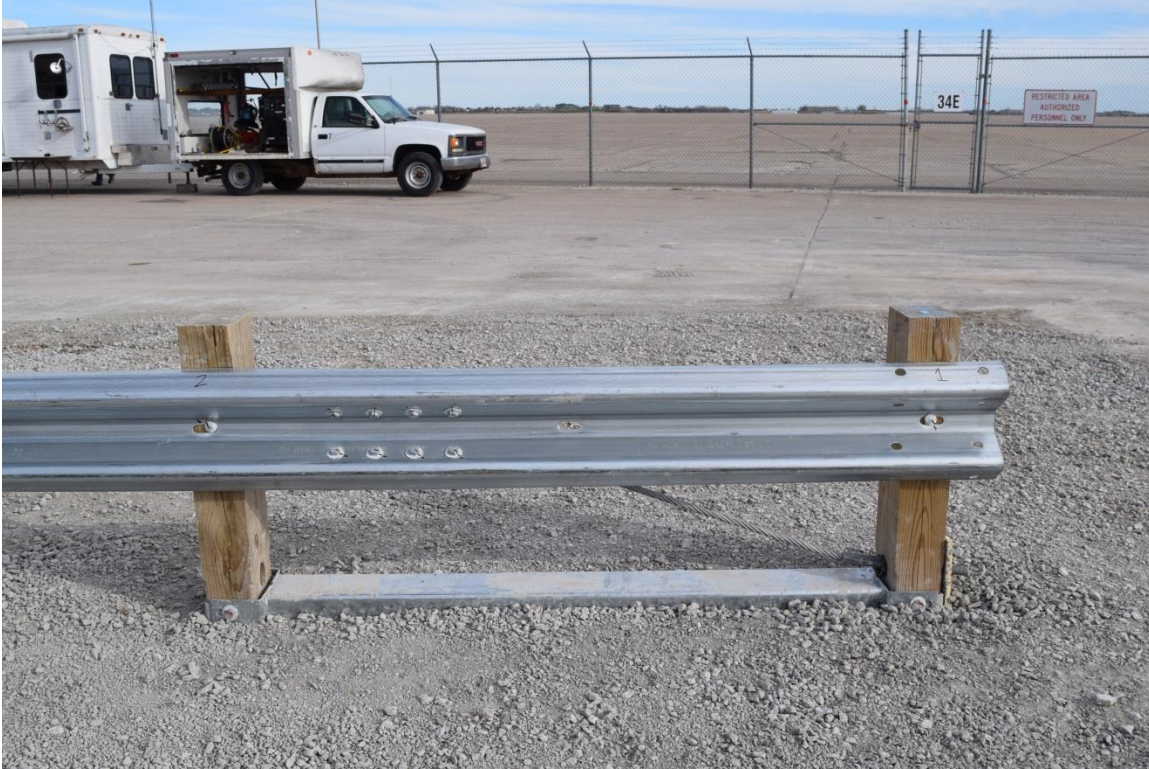
Upstream Anchorage

The upstream anchorage was undamaged, except for a $\frac{3}{4}$ -in. (19-mm) soil gap found on the upstream side of the foundation tube at post no. 1 and a $\frac{1}{16}$ -in. (2-mm) soil gap found on the downstream side of the foundation tube at post no. 2. Due to the secondary impact of the downstream anchorage, contact marks and kinks were found on the rail between post nos. 28 and 29. Contact marks and gouging were also found on post nos. 28 and 29, and post no. 29 fractured.

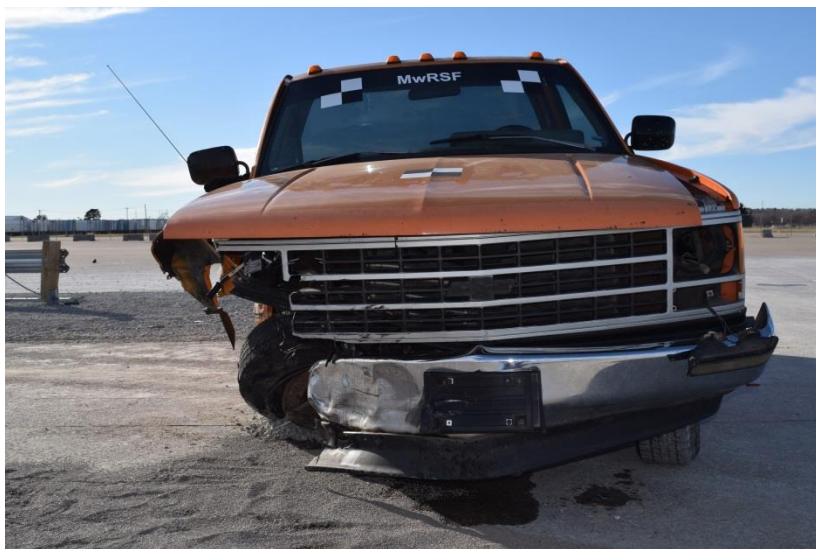
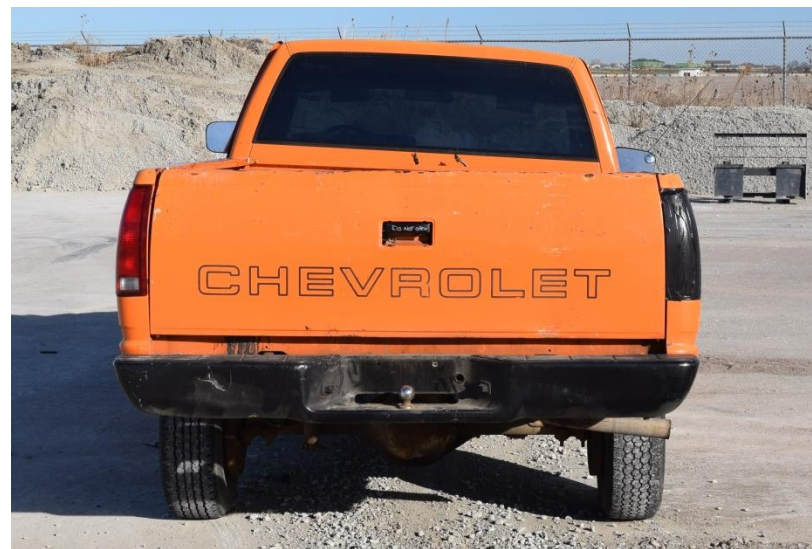
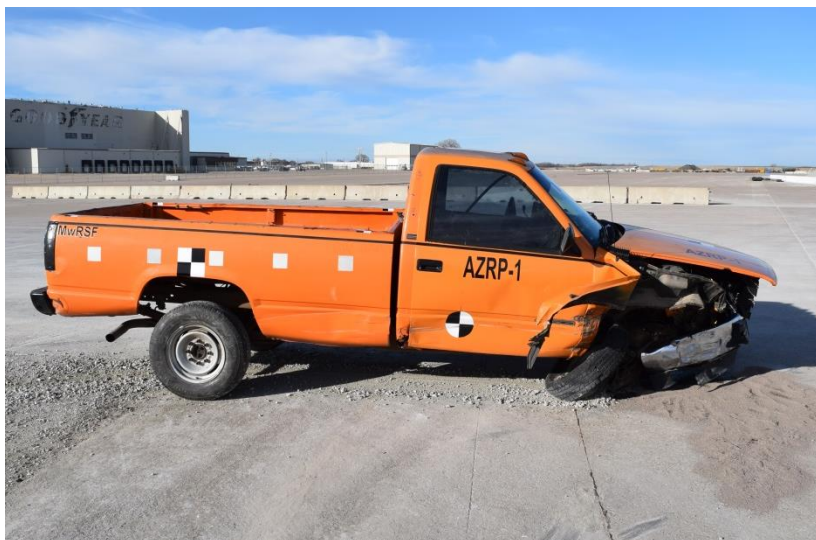
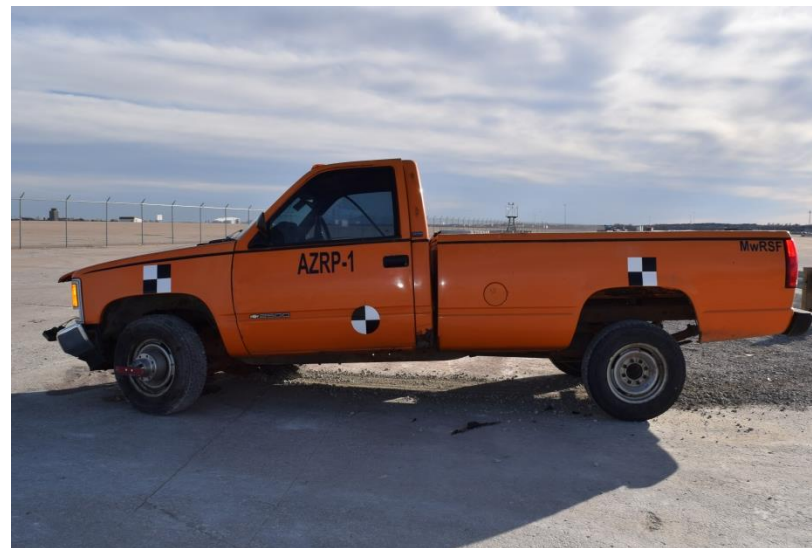
Figure 40. Vehicle Damage, Test No. AZRP-1

The damage to the vehicle was moderate, as shown in Figures 40 through 44. The maximum occupant compartment deformations are listed in Table 7. During vehicle preparation, the seat frame for the 2000P vehicle was removed and erroneously not placed back in the truck. Previous testing with the 2000P vehicles early in the implementation of NCHRP Report No. 350 found that the seat frame was critical to developing the proper rigidity of the truck floorpan. MwRSF normally has two control points to account for any occupant compartment deformations. However, due to floorboard deformation and movement, both control points encountered movement. Therefore, two sets of data are reported below. Even though both control points encountered minor movement, all deformations were below the previously-recognized NCHRP Report No. 350 deformation limits. Complete occupant compartment and vehicle deformations and the corresponding locations are provided in Appendix D.

The majority of the damage was concentrated on the right-front corner, right side, and front of the vehicle where impact had occurred. The right side of the bumper was crushed inward and backward. The right-front fender was dented, buckled, kinked, and was peeled backward. The right-front steel rim was severely deformed with significant crushing and dents. The right-front tire was torn and deflated. The grill was fractured around the right-side headlight assembly. The right-side and left-side headlights and signal lights were disengaged. The radiator deformed inward approximately 2½ in. (64 mm). The right side of the radiator support bent backward approximately 7 in. (178 mm). Denting and scraping were observed on the entire right side. The right-side door had a 1½-in. (38-mm) deep dent starting at the bottom and extending upward 23 in. (584 mm). The right-side B-pillar and the right-side of the pickup box had ¼-in. (6-mm) and 1-in. (25-mm) deep gouging, respectively. The right-side door was ajar approximately 1½ in. (38 mm), while the left-side door was ajar approximately 1¾ in. (44 mm). The left side of the front bumper was bent forward 4 in. (102 mm). The right side of the windshield had an 8 in. (203-mm) wide spider web cracking in the lower right corner. Hairline cracking began at the lower middle of the windshield and extended 29 in. (737 mm) upward, progressing into the right side of the windshield.

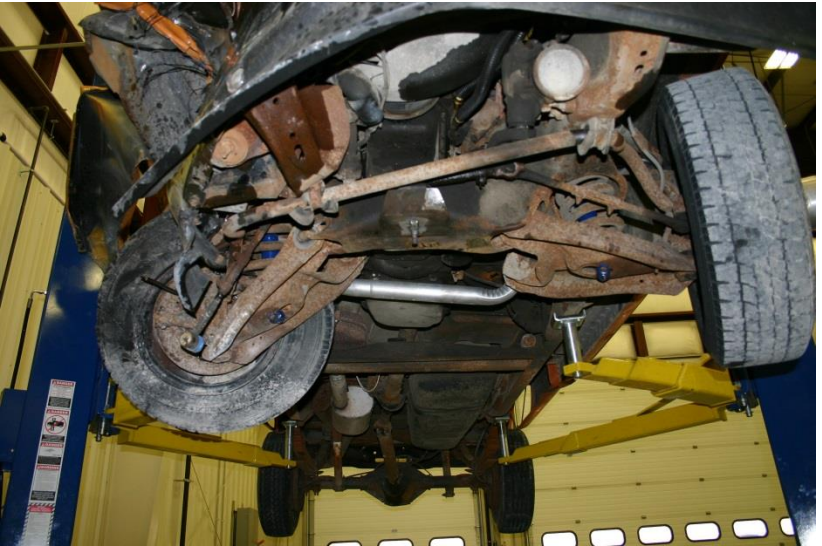
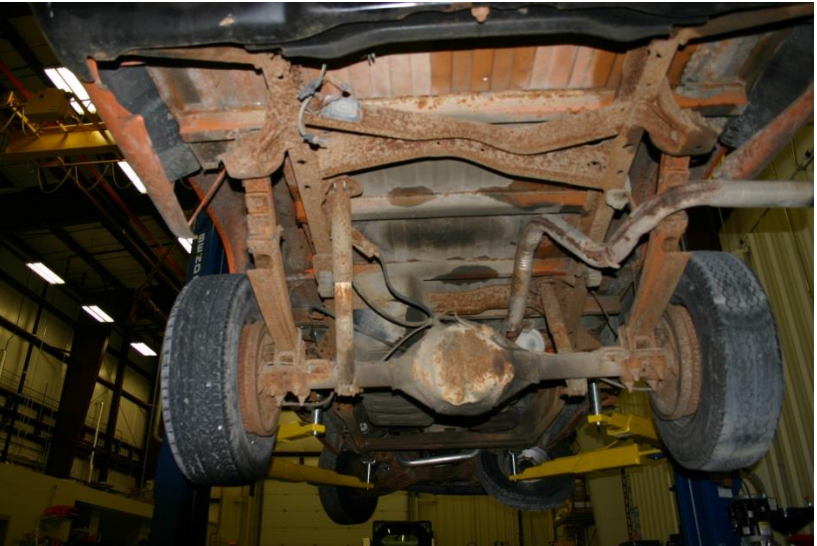
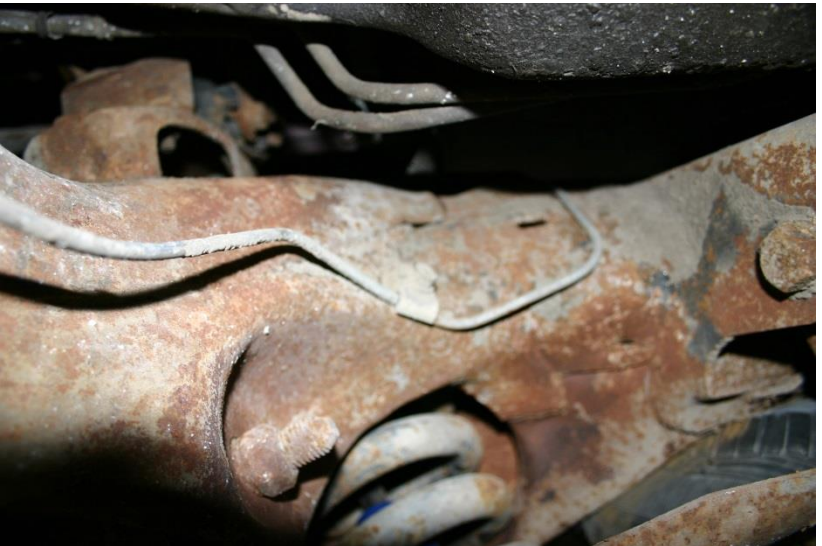
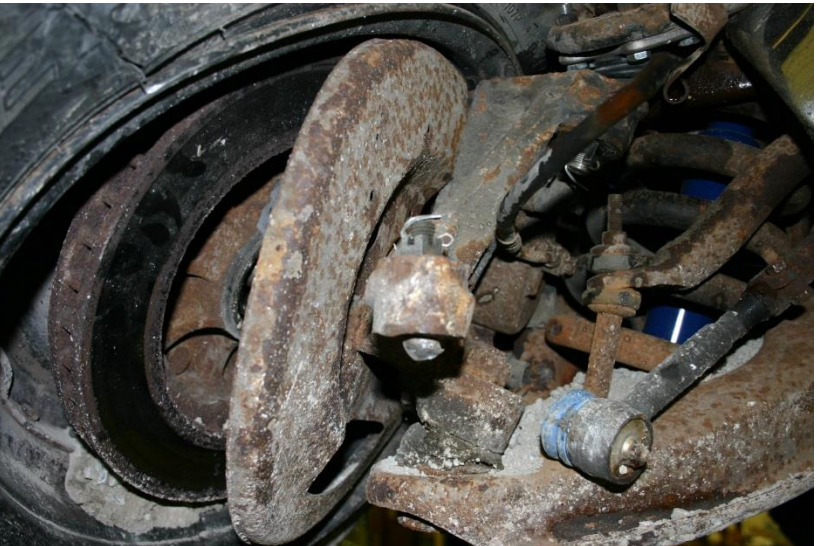
Figure 44. Vehicle Undercarriage Damage, Test No. AZRP-1

The lower-right control arm was scraped and crushed. The right control arm, front frame joints pulled through the frame. The lower-right shock mount bent inward, and the right spring pushed out of the lower spring pocket. The right sway bar bent rearward. The lower-right control arm mounts, the right sway bar frame mount, and the right idler arm deformed inward. The right steering knuckle, wheel bearing fractured, and the tie rod fractured at the knuckle. The drive shaft carrier bearing disengaged away from the mount. The rear transmission mount separated, and the transmission deformed upward 3½ in. (89 mm) and 1½ in. (38 mm) toward the left side. The right frame rail bent inward and forward of the transmission cross member. The frame rail

crushed inward 4½ in. (114 mm) at the right-front cab mount. The right frame rail at the lower control arm mount deformed inward 4 in. (102 mm) and upward 2¾ in. (70 mm). A 4-in. (102-mm) long tear was found in the frame rail near the lower-rear control arm mount. The right frame horn bent rearward 4½ in. (114 mm) and buckled 12 in. (305 mm) behind the leading edge. The right-front cab frame mount deformed inward, and the bushings separated. The left-rear cab mount bolt fractured, and the cab shifted laterally toward the left side. The right-front brake line was torn.
