*Midwest States Regional Pooled Fund Research Program  
Fiscal Year 2013 (Year 23)  
Research Project Number TPF-5(193) Supplement #56  
NDOR Sponsoring Agency Code RFP-13-MGS-3*

# **INCREASED SPAN LENGTH FOR THE MGS LONG-SPAN GUARDRAIL SYSTEM PART II: FULL-SCALE CRASH TESTING**

MwRSF Research Report No. TRP-03-339-17

April 7, 2017

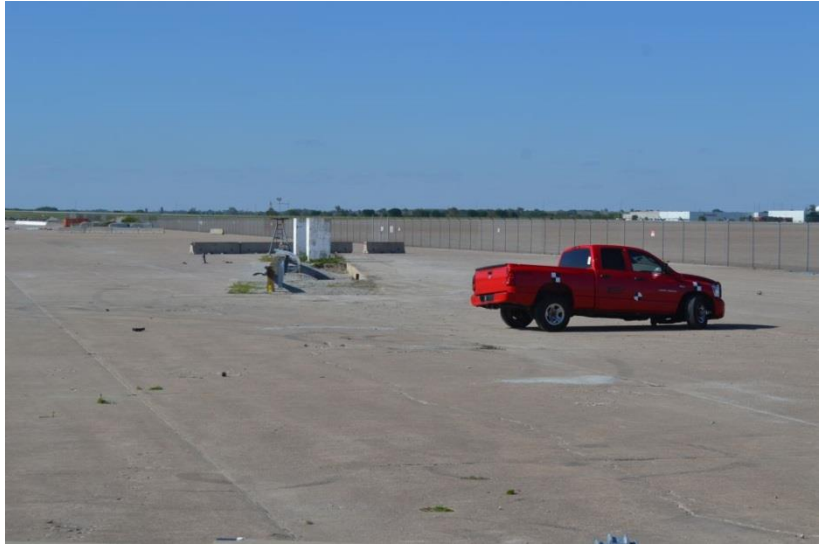
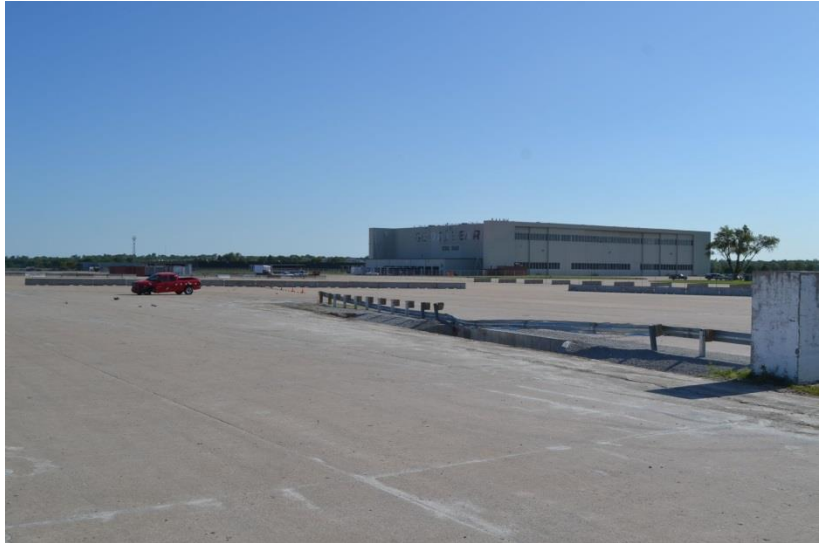
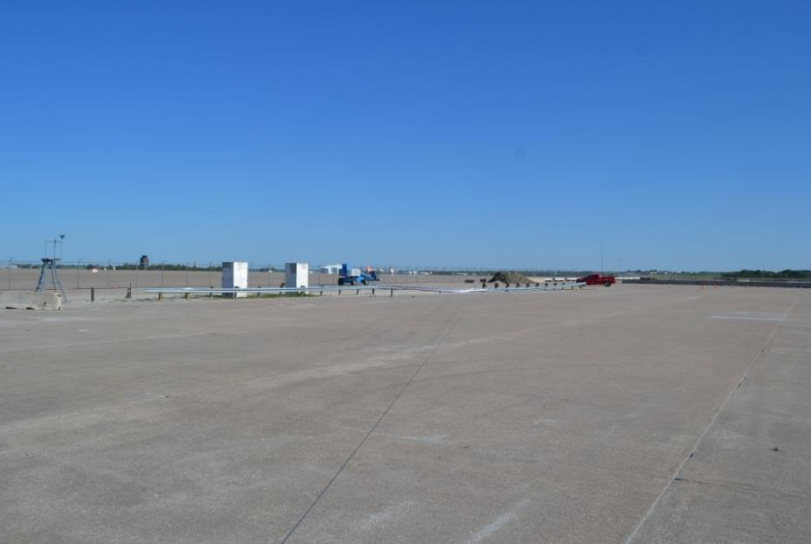
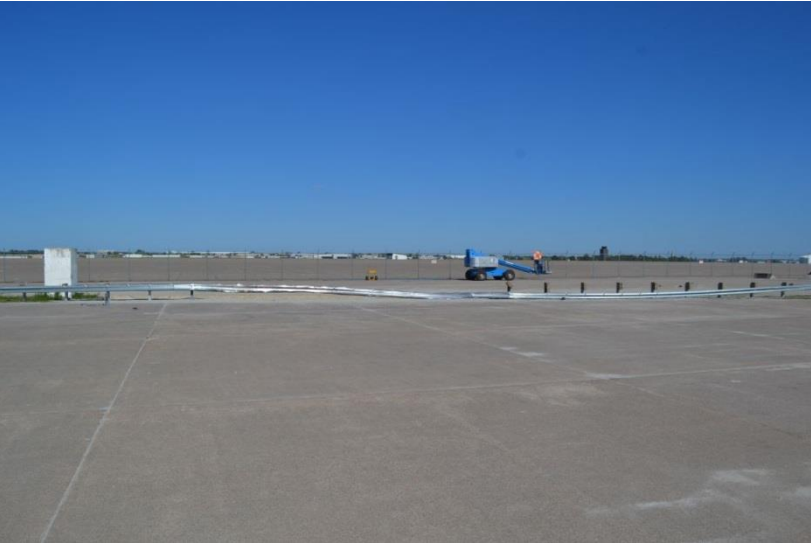
Figure 48. System Damage, Test No. MGSLS-1

Damage to the barrier was moderate, as shown in Figures 48 through 55. All system damage photographs depicted in Figures 48 through 55 were taken after the cable anchors were disassembled and removed from the system. Barrier damage consisted of rail deformation, disengagement of the W-beam rail from the posts, bending of the steel posts, fracture of the wooden posts, and damage to the culvert. The length of vehicle contact along the barrier was approximately 52 ft – 8 in. (16.1 m), which spanned from 1¾ in. (44 mm) downstream from the center of post no. 11 through 34 in. (864 mm) downstream from the center of post no. 15.

Deformation of the W-beam rail occurred between post nos. 2 through 16 with the most significant damage occurring where the vehicle initially contacted the barrier between post nos.

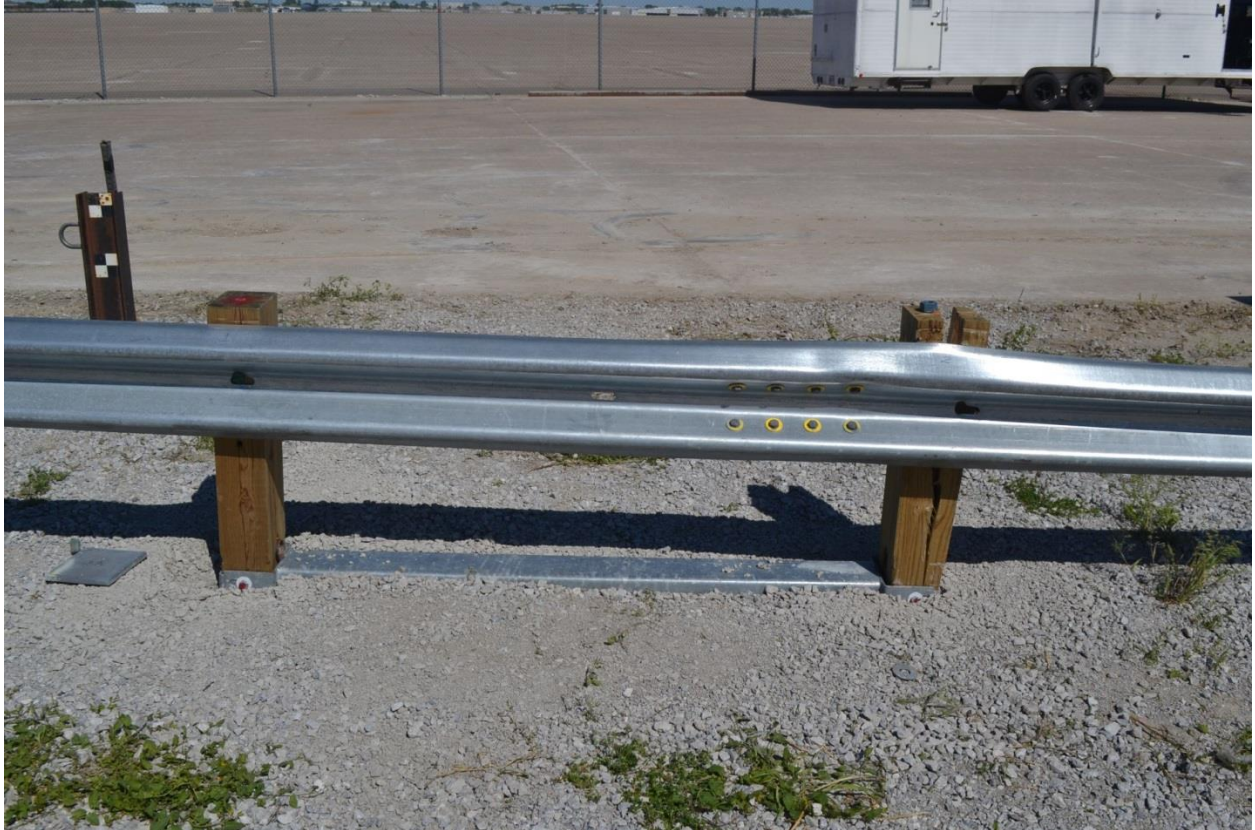
Figure 49. Upstream End Anchor Damage, Test No. MGSLS-1

Wood post damage included splitting, rotation, and displacement of the posts. Post no. 1 rotated downstream and had a 3-in. (76-mm) cut located at the top of the guardrail. A 1¾-in. (44-mm) soil gap was found on the upstream face of post no. 1. Post no. 2 had a 25-in. (635-mm) long vertical crack down the post with a 2-in. (51-mm) opening at the top. The downstream end system anchorage rotated upstream and post no. 25 had a 1-in. (25-mm) soil gap on the downstream side of the post.

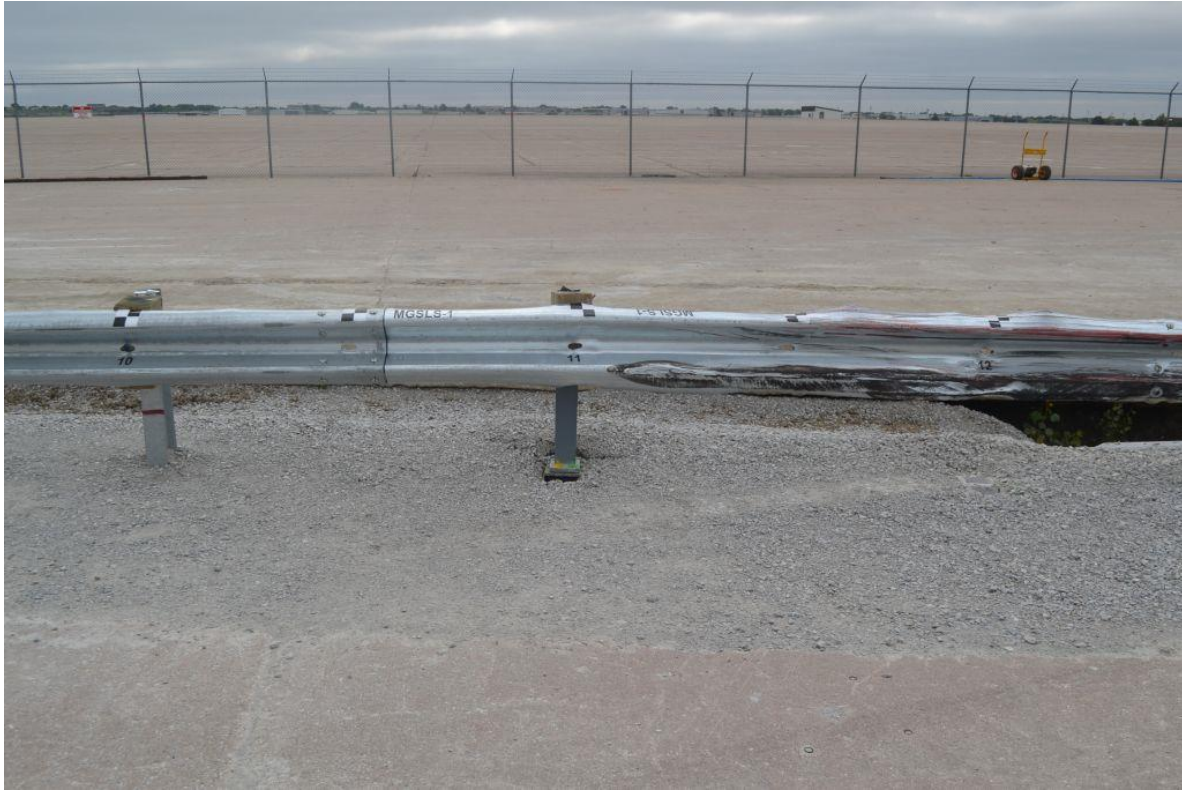
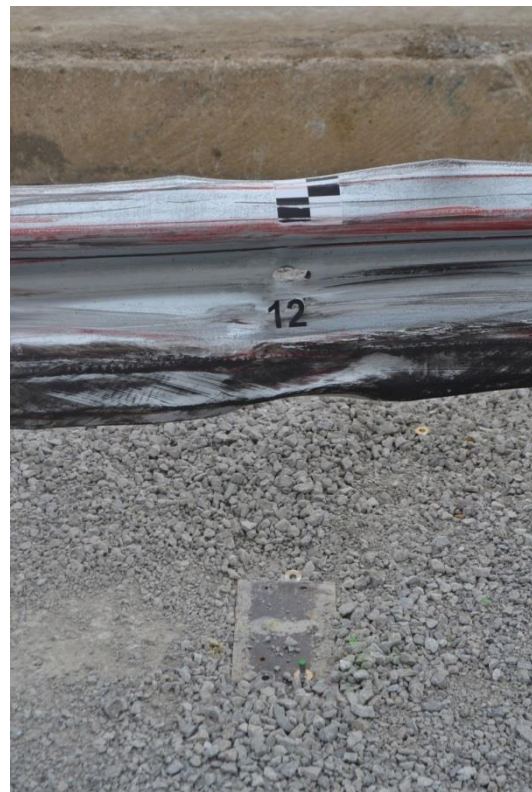
Figure 51. Damage Between Post Nos. 10 and 12, Test No. MGSLs-1

Steel post damage included twisting, rotation, and detachment from the post bases. Post no. 10 twisted downstream. Post no. 11 rotated backward and twisted downstream. Post no. 15 rotated backward and downstream. Post nos. 12, 13, and 14 disengaged from the rail and the post bases. At post no. 12, the baseplate bent ¼ in. (6.4 mm) downward. At post no. 13, the lower section of the post rotated backward and was found with the two bolts on the front of the baseplate to be missing and the two bolts on the back side bent backward. Soil gaps of 1 in. (25

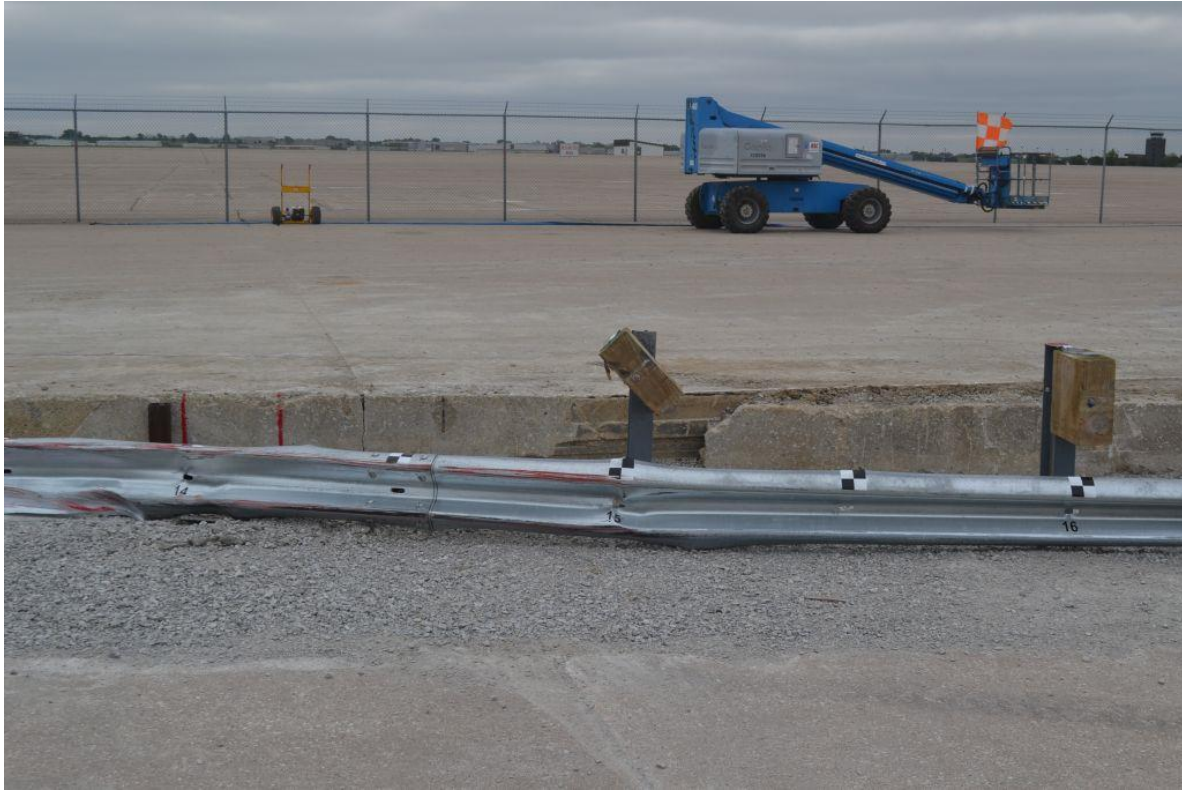
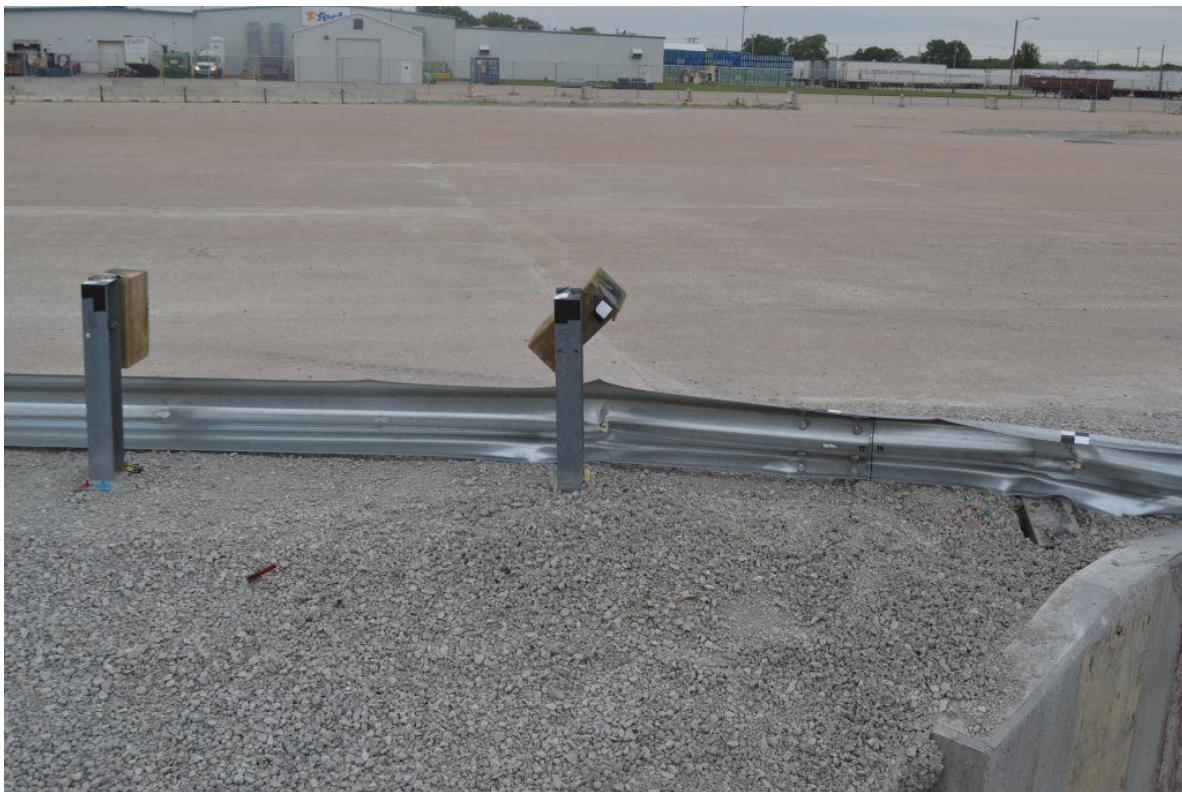
Figure 54. Damage Between Post Nos. 14 and 16, Test No. MGSL-1

mm) or less were found at post nos. 1, 2, and 10, while soil heaves and craters were found around post nos. 11 and 13 through 15. Post no. 14 had the largest soil movement with a 40-in. (1,016-mm) diameter by 2-in. (51-mm) tall soil heave and an 18-in. (457-mm) diameter by 10-in. (254-mm) deep soil crater. Post no. 11 also had relatively-large soil movement with a 32-in. (813-mm) diameter by 4-in. (102-mm) tall soil heave and a 6-in. (152-mm) diameter by 22-in. (559-mm) deep soil crater.

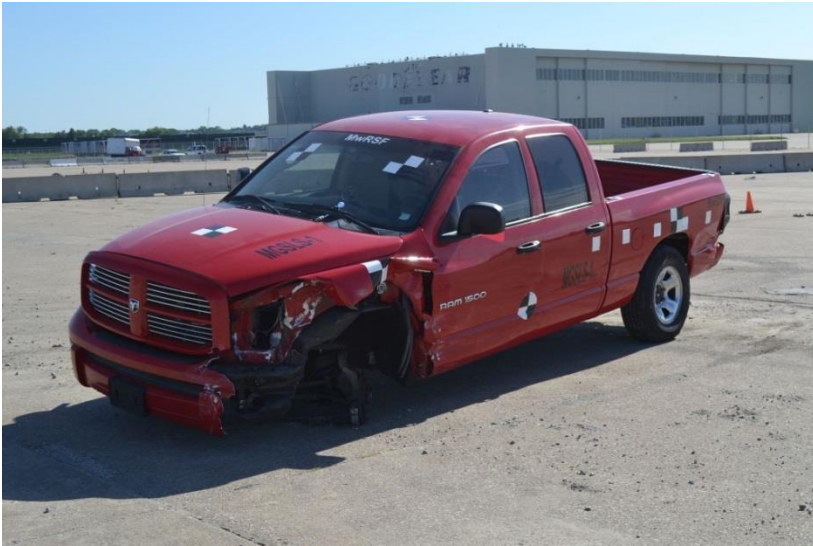
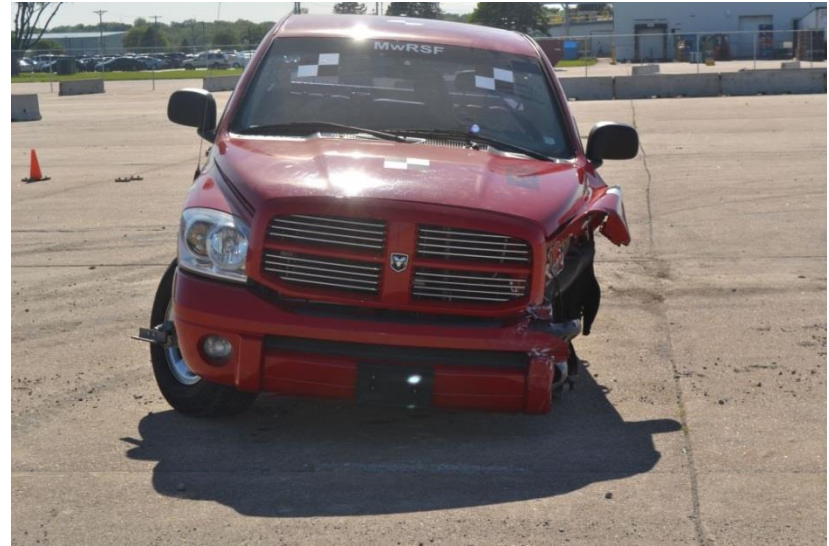
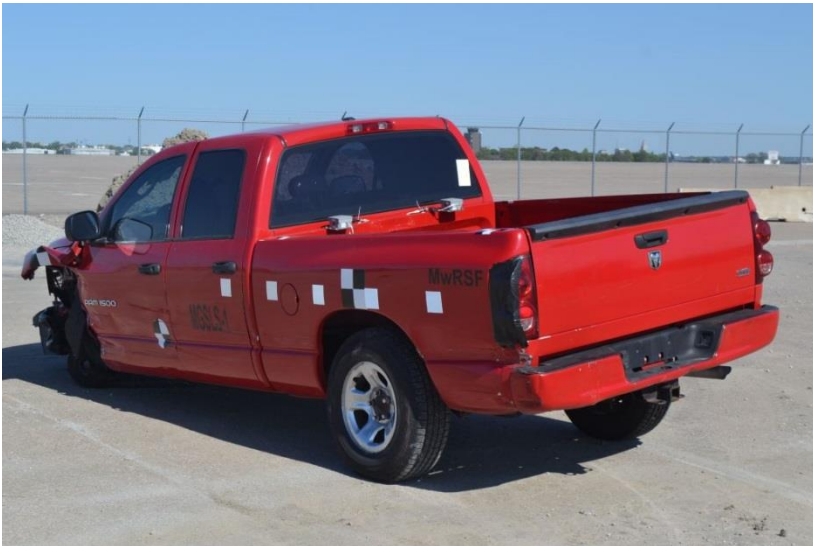
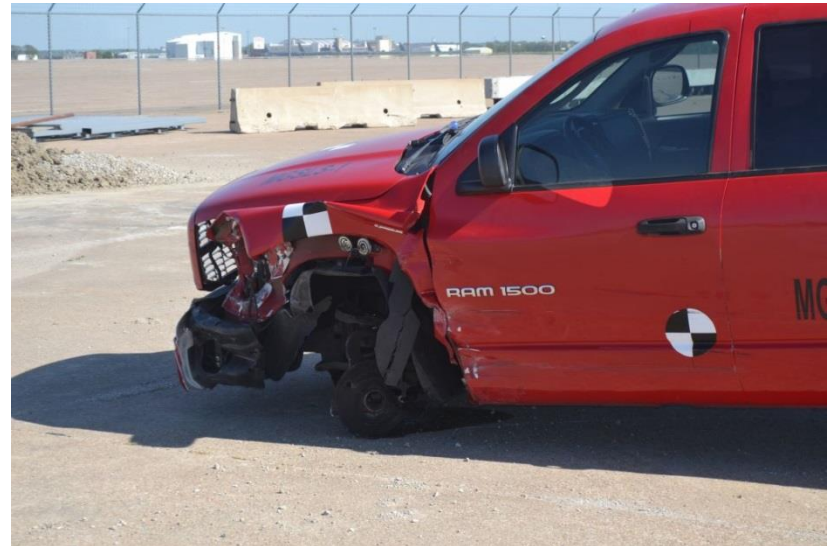
Figure 56. Vehicle Damage, Test No. MGSLS-1

The damage to the vehicle was moderate, as shown in Figures 56 through 58. The maximum occupant compartment deformations are listed in Table 5 along with the deformation limits established in MASH for various areas of the occupant compartment. Note that none of the MASH-established deformation limits were violated. Complete occupant compartment and vehicle deformations and the corresponding locations are provided in Appendix D.

The majority of the damage was concentrated on the left-front corner and left side of the vehicle where the impact occurred. The left side of the bumper fractured 23 in. (584 mm) left of center and was kinked 12 in. (305 mm) from the top. An 18-in. x 11-in. (457-mm x 279-mm) piece disengaged from the left fender starting at the hood. The left fender also had a 9-in. (229-mm) deep x 23-in. (584-mm) diameter dent. A 16-in. (406-mm) long kink occurred longitudinally in line with the base of the A-pillar, 6 in. (152 mm) down from the hood. The left fender separated 2 in. (51 mm) from the left-front door, and gouging occurred on the left fender and the left-front door. The top of the plastic wheel well on the left-front side of the vehicle had a 4-in. (102-mm) crack. The left-front rim was dented and kinked. The left-front steering knuckle cracked at the tie rod flange and the wheel bearing disengaged. The left-front wheel disengaged from the vehicle. Tears were also found on the left-front tire. Tears and gouges were found on the left side of the grill, which was partially detached from the vehicle. The left-side headlight disengaged from the vehicle. Contact marks extended the length of the left side of the vehicle. Dents were found on the left-front door near the bottom and the top of the door had separated ½ in. (13 mm). A 25-in. (635-mm) long by 4-in. (102-mm) tall by 2-in. (51-mm) deep dent

occurred on the left-rear quarter panel between the wheel well and the rear of the vehicle, 11 in. (279 mm) from the bottom of the panel. The rear bumper was slightly kinked 22 in. (559 mm) left of center. A 5-in. x 2-in. (127-mm x 51-mm) piece of the rear bumper partially disengaged. The front hood had a gap of 2 in. (51 mm) on the right side. Although the steering rack appeared to be intact, power steering fluid was found to be leaking from the vehicle. The roof and all vehicle windows remained undamaged.

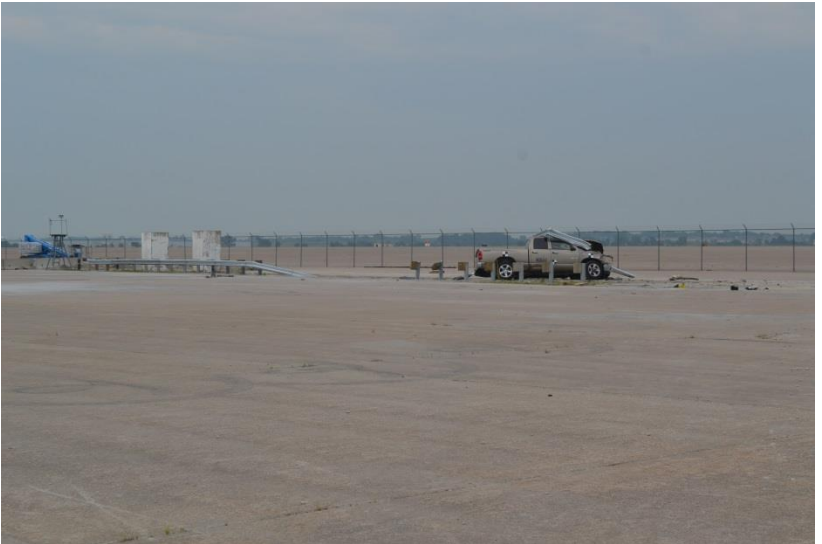
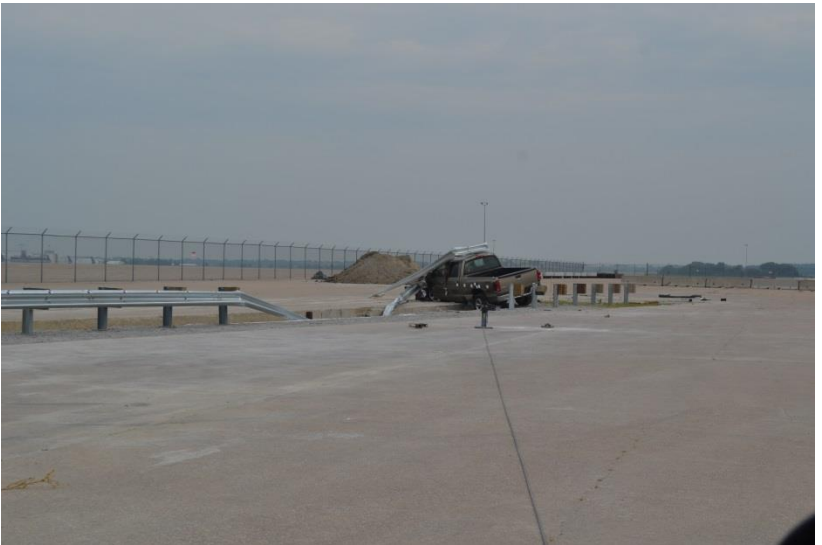
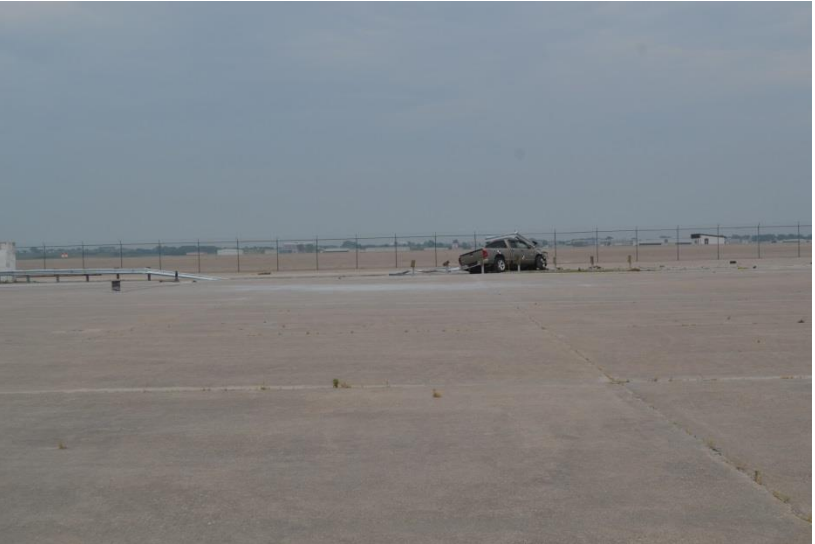
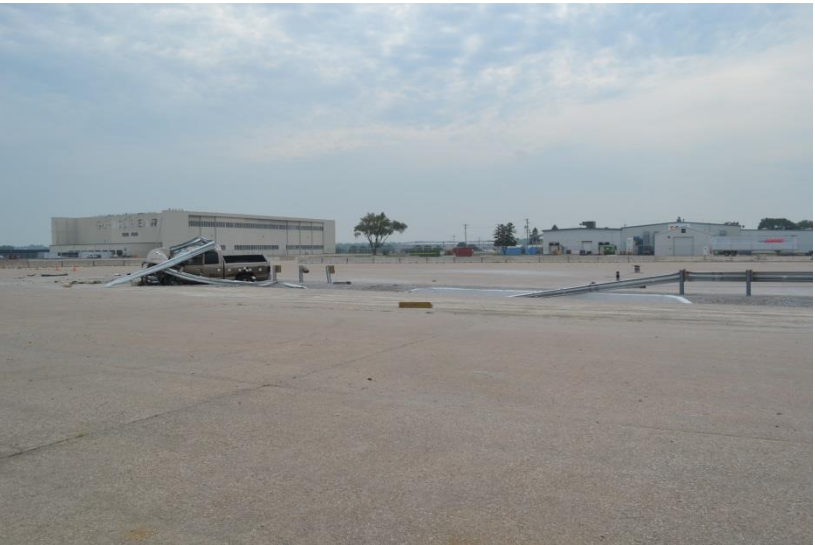
Figure 68. System Damage, Test No. MGSLS-2

Damage to the barrier system was severe, as shown in Figures 68 through 79. Barrier damage consisted of rail deformation and tearing, disengagement of W-beam rail away from posts, bending of steel posts, fracture of wood posts, and damage to the concrete culvert. The length of vehicle contact along the barrier was approximately 80 ft (24.4 m), which began 239<sup>7</sup>/<sub>8</sub> in. (6.1 m) upstream from post no. 13 and extended through the end of the barrier system.

Deformation of the W-beam rail occurred at post no. 2 as well as between post no. 13 and the downstream end of the barrier system. A majority of the damage occurred between post no. 14 and the downstream end of the system. At post no. 2, the top corrugation of the guardrail was slightly bent. At post no. 13, there was a kink in the guardrail that extended the height of the rail. Numerous kinks were found on the guardrail between post nos. 13 and 14. Flattening of the bottom corrugation on the guardrail began 15 in. (381 mm) upstream from post no. 14 and extended to 16½ in. (419 mm) downstream from post no. 16. The rail released from the posts at post nos. 1, 2, 24, and 25. The rail released from the blockouts at post nos. 3, 5, 6, 9, and 11 through 23. Tearing occurred at post no. 17 at the top corrugation that was 2 in. (51 mm) long, and there was a 1½-in. (38-mm) long tear on the bottom corrugation. There was also a ½-in. (13-mm) long tear at the bottom of the corrugation 17 in. (432 mm) downstream from post no. 16. Tearing was also present on the top of the rail 6 in. (152 mm) upstream from post no. 25 that was 3 in. (76 mm) long by 1¼ in. (32 mm) deep. There was buckling located at post no. 17 that

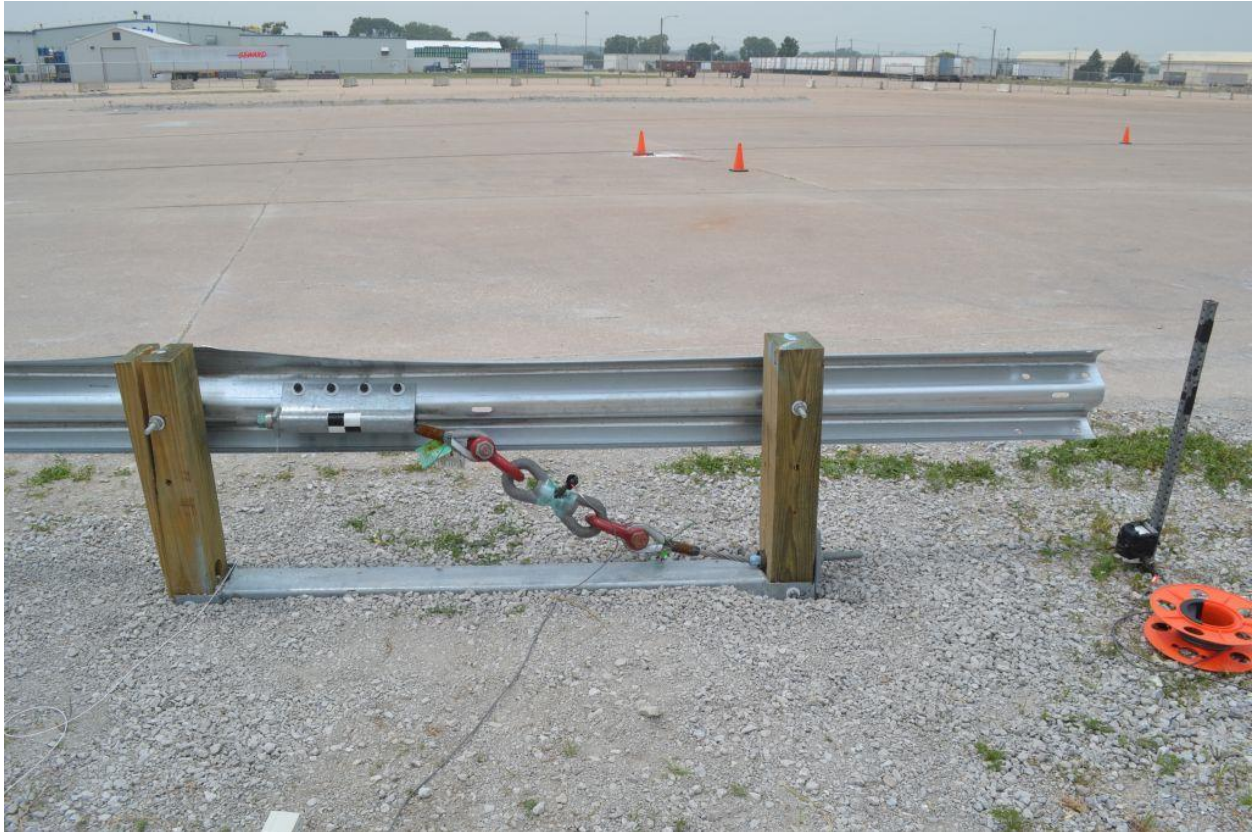
Figure 69. Upstream End Anchor Damage, Test No. MGSLS-2

Wood post damage included fracturing, gouging, and displacement of posts. Post no. 1 had gouging on the front face due to rail contact. Post no. 2 split vertically along the height of the post through the guardrail bolt hole on the front side of the post. Post nos. 24 and 25 fractured at the ground line and post no. 24 also split along the vertical plane of the centerline of the post. Post no. 25 had a 7½-in. (191-mm) deep by 3-in. (76-mm) wide crack located 2¼ in. (57 mm) downward from the top of the back face of the post, as well as a 3-in. (76-mm) diameter dent on the back downstream face of the post.

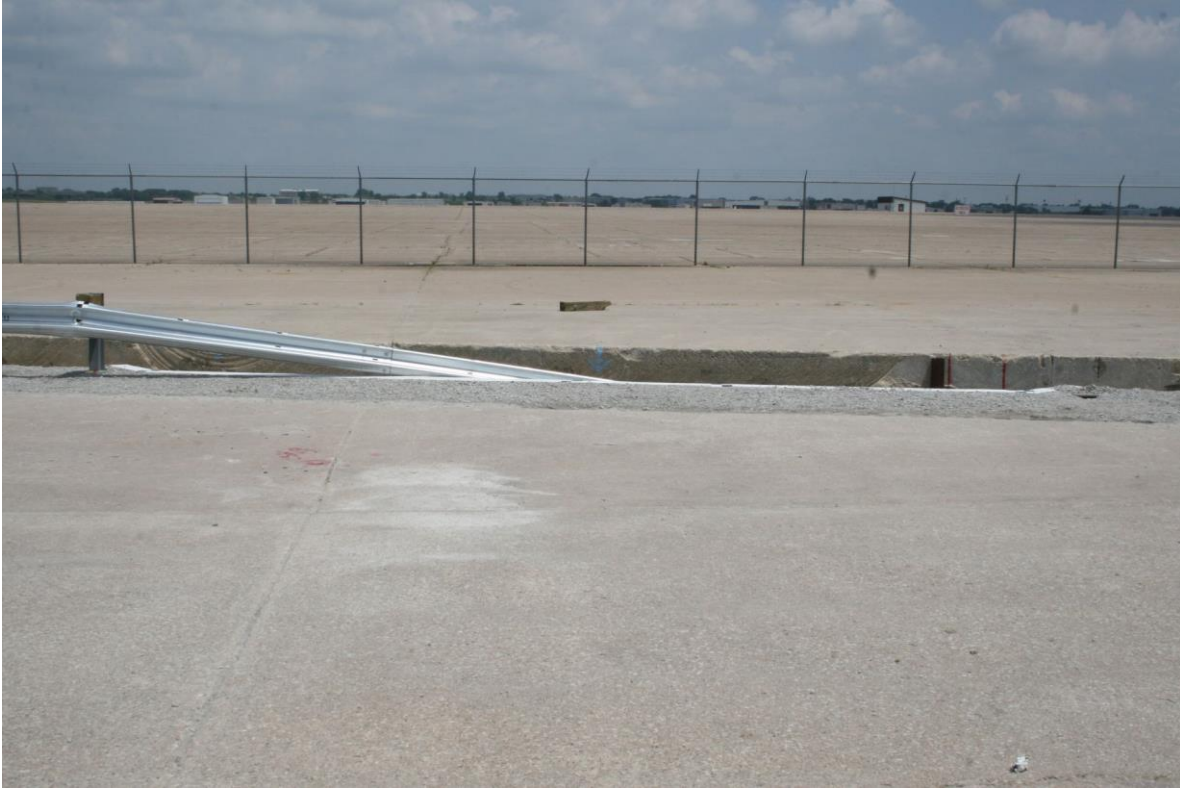
Figure 73. Damage at Post No. 14, Test No. MGSLS-2

Steel post damage included twisting, rotation, and detachment from the post bases. UBSP post nos. 14 through 16 fractured at the ground line. The baseplate for post no. 14 rotated backward, and the back-side upstream flange twisted upstream. The baseplate for post no. 14 was also dented on the back-side and the top of the downstream side. There were also contact marks on the lower 9½ in. (241 mm) of the front face of the post. The front web and flange of post no. 15 twisted upstream, and the base plate rotated backward. There were contact marks found on the top of the front flange of post no. 16 that extended 9¼ in. (235 mm) downstream. Post no. 17 bent downstream, and post no. 18 bent backward 1½ in. (38 mm) at the top of the upstream flange.
