# **MASH TEST NO. 3-10 OF A NON-PROPRIETARY, HIGH-TENSION CABLE MEDIAN BARRIER FOR USE IN 6H:1V V-DITCH (TEST NO. MWP-8)**

MwRSF Research Report No. TRP-03-331-17

May 10, 2017

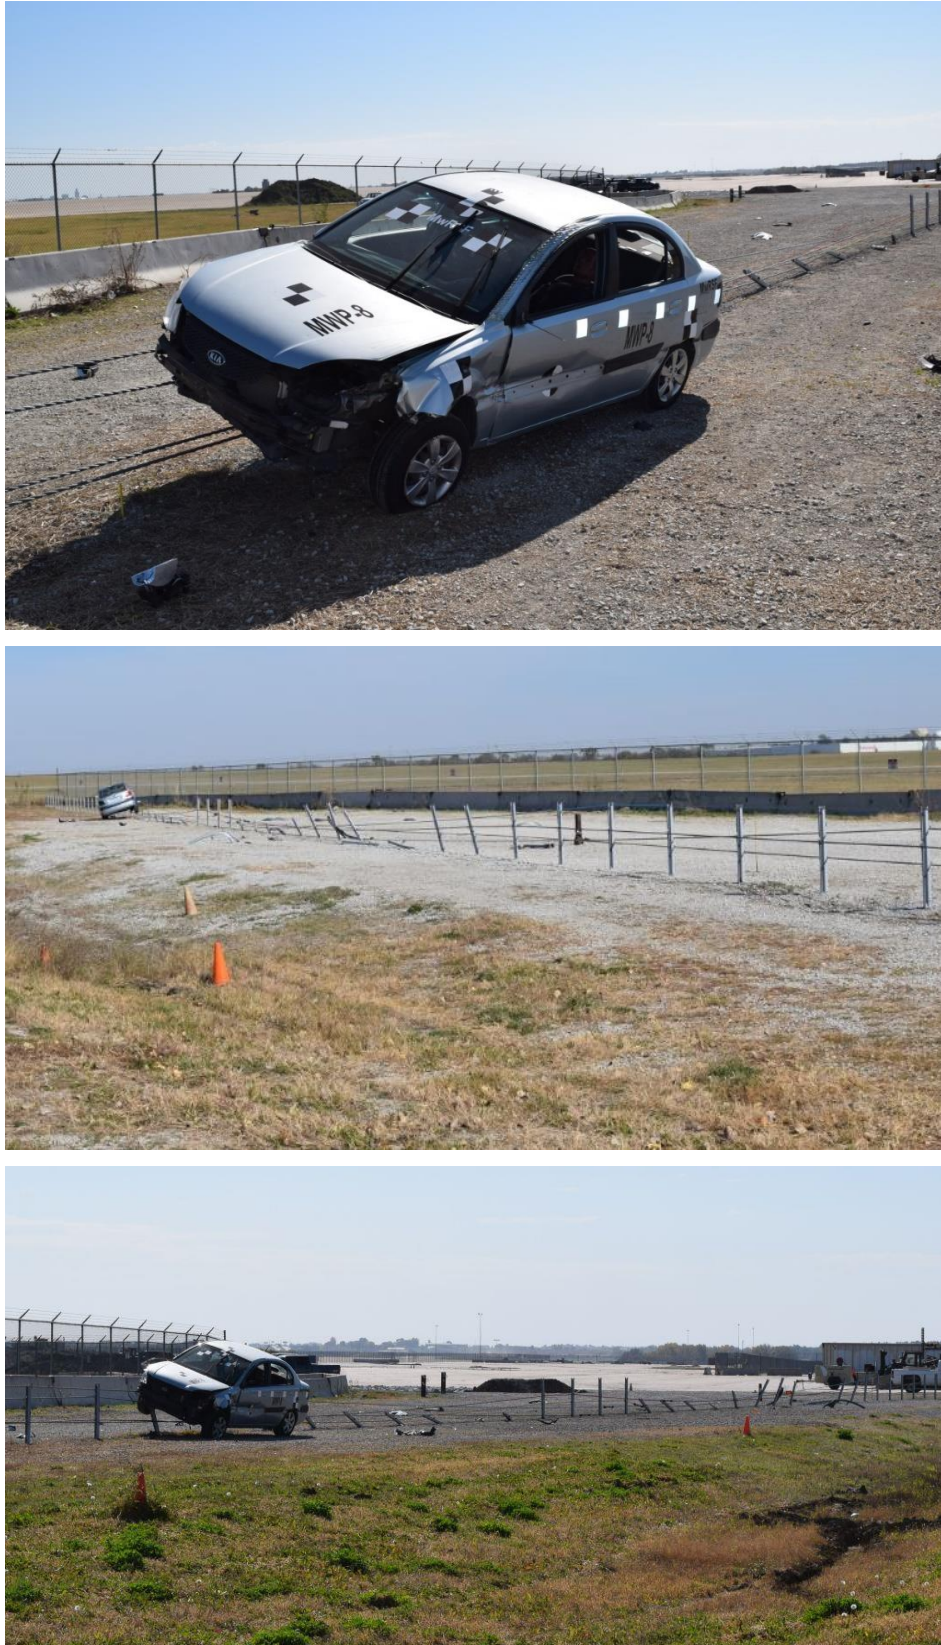
Damage to the barrier was moderate, as shown in Figures 45 through 73. Barrier damage consisted of bent posts, disengaged cables, and deformed brackets. At its final resting position, the vehicle was still in contact with the cables. Cable nos. 2 and 3 were underneath the vehicle while cable nos. 1 and 4 were on the non-impact side of the vehicle. The length of vehicle contact along the barrier was approximately 181 ft (55.2 m), which spanned from 3 ft – 4½ in. (1 m) upstream of post no. 31 to post no 53. Table 5 summarizes the release mechanisms of each cable from the posts.

Figure 45. System Damage, Test No. MWP-8

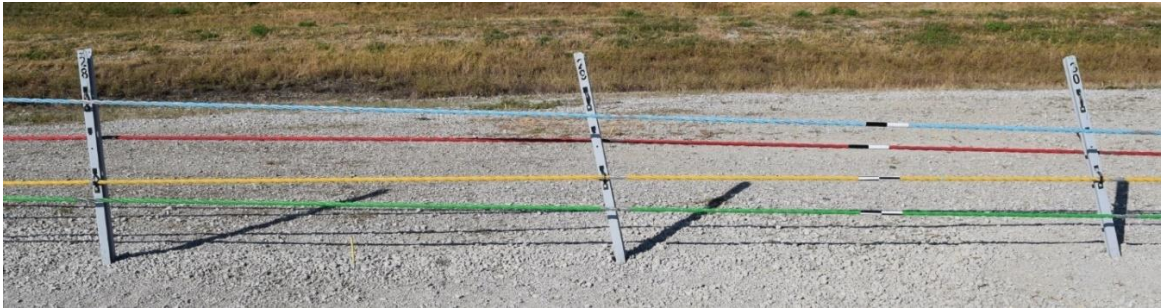
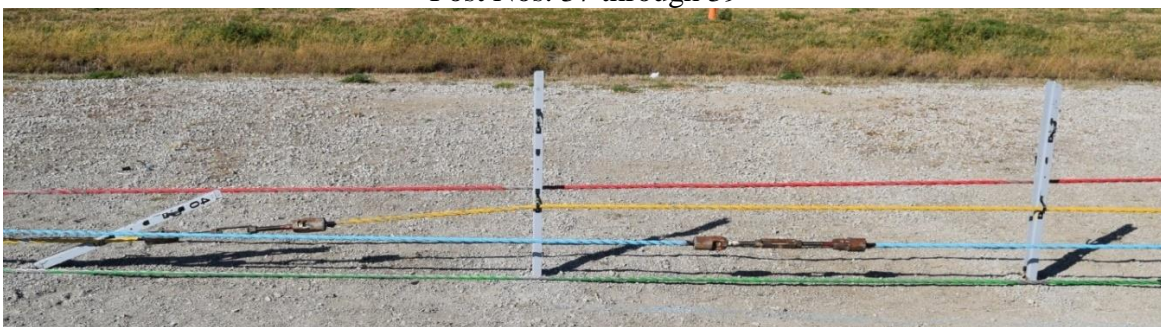
Post Nos. 28 through 30

Post Nos. 40 through 42

Figure 46. Post Damage, Test No. MWP-8

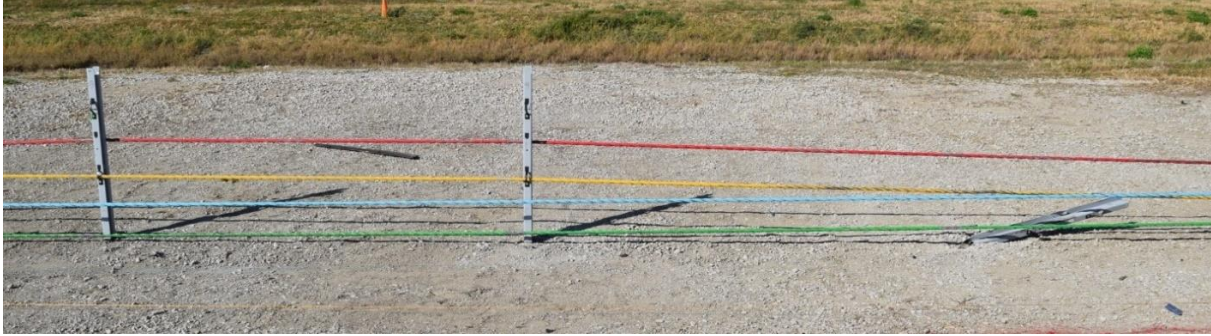
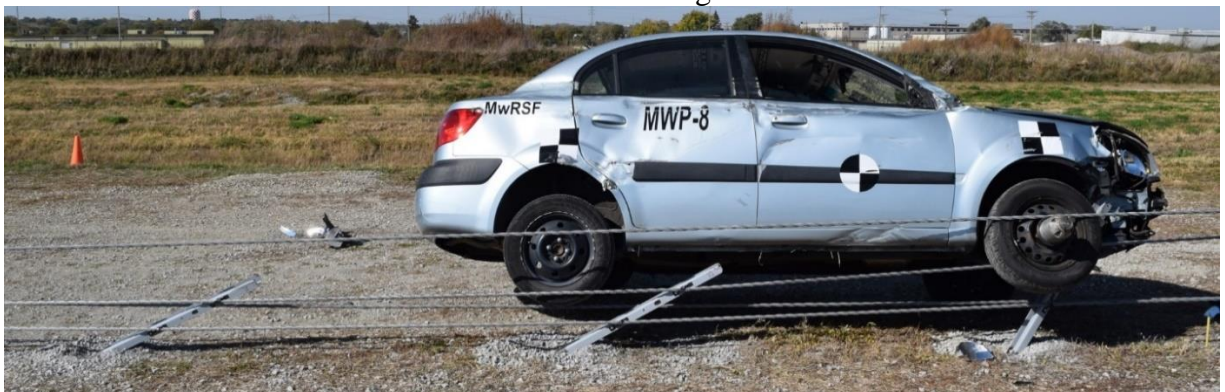
Post Nos. 43 through 45

Post Nos. 51 through 53

Figure 47. Post Damage Continued, Test No. MWP-8

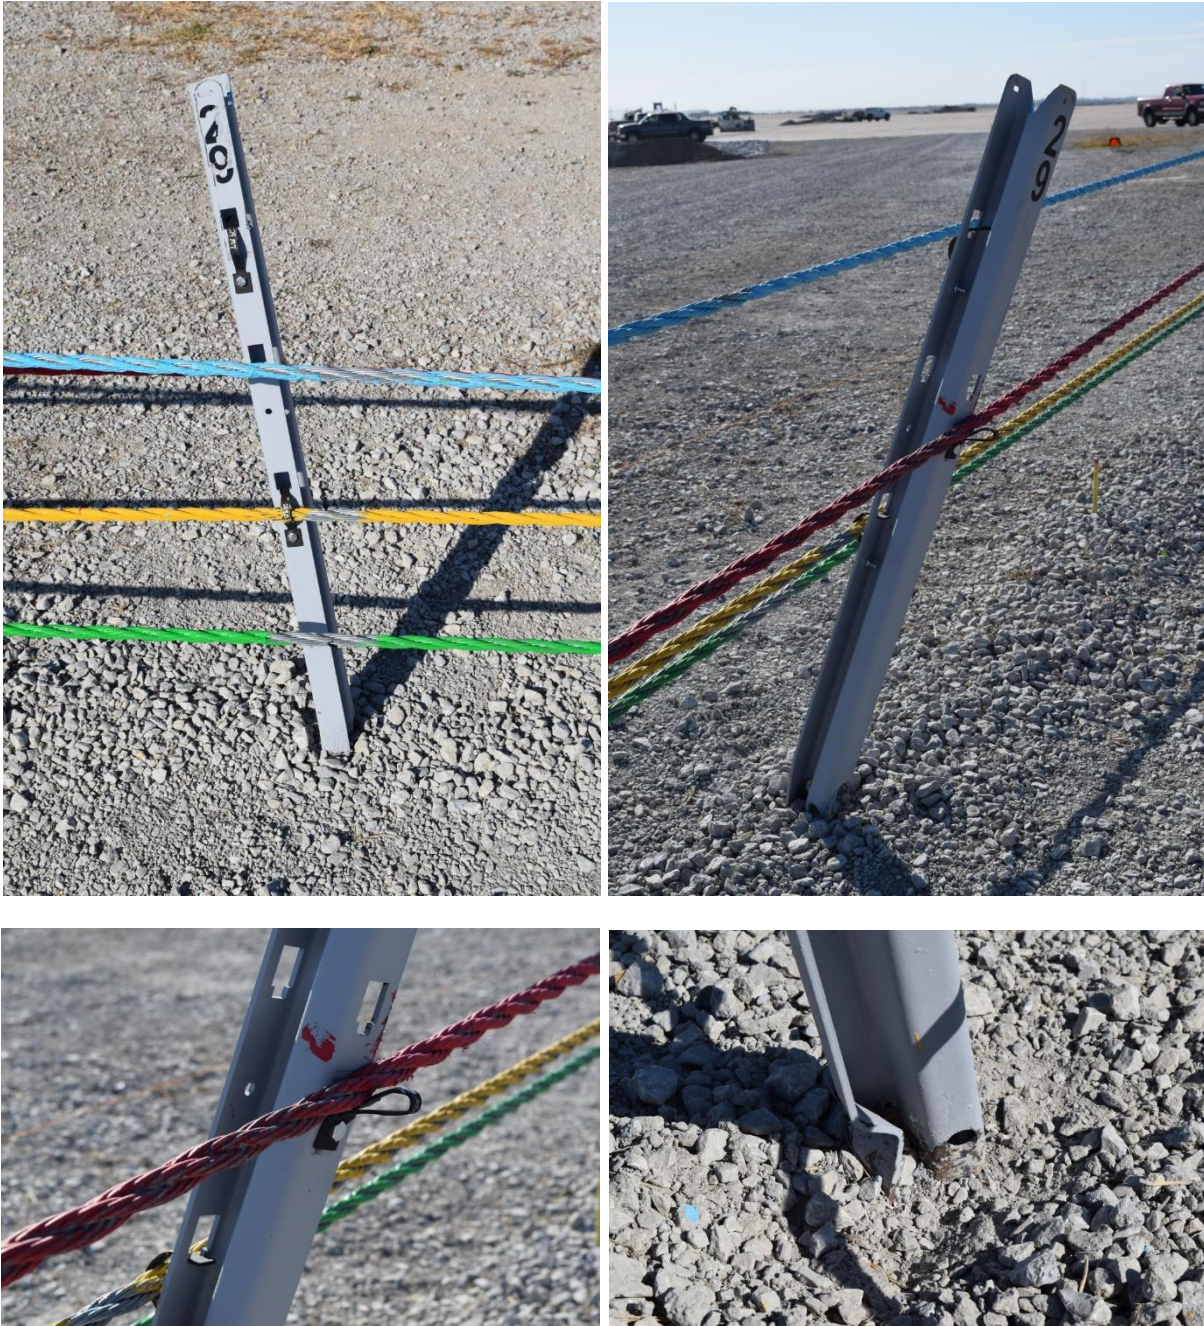
Figure 48. Post No. 29 Damage, Test No. MWP-8

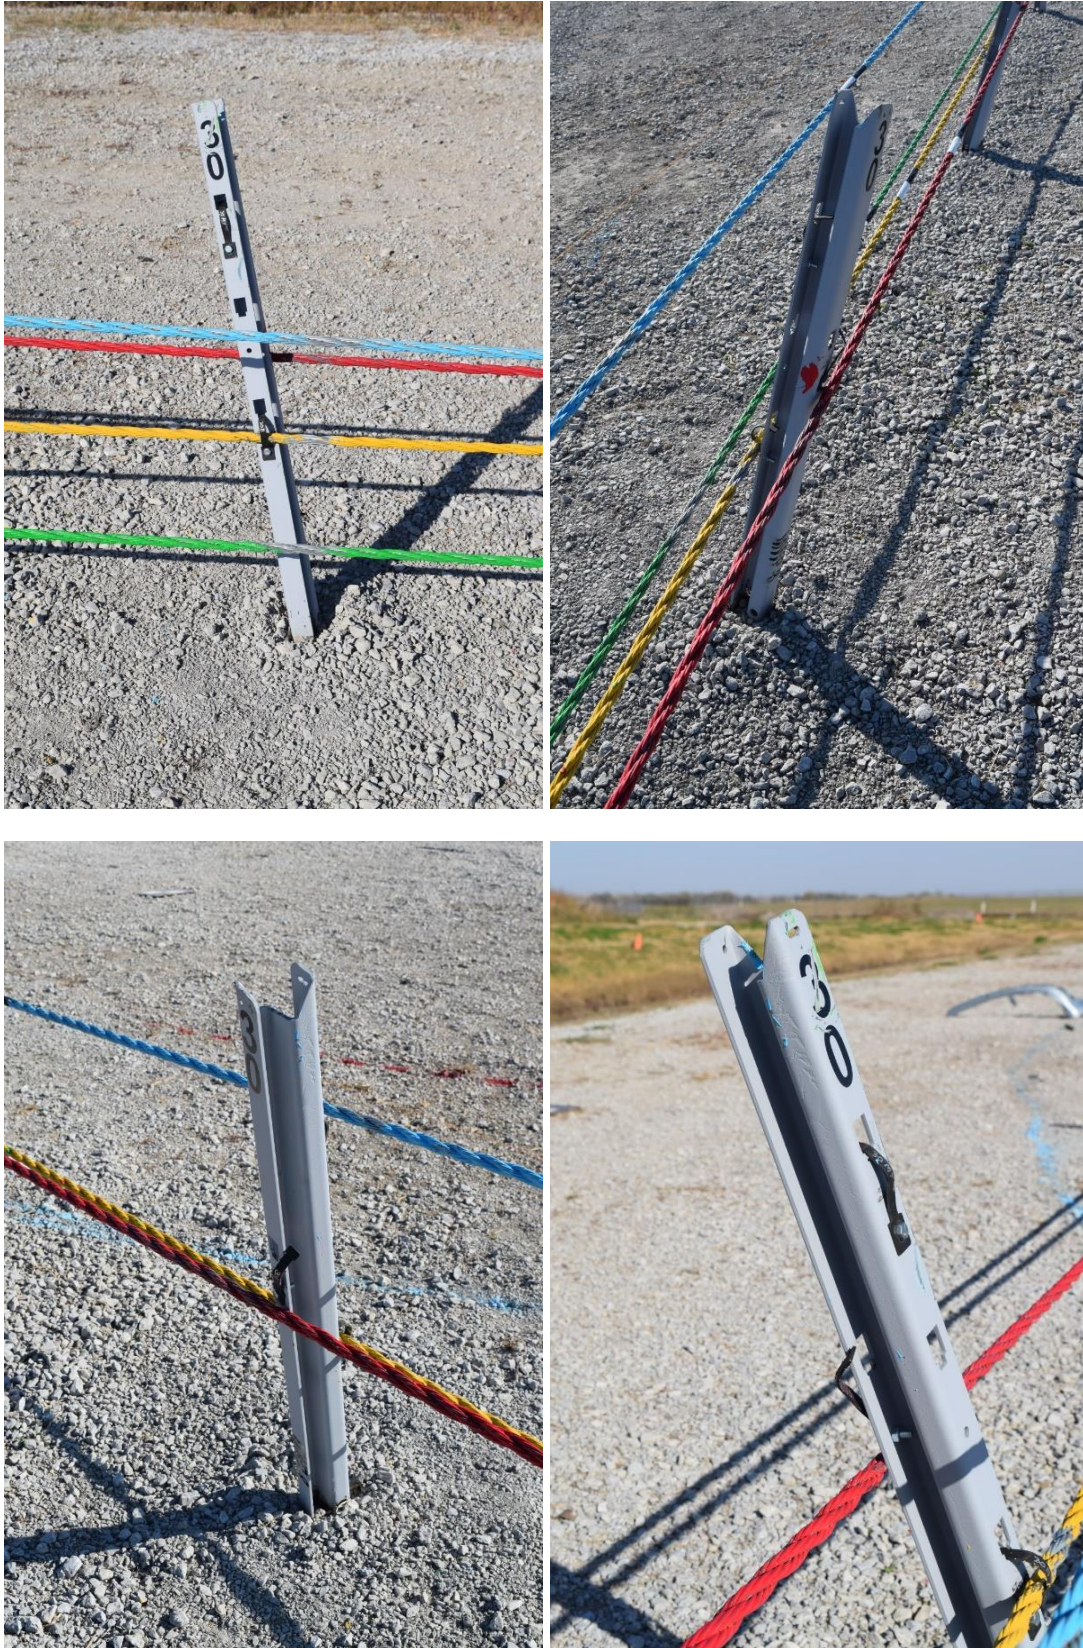
Figure 49. Post No. 30 Damage, Test No. MWP-8

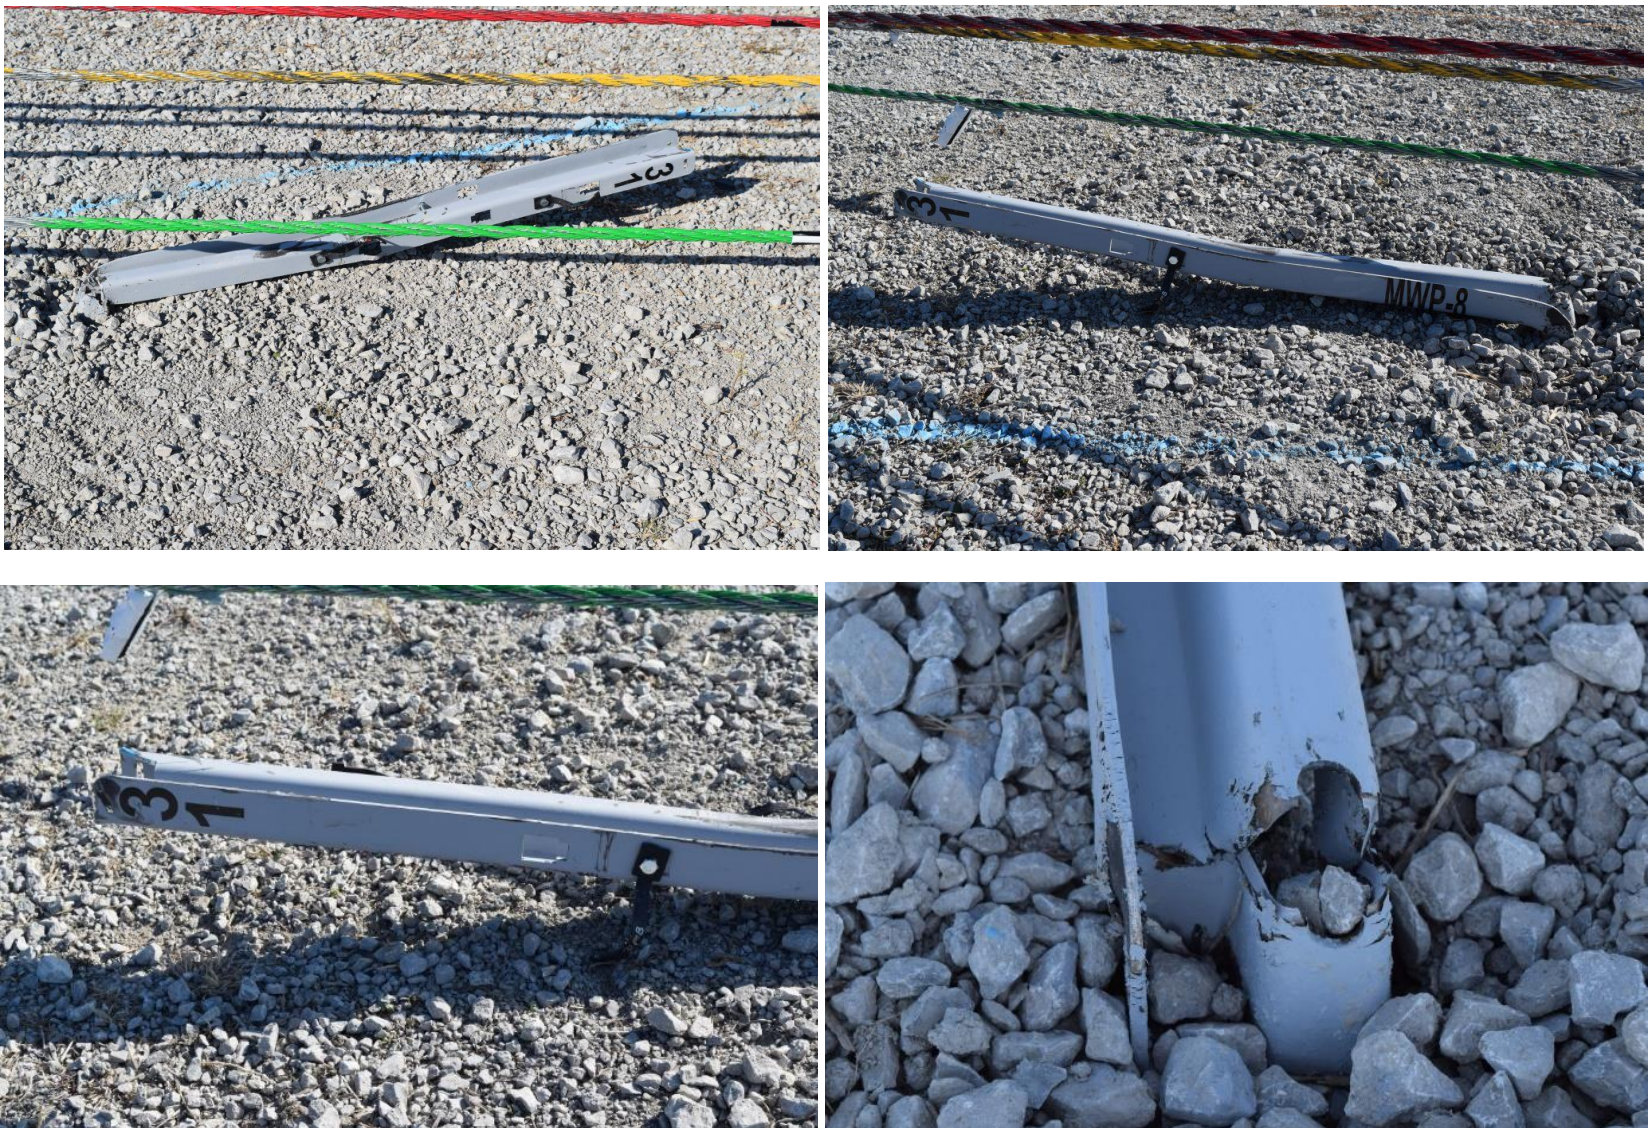
Figure 50. Post No. 31 Damage, Test No. MWP-8

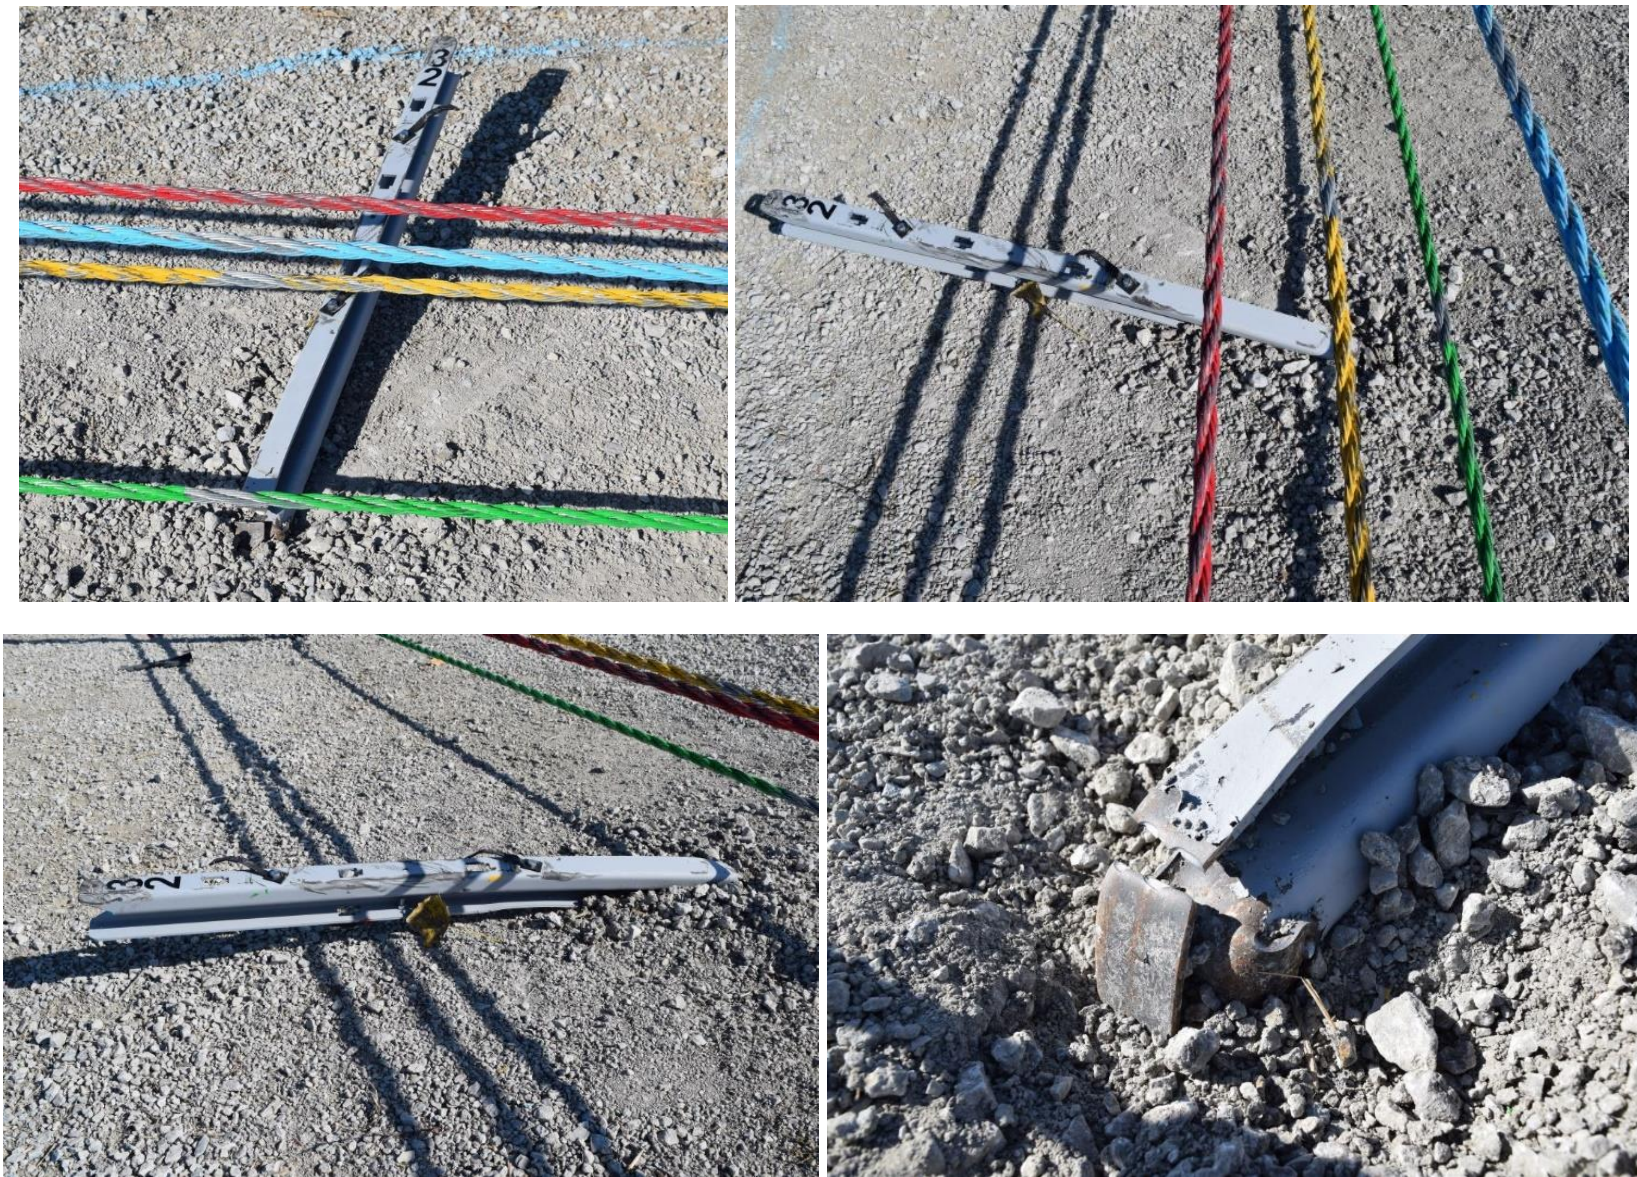
Figure 51. Post No. 32 Damage, Test No. MWP-8

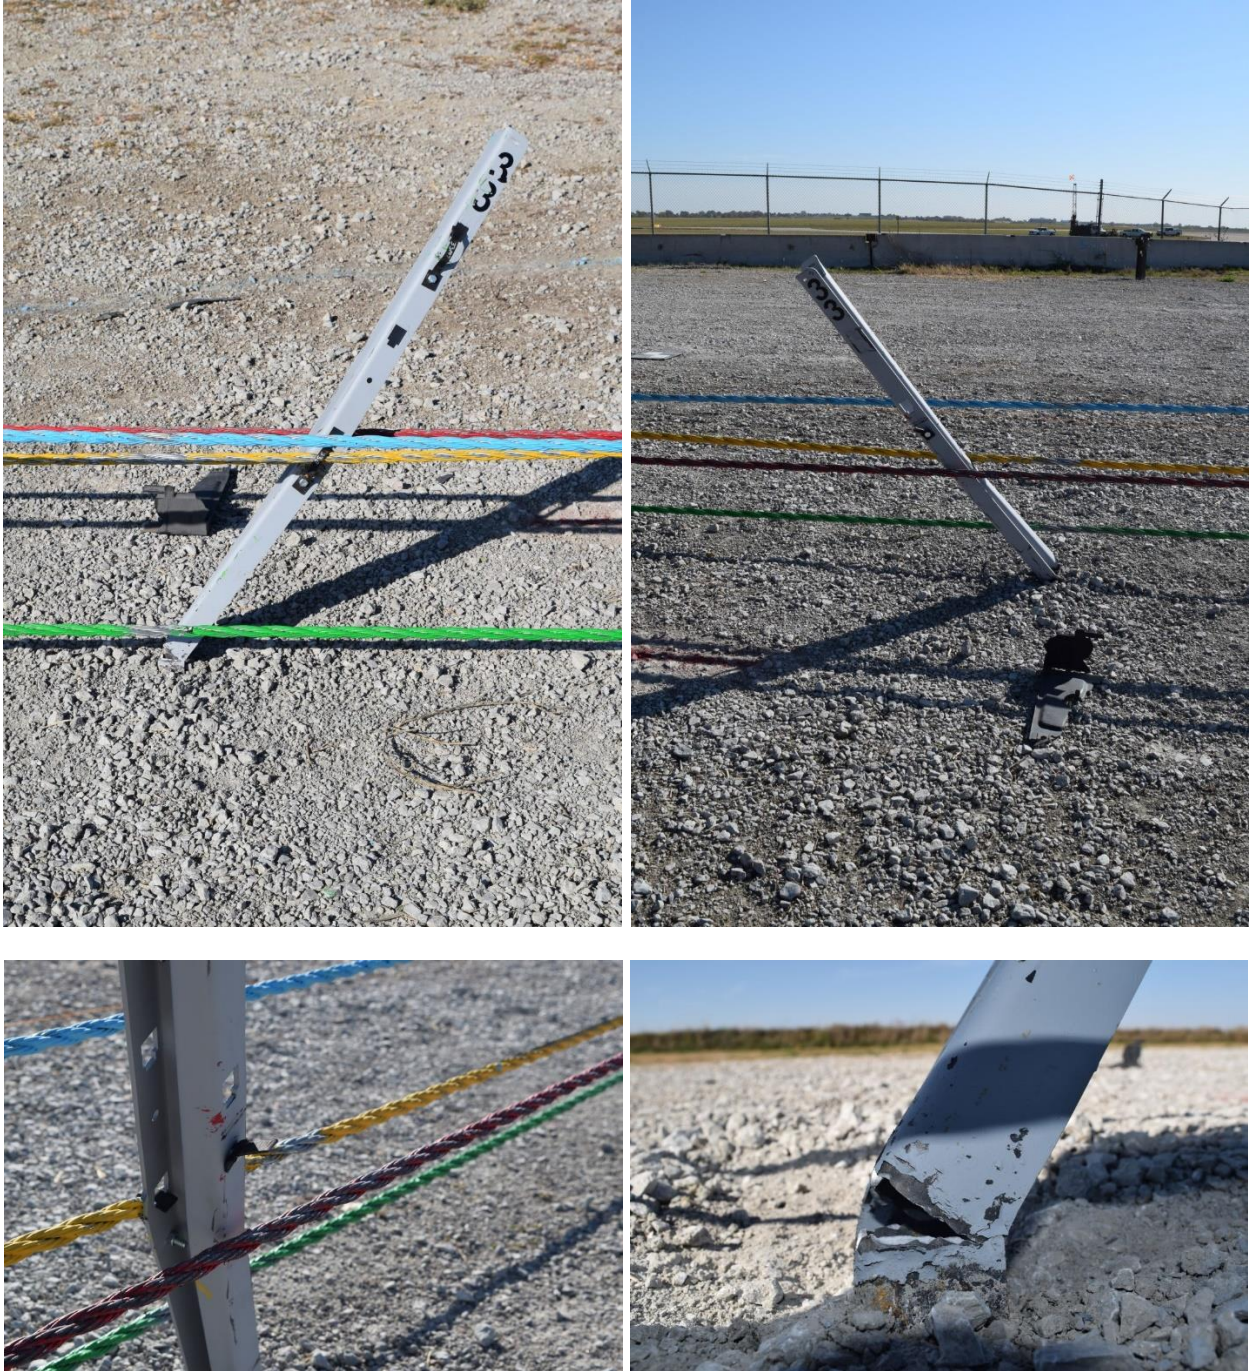
Figure 52. Post No. 33 Damage, Test No. MWP-8

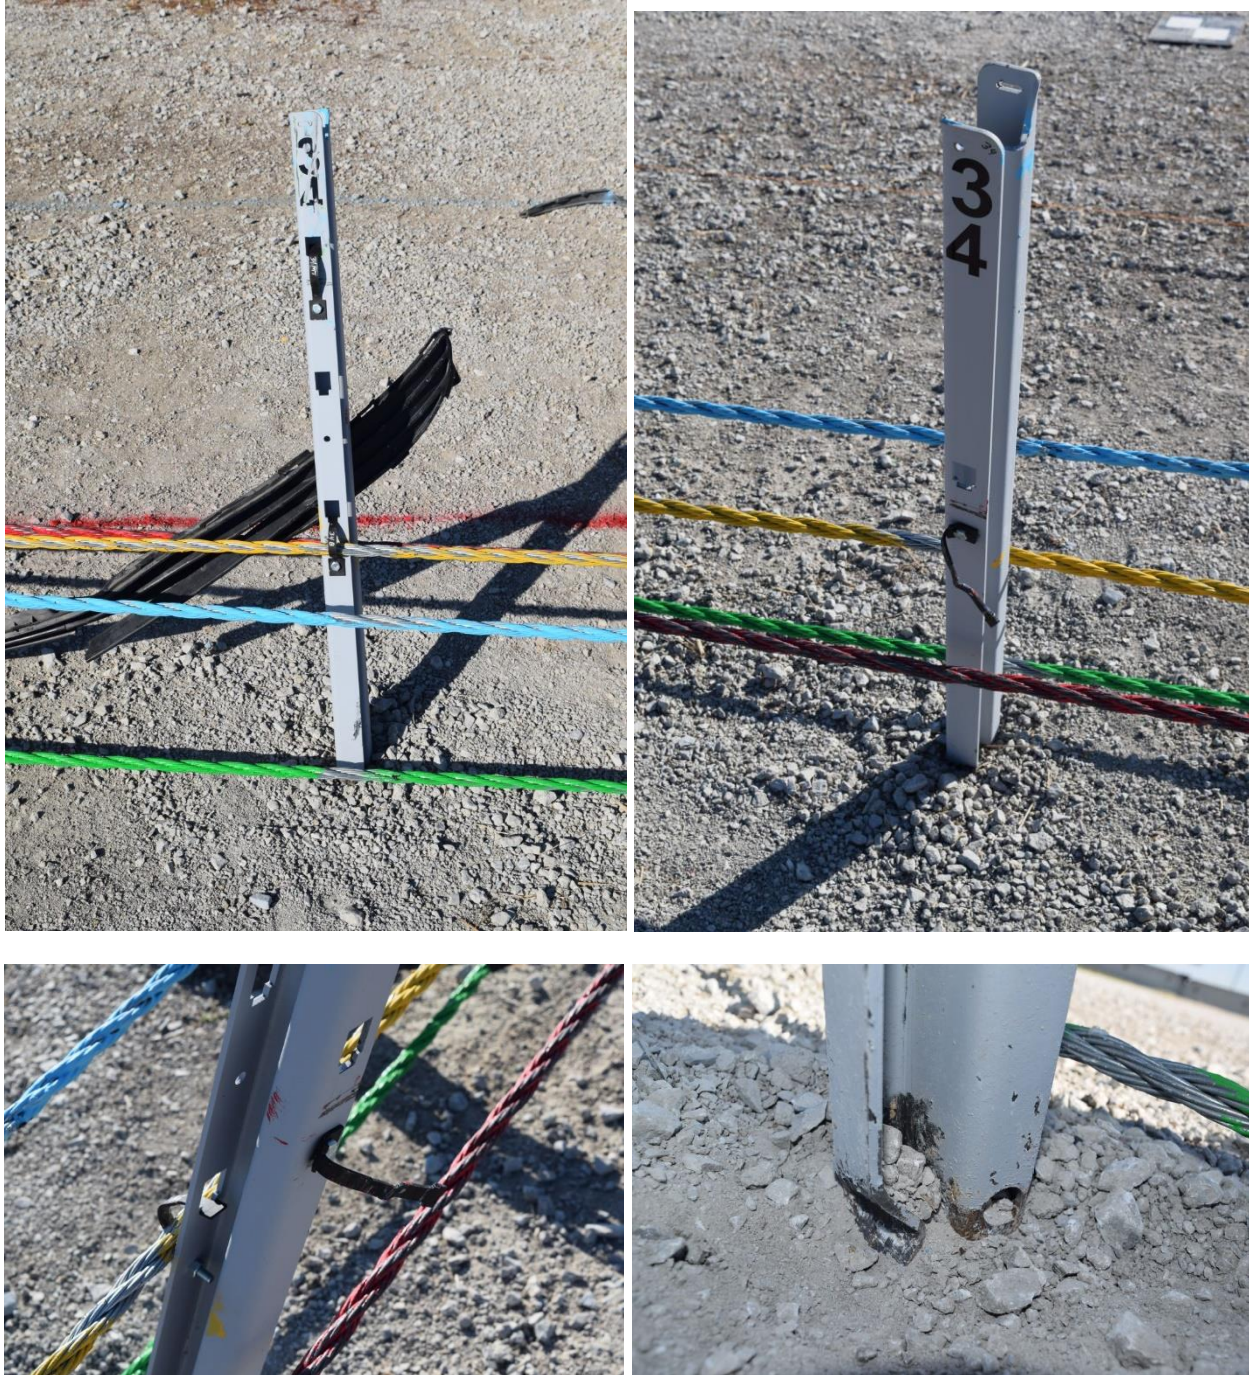
Figure 53. Post No. 34 Damage, Test No. MWP-8

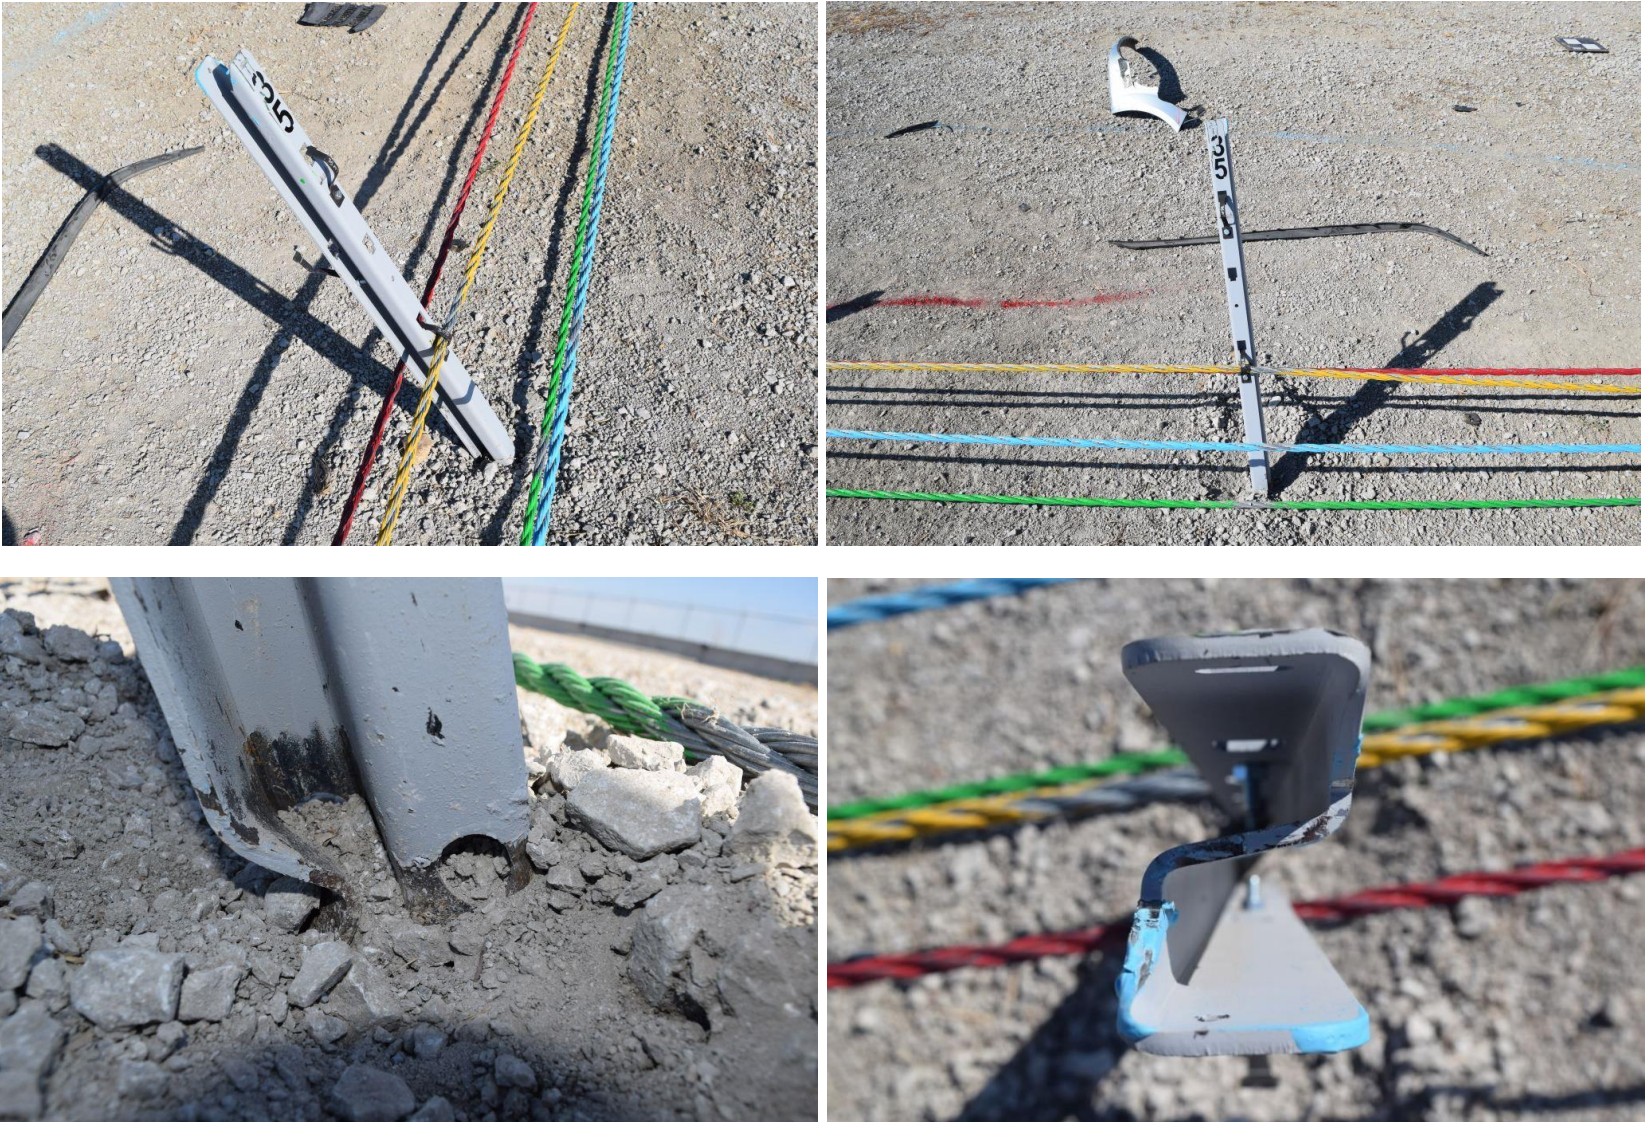
Figure 54. Post No. 35 Damage, Test No. MWP-8

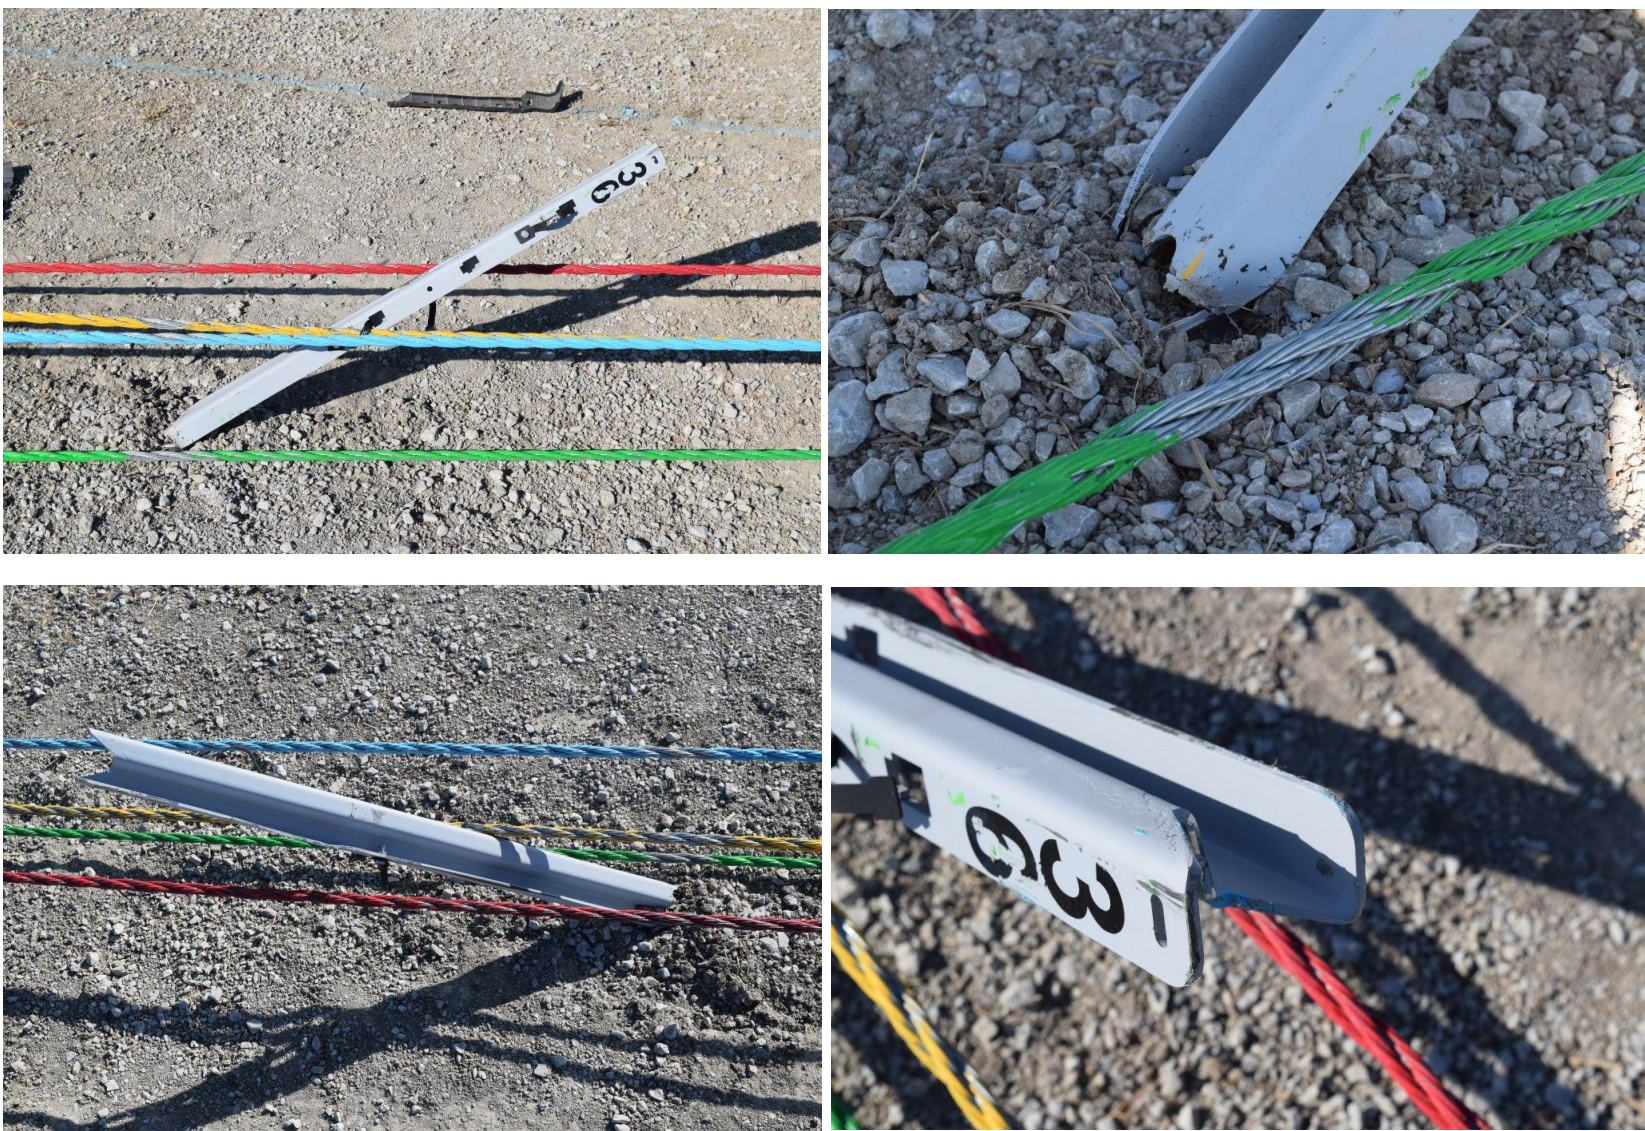
Figure 55. Post No. 36 Damage, Test No. MWP-8

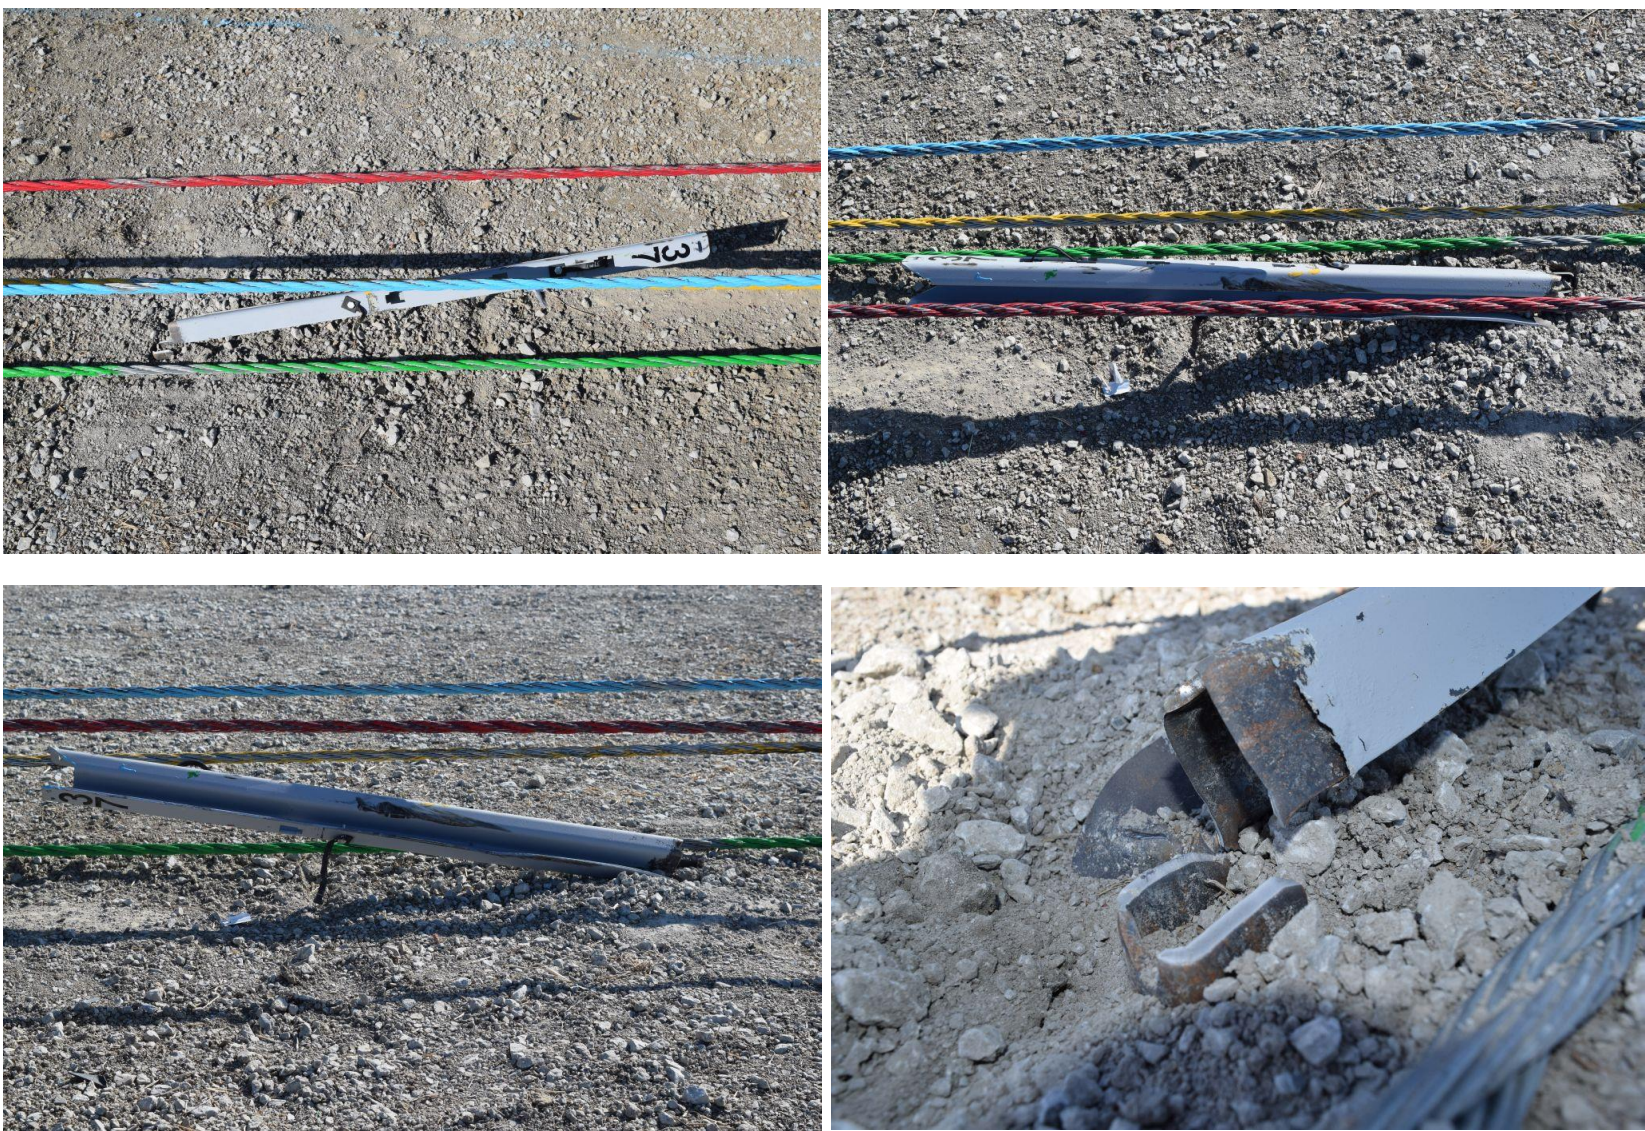
Figure 56. Post No. 37 Damage, Test No. MWP-8

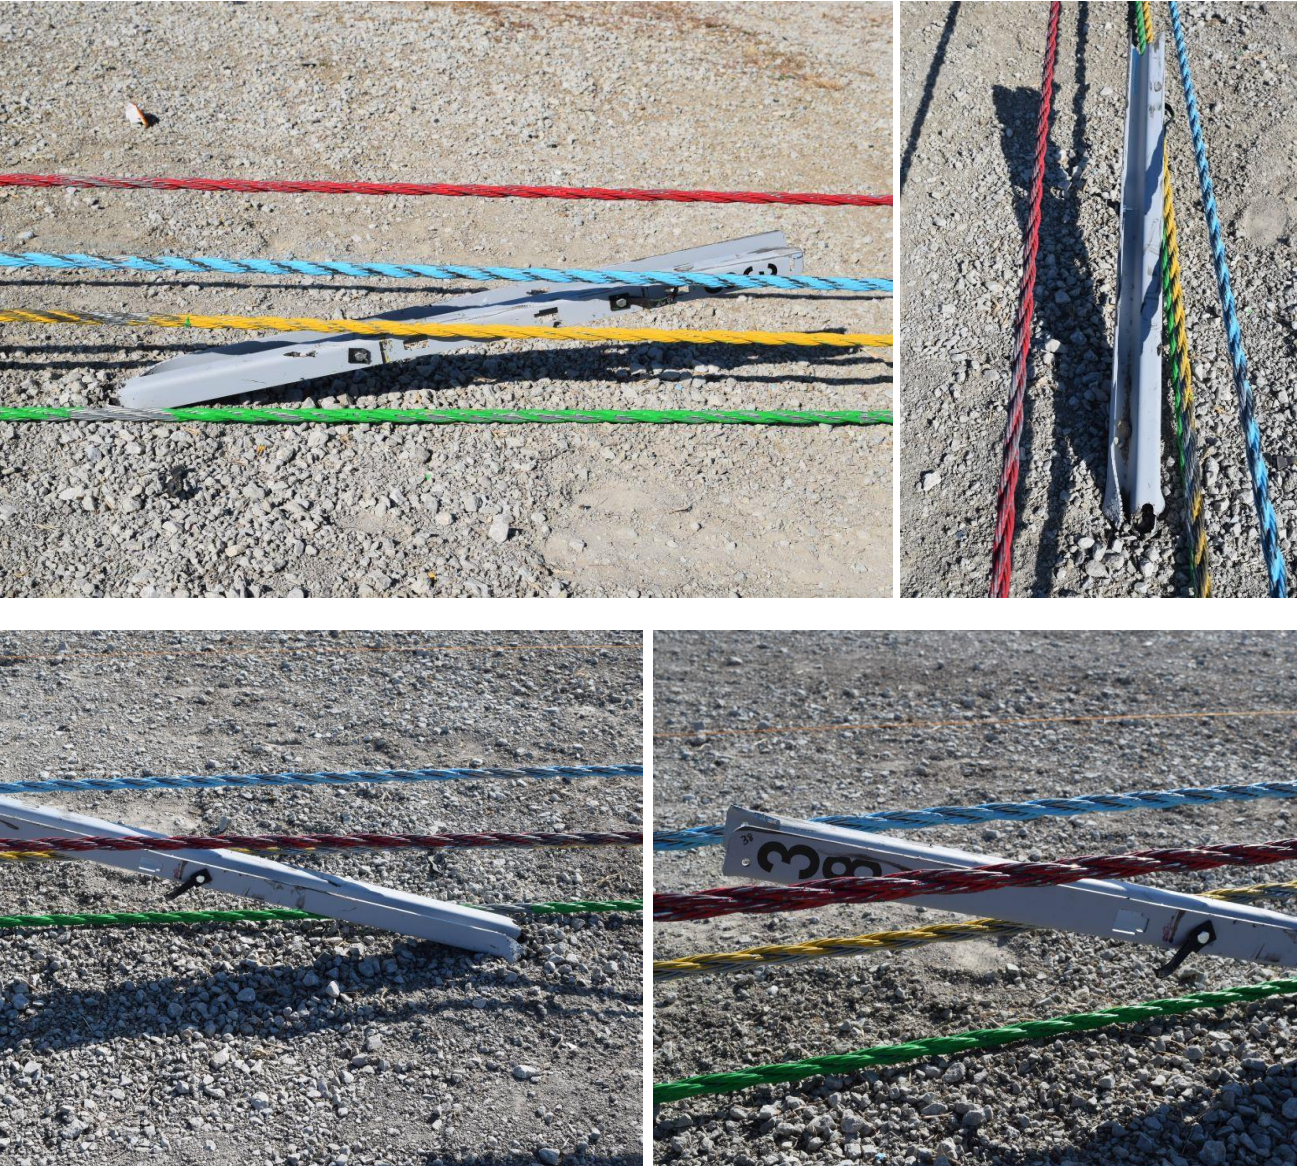
Figure 57. Post No. 38 Damage, Test No. MWP-8

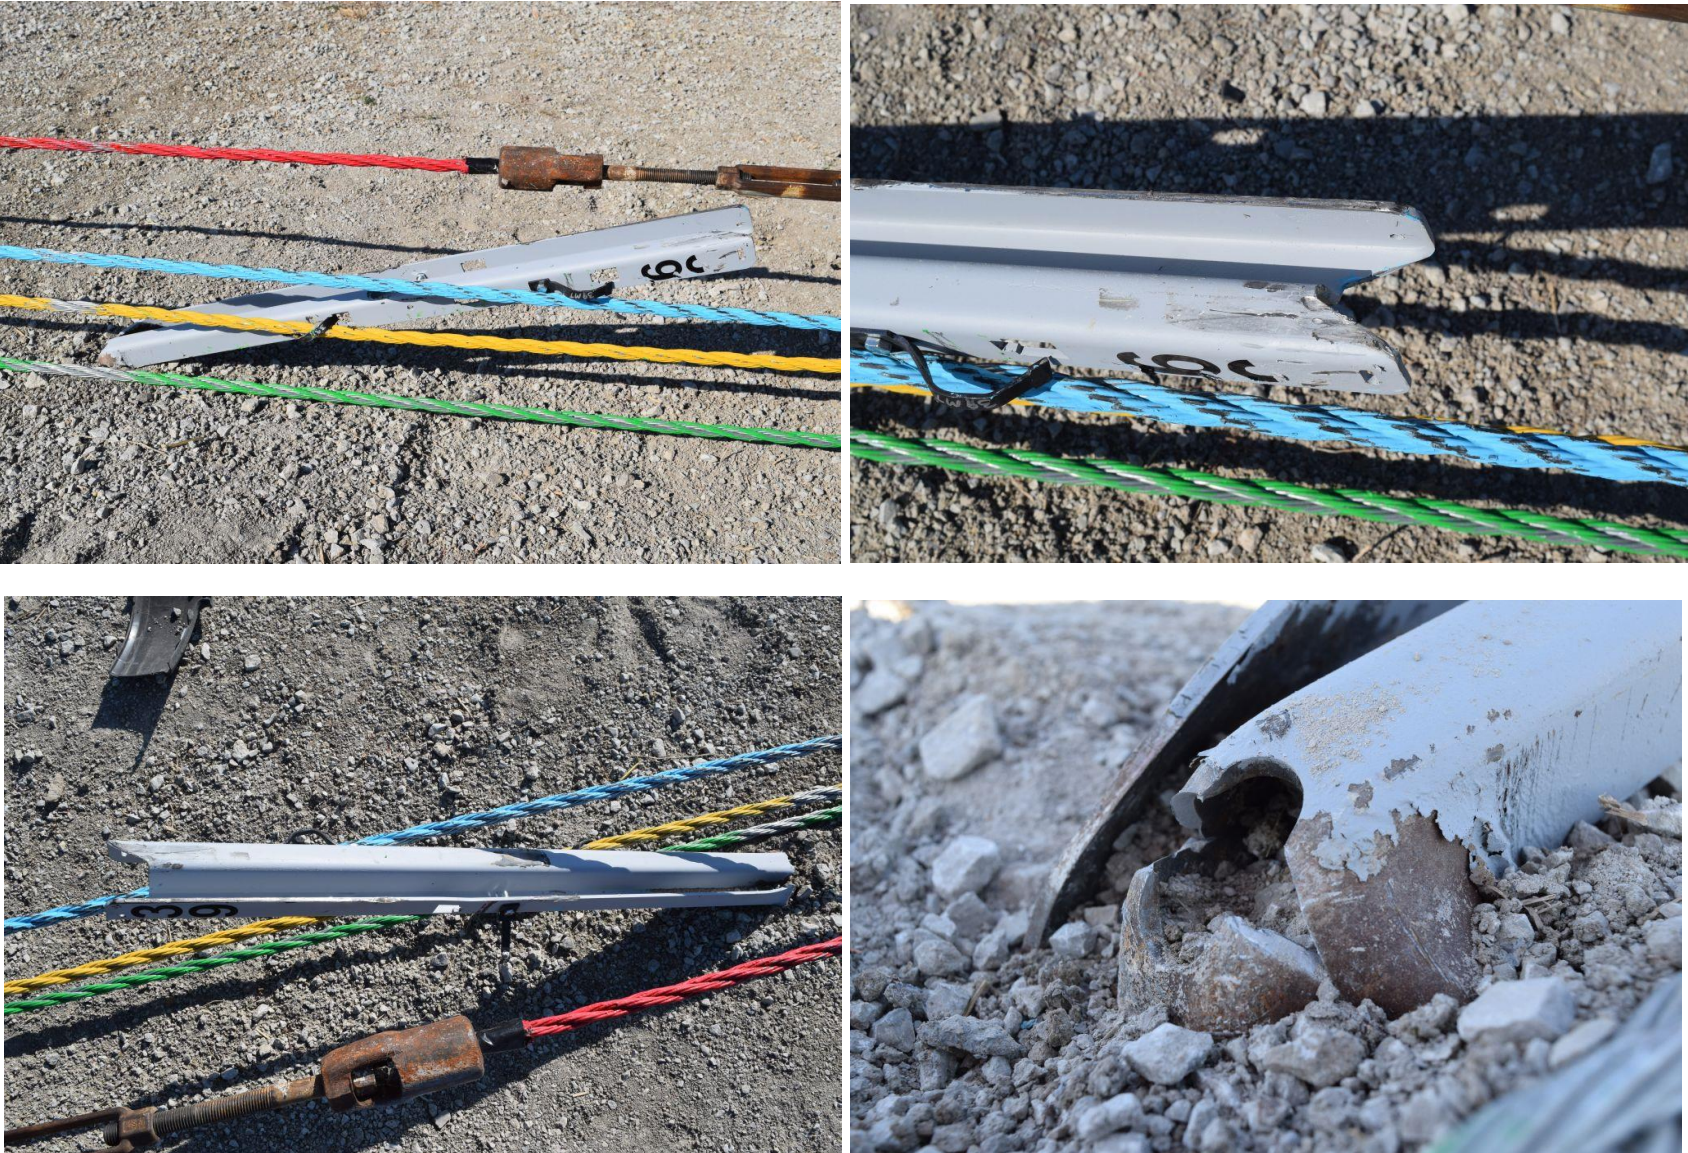
Figure 58. Post No. 39 Damage, Test No. MWP-8
