# **MASH TEST NO. 3-10 OF A NON-PROPRIETARY, HIGH-TENSION CABLE MEDIAN BARRIER FOR USE IN 6H:1V V-DITCH (TEST NO. MWP-8)**

MwRSF Research Report No. TRP-03-331-17

May 10, 2017

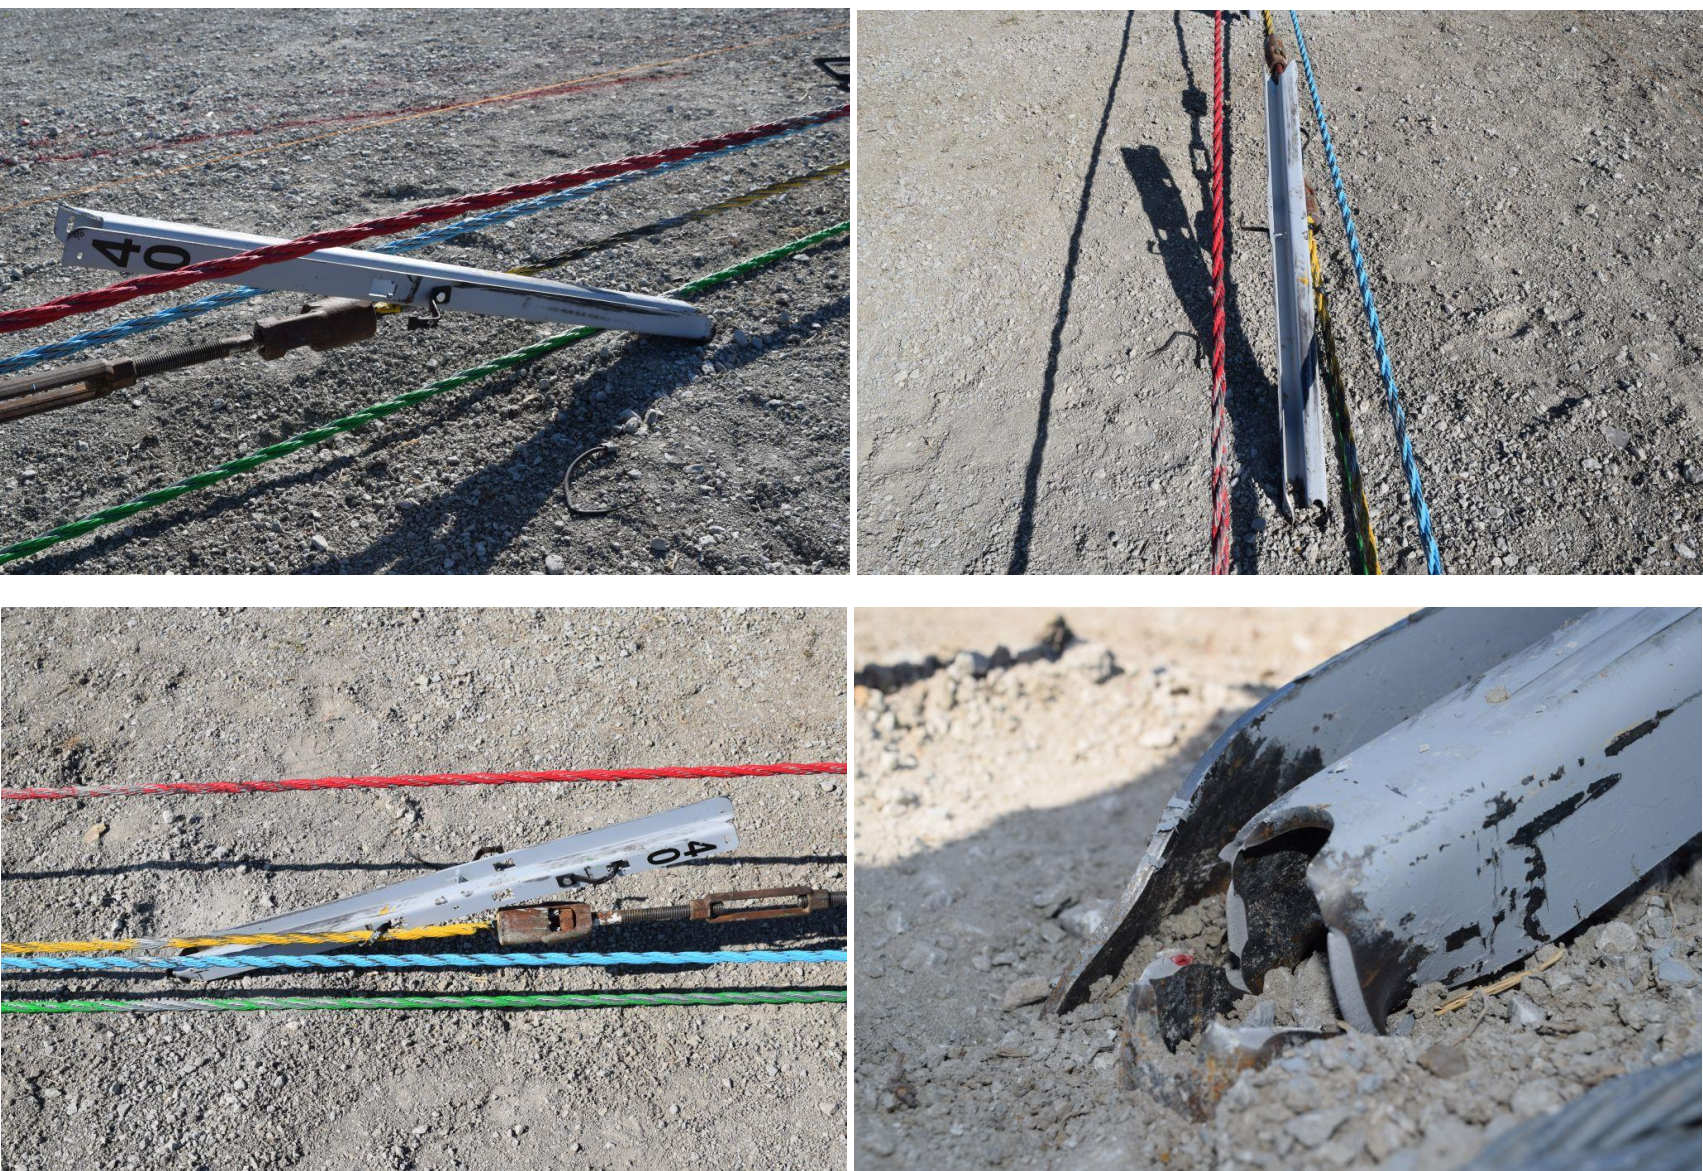
Figure 59. Post No. 40 Damage, Test No. MWP-8

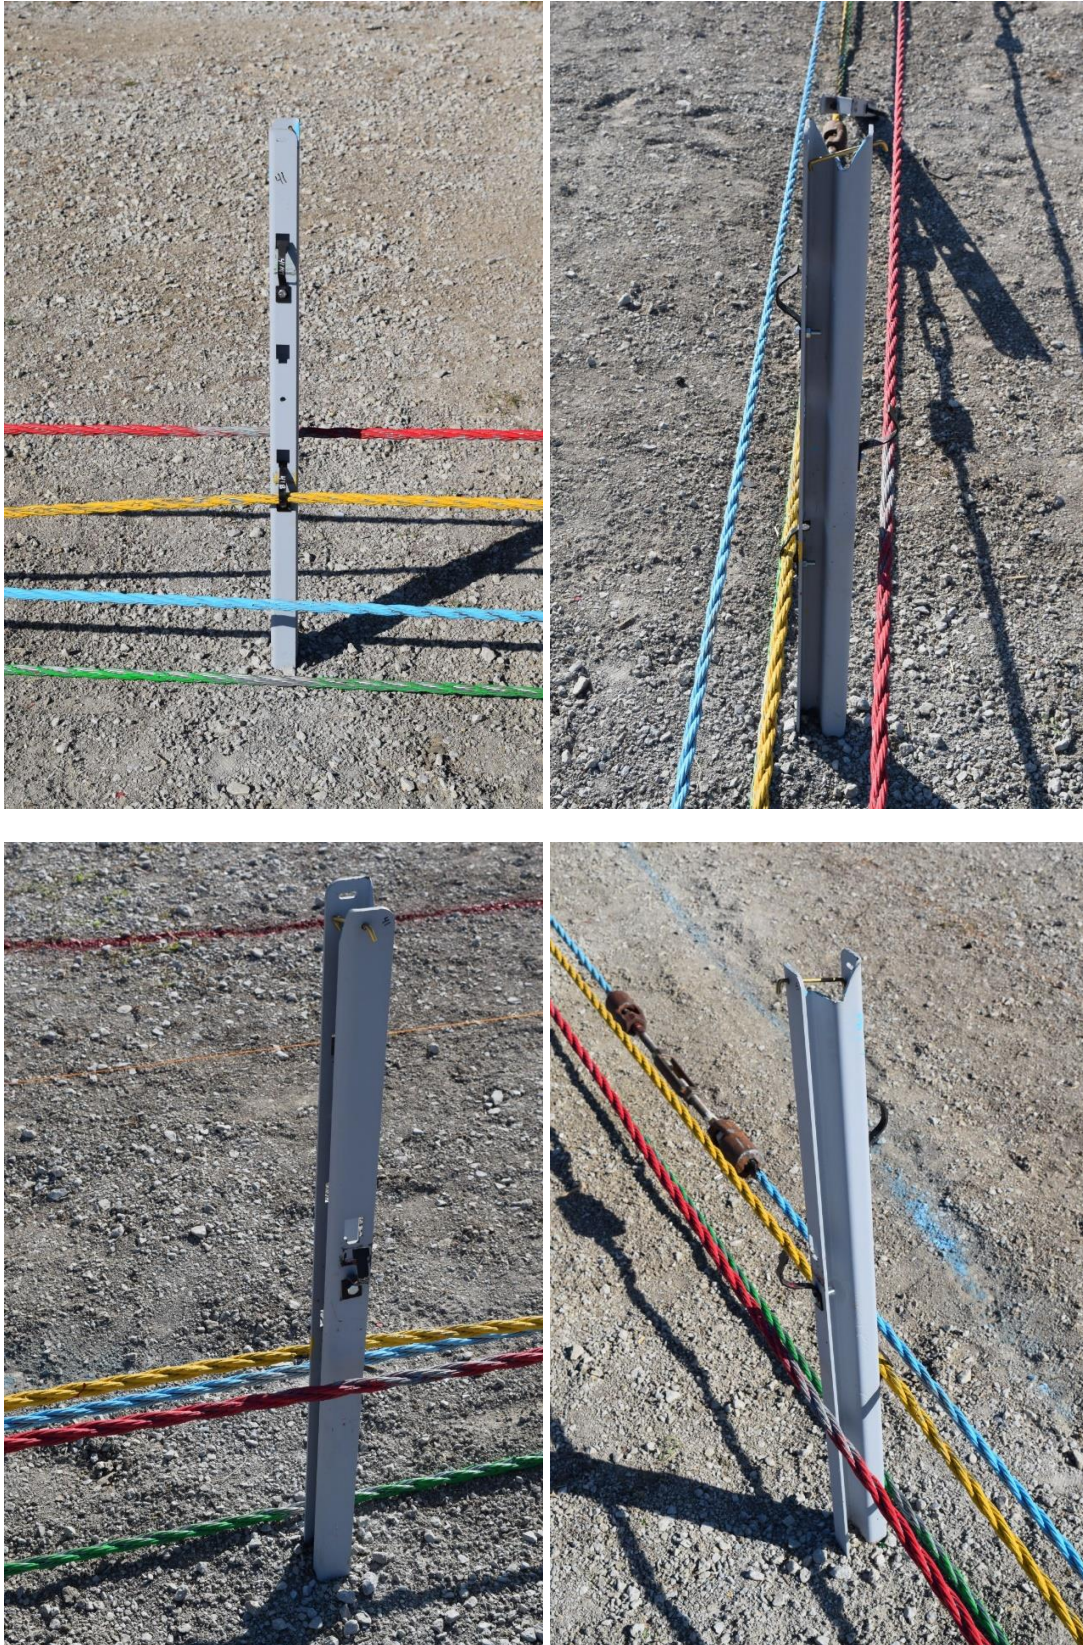
Figure 60. Post No. 41 Damage, Test No. MWP-8

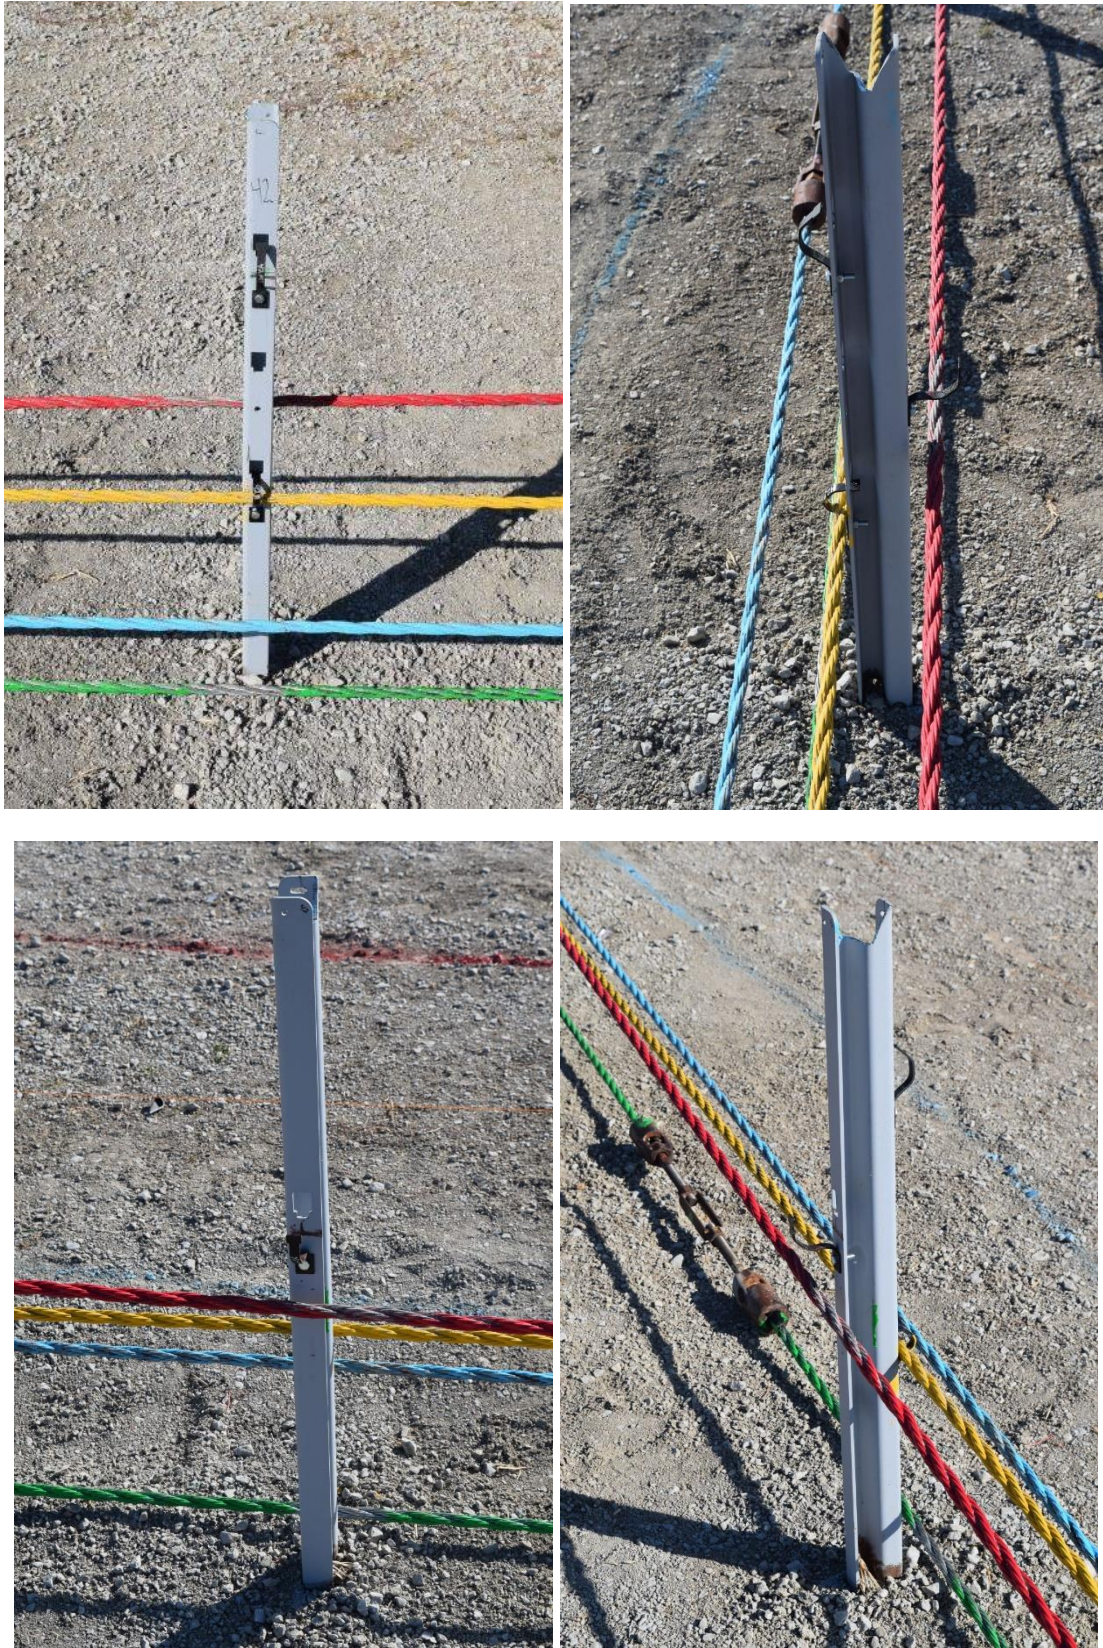
Figure 61. Post No. 42 Damage, Test No. MWP-8

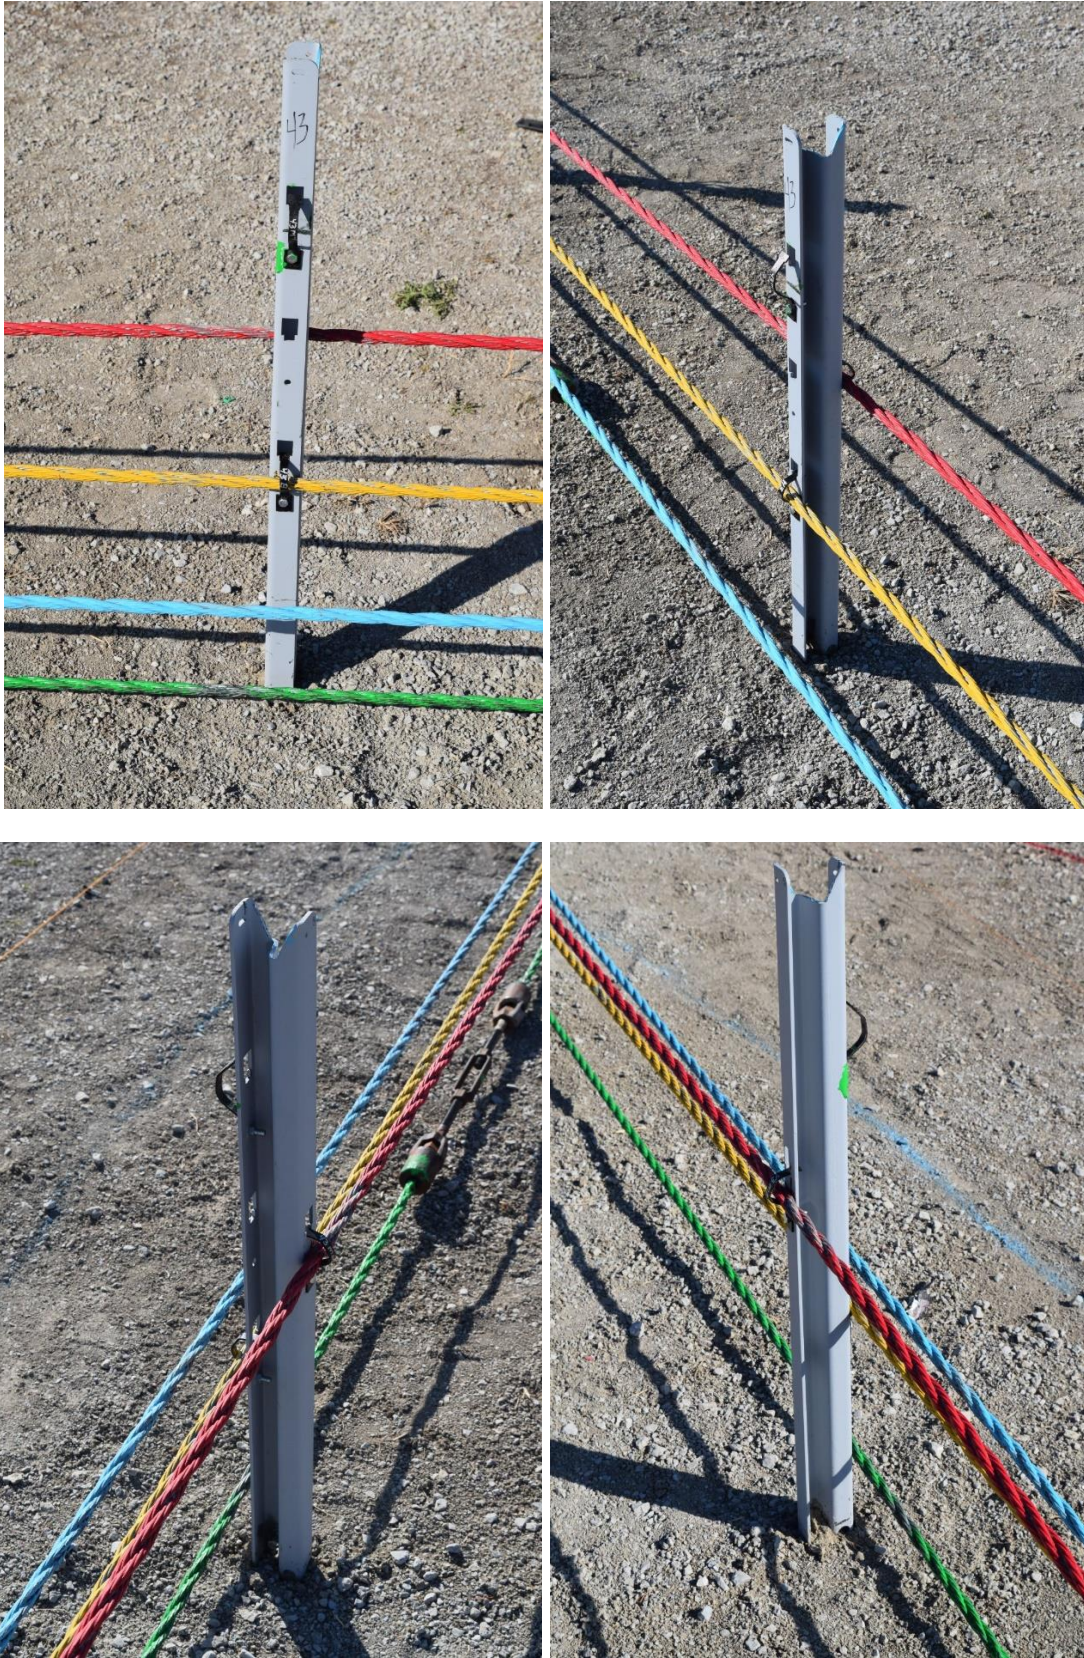
Figure 62. Post No. 43 Damage, Test No. MWP-8

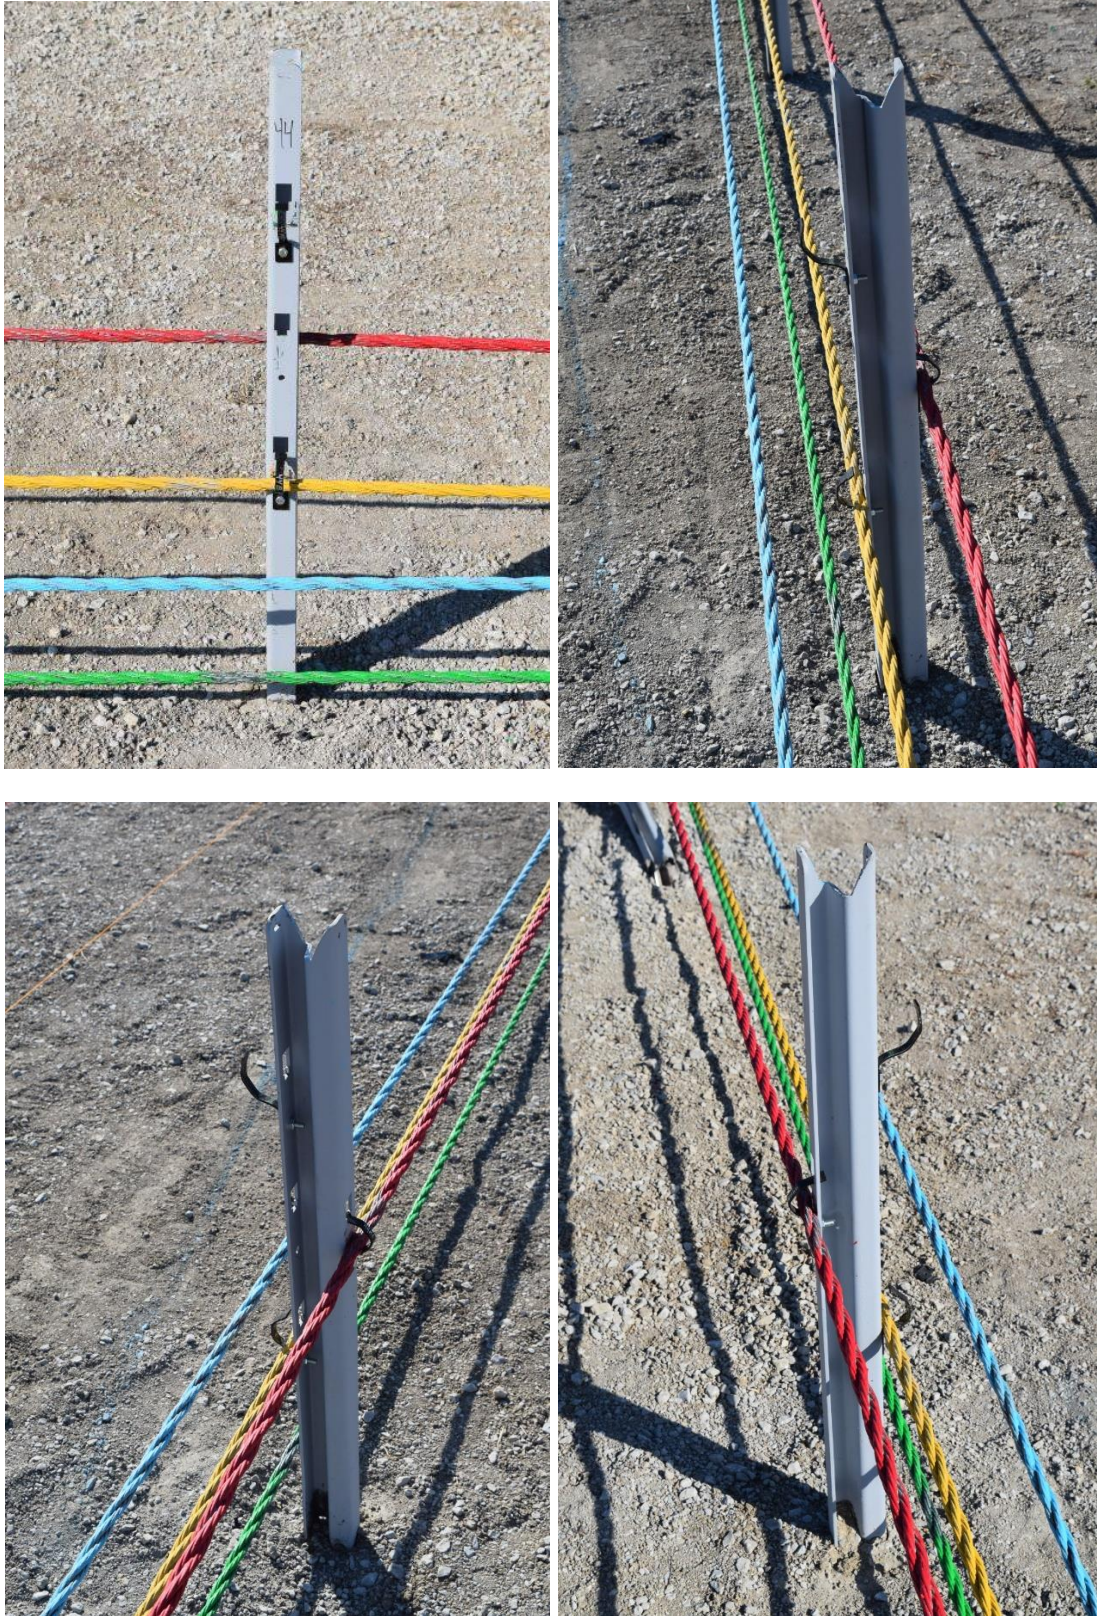
Figure 63. Post No. 44 Damage, Test No. MWP-8

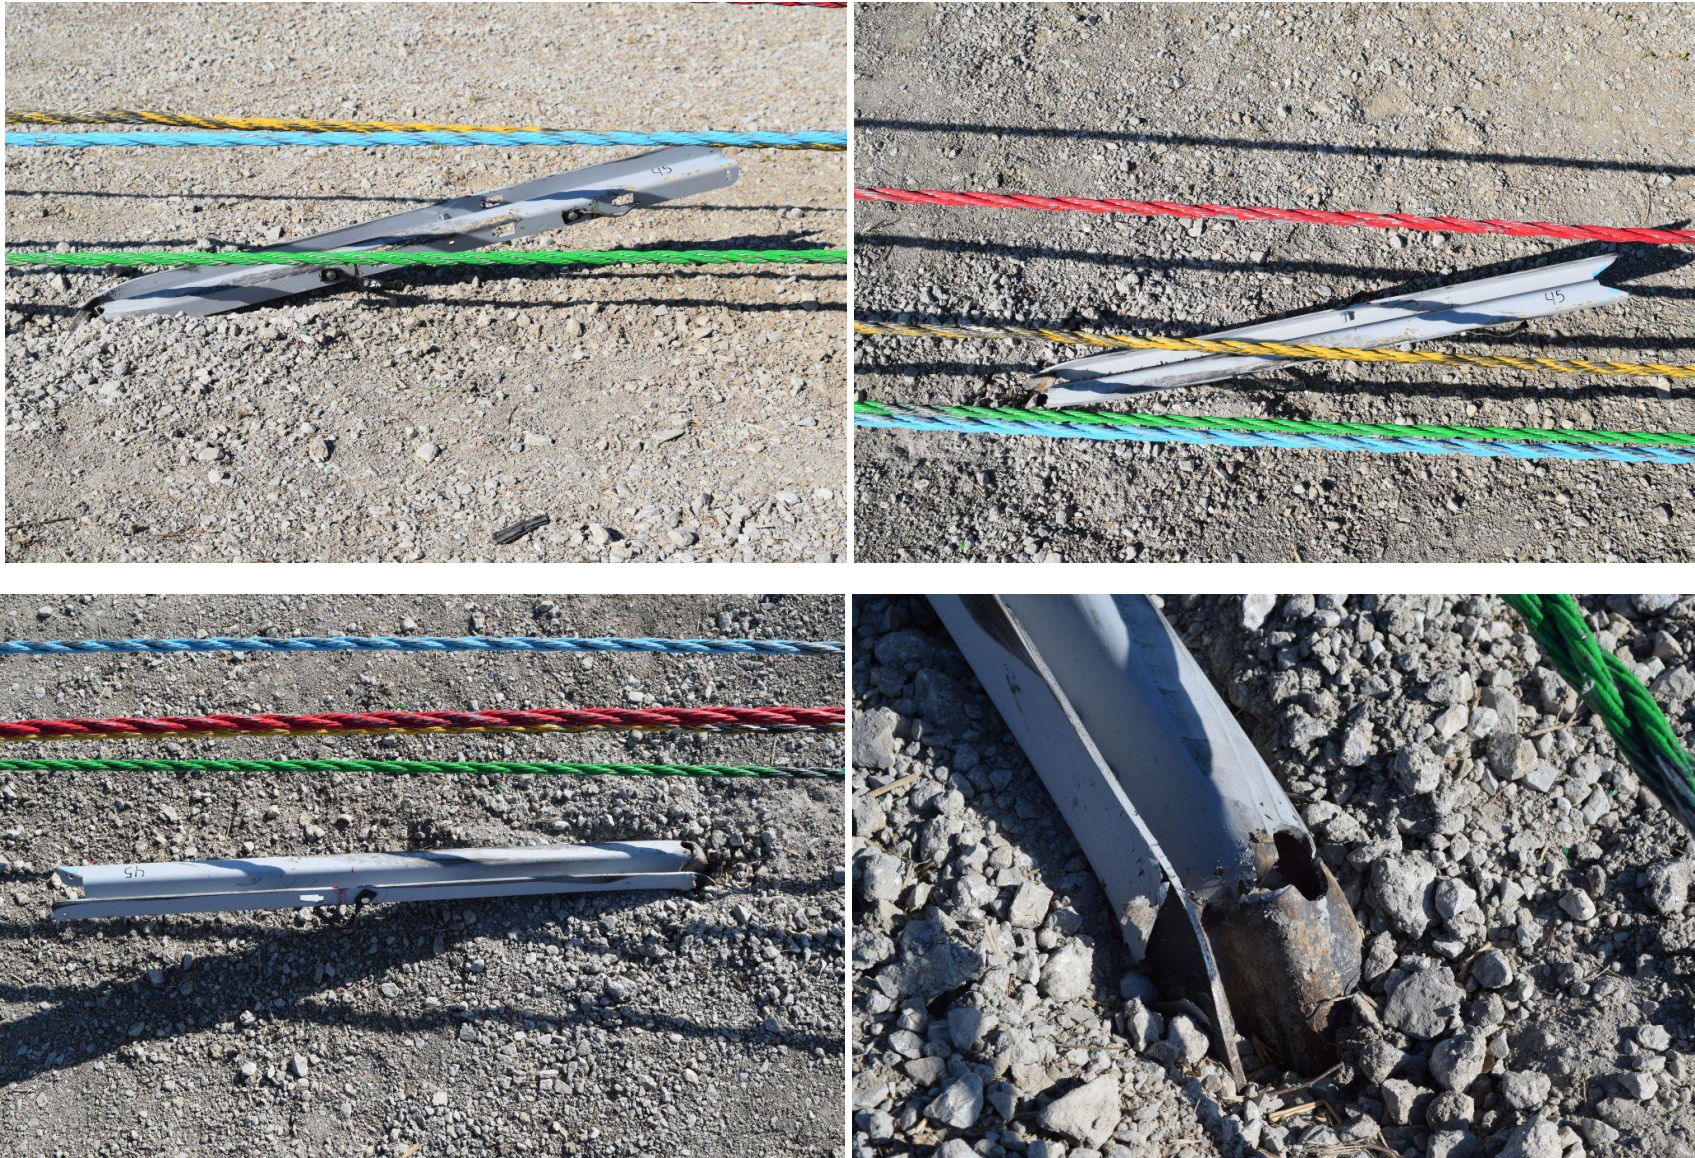
Figure 64. Post No. 45 Damage, Test No. MWP-8

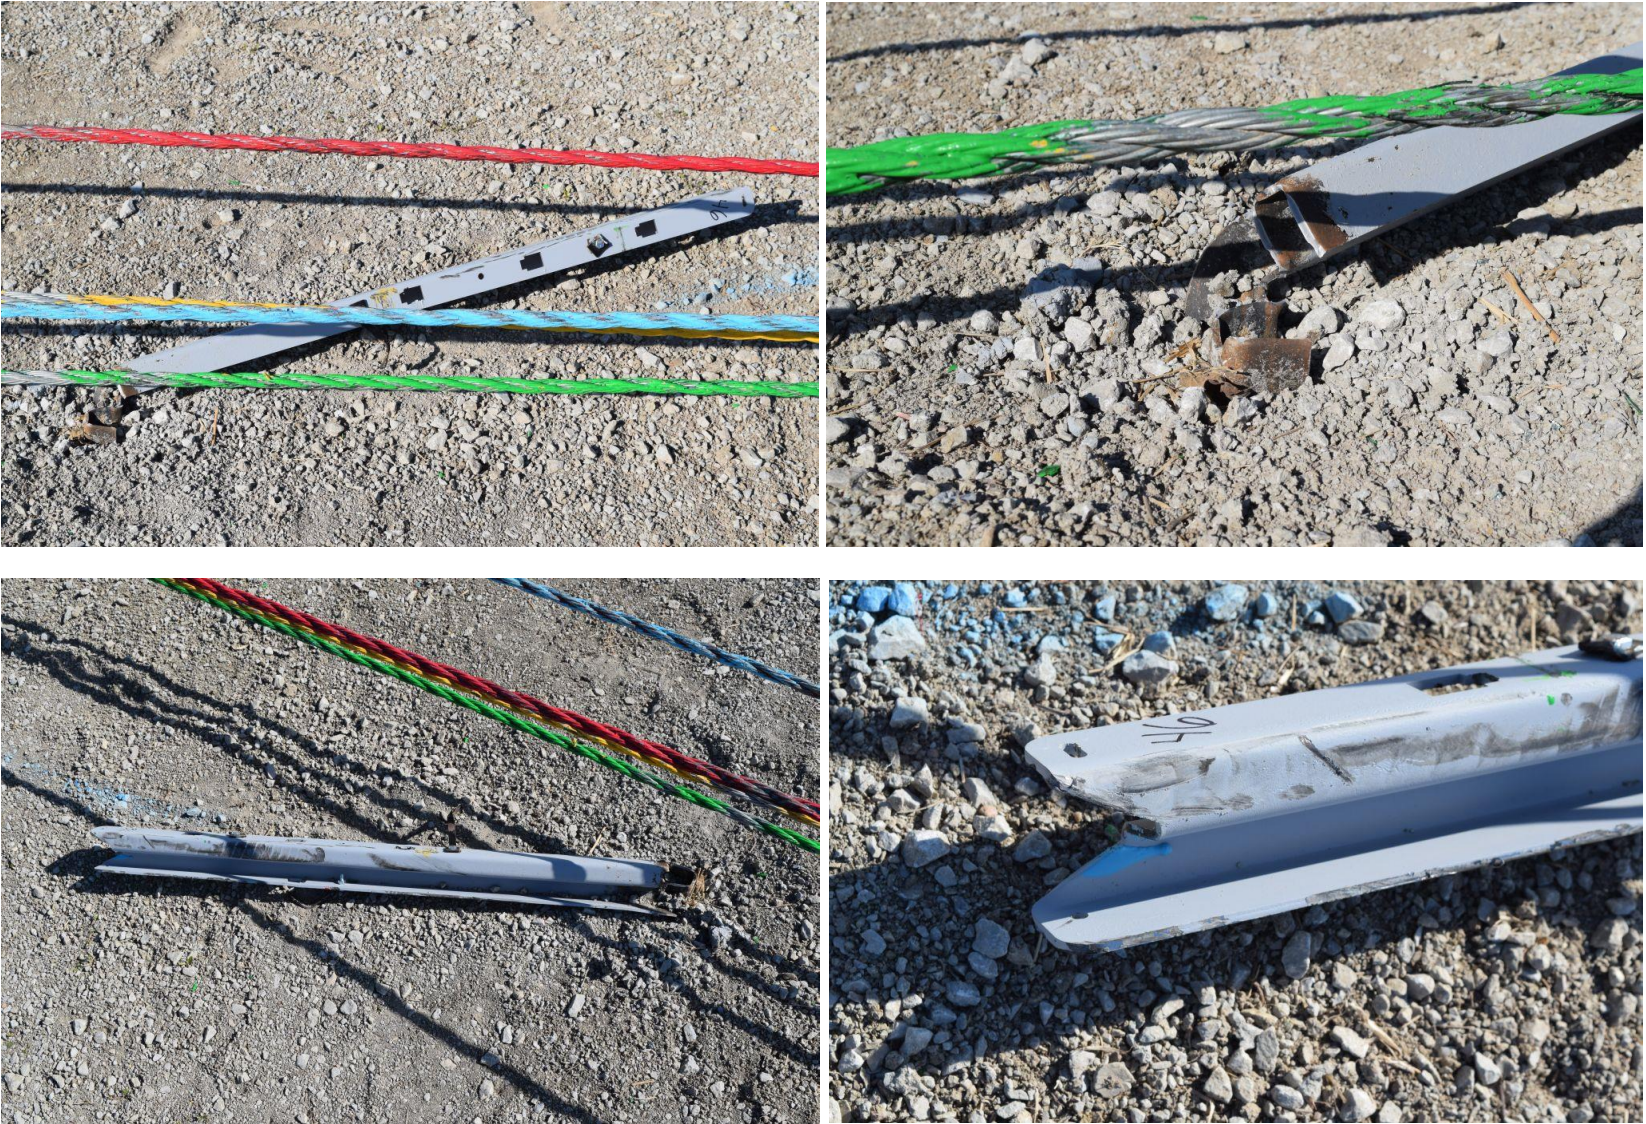
Figure 65. Post No. 46 Damage, Test No. MWP-8

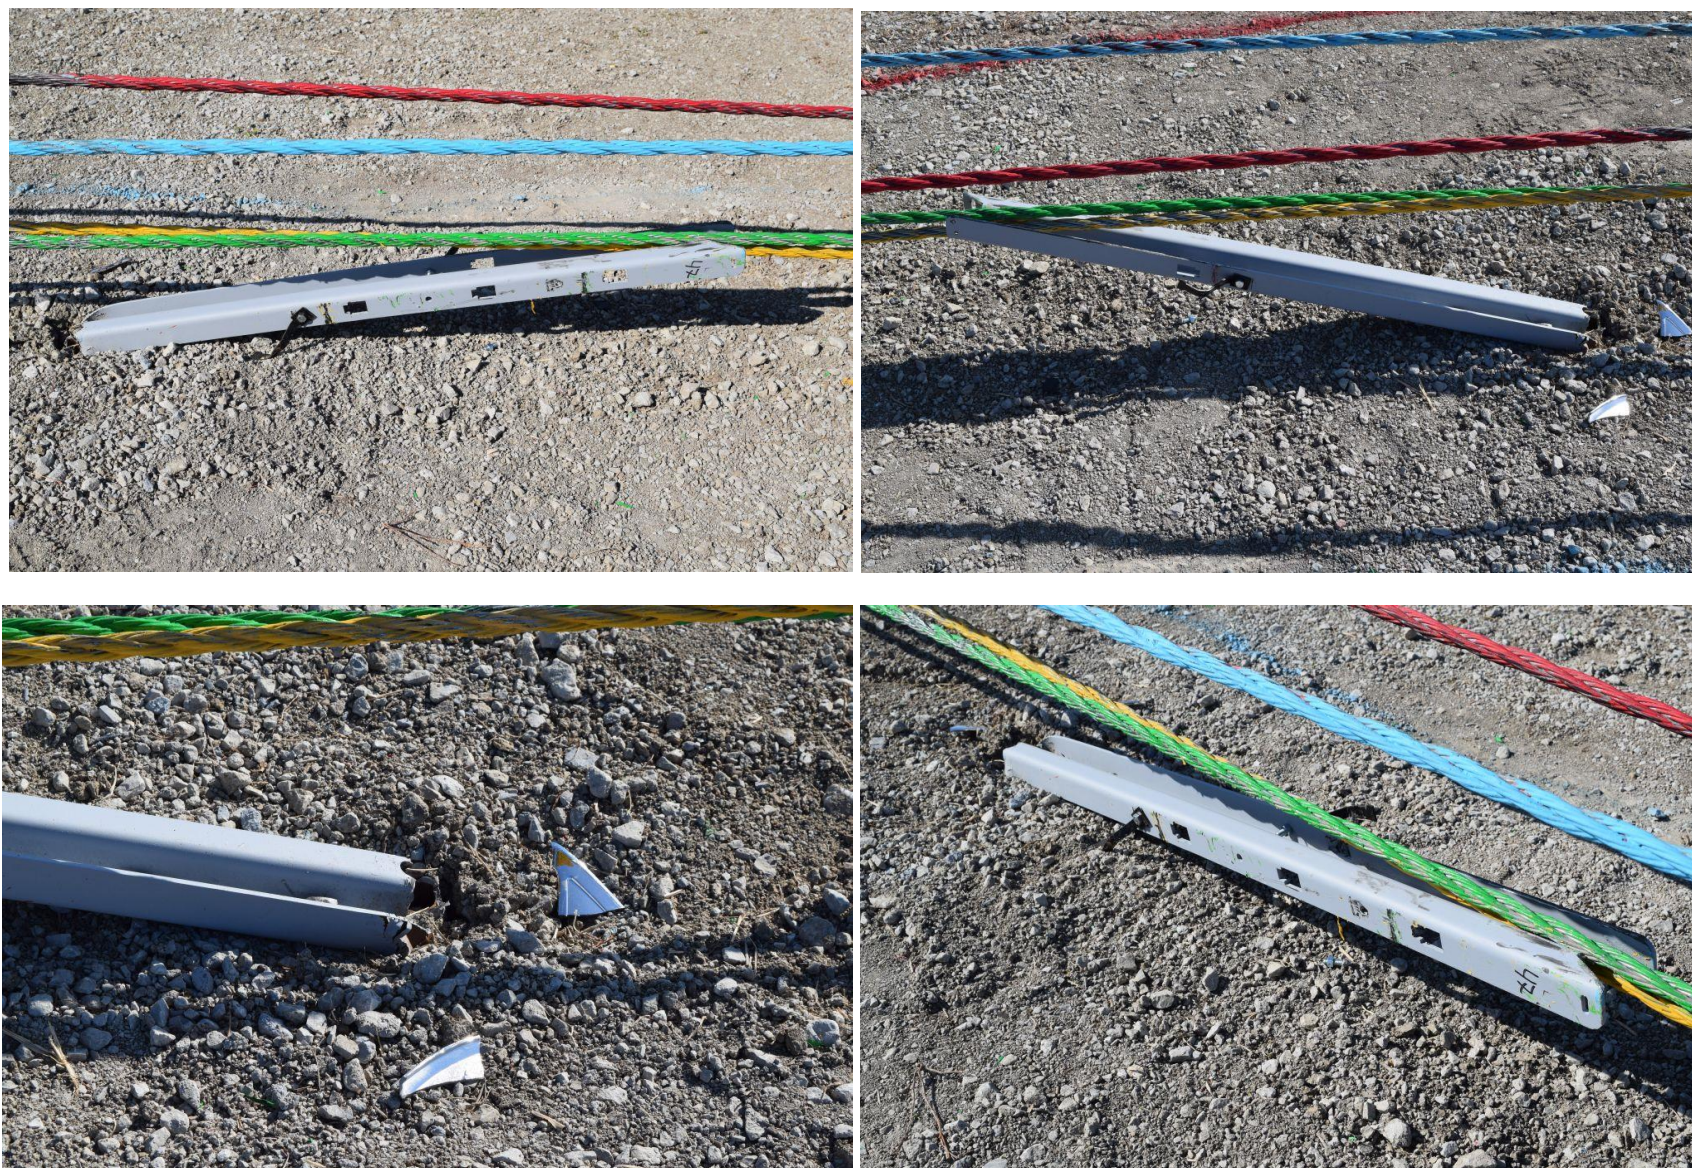
Figure 66. Post No. 47 Damage, Test No. MWP-8

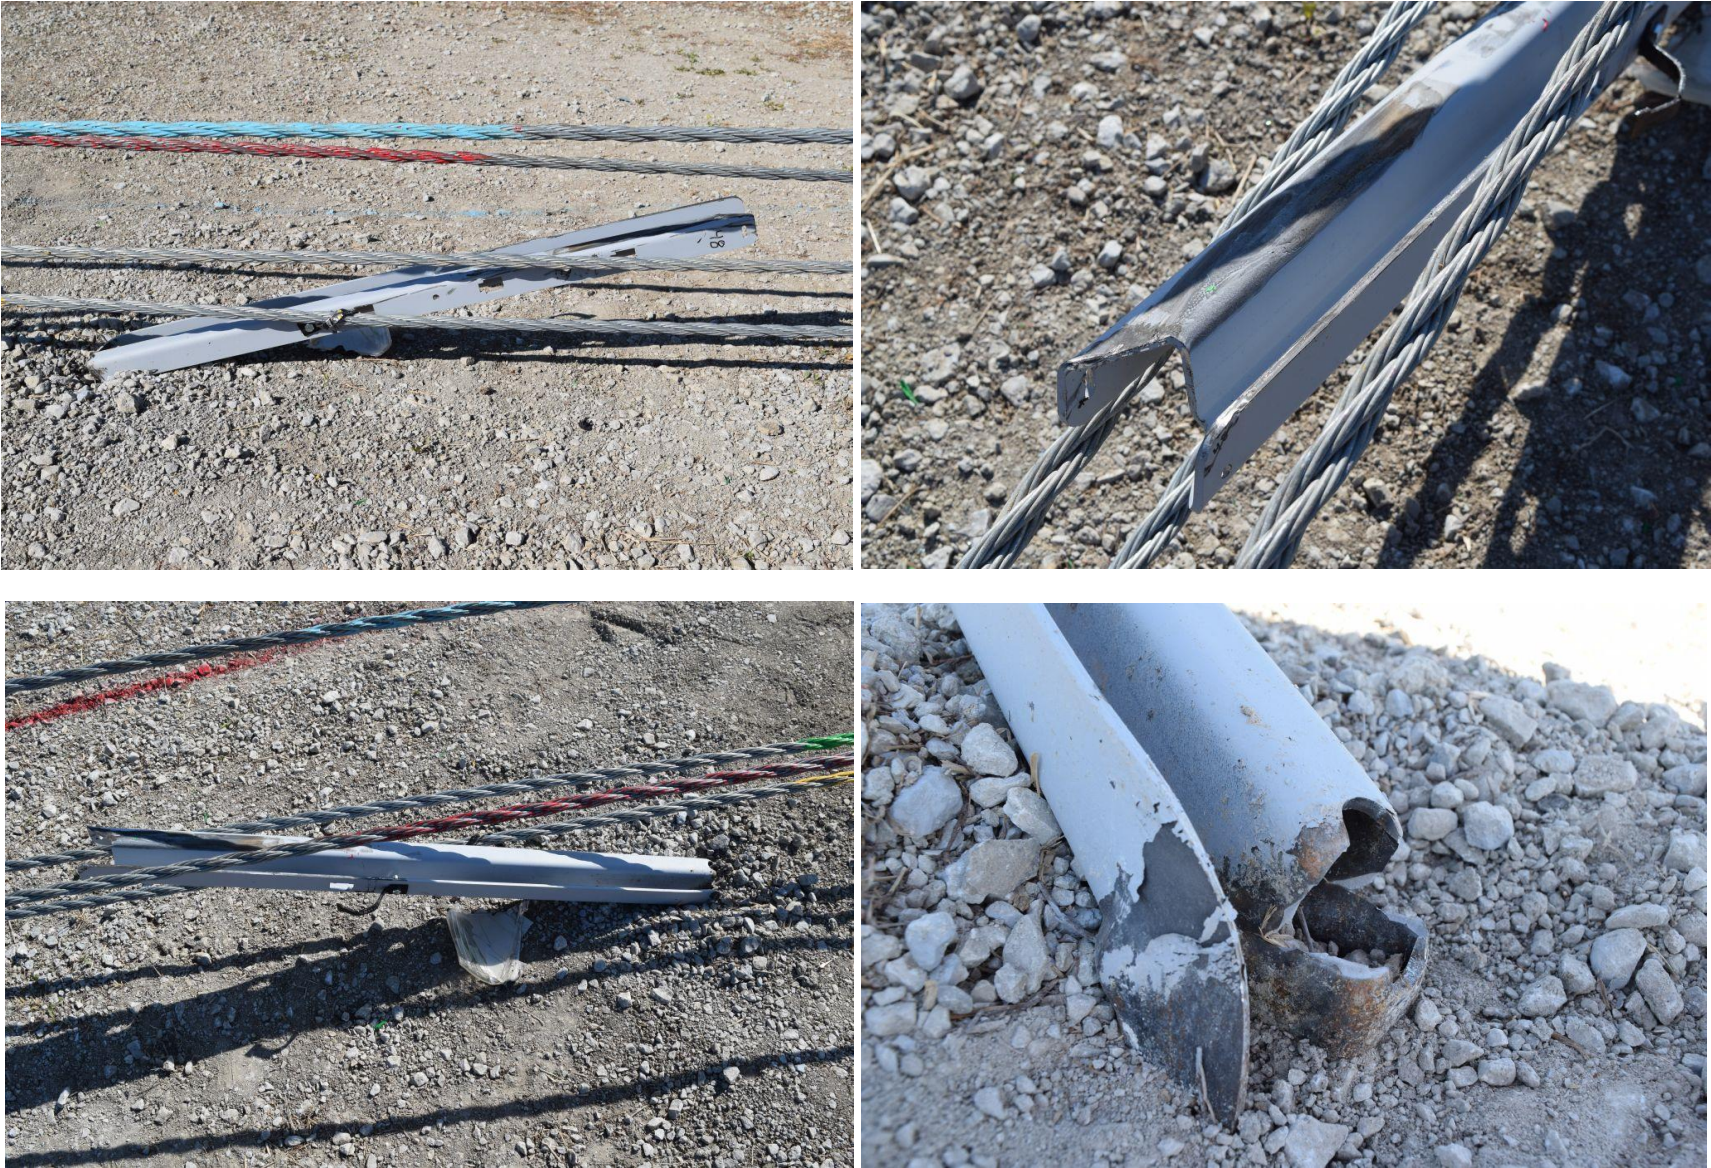
Figure 67. Post No. 48 Damage, Test No. MWP-8

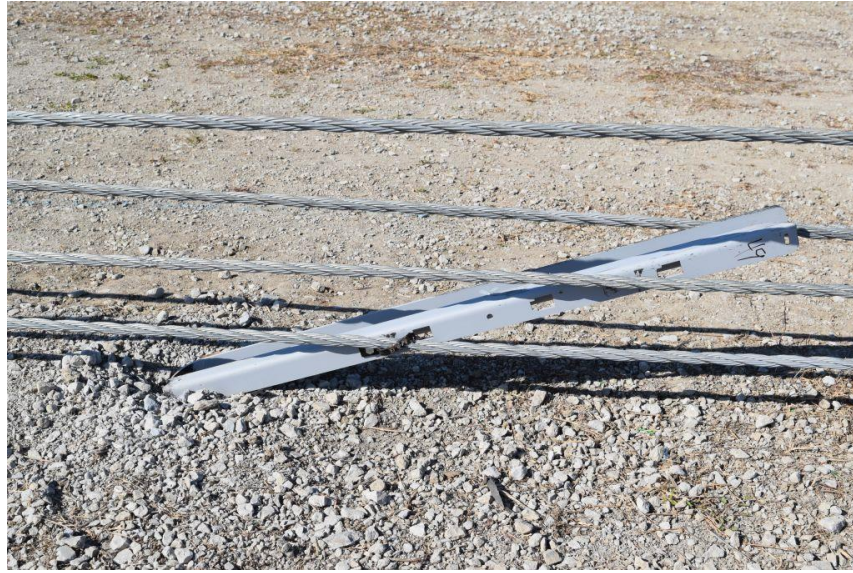
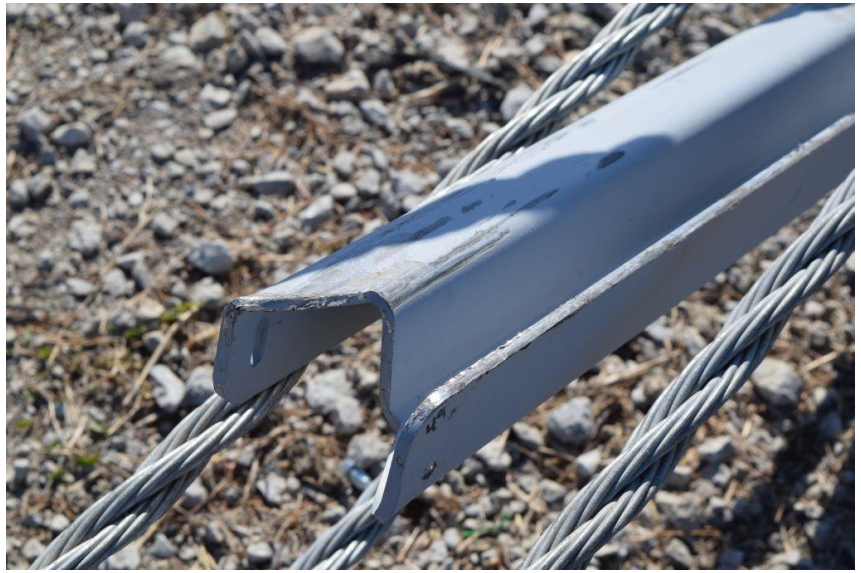
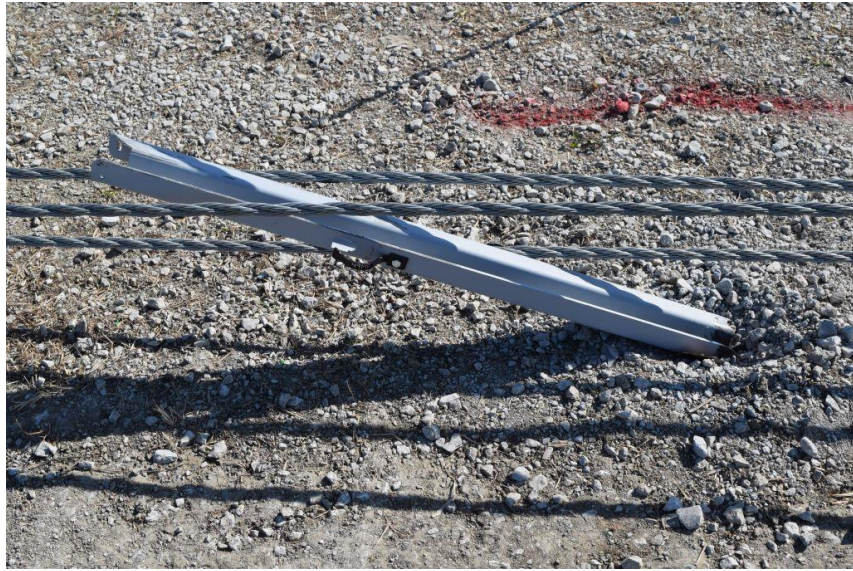
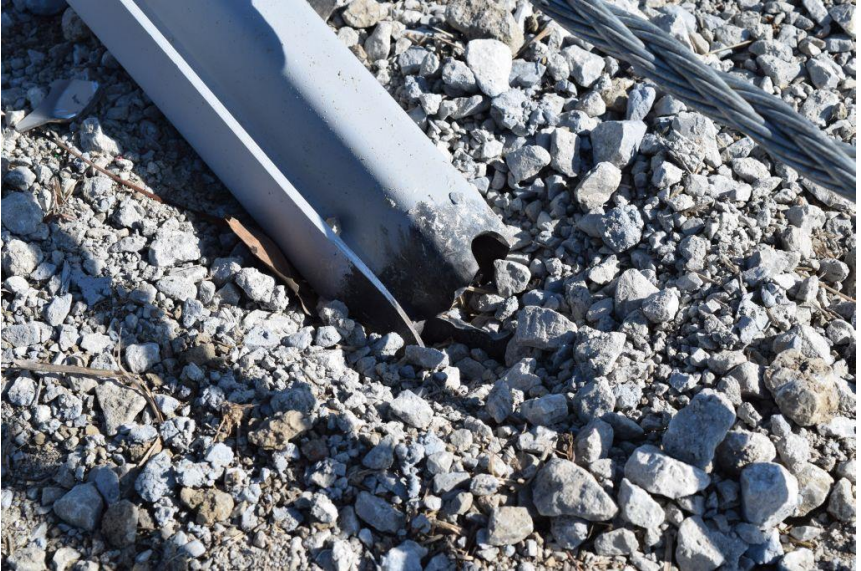
Figure 68. Post No. 49 Damage, Test No. MWP-8

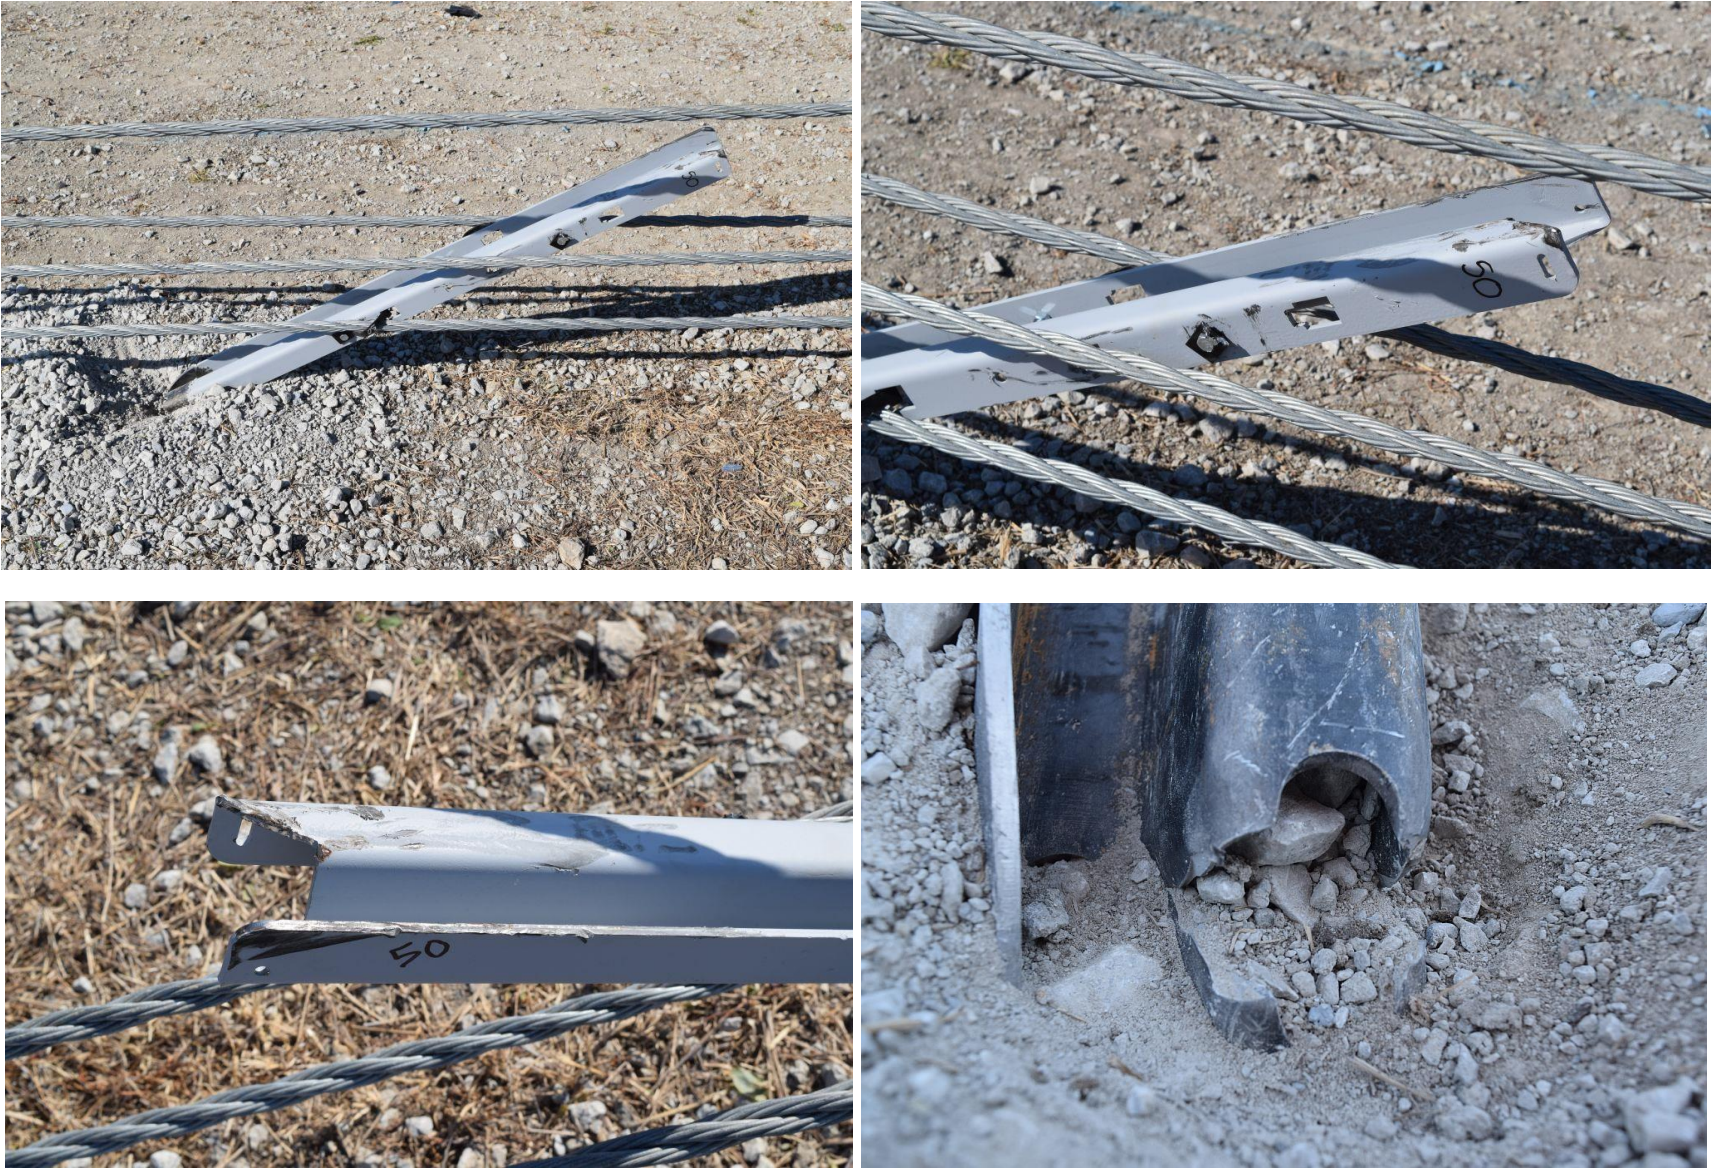
Figure 69. Post No. 50 Damage, Test No. MWP-8

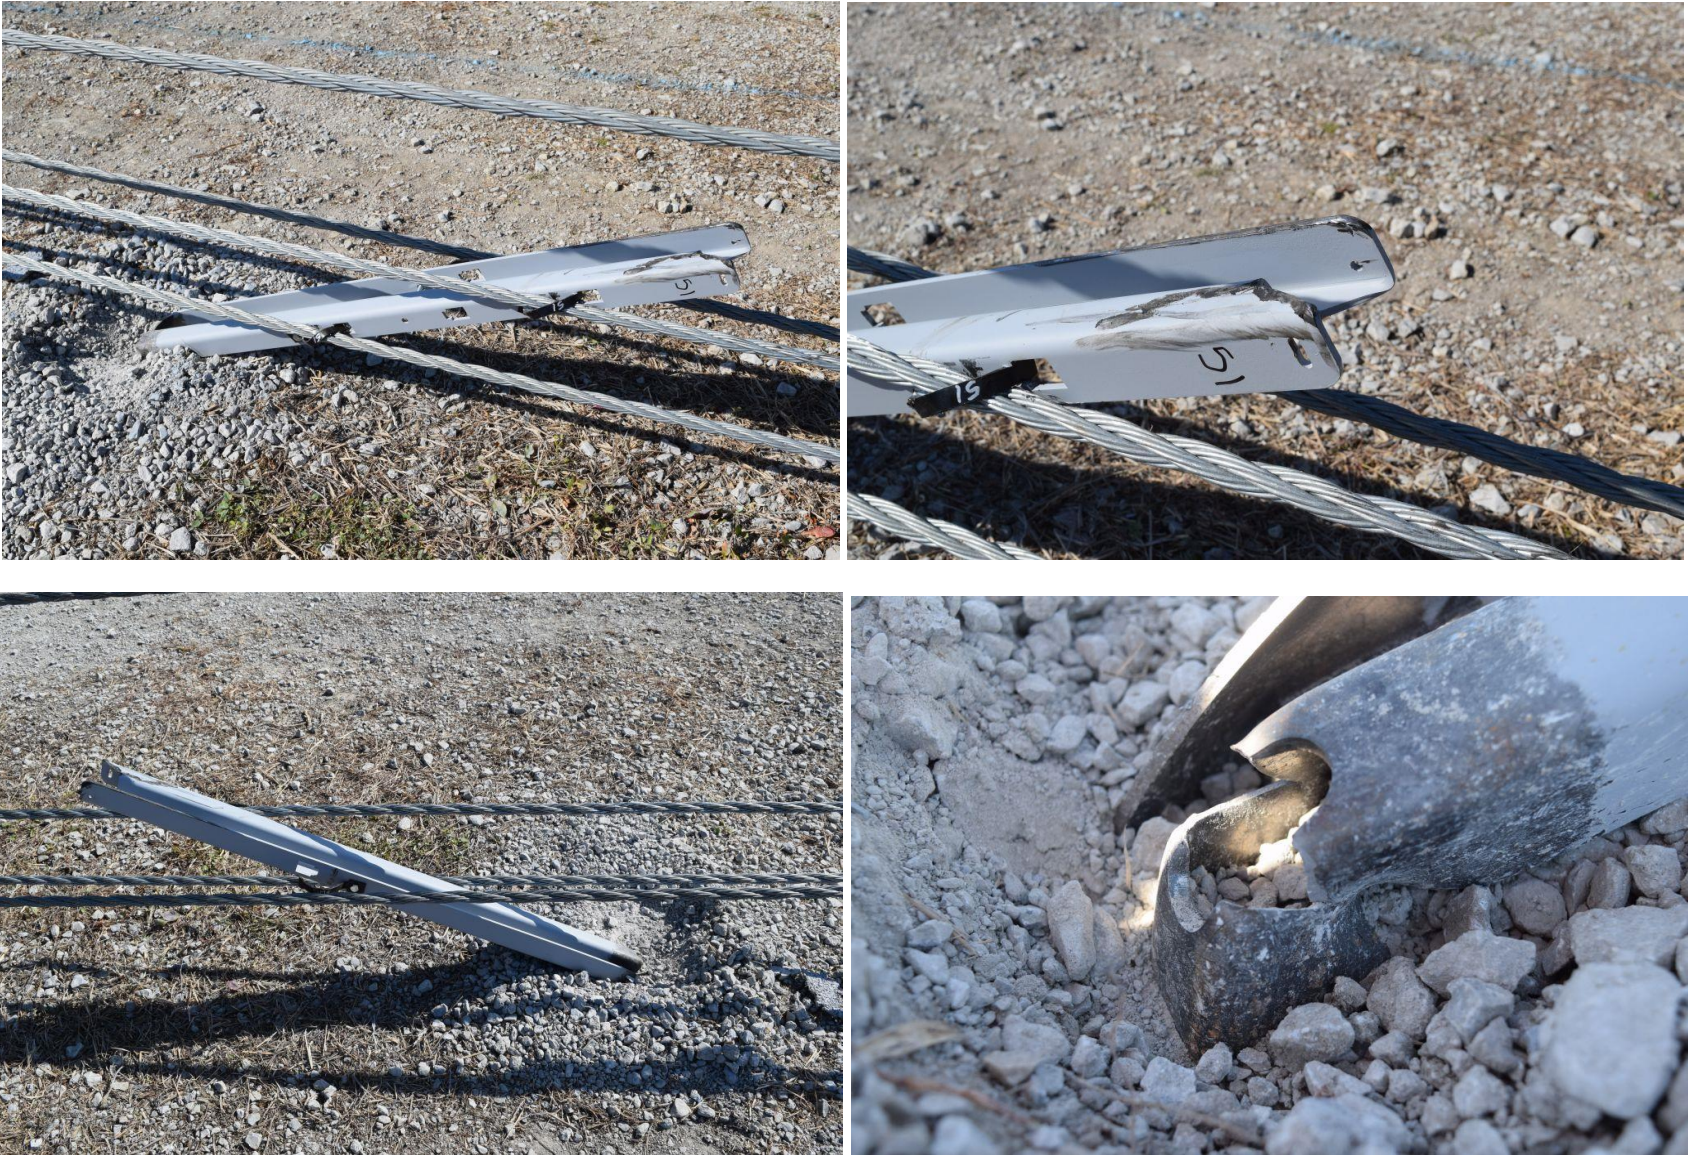
Figure 70. Post No. 51 Damage, Test No. MWP-8
