# **MASH TEST NO. 3-10 OF A NON-PROPRIETARY, HIGH-TENSION CABLE MEDIAN BARRIER FOR USE IN 6H:1V V-DITCH (TEST NO. MWP-8)**

MwRSF Research Report No. TRP-03-331-17

May 10, 2017

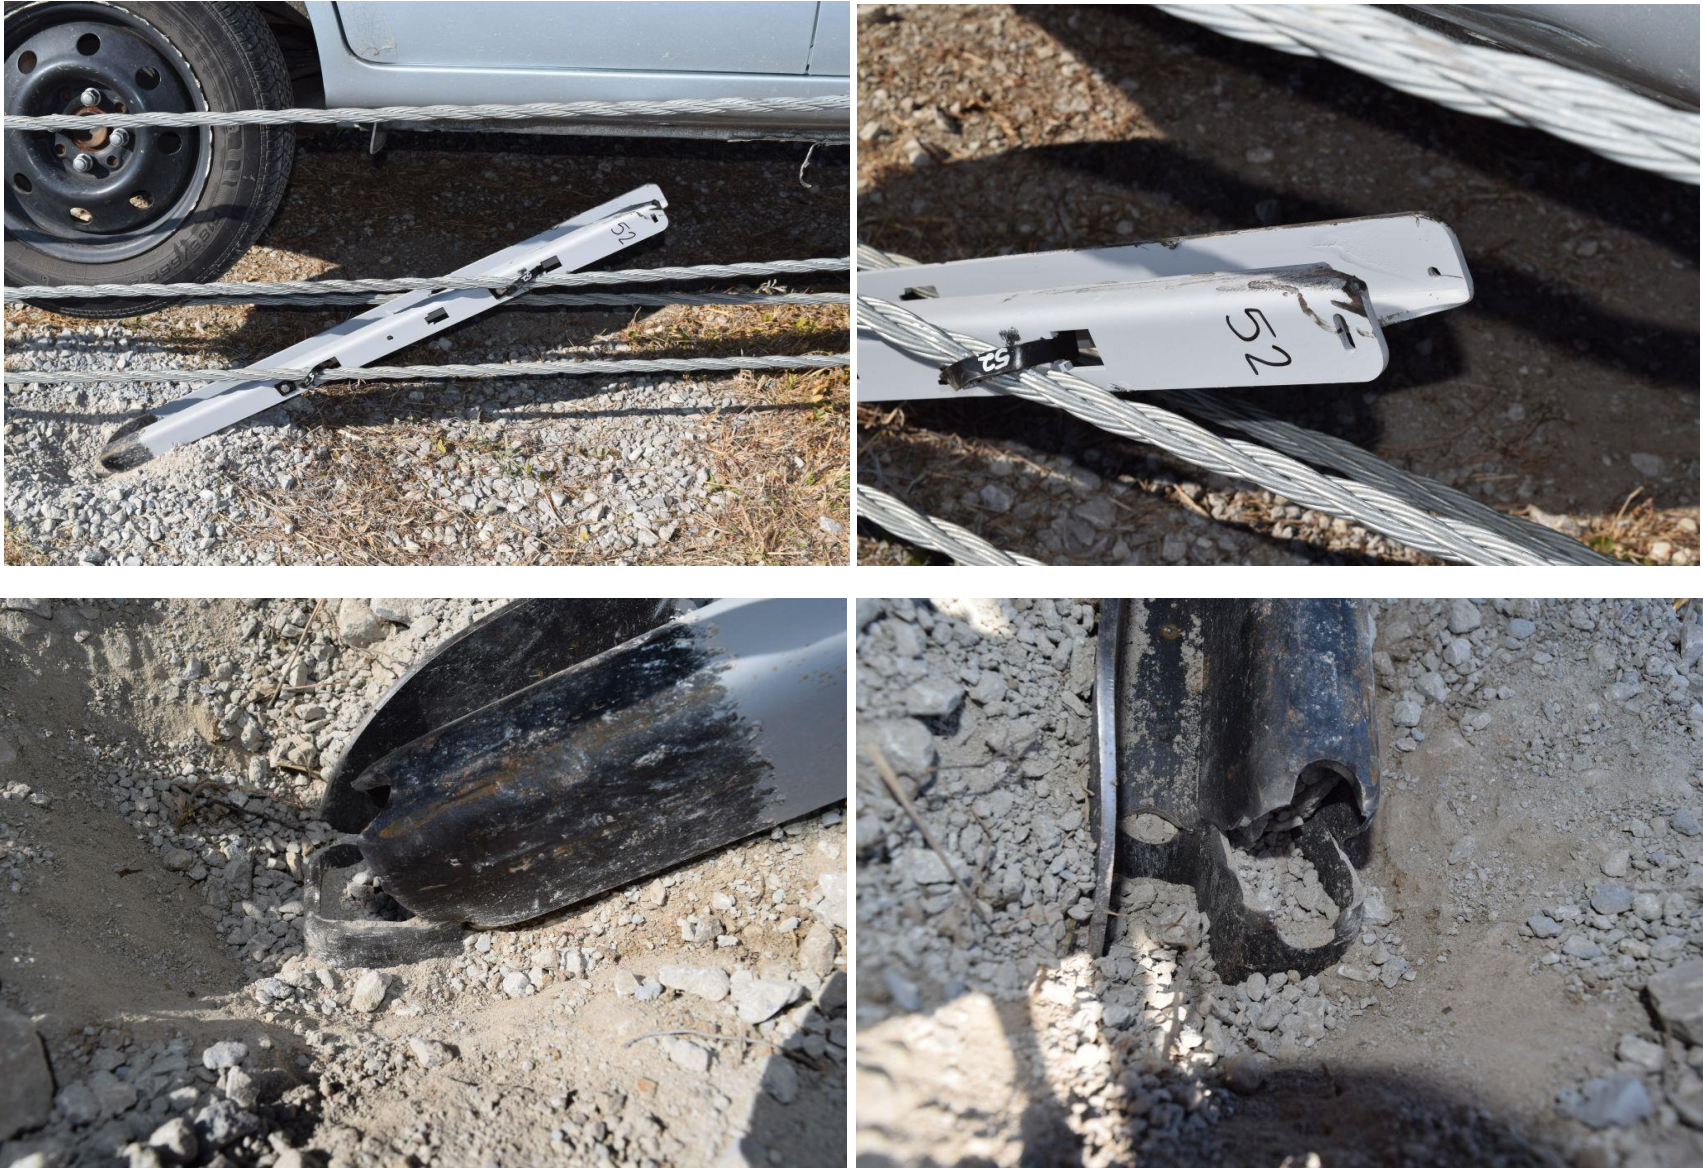
Figure 71. Post No. 52 Damage, Test No. MWP-8

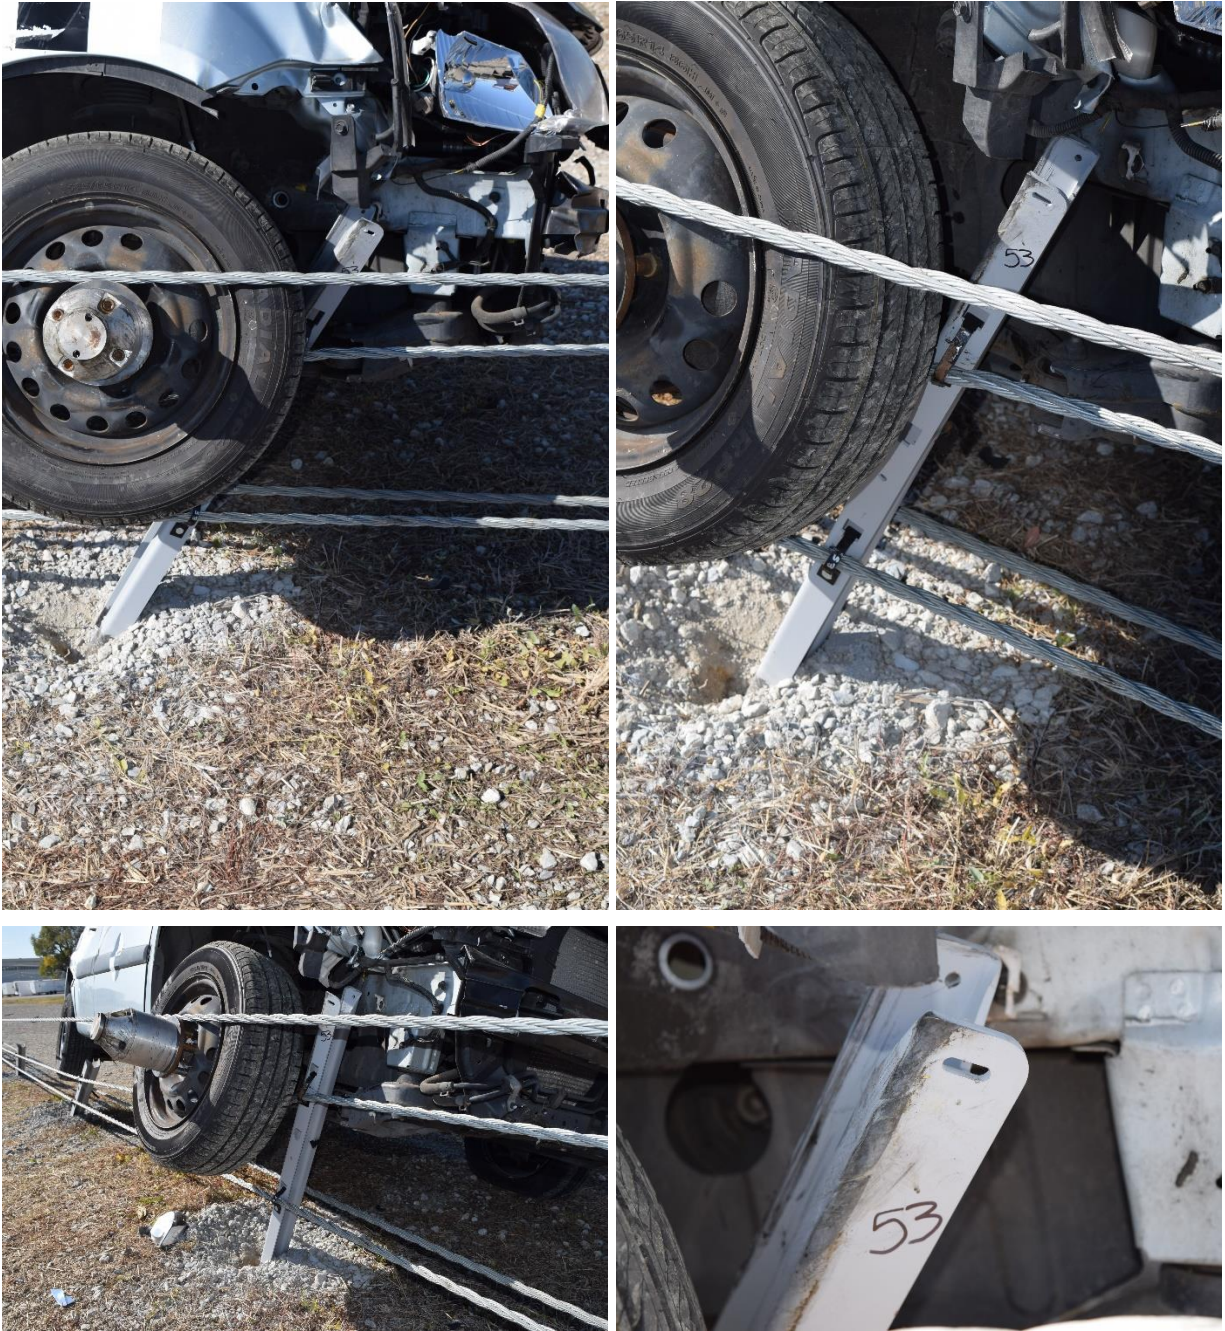
Figure 72. Post No. 53 Damage, Test No. MWP-8

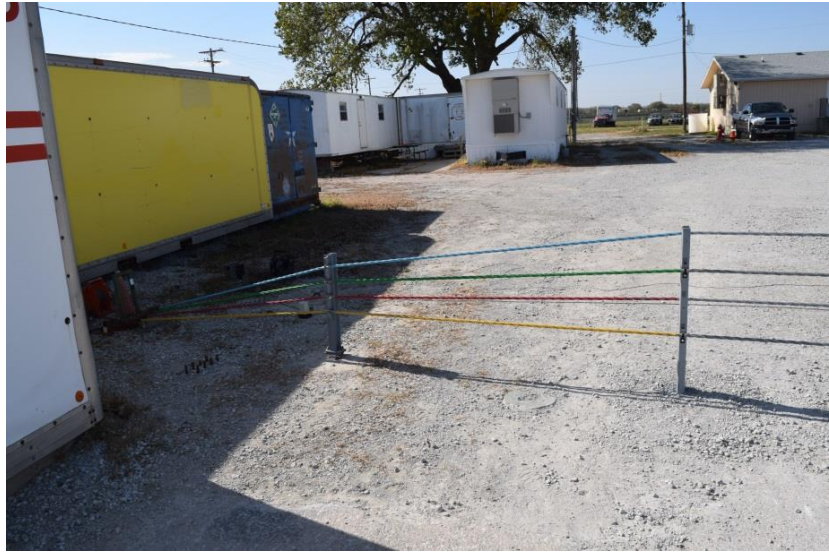
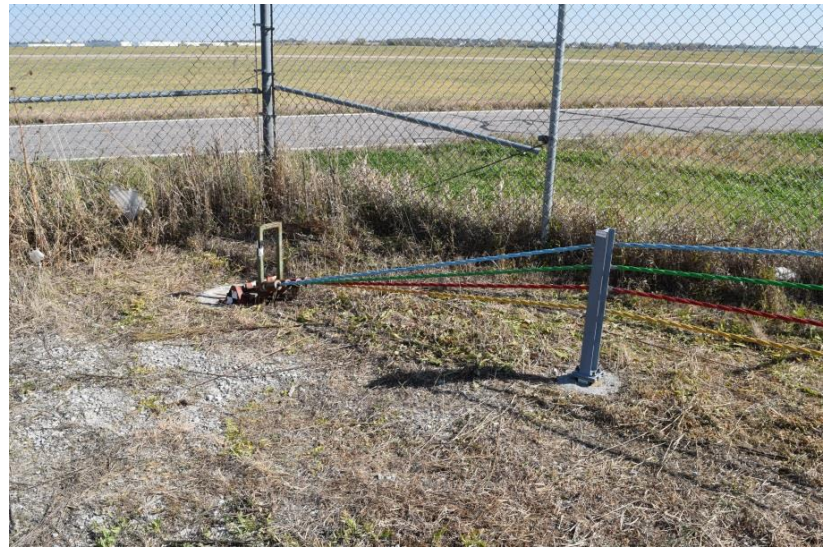
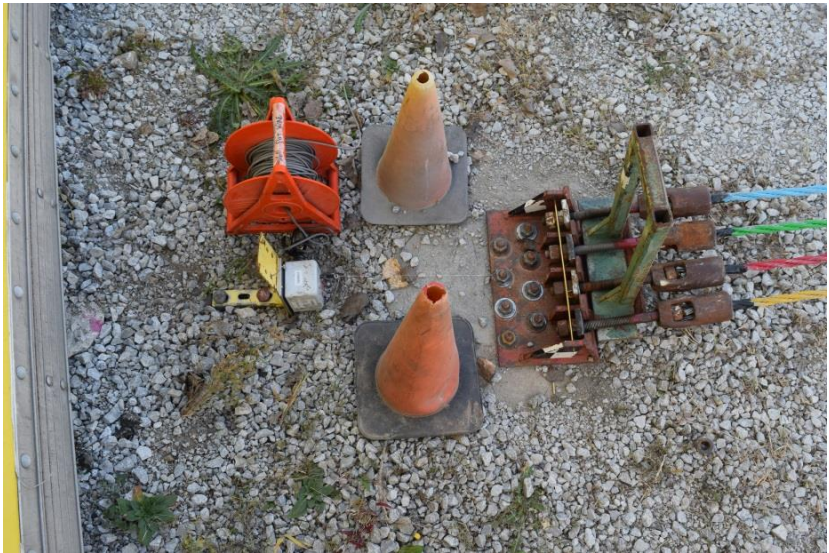
Upstream Anchorage

Figure 73. Anchorage Damage, Test No. MWP-8

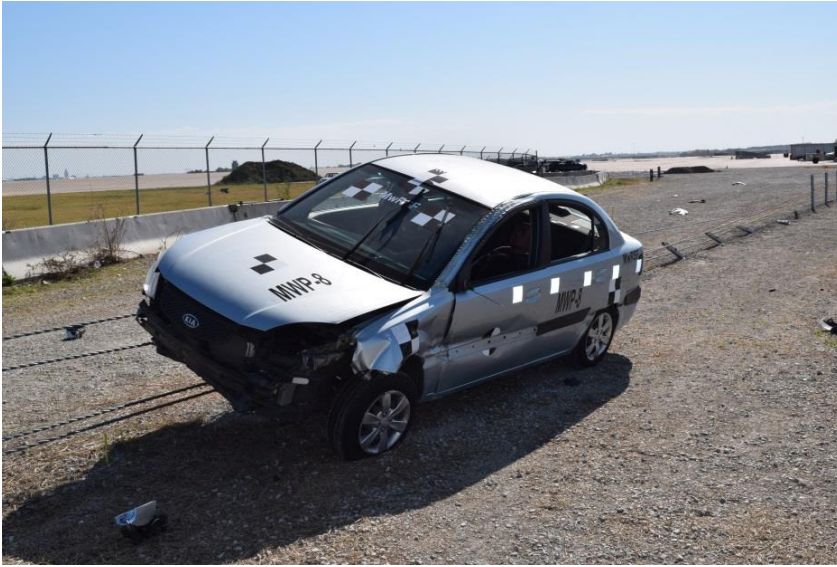
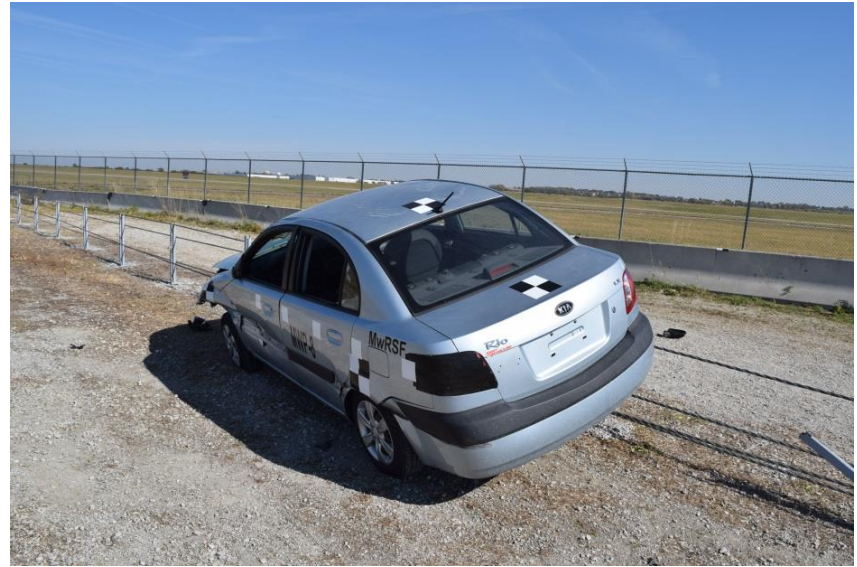
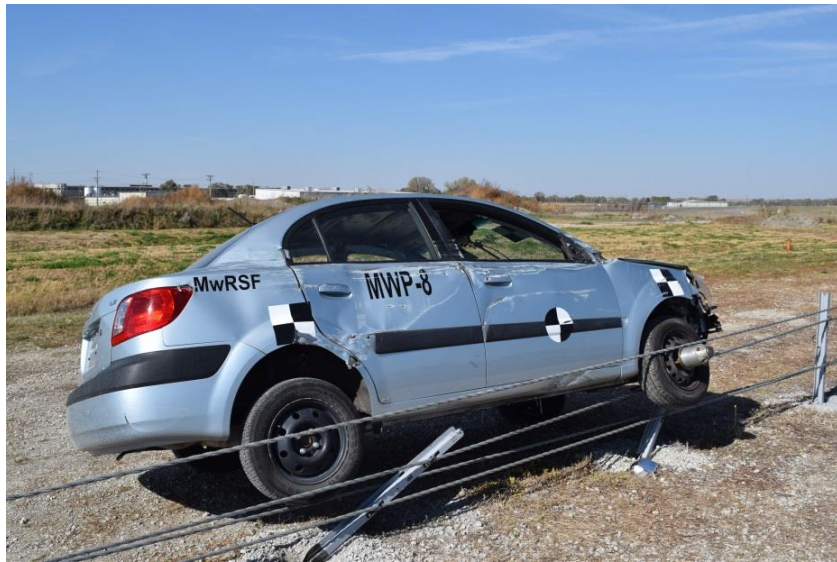
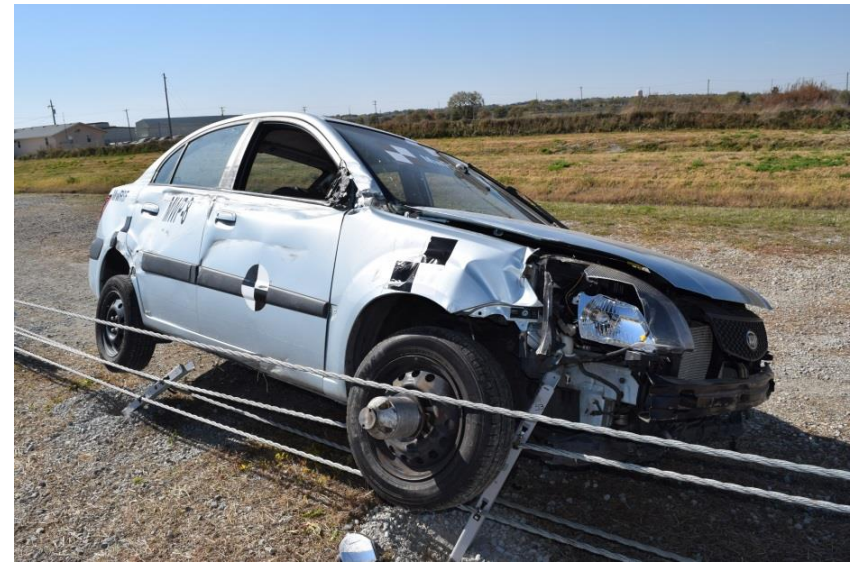
The majority of the vehicle damage was concentrated on the left-front corner, where primary impact occurred, and on the right-front corner, where it redirected back into the system. The cables caused striation marks, scrapes, and denting along the left- and right-front fenders and up the entire length of the A-pillar on both sides of the vehicle. Striation marks were also found on the roof, which were caused by the vehicle underriding cable nos. 3 and 4. The largest dent, which was 7 in. (178 mm) long and 4 in. (102 mm) wide, occurred at the rear of the left-front wheel well, and was caused by cable no. 2. The entire front bumper and fascia, left-side headlight, both side mirrors, and windshield fluid reservoir disengaged from the vehicle. The right-side headlight and right-side window were shattered. The left-front rim had gouges, and the tire was deflated. The right-rear rim was also gouged and the left-rear tire was scraped.

Figure 74. Vehicle Damage, Test No. MWP-8

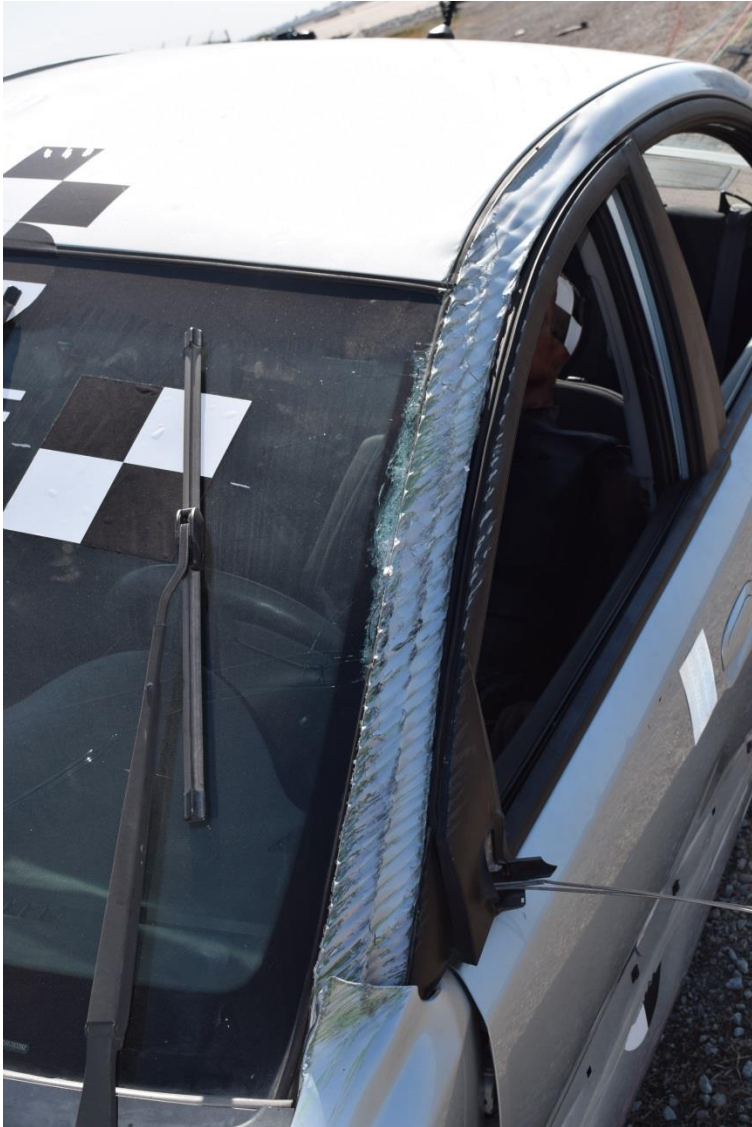
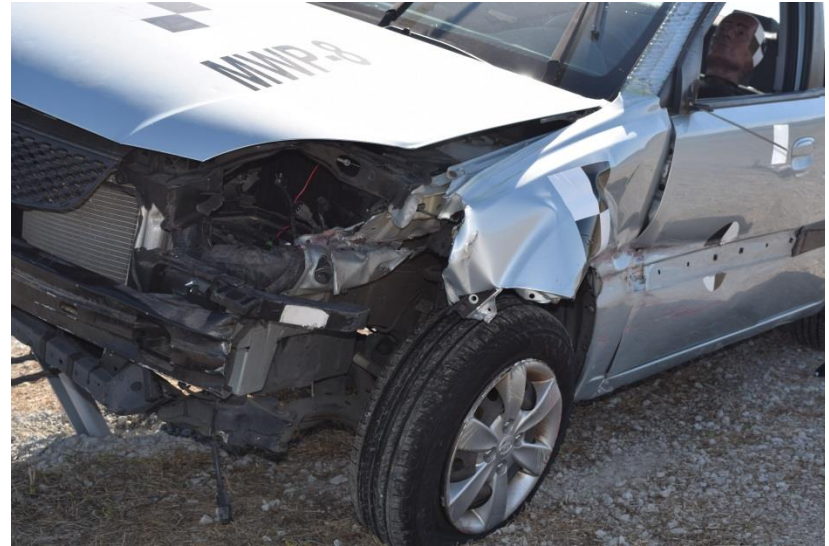
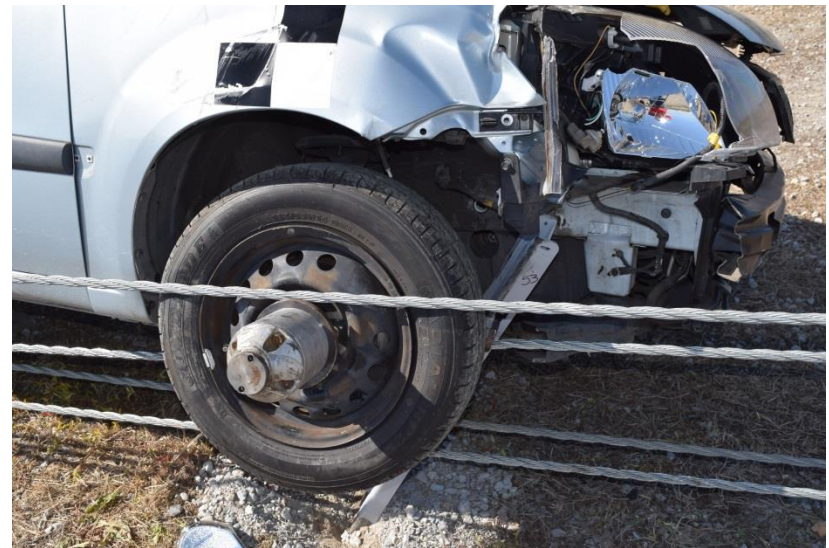
Figure 75. Vehicle Damage, Test No. MWP-8

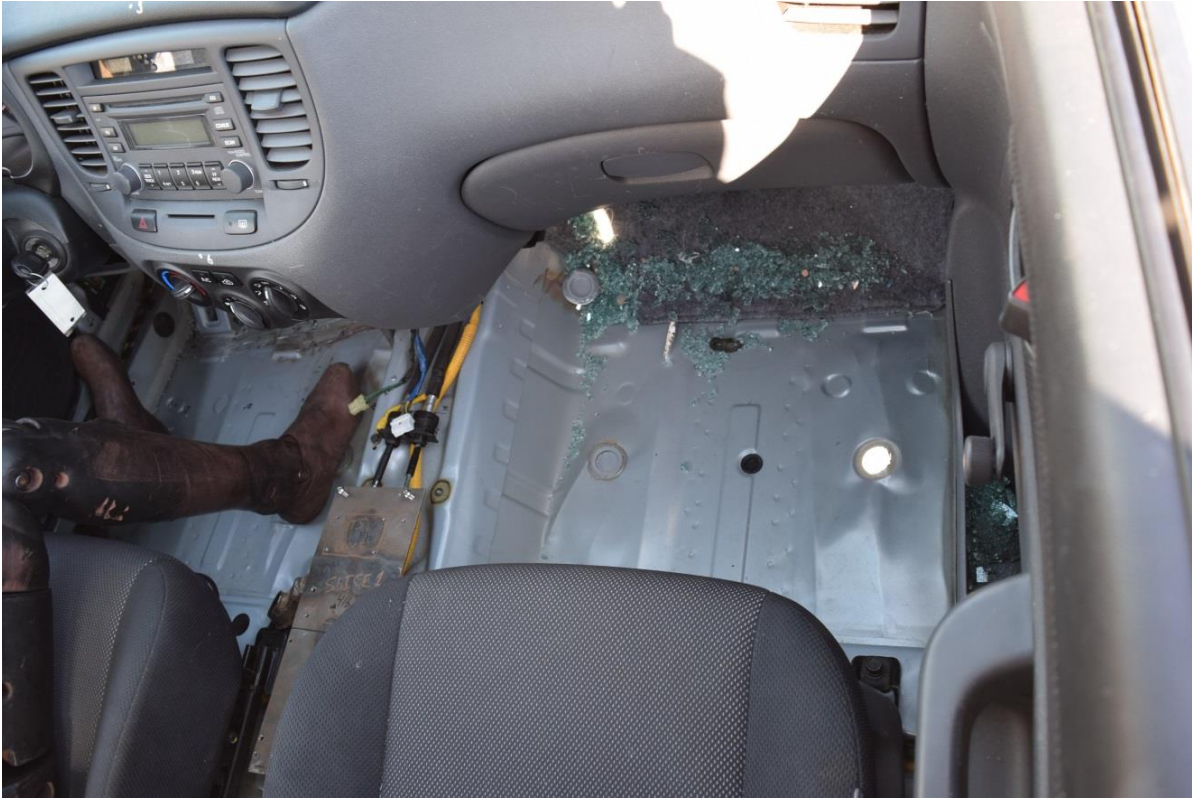
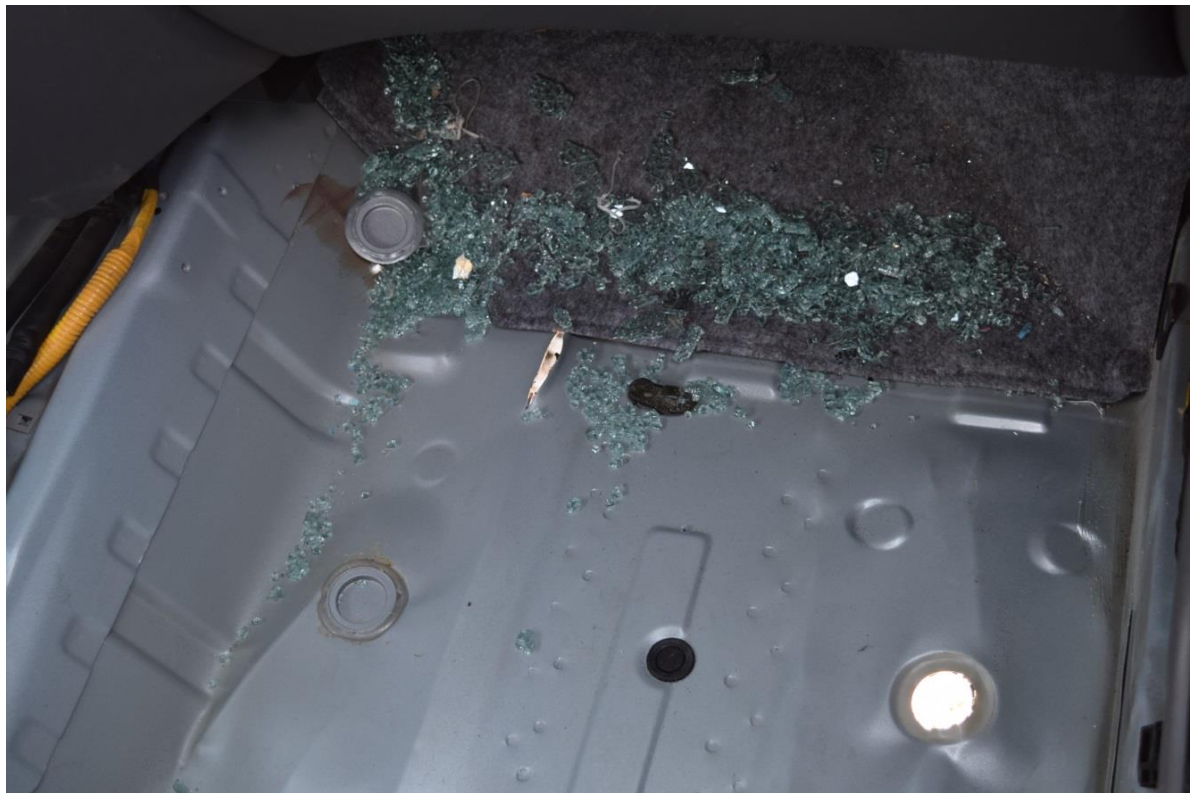
Two tears were found in the floorpan of the vehicle. One was a 3-in. (76-mm) long tear in the right-front floorpan and the other was a 7-in. (178-mm) long tear underneath the right-front seat, as shown in Figures 76 and 77. Although the occupant compartment deformations are within the bounds set by MASH, the occupant compartment penetration was unacceptable. The floorpan tearing was caused by the free edge of a post as the vehicle overrode the post.

Figure 76. Floorpan Damage, Test No. MWP-8

As mentioned previously, floorpan tearing occurred on the right side of the floorpan of the vehicle utilized in test no. MWP-8. Photographs of the floorpan damage can be seen in Figures 76 and 77. Although the occupant compartment deformations were within the bounds established in MASH, the occupant compartment penetration was unacceptable. Therefore, an investigation was conducted to determine which post(s) caused the penetration as well as the causes of the penetration.

As a result of the unsuccessful 1100C crash test, the prototype high-tension, four-cable, median barrier system will need to be further redesigned to prevent penetration of the occupant compartment observed in test no. MWP-8. Possible design changes may include, but are not limited to, alternative post spacings, reduction of weak-axis post strength at the ground line, further treatment of the post edges, redesign of the cable-to-post attachment bracket, and changes to post geometry. After the cable barrier system has been redesigned, it will need to be re-evaluated according to MASH test designation no. 3-10 criteria before proceeding with remaining tests listed within the recommended testing matrix for cable barriers installed within median V-ditches. Depending on the nature of the design changes, it may be necessary to evaluate whether prior successful crash tests need to be rerun.

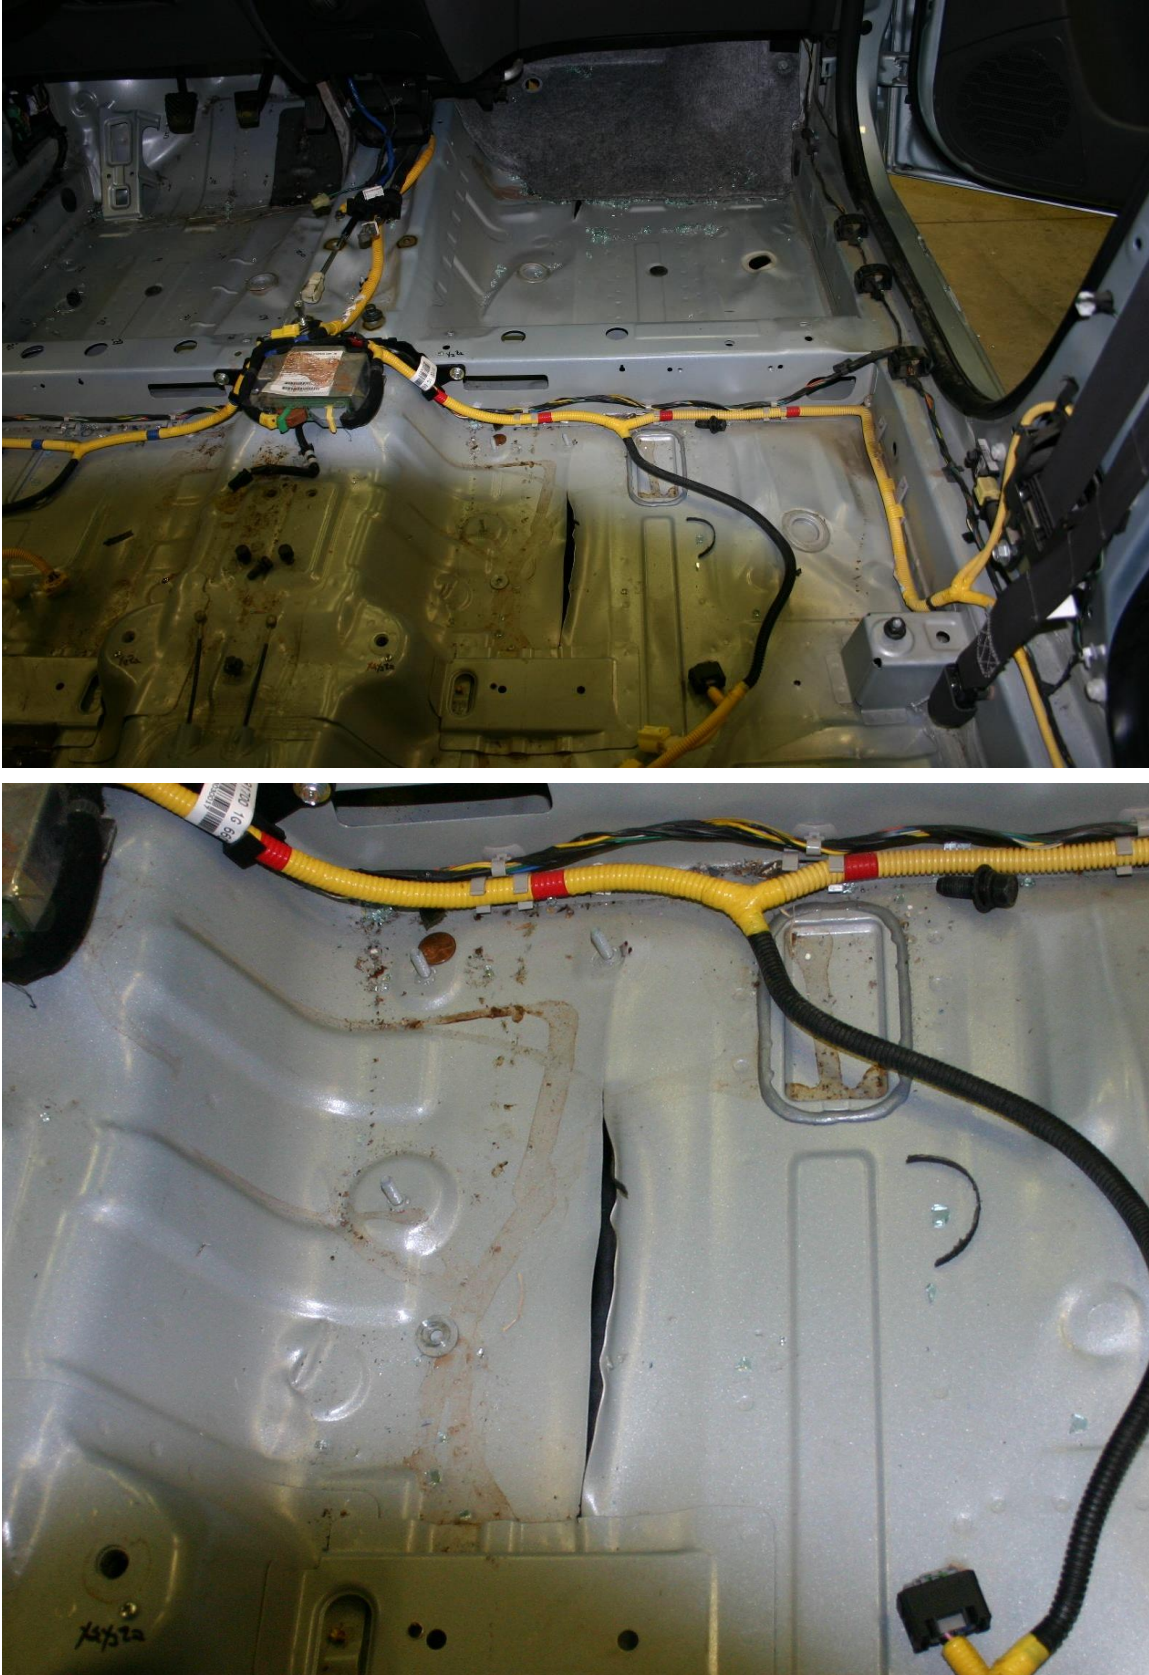
Figure 77. Floorpan Tearing, Test No. MWP-8

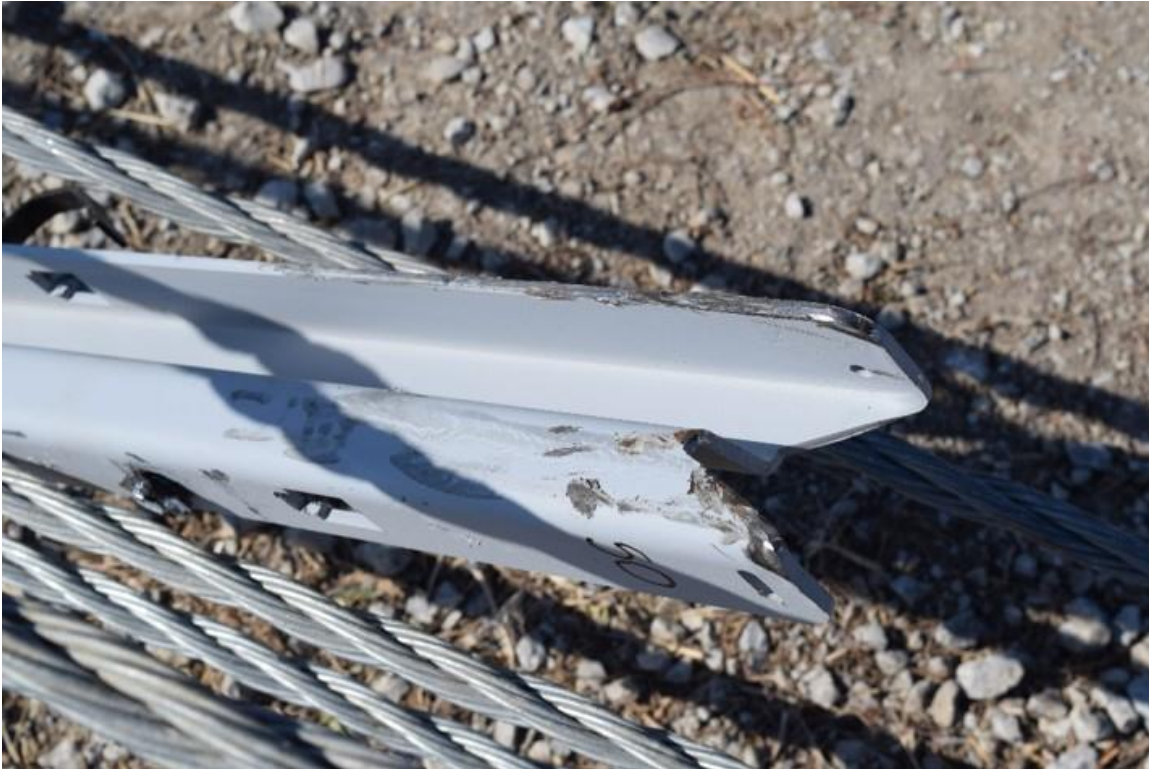
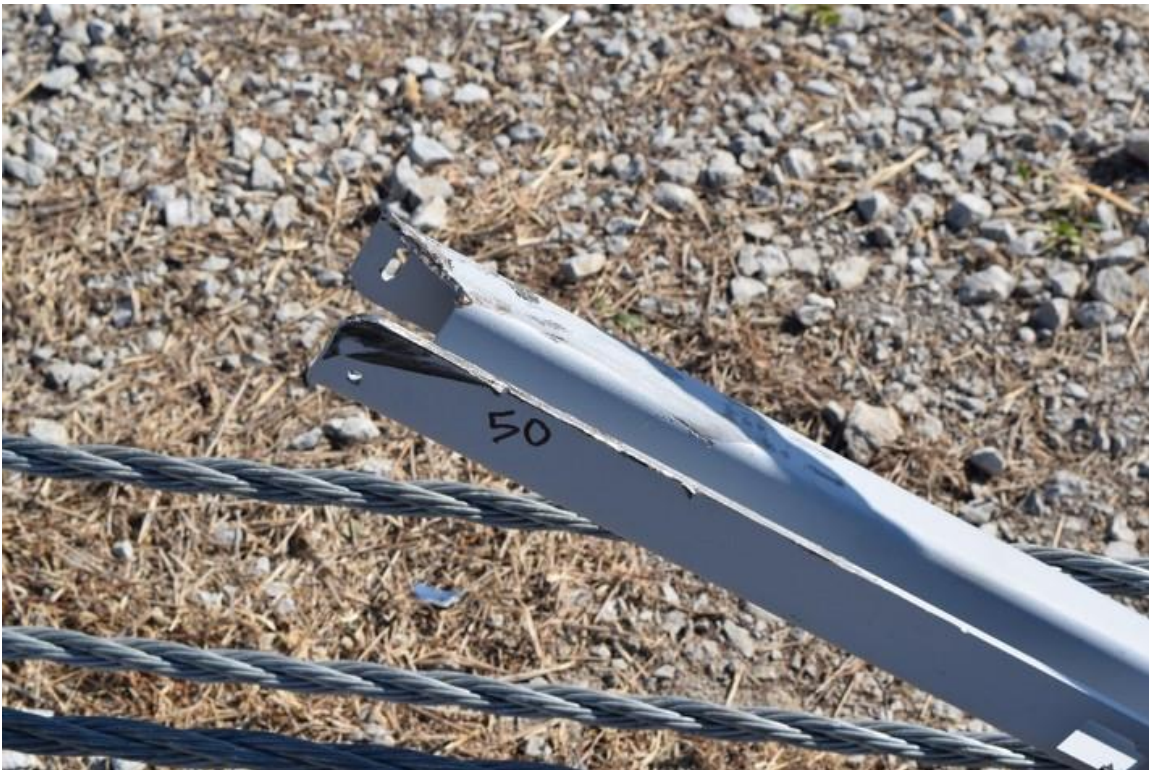
In addition, contact marks and damage on post nos. 47 through 52 were reviewed. During this review, heavy damage was found on the upper free edge of post no. 50, as shown in Figure 78. This further reinforced the conclusions of the original investigation that the floorpan tears were caused by post no. 50.

Figure 78. Post No. 50 Damage, Test No. MWP-8

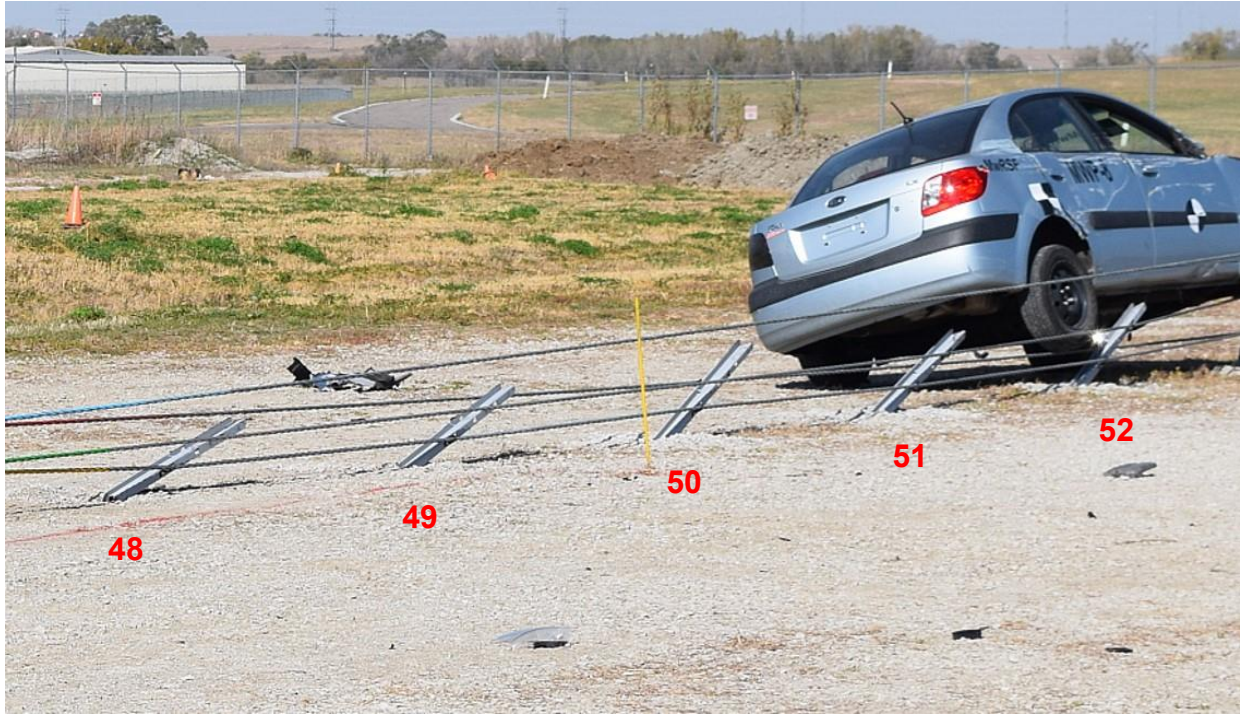
Combining the video and accelerometer analyses allowed for the floorpan damage from each individual post to be identified. Deformations to the floorpan caused by post nos. 45 through 49 was minimal. However, significant localized deformations occurred as the vehicle overrode post nos. 50 through 52, and the top of post no. 50 tore the floorpan in two locations. The difference in the behavior of these two sets of posts as the vehicle overrode them can be explained by the extent in which the posts were bent over. Post nos. 45 through 49 were bent to a nearly 90 degree angle and resulted in the top of the post being close to the ground. Post nos. 50 through 52 were not bent as severely and the tops of these posts were higher above the ground, as shown in Figure 79.

Partial tearing was observed at groundline on each of the posts in this region of the barrier system. The weakening holes had performed correctly and initiated tearing in the upstream webs of each post. Thus, the resistance to bending deformations observed in post nos. 50 through 52 could not be explained by differing post strengths or inconsistent activation of the weakening mechanism in the posts.

The difference in behavior between these groups of posts was determined to be linked to the cable release, or lack thereof, of the cable-to-post attachment brackets on cable no. 3. The upper tabs of the brackets on post nos. 47 through 49 were pulled out of the keyways in the posts and allowed cable no. 3 to disengage from the post. However, the brackets attaching cable no. 3 to post nos. 50 through 52 did not release as intended. The brackets remained attached to the post and held cable no. 3 in place. Cable no. 3 then applied a vertical force to each of these three posts that prevented them from completely bending over and resulted in excessive contact between the top of the posts and the vehicle floorpan.

Figure 79. Post Deformation Difference – Post Nos. 48 Through 52, Test No. MWP-8

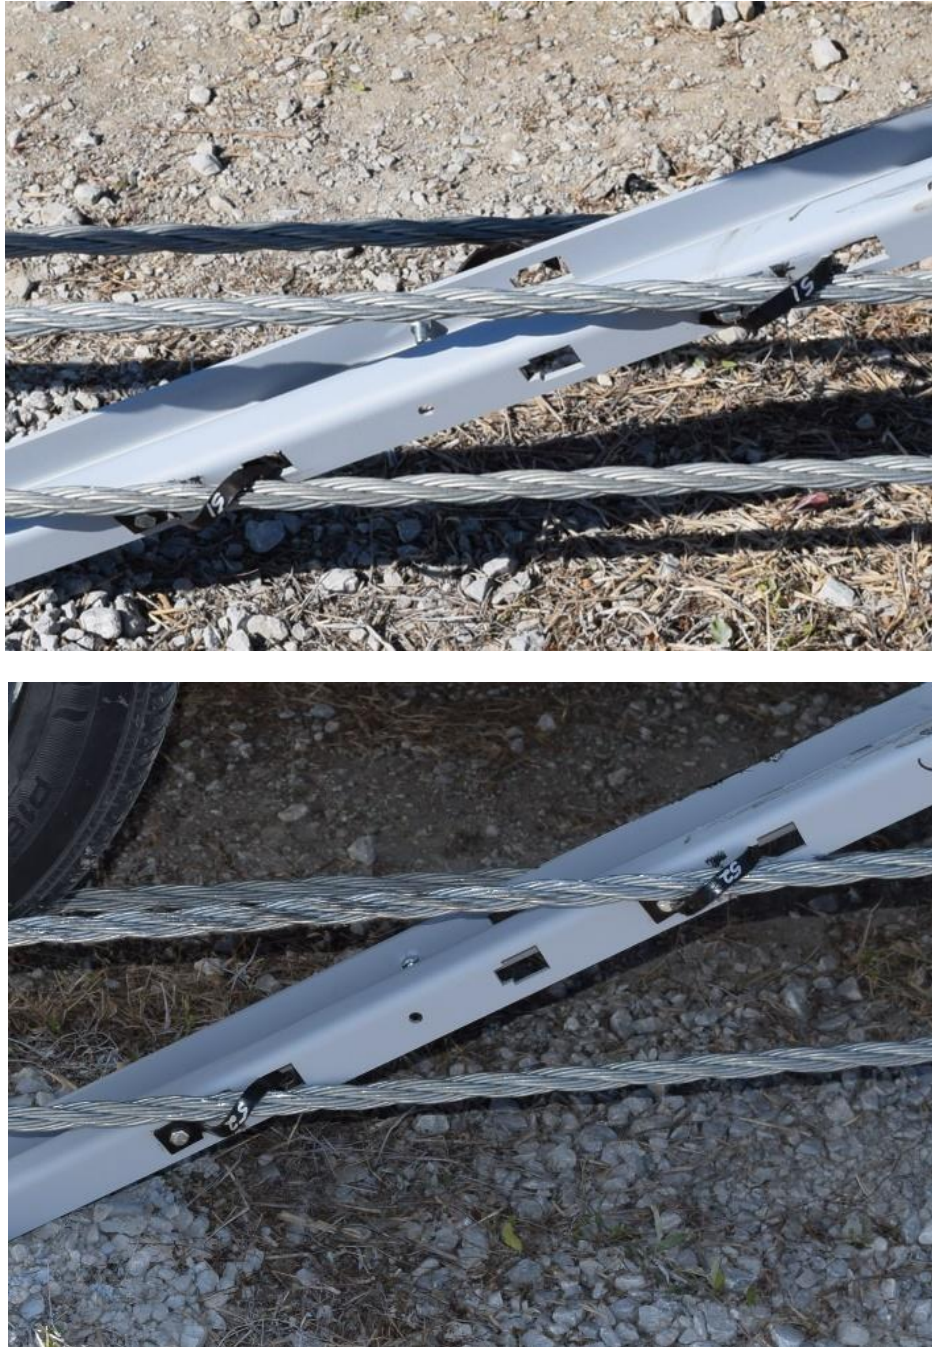
At the time of impact with post nos. 50 through 52, the vehicle was traveling very near to parallel with the system. Thus, the posts were pushed almost directly downstream as they were pushed and bent over. This motion cause the bracket to twist within the keyway as the cable resisted the displacement. The edges of the bracket tabs were then jammed against the side of the keyway and prevented the bracket from releasing the cable. This behavior is shown in Figure 80. Note, after the test, cable no. 3 was found disengaged from post no. 50. However, the bracket had fractured through its neck instead of releasing through the keyway as the cable brackets had on post nos. 47 through 49. This outcome indicated that the bracket had not released as intended, but it was instead twisted on the post and only fractured after high loading was applied through the cable to the bracket.

This bracket twisting was also observed in the brackets attaching cable no. 1 to nearly all of the posts between post nos. 47 and 52. However, since cable no. 1 is the bottom cable on the system and is so low to the ground, minimal vertical forces would be applied through cable no. 1 if it remains engaged with the post. Therefore, the failure of the brackets to release cable no. 3 were thought to provide a much greater vertical force to the posts which resisted post deformations.

Figure 80. Cable Mounting Bracket Twisting – Post Nos. 51 and 52, Test No. MWP-8
