EVALUATION OF FLOORPAN TEARING AND CABLE SPICES FOR CABLE BARRIER SYSTEMS

MIDWEST ROADSIDE SAFETY FACILITY

MwRSF Research Report No. TRP-03-324-17

May 16, 2017

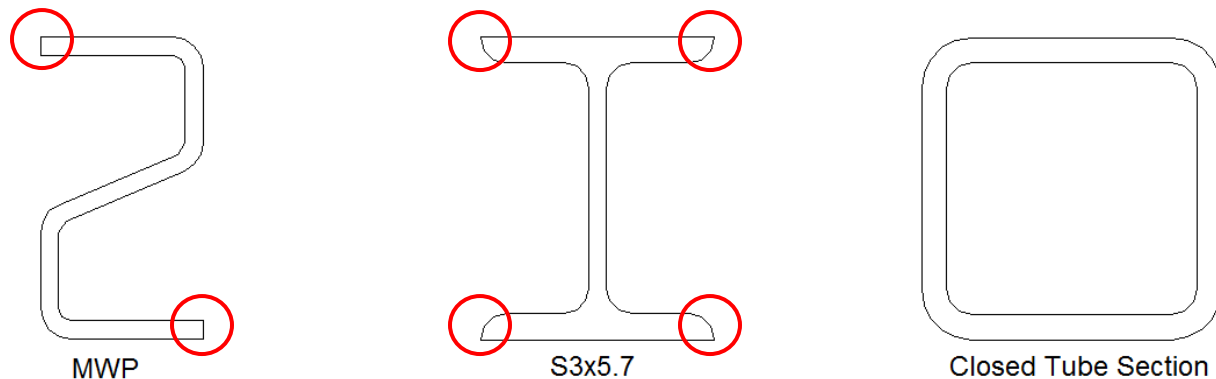
Figure 2. Post Shape Free Edges

The weak-axis bending strength of the post, and specifically the elastic response, is critical for the top of the post to contact, crease, and tear the vehicle's floorpan. When a vehicle runs over a post, a plastic hinge forms in the post, and the post is bent over such that the top of the post passes underneath the vehicle's bumper and undercarriage. However, an elastic response in the post causes it to spring back and push up against the vehicle's floorpan. The top of the post then applies a vertical force to the vehicle floorpan proportional to the elastic restoration strength remaining in the hinged post. Since material failure is associated with the magnitude of the applied force, the propensity for floorpan tearing is directly related to the elastic bending strength of the posts utilized in the barrier system.

The presence of free edges within the post's cross-section amplifies the effect of this restoration force. Free edges are characterized as areas of the post's cross section where an end of a flange, or another thin element, is exposed within the cross section. The location of free edges on common post shapes are shown in Figure 2. The thin elements and small contact areas of these free edges result in higher stress concentrations during impact events. Thus, under equivalent restoration forces, posts with free edges will impart higher stresses to the vehicle's floorpan than posts with continuous faces or closed cross sections.

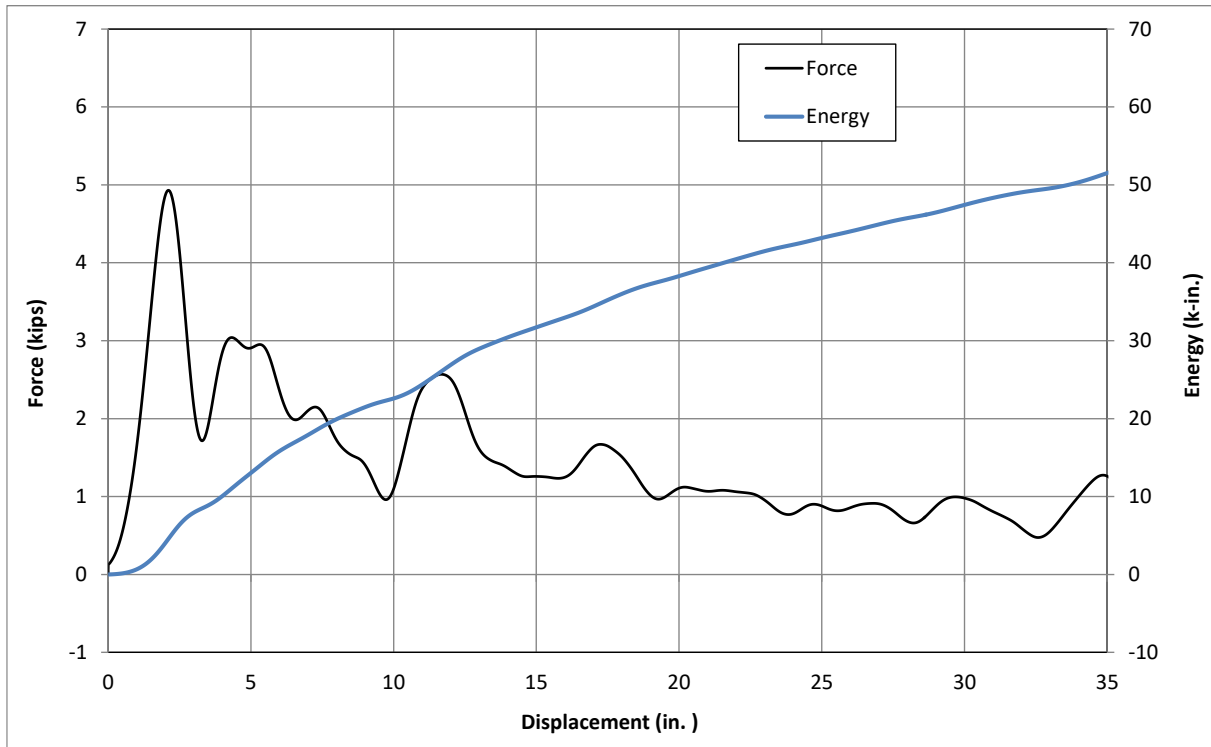
Figure 79. Force vs. Deflection and Energy vs. Deflection, Test No. MWPF9-9

Sequential and post damage photographs are shown in Figure 80. Contact marks were present along the top portion of the impact-side flange. A plastic hinge was observed around the weakening holes near groundline, and the post flanges collapsed inward toward the web. The weakening holes were deformed, but the post did not tear.

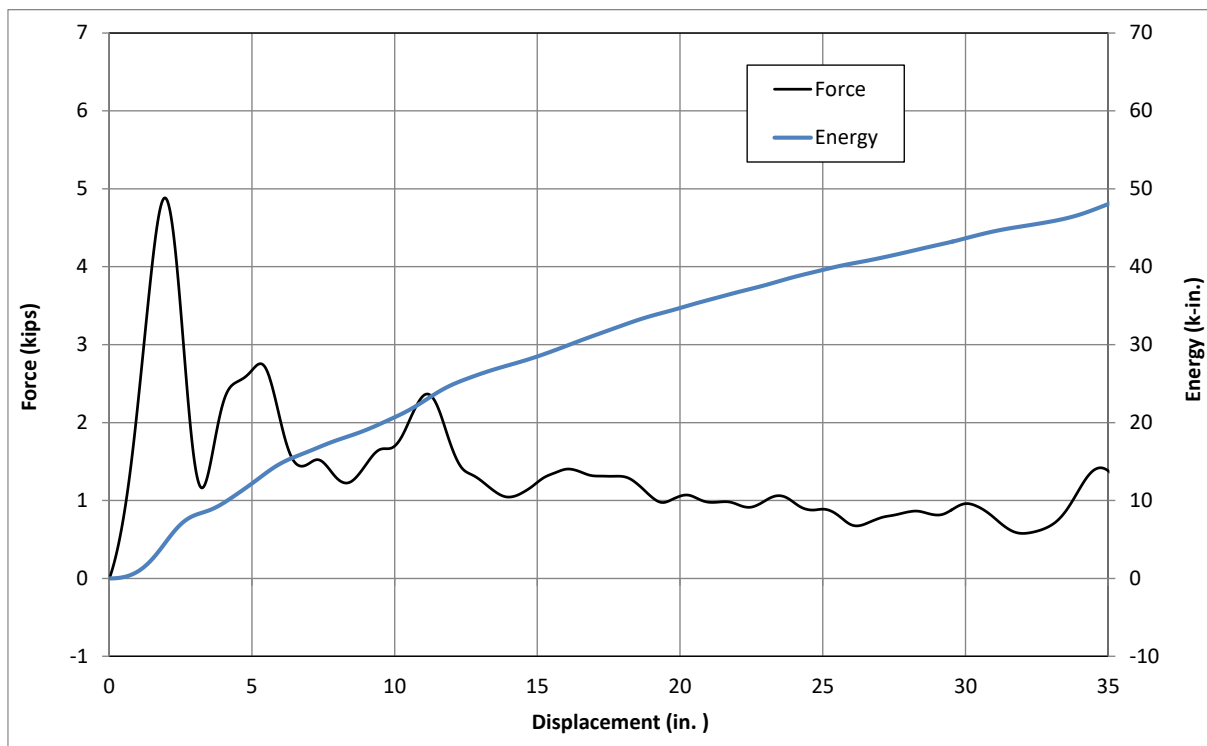
Figure 81. Force vs. Deflection and Energy vs. Deflection, Test No. MWFPF-10

Sequential and post damage photographs are shown in Figure 82. Contact marks were present along the top portion of the impact-side flange. A plastic hinge had formed in the post near the groundline, and the post flanges collapsed inward toward the web, but the post did not tear.

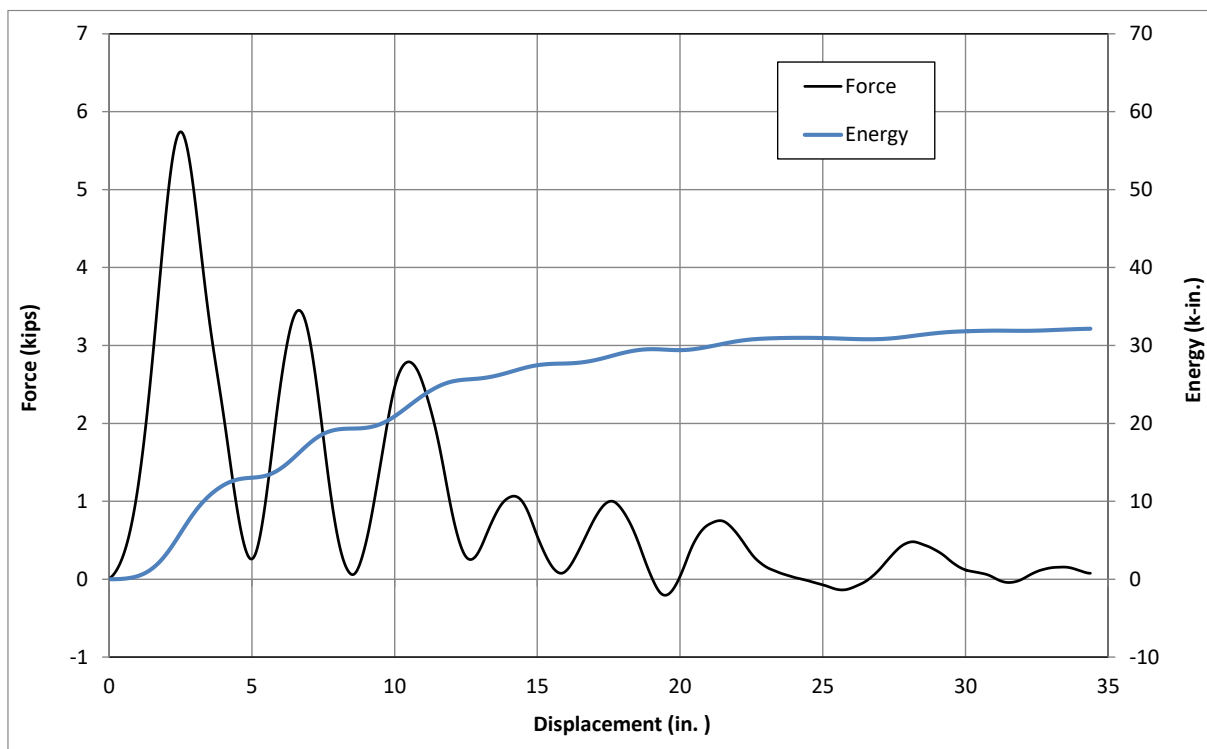
Figure 83. Force vs. Deflection and Energy vs. Deflection, Test No. MWFPF-16 Post 1

Sequential and post damage photographs are shown in Figure 84. Contact marks were present along the top portion of the impact-side flange. The post was bent and tore near the groundline. The front flange was completely torn, and the tear extended through the adjacent weakening holes. A second tear occurred between the weakening holes on the backside of the post.

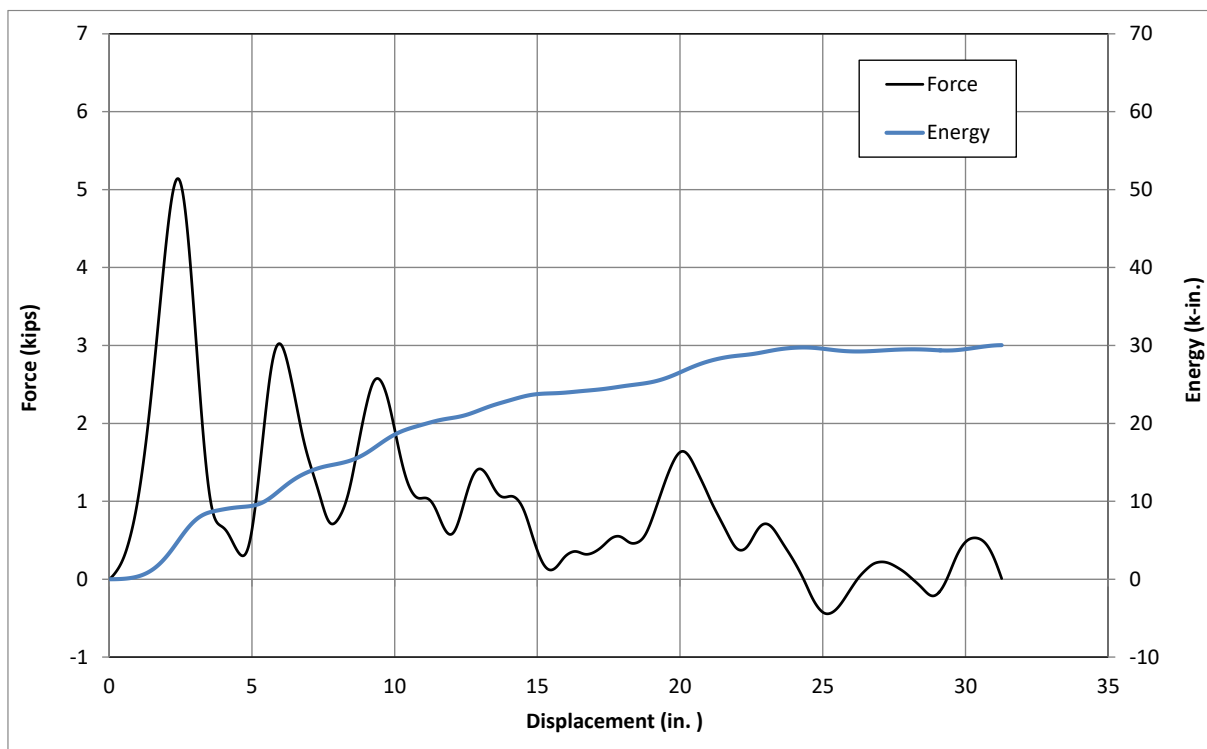
Figure 85: Force vs. Deflection and Energy vs. Deflection, Test No. MWPFP-16 Post 2

Sequential and post damage photographs are shown in Figure 86. Contact marks were present along the top portion of the impact-side flange. The post was bent and tore near the groundline. The front flange was completely torn, and the tear extended through the adjacent weakening holes. A second tear occurred between the weakening holes on the backside of the post.

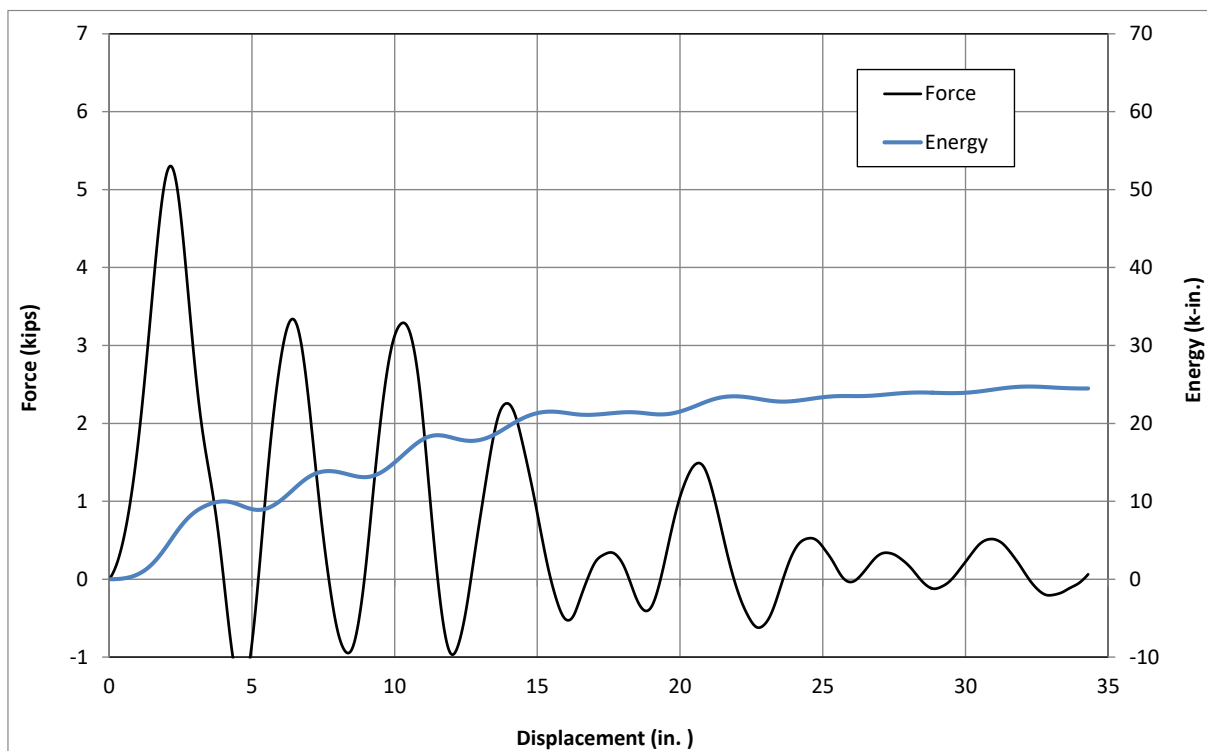
Figure 87. Force vs. Deflection and Energy vs. Deflection, Test No. MWFPF-17 Post 1

Sequential and post damage photographs are shown in Figure 88. Contact marks were present along the top portion of the impact-side flange. The post was bent near the groundline, and the front flange tore completely adjacent to the slot. The back flange buckled inward at the location of the plastic hinge. The slot adjacent to the back flange was deformed, but no additional tearing was observed.

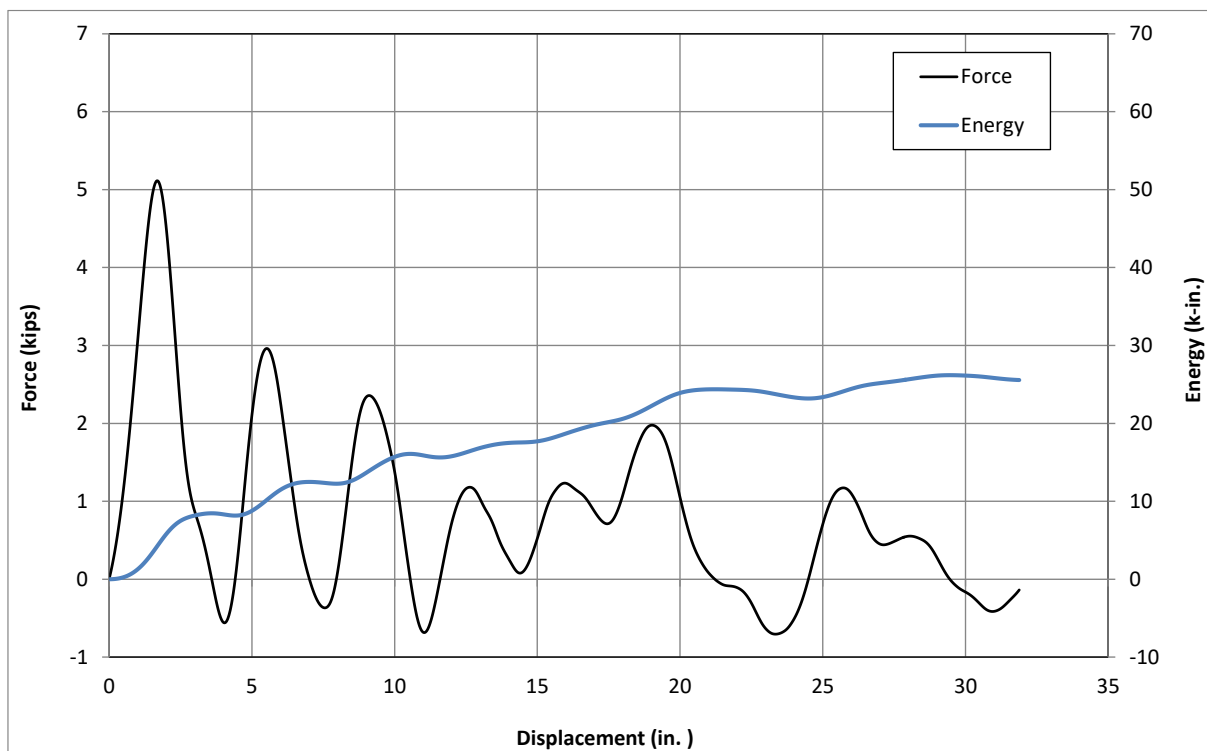
Figure 89. Force vs. Deflection and Energy vs. Deflection, Test No. MWPFP-17 Post 2

Sequential and post damage photographs are shown in Figure 90. Contact marks were present along the top portion of the impact-side flange. The post was bent near the groundline, and the front flange tore completely adjacent to the slot. The back flange buckled inward at the location of the plastic hinge. The slot adjacent to the back flange was deformed, but no additional tearing was observed.

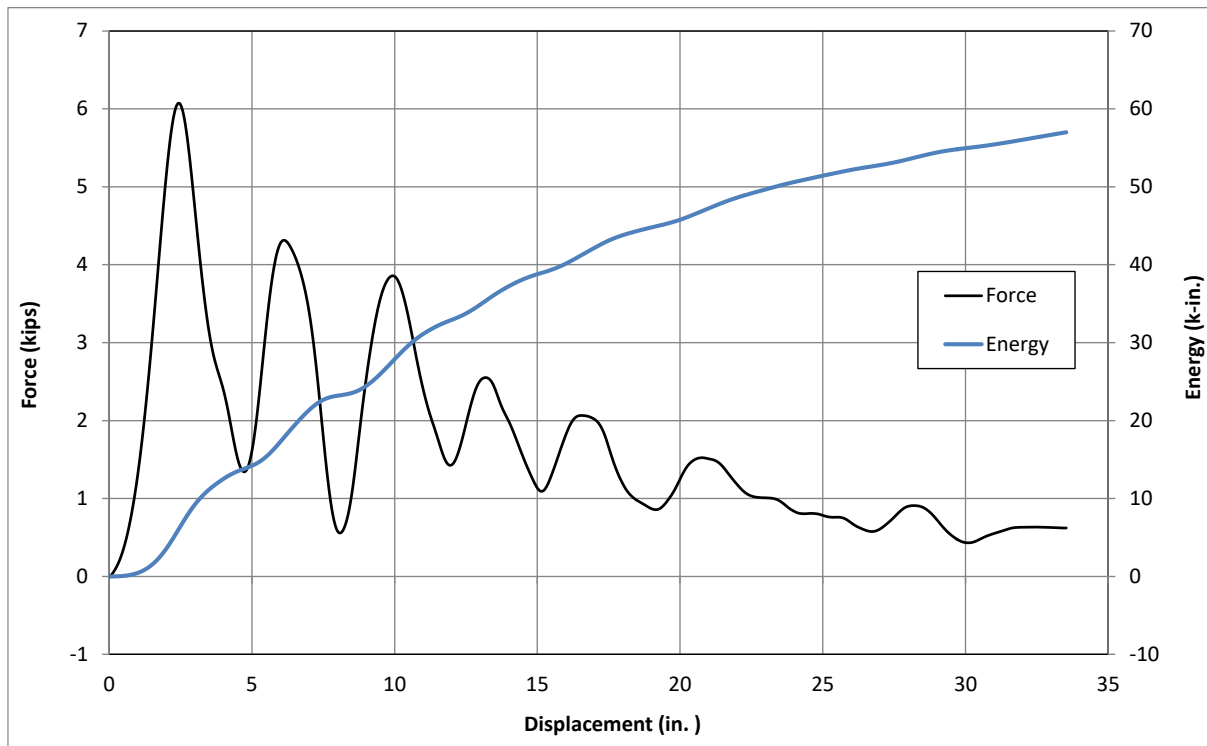
Figure 91. Force vs. Deflection and Energy vs. Deflection, Test No. MWPF-19

Sequential and post damage photographs are shown in Figure 92. Contact marks were present along the top portion of the impact-side flange. A plastic hinge had formed in the post near the groundline, and the post flanges collapsed inward toward the web, but the post did not tear.

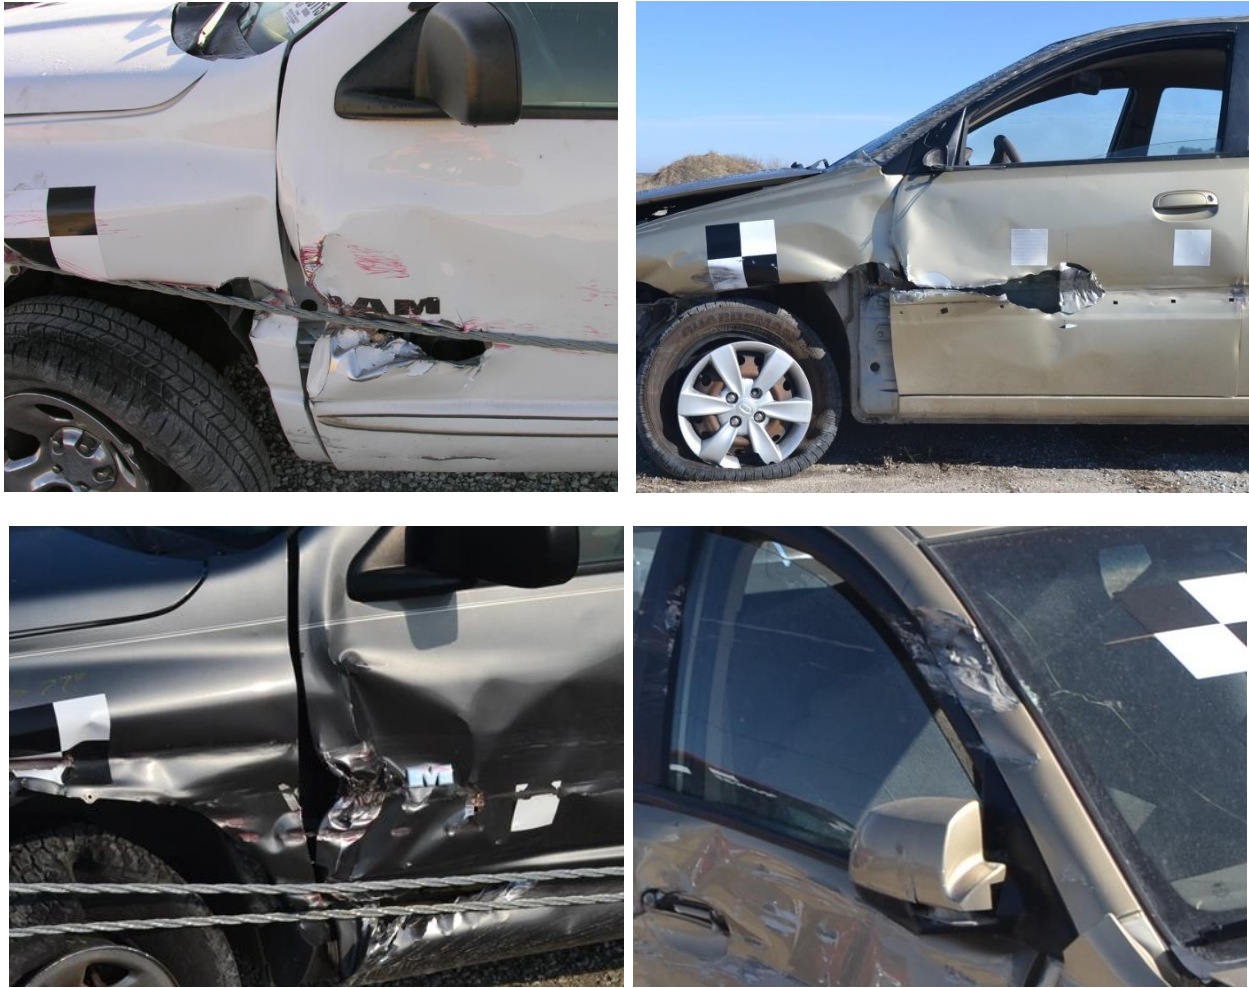
Figure 96: Vehicle Door and A-Pillar Damage from Splice Snagging

During the full-scale crash testing of the cable median barrier prototype, observations were made concerning tears in the vehicle's exterior sheet metal due to contact with the cable splices during redirection [3-4]. Sheet metal tearing had been observed on all three vehicle types (1100C, 1500A, and 2270P) and was common along vehicle fenders, front doors, and A-pillars. These tears were only to the exterior sheet metal layer and did not result in penetration of the occupant compartment. Thus, they did not affect the MASH evaluation of the cable barrier. However, they do illustrate the ability of the current cable splice to act as a potential snag hazard and could potentially cause significant damage to the vehicle. Utilization of different cable splice hardware may reduce the propensity for snag and/or sheet metal tearing. Therefore, an evaluation was desired into the strength and geometry of all available cable splice hardware.
