INCREASED SPAN LENGTH FOR THE MGS LONG-SPAN GUARDRAIL SYSTEM PART III: FAILURE ANALYSIS

MIDWEST ROADSIDE SAFETY FACILITY

MwRSF Research Report No. TRP-03-362-17

September 29, 2017

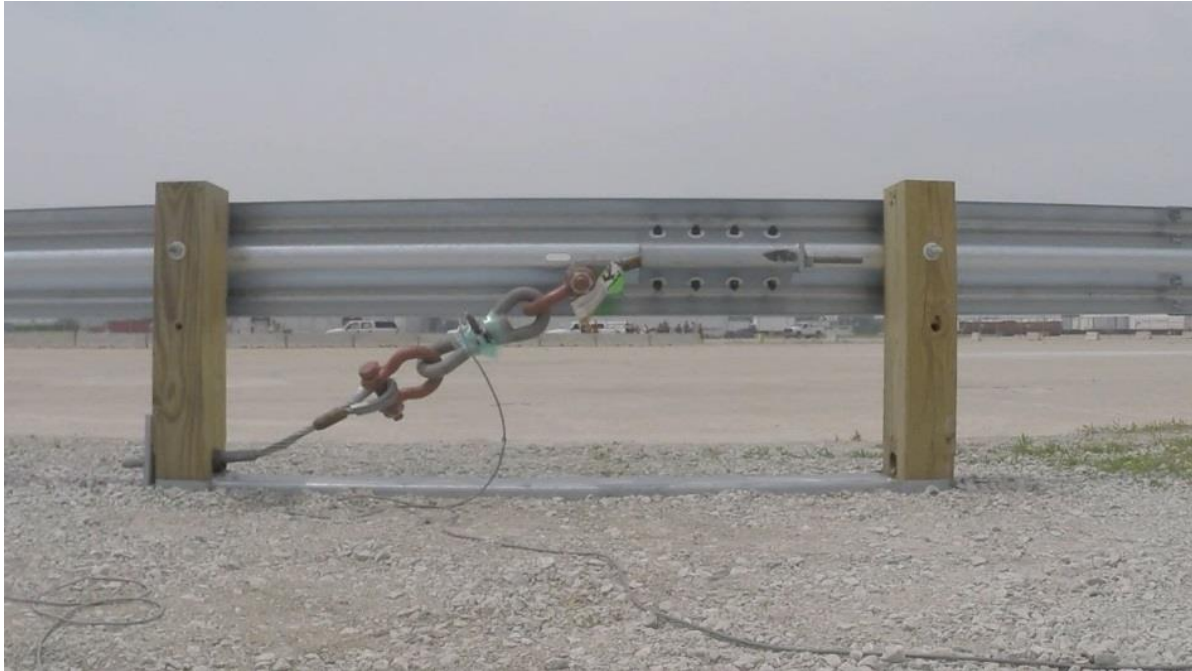
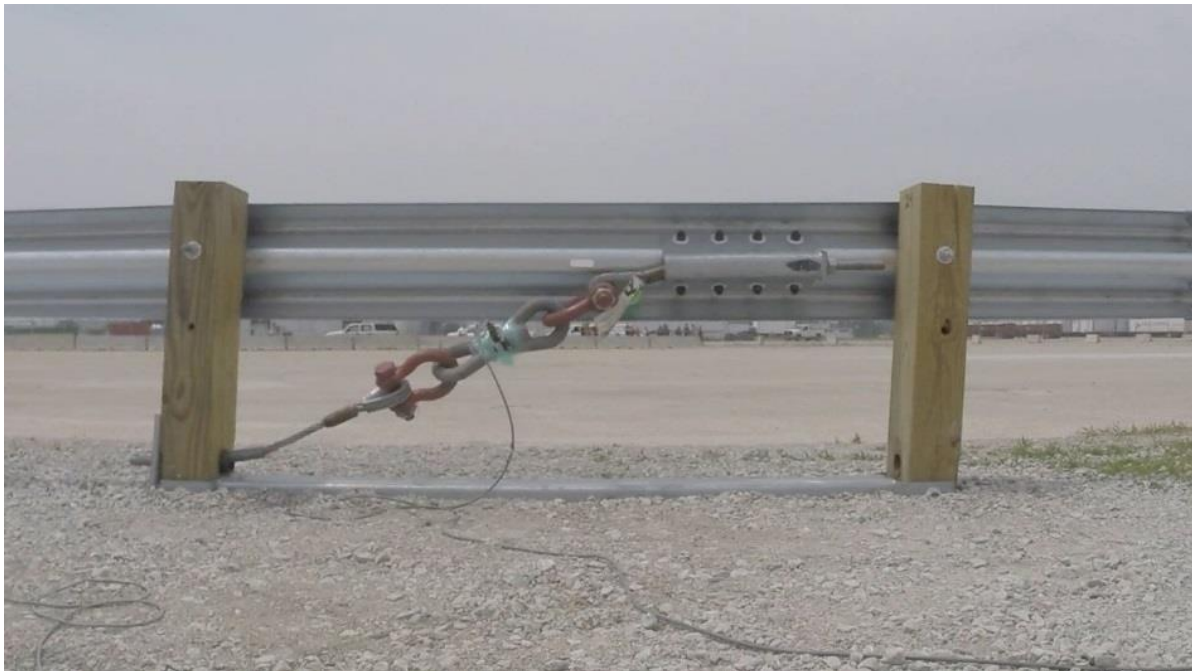
Figure 6. Sequential Photographs of Downstream End Anchorage, Test No. MGSLS-2

As the vehicle was redirected, the BCT posts at the downstream end anchorage, post nos. 24 and 25, were deflected longitudinally upstream due to tensile loads in the guardrail and the cable anchorage. Vertical cracking in post no. 24 was initiated at approximately 0.095 sec due to longitudinal loading of the post through the post bolt connecting the post to the guardrail, as shown in Figure 6 and Figure 7. As loading of the downstream anchorage continued, a diagonal crack initiated near the top of the BCT cable anchor plate on the downstream face of post no. 25. This crack propagated down to the hole in the base of the BCT post and caused complete fracture and release of post no. 25 at approximately 0.140 sec after impact. Following the release of the cable anchorage at post no. 25, post no. 24 fractured and released as well. Release of the downstream end anchorage caused the guardrail to lose tensile on the downstream end of the system and allowed the 2270P vehicle to penetrate into the barrier system in an uncontrolled manner.

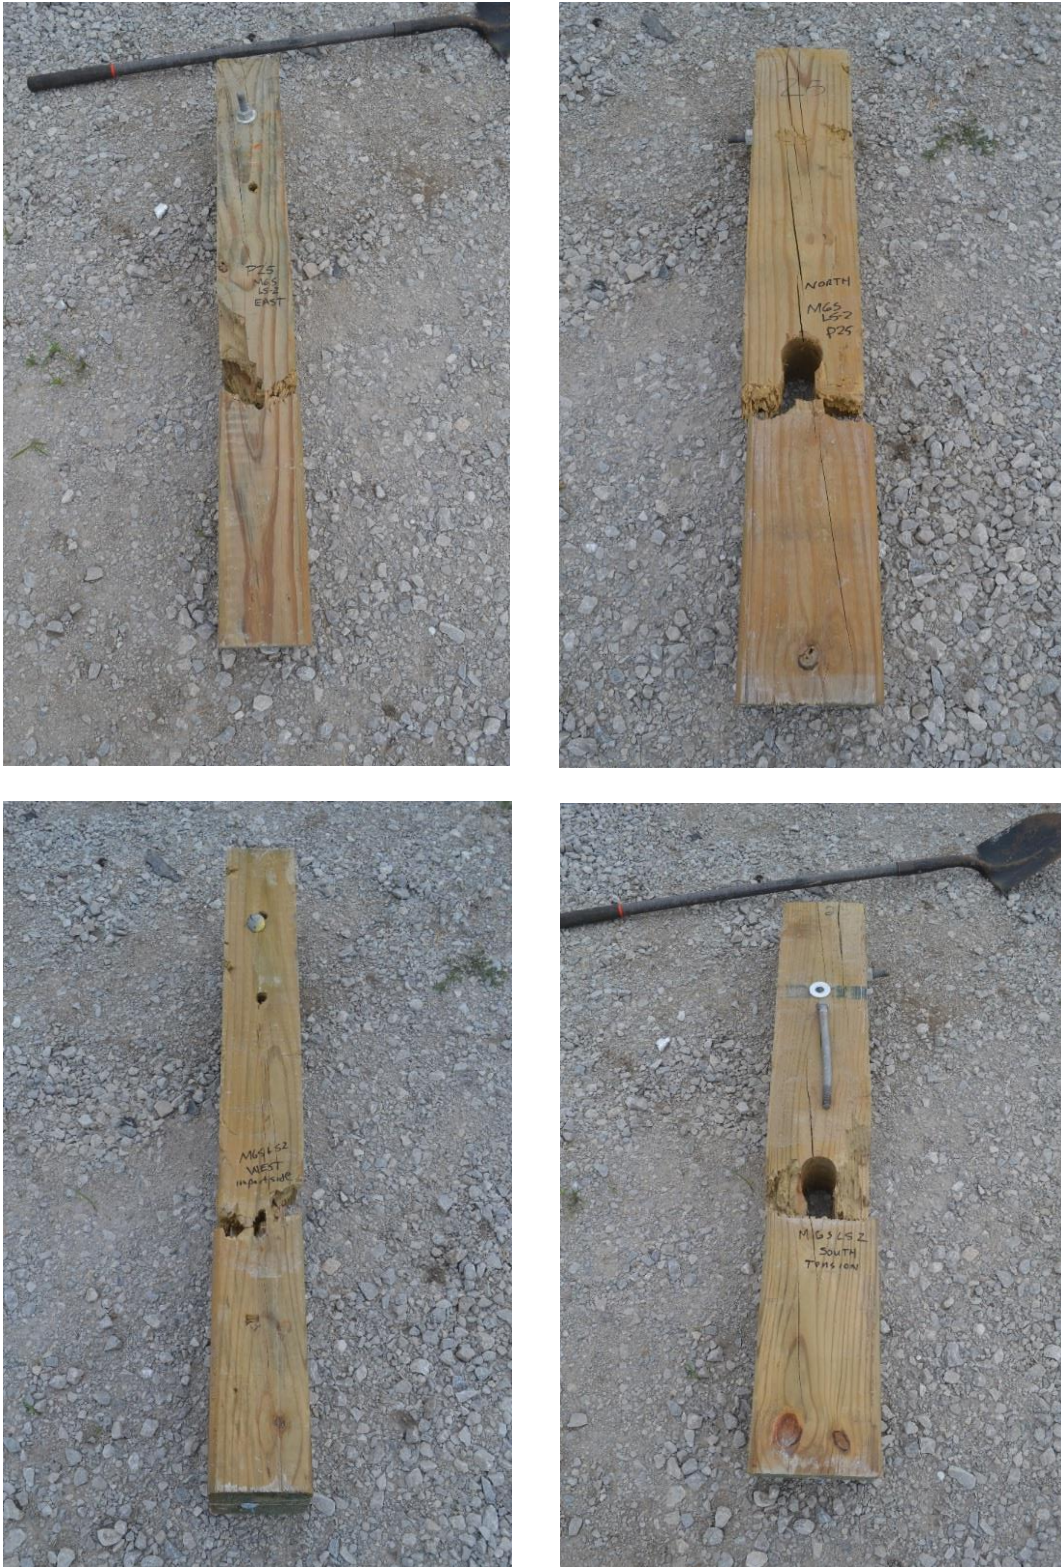
Figure 9. Post No. 25 Damage, Test No. MGSLs-2

Wood post damage included fracturing, gouging, and displacement of posts. Post no. 1 had gouging on the front face due to rail contact. Post no. 2 split vertically along the height of the post through the guardrail bolt hole on the front side. Post nos. 24 and 25 fractured at the ground line and post no. 24 also split along the vertical plane of the centerline of the post. Post no. 25 had a 7½-in. (191-mm) deep by 3-in. (76-mm) wide crack located 2¼ in. (57 mm) downward from the top of the back face of the post, as well as a 3-in. (76-mm) diameter dent on the back downstream face of the post. The post-test photographs of the end anchorage system for test no. MGSL-2 are shown in Figure 8. No knots or asperities were observed in the fracture region of post no. 25, as shown in Figure 9.

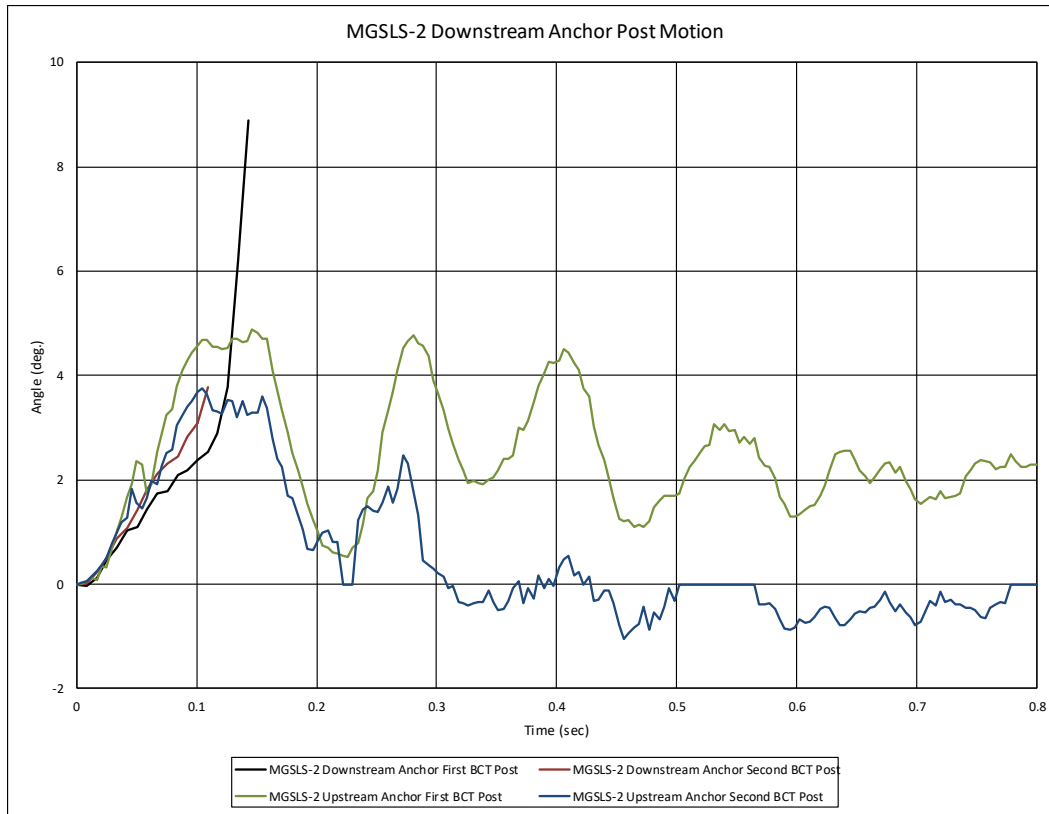
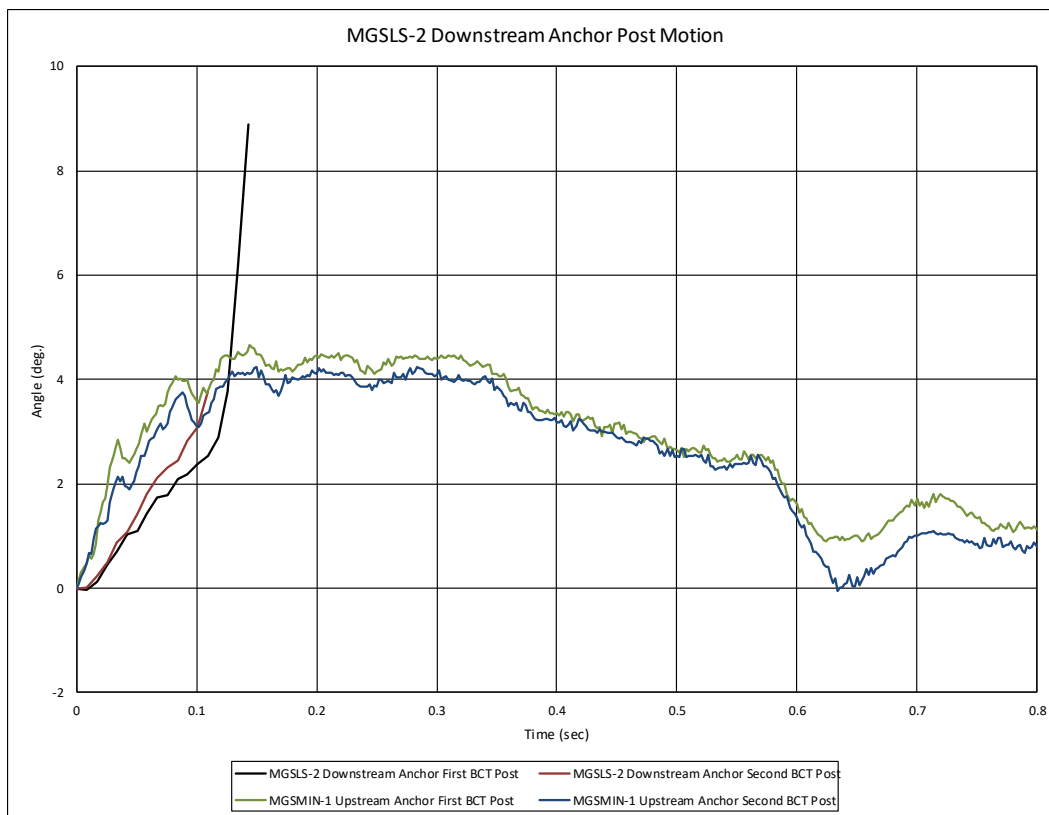
Figure 18. MGSL-2 Downstream Anchor Post Motion

Film analysis was used to compare the deflection angle of the posts from vertical as the anchorages were loaded, as shown in Figures 18 and 19. Note that the deflection angle of the second BCT post from vertical for in test no. MGSLS-2 was not measured after the vertical splitting of the anchor post, and the angle of the first BCT post in test no. MGSLS-2 increased rapidly after 0.120 sec due to the formation of the crack near the top of the cable anchor plate noted previously. Comparison of the deflection angles found that the deflection of the BCT posts in the downstream anchor from test no. MGSLS-2 was not markedly different or excessive as compared to previous tests without anchor failure prior to fracture of the anchor posts.

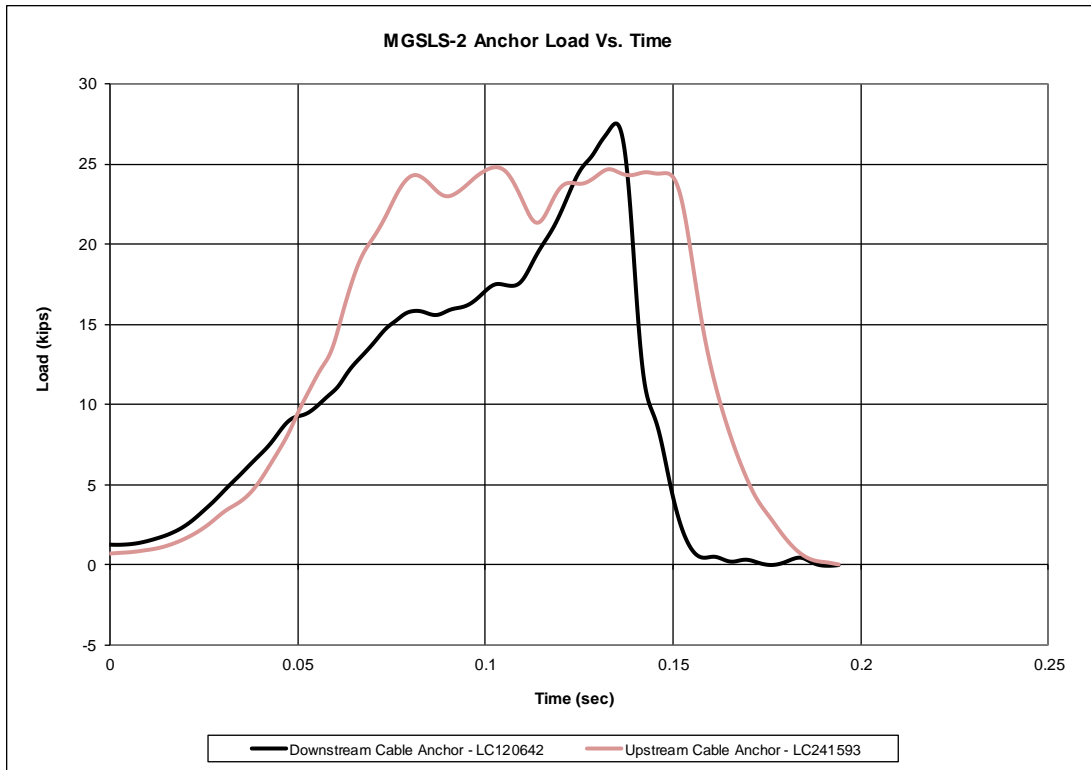
Figure 20. Anchor Load Vs. Time, Test No. MGSL-2

The anchor loading of failed test no. MGSLS-2 was reviewed first. Anchor load versus time and anchor load versus foundation tube deflection for the upstream end anchorage and the downstream end anchorage that failed in test no. MGSLS-2 are shown in Figure 20 and Figure 21, respectively. The downstream anchorage in test no. MGSLS-2 developed a peak load of 27.5 kips (122.3 kN) at approximately 1.6 in. (41 mm) of deflection prior to failure of post no. 25 and release of the anchor cable. The upstream anchorage in test no. MGSLS-2 developed a peak load of 24.4 kips (108.5 kN) at approximately 1.8 in. (46 mm) of deflection, but the upstream end anchorage did not show any signs of anchor failure. Thus, similar load and deflection were observed in the upstream and downstream anchorages, but only the downstream anchorage failed.

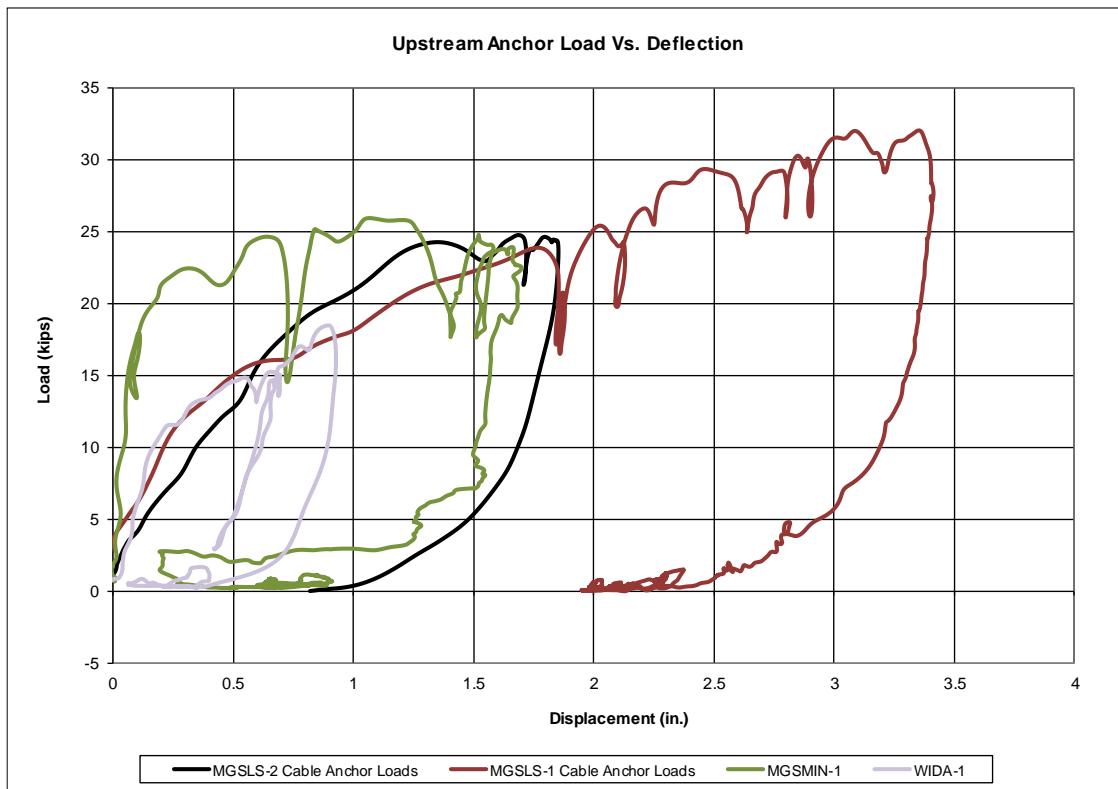
Figure 25. Upstream Anchor Load vs Deflection, Test Nos. MGSL-2, MGSL-1, MGSMIN-1, and WIDA-1

In order to further investigate, a comparison of the anchor load versus time and anchor load versus foundation tube deflection for the available upstream and downstream anchor data from test nos. MGSLS-1, MGSMIN-1, and WIDA-1 were compared with the results from the failed downstream end anchorage in test no. MGSLS-2. The results were divided between upstream and downstream anchor data, and the comparisons are shown in Figure 25 and Figure 26. Review of the upstream end anchor load versus deflection data from the selected tests found that the peak upstream end anchor load was similar to or less than several previous full-scale crash tests, including test nos. MGSMIN-1 and MGSLS-1. This would suggest that the tensile rail loads developed in test no. MGSLS-2 were not excessive as compared to previous MGS barrier tests that did not experience anchor failure. It was also noted that the upstream end anchorage in test no. MGSLS-1 developed a peak load of 34.0 kips (151.2 kN) without anchor failure, which was 23.6% more than the measured peak load in the downstream end anchorage that failed in test no. MGSLS-2. The load versus deflection plot also displayed similar slopes for the four tests. Test nos. MGSLS-2, MGSLS-1, and WIDA-1 had very similar slopes, while test no. MGSMIN-1 displayed increased slope during loading of the end anchorage. This would suggest that the upstream anchors had similar stiffness in the compared tests.

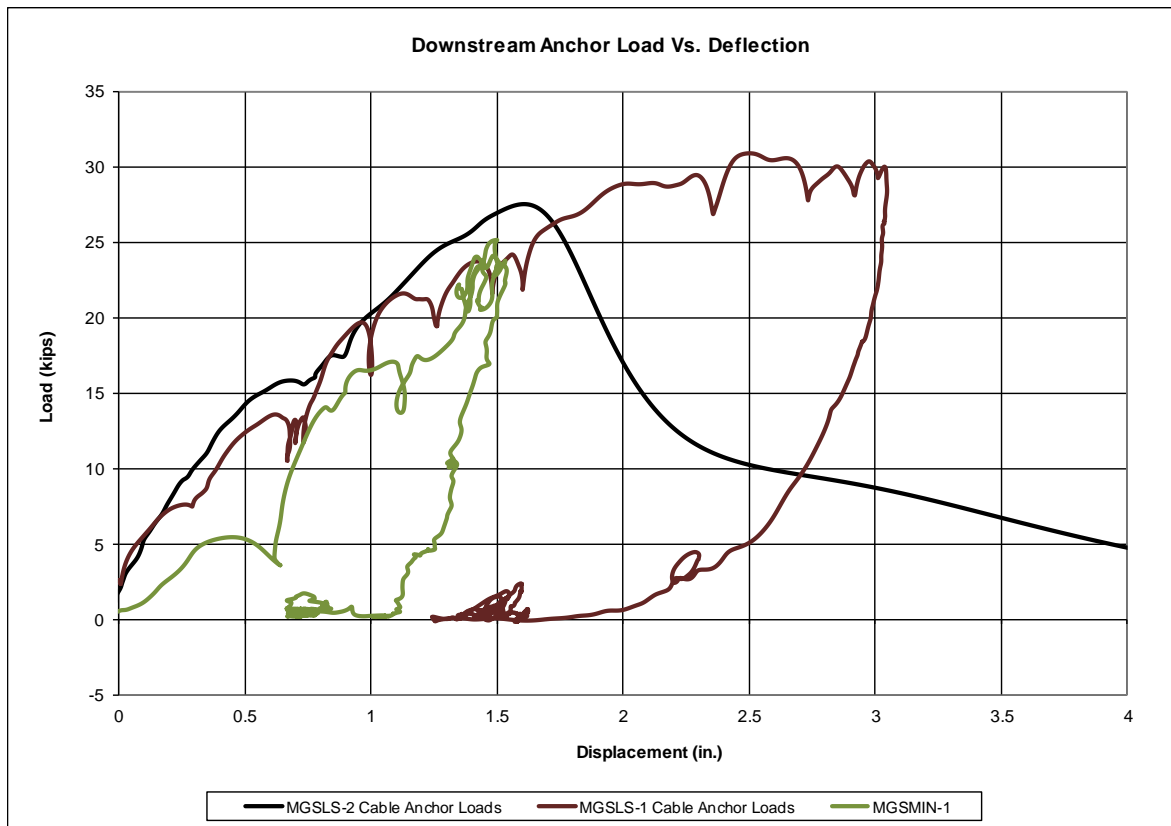
Figure 26. Downstream Anchor Load vs Deflection, Test Nos. MGSLS-2, MGSLS-1, and MGSMIN-1

Comparison of the downstream end anchorage load versus deflection data from test nos. MGSLS-1, MGSMIN-1, and MGSLS-2 showed similar trends. The stiffness or slope of the load versus deflection curves were similar for each of the three tests with available data. Additionally, test no. MGSLS-1 developed a peak load in the downstream end anchor of 30.9 kips (137.5 kN) without failure, which was 12.3% higher than the measured peak load in the downstream end anchorage that failed in test no. MGSLS-2.

Analysis and comparison of the end anchorage load and deflection from test no. MGSLS-2 and other comparable tests did not identify a potential source of the end anchorage failure observed in test no. MGSLS-2. The peak load recorded in the failed anchorage did not appear to be excessive when compared with similar full-scale crash tests and did not exceed previous dynamic load testing of similar anchorages. The deflection and stiffness of the failed end anchorage did not suggest any significant departure from previous anchor testing. Finally, no behaviors were noted during loading of the end anchorage that were different from those observed in other end anchorages.

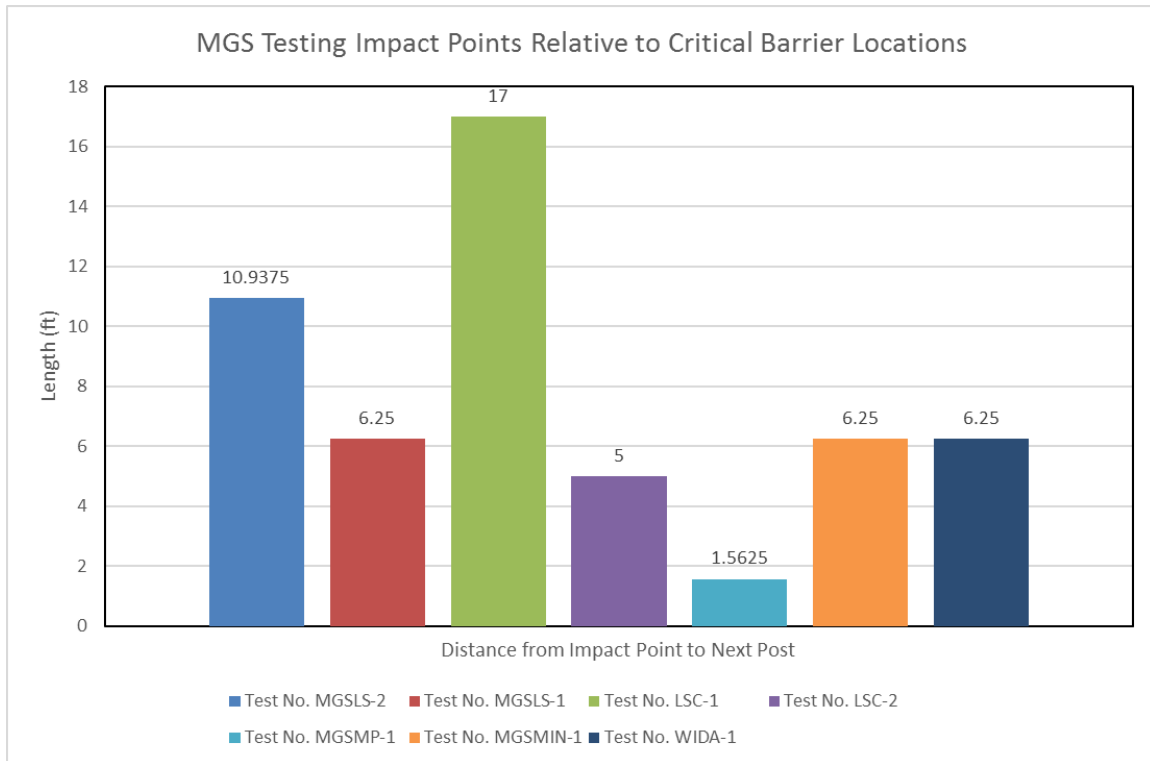
Figure 29. MGS Testing Impact Points Relative to First Post Downstream of Impact

Review of the data found that the impact point for test no. MGSLS-2 fell into the mid-range with respect to distance to the first post downstream of impact, which suggested that the impact point with respect to the first impacted post likely had little effect on loading of the end anchorage. However, rail pocketing caused by the impact location relative to a post may have increased anchor loads, as noted previously. Similarly, the distance from the impact point to the first splice downstream for test no. MGSLS-2 fell into the mid-range of the comparable systems. It was noted that in test no. MGSLS-2 the impact was closer to the downstream end anchorage than in previous long span guardrail tests and was closer to the end of the guardrail system than all comparable tests except test nos. WIDA-1 and MGSMIN-1. Test no. LSC-1 was impacted farther from the first post downstream of the unsupported span than test no. MGSLS-2, but no concerns with anchor failure were associated with the former test. Test no. WIDA-1 evaluated an impact near the end of the redirective length of the MGS with a trailing end terminal. In this test, the end anchor failed, but it did not release until the 2270P vehicle had nearly reached the end of the barrier system, and high lateral and longitudinal loads were imparted on the trailing end anchorage. Thus, the failure mode was not similar to the failure under longitudinal loading observed in test no. MGSLS-2. Test no. MGSMIN-1 evaluated a 75-ft (22.9-m) long MGS and impacted 56 ft-3 in. (17.1 m) from the end anchorage. However, the 2270P vehicle was safely redirected and no failure of the end anchorage occurred as a result of the impact closer to the downstream end anchorage. Thus, while the impact point for test no. MGSLS-2 was different as compared to previous tests of the MGS and MGS long span, no evidence was found that suggested the impact point directly contributed to the anchor failure.

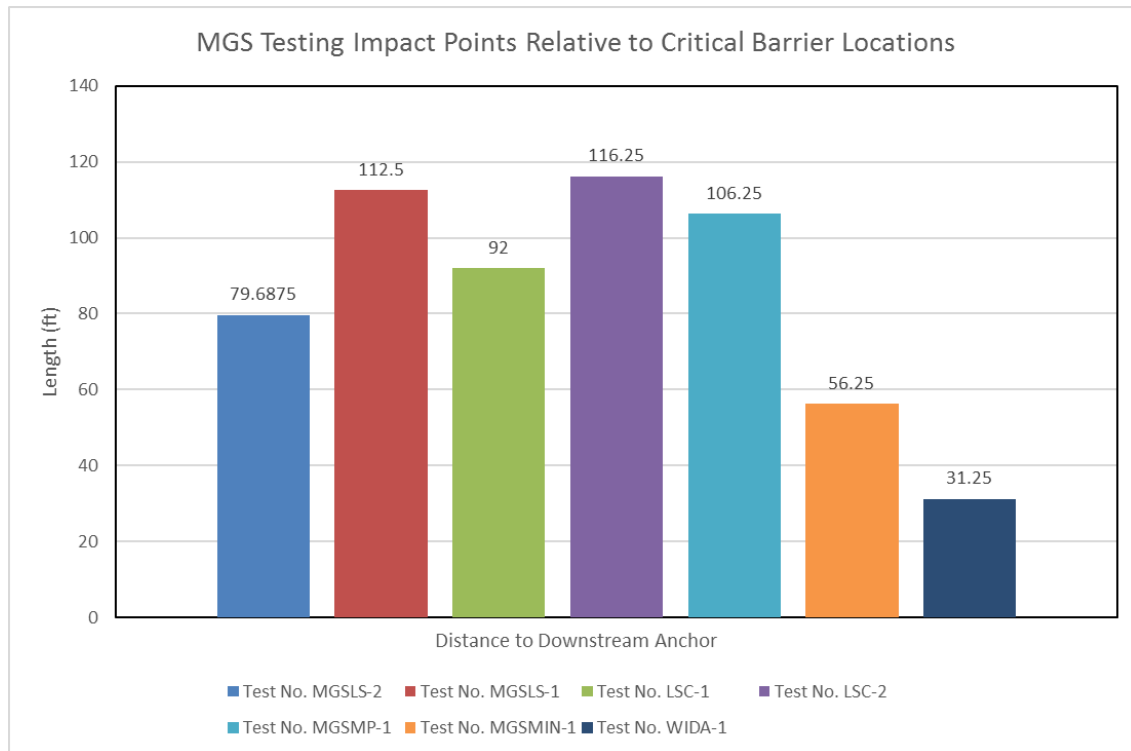
Figure 31. MGS Testing Impact Points Relative to End Anchorage

Differences between the vehicle impact point of test no. MGSLS-2 and other comparable tests were reviewed to determine if the vehicle impact point may have contributed to the failure of the downstream end anchorage. The impact point for test no. MGSLS-2 was compared with other similar tests with respect to its proximity to the first post downstream of impact, its proximity to the first rail splice downstream of impact, and the distance to the downstream end anchorage. It was believed that the position of the vehicle impact relative to these critical points may have affected the barrier performance and altered the loading of the end anchorage. Impact points for test no. MGSLS-2 and several comparable tests are shown in Figure 27 and Figure 28. The impact points relative to the first post downstream of impact and the first splice downstream of impact to for test no. MGSLS-2 and comparable tests are shown in Figure 29 and Figure 30, respectively. Finally, the position of the impact points for each test relative to the location of the downstream end anchorage is shown in Figure 31.

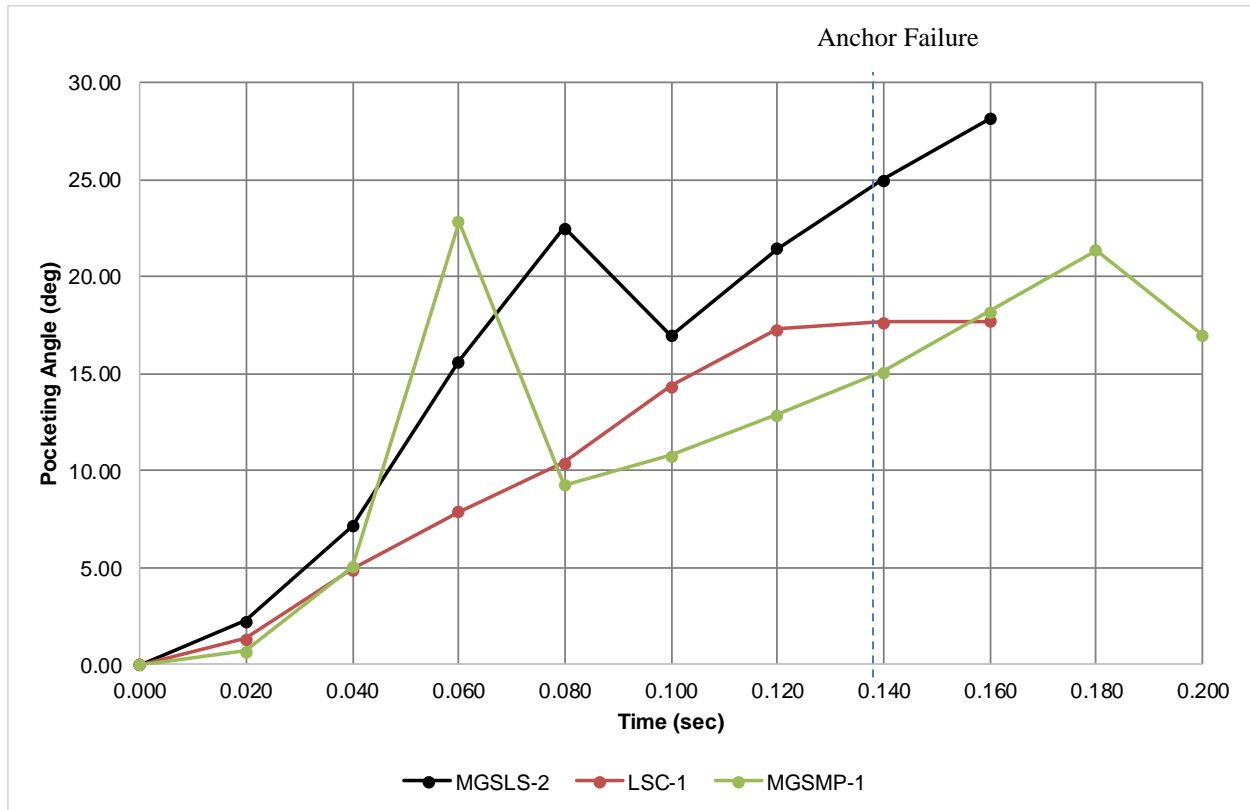
Figure 38. Pocketing Angle Versus Time, Test Nos. MGSLS-2, MGSMP-1, and LSC-1

the threshold of 23 degrees that has previously been deemed acceptable. Additionally, the maximum pocketing angles for test nos. MGSLS-2 and MGSMP-1 were very similar prior to anchor failure, but the end anchor in test no. MGSMP-1 did not fail. The pocketing analysis also noted that some kinking of the rail was observed at the first post downstream of the unsupported span in test no. MGSLS-2 which was not observed in test nos. MGSMP-1 and LSC-1. This may indicate that the UBSF provided additional stiffness prior to fracture and potentially affected rail loading as compared the other tested systems. However, the kinking observed was not sufficient to believe to be a direct cause of the failure of the end anchorage.

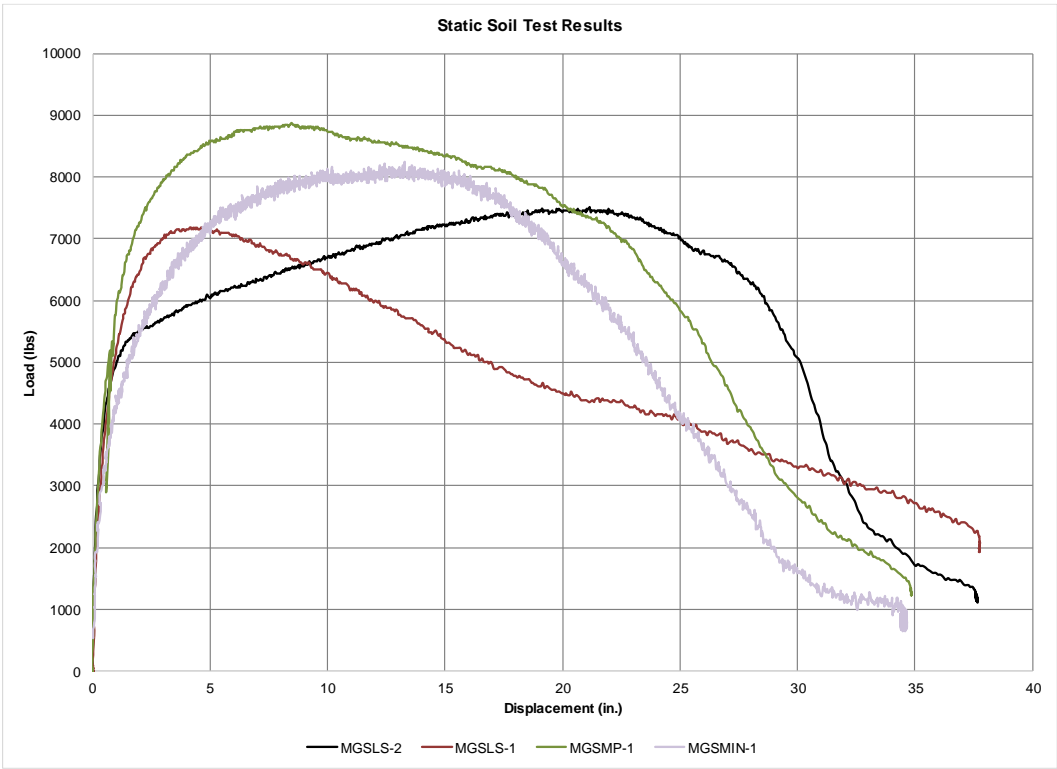
Figure 43. Static Soil Test Comparisons

A comparison of the force versus deflection data from test nos. MGSLS-2, MGSLS-1, MGSMIN-1, and MGSMP-1 is shown in Figure 43. The data showed that the peak load developed in the static soil test for test no. MGSLS-2 was similar to that of previous tests. The initial slope or stiffness of the soil response was similar as well. The general shape of the curves shown do differ from test to test, but all the soil tests reviewed were acceptable under the MASH soil requirements for full-scale crash testing. Based on these results, the soil response from test no. MGSLS-2 would not have been expected to produce more severe loading of the end anchorage. This conclusion would be consistent with the anchor load comparison, which indicated that the loading of the end anchor was consistent with previous tests of similar anchorages.

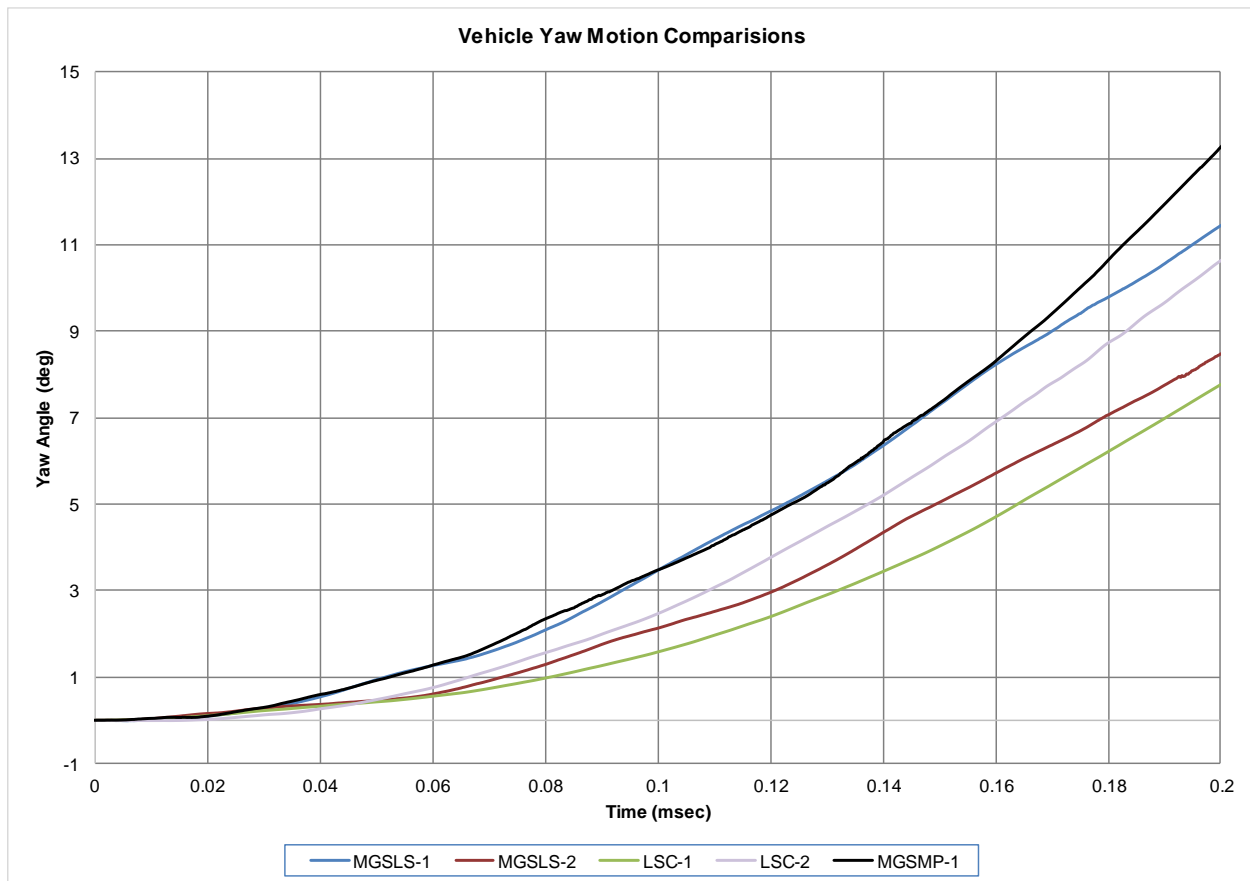
Figure 45. Vehicle Yaw Motion Comparisons

Review of the vehicle roll and pitch data from these five tests showed little to no difference through the first 0.150 sec after impact. All of the vehicles remained very stable with little to no roll or pitch early in the impact. Comparison of the vehicle yaw angles for all five tests is shown in Figure 45. Vehicle roll and pitch was minimal and showed little to no difference prior to anchor failure. The yaw data showed that test no. MGSL-2 redirected the impacting vehicle more slowly than all tests except test no. LSC-1. The slower yaw rate for these two tests correlated with tests that impacted within the unsupported span of the long-span guardrail. The lack of lateral support of the rail led to lower redirective forces and slower vehicle yaw. While the yaw angle data denoted a different system response for those tests, neither the yaw data nor the vehicle roll and pitch indicated any potential effect on end anchorage loading or failure.
