PHASE II EVALUATION OF FLOOR PAN TEARING FOR CABLE BARRIER SYSTEMS

MIDWEST ROADSIDE SAFETY FACILITY

MwRSF Research Report No. TRP-03-359-18

March 30, 2018

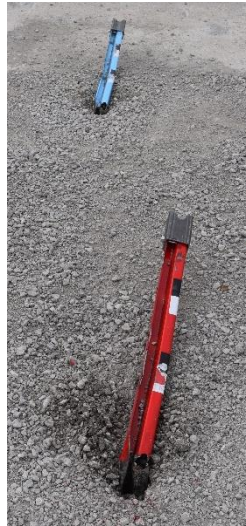
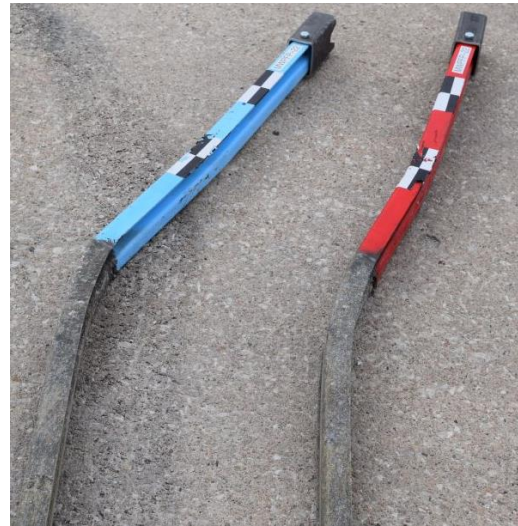
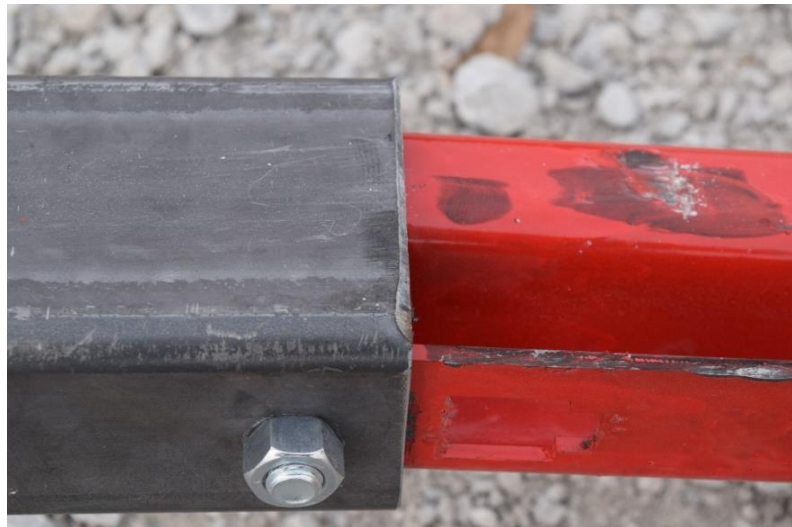
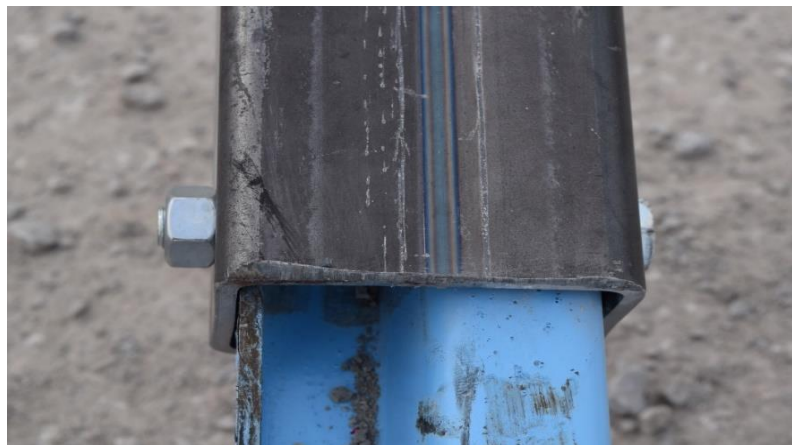
Figure 25. Time-Sequential and Post-Impact Photographs, Test No. MWPF22

The posts were bent plastically near the ground line, and tearing was found in both posts, as shown in Figure 25. The tears initiated from the weakening holes on the impact side of the posts and extended into the webs and adjacent flanges. Contact marks were found on the top half of the posts and on the steel tube cap. The top corners of both posts left creasing on the bottom side of the simulated floor pan. Creasing was found in both the front and rear bays of the simulated floor pan, as shown in Figure 26. The cap used in test no. MWPF22 was not as tight of a fit as desired due to the use of a standard HSS tube size that was available. Consequently, extensive snagging of the cap on the underside of the bogie vehicle occurred during test no. MWPF22.

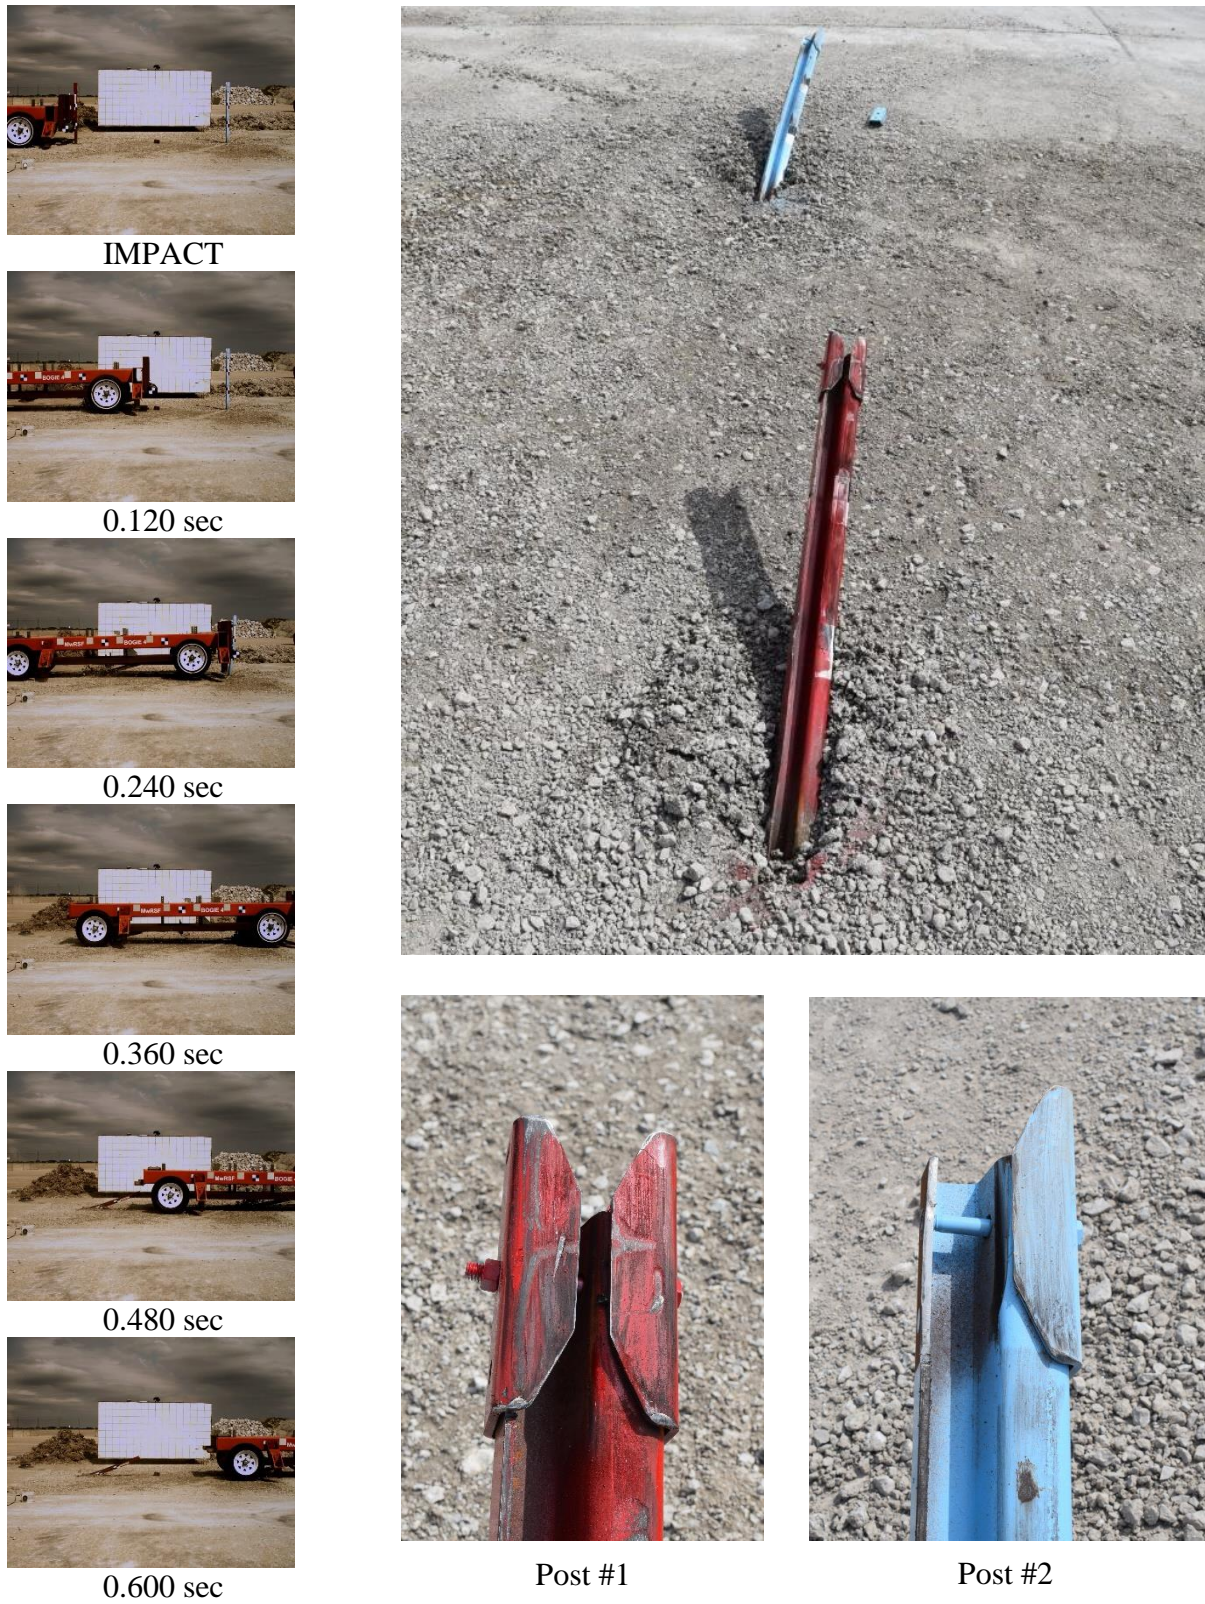
Figure 28. Time-Sequential and Post-Impact Photographs, Test No. MWPFP-23

Sequential and post damage photographs are shown in Figure 28. The posts were bent plastically near the ground line, and the top corners of both posts left moderate creasing on the bottom of the simulated floor pan as well as tearing at the rear of the simulated floor pan. During test no. MWFPF-23, one side of the cap snagged on the underside of the bogie and the connection bolt sheared. After the cap disengaged and exposed the post edges, a tear formed in the simulated floorboard. The simulated floor pan damage is shown in Figure 29.

Test nos. MWPFPP-23 and MWPFPP-24 were conducted on MWPs with steel plate edge protectors mounted to the top of the posts. In test no. MWPFPP-23, the posts were installed in an 18-in. (457-mm) diameter hole filled with MASH 2016 strong soil with a 0-degree orientation angle. In test no. MWPFPP-24, the posts were installed in an 8-in. (203-mm) diameter rigid sleeve with a 0-degree orientation angle. In both tests, the edge protector connection bolt sheared and allowed the posts' free edges to contact the simulated floor pan. However, the edge protector disengagement caused floor pan tearing in only one test, test no. MWPFPP-23.

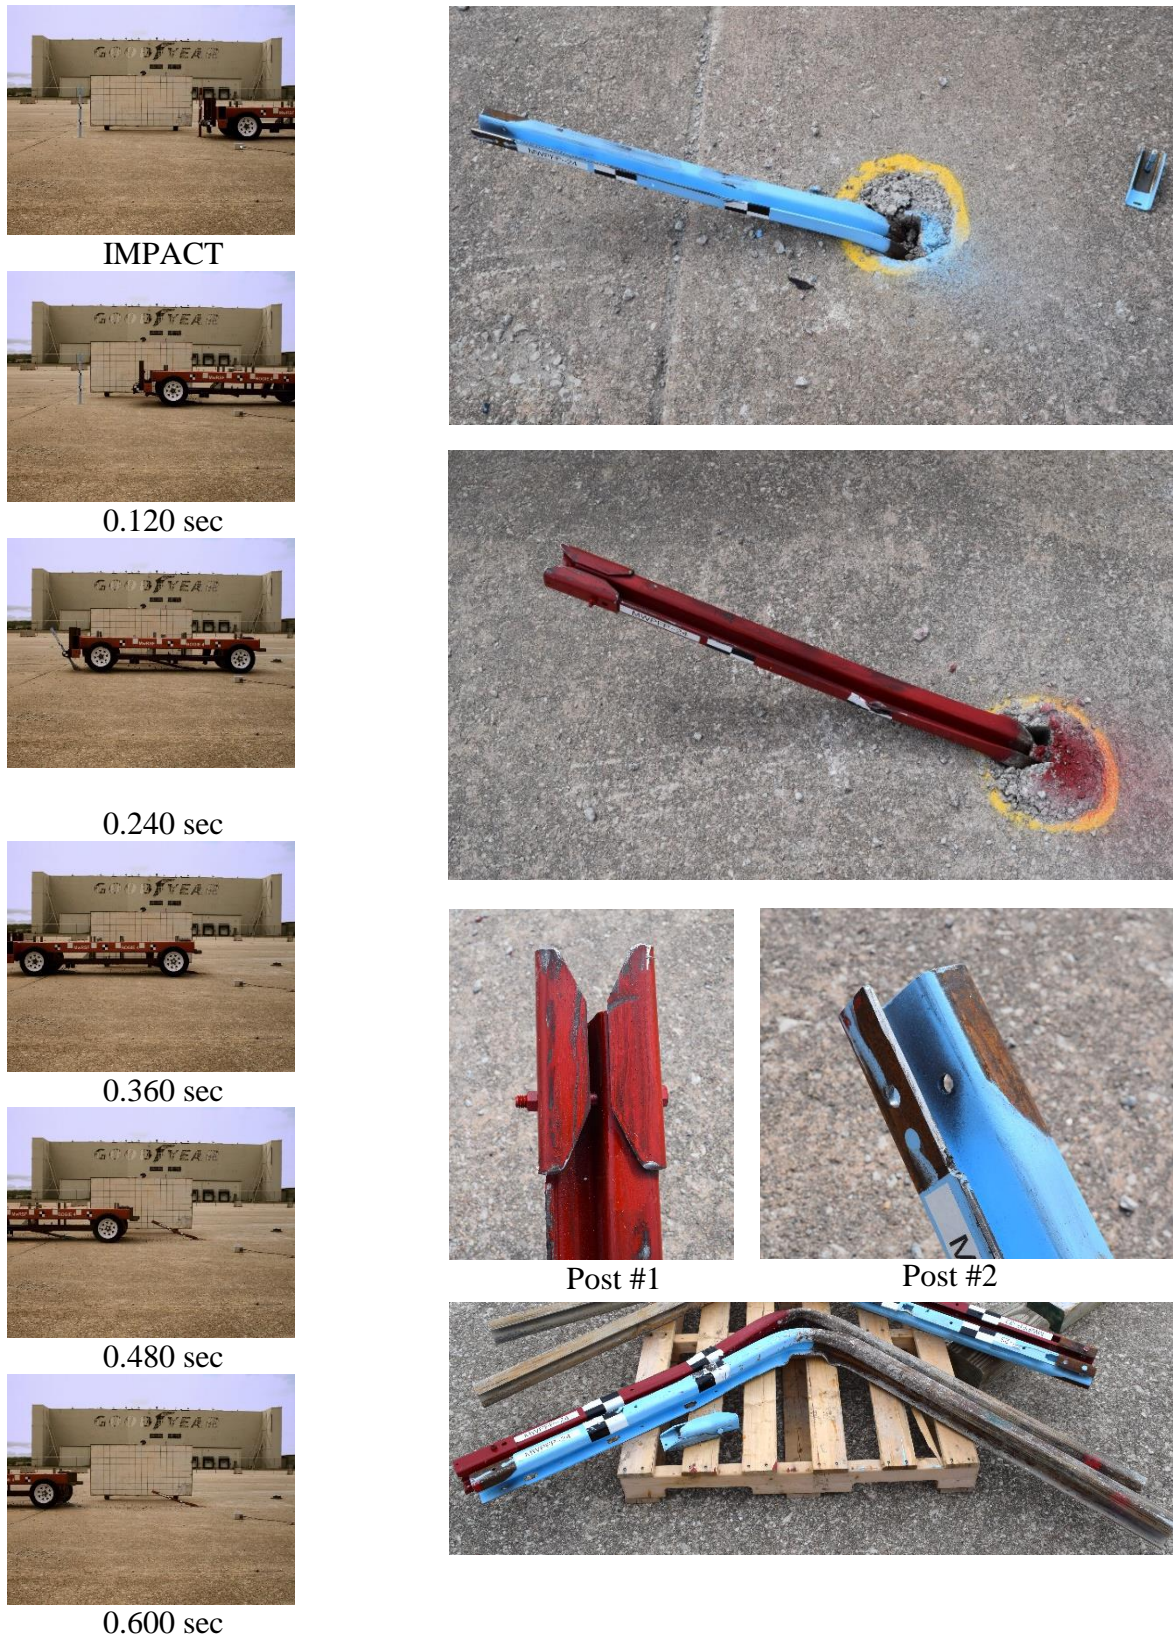
Figure 31. Time-Sequential and Post-Impact Photographs, Test No. MWPFPP-24

Sequential and post damage photographs are shown in Figure 31. The posts were bent plastically near the ground line, and the top corners of both posts left minor creasing on the bottom of the simulated floor pan, as shown in Figure 32. During the test, the edge protector retainer bolt for post no. 2 sheared upon impact with the second floor pan's horizontal member, which allowed both edge protectors to disengage. This disengagement allowed the posts' free edges to impact the bogie floor pan, but did not cause tearing.

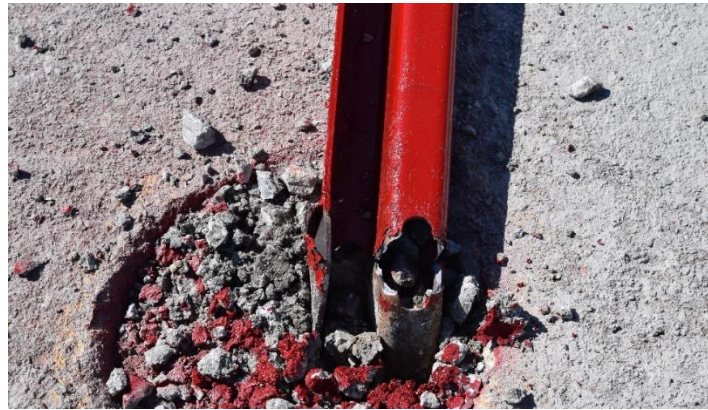
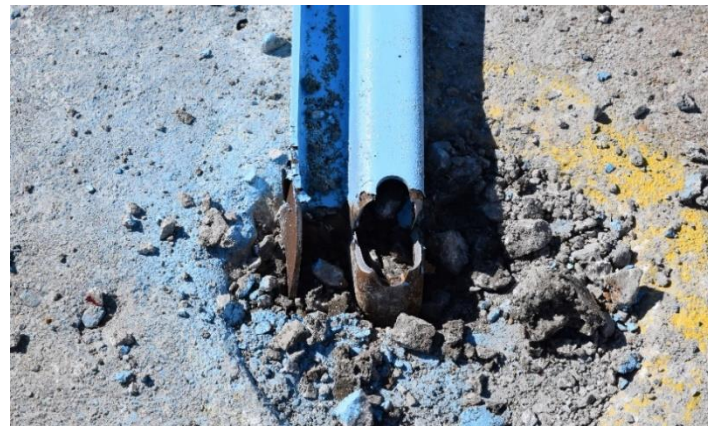
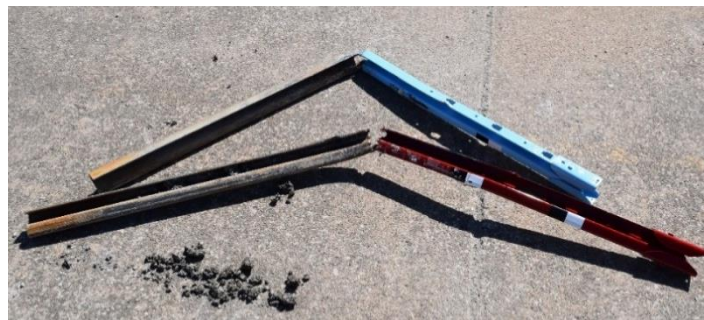
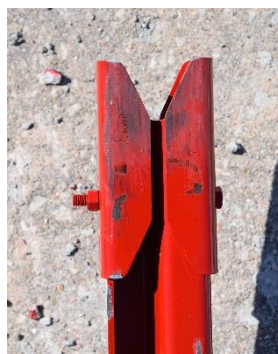
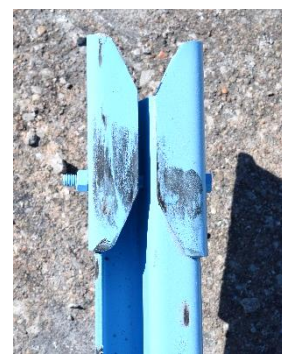
Figure 34. Time-Sequential and Post-Impact Photographs, Test No. MWPFP-25

Sequential and post damage photographs are shown in Figure 34. The posts were bent plastically near the groundline, and tearing was found in both posts. The tears initiated from the weakening holes on the impact side of the posts and extended into the webs and adjacent flanges. The tears initiated from the weakening holes on the impact side of the posts and extended into the webs and adjacent flanges. Contact marks were found on the top half of the posts and on the edge protectors. Minor creasing was found in both the front and rear bays of the simulated floor pan, as shown in Figure 35. In test no. MWFPF-25, minor snagging of the cap occurred on the underside of the bogie vehicle. Moreover, in reviewing the hardware after the test, the connection bolt had bent slightly.

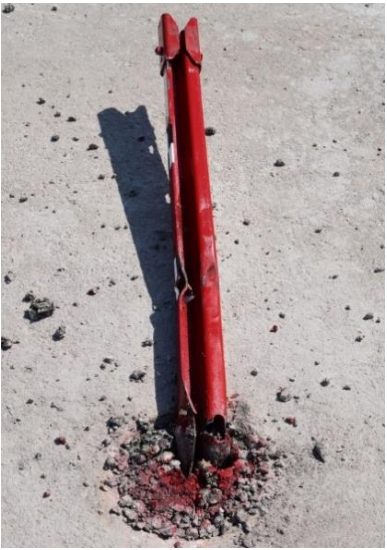
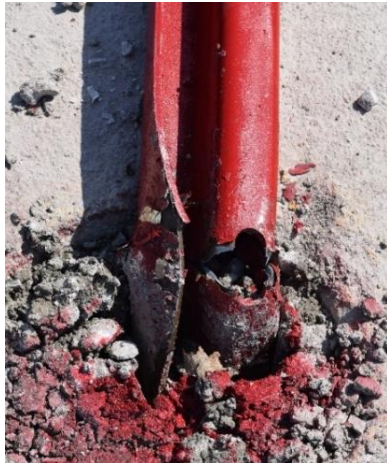
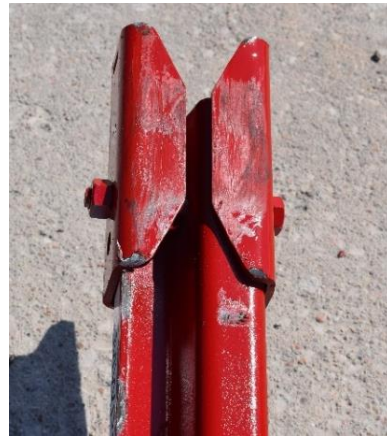
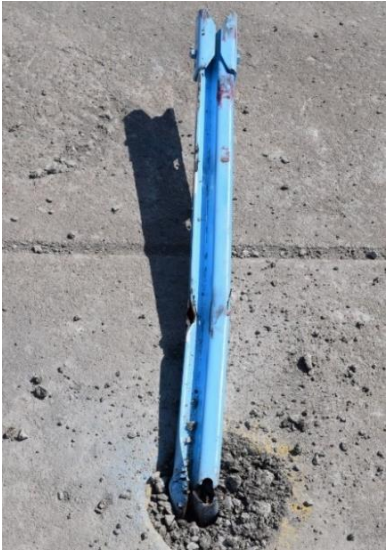
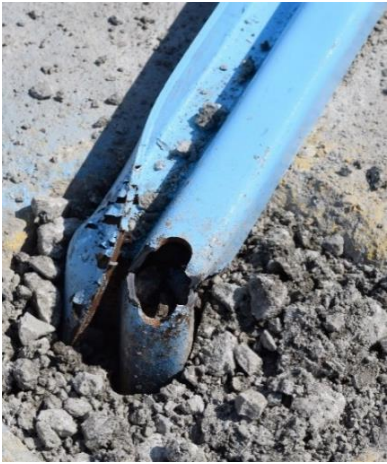
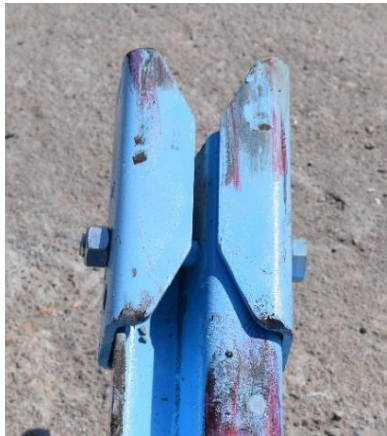
Figure 37. Time-Sequential and Post-Impact Photographs, Test No. MWPFP-26

Sequential and post damage photographs are shown in Figure 37. The posts were bent plastically near the groundline, and tearing was found in both posts. The tears initiated from the weakening holes on the impact side of the posts and extended into the webs and adjacent flanges. Contact marks were found on the top half of the posts and on the edge protectors. Minor creasing was found in both the front and rear bays of the simulated floor pan, as shown in Figure 38. In addition, snagging of the cap on the underside of the bogie vehicle was reduced and connection bolt bending was eliminated.

It is believed that the edge protectors consisting of two U-shaped bent plates bolted to the weakened MWP with a 1/2-in. (13-mm) diameter through bolt placed at 4 in. (102 mm) down from the top of the cap and 2 5/8 in. (67 mm) down from the top of the weakened MWP could eliminate the floor pan tearing. It should be noted that a tube of similar shape could also reduce the propensity for floor pan tearing. Therefore, a combination of weakening holes and edge protectors using steel bent plates at top of the MWP was recommended for further evaluation through full-scale vehicle crash testing.
