Guardrail Testing Program II

Final Report

Midwest Roadside Safety Facility
Civil Engineering Department
University of Nebraska-Lincoln
1901 'Y' Street, Bldg. 'C'
Lincoln, Nebraska 68588-0601

Transportation Research Report TRP-03-52-95

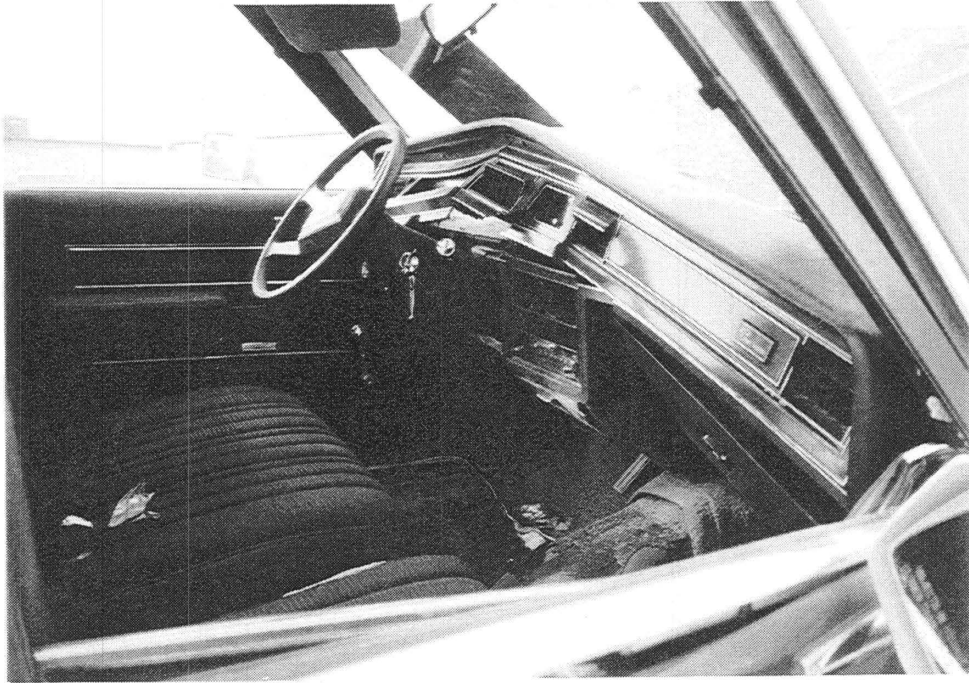
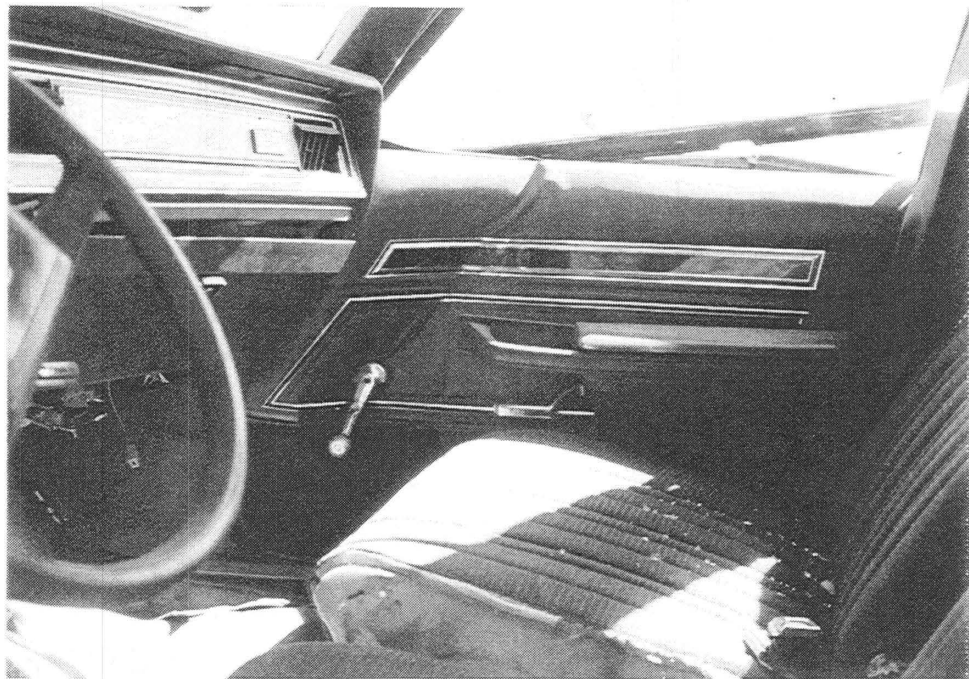
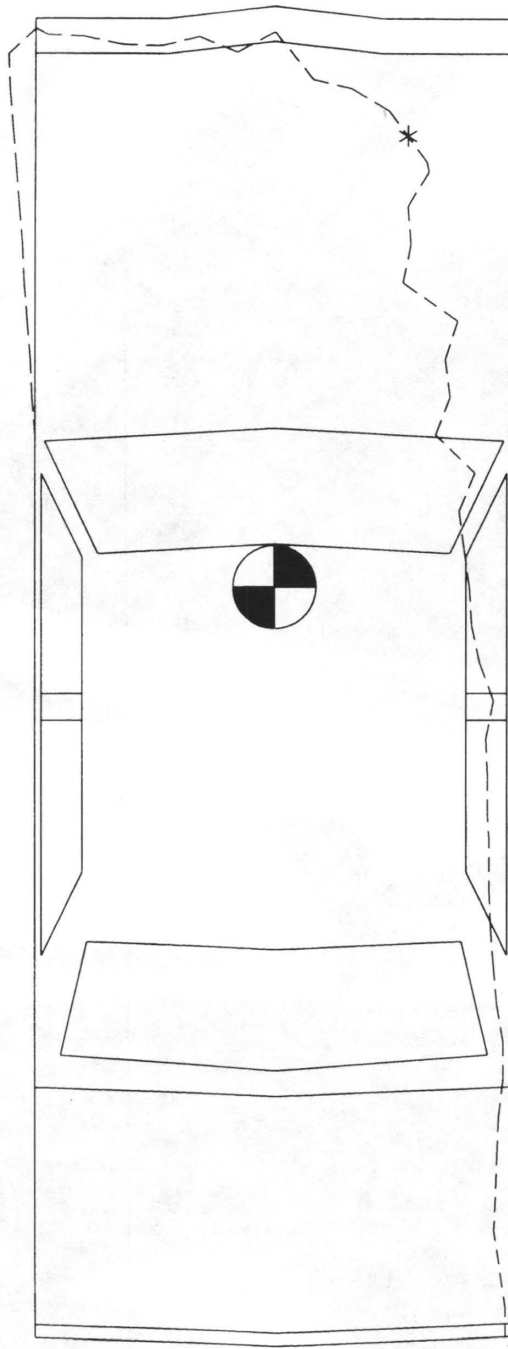
Figure 6. Vehicle Damage, Test SBT-1.

Damage to the vehicle, which can be seen in figure 6, included major crushing and deformation of the right-front corner of the vehicle, as well as buckling of the vehicle roof. The entire front half of the vehicle was bent slightly toward the driver's side. Interior occupant compartment damage included buckling of the floorboard on the passenger's side, as well as buckling of the dash. The maximum crush deformation of 17 in (492 mm) is shown in figure 7.

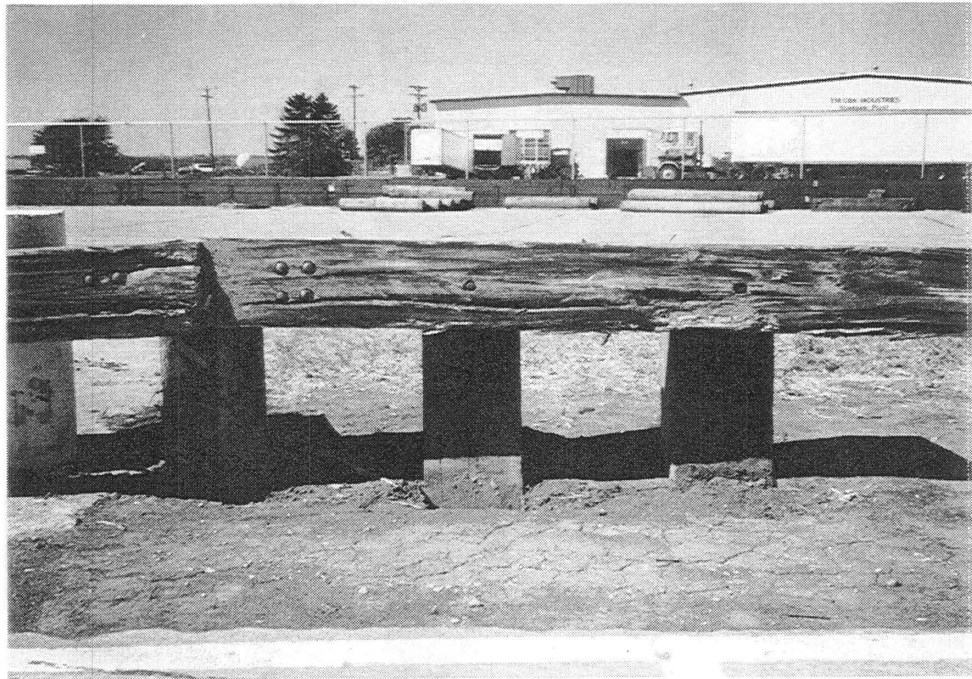
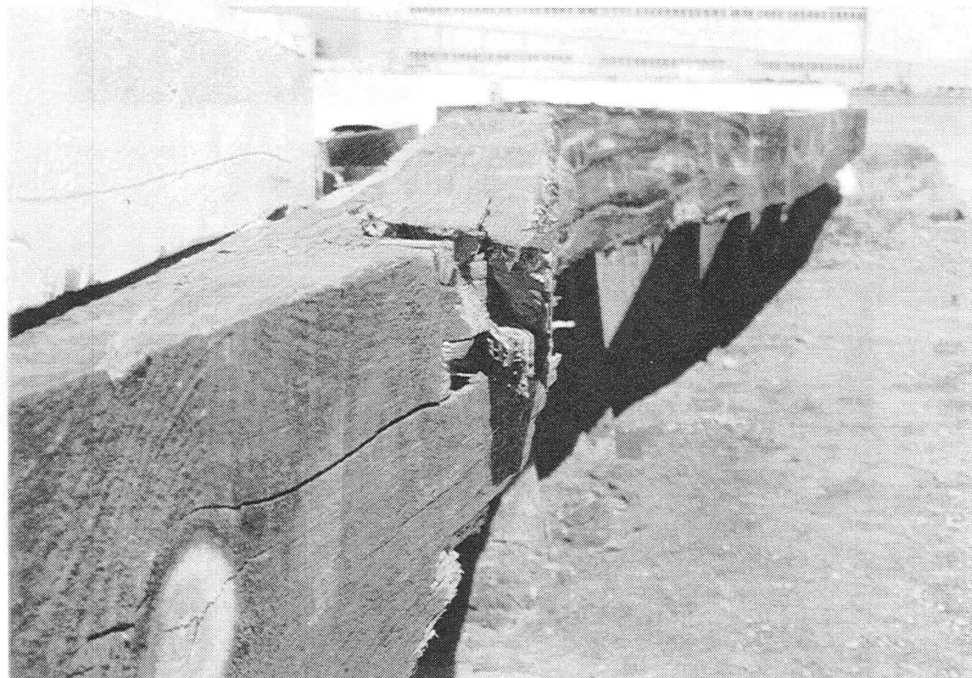
Figure 8. System Damage, Test SBT-1.

The damage to the system, shown in figures 8 and 9, consisted of a maximum permanent set deformation of 11.25 in (286 mm) at post no. 1. A flexural failure occurred in the first timber rail section, approximately 4.5 ft (1.37 m) from the downstream end of the rail. The 8-in (203-mm) inside diameter (I.D.) pipe located between the first rail and the concrete abutment was completely flattened. There was evidence of vehicle snagging at the splice between rails no. 1 and 2, as sheet metal from the vehicle was embedded in the end of rail no. 1. There were continuous scrape marks along the face of the rail from the point of impact to exit, as well as impact markings on the concrete abutment.

vehicle to impact the end of the concrete abutment. The system was redesigned by Eastern Federal Lands Highway Division engineers for the next test by increasing the length of posts no. 1, 2, and 3 from 7 ft (2.13 m) to 8 ft (2.44 m). The 8-in (203-mm) I.D. pipe spacer between the rail and concrete abutment was replaced with an angled block of wood to restrict the deflection of the first rail. The splice between the first and second rails was stiffened by adding a second $\frac{3}{8}$ -in (10-mm) backup plate. The bolts at this splice were moved closer to the post and increased in number from 8 to 12. The details of these design changes are presented in the plan drawings in appendix A.

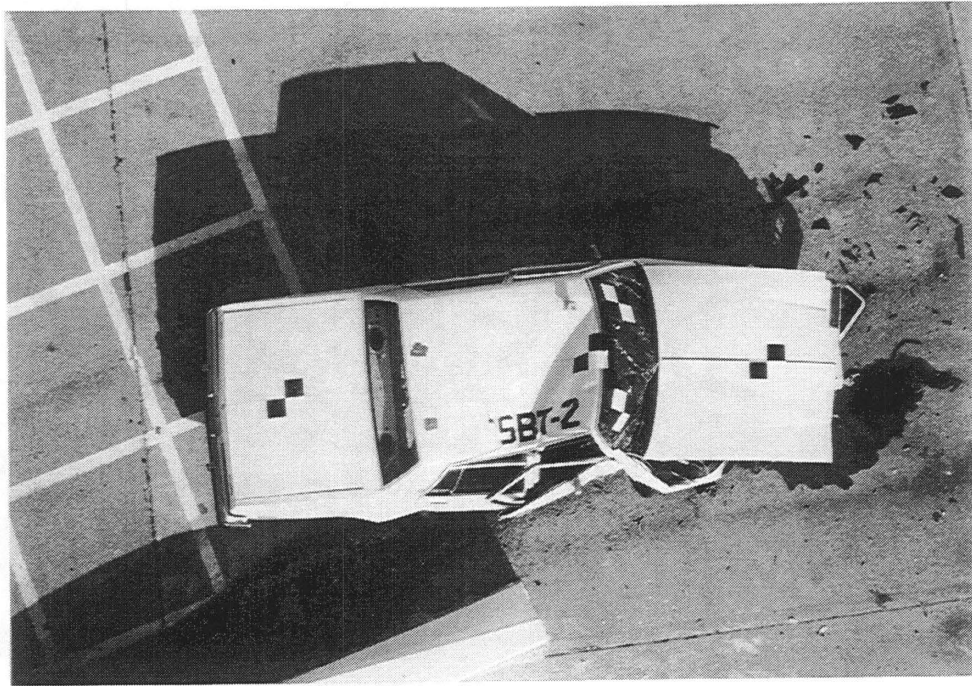
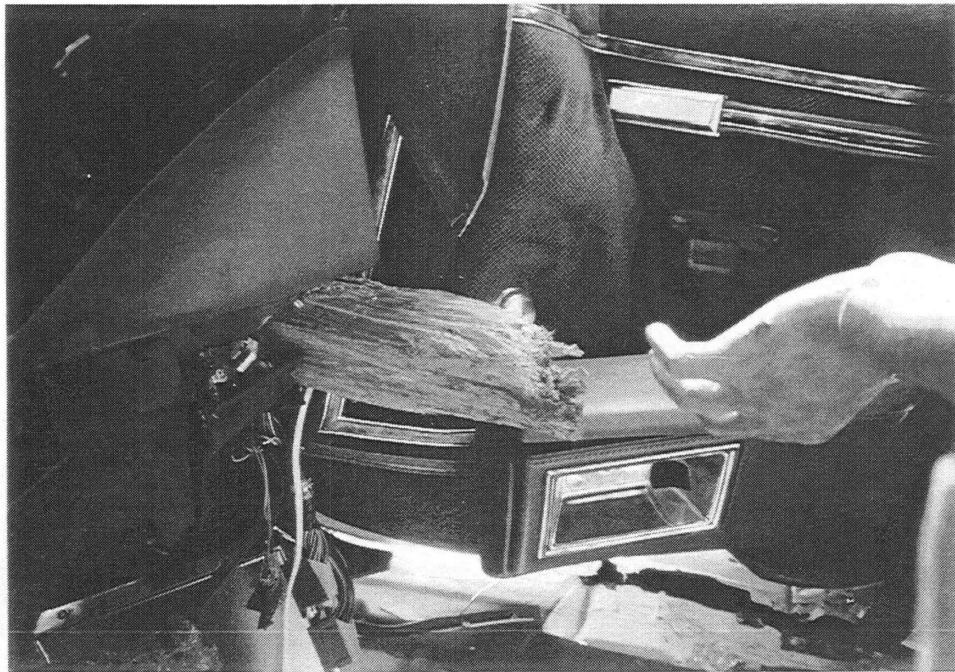
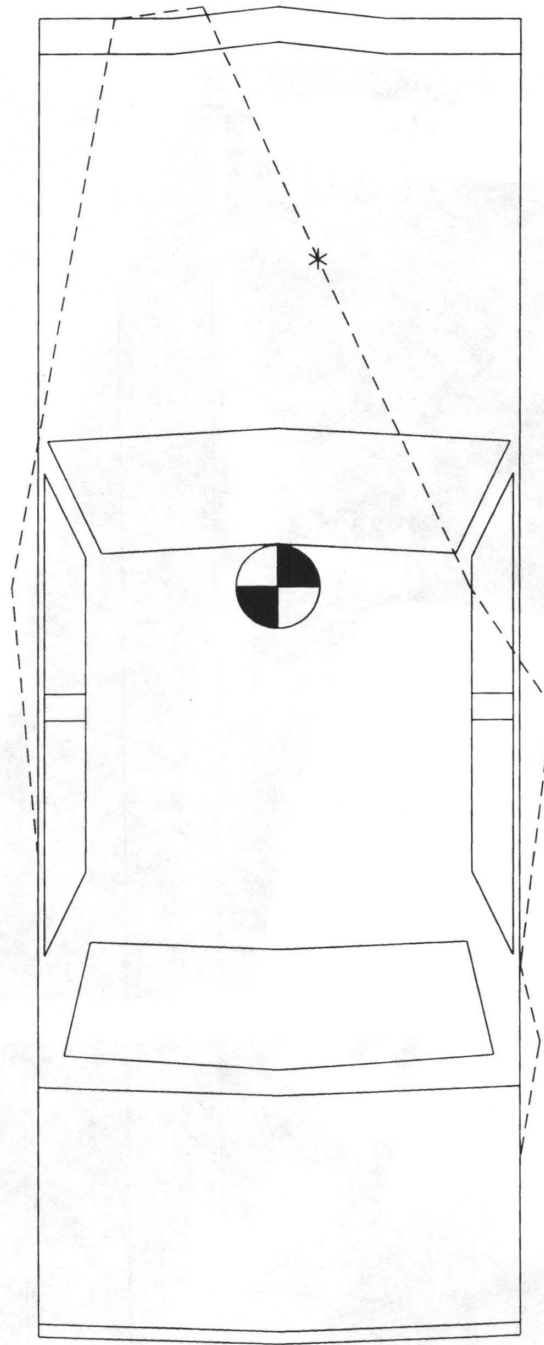
Figure 15. Vehicle Damage, Test SBT-2.

The damage to the vehicle was substantial, as shown in figure 15. The entire right-front portion of the vehicle was crushed and pushed back toward the occupant compartment. The firewall and floorboard were pushed backwards and up on the passenger's side, and a section of the wood rail penetrated the firewall on the extreme right-hand side. The windshield was broken and the roof of the vehicle was buckled considerably. The maximum vehicle crush of 31.5 in (800 mm) is shown schematically in figure 16.

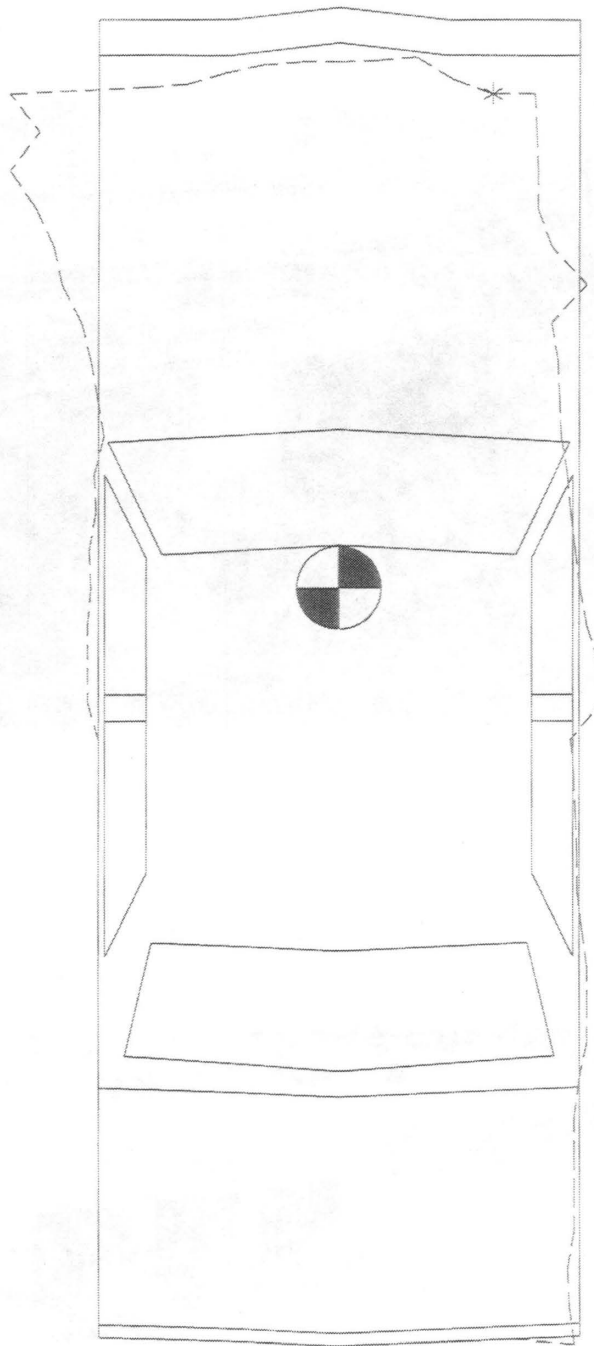
Figure 23. Vehicle Damage, Test SBT-3.

The vehicle damage, shown in figure 23, consisted of the crushing of the right-front corner of the vehicle, as well as scrapes and dents continuing down the side to the rear wheel assembly. The tire was torn off the right-front wheel, and the rim was bent. Occupant compartment damage included buckling of the floor on the passenger's side of the vehicle, as well as buckling of the dashboard. The maximum crush deformation of 13.75 in (349 mm) is shown schematically in figure 24.

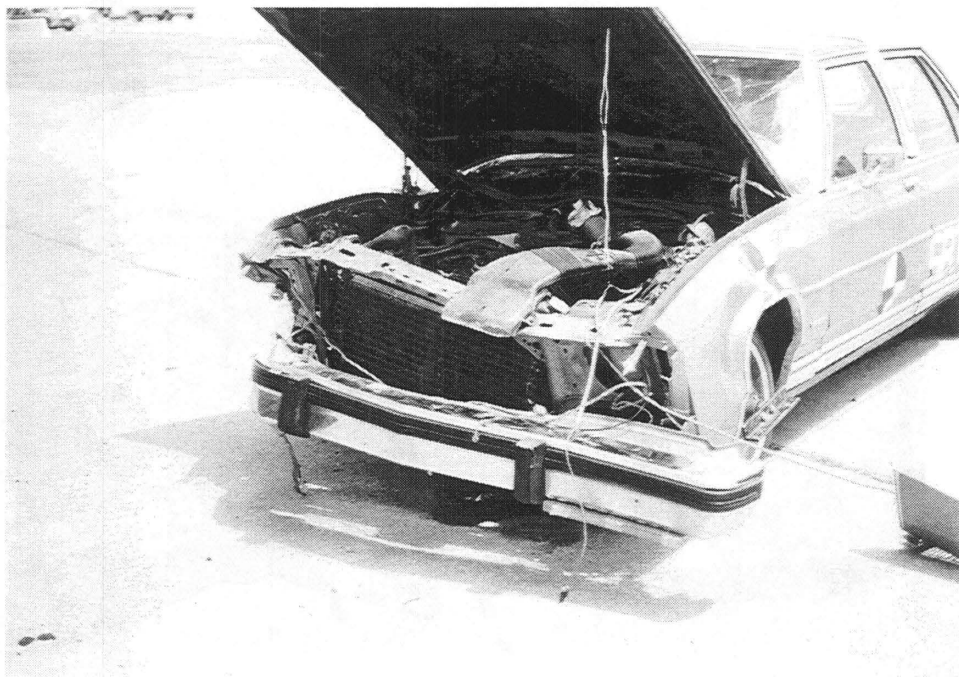
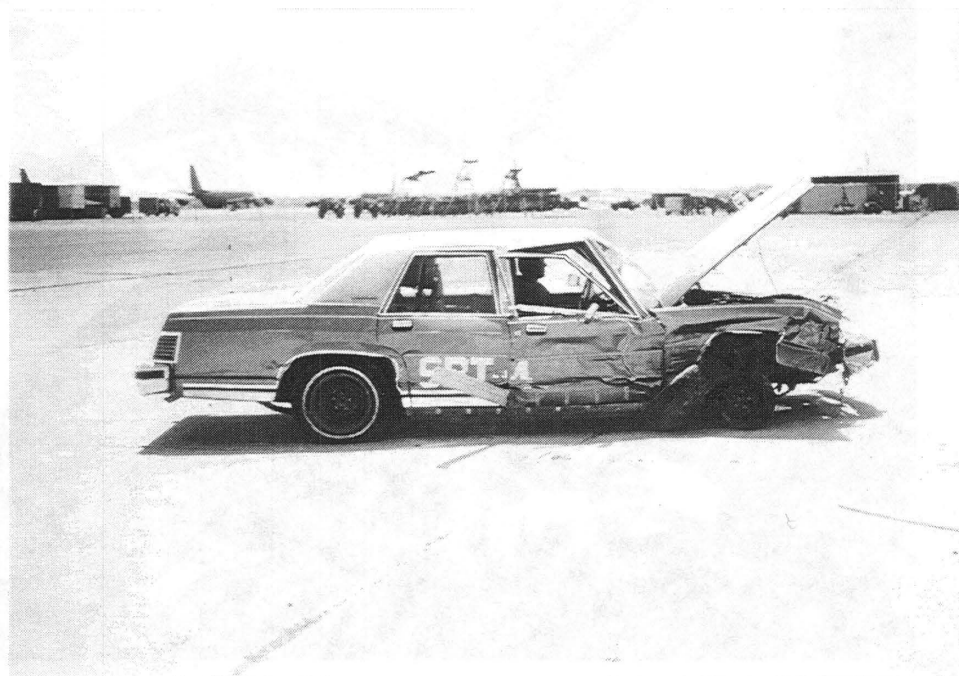
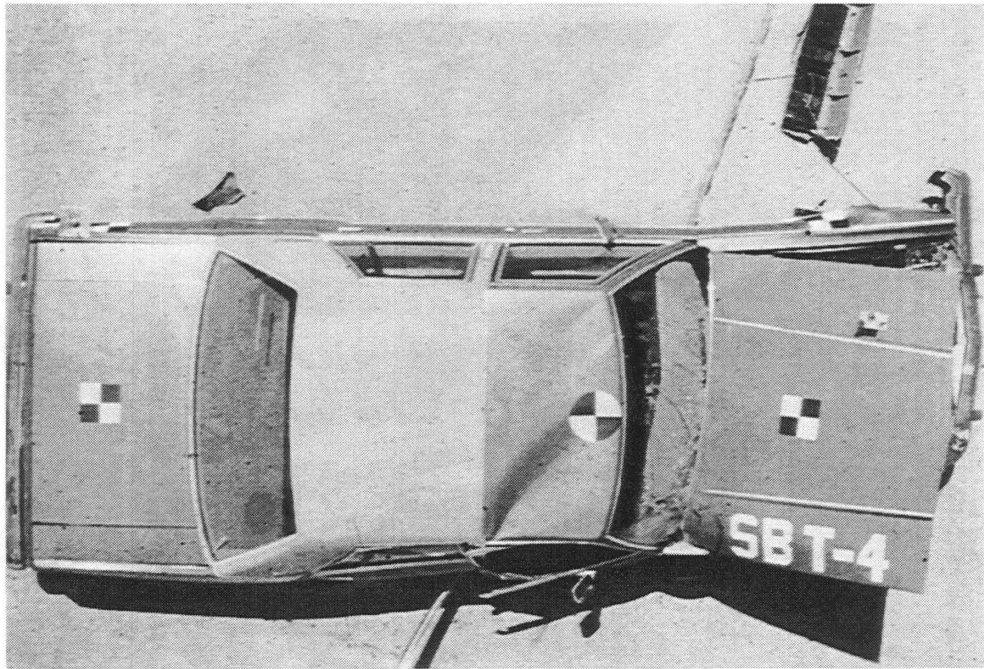
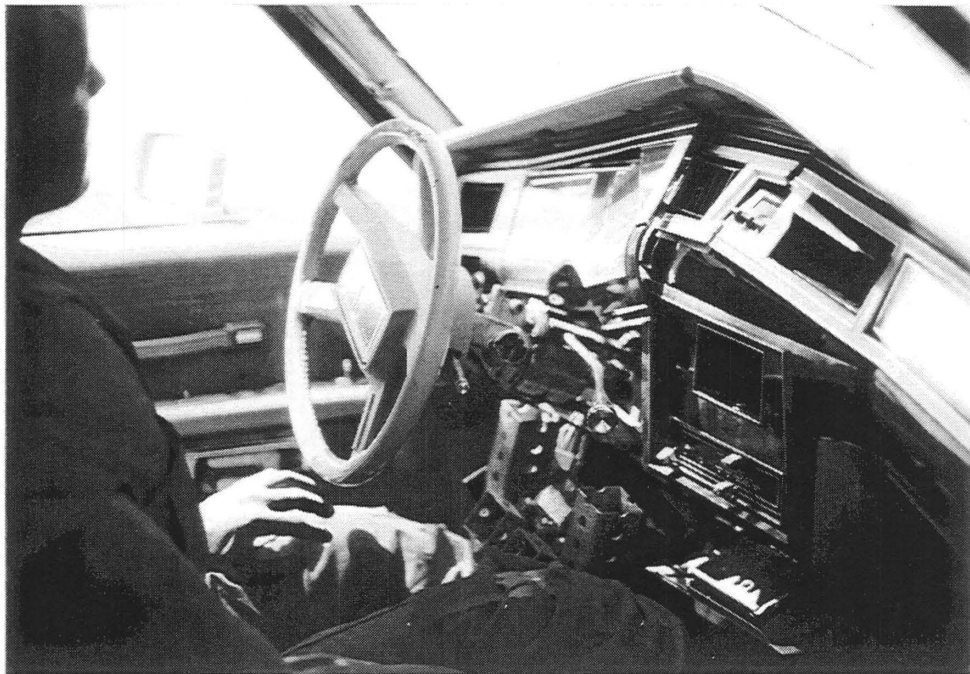
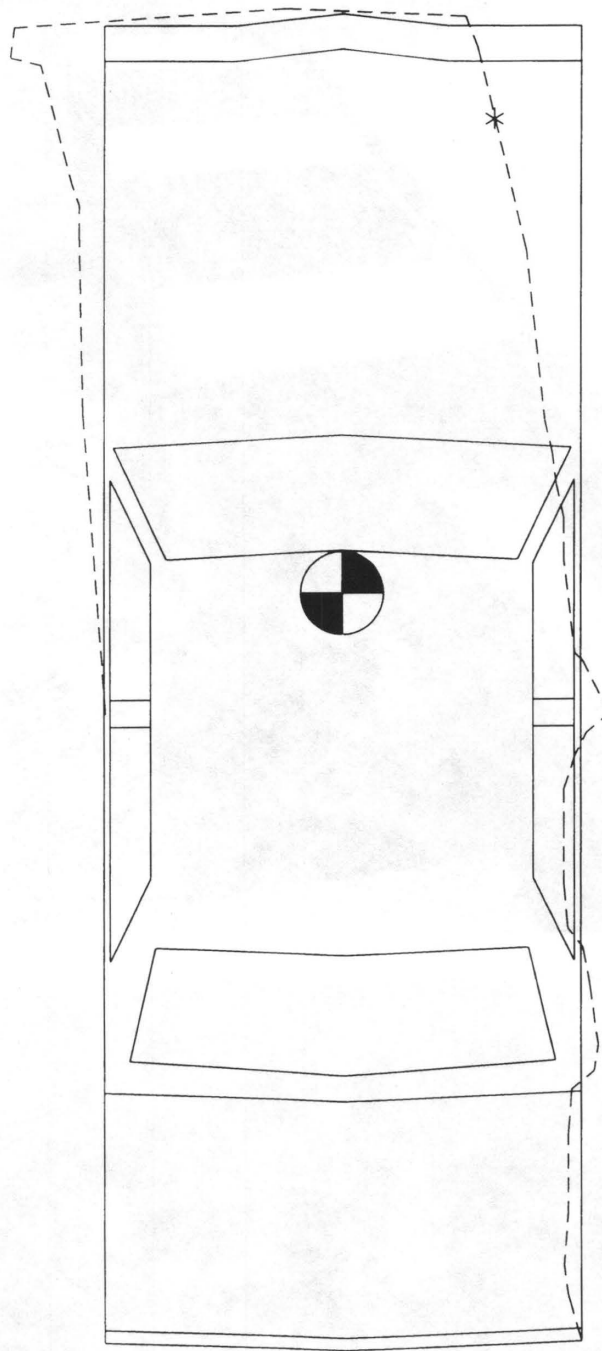
Figure 31. Vehicle Damage, Test SBT-4.

The damage to the vehicle, shown in figure 31, consisted of deformation of the right-front corner of the vehicle, which continued down the passenger side of the vehicle as scrapes and dents. The left-front tire was removed from the rim, and the front bumper was pushed toward the left, away from the longitudinal centerline of the vehicle. The entire front end of the vehicle was pushed toward the left side, and the roof was buckled. Interior occupant compartment damage consisted of buckling of the floorboard on the passenger side and the front dashboard. The maximum crush deformation of 13.75 in (349 mm) is shown schematically in figure 32.

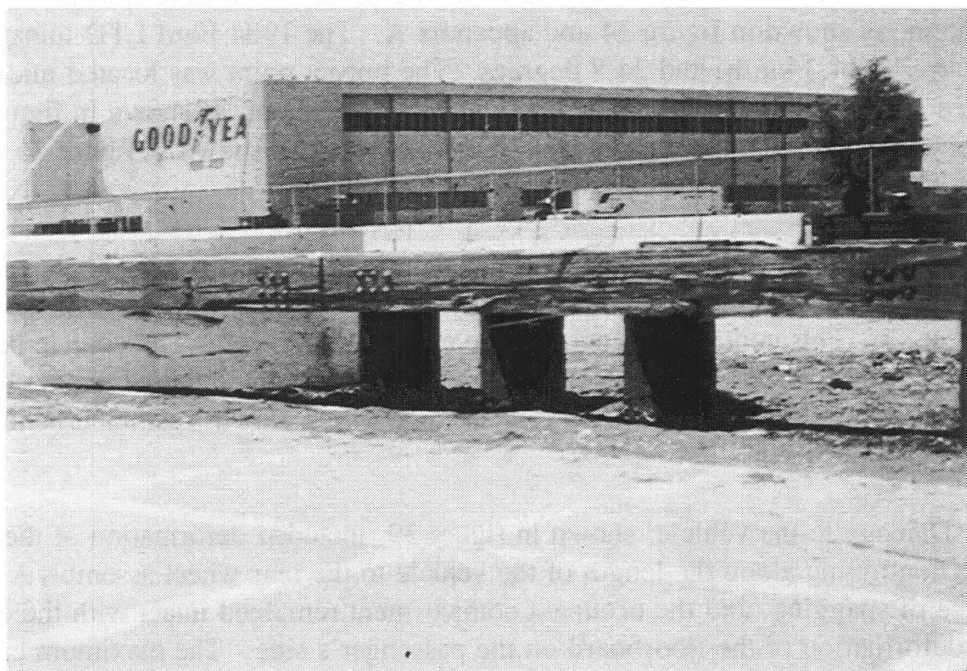
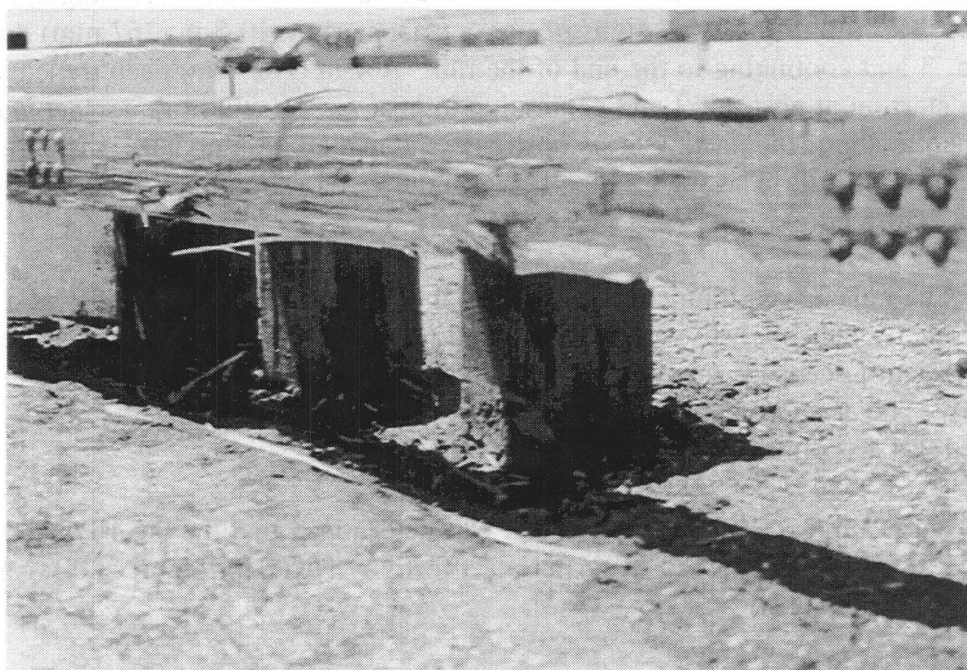
Figure 33. System Damage, Test SBT-4.

Damage to the system, shown in figure 33, consisted of scrapes and gouges along the face of the rail from the impact point to the midspan of the first rail. The spacer pipe between the rail and concrete abutment was deformed slightly, and the soil was gouged considerably in front of posts no. 1, 2, and 3. Markings on the posts indicated that the vehicle snagged approximately 1 in (26 mm) on post no. 1 and 3 in (76 mm) on post no. 2.

3.55-m) wood rub rail was attached to posts no. 1, 2, and 3 for the next test. The details of this design change can be found in appendix A.

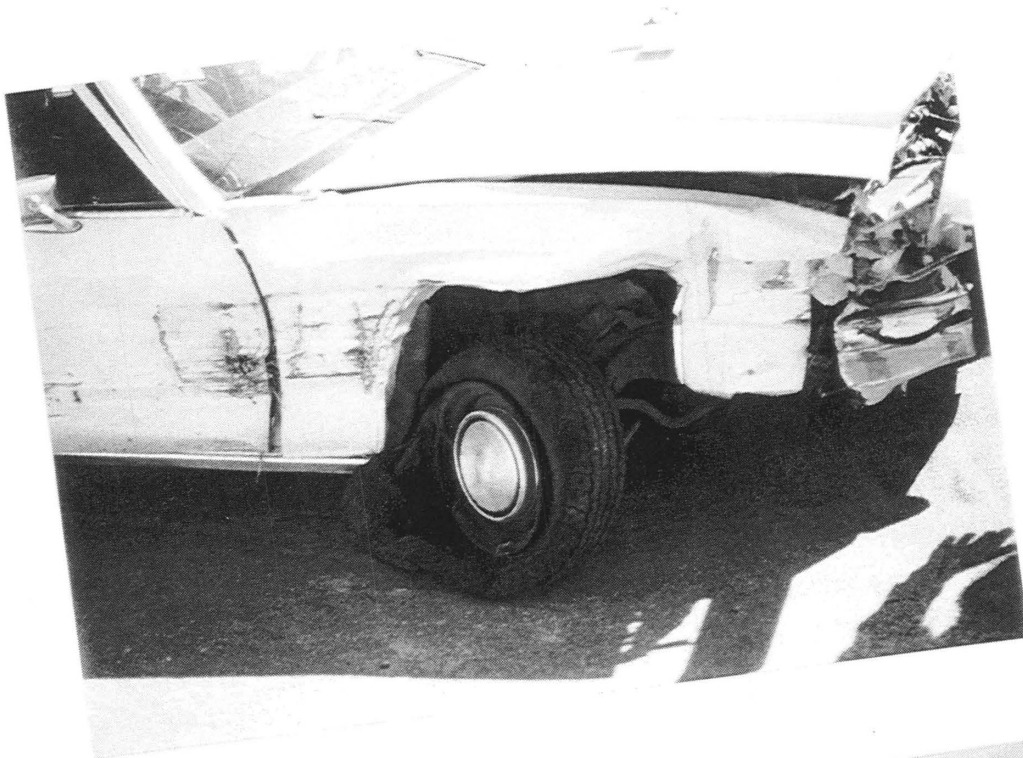
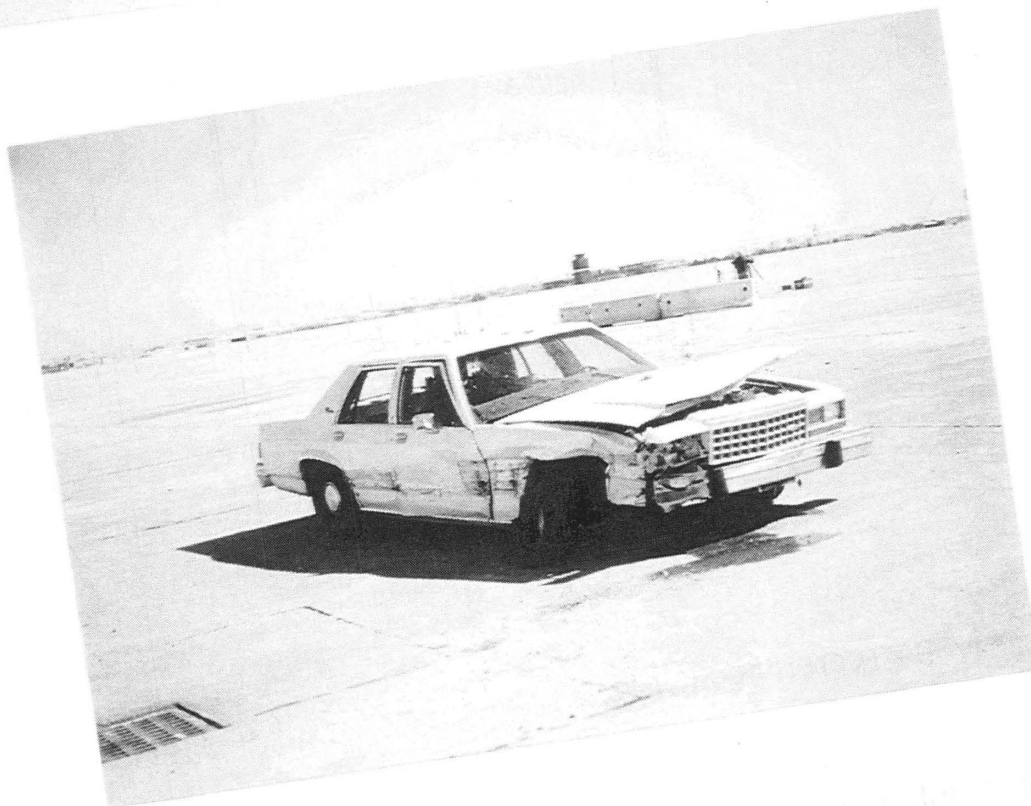
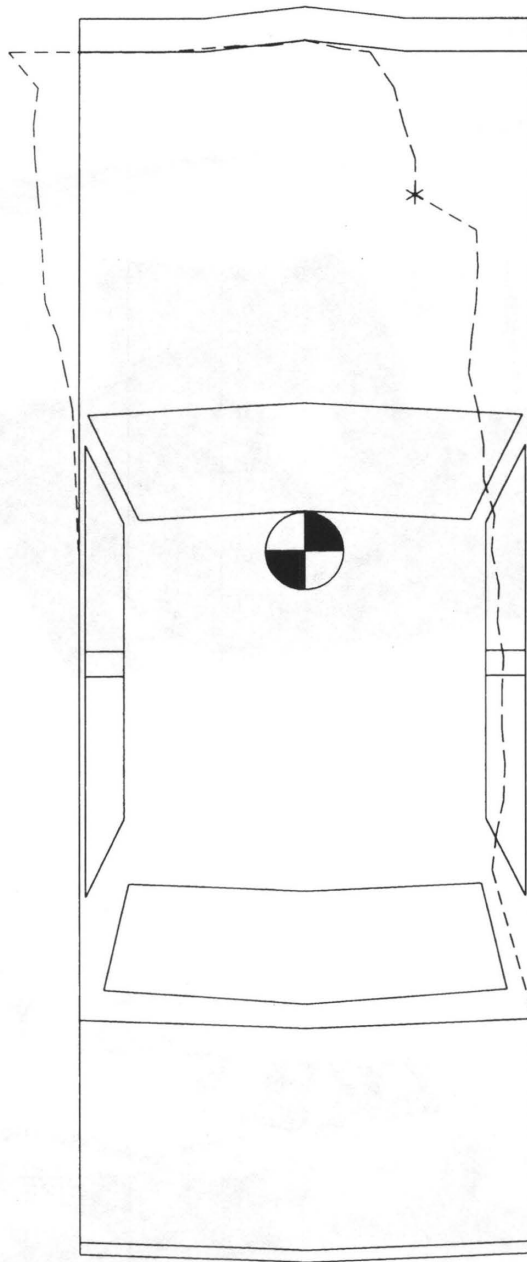
Figure 39. Vehicle Damage, Test SBT-5.

Damage to the vehicle, shown in figure 39, included deformation of the right-front corner, continuing along the length of the vehicle to the rear wheel assembly. There was no evidence of snagging, and the occupant compartment remained intact with the exception of minor deformation of the floorboard on the passenger's side. The maximum crush deformation of 19.4 in (492 mm) is shown schematically in figure 40.

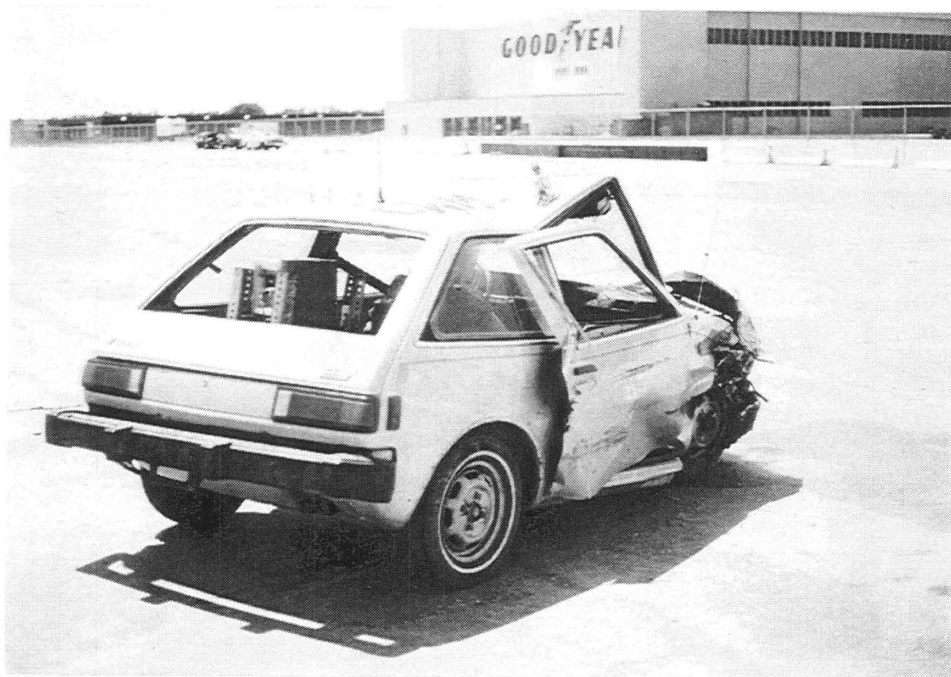
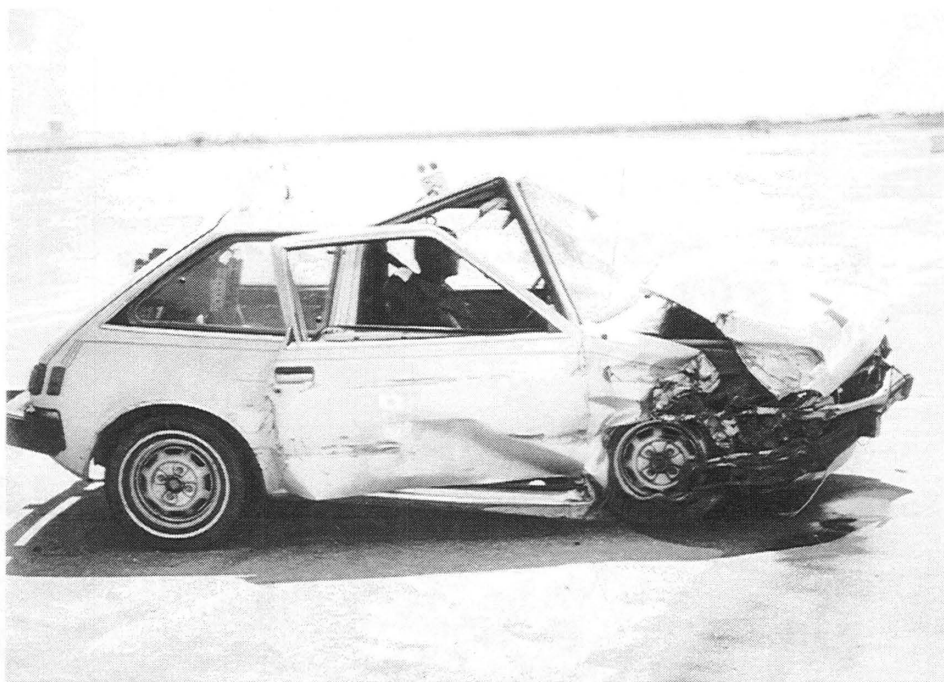
Figure 48. Vehicle Damage, Test GWMP-1.

The vehicle damage, shown in figure 48, included the crushing of the right-front corner of the vehicle, twisting of the car to the right of its longitudinal centerline, and buckling of the hood, roof, windshield frame, firewall, passenger compartment floor, and the passenger side door. The right-front tire was deflated, and the rim was deformed. The maximum crush deformation of 21 in (53.3 cm) is shown in figure 49.

As evident in the vehicle damage, shown in figure 48, there was significant occupant compartment damage to the test vehicle. This damage was caused by the snagging of the vehicle on posts no. 4 and 5. This occupant compartment deformation, accompanied by excessive lateral ridedown decelerations, caused the system to fail this compliance test. To alleviate this snagging problem, the rail size was increased from 4.5 in O.D. to 5.0 in O.D. (114 mm to 127 mm), and it was moved further out from the post, effectively moving the face of the rail 1 in (26 mm) further from the post. The design details of this change can be seen in appendix A.

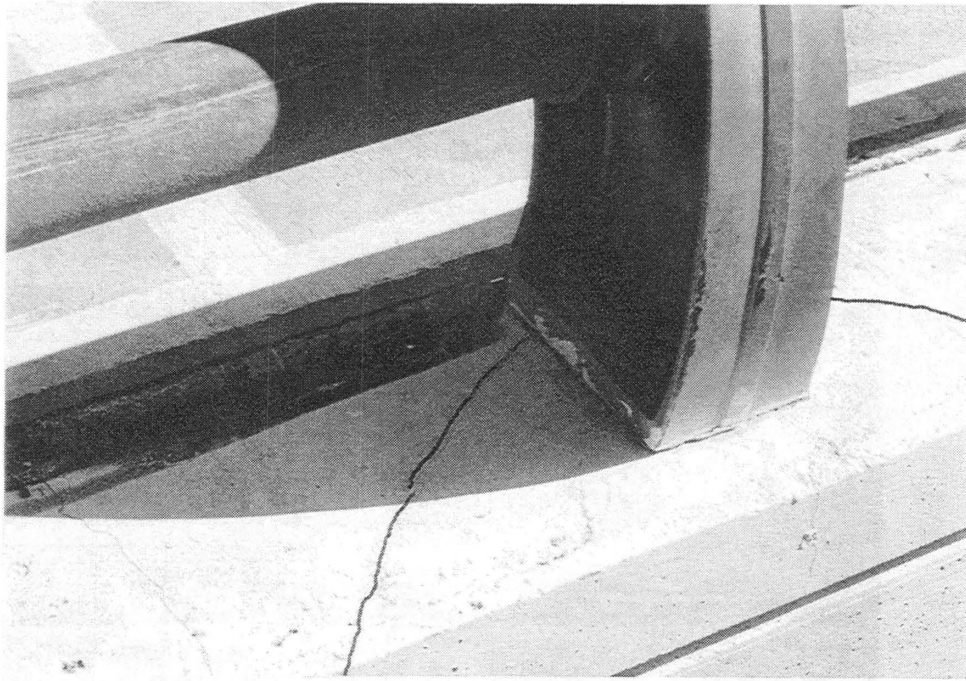
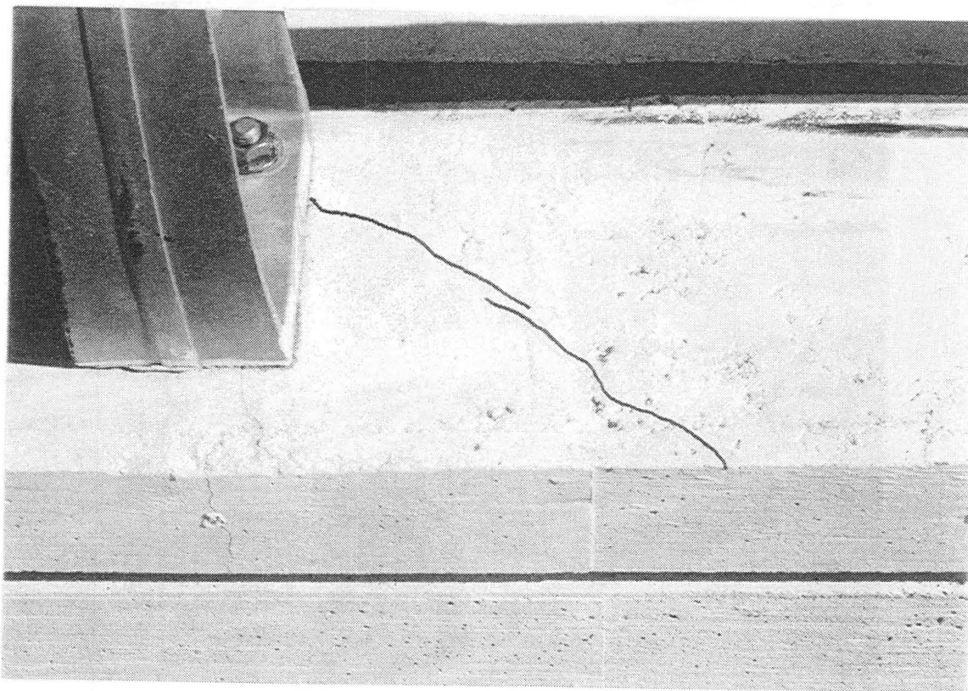
Figure 75. Cracking in Curb, Test FPAR-1 (outlined for clarity).

The only notable damage to the curb was a set of microcracks which started at the 1-in (2.54-cm) anchor bolts and extended to the back face of the curb at an angle of approximately 45 degrees. These cracks (outlined for clarity) are shown in figure 75. This was interpreted as being the beginning of a classic shear failure, and it was anticipated that the curb would fracture during the next, more severe pickup truck crash test. Therefore, the reinforcement in the curb was redesigned by FHWA engineers and replaced before Test FPAR-2.

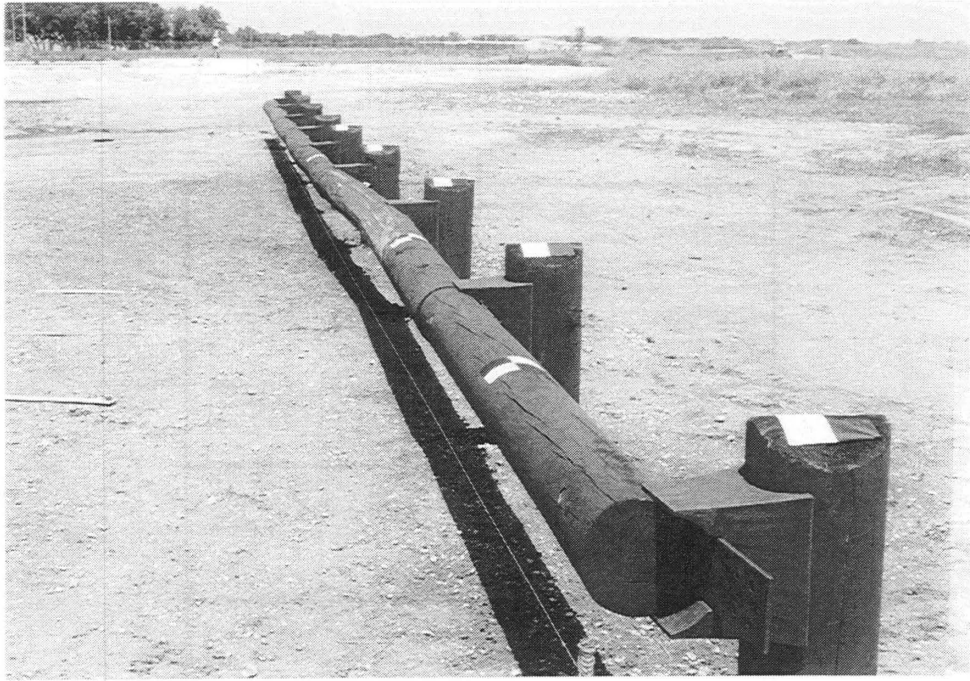
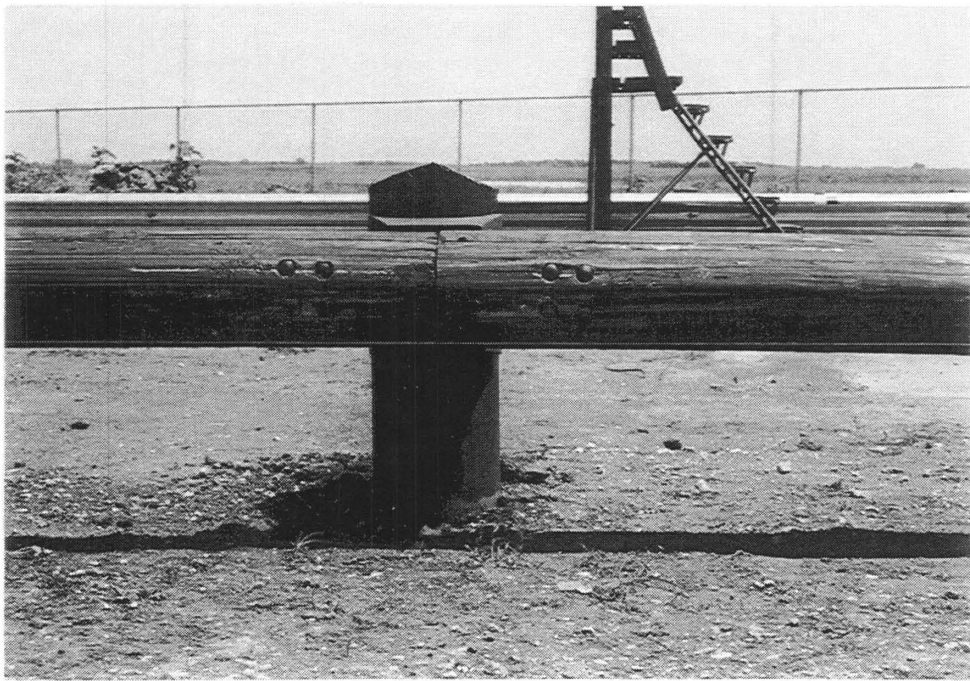
Figure 112. Log Rail Damage, Test SBLR-1.

Damage to the log rail consisted of minor scrapes on the surface of the rail and a maximum permanent deflection of 2 15/16 in (75 mm) at the first post after impact. This damage can be seen in figure 112. The effective coefficient of friction was found to be 1.18 and would be classified as marginal according to the *AASHTO Guide Specifications for Bridge Railings*.⁽⁸⁾

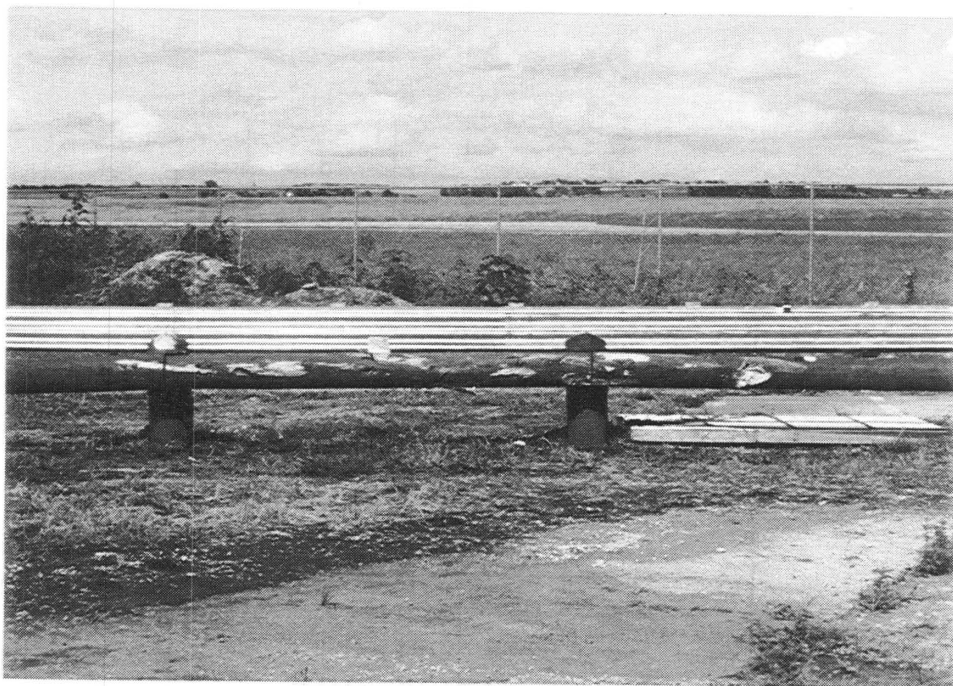
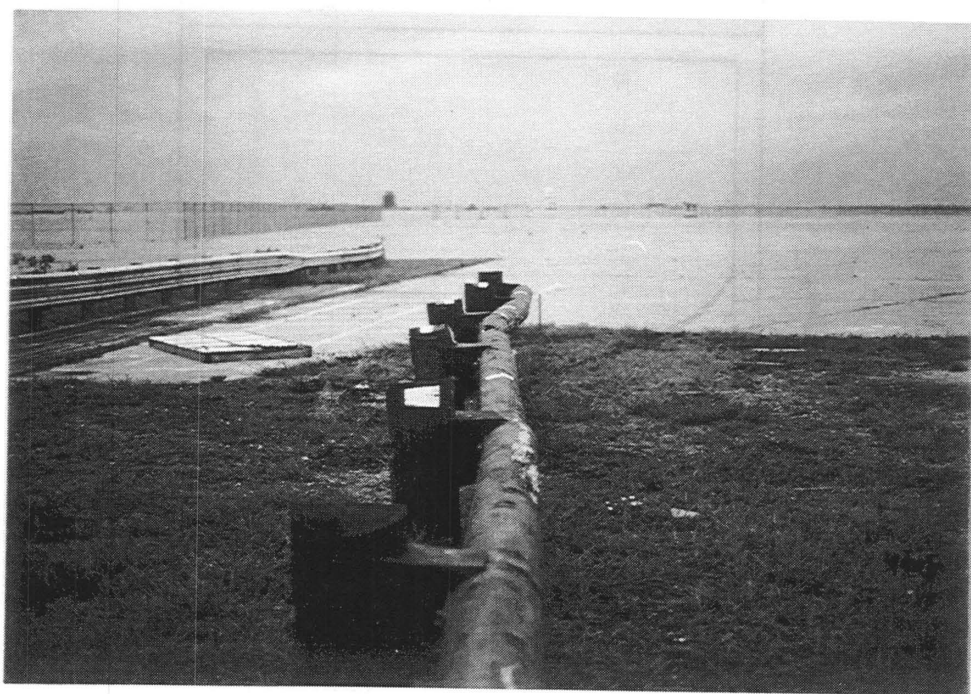
Figure 119. Log Rail Damage, Test SBLR-2.

Damage to the log rail consisted of scrapes and gouges along the traffic face and at some of the posts. A maximum permanent deflection of $9\frac{1}{8}$ in (232 mm) was measured at post no. 3. The damaged barrier is shown in figure 119.
