*Hawaii Department of Transportation  
Research Project Number 67167*

# **CRASH TESTING AND EVALUATION OF THE HDOT 34-IN. TALL AESTHETIC CONCRETE BRIDGE RAIL: MASH TEST DESIGNATION NOS. 3-10 AND 3-11**

MwRSF Research Report No. TRP-03-420-19

October 21, 2019

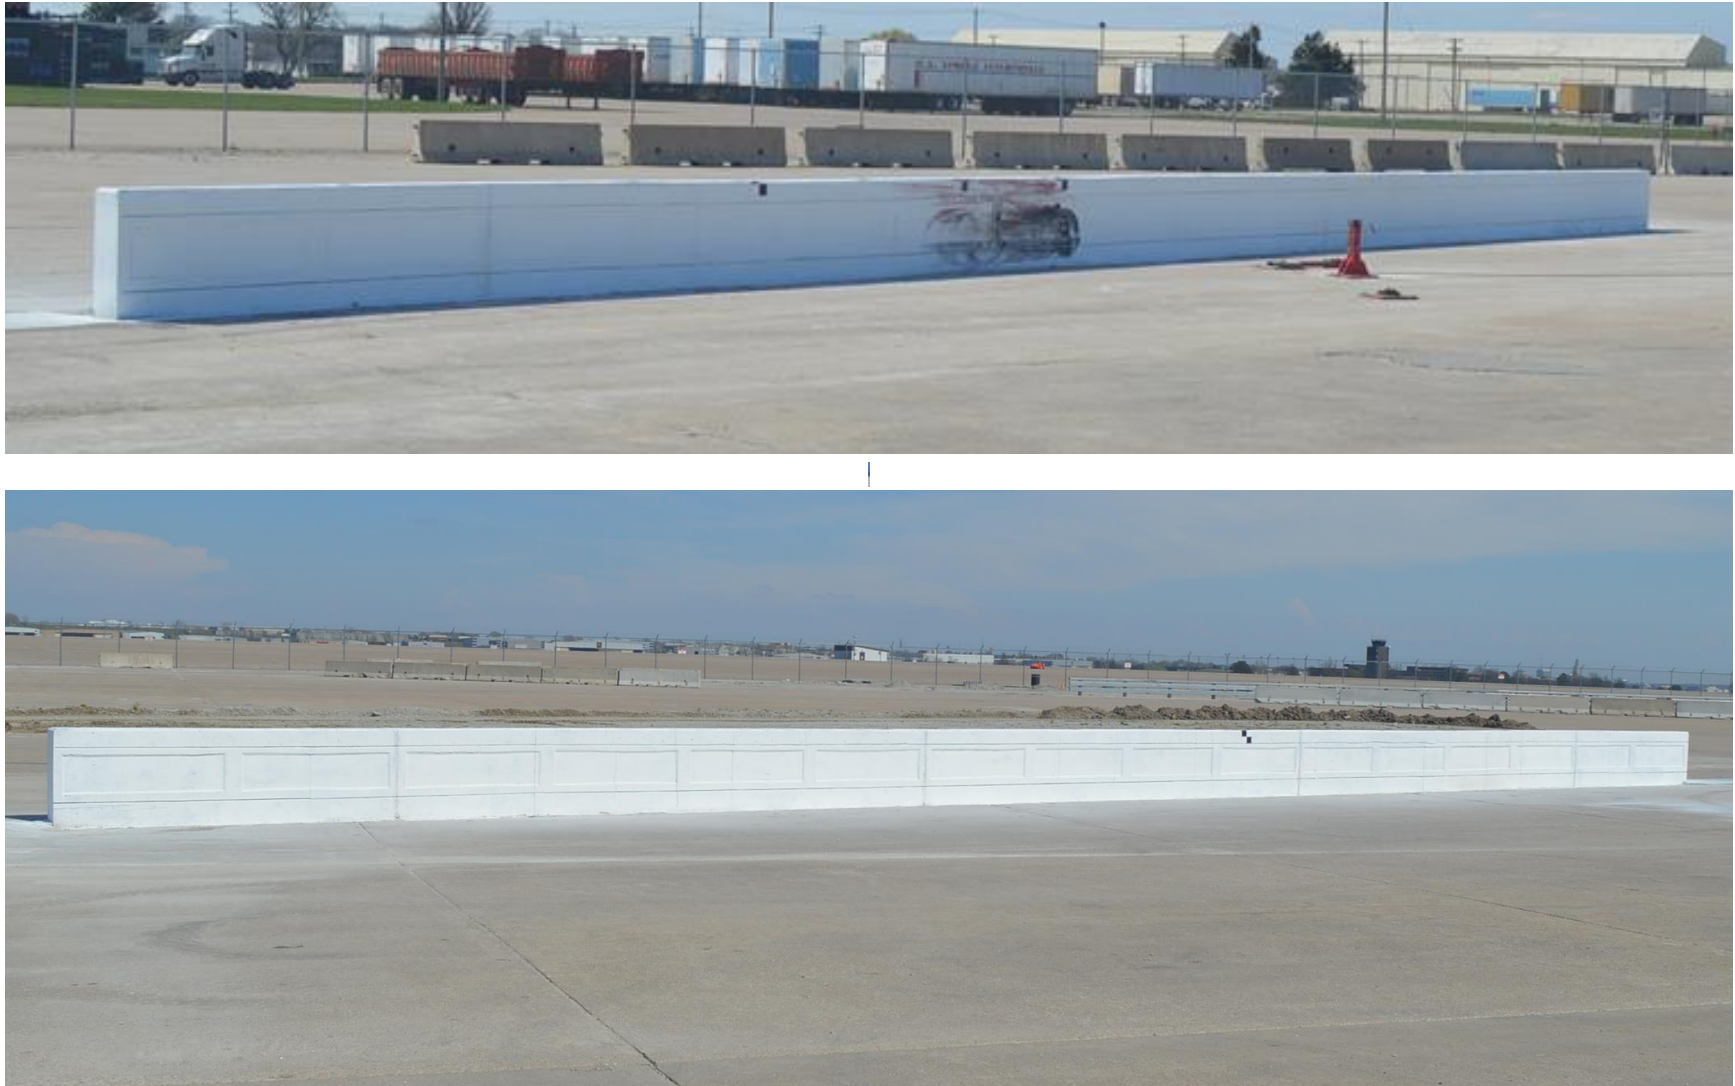
Figure 35. System Damage, Test No. H34BR-1

Damage to the barrier was minor, as shown in Figures 35 through 39. Barrier damage consisted of minor cracking, spalling, and contact marks on the parapet and minor cracking and spalling at the expansion joint between barrier nos. 3 and 4. The locations for all of the listed damage were measured from the expansion joint between barrier nos. 3 and 4 as a reference point. The length of vehicle contact along the barrier was approximately 11 ft – 3 in. which spanned from 4 ft – 9 in. upstream from the expansion joint to 6 ft – 6 in. downstream from the expansion joint.

A 45-in. long and 1½-in. tall spall on the aesthetic asperity was observed 51 in. upstream from the expansion joint. Spalling measuring 4 in. long and 2½ in. wide was found 45 in. upstream from the expansion joint and 14 in. above the ground. Spalling measuring 11 in. long and ½ in. wide was found 34 in. upstream from the expansion joint and 23 in. above the ground. Spalling measuring 5½ in. long and 2½ in. wide was found 33 in. upstream from the expansion joint and 15 in. above the ground. Spalling measuring 61½ in. long was found 32 in. upstream from the expansion joint to 29½ in. downstream of the expansion joint and 32 in. above the ground. Spalling measuring 5 in. long, 10 in. wide, and ½ in. deep was found 3 in. upstream from the expansion joint and 14 in. above the ground. Spalling measuring 6 in. long was found 2 in. upstream from the expansion joint and 24 in. above the ground. A ½-in. diameter by ½-in. deep hole was observed 53 in. upstream from the expansion joint and 17½ in. above the ground. A 1-in. diameter by ½-in. deep hole was observed 24 in. upstream from the expansion joint and 23½ in. above the ground. Grout was disengaged over a 12½ in. height at the expansion joint was observed located 9½ in. above the ground.

Minor cracking of the barrier was also observed in several locations. A 19½-in. diagonal crack that started 18½ in. above the ground and ended 33½ in. above the ground was found 70½ in. upstream from the expansion joint. An 18½-in. diagonal crack that started 11 in. above the ground and ended 18½ in. above the ground was found 60 in. upstream from the expansion joint. A third smaller crack was noted on the top of the barrier starting near the middle of the expansion joint between barrier nos. 3 and 4 and extending diagonally approximately 8 in. downstream and toward the back of the barrier.

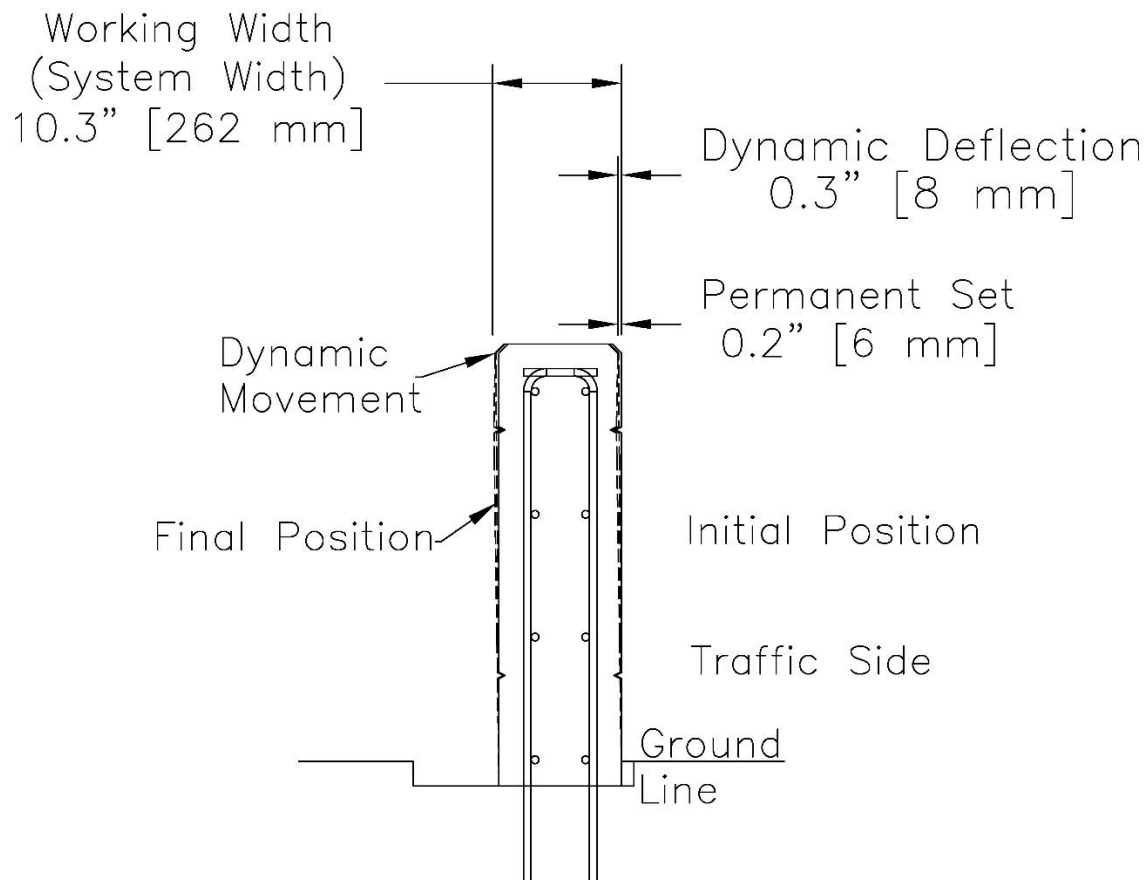
Figure 40. Permanent Set Deflection, Dynamic Deflection, and Working Width, Test No. H34BR-1

The maximum lateral permanent set of the barrier system was 0.2 in., which occurred at the downstream end of barrier no. 2, as measured in the field. The maximum lateral dynamic barrier deflection, including tipping of the barrier along the top surface, was 0.3 in. at the upstream end of barrier no. 3, as determined from high-speed digital video analysis. The working width of the system was found to be 10.3 in., also determined from high-speed digital video analysis. A schematic of the permanent set deflection, dynamic deflection, and working width is shown in Figure 40.

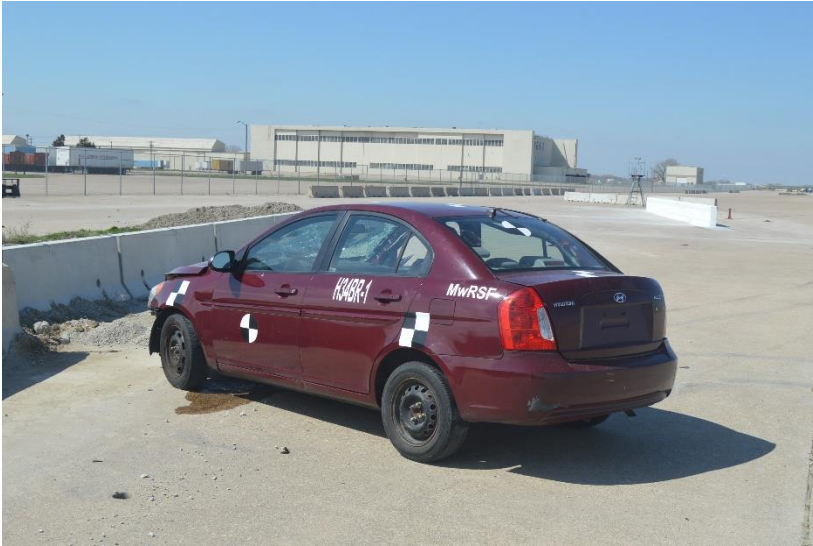
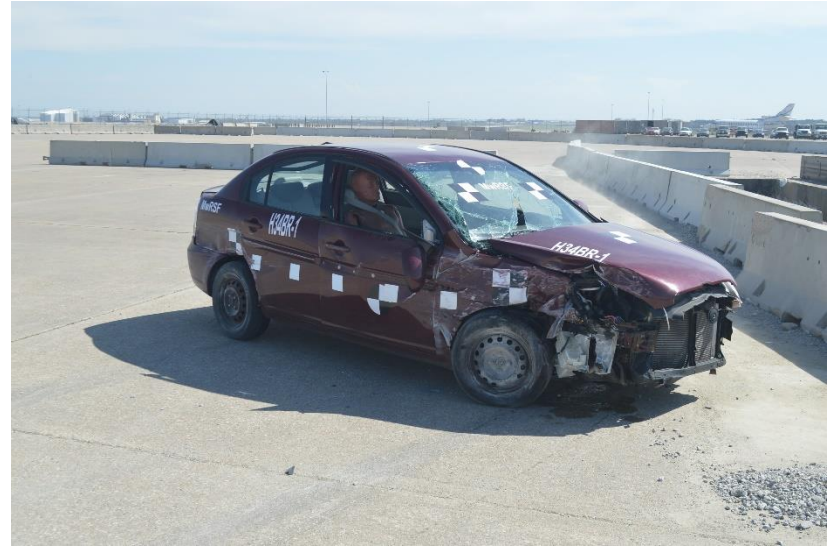
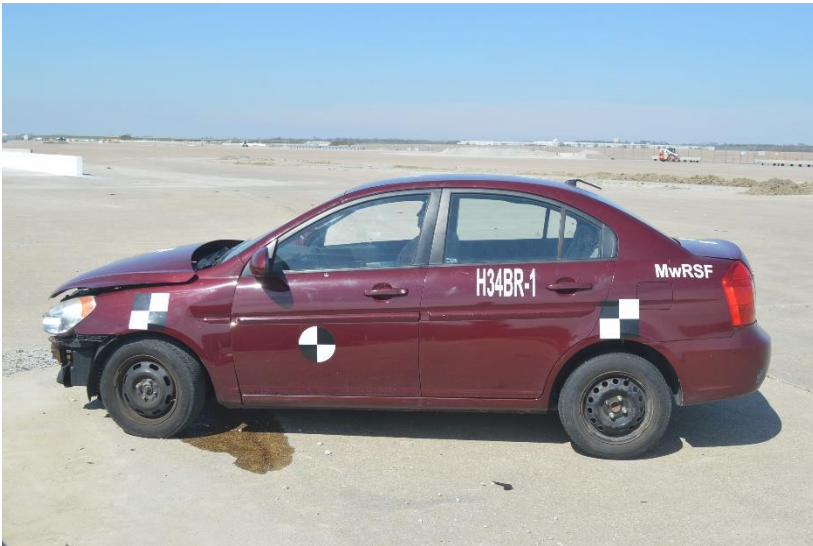
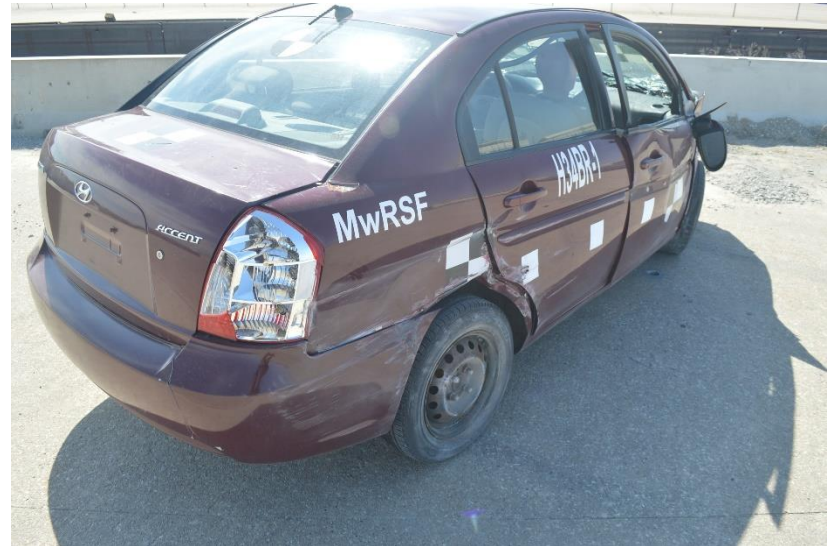
Figure 41. Vehicle Damage, Test No. H34BR-1

The damage to the vehicle was moderate, as shown in Figures 41 through 45. The maximum occupant compartment intrusions are listed in Table 5 along with the intrusion limits established in MASH 2016 for various areas of the occupant compartment. MASH 2016 defines intrusion or deformation as the occupant compartment being deformed and reduced in size with no observed penetration. Note that none of the established MASH 2016 intrusion limits were violated. The lateral B-Pillar and side door above and below the seat deformed slightly outward, which is not considered crush toward the occupant, is denoted as negative numbers in Table 5, and is not evaluated by MASH 2016 criteria. Complete occupant compartment and vehicle intrusions and the corresponding locations are provided in Appendix C.

The majority of the damage was concentrated on the right-front fender and right-front wheel of the vehicle where the impact had occurred. A small section of the seam where the floor pan and toe pan connected near the left-front corner of the right-side floor pan split due to floor pan deformation. The split seam was not due to intrusion of the barrier or a component of the vehicle. The vehicle's engine hood partially disengaged, but it remained attached to the vehicle's body. The front bumper and bumper cover disengaged from the vehicle. Kinks were found on the bottom support of the radiator, and the right radiator support was bent toward the engine compartment. A 23 $\frac{1}{8}$ -in. dent on the right side of the hood crushed 5 in. inward and toward the engine compartment. The right-front fender was crushed and had contact marks with the most significant occurring near the front of the wheel well. A 38 $\frac{1}{2}$ -in. long x 7 $\frac{1}{8}$ -in. wide x 1 $\frac{1}{2}$ -in. deep dent was found on the right-front door. The right-rear door was dented and scraped just ahead of the rear quarter panel.

It should be noted that the passenger side window fractured, and a large tear was visible in the vehicle windshield. Review of the high-speed video revealed that the side window damage was due to crush of the side of the vehicle door and not due to direct contact with the test article. Similarly, the video data showed that the tearing of the windshield was formed due to crushing of the right front corner of the windshield which propagated a shear crack through the glass and the liner. Neither of these items were in violation of the MASH 2016 criteria as none of the damage occurred due to contact with the test article or debris, nor was there the potential for the barrier to intrude into the occupant compartment.

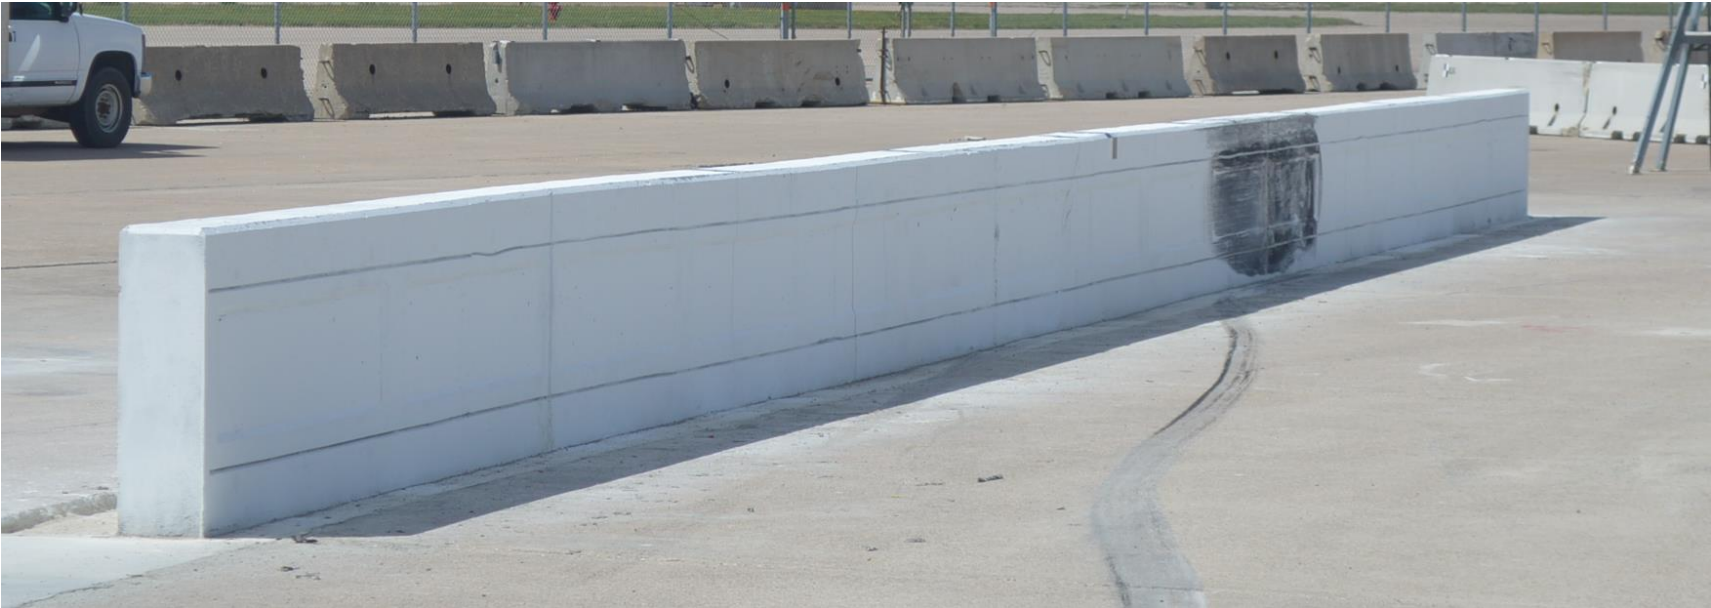
Figure 55. System Damage, Test No. H34BR-2

Damage to the barrier was minimal, as shown in Figures 55 through 58. Barrier damage consisted of contact marks on the front face of the concrete segments, spalling of the concrete, and concrete cracking. The length of vehicle contact along the barrier was approximately 12 ft – 9 in. which spanned from 5 ft – 6¼ in. upstream from the center of the joint between barrier nos. 2 and 3 to 7 ft – 3 in. downstream from the center of the joint between barrier nos. 2 and 3. The locations for all of the listed damage were measured using the expansion joint between barrier nos. 2 and 3 as a reference point.

Tire marks and scuff marks were visible on the front face of barrier nos. 2 and 3. Concrete spalling and cracking occurred at the downstream end of barrier no. 2 and upstream end of barrier no. 3. A 17½-in. x 5-in. x 1-in. piece of concrete was removed 2 in. upstream from the center of the expansion joint between barrier nos. 2 and 3. A 6½-in. long x 2½-in. wide concrete piece that was located 16½ in. from the ground was removed 54 in. upstream from the expansion joint. A 12-in. long x 9½-in. wide piece of concrete, which was located 19½ in. from the ground, was removed 46½ in. upstream from the expansion joint. An 8-in. long x 3¾-in. wide concrete piece that was located 8¾ in. from the ground was removed 4½ in. upstream from the expansion joint.

A 2¼-in. long crack that began on the top face of the barrier was found 56½ in. upstream from the expansion joint. A longer crack was found 42 in. upstream from the expansion joint starting 6½ in. from the ground on the back side of the barrier and extending across the top face to 7 in. A crack was found 68¼ in. upstream from the expansion joint that started 29¾ in. above the ground and extended diagonally upstream and ended 18½ in. above the ground. The most significant crack formed on the back-side surface, which started at the bottom of the barrier and extended on top of the barrier. It started from the bottom and 3 in. upstream of the expansion joint, extending 6¼ in. upstream of the expansion joint and 11¼ in. above the ground, and ended at the top of the barrier and 1 in. upstream of the expansion joint.

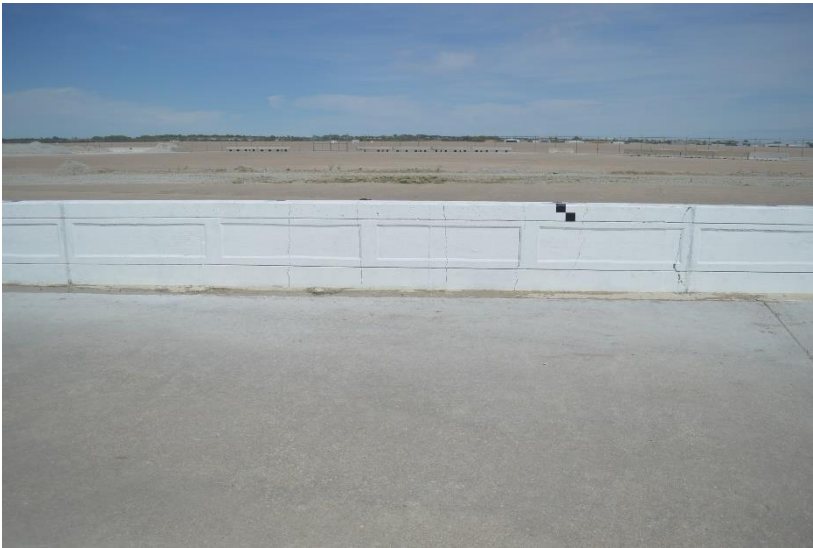
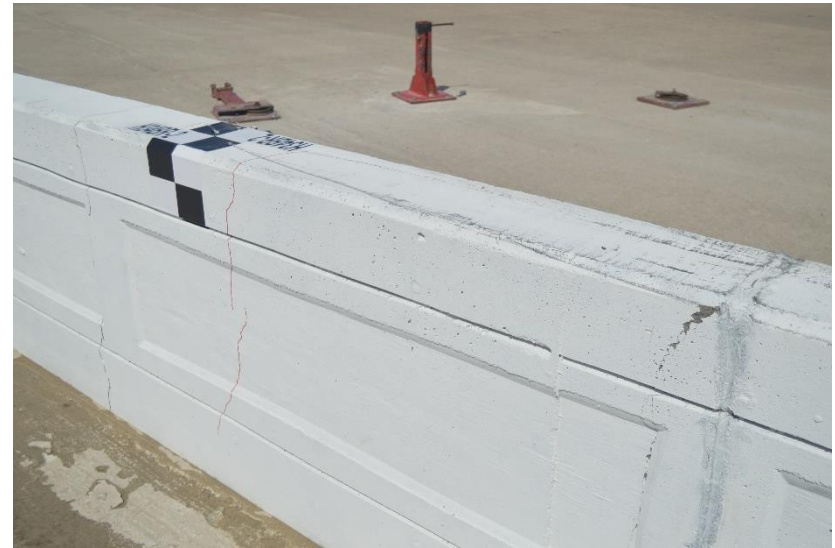
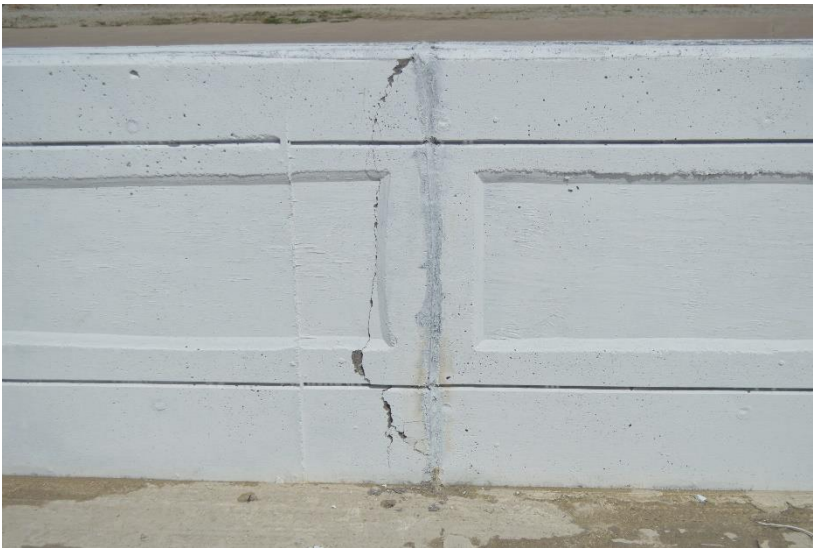
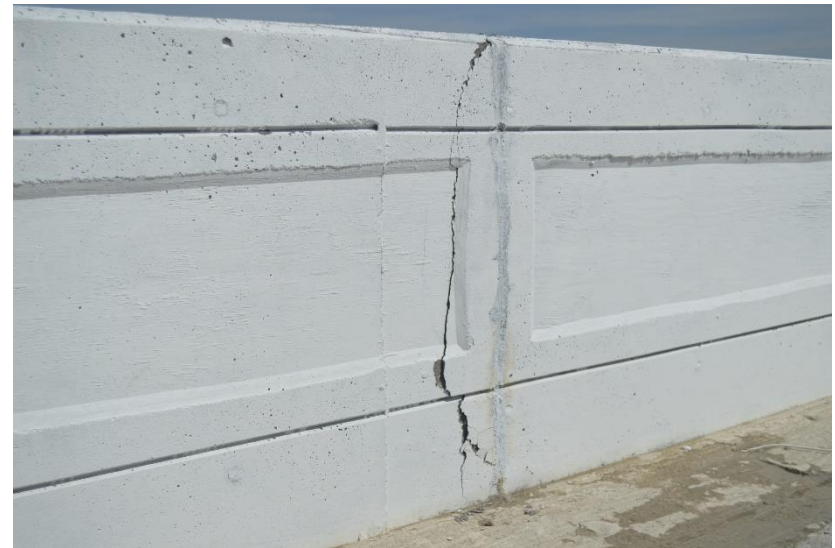
Figure 58. Back-Side System Damage, Test No. H34BR-2

on the barrier system near the ends of the bridge rail segments in both tests. Additionally, a long vertical crack that started at the bottom and extended to the top of the barrier was observed on the back side in test no. H34BR-2 due to loading of the dowel bars that transferred shear loads across the expansion joint. Cracking and damage of the barrier, especially near the expansion joint discontinuity, could weaken the bridge rail section and adversely affect its capacity and performance under secondary impacts. It is noted that reducing the spacing of the vertical reinforcement near the end sections of the barrier could potentially mitigate some of the cracking and damage that was observed in the full-scale crash tests and reduce the need for repair of the bridge rail. HDOT should consider reviewing the end sections of the bridge rail following accidents to determine if repair of the barrier is needed due to cracking similar to that observed in the testing herein.

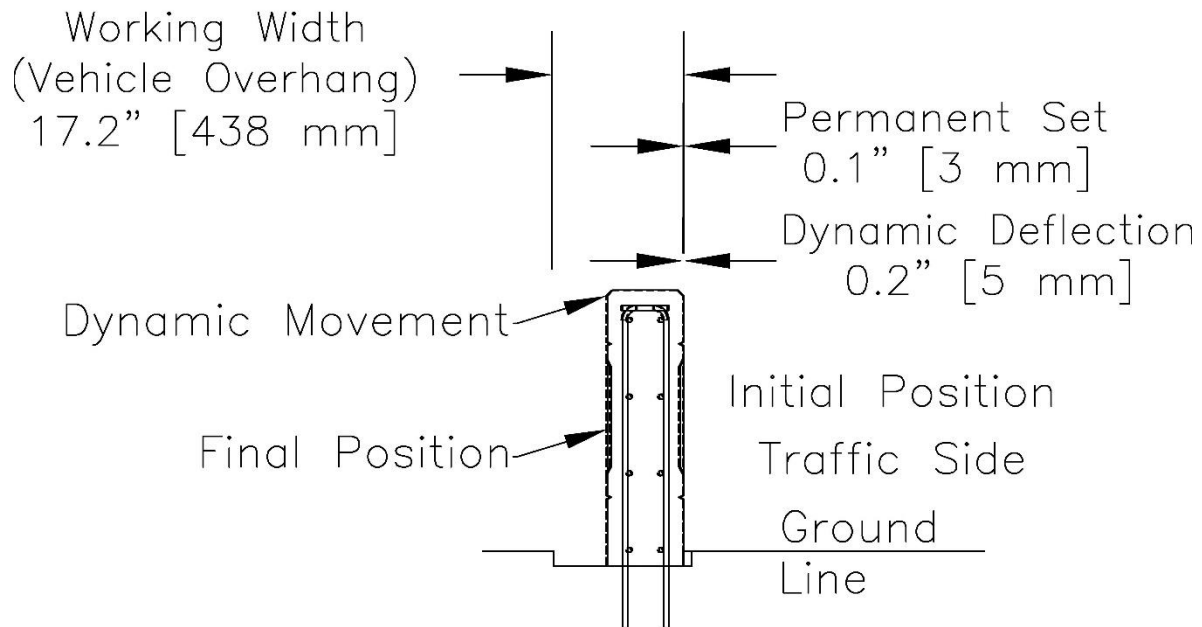
Figure 59. Permanent Set Deflection, Dynamic Deflection, and Working Width, Test No. H34BR-2

The maximum lateral permanent set of the barrier system was 0.1 in., including barrier and deck panel shift, which occurred at the downstream end of barrier no. 2, as measured in the field. The maximum lateral dynamic barrier deflection, including tipping of the barrier along the top surface, was 0.2 in. at the upstream end of barrier no. 3, as determined from high-speed digital video analysis. The working width of the system was found to be 17.2 in. also determined from high-speed digital video analysis. A schematic of the permanent set deflection, dynamic deflection, and working width is shown in Figure 59.

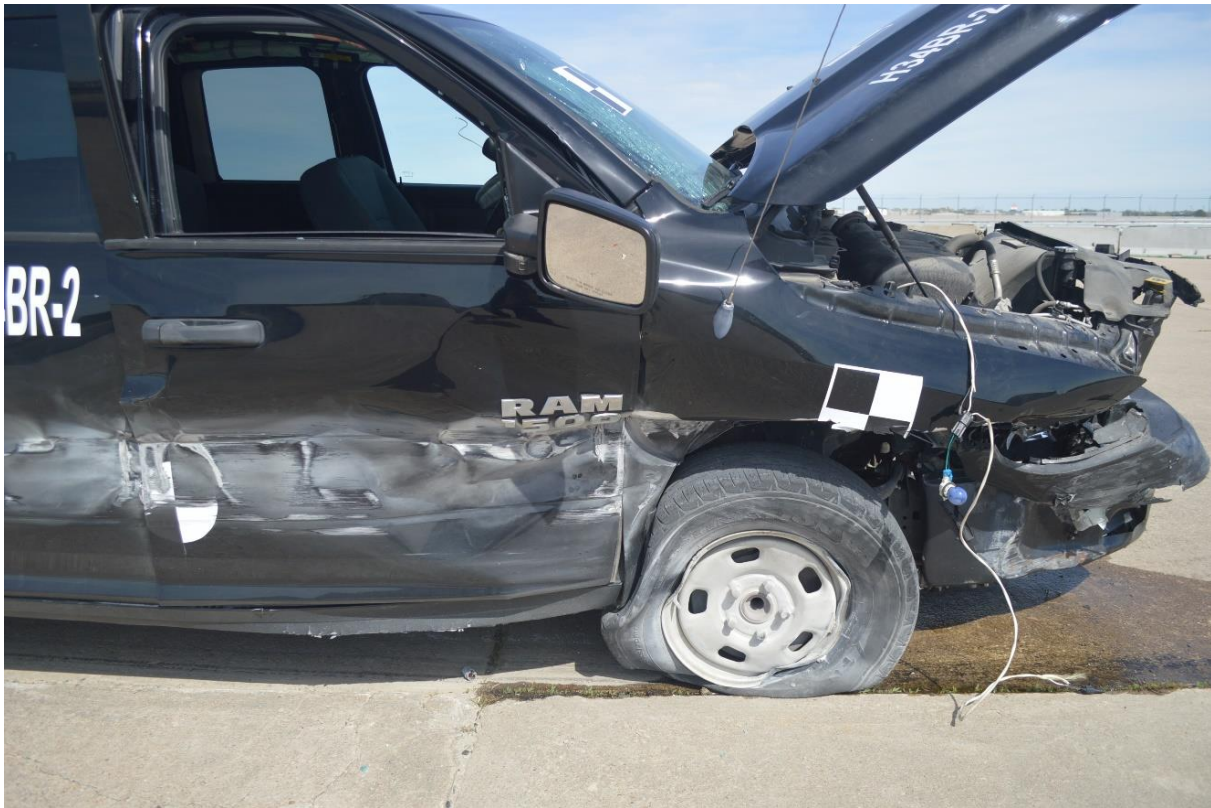
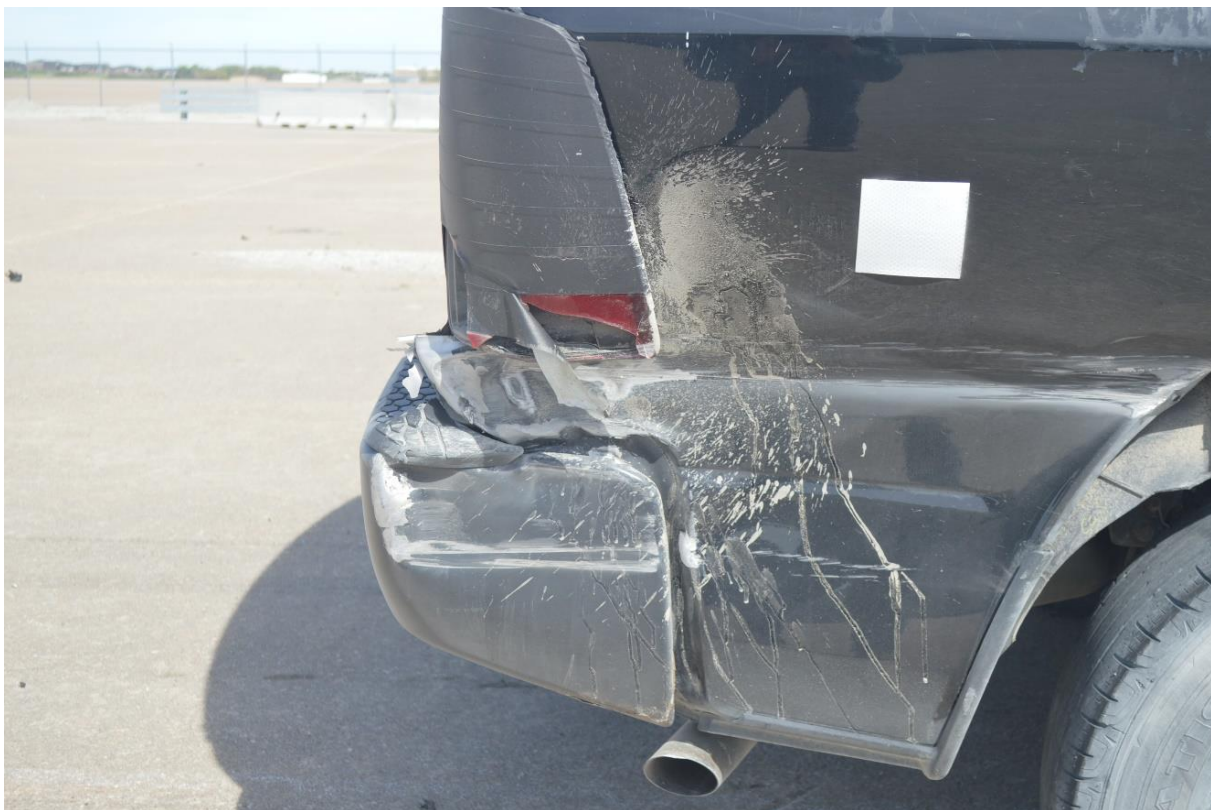
Figure 61. Vehicle Damage, Test No. H34BR-2

The damage to the vehicle was moderate, as shown in Figures 60 through 64. The maximum occupant compartment intrusions are listed in Table 9 along with the intrusion limits established in MASH 2016 for various areas of the occupant compartment. MASH 2016 defines intrusion or deformation as the occupant compartment being deformed and reduced in size with no observed penetration. Note that none of the established MASH 2016 intrusion limits were violated. The lateral A- and B-pillars and the side door above the seat deformed slightly outward, which is not considered crush toward the occupant, is denoted as negative numbers in Table 9, and is not evaluated by MASH 2016 criteria. Complete occupant compartment and vehicle intrusions and the corresponding locations are provided in Appendix C.

The majority of the damage was concentrated on the right-front corner and right side of the vehicle where the impact had occurred. The right side of the bumper was crushed inward and backward. The right-front fender was crushed inward toward the centerline of the vehicle and engine compartment. The right-front steel rim was deformed and crushed, and the right-front tire was torn and deformed. The right upper control arm was fractured. The grille was disengaged away

from the vehicle. The left-side headlight was disengaged away from the vehicle and right-side headlight and fog light were shattered. The right side of the radiator was pushed backward. A 16 $\frac{1}{2}$ -in. long x 21-in. wide x 2 $\frac{1}{2}$ -in. deep dent and scraping were observed on the entire right side. The right-front door was ajar, and creases were found in the door's sheet metal. The right-rear steel rim was crushed, and the tire was torn. The right side of the rear bumper was dented and scuffed. It should be noted that the window on the right-front side was shattered. It should be noted that the passenger side window was fractured. Review of the high-speed video revealed that the side window damage was due to crush of the side of the vehicle door and not due to direct contact with the test article. Thus, the side window damage was not in violation of the MASH criteria as it did not occur due to contact with the test article or debris. The bottom-right side of the windshield had a hairline crack, and no cracks were found on the left side of the windshield. The left-front fender was dented at the top and back. Minor scrapes and dents were found at the left-front and left-rear doors. The roof and remaining window glass remained undamaged.
