*Hawaii Department of Transportation
Research Contract No. 68212
Research Project No. STP-1500(092) – Phase II*

MASH TL-3 EVALUATION OF TRANSITION TO HAWAII MODIFIED DELAWARE RETROFIT THRIE-BEAM BRIDGE RAIL

MwRSF Research Report No. TRP-03-449-22

August 22, 2022

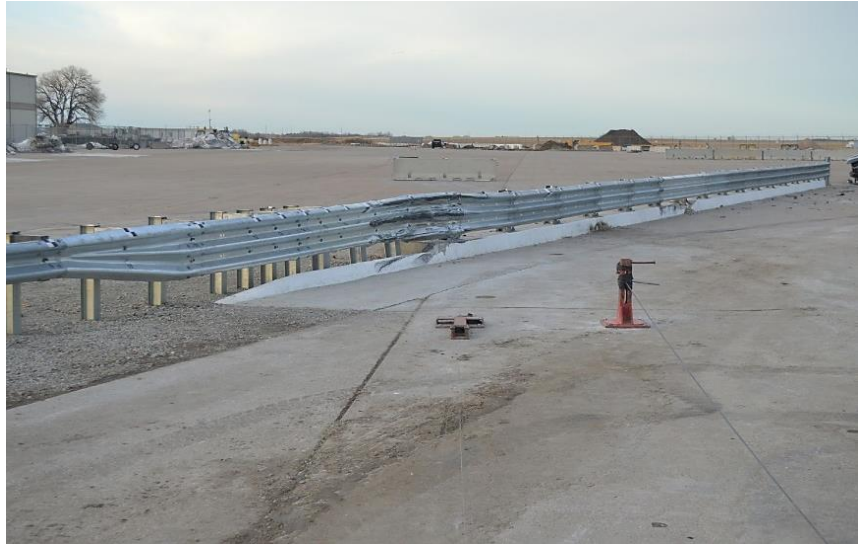
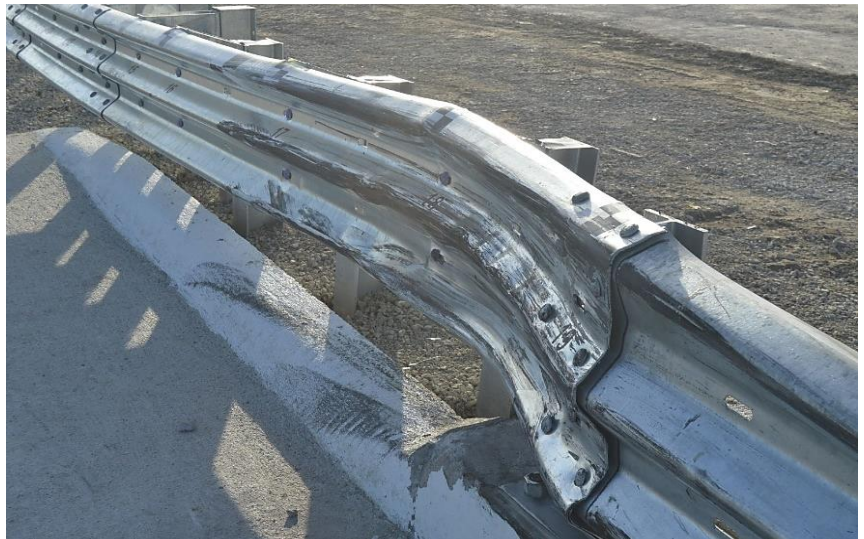
Figure 68. System Damage, Test No. HMDT-1

Damage to the barrier was moderate, as shown in Figures 68 through 70. Note that some pre-existing damage to the bridge rail was present from a previous test, test no. HMBDR-1, which has been previously reported [2]. The pre-existing damage included spalling of the concrete sidewalk between post nos. 24 and 26, missing post no. 25, and contact marks on the thrie-beam rail and sidewalk at post no. 24.

Tire contact marks were visible on the traffic side and top of the curb starting upstream from post no. 17, which extended for the length of 73½ in. downstream. The tire contact marks on the concrete sidewalk began from its upstream end and extended 55¾ in. downstream. Minor concrete spalling, measuring 5 in. x 7 in. x 3½ in. deep and 9 in. x 7 in. x 2¼ in. deep, was found on the top and front edge of the transition curb and sidewalk, respectively, at the joint between the transition curb and concrete sidewalk.

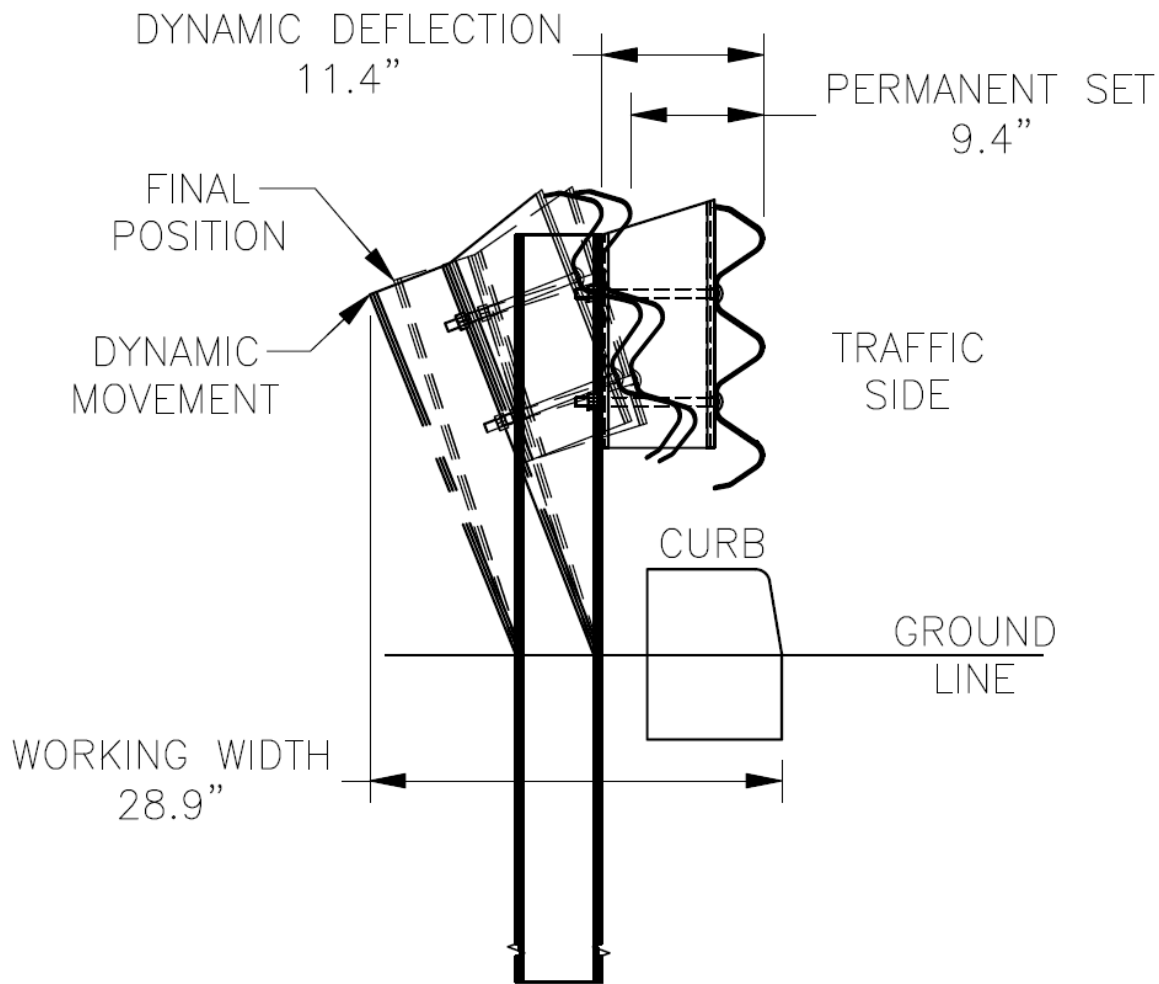
Figure 71. Permanent Set Deflection, Dynamic Deflection, and Working Width, Test No. HMDT-1

The maximum lateral permanent set of the barrier system was 9.4 in., which occurred in the thrie-beam rail between post nos. 17 and 18, as measured in the field. The maximum lateral dynamic barrier deflection was 11.4 in. at the rail at post no. 18, as determined from high-speed digital video analysis. The working width of the system was found to be 28.9 in., also determined from high-speed digital video analysis. A schematic of the permanent set deflection, dynamic deflection, and working width is shown in Figure 71.

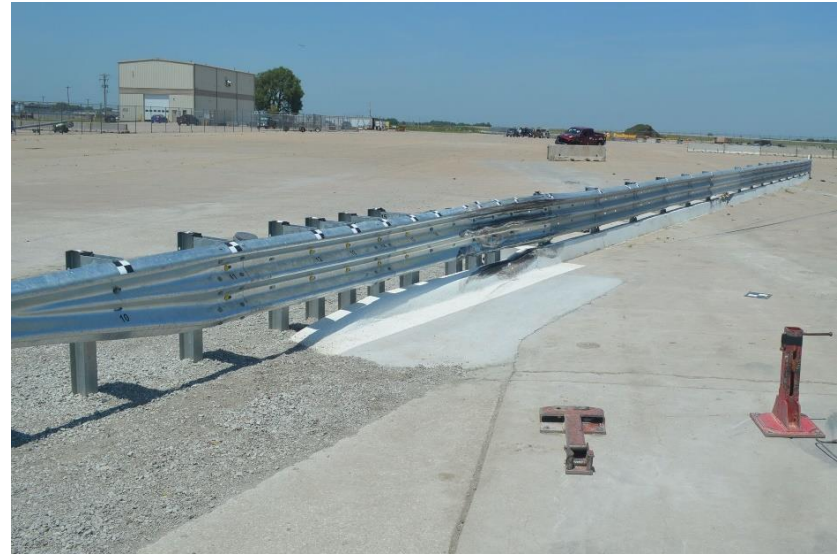
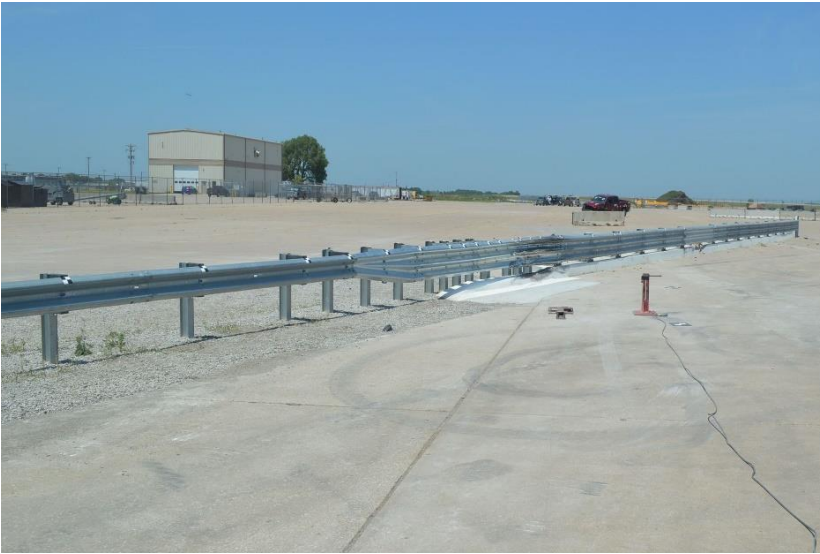
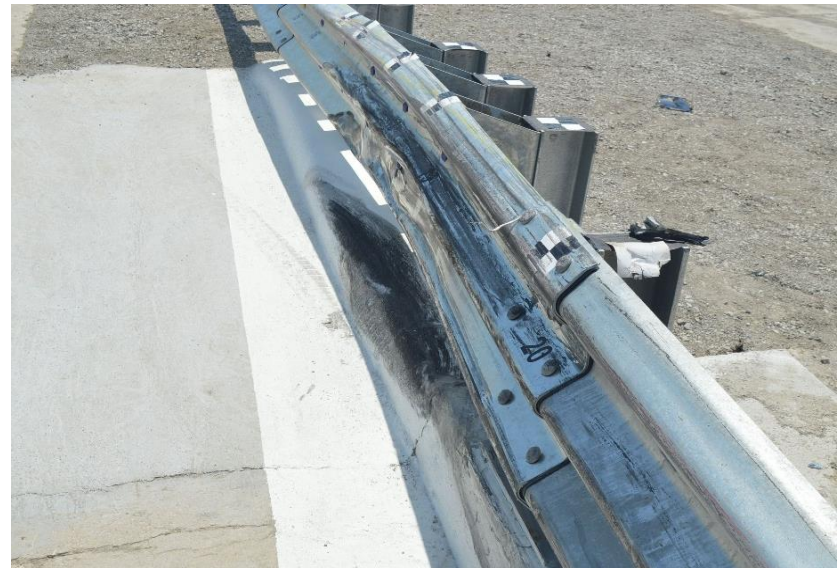
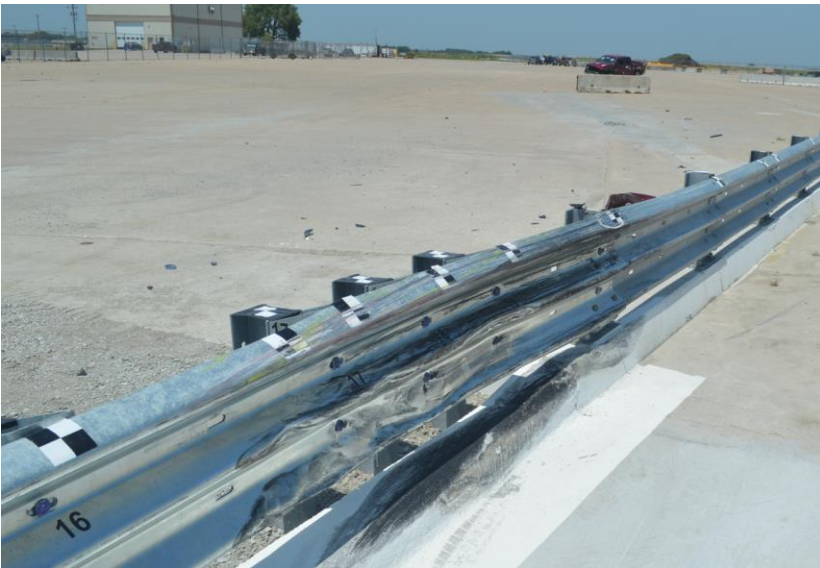
Figure 123. System Damage, Test No. HMDT-2

Post nos. 17, 18, and 19 rotated slightly backward. No other post damage or deflection was observed. Posts nos. 15, 16, and 17 through 19 had minor soil gaps measuring less than ¾ in. in front of and behind the posts. No movement was observed in the upstream anchorage system.

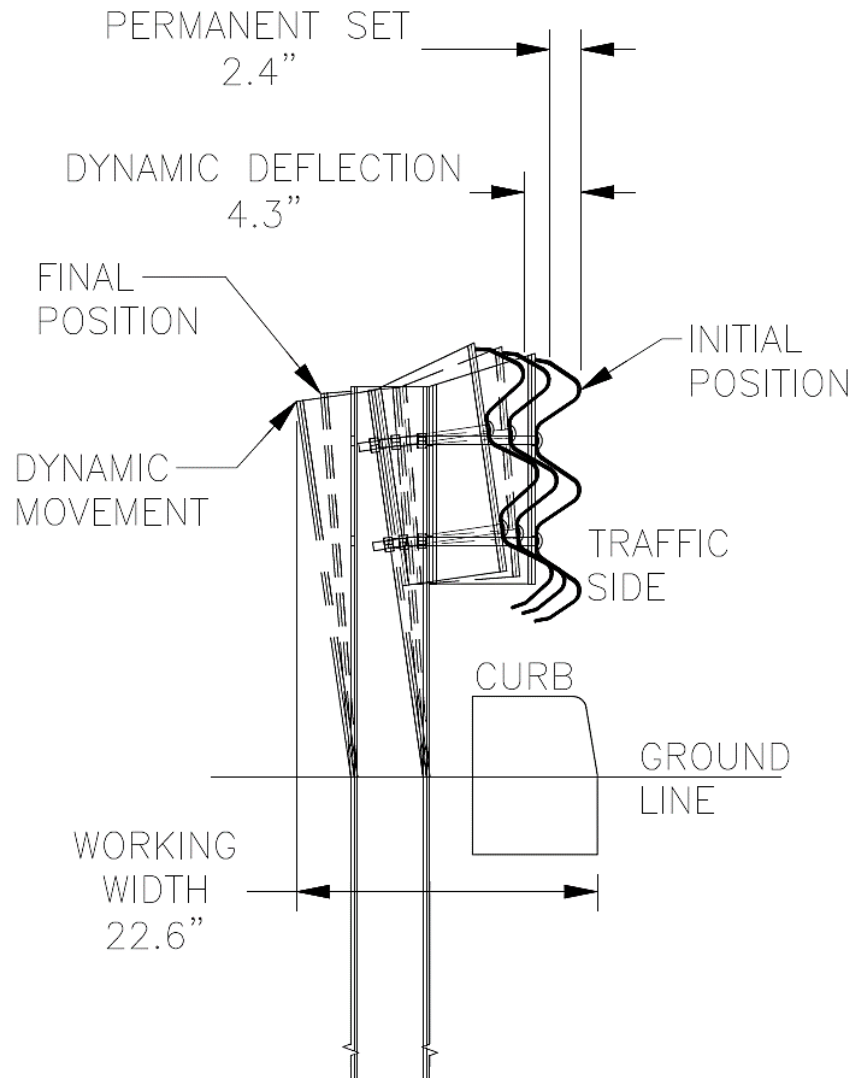
Figure 126. Permanent Set Deflection, Dynamic Deflection, and Working Width, Test No. HMDT-2

The maximum lateral permanent set of the barrier system was 2.4 in., which occurred at the rail at post no. 18, as measured in the field. The maximum lateral dynamic barrier deflection was 4.3 in. at post no. 18, as determined from high-speed digital video analysis. The working width of the system was found to be 22.6 in. at post no. 18, also determined from high-speed digital video analysis. A schematic of the permanent set deflection, dynamic deflection, and working width is shown in Figure 126.

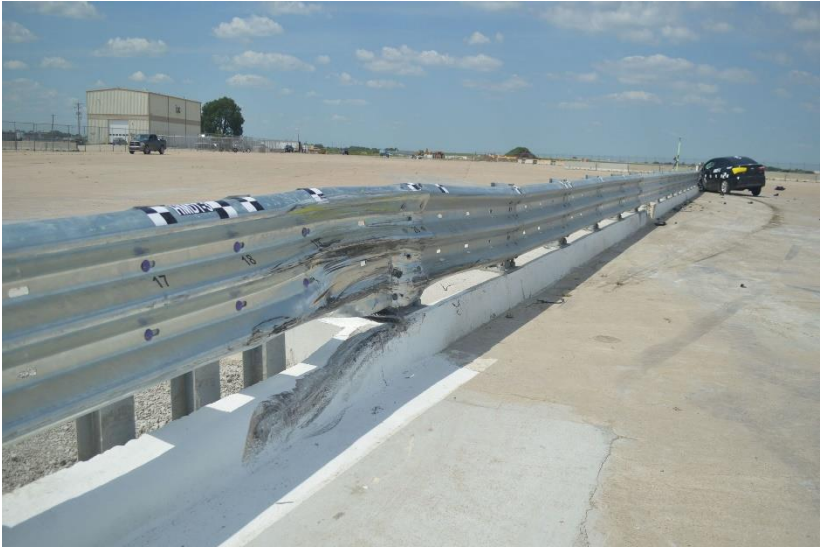
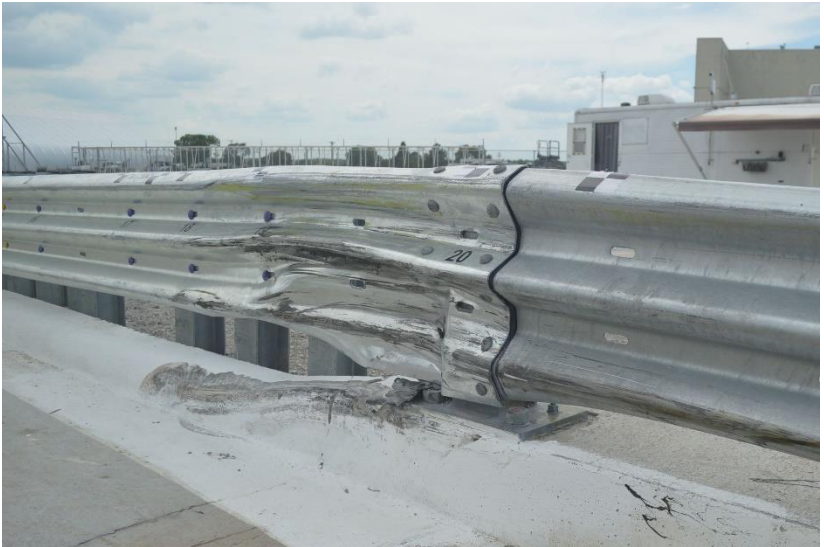
Figure 137. System Damage, Test No. HMDT-3

Post nos. 10 and 11 rotated counterclockwise. Post deflection was minor and limited to post nos. 17 through 19. Post no. 20 bent backward. Posts nos. 17 and 19 had minor soil gaps measuring less than ½ in. between the curb and soil. No movement was observed in the upstream anchorage system.

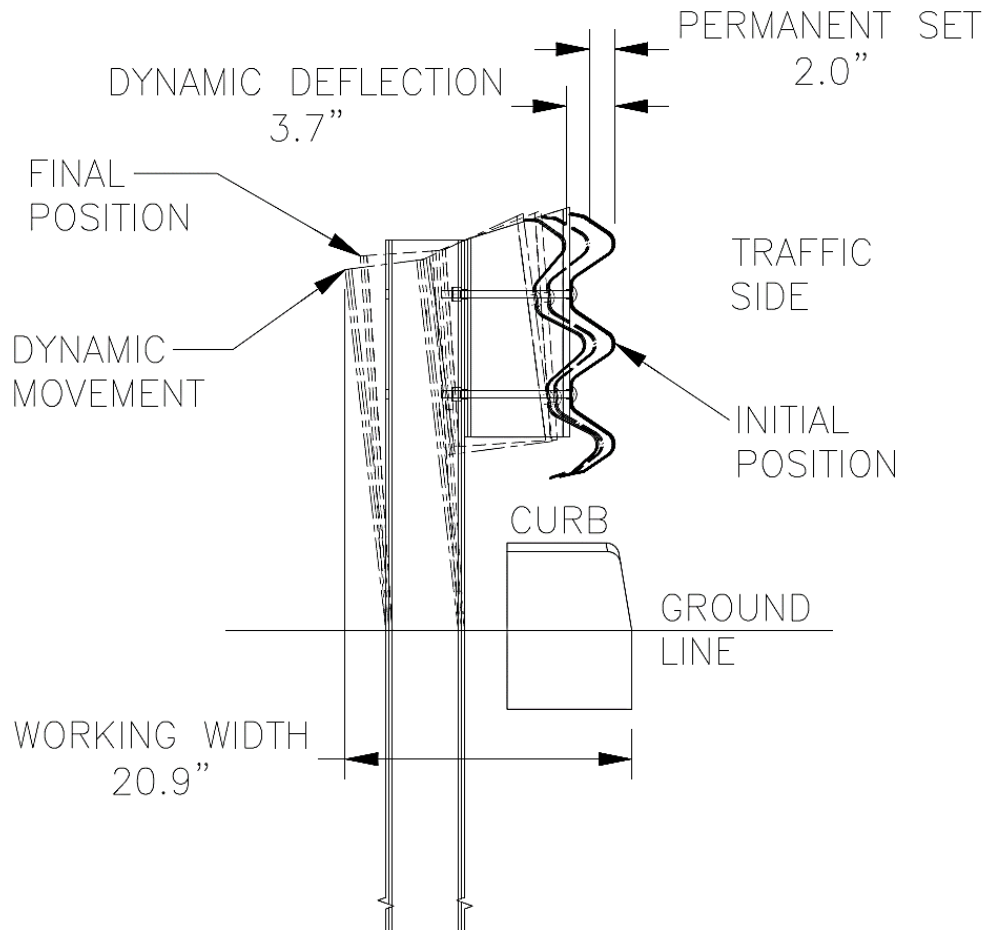
Figure 140. Permanent Set Deflection, Dynamic Deflection, and Working Width, Test No. HMDT-3

The maximum lateral permanent set of the barrier system was 2.0 in., located at post no. 18, as measured in the field. The maximum lateral dynamic barrier deflection was 3.7 in. at post no. 19, as determined from high-speed digital video analysis. The working width of the system was found to be 20.9 in. at post no. 19, also determined from high-speed digital video analysis. A schematic of the permanent set deflection, dynamic deflection, and working width is shown in Figure 140.

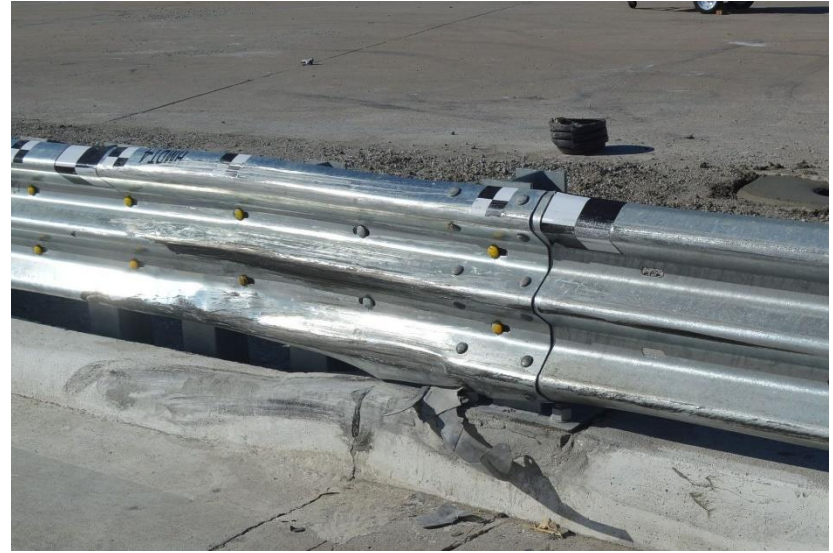
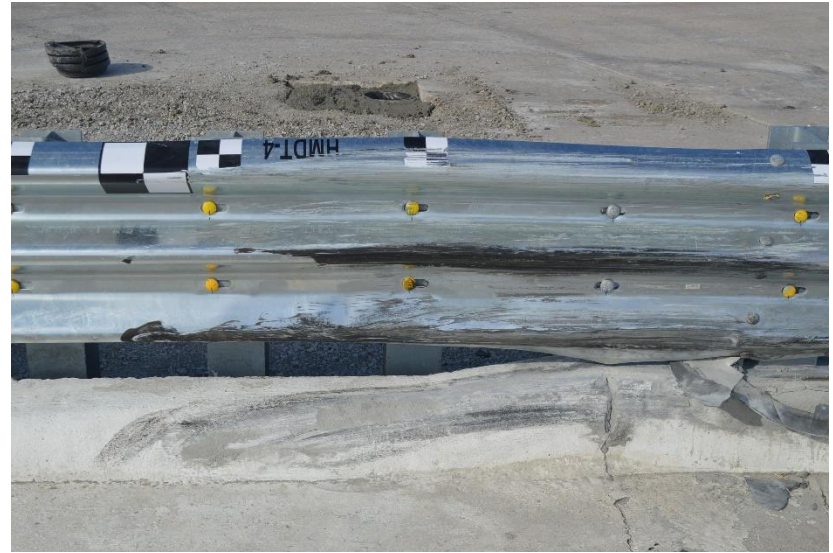
Figure 190. System Damage, Test No. HMDT-4

Post no. 17 had a soil gap of 1/16 in. on the back of the post, and post no. 19 had soil gaps of ¾ and ¼ in. in front and back of the post, respectively. Post nos. 18 and 19 had a soil heave on the back side and measured 11 in. diameter and 1½ in. high. No post damage or movement occurred to the upstream anchorage system.

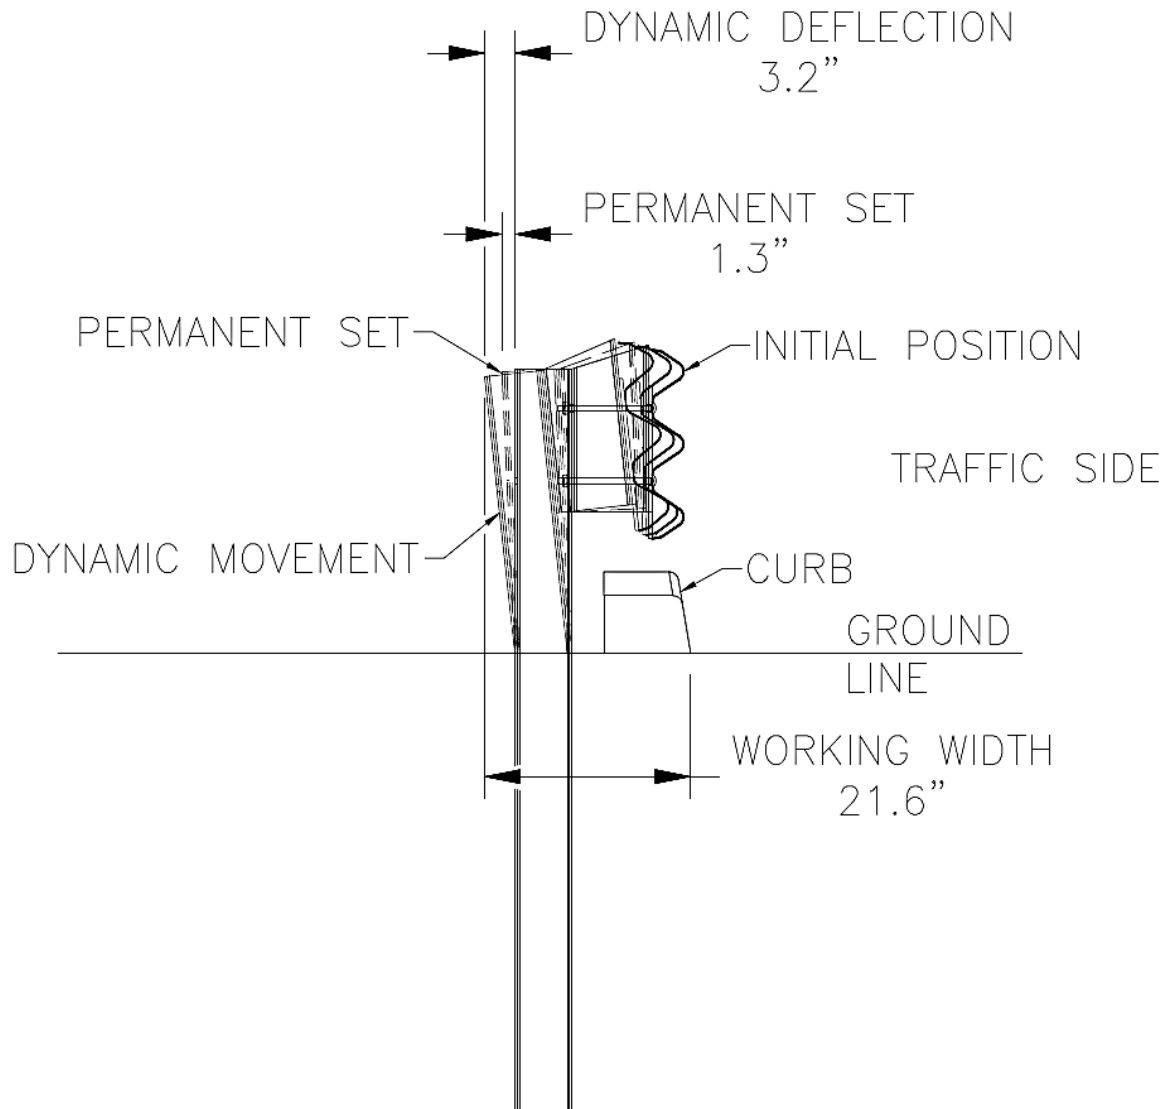
Figure 192. Permanent Set Deflection, Dynamic Deflection, and Working Width, Test No. HMDT-4

The maximum lateral permanent set of the barrier system was 1.3 in., which occurred at the rail between post nos. 19 and 20, as measured in the field. The maximum lateral dynamic barrier deflection was 3.2 in., which occurred at post no. 19, as determined from high-speed digital video analysis. The working width of the system was found to be 21.6 in., also determined from high-speed digital video analysis. A schematic of the permanent set deflection, dynamic deflection, and working width is shown in Figure 192.

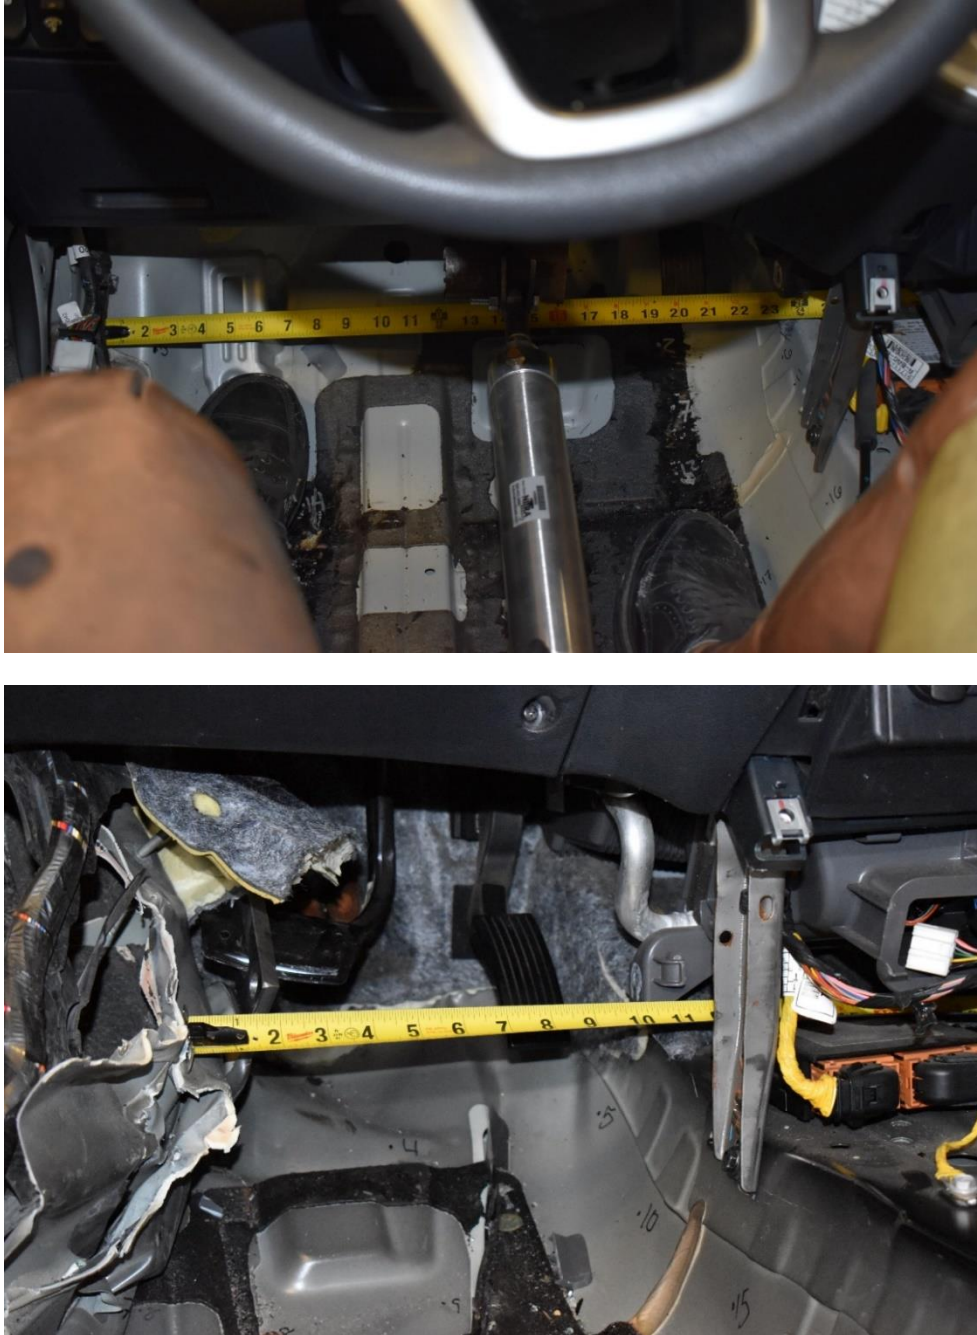
Figure E-15. Maximum Occupant Compartment Deformation by Location, Test No. HMDT-3

Note, damage to the occupant compartment including the floor pan on the impact side was extensive and reference measurements could not be made to pre-test data points for test no. HMDT-3. An exemplar vehicle and occupant compartment floorpan were used to estimate the occupant compartment deformation.

Using an undamaged vehicle of the same body style, several areas of deformation were analyzed. The maximum lateral deformation was 13 $\frac{3}{8}$ in. at the side front panel.
