*Hawaii Department of Transportation
Research Project Number 67167*

CRASH TESTING AND EVALUATION OF THE HAWAII THREE BEAM APPROACH GUARDRAIL TRANSITION: MASH TEST NOS. 3-20 AND 3-21

MIDWEST ROADSIDE SAFETY FACILITY

MwRSF Research Report No. TRP-03-425-20

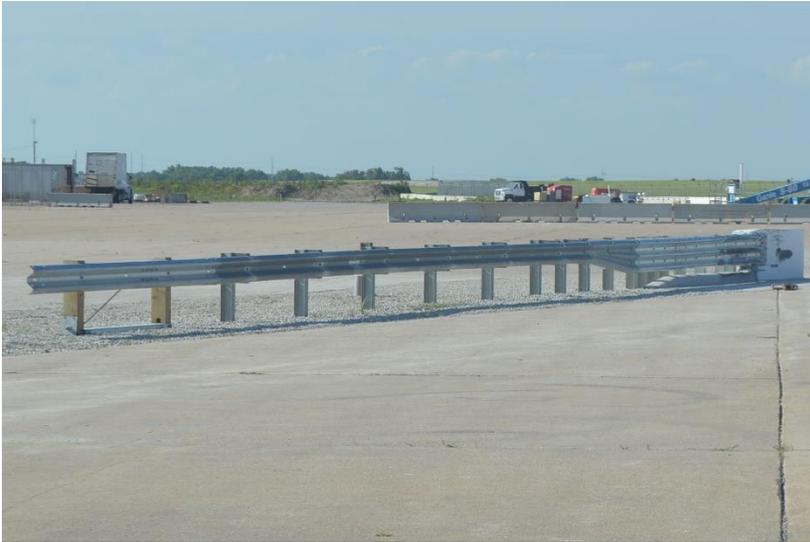
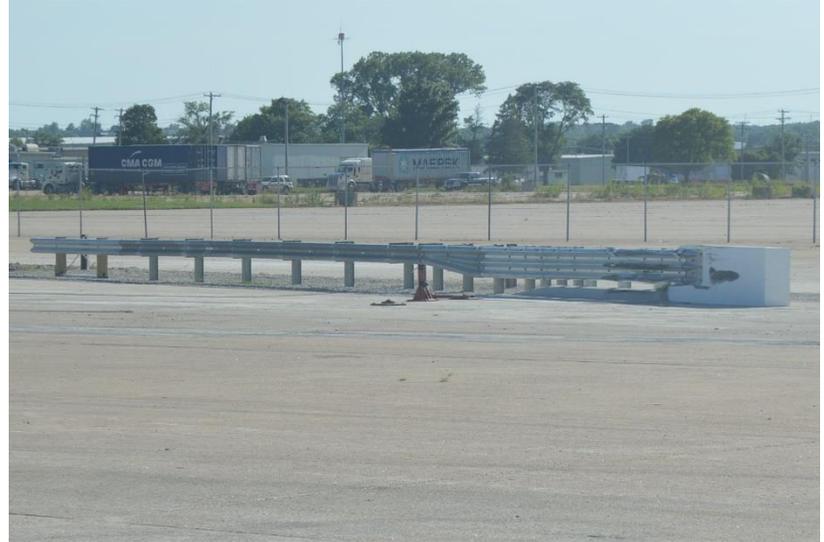
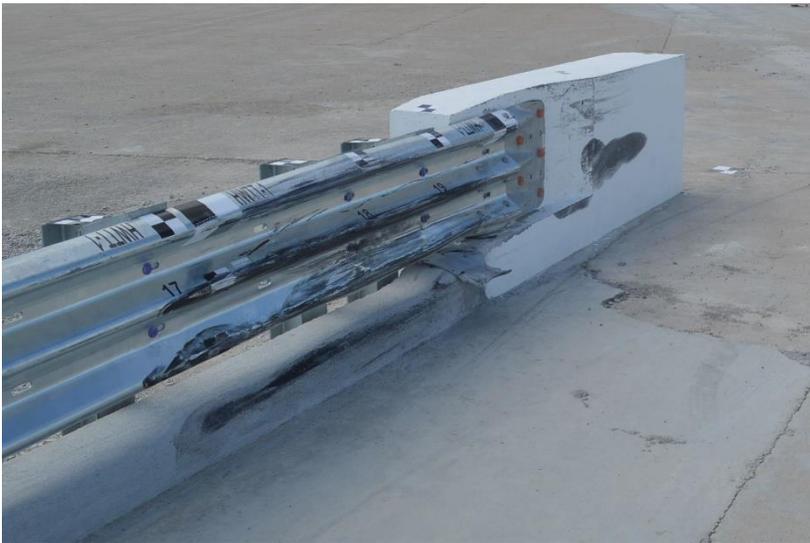
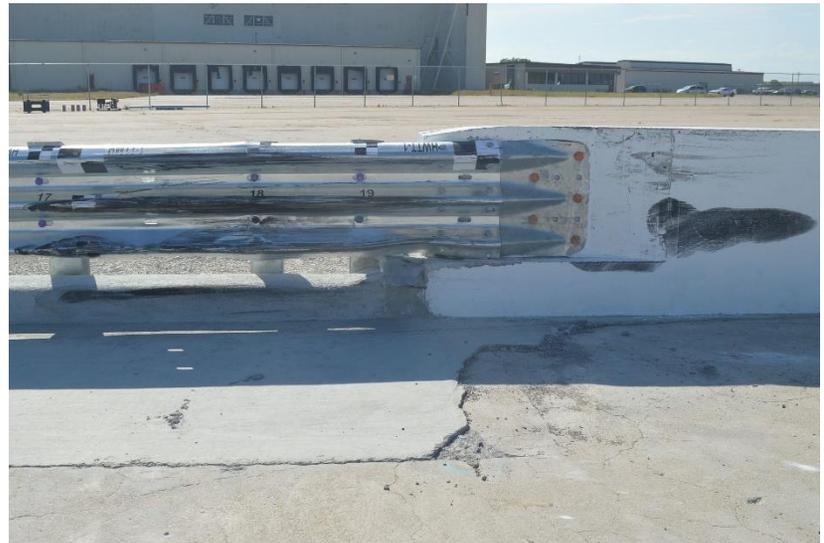
Figure 60. System Damage, Test No. HWTT-1

Damage to the barrier was minimal, as shown in Figures 60 through 62. Barrier damage consisted of contact marks and kinks of the thrie beam sections, contact marks on the front face of the concrete end post, and minor spalling of the concrete. The length of vehicle contact along the barrier was approximately 13 ft – 7½ in., which began 23½ in. upstream from the center line of post no. 17.

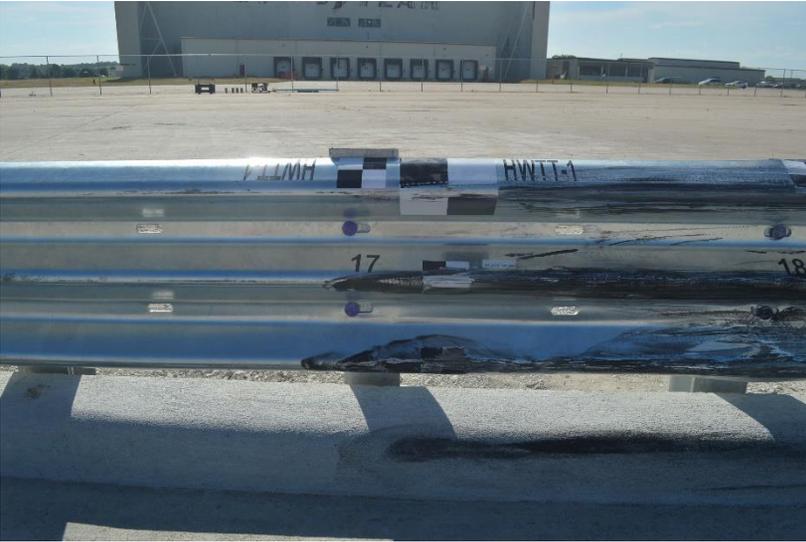
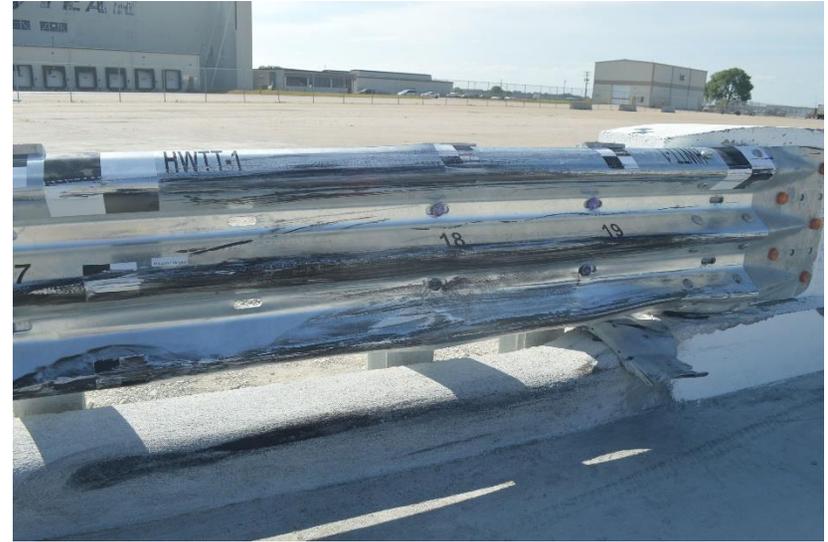
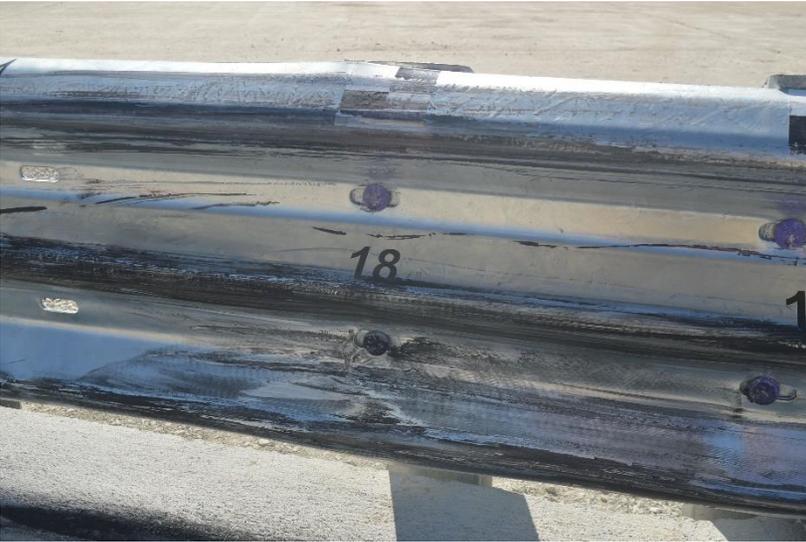
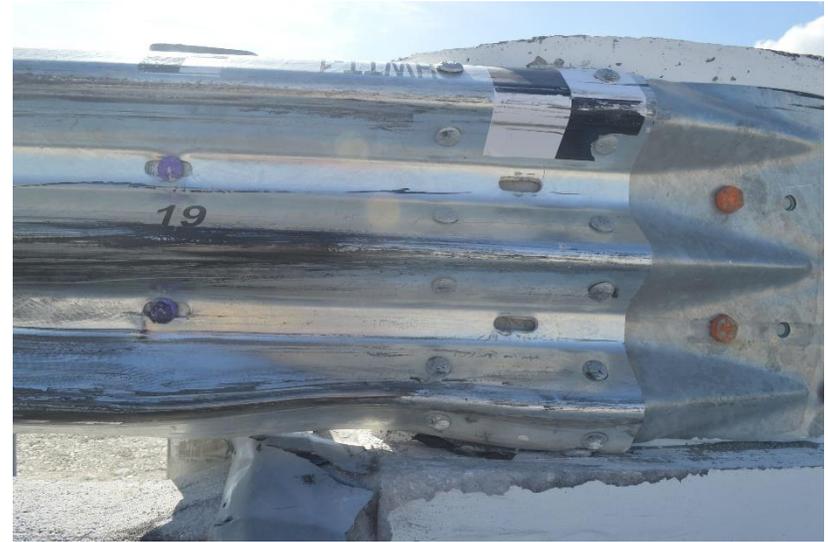
Figure 61. Thrie Beam Damage, Test No. HWTT-1

Contact marks on the thrie beam began 23½ in. upstream from the centerline of post no. 17 and continued downstream through to the concrete end post. The bottom corrugation sustained various degrees of flattening damage beginning 23 in. upstream from post no. 18 and continued downstream. Multiple kinks were found on the top and bottom of the thrie beam around post nos. 17 and 18. Post nos. 18 and 19 slightly rotated counterclockwise and sustained minor damage to the top front upstream corner of the blockouts. Post nos. 17 through 19 had soil gaps between ⅛ in. and ¼ in. in front of the posts. A ½-in. soil gap was observed behind the back of curb. No movement was observed in the upstream anchorage system.

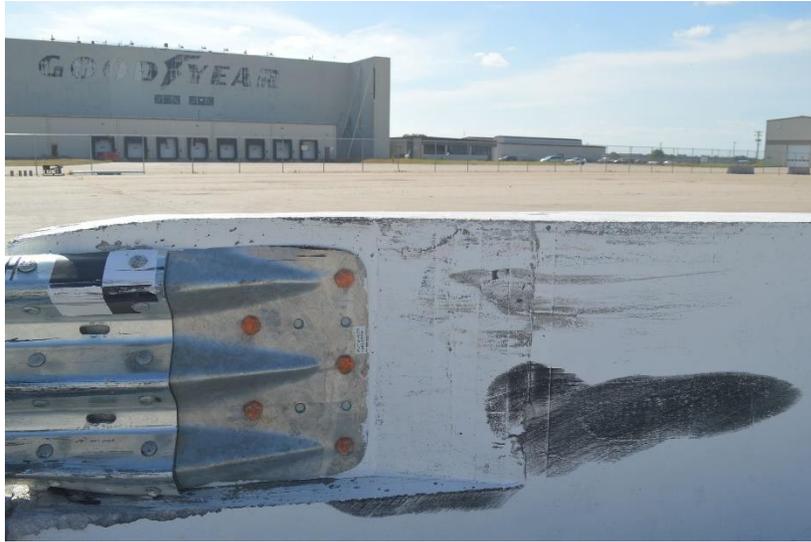
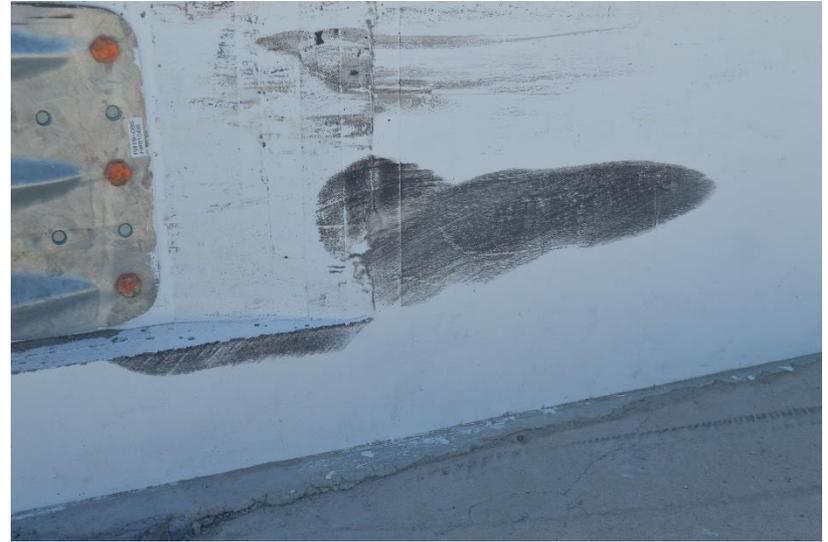
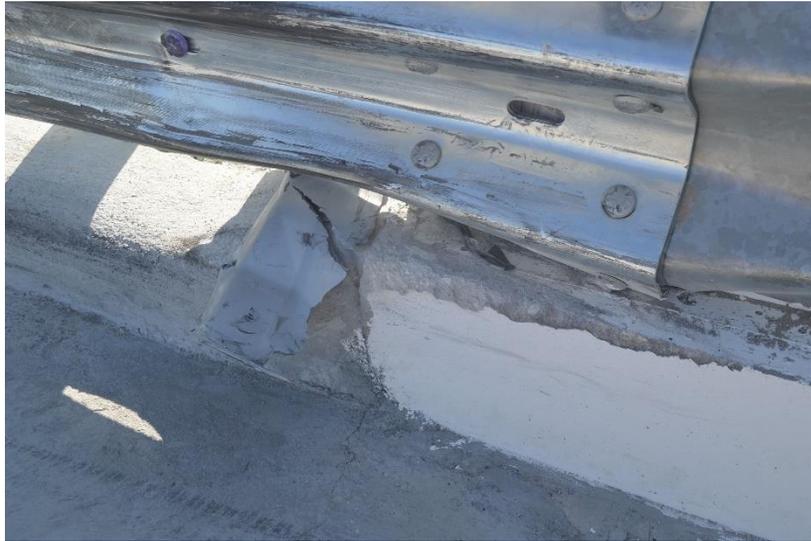
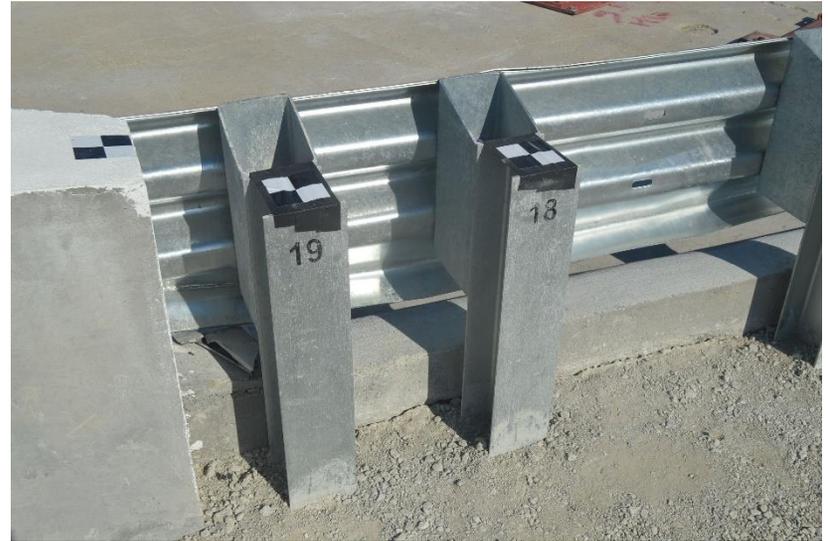
Figure 62. Rail Connection Terminal, Buttress and Post Damage, Test No. HWTT-1

A contact mark was found on the concrete curb starting ¾ in. upstream from post no. 17 and extending to the concrete end post. The curb also sustained minor spalling along its top edge beginning 1 in. upstream from post no. 19 and continued downstream onto the Type D2 End Post.

Minor spalling on the top edge of the end post below the rail extended from the upstream extended 12½ in. downstream. Contact marks were found on lower face of the Type D2 End Post below the thrie beam terminal connector. Additional contact marks were found on the angled portion of the end post recess that extended downstream approximately 2 ft.

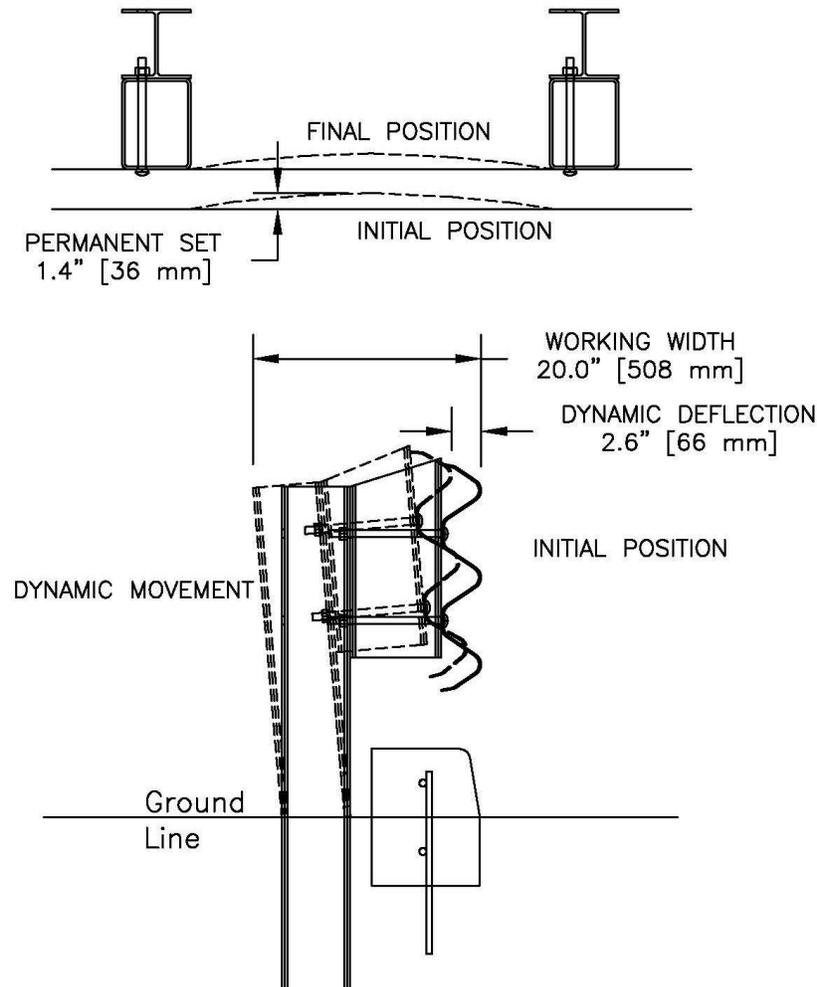
Figure 63. Permanent Set Deflection, Dynamic Deflection, and Working Width, Test No. HWTT-1

The maximum lateral permanent set of the barrier system was 1.4 in. which occurred in the thrie beam between post nos. 17 and 18, as measured in the field. The maximum lateral dynamic barrier deflection was 2.6 in. at post no. 18, as determined from high-speed digital video analysis. The working width of the system was found to be 20.0 in. at post no. 18, also determined from high-speed digital video analysis. A schematic of the permanent set deflection, dynamic deflection, and working width is shown in Figure 63.

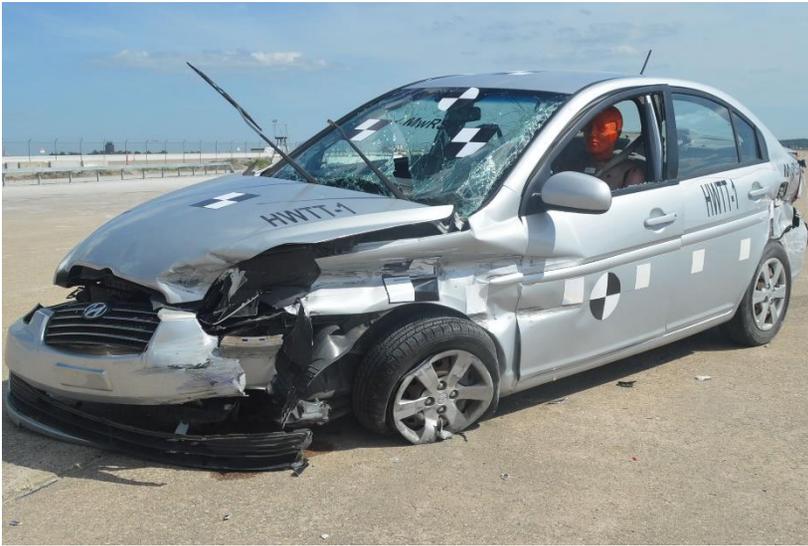
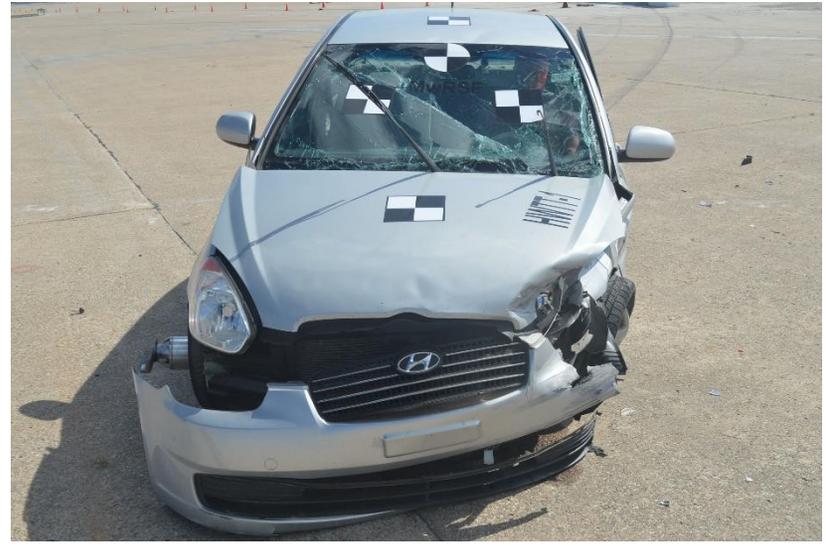
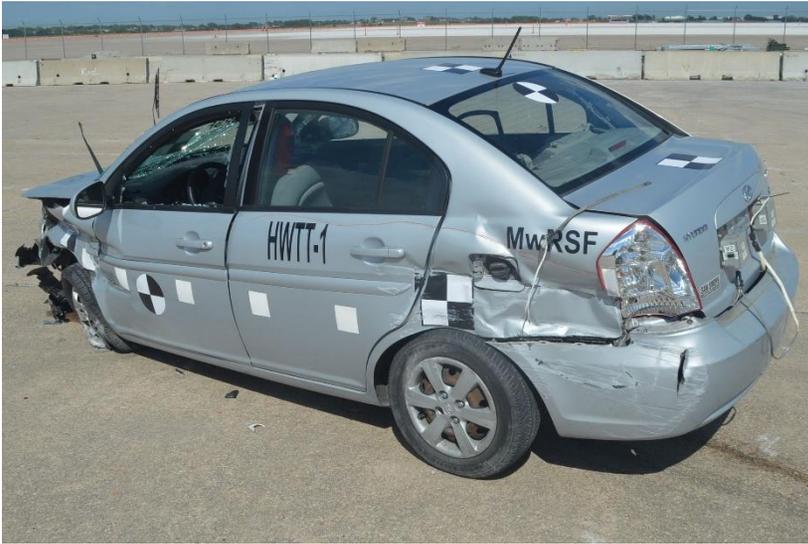
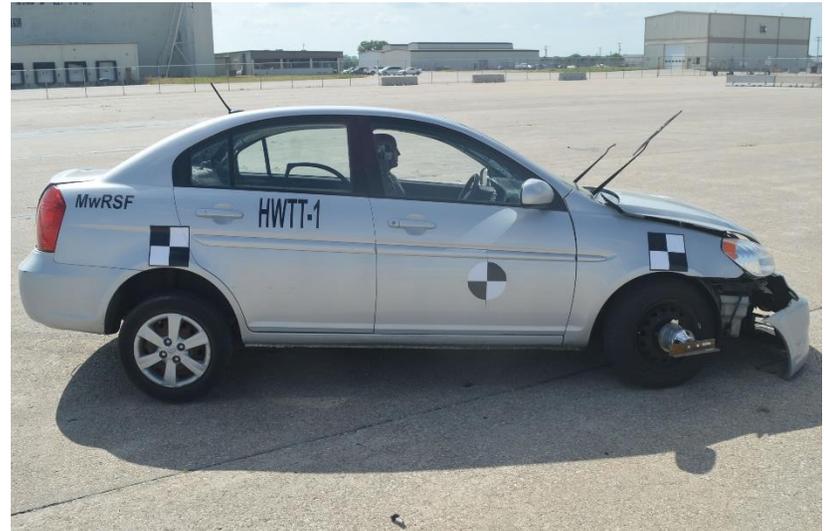
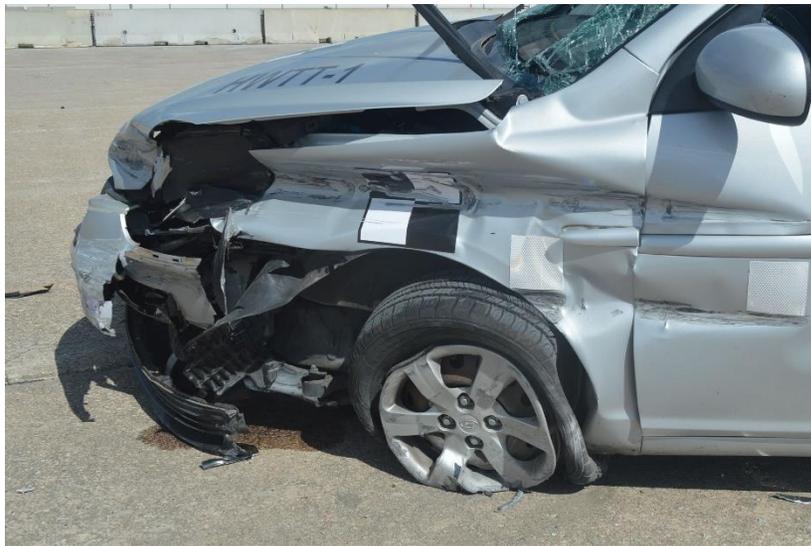
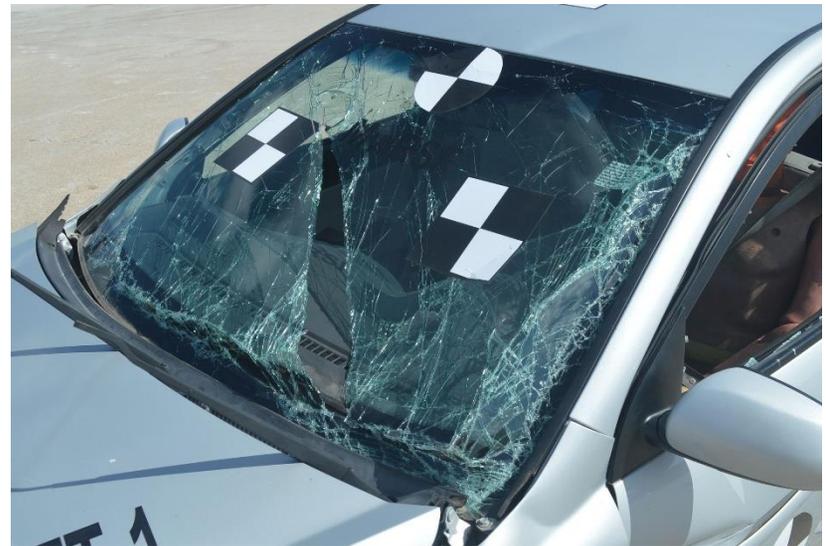
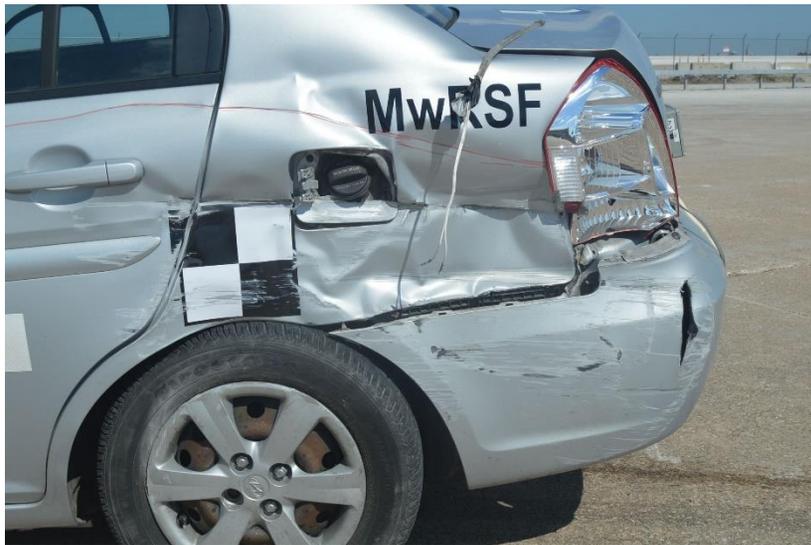
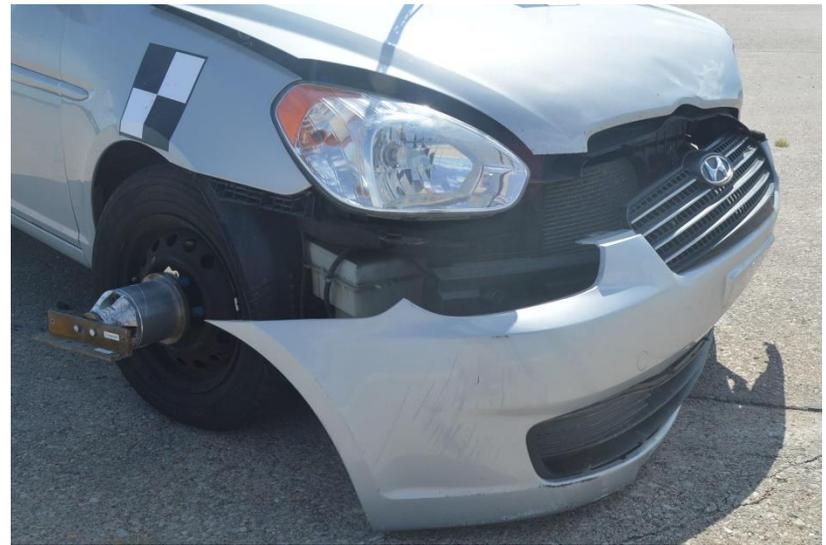
Figure 64. Vehicle Damage, Test No. HWTT-1

The damage to the vehicle was moderate, as shown in Figures 64 through 66. The majority of the damage was concentrated on the left-front corner and left side of the vehicle where the impact occurred. The left side of the vehicle hood was crushed inward toward the engine compartment. Scraping and inward crushing was recorded on the left-side bumper and left-front fender. The front bumper cover was disengaged on the right side. A piece of the bumper cover disengaged after snagging between the thrice beam and curb. The left-front headlight shattered, and the left-front door was scraped and crushed inward behind the front fender, causing the middle section of the door to be forced outward. The left-rear door was dented and scraped, starting at the door handle and ending at the door seam. The left-rear quarter panel was scraped and crushed along the entirety of its length, and it was cut from the bottom of the fuel fill door to the rear panel. The fuel door was disengaged from the vehicle. The left-rear taillight was shattered, and the rear bumper was crushed inward. Contact with the head of the test dummy caused the left-front window to shatter.

The windshield was significantly deformed and a large tear in the windshield stretched from the lower left corner to the upper right side of the windshield. However, the system never contacted the windshield. This tear was caused by deformations to the vehicle's front-left side, quarter panel, and lower A-frame. Additionally, the tearing and cracking of the windshield allowed the glass to sag adjacent to the tear. This behavior resulted in a maximum of 3.5 in. of deformation to the windshield adjacent to the tear, which would violate the MASH accepted limit. However, since the system never contacted the windshield and the tearing and deformations were the result of vehicle deformations, this windshield damage did not result in test failure. Similar windshield damage has been observed in other recent MASH 1100C tests into rigid barriers, including testing of the Hawaii 34-in. tall concrete bridge rail [2]. Windshield damages in the form of tearing and deformations have been allowed for these other systems/tests when the barrier does not make direct contact with the system.

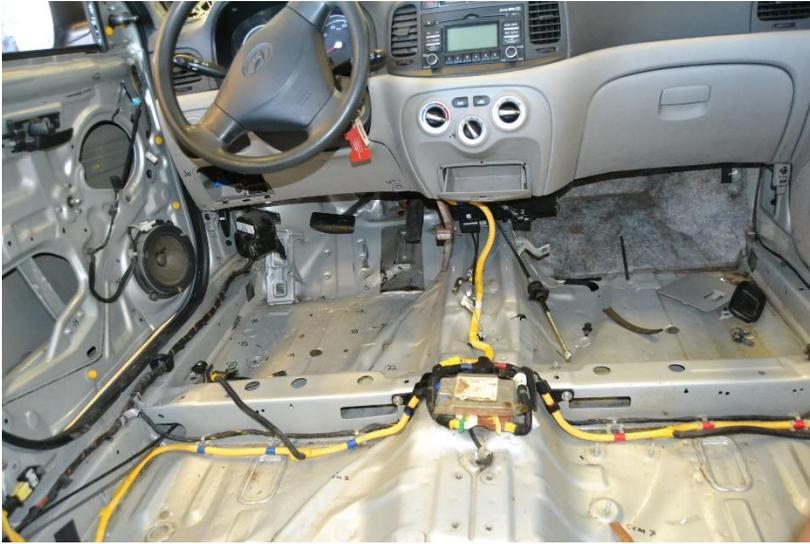
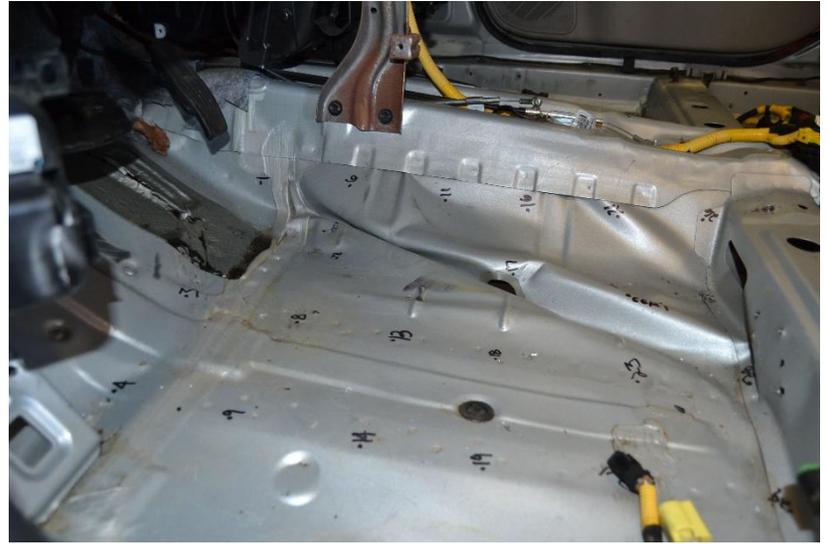
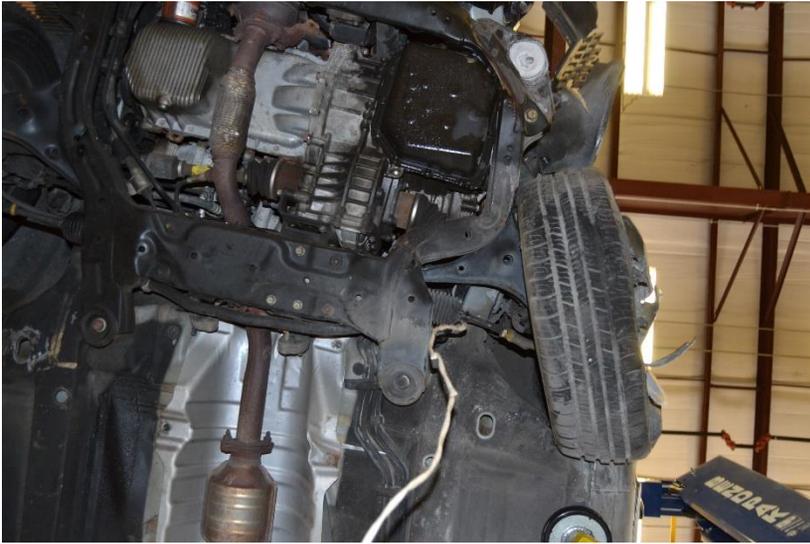
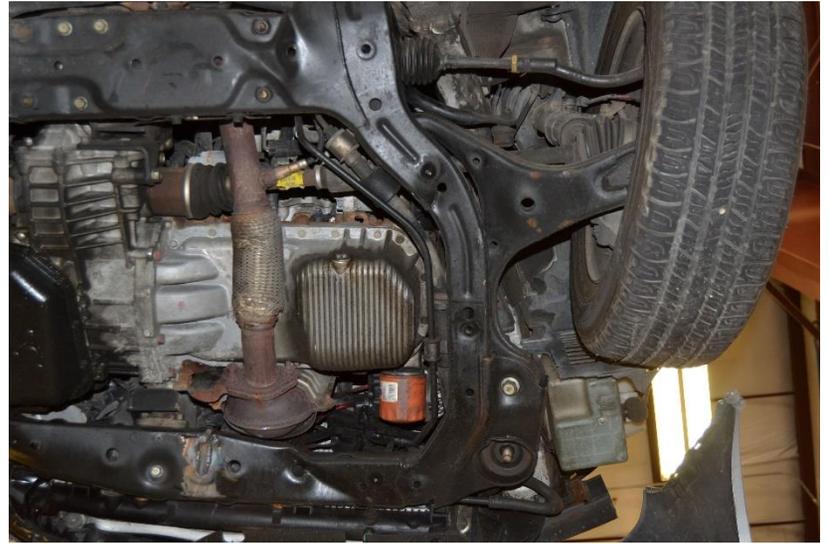
Figure 66. Interior and Undercarriage Damage, Test No. HWTT-1

Undercarriage damage was minimal. The left control arm was bent toward the rear of the test vehicle. The left-outer tie rod was bent toward the center of the test vehicle. The transmission and oil pan had scrapes in the middle and along the bottom, and on the left side, respectively. The frame rail on the left side twisted slightly, and it was bent up in front of the rear axle. The front cross member folded and twisted, while the rear cross member compressed in on itself. The left cross member bent toward the middle, and the right cross member showed indicators of beginning to fold. The frame horn was pushed rearward and inward toward the engine compartment. A wrinkle also occurred across the entire length of the floor pan.

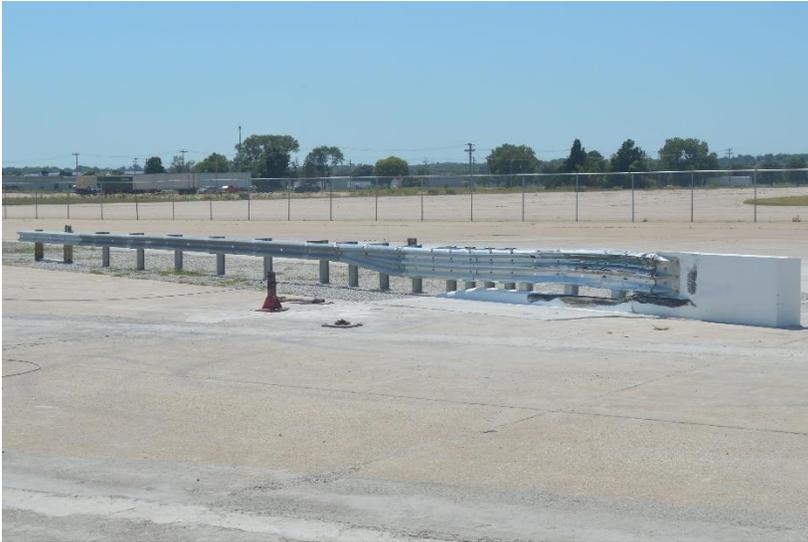
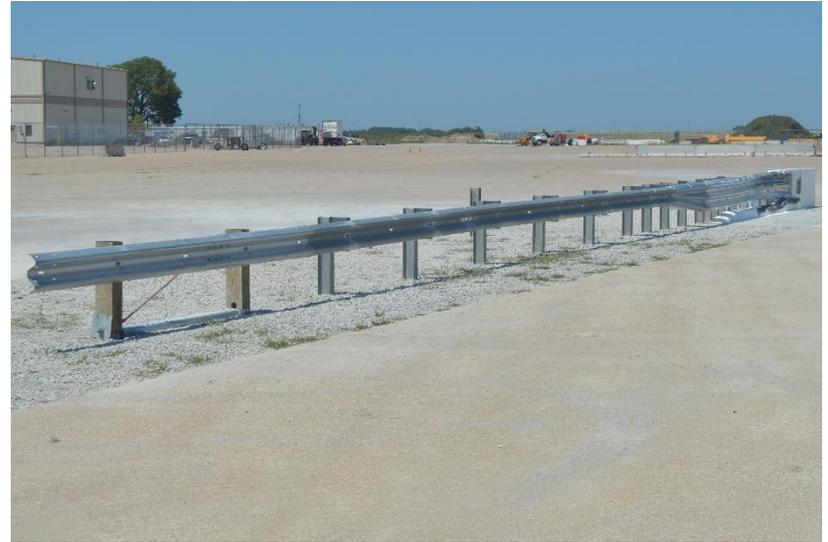
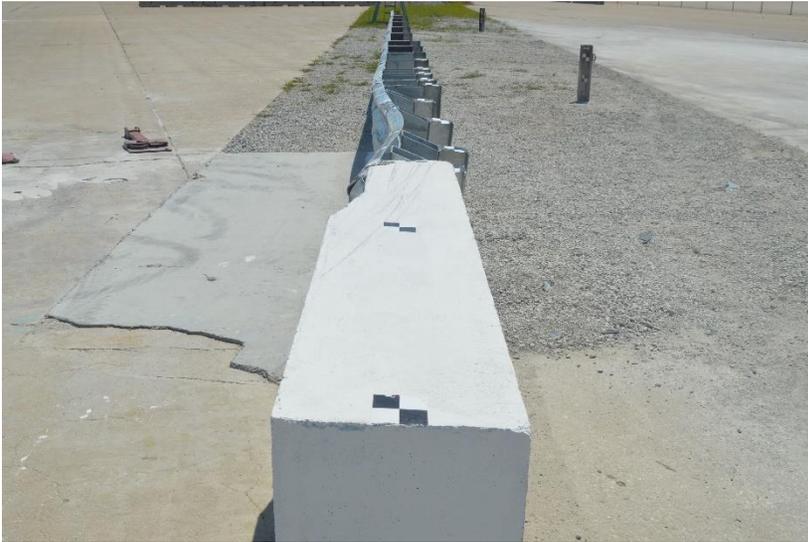
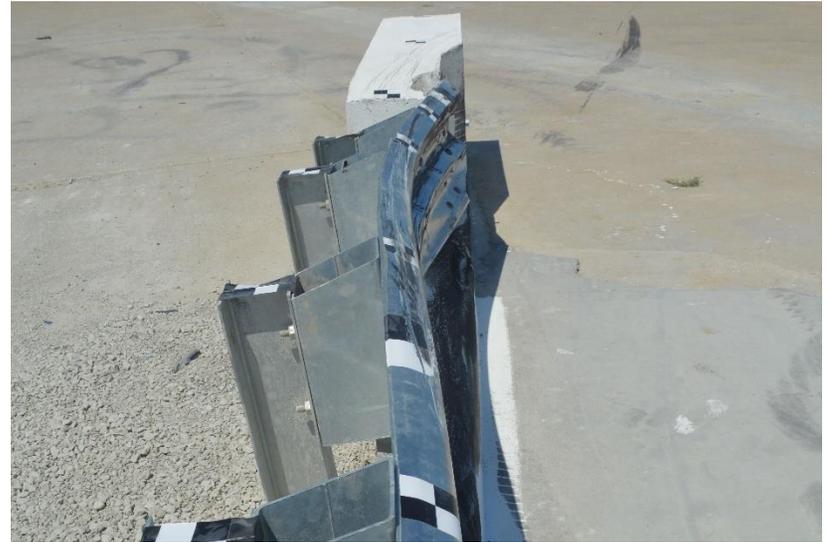
Figure 73. System Damage, Test No. HWTT-2

Damage to the barrier was moderate, as shown in Figures 73 through 75. Barrier damage consisted of contact marks, post deflection, rail kinking, and gouging and spalling to the concrete parapet and curb. The length of vehicle contact along the barrier was approximately 13 ft – 8 in., which began 6 in. downstream from the center of post no. 16 and extended 5 ft – 6 in. onto the concrete end post.

Post no. 1 had a 1/8 in. soil gap on the upstream side, but no other damage was documented to the upstream anchorage. Post nos. 3 through 17 all experienced slight counterclockwise rotation around the vertical axis. Post nos. 15 through 19 rotated backward leaving soil gaps adjacent to the front flange, the largest of which were measure to be around 2 1/2 in. at post nos. 17 and 18. In addition to being deflected backward, post nos. 18 and 19 experienced clockwise rotation resulting in minor localized deformations to the upstream sides of the front flanges adjacent to the blockouts.

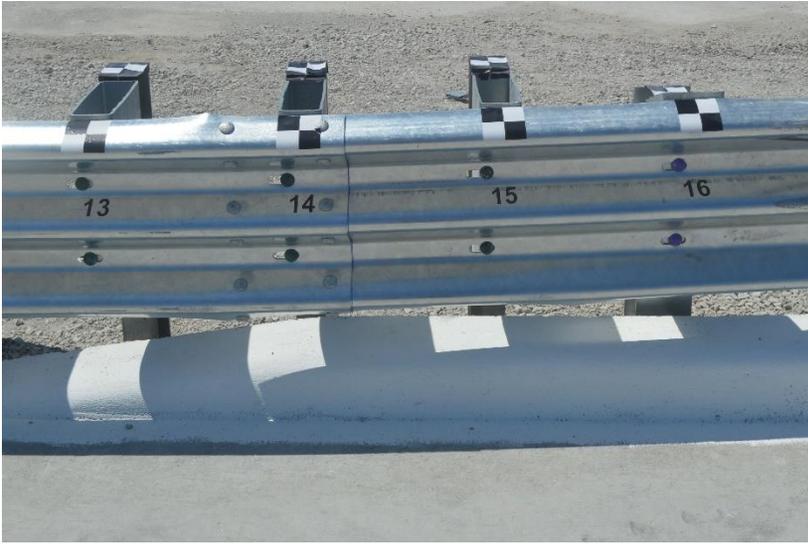
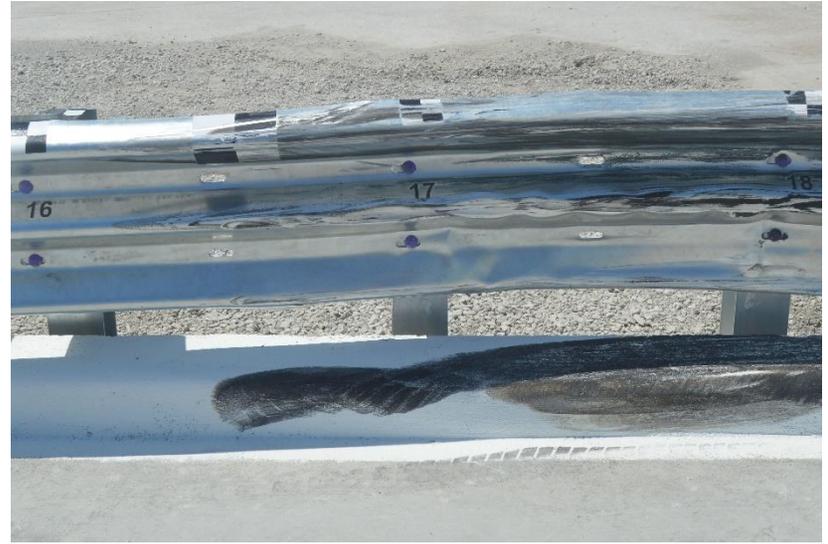
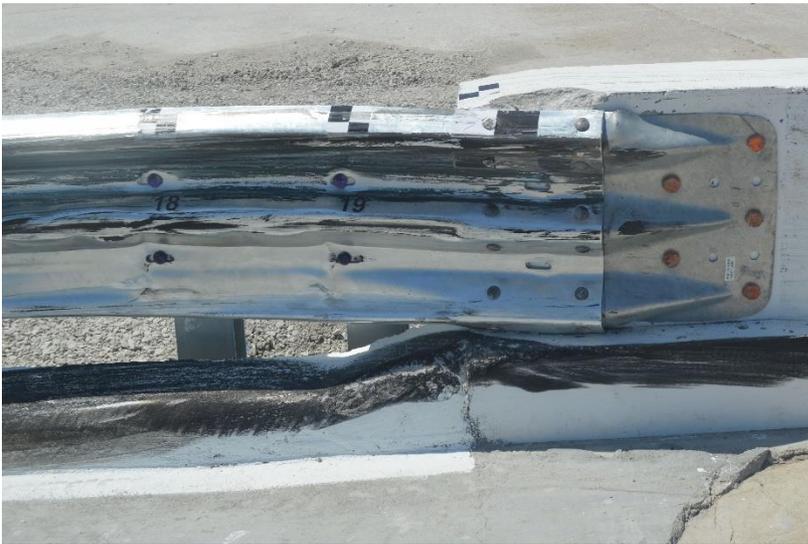
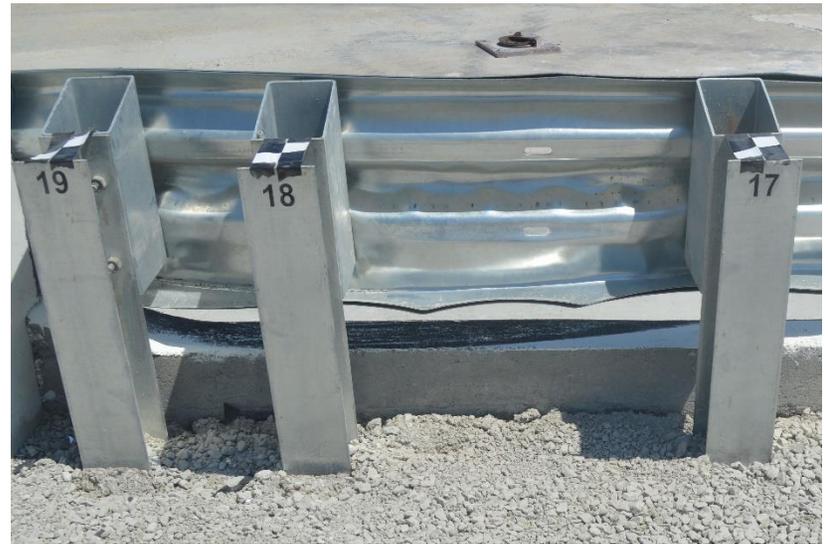
Figure 74. Thrie Beam Damage, Test No. HWTT-2

Contact marks were found on the thrie beam and were mostly concentrated on the upper and middle corrugations. The marks started 6 in. downstream from post no. 16 and onto the terminal connector. The upper half of the thrie beams between post nos. 17 and 19 were flattened. Various rail kinking was found on the guardrail spanning from post no. 14 to post no. 19. The largest rail kinks were found around post nos. 17 and 18. The lower corrugation was also folded upward between post nos. 17 and 19.

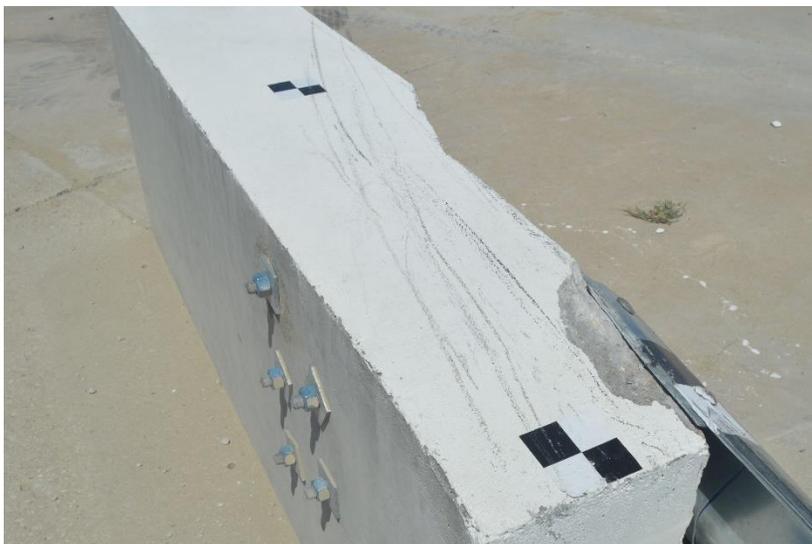
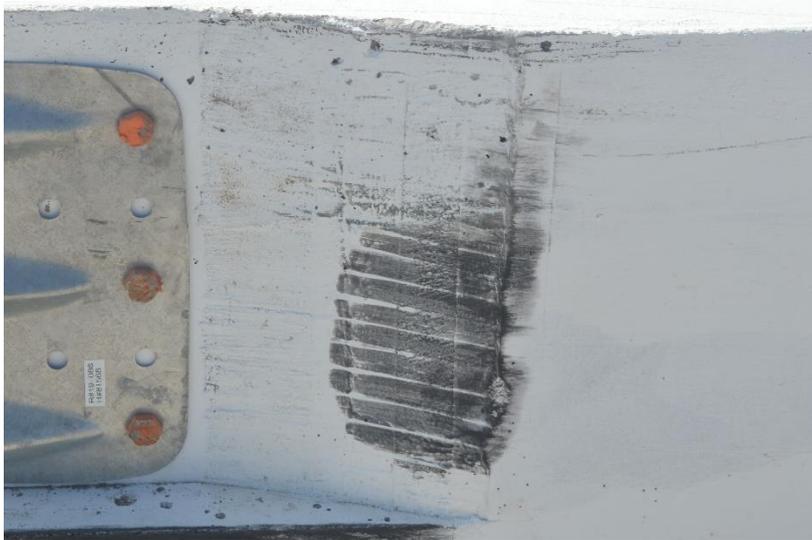
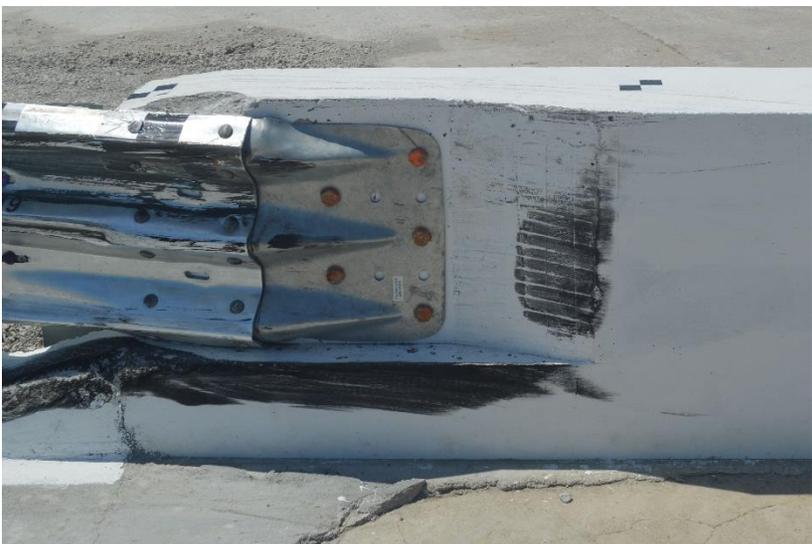
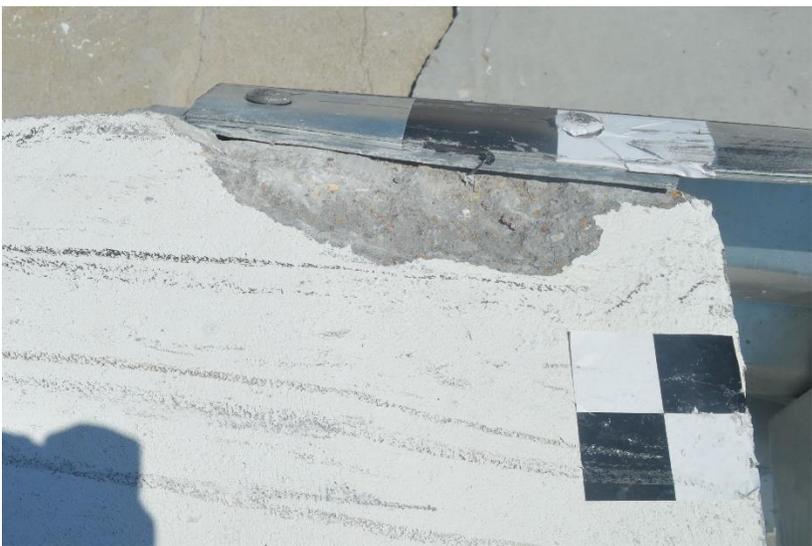
Figure 75. Buttress Damage, Test No. HWTT-2

The concrete curb had tire marks on the top and face starting 15 1/2 in. downstream from post no. 16 and continuing 44 in. onto the lower face of the Type D2 End Post. Another tire mark was found on the angled section at the downstream end of the lateral recess on the end post. Scratches were also recorded on the top of the barrier starting at the upstream end and continuing for 71 in. Concrete spalling was found on the top-front edge of the end post behind the nested thrie beam, as shown in Figure 75. Minor concrete spalling also occurred at the joint between the curb and the concrete end post.

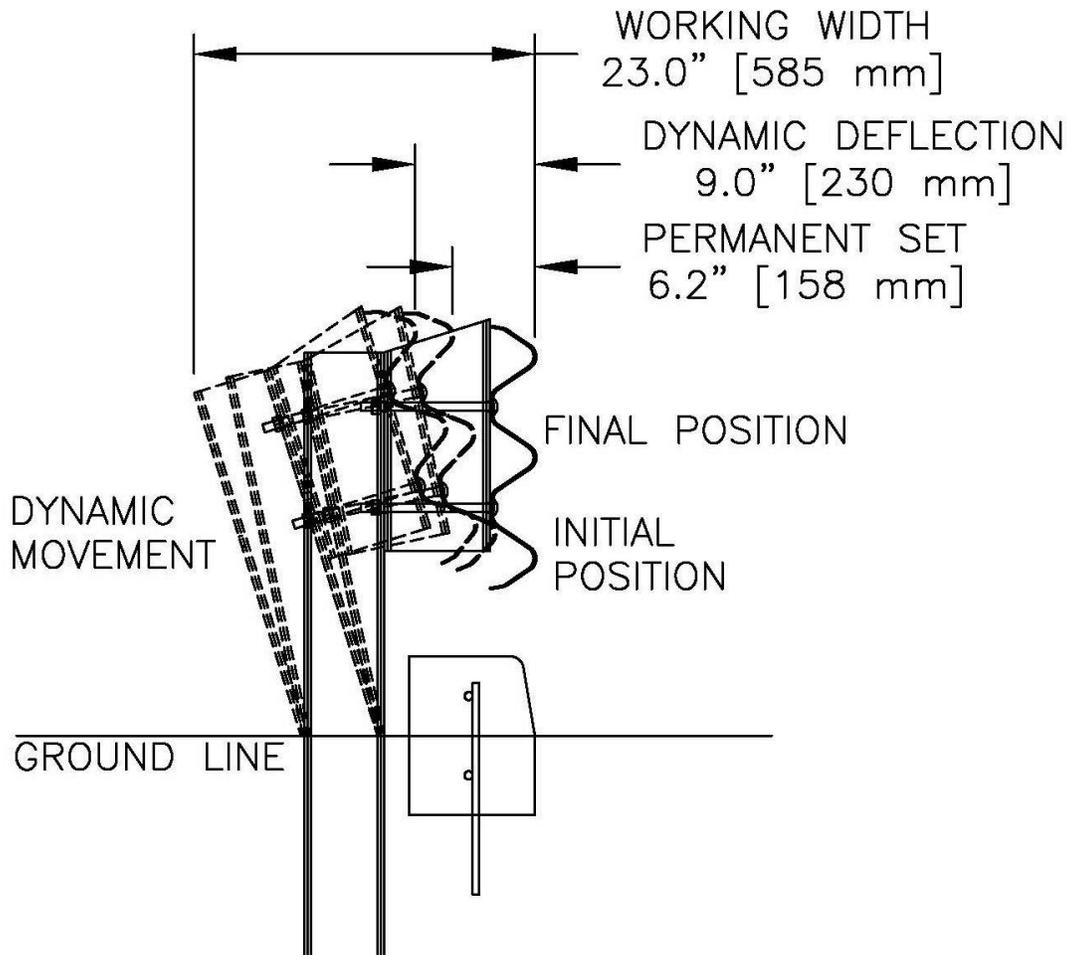
Figure 76. Permanent Set Deflection, Dynamic Deflection, and Working Width, Test No. HWTT-2

The maximum lateral permanent set of the barrier system was 6.2 in., which occurred in the thrie beam between post nos. 18 and 19, as measured in the field. The maximum lateral dynamic barrier deflection was 9 in. at post no. 18, as determined from high-speed digital video analysis. The working width of the system was found to be 23 in., also determined from high-speed digital video analysis. A schematic of the permanent set deflection, dynamic deflection, and working width is shown in Figure 76.
