*Hawaii Department of Transportation
Research Project Number 67167*

CRASH TESTING AND EVALUATION OF THE HAWAII THREE BEAM APPROACH GUARDRAIL TRANSITION: MASH TEST NOS. 3-20 AND 3-21

MIDWEST ROADSIDE SAFETY FACILITY

MwRSF Research Report No. TRP-03-425-20

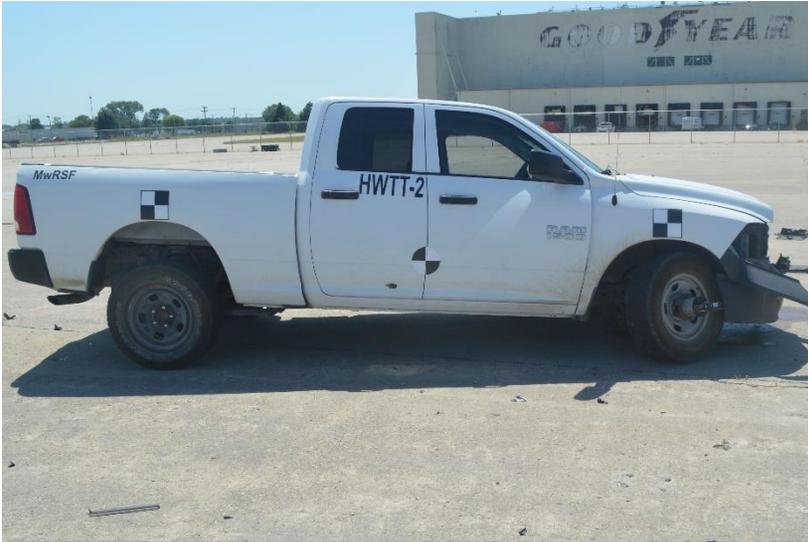
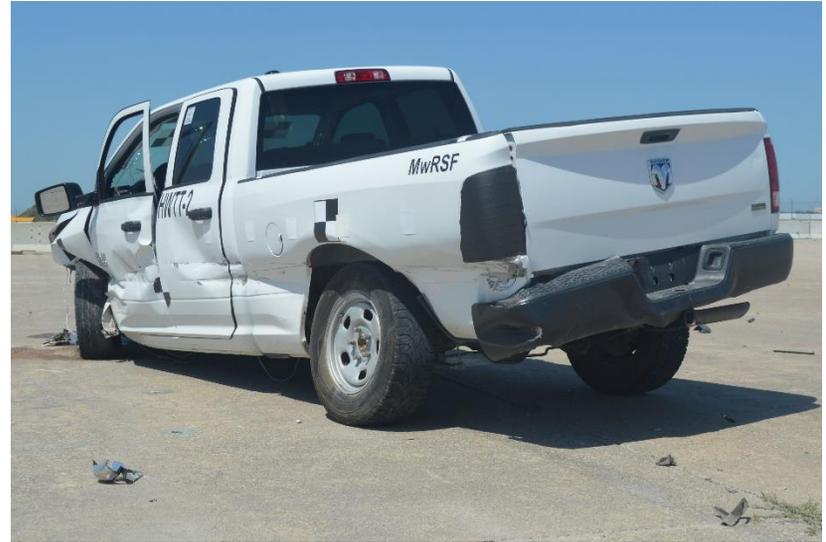
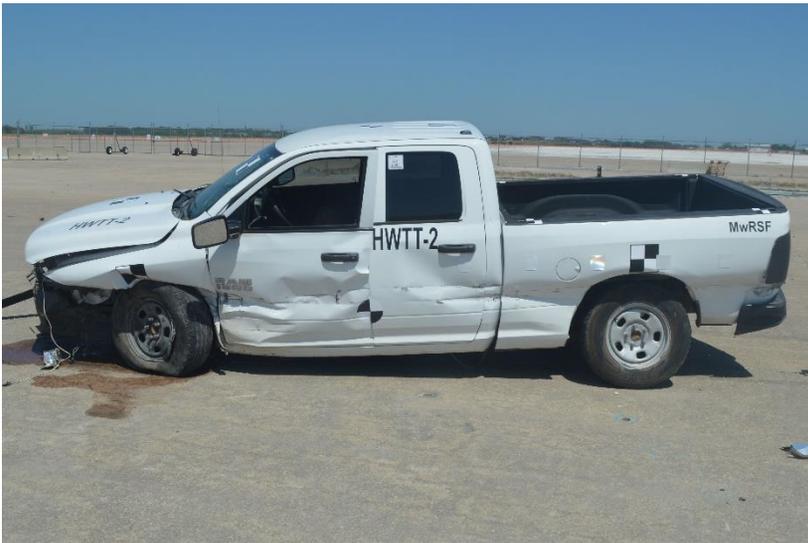
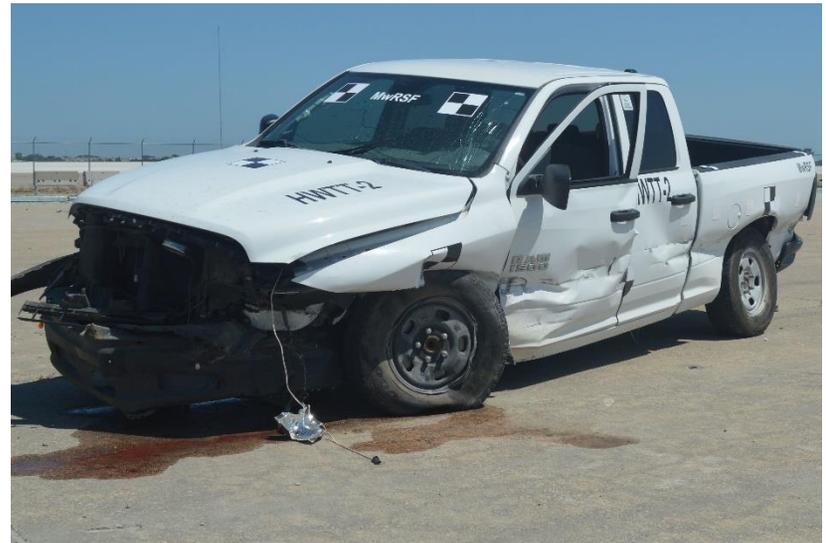
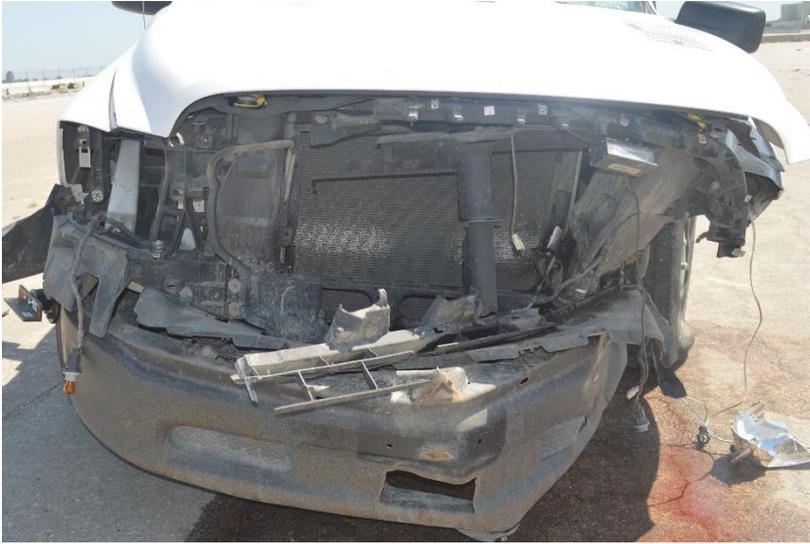
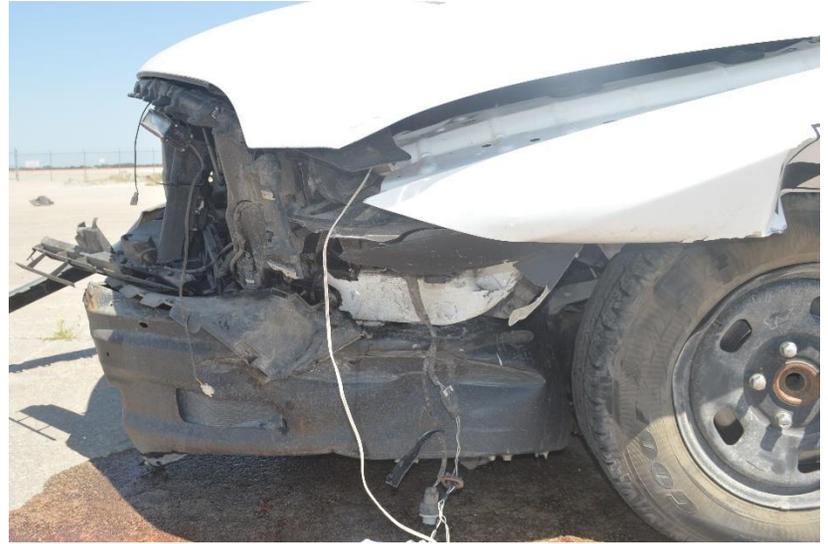
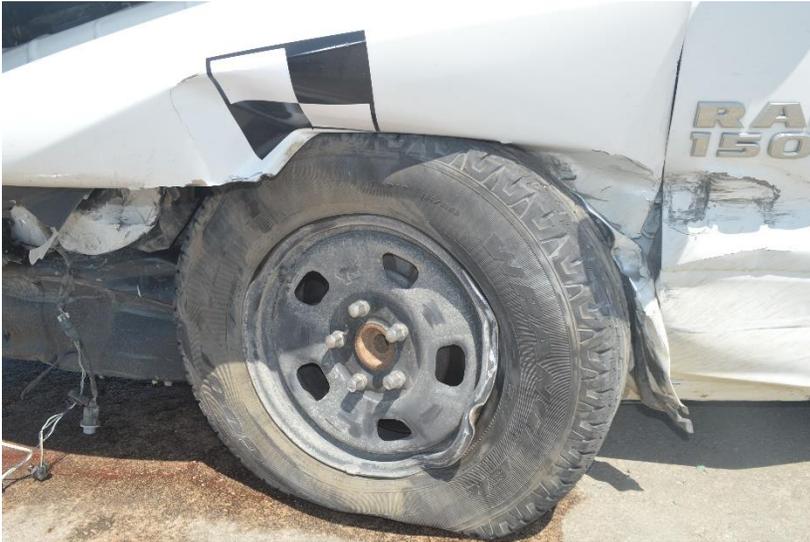
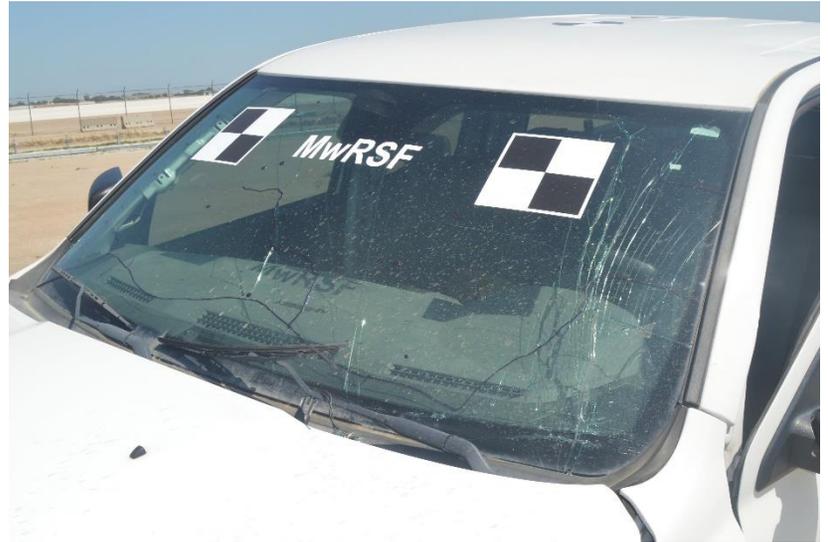
Figure 77. Vehicle Damage, Test No. HWTT-2

The damage to the vehicle was moderate, as shown in Figures 77 through 79. The majority of the damage was concentrated on the left-front corner and left side of the vehicle where the impact occurred. The grille disengaged from the vehicle, and the front bumper crushed inward. The vehicle's headlights detached, and the hood was slightly bent inward on the left side. Significant damage was imparted to the left-front fender including being crushed inward and rearward. The left-front door was scraped and crushed inward along the entirety of its length causing the door to bow outward near the top. The left-rear door experienced scraping down its entire length and was crushed in the middle. Similarly, the left-rear fender was scraped and crushed, and the rear bumper bowed outward in the middle due to crushing of the left corner. The windshield was cracked prior to testing, but the impact caused further cracking to the left side of the windshield.

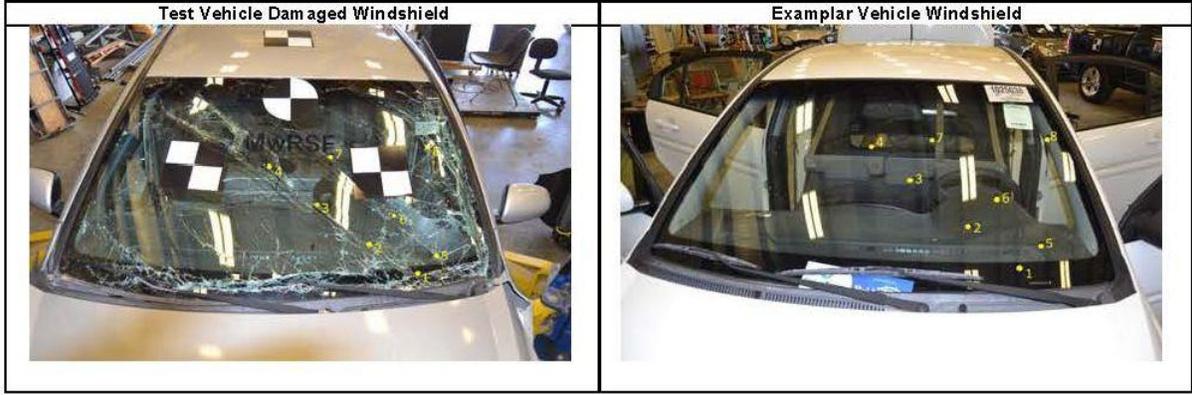
Figure D-3. Windshield Deformation, Test No. HWTT-1

Windshield Deformation Notes:
The windshield was torn due to movement of the windshield frame not from direct contact with anything. The tearing of the windshield caused the glass to sag from it's weight.
