Research Project Number TPF-5(193) Supplement #132

MASH 2016 EVALUATION OF THE MODIFIED THRIE BEAM SYSTEM

MwRSF Research Report No. TRP-03-417-20

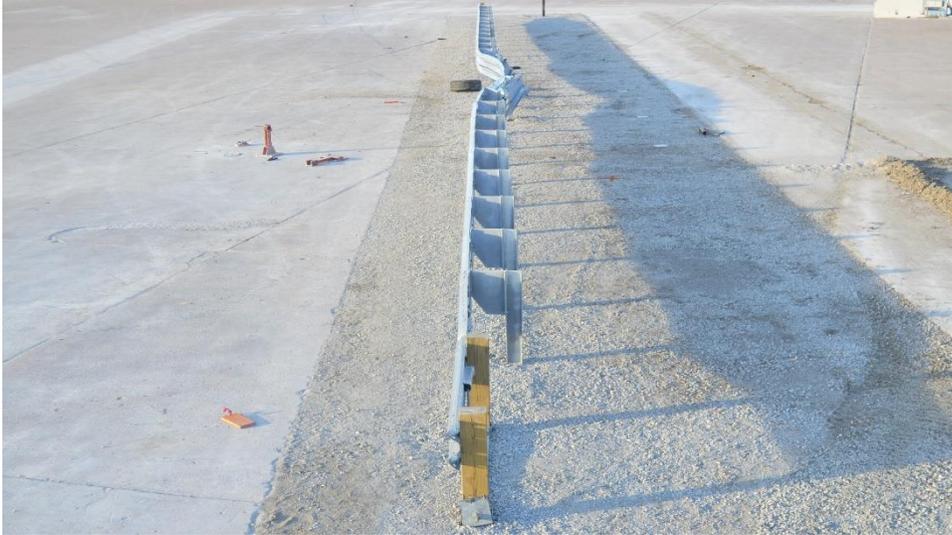
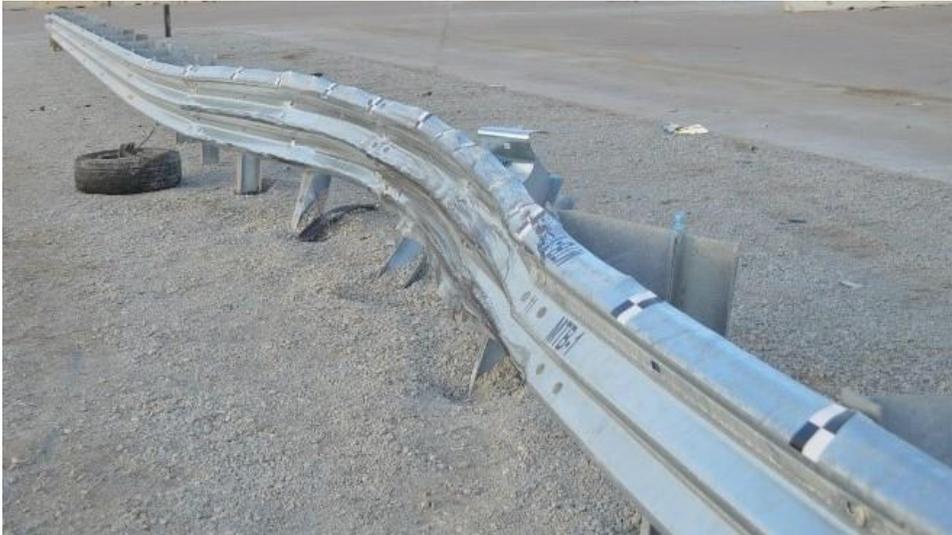
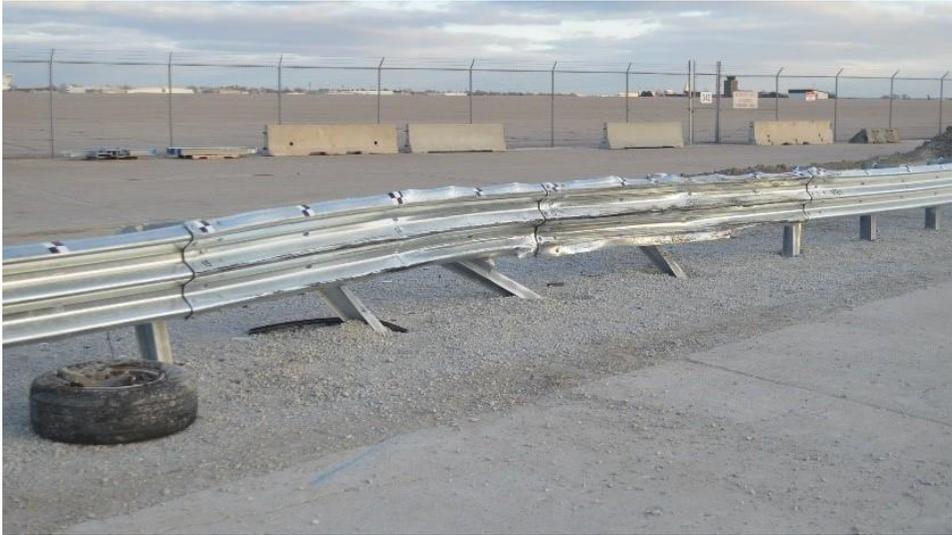
Figure 31. System Damage, Test No. MTB-1

Barrier damage was moderate, as shown in Figures 31 through 33, consisting of contact marks, deformation, disengaged rail elements, and bending, kinking, rotation, and twisting of the steel posts. The total length of vehicle contact along the barrier was approximately 37 ft – 10½ in., which spanned from 2 in. upstream from post no. 10 to 2½ in. downstream from post no. 16. All measurements were taken from post centerlines.

The most significant damage occurred between post nos. 11 and 13 where impact occurred. A 19-in. long contact mark was found on the top of the rail, beginning 13 in. upstream from post no. 11. A 23-in. long contact mark was found on the middle corrugation, beginning 18 in. upstream from post no. 11. A 24-ft 7-in. long contact mark was found across the entire front face of the rail, beginning 7½ in. downstream from post no. 11 and ending 5 in. downstream of post no. 15. The top slot at post no. 12, used to attach the blockout to the guardrail, was torn as a result of bolt pull out. The bottom rail corrugation was flattened from 17 in. upstream from post no. 12 to 7½ in. upstream from post no. 15. The top slot at post no. 13 and the top and bottom slots at post no. 14 were indented as a result of bolt pull out. A 4-in. long tear was found at the bottom edge of the rail 8 in. downstream from post no. 13. A 17-in. long contact mark was found on the top edge of the rail, beginning 8 in. downstream from post no. 15. Various kinks and dents were observed on the rail between post no. 9 and post no. 17.

The front flange of the blockouts at post nos. 3 through 11 twisted clockwise. The lower front flange of the blockout at post no. 10 bent inward, 7 in. from the bottom. The lower front flange of the blockout at post no. 11 bent inward 6 in. from the bottom. The front flange of post no. 12 twisted counter-clockwise, 35 in. from the top, and the back flange twisted clockwise 24 in. from the top. The blockout at post no. 12 bent clockwise 3½ in. from the front face, and the lower front flange of the blockout bent inward 7 in. from the bottom. The backing plate at post no. 12 bent inward 11 in. from the top and twisted clockwise 11 in. from the bottom. A 9-in. tall contact mark was found on the front flange of post no. 12, 29 in. from the top of the post. The front flange of post no. 13 was bent 17 in. from the top. The blockout at post no. 13 bent 4 in. upstream from the back of the blockout. The front flange of the blockout at post no. 13 bent clockwise, and the base of the blockout bent inward 7 in. from the bottom. A 10-in. tall contact mark was found on the upstream side of the front flange of post no. 13, 27 in. from the top. The front flange of post no. 14 was bent 18 in. from the top. The front flange of the blockout at post no. 14 bent clockwise, and the base of the blockout was bent 7 in. from the bottom. The stiffener at post no. 14 bent inward 7 in. from the bottom. A 6-in. tall contact mark was found 26½ in. from the top of post no. 14. Post no. 15 twisted counterclockwise 35 in. from the top. The front flange of the blockout at post no. 15 bent clockwise, and the base of the blockout bent inward 7 in. from the bottom. The front flange of the blockout at post no. 16 bent inward 6 in. from the bottom. Post no. 15 twisted counter-clockwise 35 in. from the top. The base of the front flange bent inward 7 in. from the bottom of the post. The blockout of post no. 16 was bent inward 6 in. from the bottom of the post. The blockout web of post no. 23 was bent 7 in. downstream from the front flange. No damage was observed on post nos. 1 and 2, 17 through 22, and 24 through 29.

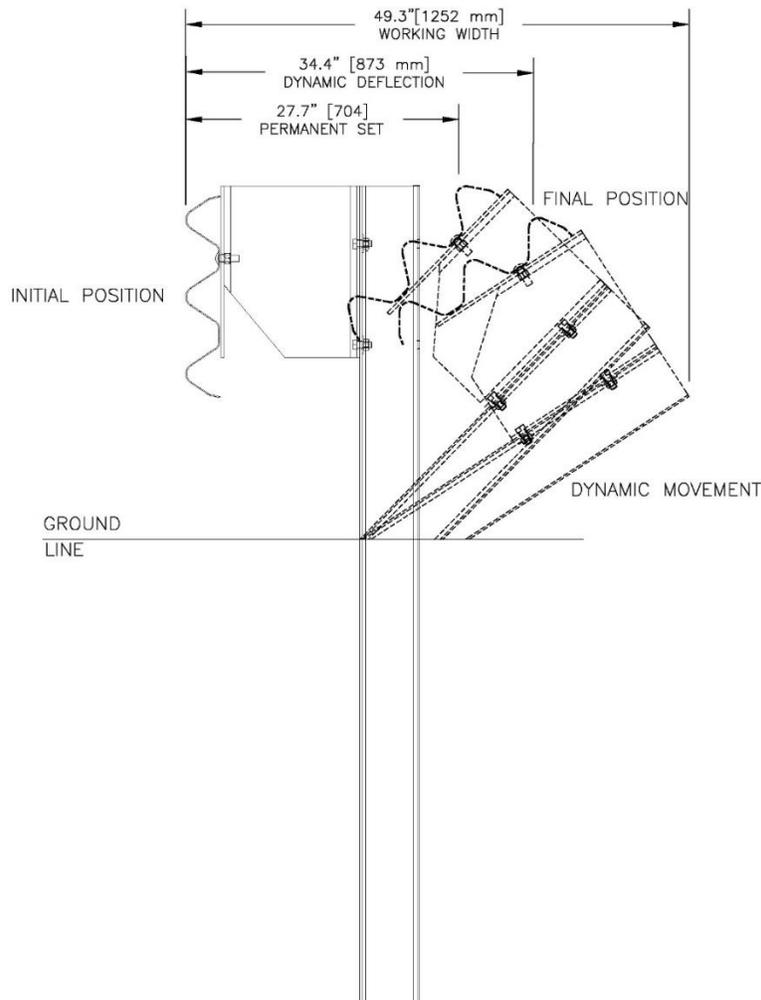
Figure 34. Permanent Set Deflection, Dynamic Deflection, and Working Width, Test No. MTB-1

The maximum lateral permanent set deflection was 27.7 in. at post no. 13, as measured via GPS. The maximum lateral dynamic rail and barrier deflections were 34.4 in. at the midspan of rail no. 12, and 38 in. at post no. 13, respectively, as determined from high-speed digital video analysis. The working width of the system was found to be 49.3 in. at post no. 13, also determined from high-speed digital video analysis. A schematic of the permanent set deflection, dynamic deflection, and working width is shown in Figure 34.

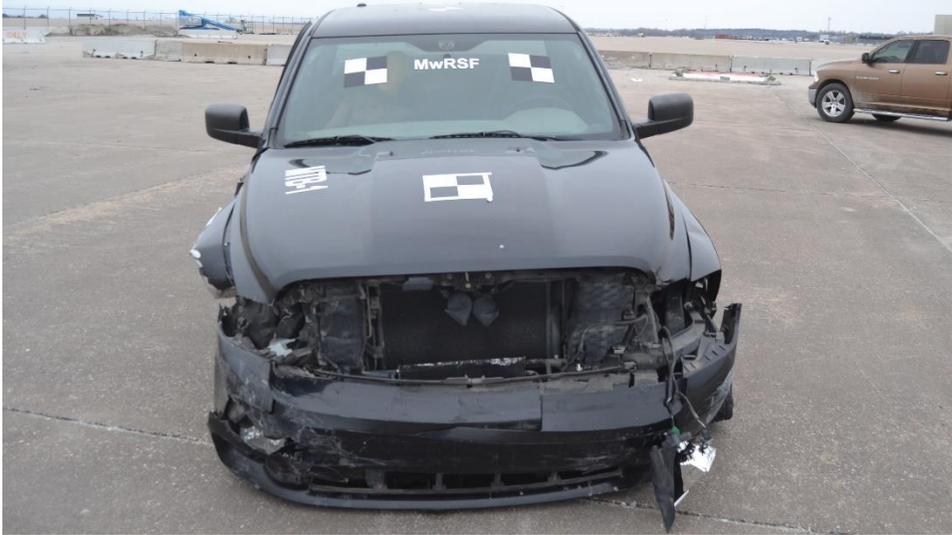
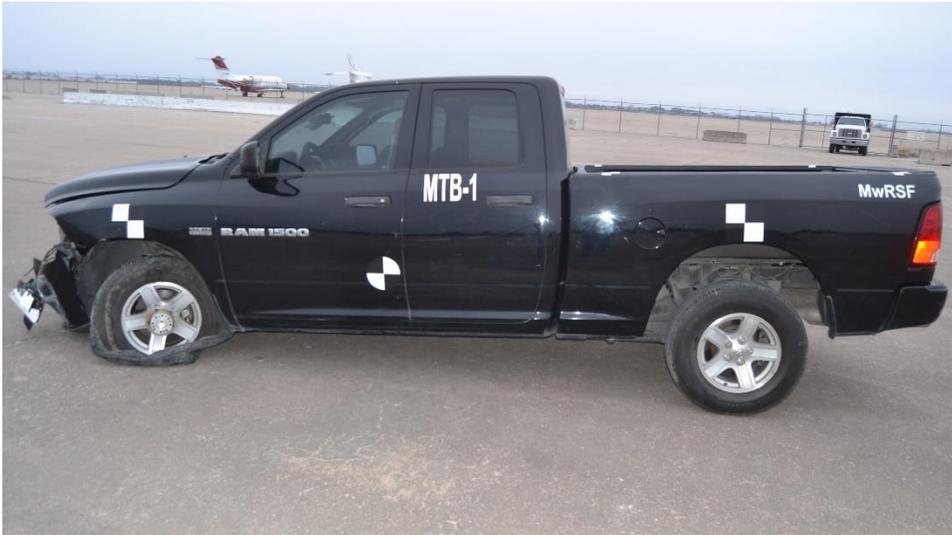
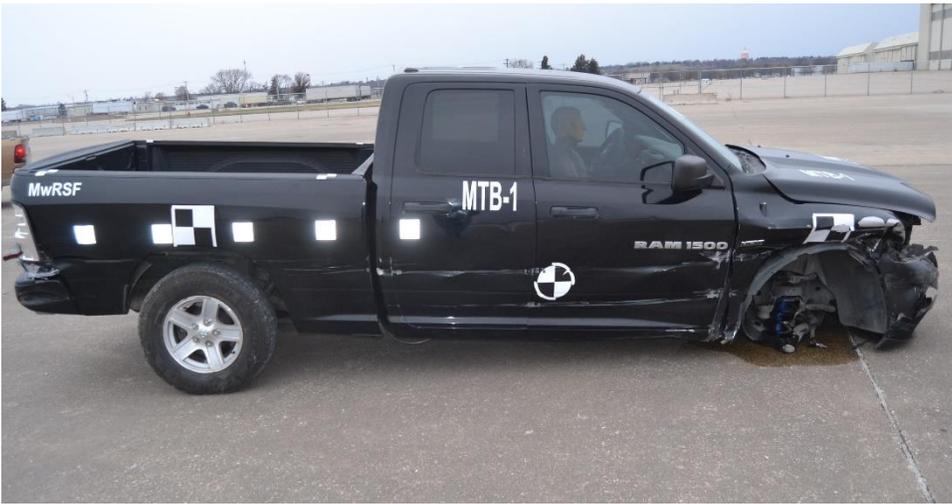
Figure 36. Vehicle Damage, Test No. MTB-1

Damage to the vehicle was moderate, as shown in Figures 35 through 39. The maximum occupant compartment intrusions are listed in Table 6 along with the intrusion limits established in MASH 2016 for various areas of the occupant compartment. MASH 2016 defines intrusion or deformation as the occupant compartment being deformed and reduced in size with no observed penetration. There were no penetrations into the occupant compartment and none of the established MASH 2016 intrusion limits were violated. Complete occupant compartment and vehicle deformations and the corresponding locations are provided in Appendix E.

The majority of damage was concentrated on the right-front corner and right side of the vehicle where impact occurred. The front bumper cover was crushed in and partially torn from the vehicle. The grille and both headlights were disengaged from the vehicle. The right-front wheel assembly was torn from the vehicle. The front and side of the right-front fender were crushed inward. The right side of vehicle was deformed or scratched along its entirety. The right tail light was crushed. The right-side shocks bent backward. The right-side sway bar end link was disconnected from the lower control arm. The right-side steering knuckle disengaged from the vehicle. The right-side lower control arm broke and the upper control arm bent backward. The steering gear box broke apart and the right-side tie rod was bent. The front bumper mounts were bent backward.

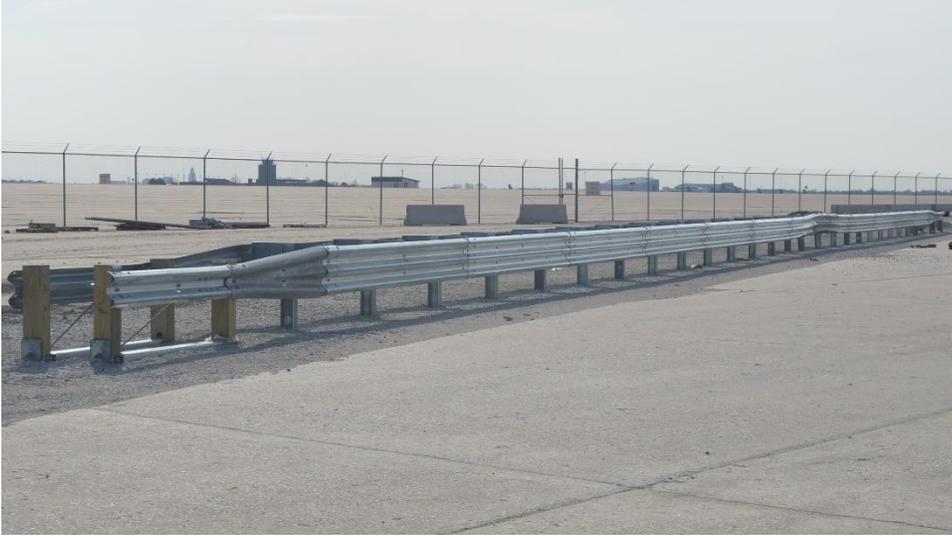
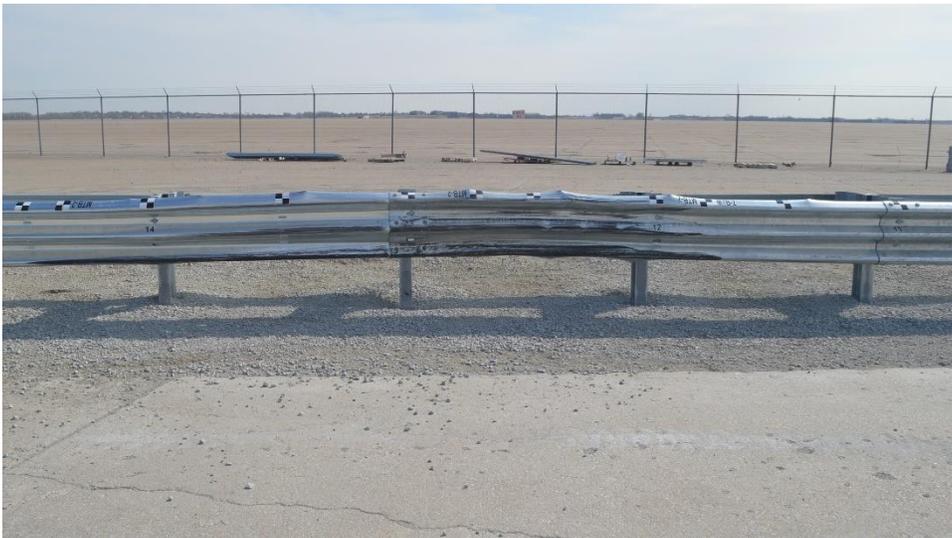
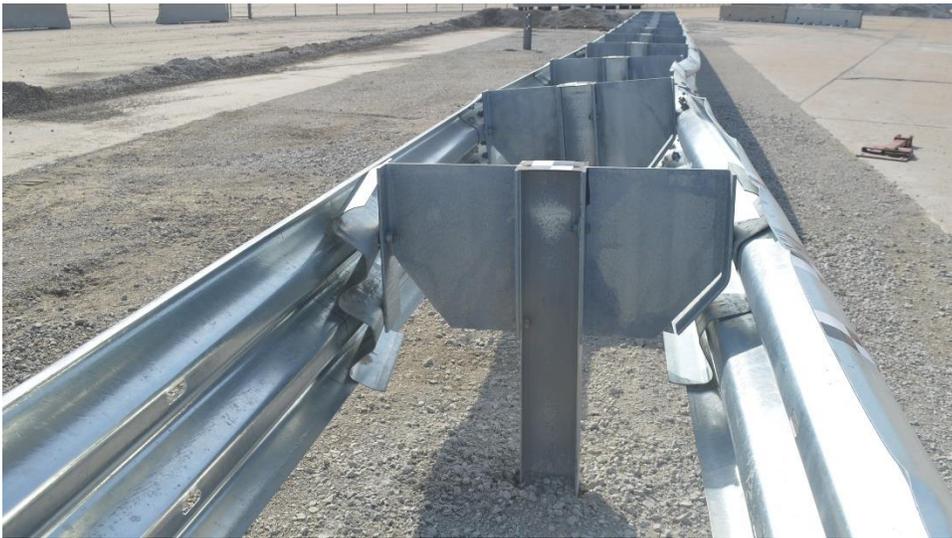
Figure 63. System Damage, Test No. MTB-2

Barrier damage was moderate, as shown in Figures 63 through 65, mainly consisting of bending, kinking, denting, and contact marks on the front face of the rail. The length of vehicle contact along the barrier was approximately 17 ft – 3 in., which spanned from 22 in. upstream from post no. 12 to 38 in. downstream from post no. 14.

A 17 ft – 3-in. long contact mark was found on the bottom corrugation beginning 22 in. upstream from post no. 12. A 13-ft – 5-in. long contact mark was found on the middle corrugation, beginning 22 in. upstream from post no. 12. A 12-ft – 7-in. long contact mark was found on the top corrugation, beginning 12 in. upstream from post no. 12. A small contact mark was found on the top front face of the blockout at post no. 12. Dents were found on the middle corrugation 22 in. and 33 in. downstream from post no. 12. The rail bent backward and was slightly flattened between post nos. 12 and 14. The bottom corrugation at post no. 12 bent outward 1 in. The bottom corrugation at post no. 14 bent outward $\frac{3}{4}$ in. and the backing plate on the non-traffic side detached as a result of bolt pull out. A 1-in. long gap between the guardrail and backing plate was found on the non-traffic side blockout at post no. 16. Various kinks were found on the rail between post nos. 10 and 15.

Post nos. 10 and 12 rotated clockwise. The lower front flange on the traffic-side blockouts at post nos. 11 through 14 were bent inward 10 in. from the top. The non-traffic-side blockouts at post nos. 12 and 13 bent slightly near the bottom. Contact marks were noted on the flanged of post no. 13 due to wheel and tire contact. Bolt pullout occurred on the non-traffic side at post nos. 14 and 15, and at post no. 15 the bolt was removed entirely. The traffic-side blockout at post no. 15 bent 11 in. from its top. The front flange of the traffic-side blockout at post no. 16 bent slightly at the top. Soil gaps were found around post nos. 11 through 16. Soil heave formed around post nos. 12 through 15. No damage was observed on the remainder of the posts.

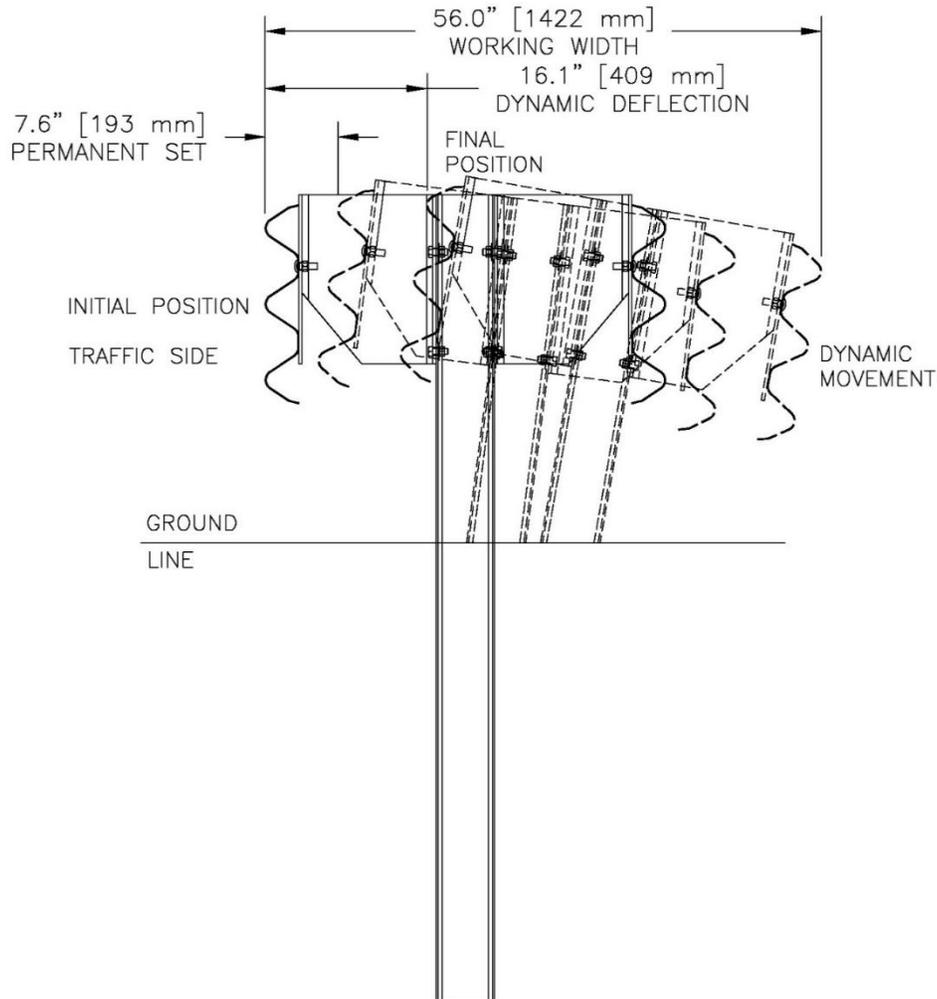
Figure 66. Permanent Set Deflection, Dynamic Deflection, and Working Width, Test No. MTB-2

The maximum lateral permanent set of the barrier system was 7.6 in., which occurred at post no. 13, as measured via GPS. The maximum lateral dynamic barrier deflection, was 16.1 in. at post no. 13, as determined from high-speed digital video analysis. The working width of the system was found to be 56.0 in., also determined from high-speed digital video analysis. A schematic of the permanent set deflection, dynamic deflection, and working width is shown in Figure 66.

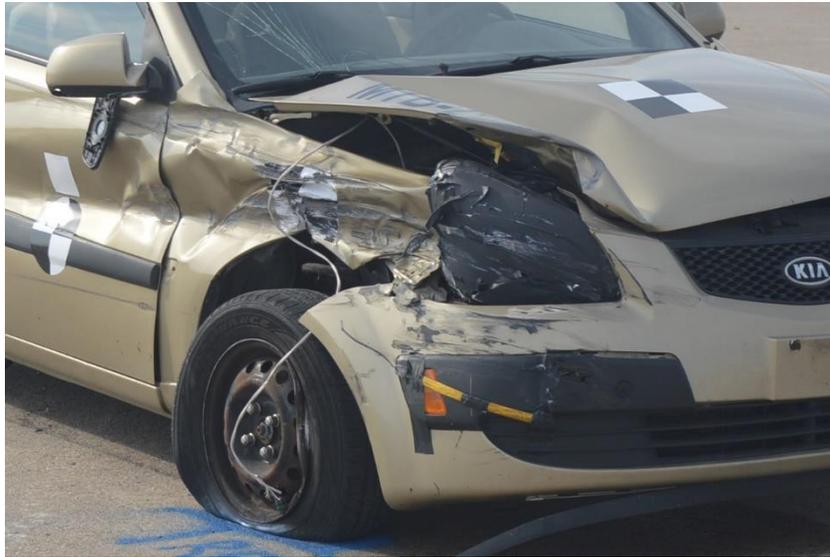
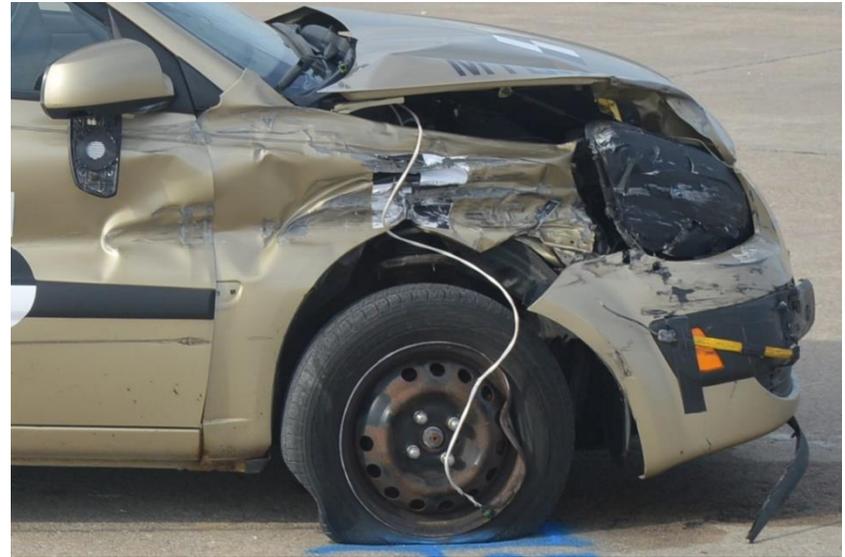
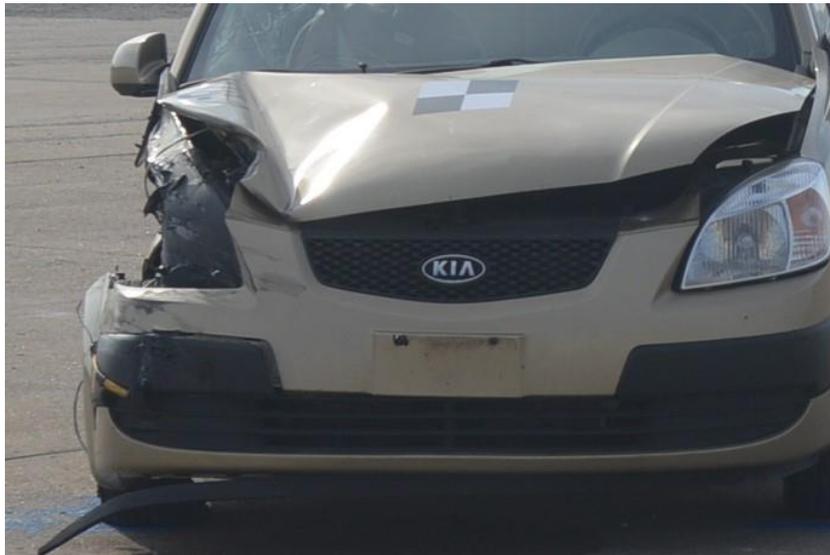
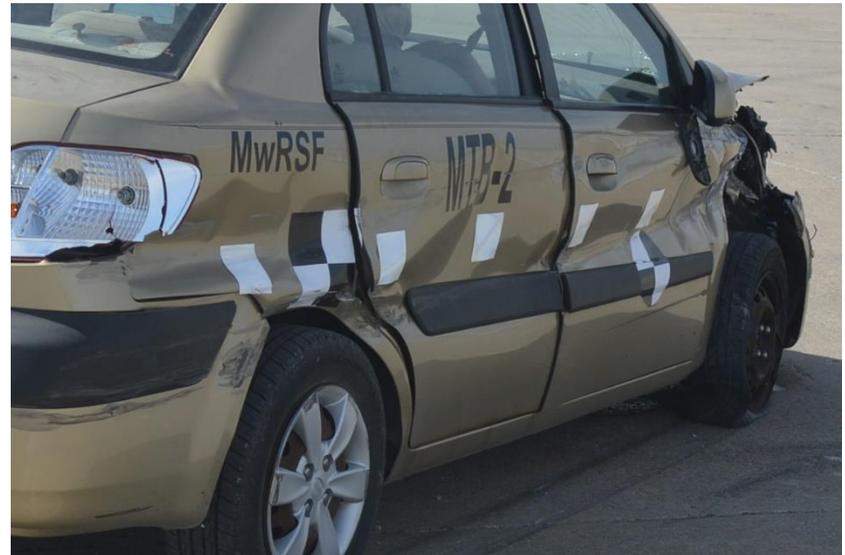
Figure 68. Vehicle Damage, Test No. MTB-2

The majority of the damage was concentrated on the right-front corner and the right side where impact occurred. The hood kinked on the right side. The front bumper detached, and the right-front quarter panel was deformed inward and scraped. The right-front door was deformed inward along its length and dented near the handle. The right-rear door was dented and scraped along its length. The right-rear quarter panel was crushed inward and scraped along its length. The right-rear wheel well was crushed inward, and the right-front wheel was dented due to contact with post no. 13. The right taillight was broken, and the cover was disengaged. The windshield was cracked and buckled outward. The rest of the window glass and roof were undamaged. The right-side spring perch was bent. The right lower control arm was bent backward. The front cross member of the vehicle was bent upward near the mid point.

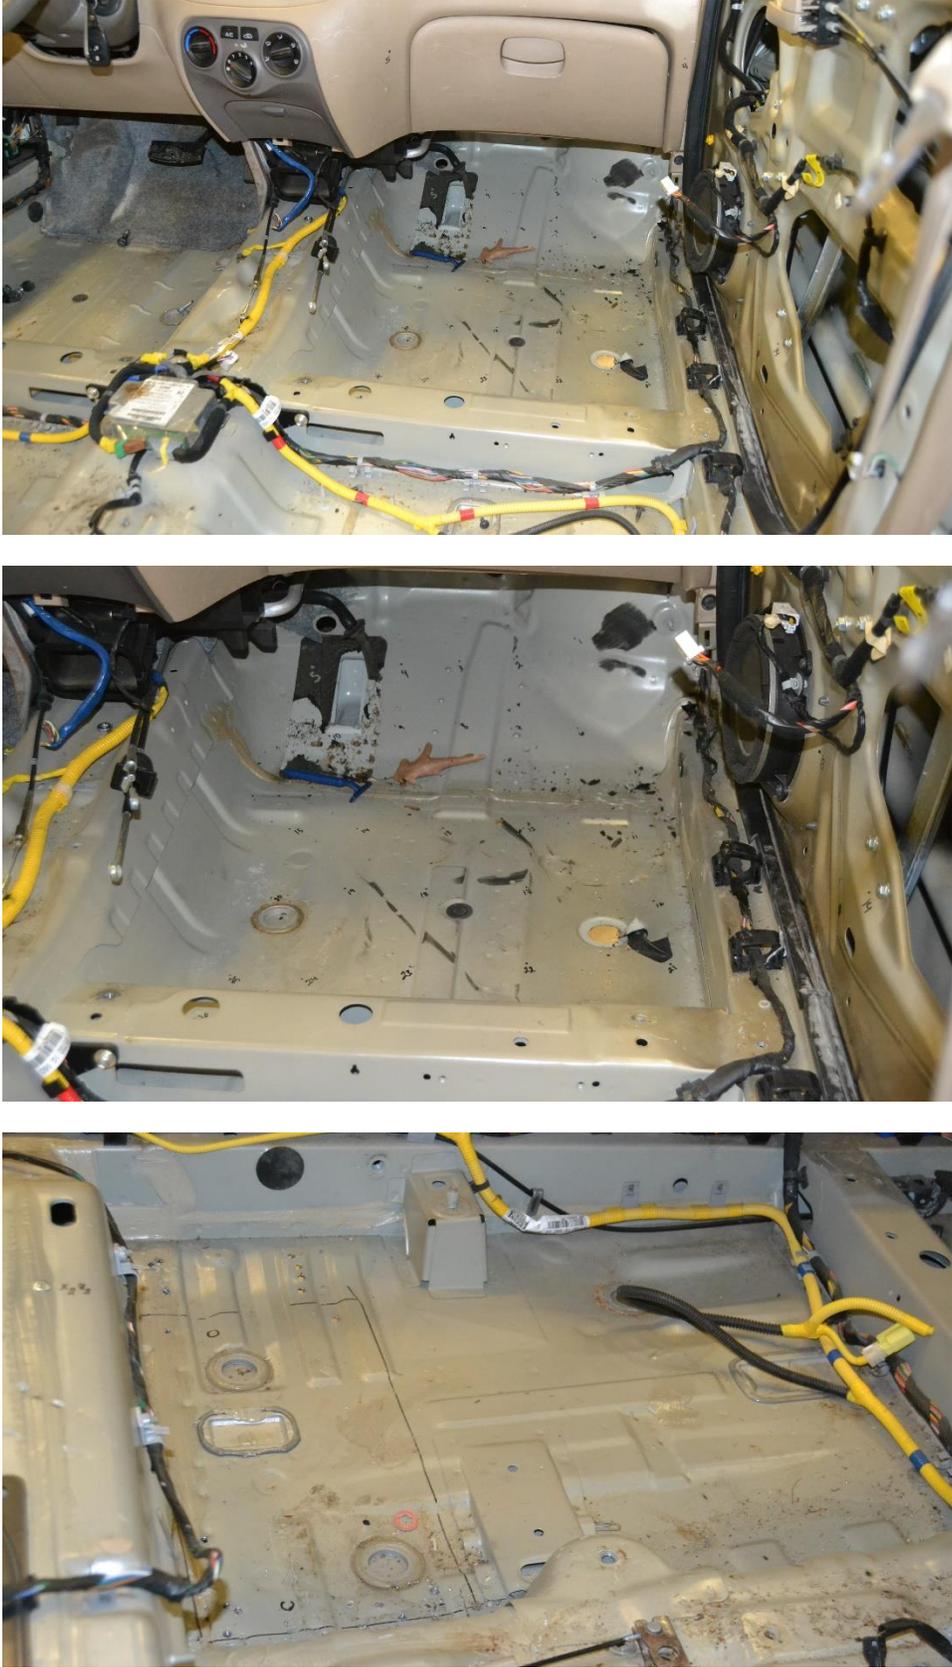
Figure 69. Occupant Compartment Damage, Test No. MTB-2

Damage to the vehicle was moderate, as shown in Figures 67 through 70. The maximum occupant compartment intrusions are listed in Table 10, along with the intrusion limits established in MASH 2016 for various areas of the occupant compartment. MASH 2016 defines intrusion or deformation as the occupant compartment being deformed and reduced in size with no observed penetration. There were no penetrations into the occupant compartment and none of the established MASH 2016 deformation limits were violated. Complete occupant compartment and vehicle deformations and the corresponding locations are provided in Appendix E.
