PHASE I MASH TESTING OF A THRIE BEAM BULLNOSE WITH BREAKAWAY STEEL POSTS (TEST NOS. MSPBN-1, -2, AND -3)

MIDWEST ROADSIDE SAFETY FACILITY

MwRSF Research Report No. TRP-03-389-20

August 27, 2020

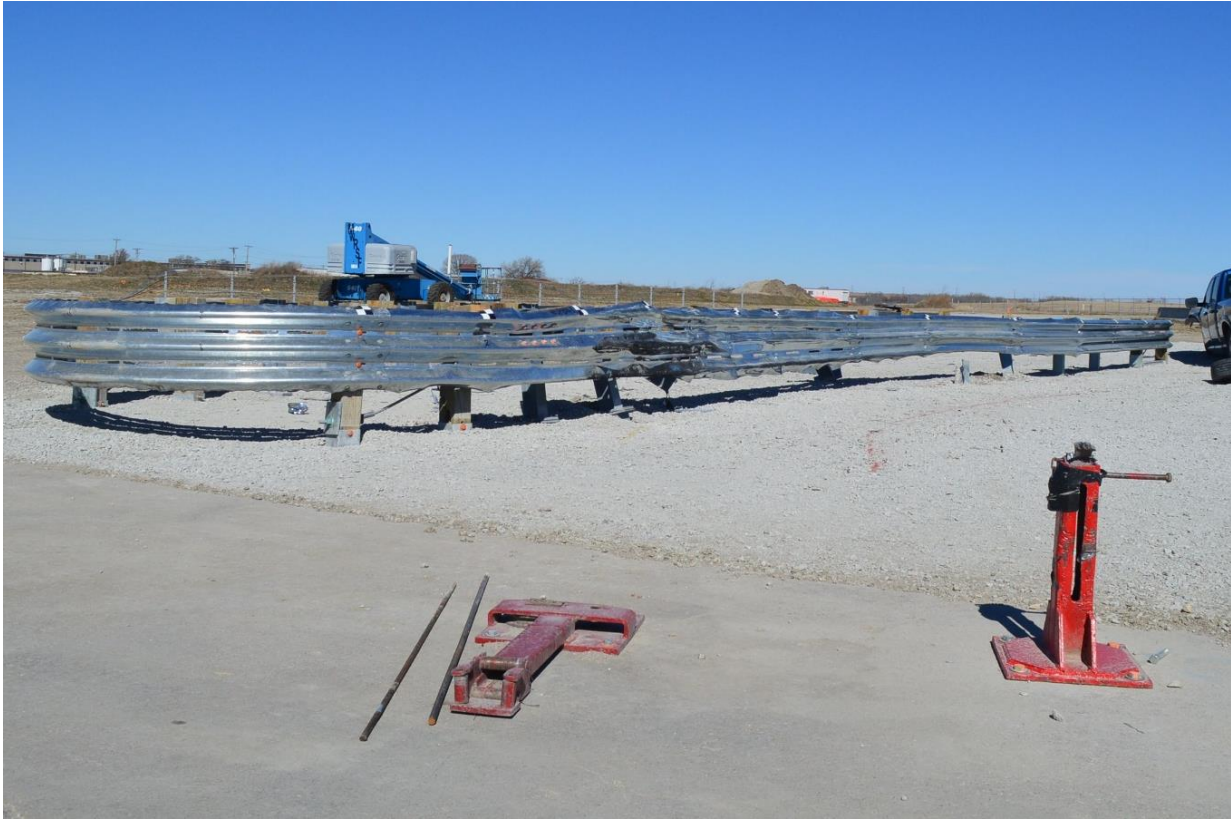
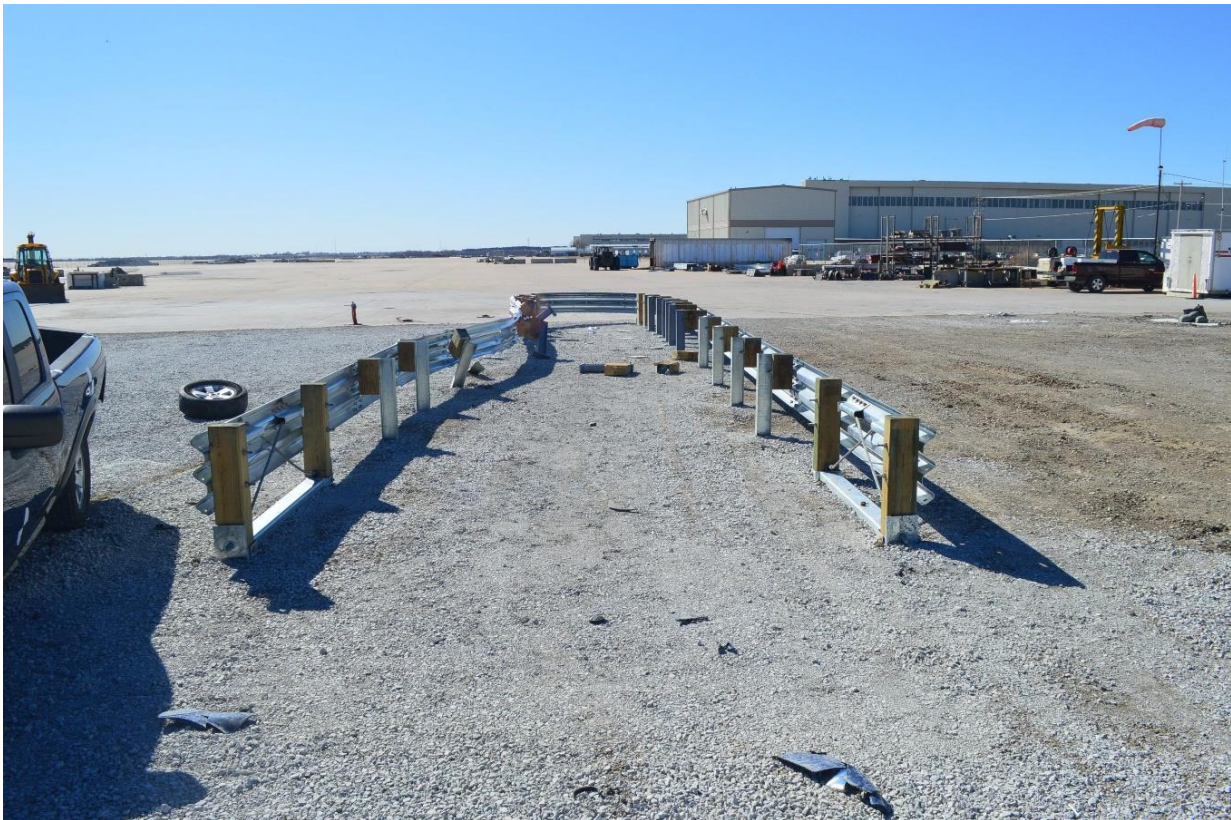
Figure 57. System Damage, Test No. MSPBN-1

The foundation tube of post no. A1 was crushed in on the upstream side. Post no. A2 fractured on the upstream side of the post at the foundation tube bolt. The post base bolts of post nos. A5 through A8 fractured at the ground line. Post nos. A6 and A7 were detached from the rail. Post no. A9 was bent backward and downstream, the blockout disengaged from the post and the rail, the guardrail bolt fractured, and there were dents on the front and back upstream flanges 17 in. (432 mm) and 20½ in. (521 mm) from the top of the post, respectively. The back upstream flange of post no. B9 was dented 18½ in. (470 mm) from the bottom by post no. A7, which flew backward.

Kinks in the thrie-beam were located at the center of the target of post no. A1, 10 in. (254 mm) and 24 in. (610 mm) downstream from the target and on the lower face of the lower corrugation 12 in. (305 mm) downstream from post no. A1. The rail was dented on the upper face of the lower corrugation, 10½ in. (267 mm) upstream from the center of post no. A2. Kinks were located on the top of the rail at 2 in. (51 mm), 3 in. (76 mm), 8¾ in. (222 mm) and 34½ in. (876 mm) downstream from the center target of post no. A2. Multiple dents were located between post nos. A2 and A4. The rail began to flatten 35 in. (889 mm) downstream from post no. A3. A 3-in. (76-mm) diameter dent was located 8 in. (203 mm) upstream from the center of post no. A5. A kink was found 1 in. (25 mm) upstream from post no. A5 on the bottom on the rail. A 1½-in. (29-mm) tear was found on the top face of the upper corrugation of the top upstream bolt hole of the splice at post no. A5. A kink was found 13 in. (330 mm) downstream from post no. A5 on the top face of the top flange and 27 in. (686 mm) downstream from post no. A5 on the lower face of the lower corrugation. Kinks were located on the top flange of the rail at 2 in. (51 mm) and 28 in. (711 mm) downstream from the centerline of post no. A6 and on the lower flange of the rail 14 in. (356 mm) and 34½ in. (876 mm) downstream from post no. A6. The top flange of the rail was kinked 10½ in. (267 mm), 38½ in. (978 mm) and 55½ in. (1,410 mm) downstream from post no. A7, and the rail was kinked on the bottom flange 18 in. (457 mm), 37 in. (940 mm), and 58½ in. (1,486 mm) downstream from post no. A7. Kinking was found on the bottom rail flange 20 in. (508 mm) and 47½ in. (1,207 mm) downstream from post no. A8 and on the top rail flange, 4½ in. (114 mm) and 45 in. (1,143 mm) downstream from post no. A8. The rail along the centerline of post no. A9 was kinked on bottom flange and had a 6-in. (152-mm) diameter, ½-in. (13-mm) deep dent. Kinks were located on the top rail flange, 5 in. (127 mm), 39 in. (991 mm), and 67½ in. (1,715 mm) downstream from post no. A10 and on the bottom rail flange 38 in. (965 mm) and 89 in. (2,261 mm) downstream from post no. A10. The post bolt of post no. A11 began to pull through the rail. Post no. A1 was pushed back and downstream, resulting in a 1-in. (25-mm) soil gap upstream and ¼-in. (6-mm) soil gap on the front side of the post.

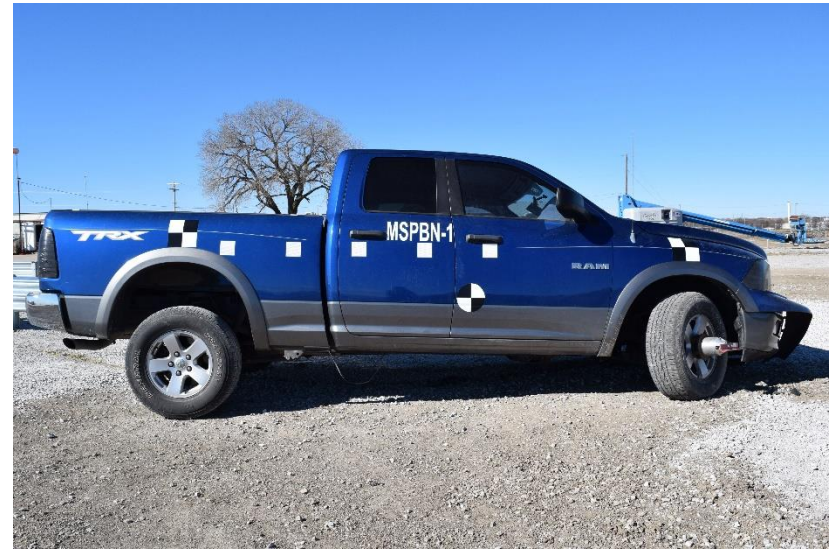
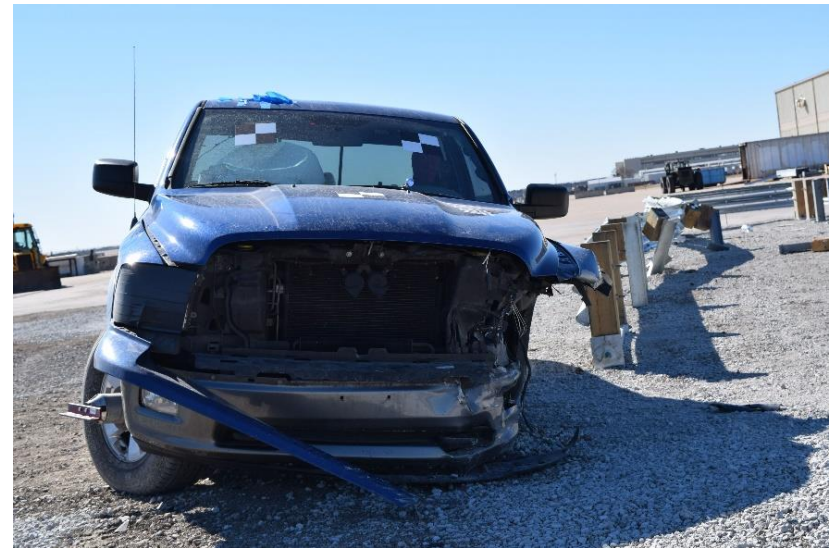
Figure 67. Vehicle Damage, Test No. MSPBN-1

The majority of the damage was concentrated on the on the left-front corner and left-front side of the vehicle where the impact occurred. The entire grille assembly was disengaged from the front of the vehicle. A 21-in. x 6-in. (533-mm x 152-mm) section on the left side of the front facia above the front bumper was detached. The remainder of the front facia was only attached by a small section on the right side of the vehicle. The left headlight and left-front fog light were disengaged. The left side of the front bumper was dented and crushed inward. The left fender was bent up and inward, and the rear section was separated. The left-front wheel, brake assembly, and tie rod were disengaged. The inner wheel well plastic was dented and kinked, and the top portion was separated from the vehicle. The front of the left-front door had a series of dents and scrapes at the middle of the door. The left-rear corner of the cab and the front edge of the right quarter panel were dented and scraped. Dents and scraping were located on the left quarter panel just below the taillight. A 27-in. (686-mm) diameter spider web crack was found in the windshield due to right-side airbag activation.

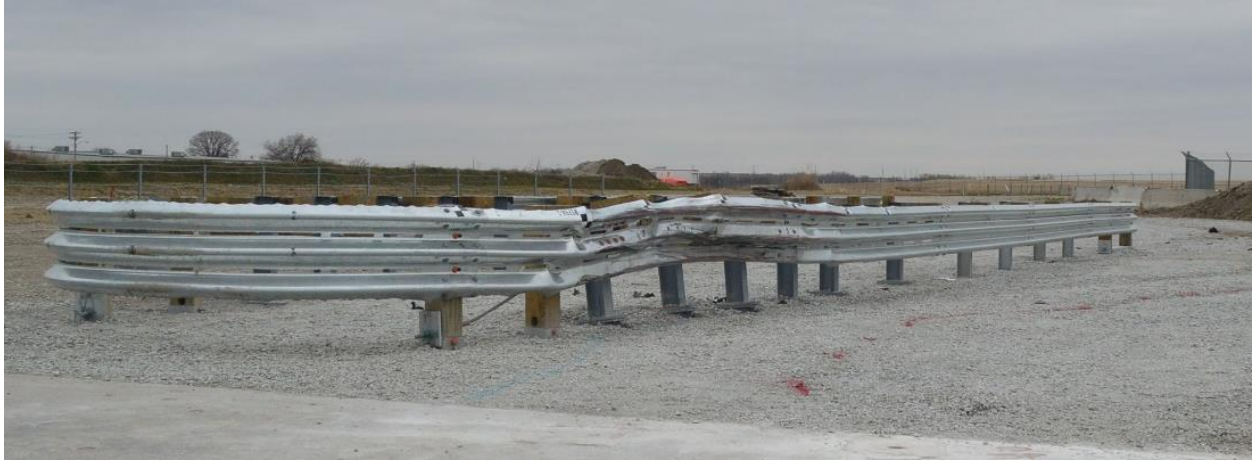
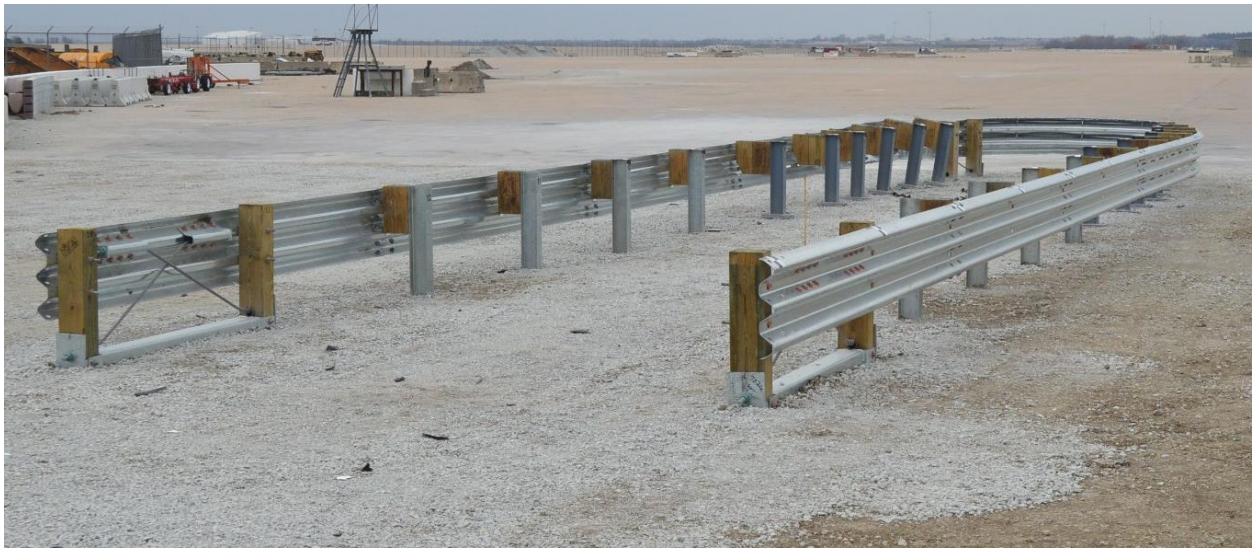
Figure 78. System Damage, Test No. MSPBN-2

Kinking occurred on the top of the top bolt slot $32\frac{3}{4}$ in. (832 mm) downstream from the first splice, on the bottom of the top bolt slots $28\frac{1}{2}$ in. (724 mm) downstream from the first splice, and on the top of the bottom bolt slots $29\frac{1}{4}$ in. (743 mm) downstream from the first splice. Kinking was found $32\frac{3}{4}$ in. (832 mm) downstream from the first splice, $22\frac{1}{2}$ (572 mm) downstream from post no. A5, 17 in. (432 mm) downstream from post no. A6, and 11 in. (279 mm) downstream from post no. A7. Kinking was also found on the bottom rail 15 in. downstream from post no. A5 and $4\frac{1}{2}$ in. (114 mm) downstream from post no. A6. Contact marks extending 141 in. (3,581 mm) and starting 6 in. (152 mm) downstream from the impact target were found in the middle of the rail. Marks were also found on the bottom peak of the rail extending 154 in. (3,912 mm) and starting 3 in. (76 mm) downstream from the impact point. Multiple dents were located between post nos. A3 and A4. The bottom of the rail was flattened starting 6 in. (152 mm) upstream from the target impact point and extending to the center of post no. A6.

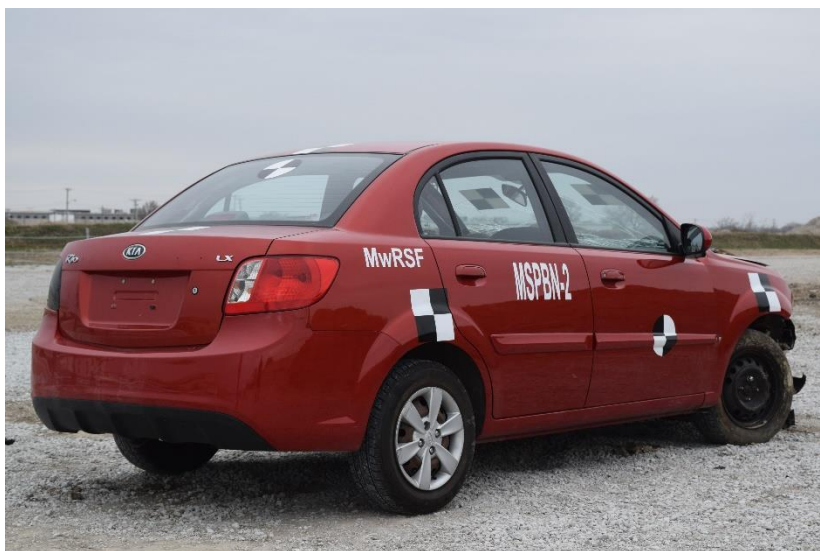
Figure 84. Vehicle Damage, Test No. MSPBN-2

The majority of the damage was concentrated on the left-front corner and left-front side of the vehicle where the impact occurred. A crease developed along the length of the vehicle on the left side along with multiple contact marks and small dents. The vehicle's fuel door on the vehicle disengaged and the fuel door hinge cracked just above the mounting bolt. An 8½-in. (216-mm) diameter dent was found 2 in. (51 mm) from the left-front door and 10 in. (254 mm) from the bottom of the window. An 11-in. x 4-in. (279-mm x 102-mm) dent formed on the rear section of the left-front door. Contact marks and multiple tears were located along the entire front of the fascia. The damage on the right side of the vehicle was mostly due to the impact with earth berm. The lower right corner of the grille assembly and the left headlight detached. A 13-in. (330-mm) tall crack extended the entire length of the windshield. A 3½-in. (89-mm) gap was found between the front right fender and the front of the hood that decreased to 1¾ in. (44 mm) at the rear of the hood. The right-front tire came into contact with the rear of the front wheel well.

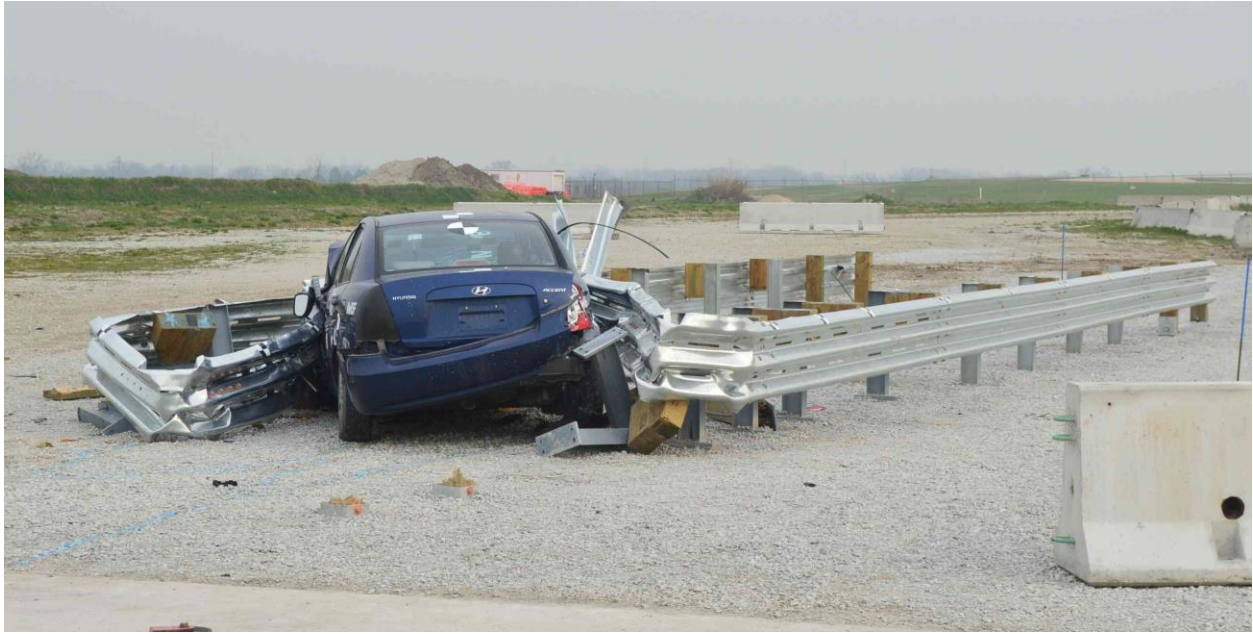
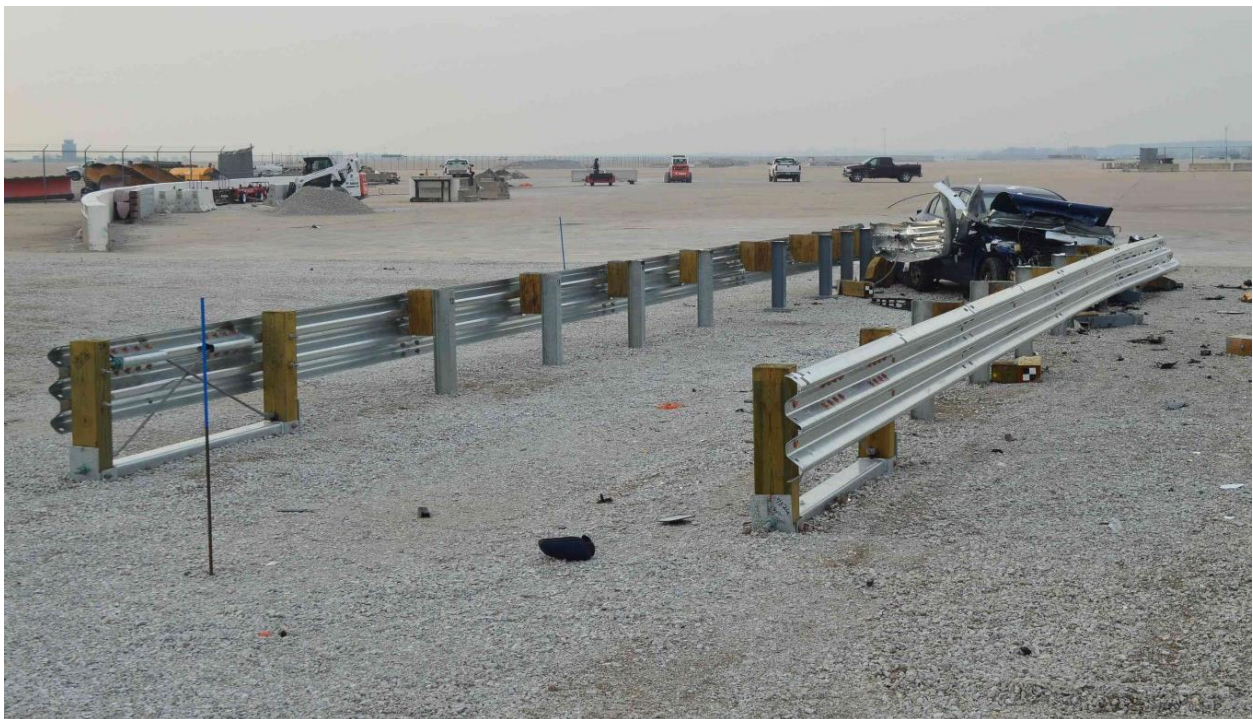
Figure 94. System Damage, Test No. MSPBN-3

Steel post damage included fracture of bolts, twisting, rotation, and detachment from the post bases. All base bolts on post nos. 3B through 7B fractured at the ground line. Post no. 3B detached from the rail and the post twisted in counter-clockwise direction. Contact marks were found on the lower base plate from the upstream to downstream corner and 5 in. (127 mm) from the back edge. The top of post nos. 5B, 9B, 10B, and 11B twisted counter-clockwise. The blockouts attached to post nos. 6B, 8B, and 9B split on the upstream face. All base bolts on post nos. 3A and 4A fractured at the ground line. The rail detached from post nos. 3A and 4A. Crushing measuring 2½ in. (64 mm) long x 1½ in. (38 mm) wide and ¼ in. (6 mm) deep was found on the front and downstream corner of the blockout on post no. 3A. The blockout of post no. 4A disengaged from the post, but the rail remained attached.
