*Midwest Pooled Fund Research Program  
Fiscal Years 2017-2019 (Years 27 through 29)  
Research Project Number TPF-5 (193) Supplement #106  
NDOT Sponsoring Agency Code RFPF-17-MGS-2*

## **EVALUATION OF THE MGS PLACED 6 IN. BEHIND A 6-IN. TALL AASHTO TYPE-B CURB TO MASH TL-3**

MWRSF Research Report No. TRP-03-390-20

August 27, 2020

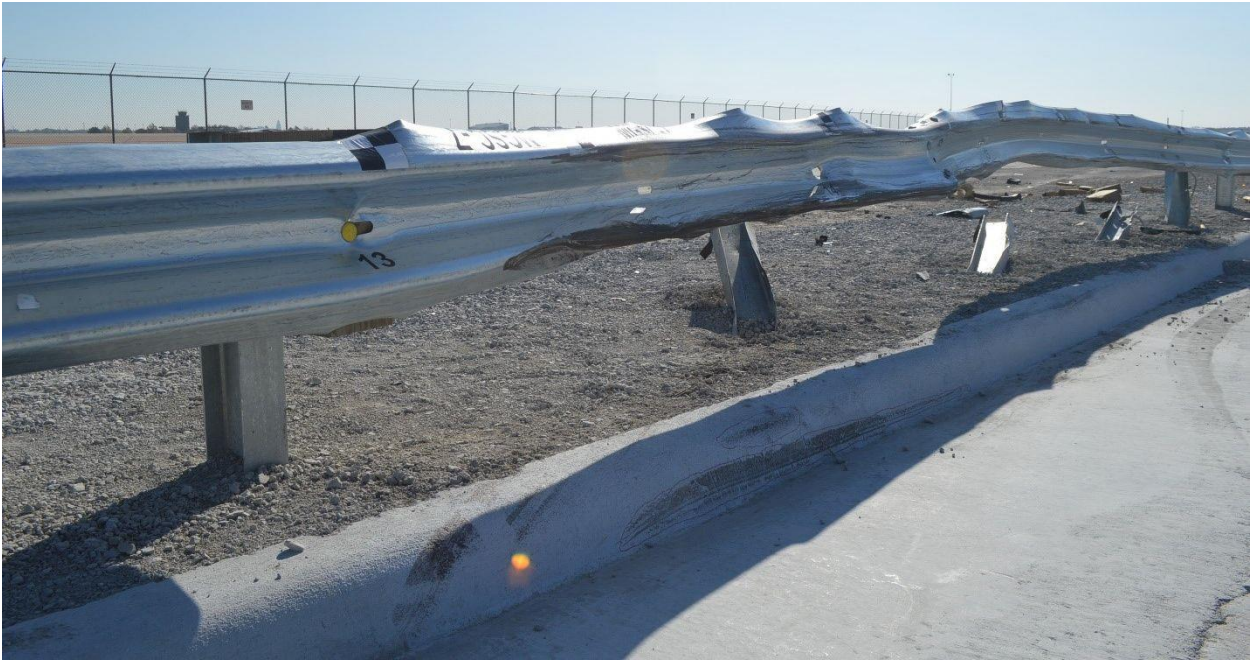
Figure 49. System Damage, Test No. MGSC-7

Damage to the W-beam guardrail with curb system was moderate, as shown in Figures 49 through 57. Damage consisted of contact marks on various MGS components, as well as bending, kinking, tearing, and twisting of the posts and guardrail. The length of vehicle contact along the barrier was approximately 25 ft – 7 in., which spanned from 12 in. downstream from post no. 13 to 19 in. downstream from post no. 17.

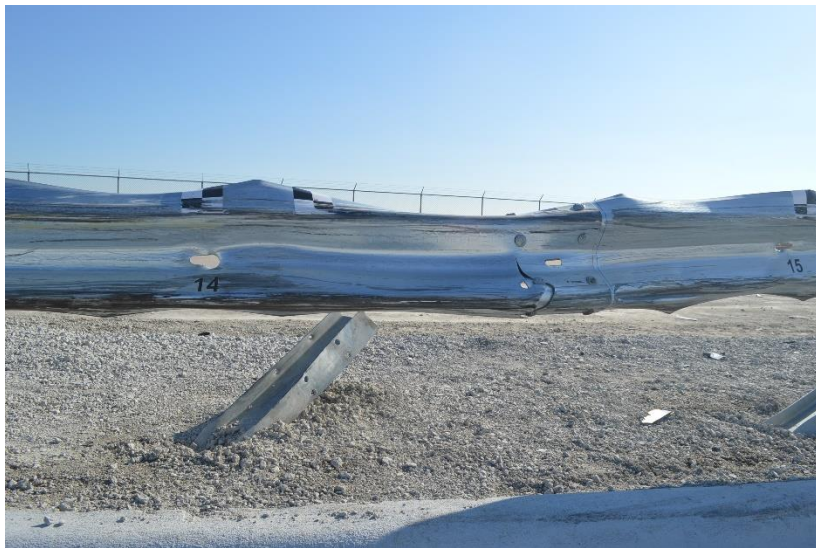
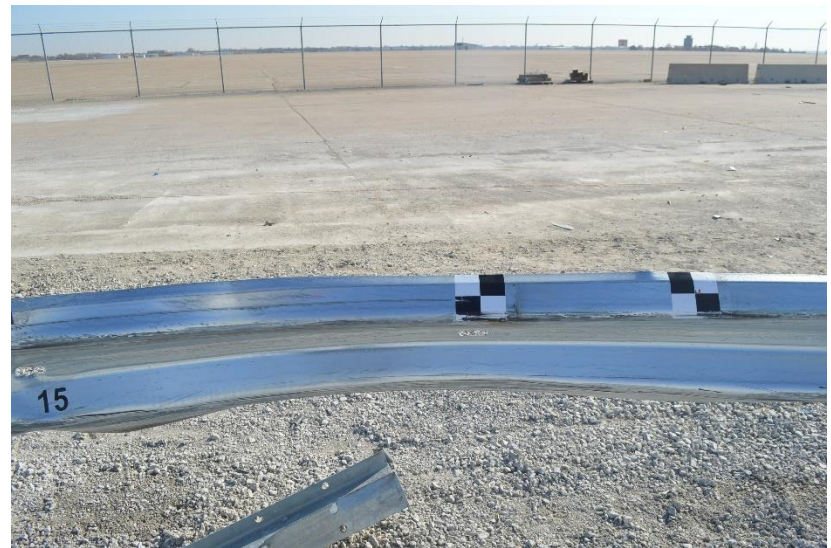
Figure 50. Guardrail Damage, Post Nos. 13 through 15, Test No. MGSC-7

The W-beam guardrail was laterally displaced between post nos. 13 and 17 and was disengaged from post nos. 14 through 17. Rail kinking and flattening was observed at multiple locations along the rail between post nos. 13 and 17. The bottom of the rail was bent upward from post no. 14 to post no. 17. The rail was partially torn at the splice location between post nos. 14 and 15. The tear extended from the bottom edge of the rail, through the lower-upstream bolt holes, and stopped near the middle of the W-beam valley.

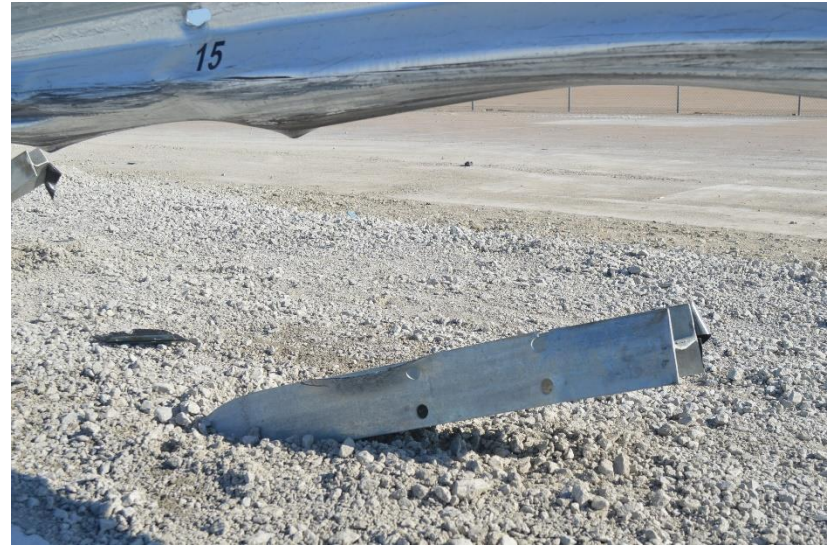
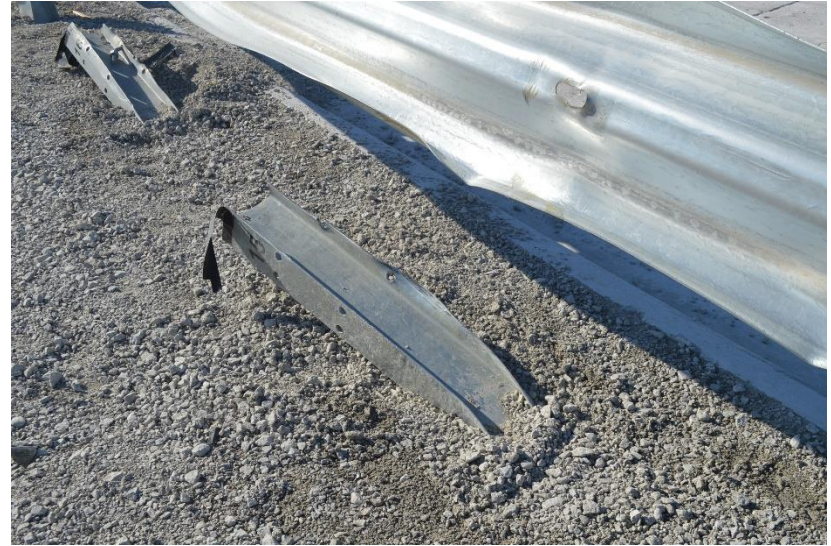
Figure 54. Post Nos. 14 and 15 Damage, Test No. MGSC-7

Post nos. 14 through 16 were bent back and downstream at ground line. Post no. 17 was bent slightly downstream and twisted to face downstream. Soil heaves and craters formed at the bases of post nos. 14 through 17. Contact marks were found on the upstream edge of post nos. 14 through 17. Post nos. 3 through 14, 16, and 17 were twisted to face downstream. Post nos. 1, 2, and 19 through 29 did not deflect and were not damaged.

Blockouts disengaged from post nos. 14 through 17. The attachment bolt of post no. 15 tore out of the upstream flange web. The blockout of post no. 18 was slightly rotated such that the top of blockout angled upstream. Minor blockout splitting was observed on post nos. 3 through 5, 7, 8, and 12. Curb damage consisted of contact marks which spanned from post nos. 13 to 15.

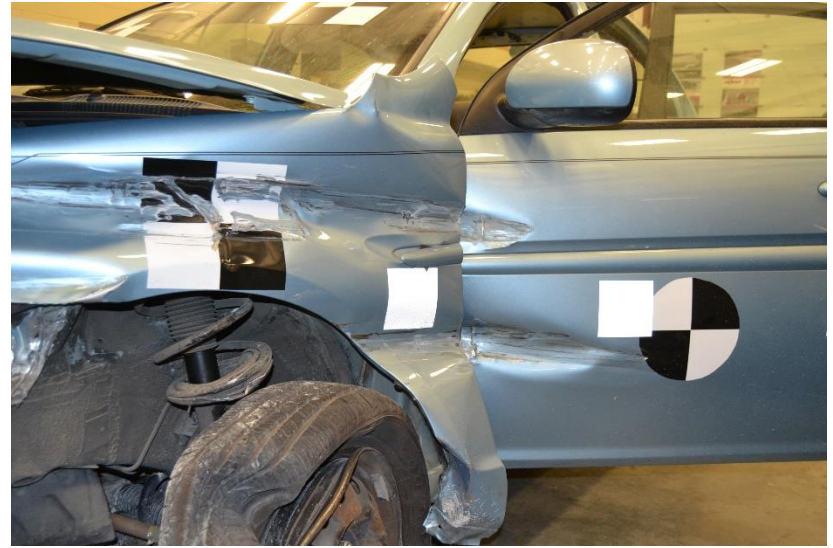
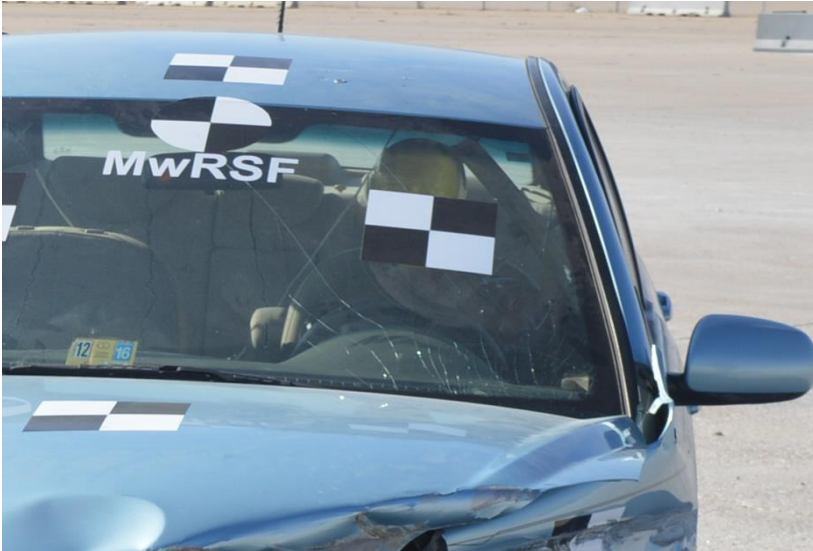
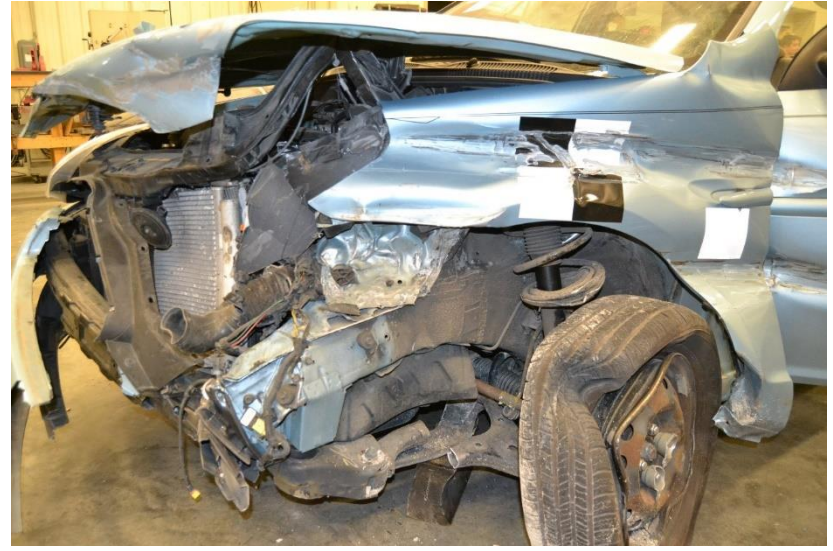
Figure 60. Vehicle Damage, Test No. MGSC-7

The majority of the damage was concentrated at the left-front corner and front end of the vehicle where the impact had occurred. The left-side of the bumper cover was ripped and detached starting 8 in. left of bumper center. The left-front bumper corner was crushed inward and down. The left-side of the radiator core support was displaced. The left-front hood was folded under and pushed in. The left-front fender was bent inward 10 in., and the bottom of the fender protruded outward 5 in. The left-front frame rail was split and crushed backward. The left-front tire was torn, and the wheel rim was bent at three locations. The left-front door was dented near the front and the latch was damaged. The windshield was cracked at the bottom left-front corner, but the roof and remaining window glass were undamaged.

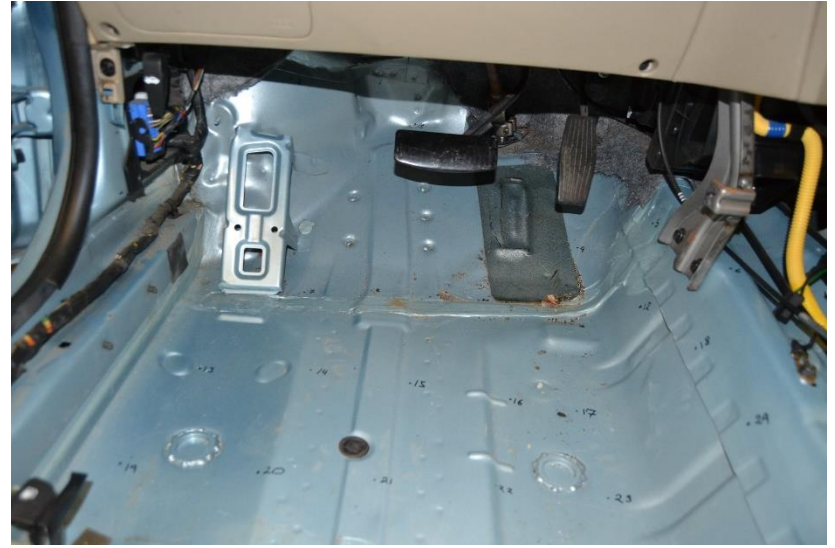
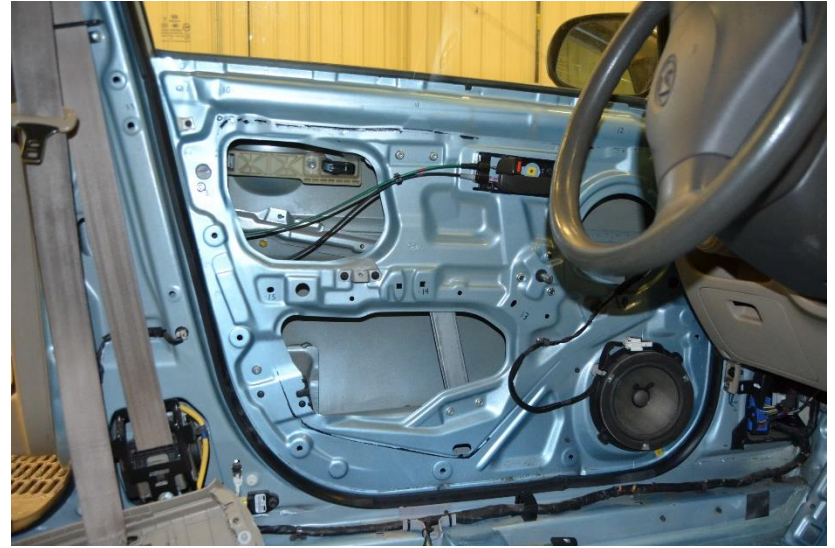
Figure 61. Occupant Compartment Damage, Test No. MGSC-7

The damage to the vehicle was moderate, as shown in Figures 59 through 62. The maximum occupant compartment deformations are listed in Table 6 along with the deformation limits established in MASH 2016 for various areas of the occupant compartment. Note that none of the established MASH 2016 deformation limits were violated. Complete occupant compartment and vehicle deformations and the corresponding locations are provided in Appendix D.

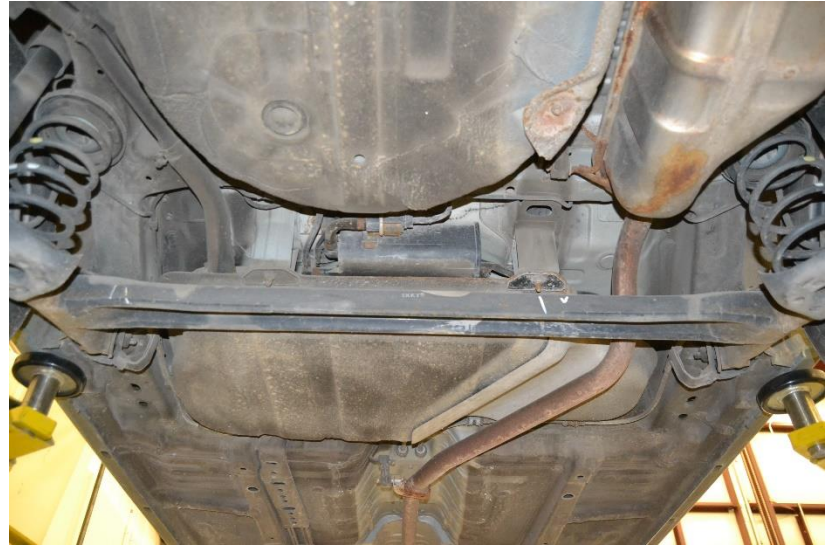
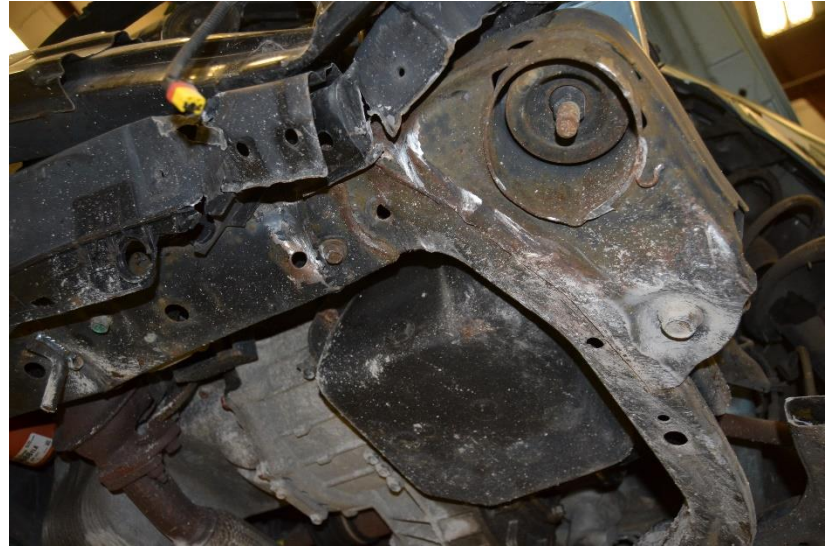
Figure 62. Vehicle Undercarriage Damage, Test No. MGSC-7

The left-front sway bar was bent upward approximately 2 in. and was in contact with the lower control arm. The left lower control arm was torn 6 in. from the center of the king pin and pulled outward 3 in. The left tie-rod was in contact with the left-front tire rim. A 2¾-in. by 6-in. scrape was found on the oil pan. Scrapes were found at multiple locations on the engine and transmission cross members. The left frame horn was crushed inward 6 in. and pushed down.

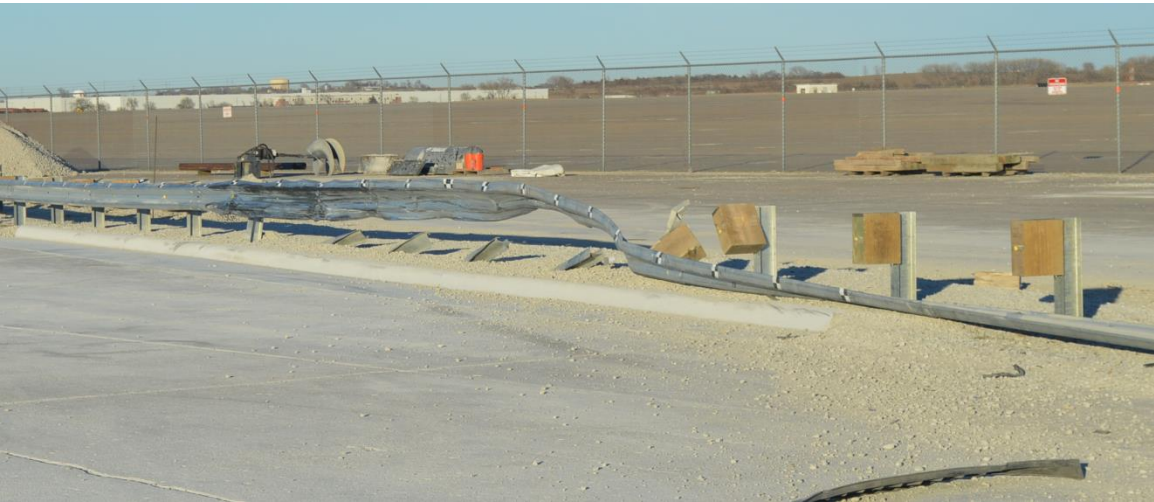
Figure 71. System Damage, Test No. MGSC-8

The most significant post displacements and deformations spanned from post no. 13 to post no. 18. Soil gaps formed at the bases of post nos. 6 through 8, 10, 12, and 22. Soil heaves and craters formed at the bases of post nos. 14 through 19, and additional soil heaves were found at post nos. 26 and 27. Post no. 13 was bent backward and twisted downstream. Blockouts disengaged from post nos. 14 through 17. Each post in this range was bent backward and downstream in addition to being twisted to face upstream. Post no. 18 was bent backward and downstream while being twisted to face downstream. The blockouts of post nos. 18 through 23 had rotated about the attachment bolt. Post nos. 26 and 17 were bent backward and downstream, and post no. 28, which was a BCT post within the downstream anchorage, fractured off at ground level.

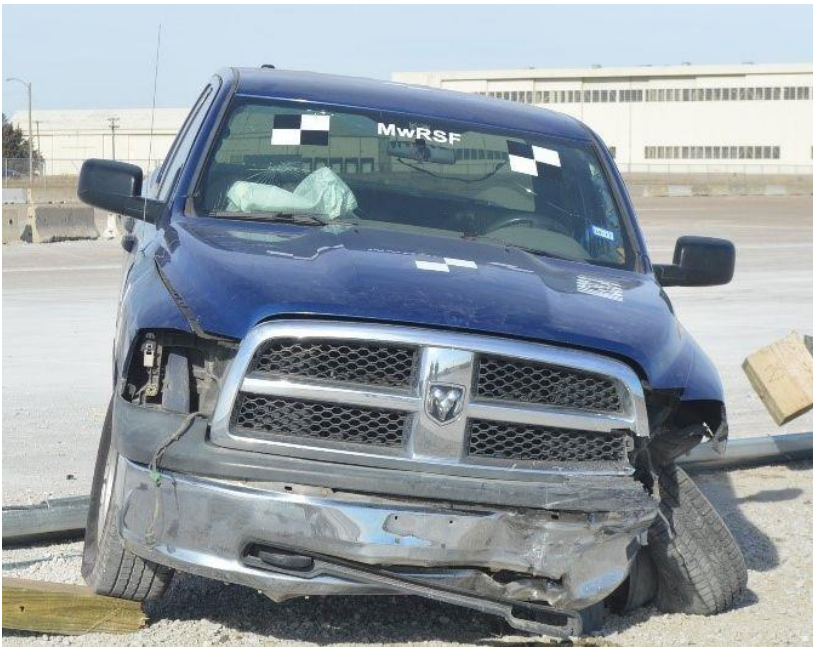
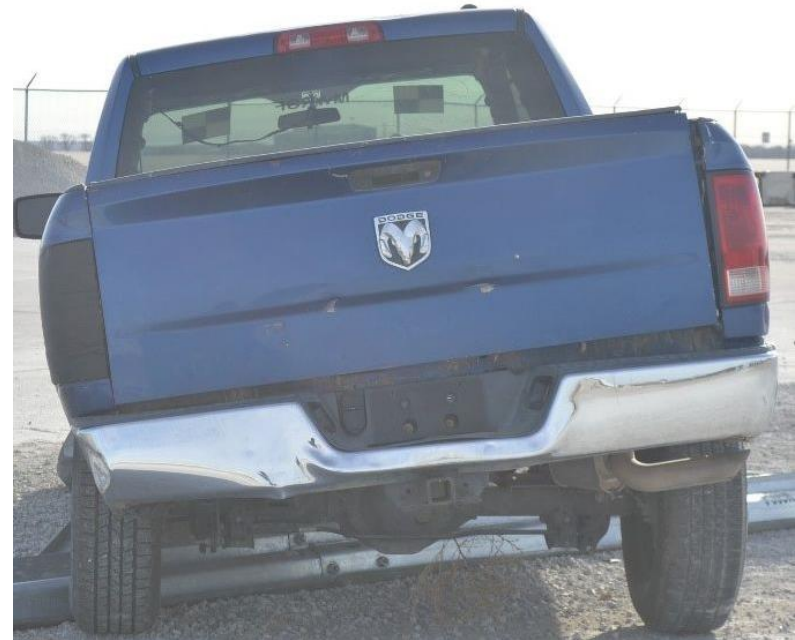
Figure 81. Vehicle Damage, Test No. MGSC-8

The majority of the damage was concentrated at the left-front corner of the vehicle where impact occurred. The left-front bumper was deformed inward toward the engine, and the grille was partially fractured and disengaged from the vehicle. Both front headlights were disengaged. The left-front fender was bent and torn, and the left-front tire sidewall was torn. The wheel rim was bent at several locations. Several minor dents were found on both the left-front and left-rear vehicle doors. Scrapes extended from the left-front fender to the rear bumper along the left side of the vehicle. The left-rear bumper was dented inward. The windshield was cracked at mid-height on the right side due to contact from the vehicle airbag. Additional cracks in the windshield extended outward from the bottom left corner of the windshield. The roof and remaining windows were undamaged.
