*Midwest Pooled Fund Research Program
Fiscal Years 2017-2020 (Year 28)
Research Project Number TPF-5(193) Supplement #123
NDOT Sponsoring Agency Code RFP-18-BULLNOSE*

MASH TESTING OF BULLNOSE WITH BREAKAWAY STEEL POSTS (TEST NOS. MSPBN-4 THROUGH MSPBN-8)

MwRSF Research Report No. TRP-03-418-20

September 1, 2020

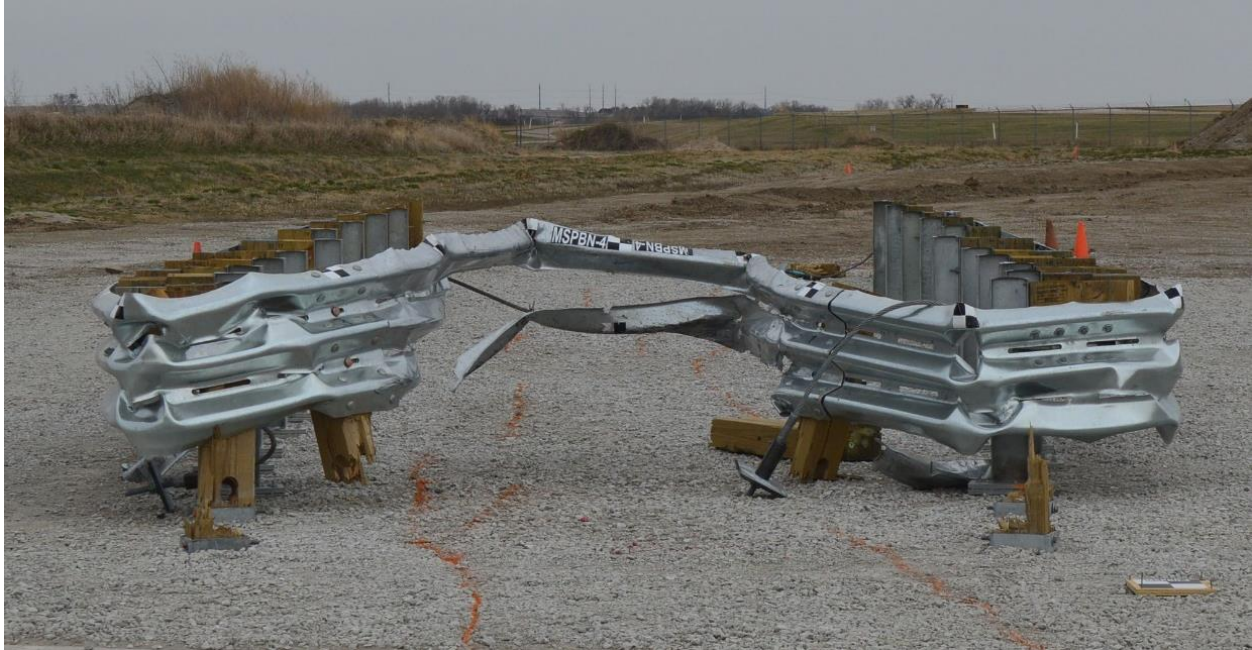
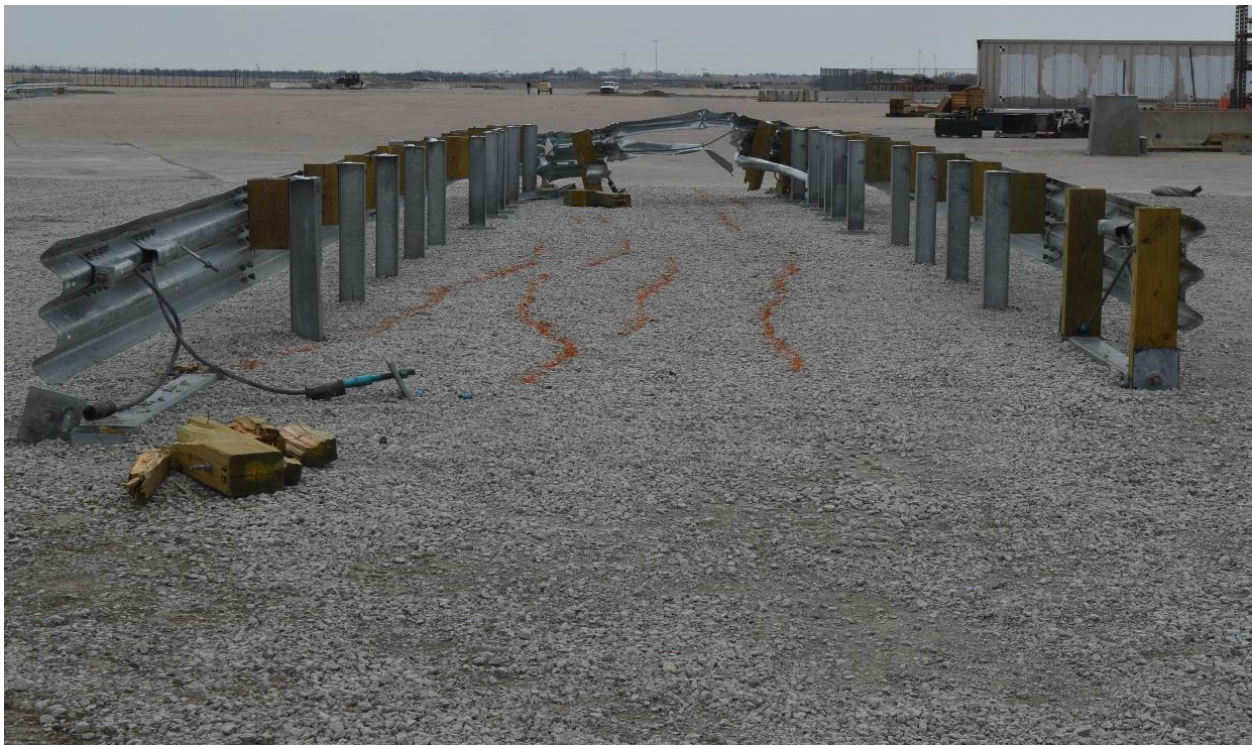
Figure 62. Overview of System Damage, Test No. MSPBN-4

The maximum longitudinal permanent set of the barrier system was 12 ft – 7 in. (3.8 m) at the midspan of the nose rail section, as measured in the field. The maximum lateral permanent set deflection was internal to the bullnose system and is not shown. A maximum longitudinal dynamic barrier deflection of 13 ft – 9.6 in. (4.2 m) was noted at the quarter point of the nose on Side A, as determined from high-speed digital video analysis. The maximum lateral dynamic barrier deflection was internal to the bullnose system and is not shown. Working widths for the system were not shown because the system did not capture the impacting vehicle. A schematic of the permanent set deflection is shown in Figure 69.

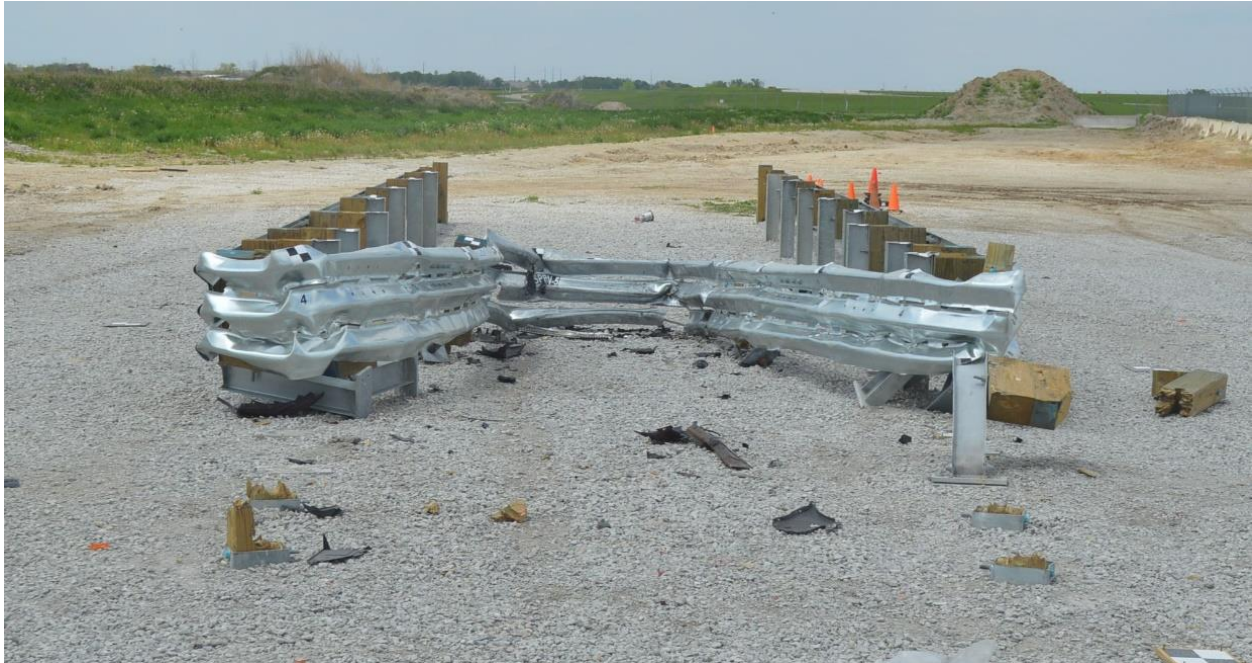
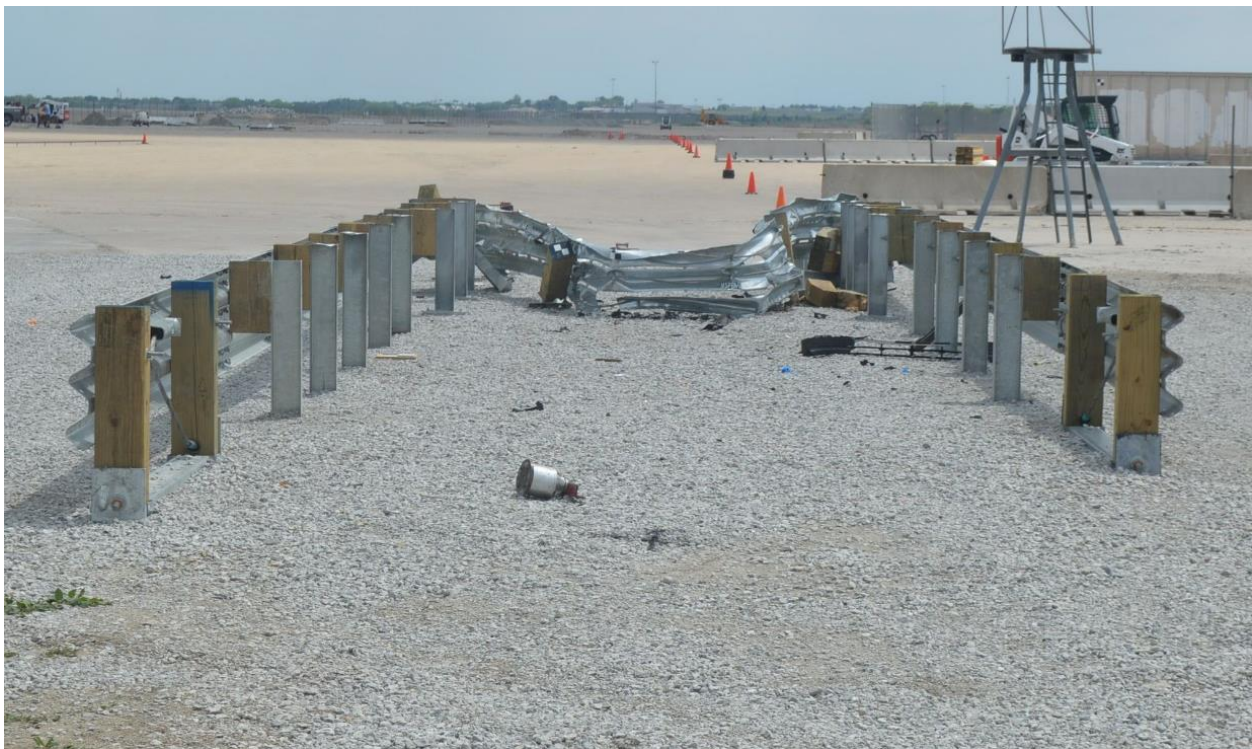
Figure 123. Overview of System Damage, Test No. MSPBN-5

The maximum longitudinal permanent set of the barrier system was 30 ft – 2¼ in. (9.2 m) in the rail at the centerline of the nose, as measured in the field. The maximum lateral permanent set deflection was internal to the bullnose system and is not shown. The maximum longitudinal dynamic barrier deflection was 30 ft – 4.3 in. (9.3 m) at the centerline target as determined from high-speed digital video analysis. The maximum lateral dynamic barrier deflection was internal to the bullnose system and is not shown. The longitudinal working width of the system was found to be 30 ft – 9.0 in. (9.4 m), and the lateral working width was found to be 15 ft – 4 in. (4.7 m), also determined from high-speed digital video analysis. A schematic of the working width is shown in Figure 131.

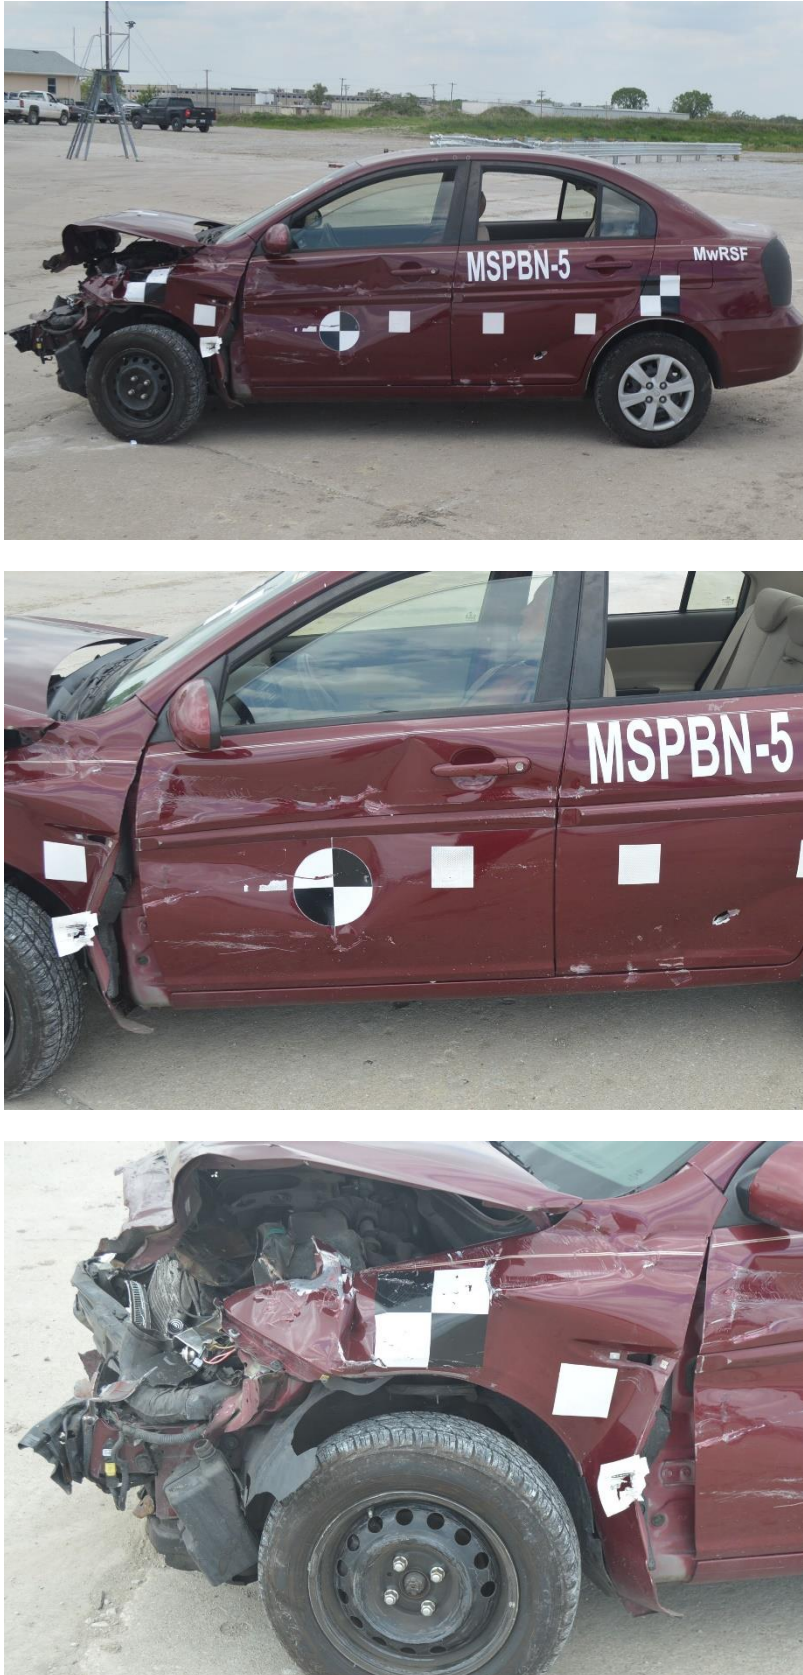
Figure 132. Vehicle Damage, Test No. MSPBN-5

The majority of the damage was concentrated on the front of the vehicle where the impact had occurred. The front bumper cover was fully disengaged from the vehicle, and the front bumper support was crushed inward. The radiator was pushed into the engine by the front bumper support. The hood buckled in the middle and was pushed into the engine bay. The left-front quarter panel was bent into the engine bay in front of the tire and flared outward behind the tire. The right-front quarter panel was pushed into the engine bay in front of the tire and was flared outward behind the tire. The left-front door was dented inward. The right-front door was dented near the right-front quarter panel. The roof, windshield, and side windows remained undamaged. The lower control arm on the right side was bent backward at the ball joint.

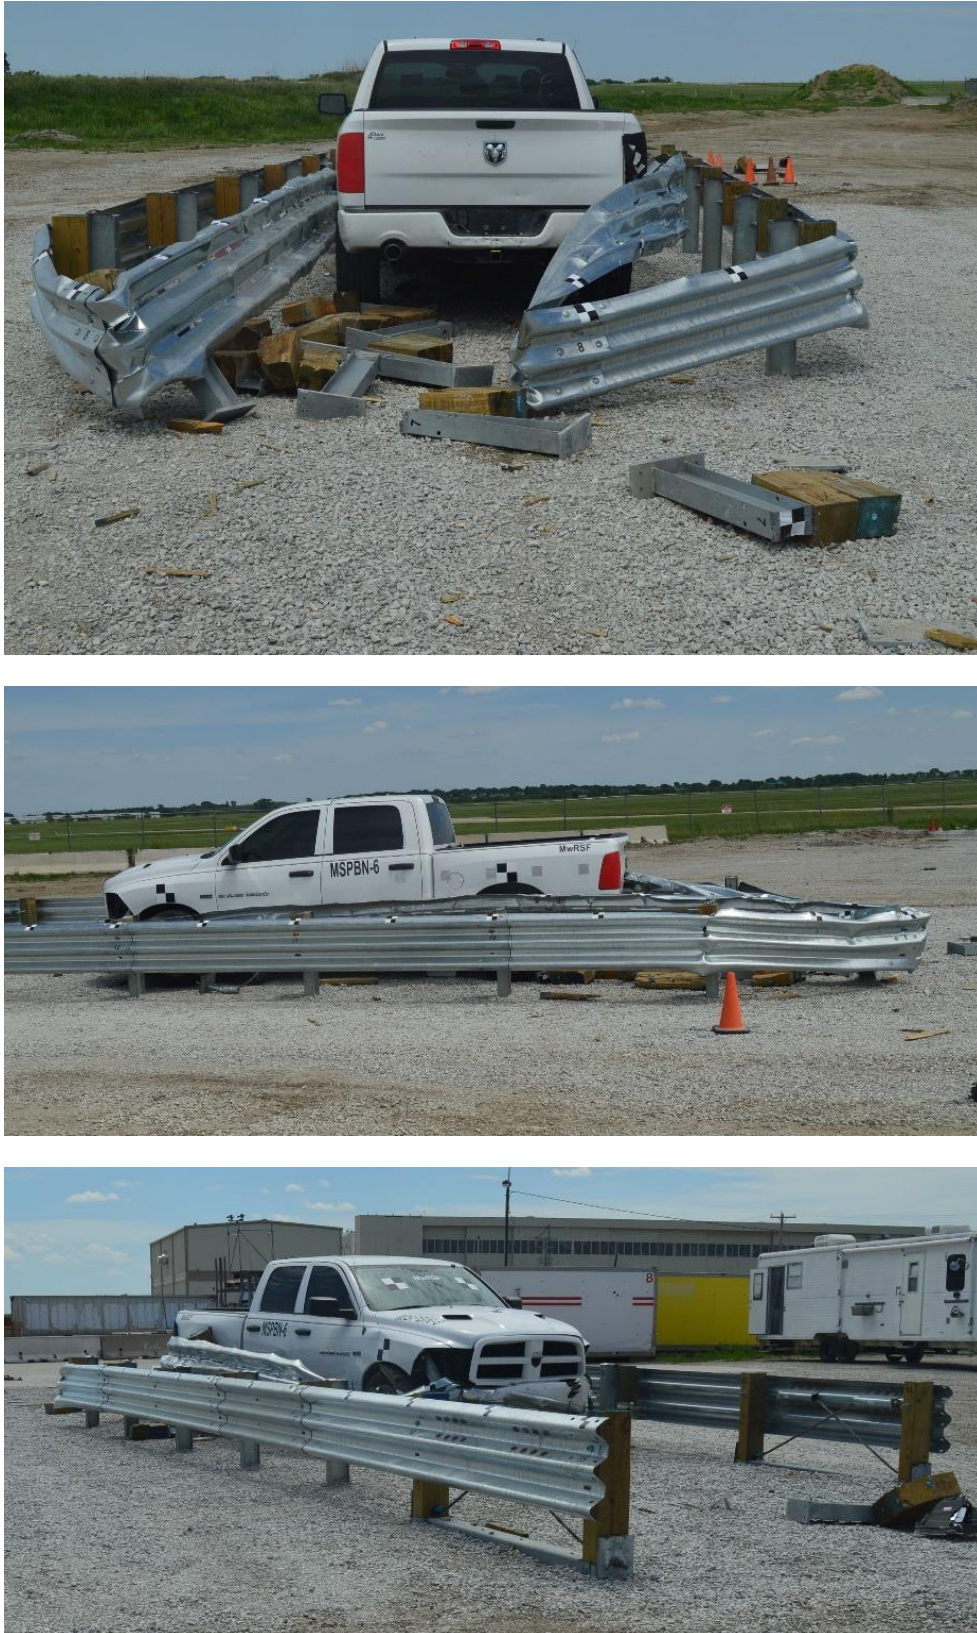
Figure 143. Overview of System Damage with Vehicle Present, Test No. MSPBN-6

The maximum longitudinal permanent set of the barrier system was 55 ft — 7 $\frac{7}{8}$ in. (17.0 m) at the centerline of the rail in the nose, as measured in the field. The maximum lateral permanent set of the barrier was interior to the system and was not reported. The maximum longitudinal dynamic barrier deflection was 55 ft — 11 in. (17.0 m) at the centerline of the barrier, as determined from high-speed digital video analysis. The maximum lateral dynamic barrier deflection was interior to the system and was not reported. The longitudinal working width of the system was found to be 56 ft — 5 in. (17.2 m), and the lateral working width was found to be 15 ft — 9 in. (4.8 m), as determined from high-speed digital video analysis. A schematic of the working width for test no, MSPBN-6 is shown in Figure 155.

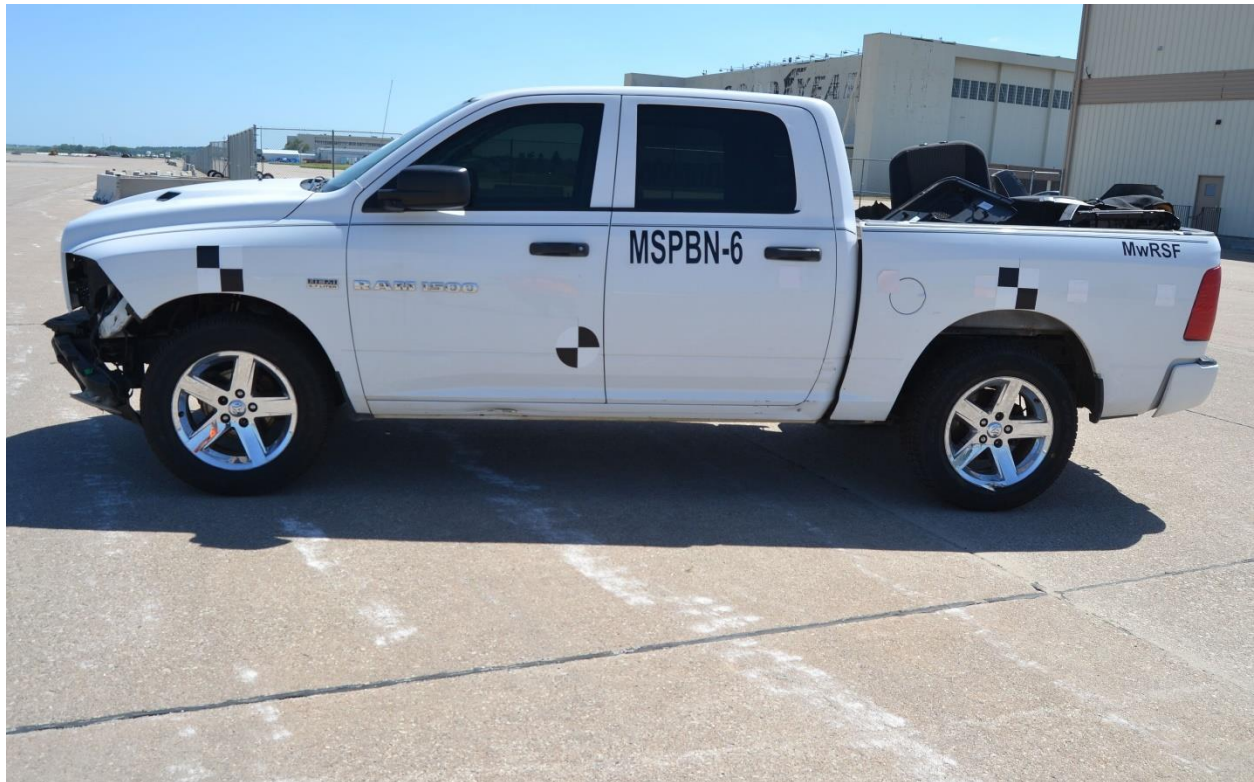
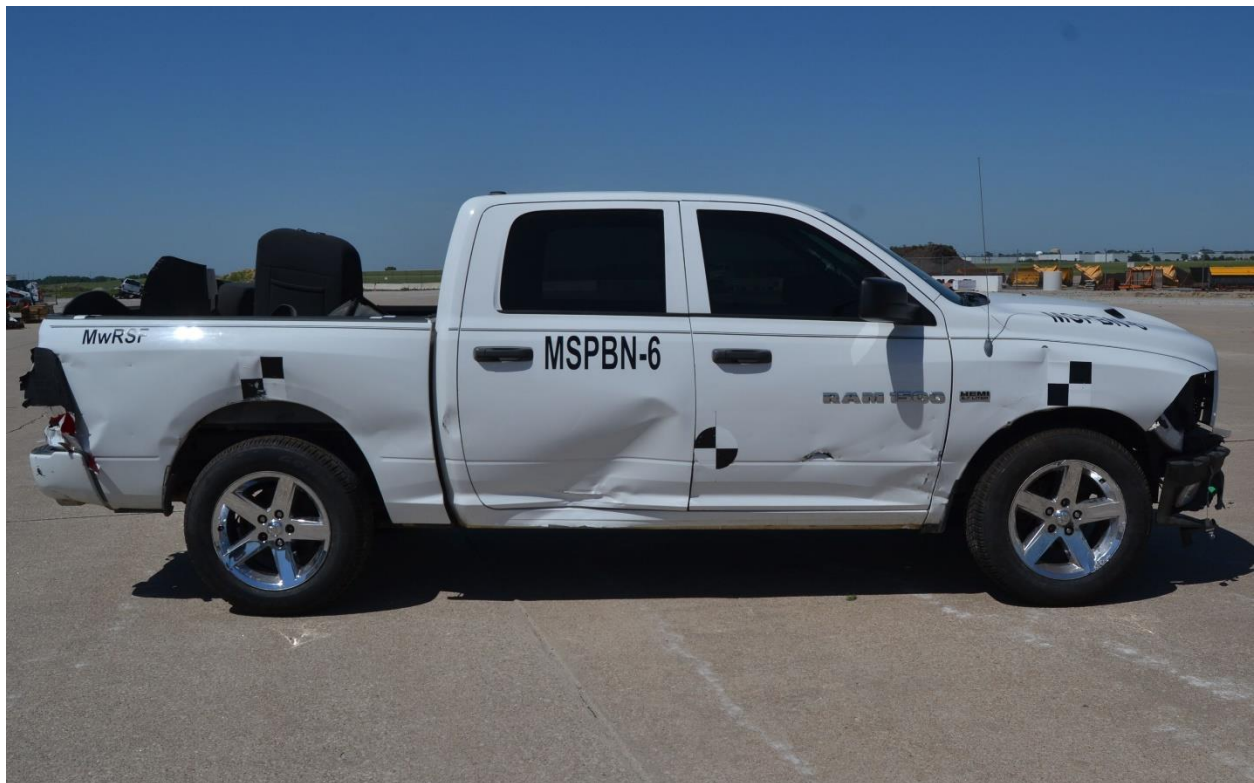
Figure 156. Vehicle Damage, Test No. MSPBN-6

The damage mainly occurred to the front and right side of the vehicle. The front bumper disengaged from the vehicle. An 8-in. (212-mm) long tear in the hood was observed. A 16-in. (406-mm) long by 5-in. (127-mm) deep dent was found in the right-front fender. The right-front door had a tear 6 in. (152 mm) long by 2¼ in. (57 mm) wide. A large dent 15 in. (381 mm) long by 11½ in. (292 mm) wide occurred on the right-front door. The right-rear door received a dent 38 in. (965 mm) long by 23 in. (584 mm) wide. Dents were also observed under the right-rear door and along the right side of the bed body. Damage to the suspension included a bent right-rear sway bar and damage due to rubbing of the front-right upper control arm. No damage was observed to the drivetrain or undercarriage. The windshield and side windows also remained undamaged.

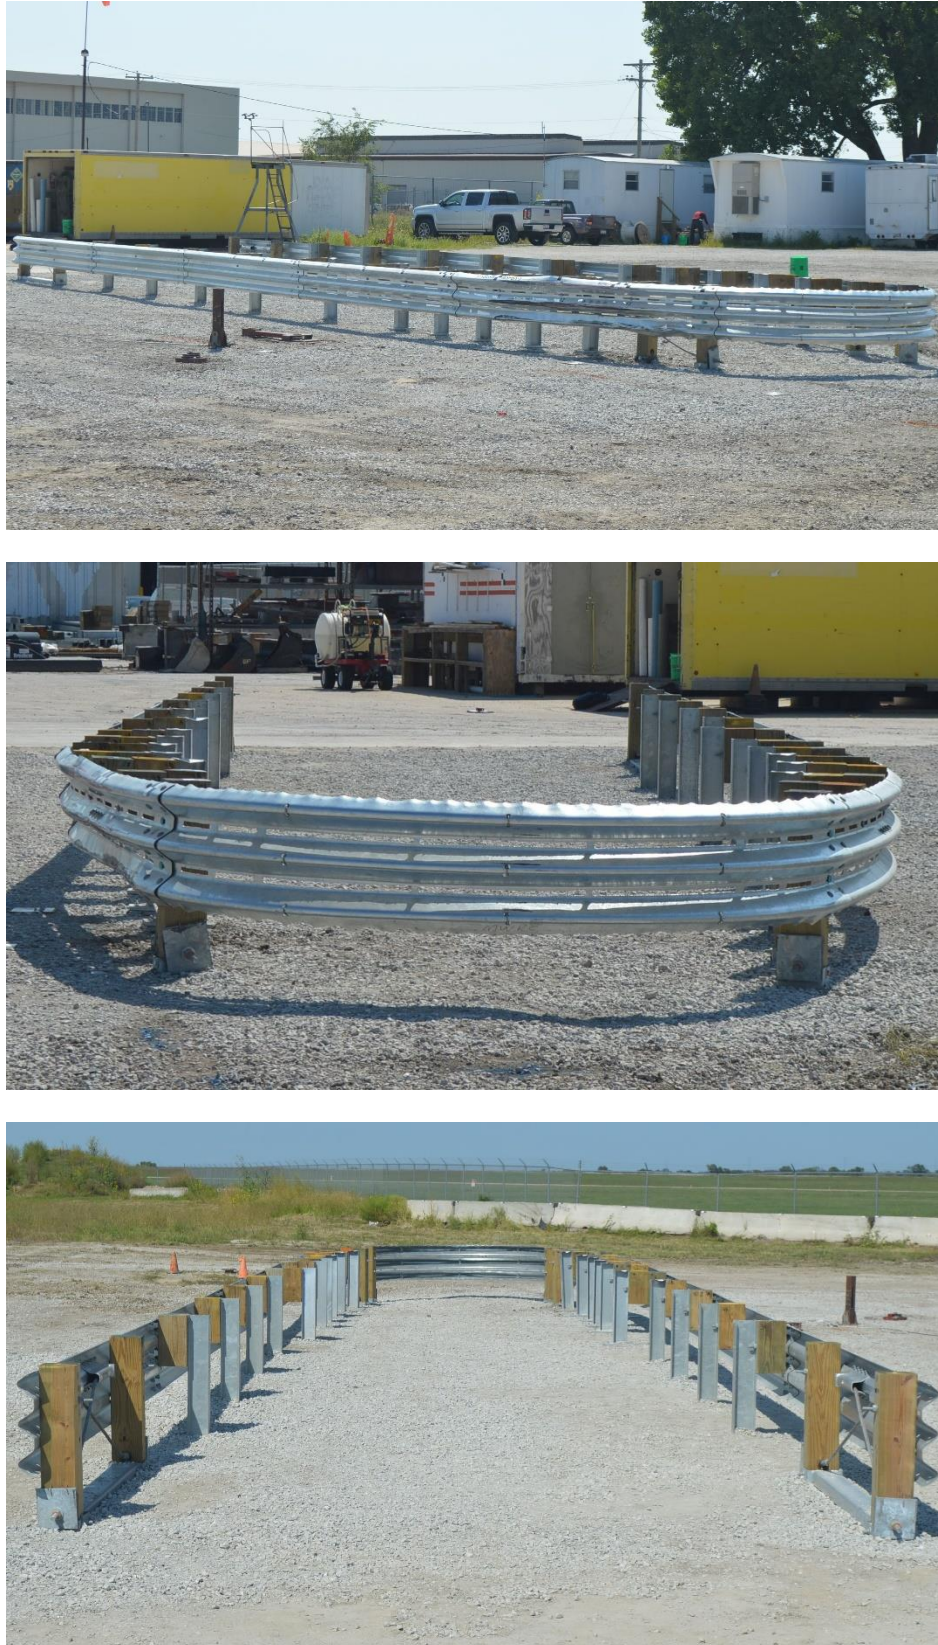
Figure 221. Overview of Damage to System, Test No. MSPBN-8

The maximum lateral permanent set of the barrier system was 2¾ in. (70 mm), which occurred at post no. A12, as measured in the field. The maximum lateral dynamic barrier deflection was 5.2 in. (132 mm) on the rail at post no. A12 as determined from high-speed digital video analysis. The working width of the system was found to be 177¼ in. (4,502 mm). A schematic of the initial and final positions is shown in Figure 225.

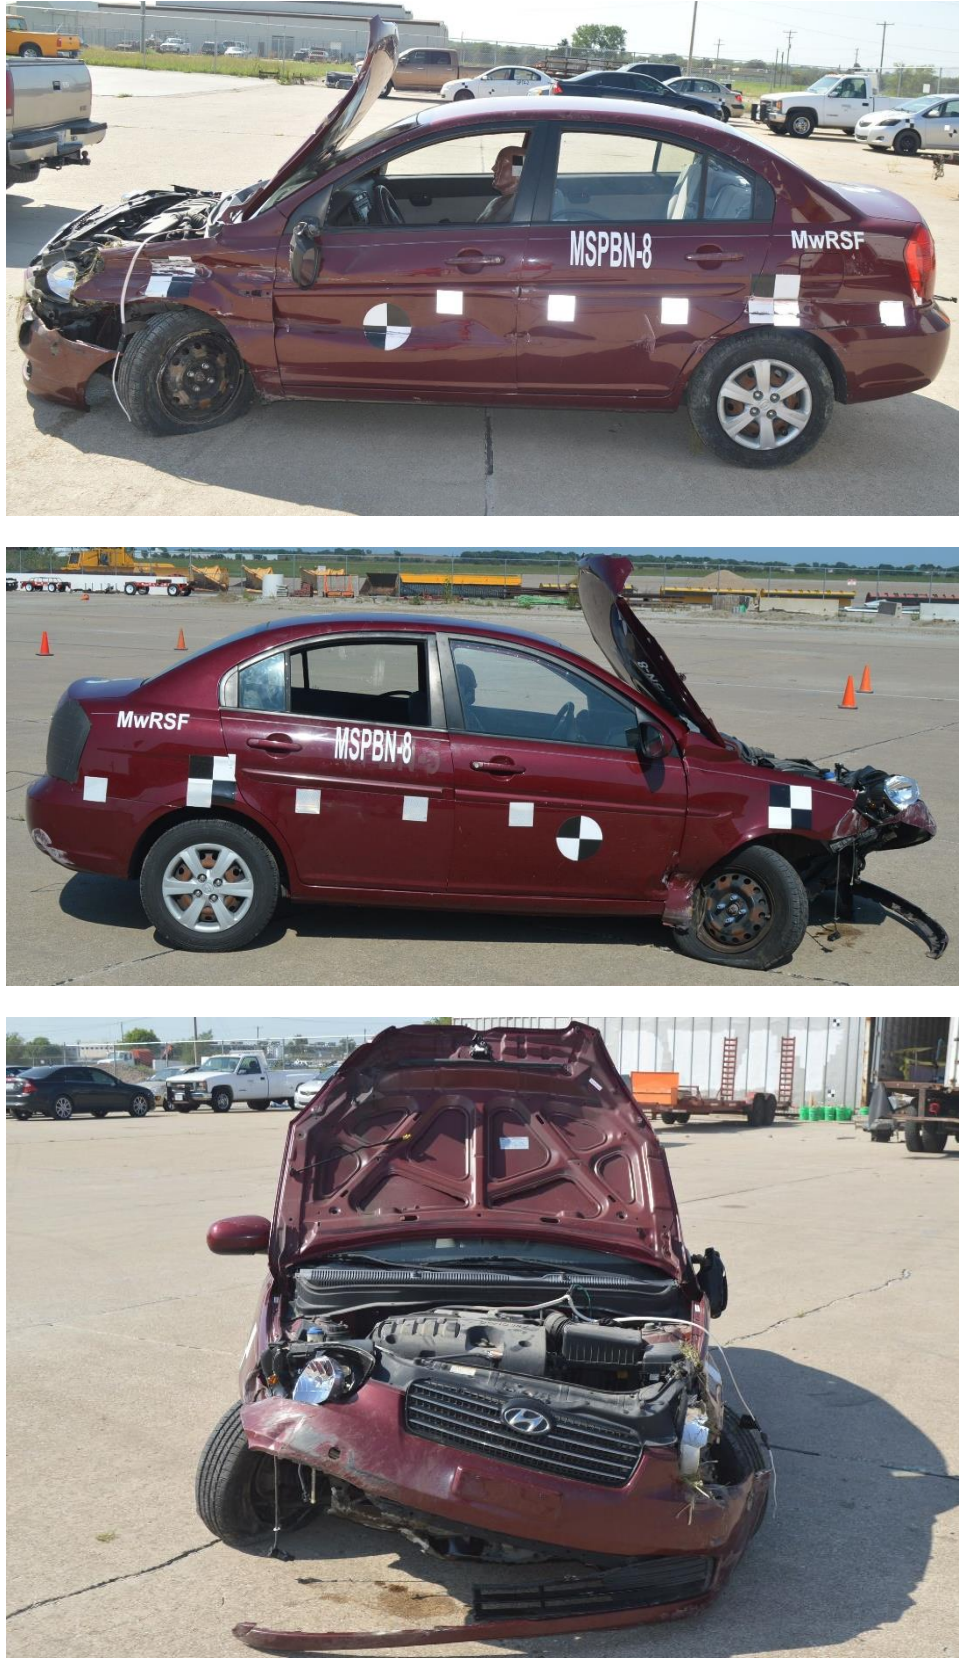
Figure 226. Vehicle Damage, Test No. MSPBN-8

Vehicle damage was minimal due to the primary impact and consisted mainly of crushing of the left-front vehicle structure and deformed sheet metal. Secondary impact damage was more extensive due to the impact with the concrete barrier and the subsequent roll onto the vehicle side. The damage to the vehicle is shown in Figure 226 through Figure 228. The maximum occupant compartment deformations are listed in Table 26 along with the deformation limits established in MASH 2016 for various areas of the occupant compartment. Note that none of the established MASH 2016 deformation limits were violated. Complete occupant compartment and vehicle deformations and the corresponding locations are provided in Appendix D.
