MGS WITH CURB AND OMITTED POST: EVALUATION TO MASH 2016 TEST NO. 3-11

MIDWEST ROADSIDE SAFETY FACILITY

MwRSF Research Report No. TRP-03-433-21

November 11, 2021

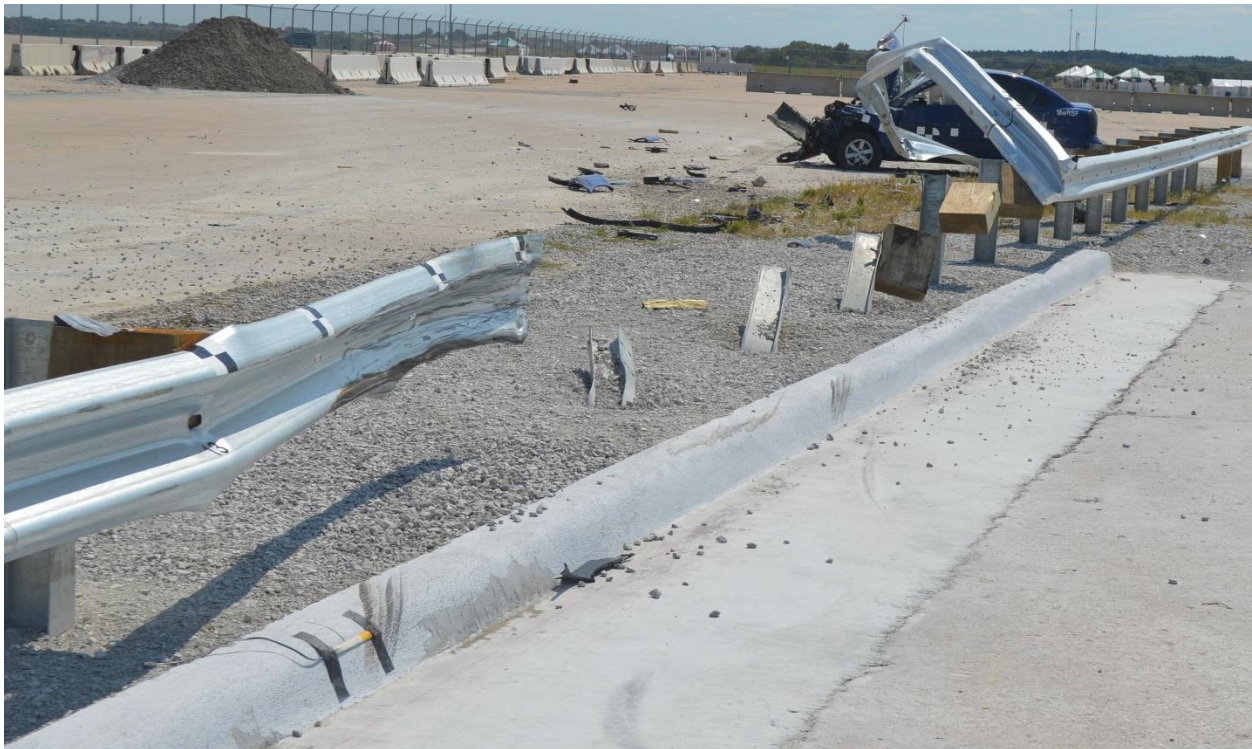
Figure 2. Rail Rupture Resulting from Test No. MGSCO-1

Following the successful evaluation of the MGS with an omitted post and the MGS adjacent to a curb, it was desired to evaluate the MGS in combination with both a curb and an omitted post. In 2017, the Midwest Pooled Fund sponsored a research project to conduct full-scale crash testing on the MGS with a curb and an omitted post according to the evaluation criteria of MASH TL-3. As in the previous curb tests, the guardrail was located 6 in. behind a 6-in. tall curb. During the first full-scale test, test no. MGSCO-1, the front of the 1100C small car wedged under the W-beam rail causing combined lateral and vertical loading to the guardrail [8]. Ultimately, the rail ruptured at the splice located within the elongated span, and the vehicle penetrated behind the system, as shown in Figure 2.

Subsequently, the system design was modified, and 37 ft – 6 in. of nested W-beam was incorporated around the omitted post location to prevent rail rupture. The nested rail was positioned to extend at least one post spacing upstream and downstream from the elongated span created by the omitted post. During test no. MGSCO-2, the modified system captured and redirected the 1100C vehicle without any observed rail tearing [8]. The vehicle remained stable and the occupant risk measures were within the MASH limits. Thus, test no. MGSCO-2 passed the safety performance criteria of MASH test designation no. 3-10.

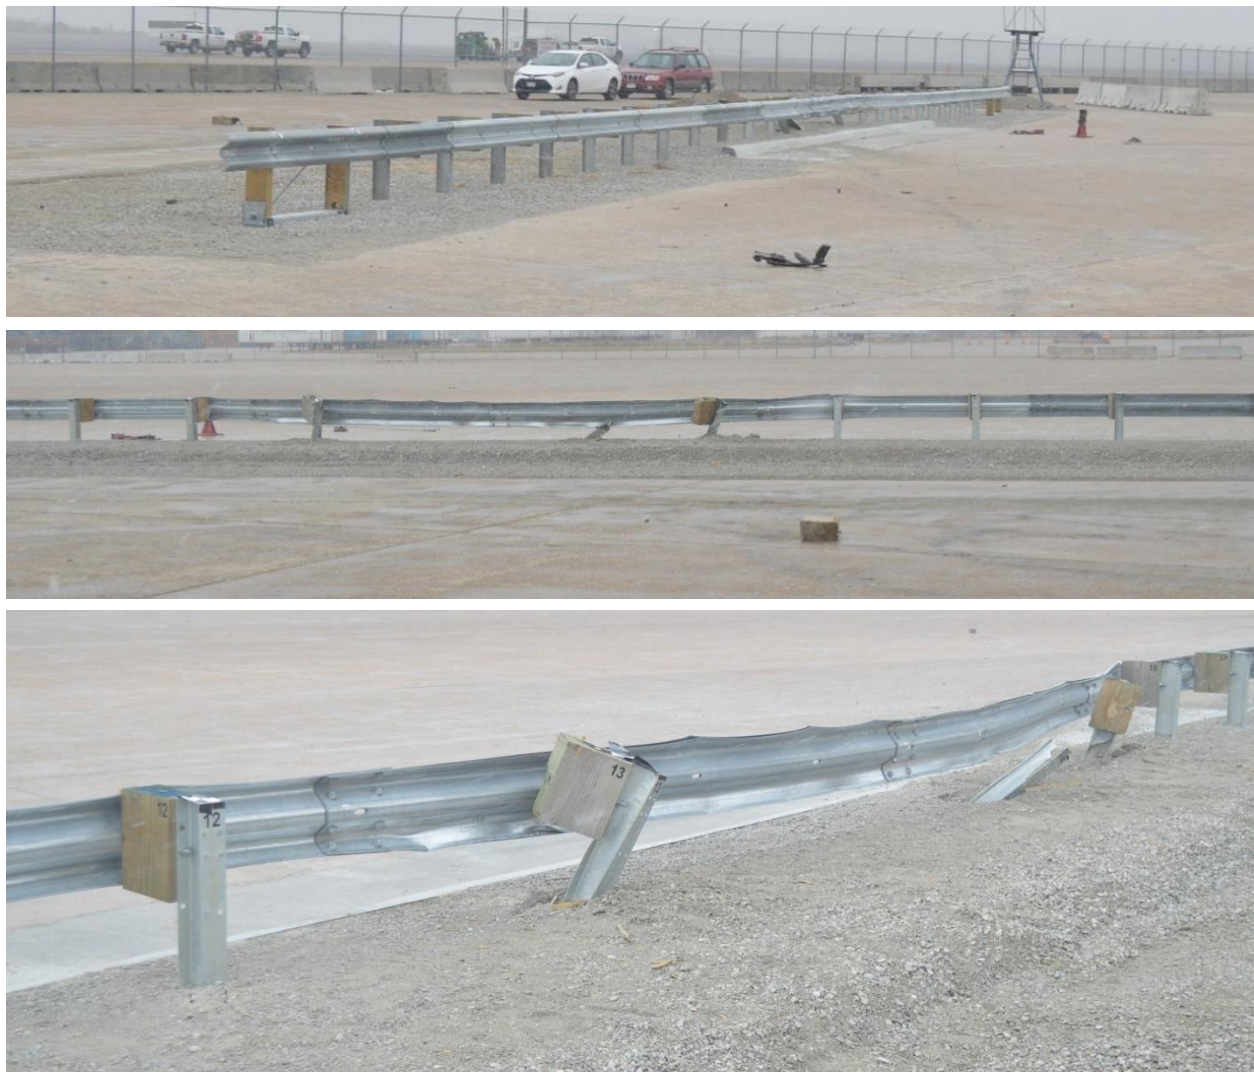
Figure 29. System Damage, Test No. MGSCO-4

Damage to the barrier was moderate, as shown in Figures 29 through 35. Barrier damage consisted of contact marks along with deformed W-beam rail, posts, post-to-rail attachment hardware, and timber blockouts. The length of vehicle contact along the rail was approximately 28 ft – 9 in., which spanned from 29 in. downstream from the center of post no. 12 to 4 in. downstream from the center of post no. 16.

At the upstream anchorage, post no. 2 had bolt pullout from the rail and the timber post fractured through the bottom hole. Post nos. 3 through 11 twisted clockwise. The guardrail was detached from post nos. 12 through 16 and the blockout detached from post no. 14. There were numerous kinks and dents on the W-beam rail between post nos. 12 and 16. Soil heaves and craters formed at the base of post nos. 12 through 16. Post nos. 12 and 13 rotated backward and twisted clockwise. Post no. 14 rotated downstream and twisted counterclockwise and the front flange buckled. Post no. 15 twisted counterclockwise and bent backward and downstream. Post no. 16 bent backward.

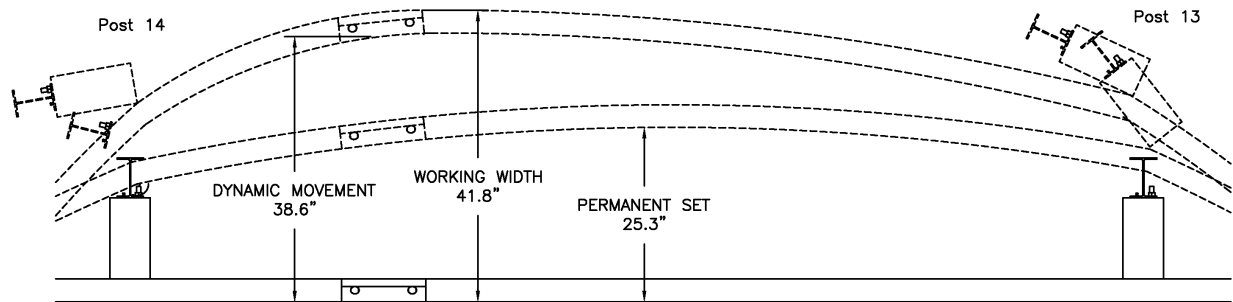
Figure 34. Permanent Set, Dynamic Deflection, and Working Width, Test No. MGSCO-4

The permanent set of the barrier system was measured in the field using GPS. The maximum lateral permanent set, inclusive of both guardrail and post deflections, was 25.3 in. at the midspan between post nos. 13 and 14. The maximum lateral dynamic barrier deflection was 38.6 in. at the splice upstream from post no. 14. This was determined from high-speed digital video analysis and included deformation of the MGS along the top surface. The working width of the system was found to be 41.8 in., also determined from high-speed digital video analysis. A schematic of the permanent set deflection, dynamic deflection, and working width is shown in Figure 34.

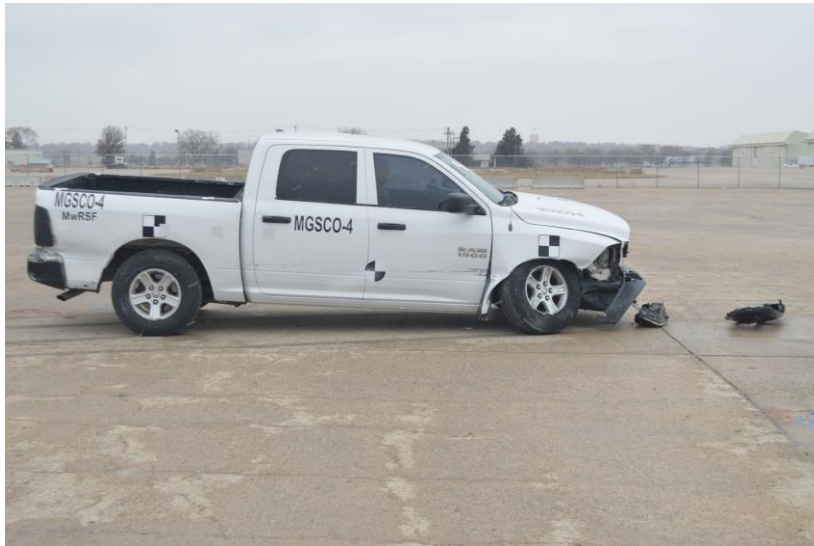
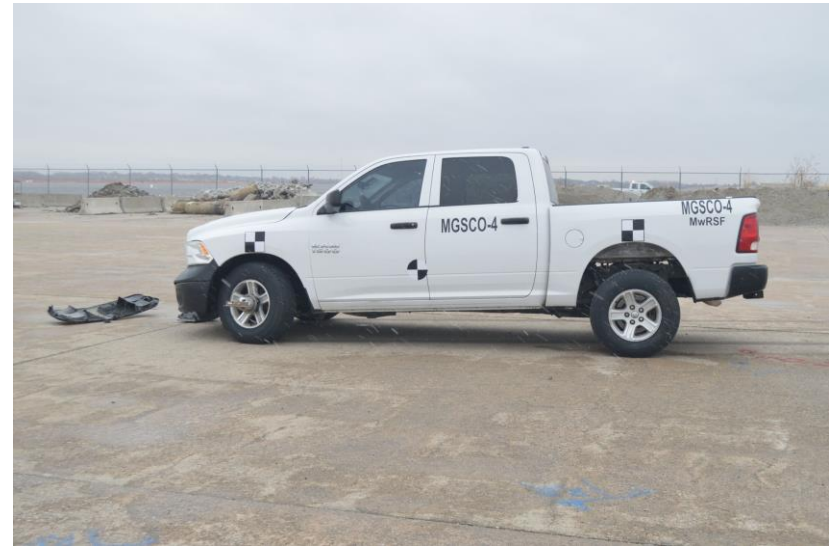
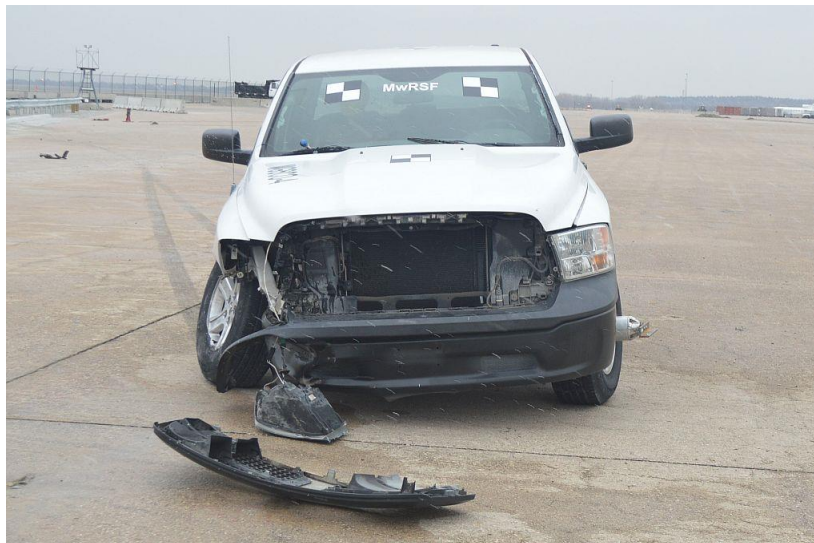
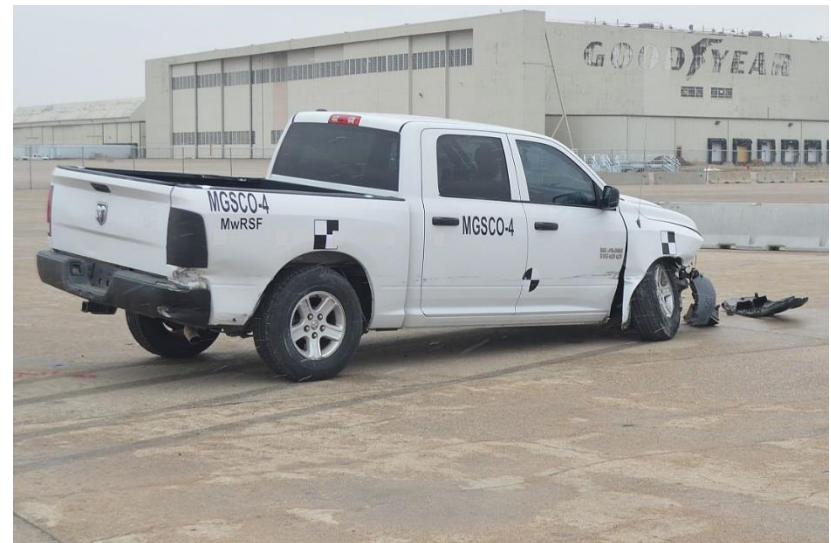
Figure 35. Vehicle Damage, Test No. MGSCO-4

The damage to the vehicle was moderate, as shown in Figures 35 through 37. The maximum occupant compartment intrusions are listed in Table 6 along with the intrusion limits established in MASH for various areas of the occupant compartment. Complete occupant compartment and vehicle deformations and their corresponding locations are provided in Appendix D. MASH defines intrusion or deformation as the occupant compartment being deformed and reduced in size with no observed penetration. There were no penetrations into the occupant compartment, and none of the established MASH deformation limits were violated. Outward deformations, which are denoted as negative numbers in Appendix D, are not considered crush toward the occupant.

The majority of damage was concentrated on the right-front corner where the impact occurred as well as the front of the vehicle. The grille and right headlight disengaged from the vehicle. The right-front bumper was dented inward, and the right-front corner of the bumper was deformed and partly disengaged. The right-front fender panel was deformed outward. Part of the right-front tire rim was chipped off. Contact marks and scratches were observed throughout the right side of the vehicle. Both right-side doors were deformed slightly. The right-rear corner of the truck was dented below the taillight and on the rear bumper. The roof, windshield, and window glass remained undamaged.

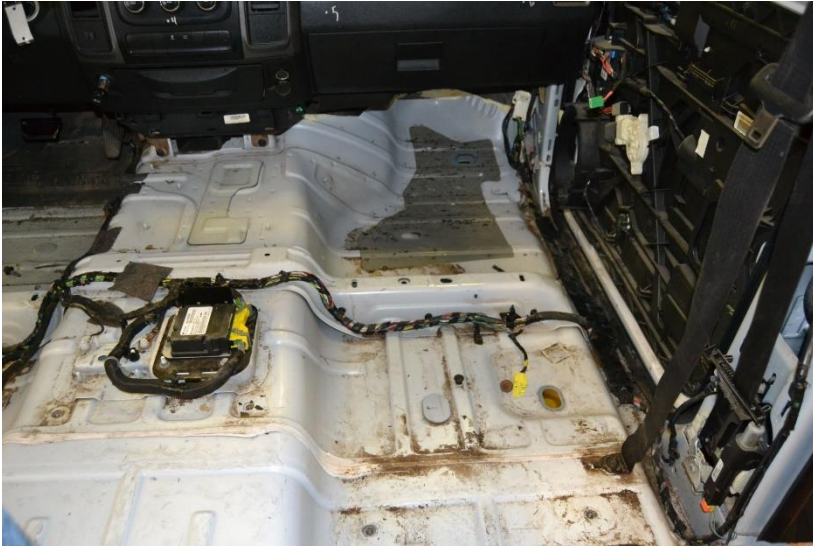
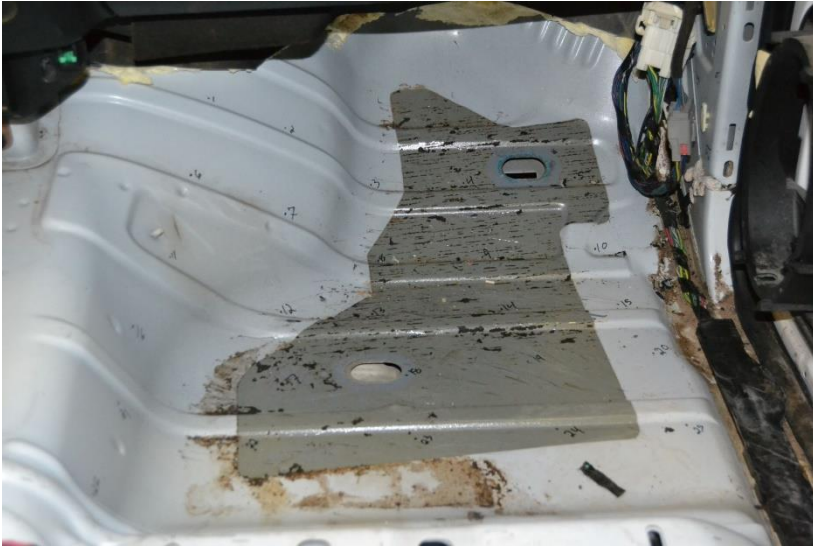
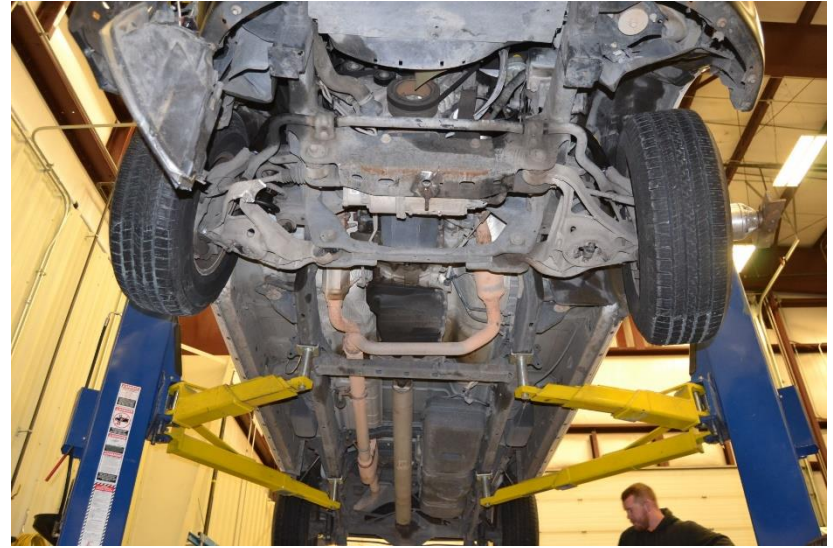
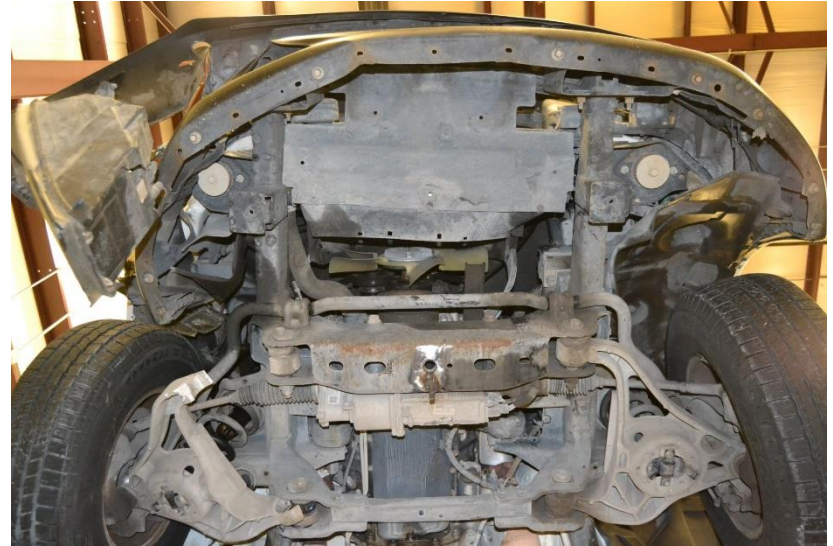
Figure 37. Occupant Compartment and Undercarriage Damage, Test No. MGSCO-4

Undercarriage damage was minimal. The right-front shock was bent outward and toward the rear of the vehicle. The right-front sway bar linkage was disconnected. The right lower control arm was disconnected and broken at the cross member mounts. The right outer tie rod was bent. Additionally, the right side steering knuckle assembly and steering gear box had minor scraping.
