## **DYNAMIC TESTING AND EVALUATION OF CULVERT-MOUNTED, STRONG-POST MGS TO TL-3 GUIDELINES OF MASH 2016**

### **MIDWEST ROADSIDE SAFETY FACILITY**

MwRSF Research Report No. TRP-03-383-20-R1

November 2, 2020

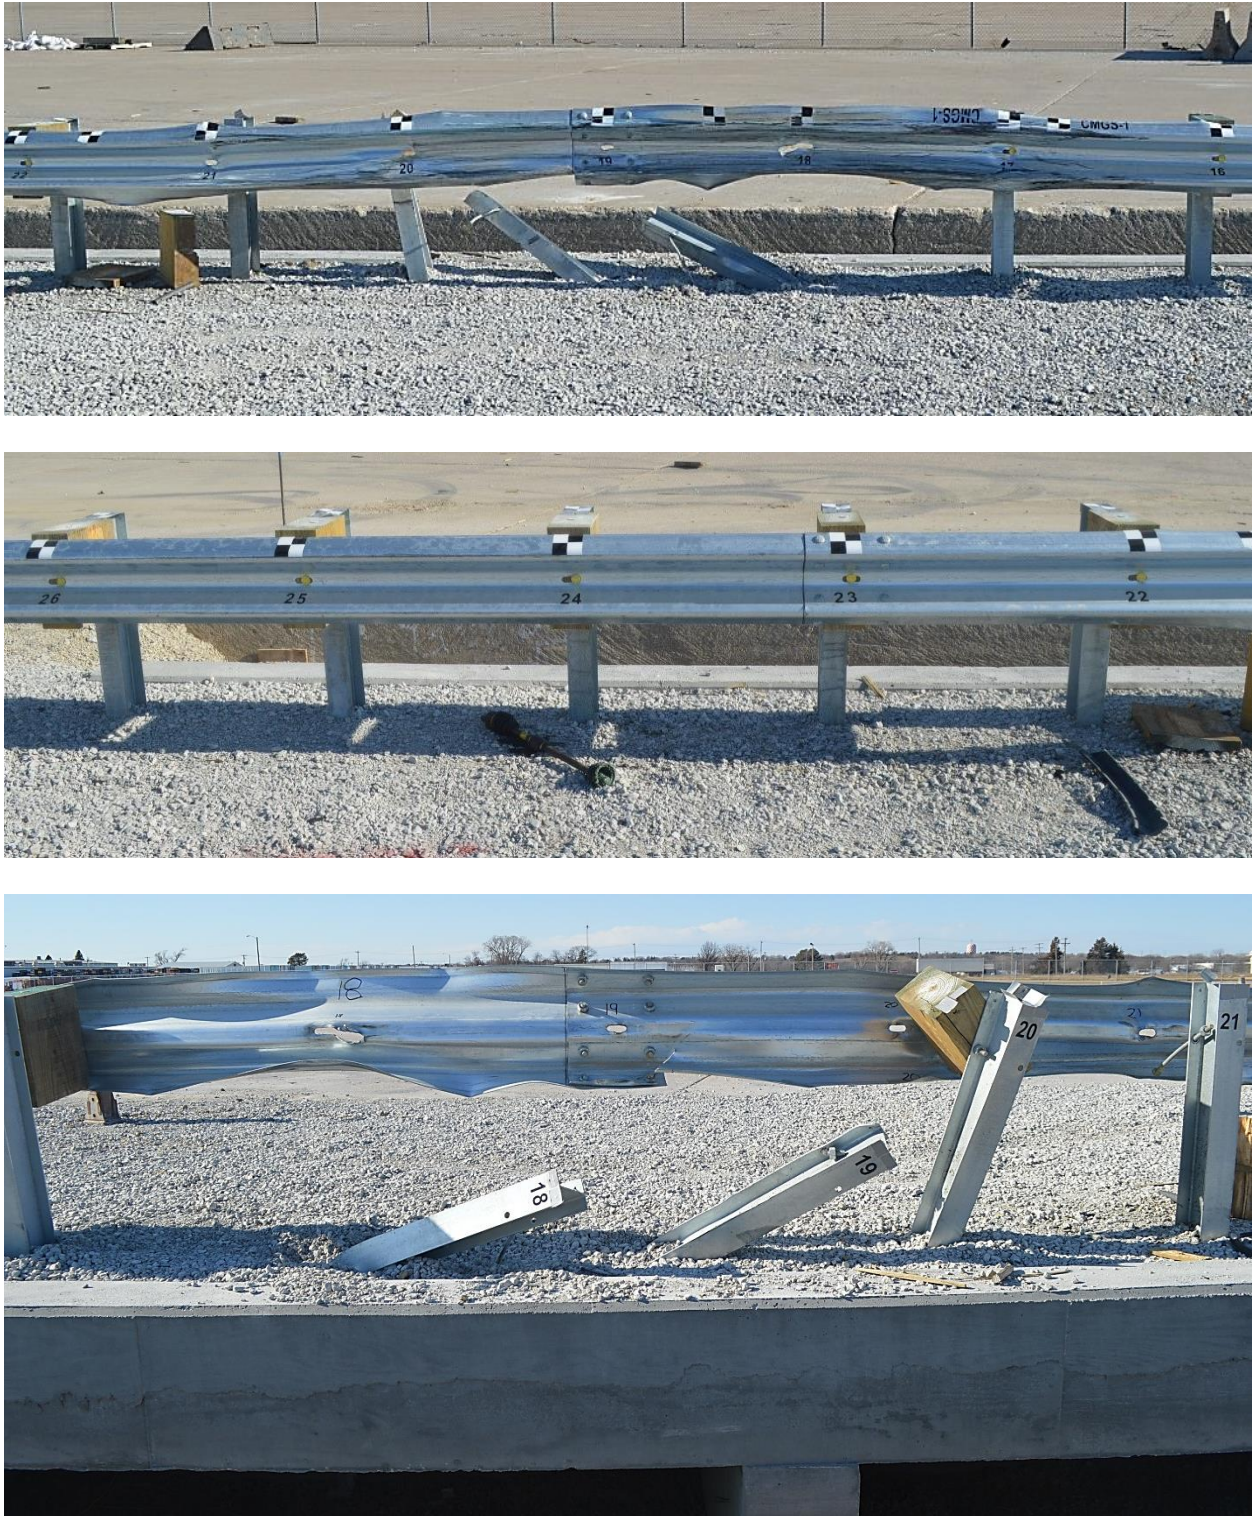
Figure 60. System Damage, Test No. CMGS-1

Following the test, the soil on top of the culvert headwall was removed for inspection of the damage to the posts and base plates as well as to review any potential damage to the culvert. Deformation of the post base plates was observed on post nos. 17 through 21. Minor cracking was observed on the weld at the front flange of the base plate of post no. 17. The upstream side of the front flange of post no. 18 was torn up to the web near the base plate weld. All anchorage bolts and epoxied threaded rods were intact and remained secure, although some minor deformation of the bolts and rods was observed. No damage was observed to the concrete culvert slab or the headwall.

The maximum lateral permanent set of the barrier system was 11 $\frac{7}{8}$  in. (302 mm), which occurred at the back of post no. 18, as measured in the field. The maximum lateral dynamic deflection was 12 in. (305 mm) at post no. 18, as determined from high-speed digital video analysis. The working width of the system was 33.1 in. (842 mm) at post no. 18, also determined from high-speed digital video analysis. A schematic of the permanent set, dynamic deflection, and working width is shown in Figure 67.

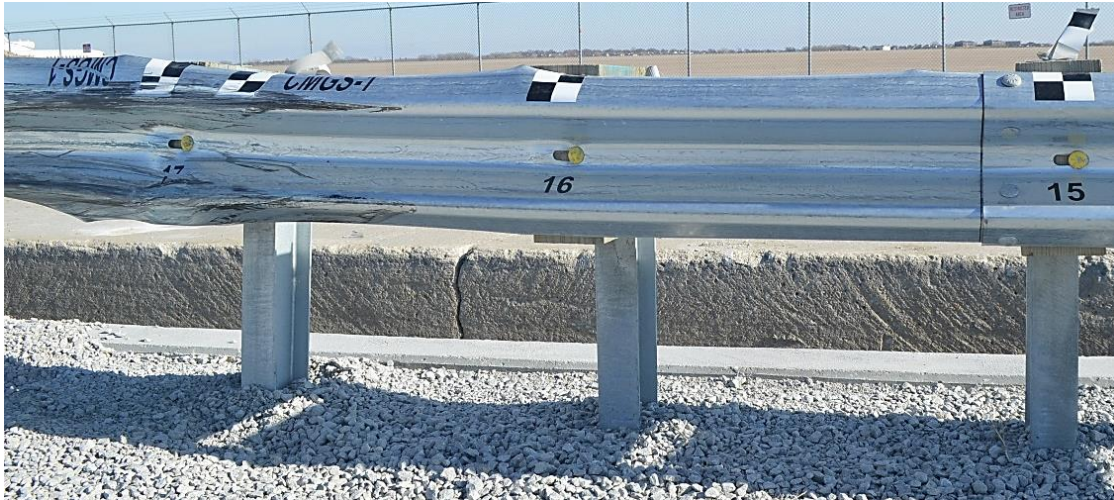
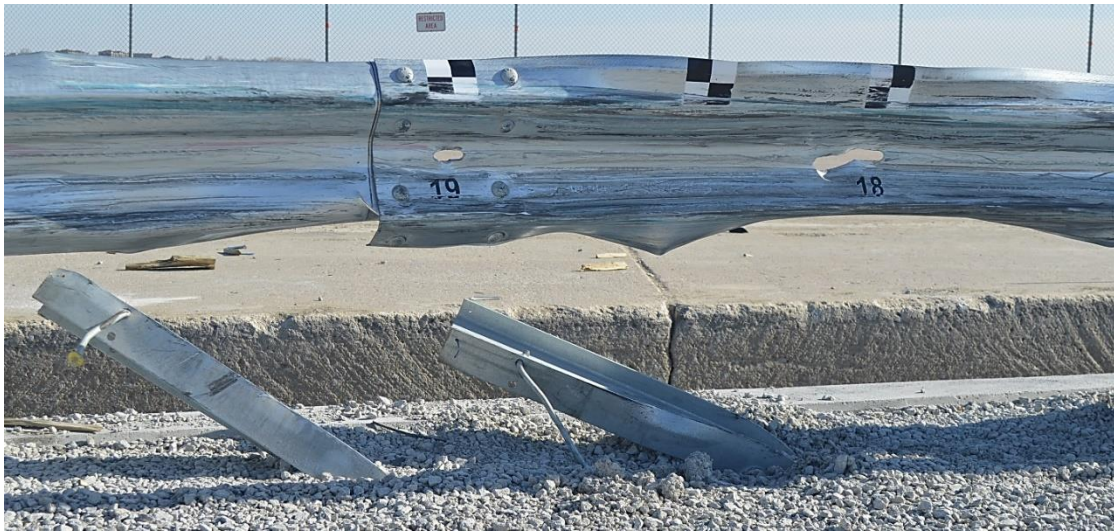
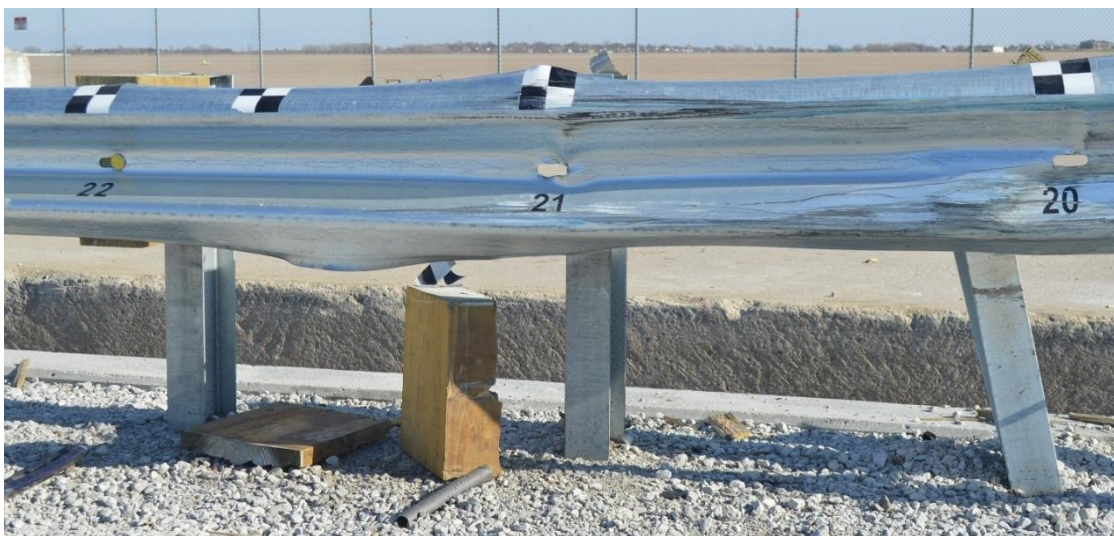
Figure 61. Damage to Post Nos. 15 through 22, Test No. CMGS-1

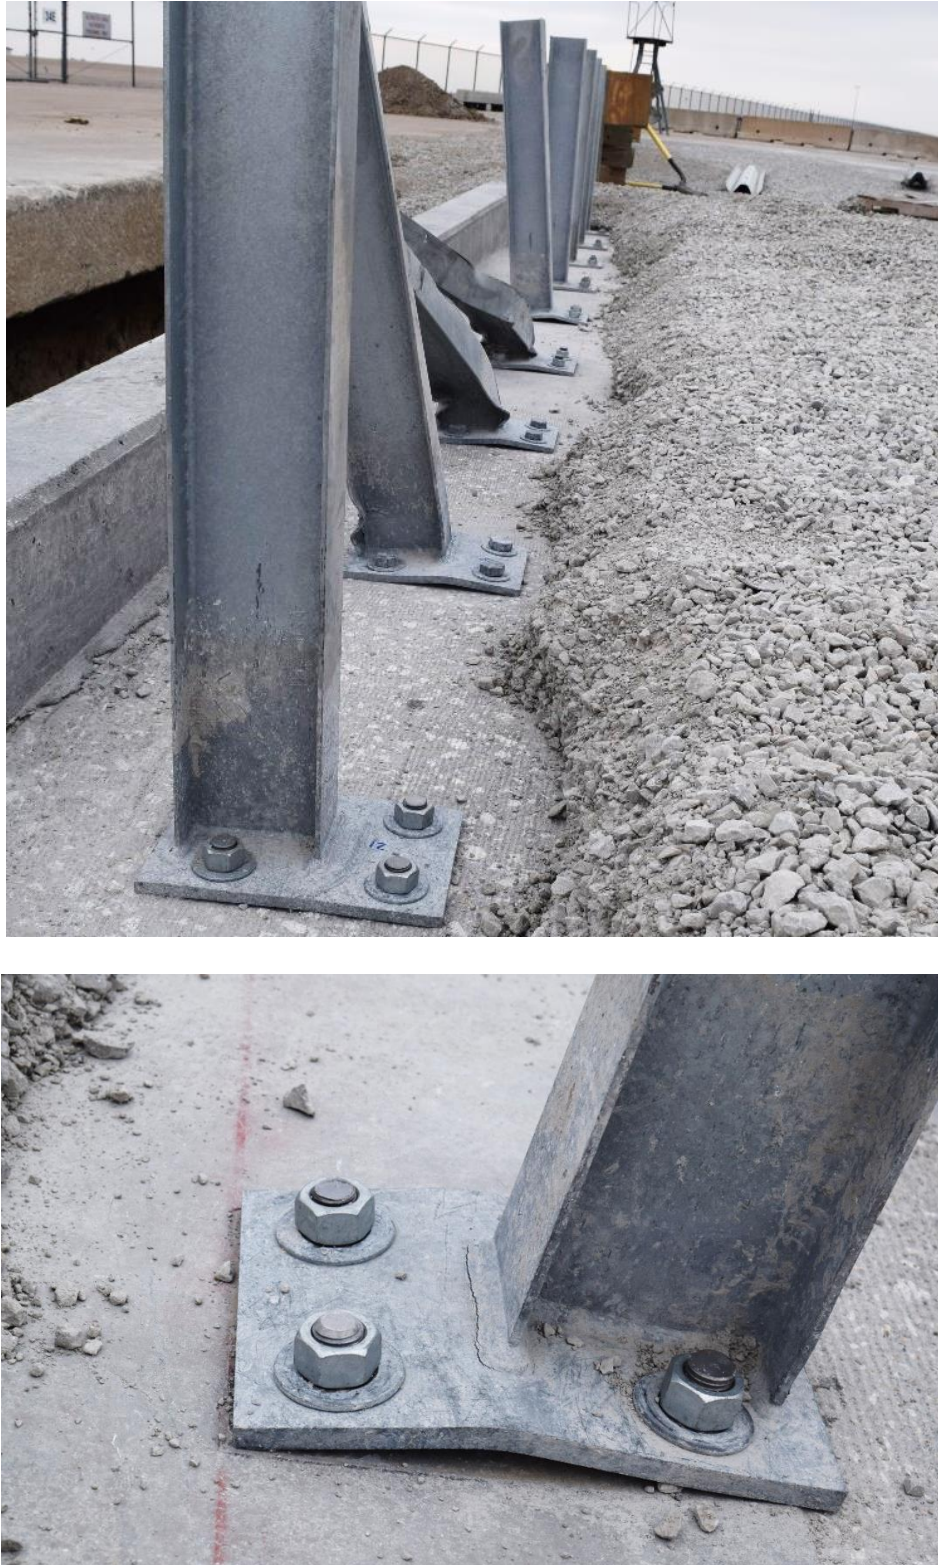
Figure 62. Damage to Post and Base Plate Nos. 17 through 21 (After Removal of Soil Fill Post and Base), Test No. CMGS-1

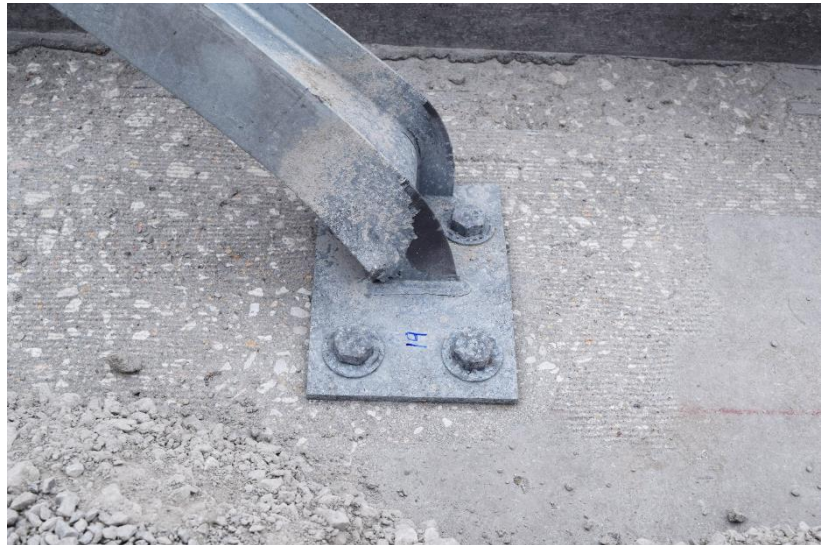
Figure 63. Damage to Post and Base Plate Nos. 18 and 19, Test No. CMGS-1

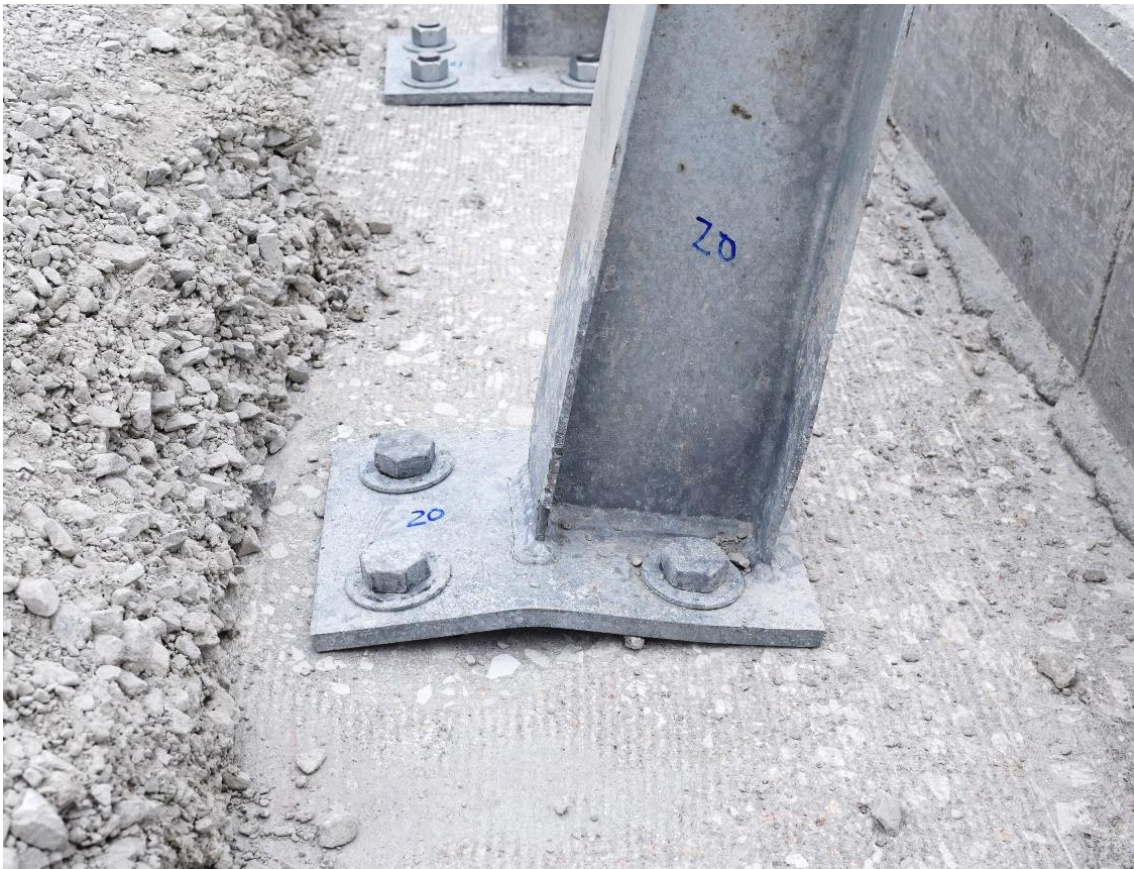
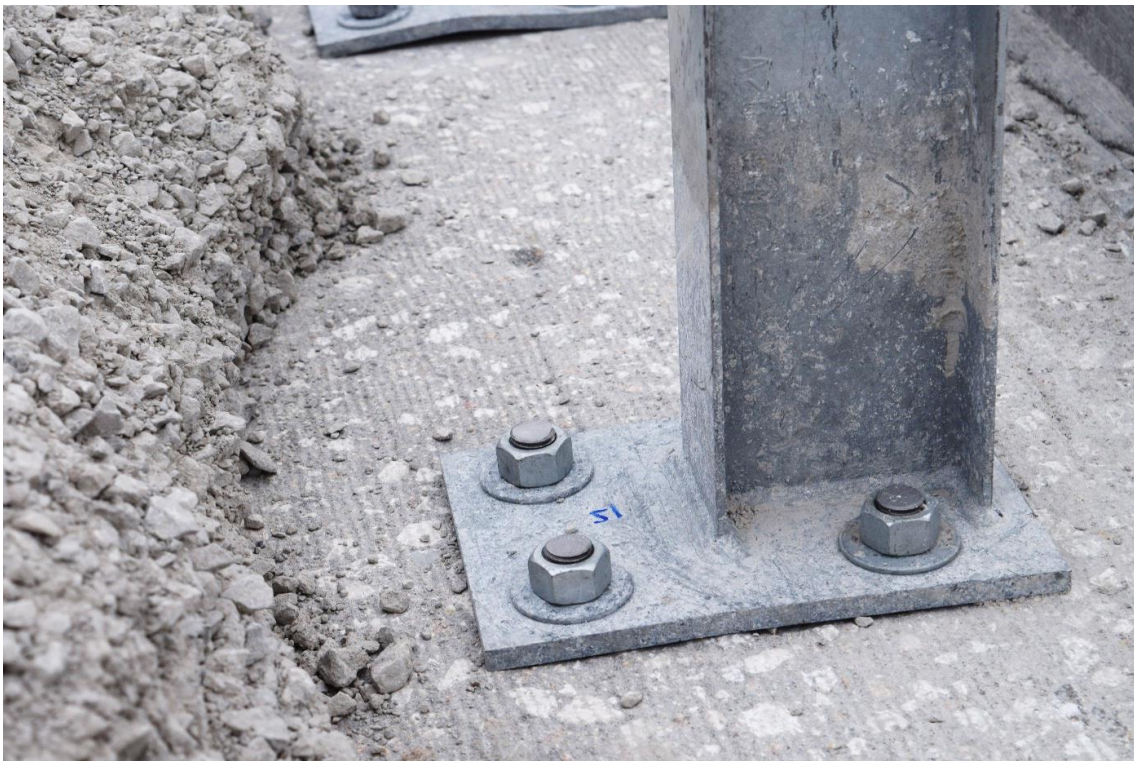
Figure 64. Damage to Post and Base Plate No. 21, Test No. CMGS-1

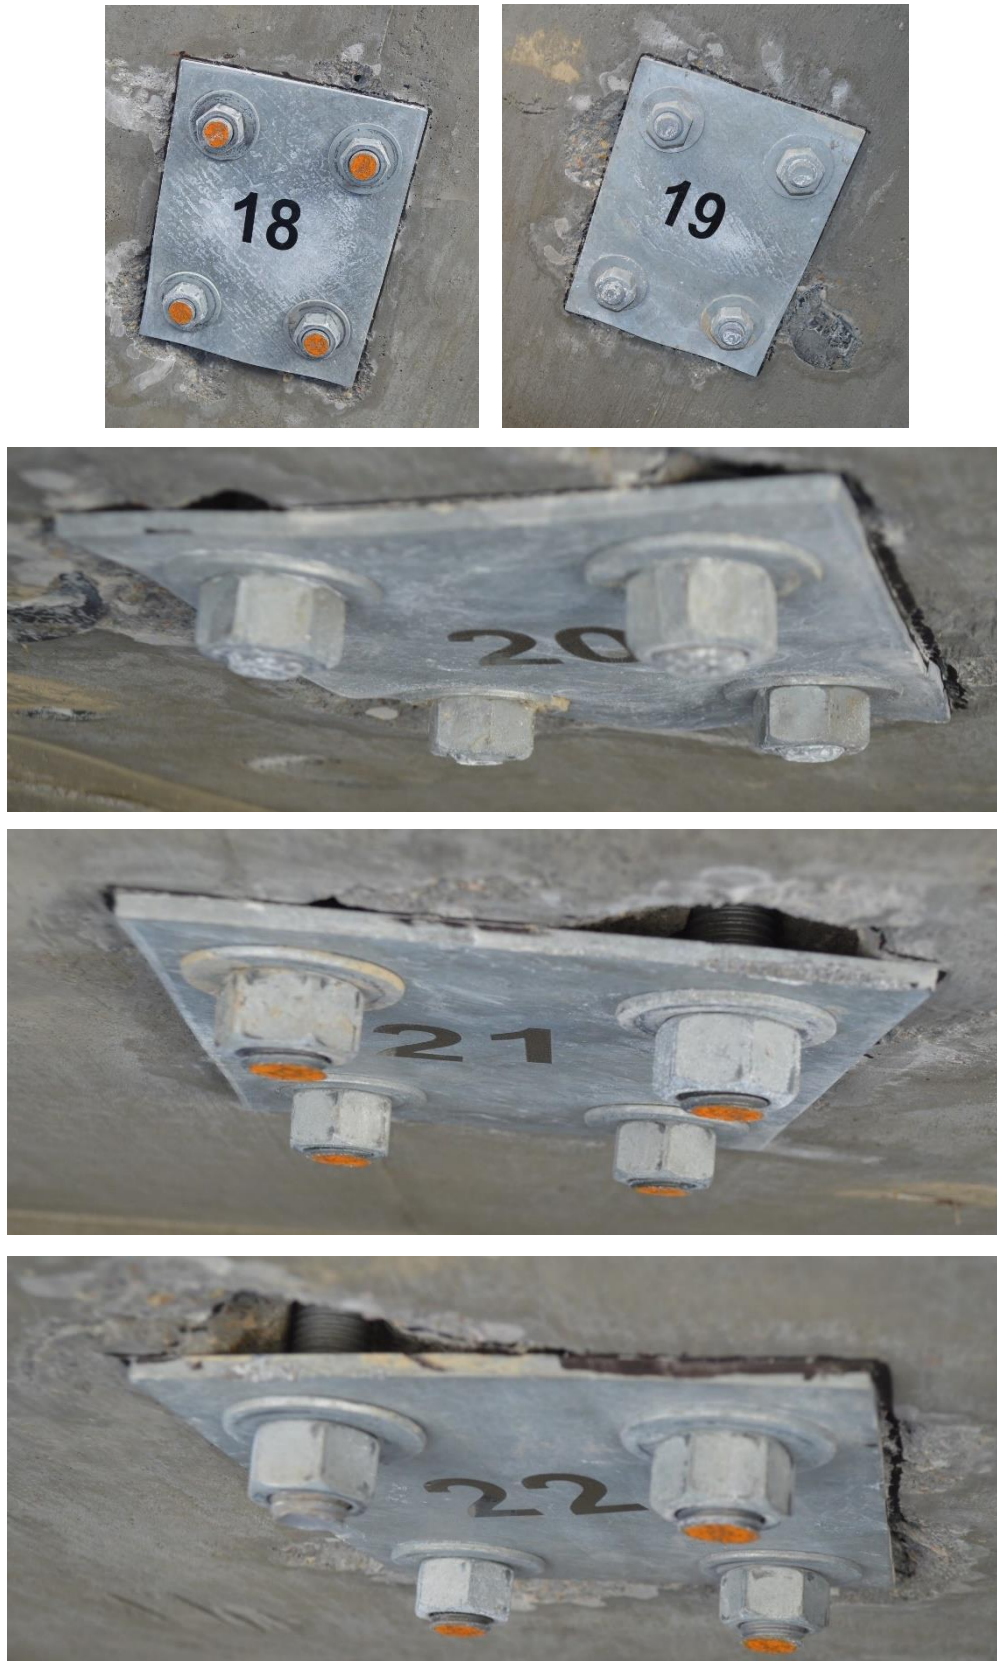
Figure 65. Washer Plate Nos. 18 through 22 After Test, Test No. CMGS-1

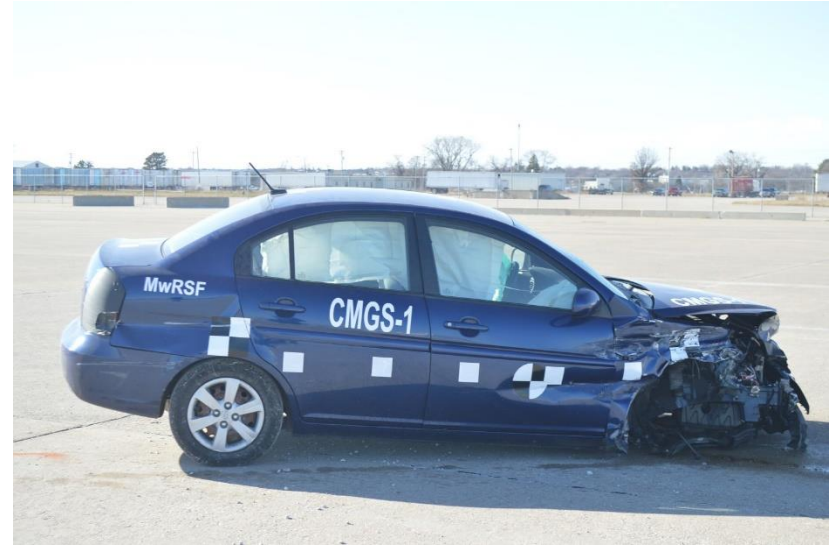
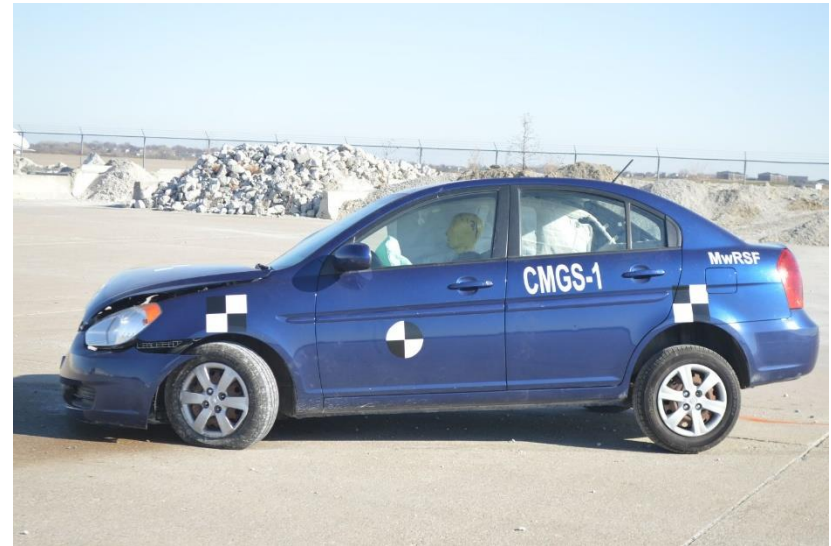
Majority of the vehicle damage was concentrated on the right-front corner, where primary impact occurred. The right-front wheel contacted post nos. 18 and 19 and was disengaged, and the left-front tire was deflated. The right corner of the hood buckled. The side and front airbags on both the passenger and driver side deployed, which caused the windshield on the passenger side to shatter but remain intact. The right-rear quarter panel was crushed inward.

The roof, the left side, and the rear of the vehicle remained undamaged. The left-side and rear window glass also remained undamaged. The front right strut broke at the weld point on the top of the gas cylinder, and only the top portion of the shock absorber was still intact. The right-side wheel hub attachment point detached from the steering rack, and the tie rod was bent. The right-front brake assembly disengaged from the car. There was no damage to the vehicle's frame, rear suspension, or rear shocks and springs.

Figure 68. Vehicle Damage, Test No. CMGS-1

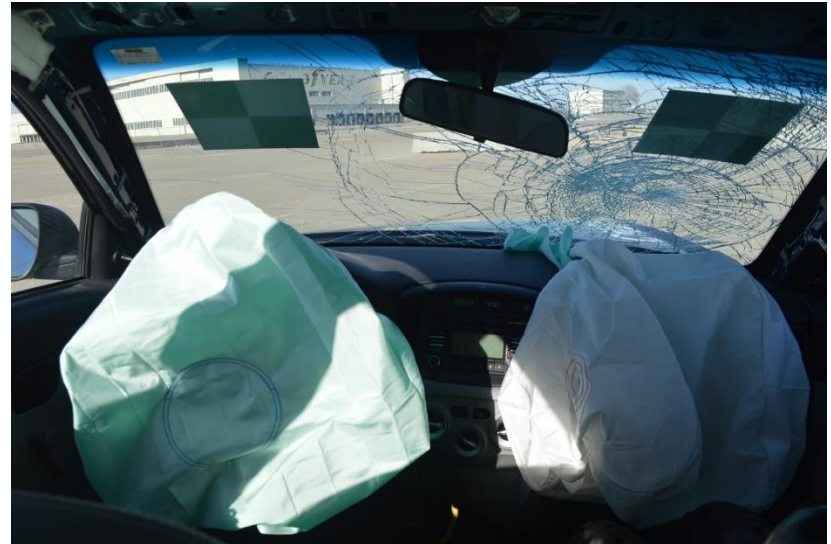
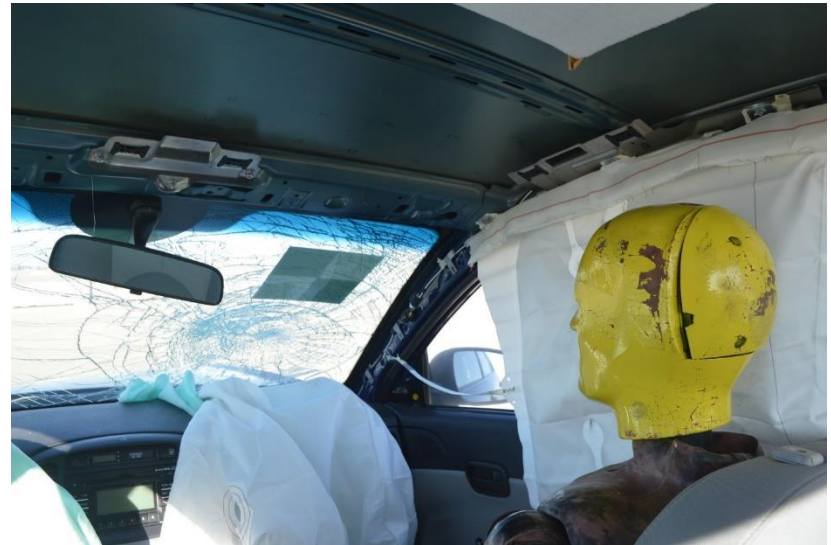
Figure 69. Additional Vehicle Damage, Test No. CMGS-1

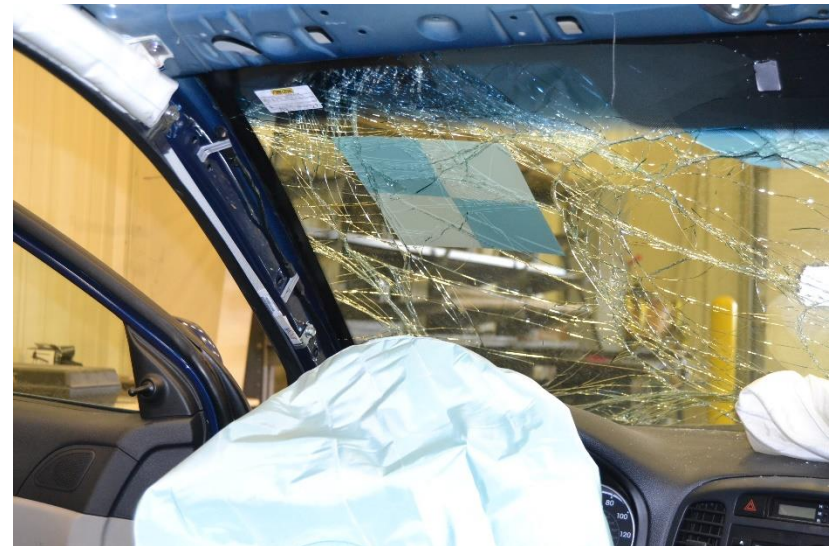
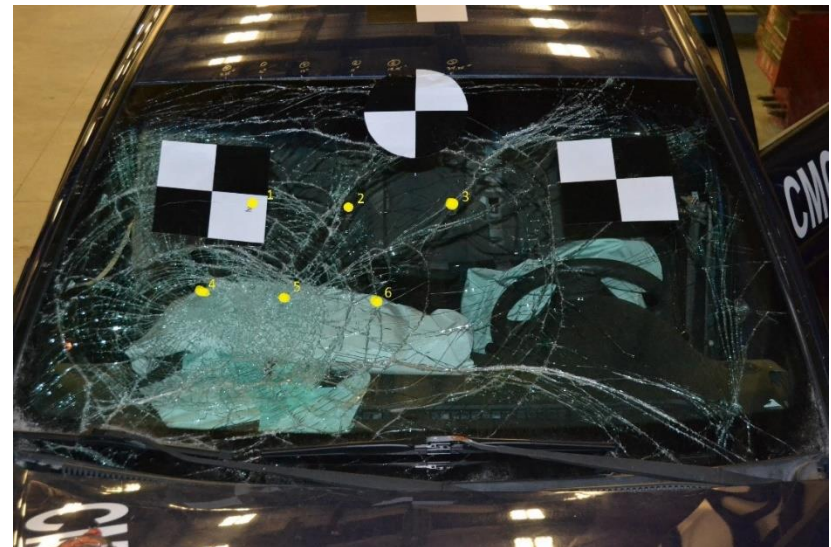
Figure 70. Vehicle Windshield Damage, (a) on Test Site on Test Day, (b) in Vehicle Shop Prior to Measurement, Test No. CMGS-1

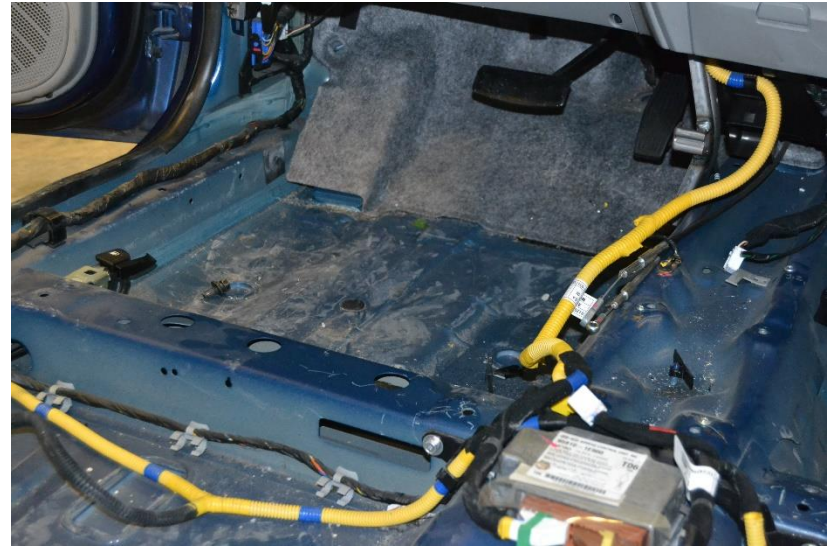
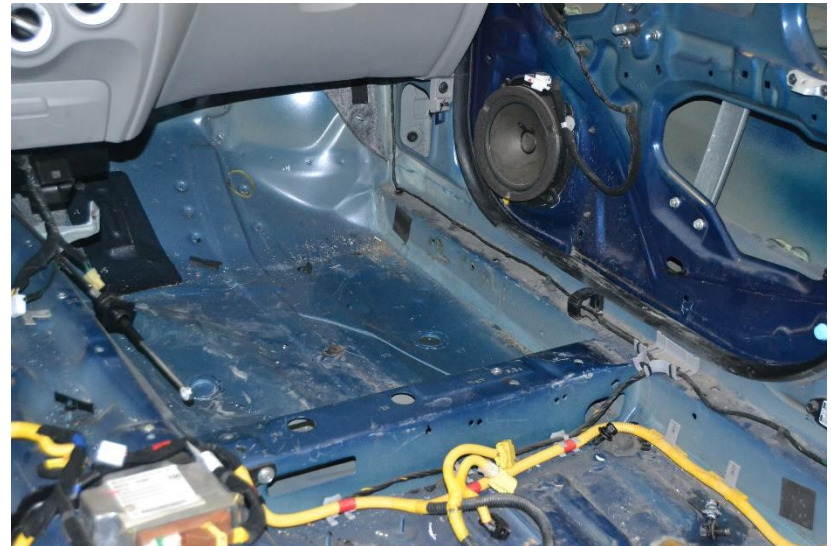
Figure 71. Occupant Compartment Damage, Test No. CMGS-1

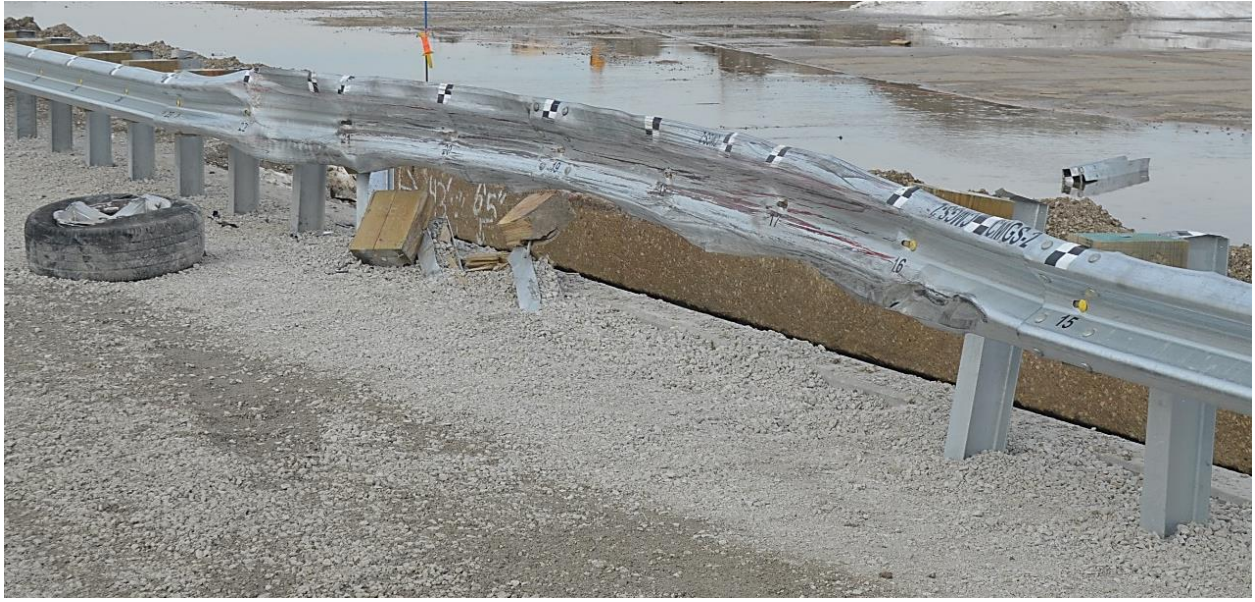
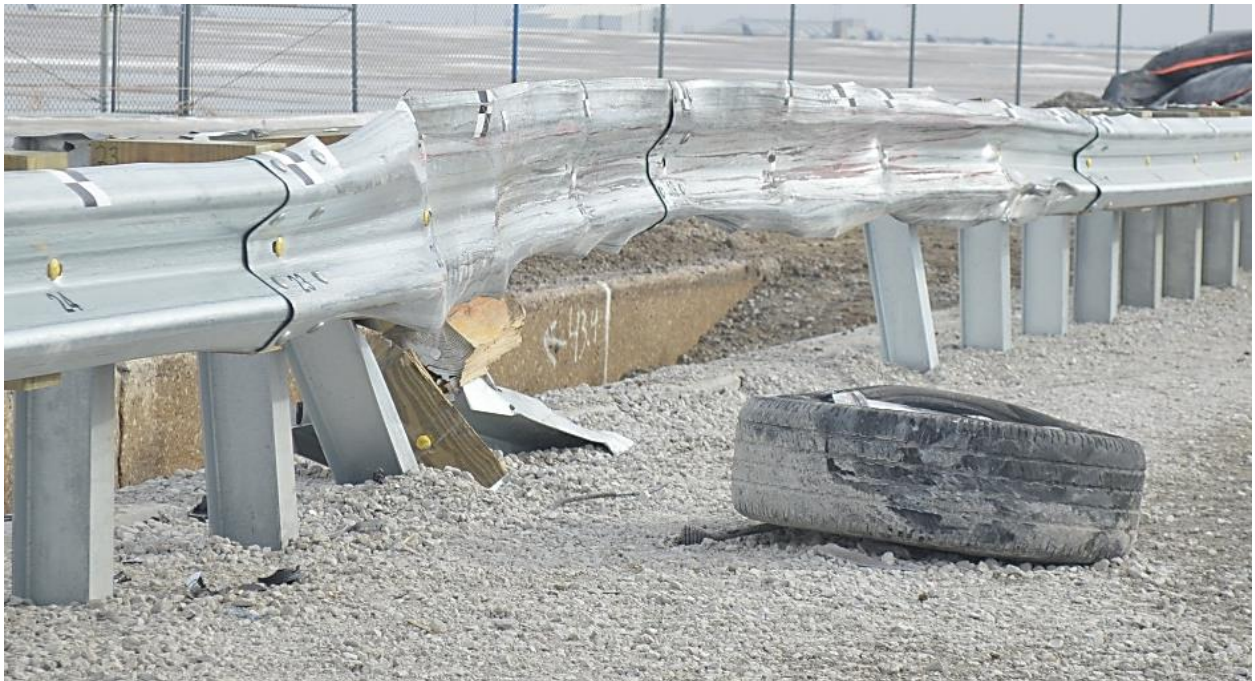
Following the test, the soil on top of the culvert headwall was removed for inspection of the damage to the posts and base plates as well as to review any potential damage to the culvert. Deformation of the post base plates was observed on post nos. 16 through 22. Post nos. 17 and 18 fractured at the base of the post above the weld line at the front flange and web of the post and through the weld at the back flange of the post. The upstream side of the front flange of post nos. 20 and 21 was torn up to the web near the base plate weld. All anchorage bolts and epoxied threaded rods were intact and remained secure, although some minor deformation of the bolts and rods was observed. No damage was observed to the concrete culvert slab or the headwall.

The maximum lateral permanent set of the barrier system was 15¾ in. (400 mm) which occurred at the back of rail at post no. 19, as measured in the field. The maximum dynamic barrier deflection was 29.6 in. (752 mm) at post no. 17. The working width of the system was 50.8 in. (1,290 mm) at post no. 17, also determined from high-speed digital video analysis. A schematic of the permanent set deflection, dynamic deflection, and working width is shown in Figure 90.

Figure 80. System Damage, Test No. CMGS-2

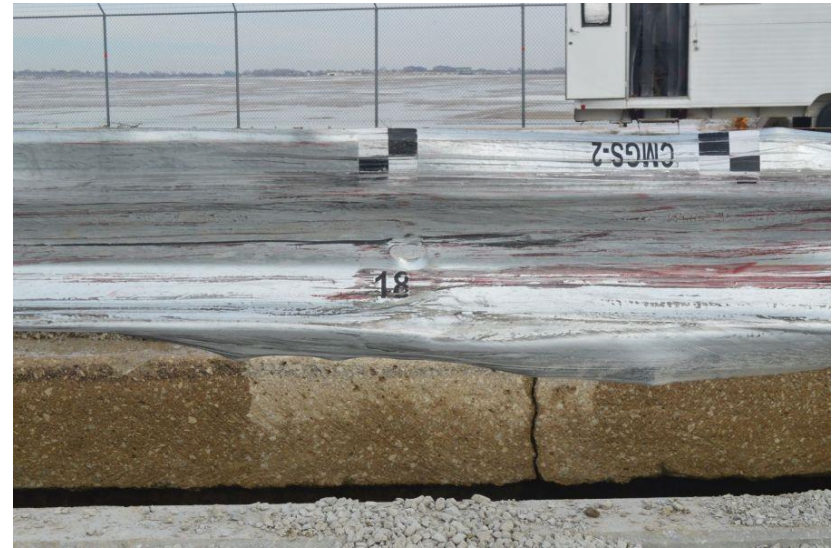
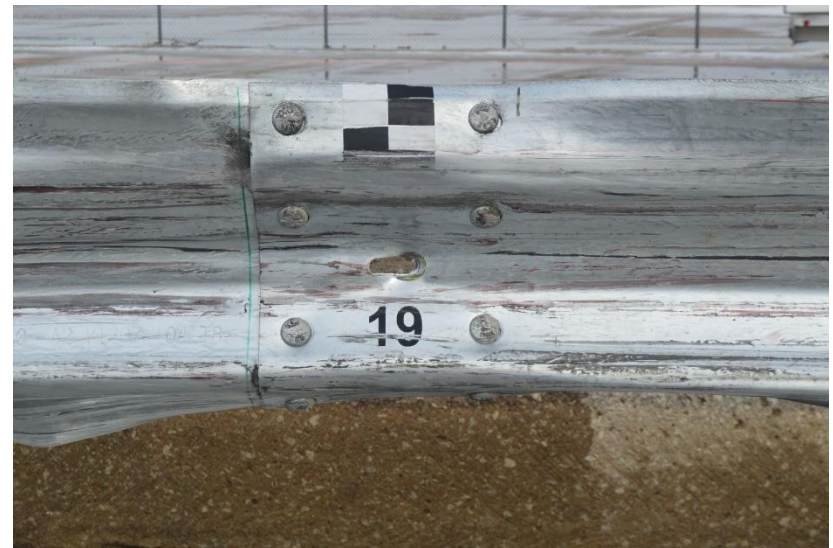
Figure 82. Guardrail Damage, Post Nos. 15 through 19, Test No. CMGS-2

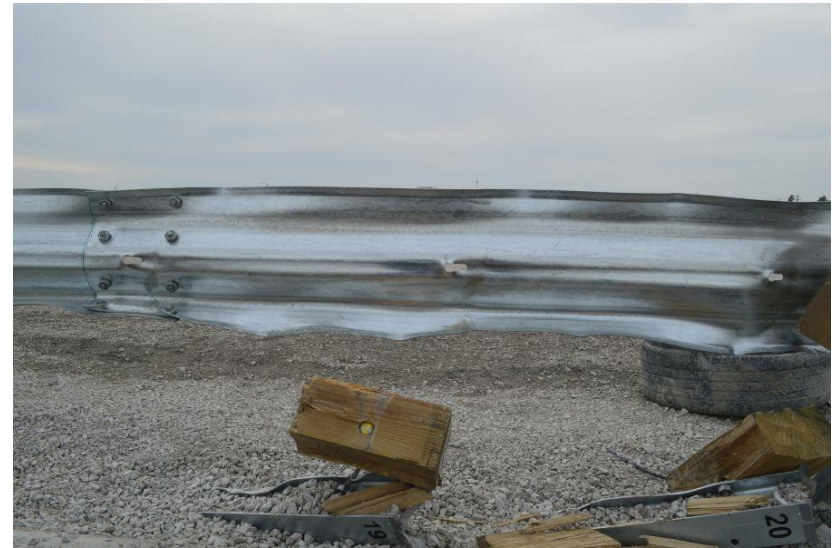
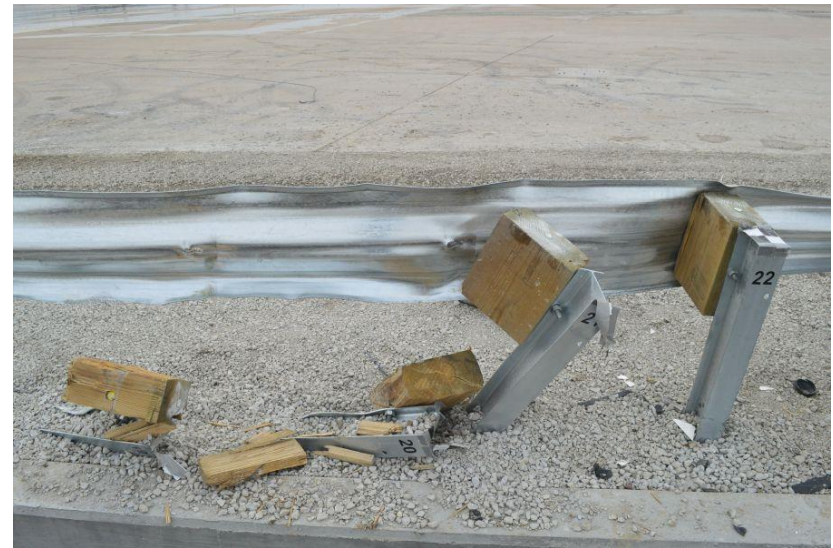
Figure 83. Guardrail Damage, Post Nos. 15 through 22, Test No. CMGS-2

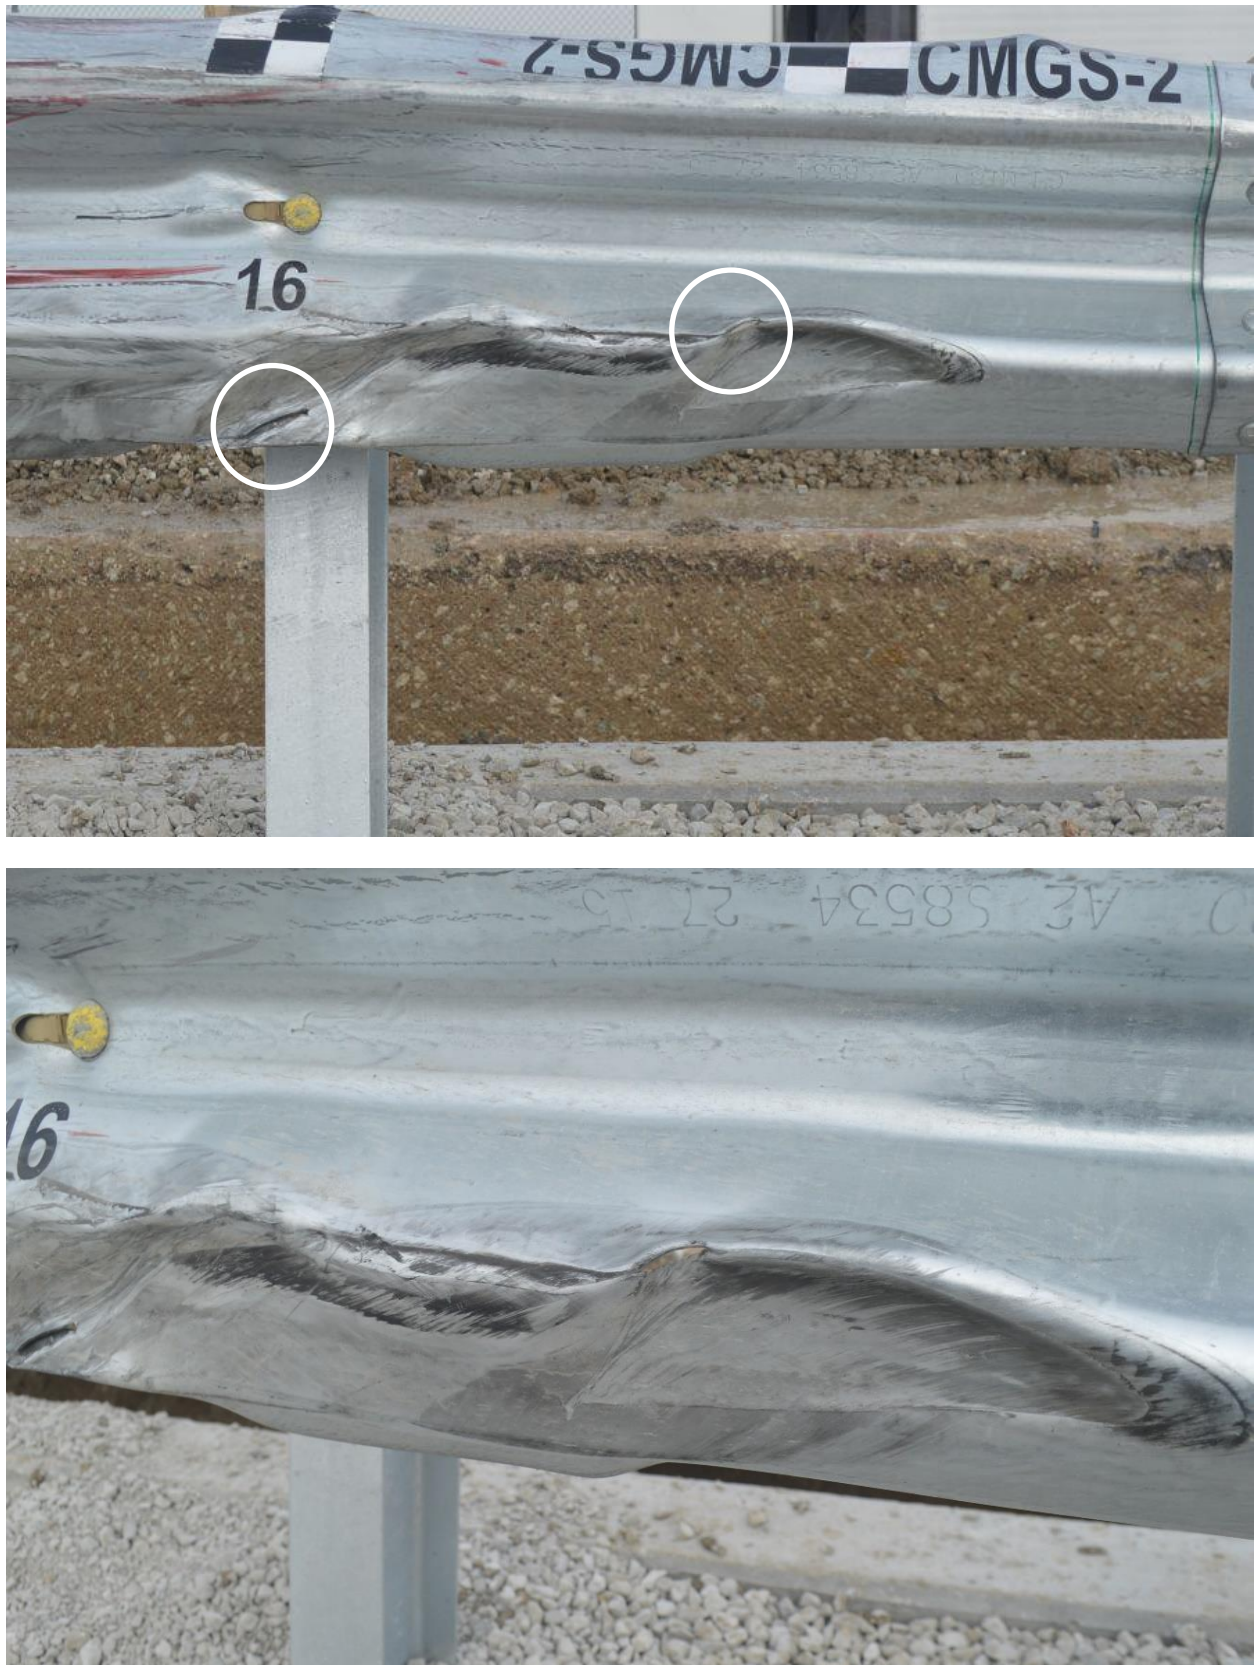
Figure 84. Rail Tears at Post No. 16, Test No. CMGS-2

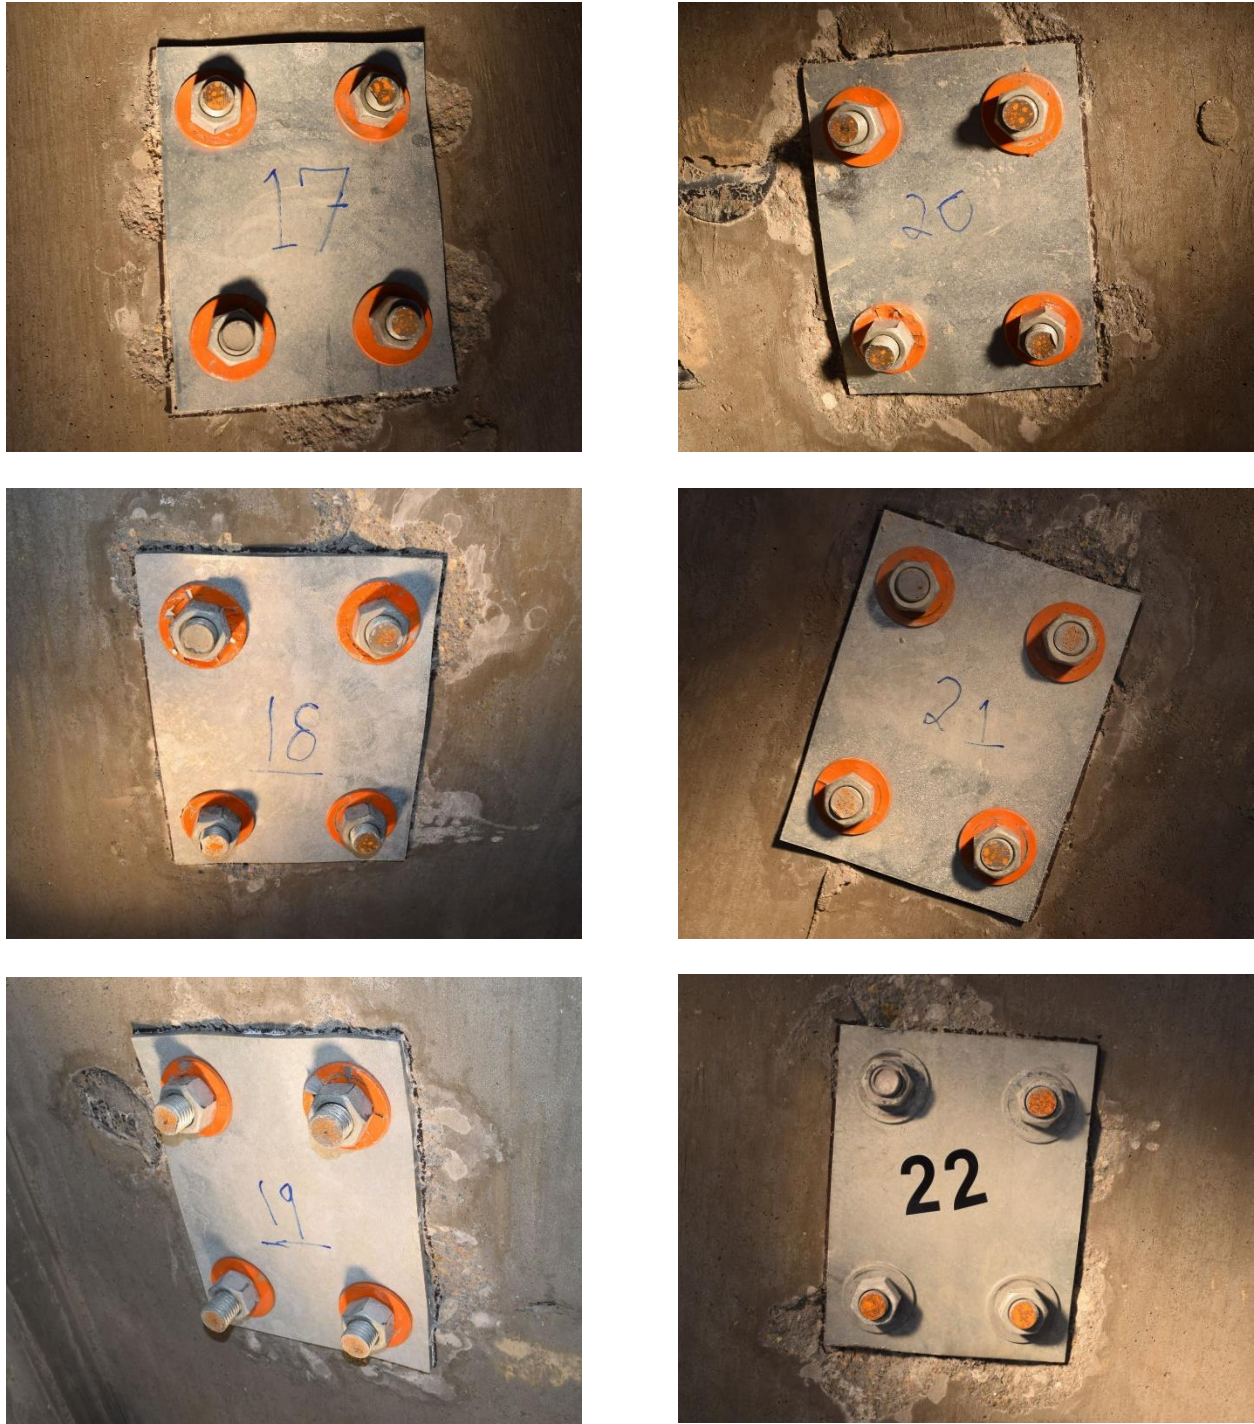
Figure 85. Damage to Base Plates of Post Nos. 17 through 22, Test No. CMGS-2

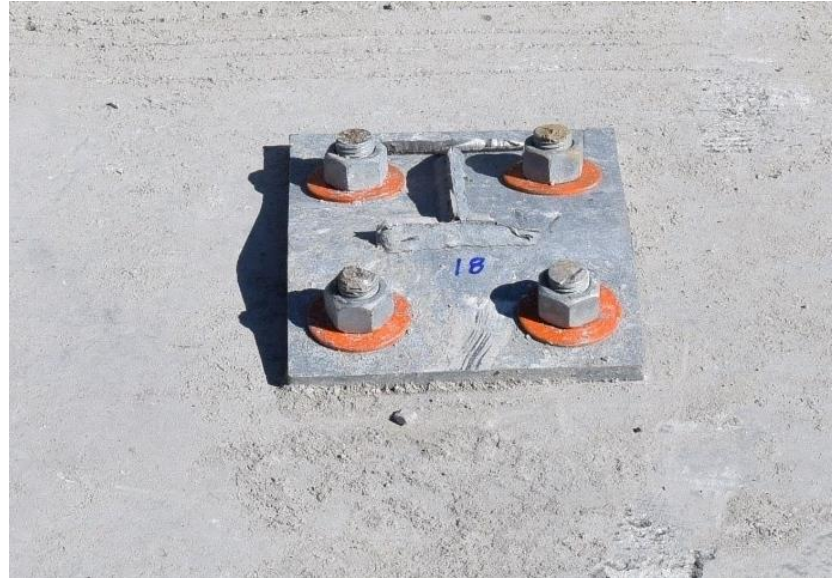
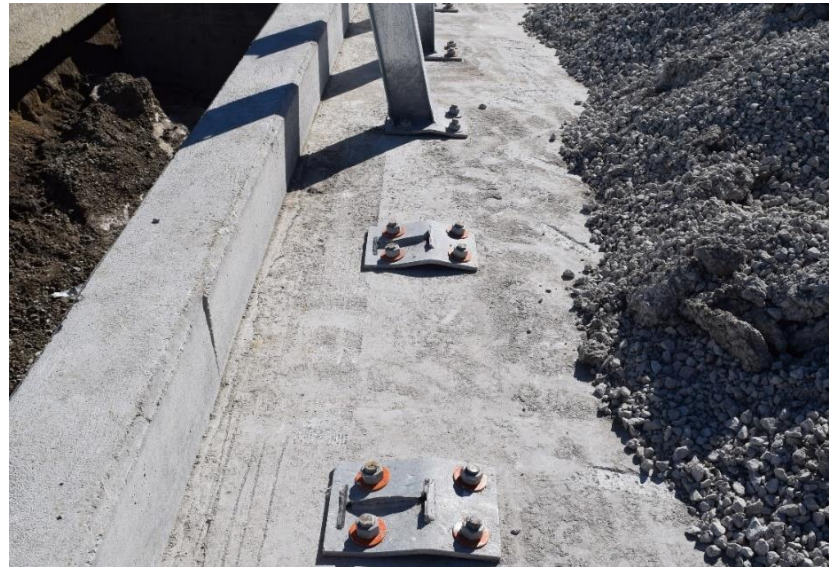
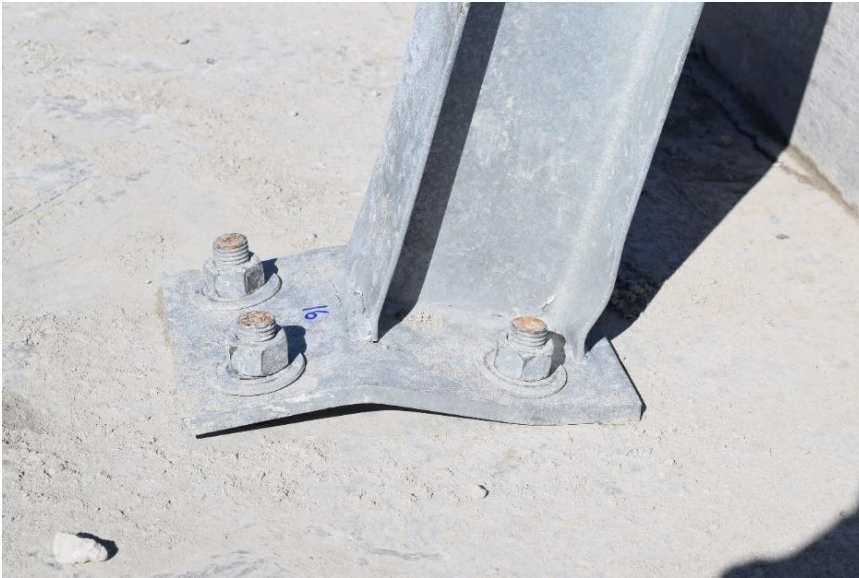
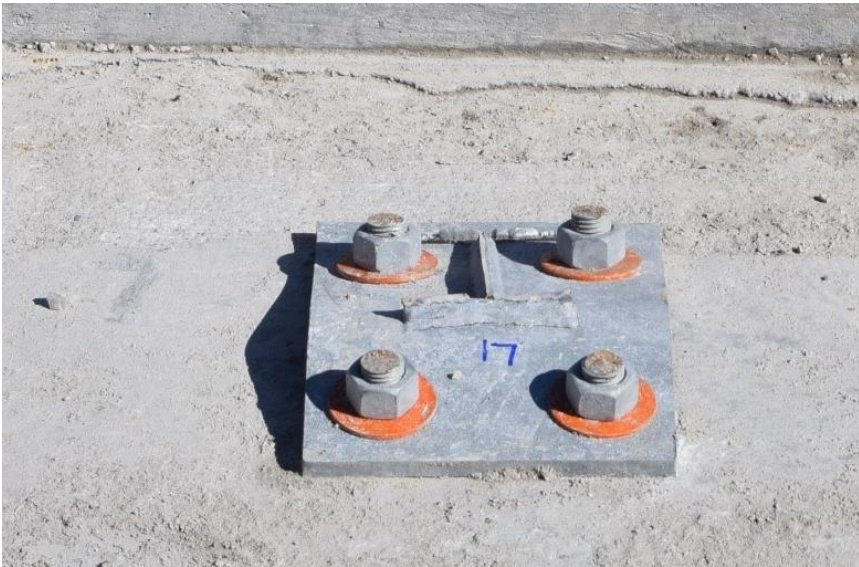
Figure 86. Damage to Base Plate Nos. 16 through 18 – After Soil Removal, Test No. CMGS-2
