## **DYNAMIC TESTING AND EVALUATION OF CULVERT-MOUNTED, STRONG-POST MGS TO TL-3 GUIDELINES OF MASH 2016**

### **MIDWEST ROADSIDE SAFETY FACILITY**

MwRSF Research Report No. TRP-03-383-20-R1

November 2, 2020

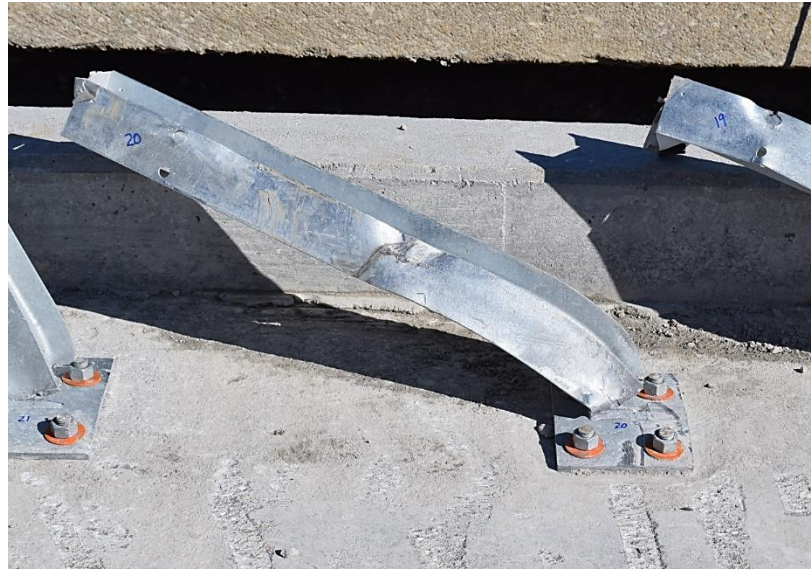
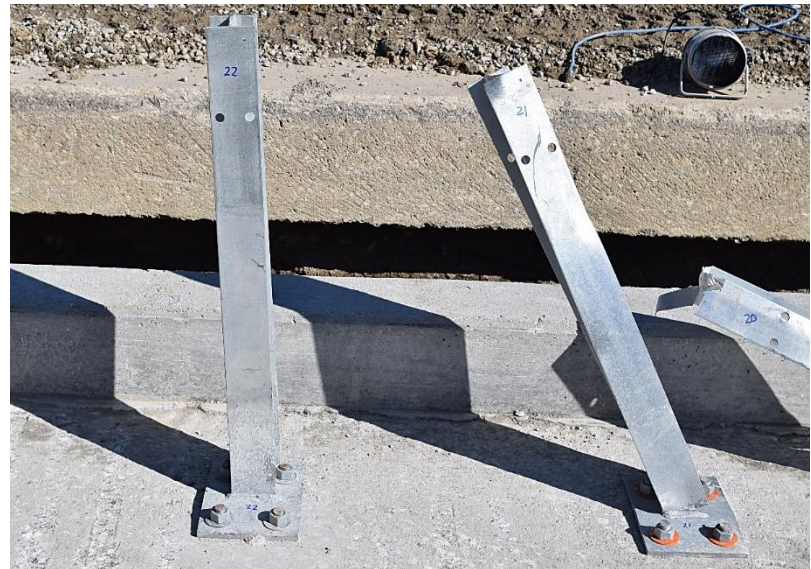
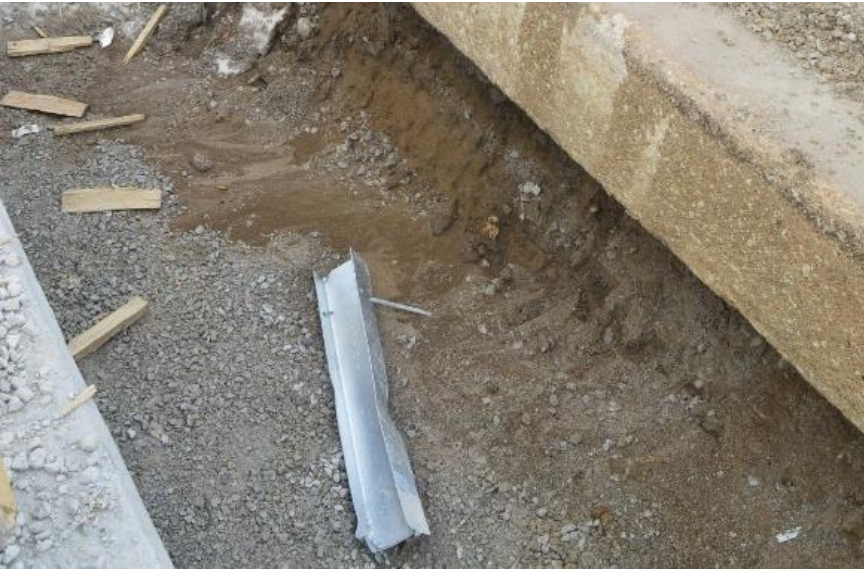
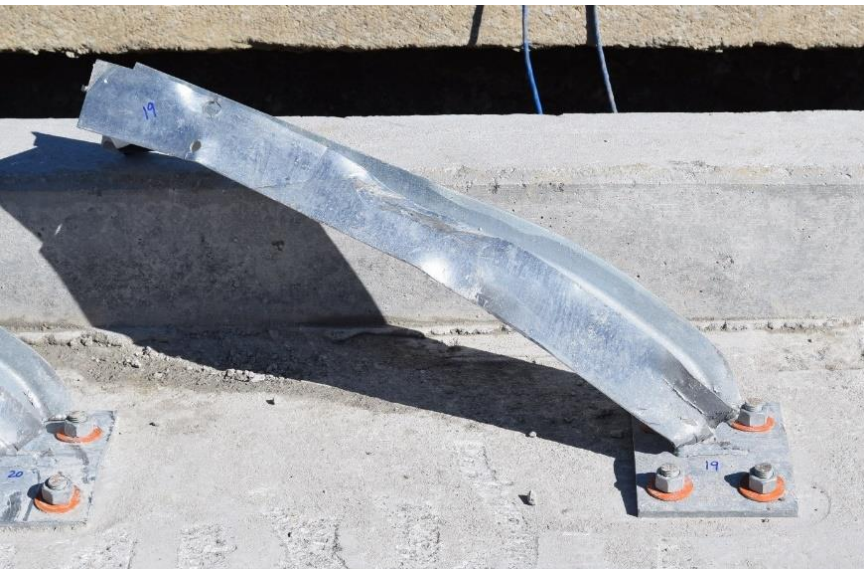
Figure 87. Damage to Post Nos. 17 through 22 Damage – After Soil Removal, Test No. CMGS-2

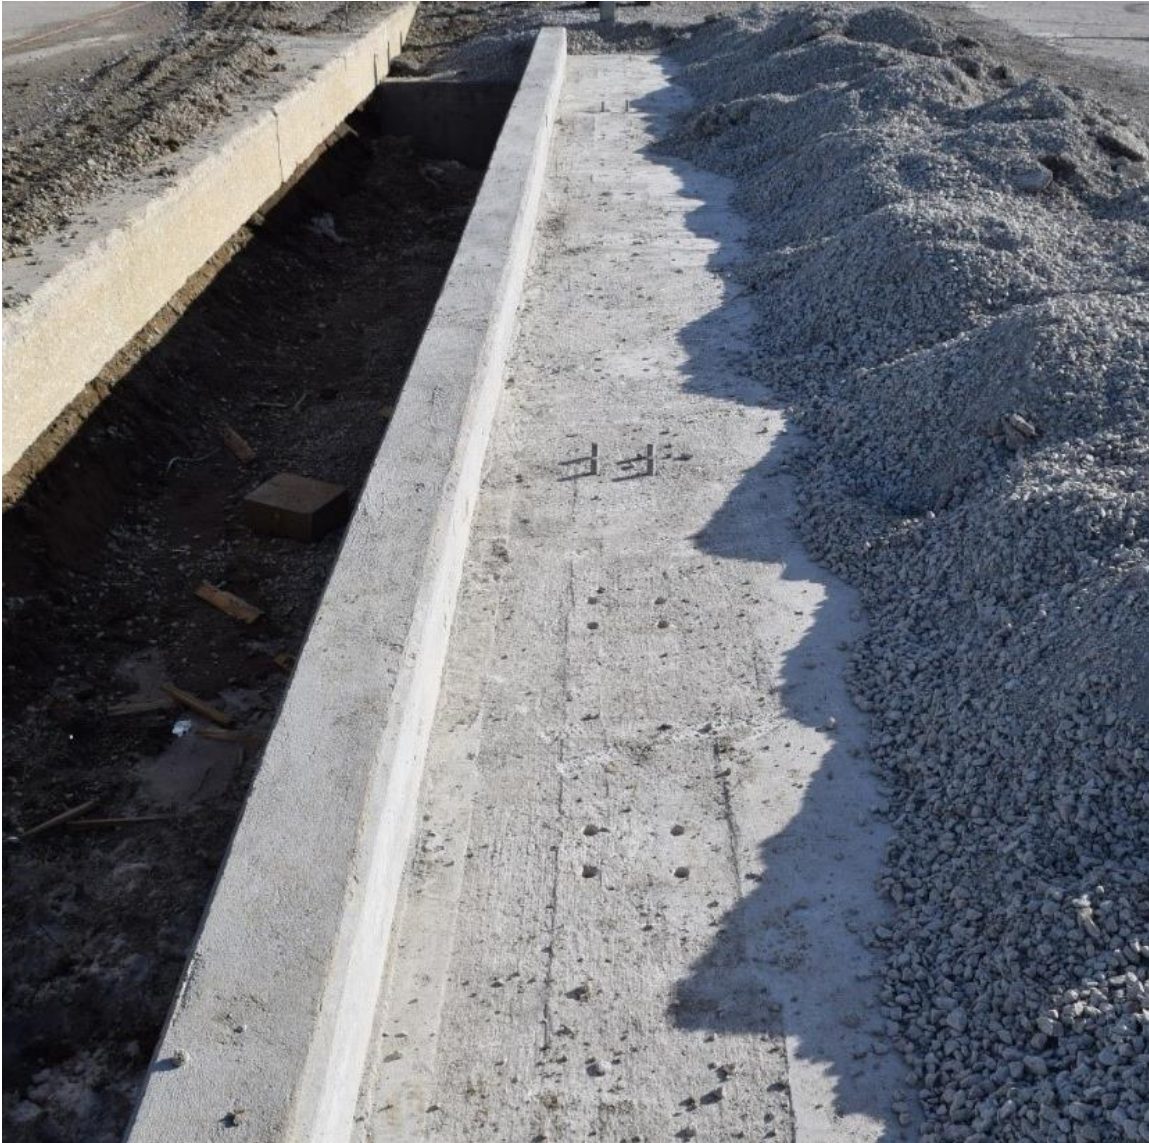
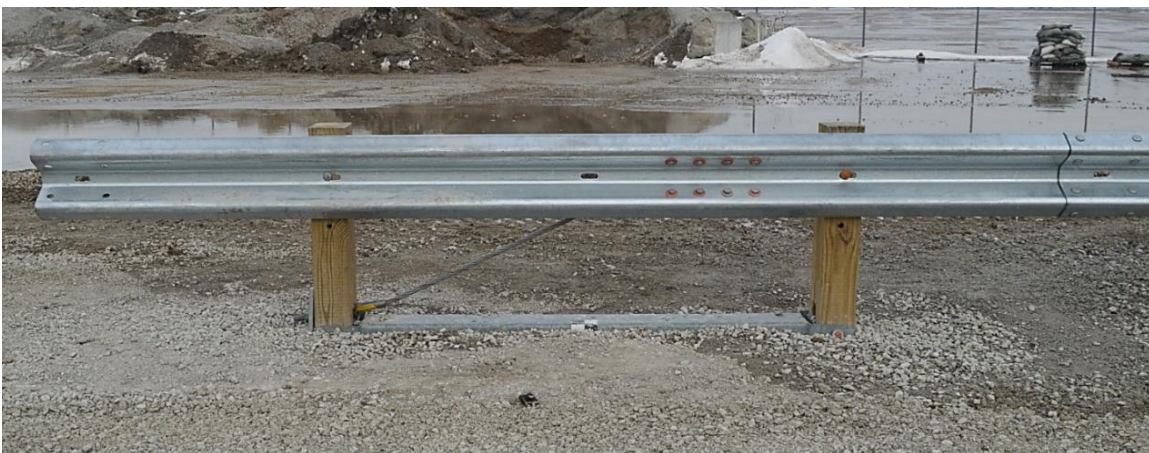
Figure 88. Culvert Deck after Removal of Soil Fill and Posts and Downstream Anchorage System Deformation, Test No. CMGS-2

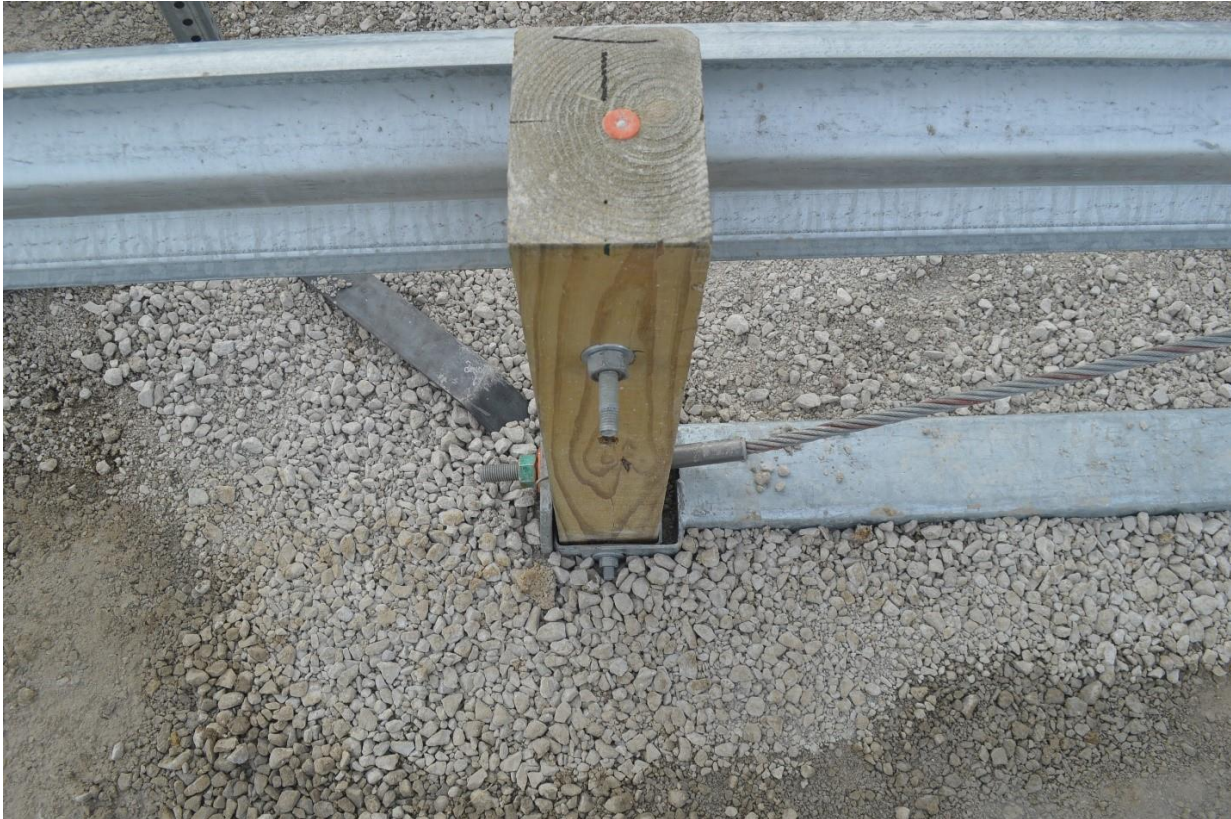
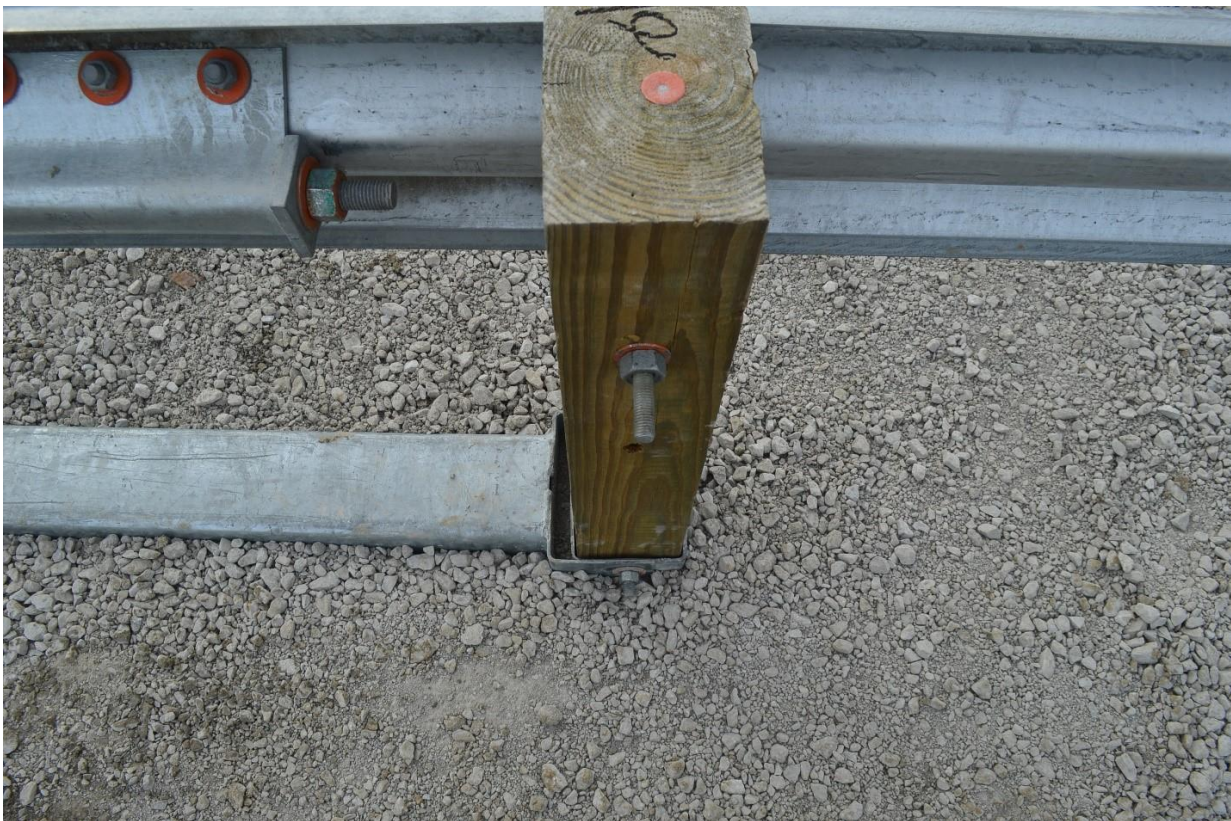
Figure 89. Damage to Upstream Anchorage System, Test No. CMGS-2

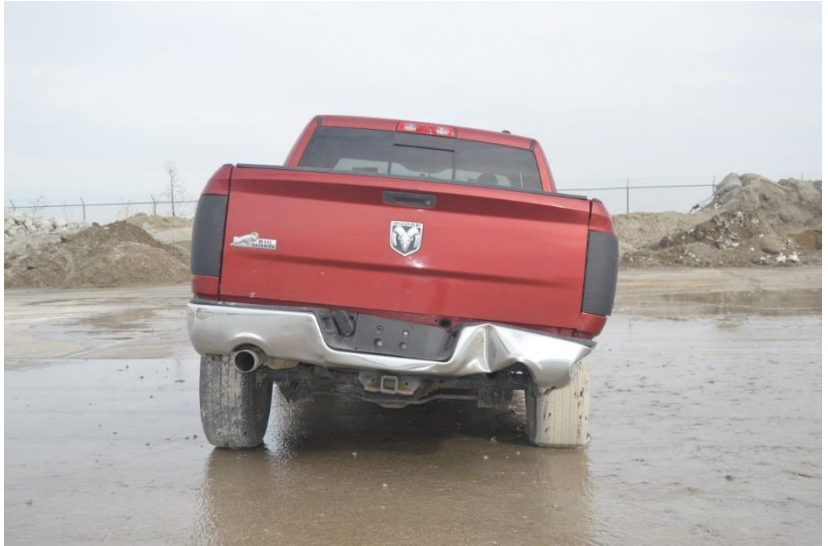
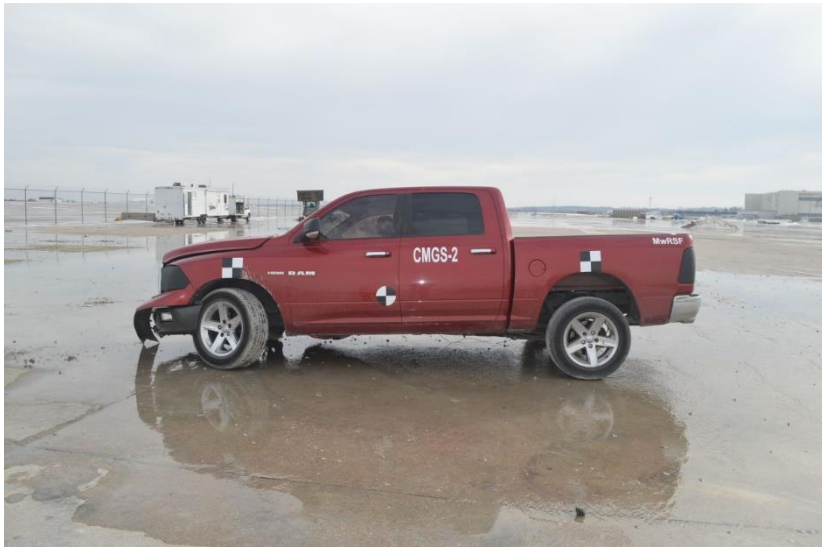
The majority of the vehicle damage was concentrated on the right-front corner, where primary impact occurred. The vehicle's front bumper was crushed inward. The lower passenger side grille was broken. The front bumper cover was torn off except for the two bolts on the driver side. The vehicle right-front wheel was disengaged, and right-rear tire was deflated. The airbags did not deploy during the impact. The right corner of the rear bumper on the passenger side buckled inward and the rear corner of the right-rear fender was deformed from the impact with the barrier.

The roof, the hood, and the left side remained undamaged. The left-side and rear window glass also remained undamaged. The airbags did not deploy during the impact. The overall undercarriage damage included a 2-in. (51 mm) bend in the lower control arm, and the steering knuckle broke along with the steering arm on the passenger side. The front passenger-side brake line was disconnected. Interior occupant compartment deformations were moderate with a maximum of 1½ in. (29 mm), which did not violate the limits established in MASH 2016.

Figure 91. Vehicle Damage, Test No. CMGS-2

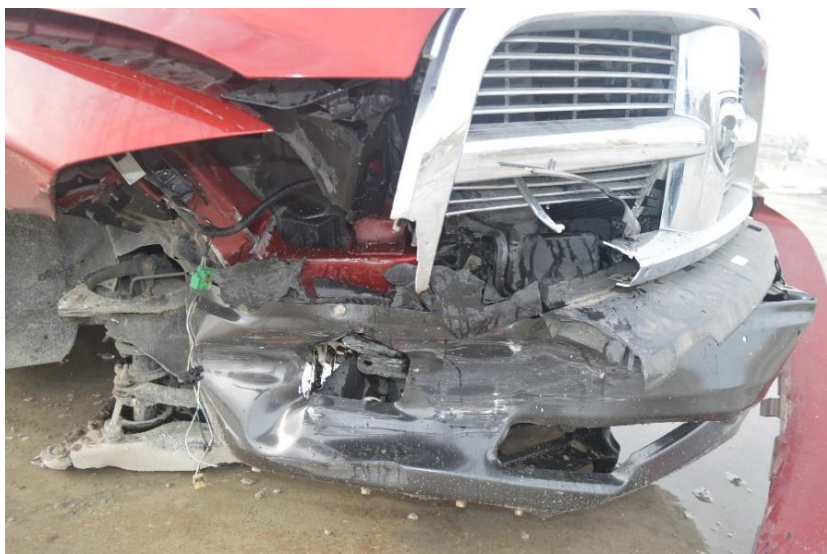
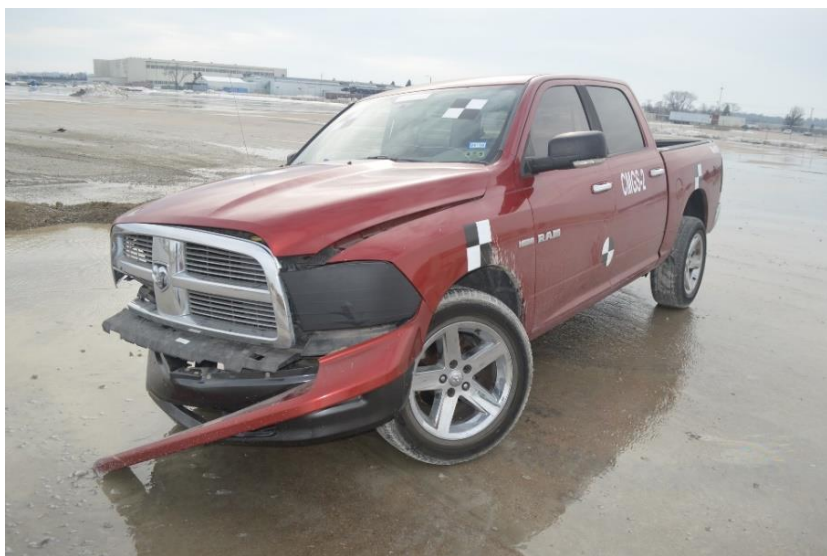
Figure 92. Additional Vehicle Damage, Test No. CMGS-2

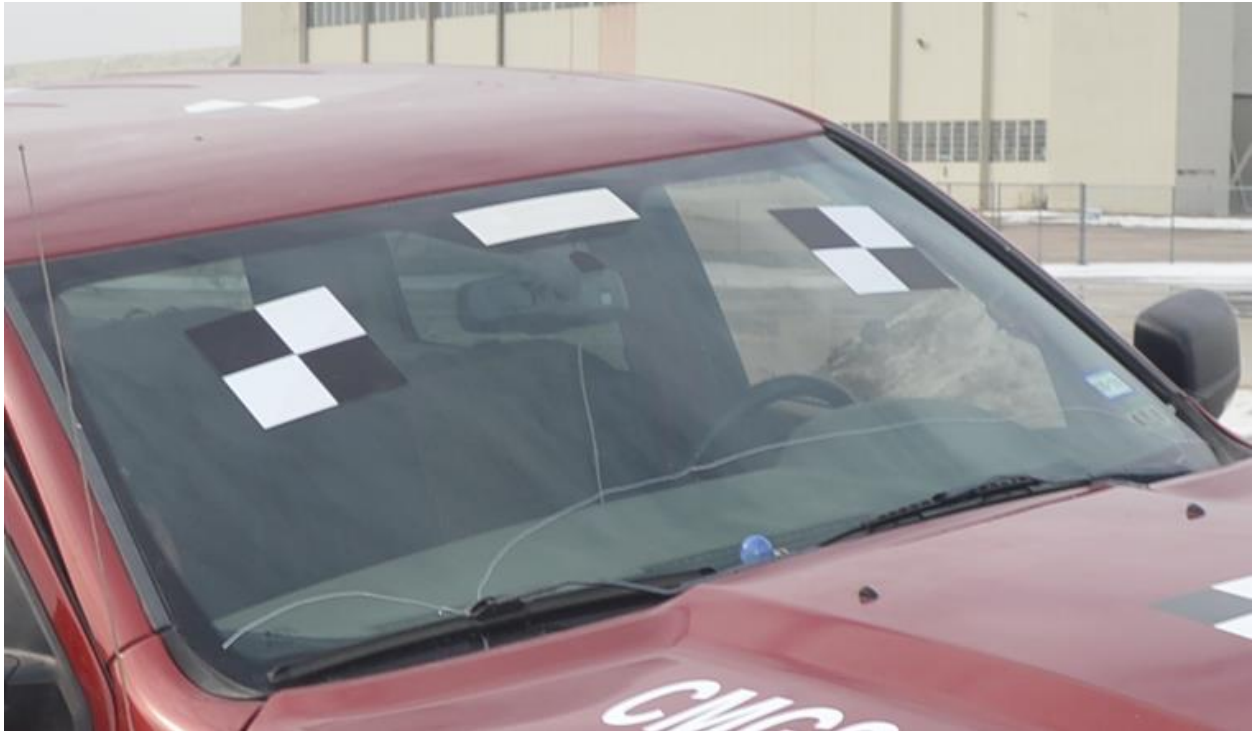
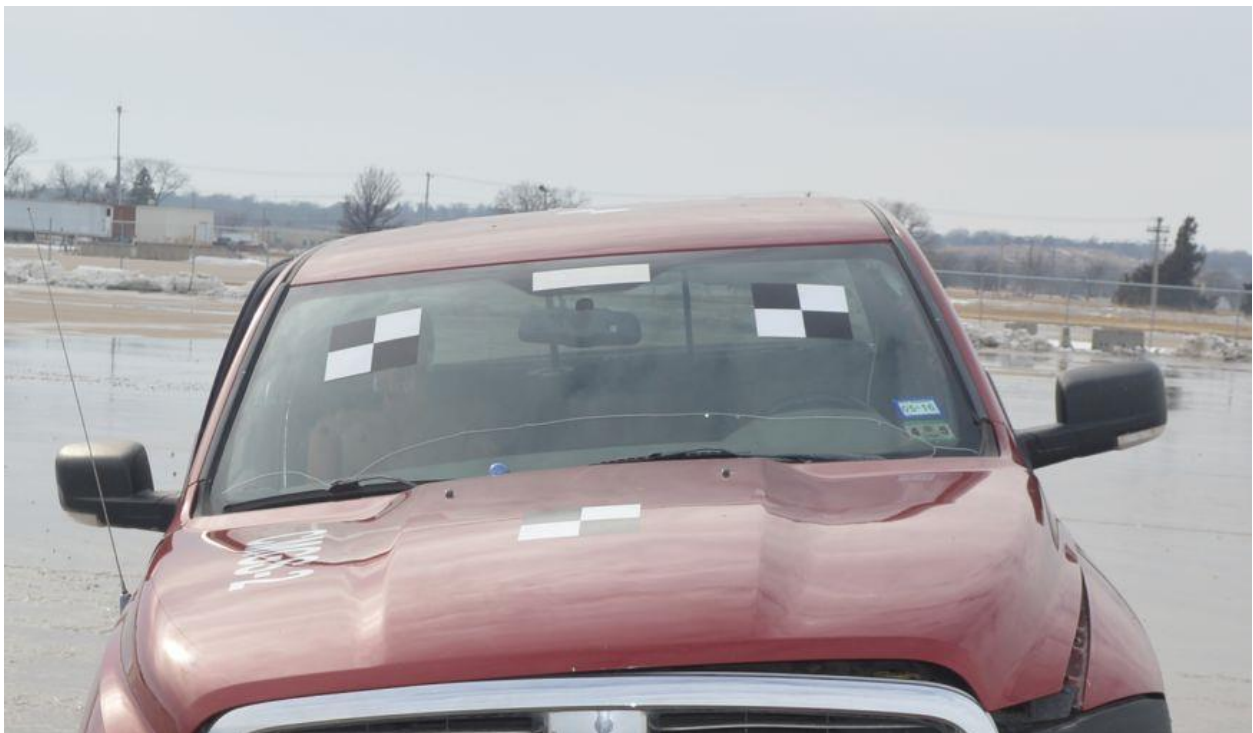
Figure 93. Vehicle Windshield Damage, Test No. CMGS-2

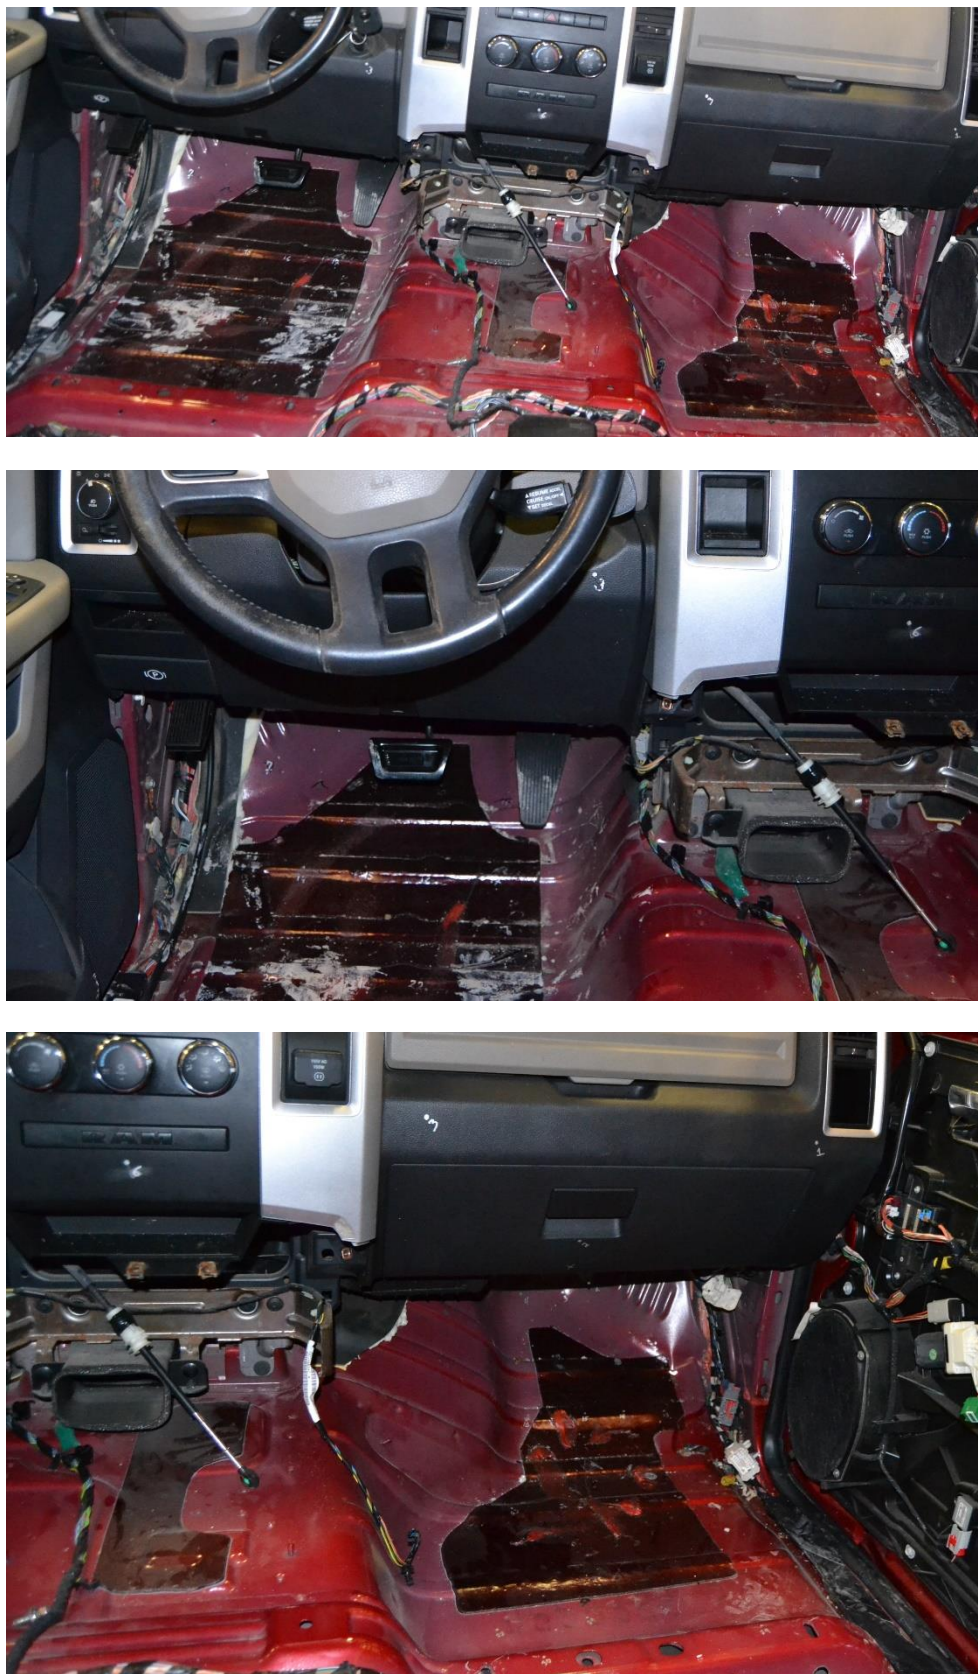
Figure 94. Vehicle Occupant Compartment Damage, Test No. CMGS-2

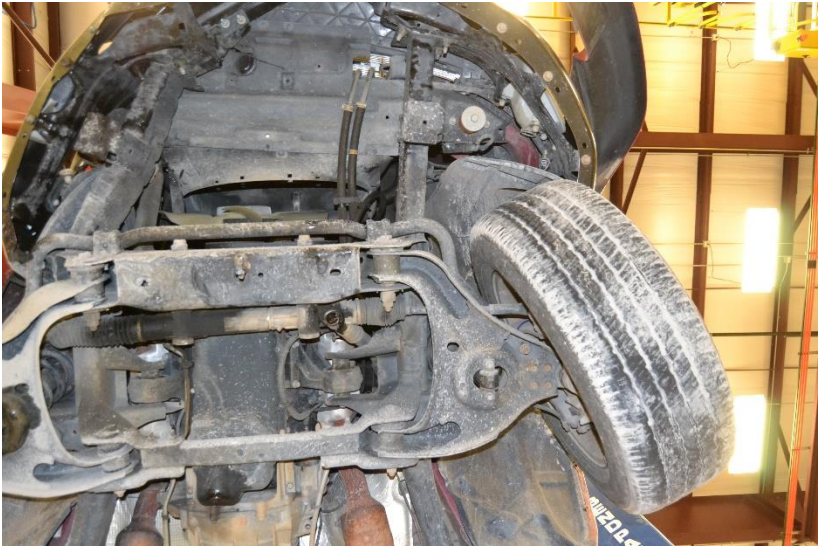
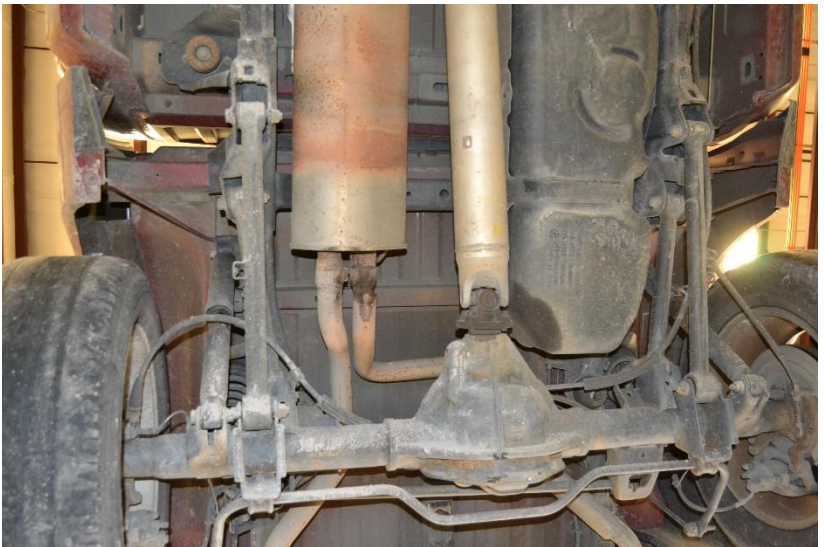
Figure 95. Vehicle Undercarriage Damage, Test No. CMGS-2
