# **INVESTIGATING THE USE OF A NEW UNIVERSAL BREAKAWAY STEEL POST – PHASE 3**

## **MIDWEST ROADSIDE SAFETY FACILITY**

MwRSF Research Report No. TRP-03-244-10

December 16, 2010

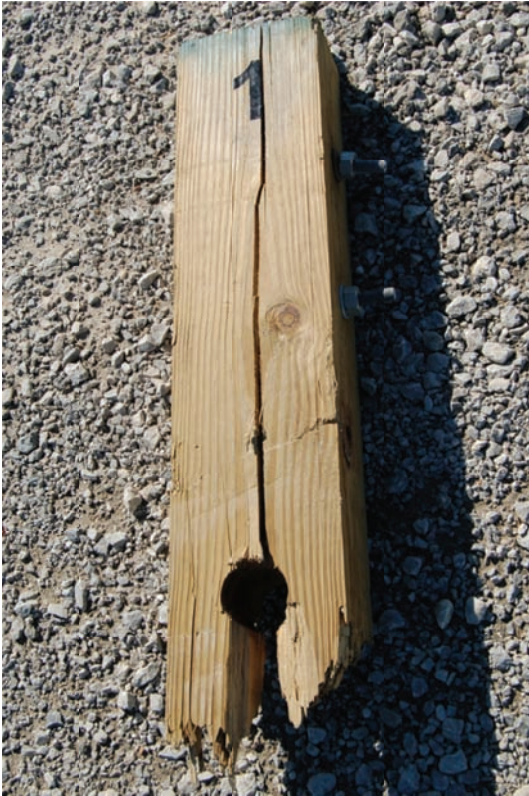
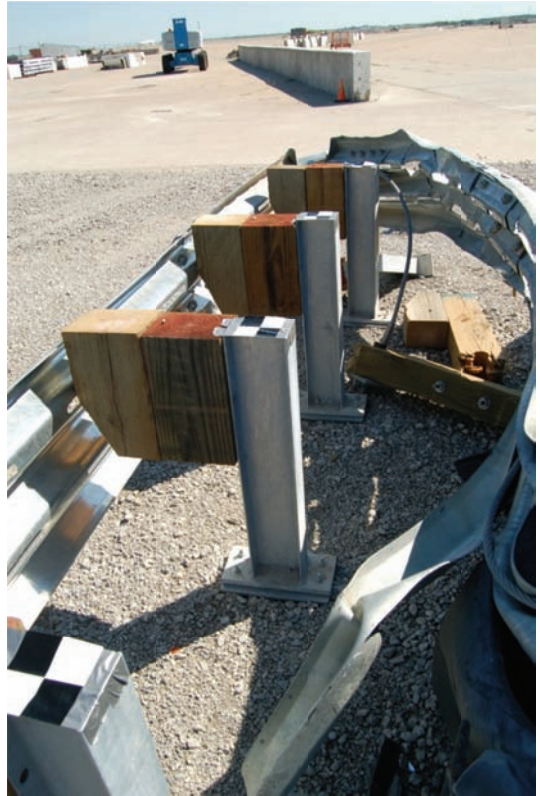
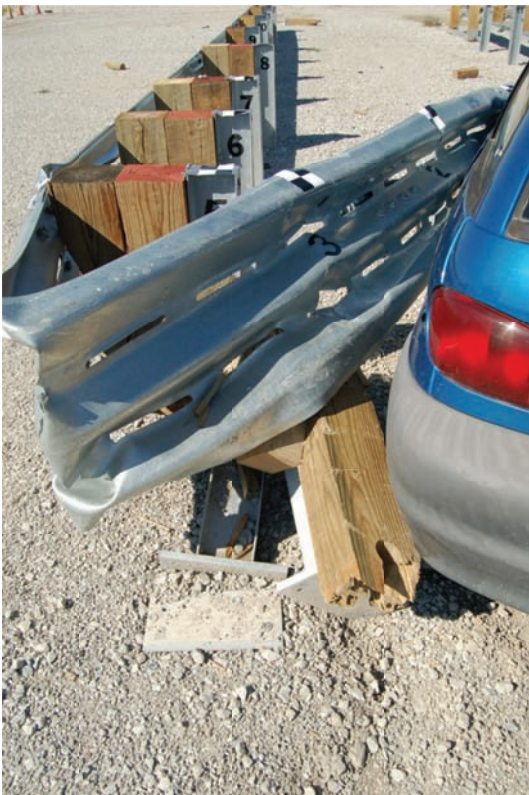
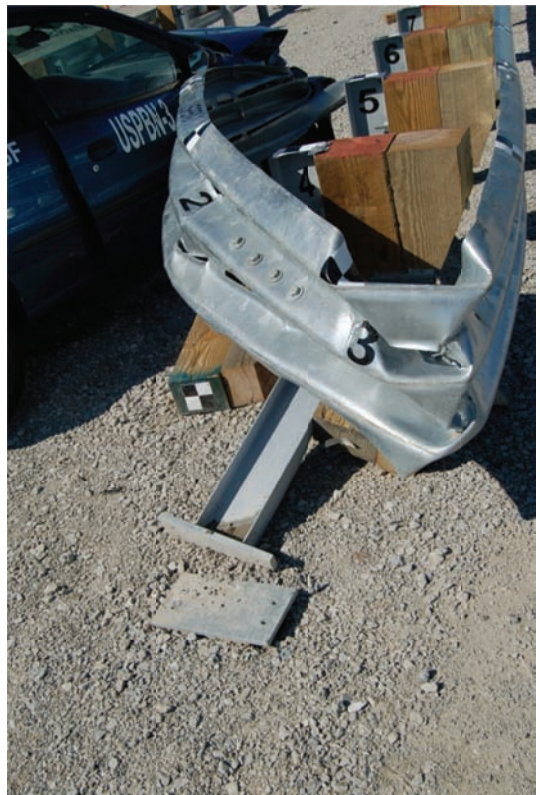
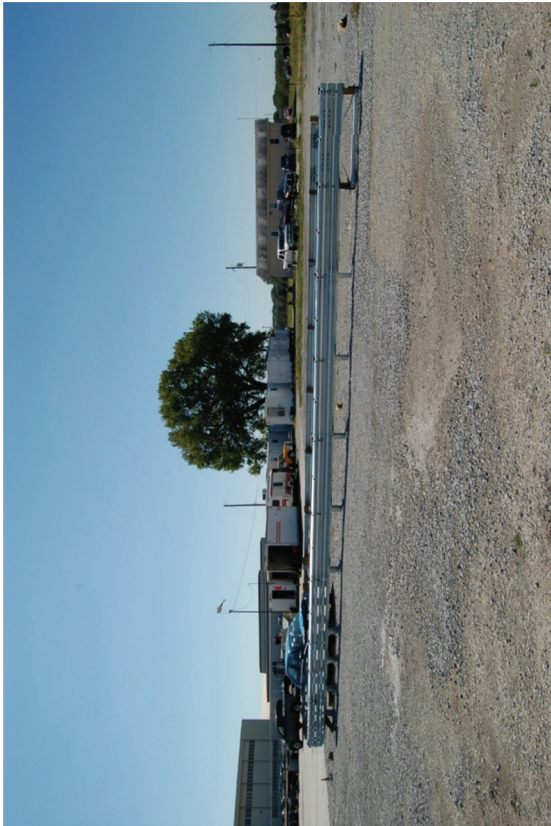
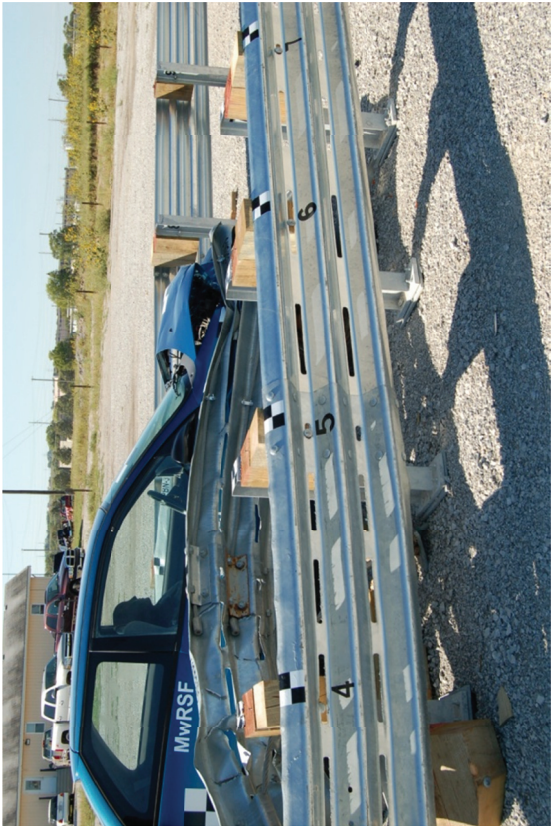
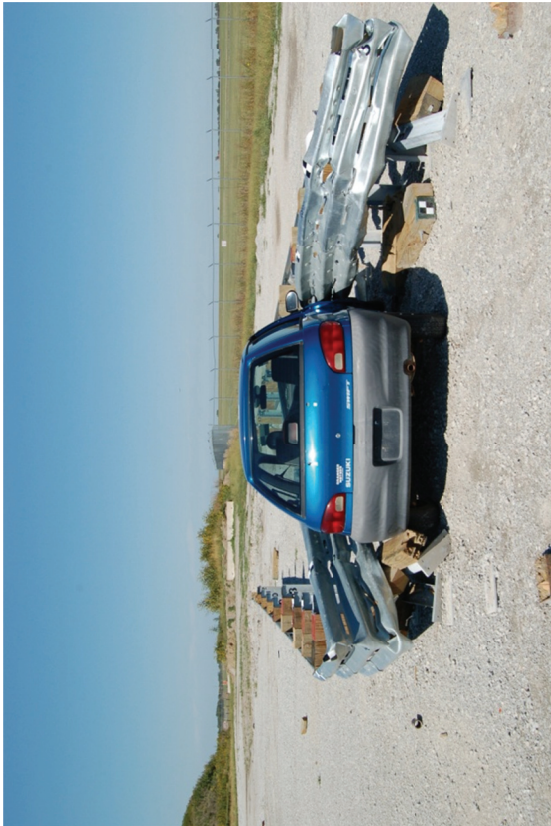
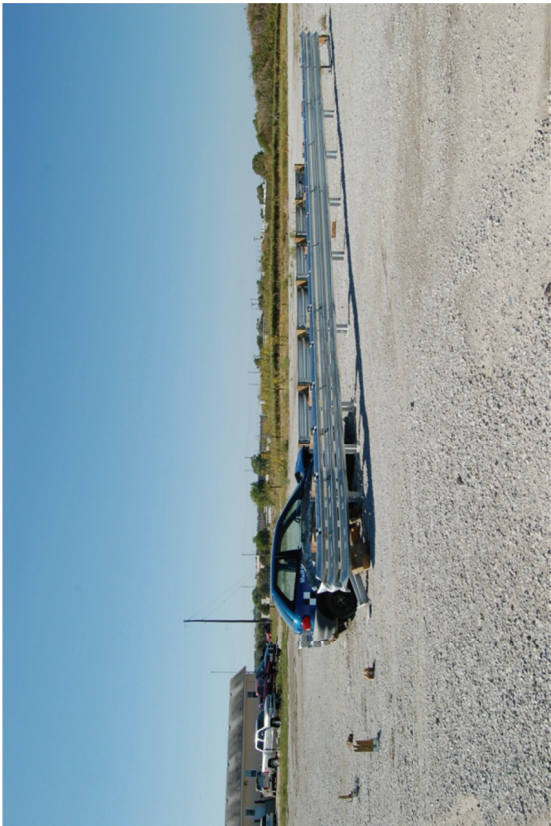
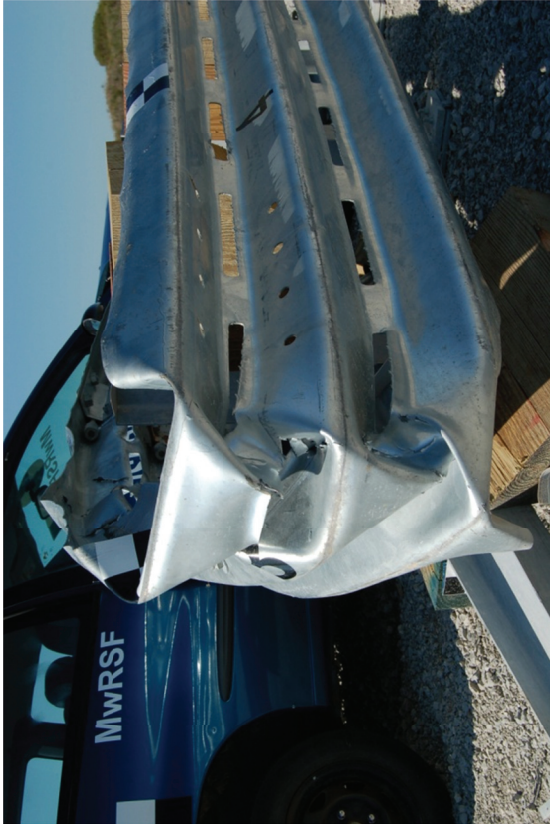
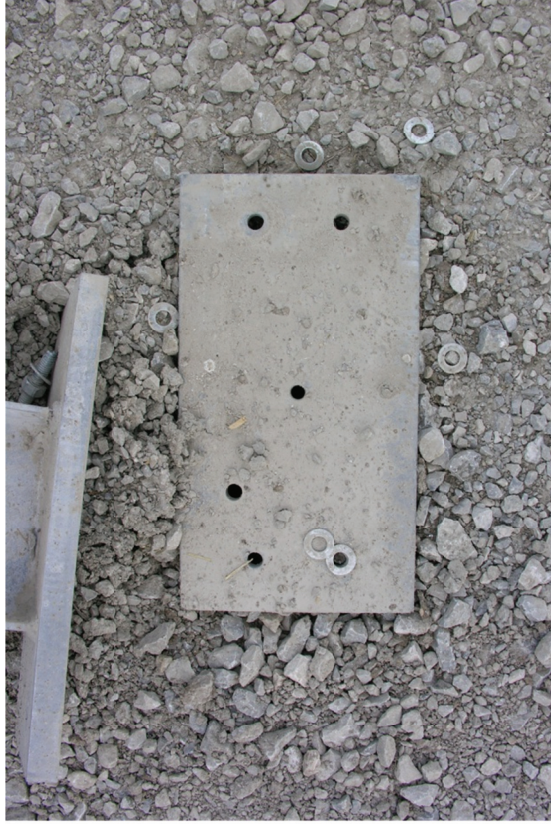
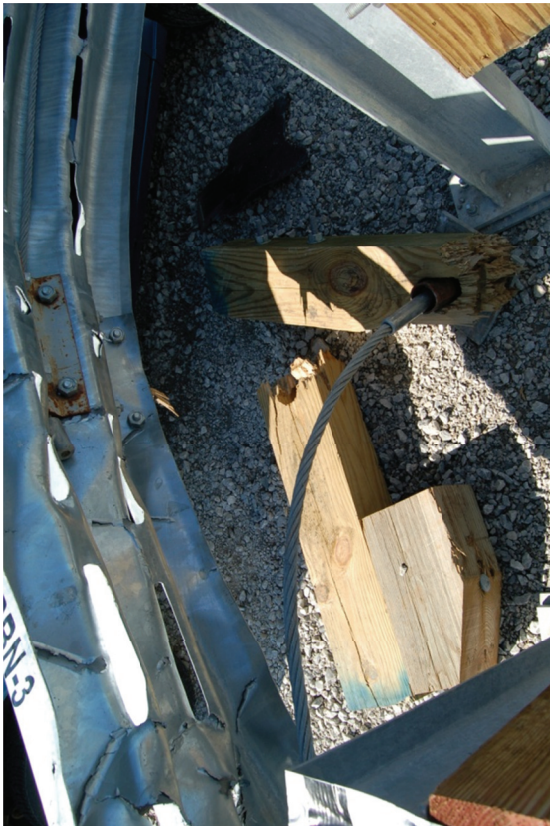
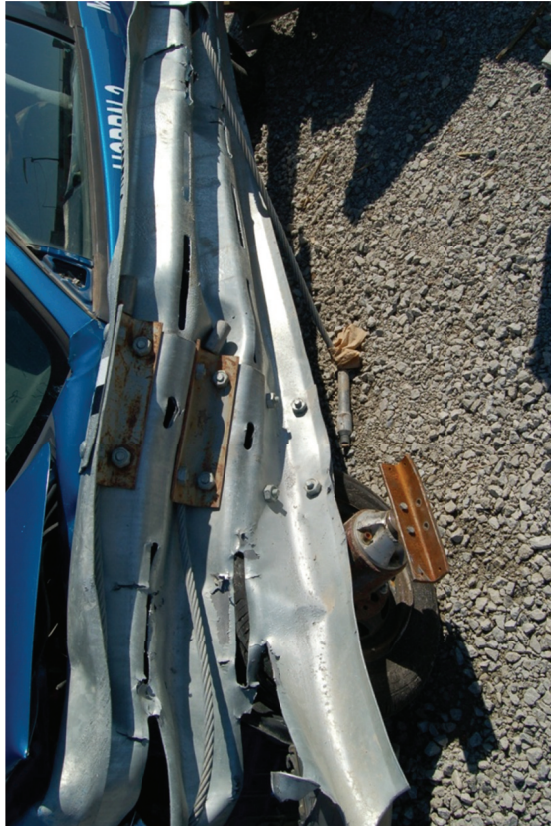
Damage to the barrier was severe, as shown in Figures 40 through 42. Barrier damage consisted of guardrail buckling and flattening, deformation of the guardrail around the front of the car, and post fracture and disengagement on both sides of the bullnose. Deformation to the rail occurred from 11 in. (279 mm) downstream of post no. 3 on Side A to 7½ in. (191 mm) downstream of post no. 5 on Side B.

The first three posts on Side A were fractured and disengaged. BCT post nos. 1 and 2 fractured through the hole at ground level. The universal steel breakaway post no. 3 disengaged from the foundation tube and lower base plate when the bolts fractured. Post no. 3 was slightly twisted downstream in relation to the upper base plate, and there was some slight chipping on the blockout. Post no. 4 was slightly twisted upstream in relation to the upper base plate. Post nos. 1 and 3 had a ¼-in. (6-mm) soil gap and a ½-in. (13-mm) soil gap on the front side of the bases, respectively. There was no visible damage to post nos. 5 through 14 on Side A.

The first four posts on Side B were fractured and disengaged. BCT post nos. 1 and 2 fractured through the hole at ground level. Post no. 1 was split on the upstream face, and the cable bearing sleeve disengaged. UBSP nos. 3 and 4 were slightly twisted upstream in relation to their upper base plates and were disengaged from the foundation tube and lower base plate when the bolts fractured. The blockouts on post no. 5 were rotated downstream. A ½-in. (13-mm) soil gap was found on the downstream side of post no. 3 with an approximate 12-in. (30-mm) diameter by 2-in. (51-mm) high soil heave. The rail-to-post bolt was pulled out at post no. 6. There was no visible damage to post nos. 7 through 14 on Side B. There was no visible damage to the foundation tubes or lower base plates on either side of the system.

The damage to the three beam guardrail consisted of buckling, tearing, and flattening of the guardrail. Flattening occurred in the three beam from post no. 3 on Side A to post no. 4 on Side B. The Side B cable end anchorage threads fractured at the post no. 1 BCT anchorage. A buckle formed 11 in. (279 mm) downstream of post no. 3 on Side A with an 8-in. (203-mm) long horizontal tear in the upper slot. Another buckle formed at post no. 3 on Side A. A 2¼-in. (57-mm) long vertical tear was located 9 in. (229 mm) upstream of the Side A quarter point in rail section no. 1. The guardrail buckled 19 in. downstream of the center of the system towards Side A. Rail section no. 1 at the lower slot was torn completely through from 18½ in. (470 mm)

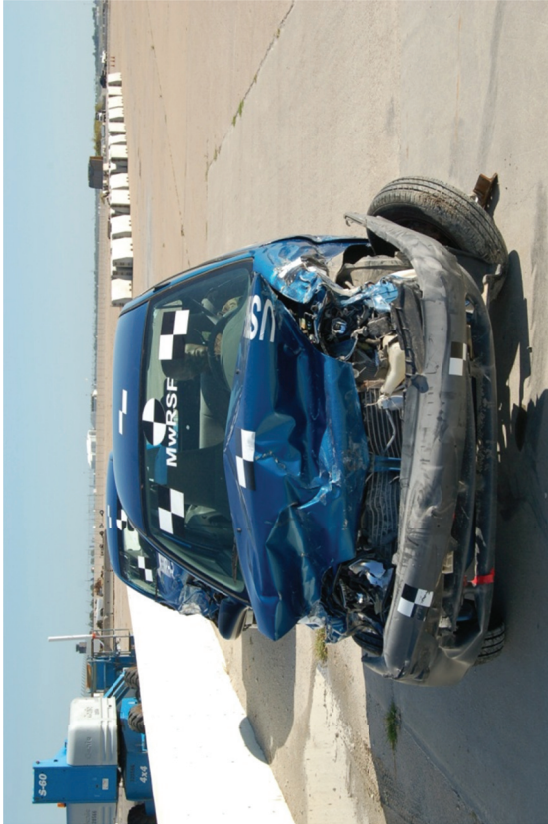
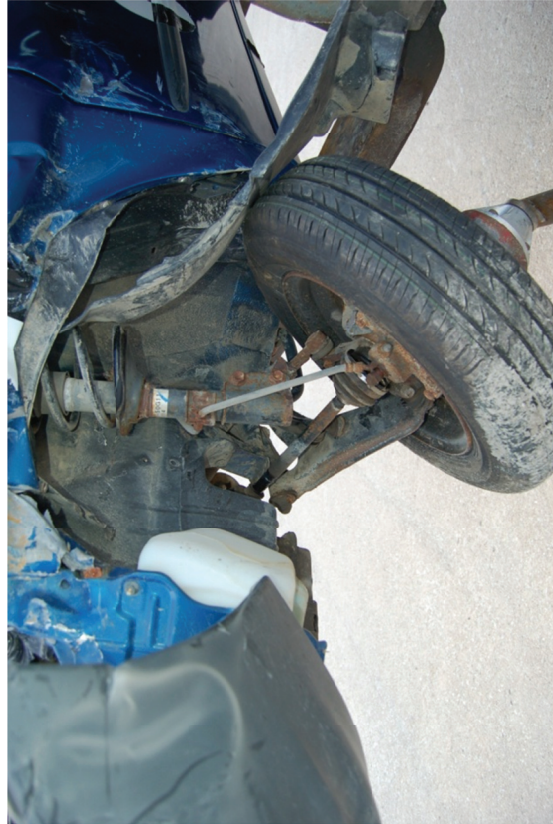
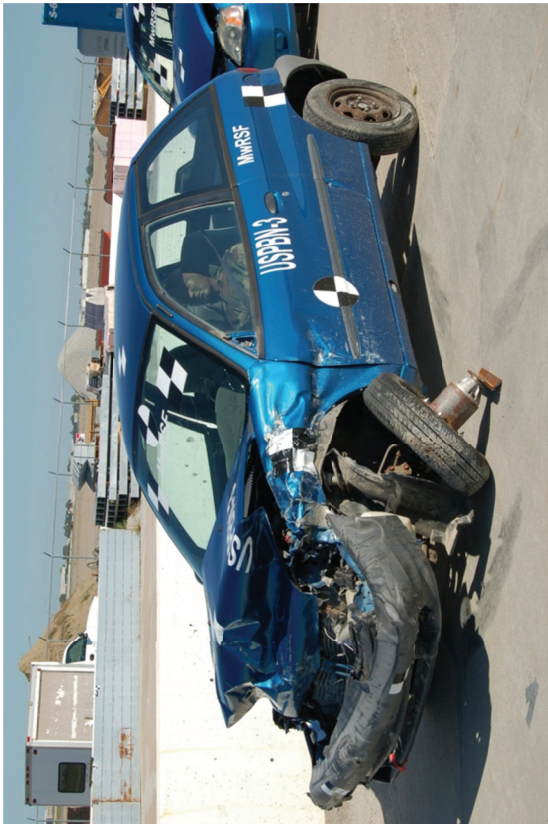
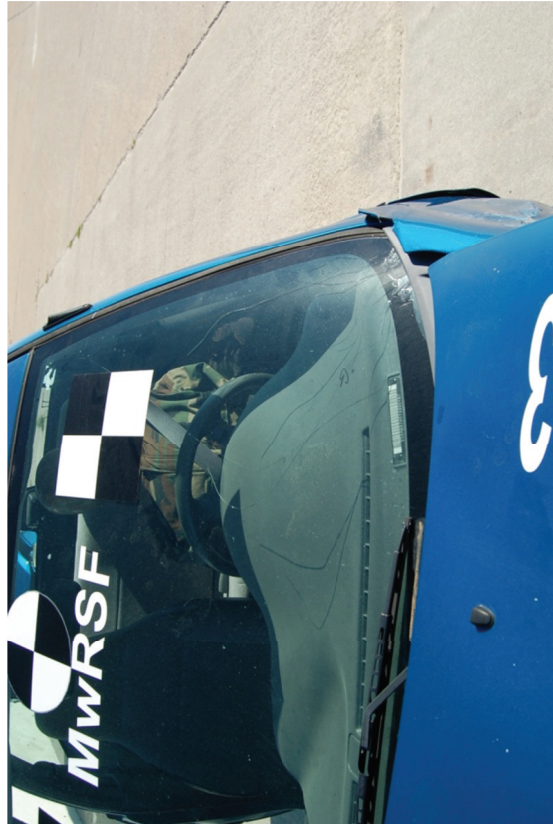
Figure 45. Vehicle Damage, Test No. USPBN-3

The damage to the vehicle was moderate, as shown in Figure 45. Deformations to the vehicle's floorboard were relatively minor, with maximum longitudinal and vertical deflections of ½ in. (13 mm) and ¼ in. (6 mm), respectively. Complete occupant compartment and vehicle deformations and the corresponding locations are provided in Appendix C.

The left door was dented and crushed. A dent was found between the left door and quarter panel. The left-fender was crushed inward and backward. The left-front strut attachment was fractured and the steering rod was bent. The left-front CV joint was pulled out, and both ends of the half shaft were damaged or pulled out. A dent was found in the left-front rim. The left mirror was disengaged. The radiator was crushed inward and shifted to the right. Both headlights were fractured. The left bumper mount was fractured. The bumper fractured near its

center. Minor cracking occurred in the lower left windshield in an area approximately 15 in. (381 mm) by 13 in. (330 mm). The hood was crushed backward and upward. The right side of the bumper cover was dented and torn. The right fender was crushed inward. The front of the right door was crushed and dented, and the door was ajar. The fuel tank was punctured, and small scrapes were found on the rear lower control arms. The roof and window glass remained undamaged.

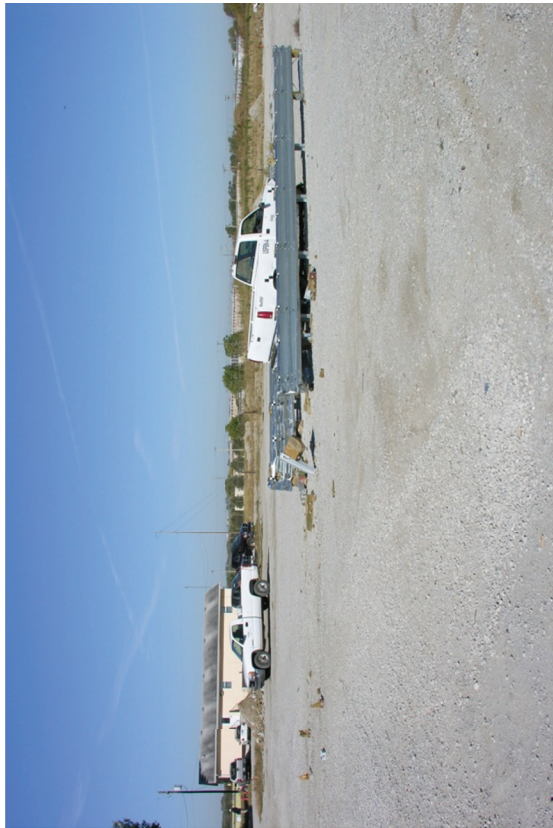
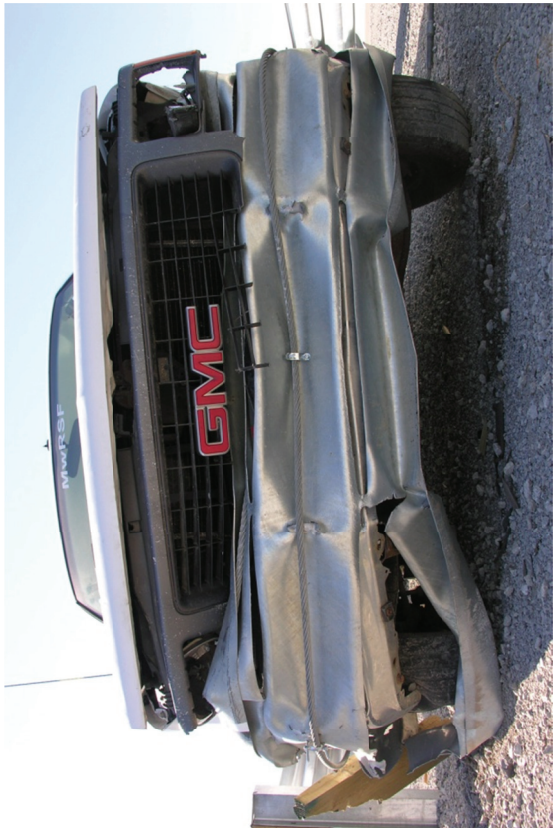
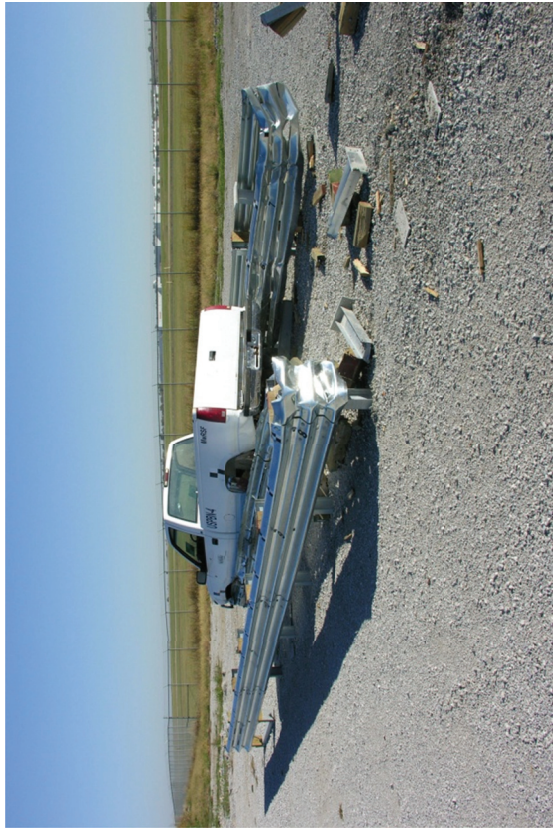
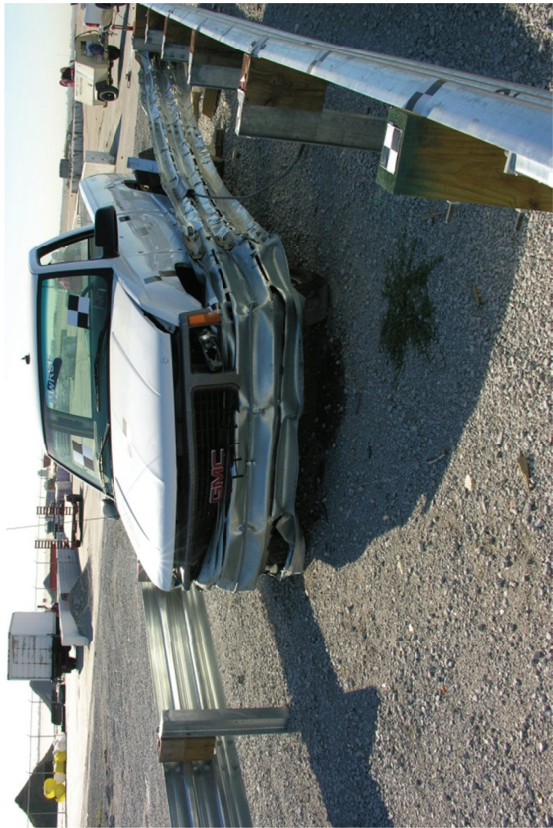
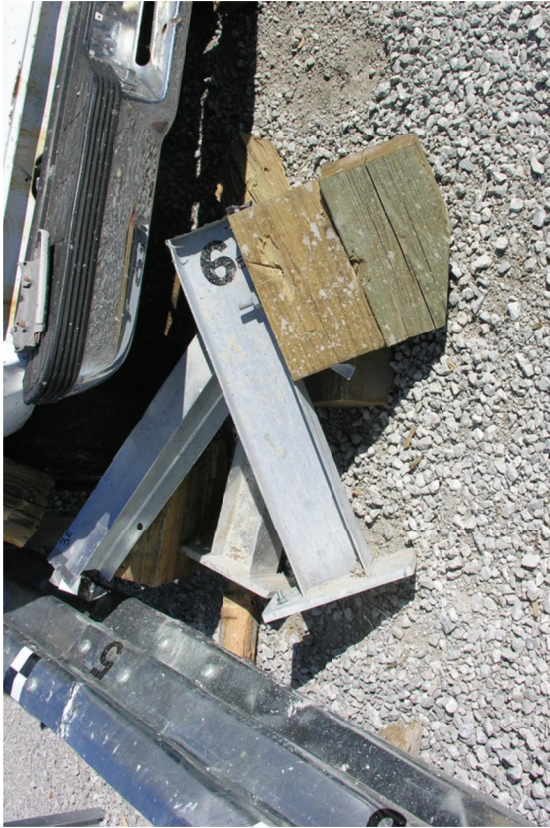
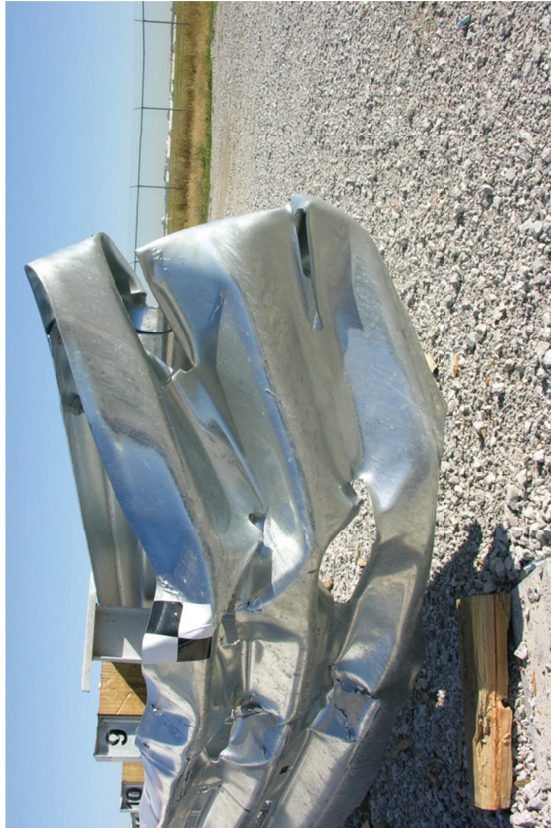
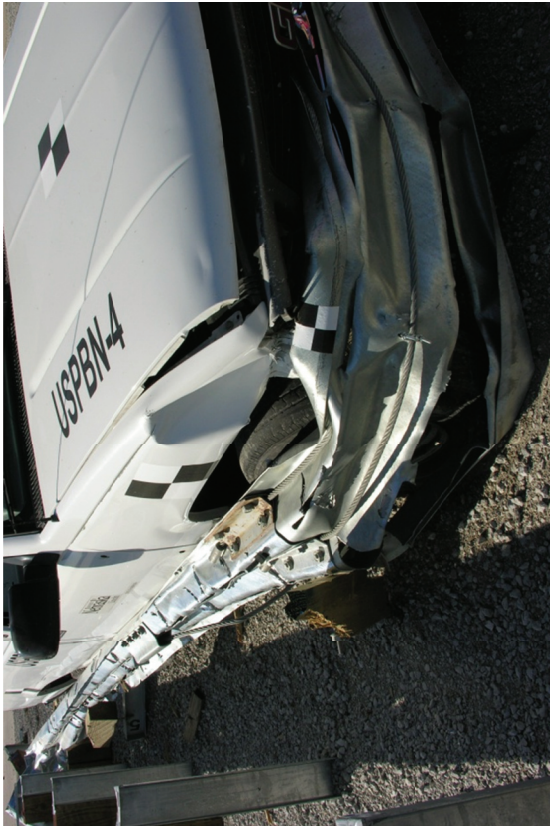
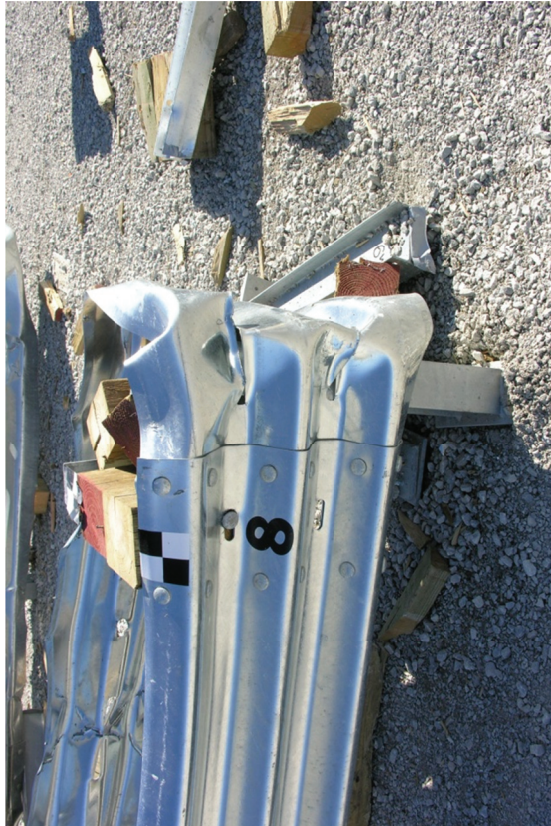
Damage to the barrier was severe, as shown in Figures 51 through 53. Barrier damage consisted of guardrail buckling and flattening, deformation of the guardrail around the front of the pickup truck, and post fracture and disengagement on both sides of the bullnose. Deformation to the rail occurred from 13 in. (330 mm) upstream of post no. 8 on Side A to 15 in. (381 mm) upstream of post no. 8 on Side B.

Post nos. 1 through 6 and post no. 8 on Side A were fractured and disengaged. BCT post nos. 1 and 2 fractured through the hole at ground level. The majority of post no. 1 remained attached to the guardrail connected through the bottom bolt. The universal steel breakaway post nos. 3 through 6 and post no. 8 disengaged from the foundation tube and lower base plate when the bolts fractured. The top portion of post no. 3 was slightly twisted in relation to the upper base plate. The back blockout was disengaged from post no. 4 and the front flange was bent. The back blockout was disengaged from post no. 5, and the front blockout was partially disengaged. The weld at the base plate of post no. 7 fractured at the front flange on the upstream side. Post no. 7 was also bent and twisted downstream in relation to the upper base plate with the rear flange buckled 2 in. (51 mm) at the lower portion of the post. There was also a  $\frac{3}{8}$ -in. (10-mm) soil gap on the upstream face of the foundation tube at post no. 7. Post no. 8 was twisted upstream in relation to the upper base plate, and the back flange and web were bent at the top of the post. Post nos. 9 and 10 had  $\frac{1}{2}$ -in. (13-mm) soil gaps on the backside and frontside of the foundation tubes, respectively. There was no visible damage to post nos. 11 through 14 on Side A.

The damage to the Side A three beam guardrail consisted of buckling and tearing of the guardrail. A buckle formed 13 in. (330 mm) upstream of post no. 8. A 1½-in. (38-mm) long vertical tear was located in the upper slot 13 in. (330 mm) downstream of post no. 7 on the Side A. Another 2-in. (51-mm) long tear was located in the upper slot 21 in. (533 mm) downstream of post no. 6. The bottom corrugation had a 6-in. (152-mm) long vertical tear 17 in. (432 mm) upstream of post no. 5. The lower slot had a small vertical tear 43 in. (1,092 mm) upstream of post no. 5. Major folding and a buckle occurred in the three beam guardrail at the Side A quarter-point cable clip on rail section no. 1. The lower slots were torn completely through from post no. 1 through 13 in. (330 mm) downstream of the center of the nose on Side A. A 4-in. (102-mm) long vertical tear and an 8-in. (203-mm) long vertical tear were located 12 in. (305 mm) and 9 in. (229 mm) upstream from post no. 1, respectively. Another 4-in. (102-mm) long vertical tear was located in the bottom corrugation 13 in. (330 mm) downstream of the center of the nose on Side A.

The damage to the Side B three beam guardrail consisted of buckling, tearing and flattening of the guardrail. Folding and flattening occurred downstream of the center of the nose on Side B. A 2-in. (51-mm) long vertical tear was located 20 in. (508 mm) upstream of post no. 1. A 3-in. (76-mm) long vertical tear and a 4-in. (102-mm) long vertical tear were located at the

lower slot 13 in. (330 mm) and 11 in. (279 mm) upstream of post no. 1, respectively. The guardrail was torn completely through at the lower slots 17 in. (432 mm) downstream of post no. 1. A 2-in. (51-mm) long vertical tear was found 7 in. (178 mm) upstream of post no. 2 at the upper slot. Another 1-in. (25-mm) long tear was found 4 in. (102 mm) downstream of post no. 3. A 3-in. (76-mm) long horizontal tear was located 43 in. (1,092 mm) downstream of post no. 7. The guardrail was buckled 15 in. (381 mm) upstream of post no. 8.

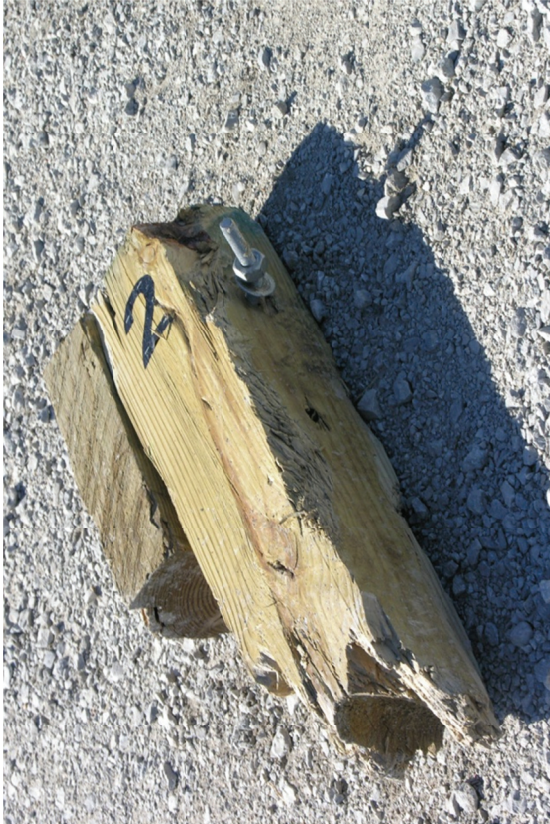
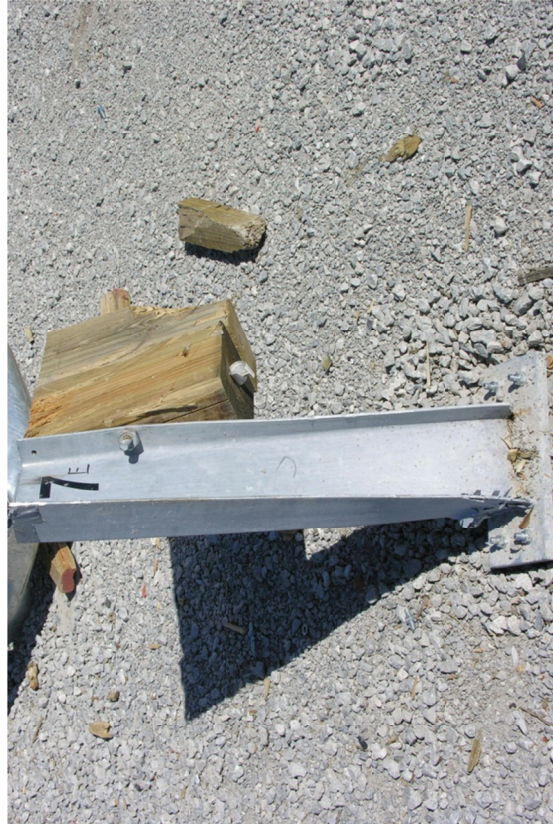
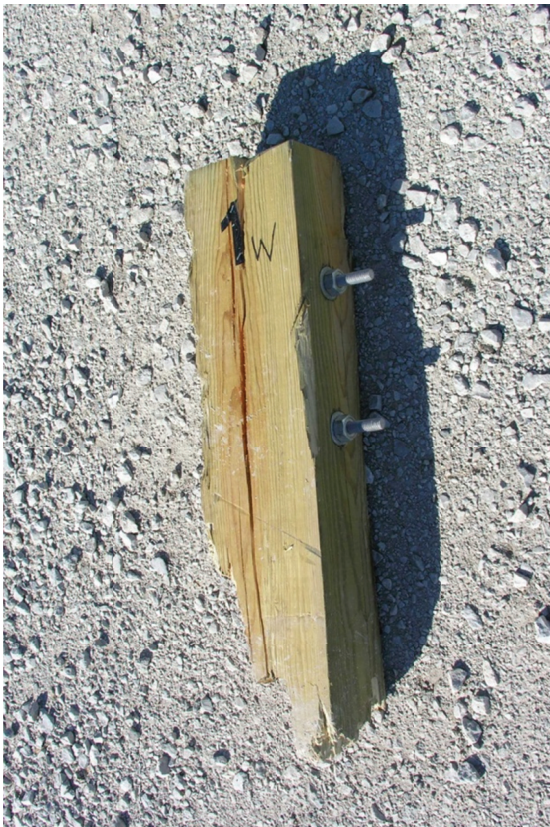
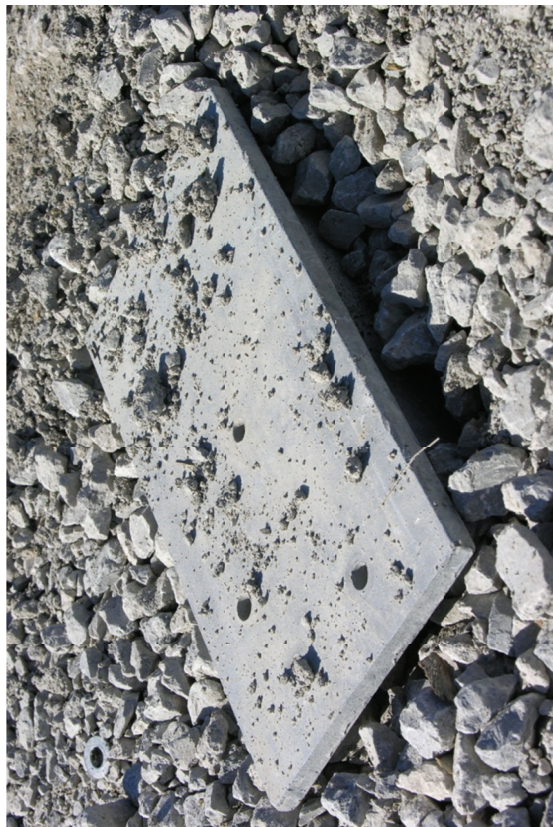
Figure 53. Post Damage, Test No. USPN-4

The first seven posts on Side B were fractured and disengaged. BCT post nos. 1 and 2 fractured through the hole at ground level. Post no. 1 was split on the upstream face. The universal steel breakaway post nos. 3 through 7 disengaged from the foundation tubes and lower base plates as the bolts fractured. Post no. 3 was slightly twisted downstream in relation to the

upper base plate, and the back flange was bent and gouged. Post no. 4 was wedged underneath the left-rear tire. The front blockout on post no. 5 was fractured. The back flange was bent and the front blockout was split on post no. 7. A ½-in. (13-mm) soil gap was found on the upstream side of the foundation tube of post no. 8. The two upstream base plate bolts fractured on post no. 8, and the post was bent slightly downstream but still in its original location. There was no visible damage to post nos. 9 through 14 on Side B. There was no visible damage to the foundation tubes or lower base plates on either side of the system.

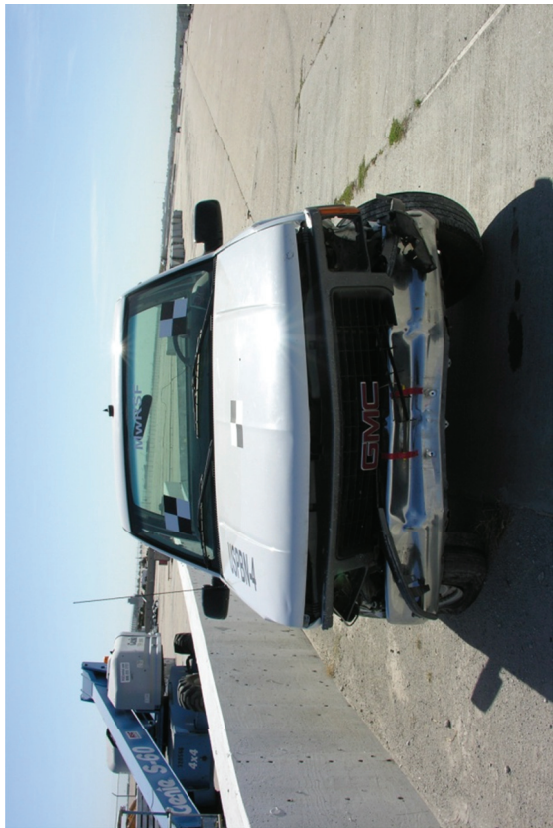
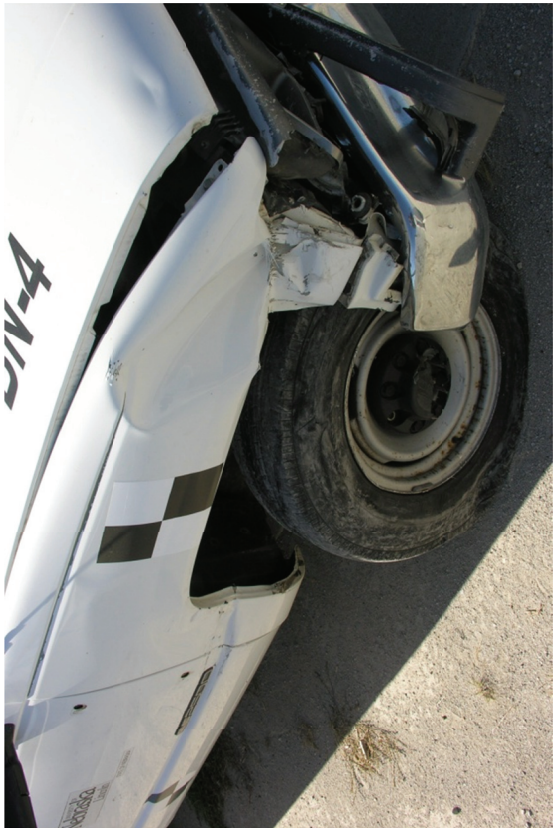
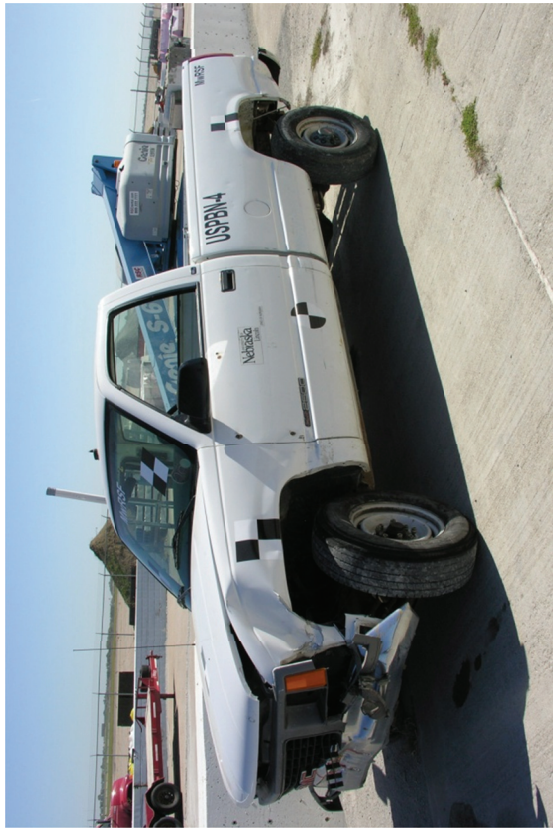
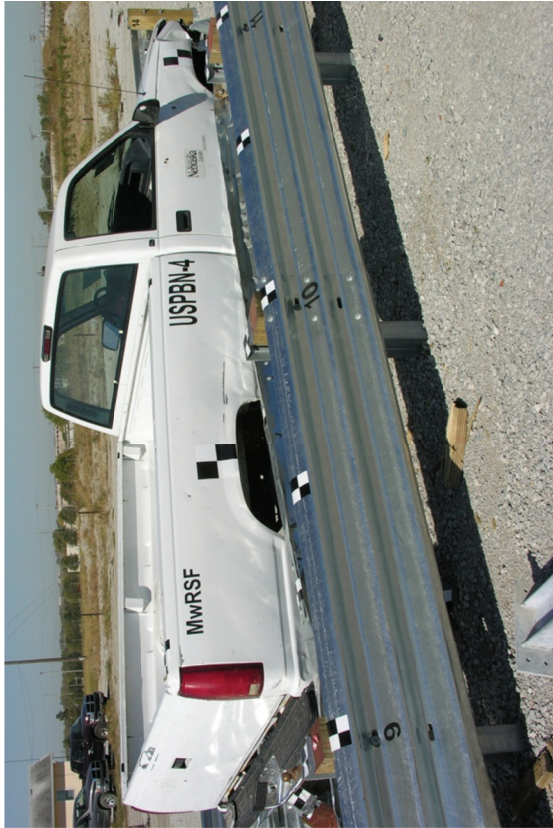
Figure 55. Vehicle Damage, Test No. USPBN-4

The damage to the vehicle was moderate, as shown in Figure 55. Deformations to the vehicle's floorboard were relatively minor, with maximum longitudinal, lateral, and vertical deflections of ½ in. (13 mm) located at the right side of the right-side floorboard near the dashboard, ½ in. (13 mm) located near the middle of the left-side floorboard, and ½ in. (13 mm) located at the right side of the right-side floorboard near the dashboard, respectively. Complete occupant compartment and vehicle deformations and the corresponding locations are provided in Appendix C.

The left-rear quarter panel was crushed approximately 3 in. (76 mm). The left-front fender was crushed backward due to contact with the cable, and a 4-in. (102-mm) long tear occurred. The left headlight was disengaged. The left side of the hood was ajar. Scrape marks occurred along the bottom edge of the longitudinal frame members. Folding occurred in the left side of the front bumper, and the bumper was significantly crushed. The grill was crushed inward due to contact with the cable. The radiator was punctured and was leaking. The right headlight was crushed inward. The right-front fender was crushed inward approximately 5 in. (127 mm), and the fender was folded. The right side of the hood was ajar. The right-front tire had a 4-in.

(102-mm) long tear in the side wall, and the hub cap was fractured. The right-rear tire had a 13-in. (330-mm) long tear in the side wall. The roof and window glass remained undamaged.
