CRASH TESTING AND EVALUATION OF HDOT'S THRIE-BEAM APPROACH GUARDRAIL TRANSITION ATTACHED TO 42-IN. TALL, SOLID CONCRETE BRIDGE RAIL WITH AESTHETIC, RECESSED, ROUNDED PANELS AND 6-FT WIDE SIDEWALK: MASH TEST NOS. 3-20 AND 3-21

MwRSF Research Report No. TRP-03-472-22

December 13, 2022

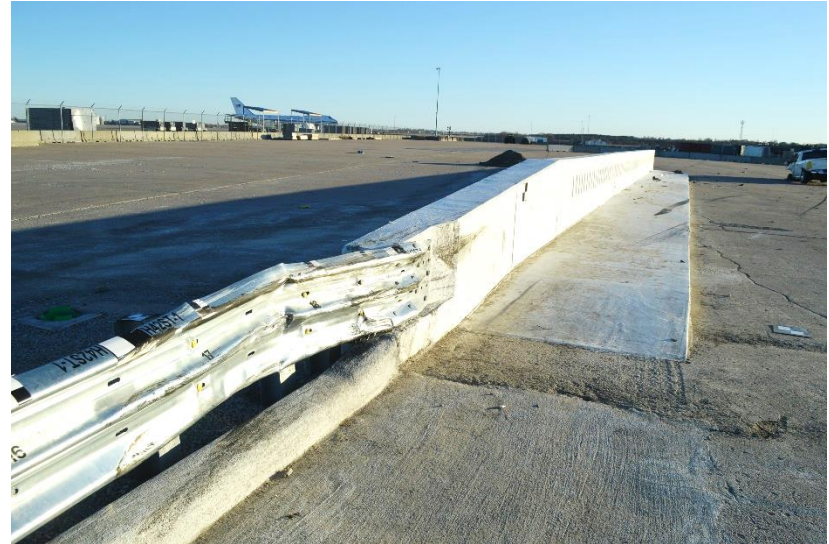
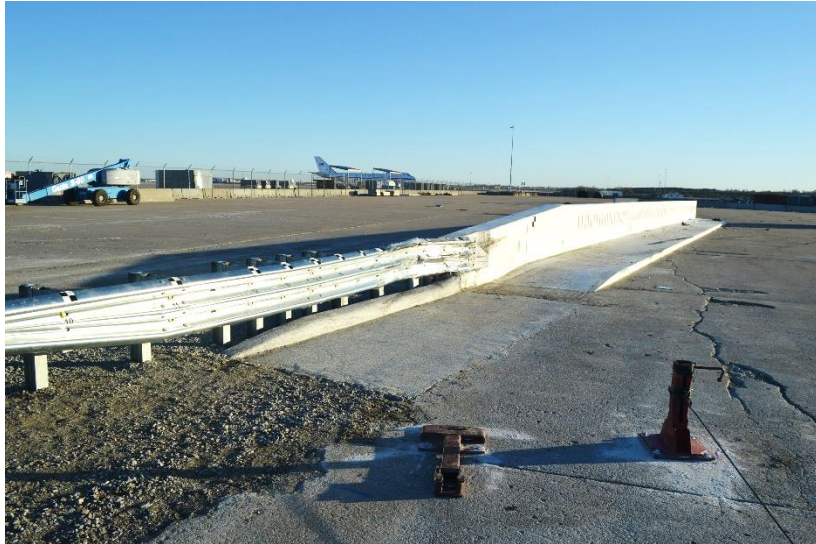
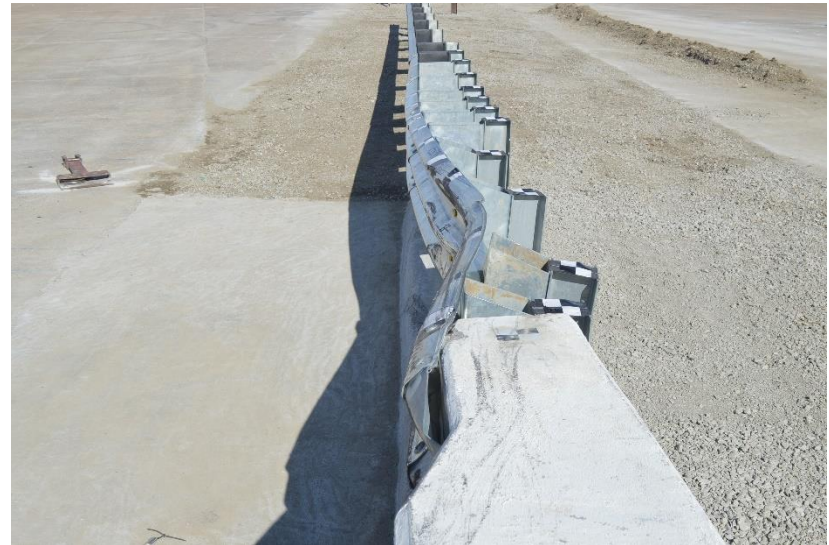
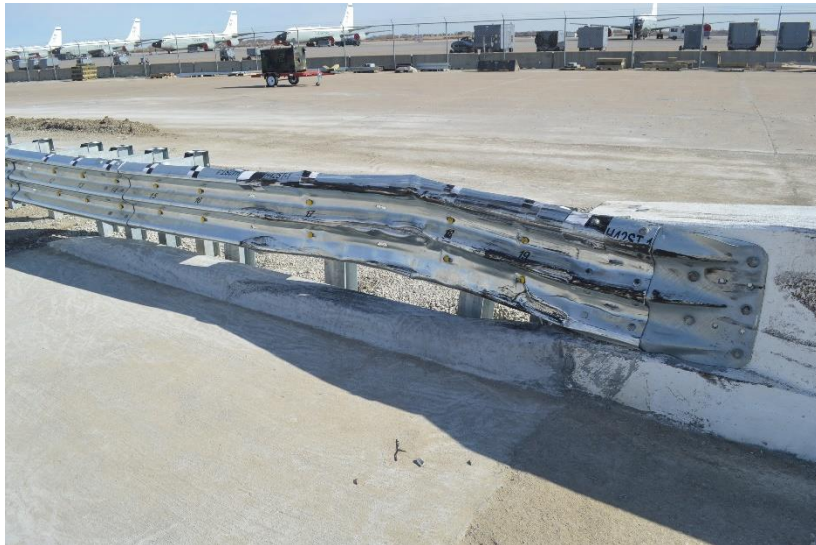
Figure 63. System Damage, Test No. H42ST-1

Damage to the barrier was moderate, as shown in Figures 63 through 66. Barrier damage consisted of post deflections, contact marks, rail kinking, and gouging and spalling of the concrete buttress and curb. The length of vehicle contact along the barrier was approximately 17 ft – 2 in., which spanned from 11 in. downstream from the center of post no. 16 and extended downstream onto the concrete buttress.

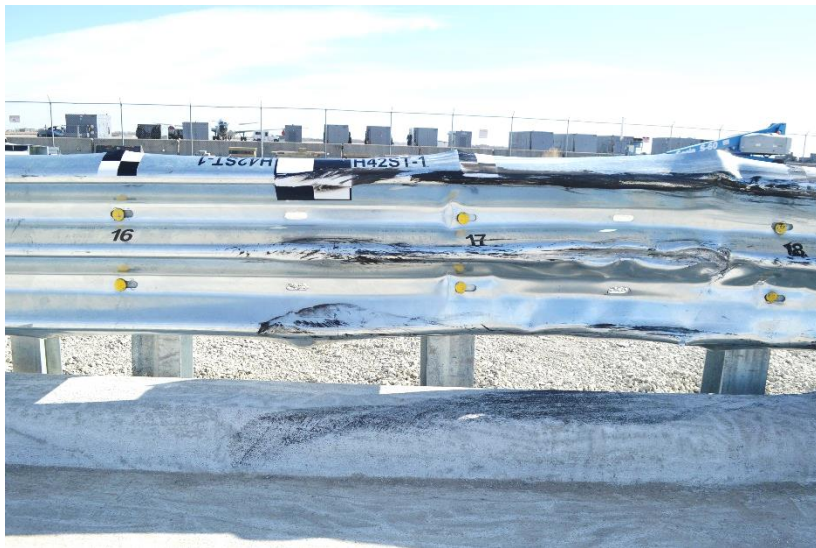
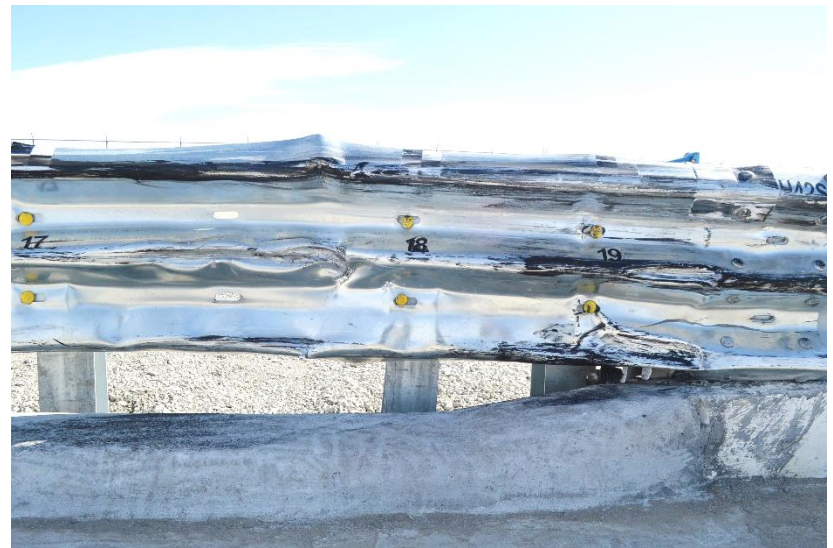
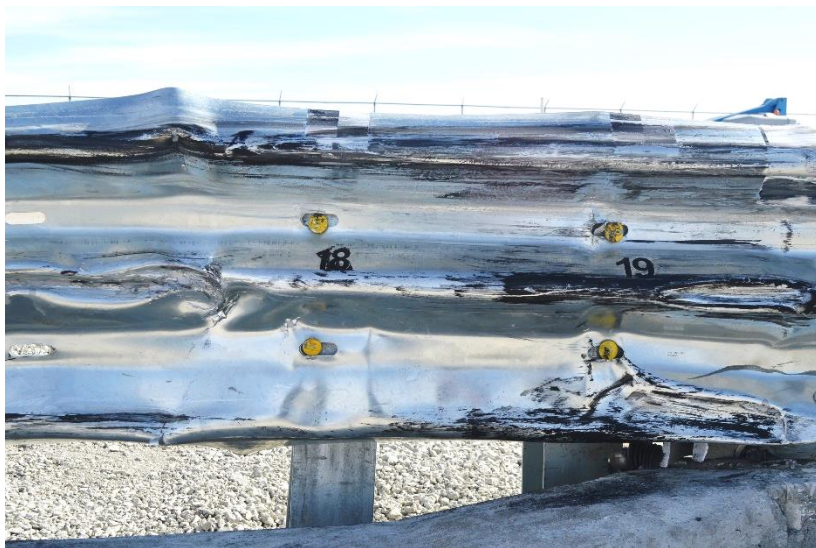
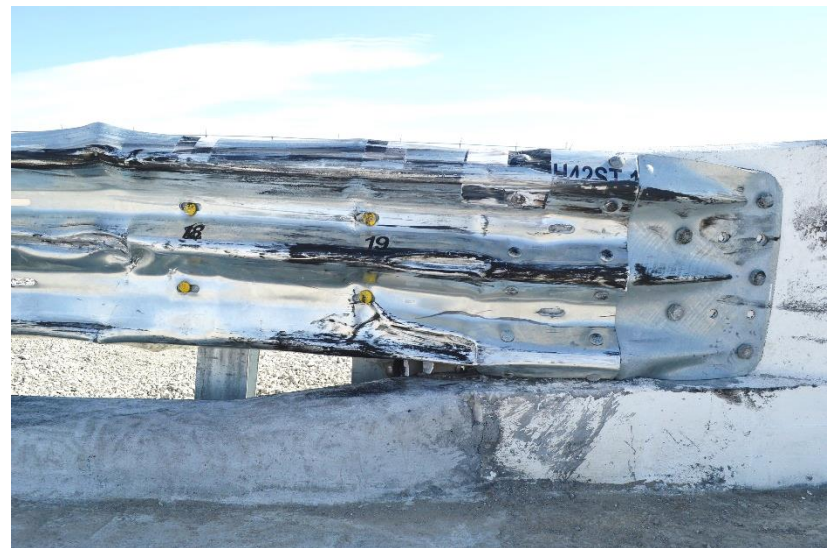
Figure 64. Thrie Beam Damage, Test No. H42ST-1

Contact marks on the thrie-beam rails were concentrated on the upper-middle and bottom corrugations. The marks started 13 in. downstream from the center of post no. 16 and onto the front and top face of the curb extending to the front and top of the concrete buttress. The upper half of the thrie-beam rails between post nos. 16 and 19 were flattened. Various rail kinking was found on the guardrail spanning from post no. 13 to post no. 19. The largest rail kinks were found around post nos. 17 and 19. The lower corrugation was also bent backward between post nos. 16 and 18.

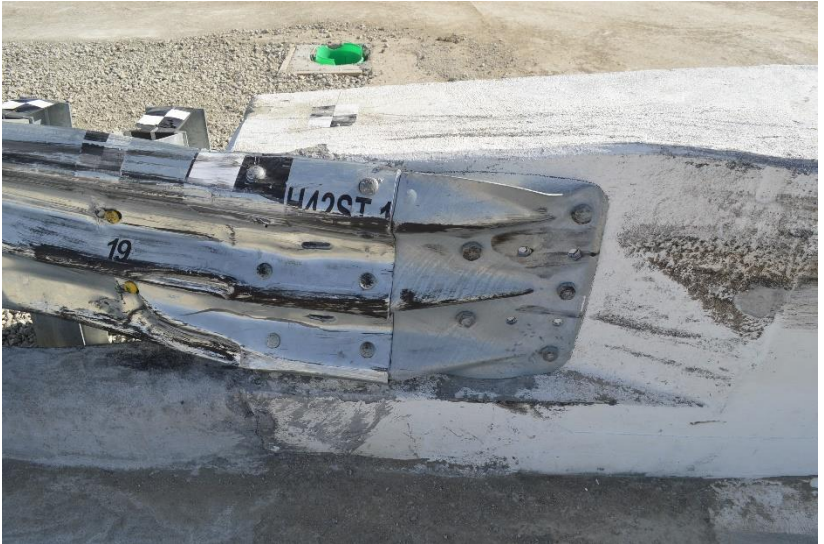
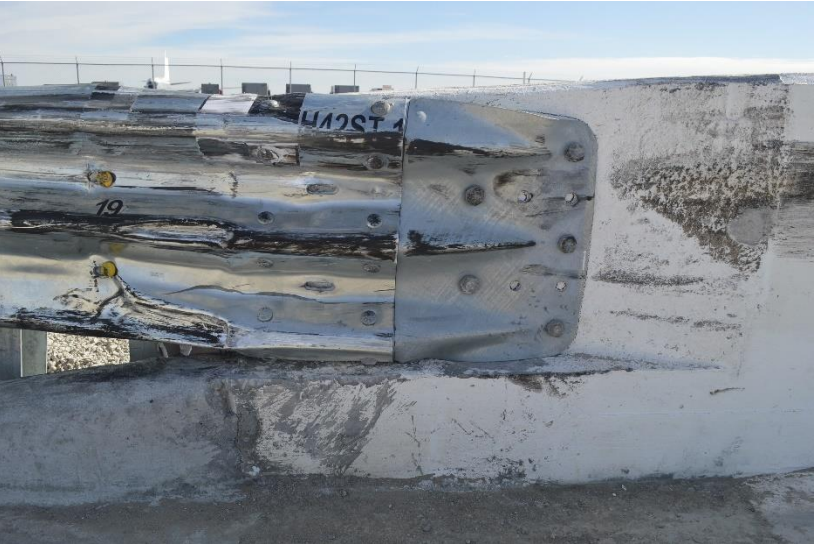
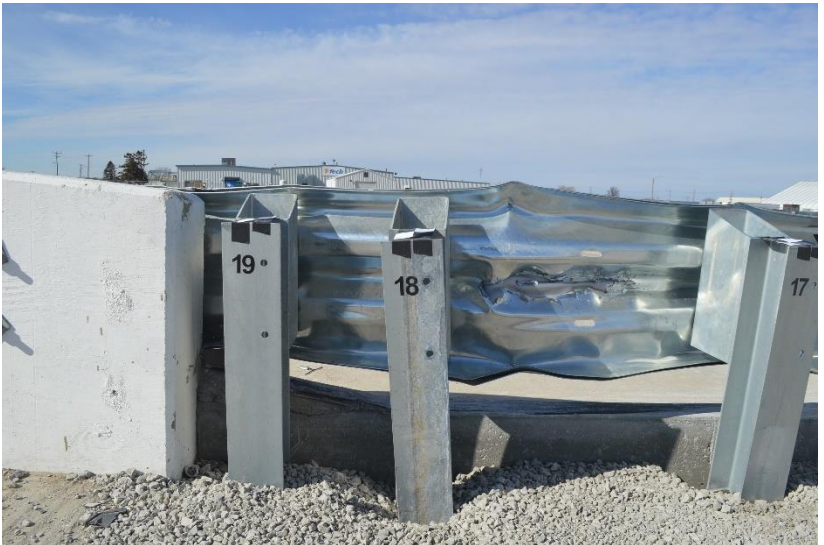
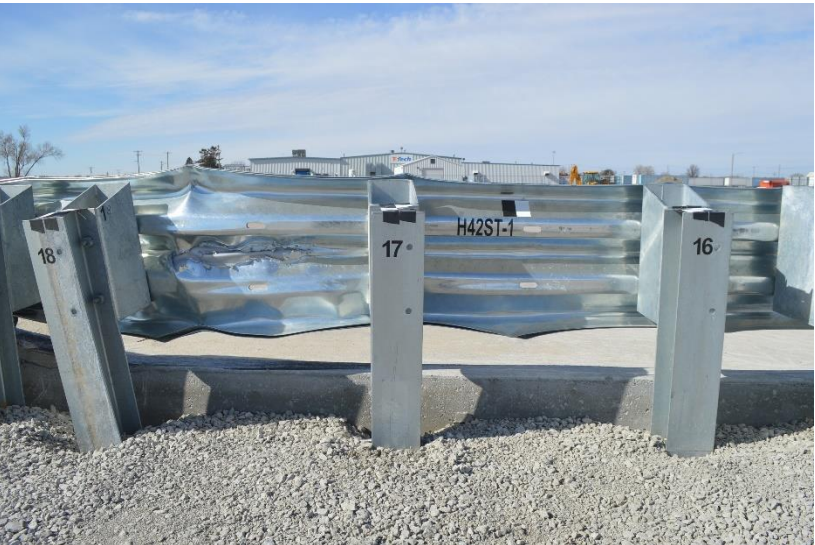
Figure 65. Rail Connection Terminal, Buttress, and Post Damage, Test No. H42ST-1

Post no. 1 had a 1-in. soil gap on the upstream side, but no other damage was documented to the upstream anchorage. Post nos. 3 through 17 experienced slight counterclockwise rotation around the vertical axis. Post nos. 16 through 19 rotated backward, leaving soil gaps adjacent to the front flange, the largest of which were measured to be around 1 in. at post nos. 17 and 18. In addition to being deflected backward, post no. 18 experienced clockwise rotation, resulting in minor localized plastic deformations to the upstream sides of the front flanges adjacent to the blockouts.

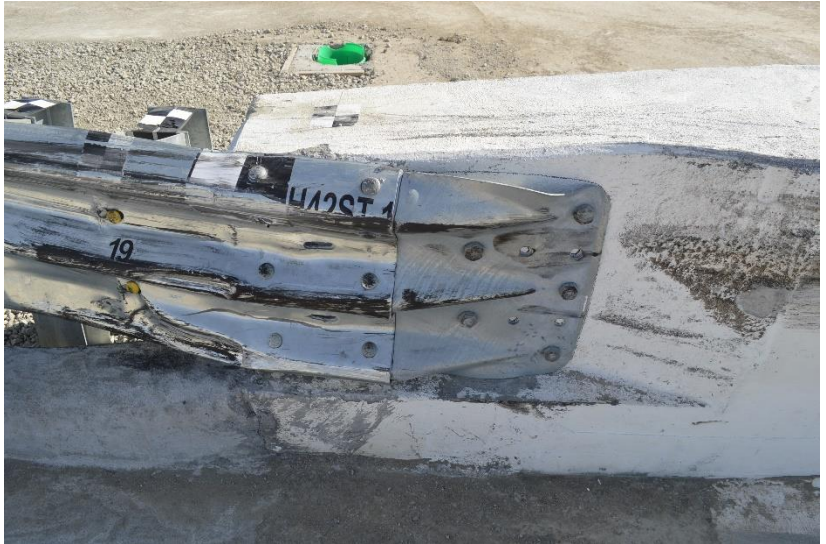
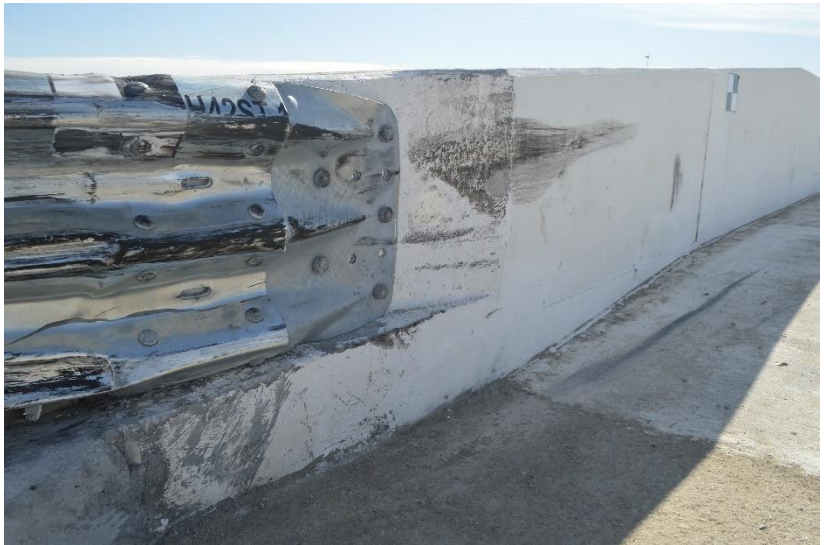
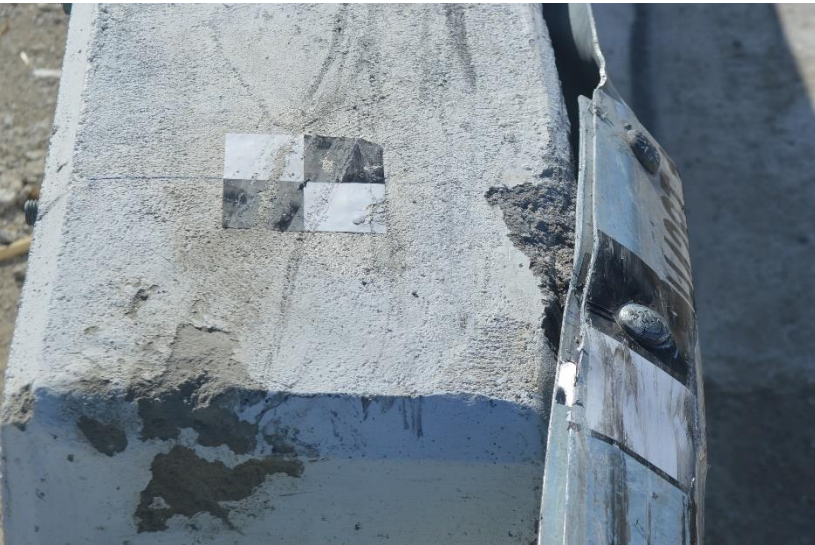
Figure 66. Buttress Damage, Test No. H42ST-1

The concrete curb had tire marks on the front and top face, starting 13 in. downstream from post no. 16 and extending onto the front and top face of the curb and front and top of the concrete buttress. The tire mark on the curb was 12 ft – 4 in long and 8 in. wide. A 6 ft – 10 in. long contact mark was found at the upstream end of the top face of the concrete buttress and extended across the entire width. Concrete spalling was found on the top-front edge of the concrete buttress behind the nested thrie beam, as depicted in Figure 66. Minor concrete spalling also occurred at the joint between the curb and the concrete buttress. Concrete cracking was observed on the back face of the curb (i.e., 3 in. from the top of the curb), starting 1 in. from the upstream face of the concrete buttress.

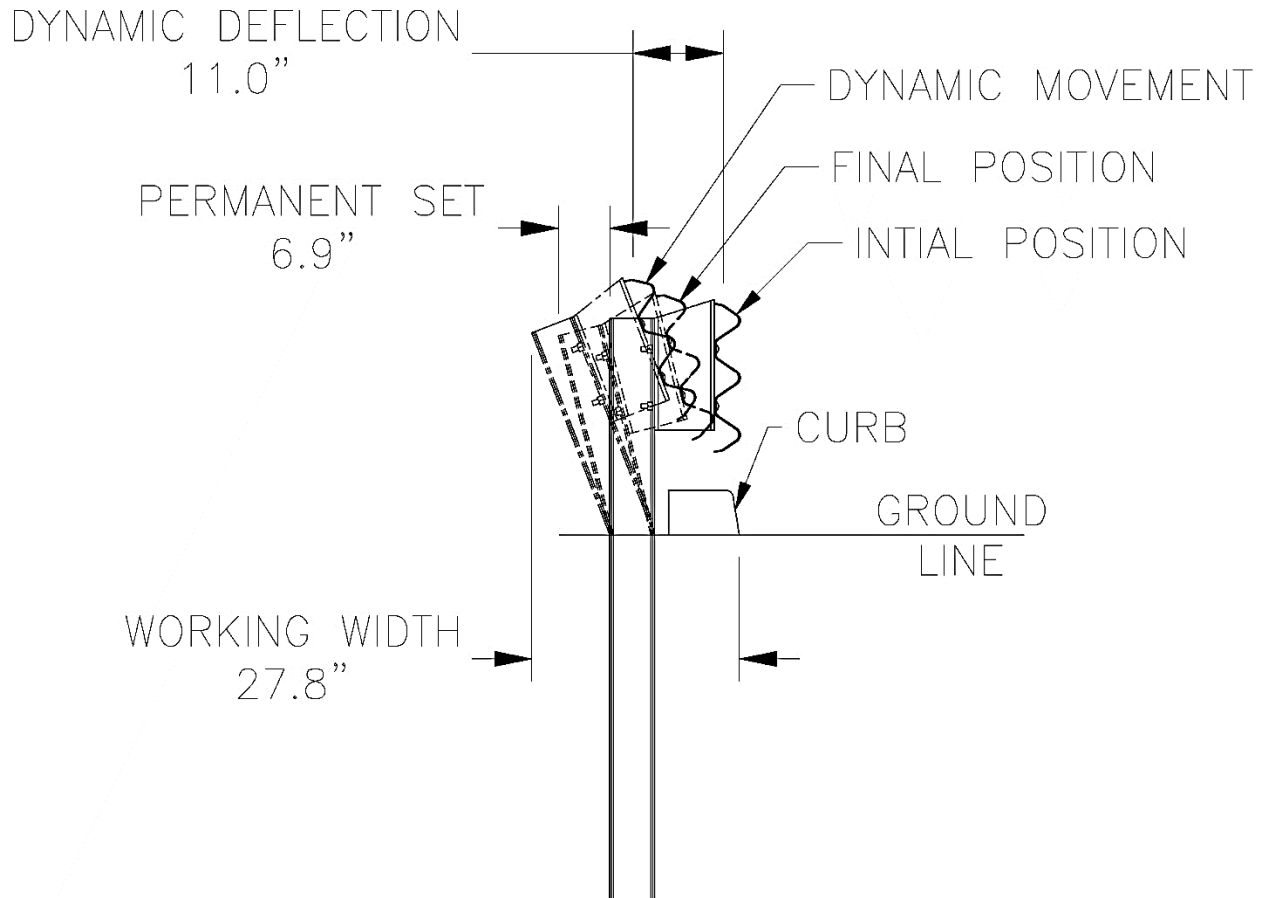
Figure 67. Permanent Set, Dynamic Deflection, and Working Width, Test No. H42ST-1

The maximum lateral permanent set of the barrier system was 6.9 in. at post no. 18, as measured in the field. The maximum lateral dynamic barrier deflection was 11.0 in. at rail no. 17, as determined from high-speed digital video analysis. The working width of the system was found to be 27.8 in. at post no. 18, also determined from high-speed digital video analysis. A schematic of the permanent set deflection, dynamic deflection, and working width is shown in Figure 67.

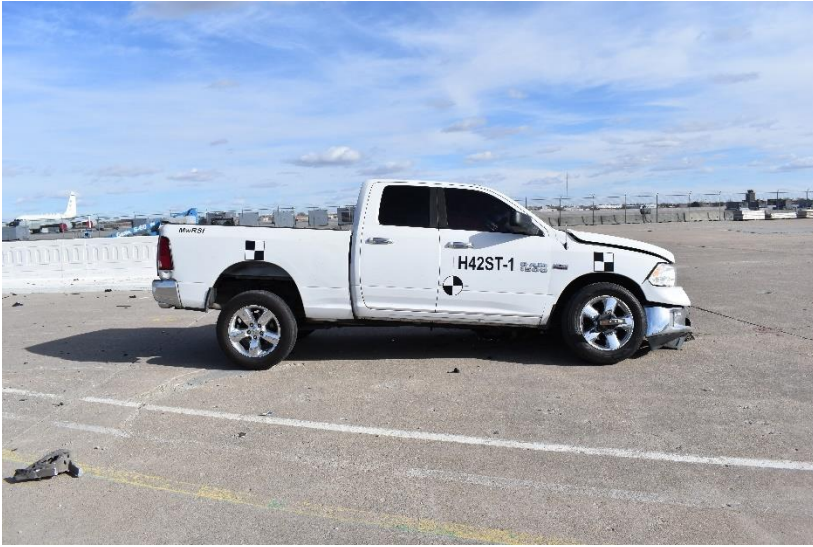
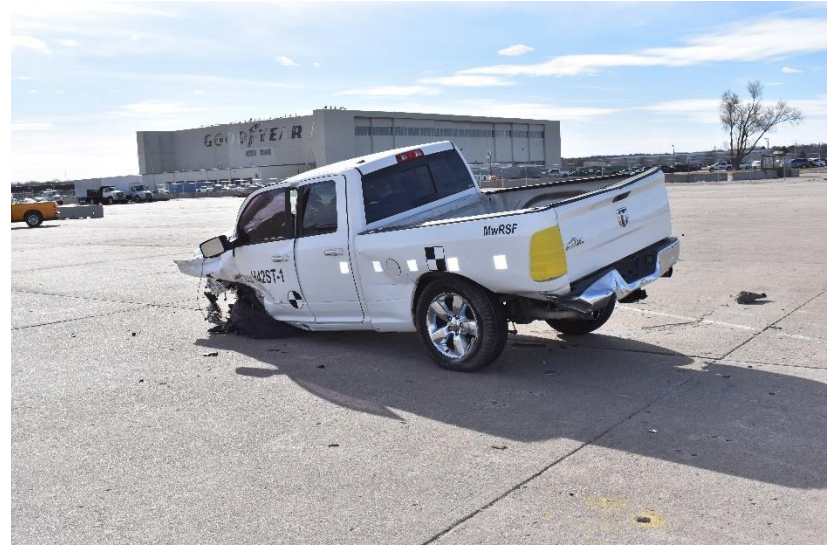
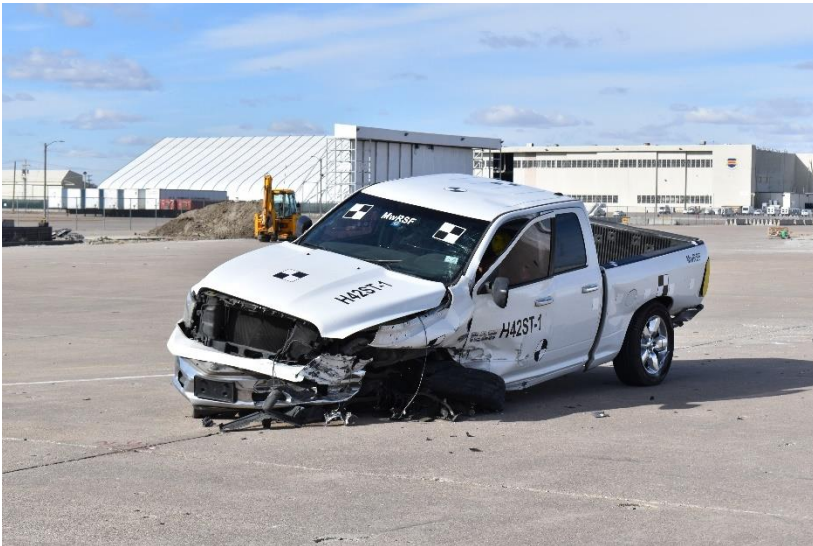
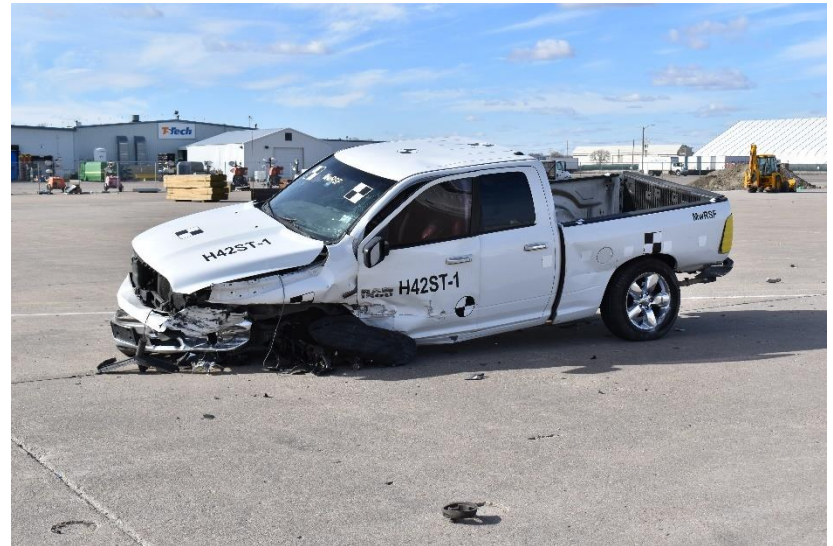
Figure 68. Vehicle Damage, Test No. H42ST-1

The majority of the damage was concentrated on the left-front corner and left side of the vehicle where the impact had occurred. The grille disengaged from the vehicle, and the front

bumper was crushed inward. The left headlight was disengaged from the vehicle, while the hood remained intact. Significant damage was imparted to the left-front fender, including being crushed inward and folded at the bottom of the panel. The region by the lower A-pillar was severely crushed and dented by the wheel opening. The left-front door was scraped and crushed inward along its entire length, causing the door to bow outward in its center with the window frame severely bent; nonetheless, the glass remained intact. The left-rear door and fender remained intact. The left side of the windshield was cracked. The left box side was dented and scraped along its entire length, with the dent starting in the vertical center of the panel and ending at the lower edge of the panel behind the rear wheel opening.

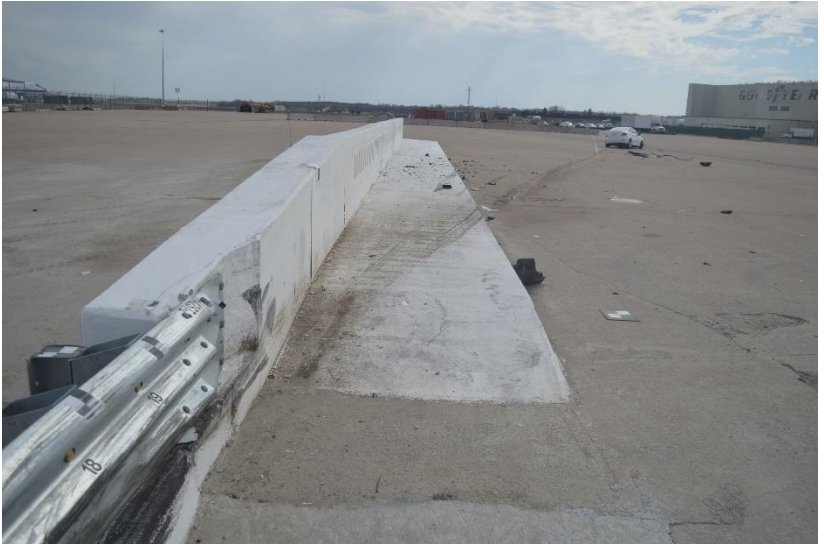
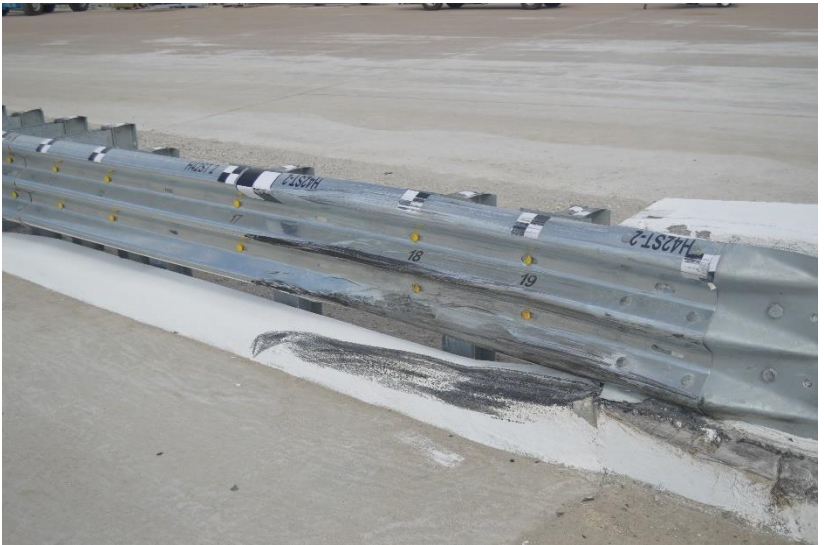
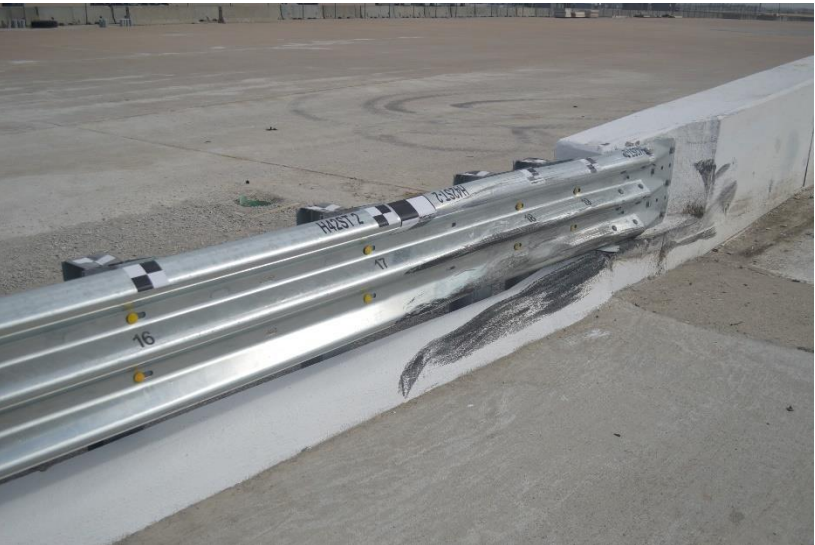
Figure 82. System Damage, Test No. H42ST-2

Damage to the barrier was minimal, as shown in Figure 82 through 84. Barrier damage consisted of contact marks and kinking of the thrie-beam sections, contact marks on the front face of the concrete buttress, and gouging of the concrete. The length of vehicle contact along the barrier was approximately 10 ft – 9 in., which began 2 in. downstream from the center of post no. 17 and extended onto the concrete parapet.

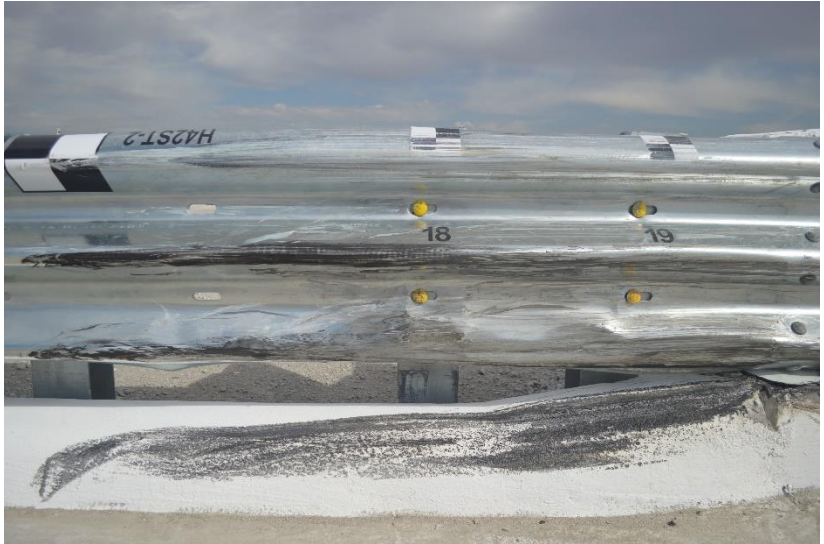
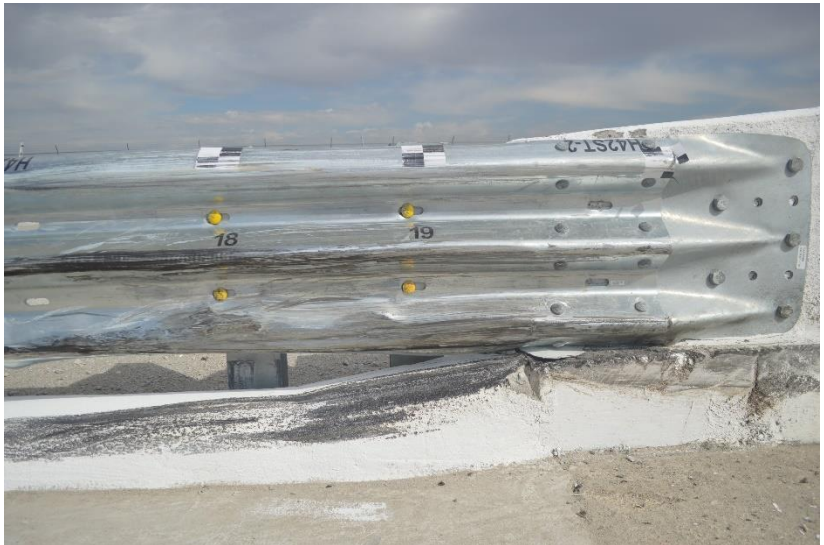
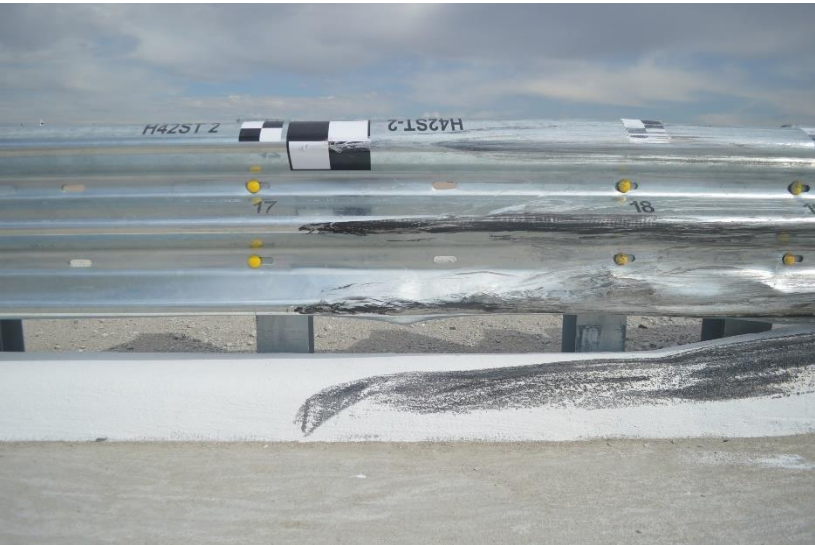
Figure 83. Thrie Beam Damage, Test No. H42ST-2

Contact marks on the thrie beam began 2 in. downstream from the centerline of post no. 17 and extended to the downstream end of thrie beam and onto the anchor plate for a total length of 6 ft – 9½ in. A contact mark was found on the upstream face of the concrete parapet with a length of 5 ft – 3 in. and extended to the downstream end of the curb. The bottom corrugation sustained various degrees of flattening damage beginning 9 in. downstream from the center of post no. 17. Multiple kinks were found on the top and bottom of the thrie beam around post nos. 13, 14, 17, and 19. Post nos. 18 and 19 slightly rotated counterclockwise, but there was no damage to the posts.

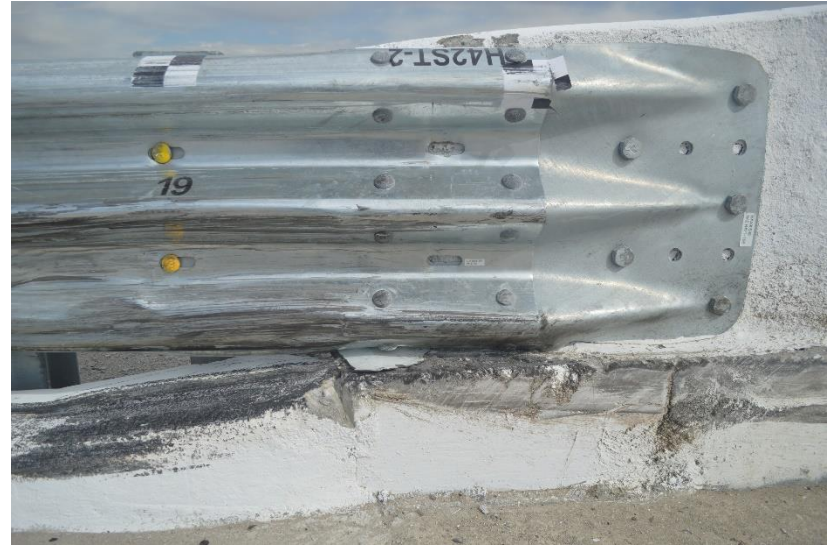
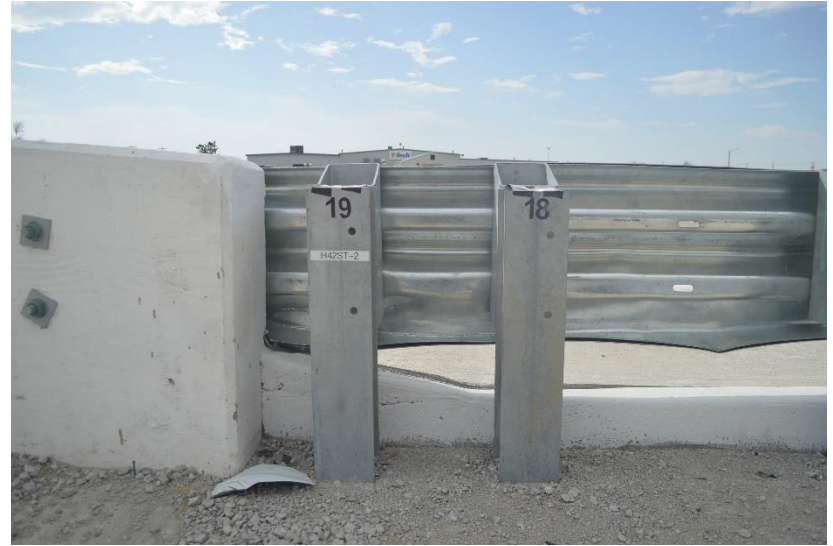
Figure 84. Rail Connection Terminal, Buttress, and Post Damage, Test No. H42ST-2

A contact mark was found on the concrete curb starting 2½ in. downstream from the centerline of post no. 17 and extending to the downstream edge of the concrete parapet. The length of this contact mark was approximately 5 ft – 4 in. The top and front edge of the curb was gouged beginning 9½ in. downstream from the centerline of post no. 19 and continued downstream onto the upstream edge of the concrete parapet. The most significant gouging occurred 21 in. downstream from the upstream edge of the concrete parapet. A ¼-in. soil gap was observed behind the back of the curb starting 15 in. upstream from the centerline of post no. 17 and extending to the upstream face of the concrete parapet.

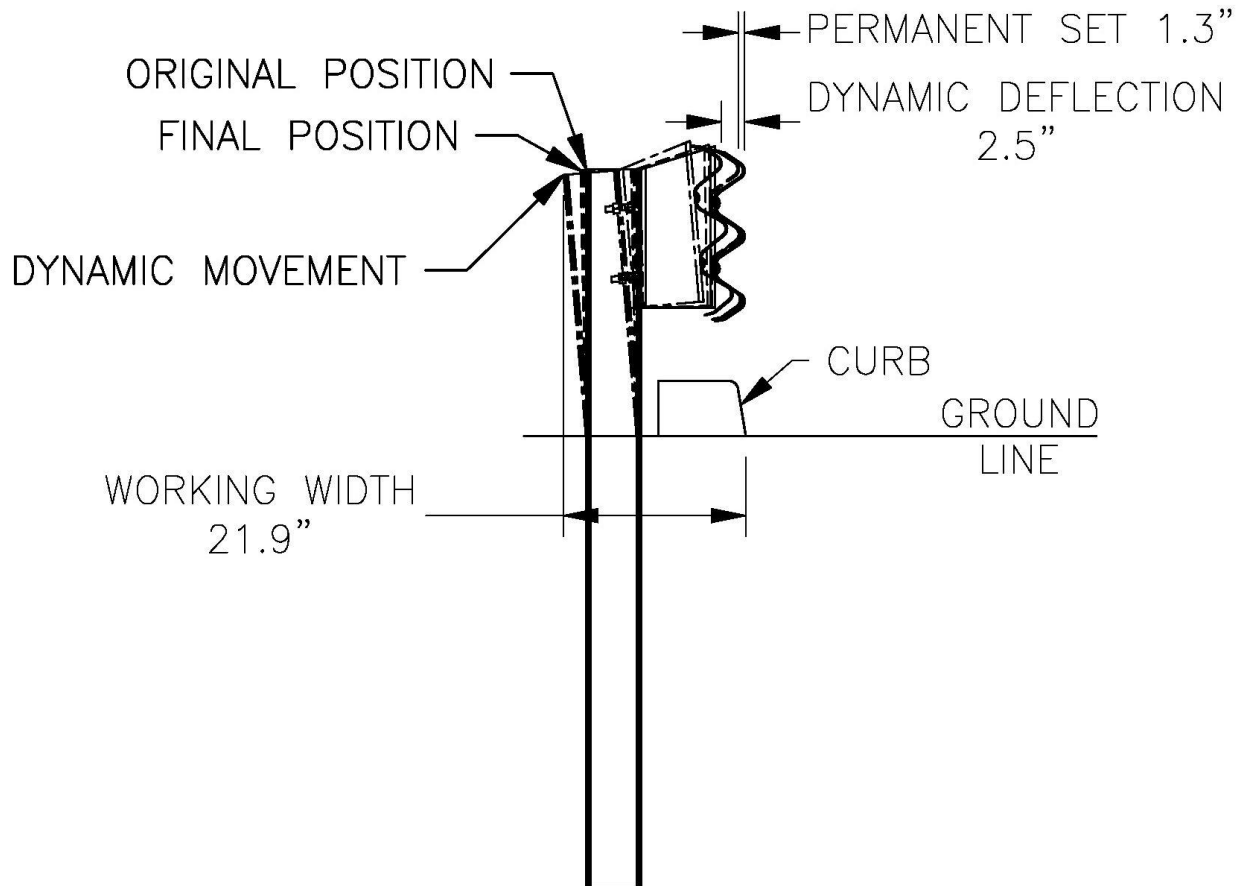
Figure 85. Permanent Set, Dynamic Deflection, and Working Width, Test No. H42ST-2

The maximum lateral permanent set of the barrier system was 1.3 in., which occurred in the thrie beam between post nos. 17 and 18, as measured in the field. The maximum lateral dynamic barrier deflection was 2.5 in. at post no. 18, as determined from high-speed digital video analysis. The working width of the system was found to be 21.9 in. at post no. 15, also determined from high-speed digital video analysis. A schematic of the permanent set deflection, dynamic deflection, and working width is shown in Figure 85.

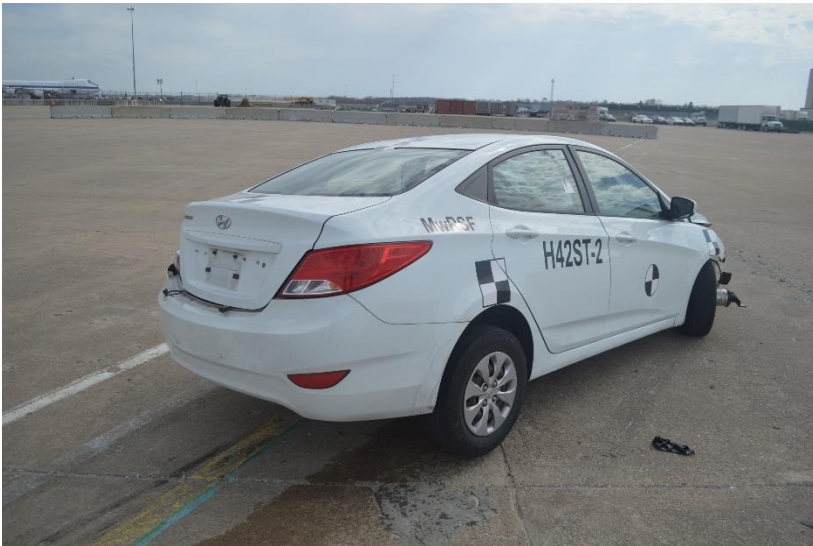
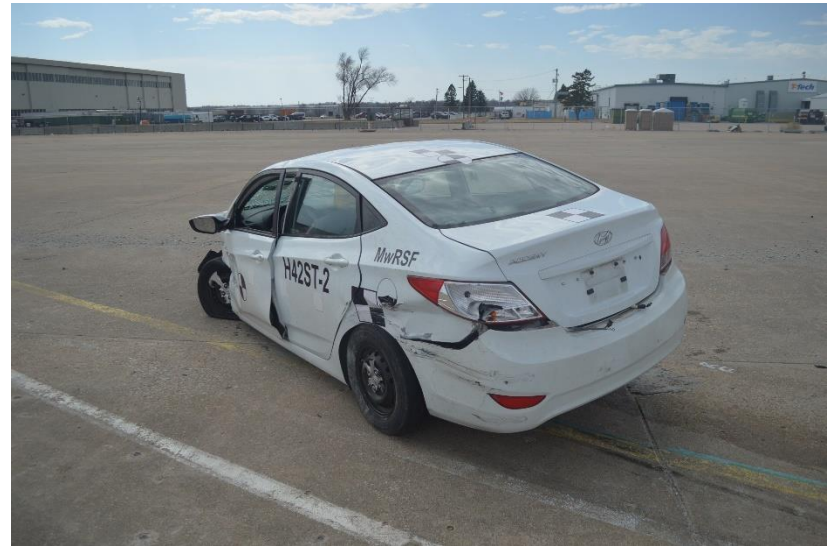
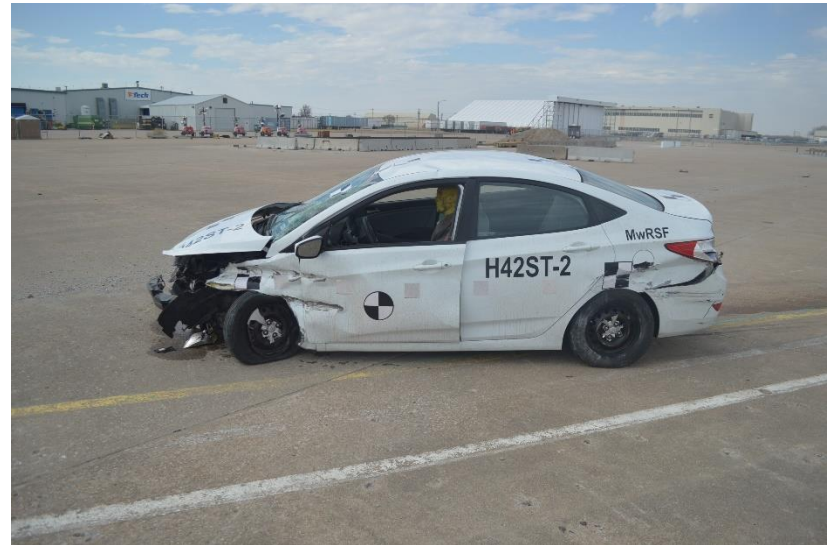
Figure 86. Vehicle Damage, Test No. H42ST-2

The majority of the damage was concentrated on the left-front corner and left side of the vehicle where the impact occurred. The left side of the vehicle hood was bent and slightly scraped.

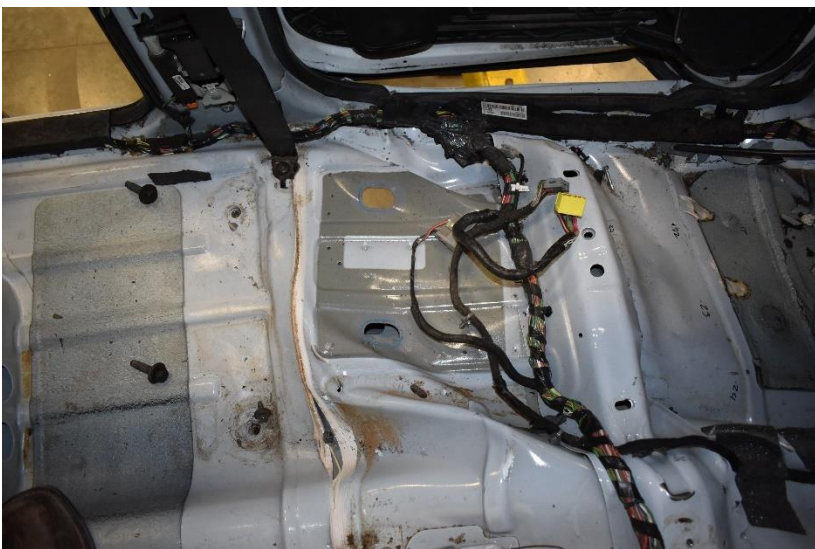
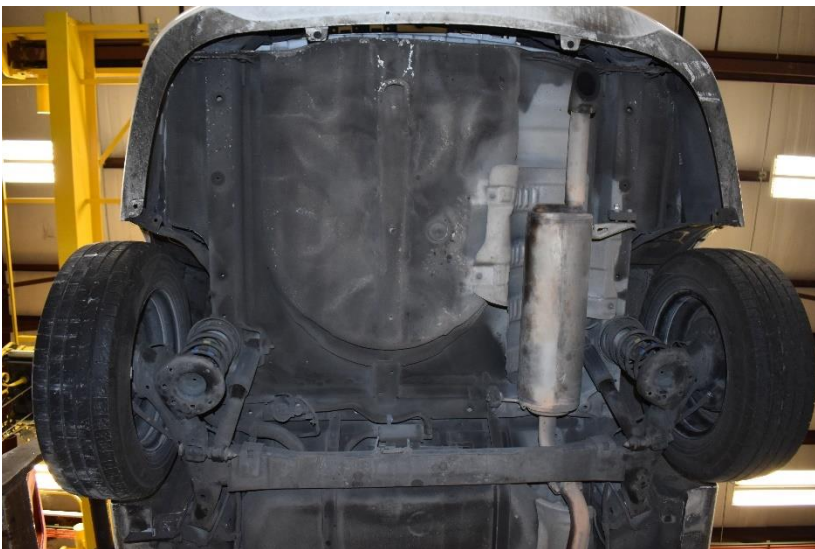
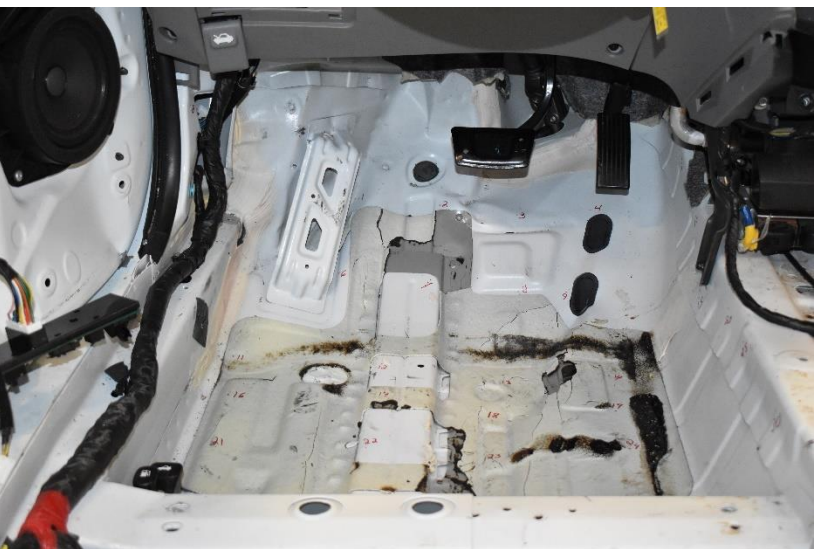
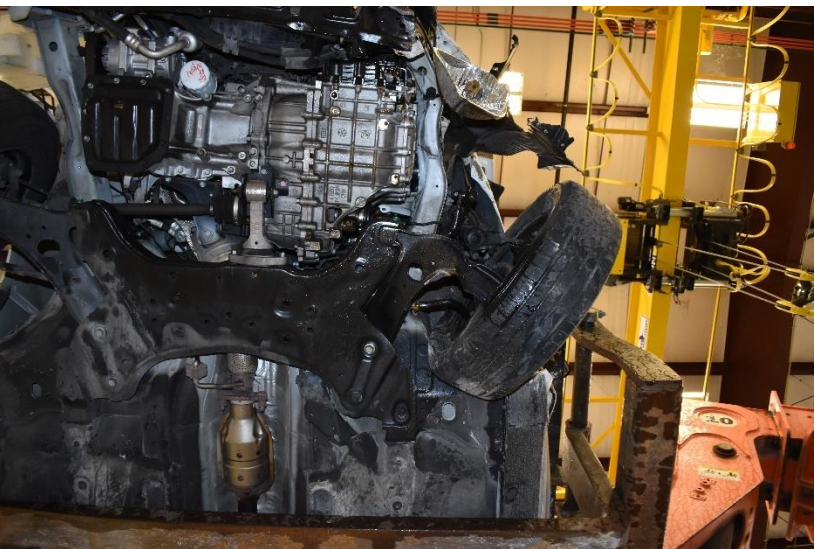
Figure 89. Vehicle Damage, Test No. H42ST-2

Undercarriage damage was moderate. No damage occurred to the left-front shock and springs, including the bump stops. The front-left side link of the sway and anti-roll bar were bent, and there was no damage to the rear side. The left-front steering knuckle was fractured at the strut mount. The left control arm was bent and slightly twisted with scraping along the trailing edge of the arm in the center of the test vehicle. The left outer tie rod of the steering control arm was significantly bent. The transmission case was cracked on the very left end. There was no damage to the oil pan, engine, or transmission mounts. The front engine cross member was bent and twisted, with the majority of the damage on the left side. The right side of the frame horn was slightly bent outward, while the left side was slightly bent inward.
