*Midwest Pooled Fund Research Program
Fiscal Year 2019 (Year 29)
TPF-5(193) Supplement #138
NDOT Sponsoring Agency Code RPFP-19-CABLE-1*

**MASH TEST DESIGNATION NOS. 3-11 & 3-17 OF A NON-
PROPRIETARY, HIGH-TENSION CABLE MEDIAN BARRIER
WITH CLOSED-SECTION POSTS**

MwRSF Research Report No. TRP-03-431-22

December 1, 2022

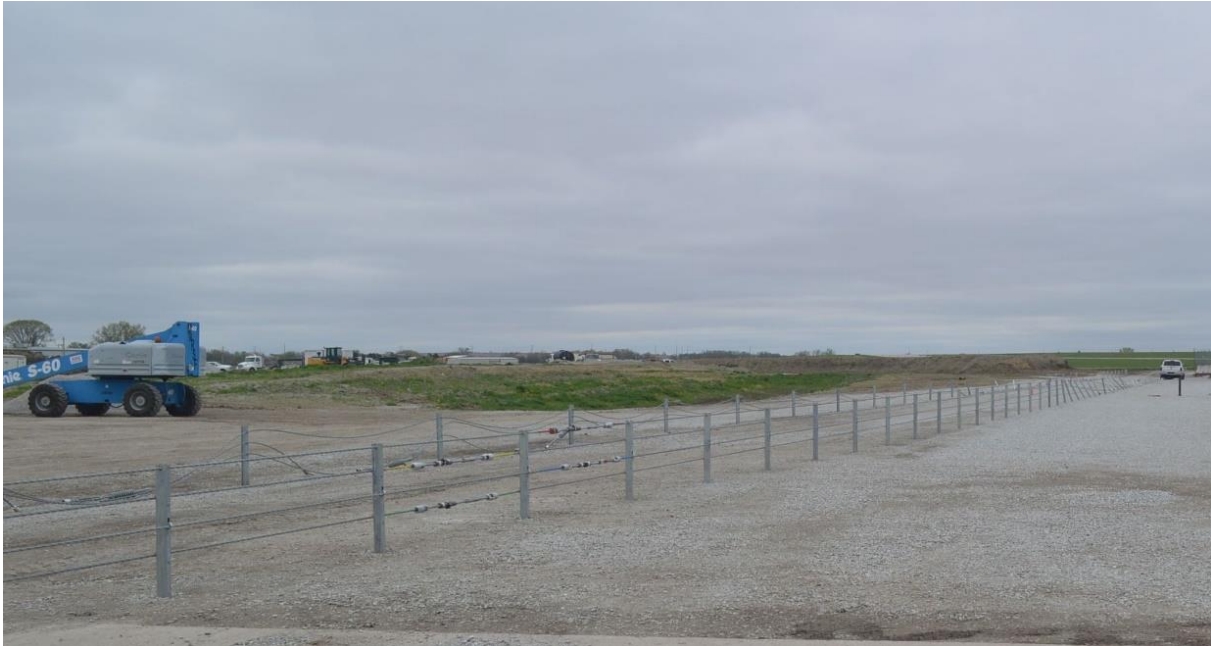
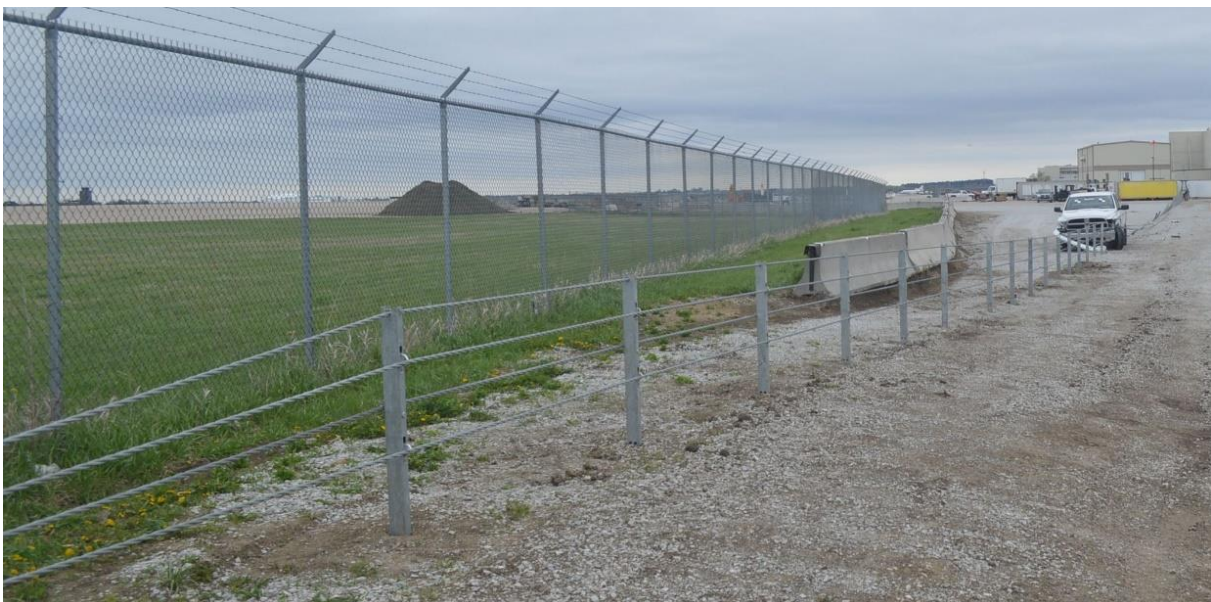
Figure 50. Overall System Damage, Test No. MTP-1

Post No.	Cable 1	Cable 2	Cable 3	Cable 4
1-17	0	0	0	0
18	0	1	0	0
19	0	1	0	0
20	0	1	0	0
21	0	1	0	0
22	0	1	0	7
23	0	1	0	0
24	0	1	0	7
25	0	1	0	6
26	0	1	1	6
27	0	1	1	6
28	0	1	1	6
29	0	1	1	6
30	0	1	1	6
31	1	1	1	6
32	1	1	1	6
33	1	1	1	6
34	1	1	1	6
35	1	1	1	6
36	0	1	1	7
37	0	1	1	6
38	0	1	1	6
39	0	1	1	6
40	1	1	1	6
41	1	1	1	6
42	1	1	1	6
43	1	1	1	6
44	1	1	1	6
45	1	1	1	6
46	1	1	1	6
47	1	1	1	6
48	1	1	1	6
49	1	1	1	6
50	1	1	1	6
51	1	1	1	6
52	1	1	1	6
53	1	1	1	6
54	1	1	1	6
55	1	1	1	6
56	1	1	1	6
57	1	1	1	6
58	1	1	1	6
59-62	0	0	0	0
63	0	1	1	7
64	1	1	1	6
65	1	1	1	0
66-76	0	0	0	0

0 = No Damage/Disengagement 4 = Fractured at Neck
1 = Deformed in Place 5 = Fractured through Bolt Hole
2 = Released Entirely 6 = Brass Rod Fractured
3 = Fractured at Tab 7 = Brass Rod Bent in Place
*Note numbers 1 through 7 also means cable disengaged

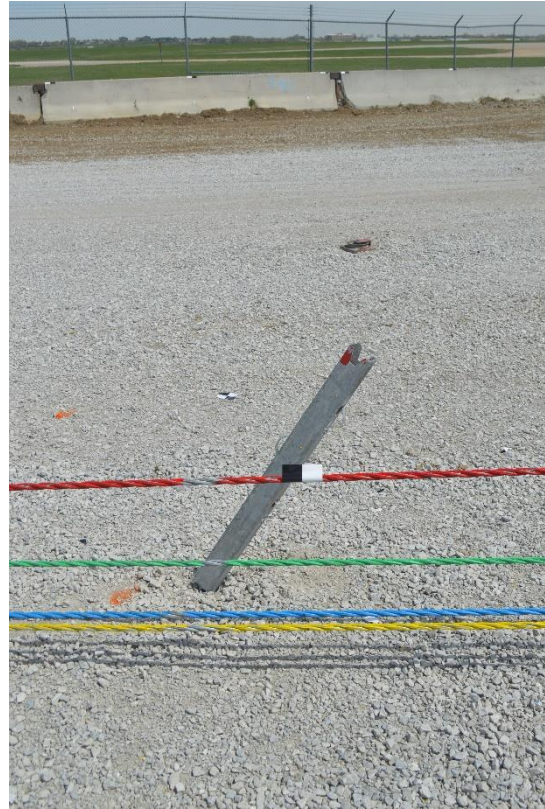
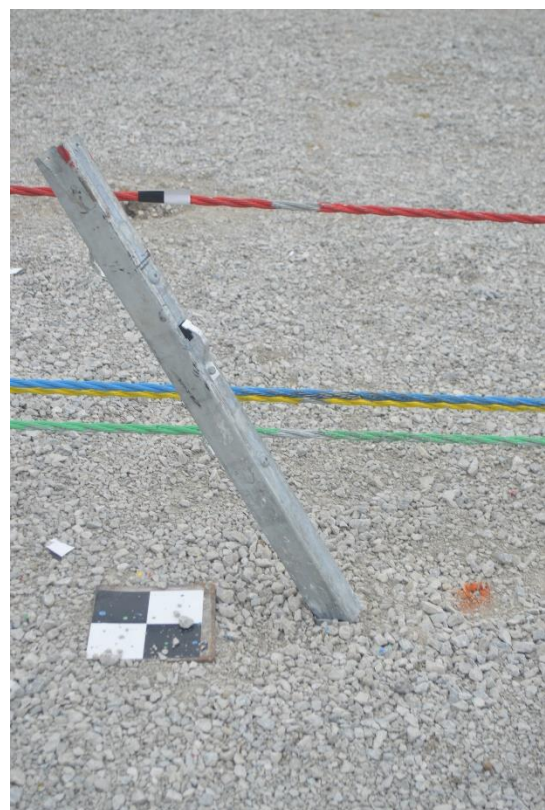
Figure 55. Post Nos. 31 (Left) and 32 (Right) Damage, Test No. MTP-1

0.032	Post no. 31 deflected backward and post no. 32 fractured.
0.038	Cable nos. 1, 2, and 3 disengaged from post no. 32.
0.050	Post no. 34 deflected backward. Vehicle's front bumper contacted cable no. 3.

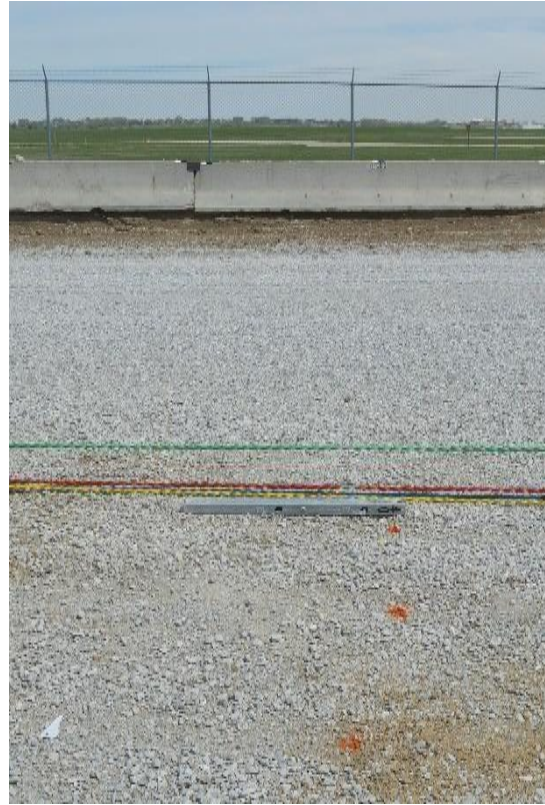
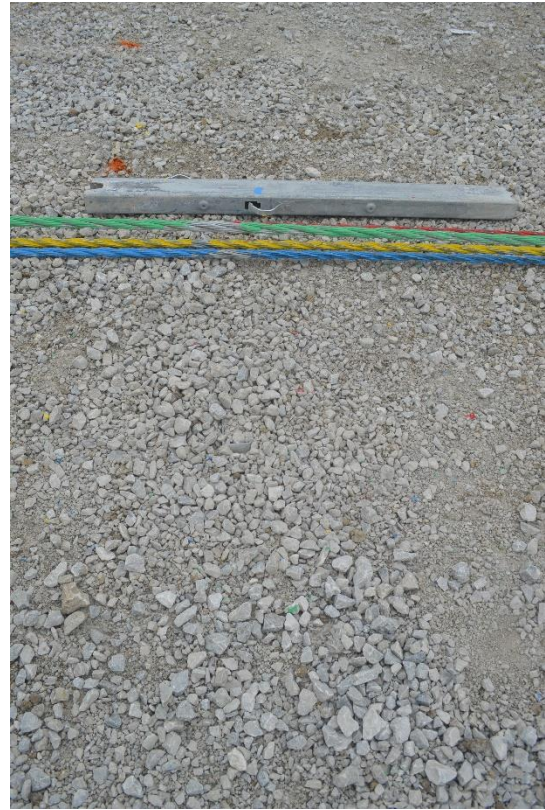
Figure 59. Post Nos. 39 (Left) and 40 (Right) Damage, Test No. MTP-1

0.286	Post no. 39 fractured.
0.288	Post no. 35 bent downstream.
0.290	Vehicle's left-front tire became airborne.
0.292	Post no. 35 fractured.
0.296	Cable no. 4 disengaged from post no. 40.

0.300	Post no. 41 bent backward. Vehicle's left-front door contacted cable no. 3.
0.306	Post no. 40 fractured.
0.308	Cable no. 3 disengaged from post no. 40.

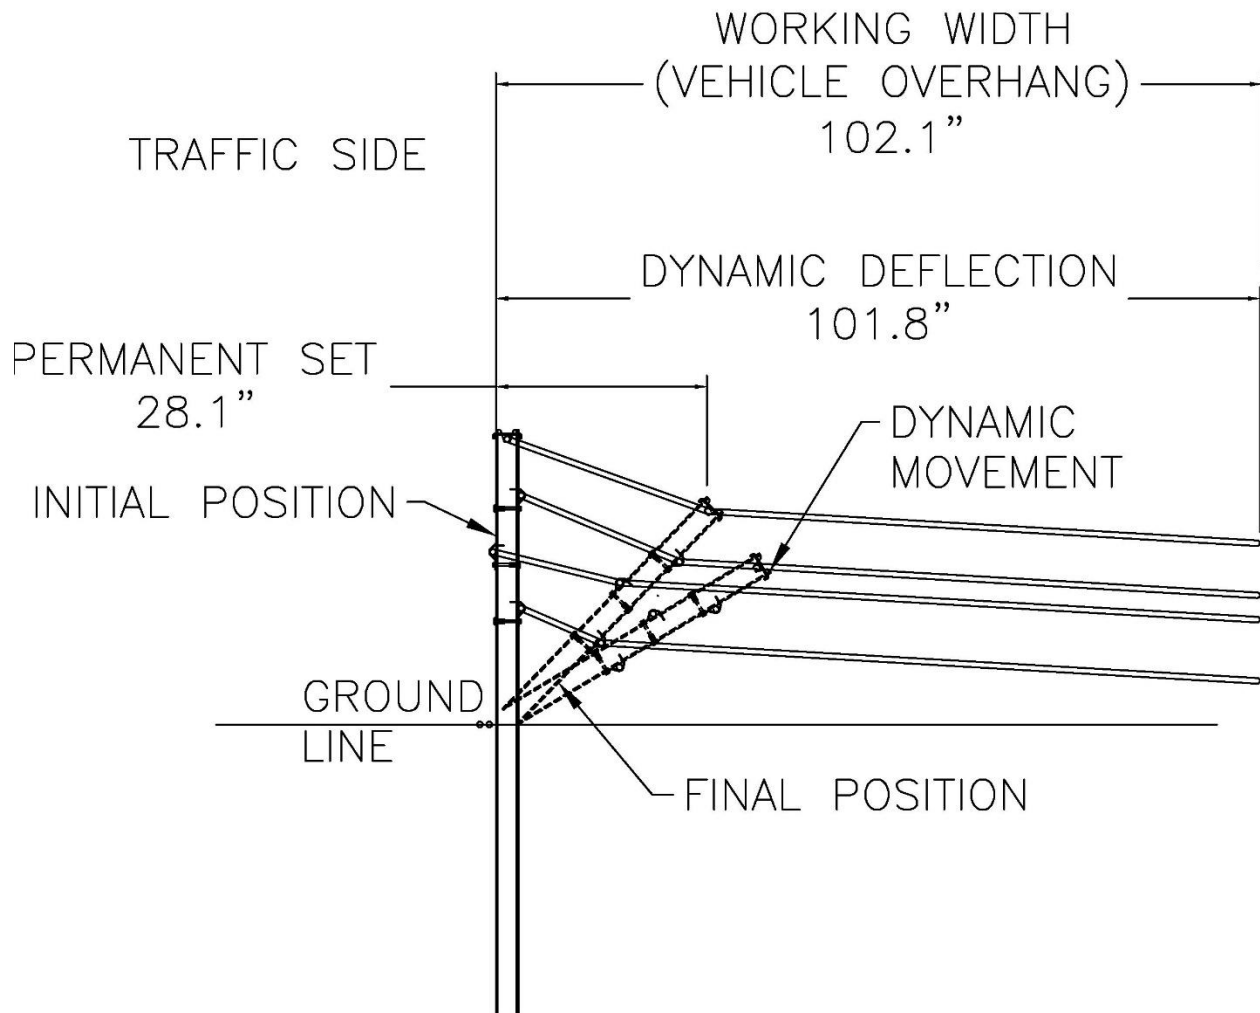
Figure 76. Permanent Set, Dynamic Deflection, and Working Width, Test No. MTP-1

The maximum lateral permanent set of the posts in the system was 28.1 in. (714 mm), which occurred at post no. 39, as measured via GPS in the field. The maximum lateral dynamic barrier deflection was 101.8 in. (2,586 mm), as determined from high-speed digital video analysis. The working width of the system was found to be 102.1 in. (2,593 mm), which was also determined from high-speed digital video analysis. The working width and dynamic deflection were determined to be the point reached by the test vehicle's left-rear bumper between post nos. 35 and 36 and the cable in contact with the bumper at that same location, respectively. A schematic of the permanent set deflection, dynamic deflection, and working width is shown in Figure 76.

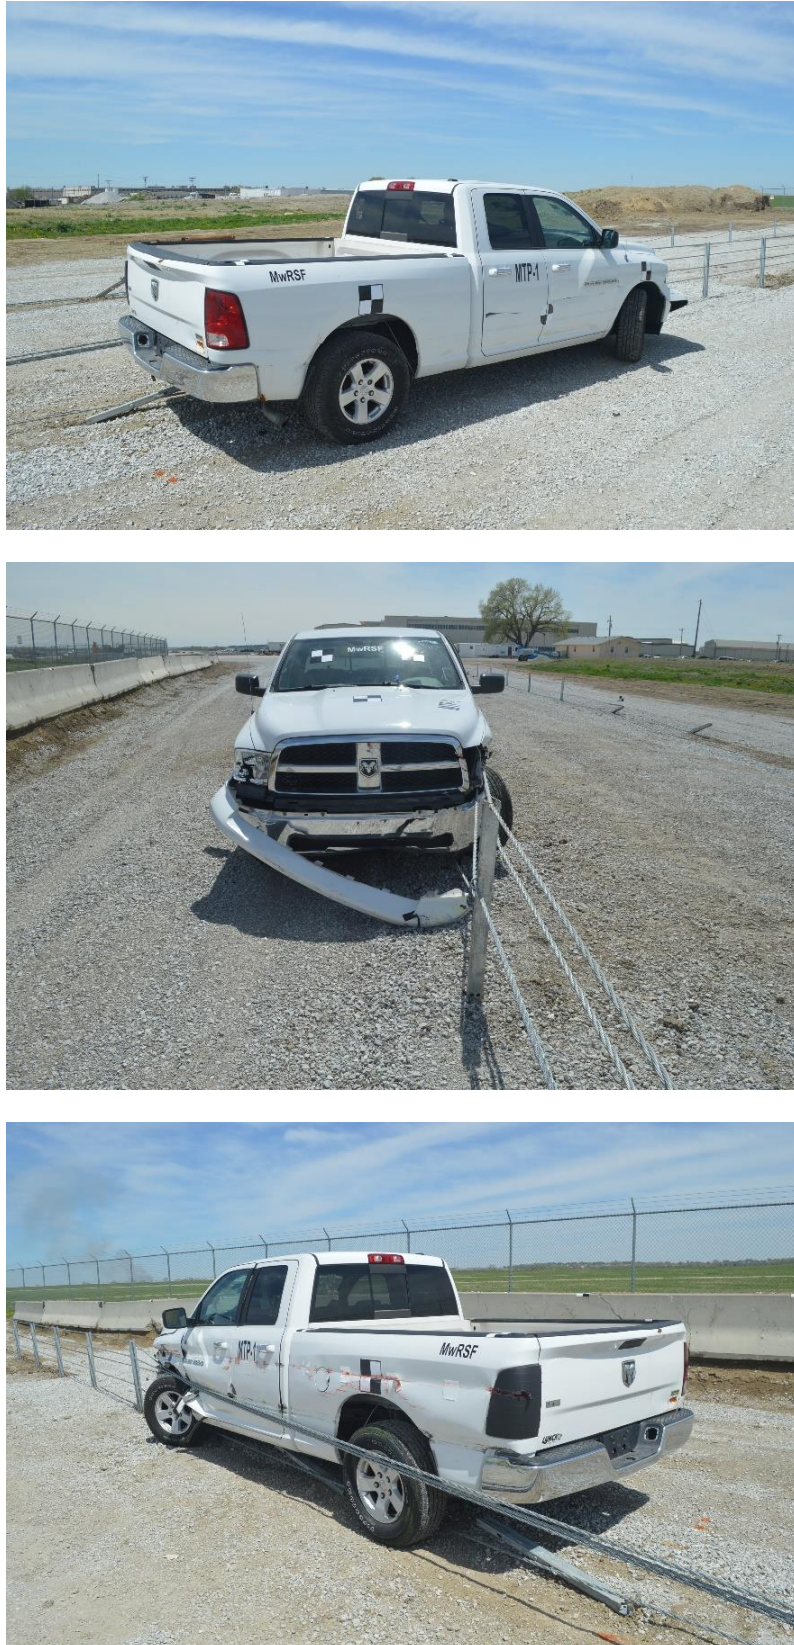
Figure 77. Vehicle Damage, Test No. MTP-1

Deformation and contact marks continued along the left side of the vehicle, decreasing in severity with distance from the impact point. The left-rear door and left quarter panel experienced only minor deformation and contact marks along the cable bearing paths. The right side of the vehicle encountered only small gouges caused by the top edge of post no. 35 as the vehicle passed the post on the non-impact side during redirection.

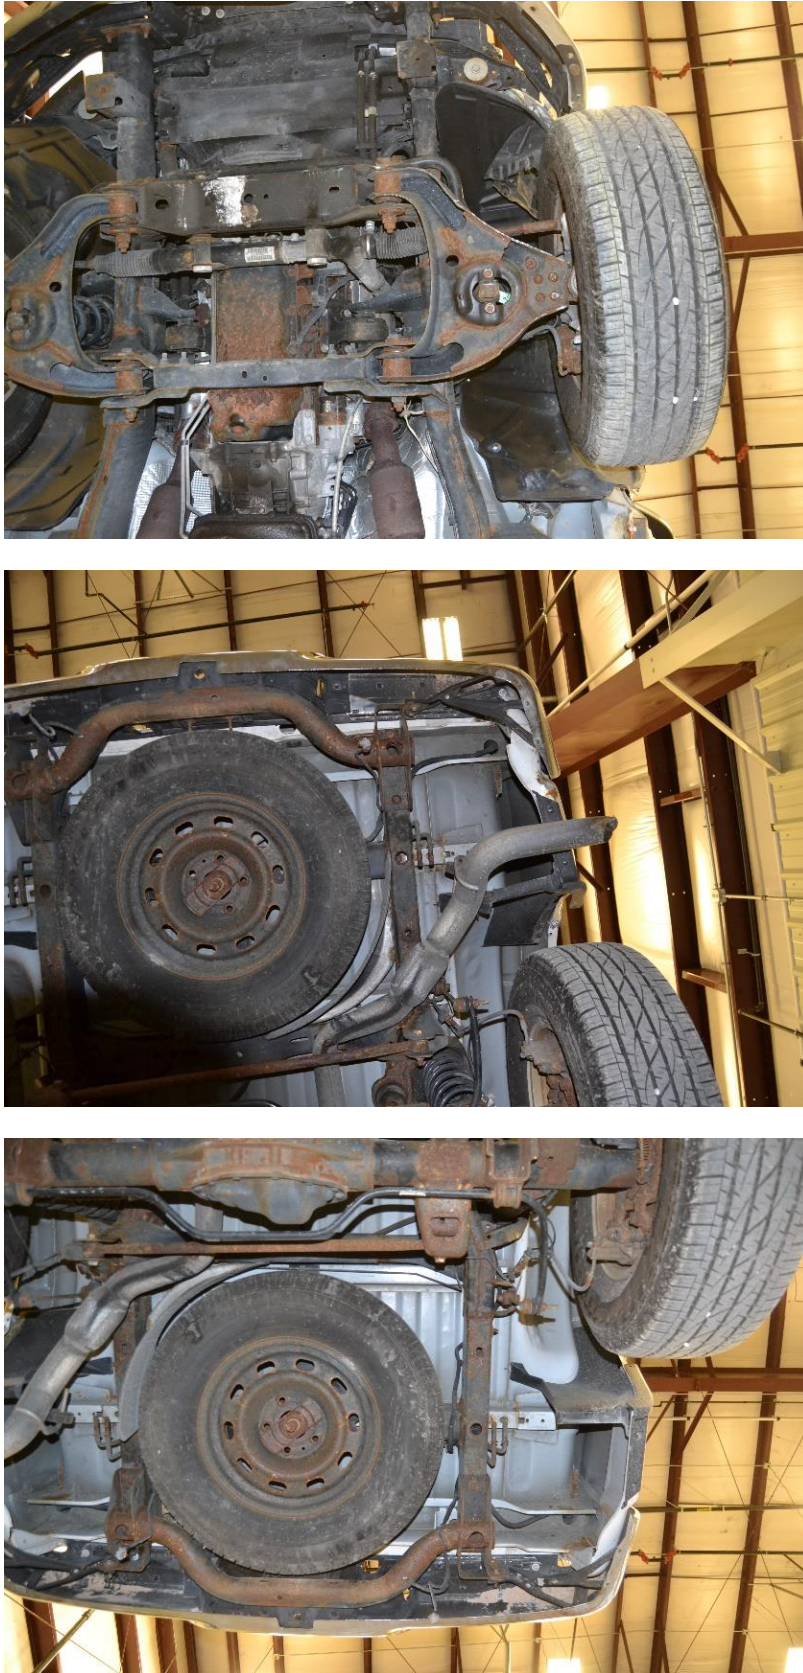
Figure 80. Vehicle Undercarriage Damage, Test No. MTP-1

The vehicle undercarriage sustained only minor damage. Scrapes were found on the left steering knuckle, the lower-left control arm, and both transmission cross members. Additionally, the frame horn on the left side was bent slightly to the right. No other undercarriage damage occurred; specifically the floor pan remained undamaged.

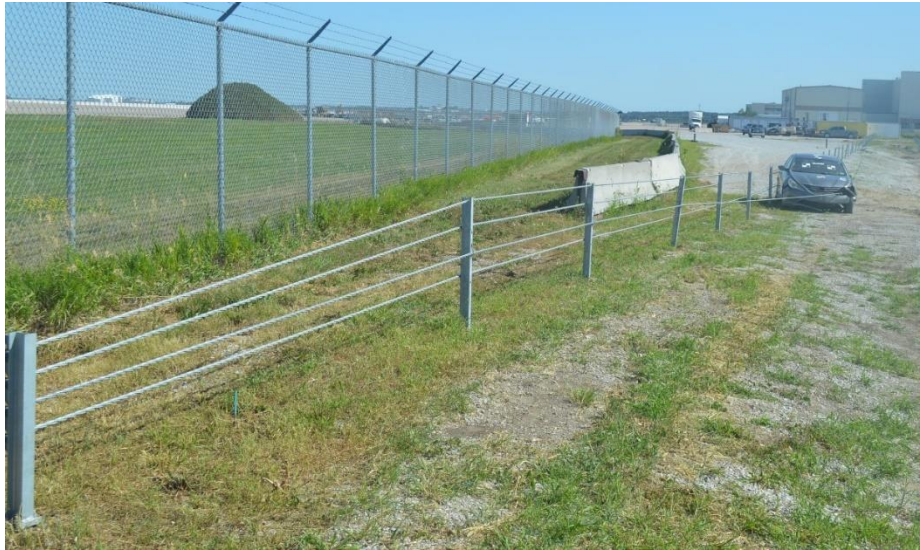
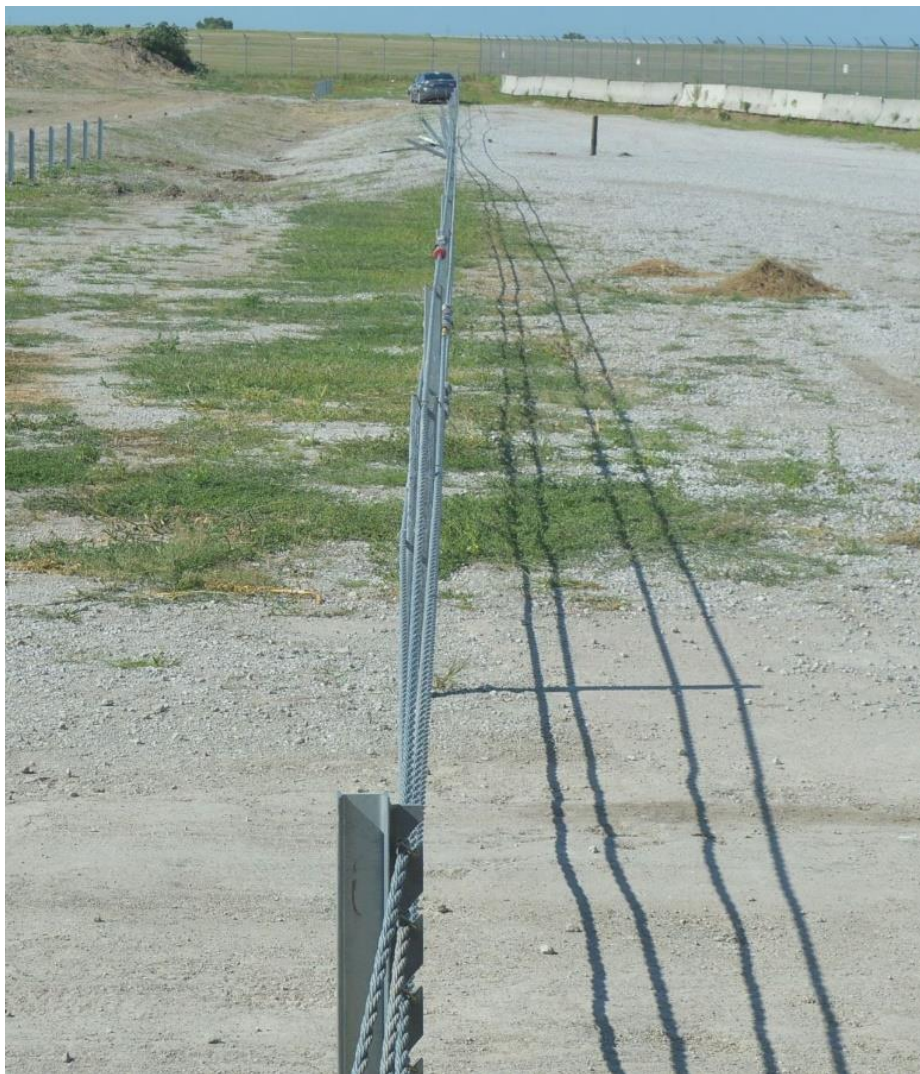
Figure 121. Overall System Damage, Test No. MTP-2

6 = Brass Rod Fractured

7 = Brass Rod Bent in Place

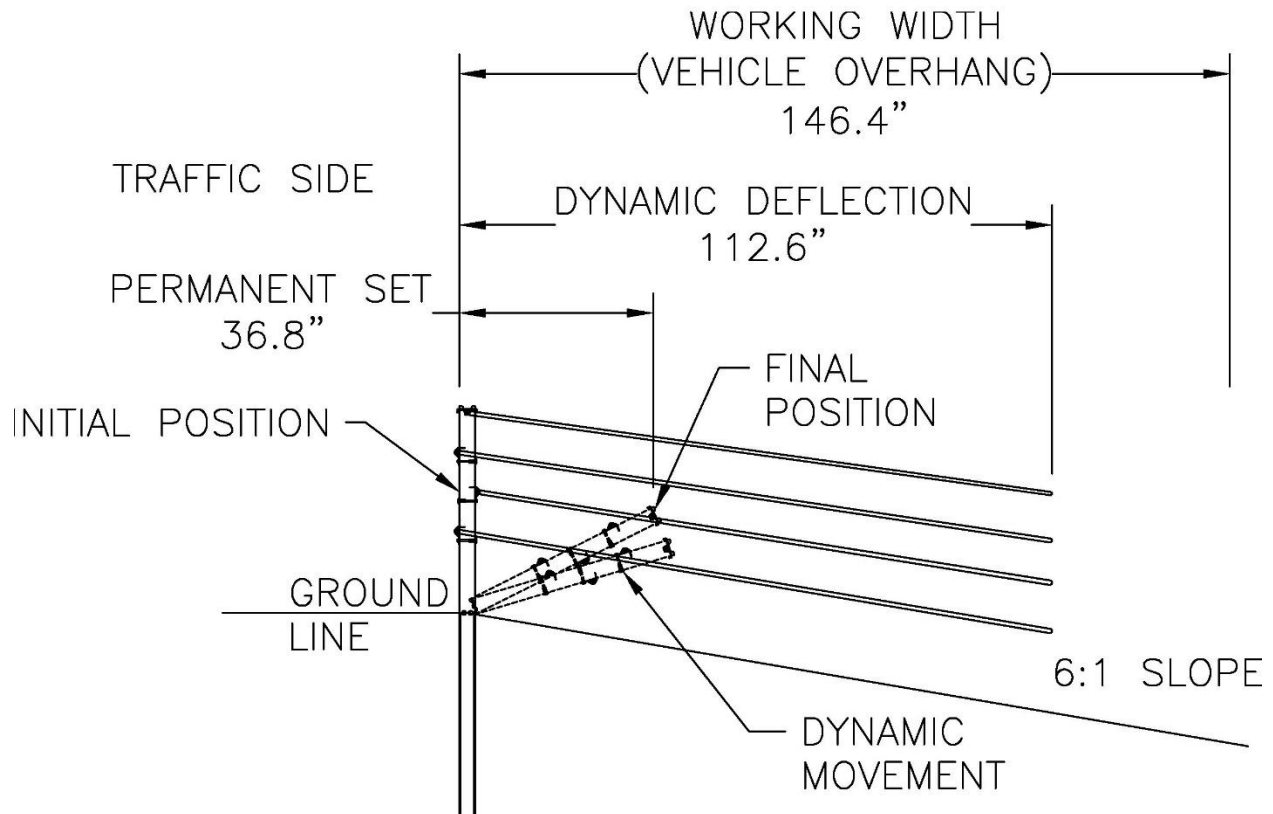
Figure 138. Permanent Set, Dynamic Deflection, and Working Width, Test No. MTP-2

The maximum lateral permanent set of the posts in the system was 36.8 in. (935 mm), which occurred at post no. 15, as measured via GPS in the field. The maximum lateral dynamic barrier deflection was 199.9 in. (5,077 mm), as determined from high-speed digital video analysis and the GPS trajectory data in the field. The working width of the system was found to be 200.6 in. (5,095 mm) determined from the GPS trajectory data in the field. The working width and dynamic deflection were determined to be the point reached by the test vehicle's left-front corner between post nos. 24 and 25 and the cable's position on the vehicle at that time, respectively. A schematic of the permanent set deflection, dynamic deflection, and working width is shown in Figure 138.

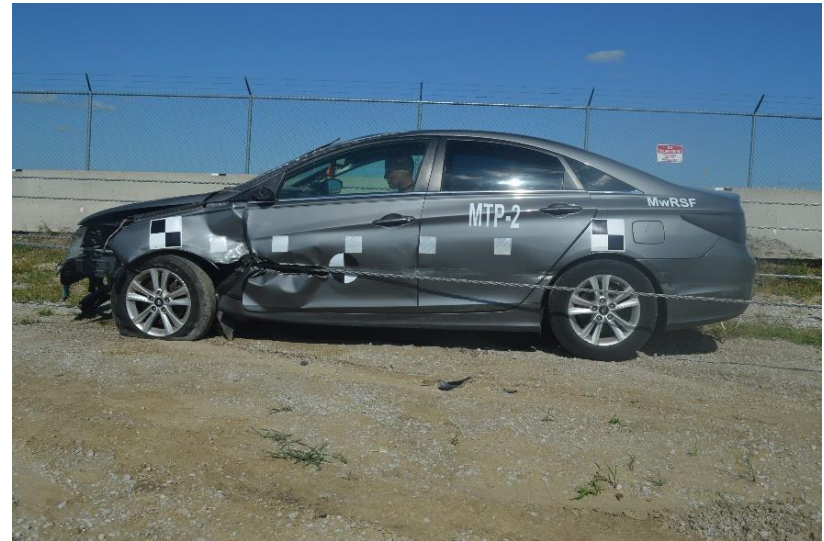
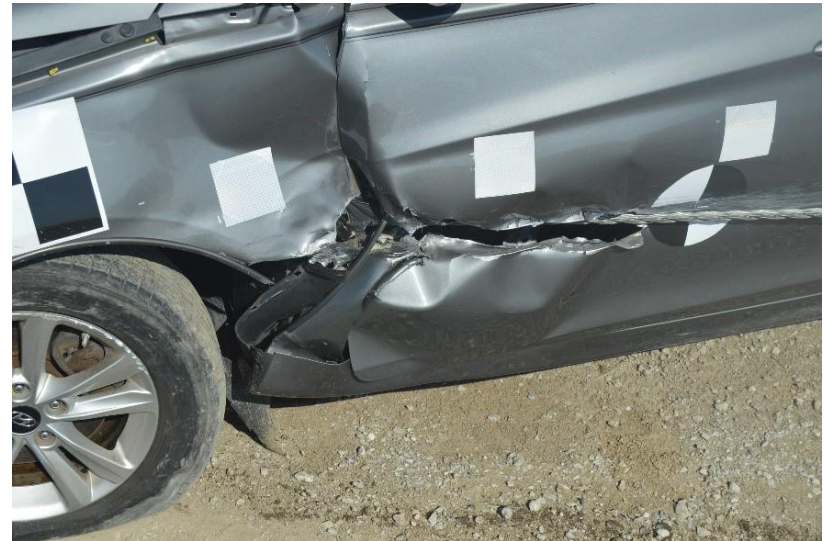
Figure 139. Vehicle Damage, Test No. MTP-2

The majority of the damage was found on the vehicle's left-front side, where the impact occurred. The grille cracked and the left side was partially disengaged. The left corner of the front bumper cover disengaged from the vehicle and the right-front corner was partially disengaged. The left-front fender was pushed inward toward the rear of the vehicle. The fender was also torn starting at the rear edge of the left-front wheel well to the left-front door. The left side mirror disengaged from the vehicle. The left A-pillar was dented along its length from cable contact. The left-front door skin was torn and scraped. The left rear door was scraped along the entire length of the door. The left-rear fender was dented in front of the wheel well. The left corner of the rear bumper cover and the roof were scraped. The windshield sustained numerous minor cracks throughout. The side windows remained undamaged.

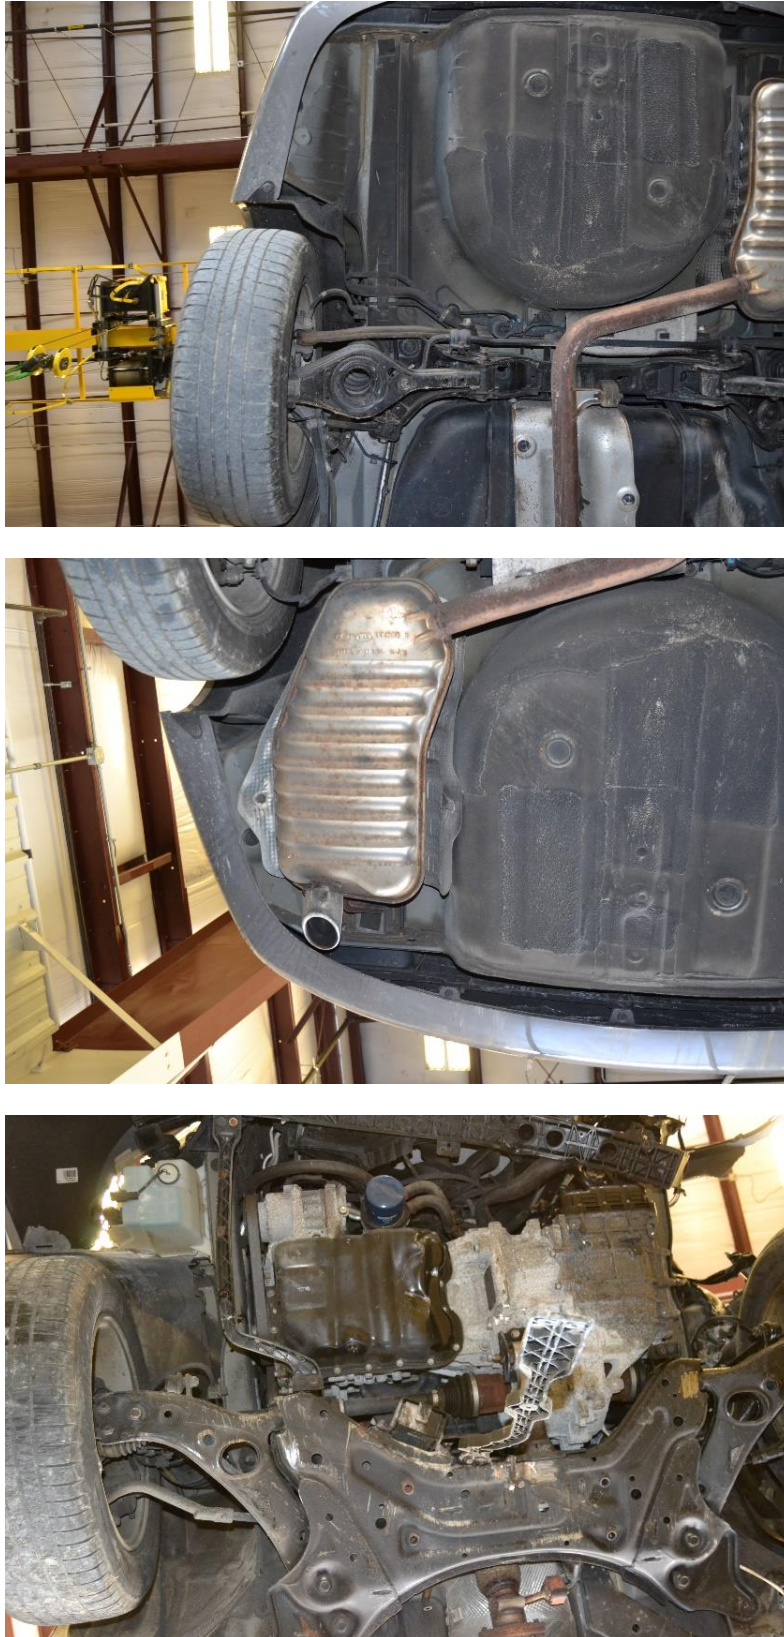
Figure 142. Vehicle Undercarriage Damage, Test No. MTP-2

The bottom of the steering control arm gear box, transmission tunnel, and transmission mount were scraped. The oil pan was scraped and dented. The left-side frame horn was bent toward the rear of the vehicle. The left skid plate mounting member disengaged and the middle mounting member disengaged from the front mount. The floor pan, gas tank, and trunk pan remained undamaged.
