*Hawaii Department of Transportation  
Research Contract No. 68212  
Research Project No. STP-1500(092) – Phase II*

## **CRASH TESTING AND EVALUATION OF THE HDOT 42-IN. TALL, SOLID CONCRETE BRIDGE RAIL WITH AESTHETIC RECESSED ROUNDED PANELS AND 6-IN. TALL SIDEWALK: MASH TEST DESIGNATION NOS. 3- 10 AND 3-11**

MwRSF Research Report No. TRP-03-455-22

December 15, 2022

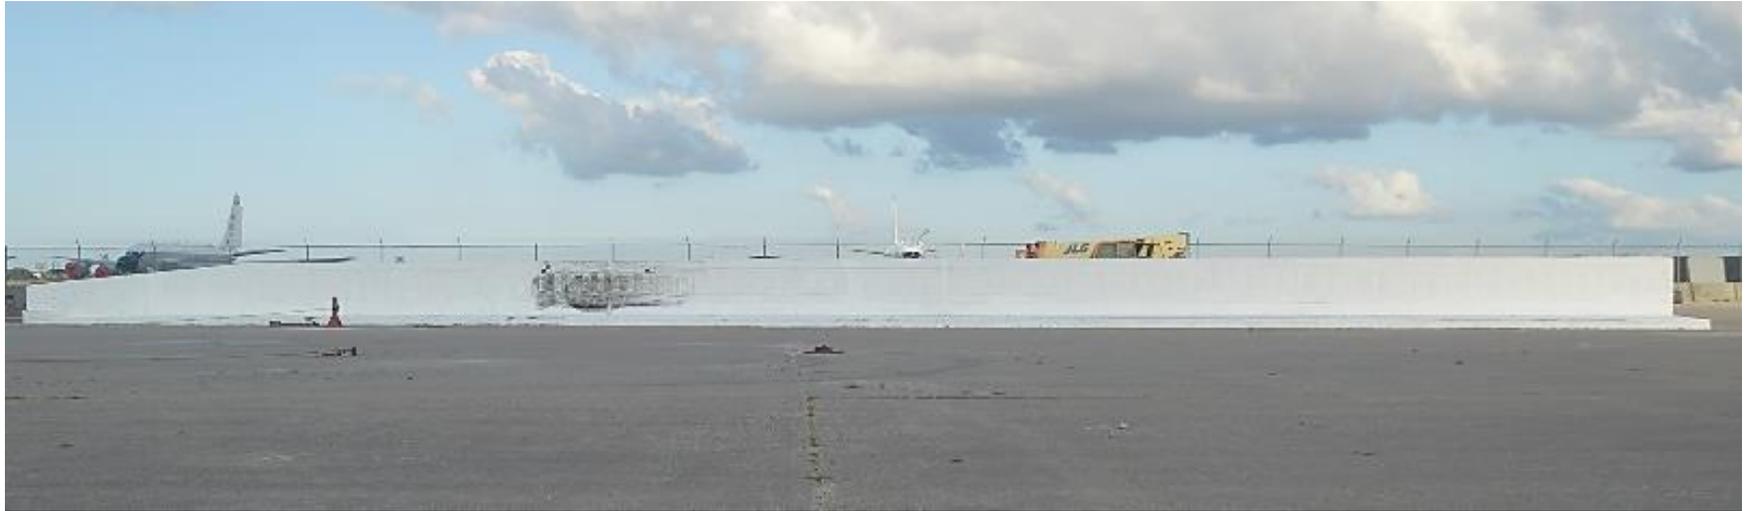
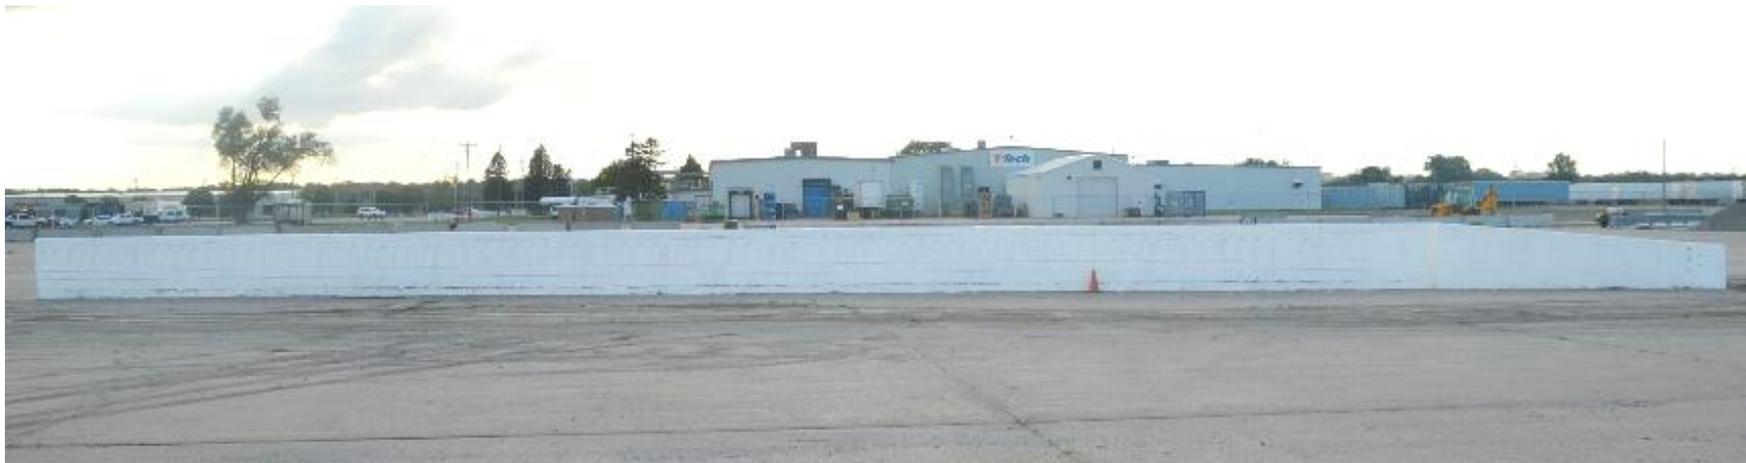
Figure 47. System Damage, Test No. H42S-1

Damage to the barrier was minimal, as shown in Figures 47 through 53. Barrier damage consisted of contact marks on the front and top faces of the concrete segments and concrete gouging. Note that some cracking visible in the system photographs was documented beforehand and did not occur due to the test no. H42S-1 impact. The length of vehicle contact along the barrier was approximately 13½ in., which spanned from 1 ft – 1½ in. upstream from the impact point.

Contact marks were visible on the front and top faces of the barrier. A 143-in. long by 42-in. tall contact mark began upstream from impact at the mid-height of the barrier. An 88-in long by 6-in. wide contact mark was found on the top face of the barrier, beginning 5½ in. downstream from impact.

The barrier sustained minor gouging, beginning 7 in. downstream from the impact point and extending 52¼ in. downstream from expansion joint no. 1, starting from the base of the barrier to 28 in. above the sidewalk. Minor gouging was observed on the downstream, upstream, and bottom edges of the five panels upstream from expansion joint no. 1 and the three panels downstream from the expansion joint. Most gouging occurred on the downstream edges of the four panels upstream from expansion joint no. 1, as shown in Figure 50. Panel gouging is summarized in Table 5. In addition to the recess panel gouging, minor gouging from vehicle wheel contact occurred along the lower half of the barrier upstream from the expansion joint, as shown in Figures 51 and 52. The expansion joint was gouged on the edges with small amounts of joint fill material removed by the vehicle, as shown in Figure 53.

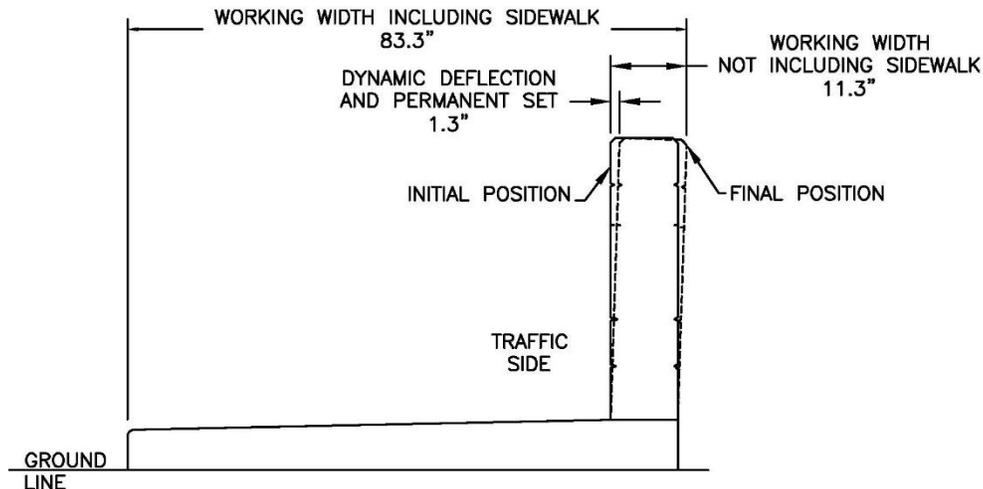
Figure 54. Permanent Set, Dynamic Deflection, and Working Width, Test No. H42S-1

The maximum lateral permanent set of the barrier system, including barrier and deck panel shift, was 1.3 in. at the rail centerline target as measured in the field. The maximum lateral dynamic barrier deflection, including tipping of the barrier along the top surface, was 1.3 in. at the rail line layout target, as determined from high-speed digital video analysis. The working width of the system was found to be 11.3 in. measured from the front face of the barrier and 83.3 in. measured from the front face of the sidewalk, respectively, also determined from high-speed digital video analysis. A schematic of the permanent set deflection, dynamic deflection, and working width is shown in Figure 54.

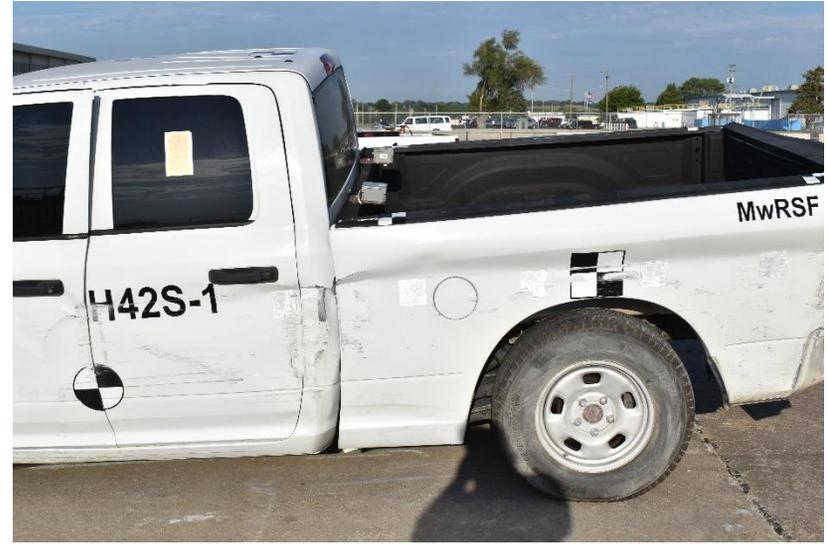
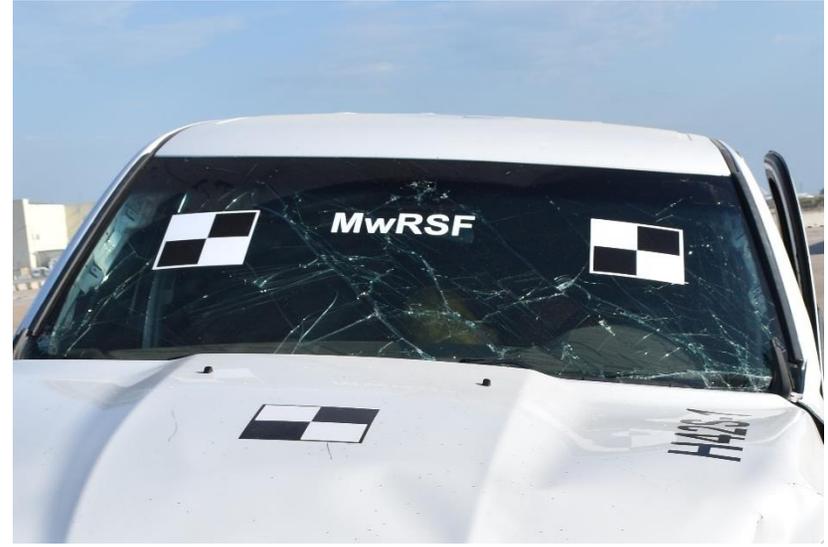
Figure 55. Vehicle Damage, Test No. H42S-1

The damage to the vehicle was moderate, as shown in Figures 55 through 58. The majority of the damage was concentrated on the left-front corner and left side of the vehicle where the impact had occurred. The left side of the front bumper and the left-front fender were crushed inward and bent. The left-front tire was partially disengaged from the rim, and the left-front rim was deformed. The front headlights and grille were disengaged from the vehicle. The hood was crushed inward on its left edge. The left-front door was crushed in the middle, pinching the latch. The entire left side of the vehicle was scraped. The left side of the bed was crushed inward along its entire length. The left-rear taillight was disengaged from the vehicle. The left side of the rear bumper was crushed inward. The windshield had cracking across its entire length. The vehicle sustained significant damage due to a second impact with the temporary concrete barriers shielding other areas of the test site when coming to rest outside of the system.

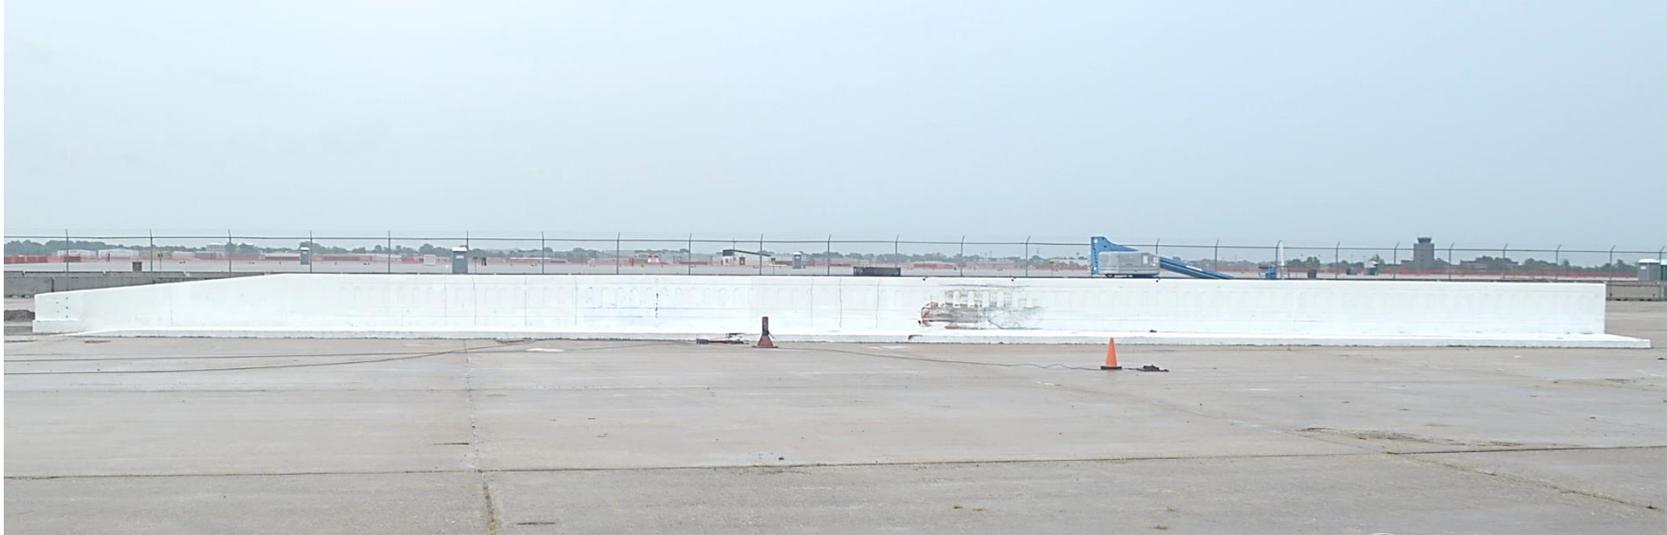
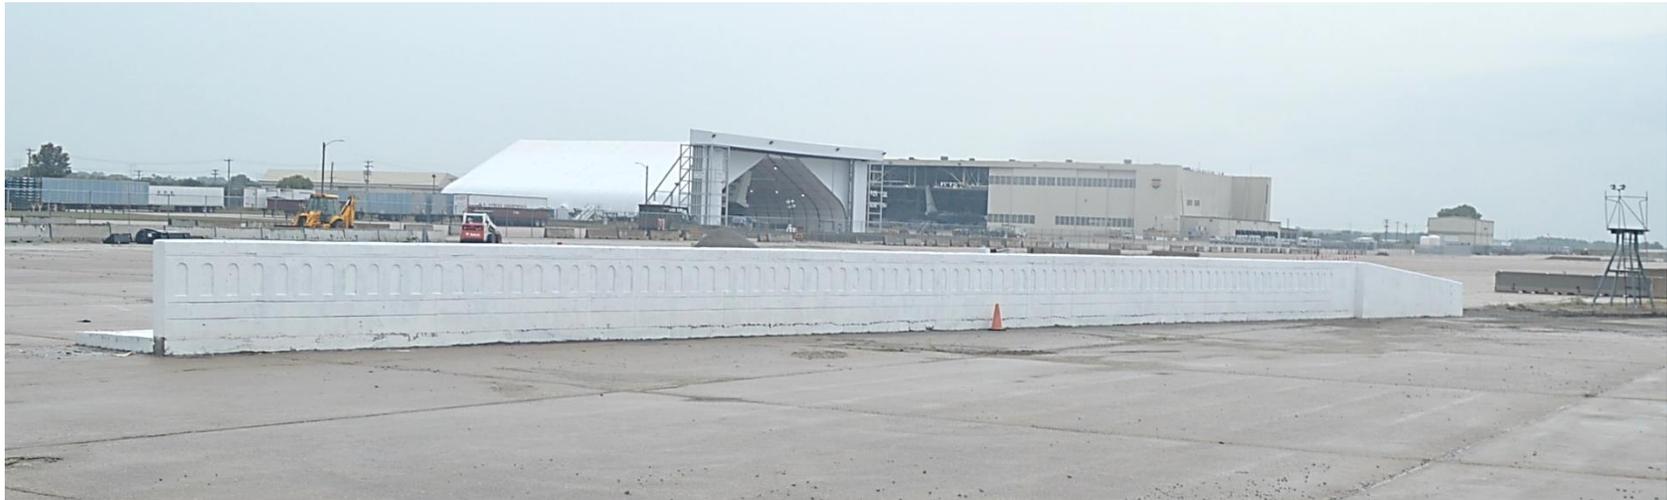
Figure 66. System Damage, Test No. H42S-2

Damage to the barrier was minimal, as shown in Figures 66 through 72. Barrier damage consisted of contact marks on the front of the concrete segments and concrete gouging. Note that some cracking visible in the system photographs was documented beforehand and did not occur as a result due to the test no. H42S-2 impact. The length of vehicle contact along the barrier was approximately 10 ft – 5 in., which spanned from 4 ft – 2 in. upstream from expansion joint no. 2 to 6 ft – 2½ in. downstream from expansion joint no. 2.

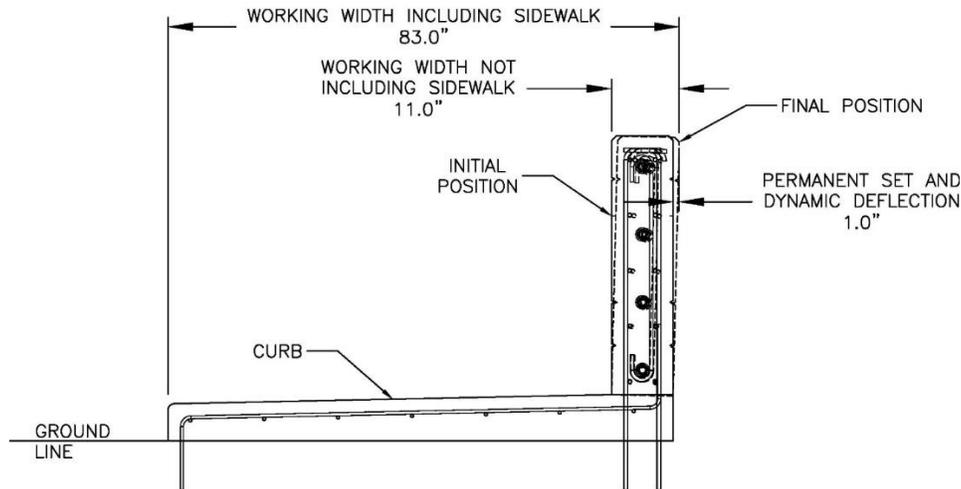
Figure 73. Permanent Set, Dynamic Deflection, and Working Width, Test No. H42S-2

The maximum lateral permanent set of the barrier system, including barrier and deck panel shift, was 1.0 in. at the target at impact, as measured in the field. The maximum lateral dynamic barrier deflection, including tipping of the barrier along the top surface, was 1.0 in. at the target between impact and the centerline target, as determined from high-speed digital video analysis. The working width of the system was found to be 11.0 in. as measured from the front face of the barrier and 83.0 in. as measured from the front face of the sidewalk, respectively, also determined from high-speed digital video analysis. A schematic of the permanent set deflection, dynamic deflection, and working width is shown in Figure 73.

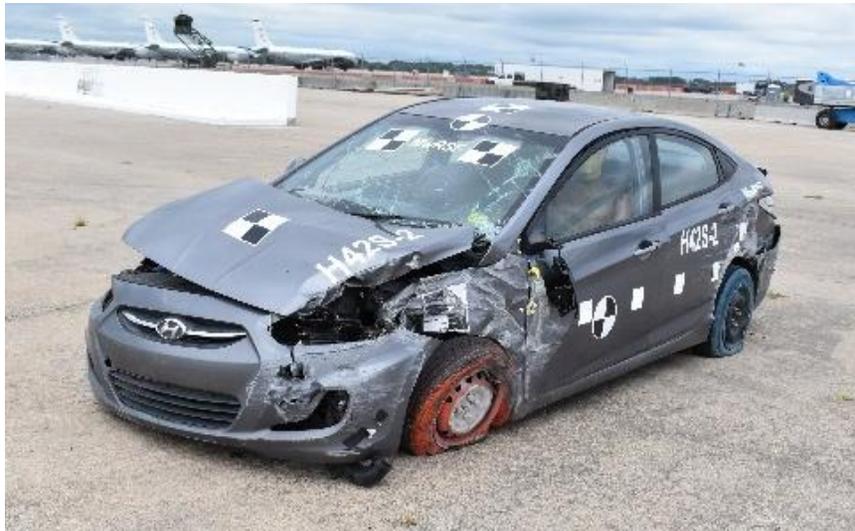
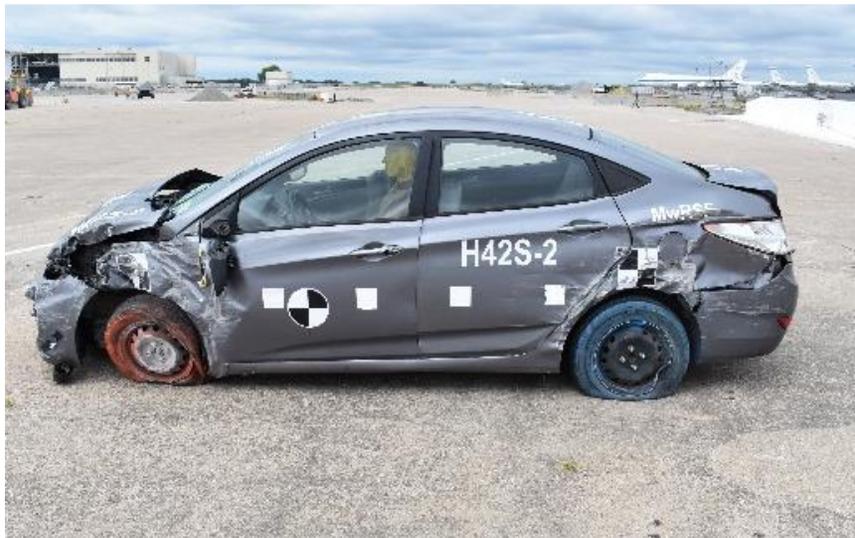
Figure 74. Vehicle Damage, Test No. H42S-2

The damage to the vehicle was moderate, as shown in Figures 74 through 77. Most damage was concentrated on the left-front corner and left side of the vehicle where the impact had occurred. The left side of the front bumper and the left-front fender were crushed inward, and the bumper was bent across its entire width. The left-front tire was partially disengaged from the steel rim, and the left-front steel rim was deformed. The front headlights were disengaged from the vehicle. The hood was crushed inward on its left edge and partially disengaged across the length of the front bumper. The left-front door was crushed in the front region, causing the door to partially open. The front and back corners of the vehicle were scraped. The left-rear bumper was crushed inward and partially disengaged from the vehicle. The windshield had severe cracking across its entire length. The vehicle sustained mild damage due to a second impact with the temporary concrete barriers shielding other areas of the test site, when coming to rest outside of the system.
