CRASH TESTING AND EVALUATION OF AN OPEN CONCRETE BRIDGE RAILING

MIDWEST ROADSIDE SAFETY FACILITY
Nebraska Transportation Center
University of Nebraska-Lincoln

MwRSF Research Report No. TRP-03-406b-24

February 29, 2024

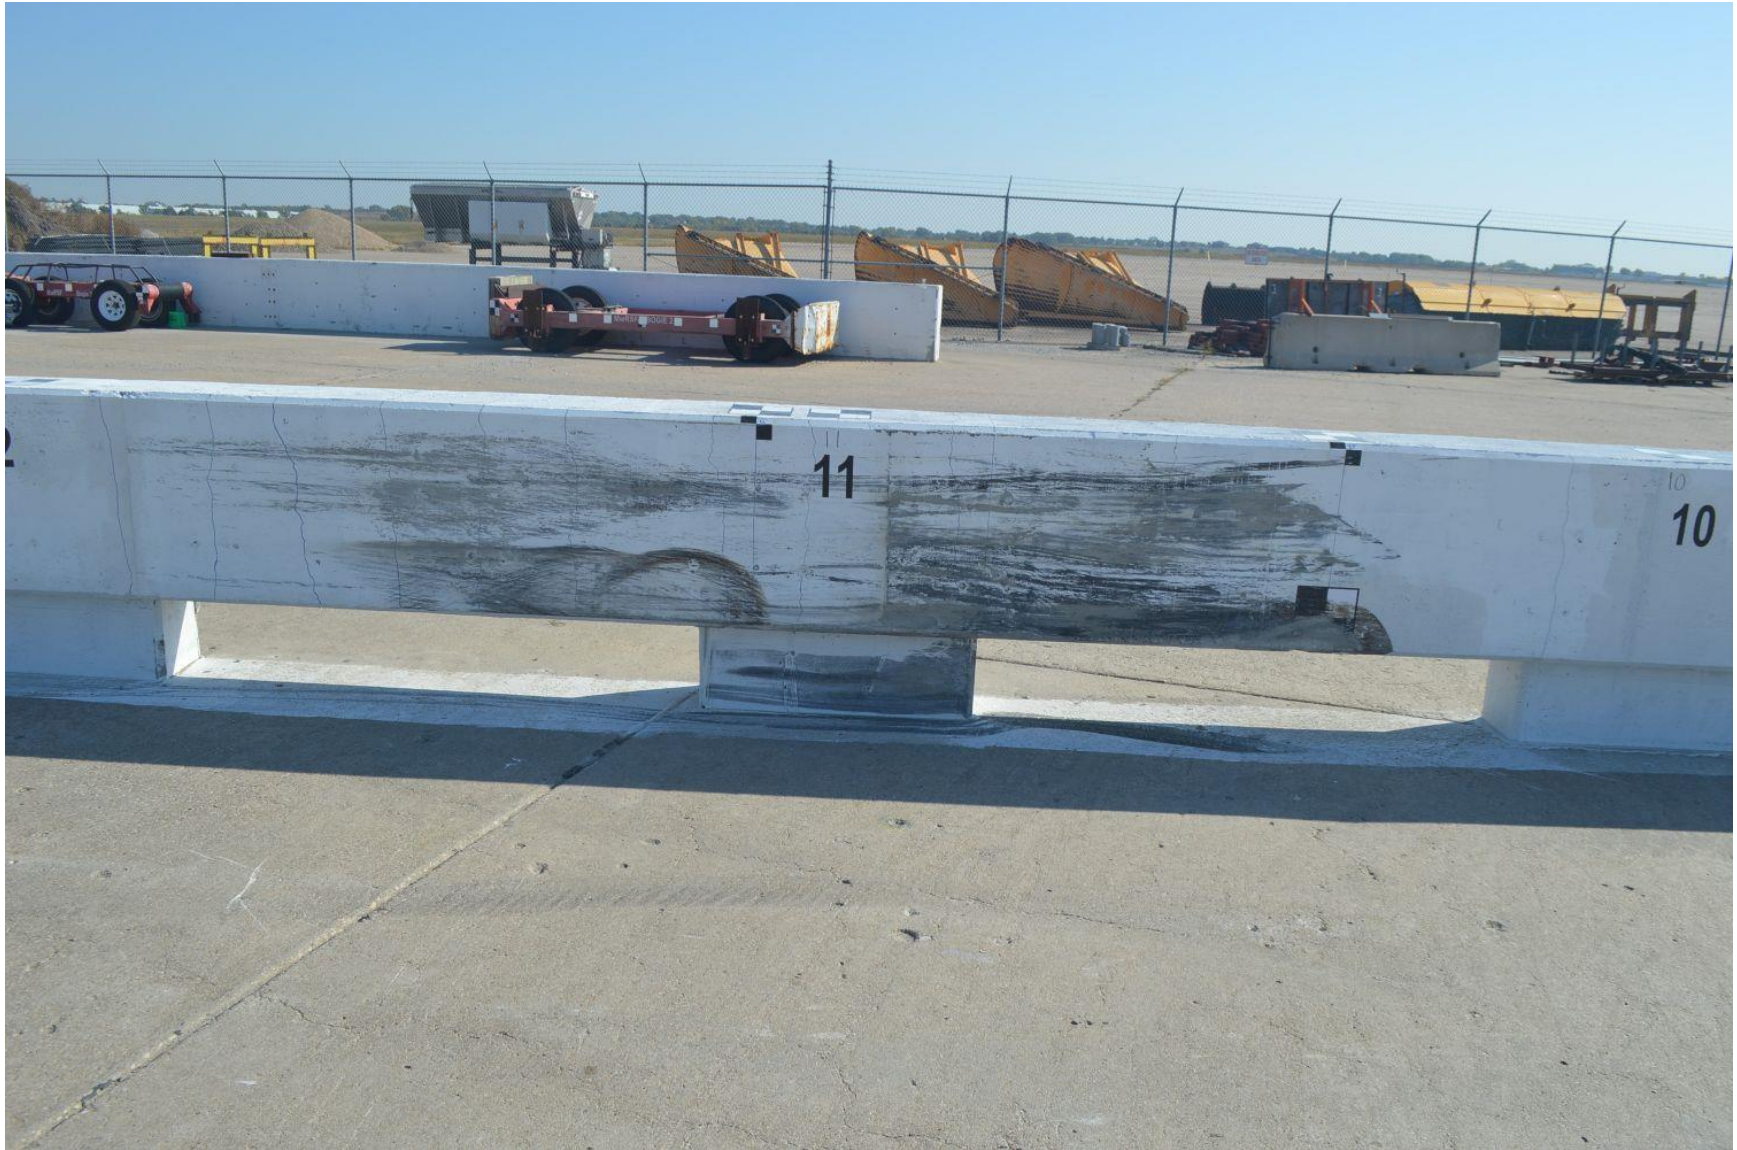
Figure 51. Overall System Damage, Test No. OCBR-1

Damage to the barrier was minimal, as shown in Figures 51 through 54. Barrier damage consisted of contact marks on the front face of the concrete segments and spalling and gouging of the concrete. Vehicle contact along the barrier began 10 in. upstream from the impact point and spanned 13 ft – 11 in. downstream.

The longest contact mark started 10 in. upstream from the impact point and spanned 160 in. downstream. Contact marks were found on the bottom-front face of the concrete barrier between 21 in. and 143 in. from the impact point with lengths between 3½ in. and 38½ in. Contact marks were found on the front face of post nos. 11 and 12. Tire contact marks on the upstream face of post no. 11 indicated 5¼ in. of overlap of the wheel and tire on the face of the post. A tire contact mark started 24 in. upstream from the impact point and extended 133½ in. downstream.

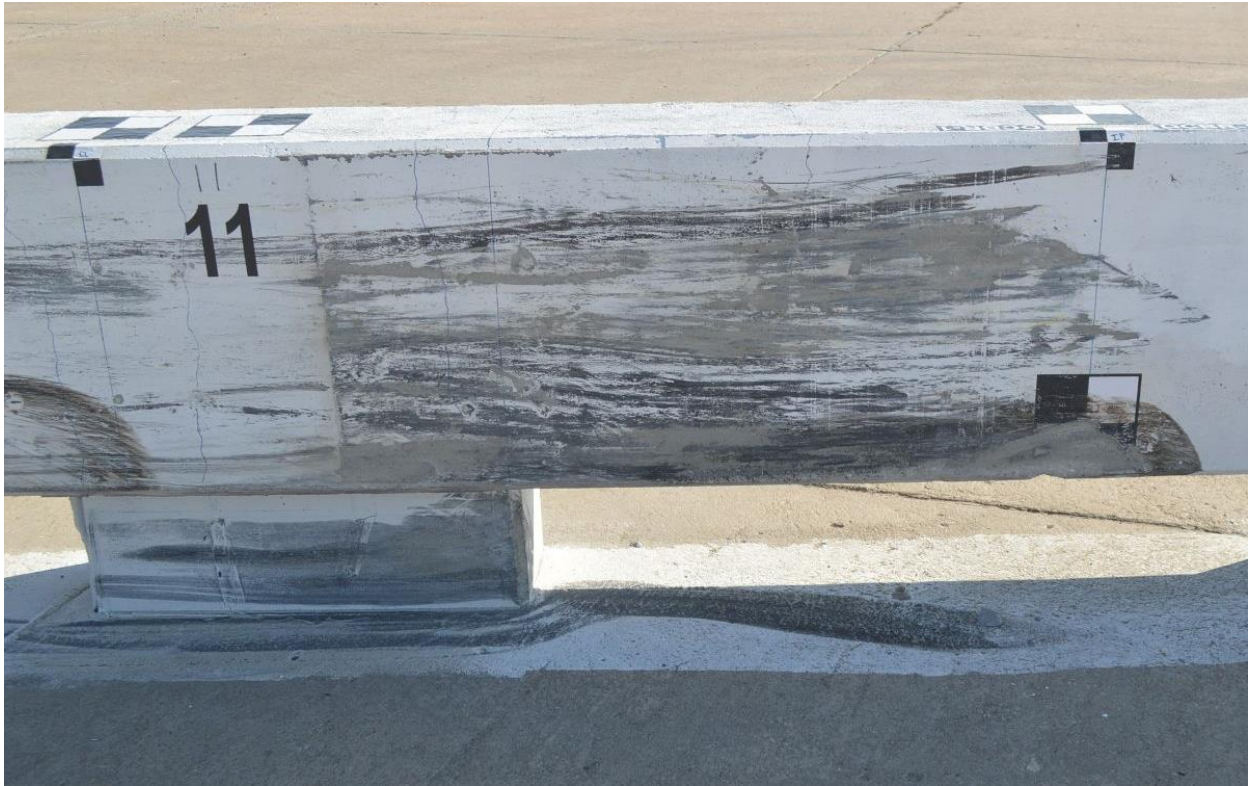
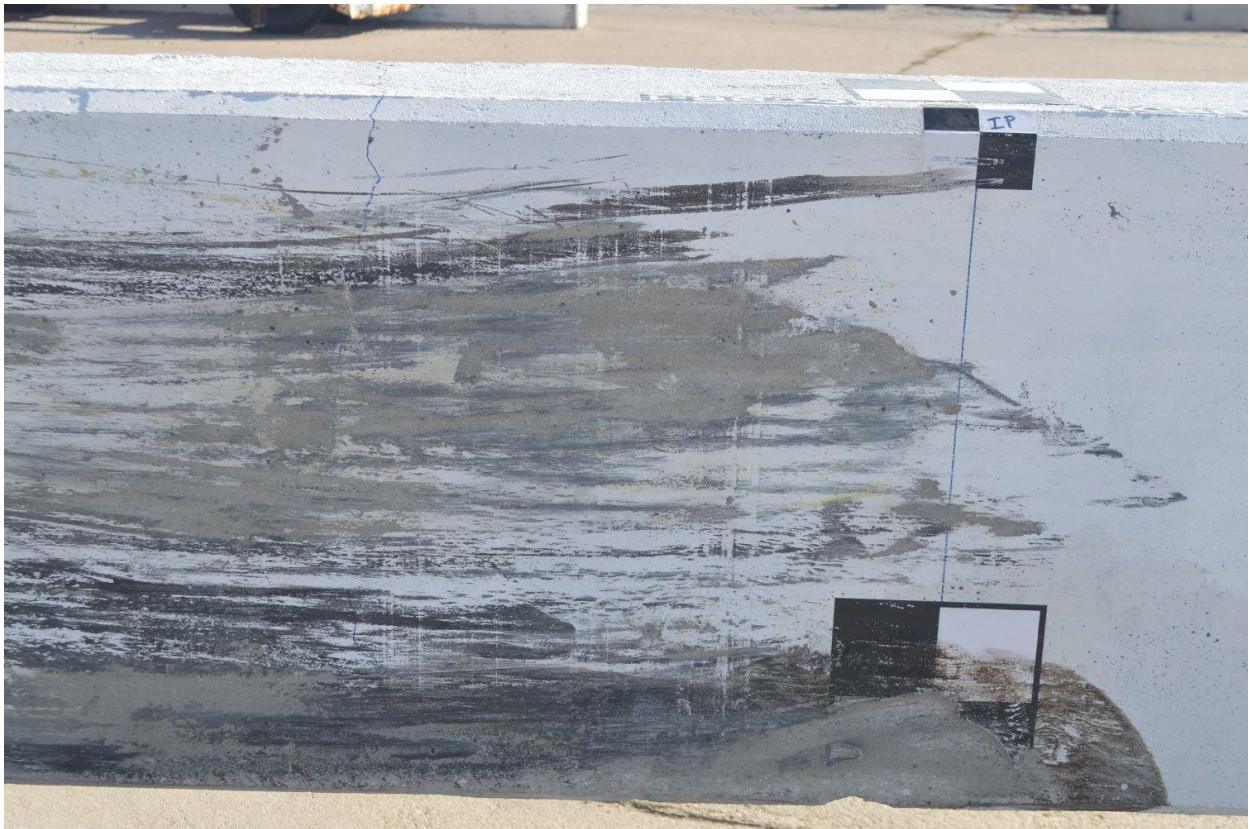
Figure 52. Concrete Beam Damage, Impact, Test No. OCBR-1

Minor spalling with lengths between 2 in. and 3¼ in. were present between 1½ in. and 19¼ in. from the impact point. Minor gouging was present between 33¼ in. and 44½ in. from the impact point. Gouges of lengths between 20¼ in. and 34 in. were present between the centerline of the impact point and 57¼ in. from the impact point. Major gouges of over 100 ft in length were present between 22½ ft downstream and 55½ ft downstream from the impact point. Post nos. 11 and 12 had gouges on their upstream faces. No cracking or structural damage to the bridge rail beam or posts was noted.

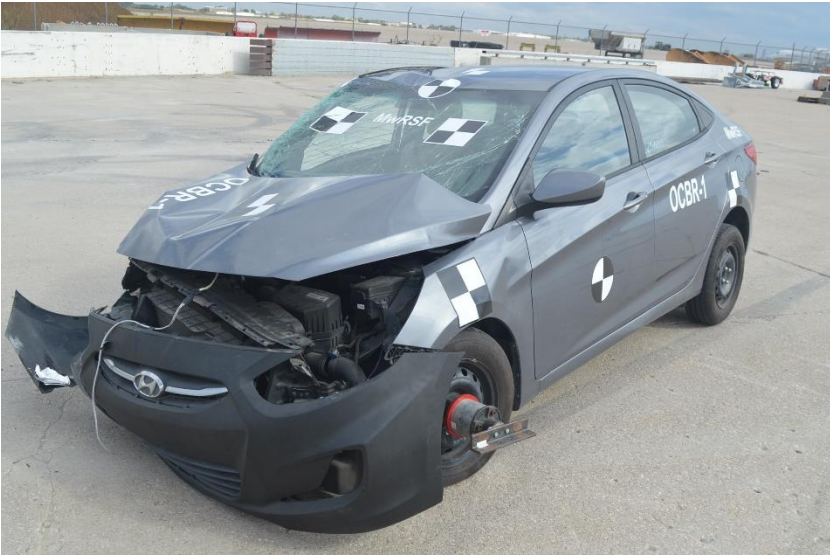
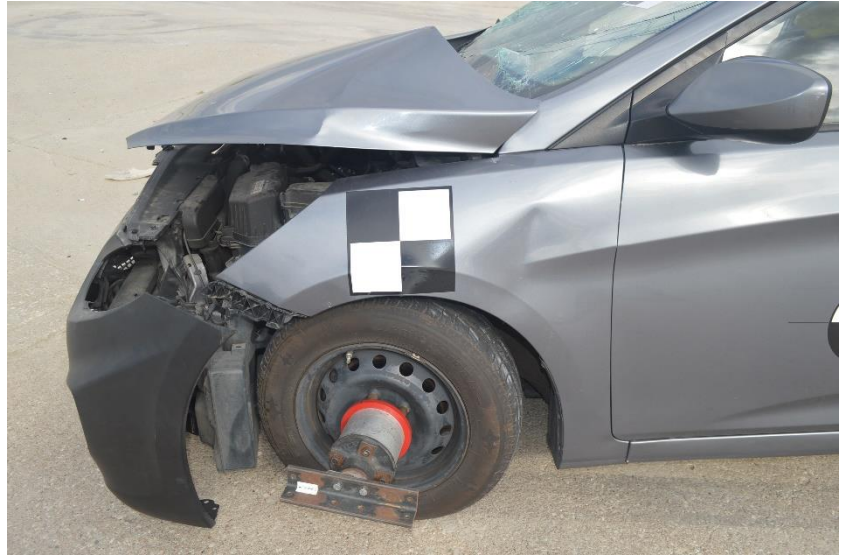
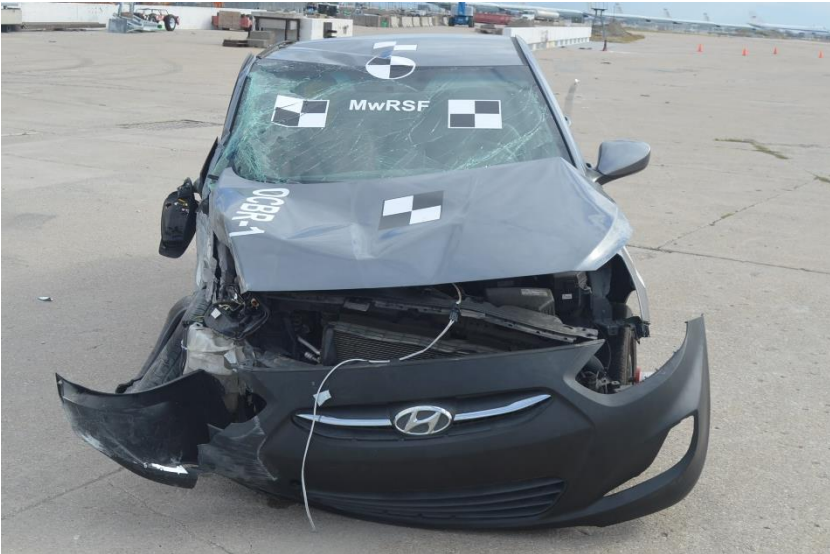
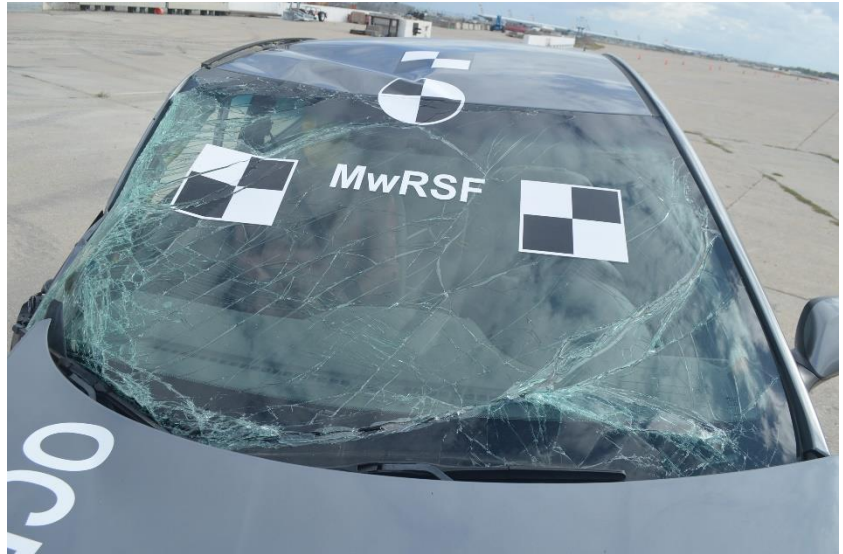
Figure 56. Vehicle Damage, Test No. OCBR-1

Majority of the damage was concentrated on the right-front corner and right side of the vehicle where the impact had occurred. The bumper cover detached from the impact side of the vehicle. The bumper was crushed inward on the right side of the vehicle. The left side of the radiator detached from the frame. As for the hood, the right side was crushed inward due to impact and significant dents were found across the right half of the hood and the rooftop. The left fender was bent inward toward the left side of the vehicle. Deformation of the fender, bumper, A-pillar, and door areas was observed. Additionally, the loading of the body structure caused deformation of the windshield and tearing of the windshield liner. The windshield deformation and windshield tearing were not an issue with respect to the MASH occupant criteria as the deformation and tearing was not caused by direct loading of the glass by the test article.

The entire right quarter panel had scrapes and was crushed toward the middle, and the right-rear door had scrapes at the rear of the door. The right-front door had scrapes throughout and was crushed at the front which caused the door to bend outward from its frame. The entire right fender experienced major scrapes and was crushed inward at the front of the fender.

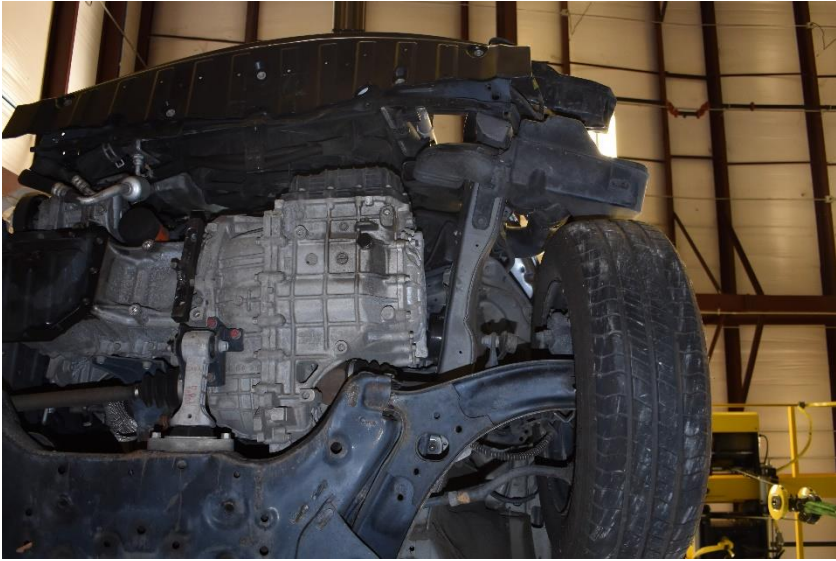
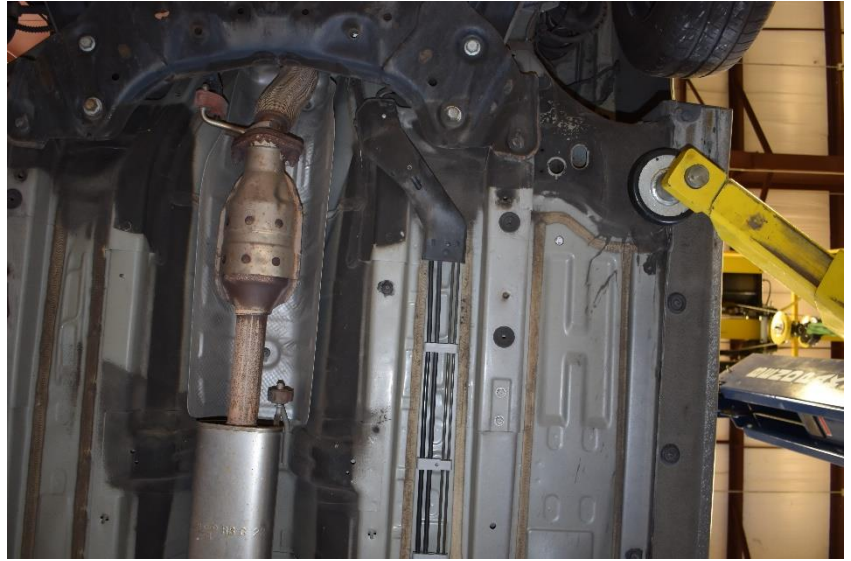
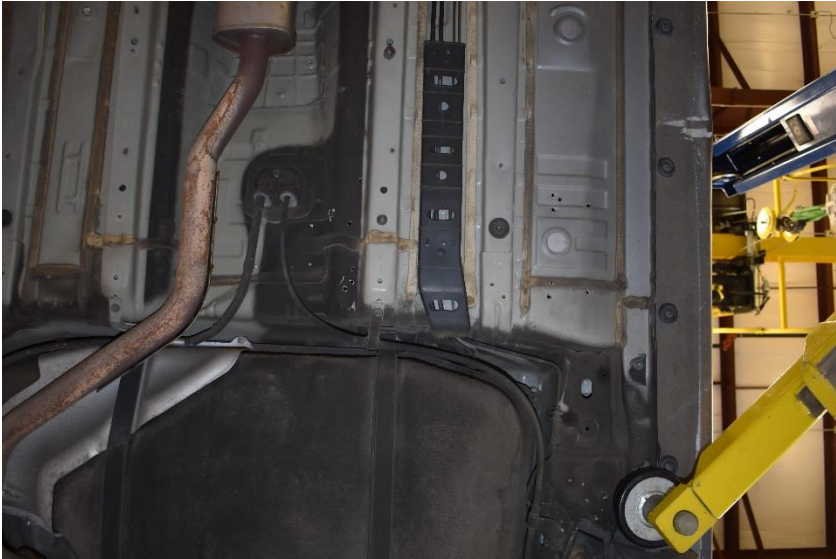
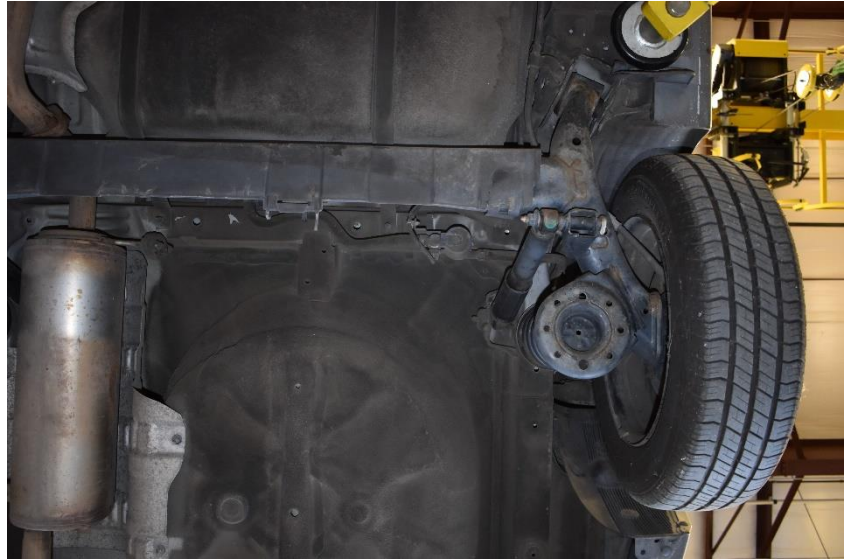
Figure 58. Interior and Undercarriage Damage, Test No. OCBR-1

Damage to the undercarriage was concentrated on the right-front area. The right side of the frame horn experienced a significant inward crush. The vehicle's right-side sprocket was slightly twisted. The right-side upper control arm sheared off from the steering knuckle. The right steering knuckle was crushed inward while the left side was undamaged. The lower control arm was still connected but bent severely. The right side of the sway bar was bent forward, bending the connecting rod. The right-side tie rod was bent at the connection with the wheel, and the front-end engine mounts were pushed slightly inward.

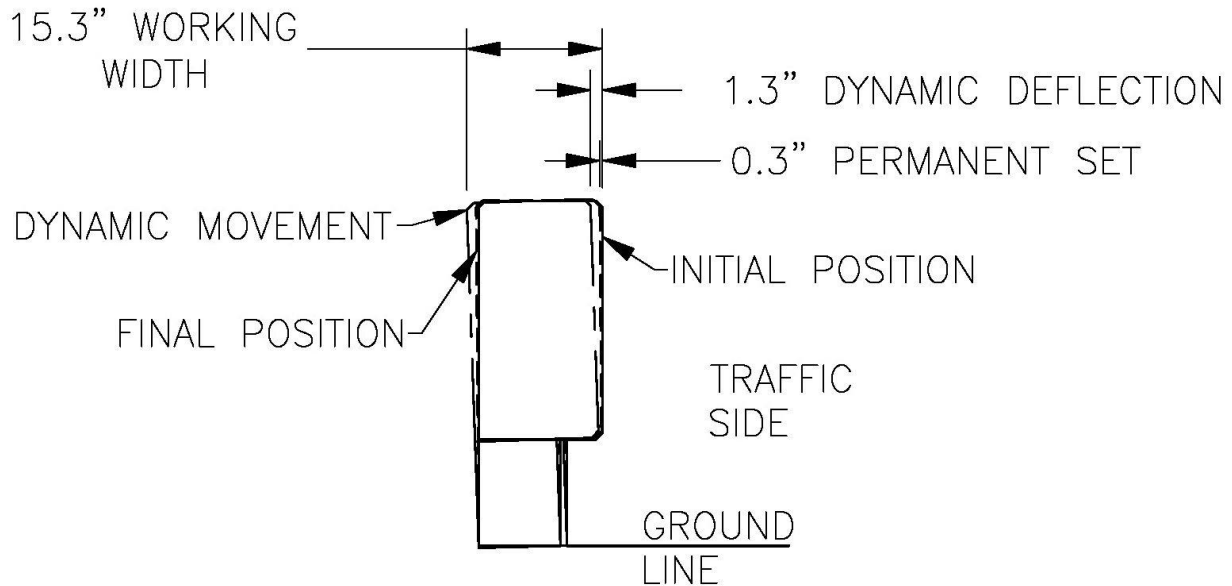
Figure 68. Permanent Set, Dynamic Deflection, and Working Width, Test No. OCBR-2

The maximum lateral permanent set of the barrier system was 0.3 in. at the rail at post no. 7, as measured in the field. The maximum lateral dynamic barrier deflection was 1.3 in. at the rail at post no. 7, as determined from high-speed digital video analysis. The working width of the system was found to be 15.3 in. at the rail at post no. 7, also determined from high-speed digital video analysis. A schematic of the permanent set deflection, dynamic deflection, and working width is shown in Figure 68.

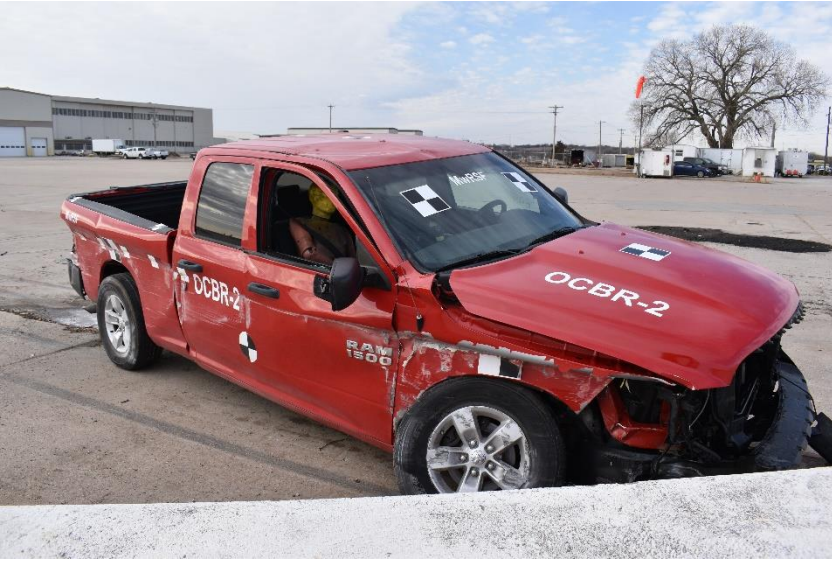
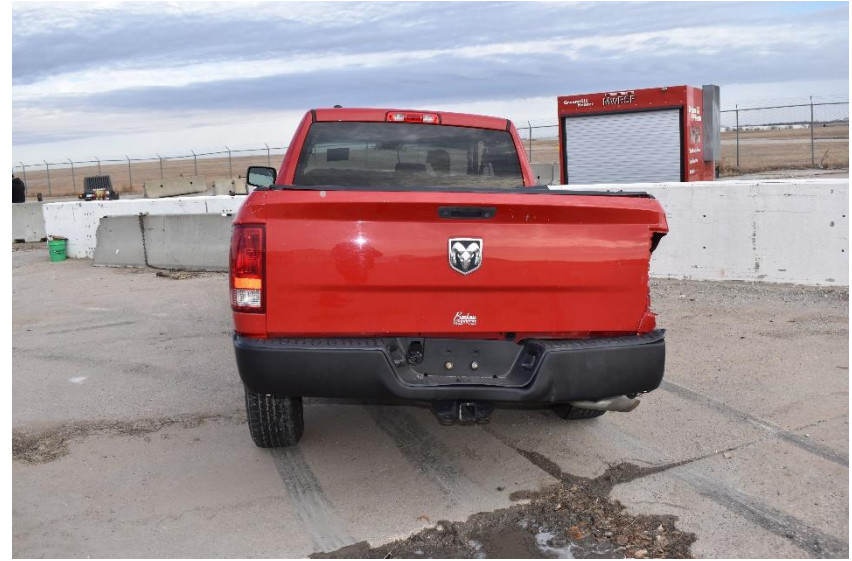
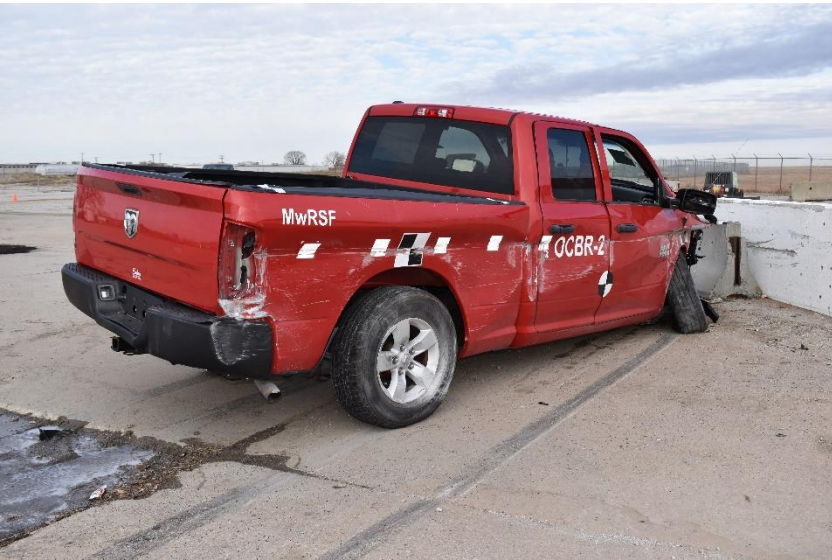
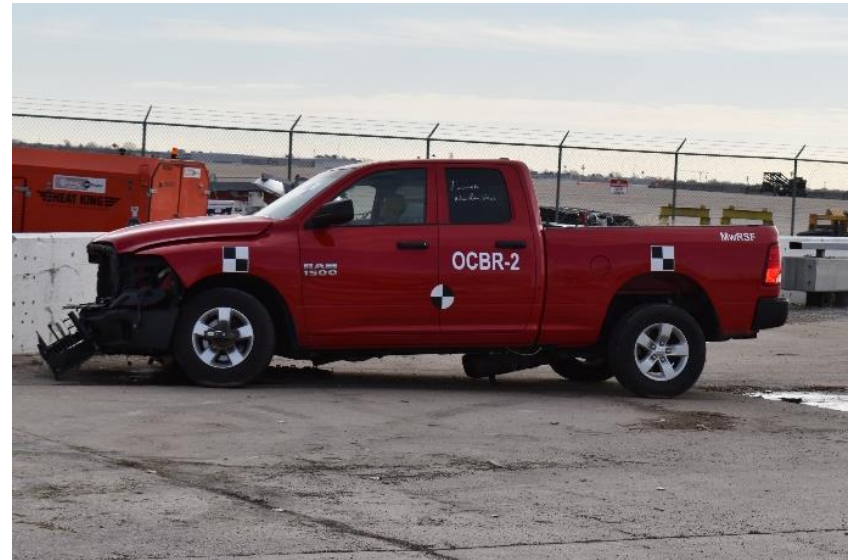
Figure 69. Vehicle Damage, Test No. OCBR-2

Majority of the damage was concentrated on the right-front corner and right side of the vehicle where the impact had occurred. The right corner of the hood had a slight dent and the grille disengaged from the vehicle. The right side of the front bumper was scraped and bent rearward, while the whole bumper moved laterally to the left. The right fender experienced major crushing and scraping along the entire length of the panel. The leading and rear edges of the right-front door panel were crushed inward while the center of the door panel bowed outward. Scraping occurred along all areas of contact. Minor crushing occurred around the midpoint of the right-rear door panel. Crush occurred on the entire length of the right box side. The right taillight disengaged. The right end of the rear bumper was scraped and crushed inward. The left fender was bent toward the

left slightly. The lower-right corner of the windshield slightly cracked, and the front-right window shattered due to contact with the simulated occupant's head. The remaining window glass remained undamaged.

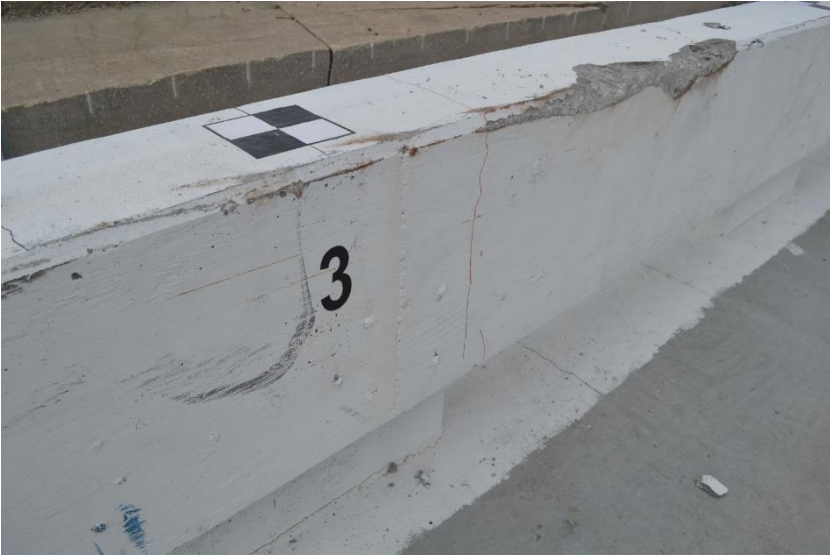
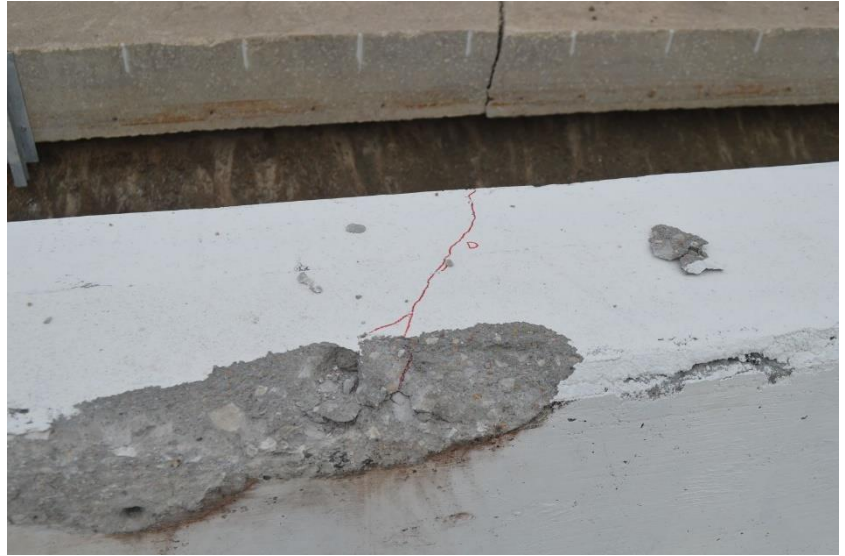
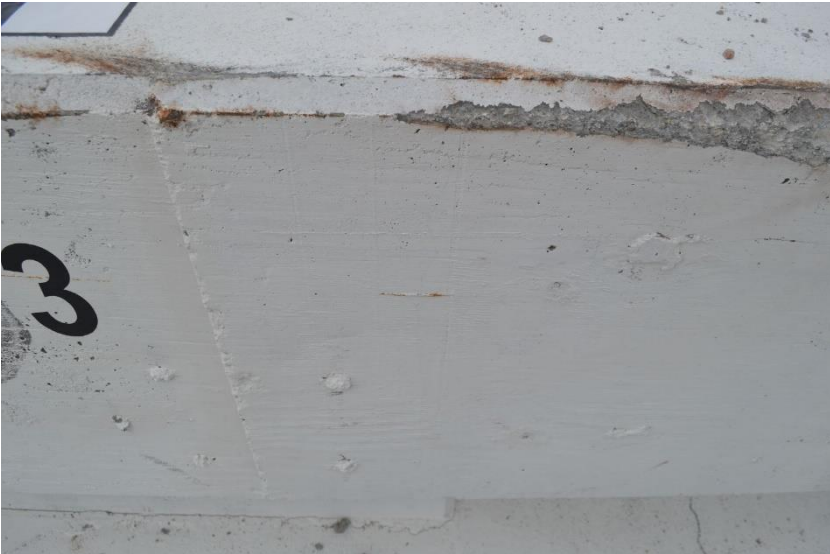
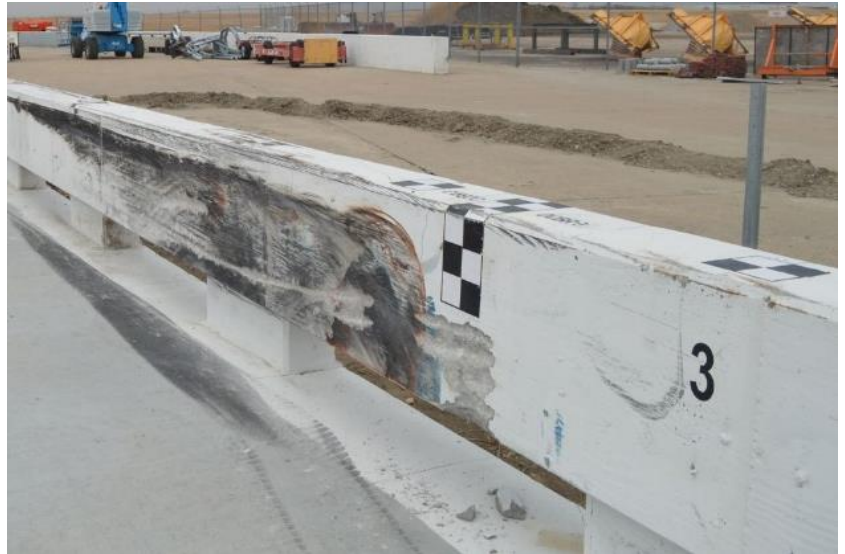
Figure 78. Concrete Beam and Deck Damage, Test No. OCBR-3

Spalling and gouging were noted on the face of the bridge rail beam due to interaction of the wheel lugs with the face of the beam. A total of seven gouges on the top face and front edge of the bridge rail beam with lengths between 4 and 111 in. were found between post nos. 2 through 5. Another set of gouges with lengths between 9½ in. and 70½ in. spanned from post no. 11 to the downstream end of the bridge rail beam. Spalling was observed 38½ in. upstream from post no. 14 spanning 20 in. downstream.

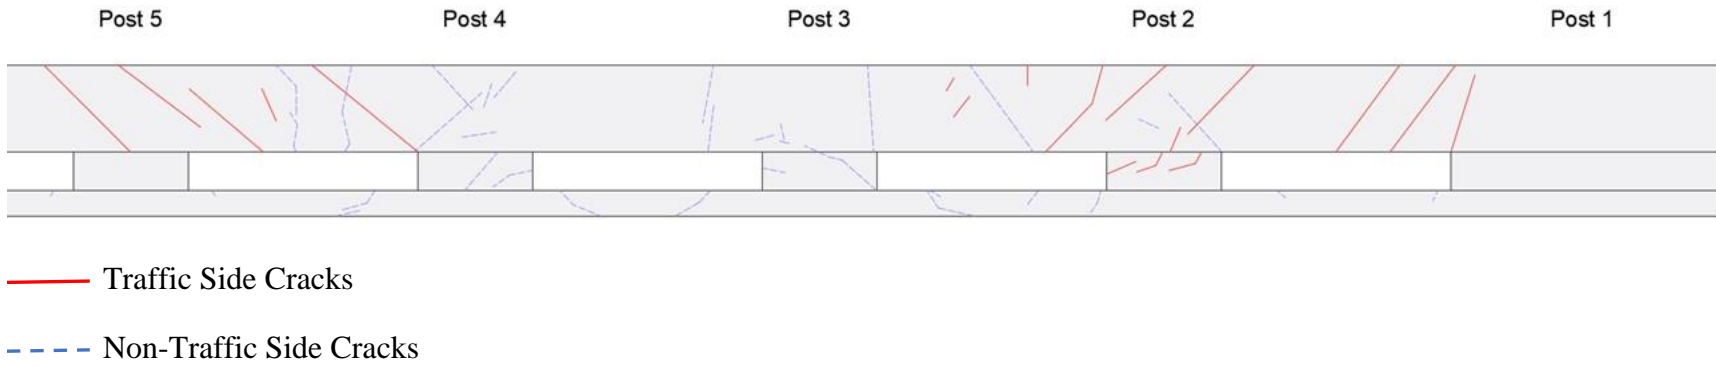
Figure 81. Schematic of Bridge Rail Cracks, Test No. OCBR-3

Hairline cracks with lengths between 9 in. and 36 in. were observed on the front face of the concrete beam spanning 31 in. downstream from post no. 1 to 36 in. upstream from post no. 3. Minor cracks on the front face of the concrete beam ranging from 1 in. to 59 in. long were present starting 40 in. downstream from post no. 2 and ending 63 in. upstream from post no. 6. Another set of cracks were present on the backside of the concrete beam with lengths between 1 in. and 31 in. spanning between post no. 2 and 82 in. upstream from post no. 5. Cracks were also present on the back side of concrete post nos. 3 and 4 with lengths between 6½ in. and 17 in. As for the concrete deck, cracks were found on the front, top, and bottom surfaces of the deck at the downstream and upstream edge of concrete posts no. 1 through 5; these cracks measured between 1 in. and 36 in. long. The deck surface at post nos. 2 through 4 all had deck-post interface cracks. The upstream edge of the deck overhang had a 3-in. tall vertical crack. Another overhang crack and tarmac joint crack spanned across the entire deck with a length of 70 ft. A schematic of the cracking observed in the beam and posts is shown in Figure 81.

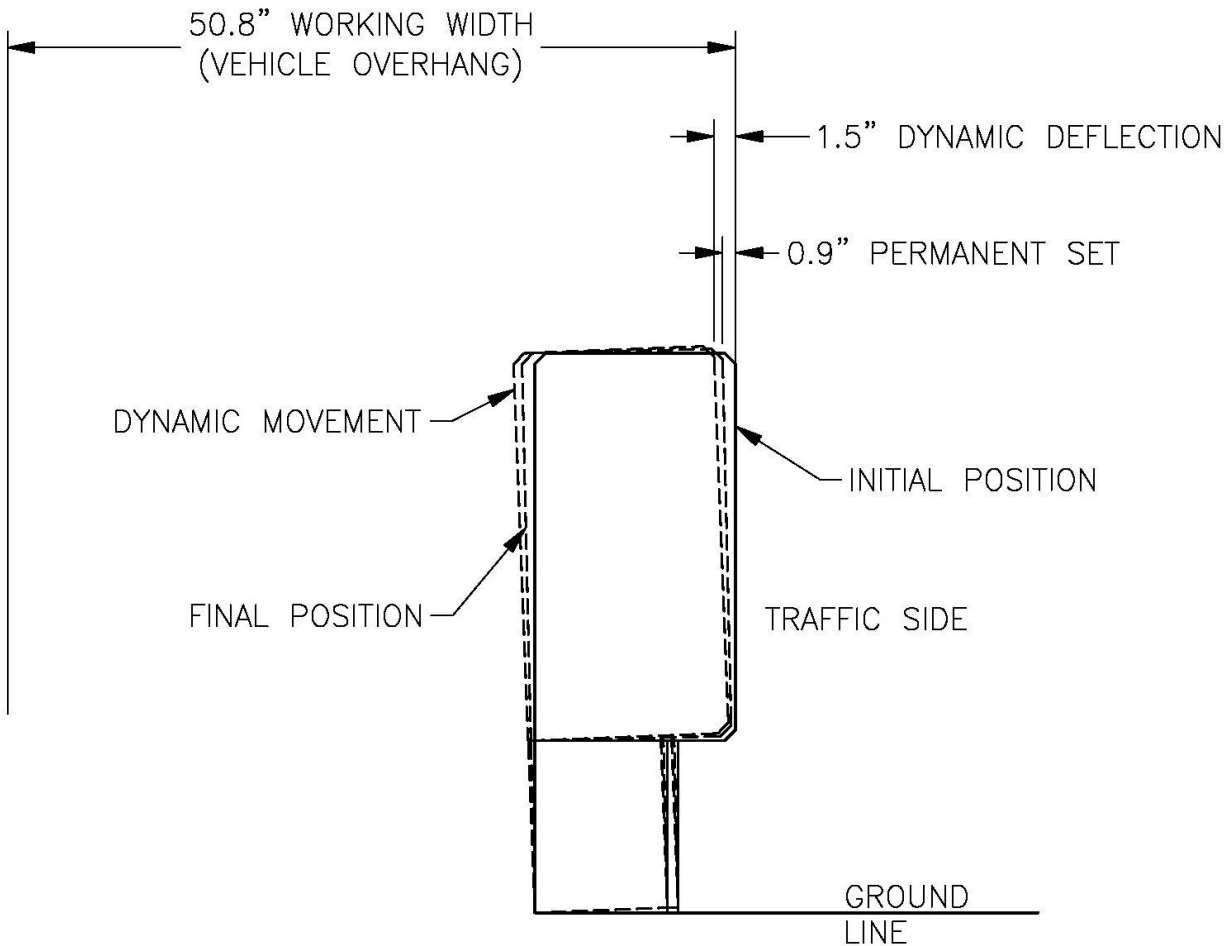
Figure 82. Permanent Set, Dynamic Deflection, and Working Width, Test No. OCBR-3

The maximum lateral permanent set of the barrier system, including barrier and deck panel shift, was 0.9 in., as measured in the field. The maximum lateral dynamic barrier deflection, including tipping of the barrier along the top surface, was 1.5 in., as determined from high-speed digital video analysis. The working width of the system was found to be 50.8 in., which included the vehicle box trailer's protrusion behind the barrier, also determined from high-speed digital video analysis. A schematic of the permanent set deflection, dynamic deflection, and working width is shown in Figure 82.

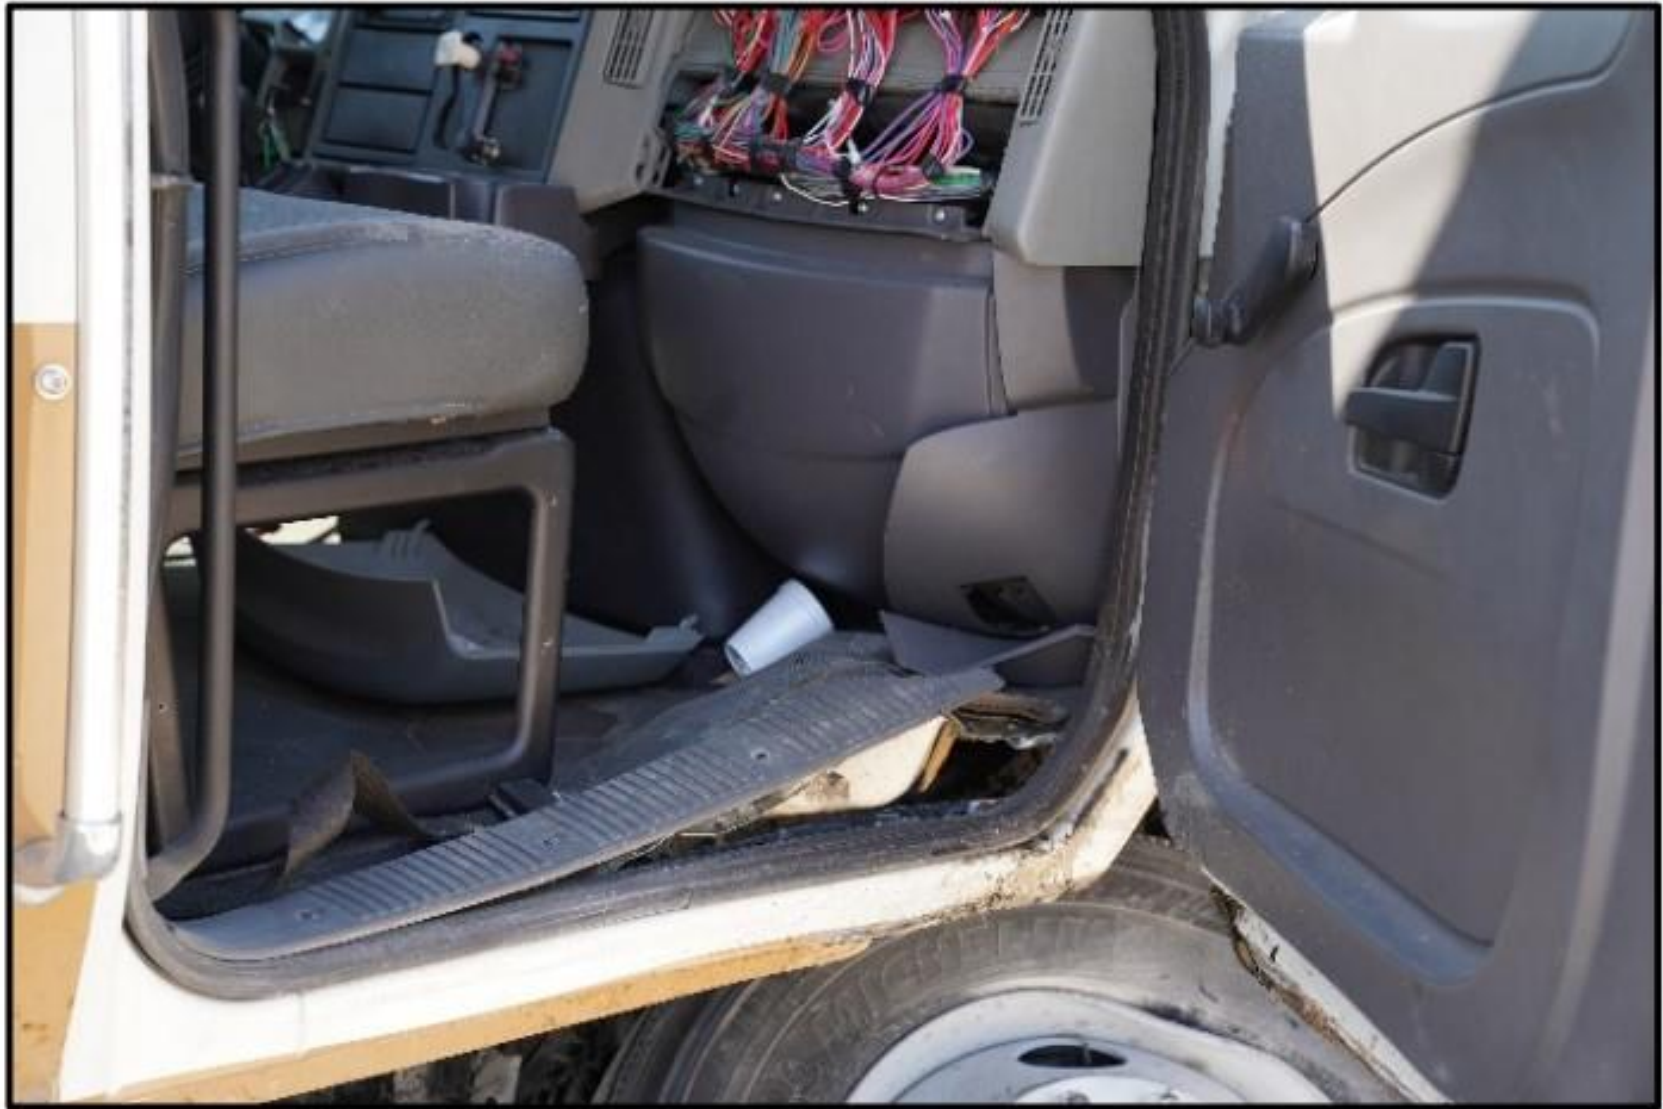
Figure 86. Vehicle Floor Pan Separation, MASH TL-4 Flared Concrete Barrier, Test No. 611901-05-1 [18]

“Note that some vehicles now incorporate glued seams on the floor board as well as other areas. In the presence of significant deformation, these bonded seams can separate and create an opening into the occupant compartment. There is no available data to relate occupant injury severity to the opening of seams in the floor pan area. However, it is generally believed that an opening in the occupant compartment by and of itself does not necessarily result in injury to the occupants unless it is accompanied by an object moving toward the occupant. Therefore, a seam separation by itself is not considered a test failure unless (1) a component of the safety device protrudes through the opening or (2) the deformation limits of 12 in. (305 mm) is exceeded.”
