Research Project Number TPF-5(430) – Supplement #10

EVALUATION OF THE MGS WITH HALF POST SPACING AND 7-FT POSTS ADJACENT TO SLOPE

MIDWEST ROADSIDE SAFETY FACILITY

MwRSF Research Report No. TRP-03-452-24

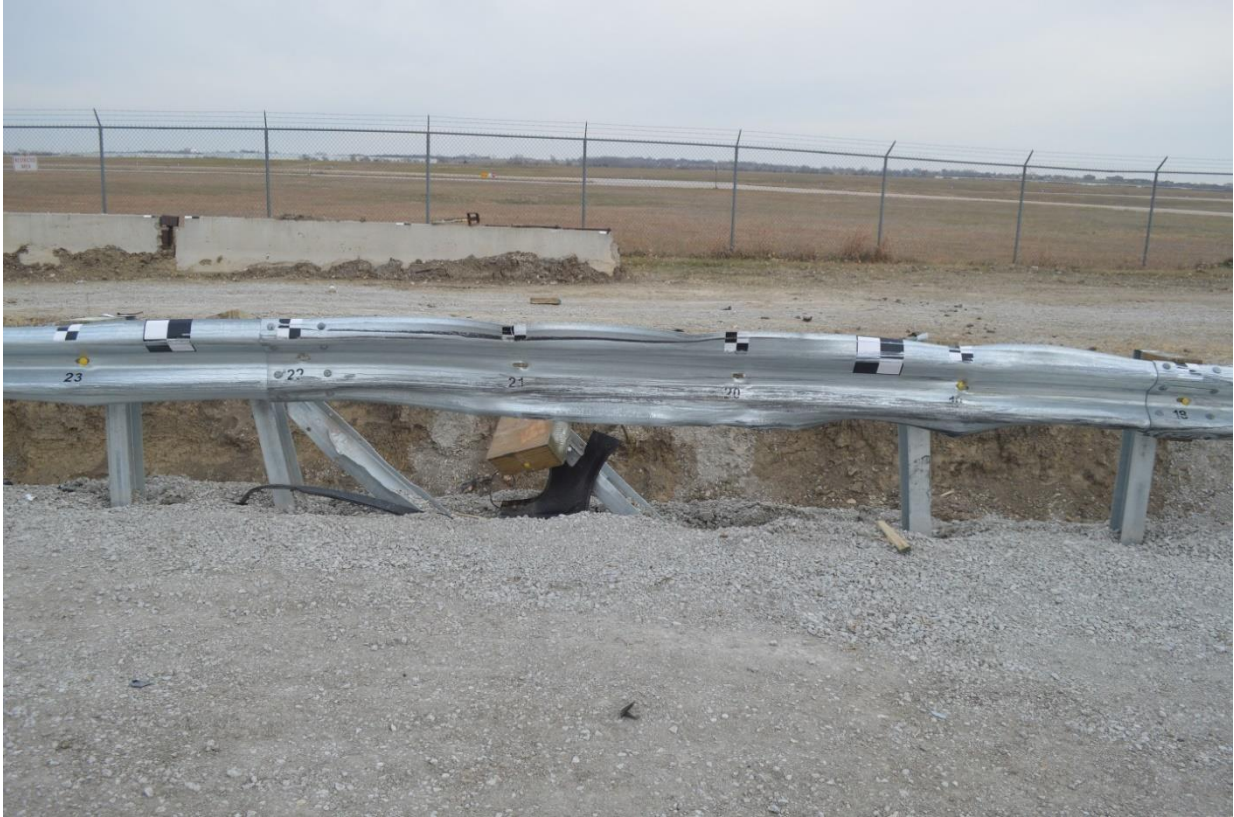
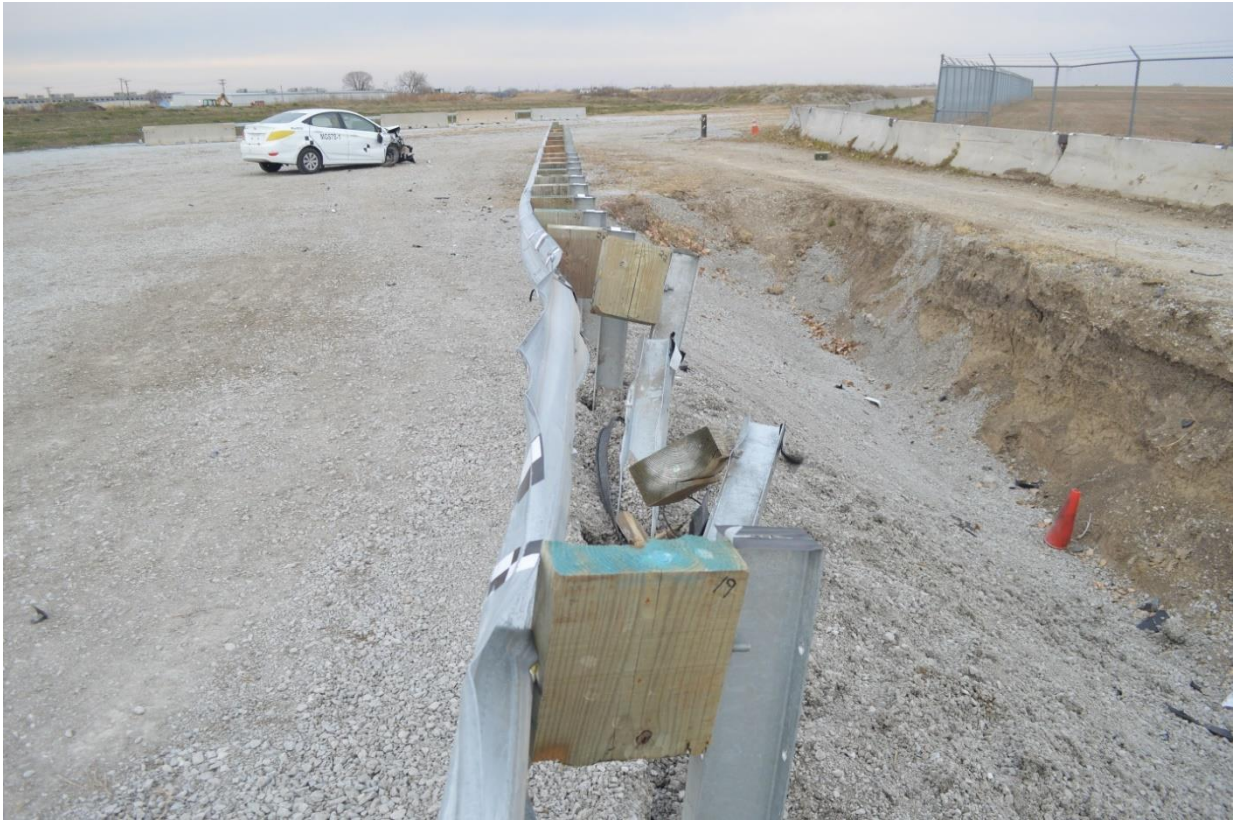
Figure 35. System Damage, Test No. MGS7S-1

Damage to the barrier was moderate, as shown in Figures 35 through 41. Barrier damage consisted of contact marks on the guardrail sections and posts, guardrail and post deformations, and post damage. The primary length of vehicle contact along the barrier was approximately 19 ft – 1 in. which spanned 14¼ in. downstream from post no. 17 to approximately 18¼ in. downstream from post no. 23. Contact marks were located on post nos. 17 through 23, spanning different lengths.

The W-beam guardrail configuration experienced rail kinking between post nos. 16 and 26. Minor rail flattening also occurred at post no. 18. Intermittent soil heaving was observed spanning from post nos. 19 through 23 which led to displacement of a portion of the 2H:1V slope behind the system.

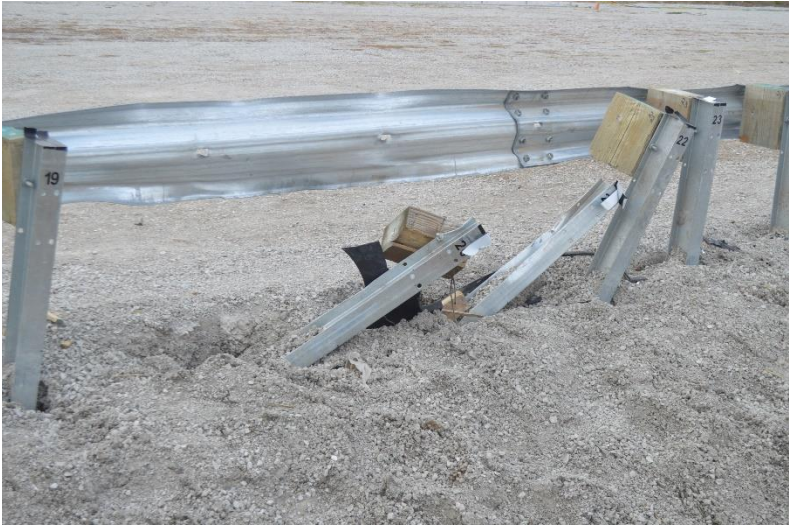
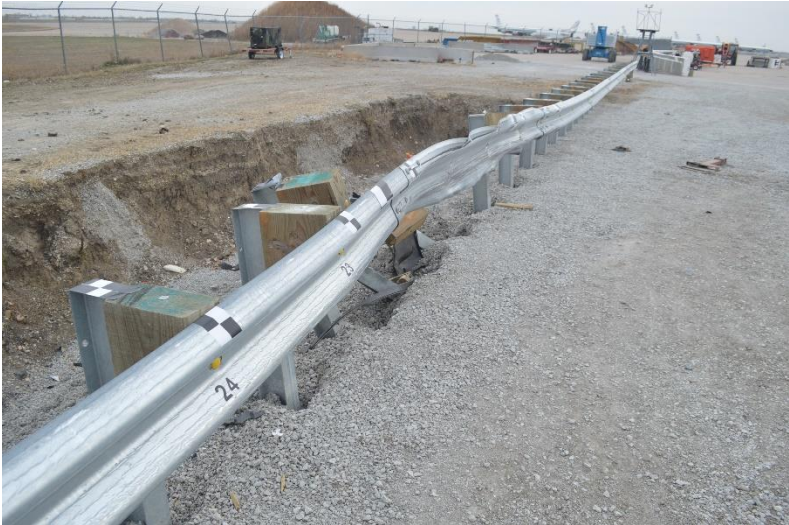
Figure 36. System Damage, Test No. MGS7S-1

The most significant post deformation occurred at posts nos. 19 to 22. Posts nos. 20 and 21 bent downstream while deflecting downstream. Post nos. 19 and 22 deflected downstream. Posts nos. 19 and 20 were twisted due to the counter-clockwise rotation caused by impact and snagging of the vehicle's right-front wheel. Posts nos. 19 through 21 were also rotated counter-clockwise. Both post nos. 19 through 22 deflected backwards. In addition, minor to moderate damage was experienced by post nos. 15 to 18 and 23 to 24, in which no permanent deformation occurred. Post nos. 15 to 18, 23, and 24 deflected backward at different angles; the angles were larger closer impact. Posts nos. 23 and 24 also experienced slight clockwise rotation.

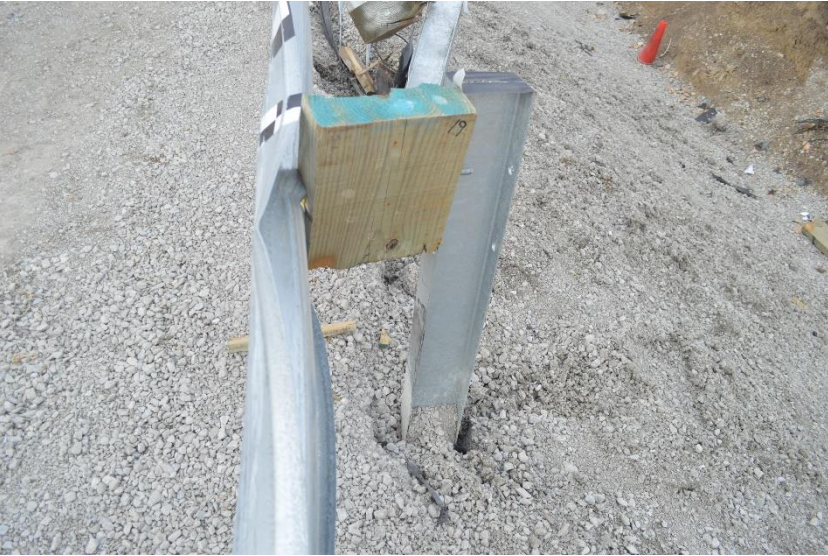
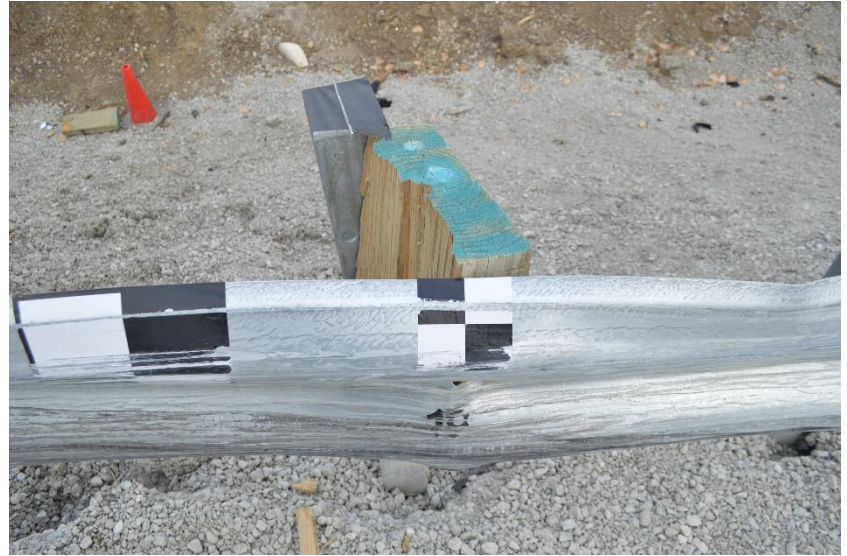
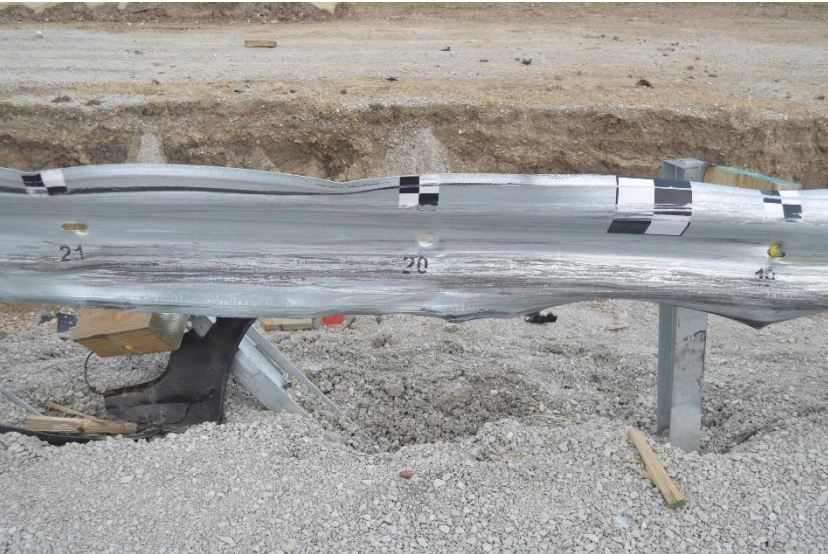
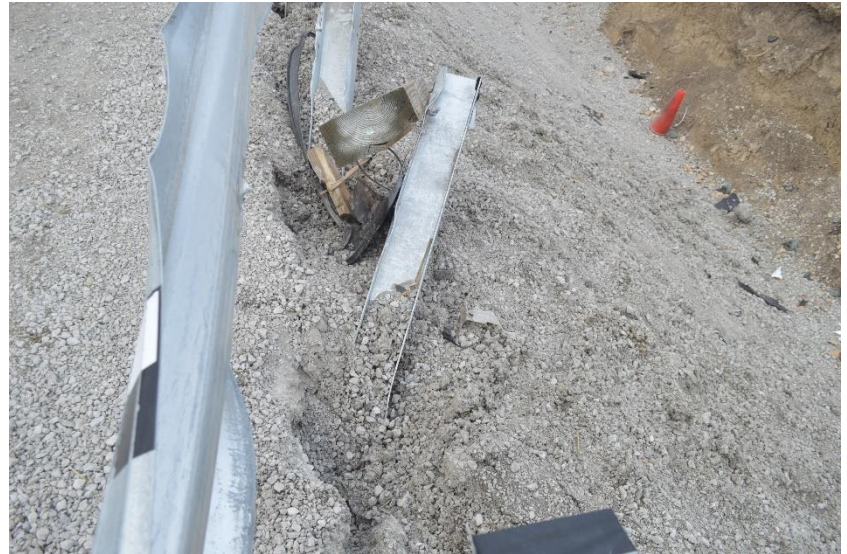
The guardrail was detached from the post at post nos. 20 through 22. Post no. 19 experienced breakout fracture on the downstream half of the breakout and buckling occurred on the back side of the flange. Post no. 20 experienced breakout fracture on the downstream half of the breakout, and a bent bolt at the post flange. The post was no longer in contact with the rail due to the post bolt releasing from the guardrail. Post no. 21 was also disengaged from the rail resulting from bolt shear at the nut on the backside of the flange. At post nos. 20 through 22, the upstream front flange was bent twice, on the top half of the post. The block at post no. 21 was detached from the post and the block at post no. 22 was dented, both following impact with the vehicle. The bolt bent at mid length on post no. 21, while the bolt on post no. 22 was bent at the flange hole. As result of the damage experienced by post nos. 20 through 22, the bolt holes became warped. Post no. 21's flange curled backward at the upper downstream corner. The back flange was then bent forward at the upstream edge. The web of the post was bent on the front half. The front flange tore on the lower bolt hole of the downstream side.

Figure 37. Damage to Post Nos. 19 and 20, Test No. MGS7S-1

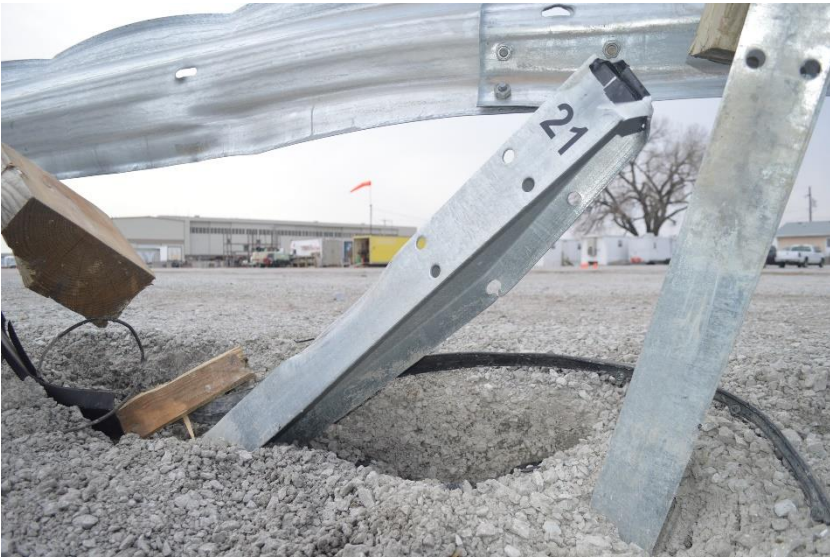
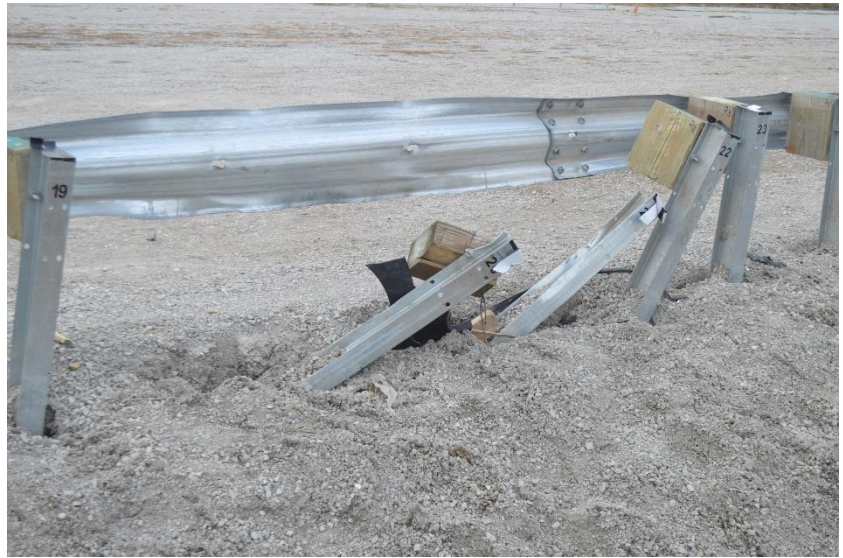
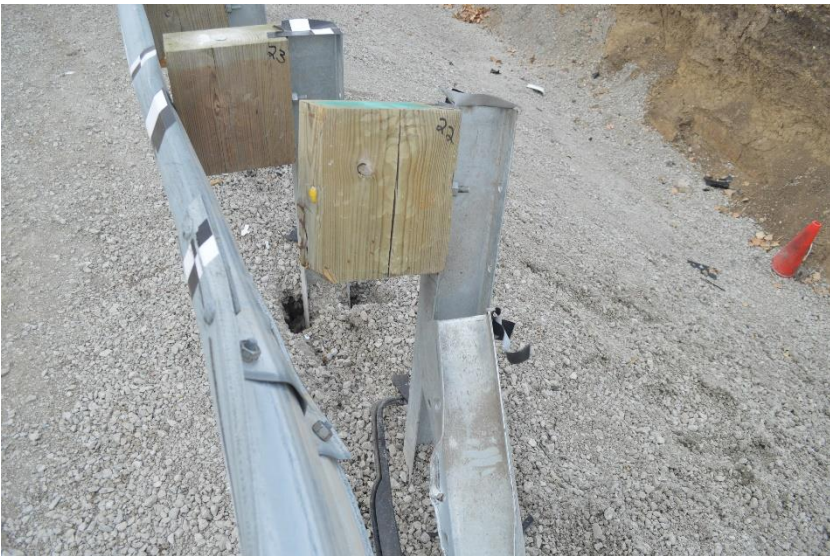
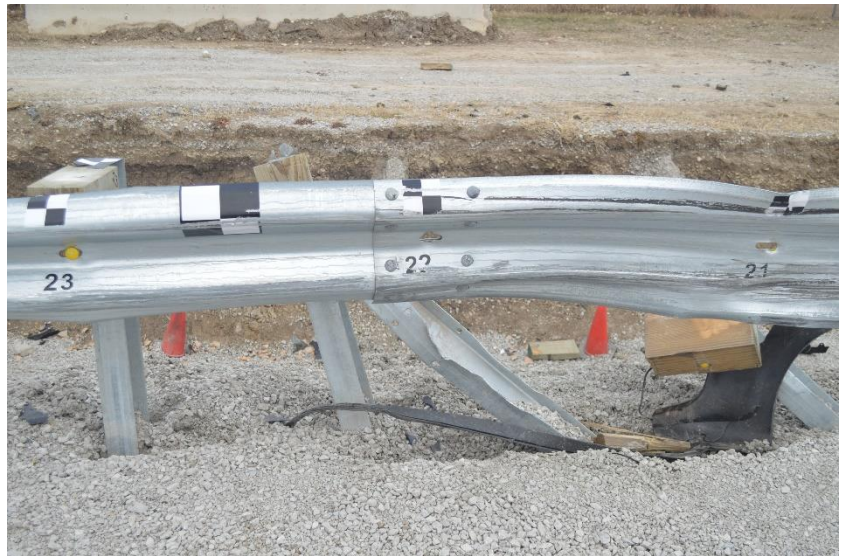
Figure 38. Damage to Post Nos. 21 and 22, Test No. MGS7S-1

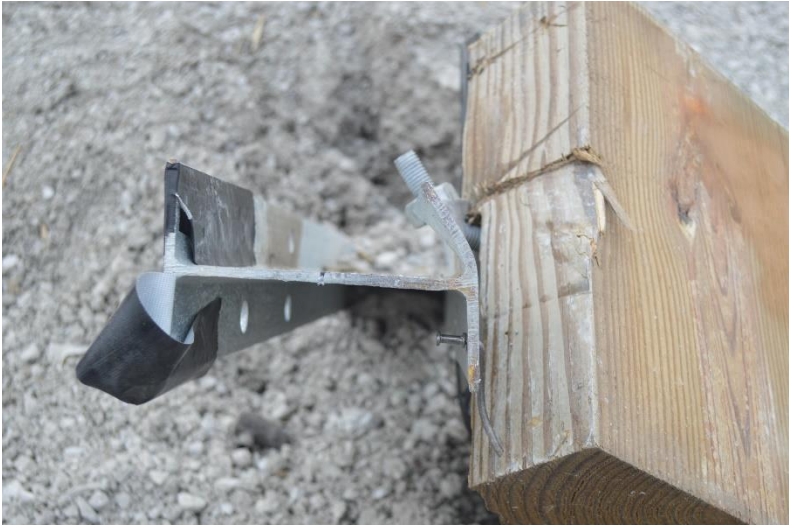
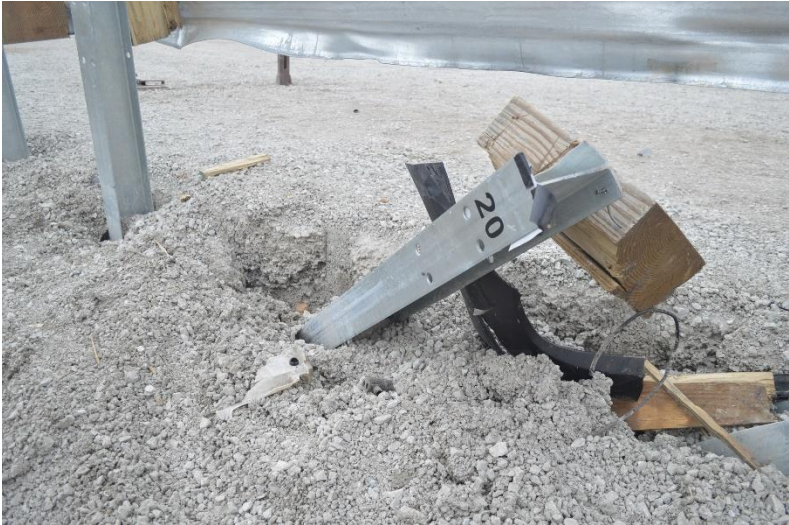
Figure 39. Post and Flange Damage, Test No. MGS7S-1

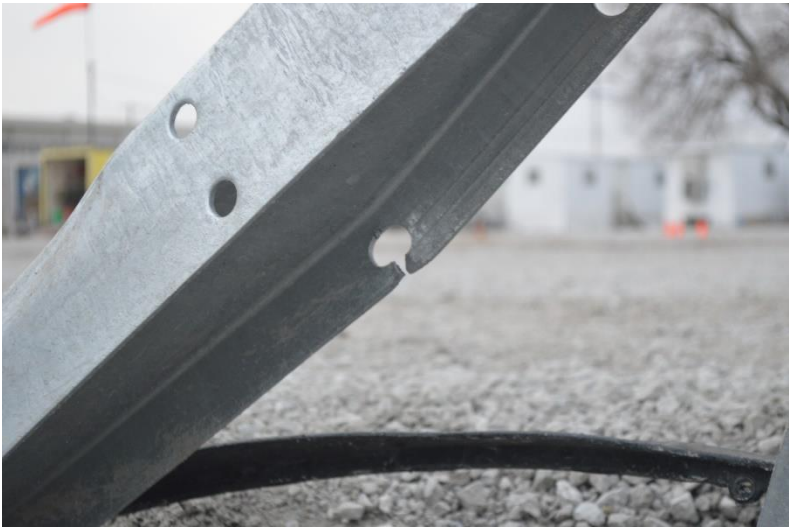
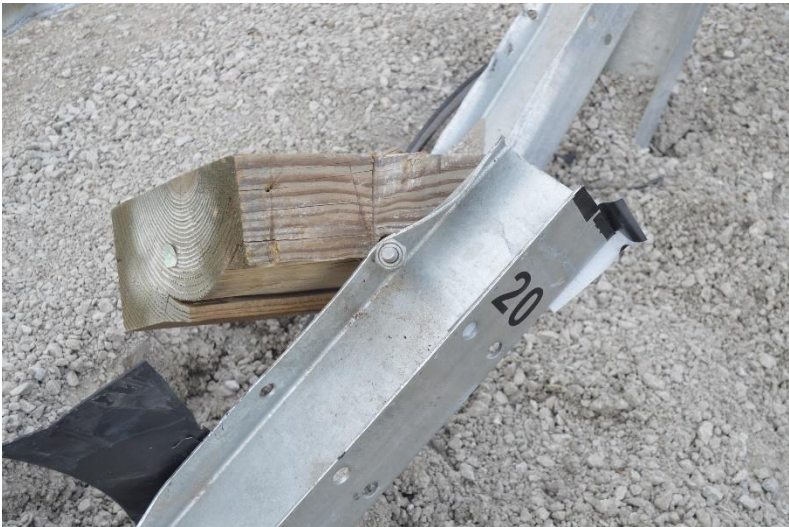
Figure 40. Bolt Hole and Bolt Damage, Post No. 20, Test No, MGS7S-1

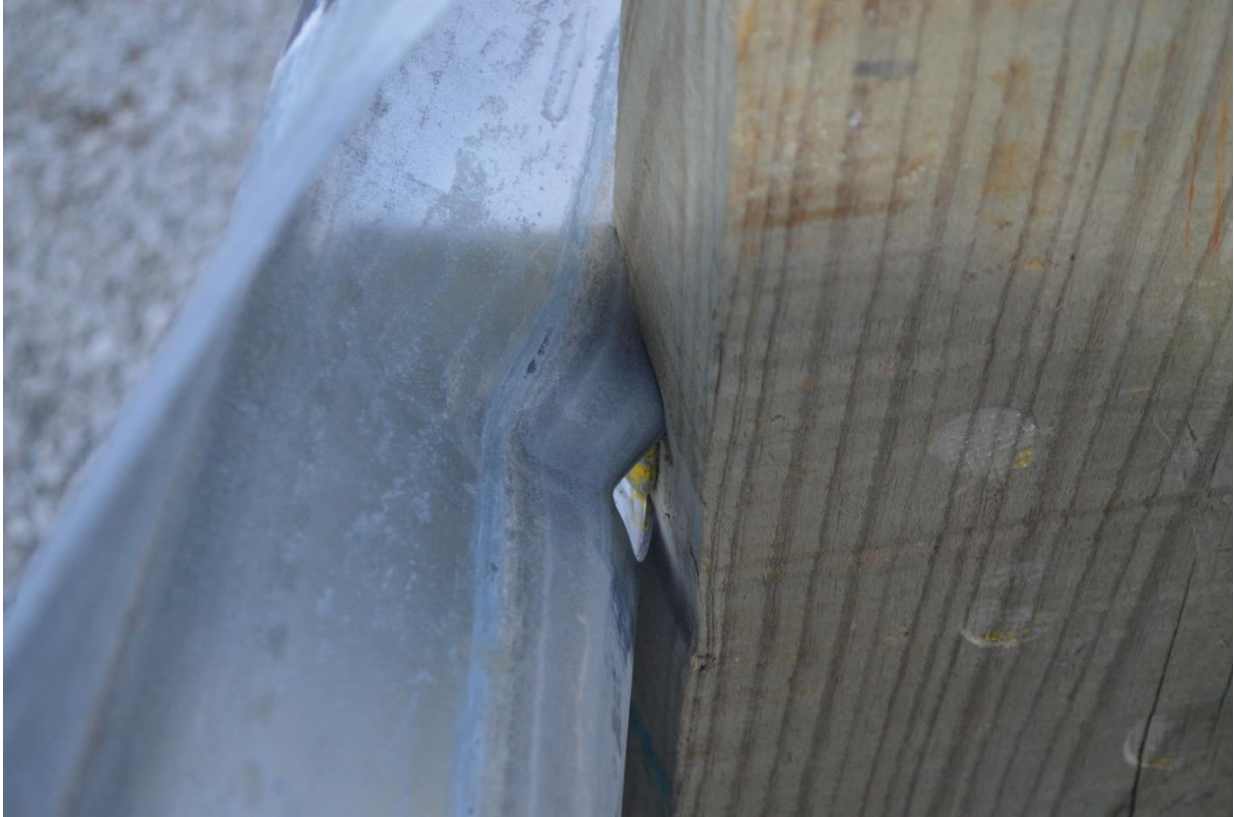
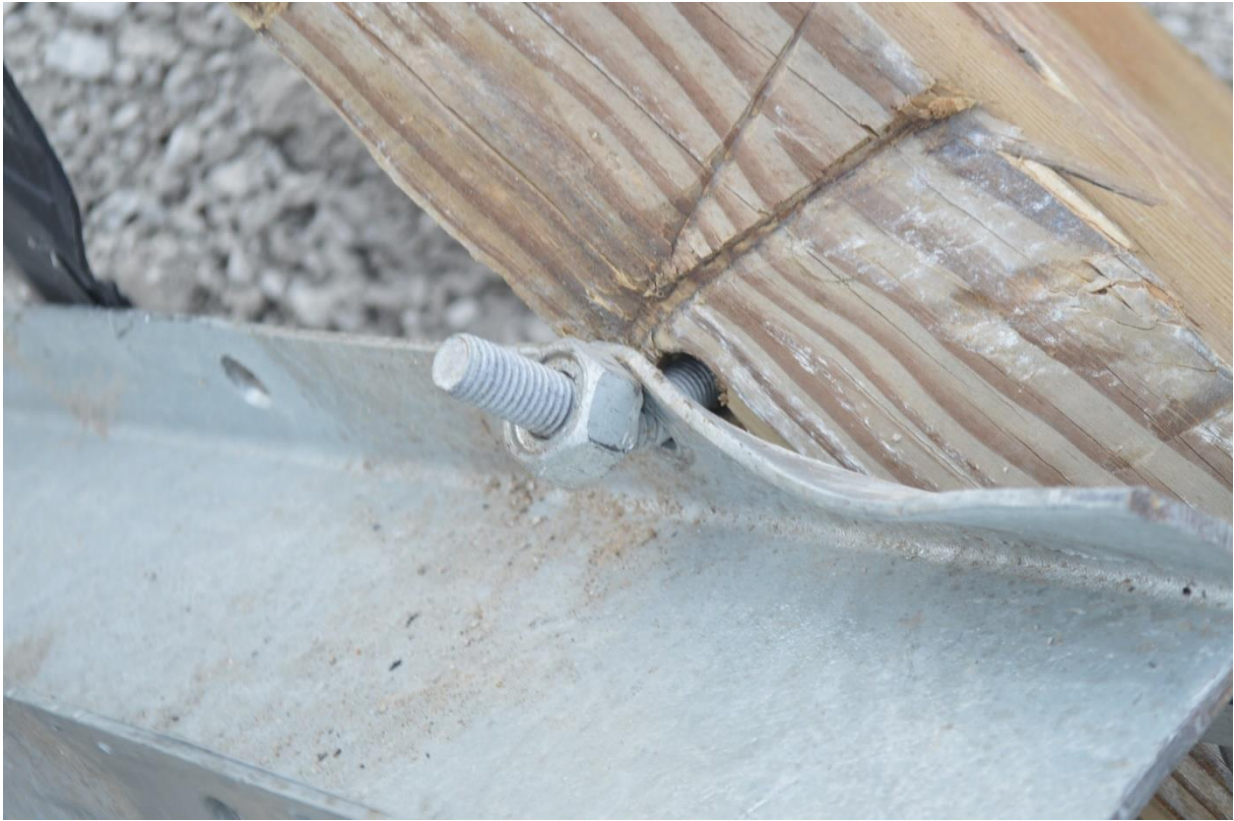
Figure 41. Bolt Hole and Bolt Damage, Test No. MGS7S-1

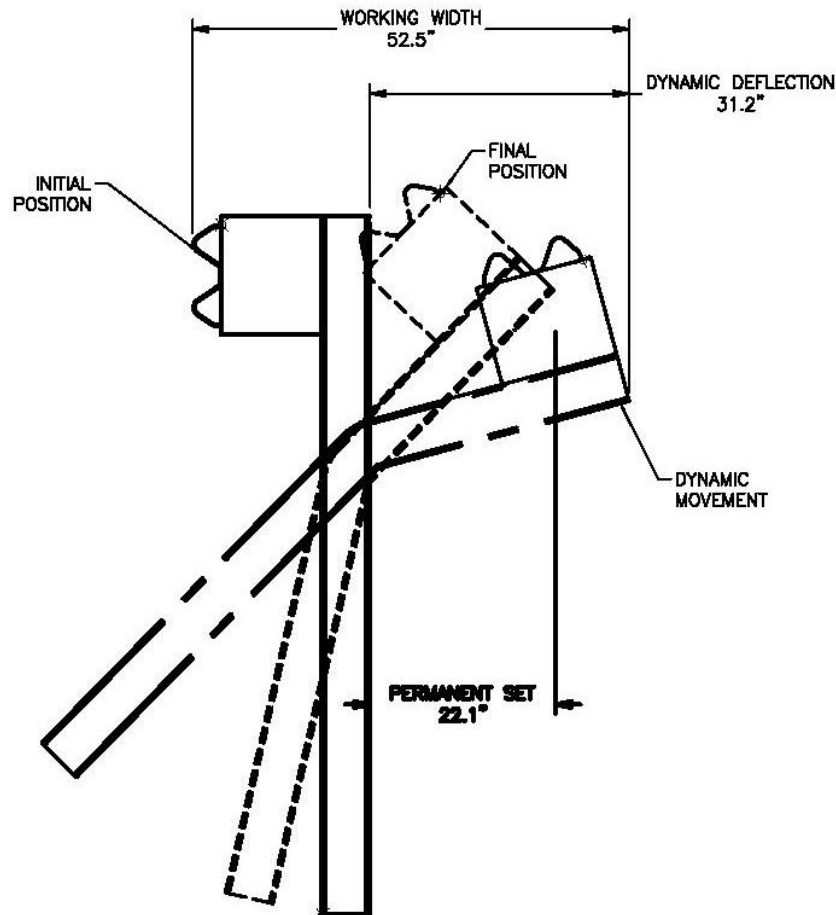
Figure 42. Permanent Set, Dynamic Deflection, and Working Width, Test No. MGS7S-1

The maximum lateral permanent set of the barrier system, including post and rail deflection, was 22.1 in. at post no. 20, as measured in the field. The maximum lateral dynamic barrier deflection, was 31.2 in. located at post no. 20, as determined from high-speed digital video analysis. The working width of the system was found to be 52.5 in. also located at post no. 20, also determined from high-speed digital video analysis. A schematic of the permanent set deflection, dynamic deflection, and working width is shown in Figure 42.

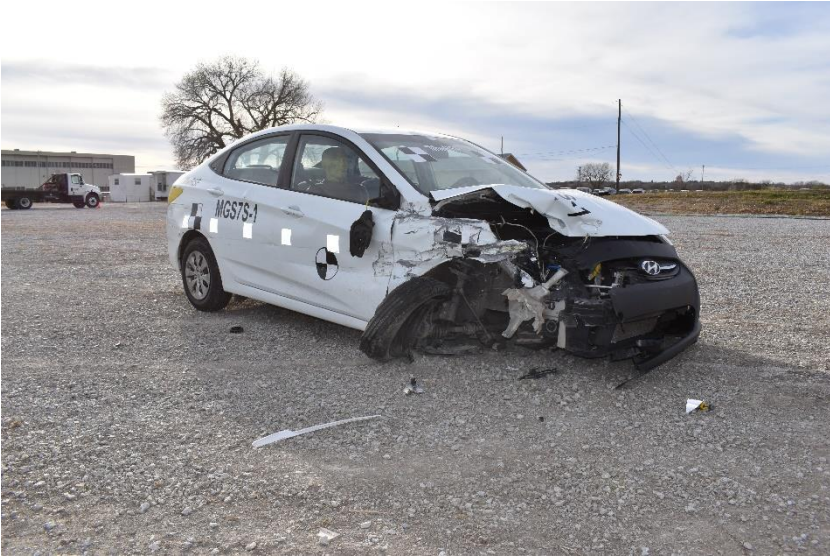
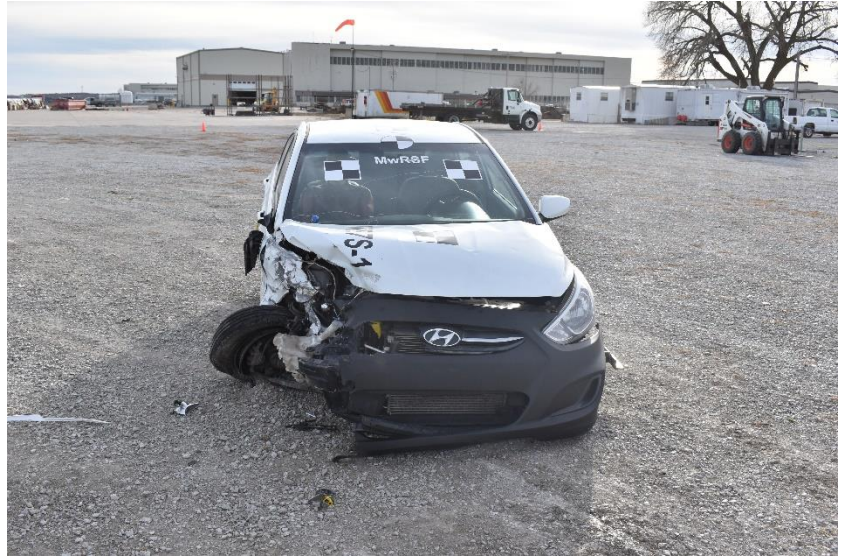
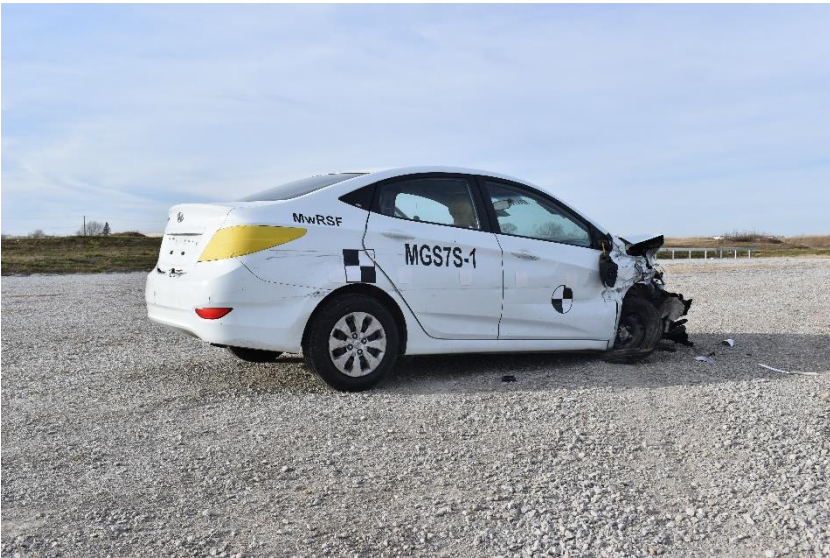
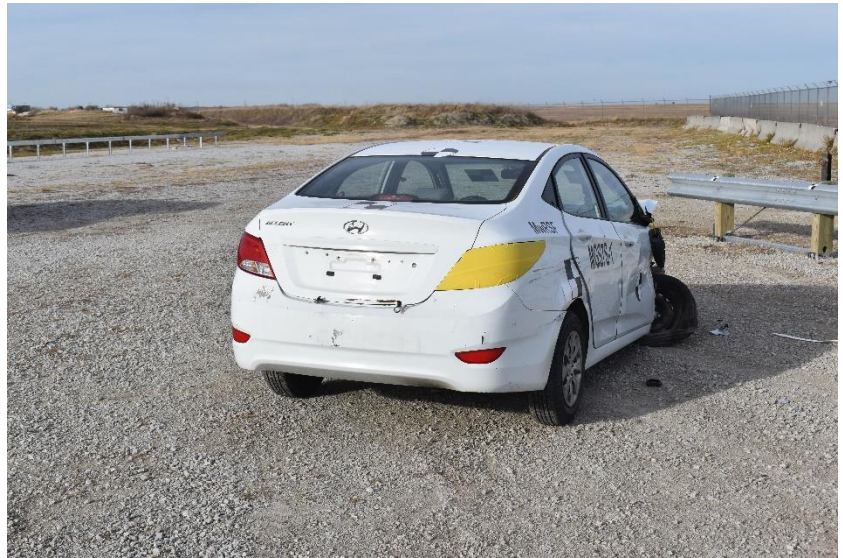
Figure 43. Vehicle Damage. Test No. MGS7S-1

Majority of the vehicle damage was concentrated on the right front corner and the right side of the vehicle where impact had occurred. One quarter of the front bumper cover, on the right side, was detached. The furthest right frame horn was crushed inwards. The hood was crushed inwards near the right side. This resulted in the hood bending into a downward “U” shape. The right fender was crushed inwards upon impact, damage was concentrated upon the front end. Significant scraping occurred throughout the crushed area. Inward crushing occurred at the leading edge of the front-right door. Scraping spanned the entire width of both right-side doors. The right quarter panel underwent rearward scrapes spanning its length. The left-side front bumper cover was deformed. Scraping was also found along the leading edge of the right-side rear bumper cover.

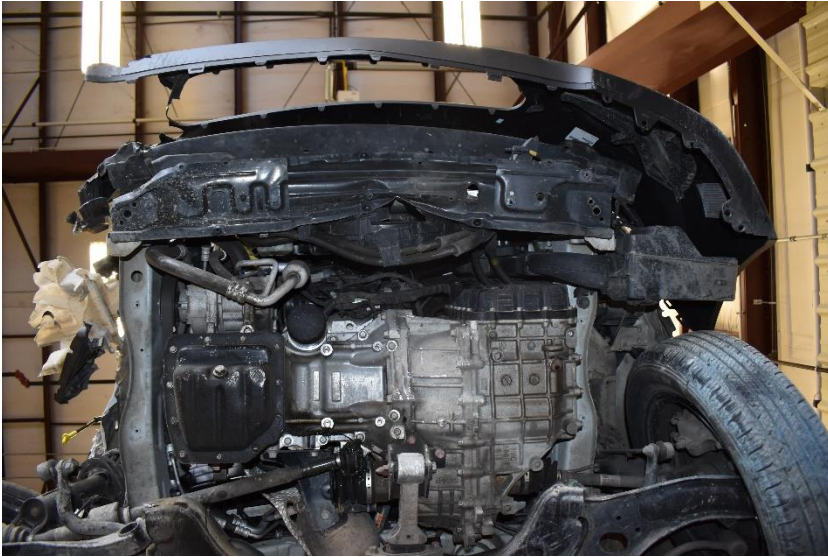
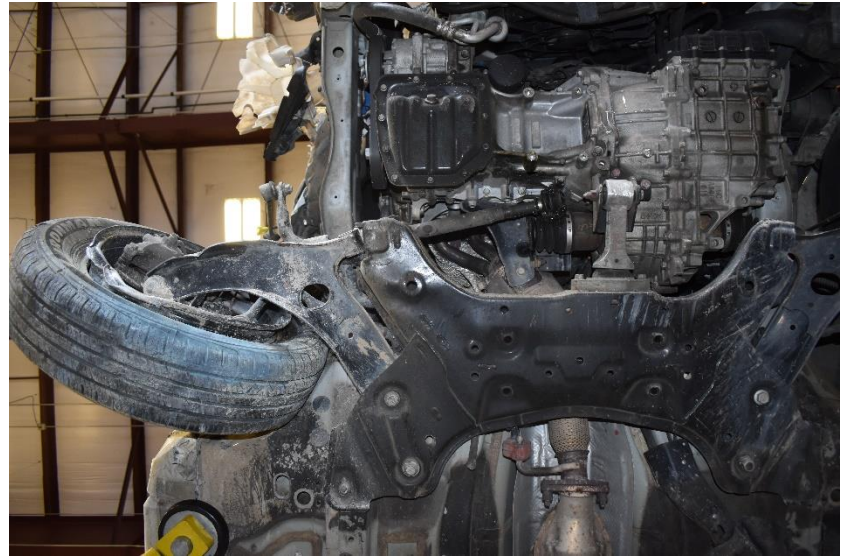
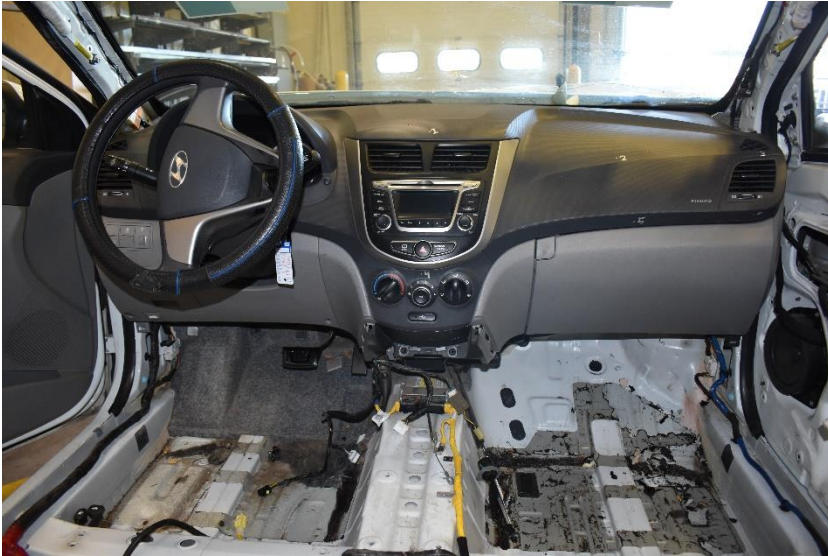
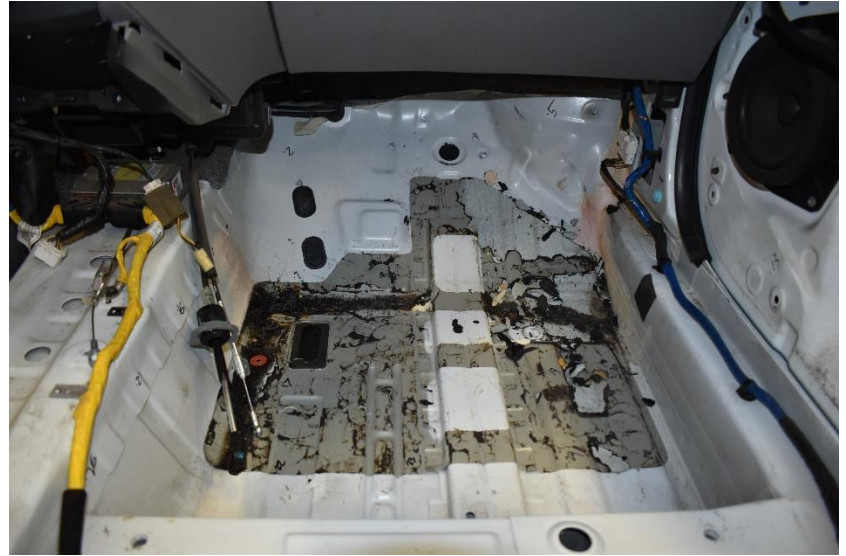
Figure 44. Vehicle Undercarriage and Occupant Compartment Damage, Test No. MGS7S-1

Similar to the vehicle body damage, the vehicle’s undercarriage was concentrated upon the right-side. The right-side control arm detached at the front most cross member of the vehicle; the strut remained attached with minor deformation. The right side of the steering rack detached at the steering rack. The right shock/spring bent outwards with a damaged steering knuckle. The right side of the front sway bar bent upwards with damaged steering knuckle. The right steering knuckle assemblies were pushed outwards with the wheel it was attached to, but all components remained intact. The right tie rod remained connected to the steering knuckle. The left-side tie rod was slightly bent at the steering knuckle connection.

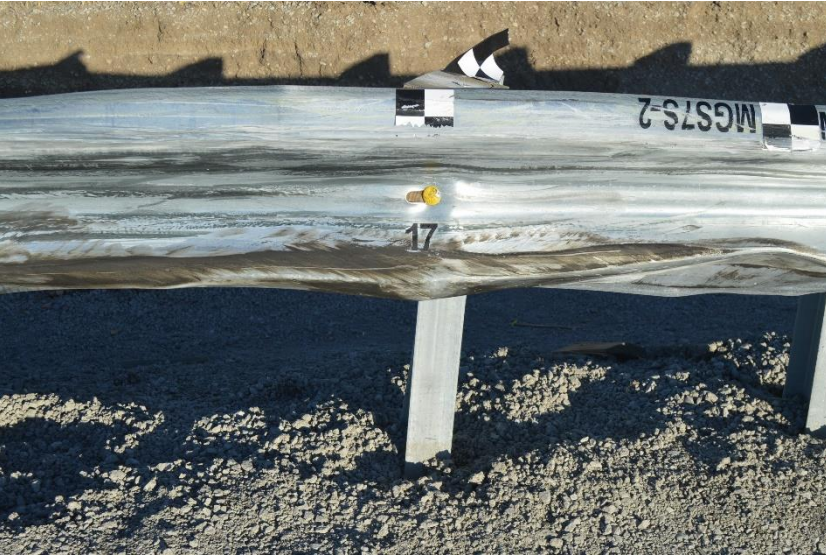
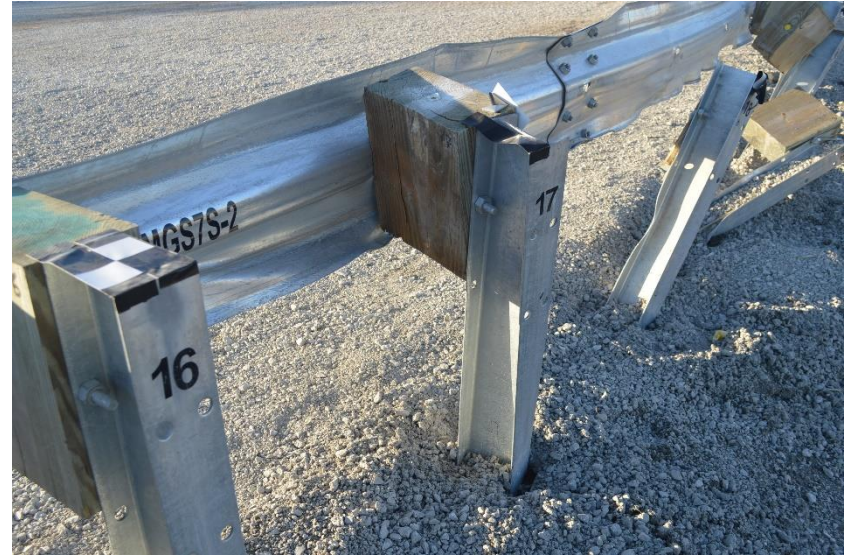
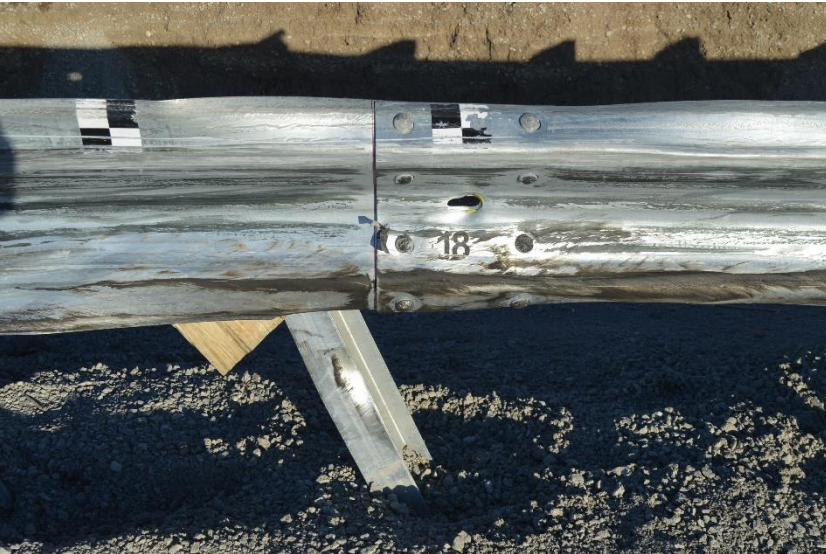
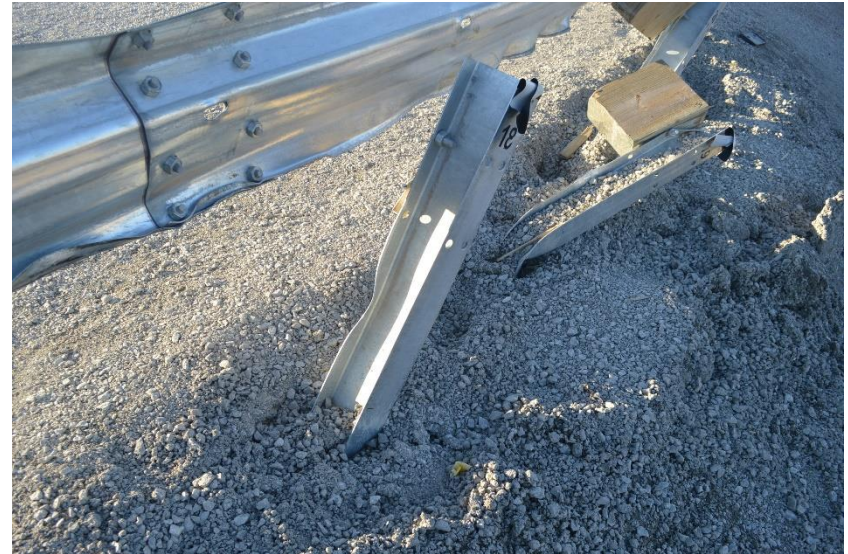
The majority of post deformation was concentrated on post nos. 17 through 22. The posts deflected backward upon impact. Post nos. 18 to 22 also experienced deflection in the downstream direction. Post nos. 18 to 21 were bent due to the deflection. In addition, post nos. 17 through 19 rotated clockwise while post nos. 20 through 22 rotated counter-clockwise. Torsional deformation occurred at these posts due to the specified rotation. Less critical damage was observed at post nos. 13 through 16, 23, and 24. Post nos. 15, 16, 23, and 24 deflected laterally backwards at lower levels. Post nos. 13 through 16 underwent clockwise rotation while post no. 24 experienced counter-clockwise rotation. Post nos. 18 and 19 displayed contact marks and flange deformation indicative of tire and wheel snag on the upstream flange of the posts.

Figure 53. Damage to Post Nos. 17 and 18, Test No. MGS7S-2

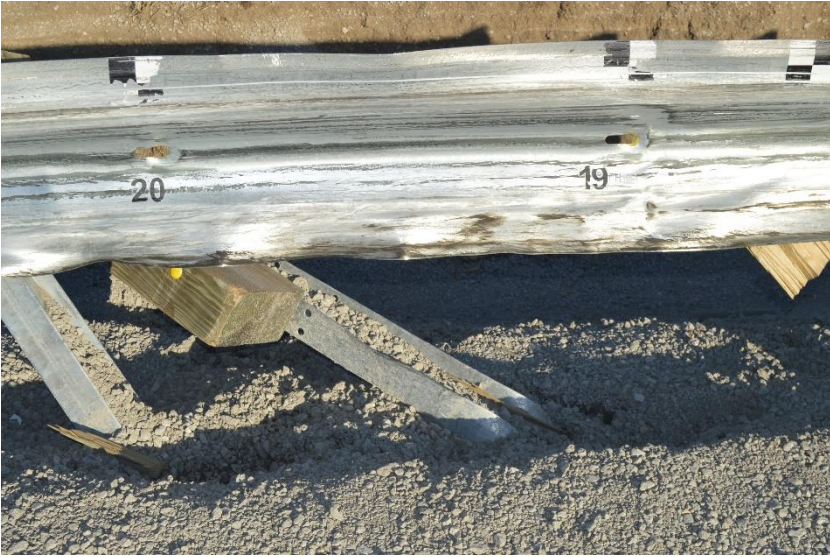
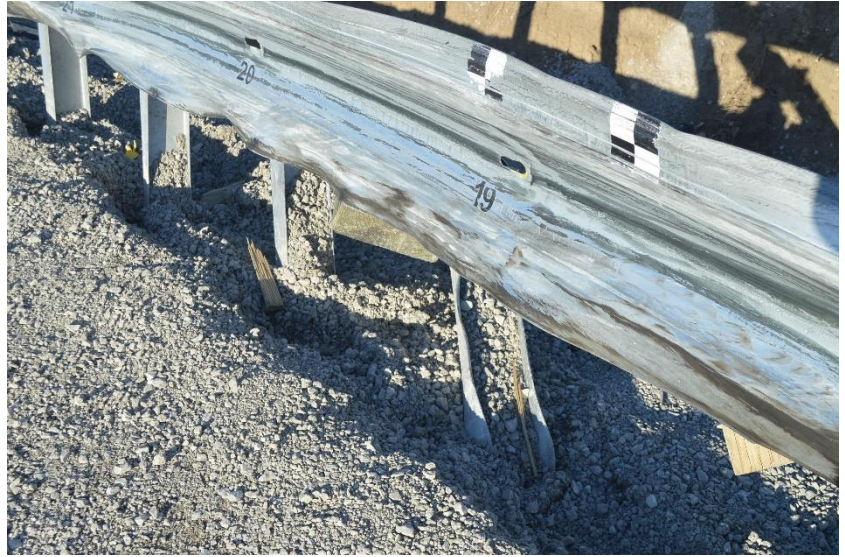
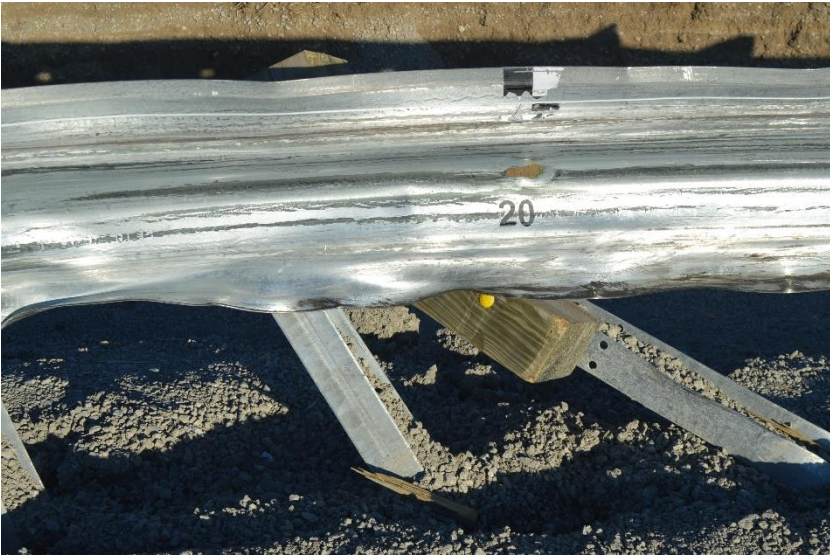
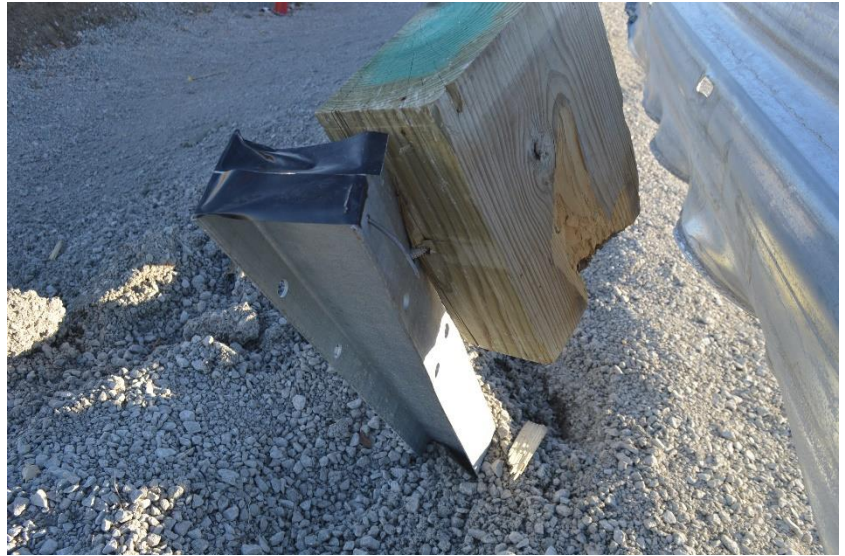
Figure 54. Damage to Post Nos. 19 and 20, Test No. MGS7S-2

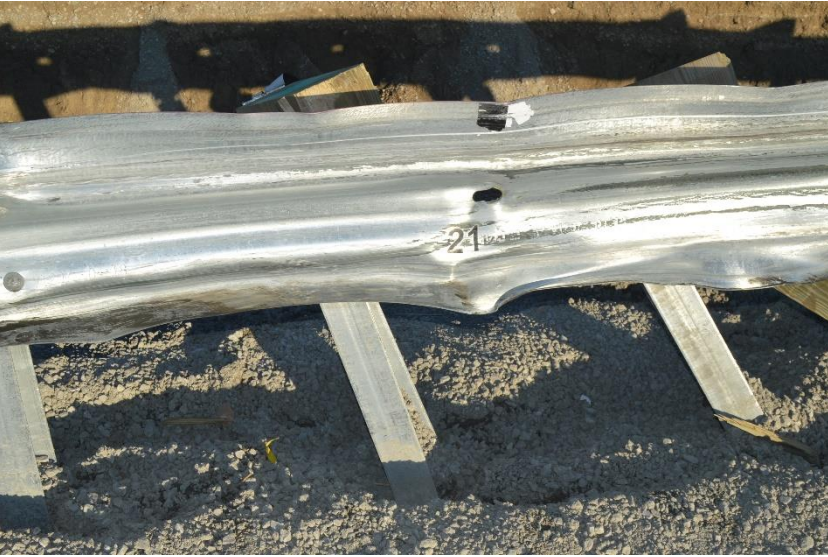
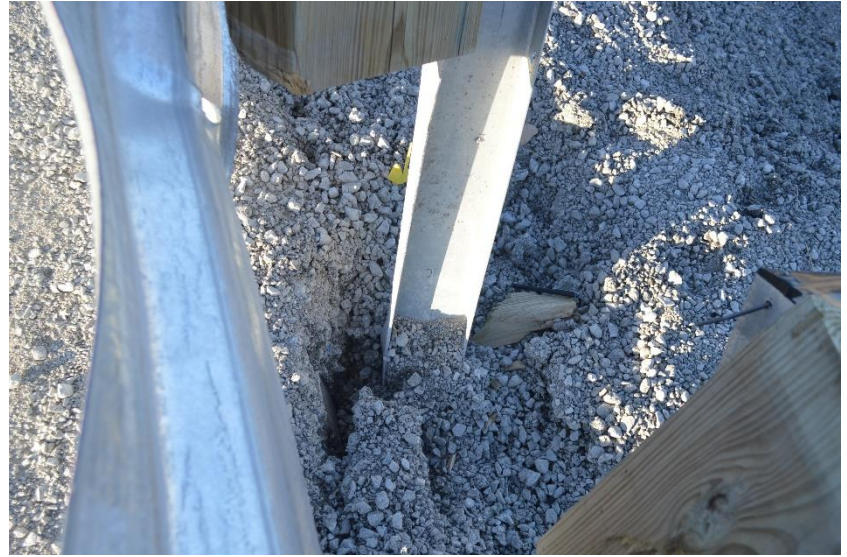
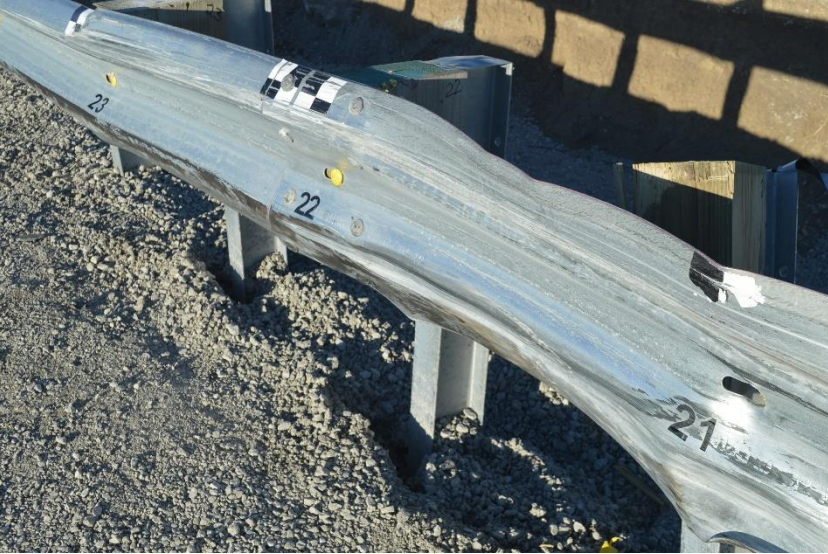
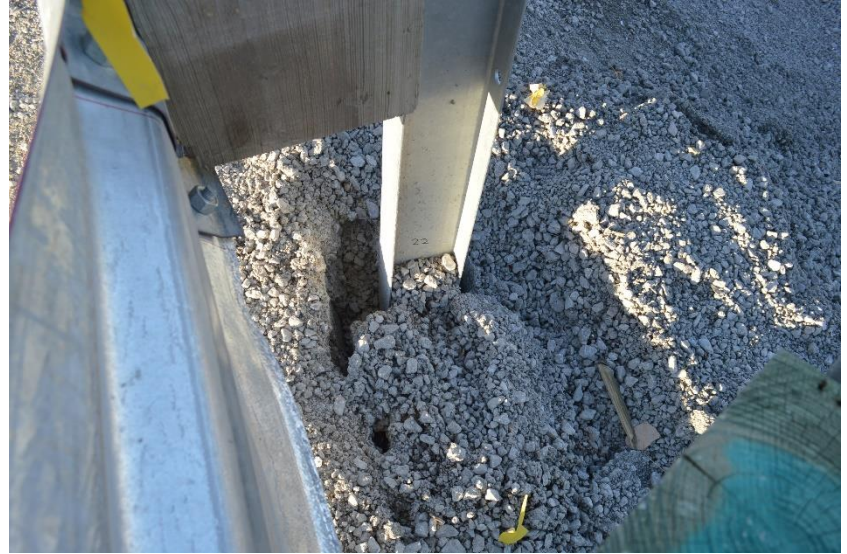
Figure 55. Damage to Post Nos. 21 and 22, Test No. MGS7S-2 Description
