Research Project Number TPF-5(430) – Supplement #10

EVALUATION OF THE MGS WITH HALF POST SPACING AND 7-FT POSTS ADJACENT TO SLOPE

MIDWEST ROADSIDE SAFETY FACILITY

MwRSF Research Report No. TRP-03-452-24

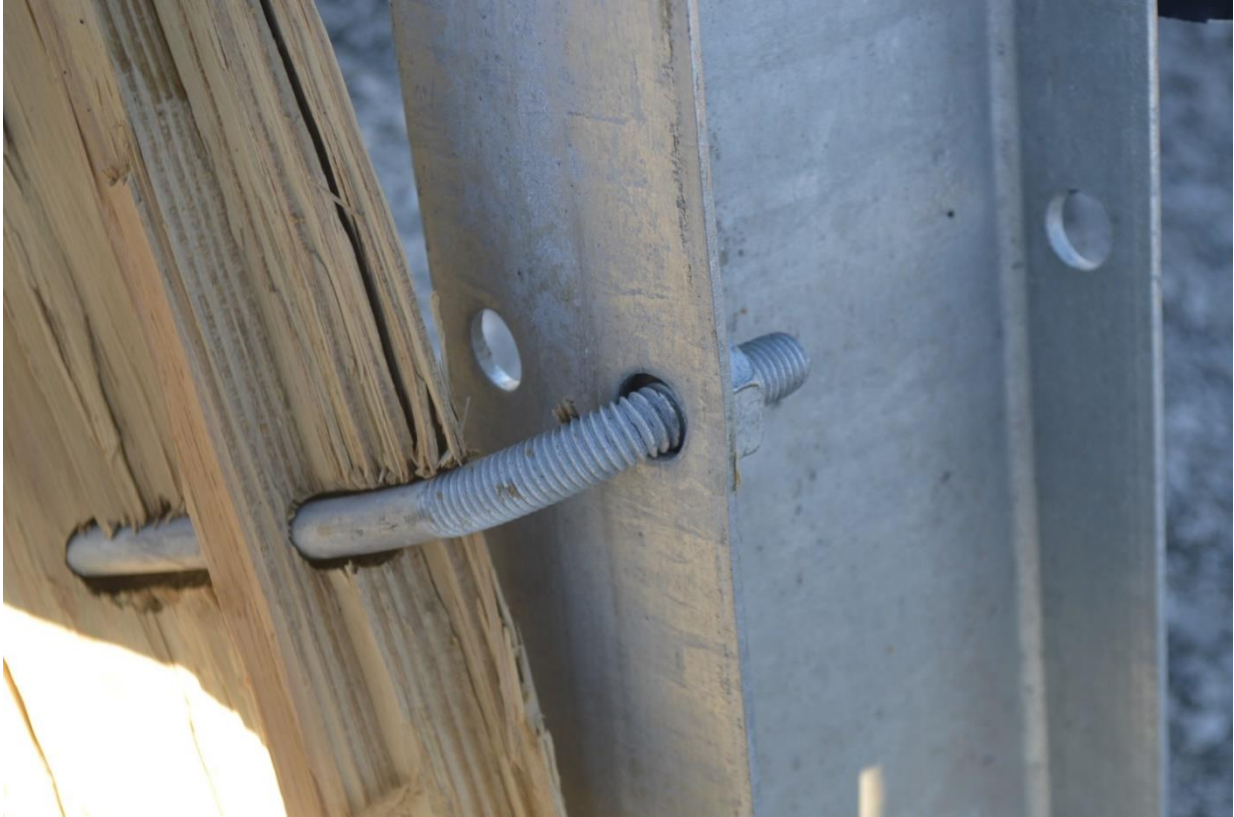
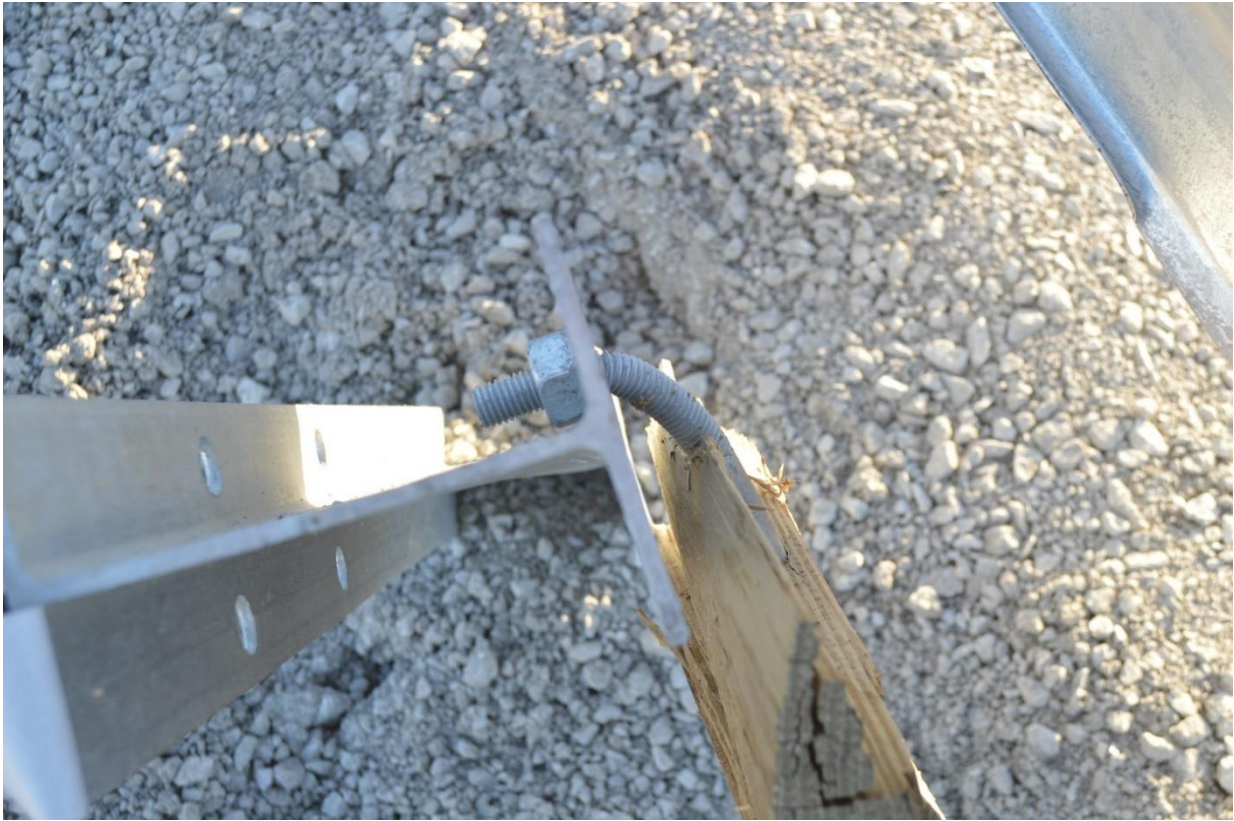
The bolt hole was deformed on post nos. 17 through 24. The blockout at post no. 18 was fractured and disengaged. Post nos. 18 through 21 were no longer connected to the rail due to the post bolt releasing through the guardrail slot. Soil fissures occurred from post no. 18 to post no. 22. Large segments of soil were pushed backwards behind the posts in the impact region which disengaged sections of the 2H:1V slope behind the system and formed a line of soil disengagement in front of post nos. 16 through 23.

Figure 56. Bolt Damage. Test No. MGS7S-2

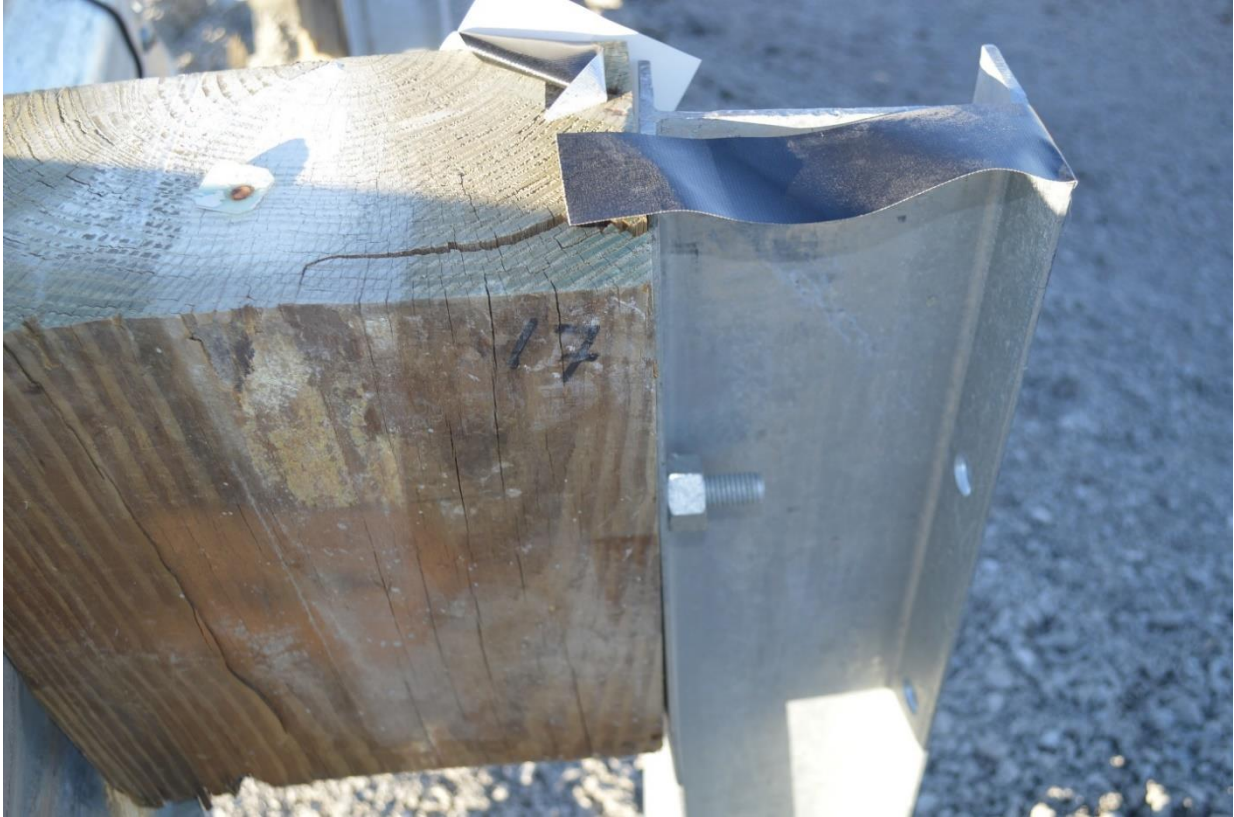
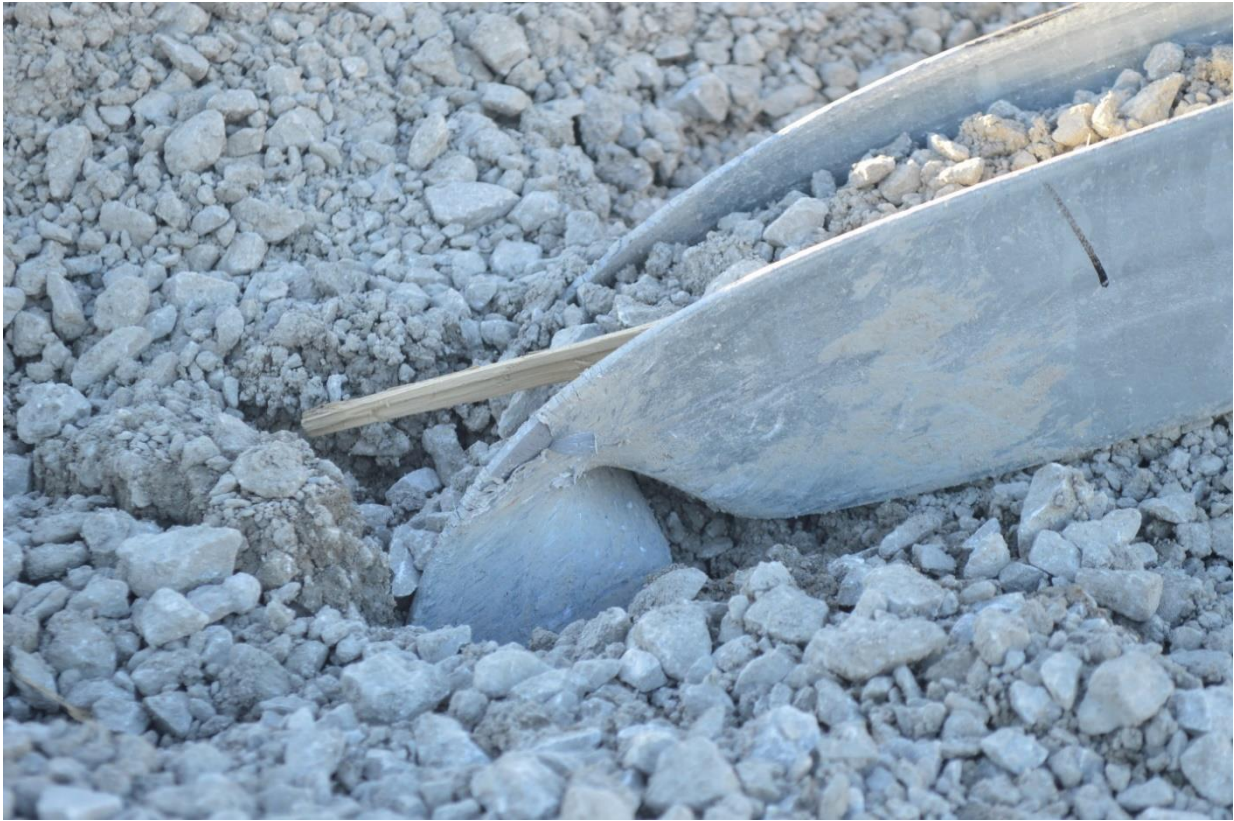
Figure 57. Blockout Damage and Post Buckling, Test No. MGS7S-2

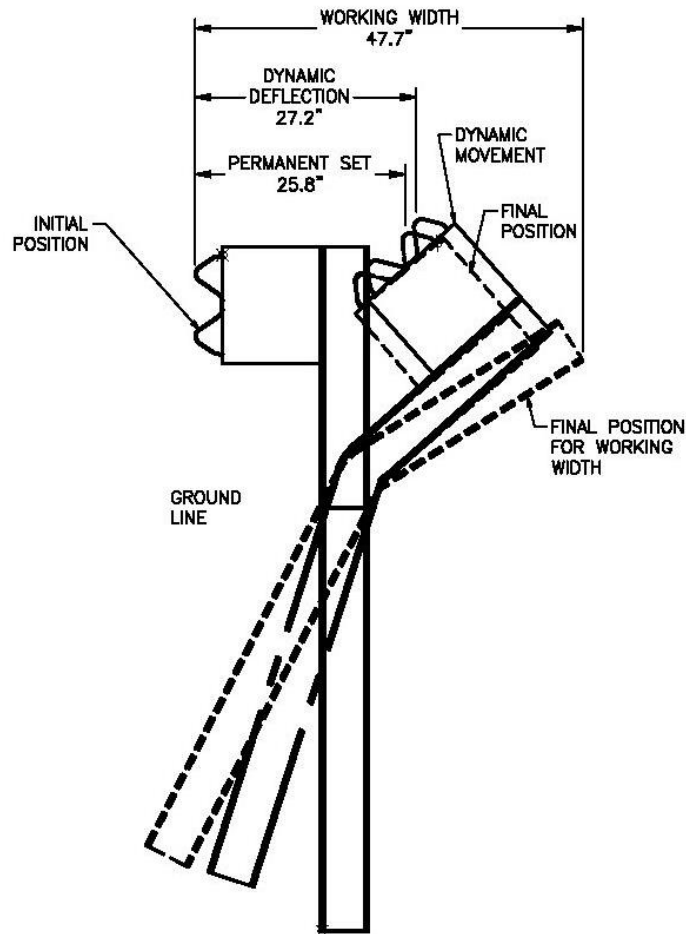
Figure 58. Permanent Set, Dynamic Deflection, and Working Width, Test No. MGS7S-2

The maximum lateral permanent set of the barrier system was 25.8 in. at post no. 19 as measured in the field. The maximum lateral dynamic barrier deflection was found to be 27.2 on the guardrail at post no. 21 as determined from high-speed digital video analysis. The working width of the system was found to be 47.7 in. at post 20, also determined from high-speed digital video analysis. A schematic of the permanent set deflection, dynamic deflection, and working width is shown in Figure 58.

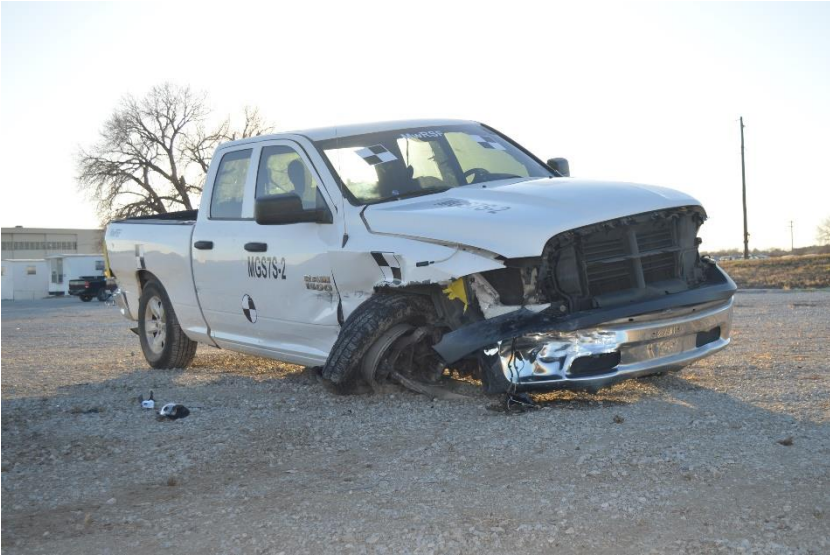
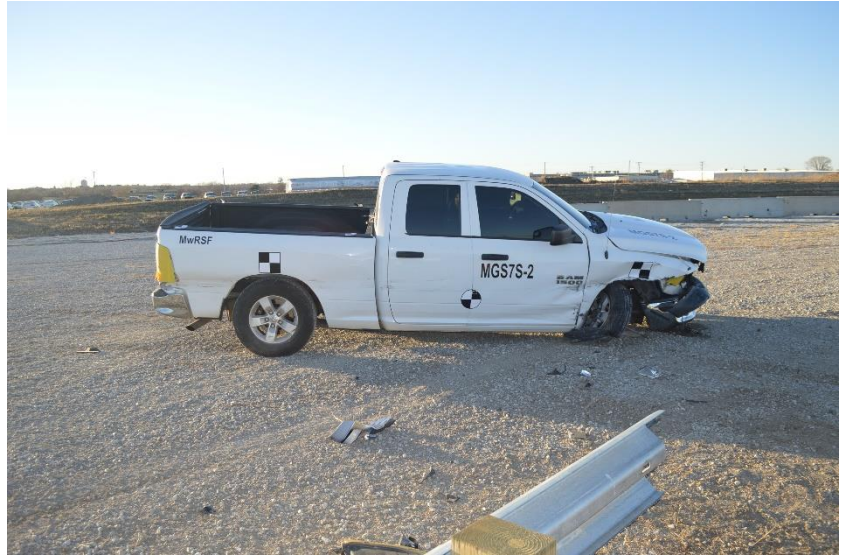
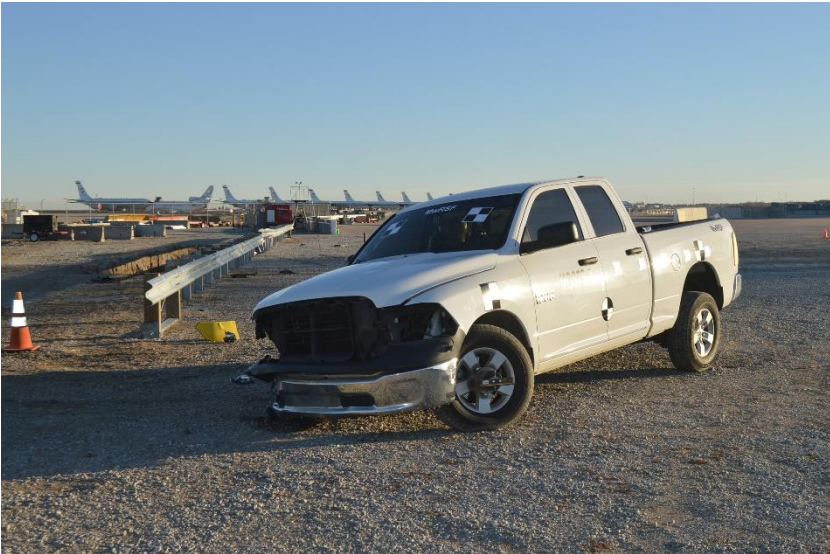
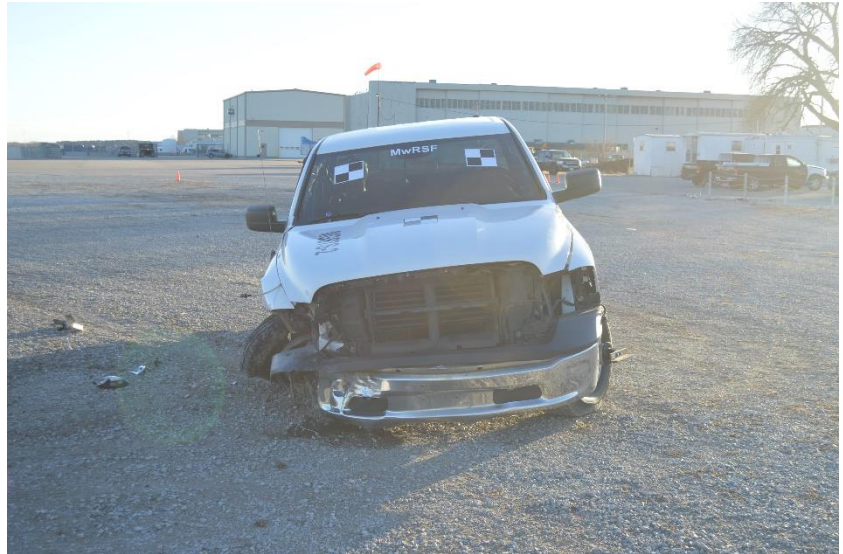
Figure 59. Vehicle Damage, Test No. MGS7S-2

The majority of vehicle damage was concentrated on the right-front corner and right side of the vehicle. Both headlights and the grille were disengaged from the vehicle. The bumper was bent inward and slightly crushed on the right side of the bumper. The right-front fender was dented and scraped along the entire length. The right-front door was scraped and dented along the entire length. Damage to the door was concentrated upon the leading edge and lower half of the panel. The right rear door was slightly dented and scraped located around the vertical center of the panel. The right side of the truck box was dented and scraped along the entire length with the majority of the damage at the back end near the taillight. Damage was also located around the vertical center of the panel. The right end of the rear bumper was dented and scraped.

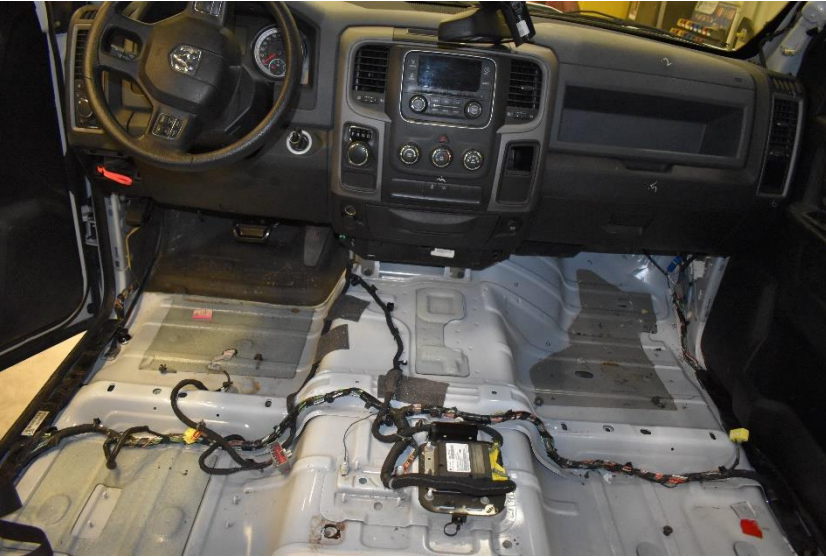
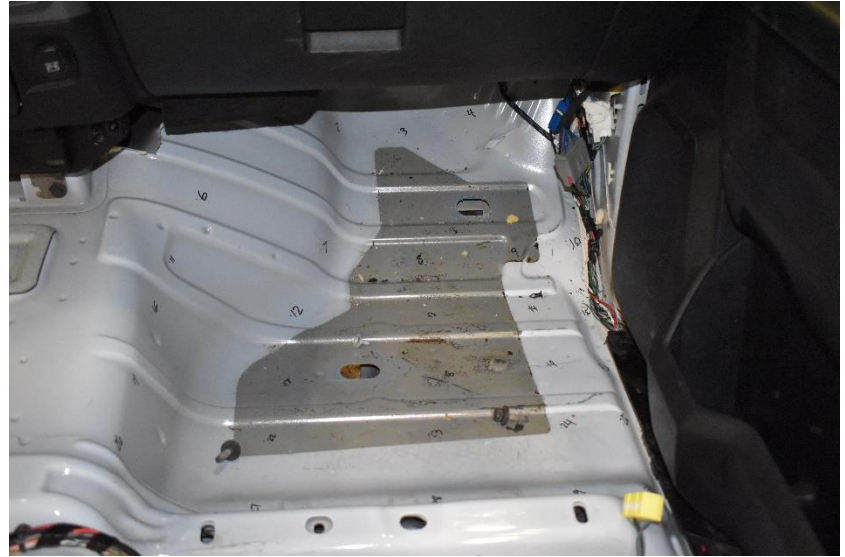
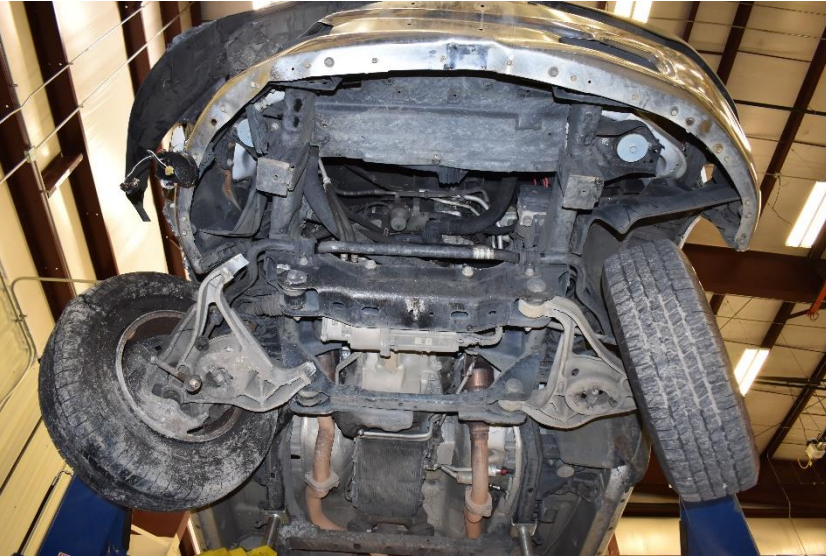
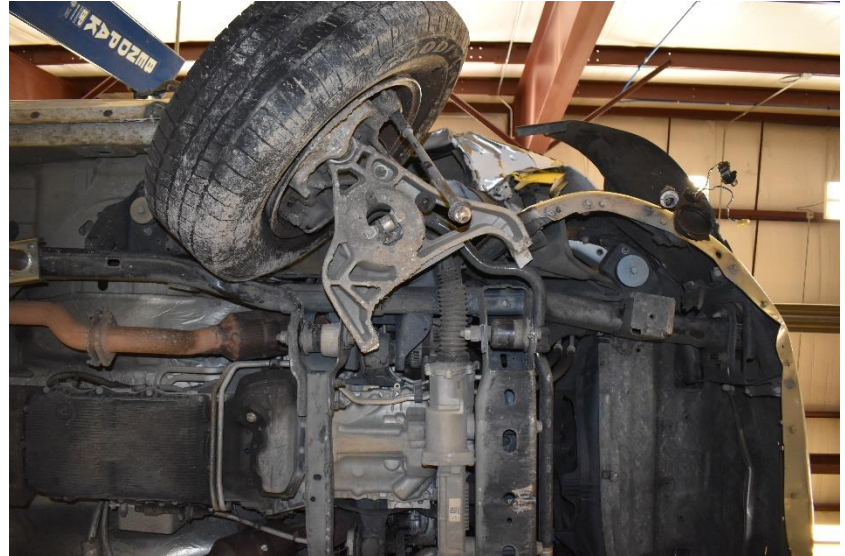
Figure 60. Vehicle Undercarriage and Occupant Compartment Damage, Test No. MGS7S-2

Vehicle undercarriage damage was also concentrated on the right side. The right lower control arm inner joints failed and detached at the control arm. The right-side inner tie rod also detached from the steering rack. The right-side frame horn was bent inward 3 in. The right-side frame rail was slightly bent inward around the second engine cross member. The right-front sway bar end link was bent at the upper mount. The right-front shock dust cover was slightly bent.
