*Hawaii Department of Transportation
Research Project Number 67167*

HAWAII DOT FLARED BURIED-IN-BACKSLOPE GUARDRAIL END TERMINAL PART 2 – REVERSE DIRECTION TESTS

MwRSF Research Report No. TRP-03-496b-25

December 16, 2025

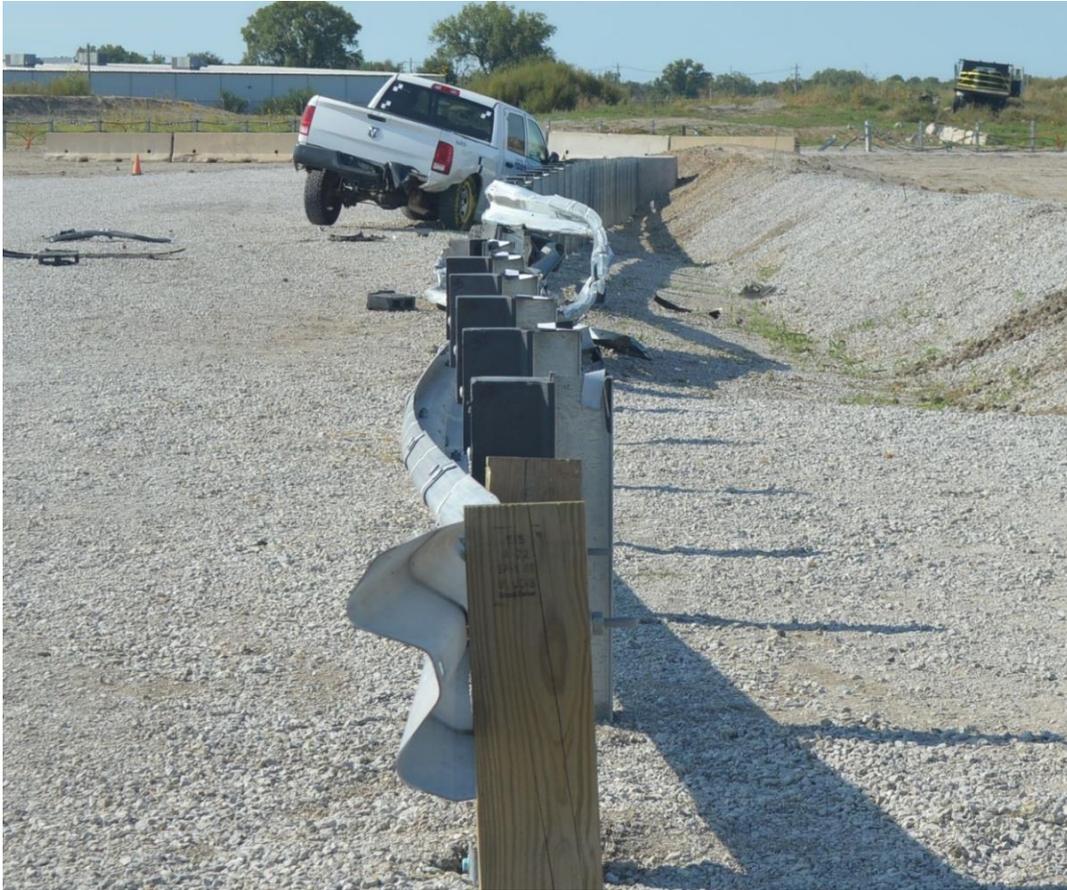
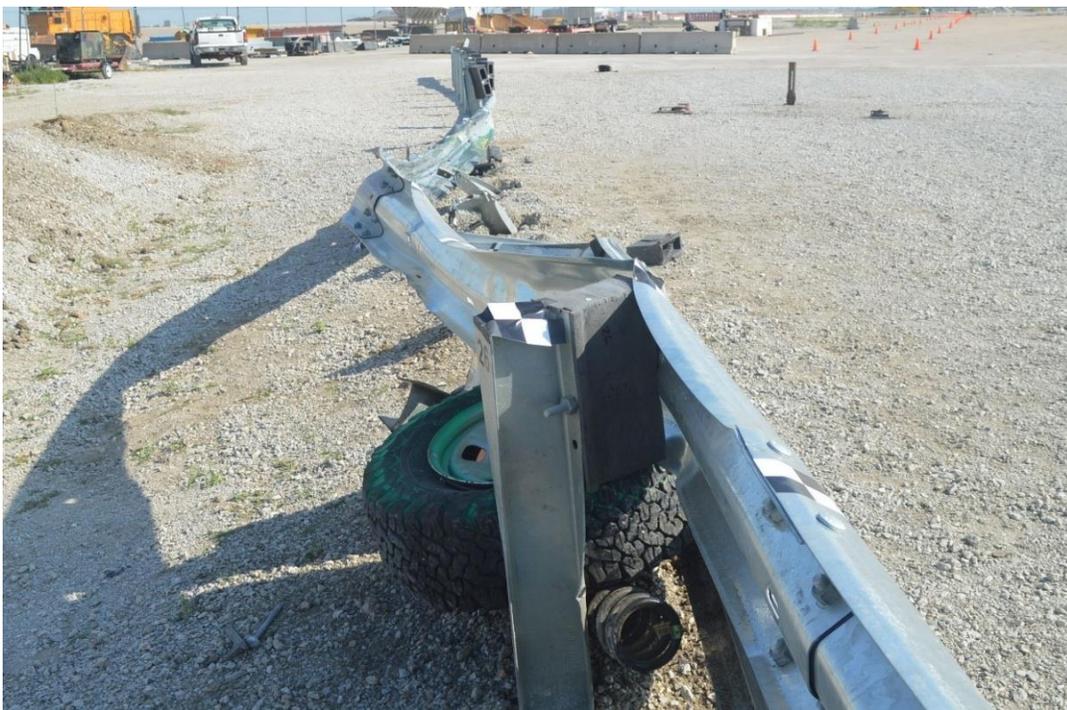
Figure 81. System Damage, Test No. HBIB-6

Several posts showed substantial deformation. Post no. 26 exhibited a kink on the front flange starting 22½ in. from the ground and measuring 1½ in. in both length and width. This post also experienced lower rail pullout, and the blockout disengaged. The front flange of post no. 27 was bent beginning 37 in. from the ground and extending 10 in. Both upper and lower rail pullouts were observed here, with the top blockout disengaged. Additionally, a 4-in. long by 1-in. wide kink was found on the upstream side of the flange of post no. 27 beginning 20 in. from the ground. Post no. 28 had a 4-in. long by 1-in. wide kink on the downstream side of the front flange. Both the upper and lower rails pulled out, and the blockout disengaged. Further deformation was recorded on post no. 29, including flange flattening, upper and lower rail pullouts, bolt hole tearout, and blockout disengagement. The lower bolt of post no. 29 remained intact, but the post was visibly bent. At post no. 30, a kink was observed on the downstream side of the front flange, starting 7½ in. from the ground and extending 8 in. with a width of 1½ in. This post also had upper rail pullout and bottom rail bolt hole tearout, with the top blockout disengaged. Post no. 31 experienced bending in both the front and rear flanges as well as the web, with the blockout disengaged. Post nos. 27 and 28 deflected 15 degrees backward and rotated 30 degrees counterclockwise, while post no. 29 deflected 20 degrees backward with a slight counterclockwise rotation.

The impact resulted in bolt deformation across various posts. At post no. 27, the upper and lower bolts exhibited bending, with the top bolt showing a pronounced bend while the bottom bolt had only minor bending. At post no. 28, the lower bolt fractured, and the upper bolt bent. Additionally, bending of the upper bolts was observed on post nos. 29 through 33. Blockouts at post nos. 32 and 33 rotated downstream, which caused the bolts at these posts to bend in the same direction. Between post nos. 34 and 38, the guardrail elongated and disengaged from the bolts, resulting in rail disengagement.

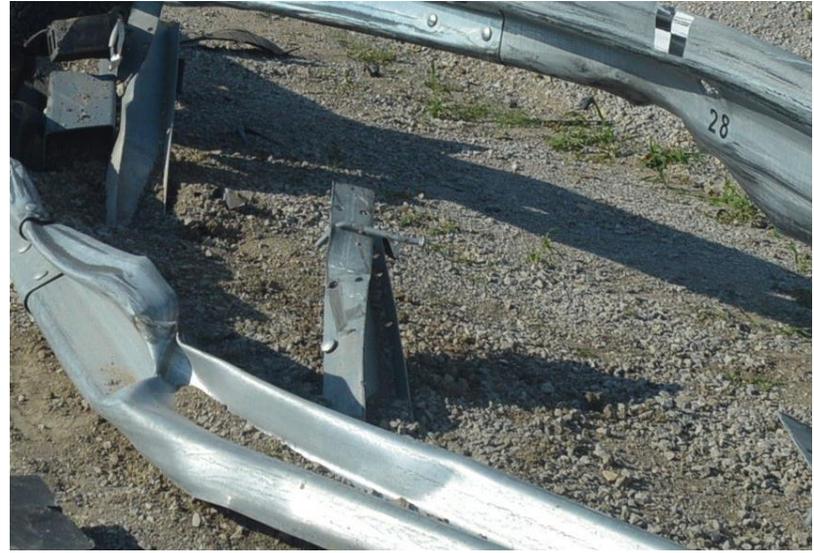
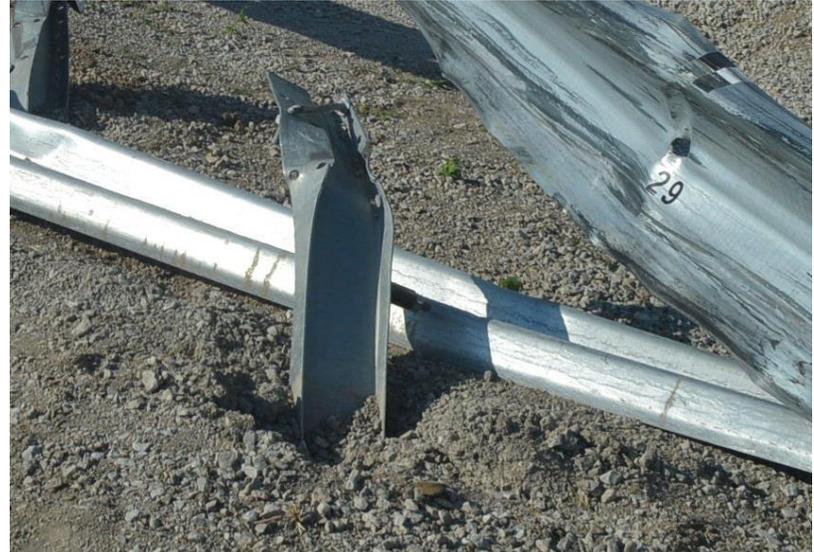
Figure 85. Post Damage, Post Nos. 26 (top left), 27 (bottom left), 28 (top right), and 29 (bottom right), Test No. HBIB-6

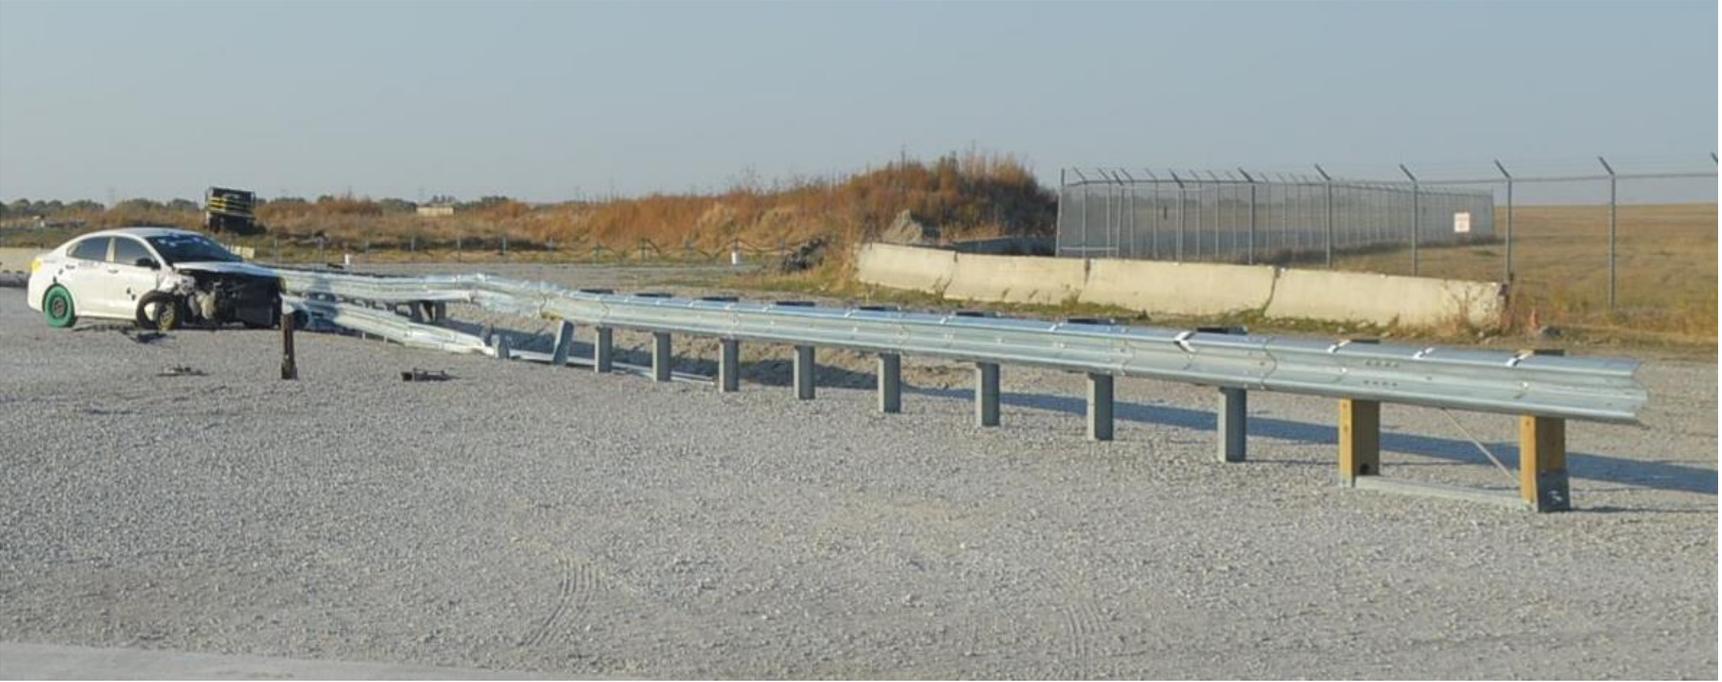
Figure 97. Overall System Damage Test No. HBIB-7

Post no. 27 exhibited a kink on the front flange starting 14½ in. from the ground, measuring 6 in. long and 1 in. wide. This post also experienced a bent flange in the front flange, measuring 21 in. long and ½ in. wide. At post no. 28, a kink on the front flange began 17 in. from the ground, measuring 2 in. long and ½ in. wide. The front flange of post no. 28 had a bend that measured 16 in. long and 1½ in. wide, and the blockout at this post disengaged. Post no. 29 had a 20-in. long and 2-in. wide bend on the front flange, a kink on the front flange starting 10 in. from the ground and measuring 2 in. long by ½ in. wide, a kink on the back flange starting 20 in. from the ground and measuring 5 in. long and ½ in. wide, and a disengaged blockout. The bottom downstream bolt hole on the front flange of post no. 30 was torn. Post no. 30 also exhibited two kinks on the front flange, one starting 20 in. from the ground and measuring 2 in. long and ½ in. wide and another starting 6 in. from the ground and measuring 3 in. long and ½ in. wide, and the blockout was disengaged. The bottom rail pulled out from the bolts on posts no. 25 through 29. The top rail pulled out from the bolts on posts no. 27 through 30, and the bolts on posts no. 27 through 30 were bent.

Several posts showed substantial deformation. The top of post no. 27 deflected 9 in. backward and 28 in. downstream, and the post rotated 40 degrees clockwise. Post no. 28 deflected 17 in. backward and 35 in. downstream with a 70-degree clockwise rotation. Post no. 29 deflected 6 in. backward and 39 in. downstream with an 80-degree clockwise rotation and bent 39 in. from the top of the post. Post no. 30 deflected 5 in. backward and 13 in. downstream and rotated 30 degrees clockwise.

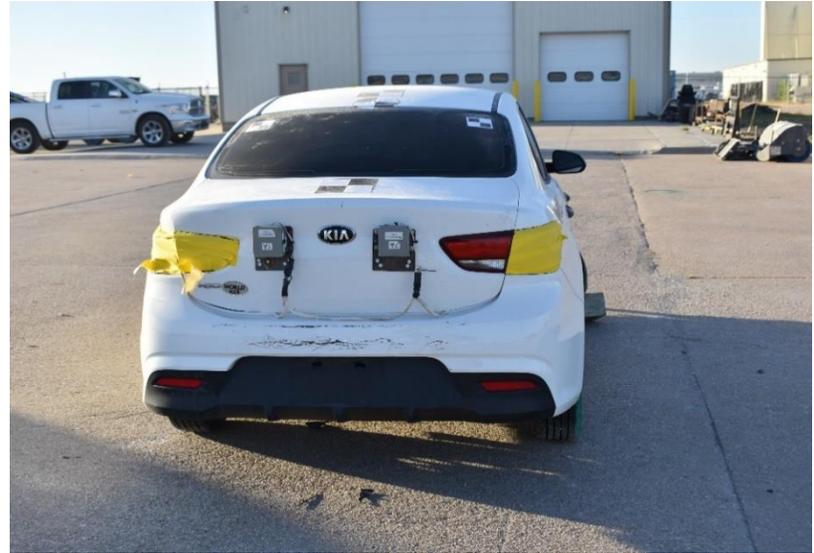
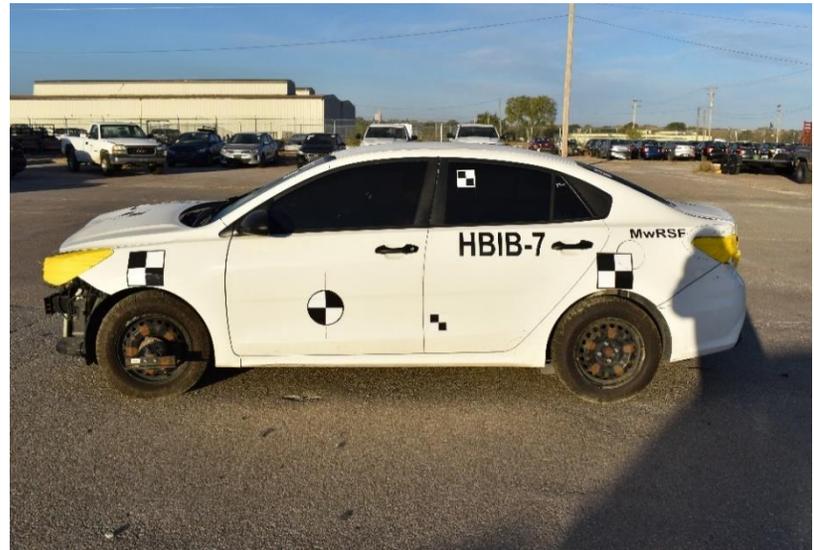
Figure 102. Vehicle Damage, Test No. HBIB-7

The undercarriage and suspension components were also affected. The right front strut was bent at both the lower mount and at the upper spring location. The front sway bar shifted toward the right side of the vehicle, with the right end of the sway bar—near its connection to the tie-rod end link—bent inward toward the motor. The right-front lower control arm was bent downward in the center and bent upward from its attachment point on the front subframe, forming a peak at the midpoint. The arm was torn from the front pivot. The left-front side lower control arm was tilted upward slightly from its attachment points on the front subframe. The right inner tie rod was bent slightly.

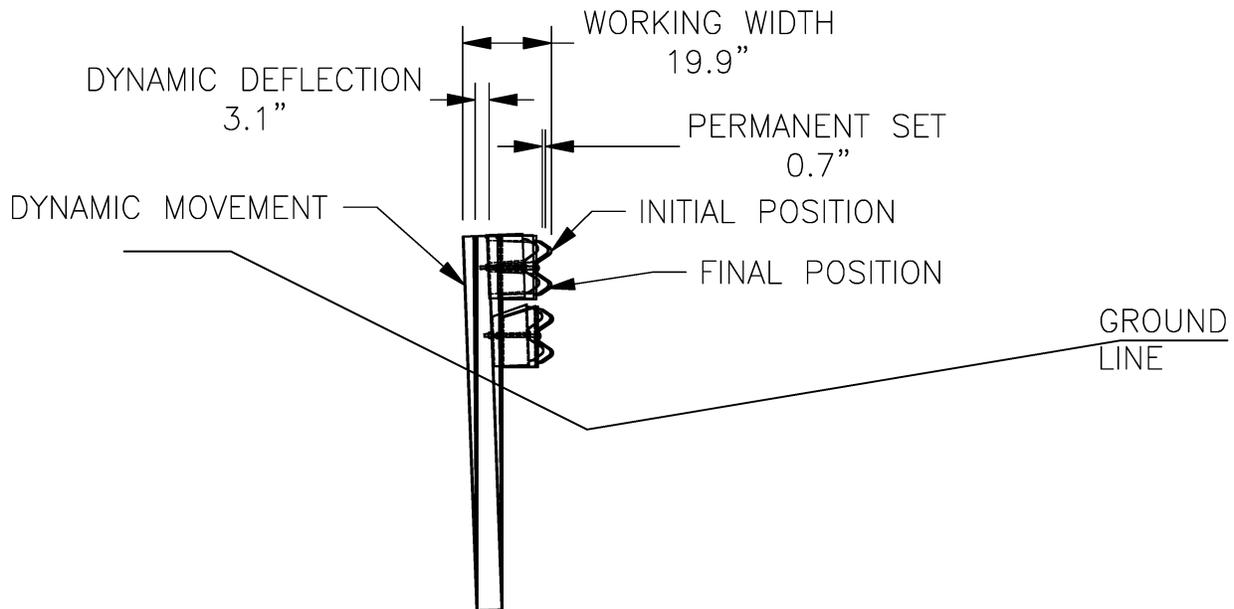
Figure 112. Permanent Set, Dynamic Deflection, and Working Width, Test No. HBIB-8

The maximum lateral permanent set of the barrier system was 0.7 in. at post no. 2, as measured in the field. The maximum lateral dynamic deflection of the rail was 2.9 in. at the rail at post no. 2. The maximum lateral dynamic deflection of the post was 3.1 in. at post no. 2. The maximum lateral dynamic deflection of the anchorage was 2.8 in. at the upstream concrete anchor, as determined from high-speed digital video analysis. The working width of the system was found to be 20.3 in. at post no. 2, also determined from high-speed digital video analysis. A schematic of the permanent set deflection, dynamic deflection, and working width is shown in Figure 112.

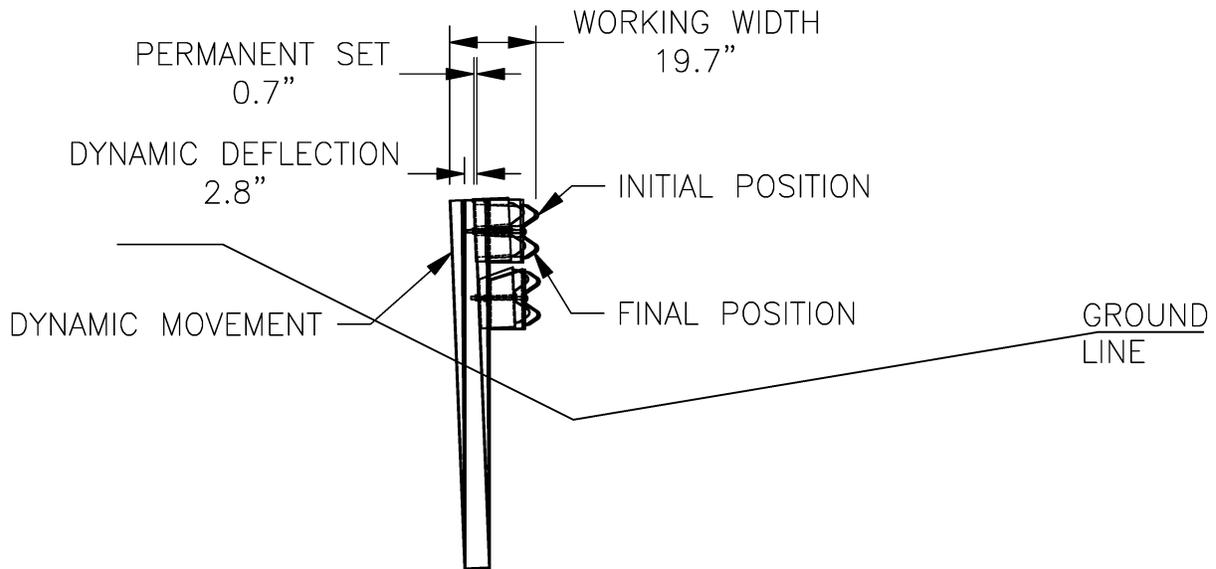
Figure 127. Permanent Set, Dynamic Deflection, and Working Width, Test No. HBIB-10

The maximum lateral permanent set of the barrier system was 0.7 in. at post no. 11, as measured in the field. The maximum lateral dynamic deflection of the rail was 2.6 in. at post no. 1, as determined from high-speed digital video analysis. The maximum lateral dynamic deflection of the post was 2.8 in. at post no. 2, as determined from high-speed digital video analysis. The working width of the system was found to be 19.7 in., also determined from high-speed digital video analysis. A schematic of the permanent set deflection, dynamic deflection, and working width is shown in Figure 127.

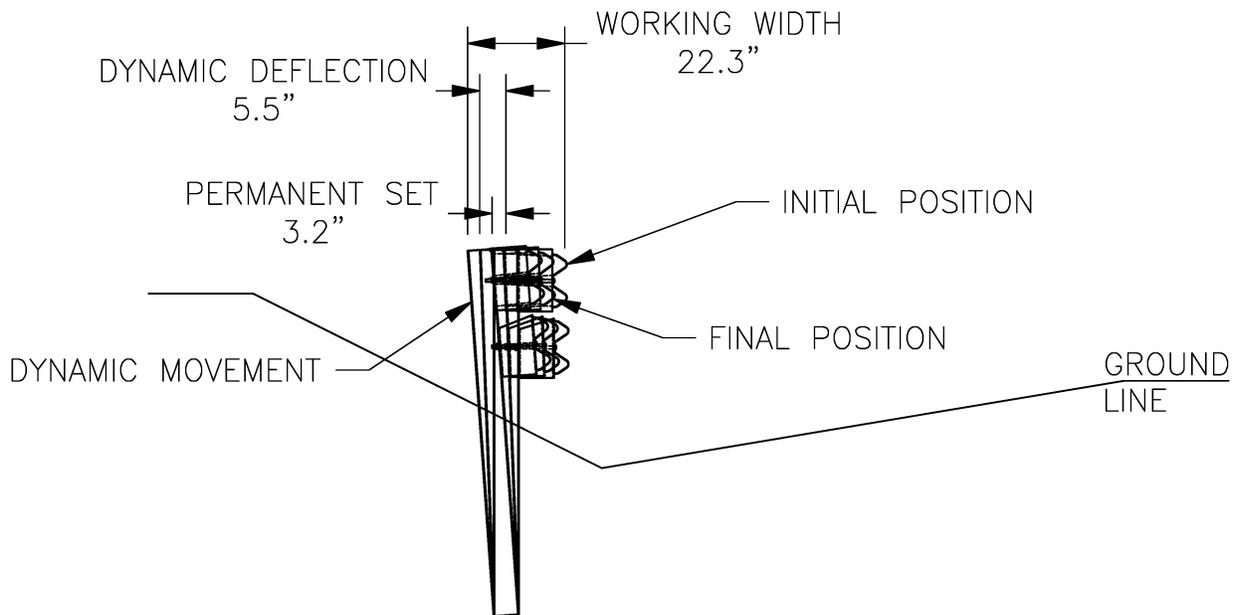
Figure 179. Permanent Set, Dynamic Deflection, and Working Width, Test No. HBIB-9

The maximum lateral permanent set of the barrier system was 3.2 at post no. 2, as measured in the field. The maximum lateral dynamic deflection of the rail was 5.5 in. at the rail at post no. 3, as determined from high-speed digital video analysis. The maximum lateral dynamic deflection of the post was 4.5 in. at post no. 2, as determined from high-speed digital video analysis. The working width of the system was found to be 22.3 in., also determined from high-speed digital video analysis. A schematic of the permanent set deflection, dynamic deflection, and working width is shown in Figure 179.
