*Hawaii Department of Transportation
Research Contract No. 69876
Research Project No. STP-1500(115) – Phase III*

EVALUATION OF THE HAWAII MODIFIED NATCHEZ TRACE BRIDGE RAIL: MASH TEST DESIGNATION NO. 3-11

MwRSF Research Report No. TRP-03-478a-25

May 16, 2025

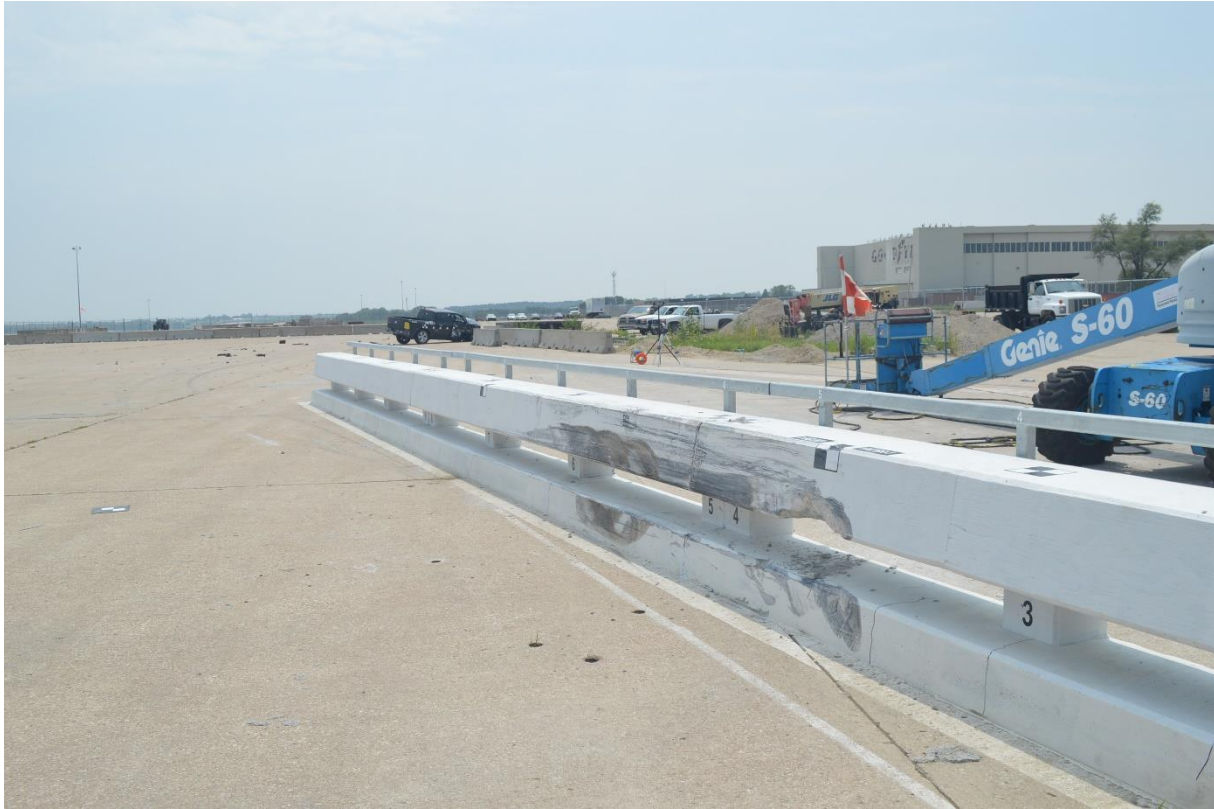
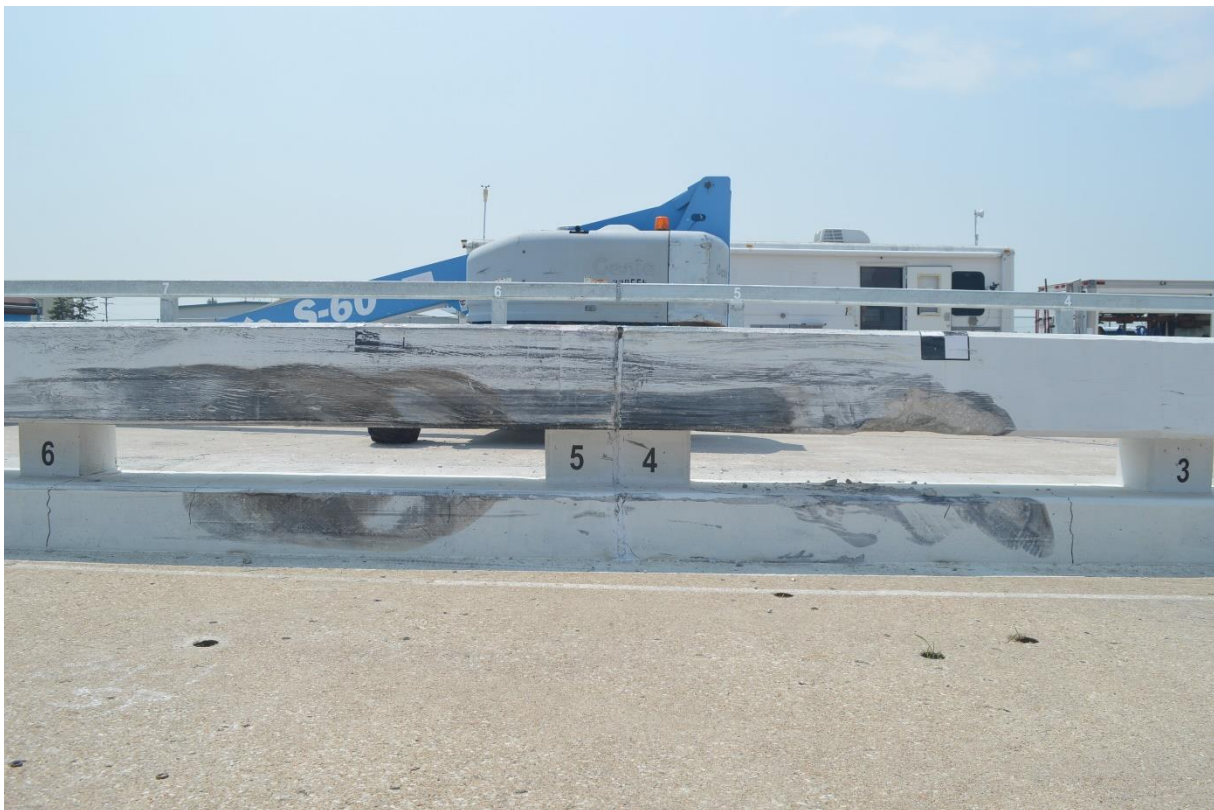
Figure 27. System Damage, Test No. HNTBR-1

Damage to the barrier was minimal, as shown in Figures 27 through 29. Barrier damage consisted of concrete spalling, contact marks on the front face of the concrete segments, and concrete cracking. The length of vehicle contact along the upper rail was 19 ft – 8 in., beginning approximately 11 in. upstream from the impact point and continuing downstream. The length of vehicle contact along the lower curb was 20 ft – 10 in., beginning 18 in. upstream from the impact point and continuing downstream.

Concrete spalling and cracking occurred during the impact event, including a 23-in. long by 8-in. wide spall located along the bottom edge of the upper concrete rail. Another significant spalled section was located on the top edge of the curb below the spalled section on the upper rail. Several other small gouges and cracks were observed on curb and upper railing around these spalled sections near initial impact. The curb was cracked on the top face adjacent to post no. 4, and a crack was found along the base of post no. 4.

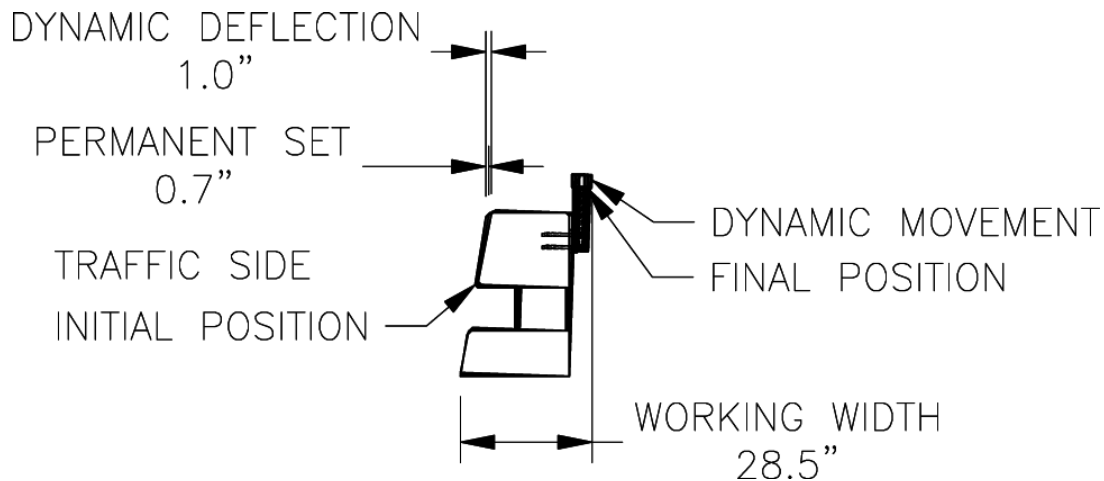
Figure 30. Permanent Set, Dynamic Deflection, and Working Width, Test No. HNTBR-1

The maximum lateral dynamic barrier deflection was 1.0 in. at railing post no. 4, which was just upstream from the impacted expansion joint, as determined from high-speed digital video analysis. The maximum lateral permanent set of the barrier system was 0.7 in. measured at the handrail just downstream from the expansion joint, as measured in the field. The working width of the system was found to be 28.5 in., also determined from high-speed digital video analysis. A schematic of the permanent set deflection, dynamic deflection, and working width is shown in Figure 30.

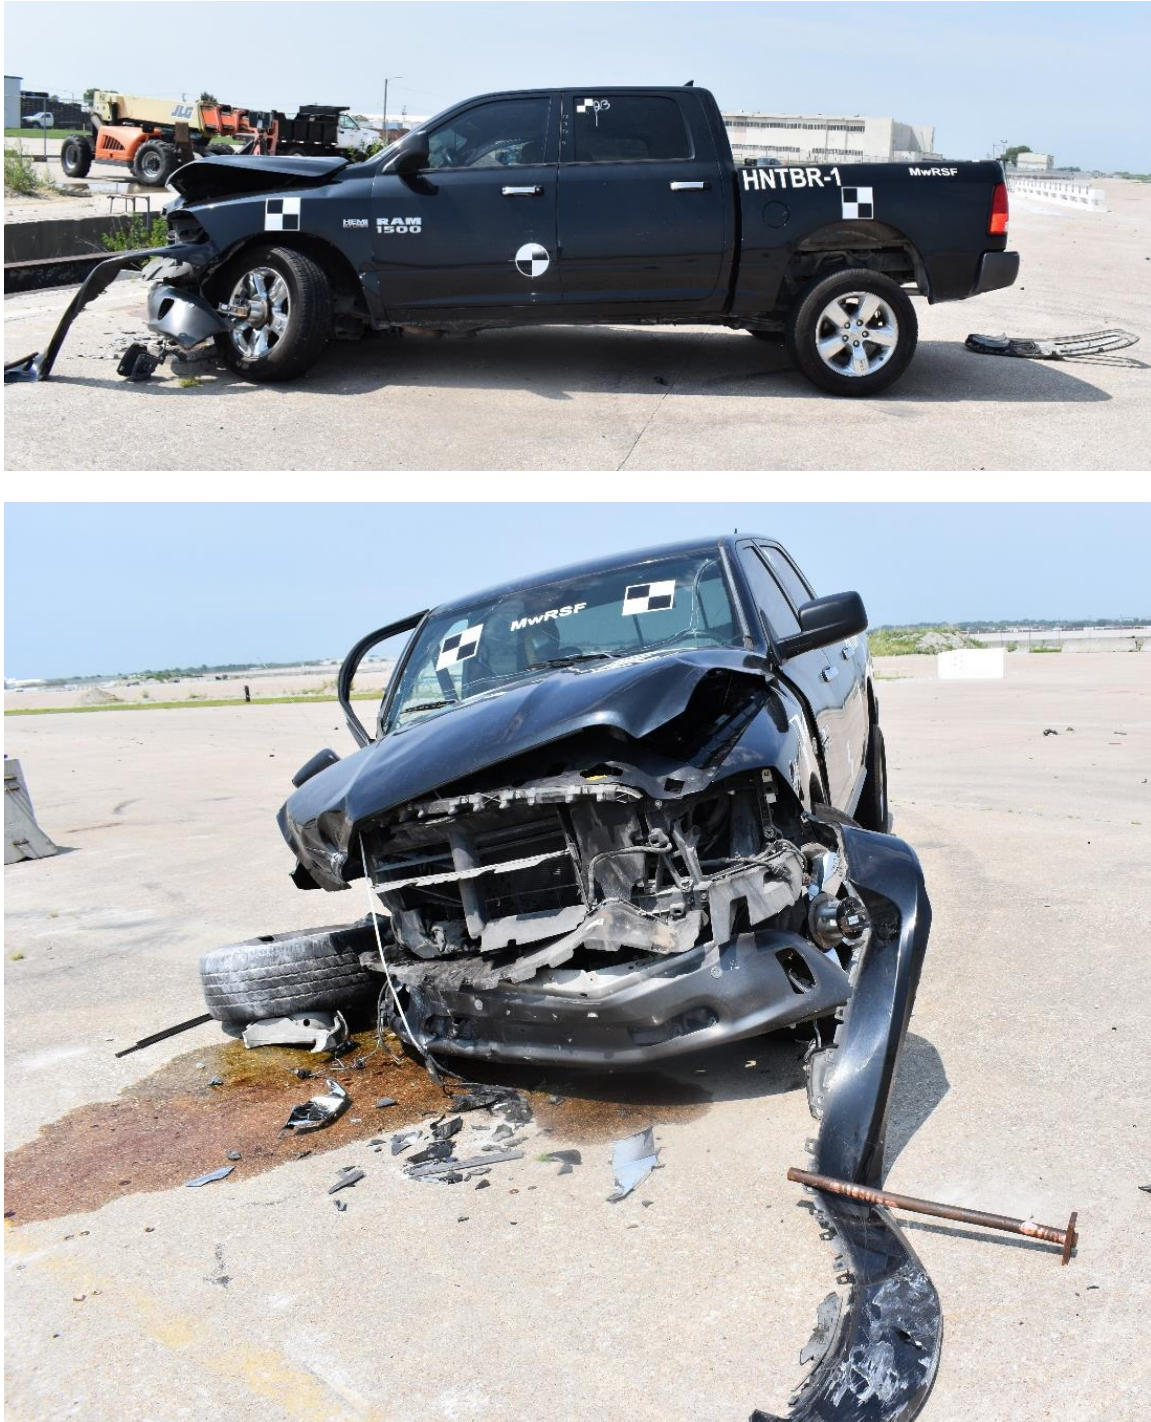
Figure 31. Vehicle Damage, Test No. HNTBR-1

Damage to the vehicle was severe, as shown in Figures 31 through 34. The impact side of the vehicle, or the passenger's side, is referred to as the vehicle's right side. The non-impact side, or driver's side, is referred to as the vehicle's left side. Majority of the damage was concentrated on the right-front corner and right side of the vehicle where the impact occurred. The right side of the front bumper was dented and scraped, and the left side of the front bumper was bent. The headlights and grille were disengaged from the vehicle. The right side of the hood was dented and scraped. Scrapes and dents were observed throughout the right-side of the vehicle. The right fender and right-front door were crushed inward. The windshield was cracked, concentrated on the right side, and the right-front side window was shattered and disengaged.

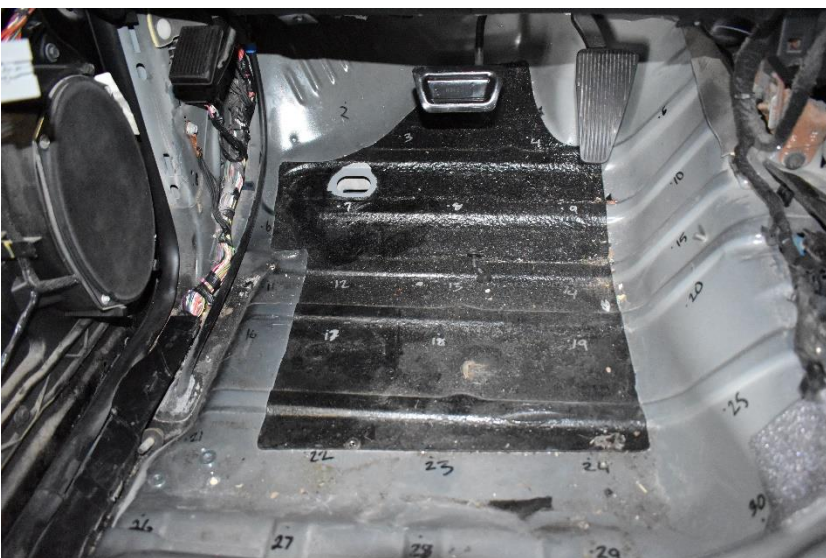
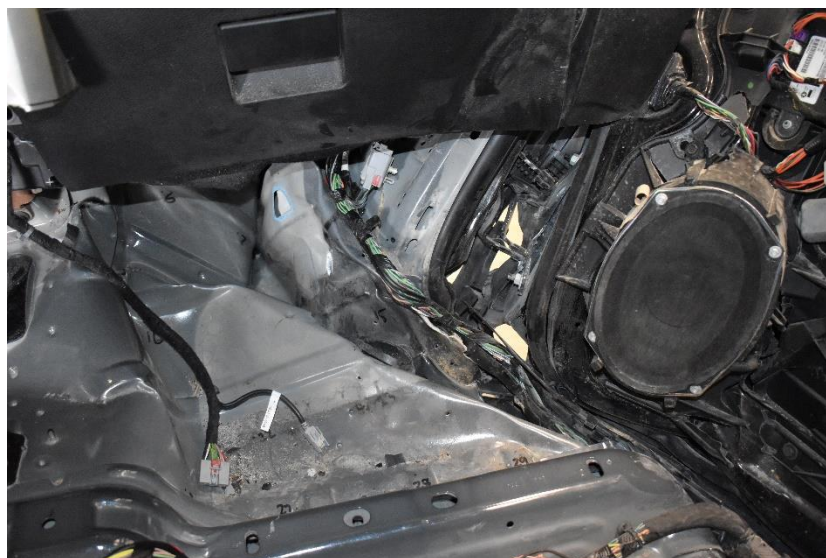
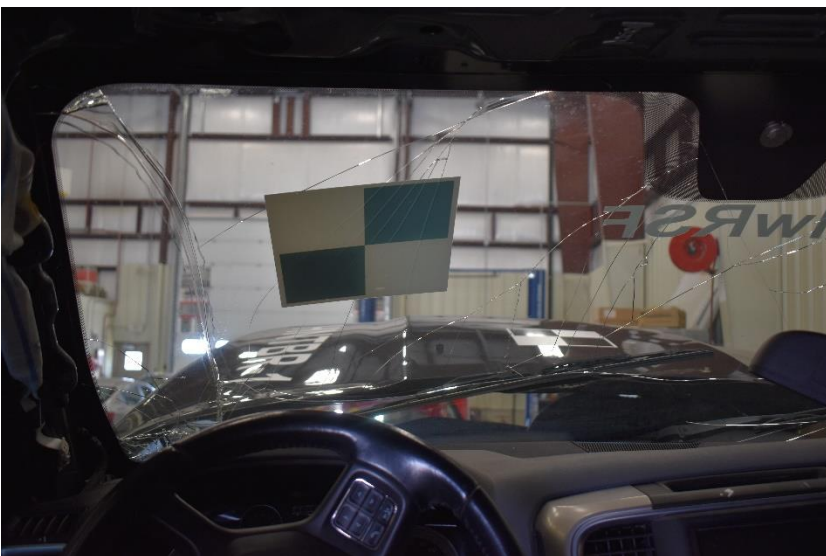
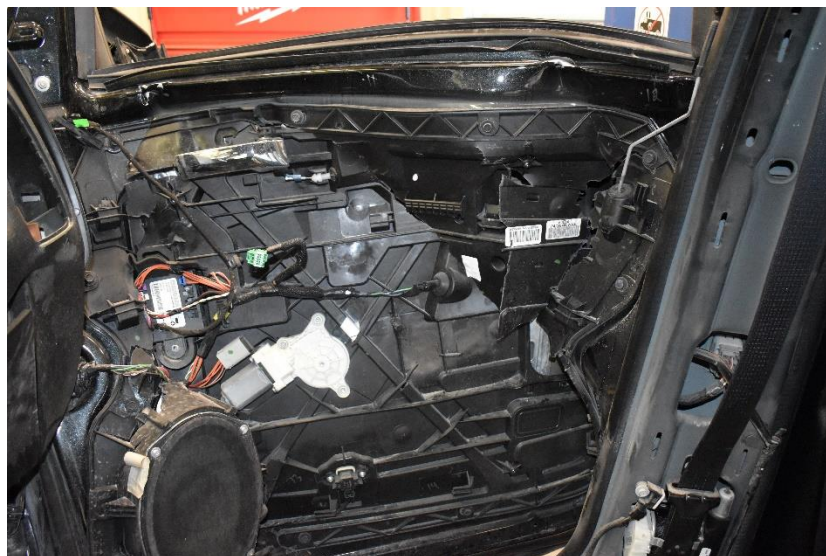
Figure 33. Vehicle's Interior Compartment Damage, Test No. HNTBR-1

Appendix D. MASH defines intrusion or deformation as the occupant compartment being deformed and reduced in size with no observed penetration. The vehicle's toe pan was deformed 12.7 in., which exceeded the 9-in. MASH intrusion limit. Outward deformations, which are denoted as negative numbers in Appendix D, are not considered crush toward the occupant, and are not evaluated by MASH criteria.
