Hawaii Department of Transportation Research Contract No. 69876 Research Project No. STP-1500(115) – Phase III

DEVELOPMENT AND CRASH TESTING OF THE HAWAII CONCRETE POST AND BEAM BRIDGE RAIL

MwRSF Research Report No. TRP-03-478b-25-R1

September 25, 2025

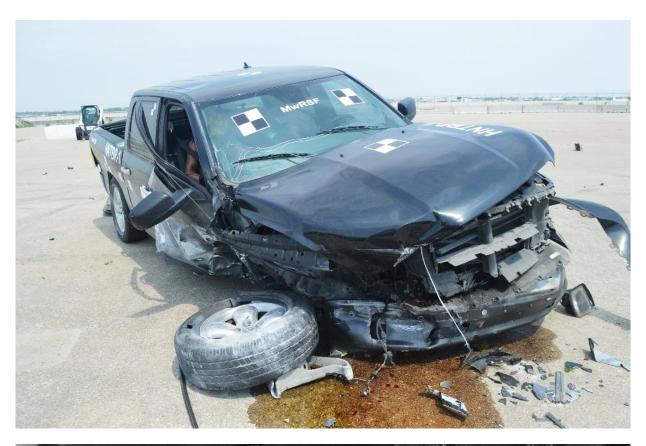
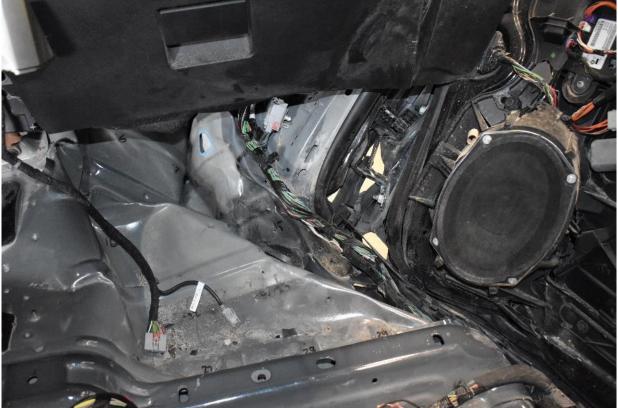
Figure 5. Vehicle Damage and Excessive Wheel and Toe Pan Intrusion – Test No. HNTBR-1

Upon the failure of test no. HNTBR-1, an investigation into the potential causes of the excessive toe pan deformations was conducted. Vehicle deformations were caused by the impact-side wheel snagging on the bridge railing and being shoved back toward the occupant compartment as the vehicle traveled downstream. Through a review and comparison of the previous crash tests on the original Natchez Trace Bridge Railing and the Hawaii Modified Natchez Trace Bridge Rail [2, 4, and 6], three factors were identified as contributors to the MASH test failure: (1) increased impact severity of the MASH test compared to the previous crash testing standards, (2) the limited curb-to-rail offset of the Hawaii Modified Natchez Trace Bridge Rail, and (3) the angled bottom edge of the upper railing.

The mass of the MASH pickup truck is significantly greater than the mass of the pickup truck specified in NCHRP Report 350. Even though the speed and impact angle for the TL-3 pickup tests were the same, the increased mass resulted in a 14 percent increase in targeted impact severity. This increase in impact severity likely contributed to increased loading during redirection and increased damage to the vehicle. Unfortunately, the MASH impact conditions were not something that could be changed, so the increased impact severity would have to be accounted for in the redesign process.

The shape of the upper rail also contributed to this snag. Most open concrete bridge rails have a rectangular shaped upper rail, whereas the Hawaii Modified Natchez Trace Bridge Rail had an angled lower edge that was more susceptible to gouging and snag, as highlighted in Figure 6. Thus, the severity of the rim snag described above was increased by the angled lower edge of the railing.

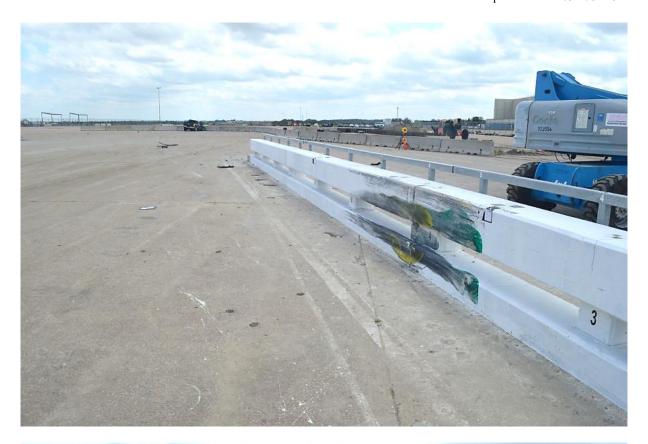
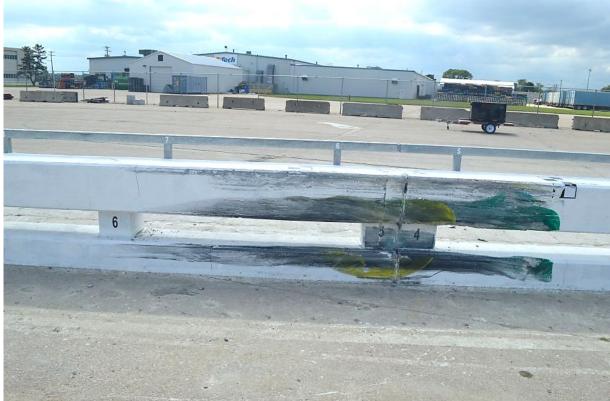
Figure 41. System Damage, Test No. HNTBR-2

Damage to the barrier was minimal, as shown in Figures 41 through 43. Barrier damage consisted of concrete spalling, gouging, and contact marks on the front face of the concrete segments. The length of vehicle contact along the concrete rail was $12 \text{ ft} - 7\frac{1}{4}$ in., beginning approximately 44 in. downstream from post no. 3. Contact marks were observed on the face of the barrier throughout the contact region. A 41-in. long and $1\frac{1}{2}$ -in. wide gouge was observed on the lower edge of the upper rail beginning 23 in. upstream from the centerline of post no. 4. Several other smaller gouges were located on the front faces of the top rail within the contact region. Concrete spalling was also observed on the edge of the curb adjacent to the expansion joint. The pedestrian handrail was undamaged as it was only contacted by disengaged vehicle components.

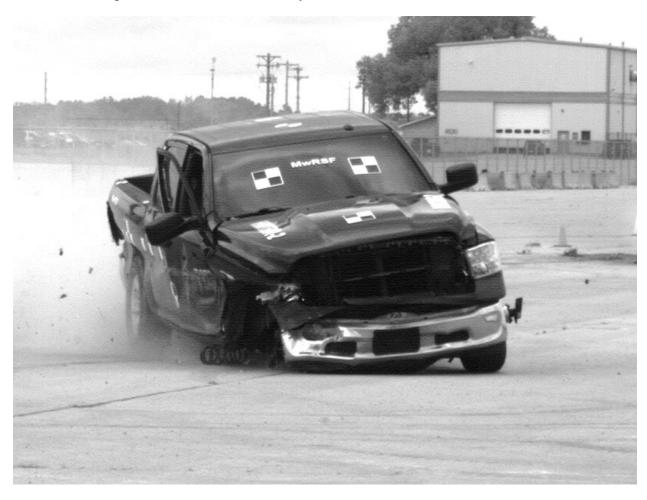
Figure 45. Vehicle Damage before Secondary Impact, Test No. HNTBR-2

The damage to the vehicle was severe, as shown in Figures 45 through 49. Note that there was a secondary impact with a row of containment barriers downstream from the test article which contributed to the damage on the front of the vehicle. Vehicle damage prior to the secondary impact is shown in Figure 45. The impact side of the vehicle, or the passenger's side, is referred to as the vehicle's right side throughout this report. The non-impact side, or driver's side, is referred to as the vehicle's left side. The majority of the damage was concentrated on the right-front corner and right side of the vehicle where the impact occurred. The right side of the front bumper was bent rearward and scraped. The right-front headlight and grille were disengaged from the vehicle. Scrapes and dents were observed throughout the right-side of the vehicle including the fender, doors, rear quarter panel, and rear bumper. Cracks were observed on the right side of the windshield, and the right-front side window was disengaged from the vehicle due to a combination of door flexure and contact with the dummy. Note, neither the side window nor the dummy contacted the bridge railing.

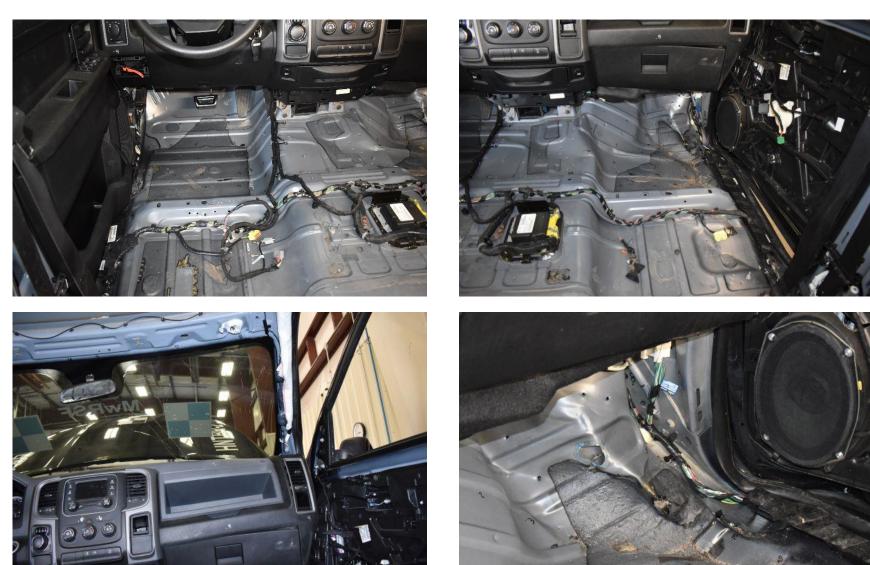
Figure 48. Vehicle's Floor Pan and Interior Compartment Damage, Test No. HNTBR-2

The maximum occupant compartment intrusions are listed in Table 5, along with the intrusion limits established in MASH for various areas of the occupant compartment. The maximum intrusion was 4.4 in. to the side front panel, which was within the 12 in. MASH limit.

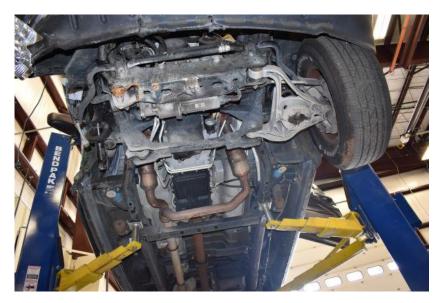
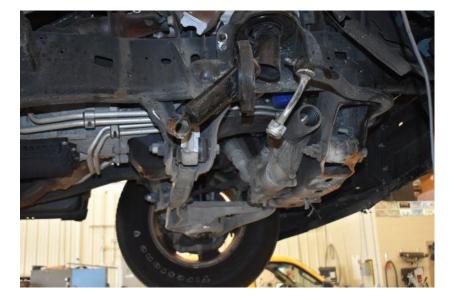
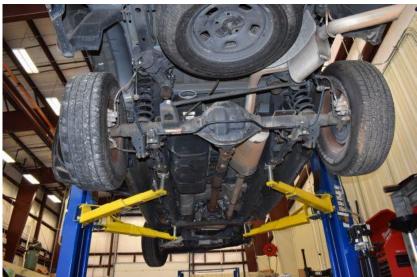
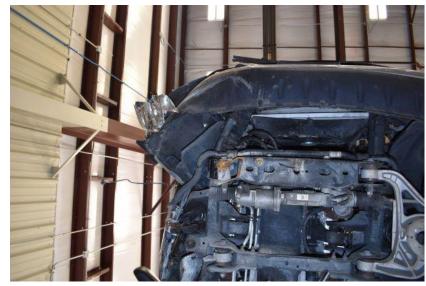
Figure 49. Vehicle's Undercarriage Damage, Test No. HNTBR-2

On the undercarriage, the right-front side spring was disengaged and the right-front shocks were bent rearward. The left-side end link was bent rearward, and the left steering knuckle was disengaged. The right lower control arm disengaged from the vehicle, and the right upper control arm was bent backward. The right tie rod disengaged and the steering rack case was fractured. The right end of the front engine cross member was scraped and twisted slightly, and the rear cross member was bent and slightly scraped. The right frame horn was bent and twisted inward, and the left frame horn was bent outward. The right-front wheel detached from the vehicle and the right rear wheel was scraped.

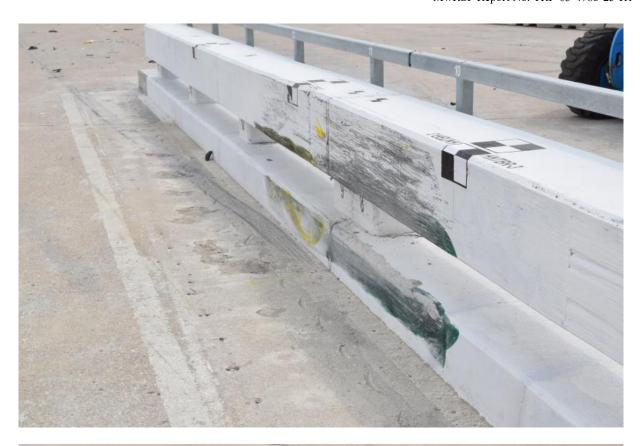
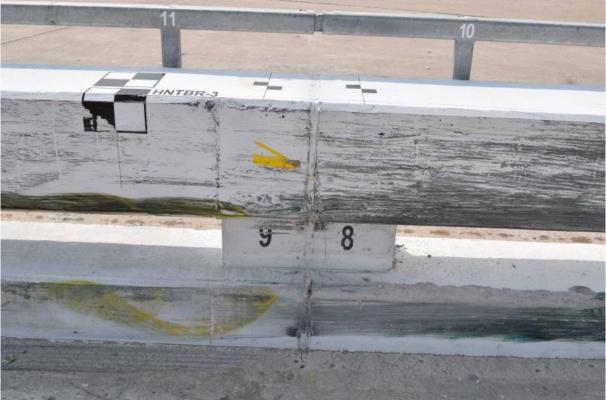
Figure 56. System Damage, Test No. HNTBR-3

Damage to the barrier was minimal, as shown in Figures 56 through 58. The length of vehicle contact along the concrete rail was 10 ft, beginning 51 in. upstream from expansion joint no. 2. Barrier damage consisted of concrete spalling and contact marks on the upper rail and lower curb of the concrete bridge rail. Concrete spalling on the top edge of the curb began near impact and continued downstream for 50 in. (to the expansion joint.). Various contact marks, minor gouges, and hairline cracks were found on the front face of both the upper rail and the lower curb throughout the contact region. Contact marks were also observed on the face of post nos. 8 and 9, which were adjacent to the expansion joint.

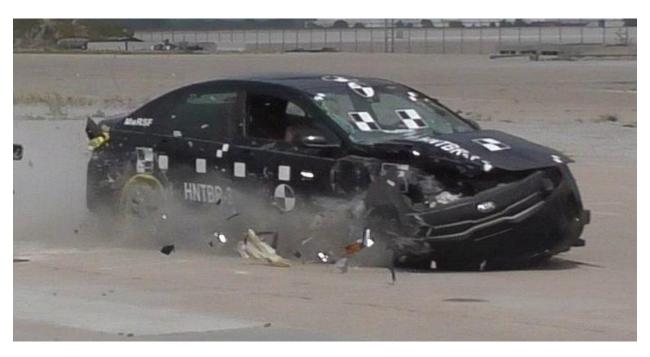
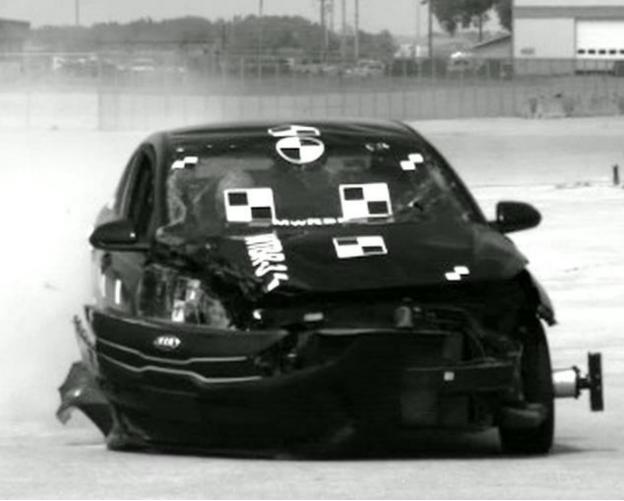
Figure 60. Vehicle Damage before Secondary Impact, Test No. HNTBR-3

The damage to the vehicle was severe, as shown in Figures 60 through 63. Note that there was a secondary impact with a row of containment barriers downstream from the test article. Vehicle damage prior to the secondary impact is shown Figure 60. The impact side of the vehicle, or the passenger's side, is referred to as the vehicle's right side throughout this report. The nonimpact side, or driver's side, is referred to as the vehicle's left side. The majority of the damage was concentrated on the right-front corner and right side of the vehicle where the impact had occurred. The front bumper cover detached, and the front bumper was pushed back into the radiator. Both front headlights were disengaged from the vehicle, and the hood was deformed. The front fender was dented and crushed. The base of the A-pillar was deformed and crushed inward. The right-front door's leading edge was dented and scraped, and the right-front window was detached from the vehicle. The right-rear door was dented along its length, and the right quarter panel was dented inward. The entire right side of the vehicle was scraped from the front fender to the rear bumper. The front half of the roof was kinked and buckled.

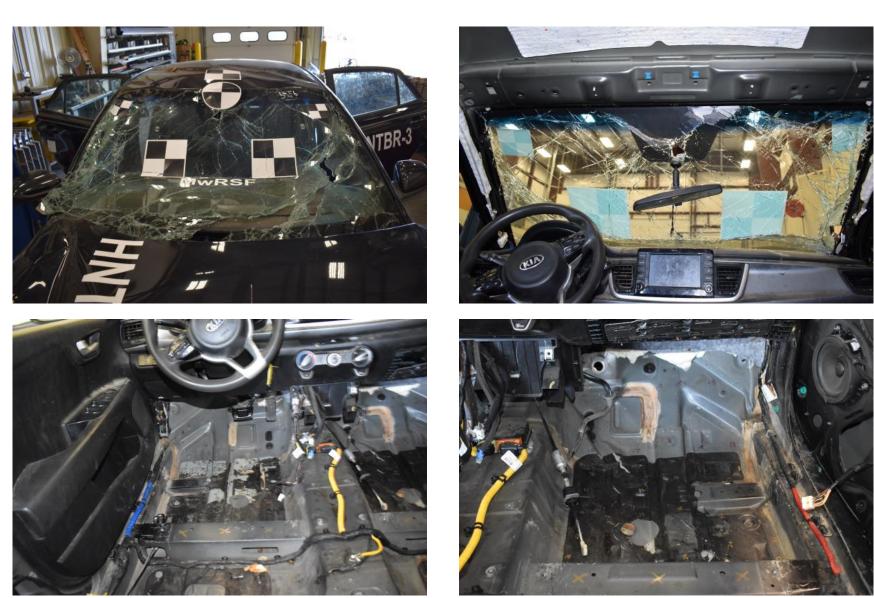
Figure 62. Vehicle's Interior Compartment Damage, Test No. HNTBR-3

The windshield shattered and tore, with a maximum deformation of 4.2 in. However, this damage was caused by loading and deformations at the base of the A-pillar rather than direct contact between the bridge rail and windshield. Furthermore, a secondary impact with a row of containment barriers downstream of the test article contributed to additional damage and deformations to the windshield. Thus, the windshield damage was not in violation of MASH safety criteria. Note, similar 1100C windshield and front window damage has been observed in previous evaluations of MASH-crashworthy concrete barriers [13, 14].

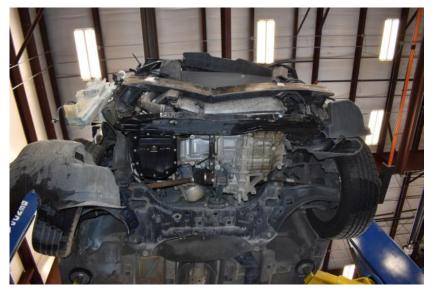
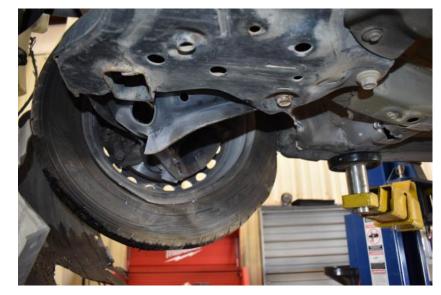
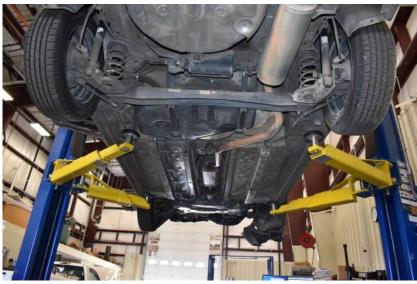
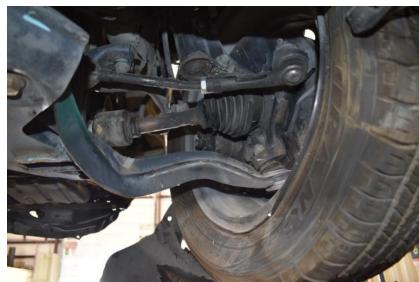
Figure 63. Vehicle's Undercarriage Damage, Test No. HNTBR-3

was cracked. The bumper bracket at the frame horn was crushed rearward, with the frame horn crushed rearward on both sides. There was also minor buckling of the right-side floor pan.
